**Behavior of a Damaged Prestressed Concrete Bridge  
Repaired with Fiber-Reinforced Polymer Reinforcement**

A thesis submitted to the Graduate Faculty of  
Auburn University  
in partial fulfillment of the  
requirements for the Degree of  
Master of Science

Auburn, Alabama  
December 12, 2011

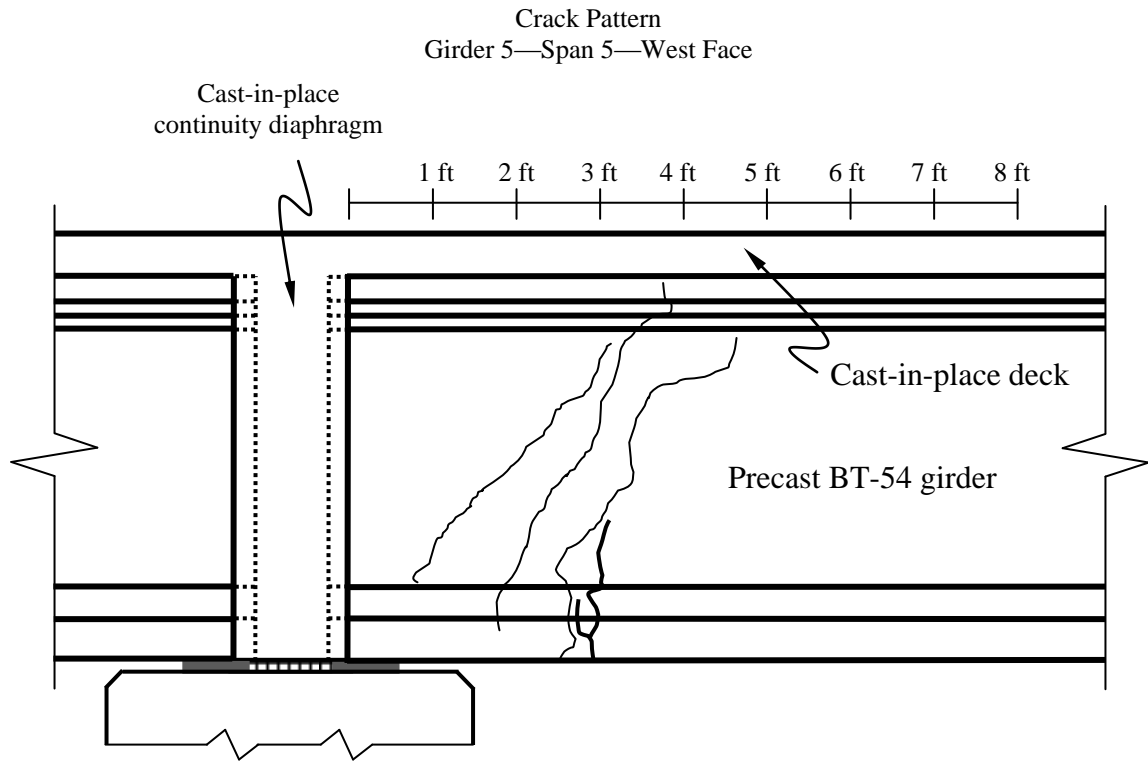
**Figure 2.16:** Cracking pattern in end region of precast girder (Barnes et al. 2006)

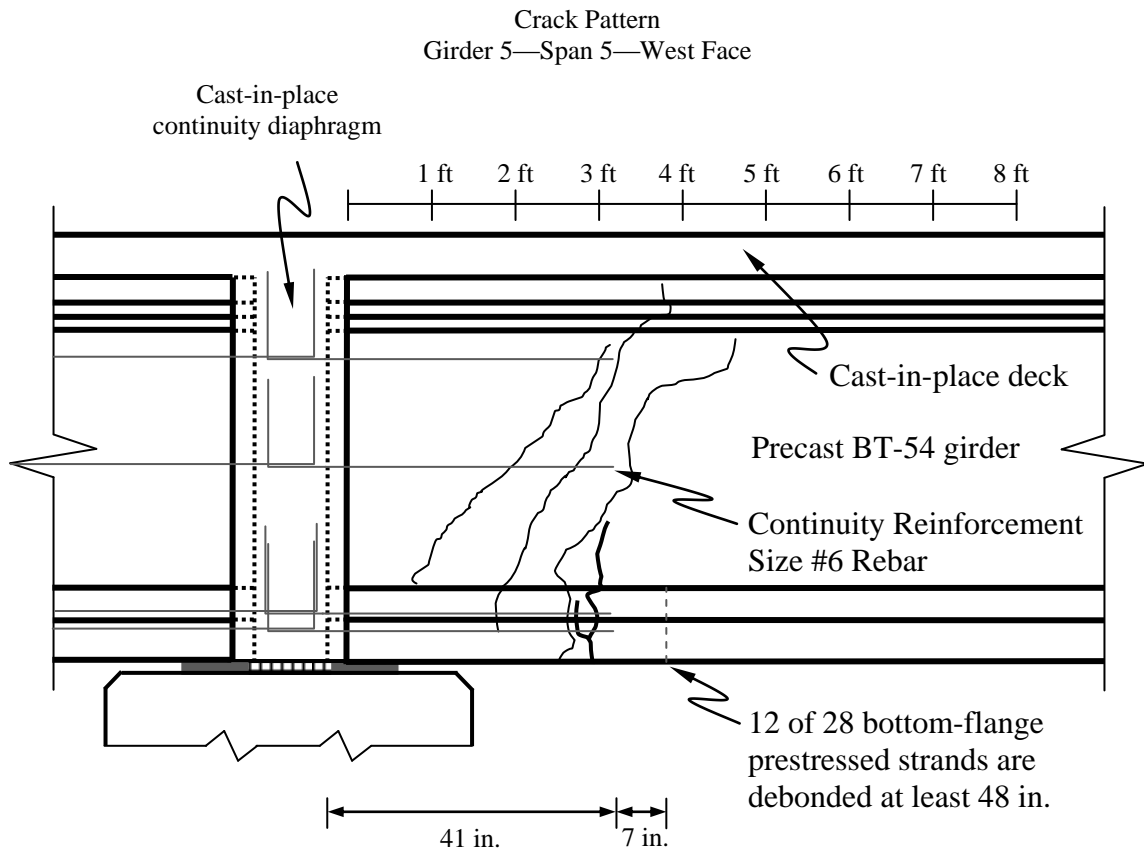
Prestressing strand debonding and continuity reinforcement details discussed in Sections 2.3.3 and 2.3.5 have an effect on the positive bending moment capacity near the continuity diaphragm. The continuity reinforcement length of 41 in. and the debonded length of 48 in. for more than one-third of the strands have been superimposed with the crack pattern observed at Girder 5 of Span 5, as shown in Figure 2.24.

**Figure 2.24:** Cracked girder with continuity reinforcement details (Barnes et al. 2006)

During a critical thermal event, bottom-flange tensile stresses could be induced near the continuity diaphragm along the girder. The debonded strands result in cross sections with a relatively weak positive moment bending capacity compared to the midspan cross sections. Due to relatively weak cross sections for a distance of 48 in. and local stress concentrations that can occur near the continuity reinforcement termination point at 41 in., cross sections near the continuity reinforcement termination location are likely points of origin for flexural cracking in response to positive moment bending.

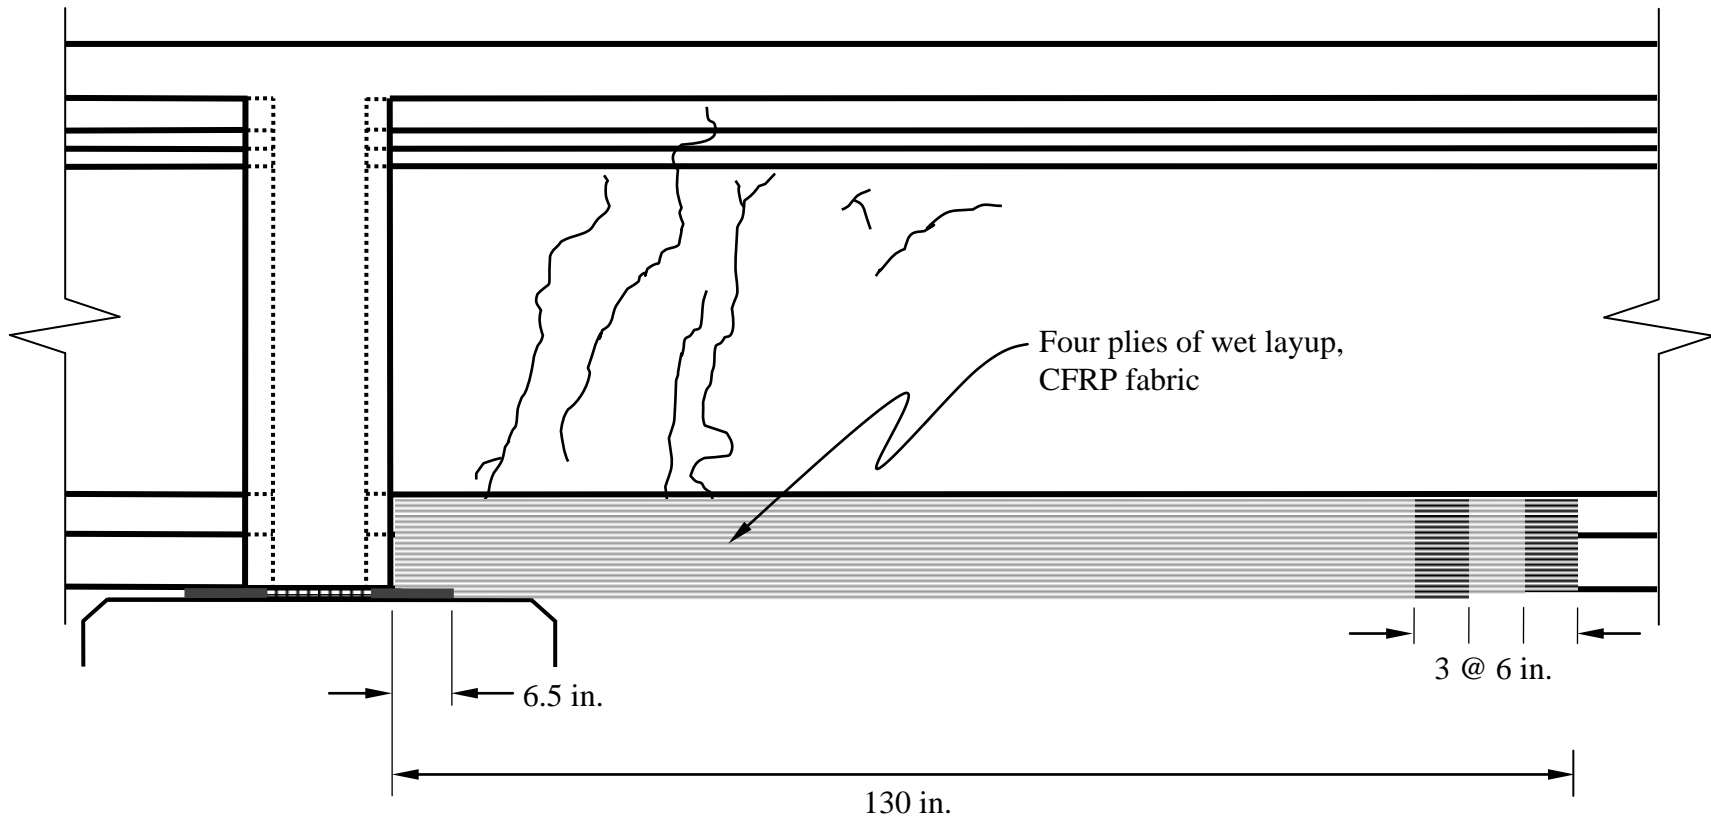
**Figure 2.26:** Longitudinal configuration profile for FRP (Barnes et al. 2006)

The repair solution recommended by Swenson (2003) was a 4-ply FRP system applied near the continuity diaphragm along the bottom flange of every girder, even those which are uncracked. The longitudinal and cross sectional configurations of the recommended 4-ply FRP system are shown in Figures 2.26–2.28.

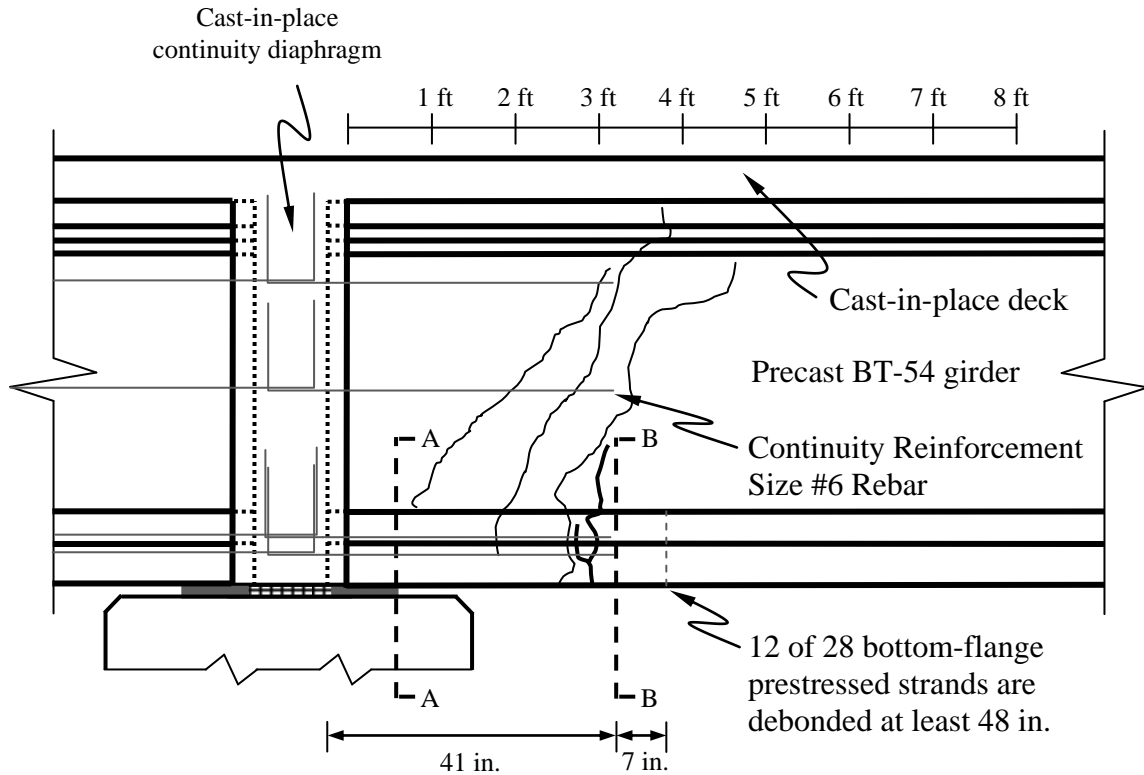
**Figure N.1:** Cracked girder with continuity reinforcement details (Barnes et al. 2006)

Shear cracks within the web were observed near the interior face of the bearing pad, and flexural cracking was observed near the termination of the continuity reinforcement, as shown in Figure N.1. These critical cross sections have also been noted for a girder with an overlaying illustration of an example FRP reinforcement system with unknown number of layers and length of FRP reinforcement, as shown in Figure N.2.

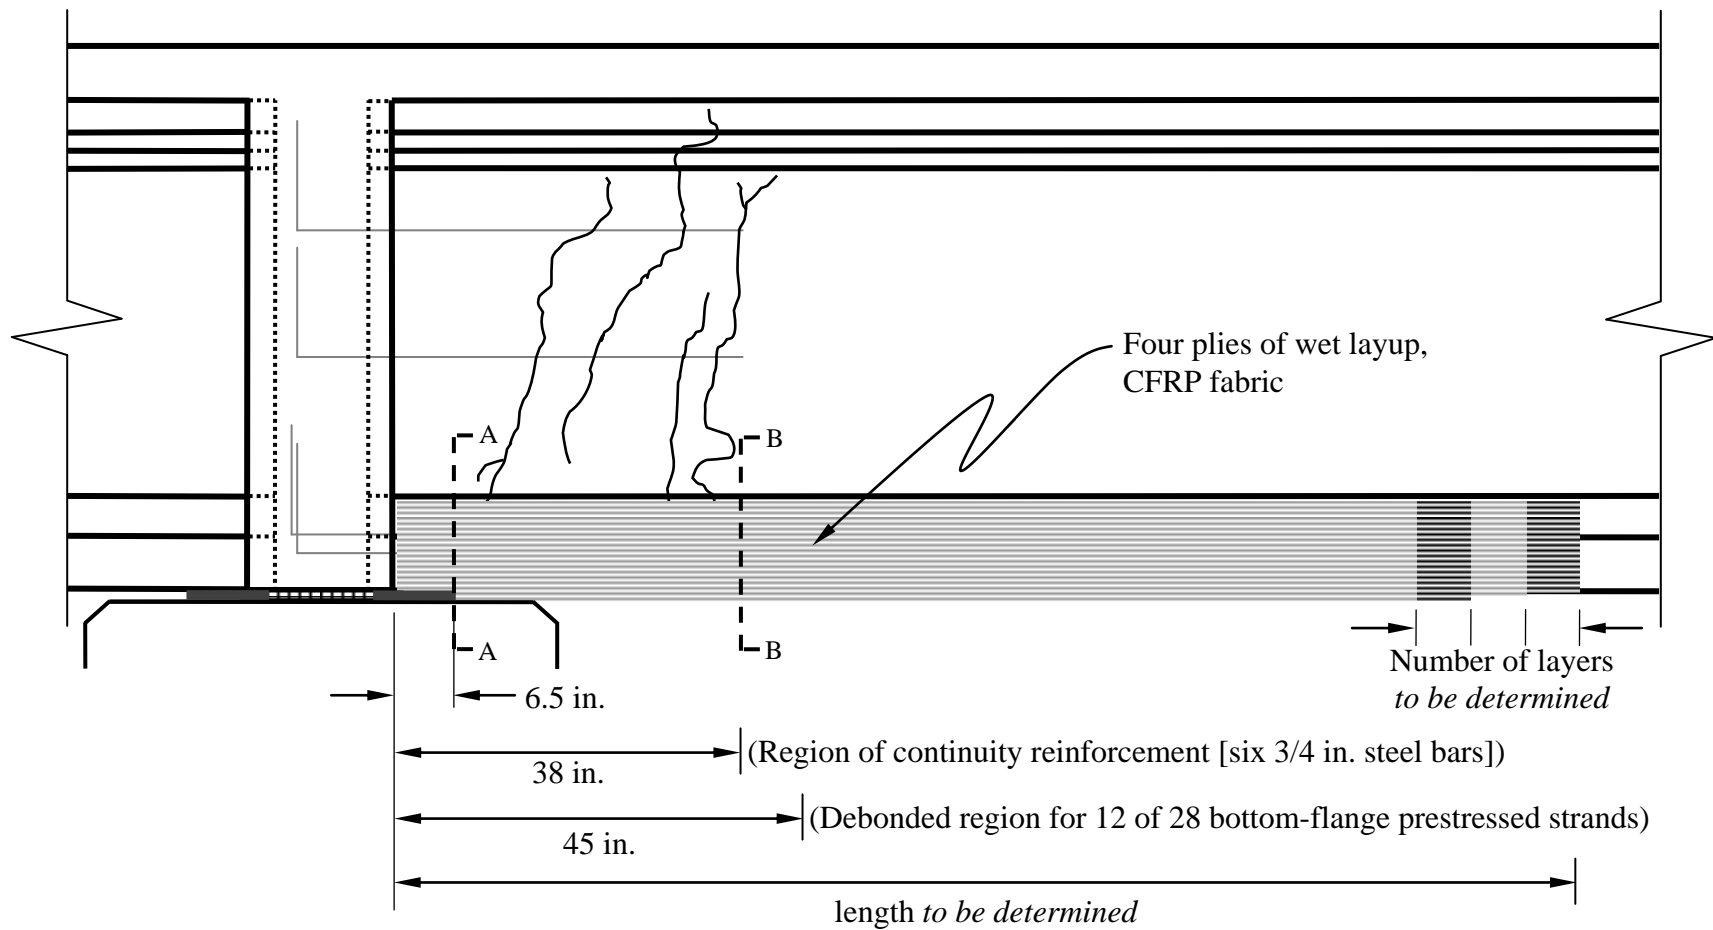
**Figure N.2:** Longitudinal configuration profile for FRP (adapted from Barnes et al. 2006)

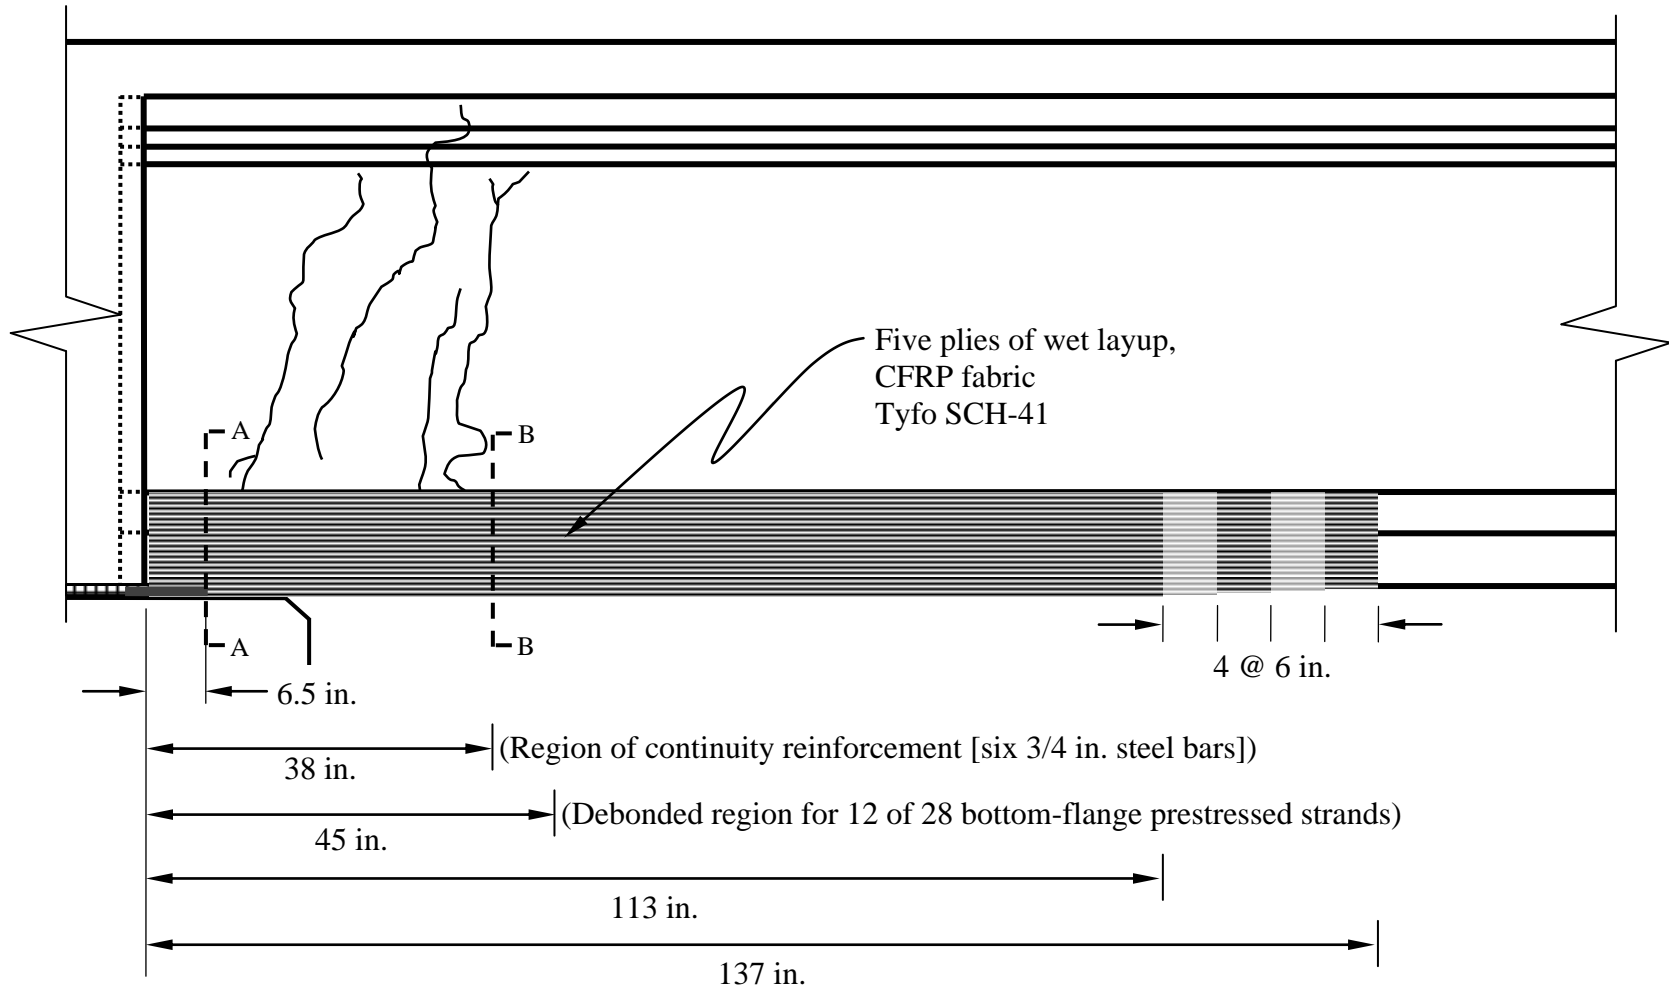
**Figure N.12:** Longitudinal configuration profile for five-layer FRP reinforcement system

Each subsequently installed layer should extend a distance 6 in. less than its respective underlying layer, as discussed in Section 6.5. Thus, the final (shortest) layer of FRP reinforcement should extend to a distance of 113 in. from the face of the diaphragm. These recommended lengths of FRP reinforcement for the five-layer FRP repair are shown in Figure N.12.
