**Analysis of Manufactured Home Vulnerability in Extreme Winds**

Brett Maxwell Davis

Auburn University

Civil Engineering, Master of Science

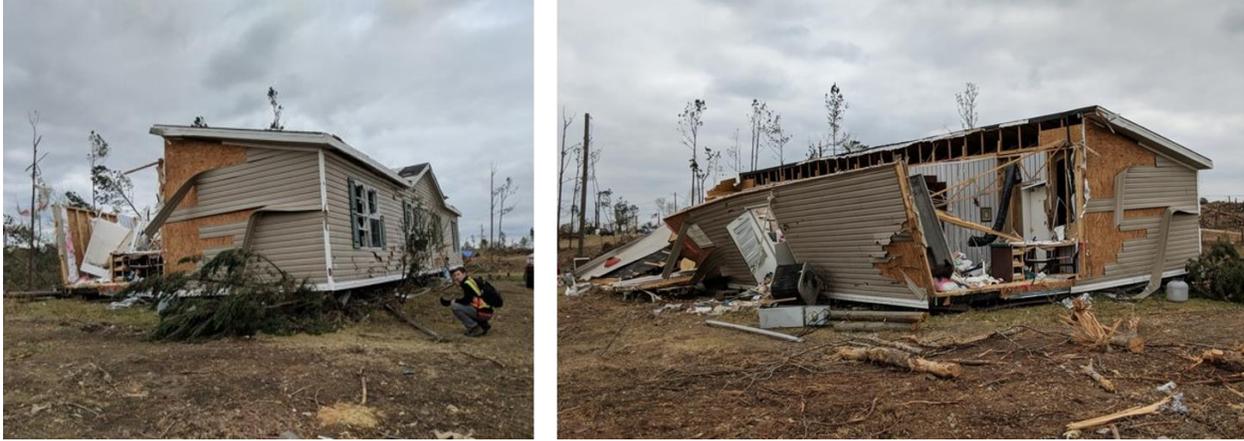
A failure mechanism seen in one particular structure was separation at the marriage line. Figure 4-2 shows two perspectives of the same structure failing in this way. Overall, this particular failure is less of a life safety risk, as a large portion of the structure remained together. This failure is due to inadequate connections between the two halves, and was infrequently observed.

*Figure 4-2. Failure at the marriage line*

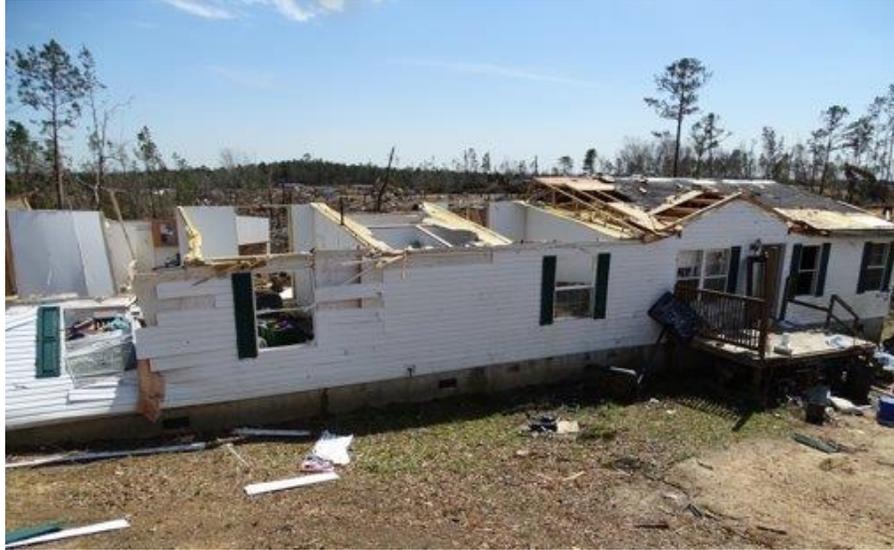
The least severe type of structural failure in MMH is the failure of the roof-to-wall connection, as it leaves the structure remaining upright and relatively safe. A picture of this type of failure can be seen in Figure 4-3. This type of failure occurs when the dead weight of the home and the anchorage systems provide adequate resistance of the uplift forces, but the connection between the roof trusses and the top plate of the wall cannot withstand the uplift forces. As seen in the left side of Figure 4-3, a consequence of losing the roof diaphragm is that the walls lose their top attachment point, and act as a cantilever, making them more prone to failure. Overall, this type of failure is typically not life-threatening to occupants and is preferred over the following failure mechanisms because the loss of the load-collecting elements in the roof also reduce the uplift loads acting on the building.

*Figure 4-3. Failure of the roof-to-wall connection*

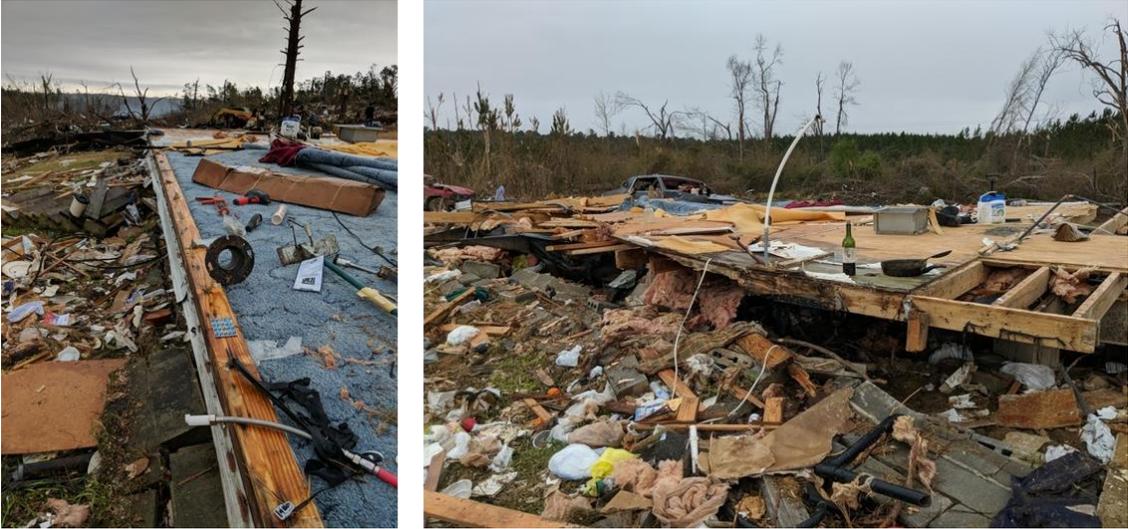
of the straps. However, this type of failure is not life-threatening to the occupants, as the MMH remains intact.

*Figure 4-4. Failure of the wall-to-floor connection*

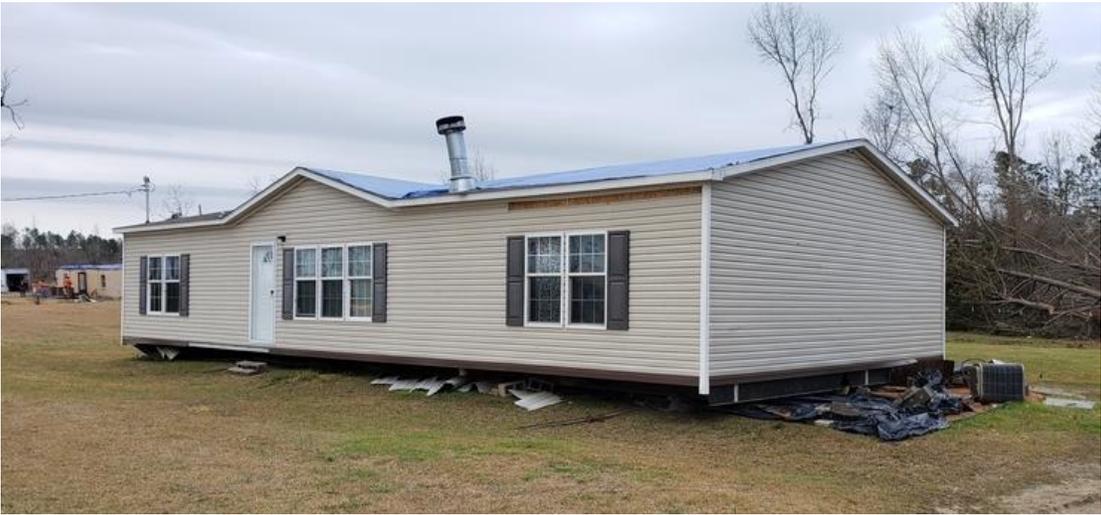
*Figure 4-5. Sliding off the home off the foundation*

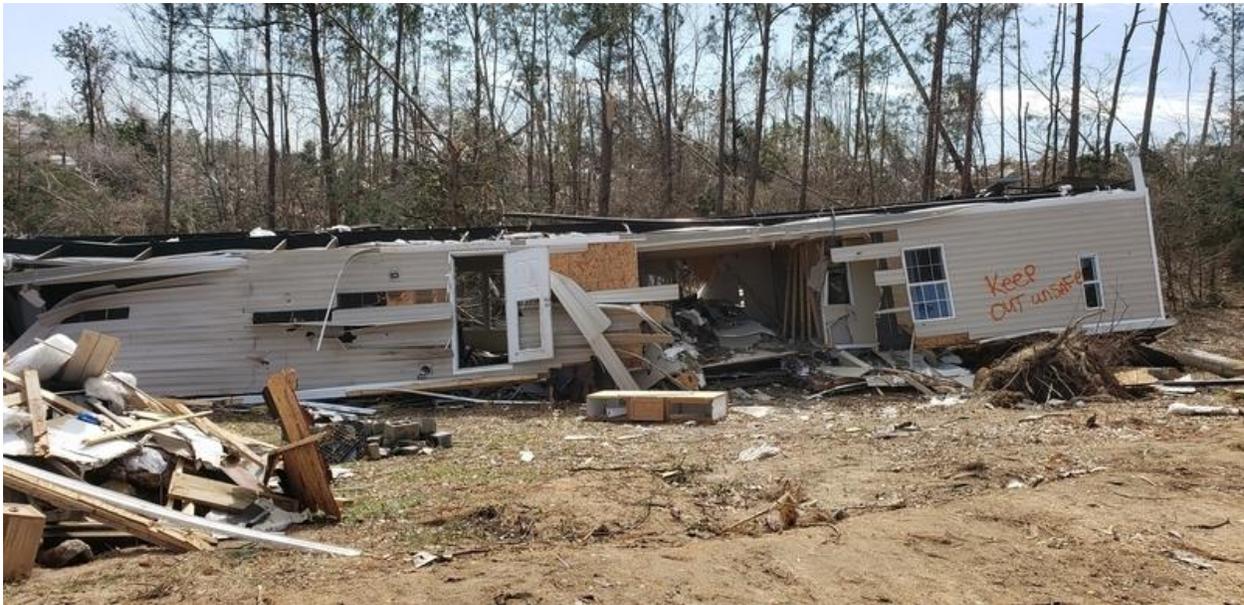
The other two failure mechanisms of anchorage systems are much more catastrophic to the structure, and consequently to the occupants. The first is the rolling of the MMH, as seen in Figure 4-6. In this case, the anchorage fails, resulting in the lateral loads rolling the home in the windward direction. Sometimes the structure essentially remains impact as seen in the picture, but the debris within the home may put the occupant in danger. The worst type of failure for any MMH, however, is the lofting of the home. When winds are strong enough and/or of sufficient duration, the structure is lifted up and thrown, or lofted, in the windward direction. In most cases the home is completely destroyed upon impact, resulting in a low chance of survival for any occupants. The result of lofting can be seen in Figure 4-7, as evidenced by the chassis being wrapped around a tree several yards off of the ground.

*Figure 4-6. Rolling of a MMH*

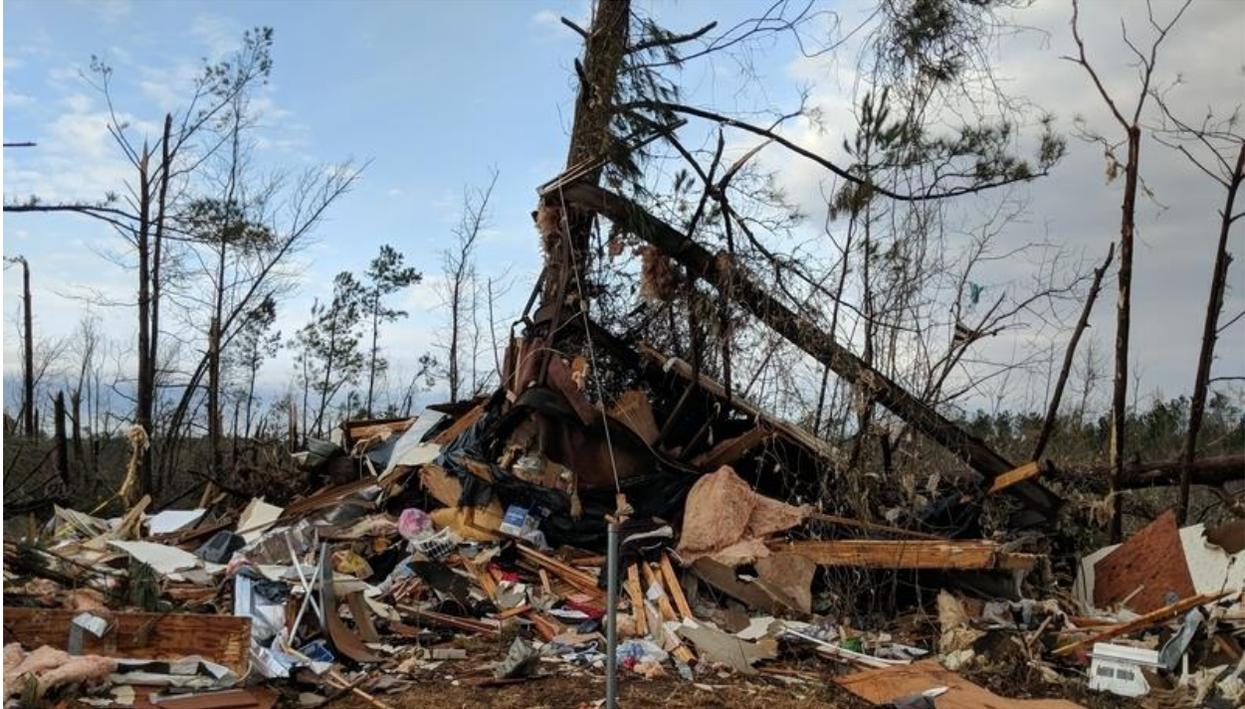
*Figure 4-7. Lofting of a MMH*

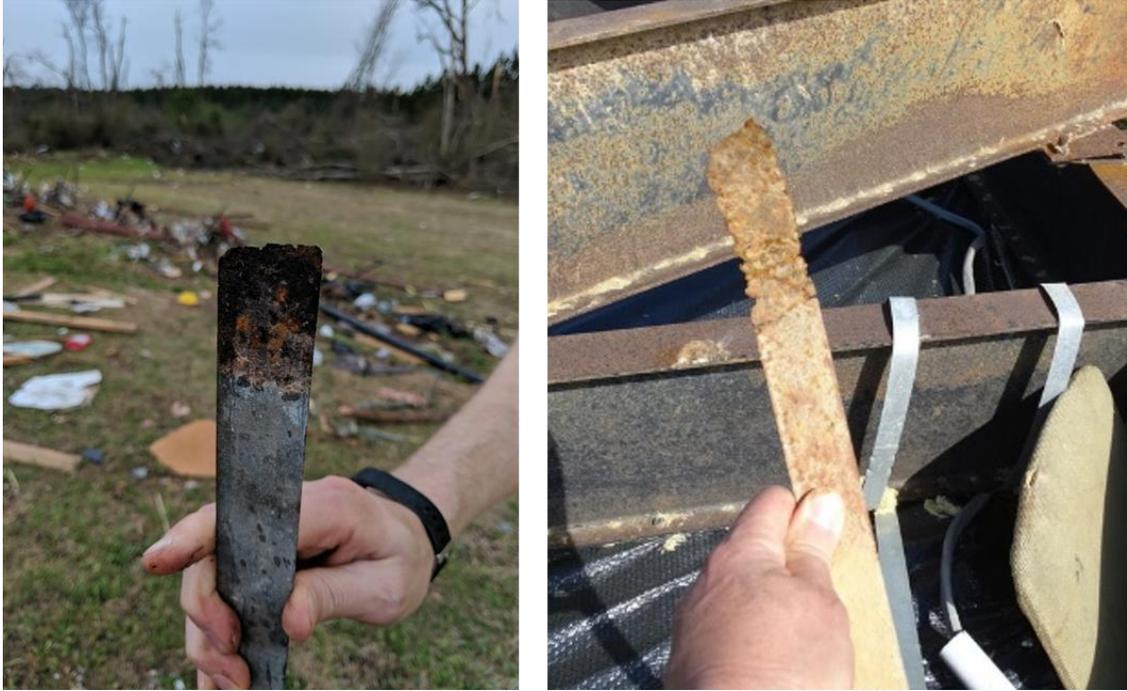
*Figure 4-8. Strap failure due to corrosion*

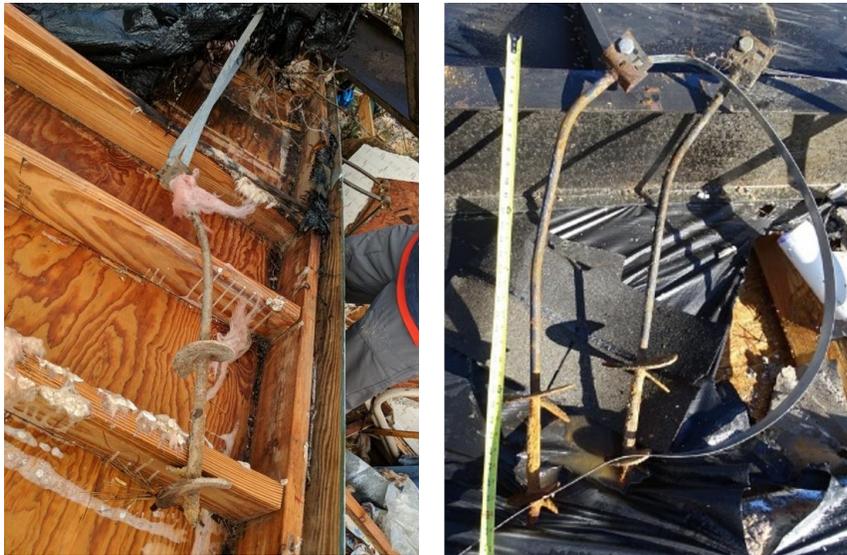
*Figure 4-9. Anchor pullout failure*

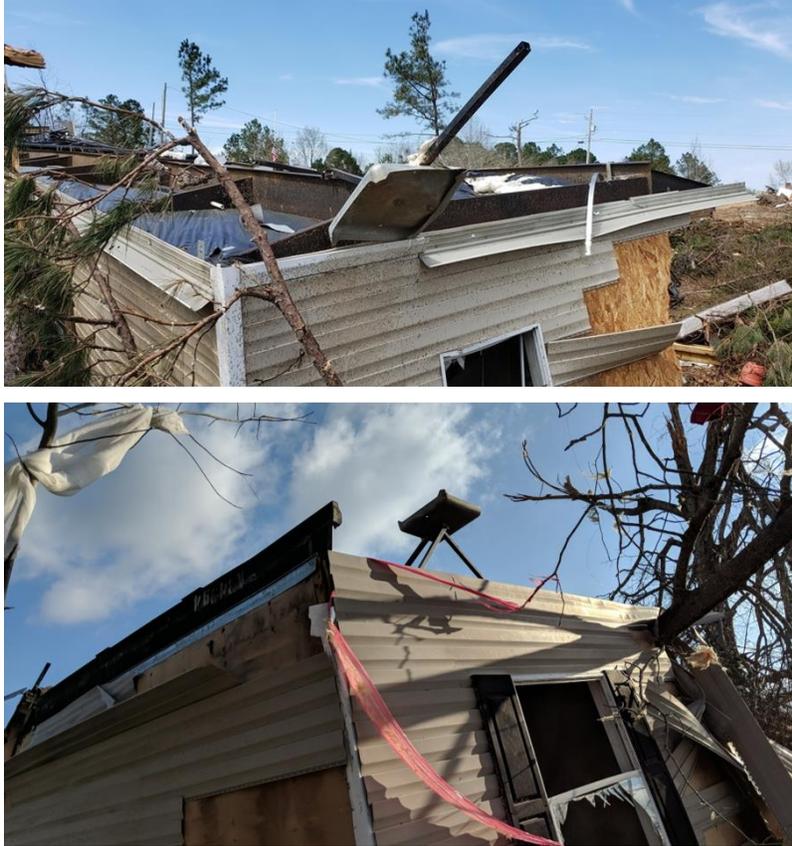
Assessments following the March 3<sup>rd</sup> 2019 Lee County tornado found that many of the homes with traditional tie-down strap and ground anchor systems that experienced failure had pre-existing issues, such as corrosion or inadequate strap spacing. Some anchorage straps were corroded completely through, essentially leaving the home with no lateral support. Corroded straps from two separate homes can be seen in Figure 4-8. Another issue with these systems was ground anchor pullout, as described in Section 3.2. Again, failed anchors from two separate homes can be seen in Figure 4-9. The failure of another type of anchorage system, the pan system, often resulted in the rolling of the home. Failure of these systems can be seen in Figure 4-10.

*Figure 4-10. Failure of pan systems*

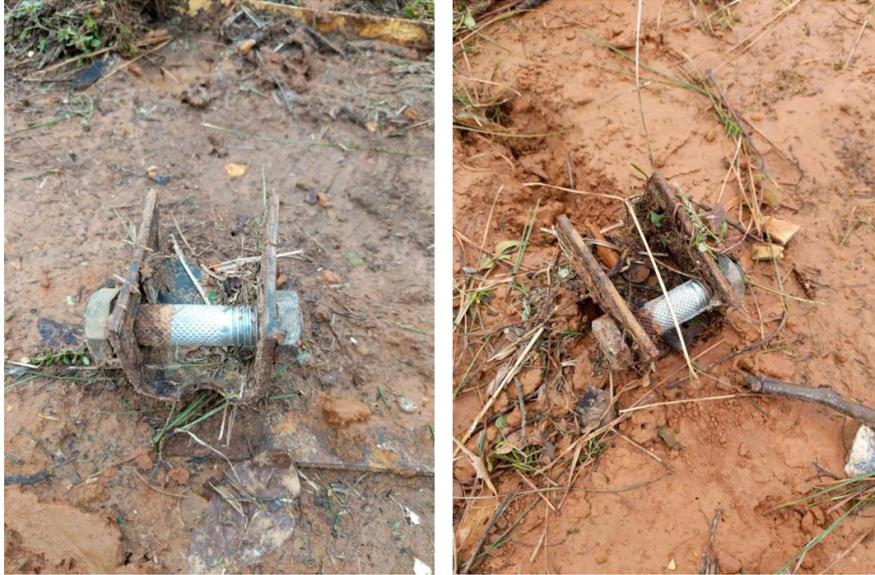
The tornado that struck homes along Settlement Rd. near Carrollton, AL, was rated an EF-2, and unfortunately it killed 3 people. A total of eight MMH were impacted, resulting in varying degrees of damage. One structure in which fatalities occurred was equipped with a traditional strap system, but it experienced a unique failure mechanism. The tie-down straps actually slipped out of the heads of the ground anchors, leaving the anchors still firmly planted in the ground. The heads of the ground anchors from which the straps slipped can be seen in Figure 4-11.

*Figure 4-11. Evidence of straps pulling out of anchor heads*

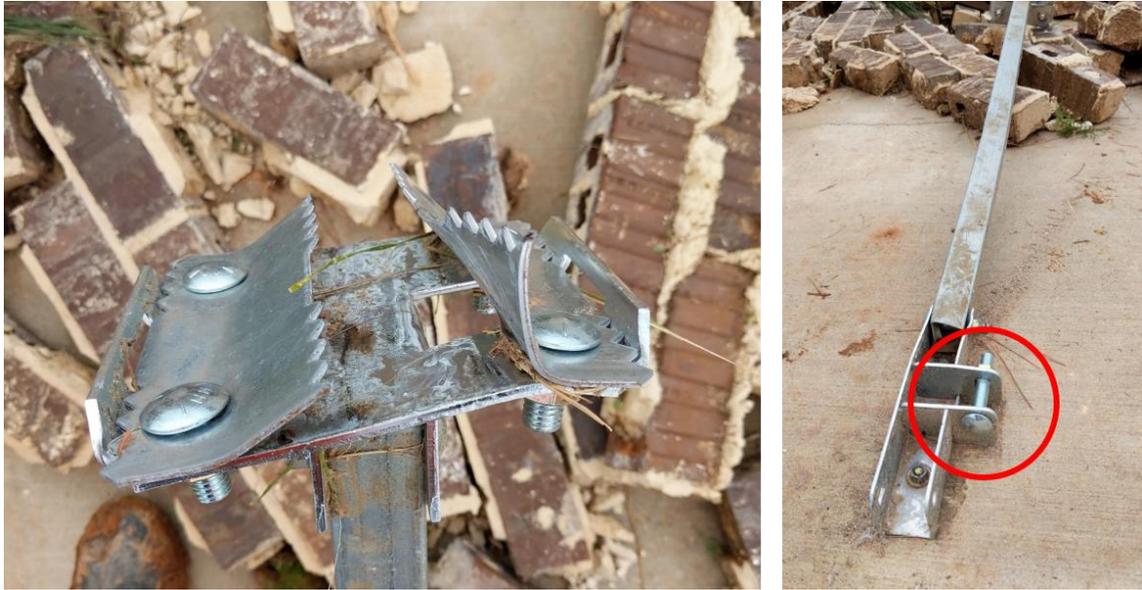
The other fatality occurred in a recently installed manufactured home that was placed on a concrete slab and had a variation of a pan anchorage system. The anchorage system appeared to have lateral load resisting struts spanning from the concrete slab underneath one I-beam up to connect to the other side I-beam, as well as longitudinal “V” struts spanning parallel to the I-beams. Figure 2-4 shows this basic layout, but with the struts connecting to a pan instead of a concrete slab. The structure was completely swept from the slab, leaving only two of the longitudinal struts still anchored into the concrete. The failure of the longitudinal struts appeared to have occurred in the connection to the I-beam rails as seen in Figure 4-12 (left), while the lateral strut was missing and appeared to have failed at the bolted connection to the slab as seen in Figure 4-12 (right).

*Figure 4-12. Failure of pan system struts at the I-beam (left) and the foundation attachment (right)*

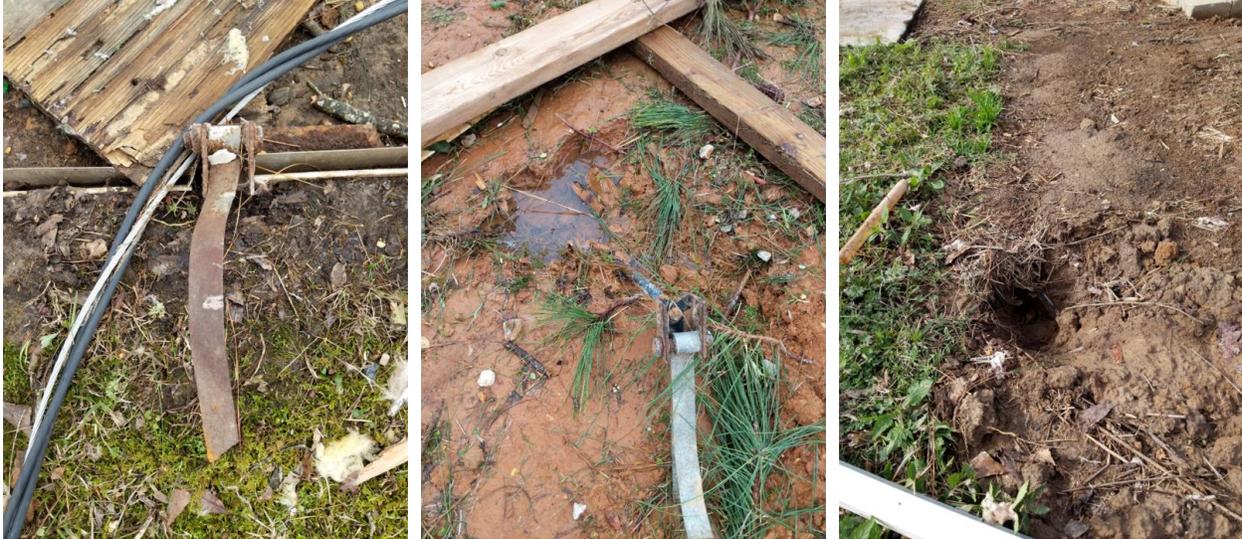
Other anchorage issues leading to failure included corrosion of tie-down straps, large deflections of ground anchors, and complete pullout of ground anchors. Figure 4-13 shows evidence of all three of these issues found on different homes, and these were all repeated from the Lee County damage observations. There were four MMH destroyed by the Carrollton tornado, and the failure of every single one of them was initiated by the anchorage system.

*Figure 4-13. Corrosion failure (left), anchor deflection (middle), and anchor pullout (right)*

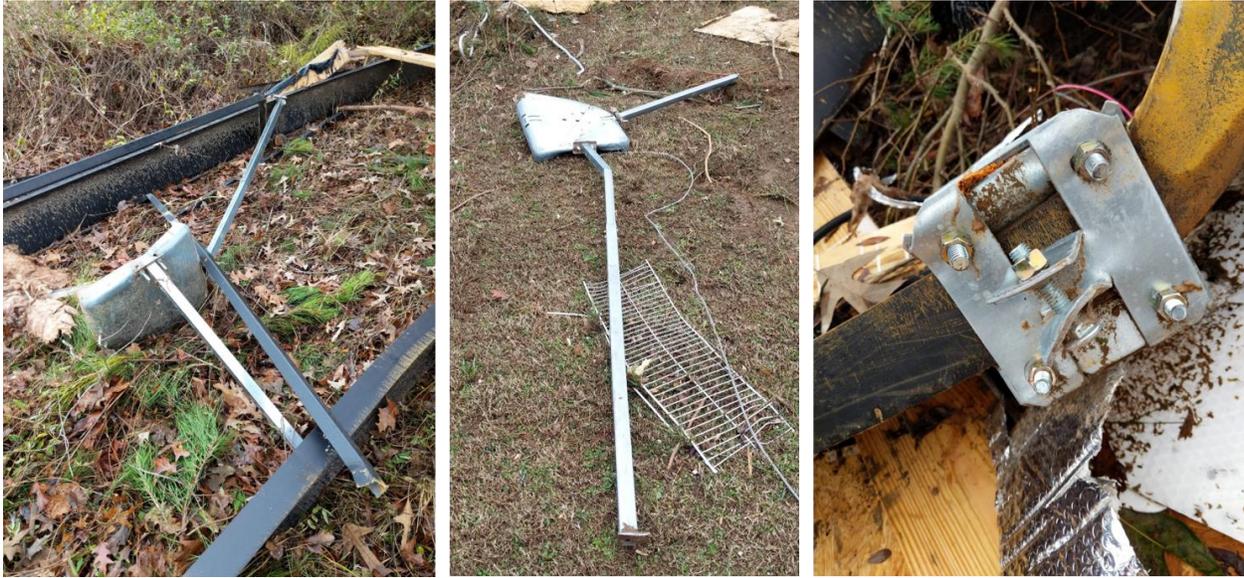
The tornado that struck homes near Town Creek, AL, was also rated an EF-2, but the only major impacts were to three MMH. The results were similar to those previously shown, in that all three homes were destroyed due to a failure of the anchorage system. The two fatalities occurred in a home that used a traditional strap and ground anchor system, which primarily failed due to anchor pullout. Of the 11 straps accounted for, 7 of them pulled the anchor out of the ground and 4 of them failed in tension. Another home that failed was a modular home that appeared to have no anchorage system. The third home that failed was a new manufactured home, less than a year since being installed, that had a pan anchorage system. The occupants were hospitalized with head injuries but were not killed. The frame of the home was resting several hundred yards from its original location, with one of the pans still attached. The other pan was near the destroyed frame, but must have torn loose during the movement of the frame. The still-attached pan, the detached pan, and the apparent connection failure point can be seen in Figure 4-14.

*Figure 4-14. Failure mechanisms of a pan system*

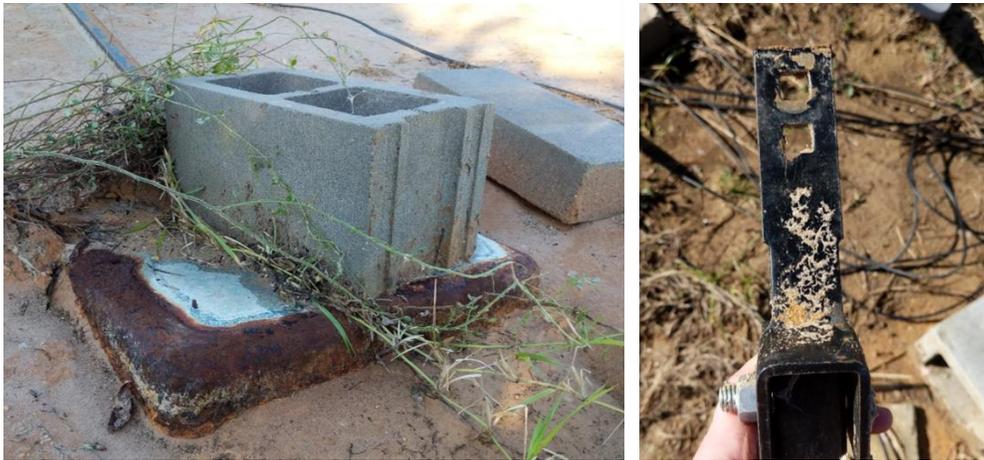
*Figure 4-15. Failure mechanisms of a Xi2 pan system*

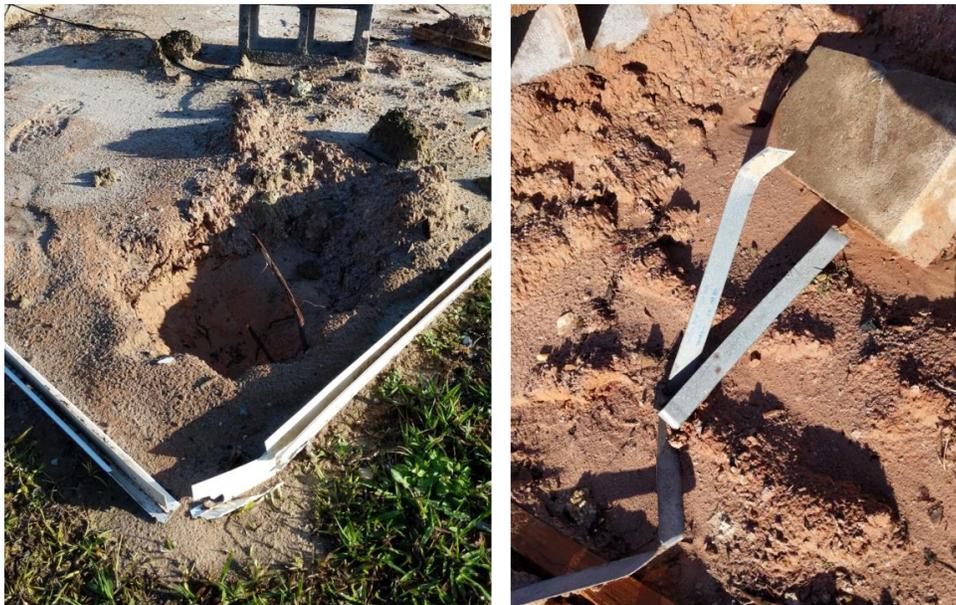
the frame connection, while the other was pulled out of the ground upon failure. As for the strap system, several straps failed at the connection to the I-beam, which can be seen along with anchor pullout in Figure 4-16.

*Figure 4-16. Anchor pullout (left) and strap failure at the I-beam (right)*

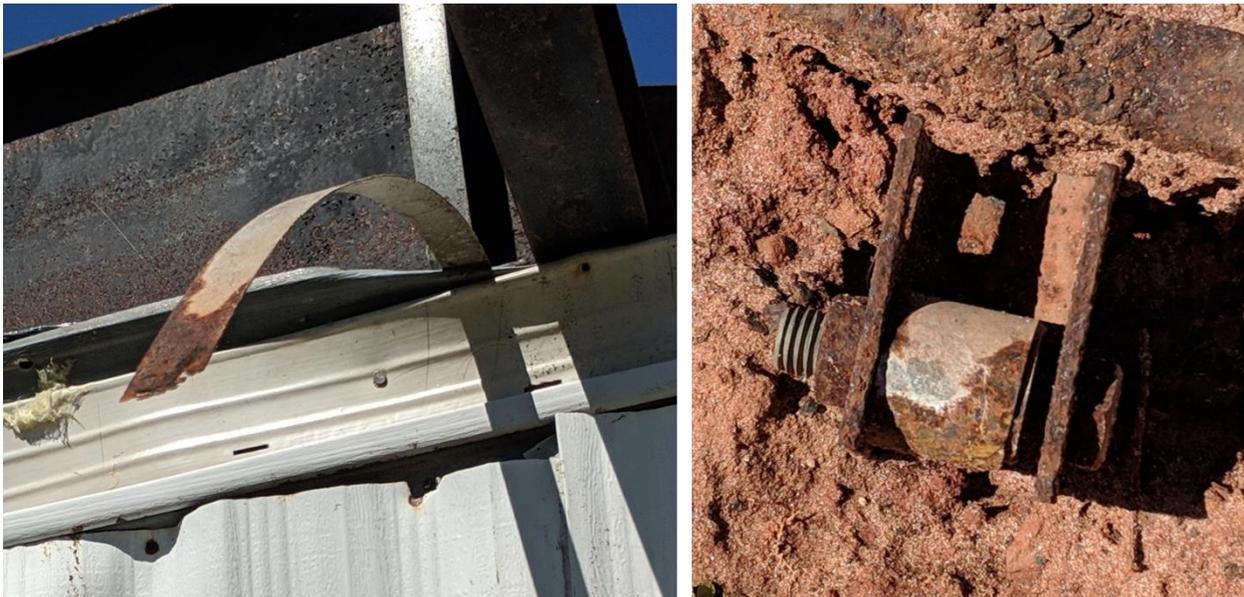
This EF-1 tornado struck a MMH park, causing significant damage to several MMH. Fortunately, there were no reported injuries or fatalities. A total of 30 MMH were assessed, and the discrepancy in the damage ratings of individual homes that were located very close together was intriguing. Multiple homes were flipped, rolled, or destroyed, while homes directly next to them were essentially undamaged. This may have been partly due to the narrow path of the tornado, but another factor may have been the anchorage inconsistencies. Several of the assessed homes had anchorage systems that degraded over time due to corrosion and were never replaced. Figure 4-17 shows two strap failures resulting from corrosion on a single home, which was rolled upside down. The ground anchor on the right showed no signs of movement in the ground, indicating that the strap may have been completely corroded through.

*Figure 4-17. Corrosion induced strap failure*

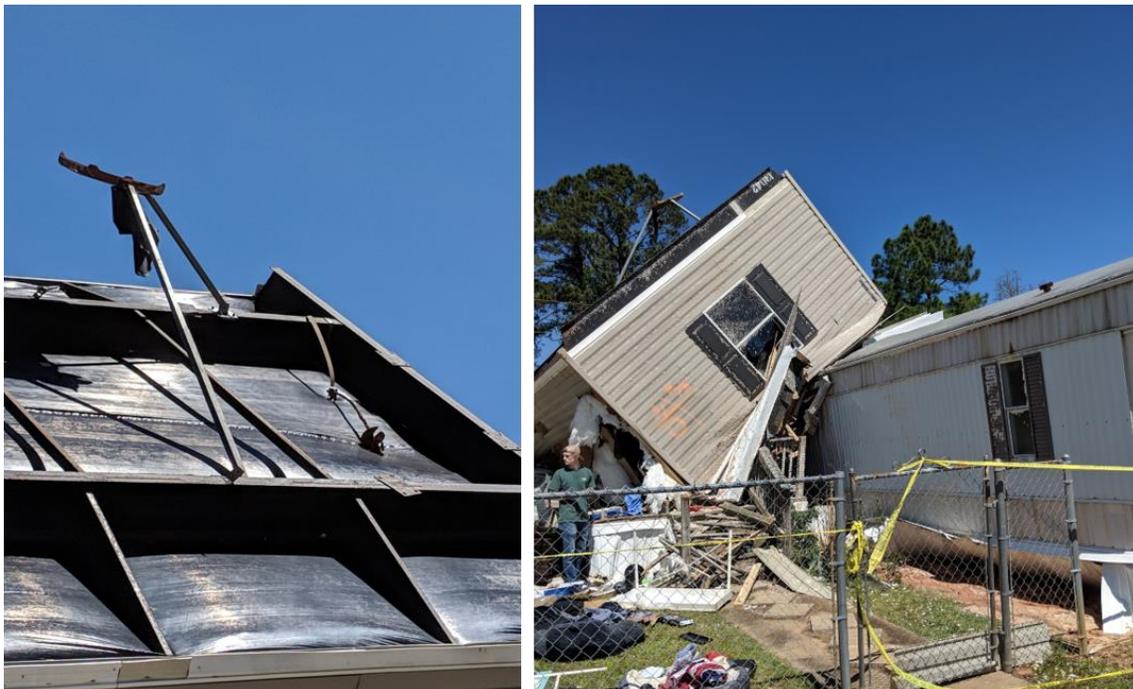
Another anchorage issue documented in Troy was the lofting of a pan system onto another home, similar to the case in the Spring Hill tornado. Additionally, the four traditional straps on the corners of the pan system home all pulled out of the ground. Pictures of the lofted home can be seen in Figure 4-18. The other home impacted also had a pan anchorage system, which appeared to have been shifted from its initial resting place. Figure 4-19 shows a picture of the impacted home's anchorage systems, with the red circle indicating the lack of a connection to the I-beam rail. This may have been a pre-existing condition, or it may have failed due to the impact from the lofted home. Finally, another lofted home with a pan system is shown in Figure 4-20. The picture also shows the devastation caused by lofting and impacting the ground. For reference, notice the home in the background with very little damage. Anchorage failure can lead to catastrophic failure of the structure as a whole, even in lower wind speed events.

*Figure 4-18. Lofting of a pan system*

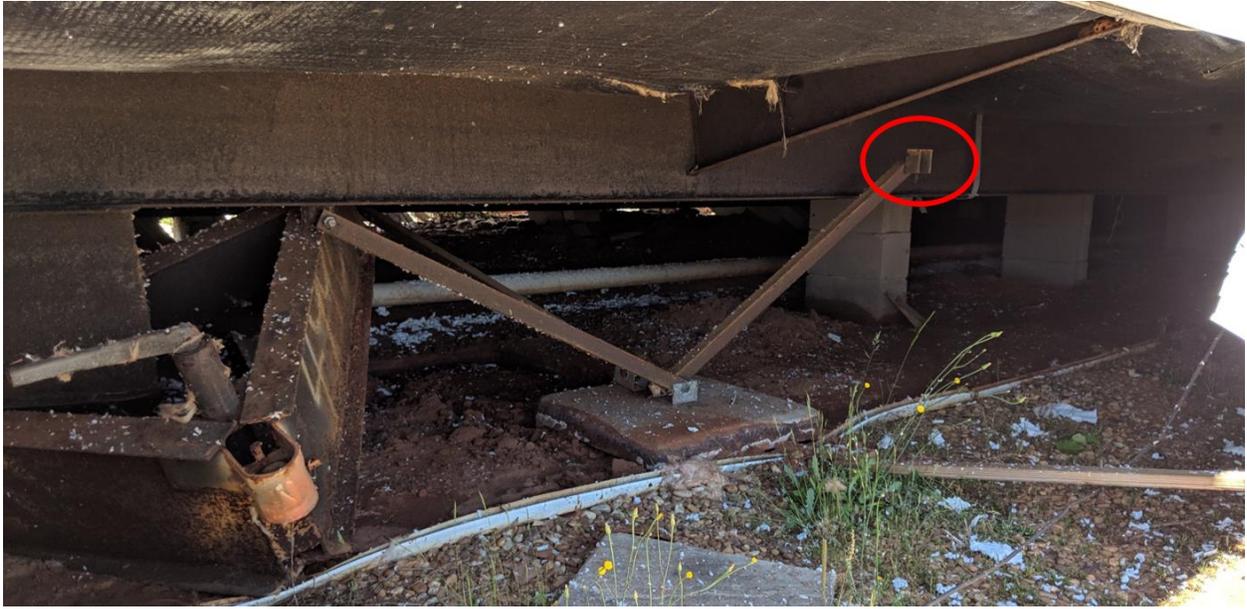
*Figure 4-19. Connection failure of an impacted pan system*

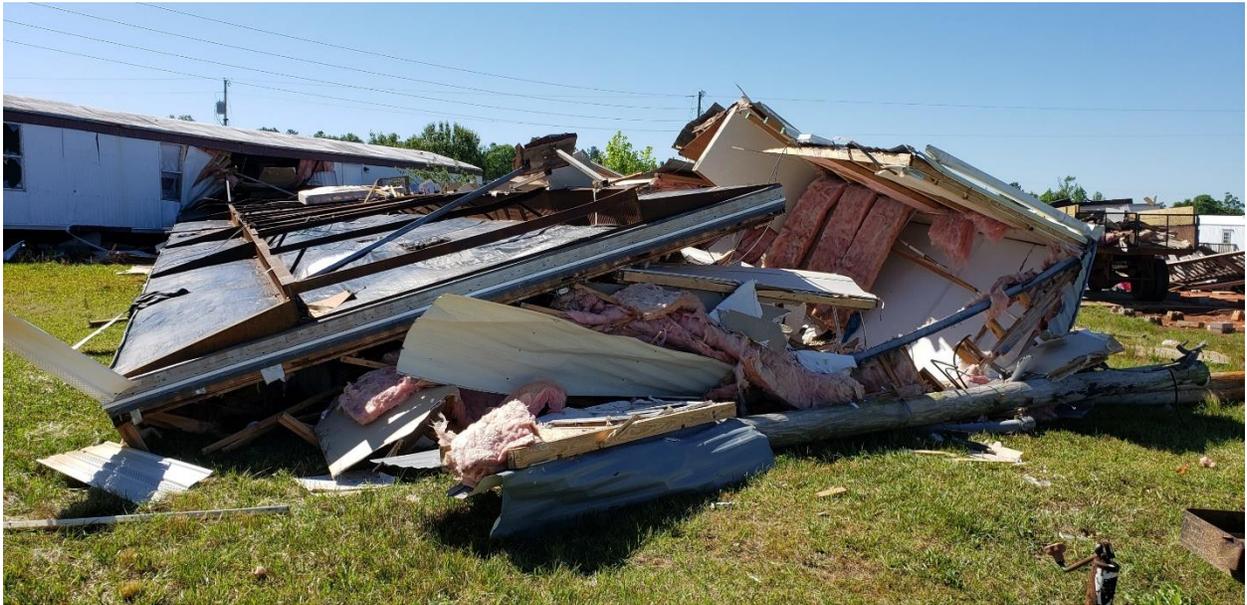
*Figure 4-20. Lofting of a pan system leading to destruction*

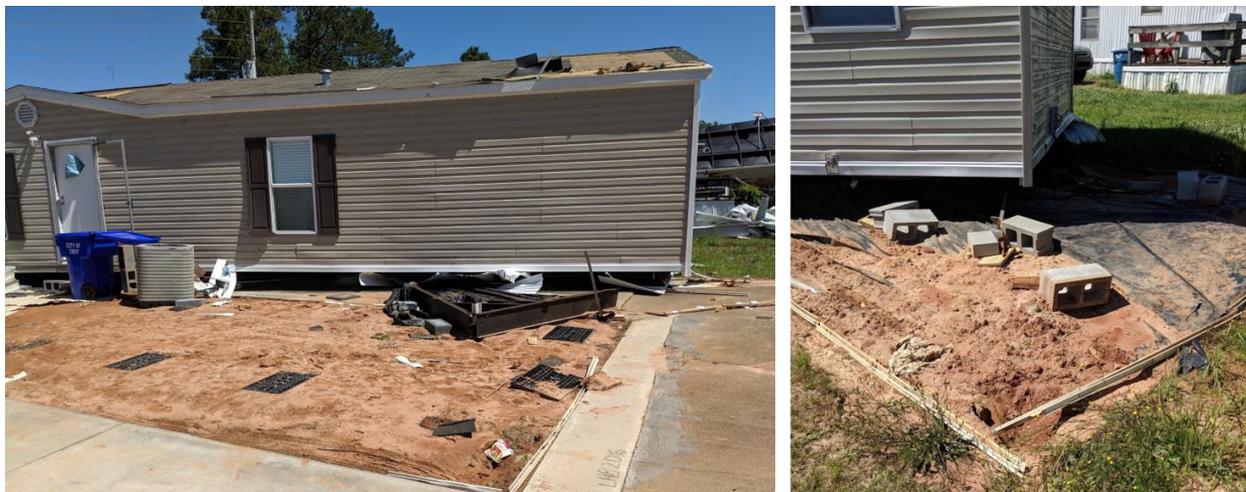
Another concerning trend from this event was the failure of several anchorage systems resulting in the structure simply being rotated or slid several feet. While this failure mechanism is certainly preferable to the rolling or lofting of homes, it indicates that while wind speeds here were not strong enough to fail the structure, the anchorage system is the weakest link in the load path. Homes slightly outside the center of the tornado path experienced much lower wind speeds, but Figure 4-21 shows two separate homes that were rotated off of their foundations due to anchorage failure. Both homes were equipped with pan anchorage systems and most likely failed due to the inability to resist much uplift force. Additionally, the corner straps of the home shown on the right failed due to anchor pullout. T.P. Marshall (1993) and McDonald (1971) suggested that the twisting or rotating of a home occurs due to inconsistent resistances across the length of the home [8], [49], which could feasibly occur in pan systems and inconsistently installed strap systems. Twisting may also occur in small tornadoes where the diameter of the vortex is of a similar scale to the length of the home, resulting in an uneven loading across the length of the home.

*Figure 4-21. MMH lifted and rotated off of foundations*

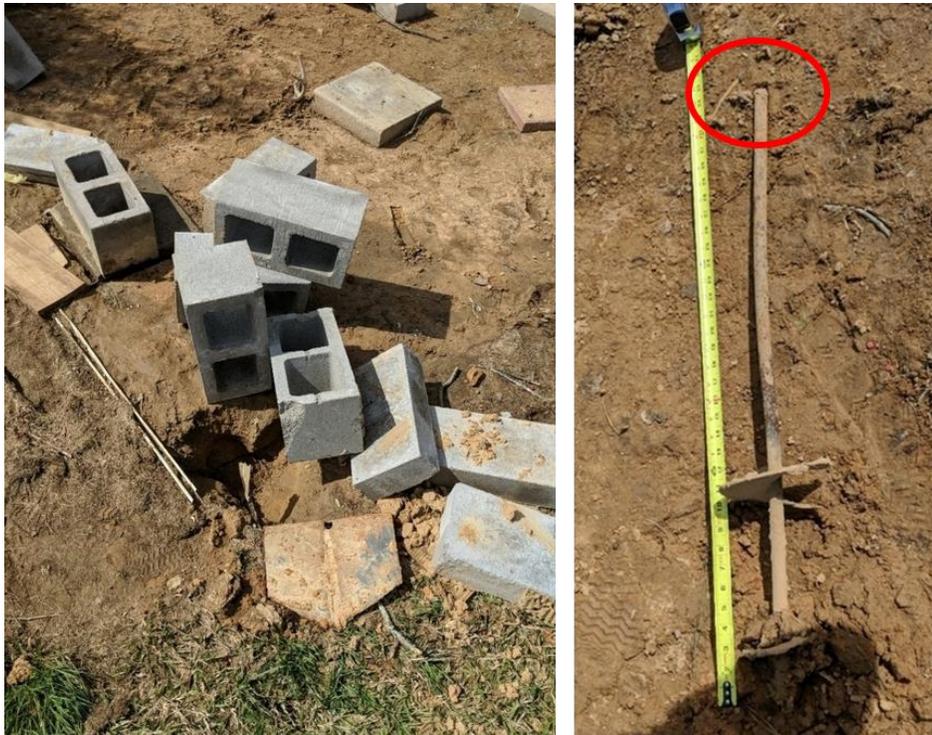
Although the Kingville tornado path was over 9 miles long, it only struck a single MMH. The single-wide home was lofted approximately 40 ft from its original location, resulting in other connection failures as well. It had a traditional strap and ground anchor system, with ground anchor pullout being the primary failure mechanism, shown in Figure 4-22. A unique failure was seen in one of the pulled-out ground anchors, as the head appeared to have detached from the shaft. However, it most likely occurred after being pulled out, and can be seen in the right side of Figure 4-22. The strap system may have been more complex than usual, as several straps were attached to a single anchor head, which is shown in Figure 4-23. However, due to the destruction of the structure, the details of the system were unable to be documented.

*Figure 4-22. Anchor pullout (left) and detachment of the anchor head (right)*

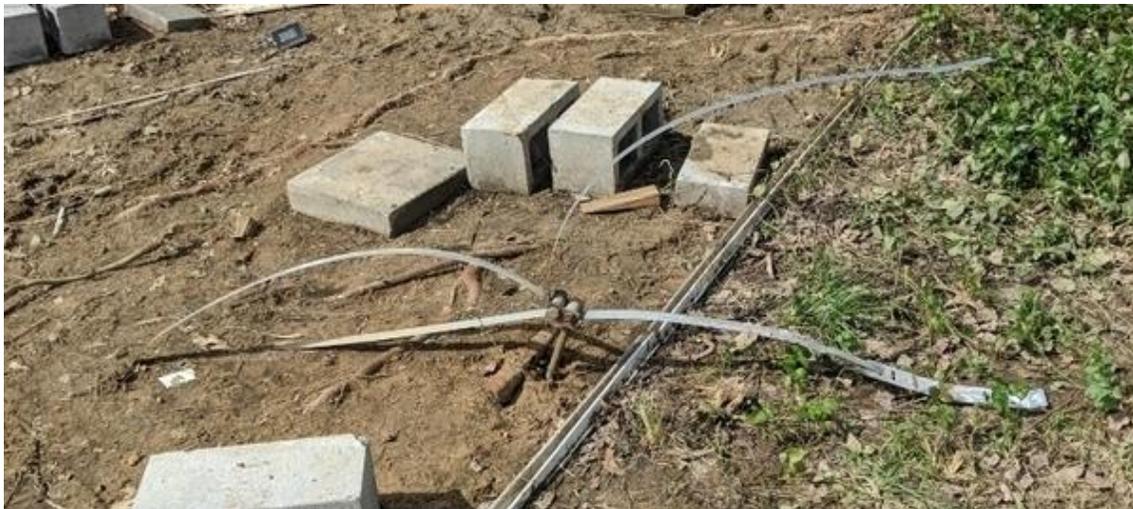
*Figure 4-23. Failed strap system with multiple apparent connections*

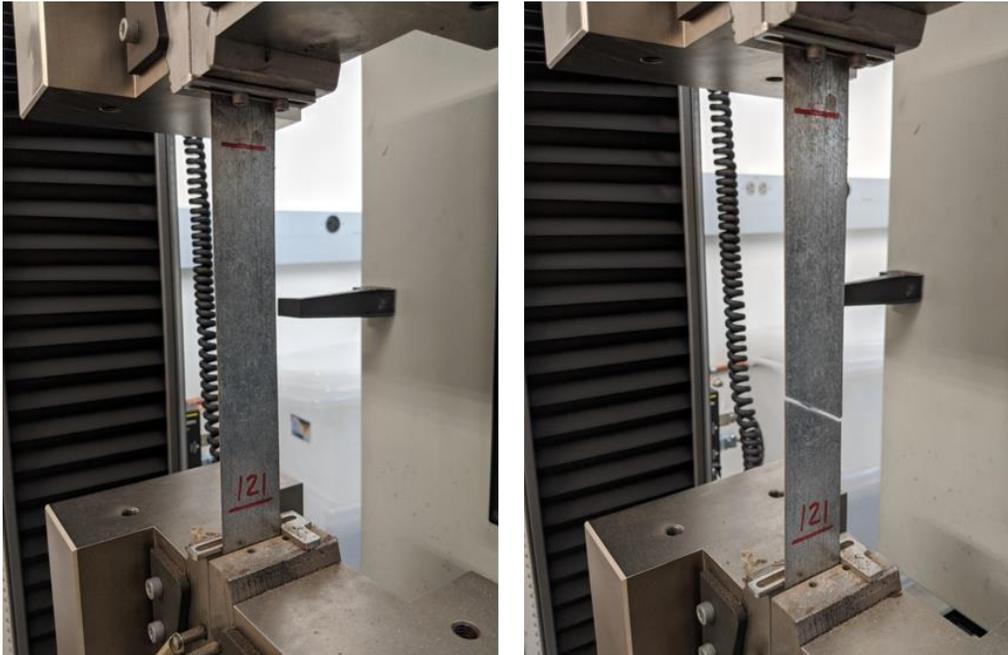
*Figure 5-2. Before and after pictures of a strap tested to failure*

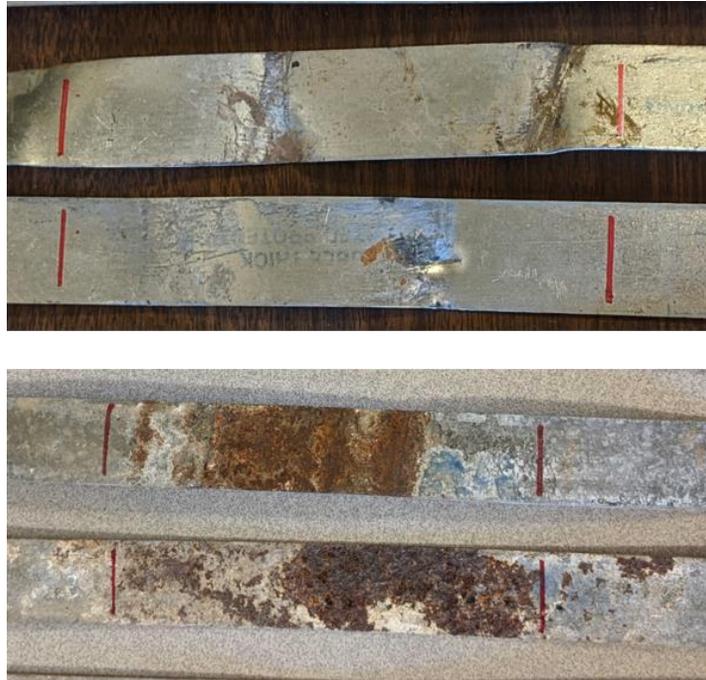
*Figure 5-4. Examples of defects such as sharp kinks (top) or corrosion (bottom)*
