STATIC LOAD TESTING OF A DAMAGED, CONTINUOUS
PRESTRESSED CONCRETE BRIDGE

A Thesis

Auburn University

Auburn, Alabama
May 9, 2009

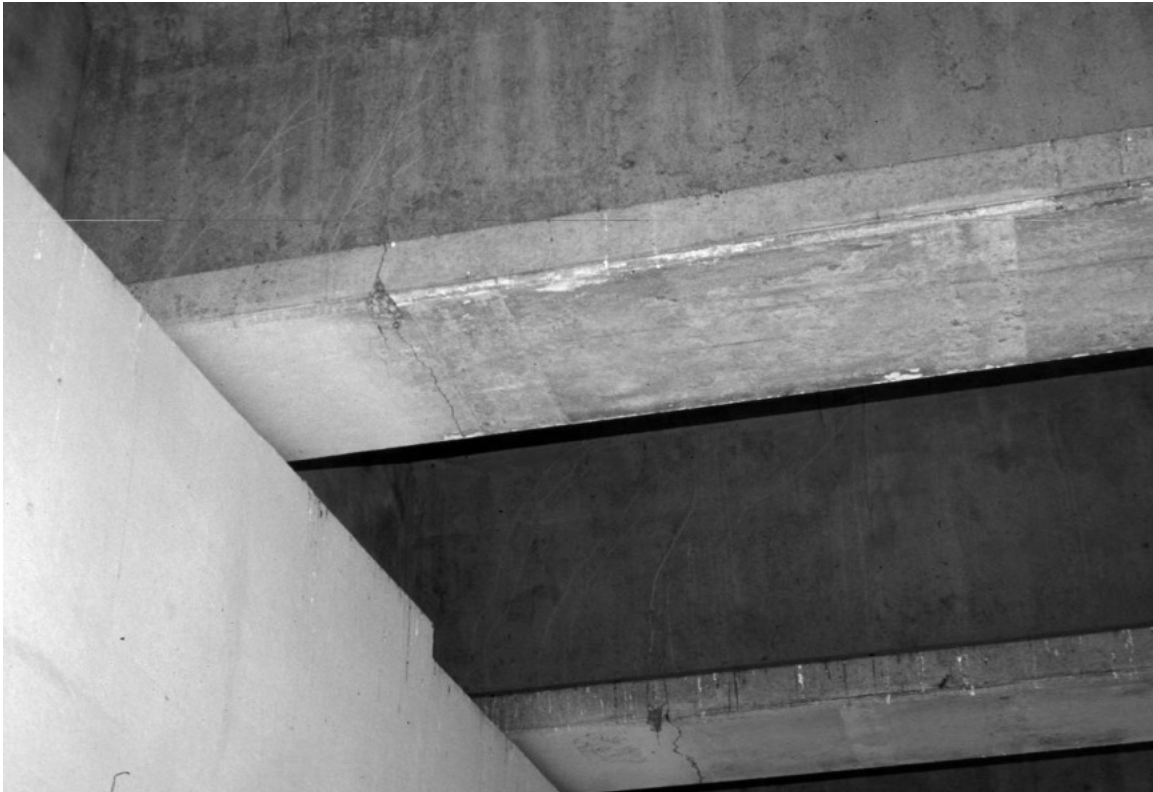
A routine bridge inspection in 1992 revealed hairline cracks in the continuous ends of many of the prestressed bulb-tee girders. During March and April of 1994, about eighteen months after the initial bridge inspection, another bridge inspection revealed much more serious cracking. Inspections revealed that the previous hairline cracks had propagated and widened up to 0.25 inches. As seen in Figure 2-1, cracks were primarily located near the continuous end of prestressed concrete bulb-tee girders made continuous for live loads. Cracks started at the bottom of the girders and propagated through the bottom flange and into the web. With cracking starting at the bottom of the girder, positive moment is the likely cause of cracking. The cracked prestressed girders types were either Bulb-Tee 54 (BT-54) or Bulb-Tee 63 (BT-63), each being 54-inches deep or

Figure 2-1: Cracks in Continuous Ends of Girders (Barnes 2007)

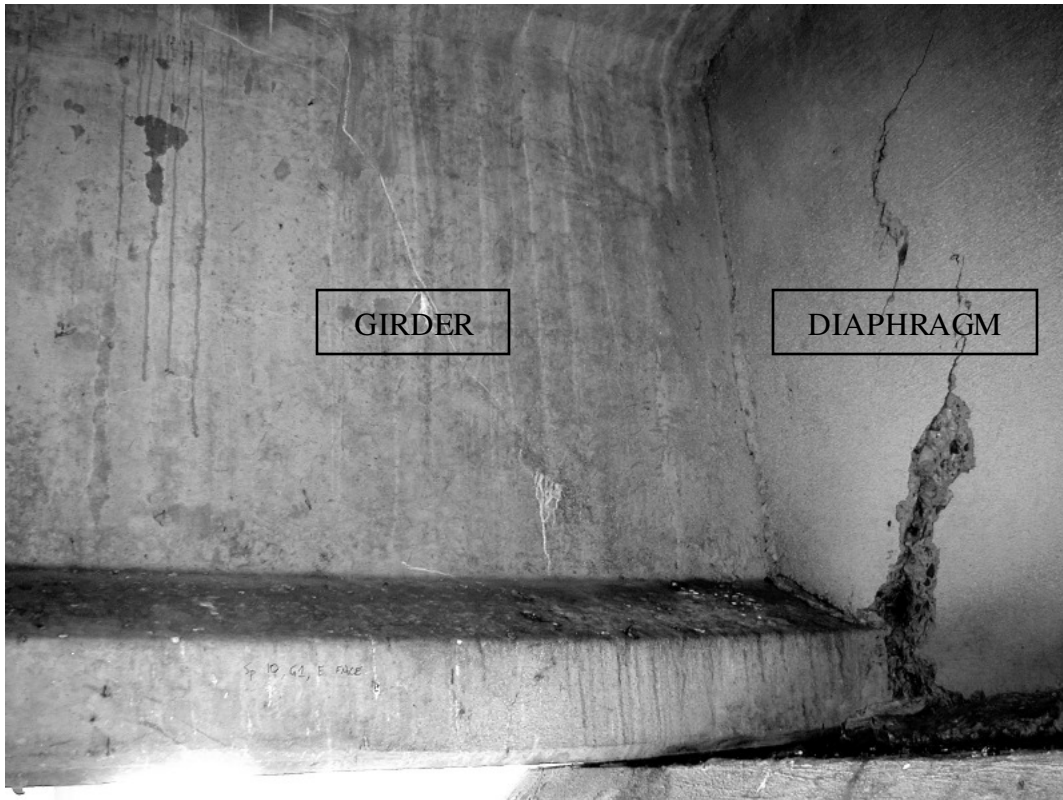
63-inches deep, respectively. Typical AASHTO I-shaped prestressed girders exhibited no cracking. Cracks in the face of the continuity diaphragms were also located during the second inspection, as indicated in Figure 2-2. ALDOT personnel thought that the diaphragm cracks were caused by the girders pulling away from the continuity diaphragm.

Figure 2-2: Cracks in Continuity Diaphragm

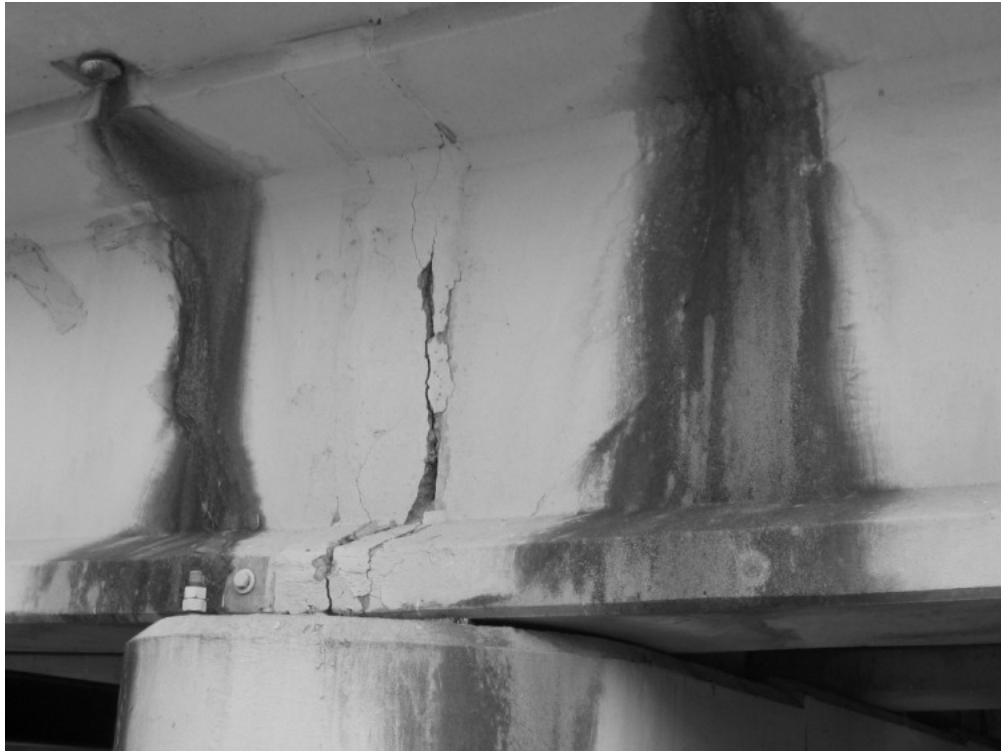
continuity diaphragm (ALDOT 1994c). An example of this cracking may be seen in Figure 2-3. From Table 2-1 below, it can clearly be seen that the bulb-tee girders, especially BT-54 girders, experienced significantly more problems than the uncracked AASHTO girders.

Figure 2-3: End Cracks in the Continuity Diaphragm

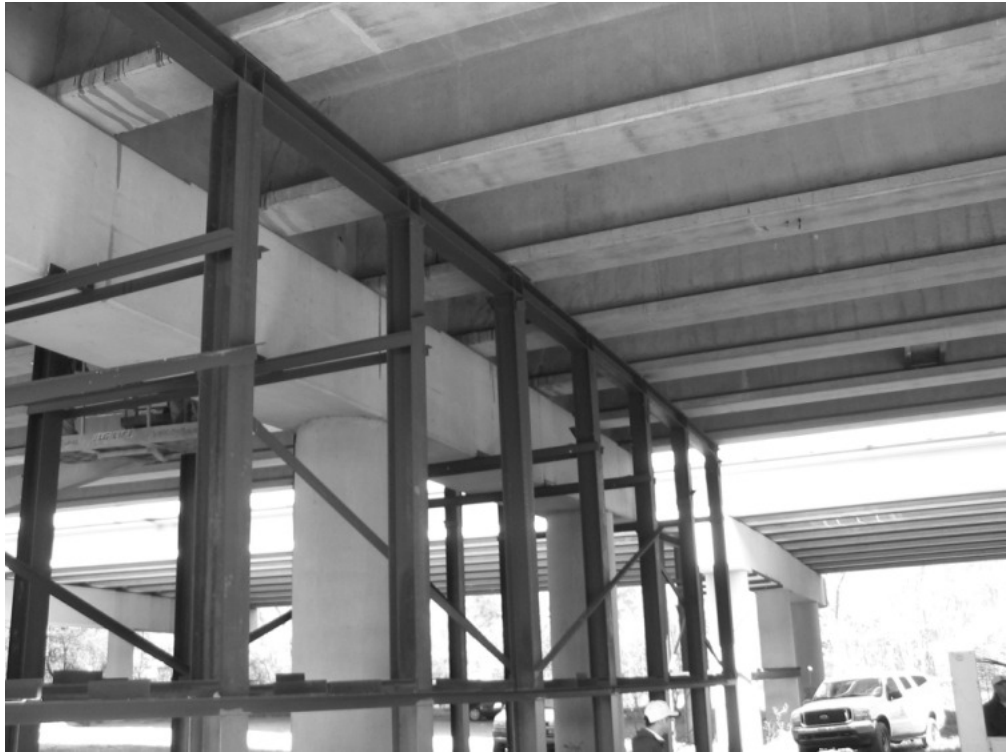
Figure 2-4: False Supports

After realizing the severity of the cracking, ALDOT personnel quickly took action to rectify the situation. False supports, as seen in Figure 2-4, were installed under all cracked girders to prevent a possible collapse. False supports were installed within 10 feet of the bents. The top of the false supports were placed approximately 1 inch from the bottom of the girder and bearing pads were attached atop the false supports between them and the girder as seen in Figure 2-5. The gap allowed for day to day movements of the bridge due to traffic and thermal loads.

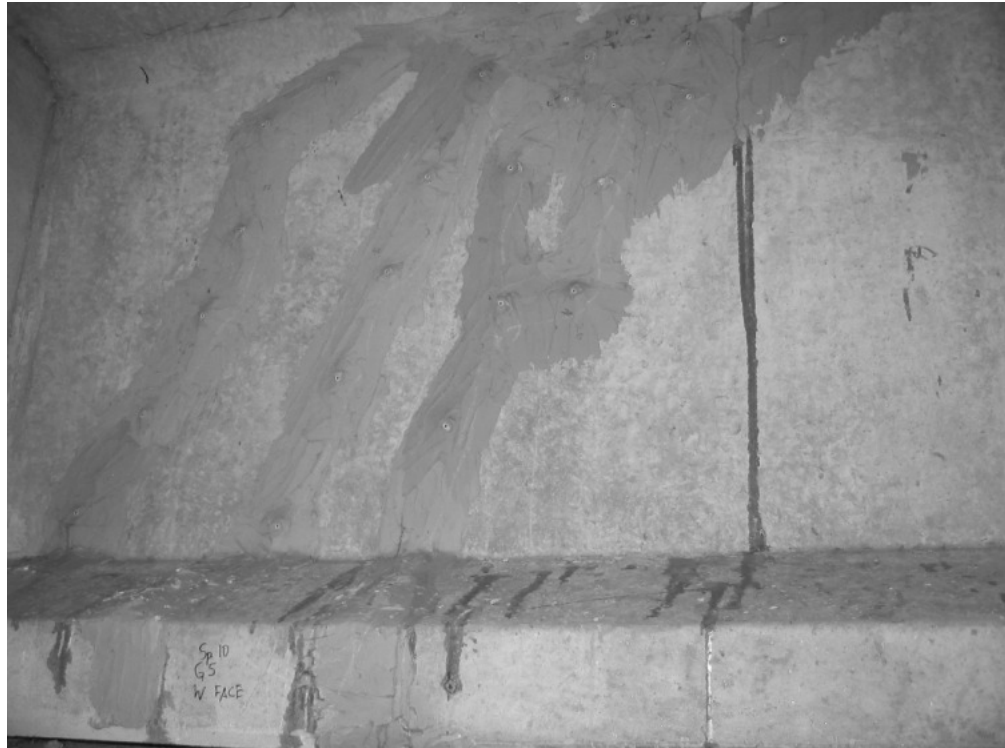
Epoxy was also injected into the cracks located near the ends of the prestressed girders when the cracks were wide open, as seen in Figure 2-6. The epoxy was used to attempt to seal existing cracks, as well as to prevent future growth of the cracks. However, new cracks often formed near the epoxy-injected cracks, and many epoxy-injected cracks reopened. Examples of this can be seen throughout these bridges.

Figure 2-6: Epoxy-Injected Cracks

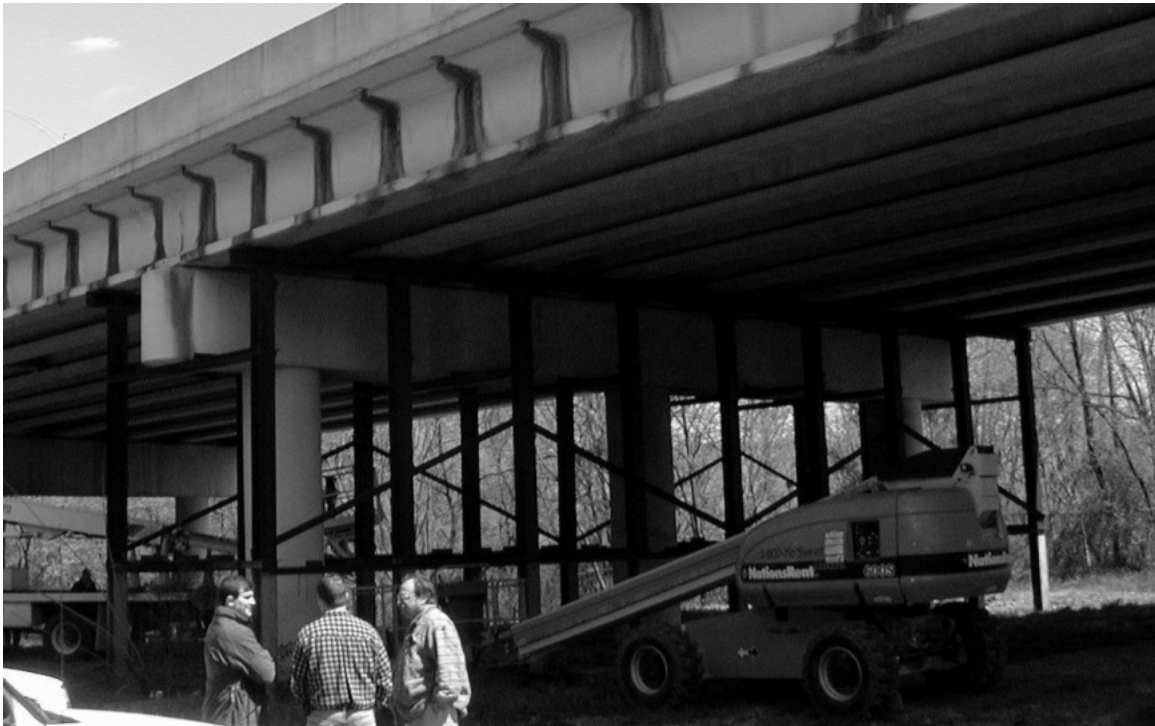
Figure 3-1: Bent 11 South View

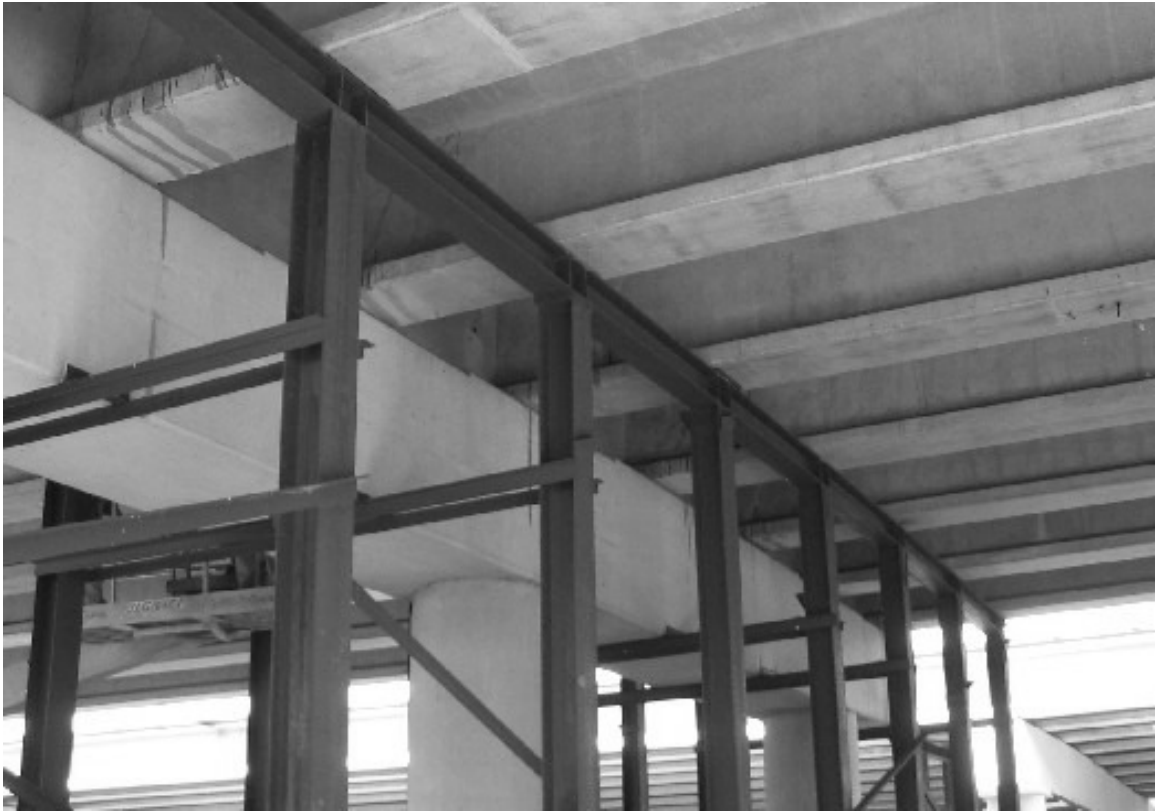
Figure 3-2: Bent 11 North View

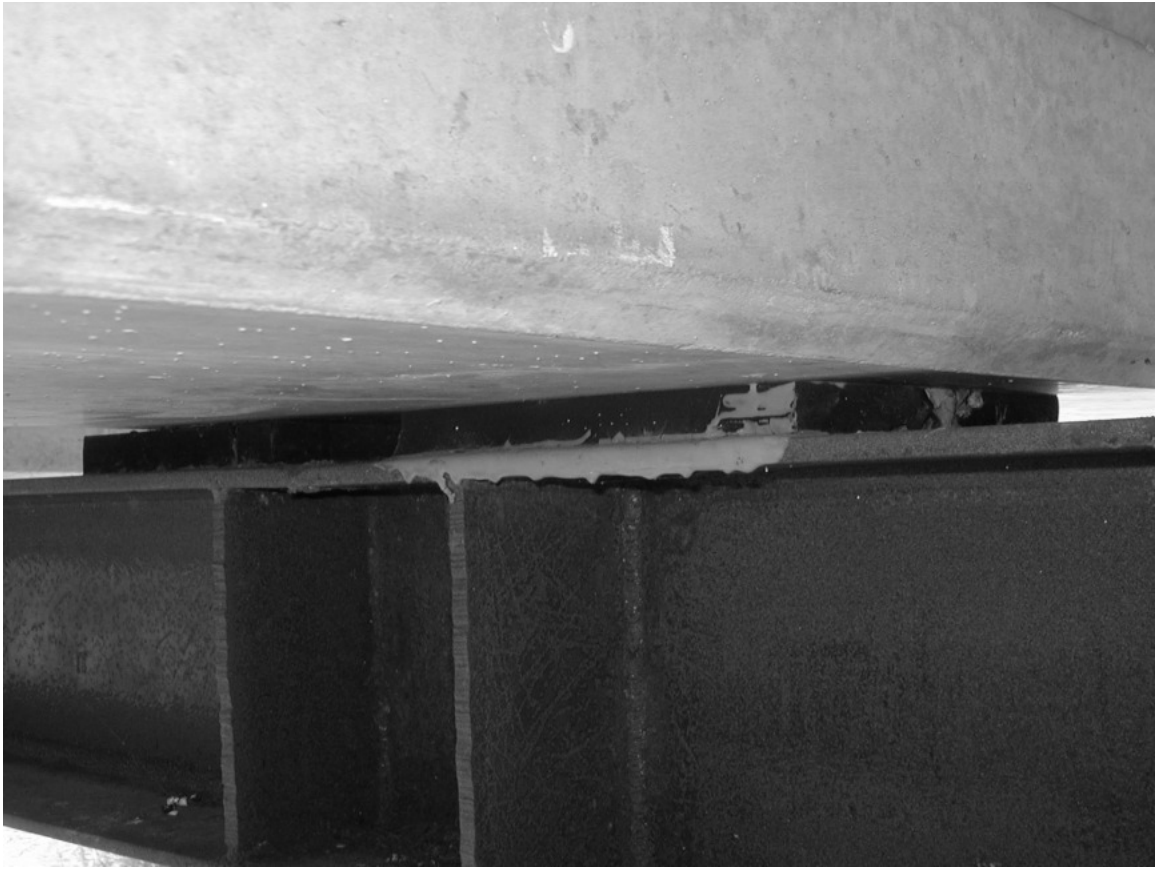
approximately six feet from the bent, to be placed one inch below the girder soffits. The one-inch gap was to be partially filled with an elastomeric bearing pad as shown in Figure 3-3. On inspection, it was obvious that the gap between some of the girders and the false supports had been reduced. As depicted in Figure 3-4, a few girders appeared as though they were actually resting on the bearing pads. The small gap or lack thereof caused several concerns. One was whether the girders were depending on the false support for adequate strength. From initial inspection, this was not thought to be the case. The second concern was how to remove the bearing pad if it is being compressed. One final concern was the difficulty of placing the FRP with only $\frac{3}{4}$ " to 1" of clearance between false supports and girders. This issue must be addressed by the FRP installer.

Figure 3-4: Girder Resting on Bearing Pad

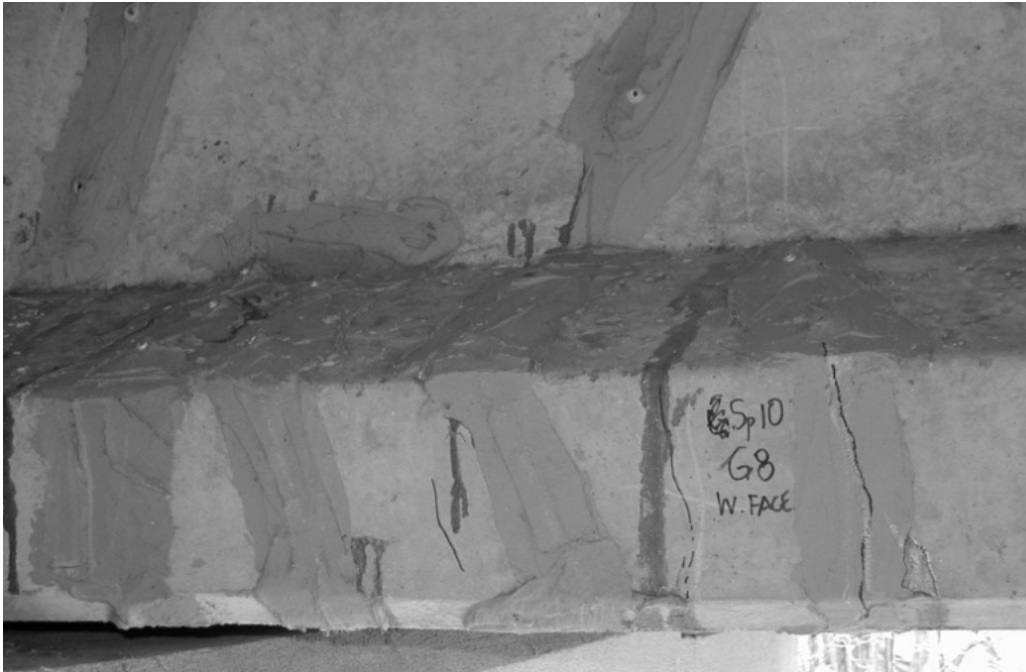
Figure 3-6: Epoxy Sealant to be Removed from Girders Prior to FRP Installation.

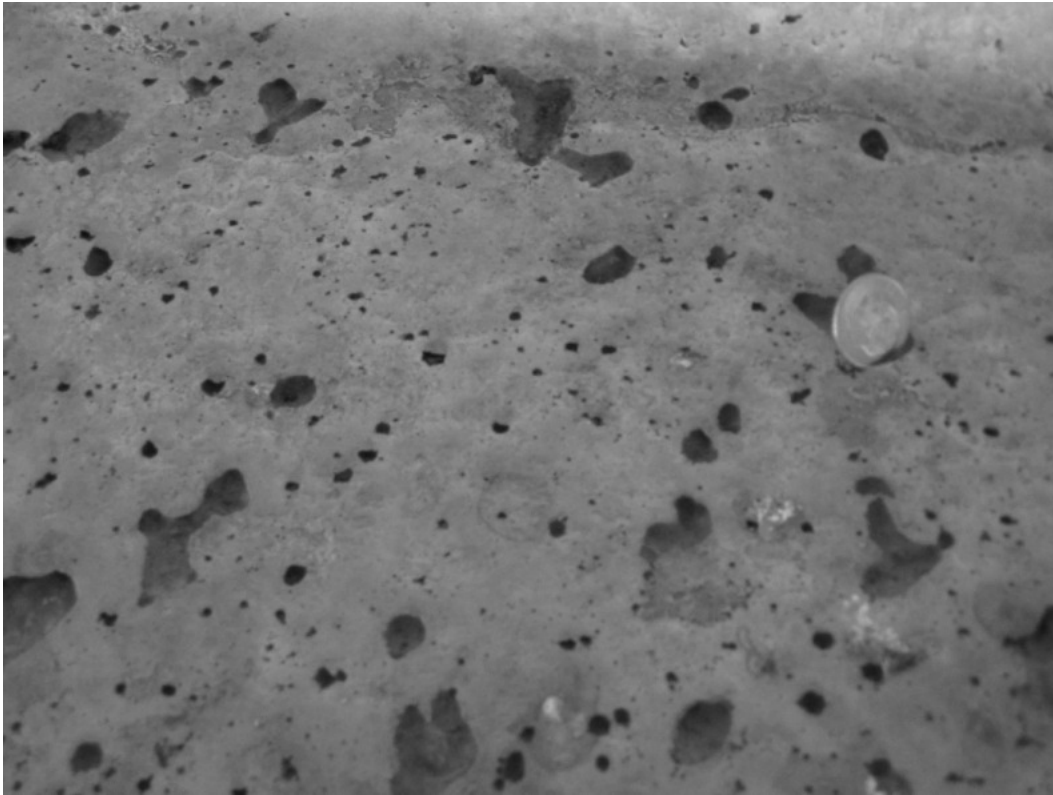
Figure 3-7: Bug Holes to be Filled with Epoxy Putty (Dime for Size Reference)

holes and voids, as seen in Figure 3-7, remaining after the surface profiling should be filled with epoxy putty. “For surfaces that do not allow complete encasement with the composite system, surfaces shall be prepared for bonding by means of abrasive blasting or grinding to achieve a 1/16” minimum amplitude. All contact surfaces shall then be cleaned by hand or compressed air” (Fyfe 2004).

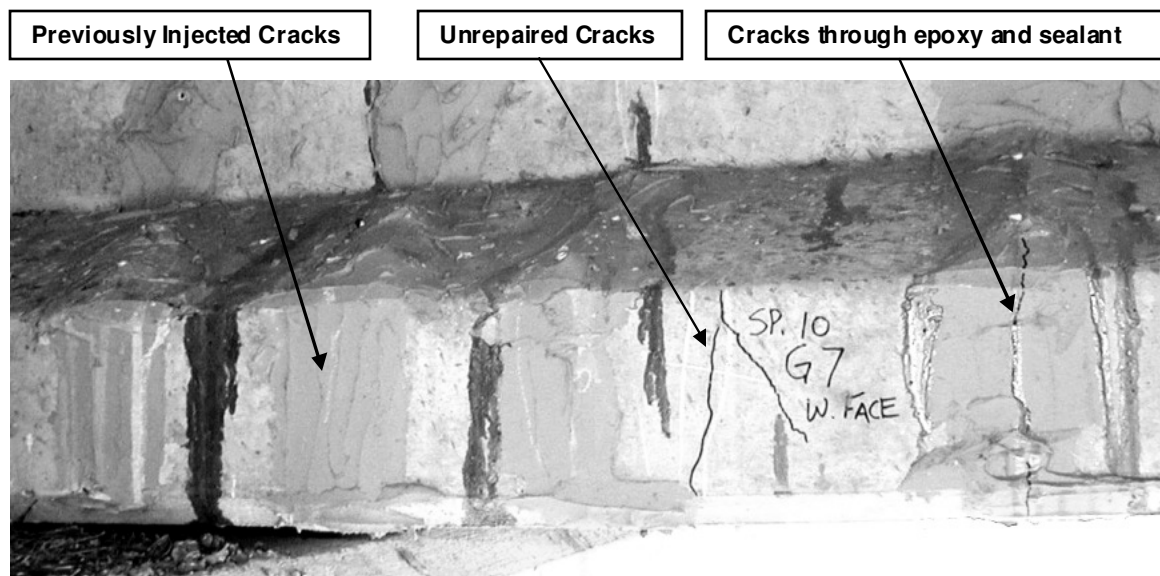
It is stated in ACI 440 that, “Some FRP manufacturers have reported that the movement of cracks 0.010 in. (0.3 mm) and wider can affect the performance of the externally bonded FRP system through delamination or fiber crushing” (ACI 440). Therefore, ACI 440 suggests that “cracks wider than 0.010 in. (0.3 mm) should be pressure injected with epoxy in accordance with ACI 224.1R.” During the inspection of the bridge, no existing cracks were found that measured larger than 0.01 in. No additional epoxy injection will be necessary prior to FRP installation.

Figure 3-8: Types of Cracking
