### Full-Scale Implementation and Testing of Non-Prestressed Full-Depth Precast Bridge Deck Panels with Continuous Shear Pockets

A thesis submitted to the Graduate Faculty of
Auburn University
in partial fulfillment of the
requirements for the Degree of
Master of Science

Auburn, Alabama December 8, 2012

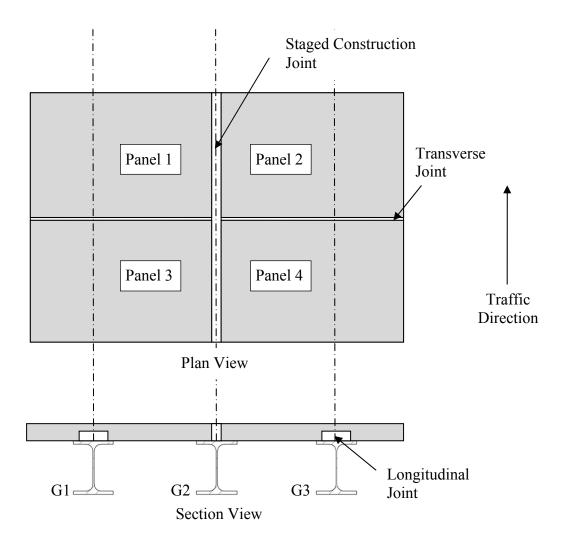
**Figure 2-1: Joint Type Illustration**

These different joint types are described below and are also illustrated in Figure 2-1.

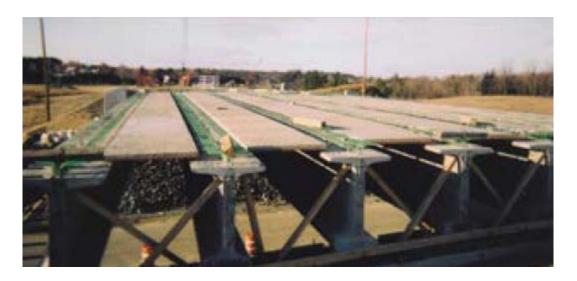
Figure 2-2: Partial-Depth Deck System (Culmo 2011)

Among the earliest applications of precast deck panels was the use of partial-depth concrete panels in order to expedite bridge deck construction projects. These partial-depth reinforced or prestressed panels are typically four inches thick and are placed on top of the beams on interior bays (Culmo 2011). After multiple panels are set in place, a top layer of conventionally reinforced concrete is installed to finish the composite decking system. These partial-depth panels are advantageous because they serve as stay-in-place formwork for the upper slab and also act as structural members useful in resisting traffic loads. Various municipalities have successfully utilized and demonstrated the merits of partial-depth precast concrete deck panels throughout the past century. For example, 85% of all bridges built in Texas utilize the partial-depth bridge deck panels shown below in Figure 2-2 (Culmo 2011).

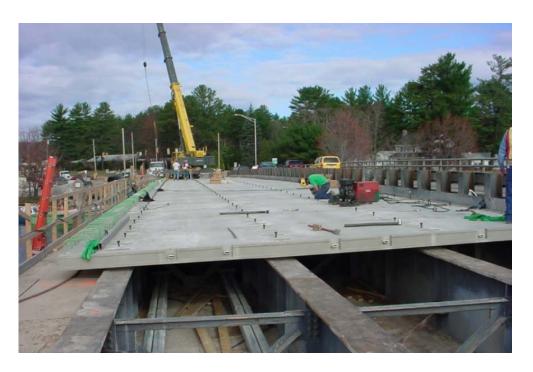
Figure 2-3: Full-Depth Deck Panel System (Culmo 2011)

After an initial popularity and positive response to the reduced deck replacement project durations achieved by partial-depth panel systems, substantial research and development efforts began to focus on other methods to further decrease deck replacement timelines. Among the most popular methods was the development of full-depth precast concrete deck panel systems by different municipalities and researchers across the United States (Badie and Tadros 2008). Similar to partial-depth panels, full-depth systems are comprised of precast concrete panels that are fabricated off-site and transported to the project site for installation as shown in Figure 2-3.

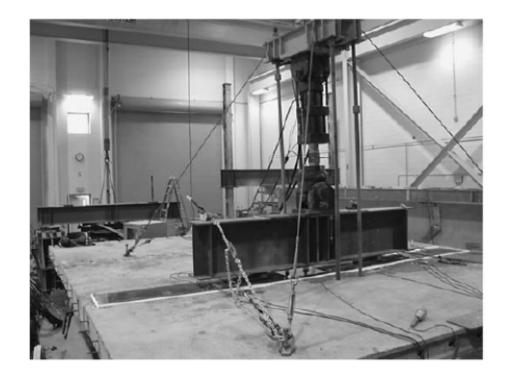
Figure 2-4: Constructed System CD-1 Specimen and Test Setup (Badie and Tadros 2008)

below in Figure 2-4. This testing program validated system CD-1 as a viable full-depth system, and it has accordingly enjoyed widespread implementation in recent years (Culmo 2011).

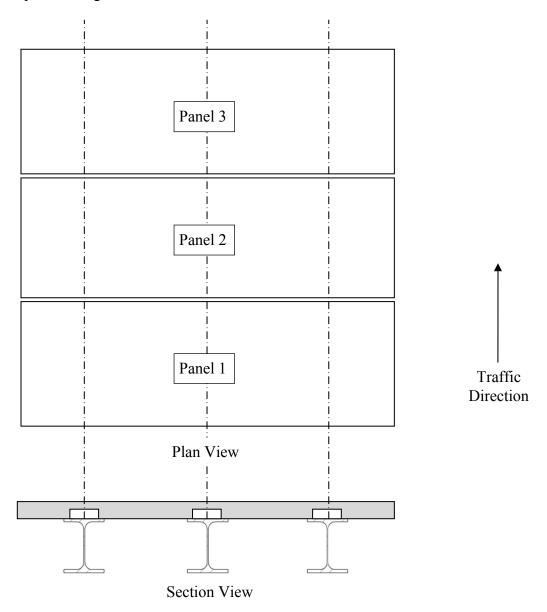
Figure 3-1: Installation Intent of NCHRP System CD-2

are installed perpendicular to the direction of traffic as shown in Figure 3-1 to form the completed bridge deck.

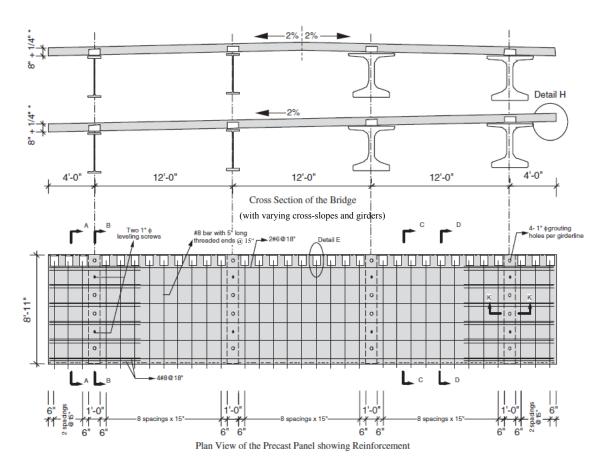
Figure 3-2: NCHRP System CD-2 Plan and Section (Badie and Tadros 2008)

its minor dimension (parallel to traffic) was proposed as 8'-11" in order to allow panel transportation by a typical tractor-trailer truck. The thickness of the deck panels as proposed in the system was 8 1/4" in order to allow for a 1/4" sacrificial grinding surface after panel installations.

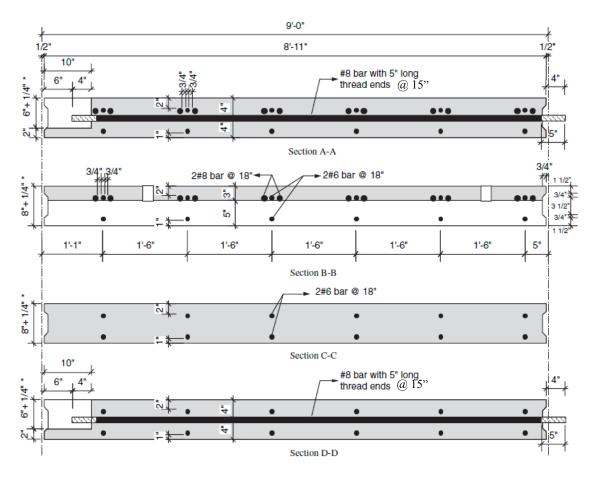
Figure 3-3: NCHRP System CD-2 Cross Sections (Badie and Tadros 2008)

Including both layers of reinforcing in this direction is expected, as bridge deck panels are customarily designed to act in one-way flexure across supporting girders. For areas spanning between girder lines in this direction, the reinforcement configuration proposed is #6 bars at 18" spacing in both the top and bottom layer as seen in Sections C-C and D-D of Figure 3-3. As expected, the cantilevered edge sections of the slab are heavily reinforced in the top reinforcement layer with two additional #8 bars bundled to each previously mentioned #6 bar as shown in Section A-A and B-B of Figure 3-3.

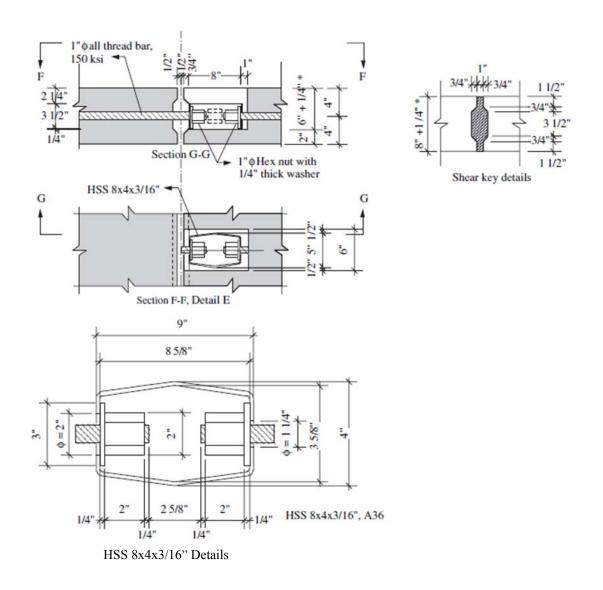
Figure 3-4: NCHRP System CD-2 Transverse Connection Details (Badie and Tadros 2008)

The grouted female-to-female shear key detail utilized in this system transmits shear forces between adjacent panels. This shear key runs the entire width of the panel, is located at approximately the slab mid-height, and includes panel depressions up to <sup>3</sup>/<sub>4</sub>" as shown in Figure 3-4. Extensive research has validated the use of grouted female-to-female shear key joints as being the most practical and durable joint type among available alternatives (Badie and Tadros 2008). In order to achieve best joint performance, it is commonly recommended that the concrete shear key detail be sandblasted to expose aggregate prior to the installation of grout.

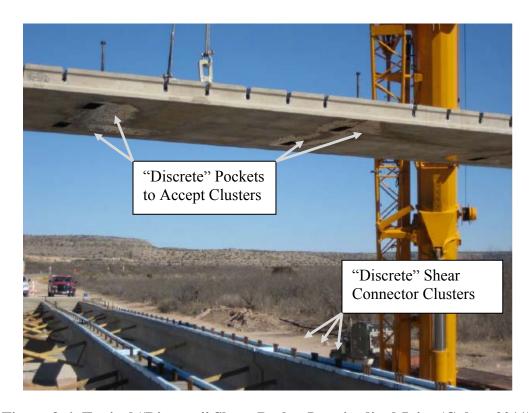
Figure 3-6: Typical "Discrete" Shear Pocket Longitudinal Joint (Culmo 2011)

components via the use of headed shear connectors welded to the steel girder top flanges. Most commonly, this connection type is achieved by the use of "discrete" clusters of shear connectors that fit into preplanned void locations in the precast panel system as shown below in Figure 3-6. This application type is typically called a "discrete" shear pocket connection and is widely utilized.

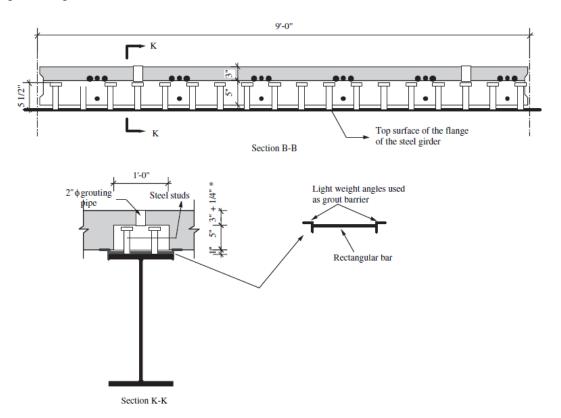
Figure 3-7: NCHRP System CD-2 Longitudinal Connection Details (Badie and Tadros 2008)

As shown in Figure 3-7, only 3 in. of concrete slab remains intact above the "continuous" pocket. This longitudinal joint configuration is not visible from the top surface of the deck panel and is therefore is referred to as a "blind" connection detail. To complete the installation, non-shrink grout is injected into the longitudinal joint through small preplanned ports from the deck surface above.

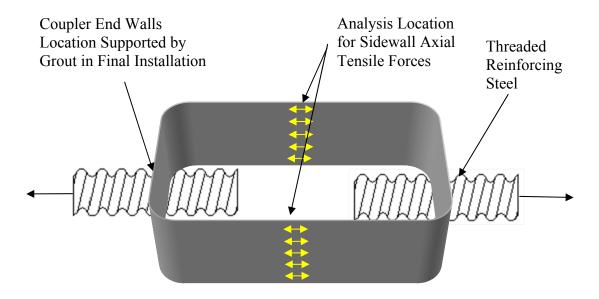
Figure 3-13: HSS Tensile Splice Coupler Design Methodology

For the transverse panel-to-panel joint, the adequacy of the revised CD-2 type detail was verified by the research team. Per AASHTO tension splice requirements, the coupler was sized to resist at least 1.25 times the yield load of the reinforcing bars being spliced (AASHTO 2010). This was accomplished by considering the axial tension forces as distributed uniformly through the HSS coupler sidewall as shown below in Figure 3-13. For analysis purposes of the transverse joint, the coupler end walls were considered continuously supported by adjacent grout in the final installed state and therefore did not require sizing for bending considerations (Badie and Tadros 2008).

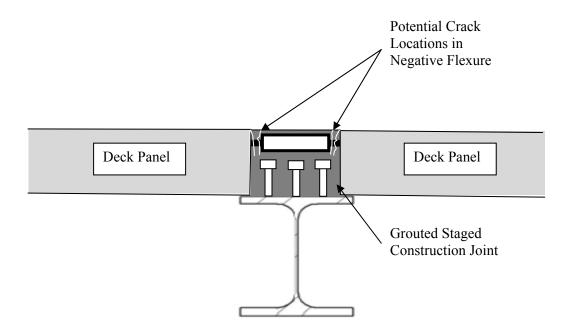
Figure 3-14: Staged Construction Joint Potential Crack Locations

The staged construction joint was designed in a manner similar to that for the transverse joint as detailed above. However, in the staged construction joint, the tension splice is located near the top of the slab instead of at its mid-height as in the transverse joint detail. At this location, the research team anticipated there may be cracking that extends through the full depth of the staged construction joint tensile splice as shown in Figure 3-14.

If this cracking occurs as shown above, it may no longer be valid to assume that the HSS coupler end wall is continuously supported by intact grout in service-level conditions. As a result, an additional method to resist endwall bending was introduced to the coupler detail at staged construction joint locations. After much consideration, the research team chose to utilize reinforcing bar stirrups as oriented in Figure 3-15 to provide confinement and continuous support to the HSS endwall and to assure that grout adjacent to the HSS endwalls remained intact.

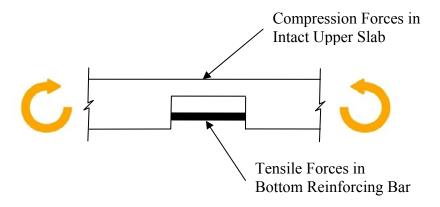
Figure 3-16: Elevation View of Longitudinal Joint in Positive Flexure

joint detail is oriented such that it is conducive to resisting lifting loads by positive flexure as shown in Figure 3-16. It should be noted, however, that the joint is capable of resisting negative flexure up to that required to buckle or yield the unbraced bottom reinforcing bars.

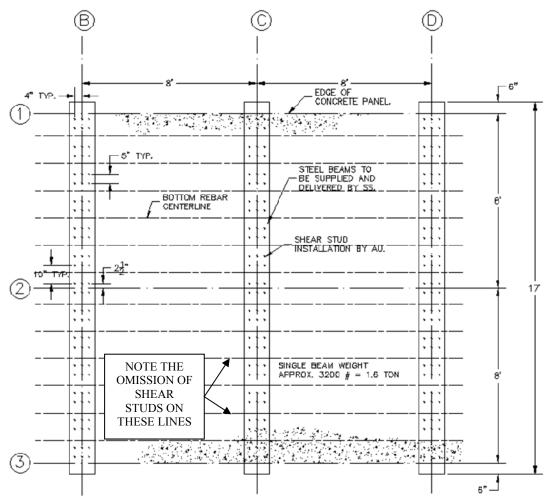
Figure 3-20: Structural Steel Plan View

The girders utilized in the full-size bridge specimen were W27x178 wide flange sections spaced at 8'-0" on center as shown below in Figure 3-20. Headed shear connectors were utilized to achieve composite action between the girders and full-depth precast panels in the final installed state. The shear connector configuration consisted of three connectors across the flange width at a typical longitudinal center-to-center pitch of five inches as shown in Figure 3-21. Shear connectors were omitted in areas which would conflict with panel reinforcing bars spanning across the longitudinal joint detail during panel installation. These conflicting bar locations are shown as dotted center lines in Figure 3-20, and shear connectors are omitted accordingly.

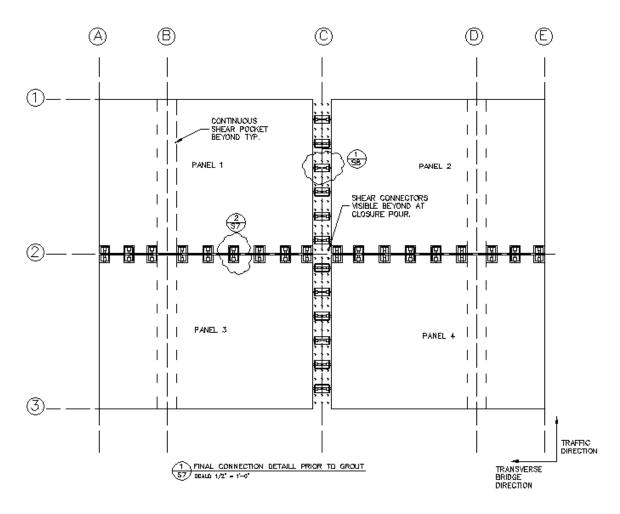
Figure 3-26: Specimen Plan Prior to Grout Installation

Substantial effort was devoted to the detailing of connections due the complexity of connection types included in the specimen. Figure 3-26 shows a specimen plan view with all panel connections visible. Figures 3-27 and 3-28 illustrate the final configuration of the transverse joints and longitudinal joints, respectively.

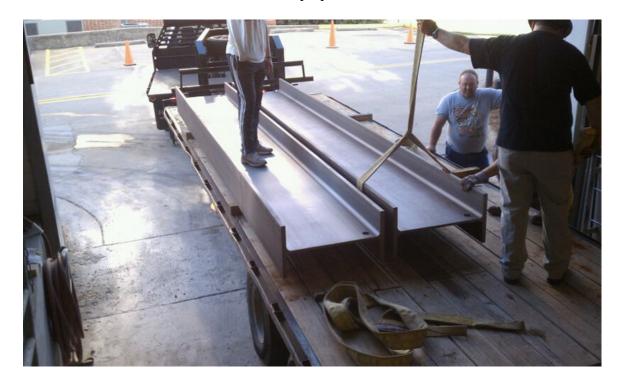
Figure 4-1: Delivery of Steel Girders

The longitudinal girders were delivered to the laboratory as W27X178 wide flange steel sections cut to 17'-0" length as shown in Figure 4-1. Each girder was

outfitted with lifting holes to assist in handling by laboratory staff. The girder top flanges were machined to remove mill scale and to prepare the surface for shear stud installation.

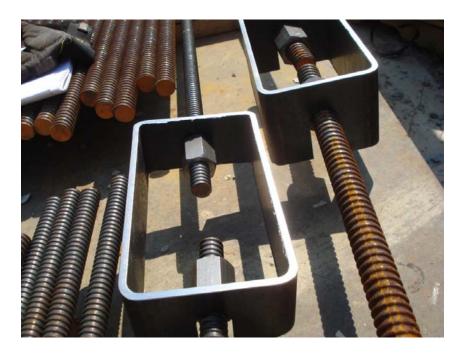
Figure 4-2: Test Fit of HSS Coupler: Staged Construction (left) and Transverse (right) End Elevation

Fabrication of the HSS couplers for both the transverse and staged construction joint was completed by a local steel fabricator. After manufacture, the couplers were test-fit onto the corresponding threaded bar size to assure intended fit as shown in Figures 4-2 and 4-3. Feedback from the fabricator regarding the prohibitive difficulty of bulging sections of this size was consistent with the preliminary findings of the research team.

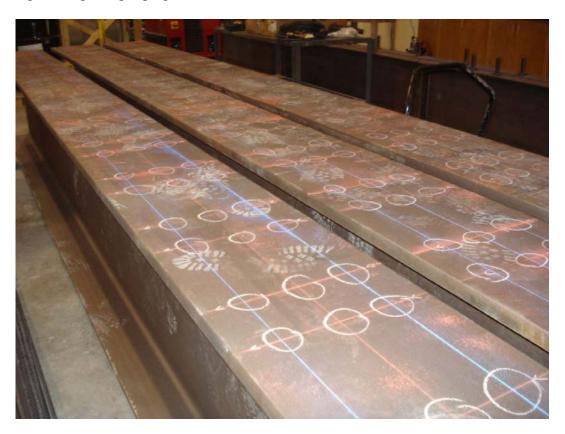
Figure 4-4: Girder Top Flange Prepared for Shear Connector Placement

Installation of the shear connectors was completed by laboratory staff under the supervision of representatives of Nelson Stud Welding Company. Figure 4-4 shows the steel girder top flanges prepared to receive welded shear connectors.

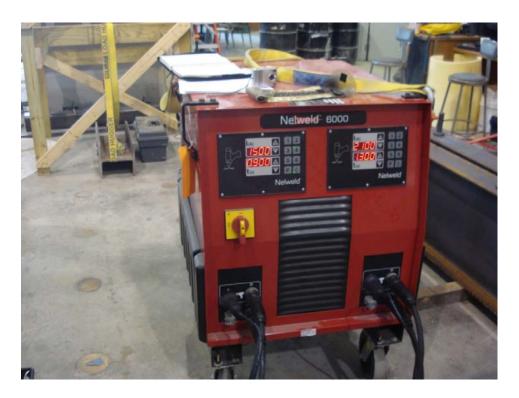
Figure 4-5: Nelson Nelweld 6000

The laboratory staff utilized a Nelson Nelweld 6000 stud welding machine equipped as shown in Figures 4-5 and 4-6. The setup consists of the stud welding machine, welding leads, and a stud welding gun.

As recommended by the stud manufacturer for the size utilized in this project, the ¾" diameter shear connectors were welded using a current of 1500 amps applied for 0.9 seconds. Welds produced using this configuration met quality control requirements for stud-type connectors as outlined in the American Welding Society (AWS) Bridge Welding Code (American Welding Society 2008). Among the most critical requirements for satisfactory welds are visual inspections showing full 360-degree flash and bend tests. Figure 4-7 shows a quality control bend test performed in accordance with the provisions of AWS Section 7.6.

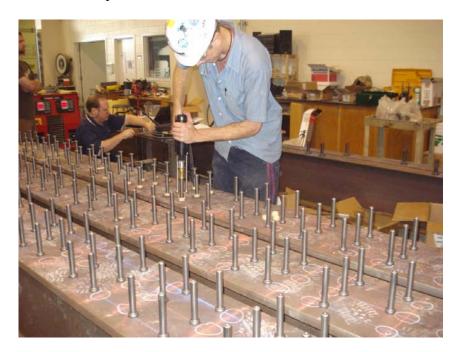
**Figure 4-8a: Shear Connector Welding Process**

The stud welding process is shown below in Figure 4-8a. The burn-off length, or the shortening of the stud due to the welding process, was consistent with manufacturer predictions and yielded final stud installations with a total height of 5" as intended by

specimen design. Figure 4-8b shows the final installation of shear connectors to girder top flanges before clean-up.

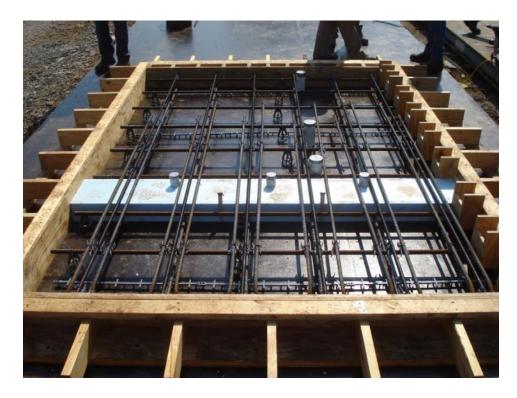
Figure 4-9: Typical Panel Formwork Looking Perpendicular to Girder Line

Due to the relative complexity of the panel geometry, significant effort was devoted to the manufacture of formwork appropriate to panel construction. The contractor noted that the system geometry is conducive to the manufacture of reusable metal formwork for future production of large panel quantities. Dense foam was utilized as a block-out for the continuous shear pocket areas. Use of this foam proved convenient to prevent concrete from entering the continuous shear pocket, while also allowing a reinforcing bar to continue through the pocket area. The formwork is shown in detail in the photos of Figures 4-9 through 4-13. These figures include detailed views for each of the joint types.

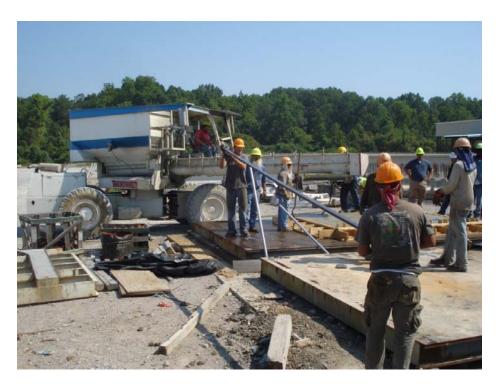
Figure 4-14: Placement of Concrete for Typical Deck Panel

Concrete was transported from the on-site mixing facility and placed as shown in Figure 4-14 using a concrete buggy. After placement, the concrete was vibrated and received a smooth troweled finish, as shown in Figure 4-15.

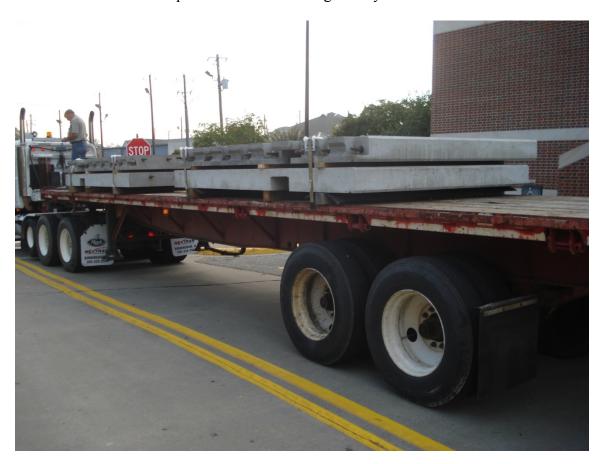
Figure 4-16: Loaded Trailer upon Arrival at Testing Facility

The precast panels in this study were successfully transported along 130 miles of highway road with no significant load shifting or damage. Figures 4-16 through 4-18 document the loaded trailer upon arrival at the testing facility.

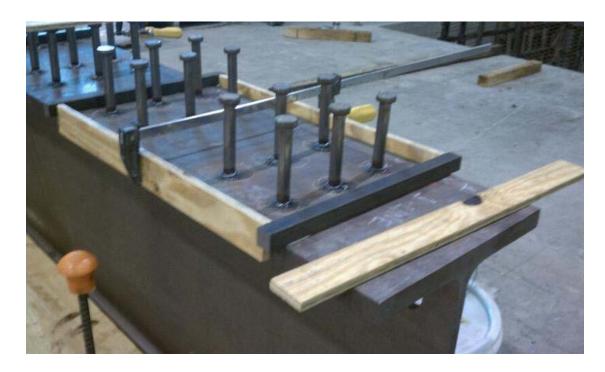
Figure 4-19: Forming of the Bridge Haunch Prior to Panel Arrival

It was important to the research team to form the haunch prior to panel placement in order to minimize the under-slab work required after panel placement. Any construction tasks required to be completed from the underside of newly-installed deck panels are among the most dangerous for construction workers and often require specialized preplanning and safety equipment on bridge replacement projects.

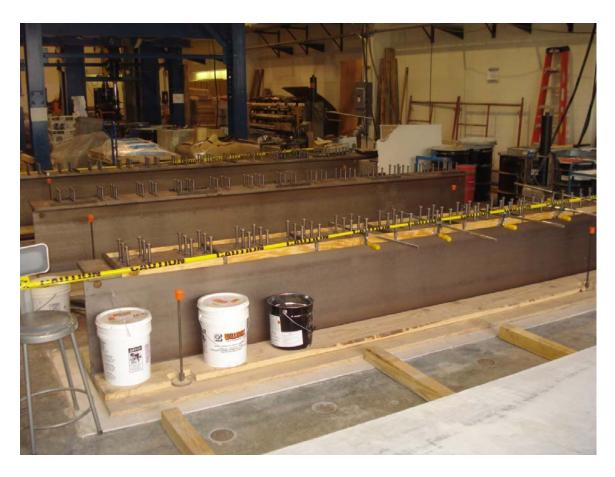
Figure 4-20: Girder Configuration Prior to Deck Panel Placement

First, the girder positions were carefully surveyed to assure proper installation. Next, the girders were moved into place by an overhead gantry crane. After positioning, the girders were attached to the laboratory floor utilizing the preplanned details included in the construction drawings. Next, the haunch was formed using one-inch-width spacing bars and plywood as shown below in Figure 4-19. A completed view of the deck support girder setup prior to panel placement is shown in Figure 4-20.

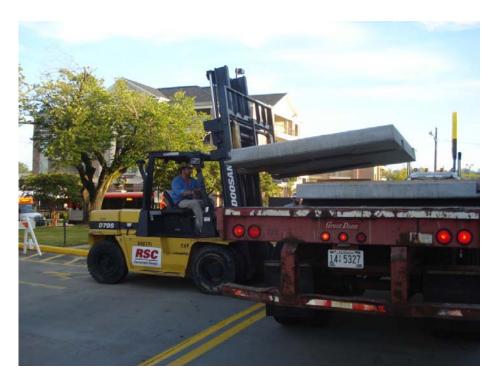
Figure 4-21: Deck Panel Offloading Using Forklift

In a real-life deck replacement project, deck panels are installed directly from truck trailers into final set position using large overhead cranes. Due to the constraints of the research laboratory used in this investigation, panels had to be offloaded using a forklift prior to lifting by the interior laboratory gantry crane. The research team took careful precautions to evaluate and analyze the deck panels for potential force effects induced by the somewhat unorthodox offloading by forklift. The photos shown in Figures 4-21 and 4-22 document the offloading process.

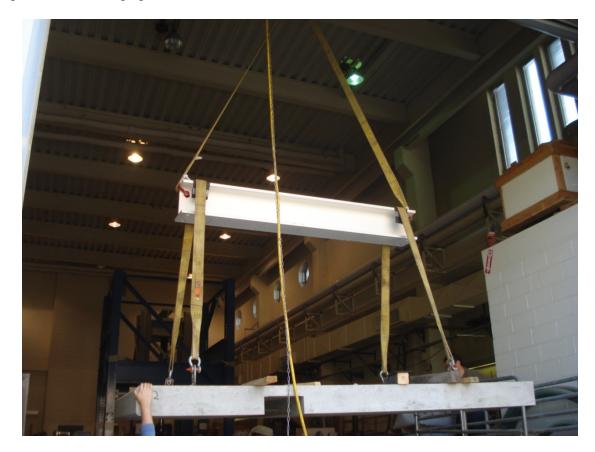
Figure 4-23: Deck Panel Lifting Configuration Including Spreader Beam

After positioning the panels within the delivery bay door, the overhead gantry crane was used to lift the panels. The research team was careful to adhere to the preplanned lifting plan, including the use of a spreader beam, as previously discussed in Chapter 3. Figure 4-23 shows the orientation of the spreader beam used during all deck panel crane lifting operations.

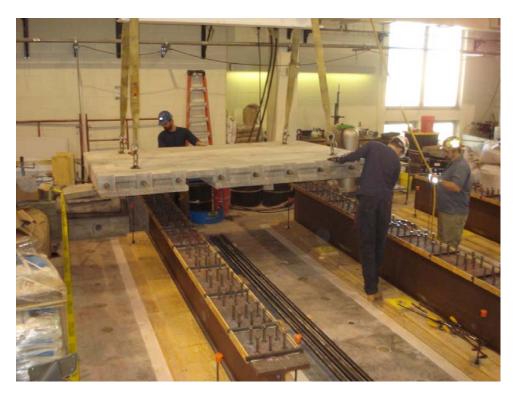
Figure 4-24: Positioning of Typical Deck Panel

The concrete deck panels were carefully maneuvered into final position using the overhead gantry crane. The laboratory staff was able to successfully locate all four panels into final position without incident in less than 90 minutes. Placement tolerances

as reflected on the construction drawings proved sufficient in all cases to avoid conflicts among various construction elements. The photographs in Figures 4-24 and 4-25 show panel placement operations.

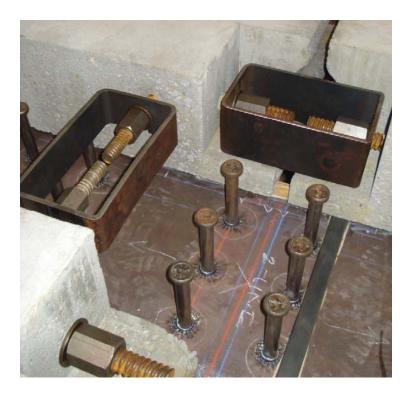
**Figure 4-26: Initial Panel-to-Panel Connections**

After all four panels were in final position, the transverse and staged construction panel-to-panel connections were made. The laboratory team completed installation of the slotted HSS couplers with ease in both joint types. After the HSS couplers were lowered into place, nuts on the threaded bars were tightened. It was necessary to use small wooden spacing blocks between panels to preserve the required 1 inch grout installation gap and also to allow uniform tightening of connections along the panel length. Finally, the staged construction joint was completed by installation of the confining horizontal steel stirrups around the HSS couplers. Preparation and installation of the stirrups for the staged construction joint proved to be the most time-consuming activity associated with panel connections. Figure 4-26 shows the initial panel connections prior to installation of staged construction joint confining stirrups. Figures 4-27 and 4-28 show detailed views of the completed transverse and staged construction connections, respectively.

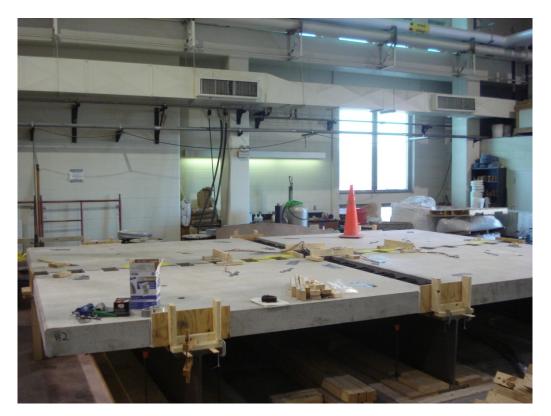
Figure 4-29: Formwork Prior to Grout Installation

After panel placement and mechanical connections were complete, the laboratory team fabricated formwork to allow grout placement from above. This consisted of end

forms on each continuous shear pocket, forms on each end of the transverse joint, and any necessary formwork below the specimen deck. The final formwork configuration is shown in Figure 4-29.

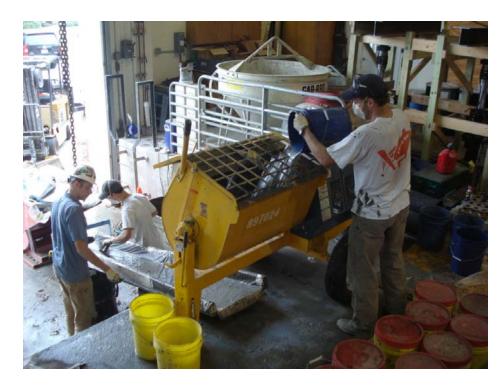
**Figure 4-30: Grout Mixing Station**

Due to the relatively small volume of grout required for this project, the grout was prepared on-site by a team of laboratory workers. The non-shrink grout utilized in this investigation was batched, mixed, and installed per published manufacturer instructions and also specific recommendations from manufacturer representatives. A team of ten workers was able to mix and place the grout in approximately 5 hours. The grout installation process is documented via photos in Figures 4-30 through 4-35.

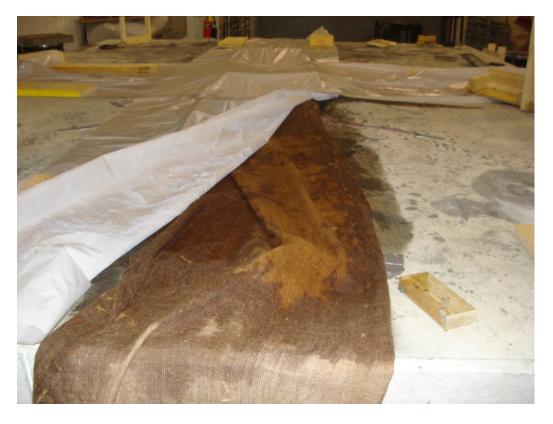
Figure 4-36: Moist Curing of Grouted Joints

The grouted joints received a moist cure per manufacturer recommendations. The research team chose to extend the duration of the moist cure past the required 24 hours in order to reduce the probability of shrinkage cracking of the grout surface. The wet cure was achieved by placing wet burlap and plastic sheathing as shown below in Figure 4-36. The laboratory team continually moistened the burlap for the wet cure duration. Upon stripping of the wet cure, the research team did note minor surface cracking perpendicular to the staged construction joint at various locations along the joint length as shown in Figure 4-37. This shrinkage cracking appeared cosmetic in nature, was documented, and monitored for growth throughout the remainder of the project.

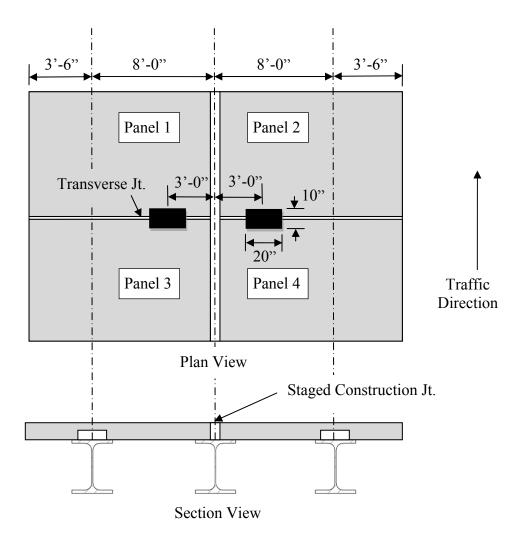
Figure 5-2: Load Positioning for Case I

In choosing the deck surface locations to apply the tire contact loads, the research team followed guidance from the ASTM C-6275 specification. This specification logically recommends that the truck wheel loads be positioned in locations as to produce the maximum force effects across critical deck sections (ASTM 1998). A summary of the two load cases as selected by influence line diagrams is illustrated below in Figure 5-2 and 5-3, respectively.

Load Case I corresponds to the maximum negative moment induced at the middle girder staged construction joint location. As seen in Figure 5-2, the tire contact areas are located symmetrically across the tranverse construction joint in this configuration. The research team chose to orient the loads in this manner in order to evaluate local moment resistance durability of the transverse joint when subject to directly applied loads.

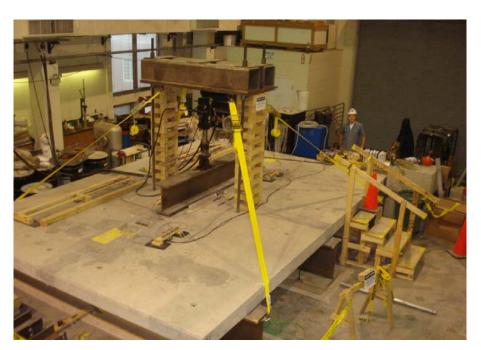
Figure 5-4: Fully Assembled Load Testing Frame from Above

A load testing frame, as shown below in Figures 5-4 and 5-5, was specifically designed for this test program in order to facilitate loading locations as detailed above. The loading frame consisted of four threaded bars, a top spreader beam, a bottom spreader beam, and stabilization straps. These can all be seen in Figures 5-4 and 5-5. Complete details for the load testing frame utilized in this investigation are included in Appendix B.

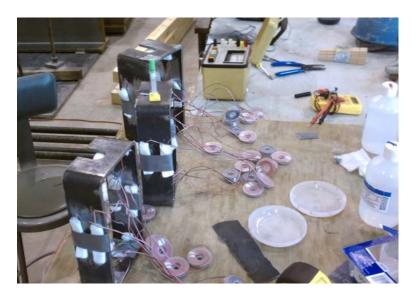
Figure 5-7: HSS Coupler Strain Gage Instrumentation

Internal instrumentation in this study consisted of four heavily instrumented HSS couplers. Internal instrumentation was positioned exclusively for use during the heavily instrumented symmetric Load Case I and was not used for later loading configurations. Figure 5-6 shows the locations of the instrumented HSS couplers, as well as the particular locations of the 52 strain gages used for this purpose. Note that the confining stirrups located at the SC1 and SC2 locations were instrumented as well and are labeled accordingly below. Figure 5-7 shows the gages installed on two couplers prior to installation, while Figure 5-8 shows the fully installed gage configuration during grout

installation. Note that sidewall gages are installed at third-points along the wall height as shown in Figure 5-7, while endwall gages are installed at coupler mid-height.

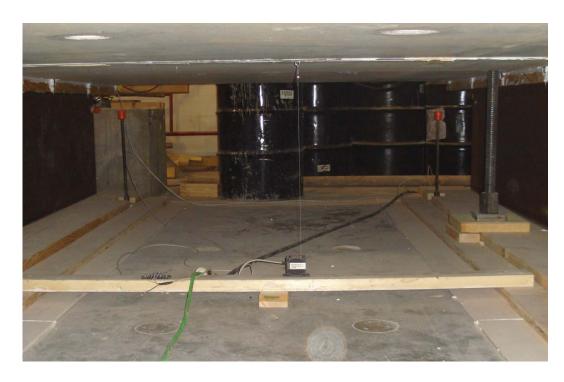
Figure 5-10: Typical Under-Slab Drawstring Displacement Gage Application

Figure 5-10 shows a typical drawstring displacement gage application attached to the underside of the concrete deck system. Figure 5-11 shows a typical joint gage configuration consisting of a laser displacement and various concrete strain gages positioned across the staged construction joint.

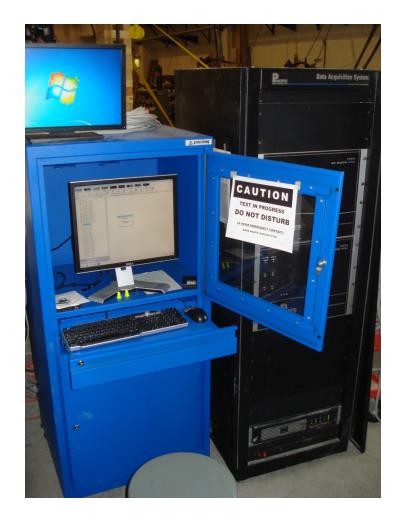
Figure 5-12: Data Acquisition System

For the purposes of this investigation, data acquisition was completed using both a Pacific Instruments 6000 Series Data Acquisition System (DAS) as well as using other manual analog data recording methods. Load Case I was closely monitored by the DAS in order to provide insight into both the global slab behavior and the HSS coupler resistance mechanisms. Load Case II, which served mainly as a validation test for the longitudinal joint, received limited instrumentation, which was manually recorded using analog methods. The DAS utilized in this experiment is shown below in Figure 5-12.

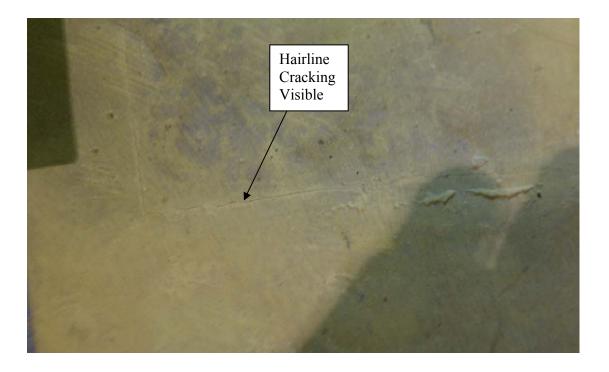
Figure 6-1: Hairline Cracking at Transverse Grout-to-Concrete Interface

observed in either the concrete of the precast panel or within the grouted areas of the joints. However, the research team did observe minor hairline cracking at certain concrete panel-to-grout interface locations during static load testing at peak loadings. These hairline cracks were only detectable by the research team under two unique circumstances: in areas where grout overspill created a thin membrane of grout across interfaces, and when interfaces were viewed through marking paint. Figure 6-1 shows a hairline crack visible through yellow marking paint at a transverse grout-to-concrete interface.

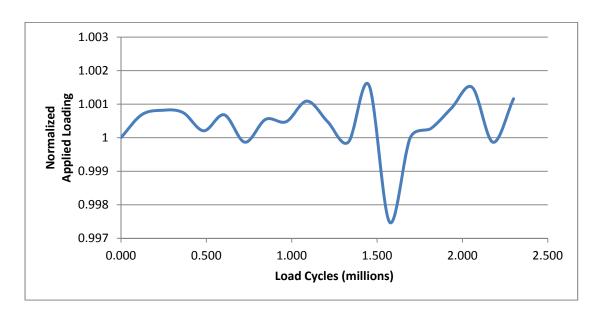
Figure 6-12: Normalized Applied Loading During Cyclic Testing

Cyclic load testing was completed as planned without interruption. The research team concluded the cyclic load testing at approximately 2,300,000 load cycles. During cyclic load testing, it was noted that the actual applied peak cycle load varied slightly from the specified peak cycle load on the analog controller. Variations such as those noted may be a result of hydraulic system limitations and/or varying dynamic response modes of the loading frame. It is important to note that although the peak load slightly varied throughout testing, the research team assured the desired 42.6 kip load range was preserved for each load cycle. Figure 6-12 shows the actual applied peak cycle loading throughout the test measured at the actuator head, normalized with respect to the initial specified peak load. Note in this plot that the applied load did not deviate from the desired load range by more than +0.15% or less than -0.25%.

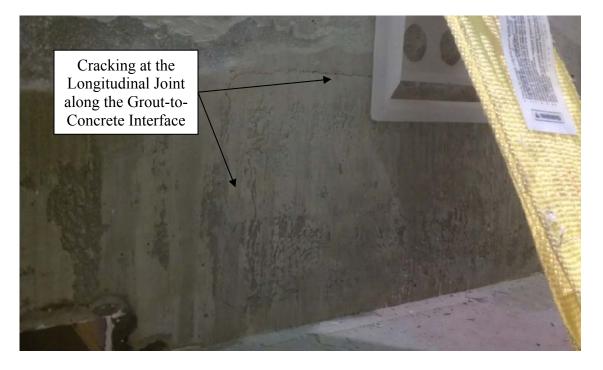
Figure 6-16: Minor Cracking at Longitudinal Joint Grout-to-Concrete Interface

Visual inspections by the research team showed no discrete cracking visible from the top surface of the bridge deck system. Similar to all previous tests, minor hairline cracks were barely detectable at grout-concrete interface locations and were not observed to increase in width throughout testing. The research team also did note the development of minor cracking around the grouted area of the longitudinal joint as visible when viewing the girder ends as shown below in Figure 6-16. These minor cracks developed along the grout-to-concrete interfaces upon initial Load Case II specimen loading, were barely detectable, and did not appear to grow in width during testing.

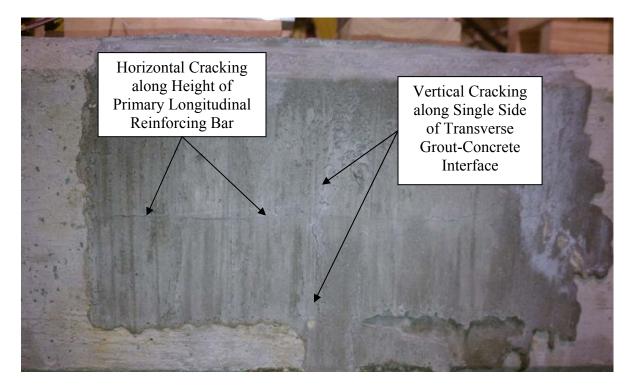
Figure 6-17: Grout Cracking at Transverse Joint Edge Splice Location

cracking appeared to be isolated and only present on the edge splice location on the side of the applied loading.

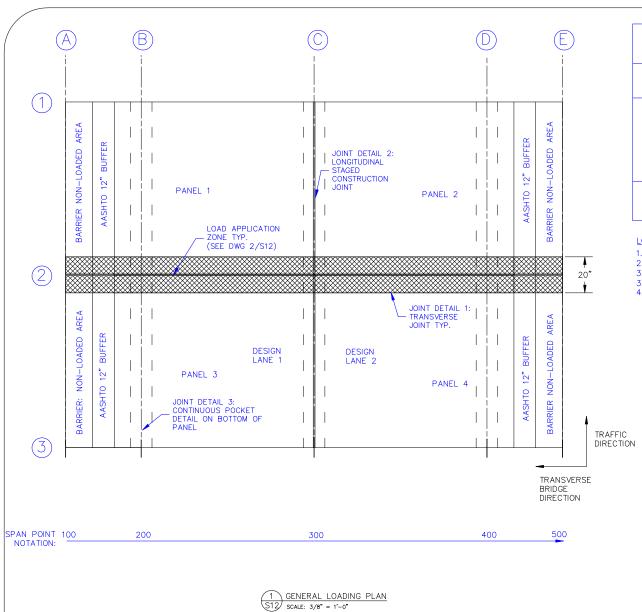
DETAIL NUMBER	JOINT TYPE	DESIGNED FOR SHEAR	DESIGNED FOR + MOMENT	DESIGNED FOR - MOMENT
1	TRANSVERSE JOINT	X	X	X
2	LONGITUDINAL STAGED CONSTRUCTION			X
3	CONTINUOUS SHEAR POCKET			X
