Laboratory and Field Testing of Precast, Three Sided Arch Culverts

A thesis submitted to the Graduate Faculty of
Auburn University
in partial fulfillment of the
requirements for the Degree of
Master of Science

Auburn, Alabama
August 4, 2012

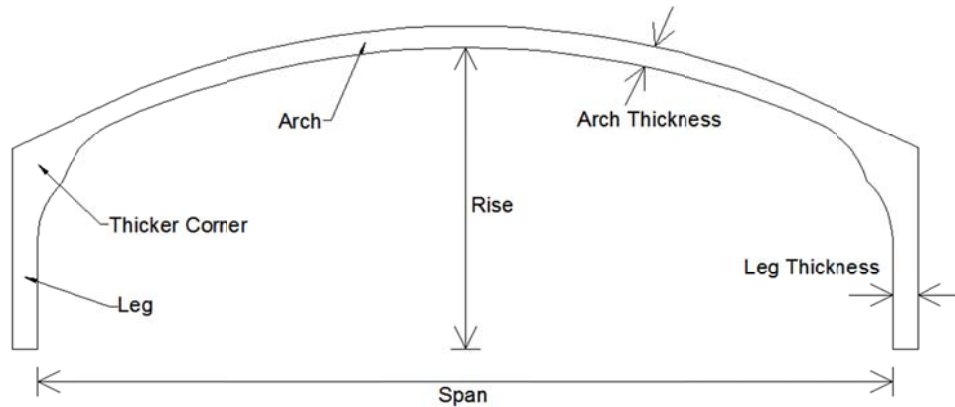
Figure 2-3 Typical Three-sided Arch Culvert Unit

The three-sided arch culvert consists of a circular arch with a large radius that frames into two legs, which bear on the foundation. The corners of these culverts have an increased thickness

to account for the higher strength demands and allow the load path to better transition into vertical loads in the legs. The arch shape converts a portion of the vertical load into axial forces in the concrete, therefore allowing these culverts to have thinner sections along their span compared to typical box culverts. Units have a uniform thickness along the arch and a uniform thickness in the legs, with geometry dictating the thickness in the corners. A sketch of a typical three-sided arch culvert unit can be seen in Figure 2-3.

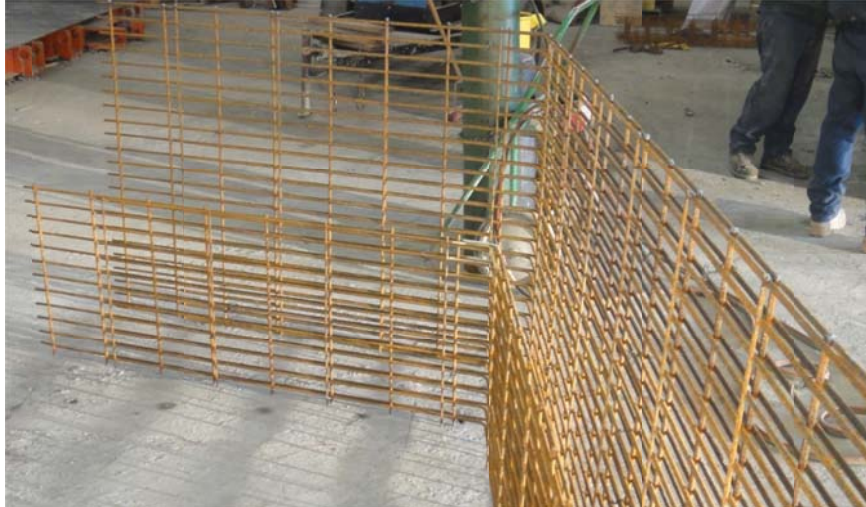
Figure 2-4 Deformed Welded Wire Fabric

Reinforcement of these units generally consists of mats of deformed welded wire fabric, such as that seen in Figure 2-4. These mats of reinforcement can be used in single or double layers, and the wires have a small enough diameter that they can be easily bowed to fit the curved arch section without kinking, as seen in Figure 2-5.

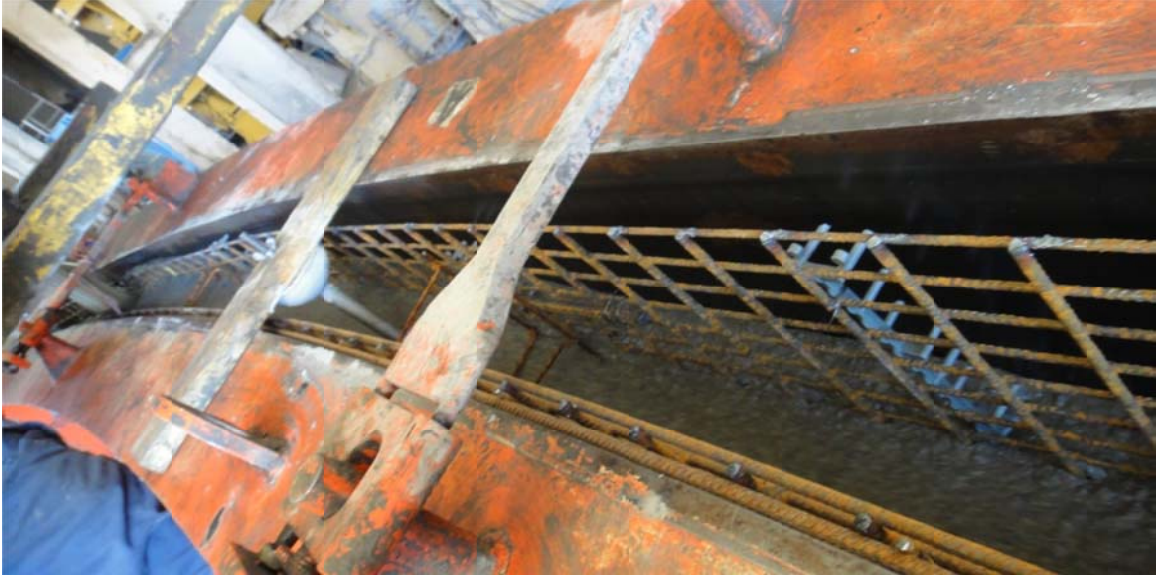
Figure 2-6 Casting of Bridge Unit

Due to the thin sections in which concrete is cast, these units are cast on their sides, using highly flowable concrete that requires minimal vibration. An image of the casting process can be seen in Figure 2-6.

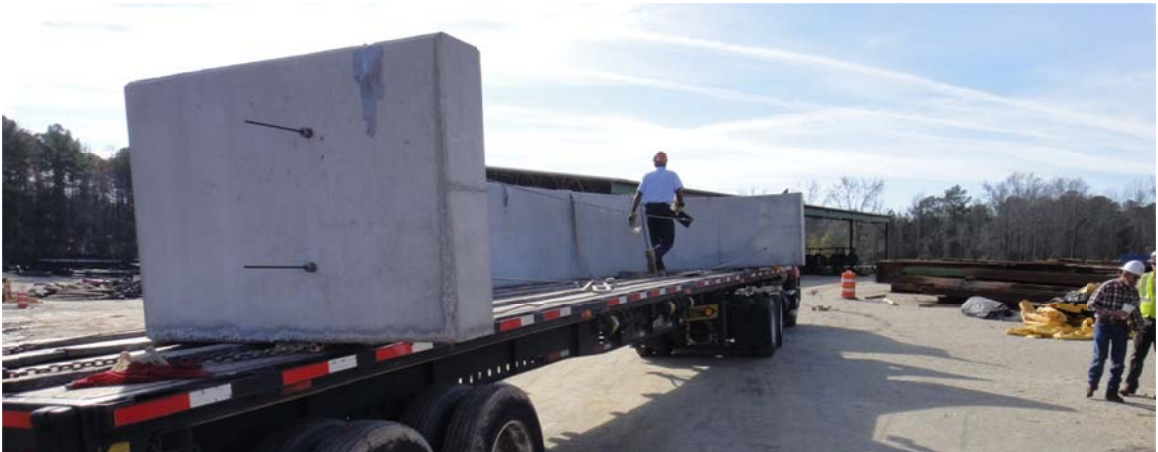
Figure 2-7 Arch Culvert Unit Being Shipped

Units are shipped via truck, with one unit per trailer, due to the geometry of the arch units. With the exception of shorter span, low-rise units, units are also shipped on their side. At the site, units are lifted, rotated in midair, and set in place by a crane using pick points. An image of the shipping orientation of an individual bridge unit can be seen in Figure 2-7, and an image of the rotating process can be seen in Figure 2-8.

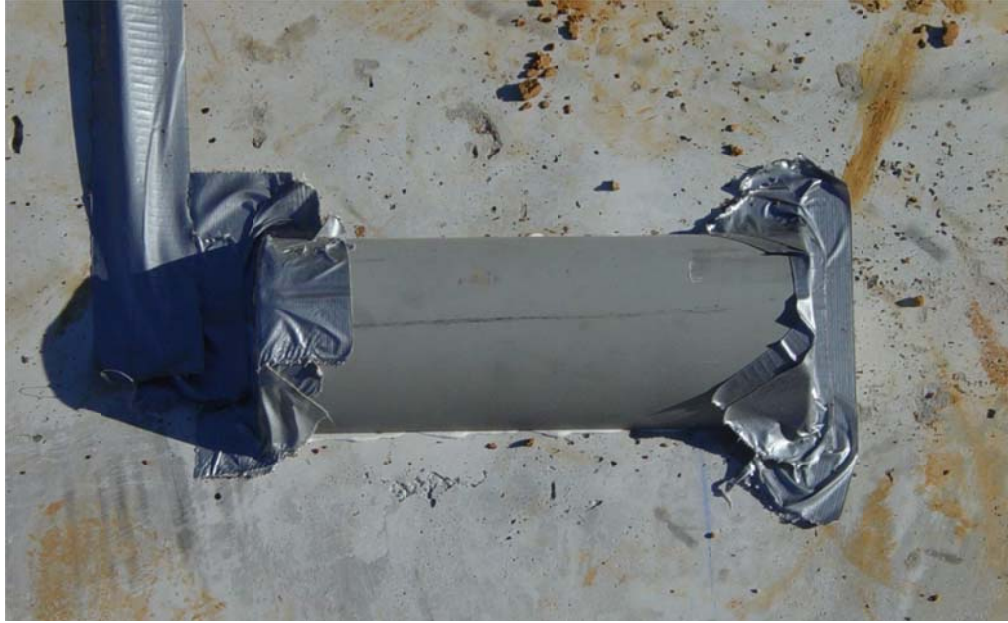
Figure 3-8 Strain Gage Protective Cover

To protect the strain gages on top of the bridge from damage, a half-cylinder piece of PVC was attached over the gages with construction adhesive as a cover, with the ends of the cover sealed with duct tape. An image of the protective cover can be seen in Figure 3-8. Strain gages underneath the bridge were left exposed.

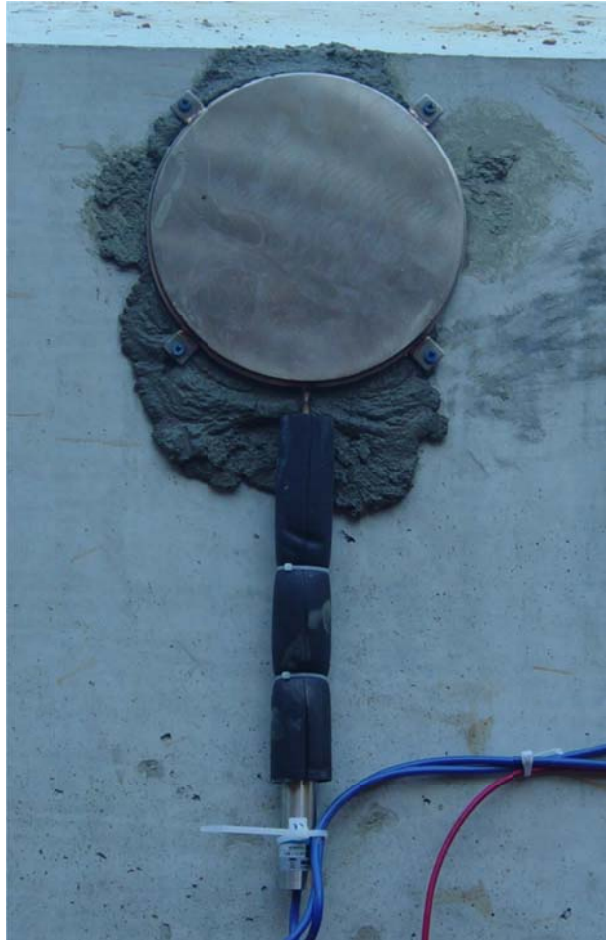
Figure 3-9 Earth Pressure Cell

Model 4810 Vibrating Wire earth pressure cells from Geokon were installed to measure soil backfill pressures on the sides of the bridge. The earth pressure cells were installed using the method recommended by Geokon for installation on existing structures. Mortar is placed on the structure at the pressure cell location, and the pressure cell is pressed in place so that the excess mortar extrudes out the edges of the pressure cell. The pressure cell is then attached to the structure by predrilling holes and using Tapcon screws through the mounting lugs on the pressure cell. An installed earth pressure cell can be seen in Figure 3-9.

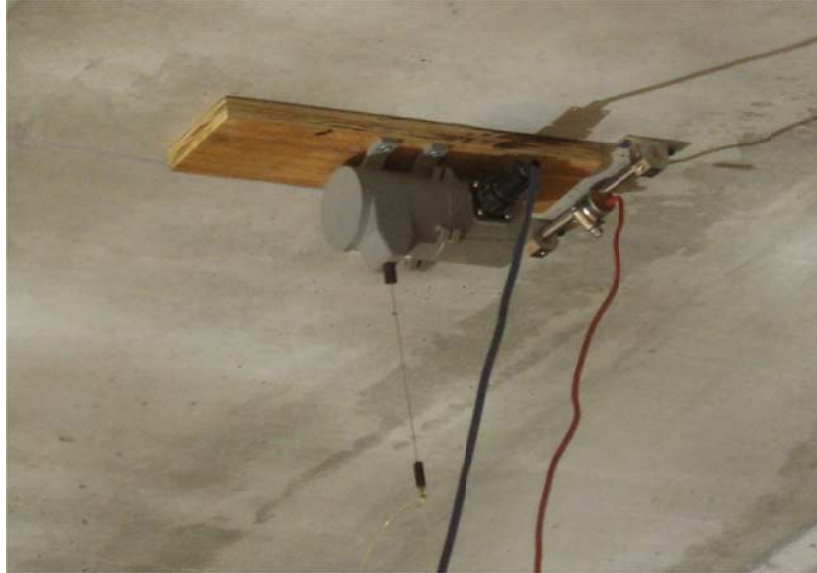
Figure 3-10 String Pot

Two PT8/PT8000 Series displacement potentiometers, or “string pots,” from Celesco were installed to measure the vertical displacement at midspan and the horizontal displacement of the legs. The string pots were attached to the bridge by first attaching each string pot to a small piece of one inch by four inch board with screws, then attaching the board to the concrete surface using Loctite 410 instant adhesive with Loctite 7452 accelerator. The string pot wires were then anchored to ground using posts and dead weight to prevent the wires from retracting. A high strength, no yield wire was used to bridge the gap between the end of the string pot wire and the anchor locations. An installed string pot can be seen in Figure 3-10.

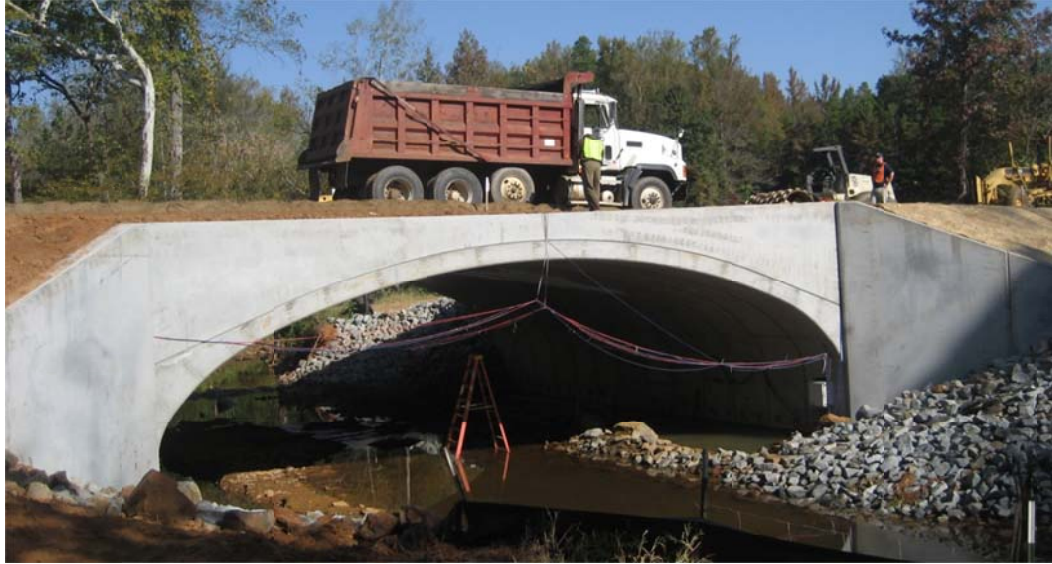
Figure 3-11 Live Load Testing

On September 19, 2010, a live load test using a full dump truck was performed. The strategy was to have the truck drive over the bridge, stopping at set intervals long enough for the data acquisition system to take several measurements, and then proceeding along the bridge. At each stop, the location of either the front axle or the centerline of the two rear axles was measured using a 100ft measuring tape that spanned the bridge. The truck made a total of three passes over the bridge, two heading toward the northeastern side and one heading toward the southwestern side. For the first and third run, traveling toward the northeastern side, the truck was aligned along the roadway such that the outside wheels ran over the highly-instrumented unit. For the second run, traveling toward the southwestern side, the truck was aligned such that the outside wheels were four feet over from the highly-instrumented unit. An image of the live load testing can be seen in Figure 3-11.

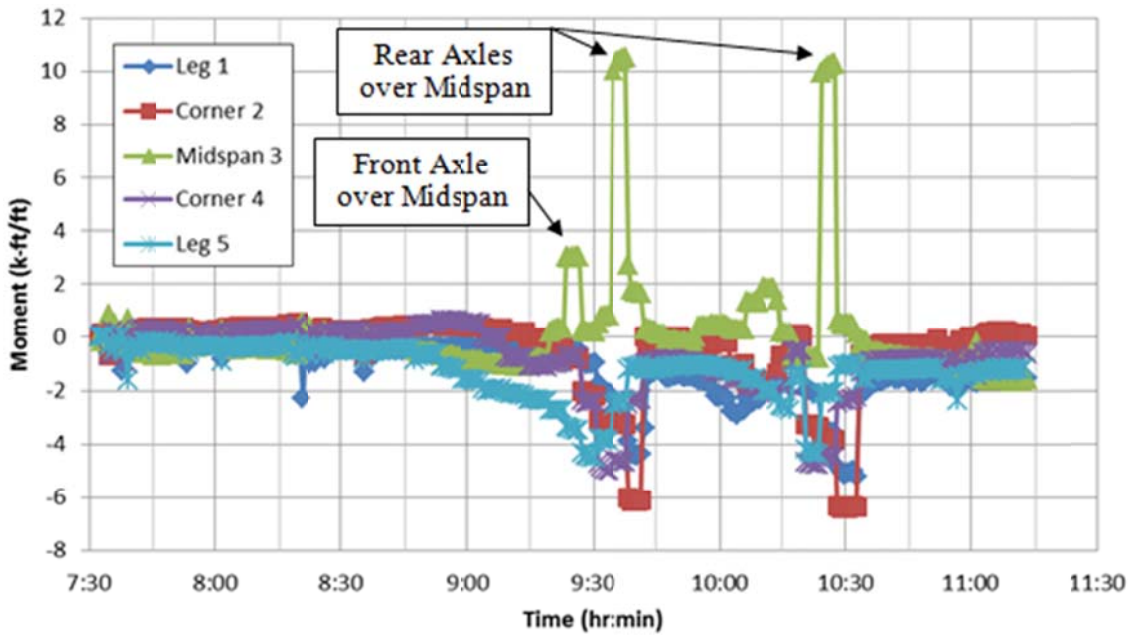
Figure 3-15 Moments due to Live Load Only Versus Time

midspan when the rear axles were centered over midspan. This compares favorably to the factored ultimate midspan moment strength of 38 kip-ft/ft. As for the cross sections, their maximum moments occurred when the rear axles were centered seven to ten feet away from midspan. The maximum moment due to the truck load was -6.5 kip-ft/ft for the corner gages and -5 kip-ft/ft for the leg gages. Figure 3-15 shows the development of moment versus time in the highly-instrumented unit, where the effect of the truck load was most pronounced. Figure 3-16, Figure 3-17, and Figure 3-18 show the development of moment versus the position of the centerline between the two rear axles for each of the three test runs. This graph provides a better illustration of the effect of the truck load as it passes over the bridge.

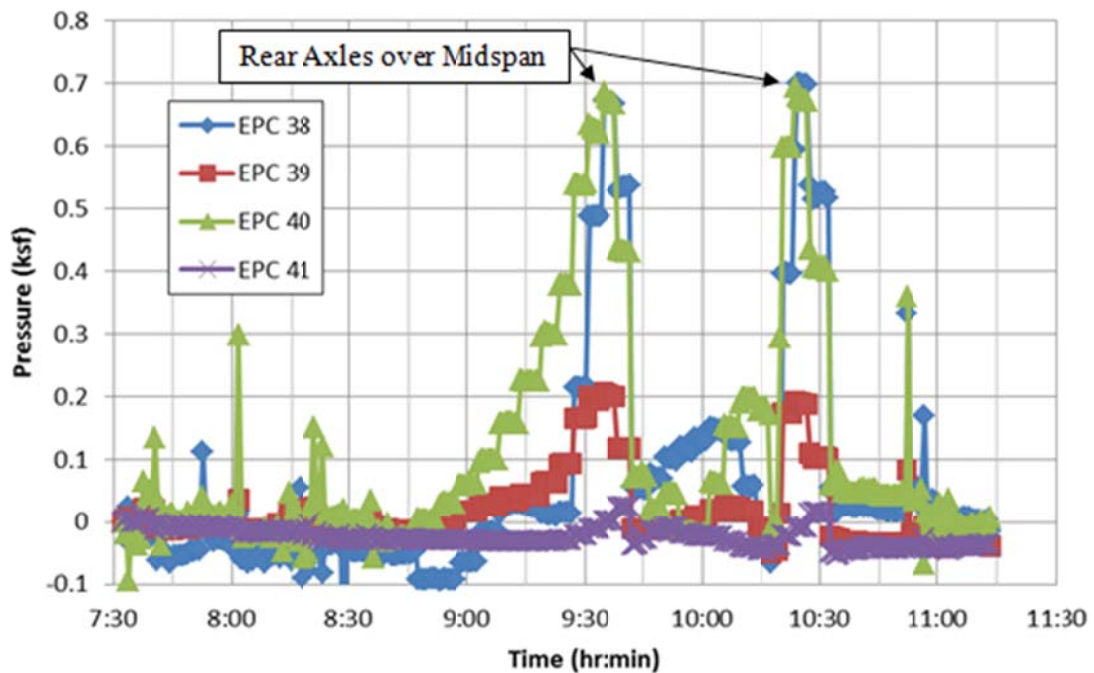
Figure 3-19 Lateral Earth Pressure due to Live Load Only Versus Time

Lateral earth pressures on the external walls developed as anticipated when the truck load was applied to the bridge. As the truck load thrust the arch outward, larger lateral earth pressures were measured at the top of the wall, while very small pressures were measured at the bottom of the wall, indicating a “pinned” support condition, as opposed to a “roller” support condition. Figure 3-19 shows how the earth pressures developed versus time during the live load test in each EPC. Figure 3-20, Figure 3-21, and Figure 3-22 show the development of earth pressures versus the position of the centerline between the two rear axles for each of the three test runs. This graph provides a better illustration of the effect of the truck load as it passes over the bridge.

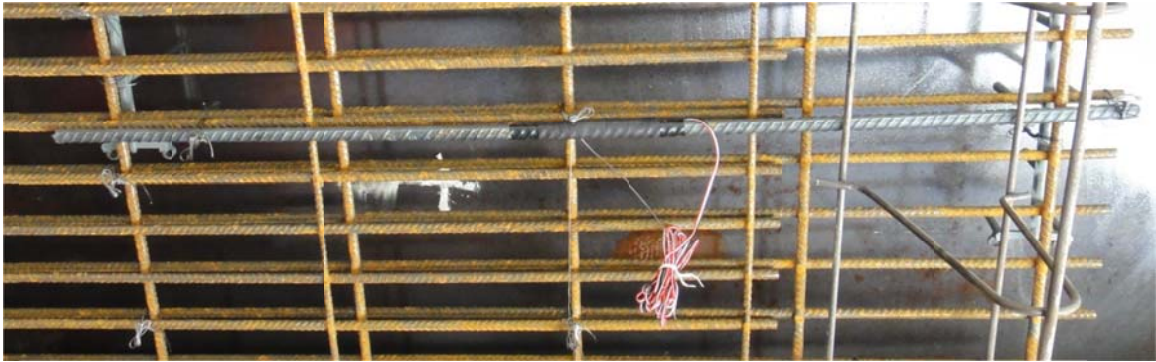
Figure 4-4 Sister Bar Installed in Reinforcement Cage

The sister bar strain gages were created by bonding an electrical resistance strain gage to the smooth, treated surface in the middle of a three foot long #4 bar. Prior to casting, these bars were tied to the normal reinforcement cage at the appropriate locations. Care was taken during

casting, storage, and shipment of the unit to ensure that unnecessary stress was not put on the wiring. A completed and installed sister bar can be seen in Figure 4-4.

Creating the sister bar strain gages consisted of first preparing a smooth, treated surface on the bar, then installing the strain gage. First, in the middle of a three foot long #4 deformed bar, a section of adequate width and length was ground smooth using a circular grinding wheel and sandpaper. The goal was to remove as little steel as possible, so as to have a minimal impact on the area of the bars. Next, the smoothed surface was prepared in accordance with techniques prescribed by Vishay Micro-Measurements. These steps consisted of degreasing with CSM-2 Degreaser, wet sanding with 320 grit sandpaper and M-Prep Conditioner A, surface conditioning with M-Prep Conditioner A, and neutralizing with M-Prep Neutralizer 5A.

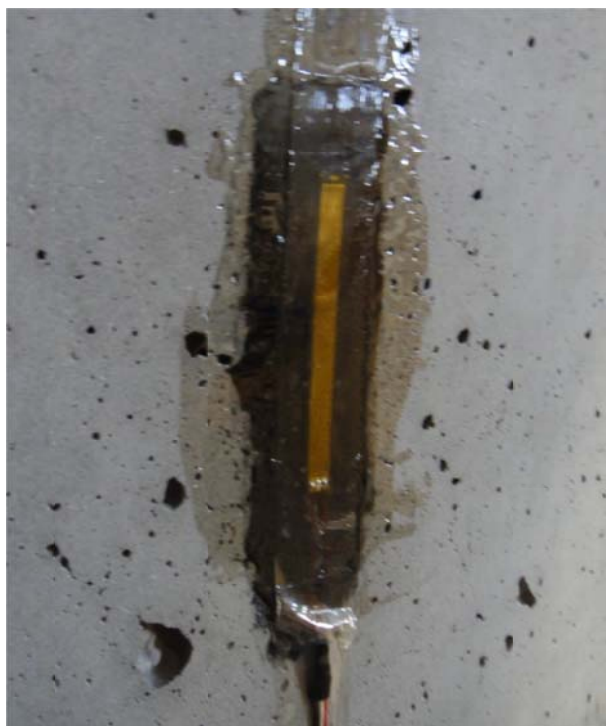
Figure 4-5 Concrete Strain Gage

Once the bridge was in the lab, concrete surface electrical resistance strain gages were attached to the bridge surface. The area where the strain gage was to be installed was firmly brushed with a metal wire brush, and then an air hose was used to remove excess concrete dust from the surface. Next, a back-coat of M-Bond GA-2 Adhesive was applied to the surface, ensuring all holes were filled and a relatively smooth surface was formed. The next day, after the adhesive cured, the back-coat layer was sanded smooth down to nearly the concrete surface, and then a damp paper towel was used to remove dust from that surface. A 20CLW strain gage with a two inch gage length from Vishay Micro-Measurements was picked up using PCT-2M gage installation tape. Finally, the gage was installed by applying a thin layer of five minute epoxy to the back-coat surface and pressing and holding the gage into place for upwards of five minutes, while ensuring no air bubbles were allowed to form. The piece of tape was left in place to provide some minimal amount of protection to the gage and because removal of the tape risked debonding the strain gage. An installed concrete surface strain gage can be seen in Figure 4-5.

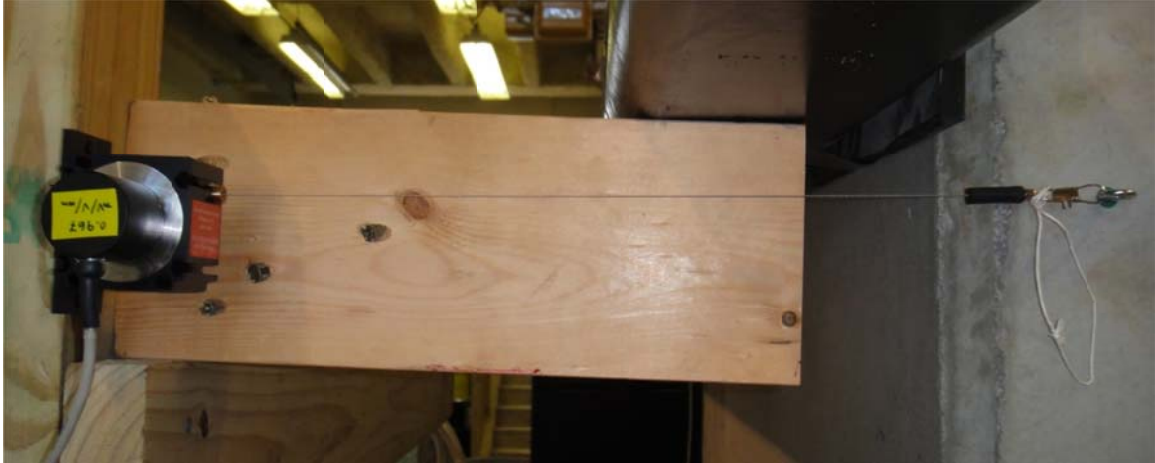
Figure 4-6 Displacement Wirepot

WDS P-60 series draw wire sensors with a range of 1000mm (39in) from Micro-Epsilon were used to measure deflections of the bridge unit. From henceforth, these sensors will be referred to as wirepots. The wirepots were attached to the bridge by drilling a small hole into the concrete, tapping in a light duty plug anchor, screwing in a small eyebolt and attaching the end of the wirepot string to the eyebolt. For wirepots measuring lateral deflection, holes were drilled into the side of the bridge unit, as seen in Figure 4-6. For the wirepot measuring vertical deflection at midspan, the hole was drilled in the bottom of the bridge arch. The lateral wirepot units were mounted to the lateral resistance frame to serve as a fixed point. The vertical wirepot was mounted to a frame built to house the wirepot and gage wire hookups around the center actuator.

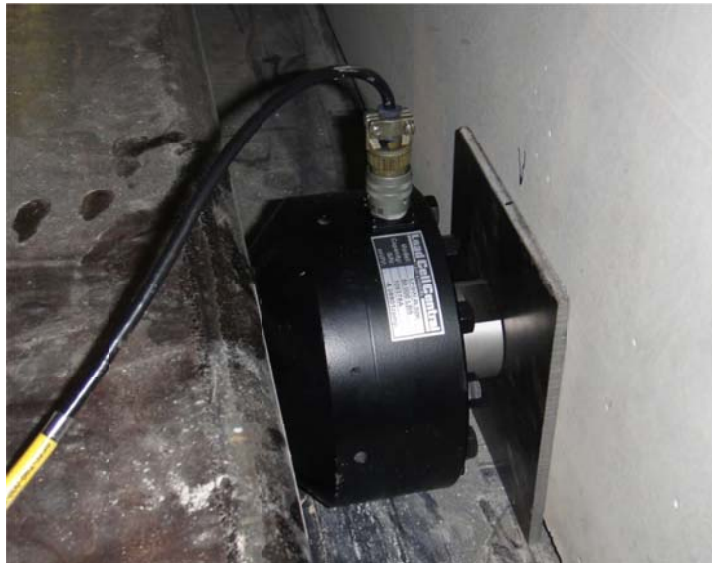
Figure 4-7 Load Cell

Four LPSW-B model load cells from Load Cell Central were used to measure the horizontal reaction at the base of the bridge unit. Each load cell has a 50,000lb capacity. The four load cells were simply placed in between the bridge and the HSS section that served as our base horizontal reaction, with a 6in x 6in x 0.25in plate bearing between the load cell contact point and the concrete surface to prevent damage due to the concentrated force of the load cell. One of the installed load cells can be seen in Figure 4-7.

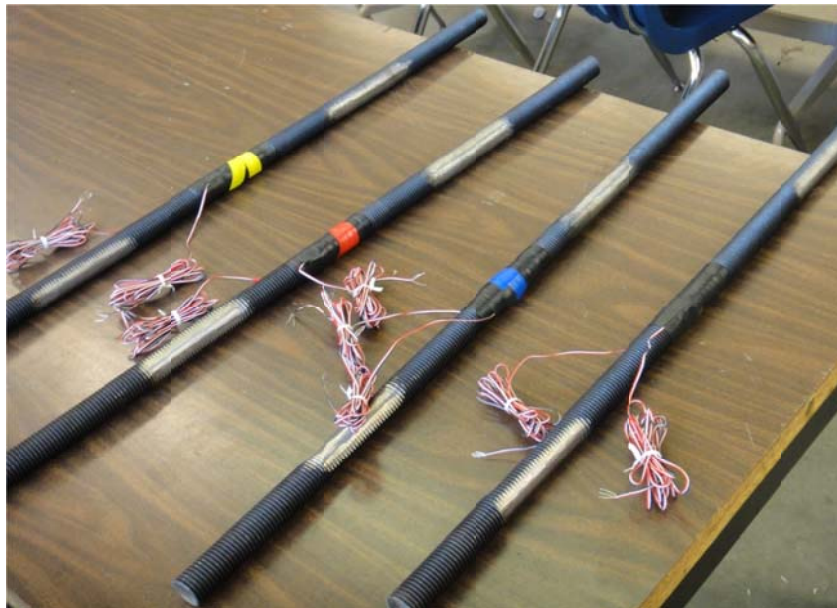
Figure 4-8 Three Foot Gaged Thread Rods

For service load testing, a lateral resistance system was devised to attempt to represent lateral soil pressures that would arise due to horizontal displacement of the bridge legs. This system was composed of four HSS 6x6x0.5 sections, two per wall, bearing at the top and middle of the bridge walls, tensioned together by multiple 12ft long threaded rods on either side of the bridge, which ran along the bridge length from one HSS to the other. In between the 12ft threaded rods was a three foot threaded rod with strain gages attached to it. Coupling nuts were used to link the 12ft threaded rods with the three foot gaged rods. All threaded rods were 1.125in diameter rods. The three foot gaged rods were used to calculate the force in each rod, and therefore the lateral force being exerted on the bridge unit. Each gaged rod had two strain gages attached at the same location on opposite sides of the cross section, so that the effects of the moment in the rod could be accounted for when calculating the tension in the rod. An image of the four gaged rods can be seen in Figure 4-8. Increasing or decreasing the lateral force on the bridge was achieved by tightening or loosening the nuts holding the rod assembly to the HSS section. A wood framing platform, which was also used to mount horizontal wirepots and gage wire hookups, was built in order to hold the HSS sections at the proper height during testing. An image of the lateral resistance frame near the legs can be seen in Figure 4-9, while an image showing the threaded rods spanning the bridge can be seen in Figure 4-10.

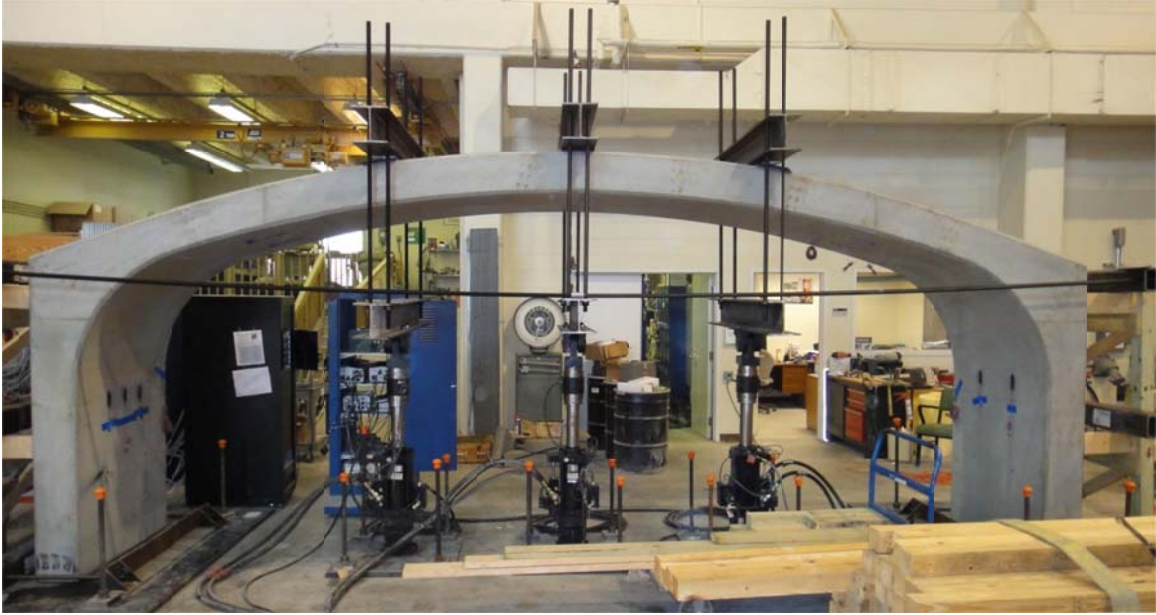
Figure 4-11 Actuator Loading Frames

The load frame designed for this project consisted of three actuators pulling down on the bridge unit from underneath. The frames with the three actuators can be seen in Figure 4-11. A W8x35 beam lied on top of the bridge unit spanning the width of the section. Two 1.125in diameter threaded rods ran through each end of the W8x35 beam to another W8x35 beam, which was attached to the actuator at the midspan of the beam. The actuator was attached to a 32in x 32in x 1.5in baseplate, which was tensioned to the laboratory strong floor. Based on the layout of anchor points in the strong floor, the three actuators were spaced at four foot intervals, with the middle actuator located at midspan of the bridge unit. For the two outer actuators, roller plate units, which can be seen in Figure 4-12, were placed underneath the top W8x35 beams in order to insure that the actuator and load path remained vertical even on the sloped concrete surface. To ensure an even bearing surface, neoprene bearing pads were used on top of the concrete bridge surface.

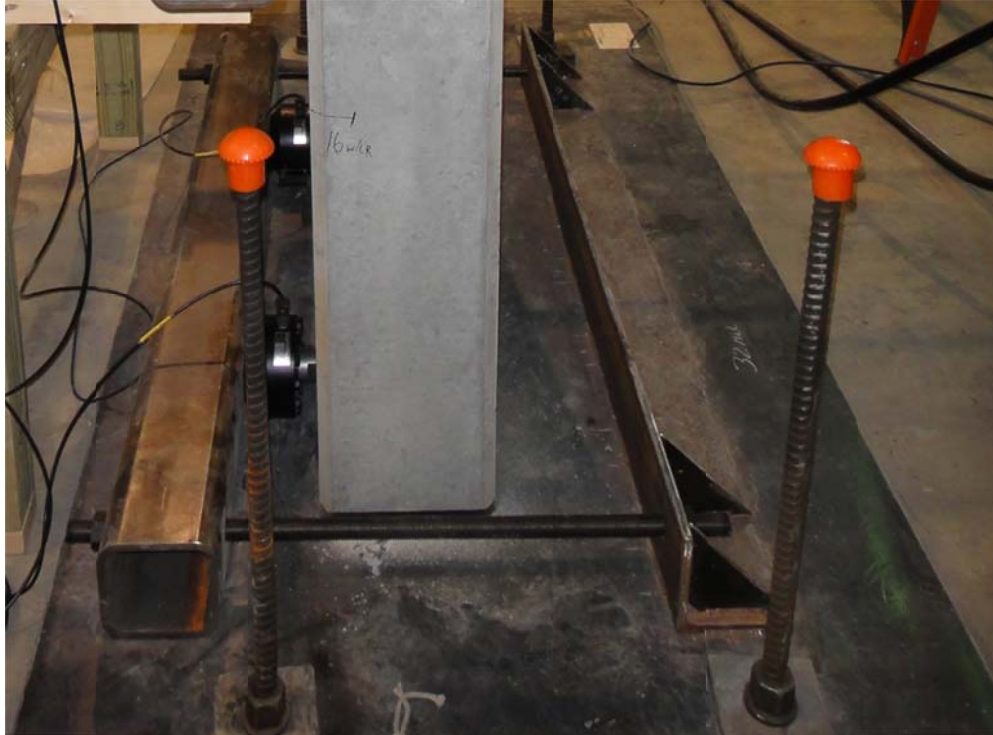
Figure 4-13 Bridge Baseplate

The baseplates for the bridge unit, seen in Figure 4-13, consisted of two 8ft x 4ft x 1.5in A36 steel plates, with an L6x6x0.5 angle welded onto each plate. Two 1.125in diameter threaded rods ran from the ends of the angle to an HSS6x6x0.5, which provided a horizontal reaction force at the base of the bridge. The horizontal restraint of the bottom of the leg was provided to simulate field conditions, in which the bridge units are placed into keyed footings.

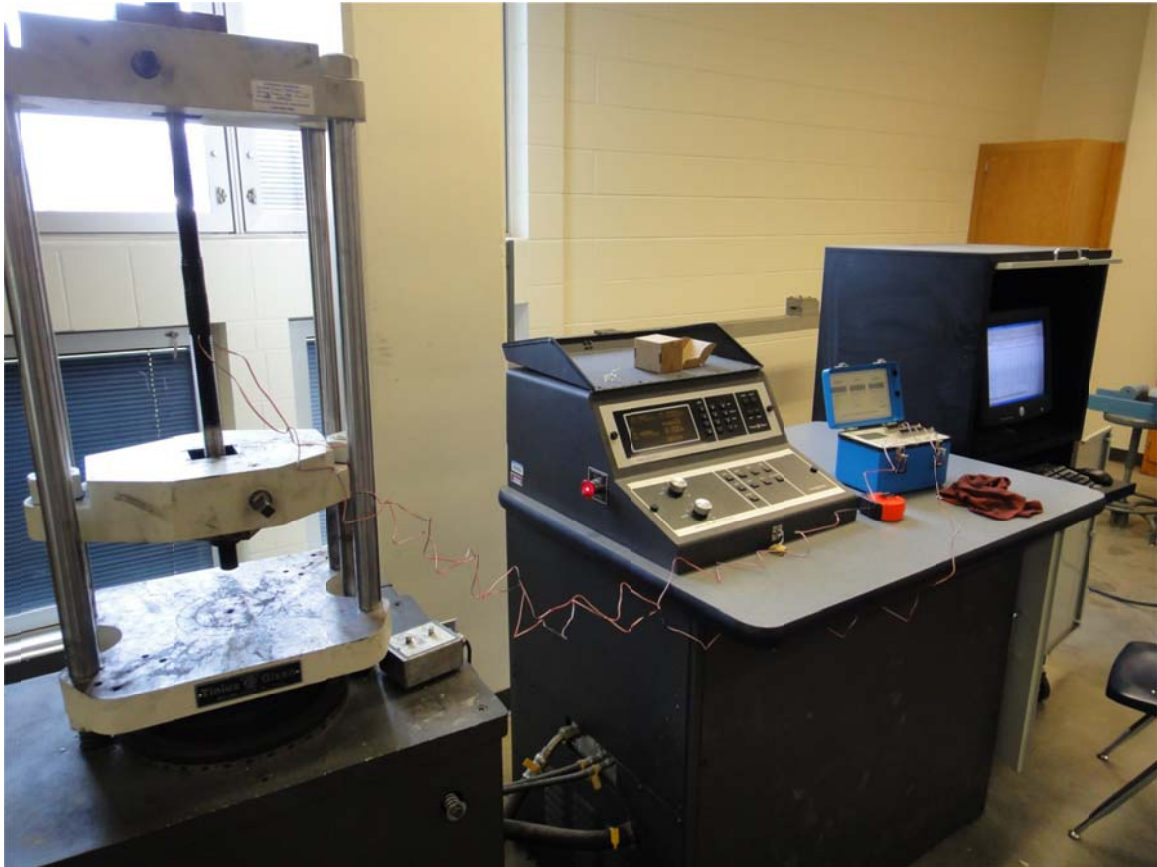
Figure 4-15 Gaged Threaded Rod Calibration

force in the rods during bridge testing. An image of the gaged threaded rod calibration setup can be seen in Figure 4-15.

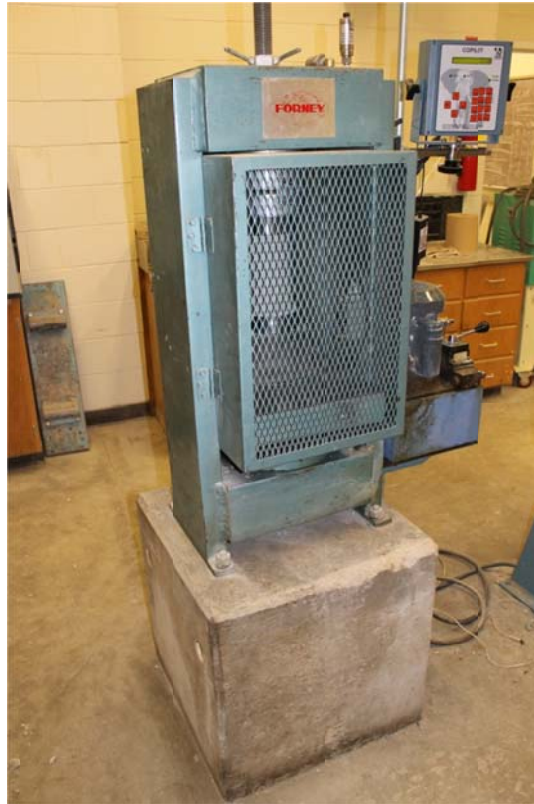
Figure 4-16 Concrete Cylinder Testing Machine

Nine concrete cylinders were prepared when the bridge unit was cast. The cylinders were eight inches long with a four inch diameter. These cylinders were kept under the same conditions as the bridge unit until the unit was shipped. At that point, the cylinders were kept indoors at the production plant in order to simulate the laboratory conditions experienced by the bridge unit. The cylinders were shipped to Auburn University and strength and modulus tests were performed on these cylinders on August 15, 2011. Compressive strength tests conformed to ASTM C39, Standard Test Method for Compressive Strength of Cylindrical Concrete Specimens (ASTM International 2005), and modulus of elasticity tests conformed to ASTM C469, Standard Test Method for Static Modulus of Elasticity and Poisson's Ratio of Concrete in Compression (ASTM International 2002). Testing consisted of loading the cylinder up to roughly 40% of f'_c with the compressometer attached in three cycles per cylinder to determine the modulus, followed by removing the compressometer and loading the cylinder until it fails to determine the compressive

strength. An image showing the test machine can be seen in Figure 4-16, and an image of the compressometer can be seen in Figure 4-17. A typical failed cylinder can be seen in Figure 4-18.

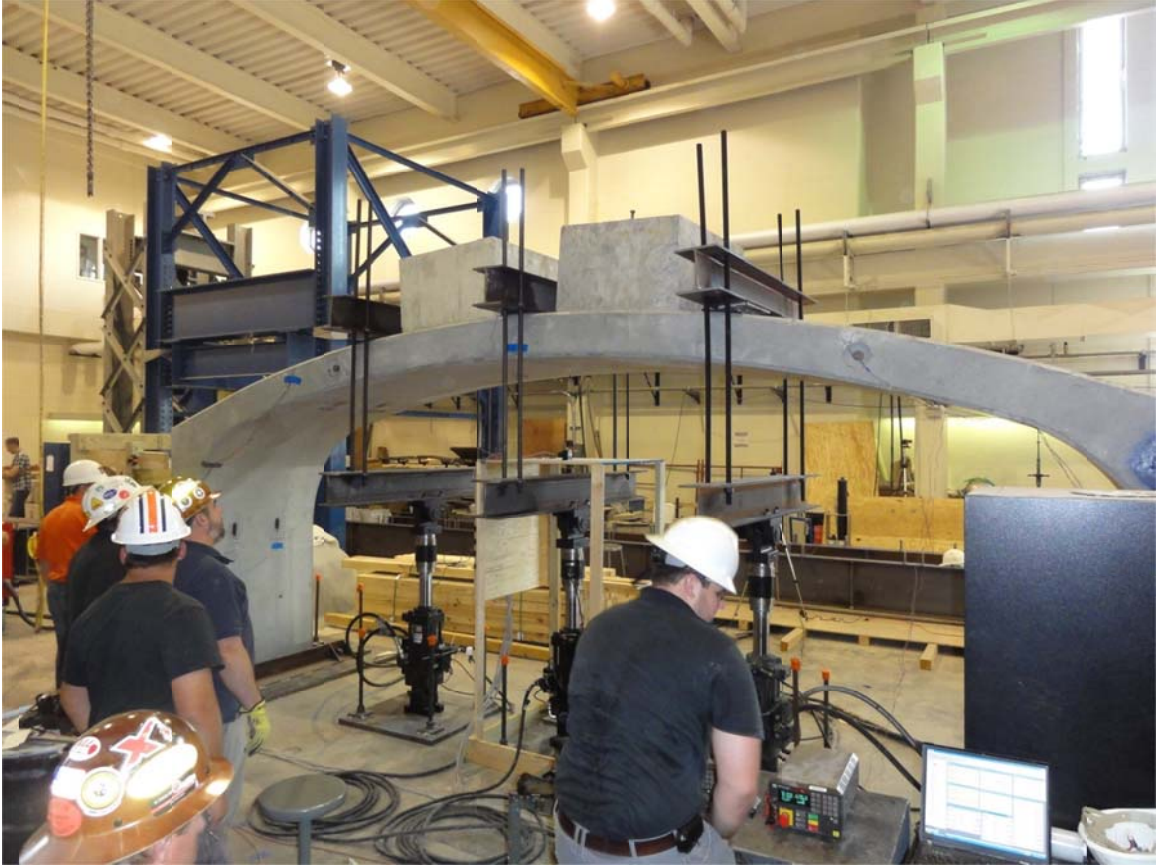
Figure 4-19 Addition of Concrete Blocks for Loading

In an attempt to fail the bridge unit, the load was dropped down to 40 kips per actuator, and two concrete blocks, each weighing roughly 1,900lbs, were placed on either side of the midspan actuator. An image of the test with the concrete blocks can be seen in Figure 4-19. The load was then increase back to 53 kips per actuator, but the additional weight of the concrete blocks was not enough to fail the bridge unit. The concrete blocks and actuator load was removed and hydraulics turned off. The effects of this reloading using the concrete blocks was negligible, and is not did not impact the results of the test.

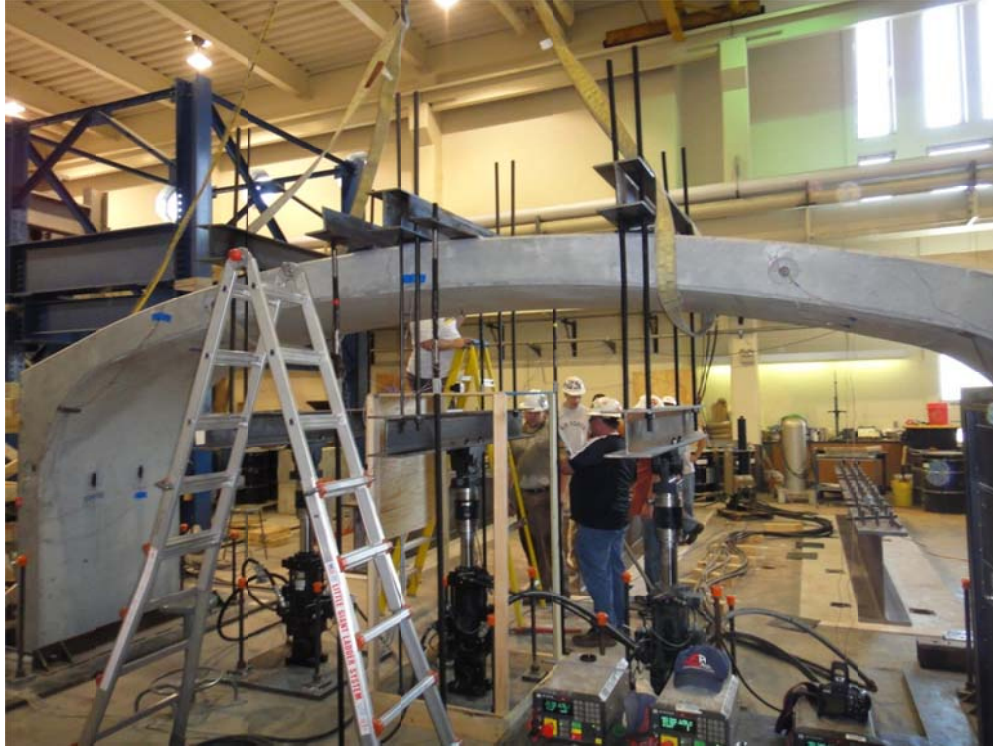
Figure 4-20 Crane Support Illustration

In anticipation of failure, the crane in the laboratory was centered over the bridge, with straps placed loosely underneath the bridge to “catch” the bridge. The ten ton capacity laboratory crane was manually controlled, and had enough capacity to keep the arch from falling on the testing equipment should a complete collapse of the structure occur. An image showing how the crane straps were position can be seen in Figure 4-20.

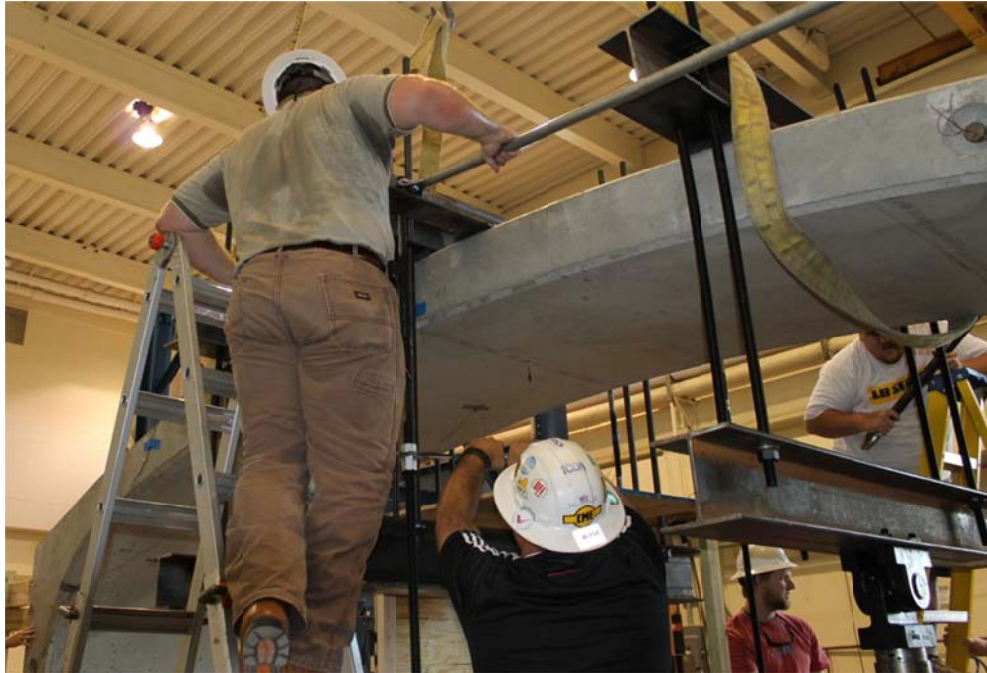
Figure 4-21 Tightening of Additional Vertical Loading Frame

The load in the actuators was gradually brought up to 50 kips per actuator and held at that load. Load was then applied using the angles and threaded rods by tightening the nuts connecting the rods to the angle while preventing the entire threaded rod assembly from rotating by gripping the coupling nut connected the two threaded rod segments. An image showing the tightening process can be seen in Figure 4-21. Each rod was brought up to a tensile force of five kips, thus providing an additional 20 kips of force on the structure. To prevent uneven loading across the width of the bridge, threaded rods attached to the same angle were tightened at the same time. Increasing load on the rods, however, relieves some of the load on the actuators. So after each rod was brought up to full force, the actuators were brought back up to 50 kips each. However, this then relieved some of the force in the threaded rods, which were then brought back to five kips each. This iterative process was repeated for several cycles, with the force in the rods being increased to 11 kips per rod at their maximum, and the force in the actuators being increased to 52 kips per actuator at their maximum. Eventually, during a cycle of reapplying load with the actuators, the bridge unit collapsed due to a shear failure in the arch near one of the corners.

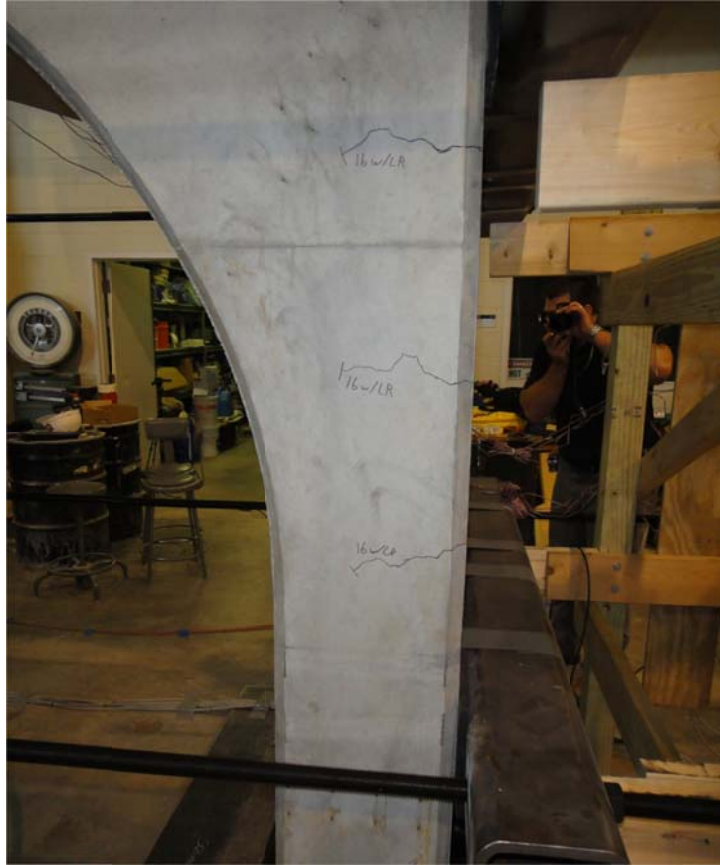
flexural cracks did not significantly propagate or widen throughout testing, because the bridge redistributed the load to the uncracked concrete. Furthermore, the lack of crack widening indicates that the reinforcement did not yield. More hairline cracks appeared as testing progressed, but crack sizes did not become significant until near ultimate loading.

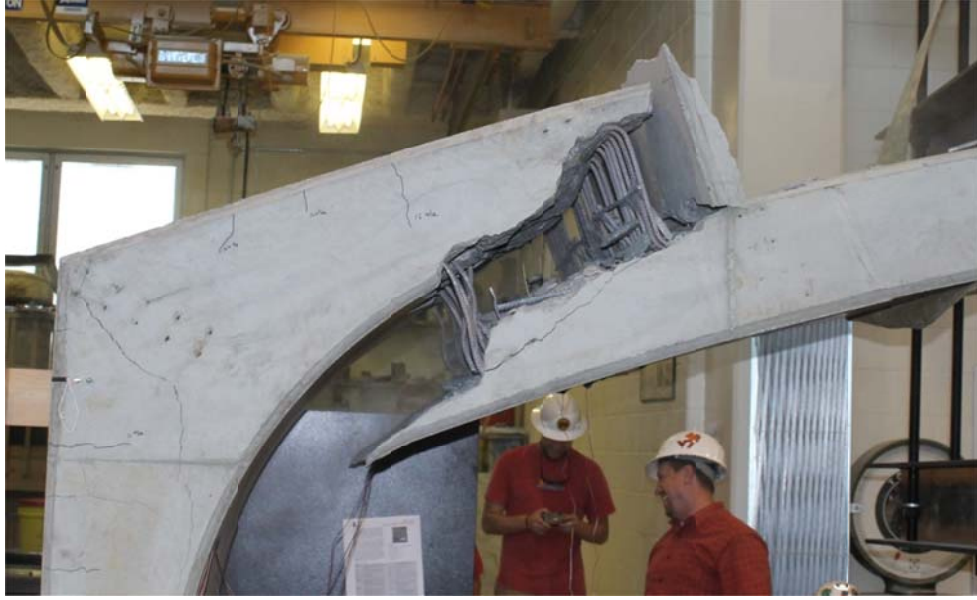
Figure 4-39 Failure Mechanism

The critical shear crack that would be the failure mechanism did not appear until approximately 175 kips of total load. This crack was a shear crack running through the arch close to the corner of the bridge. Figure 4-37 shows the crack forming, Figure 4-38 shows the crack immediately prior to failure, and Figure 4-39 shows the failure mechanism.

The 20 ft span failed under a total applied load of 182.1 kips. The failure mechanism was a shear crack near the corner on the arch itself. The shear crack opened up on the side of the bridge containing cross sections four and five, wirepots three and five, and load cells three and four. The load configuration can be seen below in Figure 4-40. A picture of the failed structure can be seen in Figure 4-41.

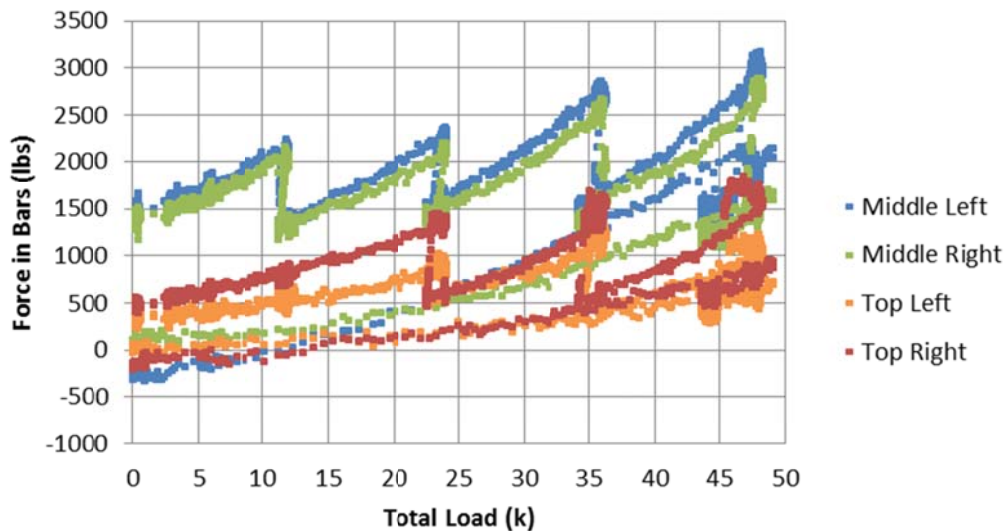
Figure 4-43 Force in Lateral Resistance Frame

The lateral resistance frame consisted of measurements from four rods. The frame consisted of a restraint at the top of the walls, and a restraint at the middle of the walls, with each restraint having two rods, one on either side of the bridge. Therefore, the rods are named according to their location, top right, top left, middle right, and middle left. “Left” and “right” in this case simply relate which side of the bridge the rod was on, and do not have a specific orientation. The forces in the rods can be seen in Figure 4-43. It is noted that the rod forces are approximately equal at each vertical location, meaning that neither the left nor the right side has more force on it. As load is applied to the bridge unit, the walls deflect laterally, causing the force in the rods to increase. However, the force in the rods increases in accordance with the stiffness of the steel, so at each four kip per actuator interval, the force in the rods is reduced and brought back down to levels that would be applied by the design backfill soil.

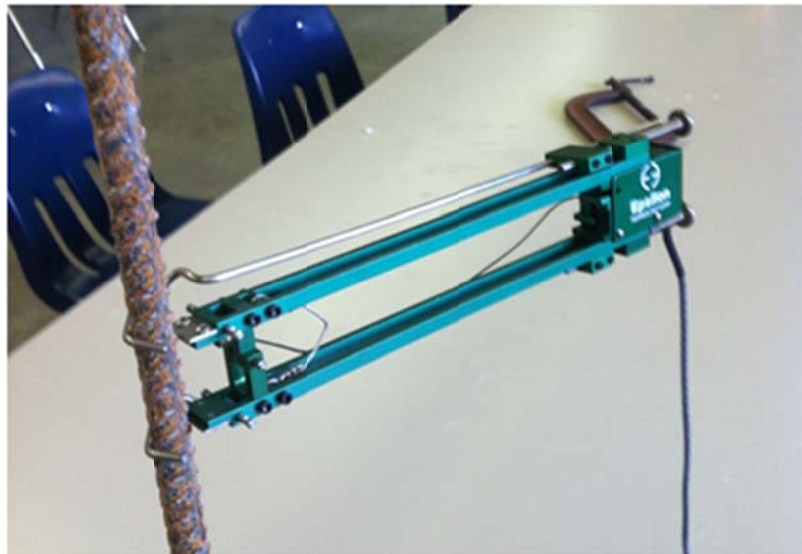
Figure 5-5 Extensometer

Tension testing was done using a Tinius-Olsen Universal Testing Machine at Auburn University, which both applied and measured the tensile force put into the specimen. This is the same machine used for calibration of the gaged threaded rods, as discussed in chapter four. Deformations in the steel samples were measured using a model 3542 axial extensometer from Epsilon Technology Corp, shown in Figure 5-5, which had an initial gage length of one inch. Each bar was run through at least one test in the linear elastic range, followed by a test running through failure. To prevent damage to the extensometer, it was removed as the sample bar neared failure. Tensile forces were converted to stresses using the nominal area of the bar, and deformations were converted to strains using the known initial gage length.

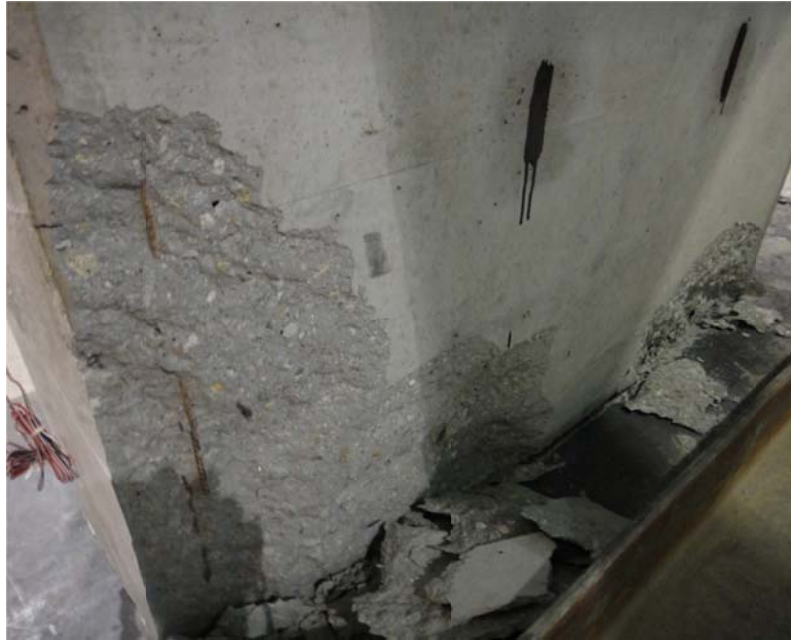
Figure 5-12 Initial Spalling on Bridge Leg

Due to issues shipping and handling the much larger and less stiff 36 ft span bridge unit, some cracking and spalling of the bridge occurred before testing was begun. During the process of getting the bridge into the lab and onto the baseplates, initial flexural cracks formed at midspan and near the corners, but were still small prior to testing. More significantly, the bridge legs were placed on the baseplates such that they were not completely vertical, but slightly angled outward. An exaggerated illustration of the angled bearing surface can be seen in Figure 5-11. This misalignment caused some spalling on the inside of the leg prior to testing, as can be seen in Figure 5-12. This misalignment also caused further spalling to occur during the test as more weight was placed on the bridge. An image of further spalling during testing on the opposite bridge legs can be seen in Figure 5-13. The spalling and initial cracking did not affect the ultimate strength of the bridge, however.
