Laboratory and Field Testing of Precast, Three Sided Arch Culverts

A thesis submitted to the Graduate Faculty of
Auburn University
in partial fulfillment of the
requirements for the Degree of
Master of Science

Auburn, Alabama
August 4, 2012

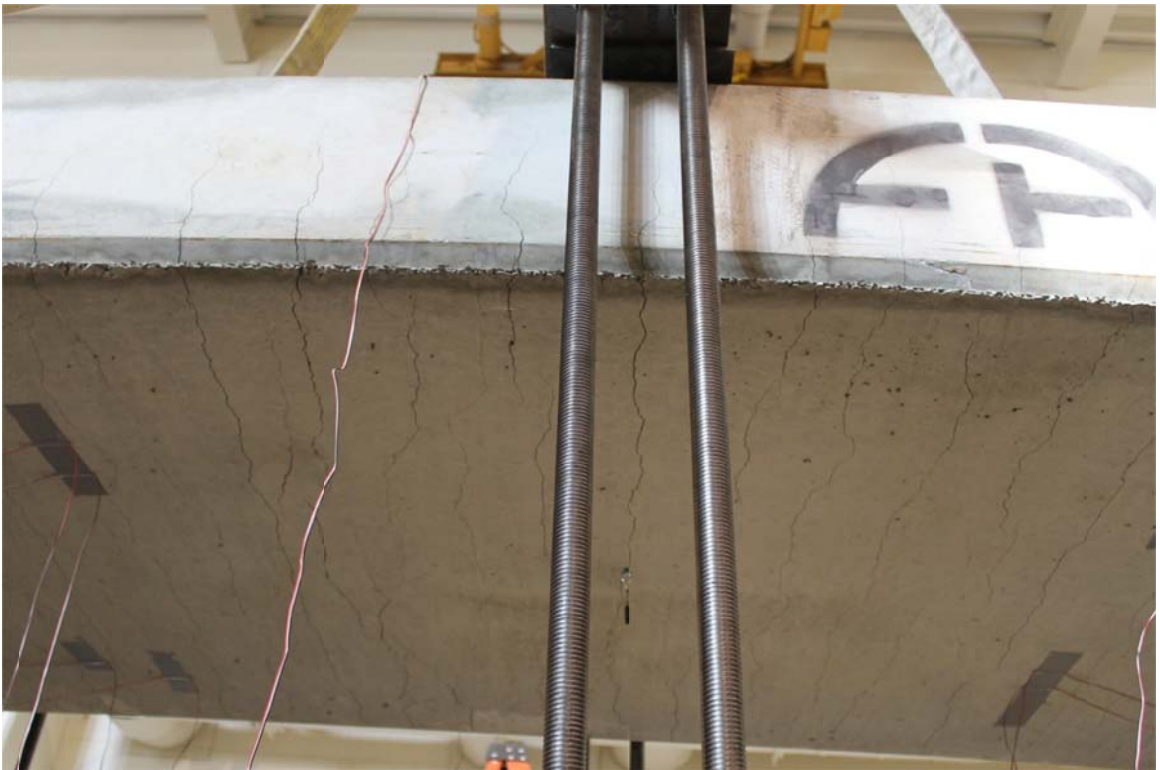
Figure 5-15 Midspan Cracking – After Failure

The first significant cracks occurred at midspan, followed by cracks developing near the corners. Several cracks formed near midspan, approximately spaced evenly at six inches. These cracks propagated up through the thickness of the bridge well past midheight before failure. An image illustrating the even spacing of the cracks near midspan can be seen in Figure 5-14. An image showing the midspan cracking pattern after failure can be seen in Figure 5-15. The cracks near the corners were also approximately evenly spaced at six inches. These cracks widened and extended until failure, indicating that some yielding of the steel reinforcement took place. An image of the largest corner cracks at 144 kips of total load can be seen in Figure 5-16.

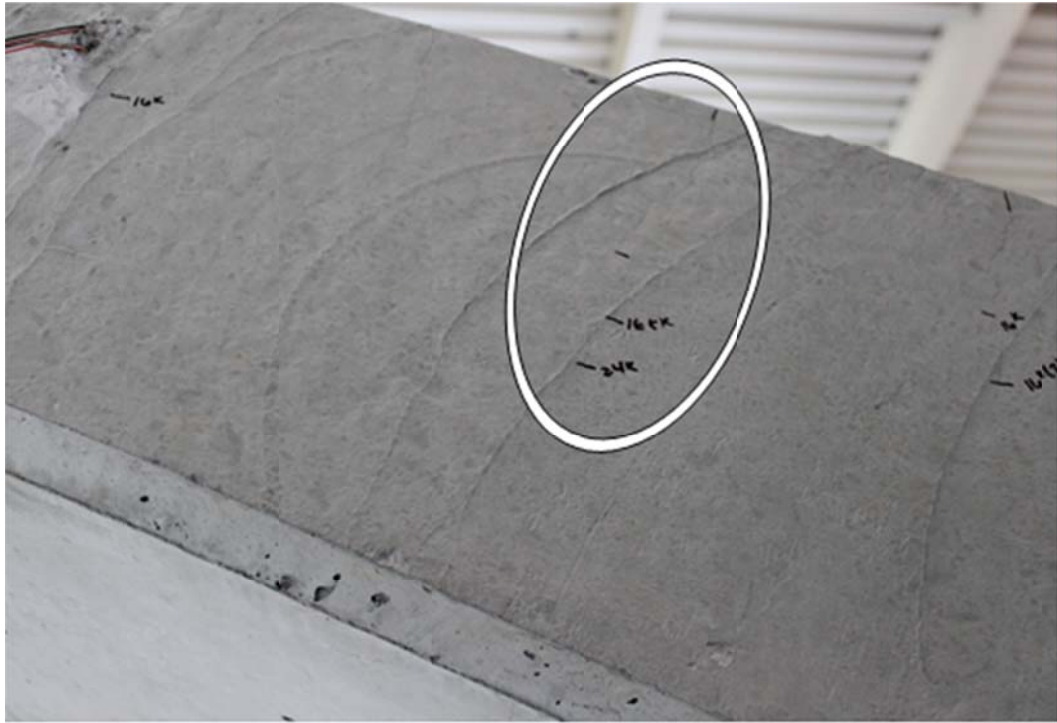
Figure 5-17 Eventual Failure Surface – 72 kips Total Load

The 36 ft span failed under a total applied load of 151.9 kips. The failure mechanism was flexural in nature, with a crack near the corner of the arch widening until the tension steel ruptured, which quickly caused the concrete to crush in compression. The remaining uncrushed concrete and compression steel allowed the bridge to continue carrying some load, but rupture of the tension steel meant that further loading of the bridge would be futile. An image of the eventual failure surface at a lower load level of 72 kips total load can be seen in Figure 5-17. An image of the failure mechanism immediately before and after failure can be seen in Figure 5-18 and Figure 5-19 respectively. An alternate image of the failure mechanism showing the crushing of the concrete can be seen in Figure 5-20. An image of the ruptured tension steel can be seen in Figure 5-21. The failure occurs between cross sections five and six, on the side of the bridge with wirepot three and load cells three and four. The ultimate load configuration can be seen in Figure 5-22.

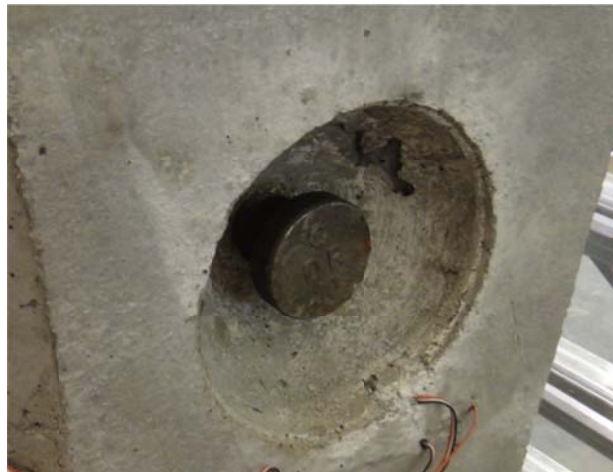
Figure 5-23 Lifter at Concrete Surface

It was noted that the failure mechanism passed through the location of the cast in place lifters used to lift the units during transportation. An image of one of these lifters on the concrete

surface can be seen in Figure 5-23. An image showing the failure surface passing through the lifter location can be seen in Figure 5-24. It was then recalled that during production of this unit, the reinforcement is cut at lifter locations in order to put the lifters in place. An image of this can be seen in Figure 5-25. This practice removed four bars from each mat, which translates to a loss of 17% of the reinforcement at that location for this particular bridge unit. This significantly weakened the ultimate load capacity of the cross section at the lifters, forcing the failure mechanism to occur at that spot. In order to prevent weakening of the structure, reinforcement bars should be properly spliced to the reinforcing mats at lifter locations to prevent a loss of effective steel area.

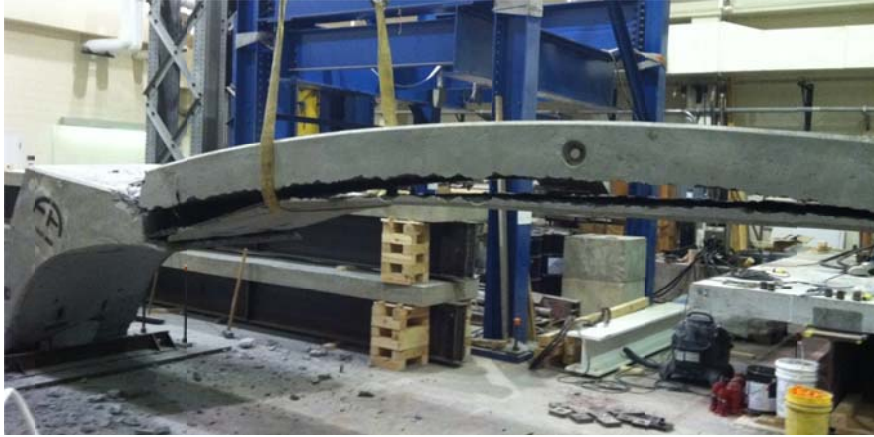
Figure 5-26 Steel Layers Delaminating

During the demolition and removal of this bridge unit from the laboratory, a unique failure of the concrete arch was observed. The unit was demolished by dividing it into three separate parts: two leg portions and the arch. After the first leg portion was separated, the second leg portion and arch were broken apart by cutting the top steel near the corner and lifting the arch to allow forcing a failure surface to form there. As the arch was being lifted, the two bottom layers of steel in the arch began to “unzip” from each other. An image of the two layers of steel delaminating from each other can be seen in Figure 5-26. These two layers delaminated across the entire arch until the bottom layer of steel was completely separate from the arch. This occurred due to the tight spacing between bars in the mesh, two inches center-to-center, and the fact that the two layers of steel were cast on top of each other with no concrete cover between them. The spacing between bars within the same mesh and in different meshes should be increased to allow concrete to fully bond around each individual bar to prevent this plane of weakness. It is noted that this failure mechanism did not occur until demolition of the bridge unit, and that it appears that it might only occur if the bridge were being lifted up while missing the top layer of steel. An image of the demolished bridge unit can be seen in Figure 5-27.
