Laboratory Scour Testing of Hard Cohesive Soils in Alabama

A thesis submitted to the Graduate Faculty of
Auburn University
in partial fulfillment of the
requirements for the Degree of
Master of Science

May 3, 2014

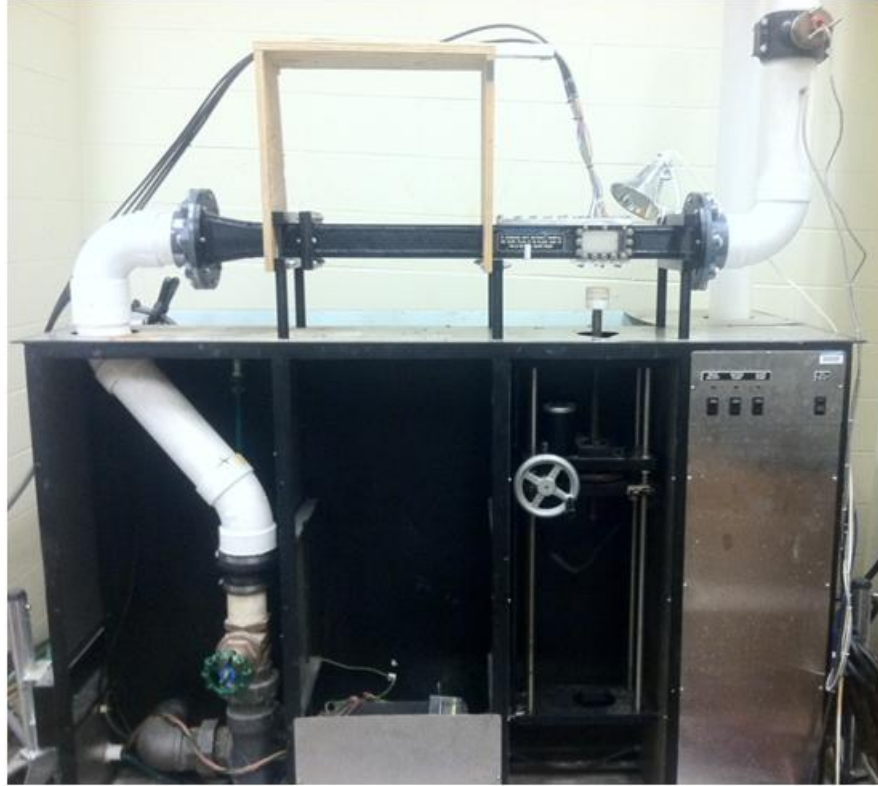
FIG. 2-1. Erosion Function Apparatus (EFA) at Auburn University.

A stepping motor forces the specimen upwards to protrude the material 1 mm into the flume. A sump pump transporting water from the reservoir into the flume allows water to flow through the flume at a constant velocity inducing a uniform shear stress over the specimen face. Over the duration of a test the volume of material eroded is determined by reducing height change data recorded from the ultrasonic sensor installed above the soil specimen. Erosion rate is then determined analytically after the sample has scoured 1 mm. From the erosion function, two parameters can be determined: critical shear stress, τ_c , and initial erodibility, S_i . While the HEC-18 analysis estimates the amount of scour in a single event, SRICOS integrates the erosion rate into the calculation to determine the amount of scour in a single or multiple events. In this method a relationship can be derived between velocity/shear stress and the

Extensive research has been presented on the subject of the rate of scour of cohesive soils. Some of the more visible work was performed by Briaud et al. (1999, 2001a, 2001b, 2004, 2009, 2011). The Scour Rate in Cohesive Soils method (SRICOS) was developed by Briaud et al. (1999) to determine erosion functions in sands, clays, and rocks. Briaud's research group was responsible for developing the EFA as a device for measuring the erosion function for cohesive soils. The EFA, shown in FIG. 2-1, is a hydraulic flume designed to erode a cylindrical soil specimen at a constant flow.

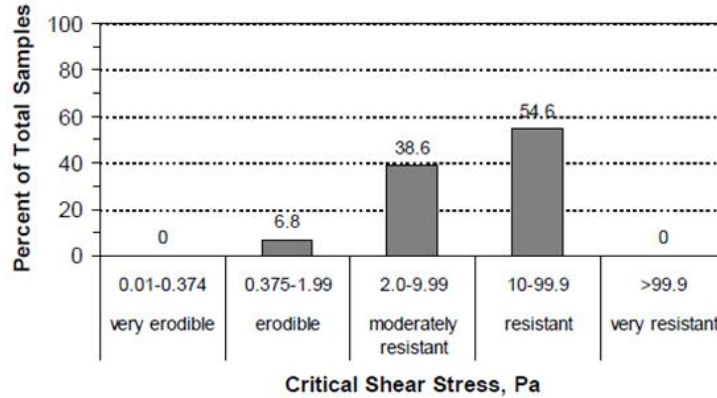
FIG. 2-2. Erodibility Classification of Georgia Soil Samples (Sturm et al. 2008).

Ravisangar et al. (2001) investigated the impact of clay chemical properties on erosion, suggesting that because clay is dependent upon the soil structure, pH may be a variable for erodibility. Sturm et al. (2008) conducted additional erosion tests on samples from five other states in the Georgia Tech flume. The results of the two studies were integrated to develop erodibility classification for Georgia soils shown in FIG. 2-2.

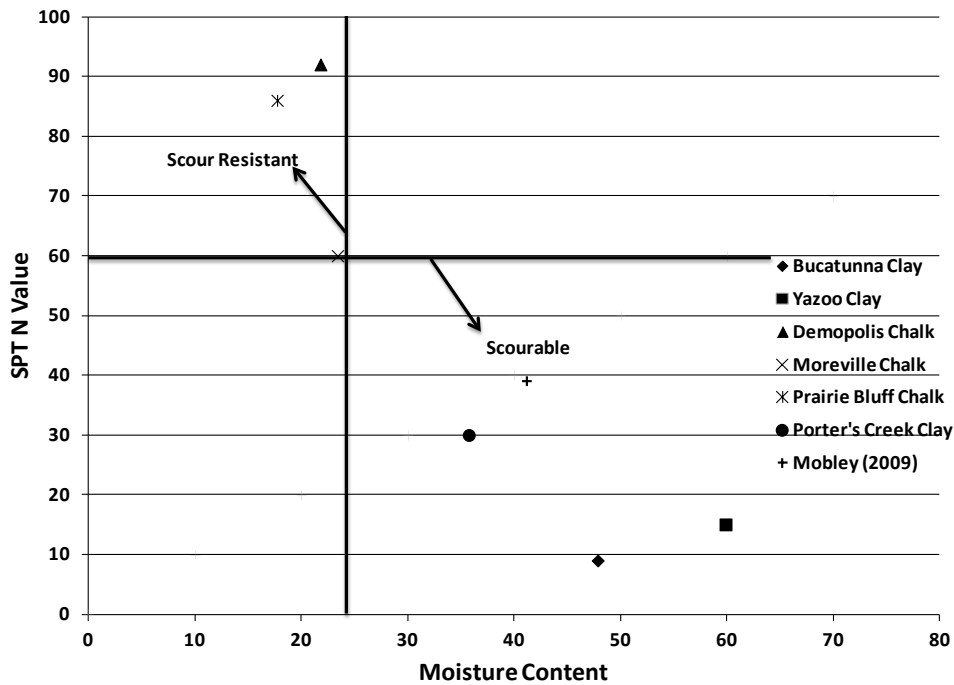
FIG. 2-3. Scour Correlation between Moisture Content and SPT N Value (Walker 2013).

Walker determined the insitu moisture content, SPT blow count, plasticity index, and determined the grain size distribution of each formation in order to generate correlations between conventional geotechnical parameters and scour rates of soils. Walker discovered that the scour resistant formations had higher SPT N values, lower insitu moisture content, higher percentages of fine particles (percent passing the No. 200 sieve), and smaller mean particle diameters. The study did not confirm any correlation between plasticity index and scour parameters, though the plasticity index for each material was highly variable. FIG. 2-3, FIG. 2-4, and FIG. 2-5 are plots constructed by Walker, relating scour potential to these dependent geotechnical parameters.

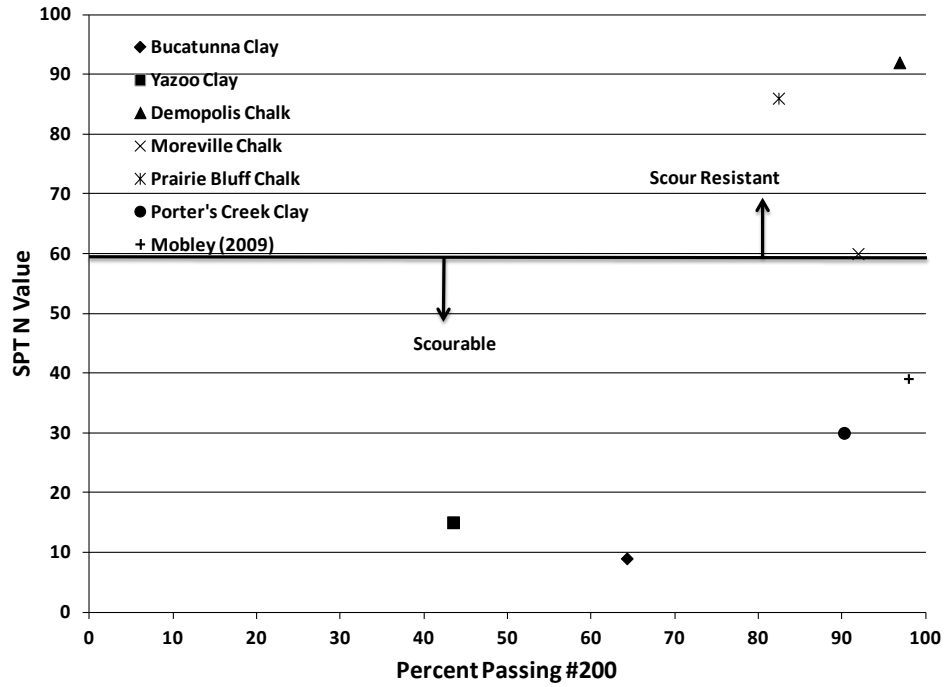
FIG. 2-4. Scour Correlation between Percent Passing #200 and SPT N Value (Walker 2013).

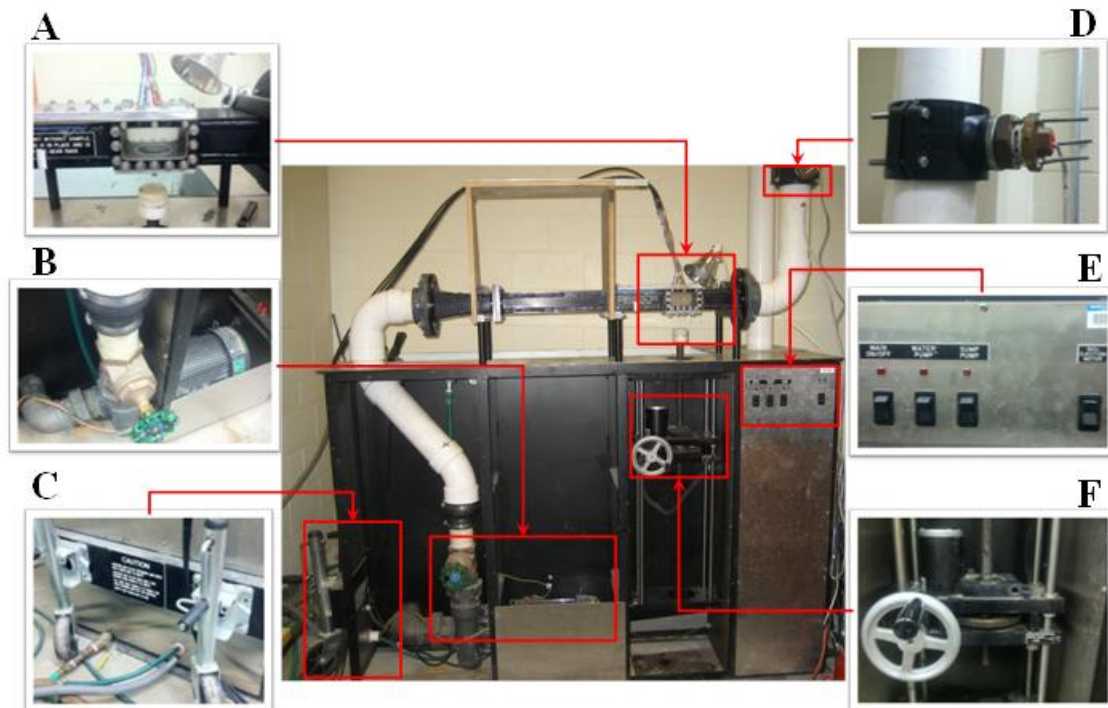
FIG. 3-1. Auburn University EFA and Critical Component Diagram.

Briaud (1999) constructed the first model of the EFA at Texas A&M University to determine quantitative data related to scour rate and magnitude of different soils. Incorporating the work of Sheppard et al. (2005), Auburn University retrofitted the device to include an ultrasonic sensor for measuring the change in specimen height. FIG. 3-1 shows a picture of the updated EFA at Auburn University and its critical components.

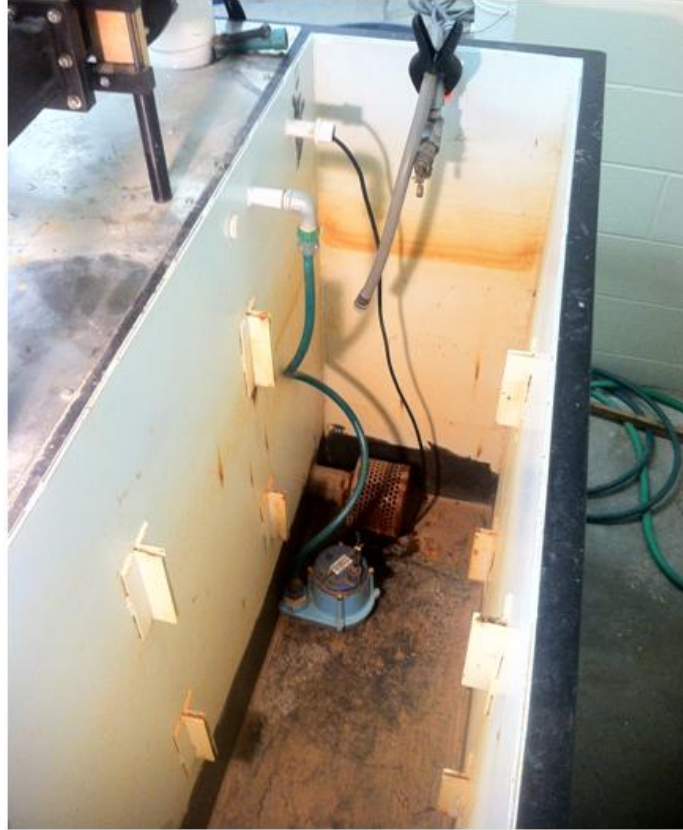
FIG. 3-2. EFA Reservoir.

The pump intake is located at the bottom of a water reservoir on the back side of the apparatus. This reservoir (shown in FIG. 3-2) is filled prior to testing. During a test a water hose is constantly supplying water to the reservoir while a sump pump is constantly pumping water out of the system. This continuous water supply is needed to control the temperature of the water in the system as the continuous use of the main pump will cause an extreme increase in temperature over time.

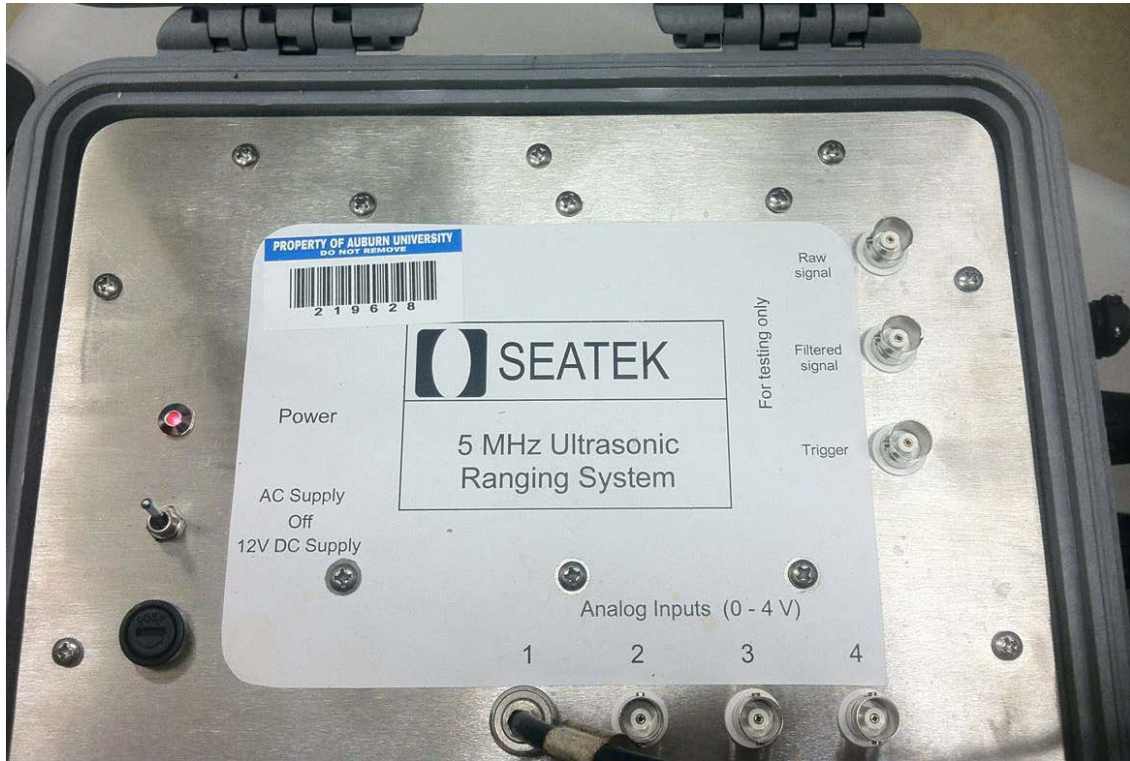
FIG. 3-5. SeaTek 5 MHz Ultrasonic Sensor Data-Logger.

capacity to communicate with one to four external analog channels of which the output voltage of said channels must be between 0 and 4 Volts. The standard connection for the SeaTek data acquisition package is an RS232 serial port connection.

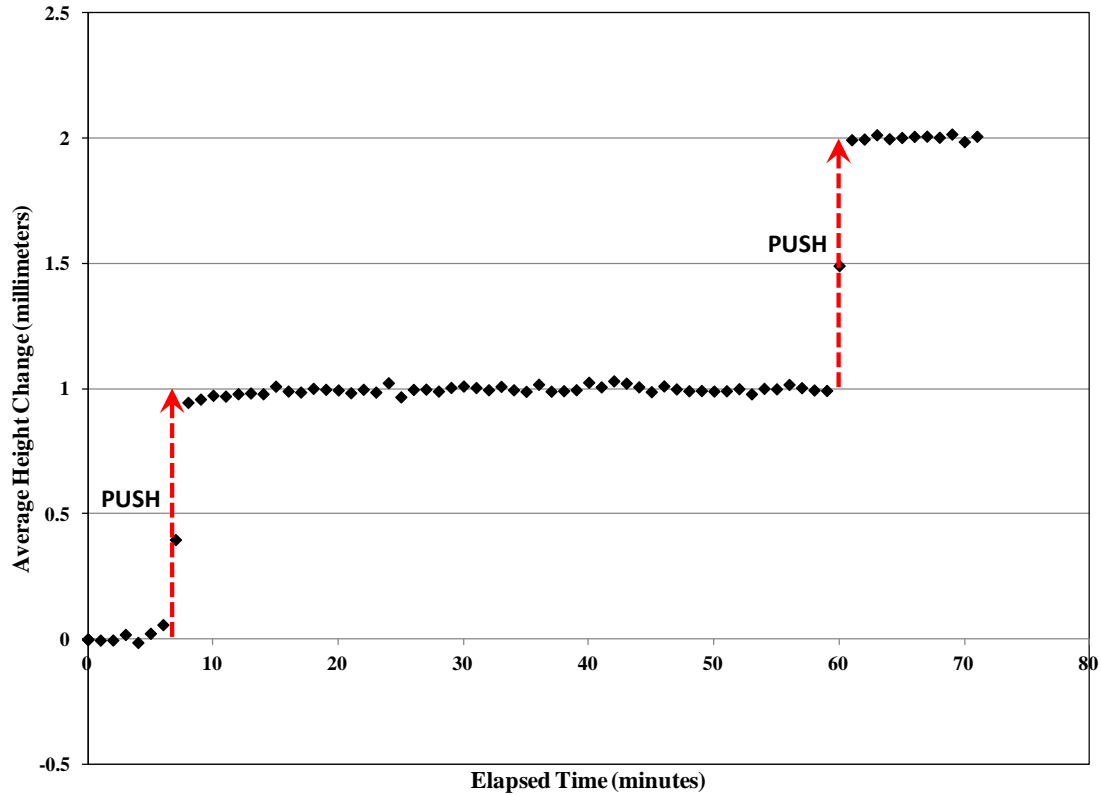
FIG. 3-11. Verification of Sensor Operation.

Following the method Walker established for sensor verification, the accuracy of sensor measurements and data reduction was confirmed by testing a non-erodible dummy sample and comparing the results to direct measurements taken. The dummy specimen, constructed by Walker for this sole purpose, consisted of a 6.35 cm diameter aluminum cylinder that is tested the same as an EFA soil sample. Because the extremely smooth aluminum surface caused erratic and inaccurate measurements from the sensors, a rugged sand surface was applied to the sample face. During this test the specimen is advanced by the motor, held constant for a period of time, advanced again, held steady again, and so on. Throughout the trial the height of the sample is measured directly and compared to height readings generated by the ultrasonic sensor.

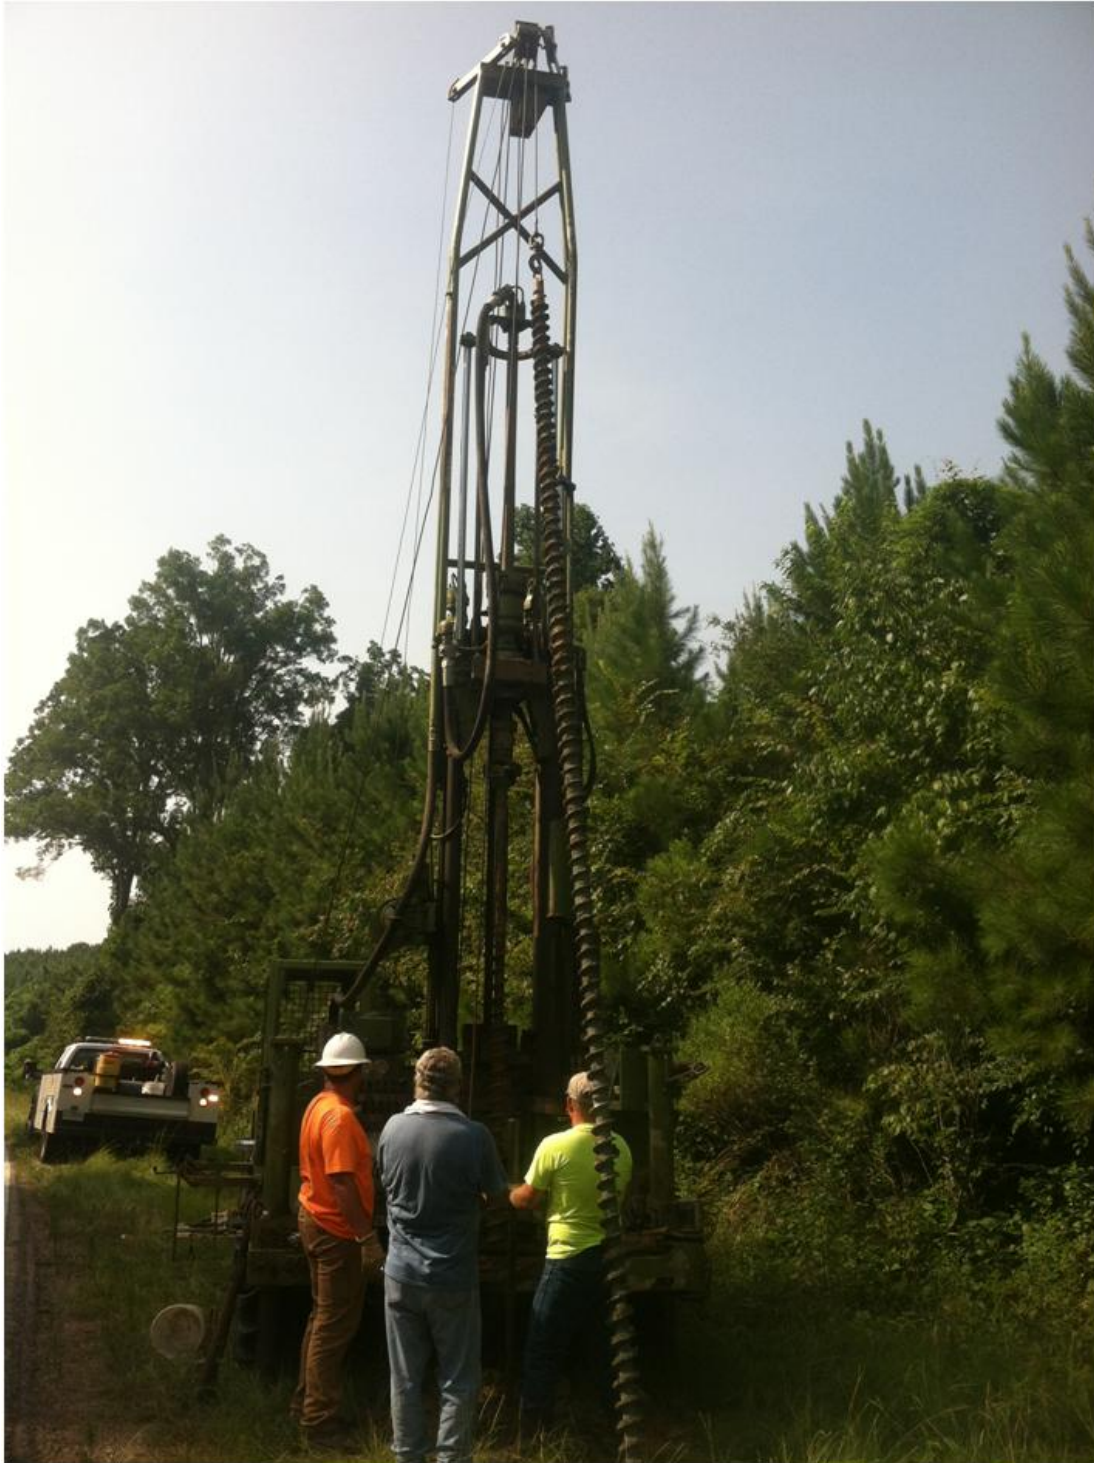
FIG. 3-12. Photograph of ALDOT Drilling for Yazoo Clay.

FIG. 3-12 shows a photograph taken during sample procurement.

The sample name and depth are written on the tubes and the samples are stored vertically. It was recommended that a minimum of 5 ft (about two acrylic tube lengths) of non-cracked, testable material was acquired before sampling was complete. In some cases this was not possible due to inhomogeneities in the sampled material such as crushed rock or mixed soil types.

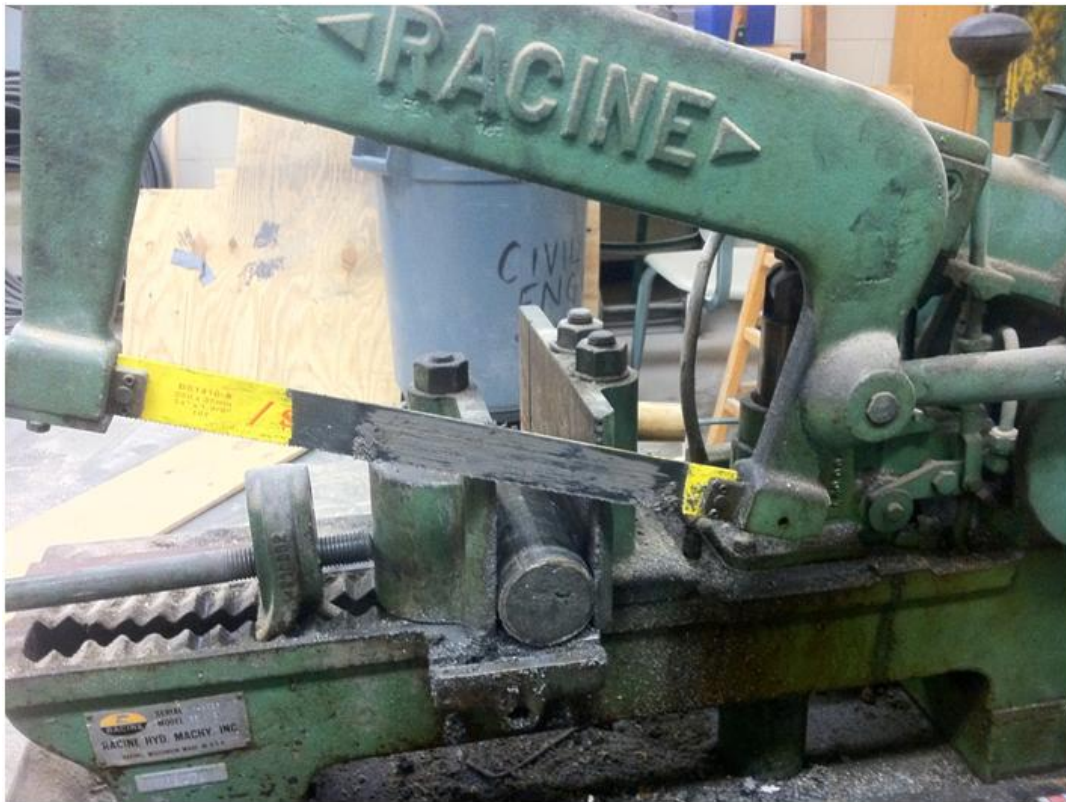
FIG. 3-13. Cutting a Test Section from 2.5 ft Tube using Power Hacks

After the samples were acquired the sealed tubes were taken directly to Auburn University to be stored in a moisture room to preserve the natural moisture content of the material. Again, the samples were stored vertically to simulate insitu state soil conditions. Prior to an EFA test, an 8” to 10” section was cut from the tube using a Racine powered hacksaw as shown in FIG. 3-13.

As seen in the photograph, a vise holds the sample in place while the sawing arm moves back and forth cutting the tube. If the vise is compressed too hard on the tube then the sample will crack. Therefore, the vise was tightened just enough to hold the sample in place.

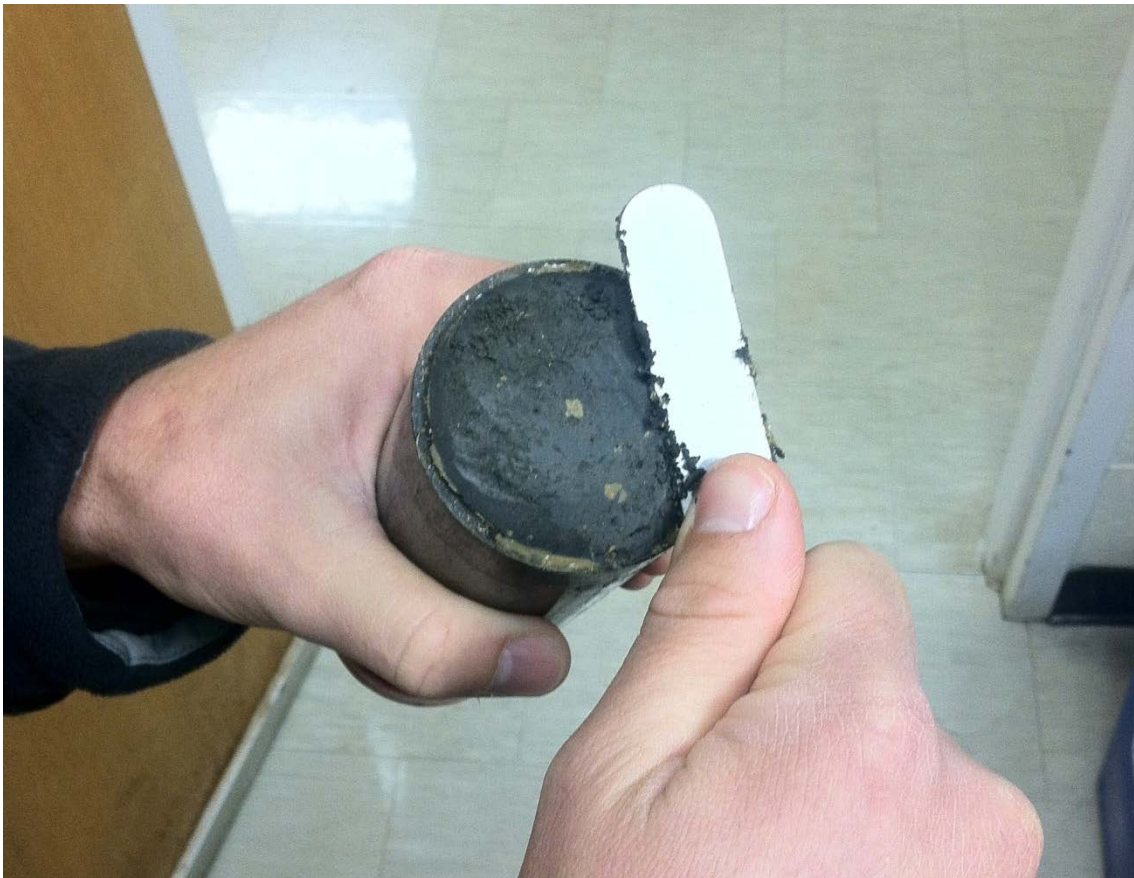
FIG. 3-14. Trimming the Sample Specimen Prior to an EFA Test.

This test section was then taken to the EFA and advanced approximately 3 to 5 mm using the stepping motor. In the case of the extremely stiff samples, the sample was extruded manually using the manual crank wheel shown in FIG. 3-1 F. The test specimen was then trimmed using a spatula so that the surface of the specimen was relatively smooth and flush with the end of the acrylic tube. FIG. 3-14 shows a sample being trimmed prior to an EFA test.

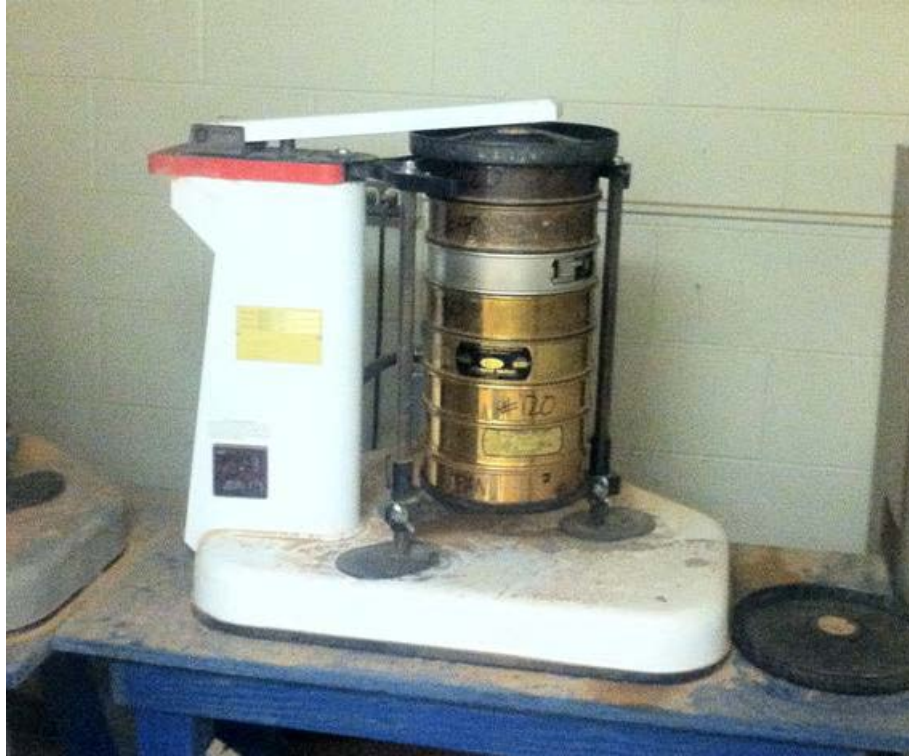
FIG. 3-15. Mechanical Sieve Shaker used in Grain Size Analysis.

The insitu moisture content was determined according to ASTM D2216 – 10 standards and all grain size analyses of the formations were determined according to the ASTM D422 – 63 standard. FIG. 3-15 and FIG. 3-16 are photographs taken during grain size analyses. Atterberg limit testing was performed according to the ASTM D4318 – 10 “Standard Test Methods for Liquid Limit, Plastic Limit, and Plasticity Index of Soils.” FIG. 3-17 and FIG. 3-18 are photographs taken during Atterberg limit testing.

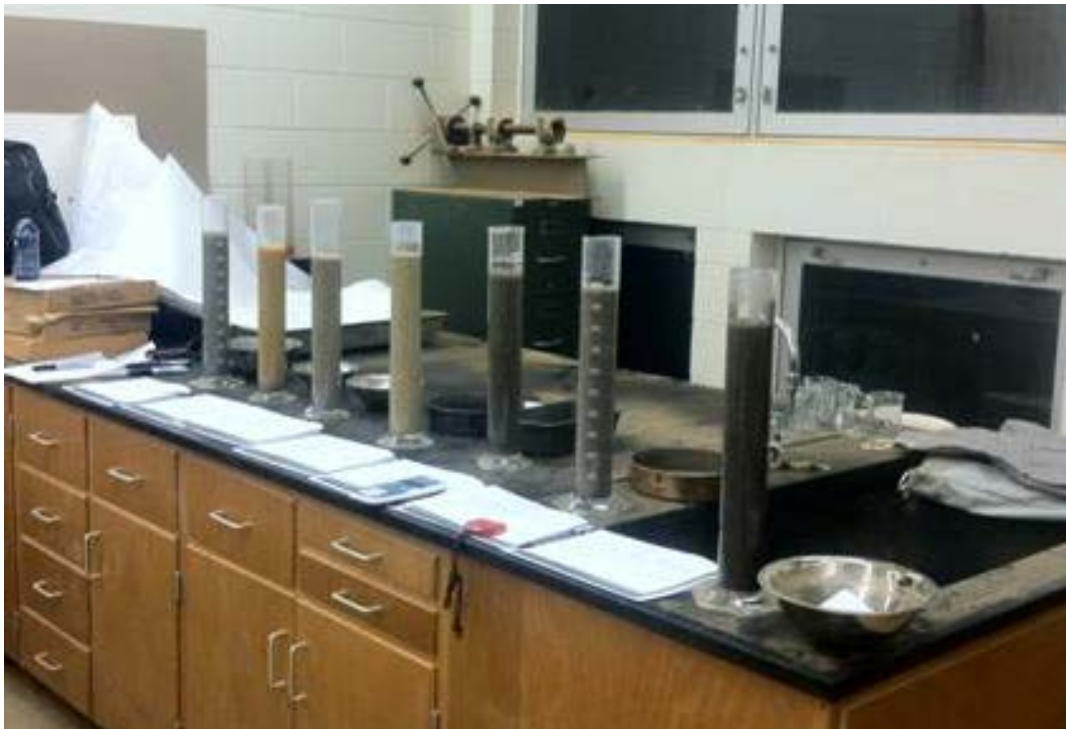
FIG. 3-16. Hydrometer Analysis for the Fine Grained Fraction of Material.

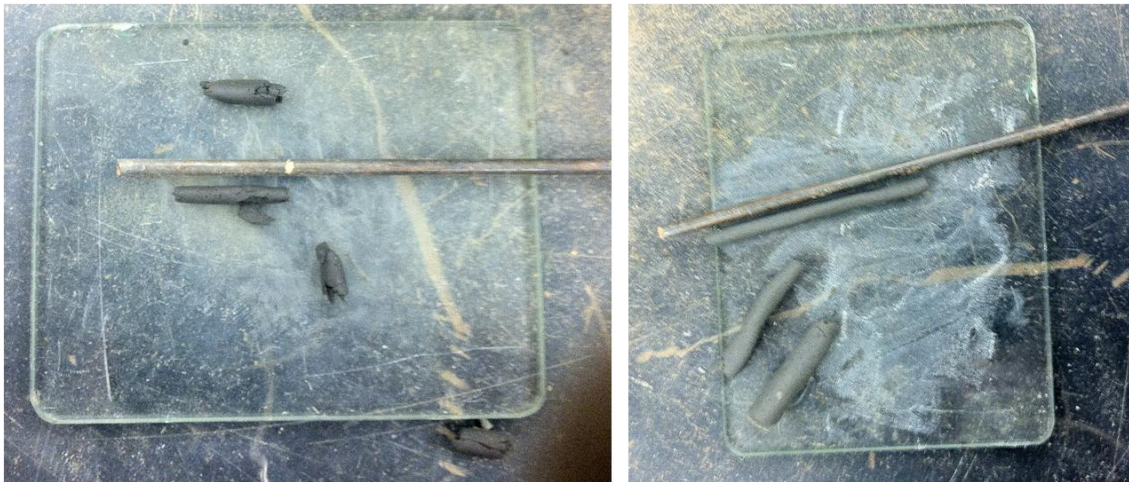
FIG. 3-18. Atterberg Limit Testing: Plastic Limit.

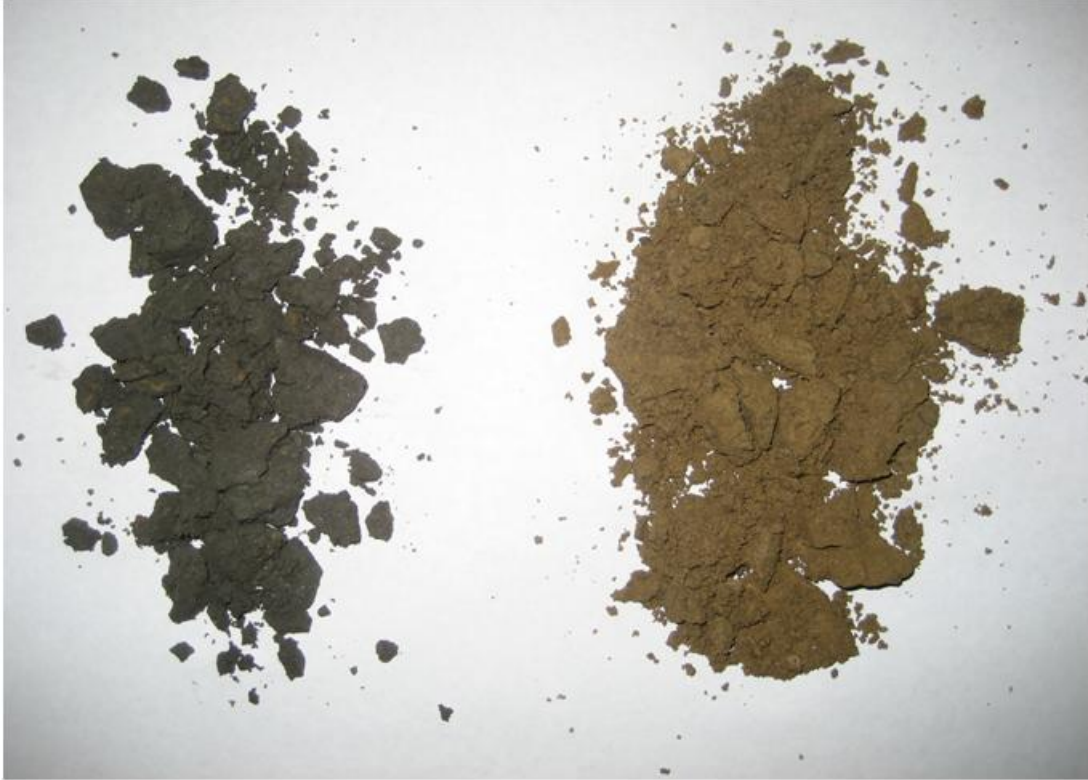
FIG. 4-6. Photograph of Naheola-Dark (left) and Naheola-Yellow (right) Formations.

Naheola clay was originally intended to be tested by Walker (2013). The material was first sampled in 2012, but due to time constraints in Walker’s study no EFA or geotechnical testing was performed. The formation was drilled again in 2013 and this second sampling will be discussed in **4.5 Naheola Clay (Re-drilled)**. As shown in FIG. 4-6, the 2012 sample consisted of two different colored soils; one portion being a yellow-brownish material and the other having a dark grey color. Because of this distinct difference in appearance the Naheola formation was divided and tested as two separate materials: Naheola (Yellow) and Naheola (Dark). The color change occurred at approximately 17 feet with the dark material overlying the yellow soil.

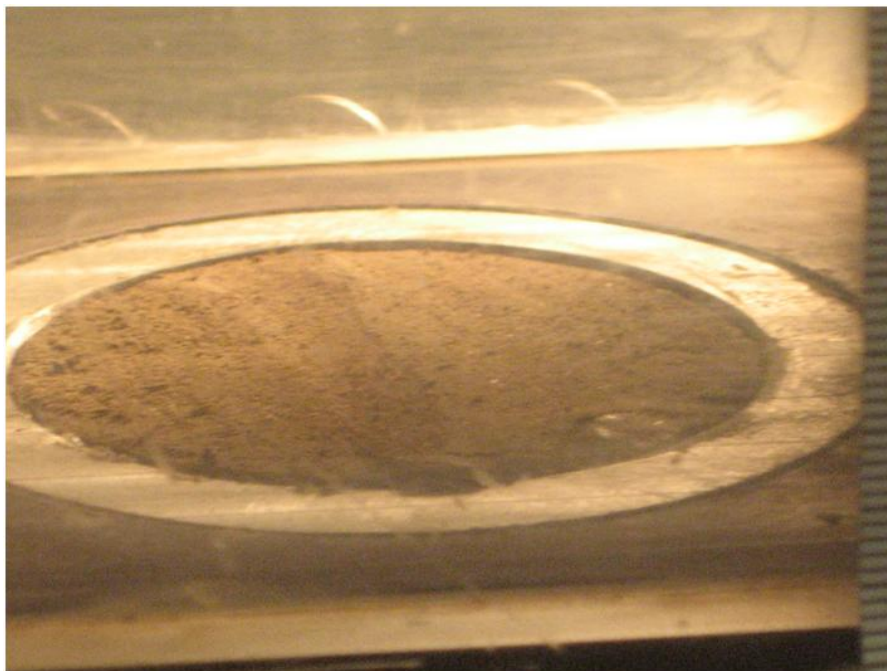
FIG. 4-7. "Naheola Clay 17.2_1" Sample Prior to 2.0 m/s EFA Test.

Table 4-9 shows the results for the single test performed at 2.0 m/s. Photographs taken at the beginning and end of the “Naheola Clay 17.2_1” test are shown in FIG. 4-7 and FIG. 4-8, respectively.

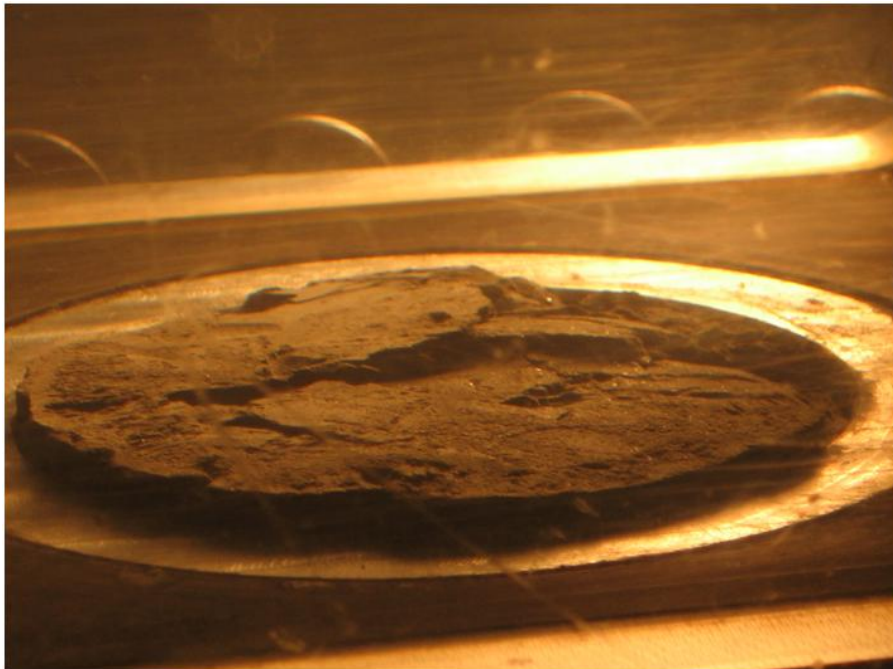
FIG. 4-11. "Naheola Clay 16.0_1" Sample at the End of 1.5 m/s EFA Test.

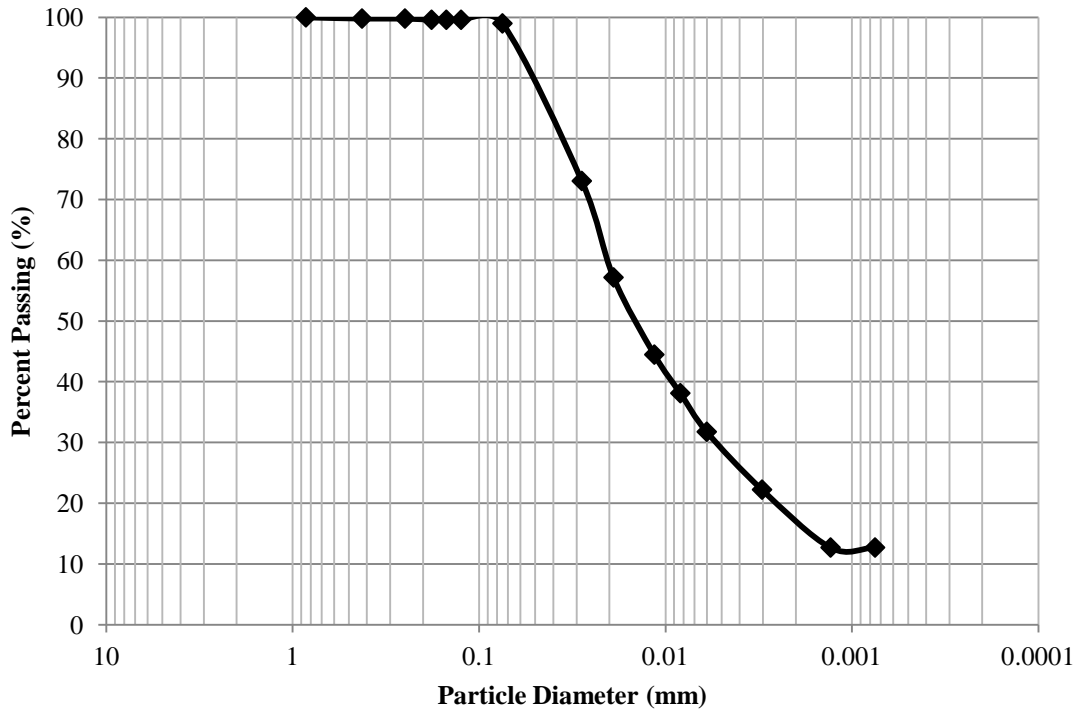
FIG. 4-12. Dark Naheola Clay Grain Size Distribution.

An average insitu moisture content of 34.3% for the dark Naheola clay was determined according to ASTM D2216 – 10 standards. A full grain size analysis, shown in FIG. 4-12, was determined for the material using the ASTM D422 – 63 test method. Because none of the material was retained on the No. 10 sieve a coarse grain size analysis was not performed. The “fines percentage” (percent passing the No. 200 sieve) was determined to be approximately 99 percent. The mean grain size diameter of the material was 0.016 mm. Atterberg limit testing was performed according to ASTM D4318 – 10 standards. The tests resulted in average values for liquid limit of 61, plastic limit of 25, and a plasticity index of 35. As previously stated, an SPT test performed by the ALDOT drill crew produced an N value of 16 blows.

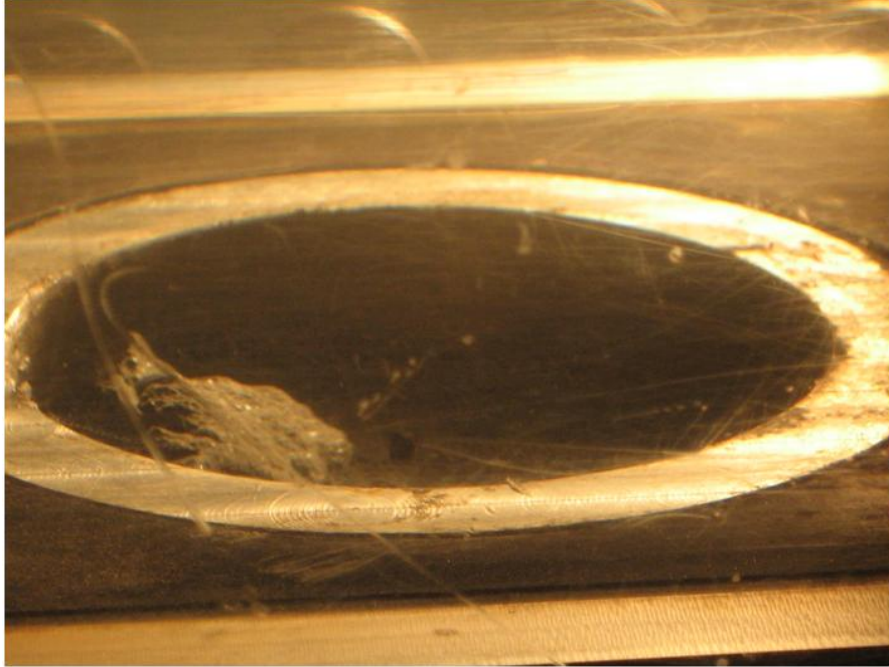
FIG. 4-20. "Clayton 29.0_7" Approximately 27 Minutes into Test.

Three tests were conducted at the 2.0 m/s velocity increment, producing a total of six individual scour events. In the first test, titled “Clayton 29.0_1”, one scour event occurred over a six minute period. The second test, titled “Clayton 29.0_4”, lasted approximately five minutes and the sample was lost in two large chunks when the flow reached a velocity of 2.0 m/s. The last test, titled “Clayton 29.0_7”, produced four separate scour events over the 26 minute test duration. Massive swelling resulted in a net increase in sample height of more than 2.6 mm. The sample swelled more than 1 mm in the last two minutes of the test. Eventually the entire top half of the sample washed away approximately 26 minutes into the test. FIG. 4-18, FIG. 4-19, and FIG. 4-20 are photographs taken at critical moments throughout the 2.0 m/s test. The massive swelling that occurred is very apparent in the photographs. Table 4-20 shows the results of the 2.0 m/s test.

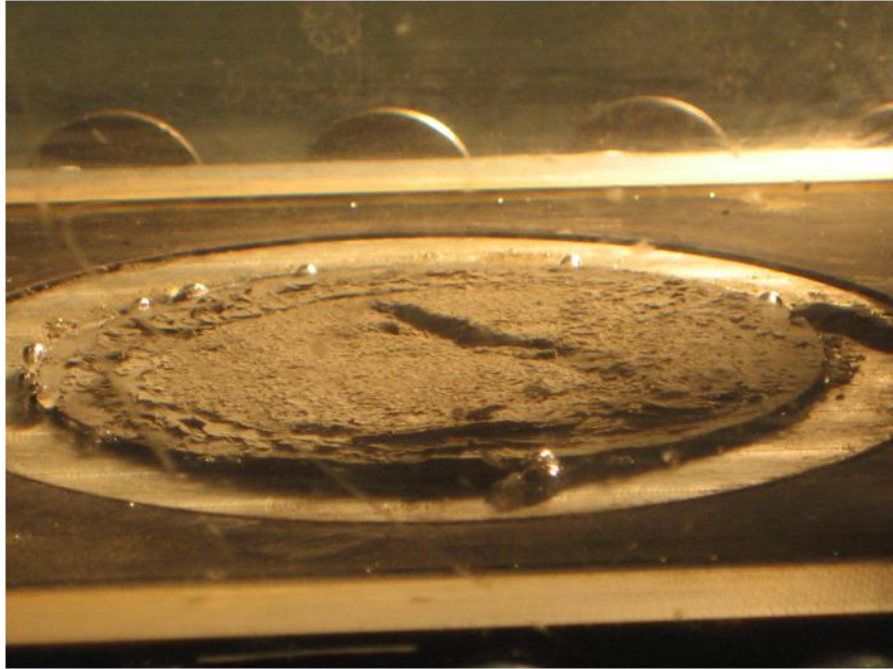
FIG. 4-22. "Bucatanna 26.0_3" Sample Approximately 3 Minutes into 3.0 m/s EFA Test

A single test, titled “Bucatunna 26.0_3”, was conducted at a velocity of 2.0 m/s. The test lasted a total of 18 minutes in which four different scour events were seen. Some soil was lost with the velocity increase and therefore that portion of the soil loss was not considered during analysis. The sample was lost in a few large pieces 14 minutes after the sample was advanced. Photographs taken during the test are shown in FIG. 4-22 and FIG. 4-23. Table 4-25 presents the results of the 2.0 m/s EFA test.

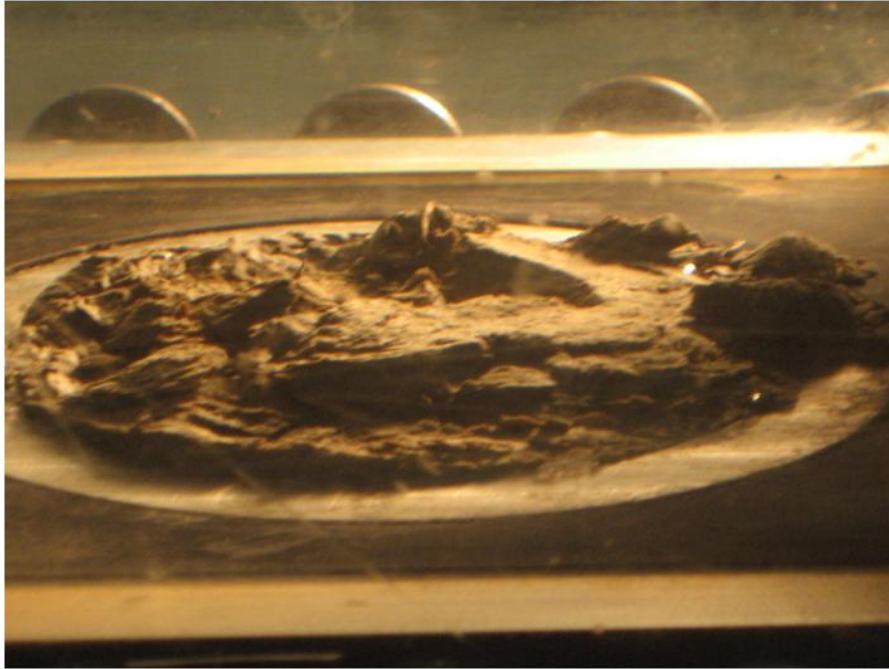
FIG. 4-26. "Porters Creek 24.0_4" Sample 15 minutes After Push.

discern from the erosion graph. In other words, the scour rate for the first event was most likely not a true depiction of total soil loss but rather a net change in specimen height. The “Porters Creek24.0_4” sample grew approximately 1.88 mm in the nine minutes between the first and second scour events. The scour-swell pattern was seen throughout the test until the majority of the sample was lost instantaneously 22 minutes after the push. FIG. 4-25 and FIG. 4-26 show photographs taken at the start of the test and 15 minutes after the sample was advanced, respectively. The second test conducted at 0.3 m/s, titled “Porters Creek24.5_1” was similar to the first. The test lasted just under 40 minutes and produced three scour events. It was noted that the second scour rate (Porters Creek24.5_1(2)) may have been negated by severe swelling, thus resulting in a conservative scour rate. In the third test, titled “Porters Creek24.5_5”, no scour was observed but the sample swelled an astounding 3.1 mm in 19 minutes. Table 4-27 shows the results of the 0.3 m/s EFA test.

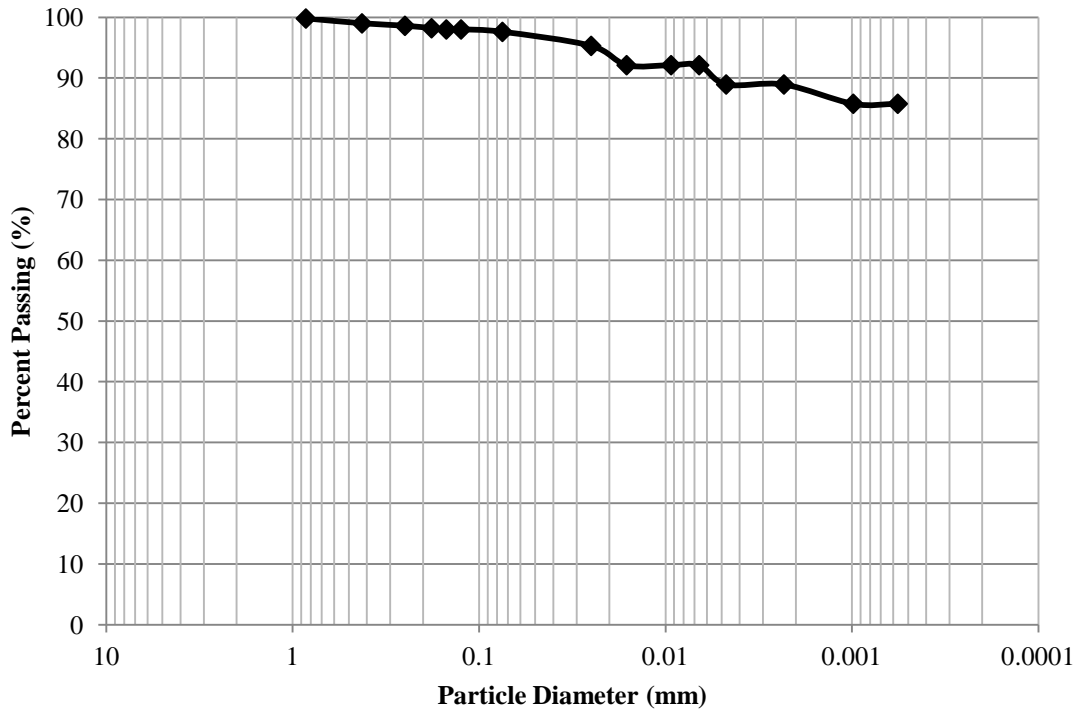
FIG. 4-27. Porter's Creek Clay Grain Size Distribution.

An average insitu moisture content of 43.6% for the Porter's Creek soil was determined according to ASTM D2216 – 10 standards. A full grain size analysis, shown in FIG. 4-27, was determined for the material using the ASTM D422 – 63 test method. Because none of the material was retained on the No. 10 sieve a coarse grain size analysis was not performed. The “fines percentage” (percent passing the No. 200 sieve) was determined to be 98 percent. The mean grain size diameter of the material was not determined because a 48 hour hydrometer test was not sufficient for this very fine material, however the mean grain size diameter was considered to be much less than 0.001 mm. Atterberg limit testing was performed according to ASTM D4318 – 10 standards. The tests resulted in average values for liquid limit of 114, plastic limit of 40, and a plasticity index of 74. As previously stated, the SPT test performed by ALDOT resulted in an N value of 13 blows.

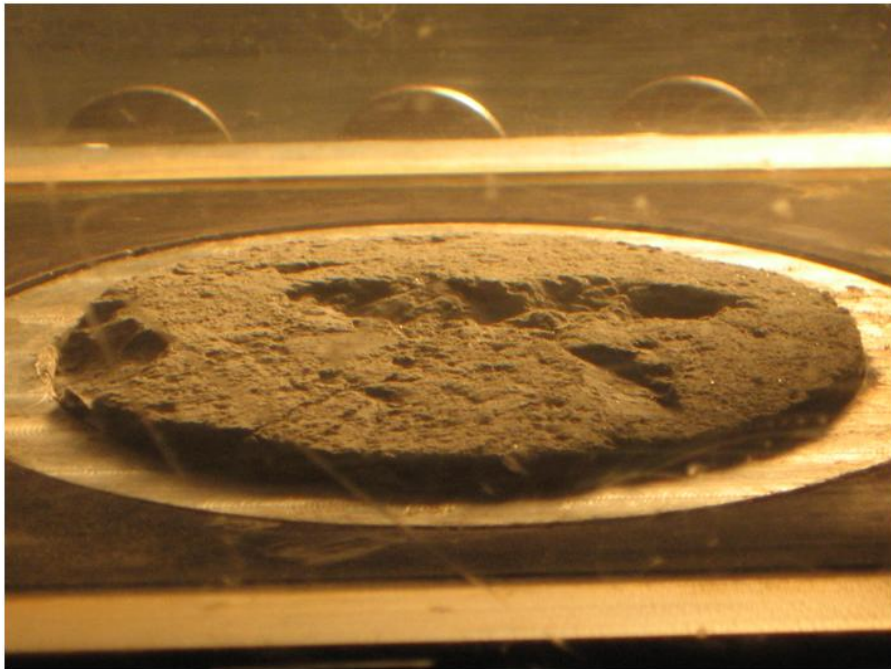
FIG. 4-29. "Yazoo21.0_4" Sample Approximately 57 Minutes After Push.

Three tests were performed at the 1.0 m/s velocity increment. In the first test, titled “Yazoo21.0_1”, significant scour was observed before the velocity reached 1.0 m/s. However, the respective data shown in Table 4-31 represents scour that occurred after the target velocity was reached. The second test, titled “Yazoo21.0_3”, lasted 26 minutes in which two scour events were observed. The scour representing the first event occurred immediately after the target velocity we met. The sample swelled but did not scour the next 24 minutes and ultimately eroded in one large chunk. The last test, titled “Yazoo21.0_4”, lasted 61 minutes and experienced three scour events. The scour-swell pattern was very apparent in this test, and although scour certainly occurred the sample still grew nearly 1 mm in height. Some erratic data points were observed over the last 10 minutes of the test. FIG. 4-28 and FIG. 4-29 are photographs taken at the beginning and end of the “Yazoo21.0_4” test. Due to the extreme swelling experienced throughout the test, the substantial scour that occurred was not nearly as evident in the erosion graph as it was visually. Table 4-31 shows the results of this 1.0 m/s EFA test on the Yazoo material.

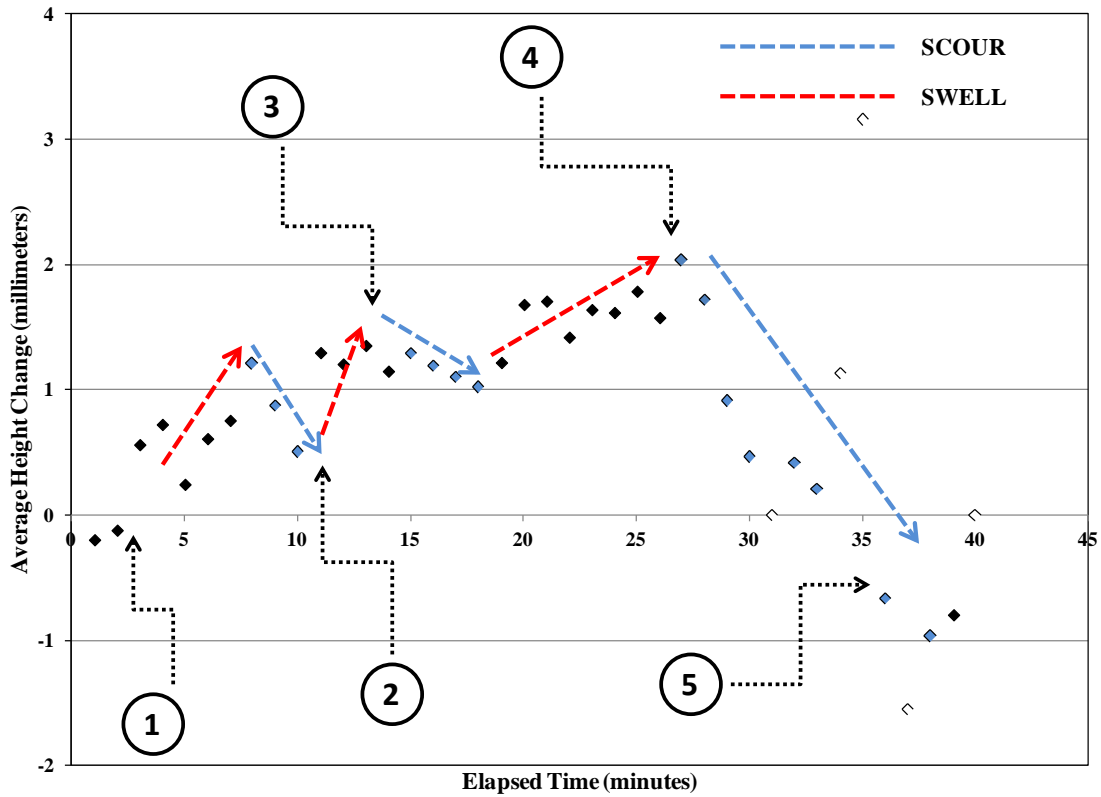
FIG. 5-5. "Scour-Swell" Pattern from "Porters Creek 24.5_1" EFA Test.

additional water and swell again. Because this pattern was so commonly seen throughout testing, it was decided that erosion rates be determined from the events in which scour occurred, referred to as “scour events” in the results, rather than from the net change in specimen height over the test duration. This pattern is illustrated in FIG. 5-5. Photographs corresponding to points 1 through 5 are shown in FIG. 5-6.

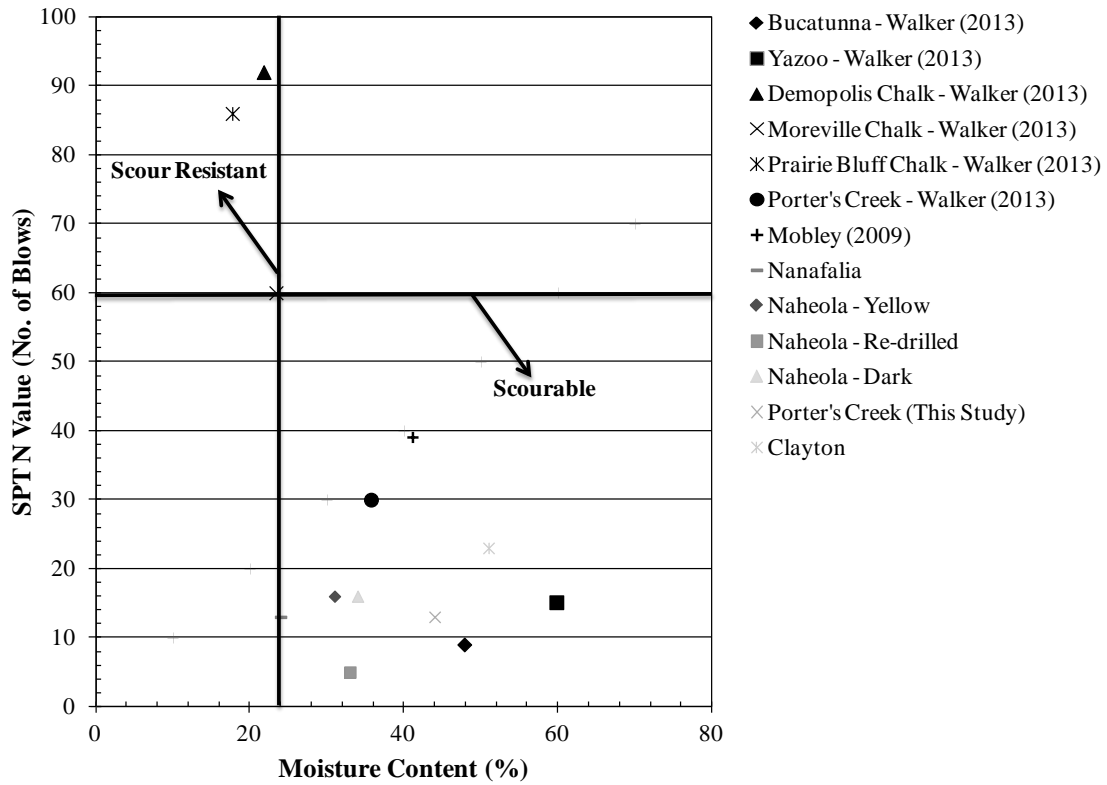
FIG. 5-22. Scourability versus SPT N Value and Moisture Content.

The SPT blow counts appeared to have a serious effect on scour resistance, as only N values 60 and above were scour resistant. Soils with moisture contents below 24 did not scour at velocities of 3.0 m/s and less. FIG. 5-22 shows a plot of scourability as it relates to SPT N value and insitu moisture content.
