Laboratory Scour Testing of Hard Cohesive Soils in Alabama

A thesis submitted to the Graduate Faculty of
Auburn University
in partial fulfillment of the
requirements for the Degree of
Master of Science

May 3, 2014

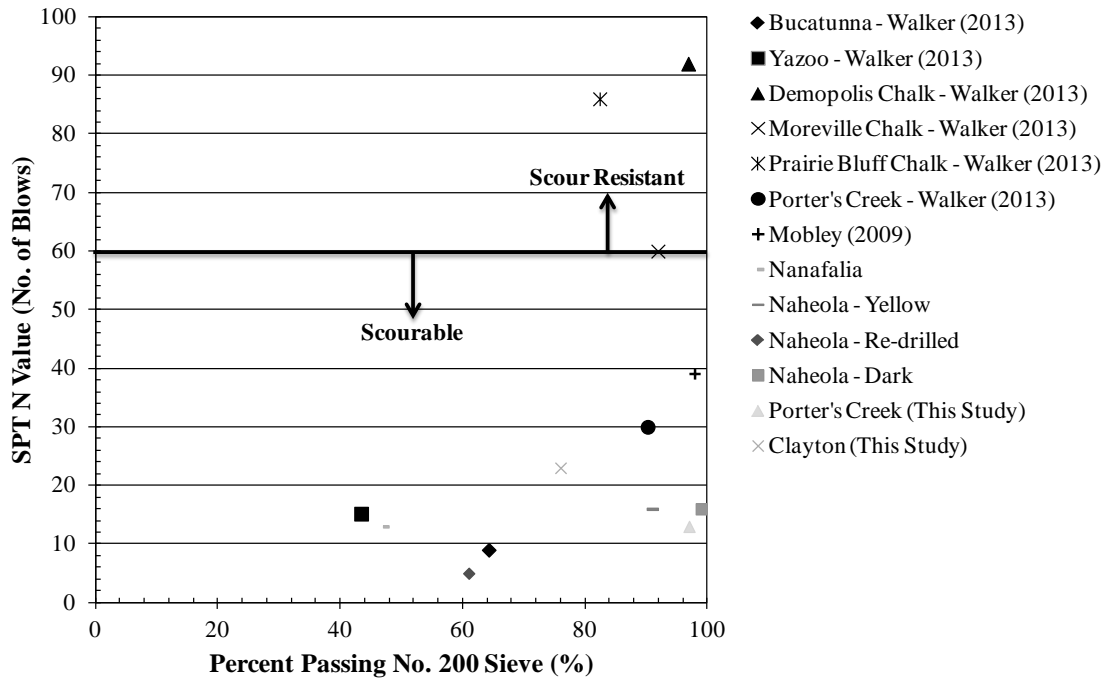
FIG. 5-23. Scourability versus SPT N Value and Percent Passing the No. 200 Sieve.

The percentage of fined grained soil (i.e. the percent passing the No. 200 sieve) did not appear to have an effect on scourability. The scour resistant soils all had fines percentages greater than about 82%, though five of the scourable materials had a fines percentage falling above this value. FIG. 5-23 shows a plot of scourability as it relates to SPT N value and fines percentage.

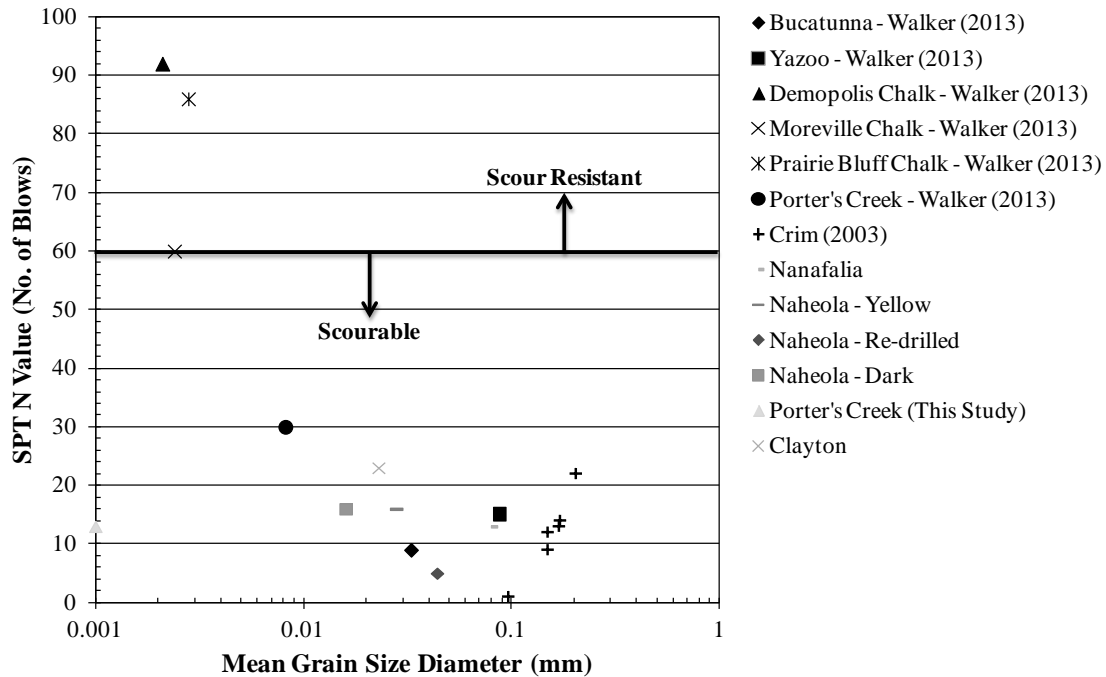
FIG. 5-24. Scourability versus SPT N Value and Mean Grain Size.

Walker observed that soils were scour resistant when the material had a mean grain size diameter less than 0.0082 mm. This correlation was seen with the exception of the Porter's Creek sample. The Porter's Creek sample tested in this study was an extremely fine material. The mean grain size diameter of the Porter's Creek material tested by Walker was approximately 0.0082 mm. As previously stated, the mean grain size diameter of the re-sampled Porter's Creek material was not determined because a 48 hour hydrometer test was not sufficient for this very fine material. Because the mean grain size was certainly less than 0.001 mm, the correlation between scourability and mean grain size cannot be made. FIG. 5-24 shows a plot of scourability as it relates to SPT N value and mean grain size diameter.
