**Effectiveness of Silane in Mitigating Alkali-Silica Reaction in the
Bibb Graves Bridge**

A thesis submitted to the Graduate Faculty of
Auburn University
In partial fulfillment of the
Requirements for the Degree of
Master of Science

Auburn, Alabama
December 14, 2013

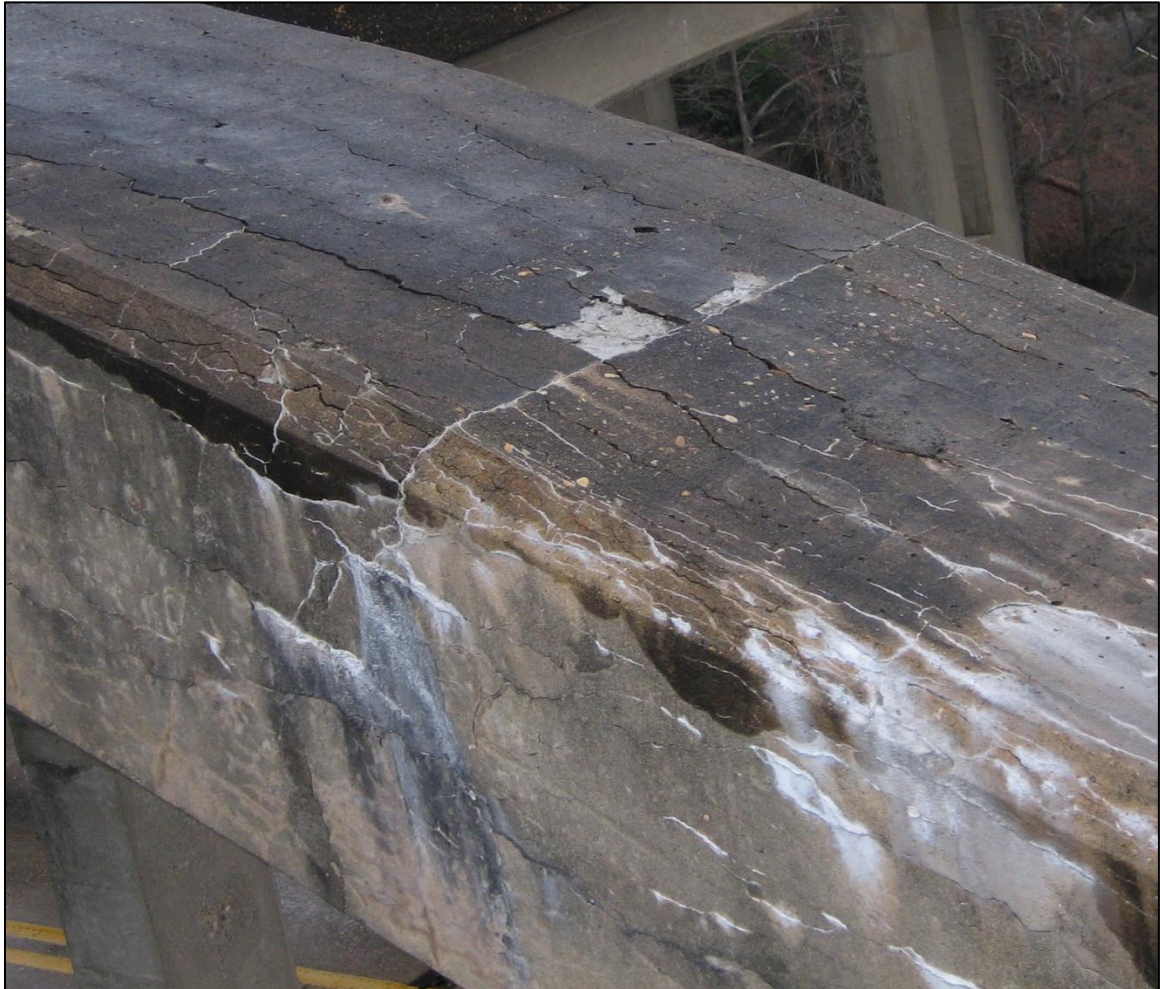
Figure 1.2. Surface deposits and ASR-induced cracking on 3/11/08

Most of this 82-year old structure is still in sound condition, but the concrete in both arches of the fifth span are severely distressed due to alkali-silica reaction (ASR). Examples of surface deposits and longitudinal cracking caused by ASR in the southern arch of span 5 can be seen in Figure 1.2.

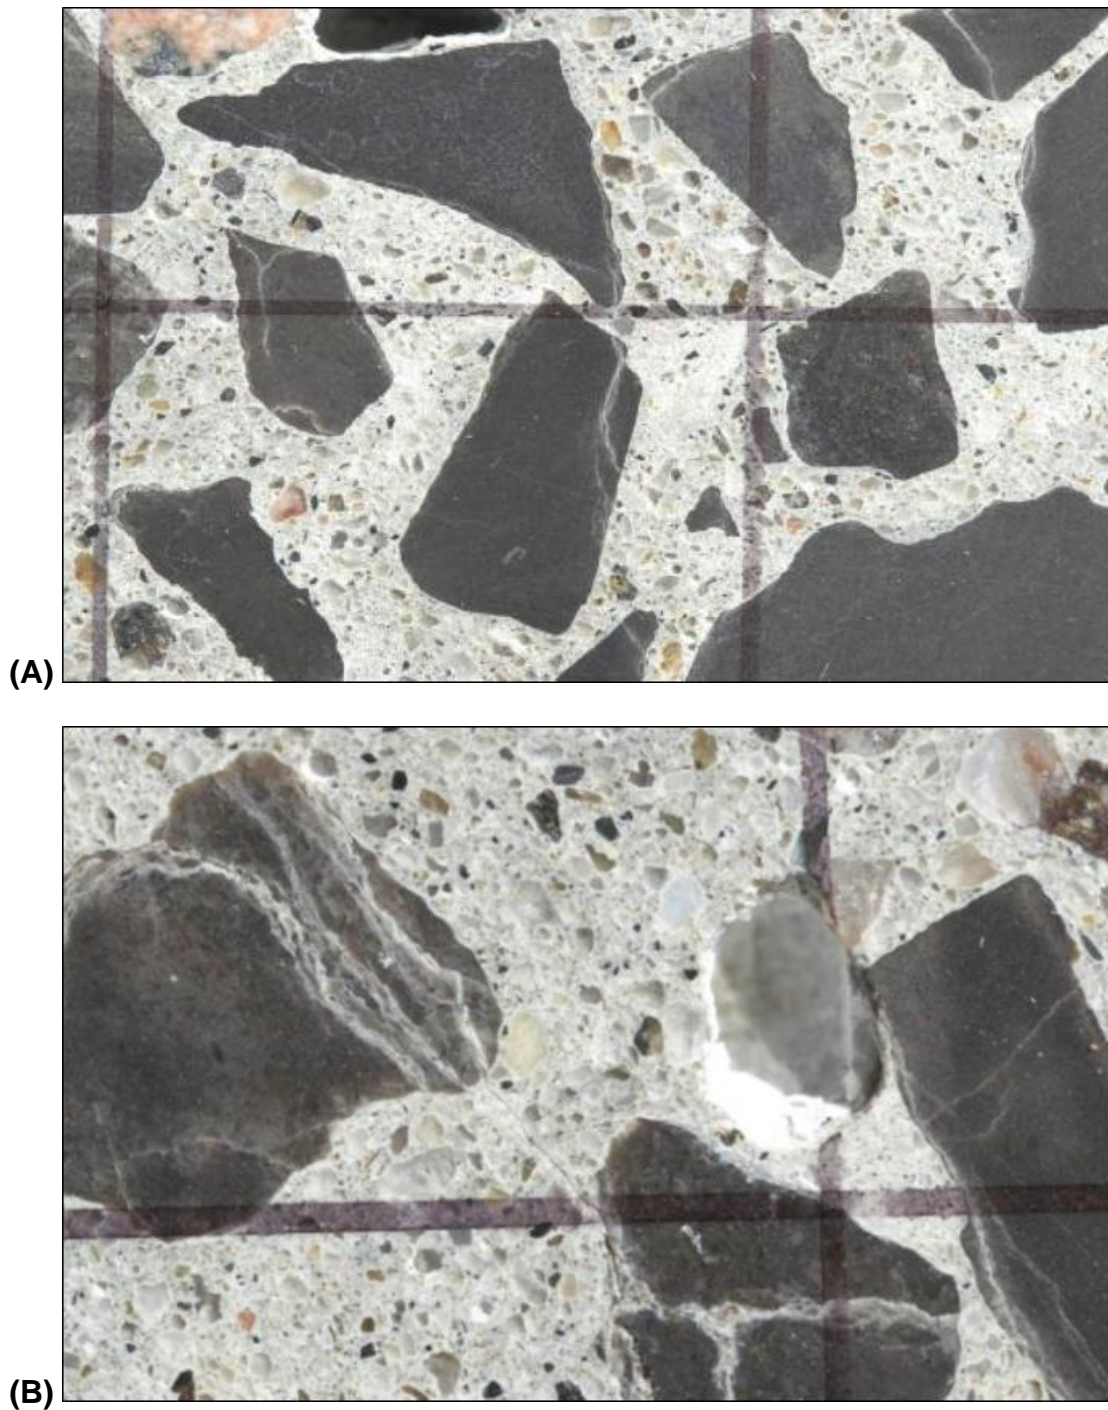
Figure 2.2. Microcracking in aggregate due to ASR with (A) 0.066% and (B) 0.283% concrete expansion (Fournier et al. 2010)

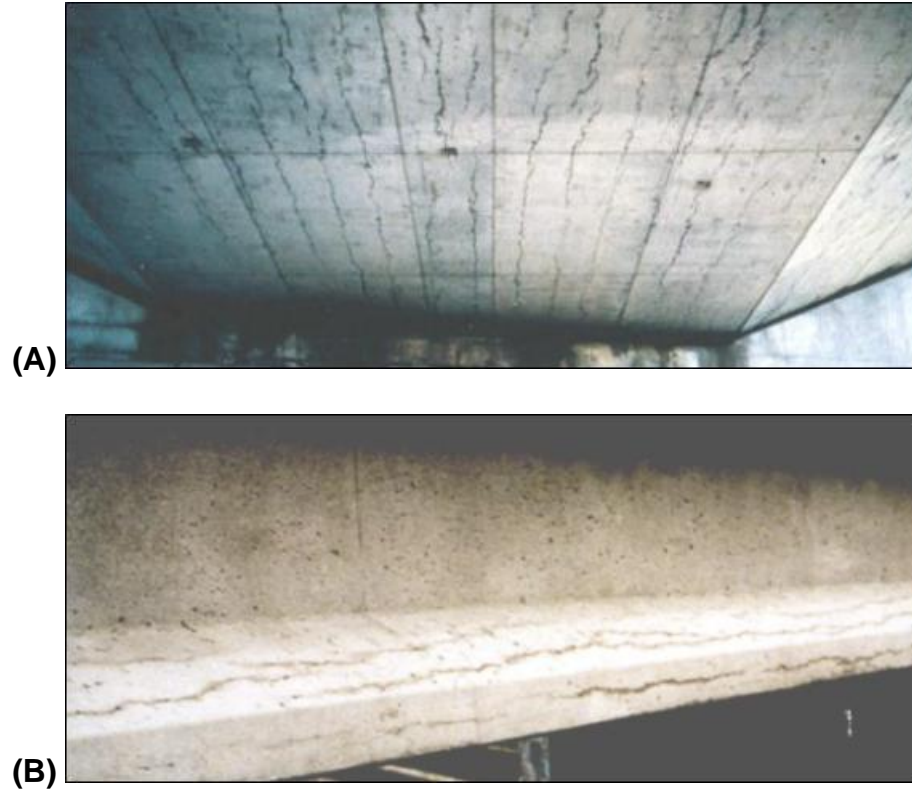
Figure 2.4. Longitudinal cracking due to ASR in (A) a bridge deck soffit and (B) a precast, reinforced concrete beam (Fournier et al. 2010)

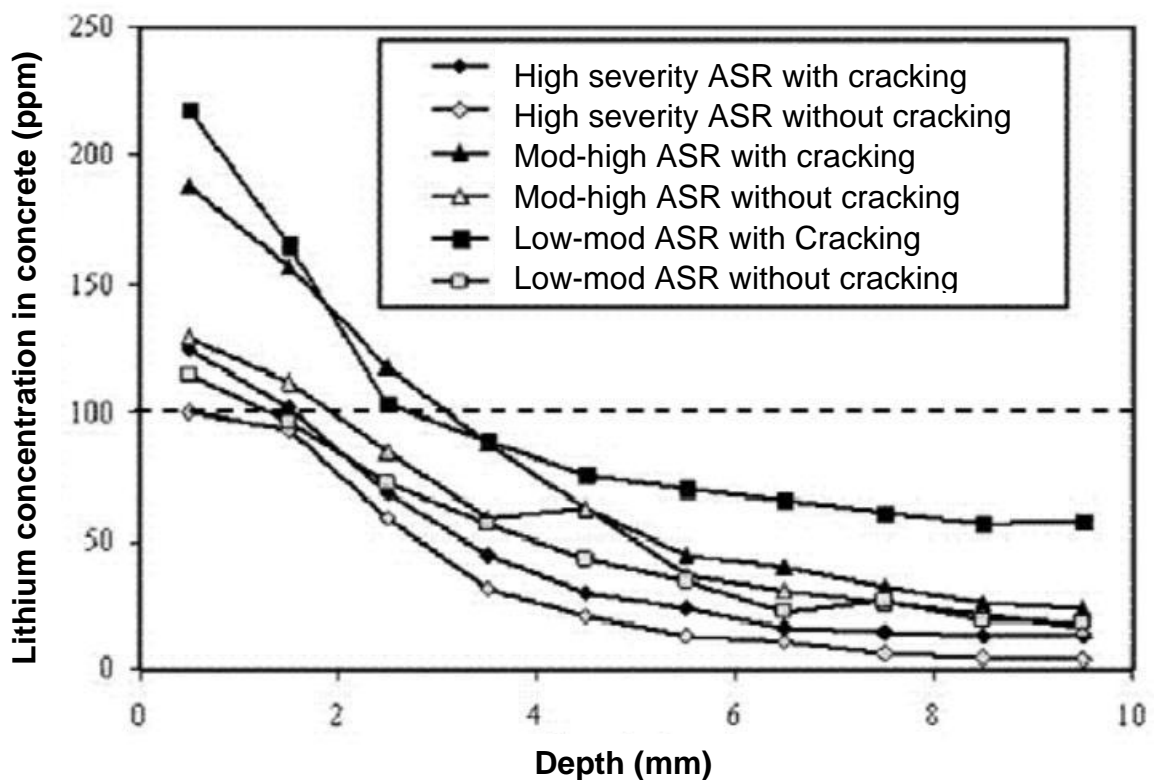
for their lithium concentration. It was found that only the upper 0.16 in. (4 mm) contained sufficient amounts of lithium, over 100 ppm, to suppress ASR expansion, and this was consistent with laboratory treatments of pavement sections from the same location and laboratory-produced concrete. Figure 2.16 contains a graphical representation of the lithium concentrations versus depth, and it can be seen in this figure that concentrations of greater than 100 ppm are only within the top 0.16 inches of the concrete. Because of only reaching a few millimeters into the concrete, topical applications of lithium nitrate do not appear to be sufficient enough to suppress future expansion and cracking caused by ASR (Folliard et al. 2009).

Figure 2.16. Depth of lithium penetration with topical application on I-84

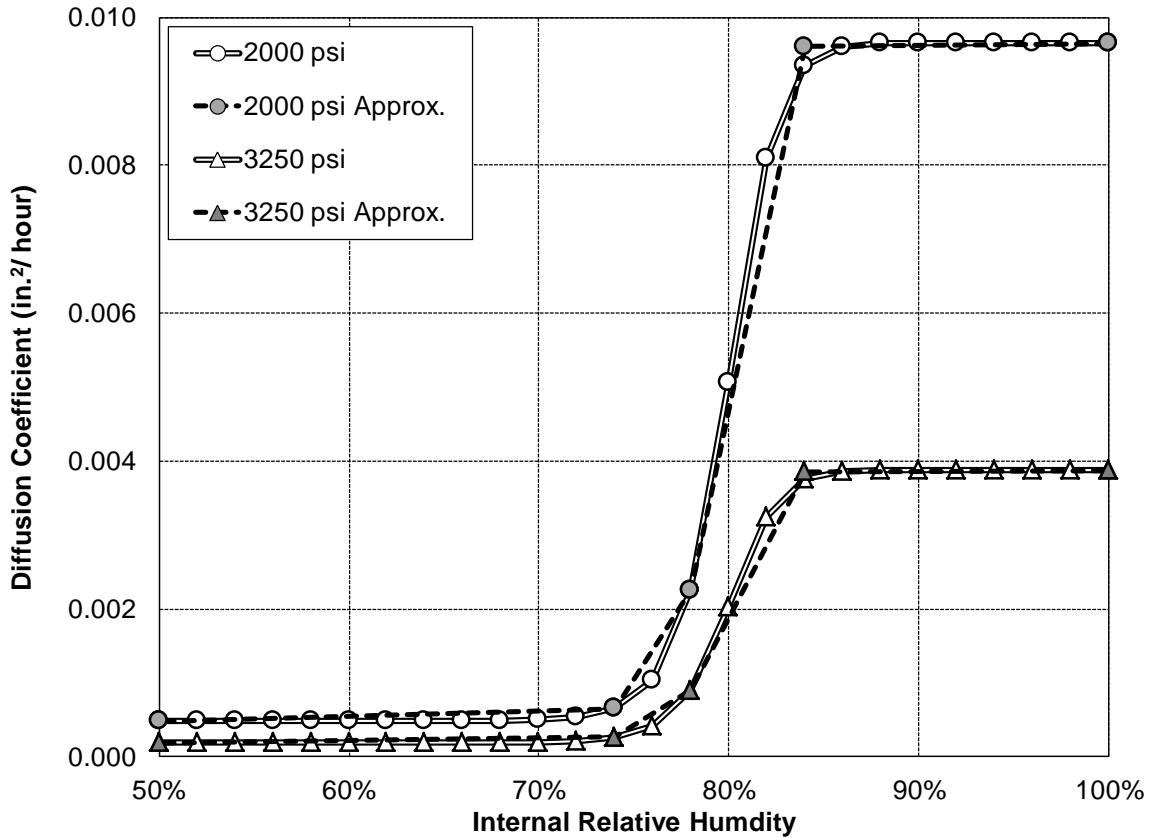
The moisture diffusion coefficients for the different concrete strengths are not constant. These coefficients are highly dependent on the internal relative humidity of the concrete among other variables, as shown in Figure 2.23. The ambient relative humidity, which is the driving force for the diffusion process, was also varied monthly in the modeling based on a 30-year monthly average for Montgomery, Alabama.

Figure 2.23. Multilinear approximation of the moisture diffusion coefficient
(Adapted from Warnock 2012)

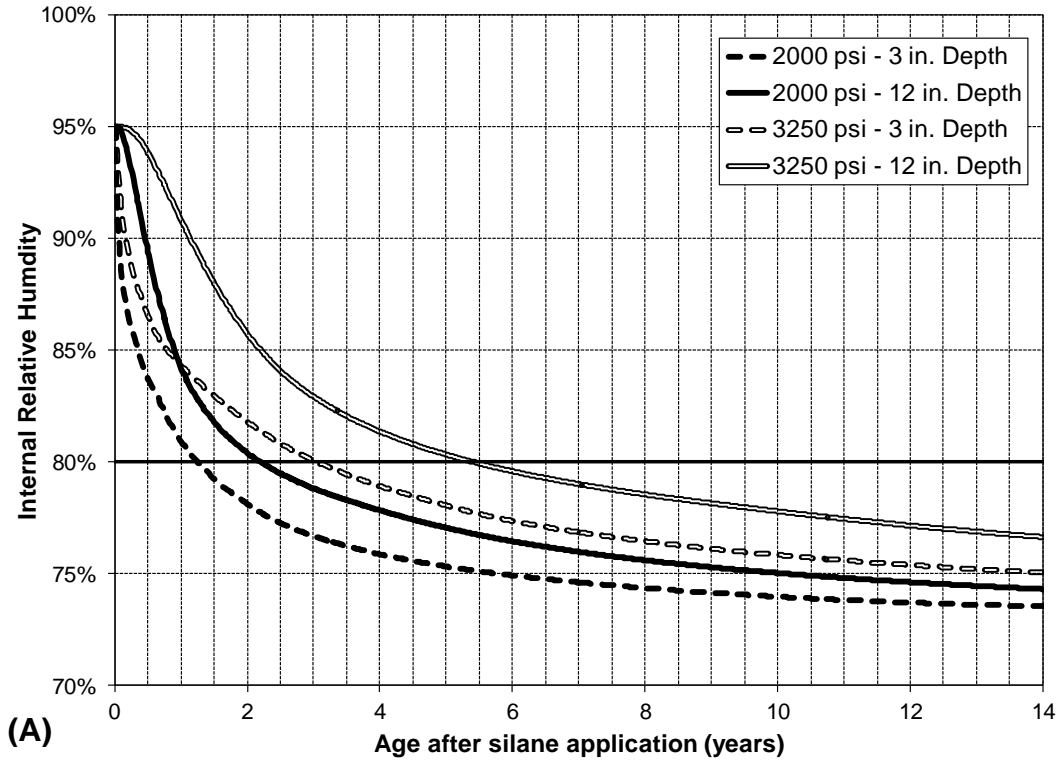
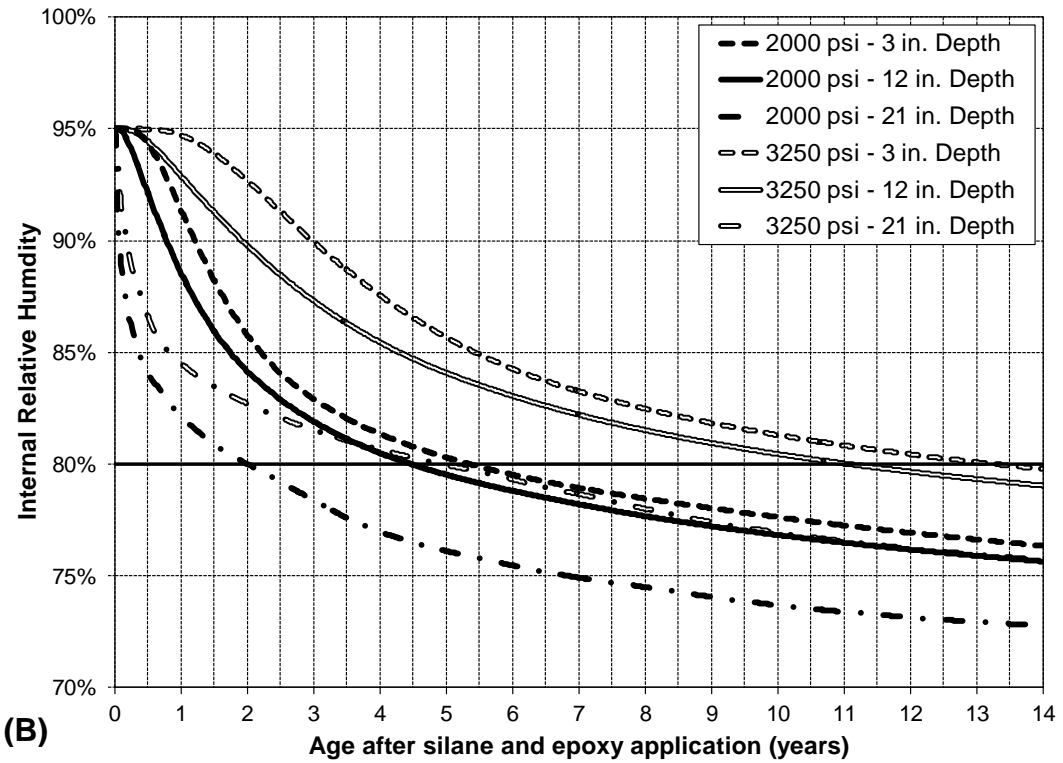
The finite element analysis of the moisture diffusion started at 95 percent relative humidity and was carried out to 14 years with automatic time steps. A minimum step of 24 hours and maximum step of 1 week were assigned to the model. The results of the moisture diffusion model are shown in Figure 2.24. Figure 2.24 (A) is for the section that represented silane only, and Figure 2.24 (B) is for the section that had top boundary conditions to simulate epoxy by not allowing diffusion through that side. The depths shown in these figures are taken from the top of the 24-inch thick cross section.

Figure 2.24. RH versus time for (A) silane only and (B) silane and epoxy

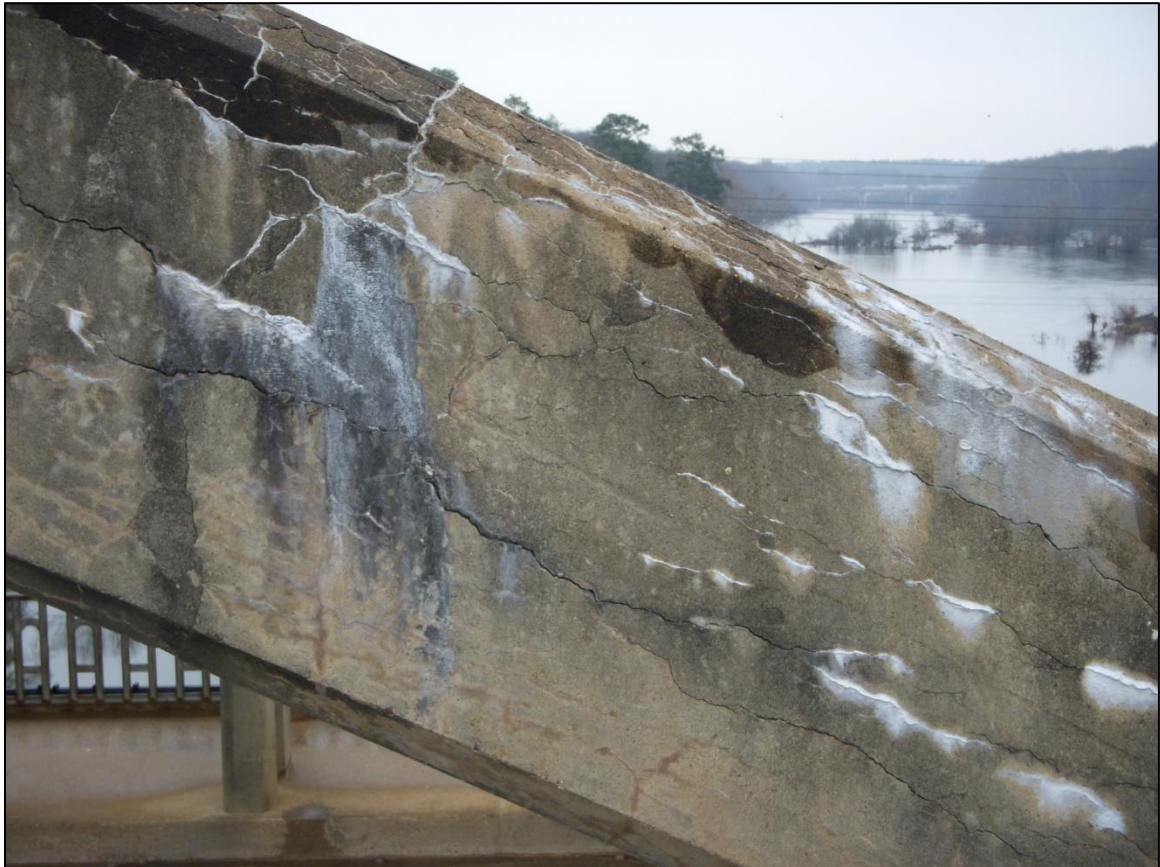
example of severe longitudinal cracking and surface deposits of efflorescence and alkali-silica on the south side of the southern arch in span 5.

Figure 3.16. Severe distress due to ASR on span 5, south arch

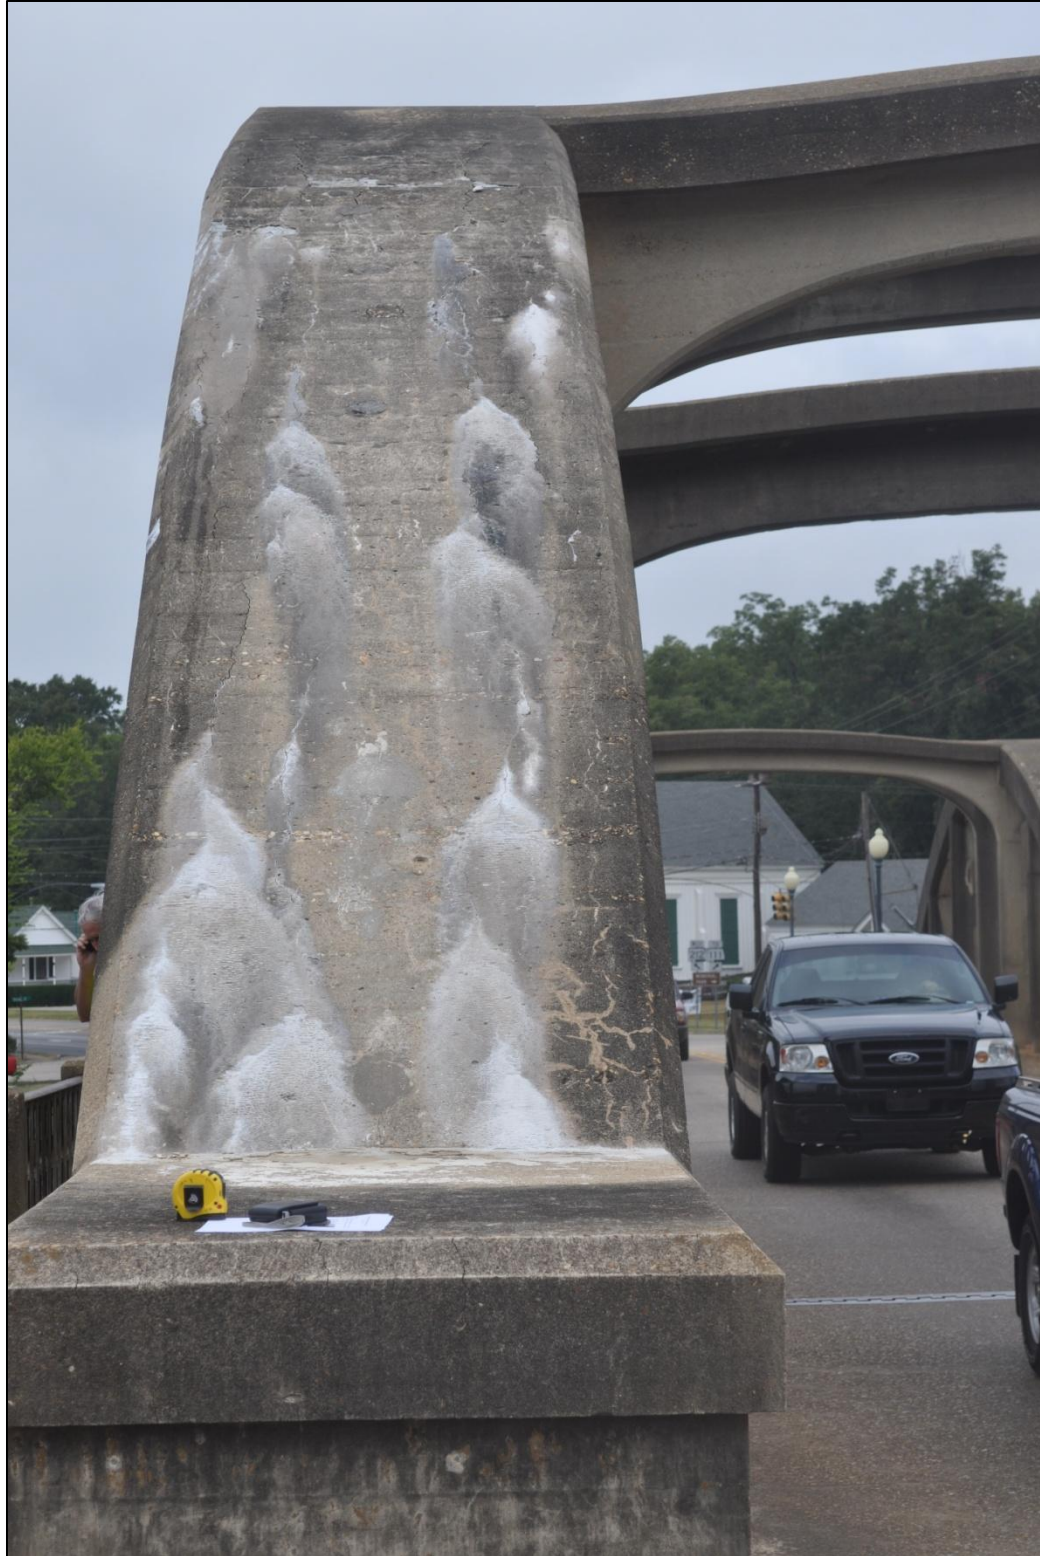
Figure 3.17 is a view of distress and surface deposits on the eastern top side of span 5 south. Figure 3.18 is a closer view of the high end of the arch shown in Figure 3.17. Figure 3.18 was taken in March of 2008 and exhibits severe spalling and longitudinal cracking. The following image, Figure 3.19, is the same location, but was taken in December of 2009. More spalling has occurred since the 2008 photo.

Figure 3.17. Distress with surface deposits of efflorescence and alkali-silica gel on the eastern side of span 5 south

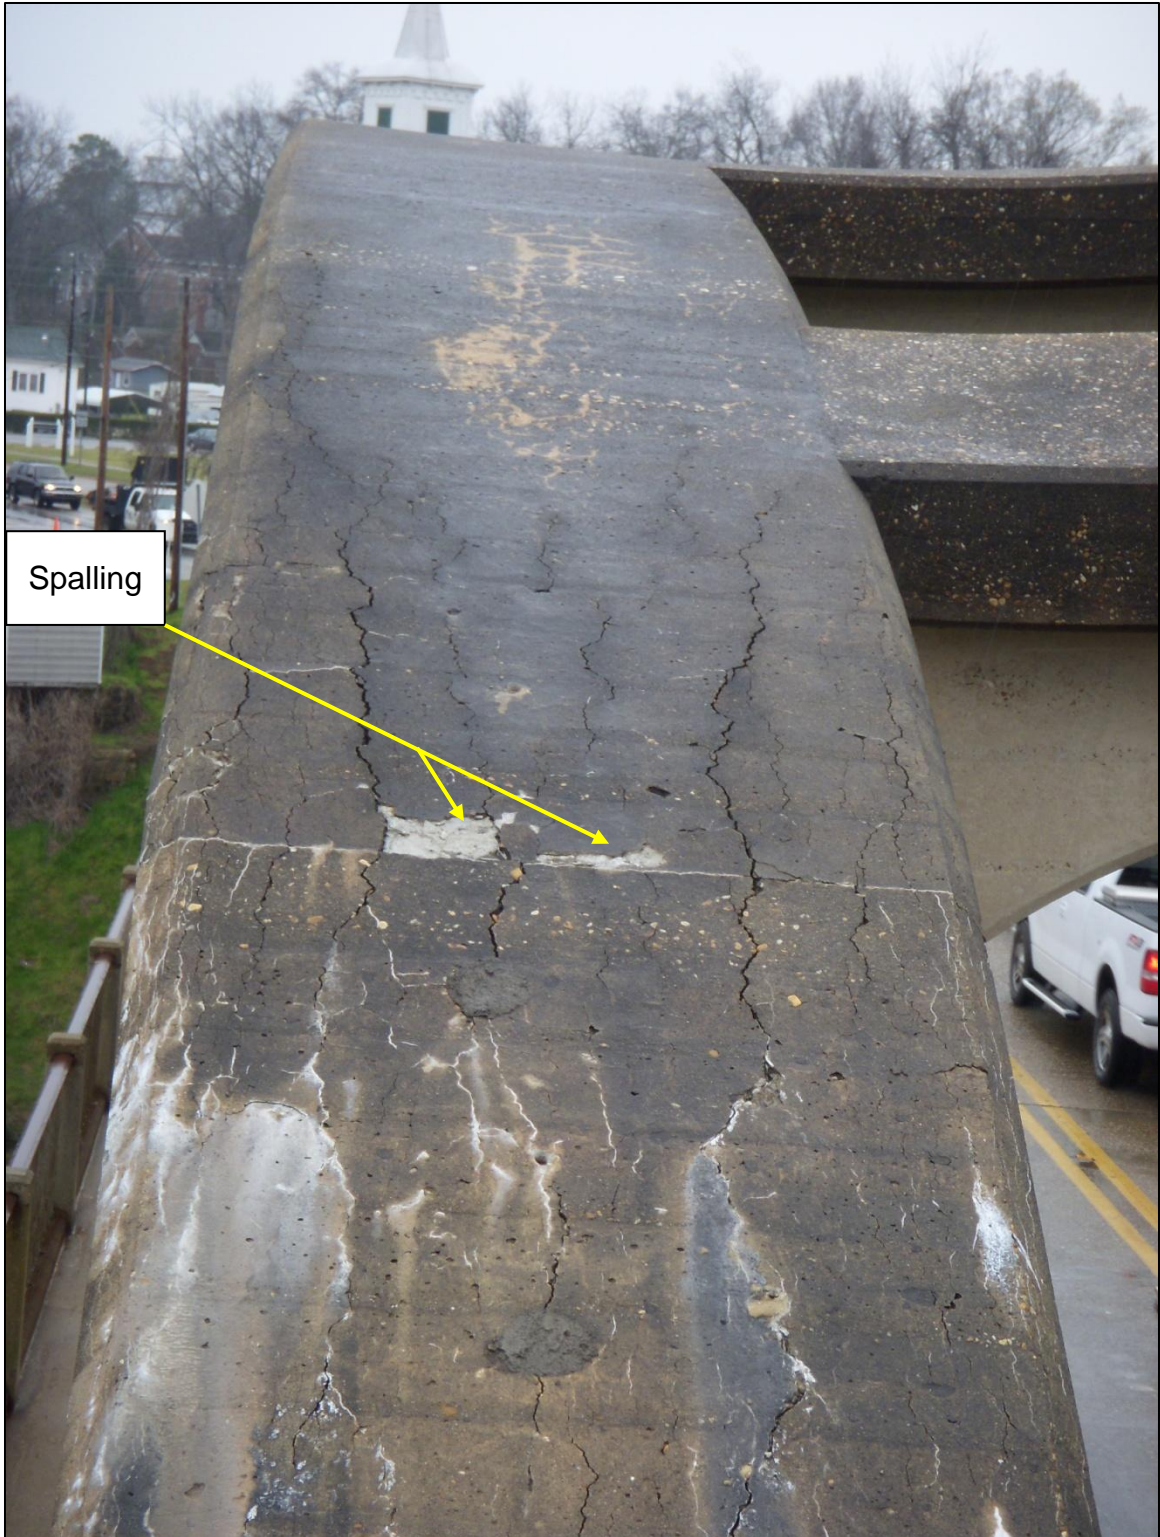
Figure 3.18. Closer view of longitudinal cracking and spalling on span 5 south on

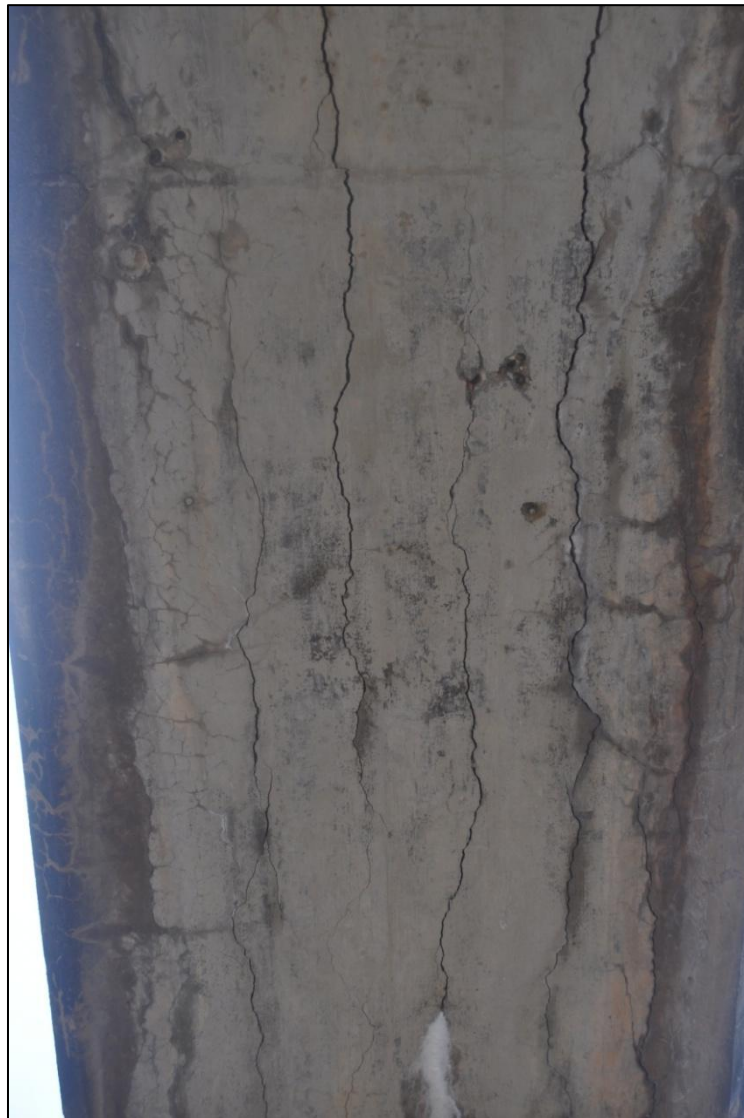
The next two images are examples of distress on the bottom of the arches. Wide longitudinal cracking and a lot of surface discoloration are shown in Figure 3.21. Figure 3.22 has cracks and surface deposits that run from the bottom of the arch to the hanger that supports the bridge deck. The Bibb Graves Bridge also has cracking and surface discoloration in map patterns in low stress and low reinforcement regions. An example of this type of cracking and surface discoloration is shown on an abutment in Figure 3.23.

Figure 3.21. Cracking and surface discoloration on the bottom of an arch

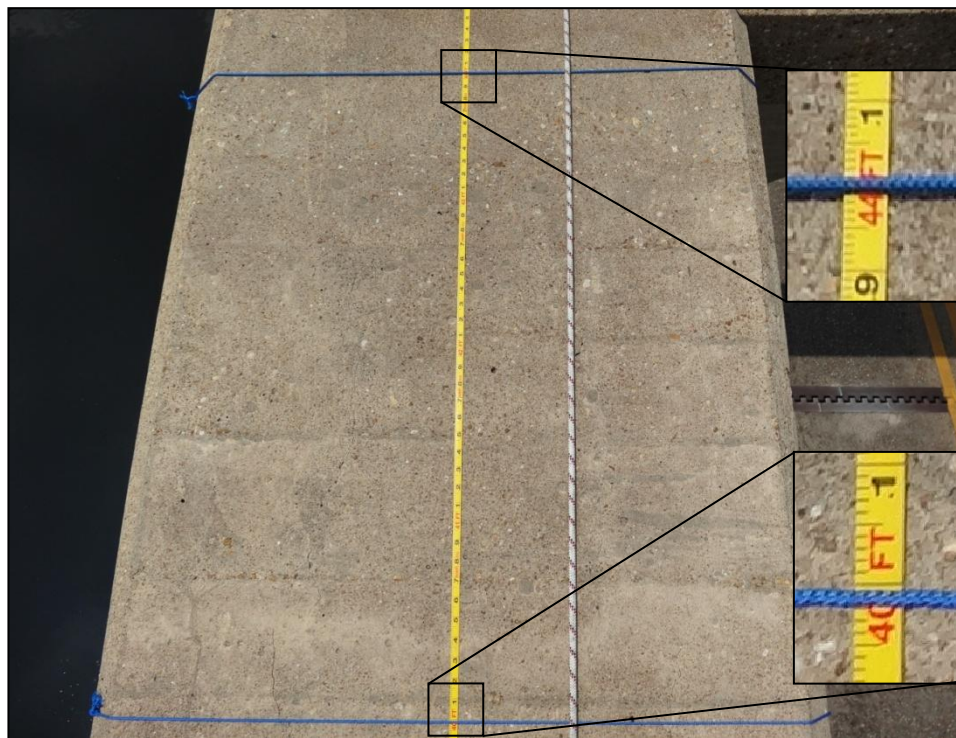
Figure 5.2. Grid spacing along arch

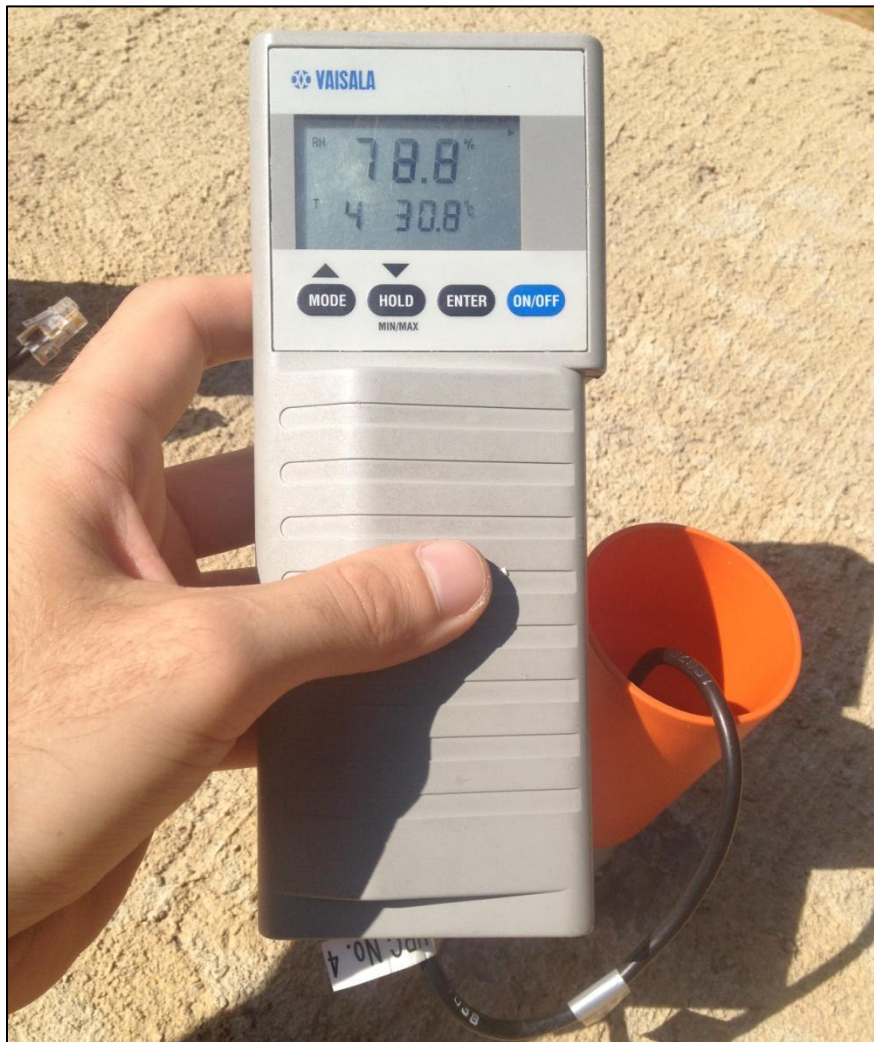
Figure 5.8. Measuring temperature and RH with indicator

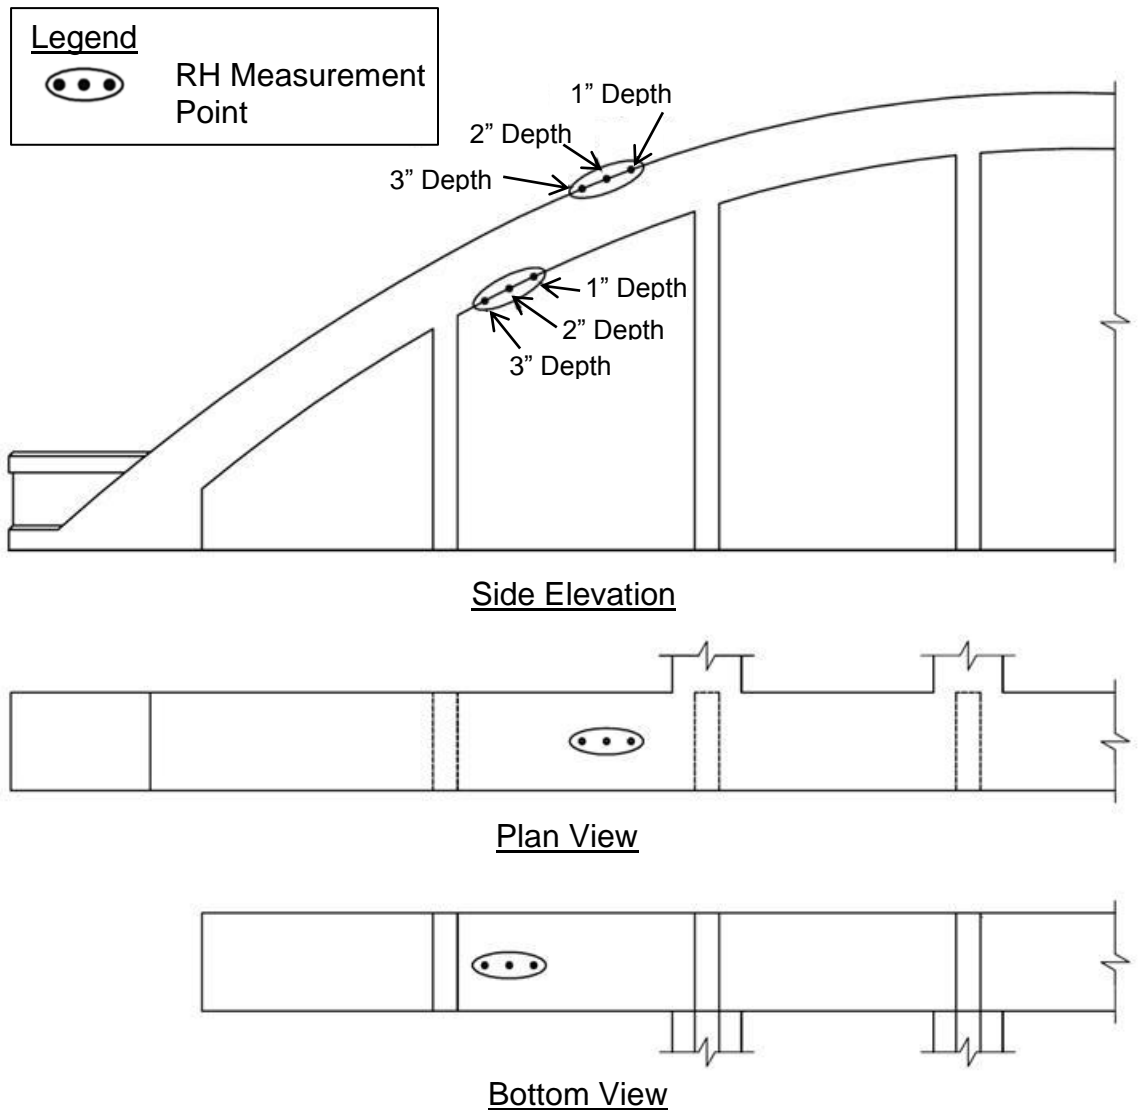
Each arch of spans 4 and 5 has four locations where the relative humidity and temperature are measured at a depth of 1, 2, and 3 inches. These locations are west top, west bottom, east top, and east bottom. The top and bottom measurement locations are shown in Figure 5.9 on one end of a generic arch. There are a total of 48 measurement points, 4 arches with 4 locations each and 3 depths per location.

Figure 5.9. Location and depth of RH measurements

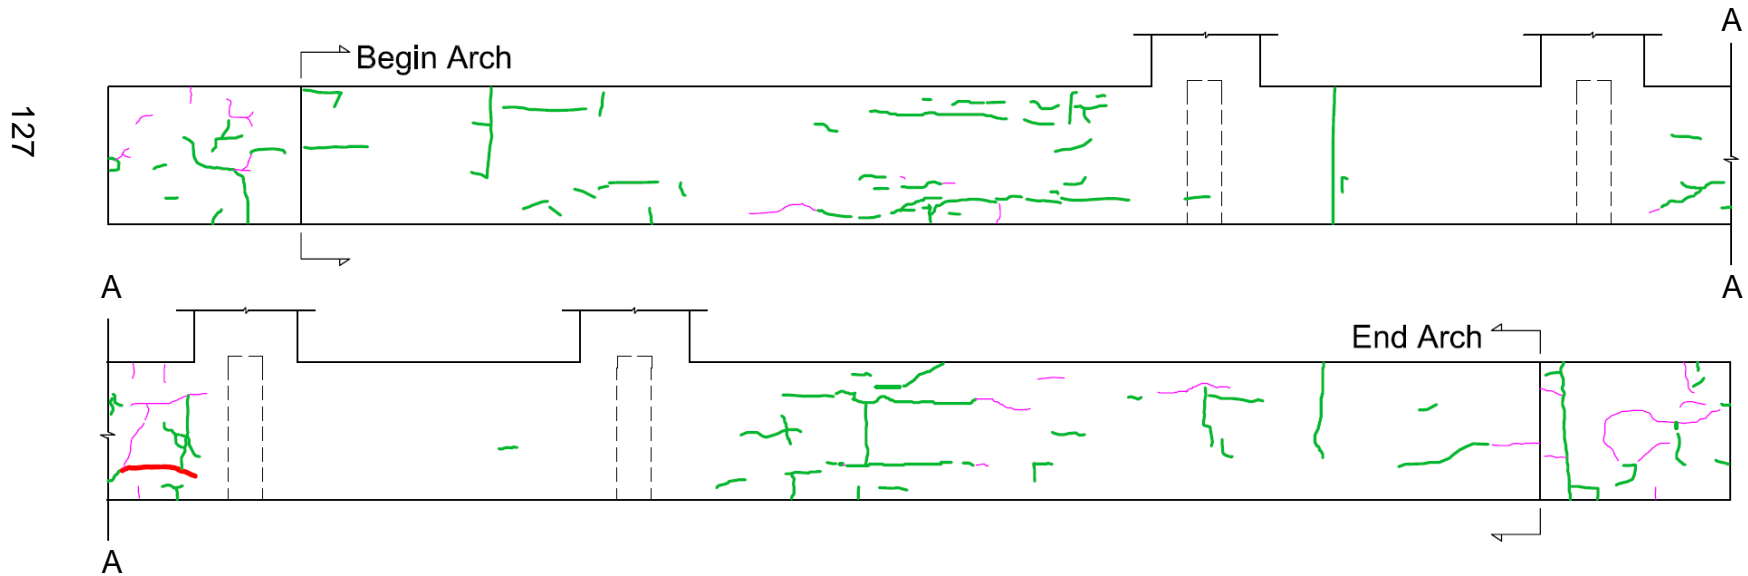
Figure 6.1. Crack mapping, November 2010, Span 4 – South Arch – Plan View

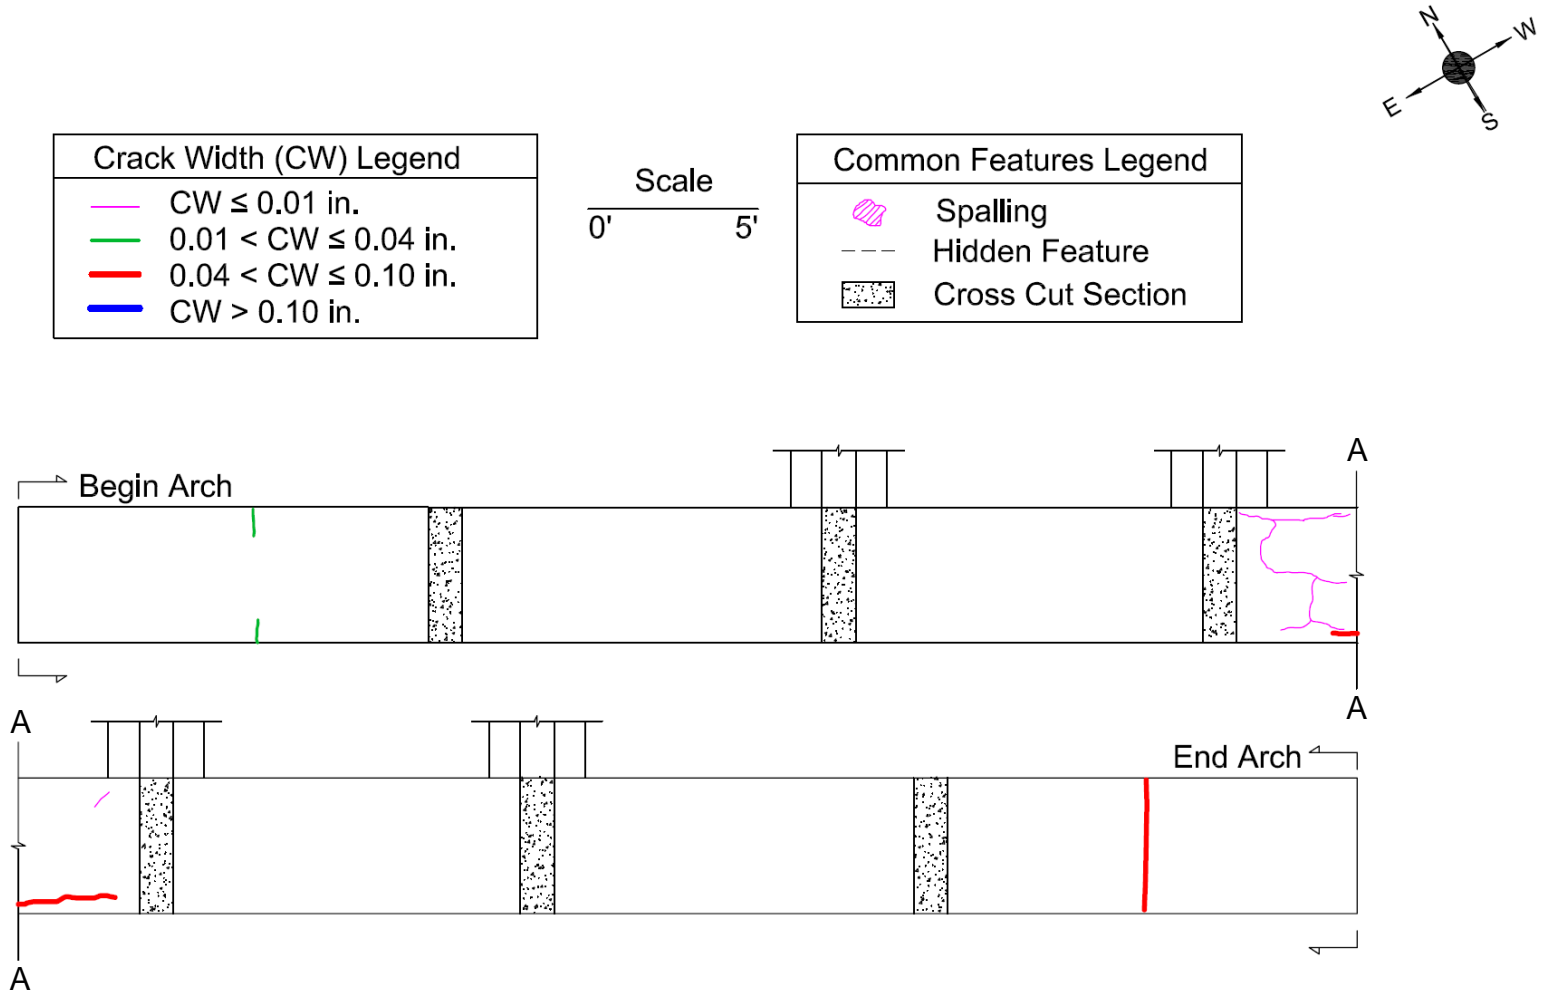
Figure 6.2. Crack mapping, November 2010, Span 4 – South Arch – Bottom View

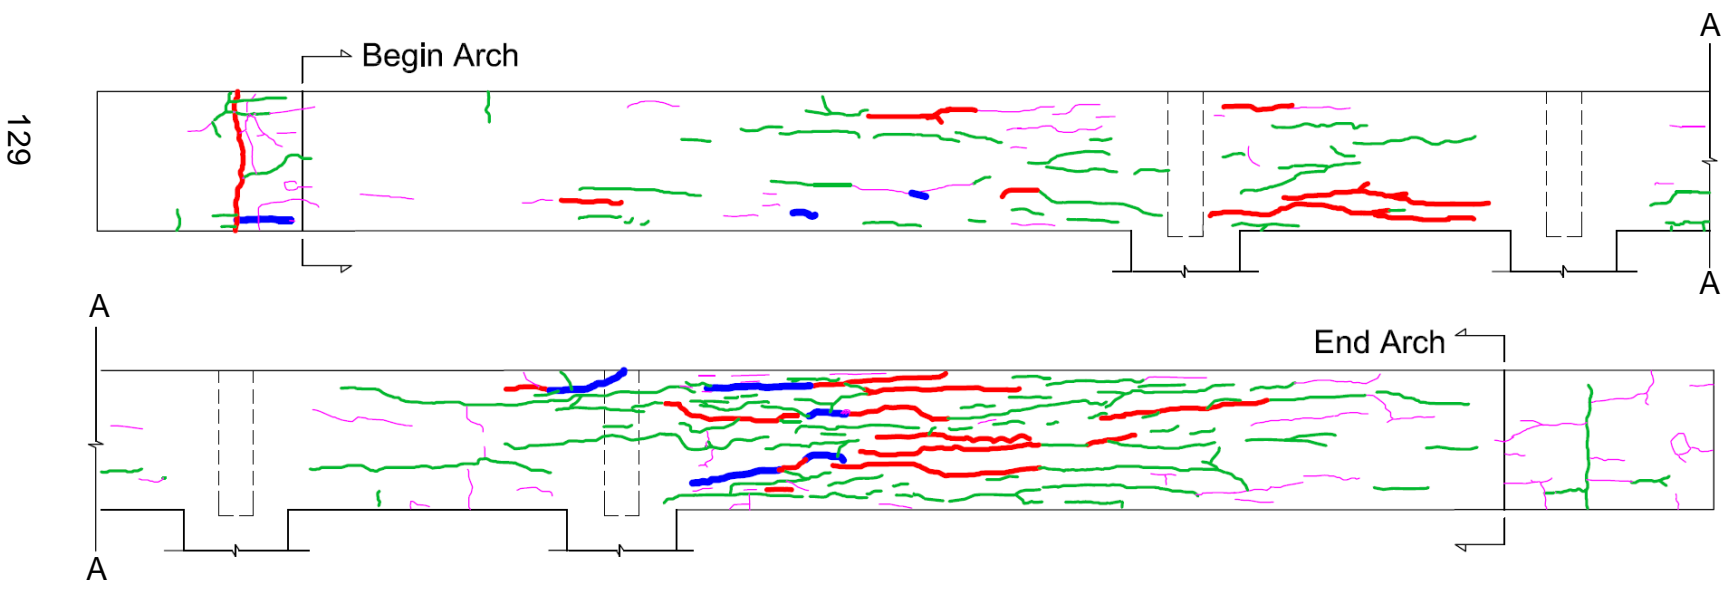
Figure 6.3. Crack mapping, November 2010, Span 5 – North Arch – Plan View

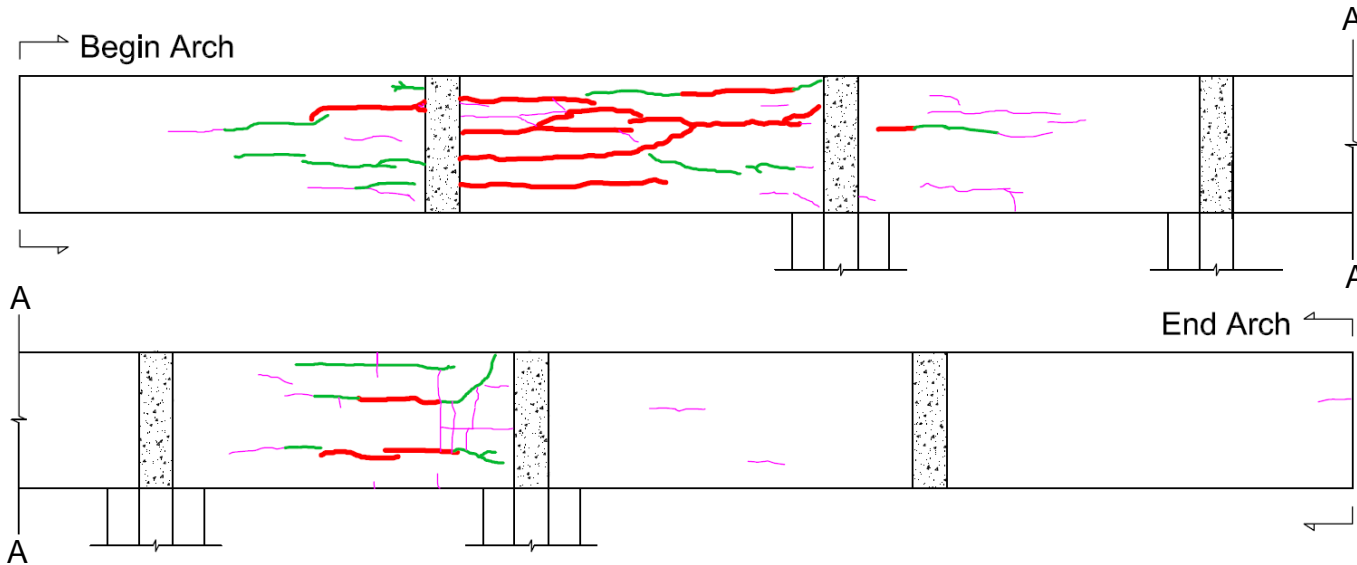
Figure 6.4. Crack mapping, November 2010, Span 5 – North Arch – Bottom View

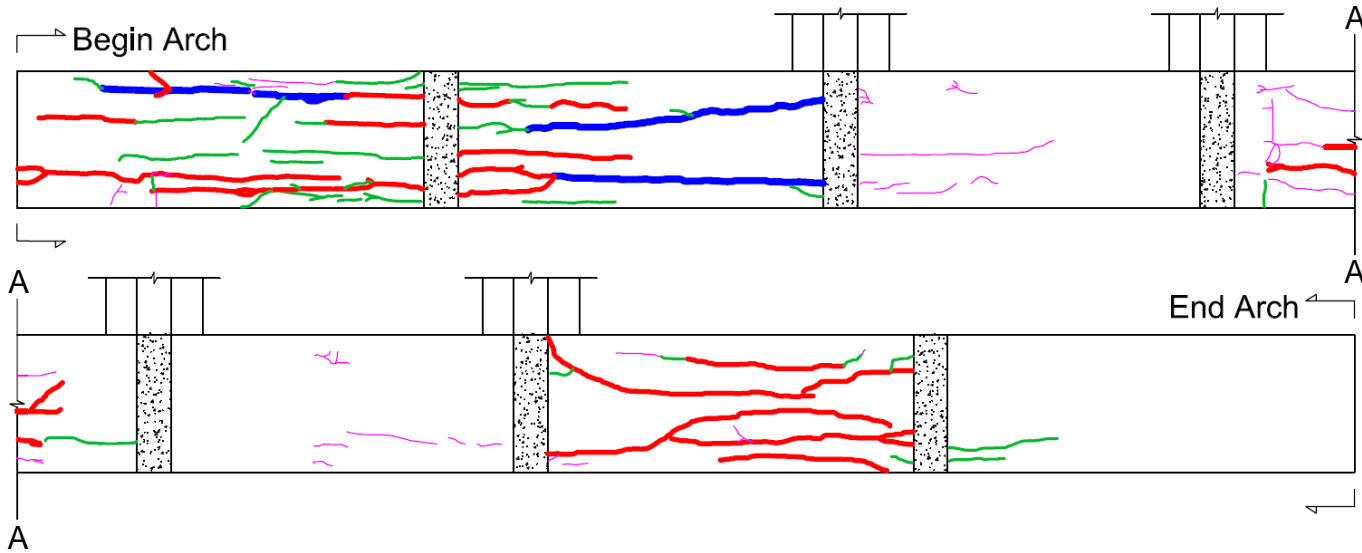
Figure 6.6. Crack mapping, November 2010, Span 5 – South Arch – Bottom View

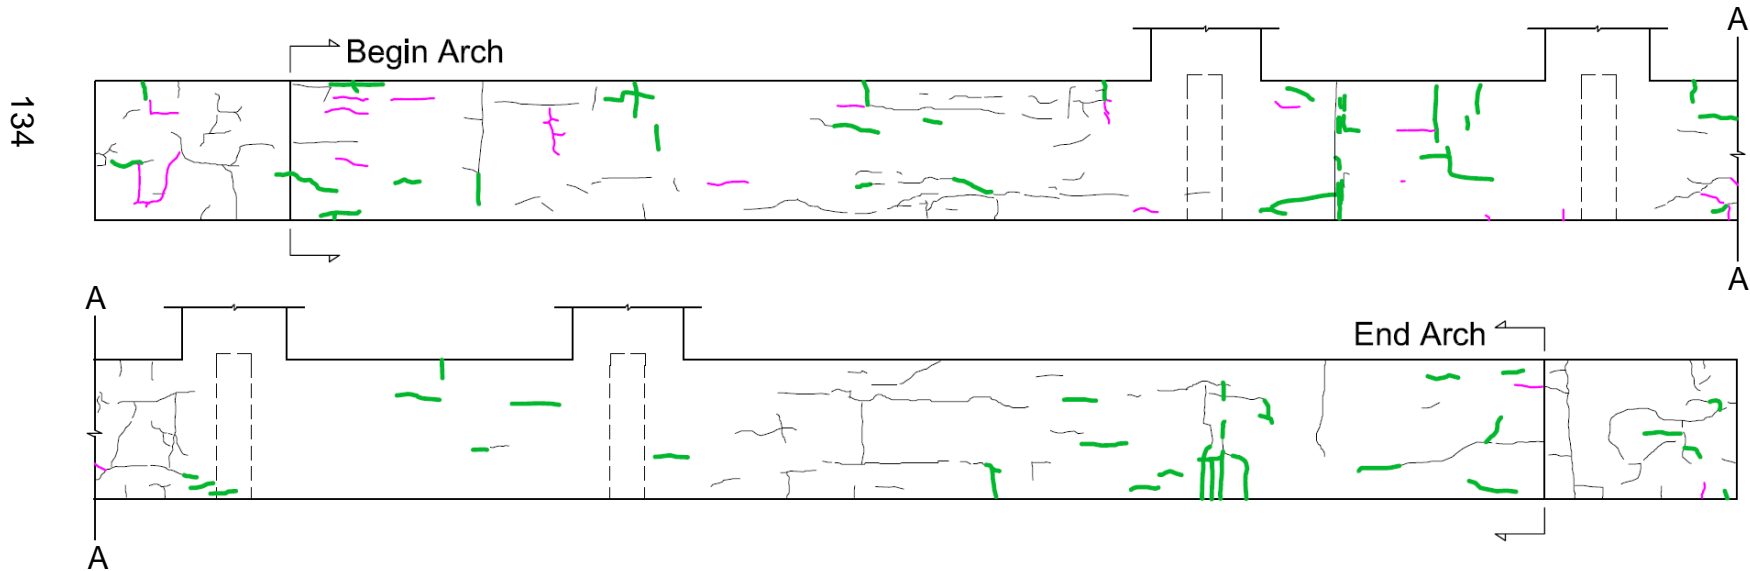
Figure 6.7. Crack mapping, August 2013, Span 4 – South Arch – Plan View
