**Effectiveness of Silane in Mitigating Alkali-Silica Reaction in the
Bibb Graves Bridge**

A thesis submitted to the Graduate Faculty of
Auburn University
In partial fulfillment of the
Requirements for the Degree of
Master of Science

Auburn, Alabama
December 14, 2013

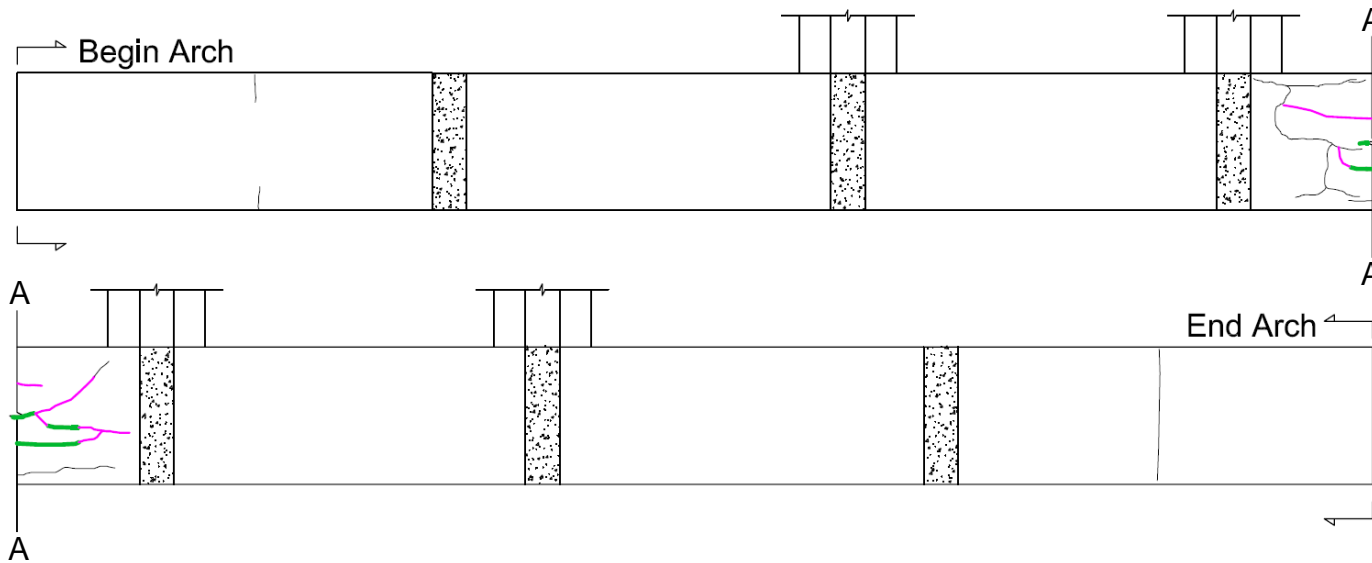
Figure 6.8. Crack mapping, August 2013, Span 4 – South Arch – Bottom View

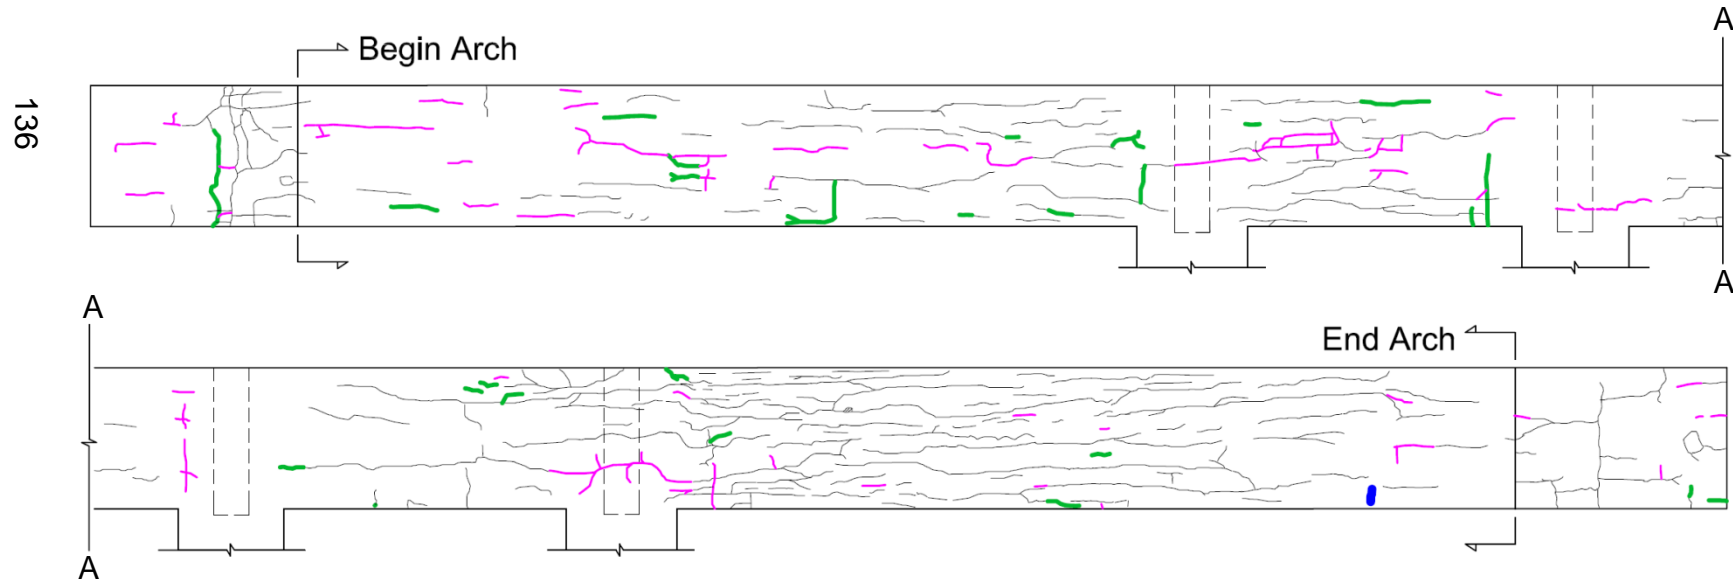
Figure 6.9. Crack mapping, August 2013, Span 5 – North Arch – Plan View

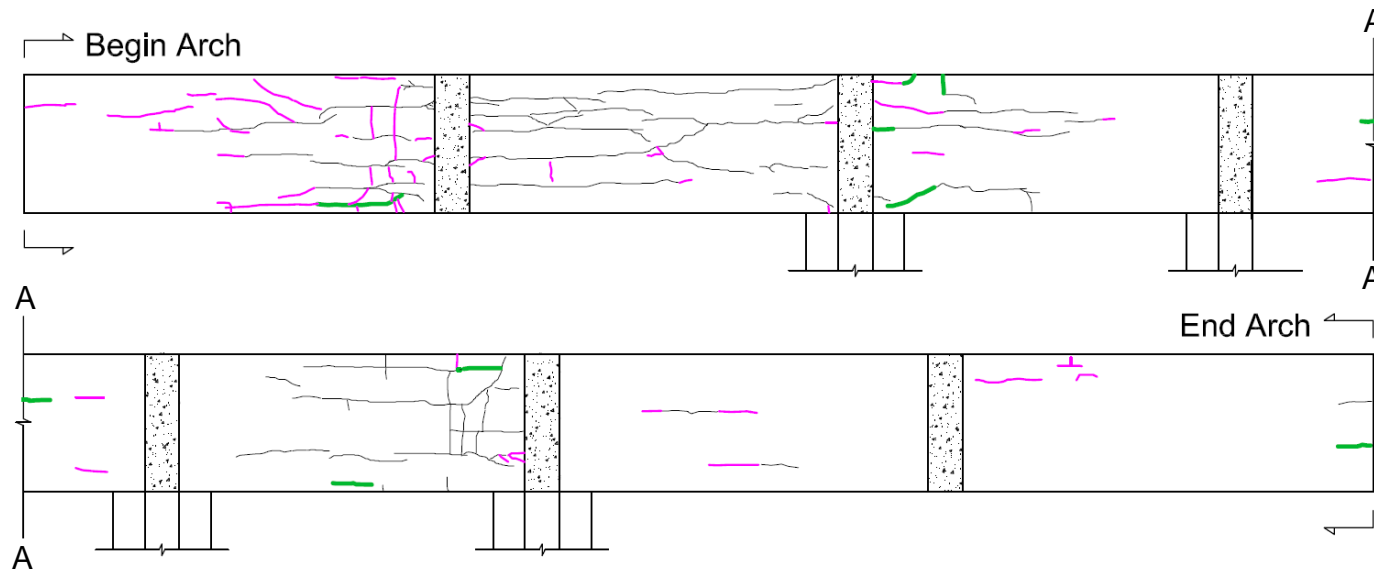
Figure 6.10. Crack mapping, August 2013, Span 5 – North Arch – Bottom View

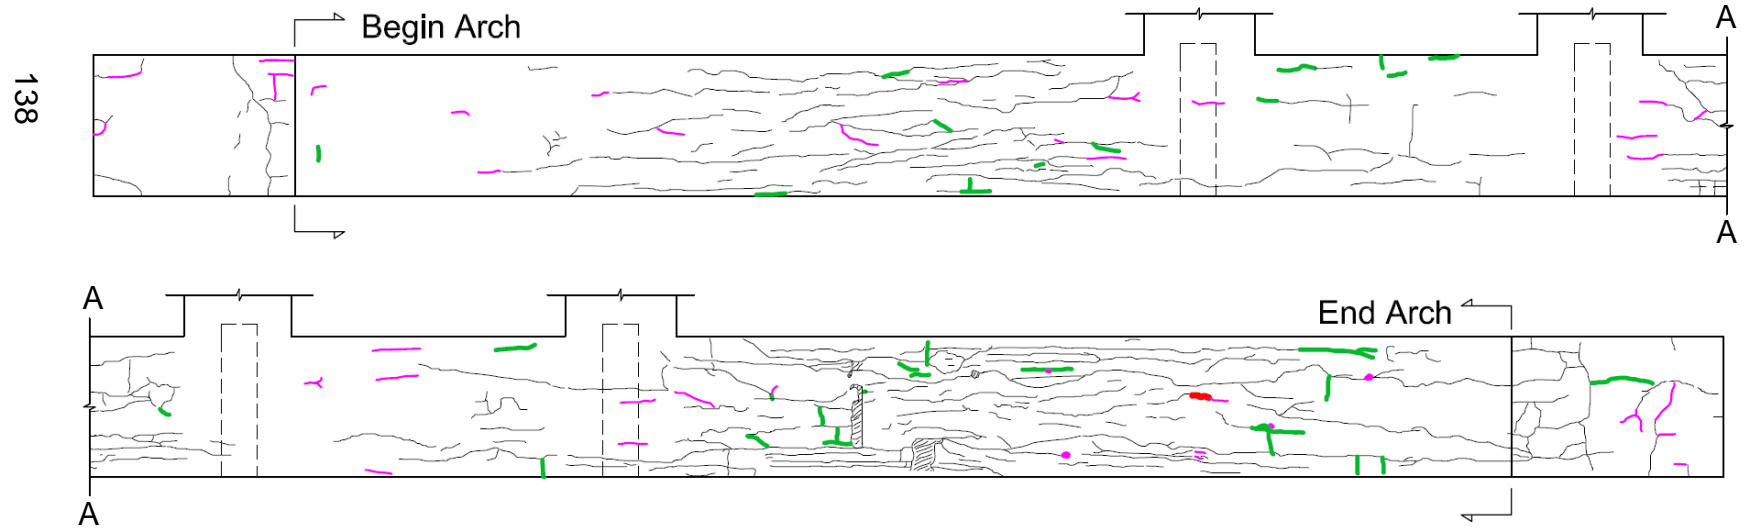
Figure 6.11. Crack mapping, August 2013, Span 5 – South Arch – Plan View

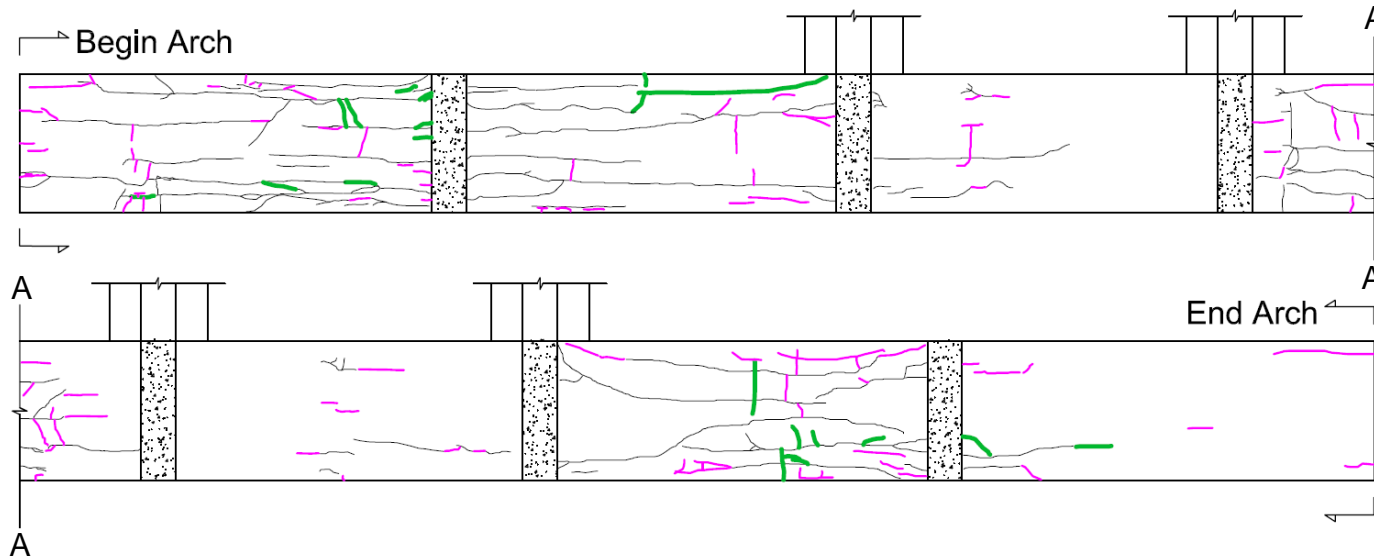
Figure 6.12. Crack mapping, August 2013, Span 5 – South Arch – Bottom View

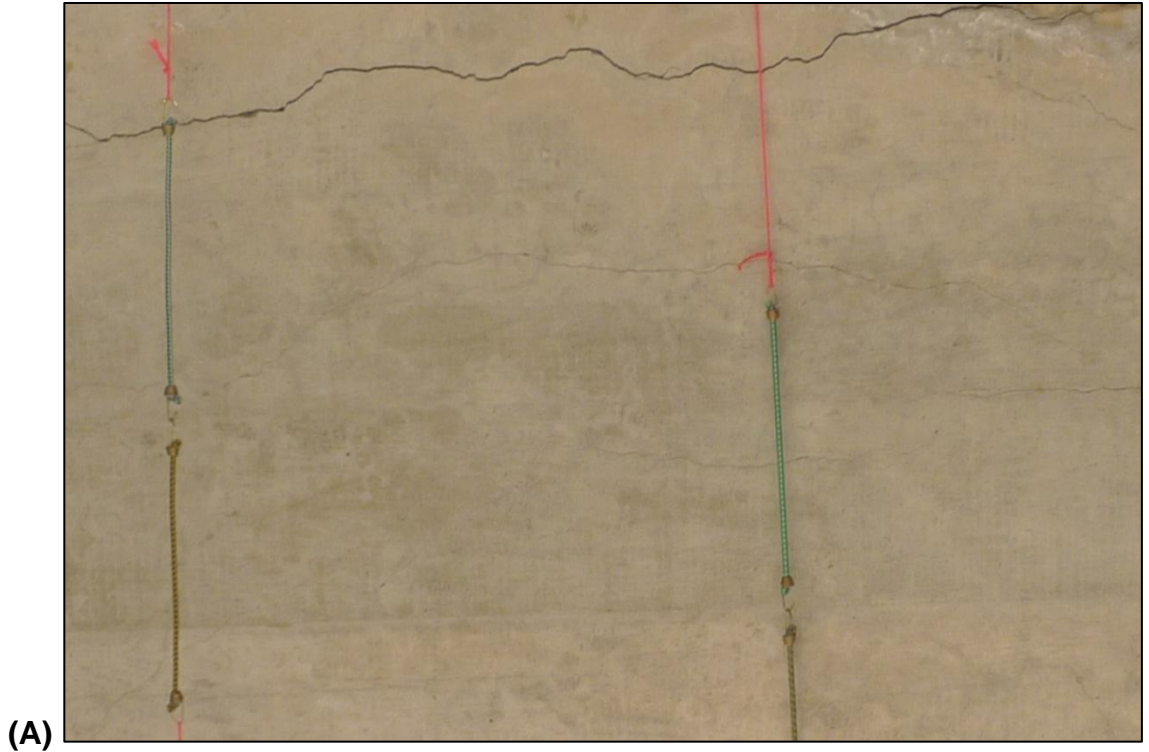
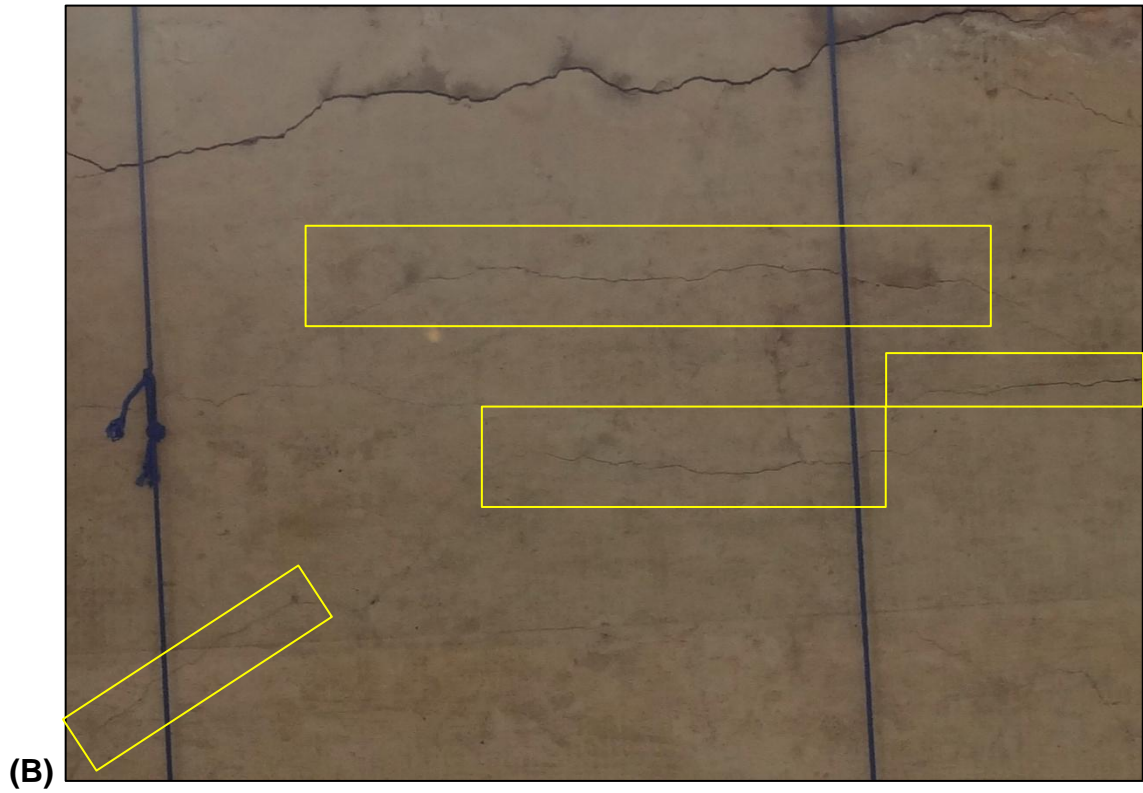
This section contains photographs taken while performing the crack mapping surveys. All of the figures have a part (A), picture taken during November 2010 survey, and a part (B), picture taken during August 2013 survey. These images show widening and elongation of existing cracks, and/or additional new cracking. Some of these images appear to be skewed between (A) and (B). This occurs when the pictures were taken from opposite ends of the grid, and thus have different camera angles.

Figure 6.13. Widening and elongation of existing cracks in span 4 – south arch,
(A) November 2010 and (B) August 2013

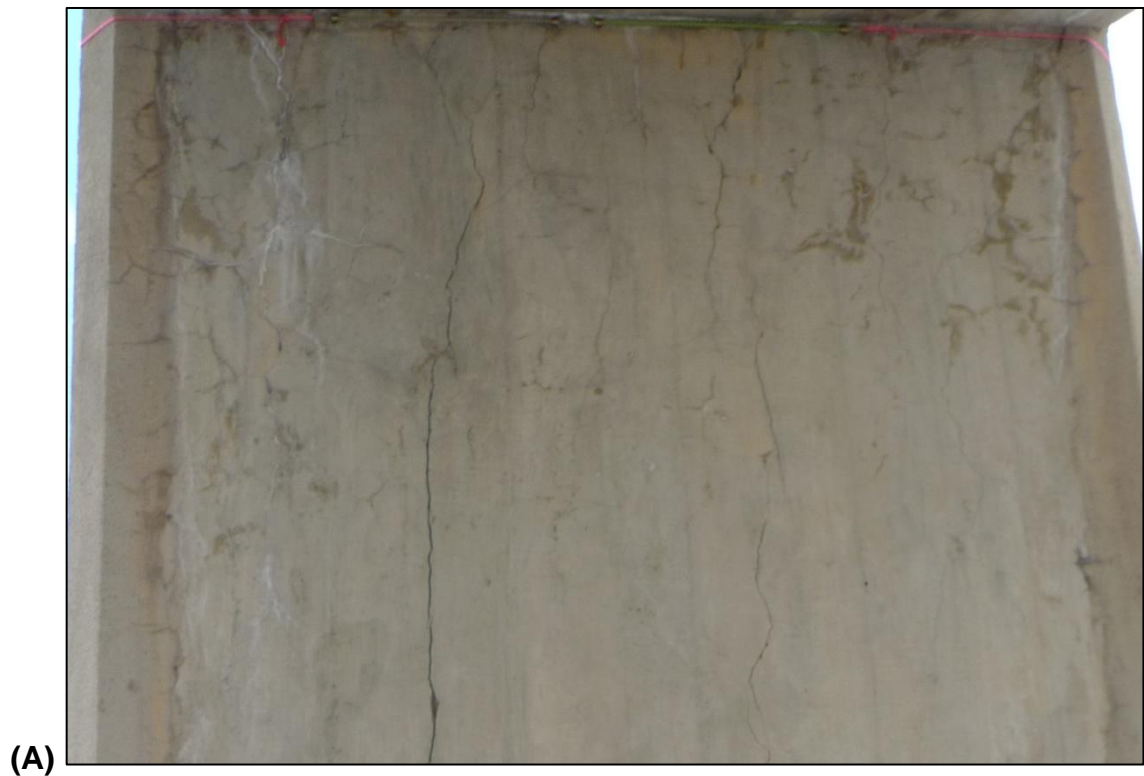
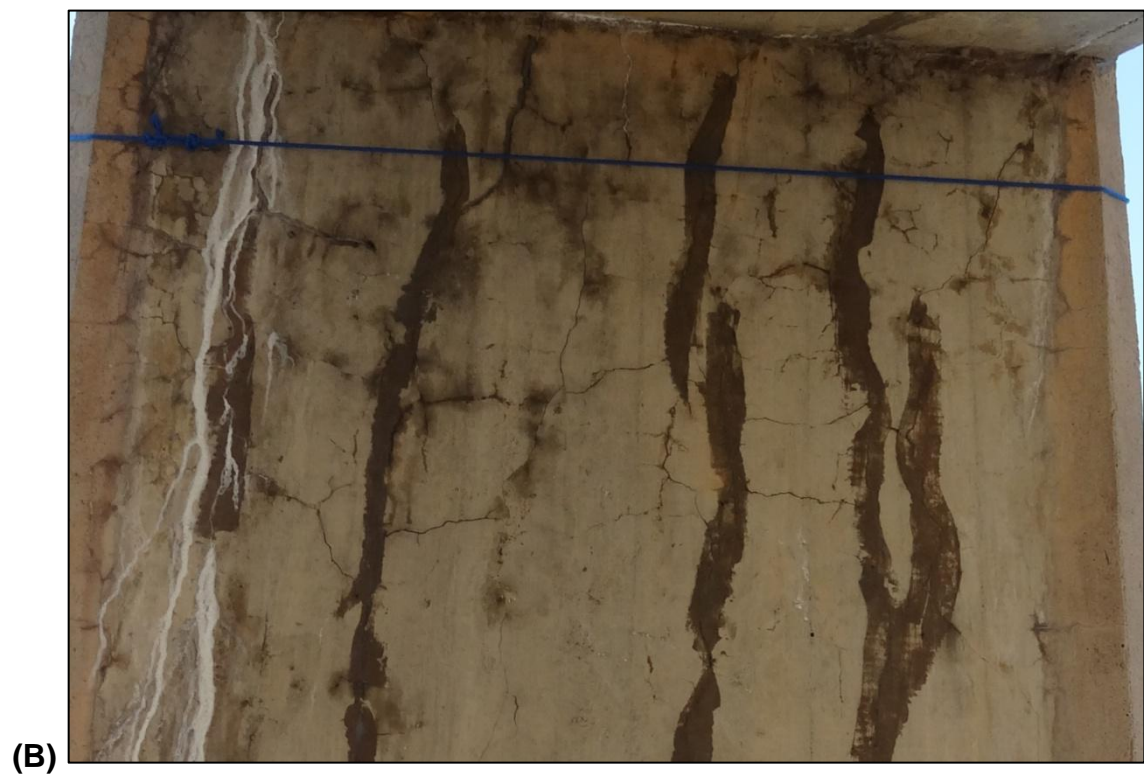
Figure 6.14. Additional cracking in span 5 – north arch, (A) November 2010 and
(B) August 2013

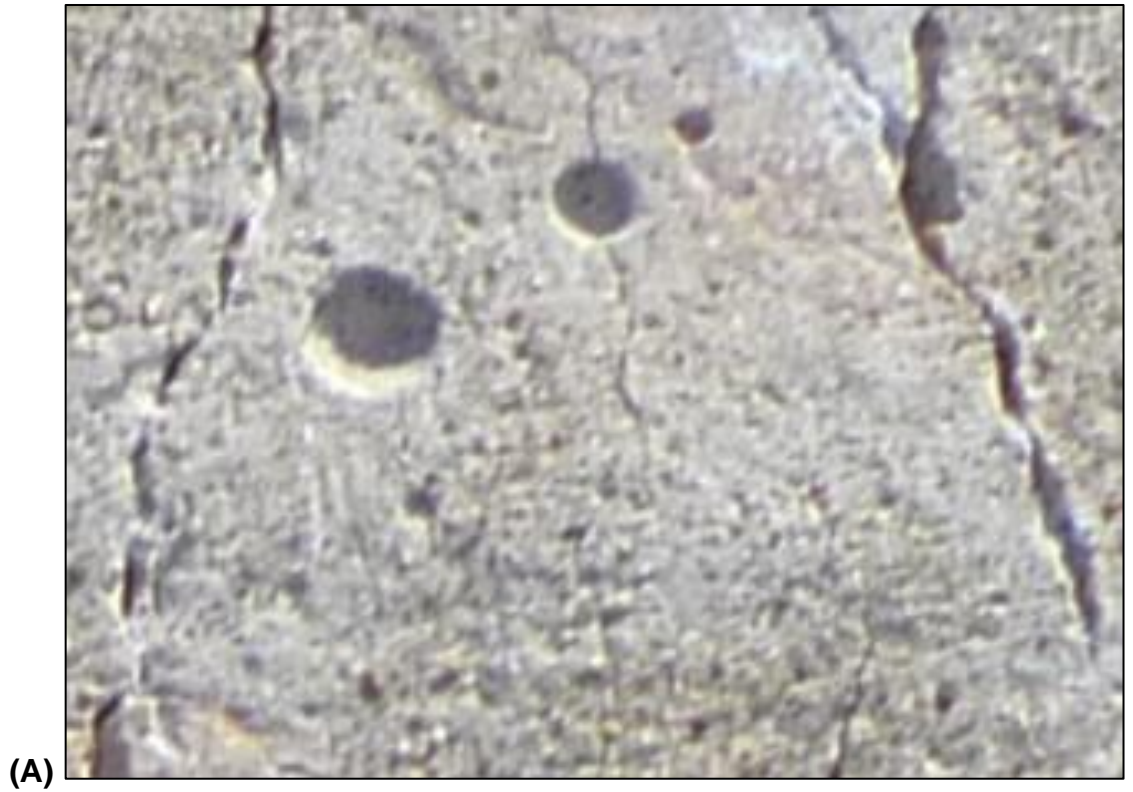
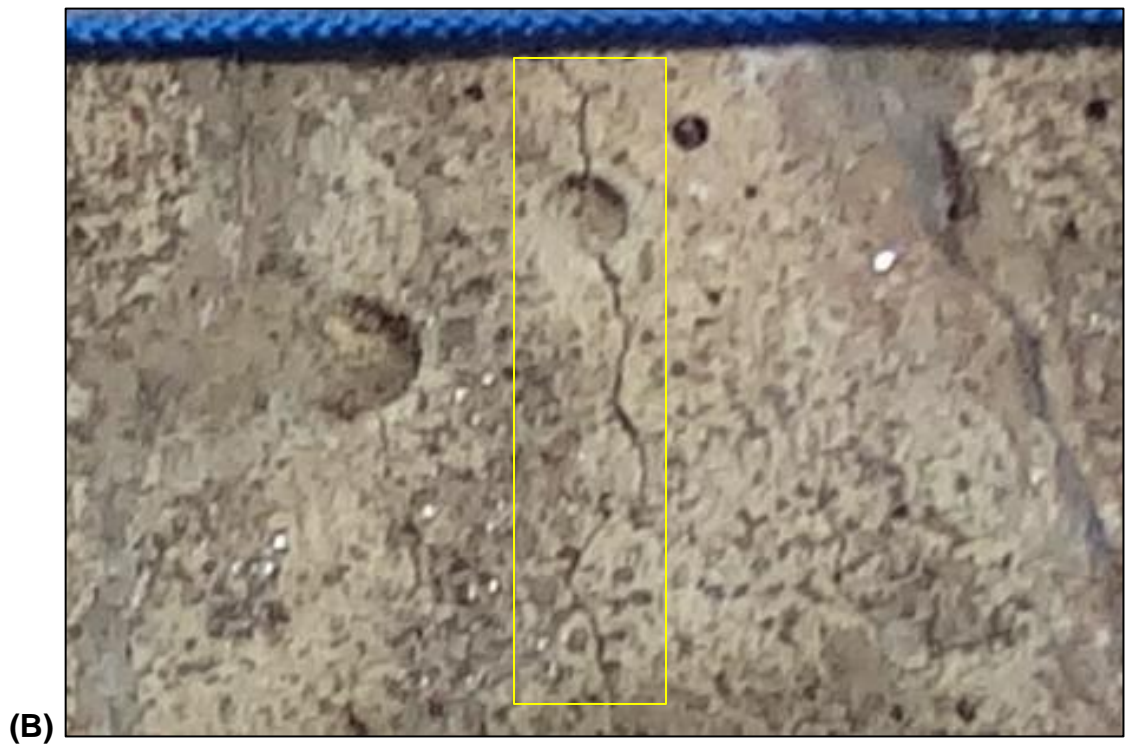
Figure 6.15. Crack widening on span 5 – south arch, (A) November 2010 and (B) August 2013

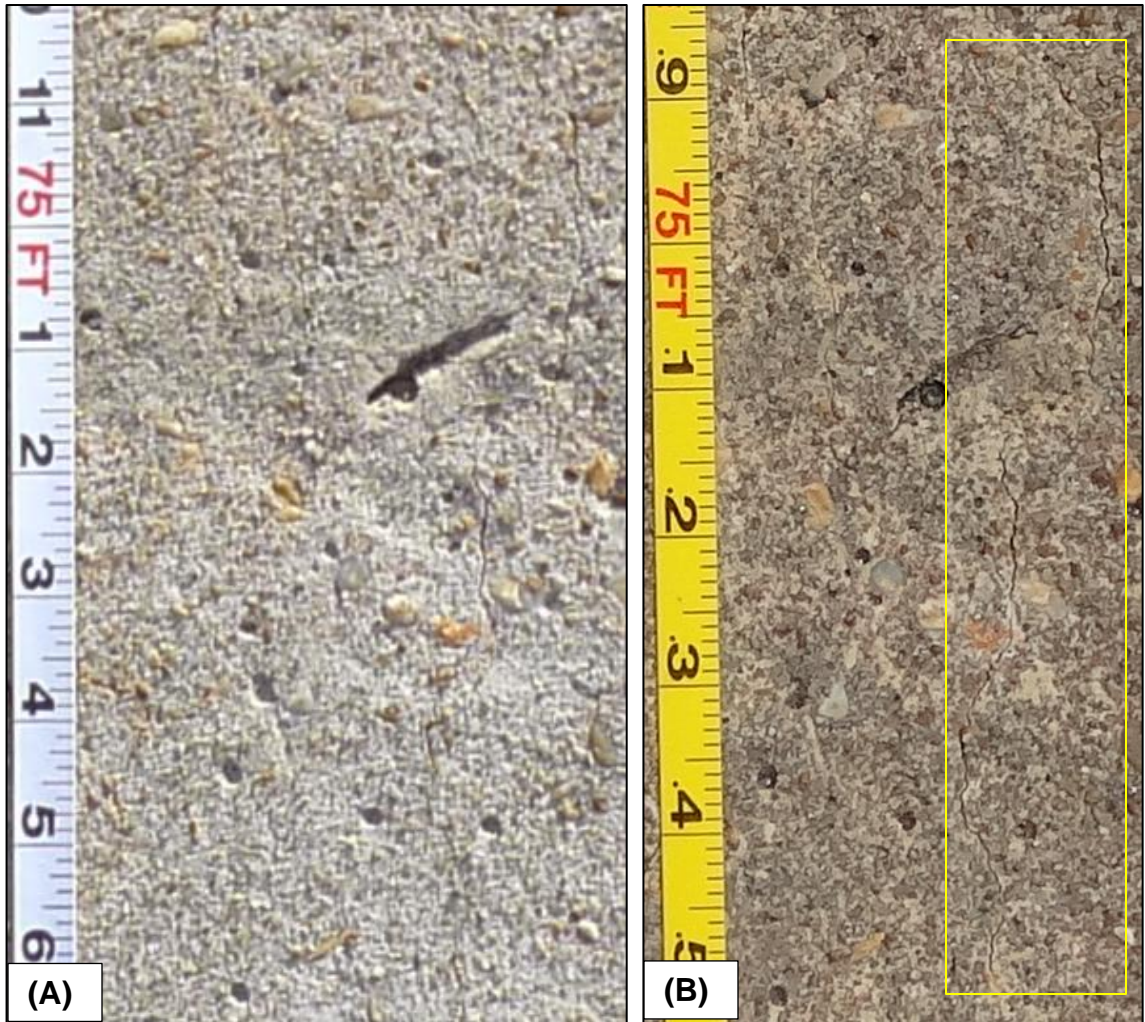
Figure 6.16. Crack widening on span 5 – south arch, (A) November 2010 and (B) August 2013

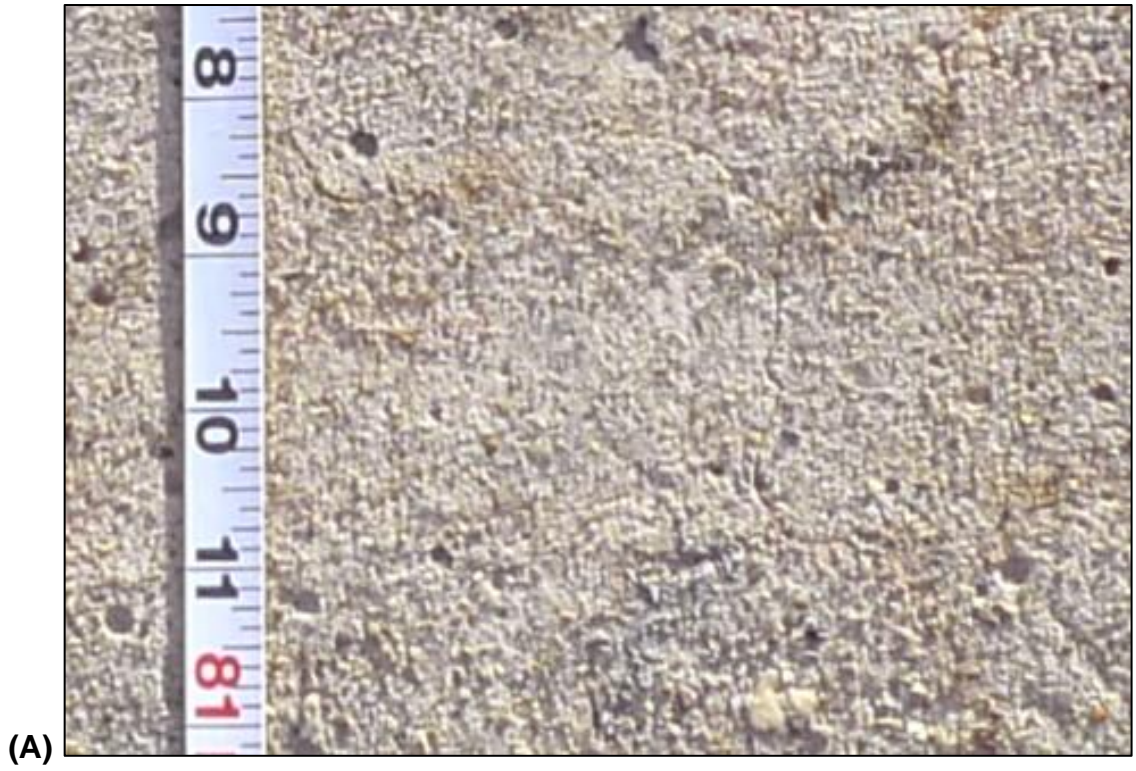
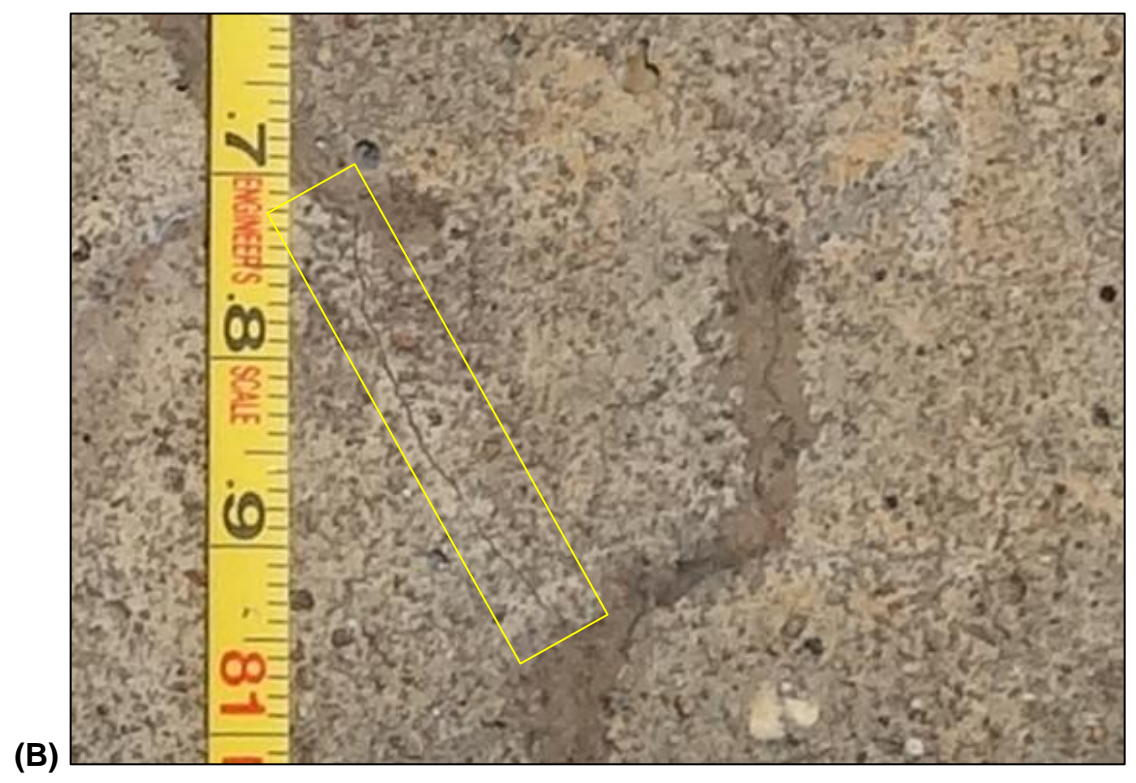
Figure 6.17. New crack on span 5 – south arch, (A) November 2010 and (B) August 2013

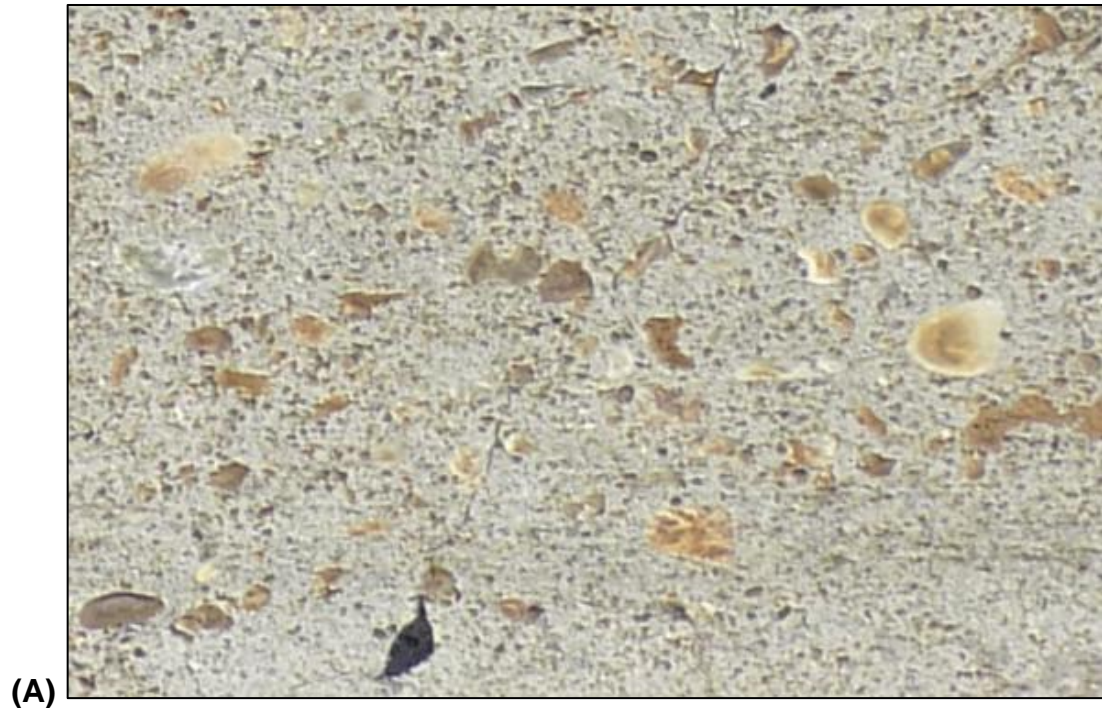
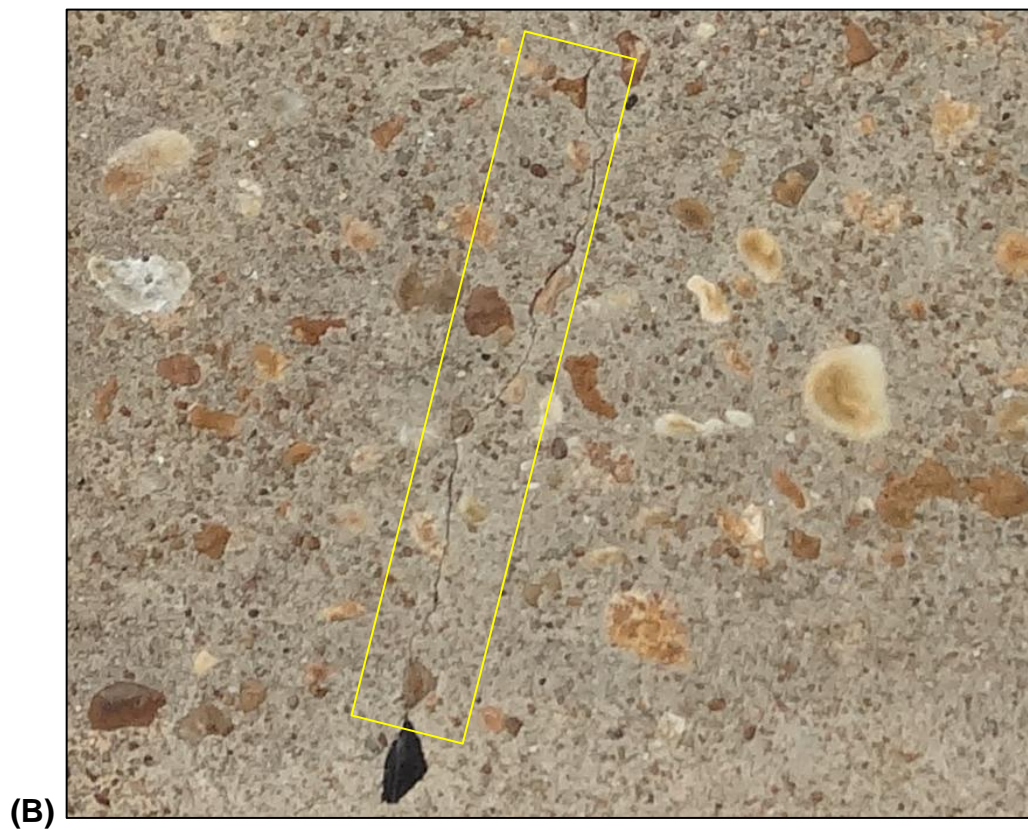
Figure 6.18. Crack widening on span 5 – south arch, (A) November 2010 and (B) August 2013

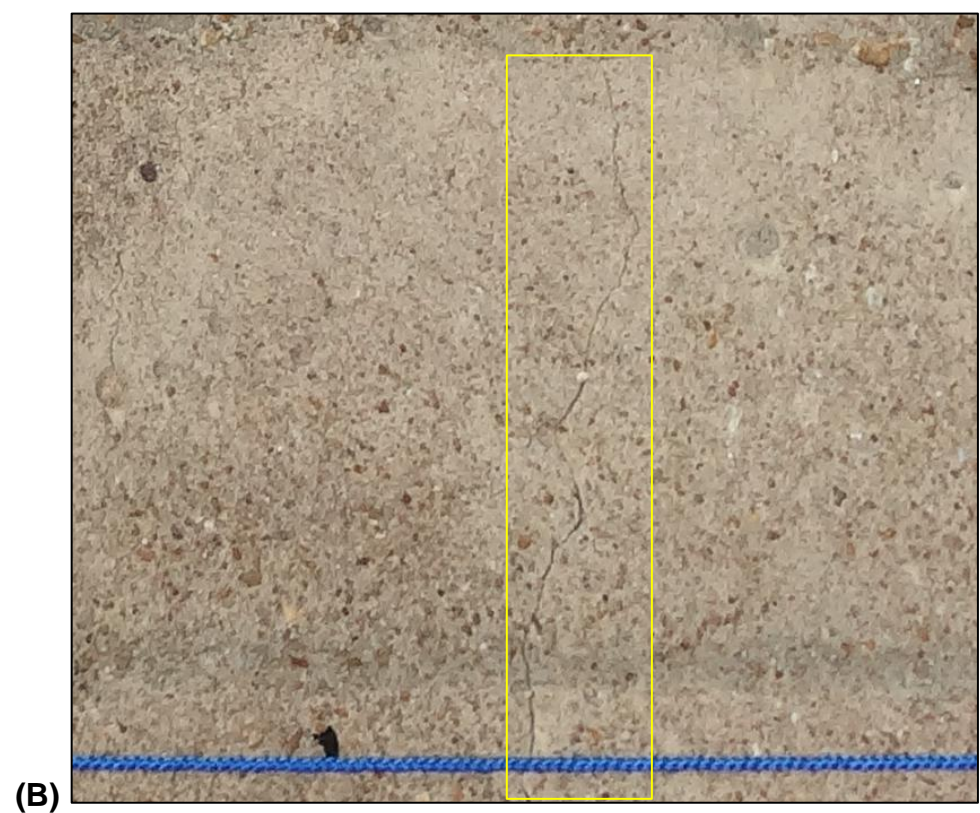
Figure 6.19. Crack extending on span 5 – south arch, (A) November 2010 and
(B) August 2013

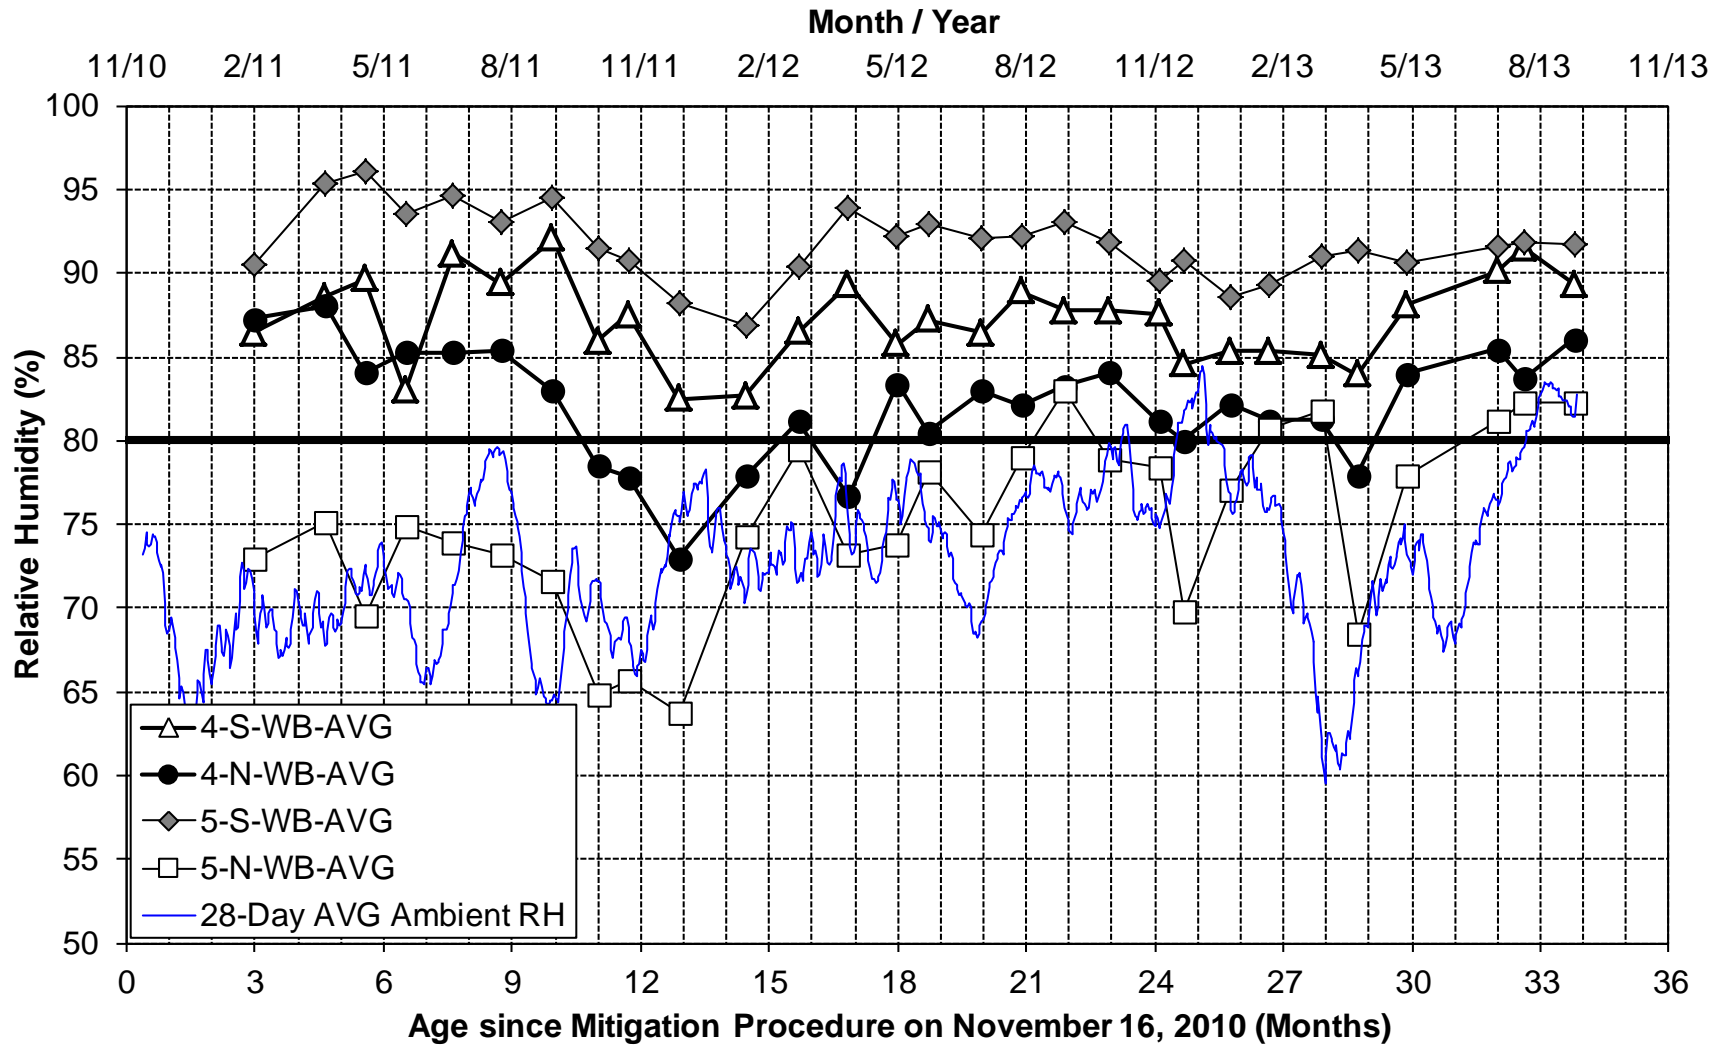
The average of the relative humidity measurement data at all three depths per location (four locations per arch) along with the 28-day running average of the ambient relative humidity are presented in next four figures. The data for the west bottom locations are graphed in Figure 6.21, and west top data are presented in Figure 6.22. The relative humidity data for the east bottom and east top measurement locations are graphed in Figure 6.23 and Figure 6.24, respectively.

Figure 6.21. RH measurements, West Bottom, average of all measurement depths

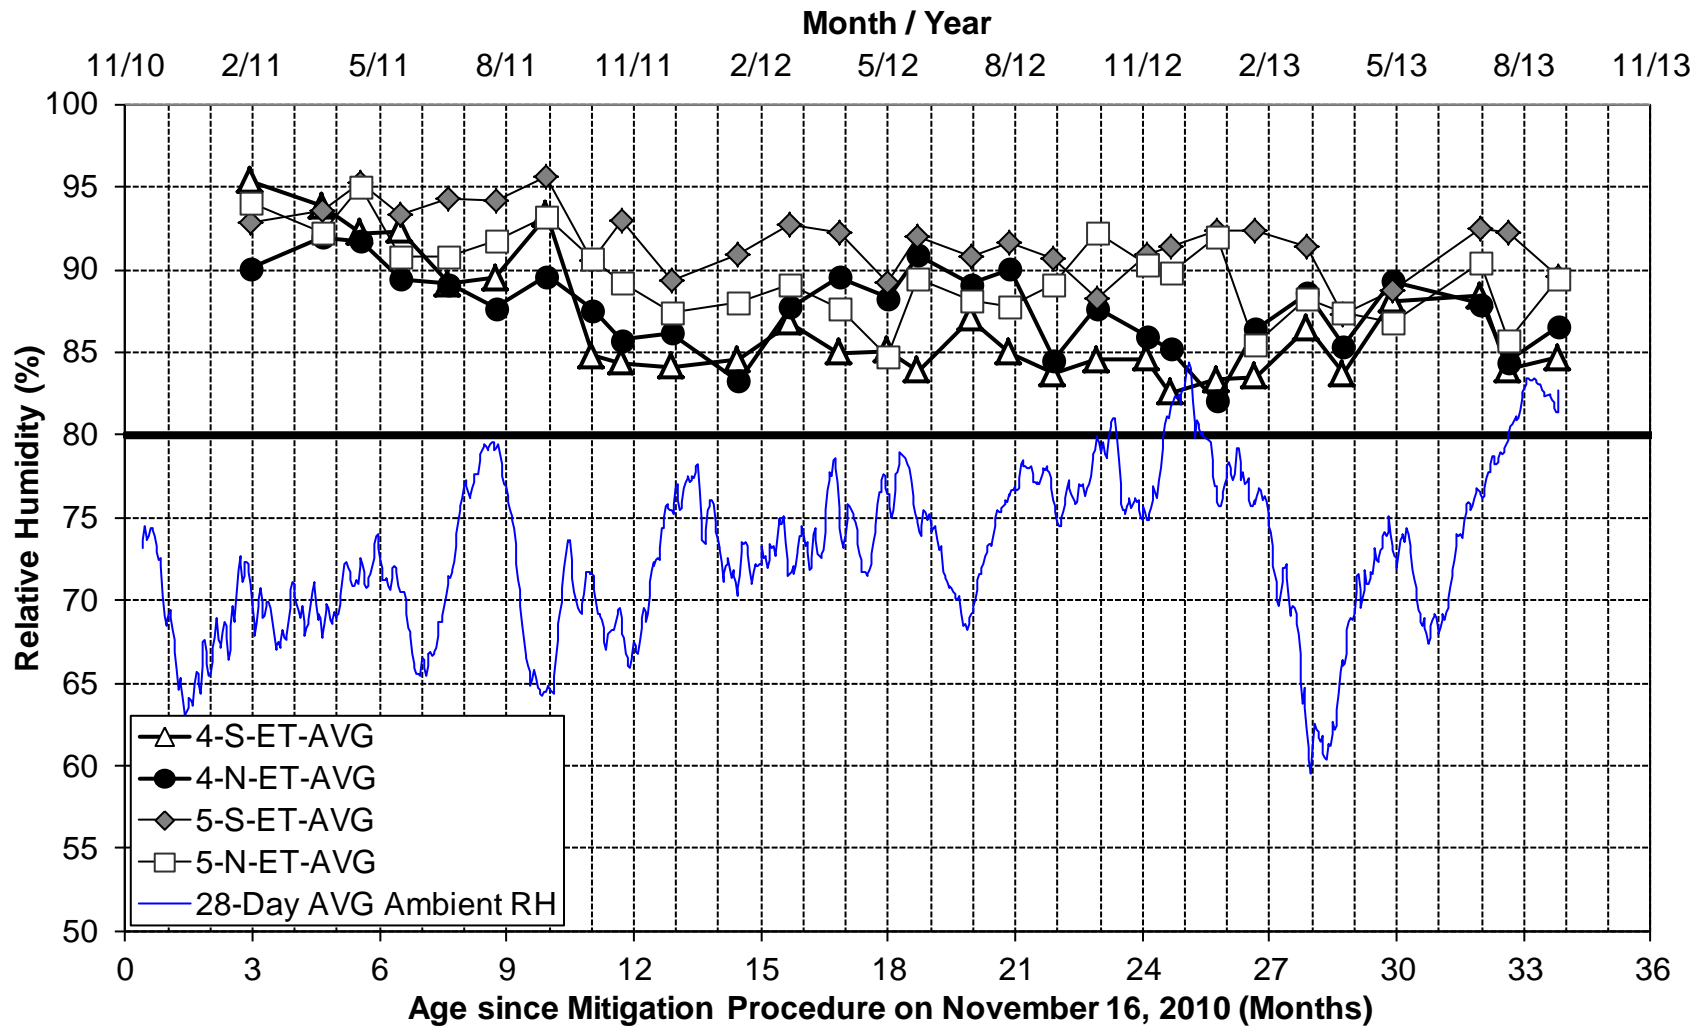
Figure 6.24. RH measurements, East Top, average of all measurement depths

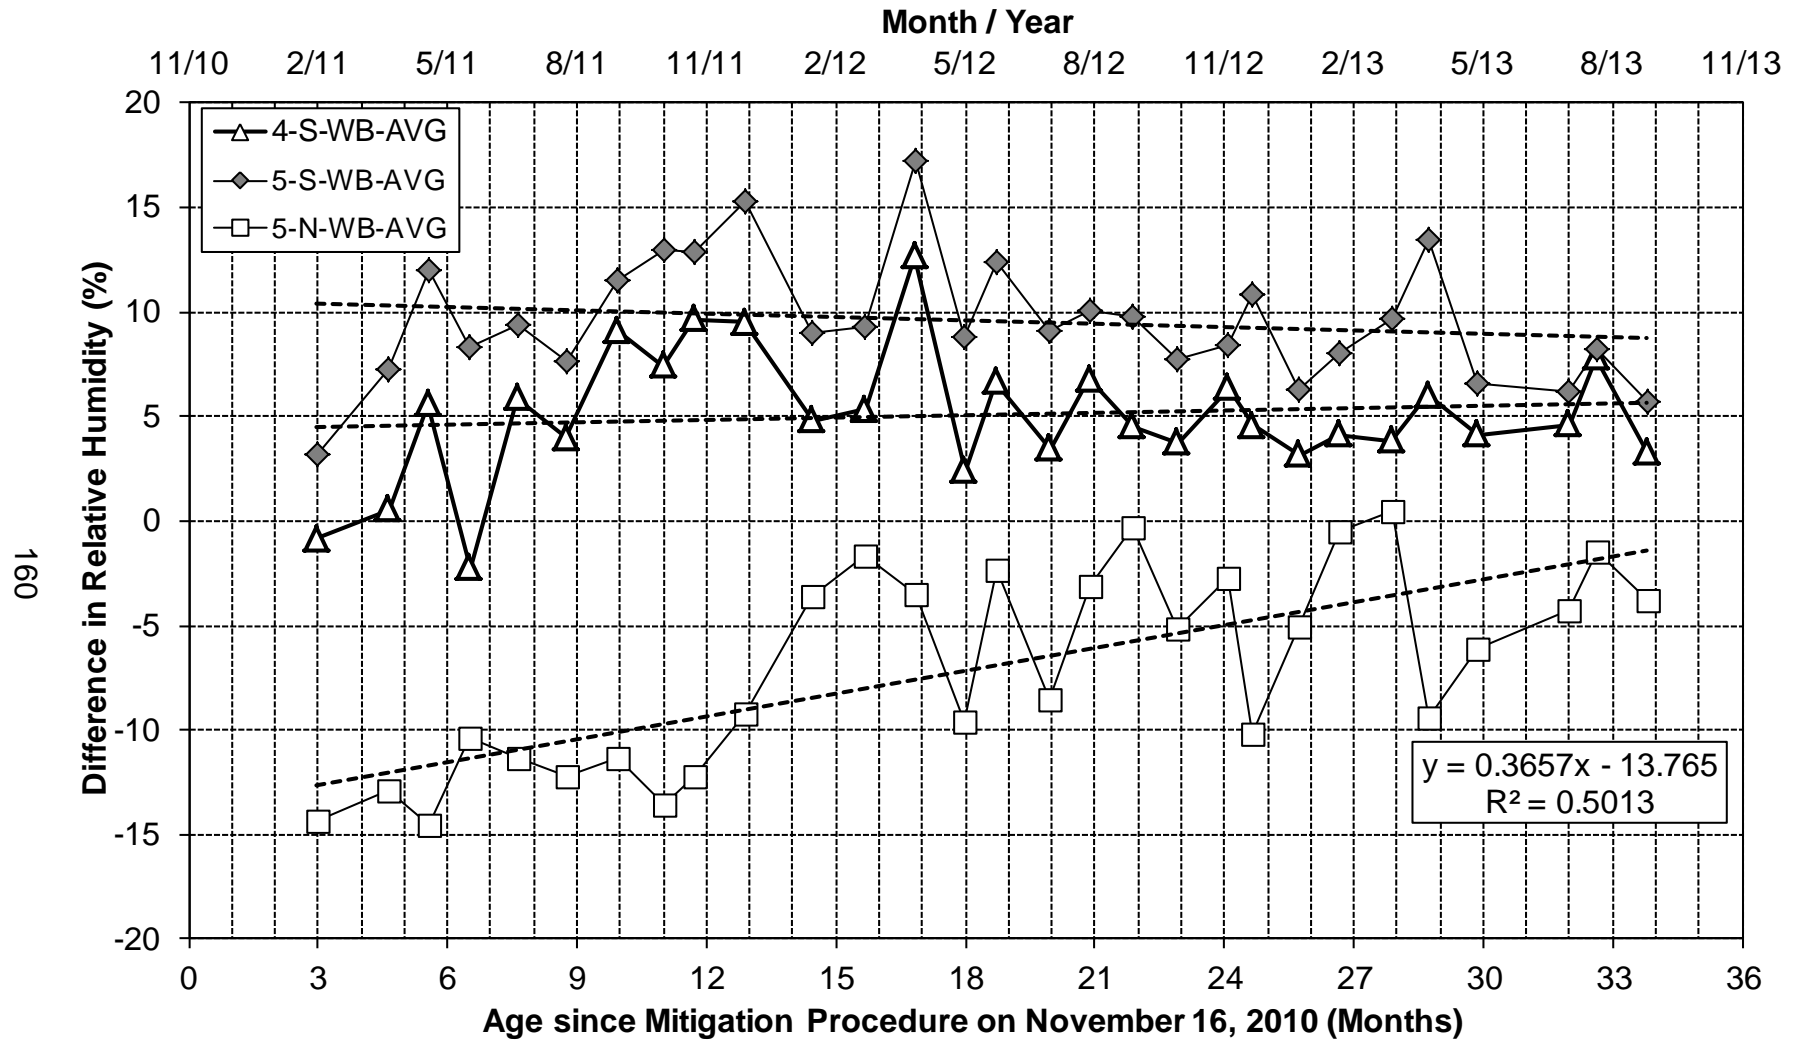
Figure 6.25. RH difference for West Bottom average

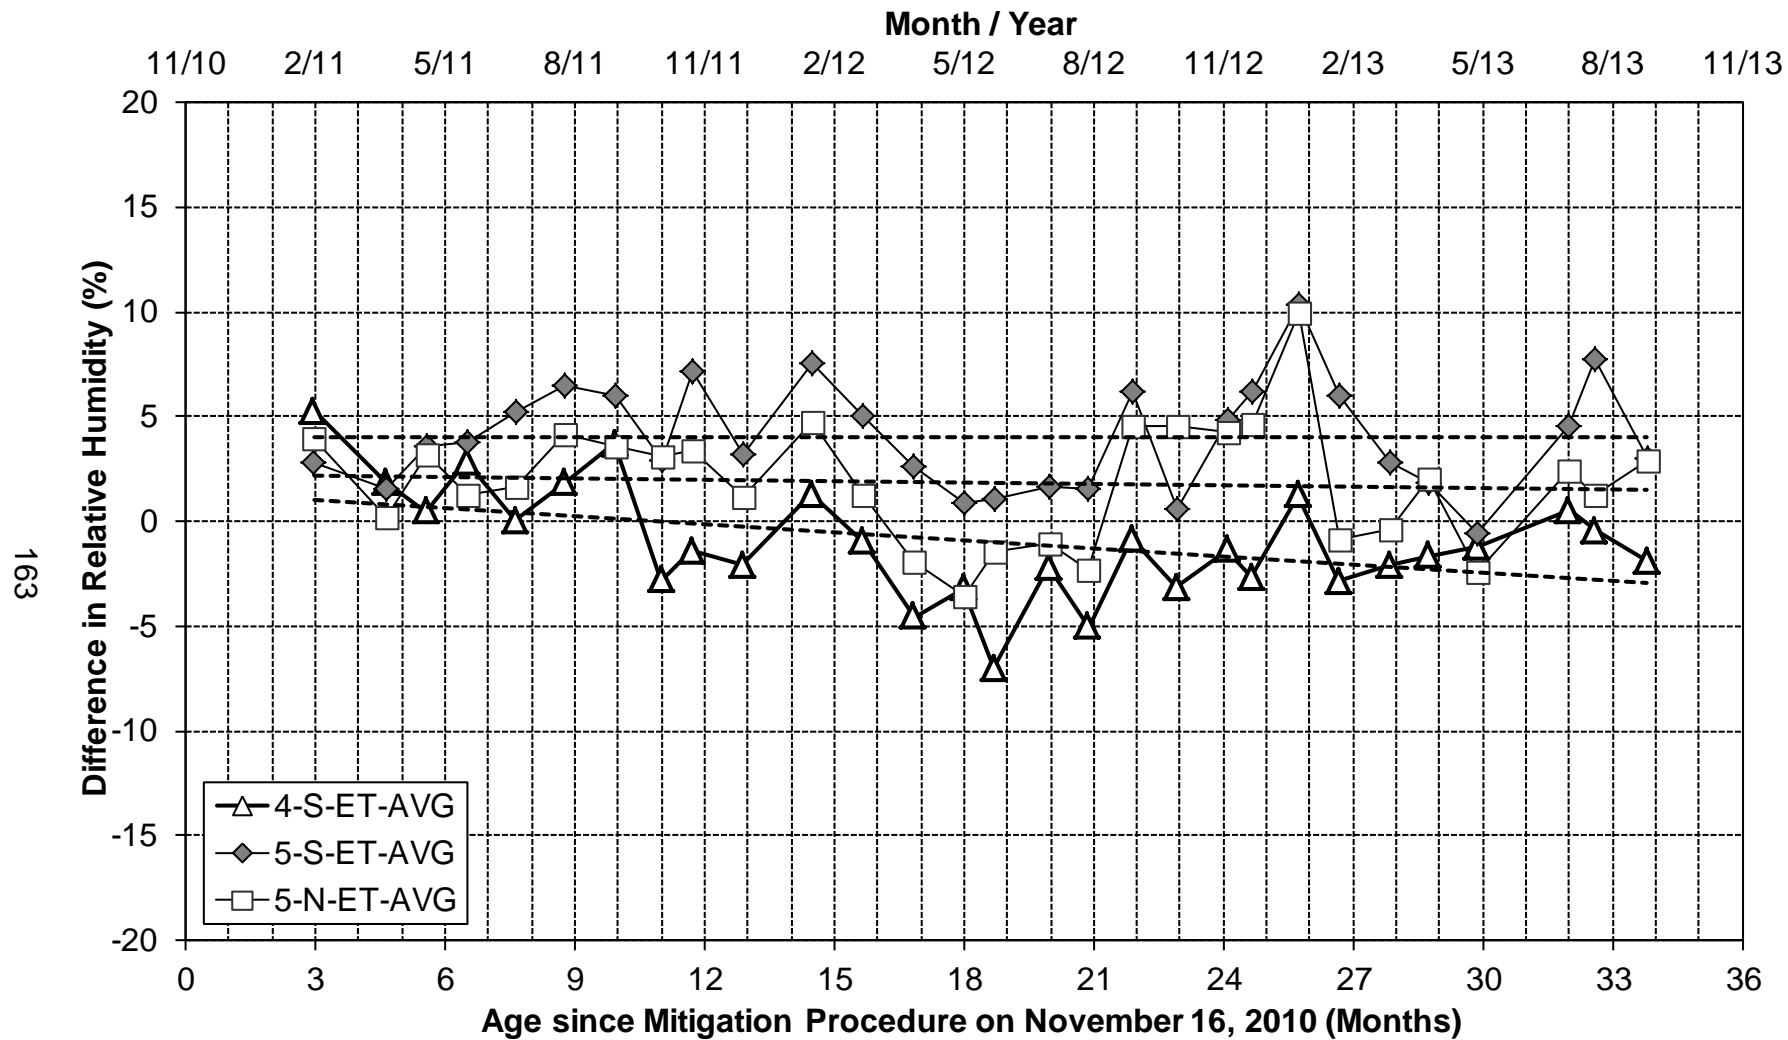
Figure 6.28. RH difference for East Top average
