**Effectiveness of Silane in Mitigating Alkali-Silica Reaction in the
Bibb Graves Bridge**

A thesis submitted to the Graduate Faculty of
Auburn University
In partial fulfillment of the
Requirements for the Degree of
Master of Science

Auburn, Alabama
December 14, 2013

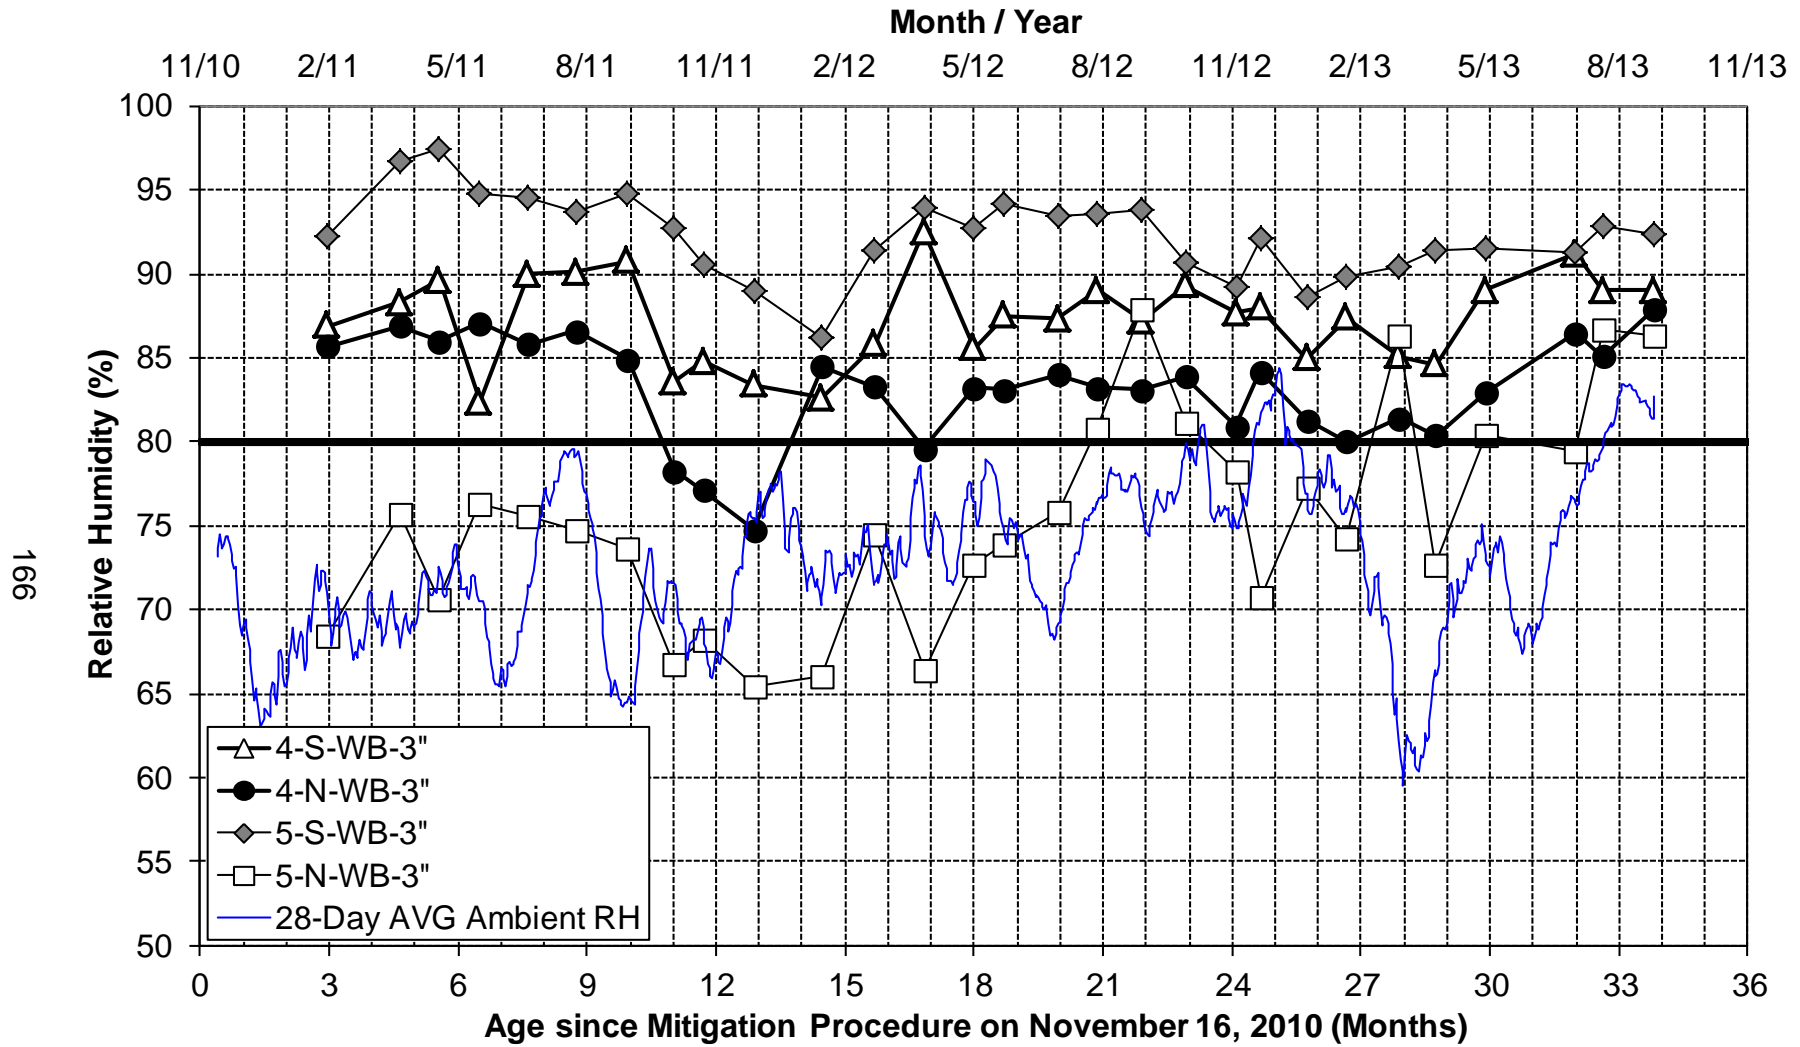
Figure 6.29. RH measurements, West Bottom, 3-inch depth

When comparing the 3-inch depth raw data to the average data, most of the locations exhibit similar relative humidity patterns, with the exception of 4-N-WT. 4-N-WT-3" (Figure 6.30) not only had a different pattern over time than 4-N-WT-AVG (Figure 6.22), but it also had a much higher overall humidity than 4-N-WT-AVG.

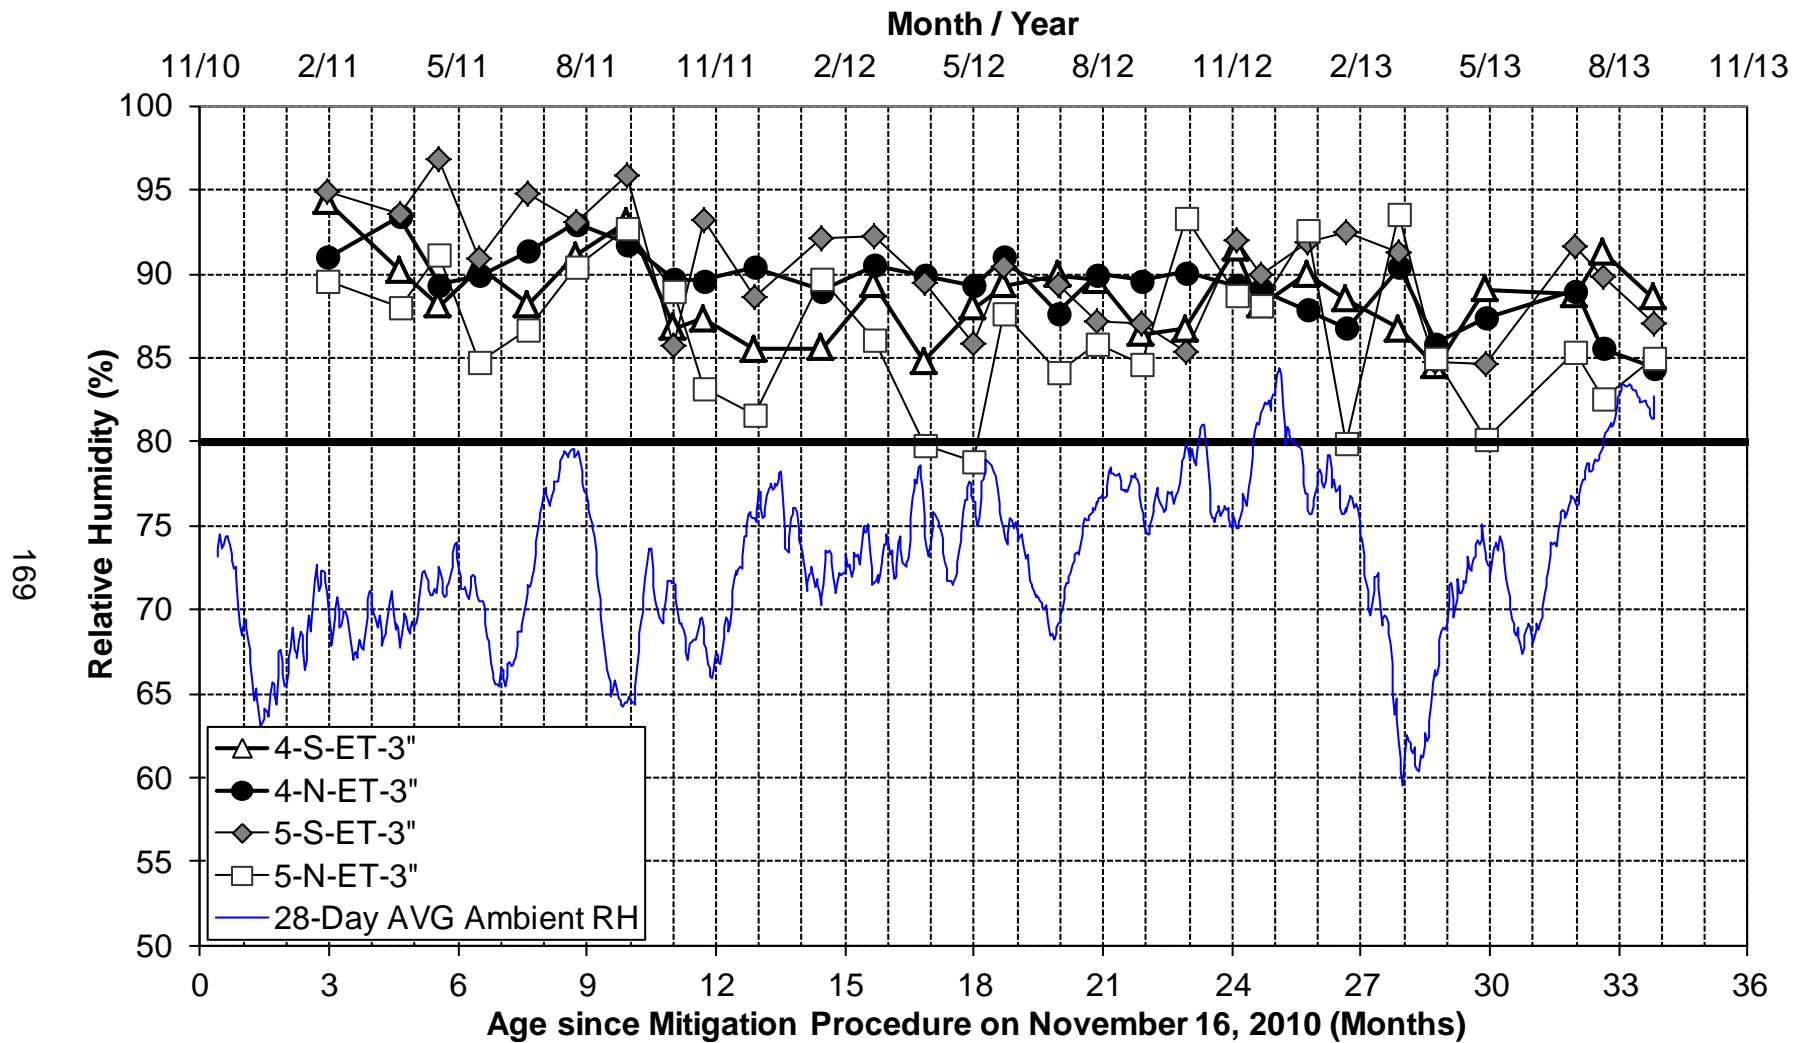
Figure 6.32. RH measurements, East Top, 3-inch depth

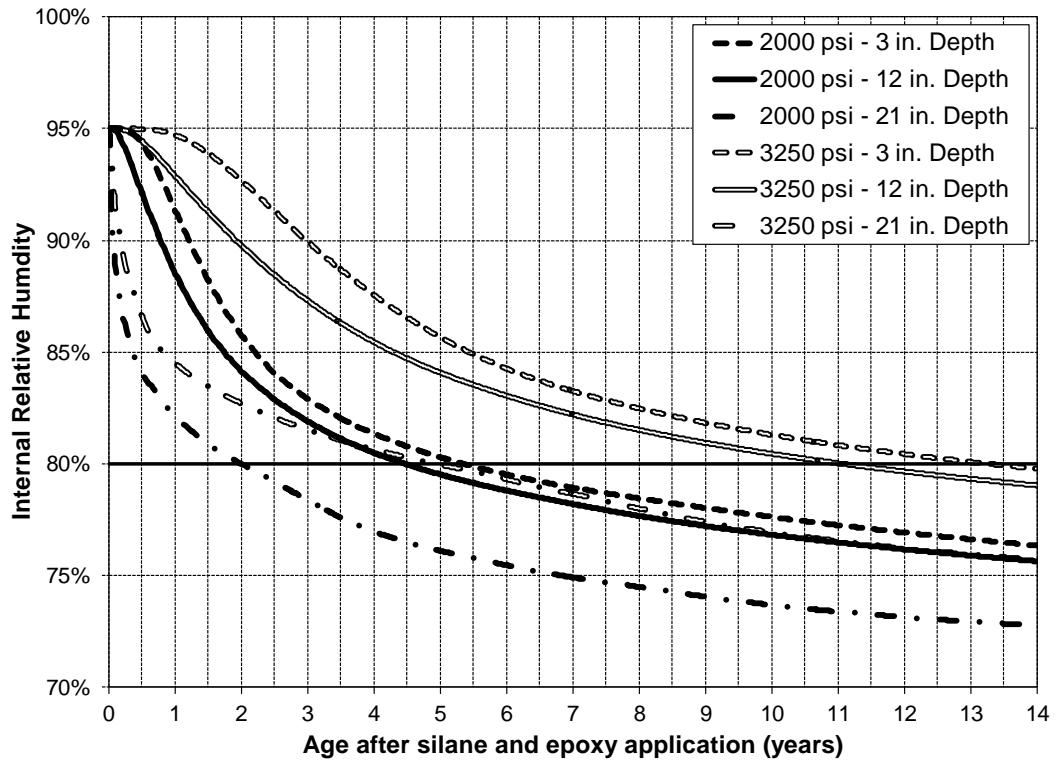
Figure 6.33. Drying time predictions for silane and epoxy treated arch section
(Adapted from Warnock 2012)

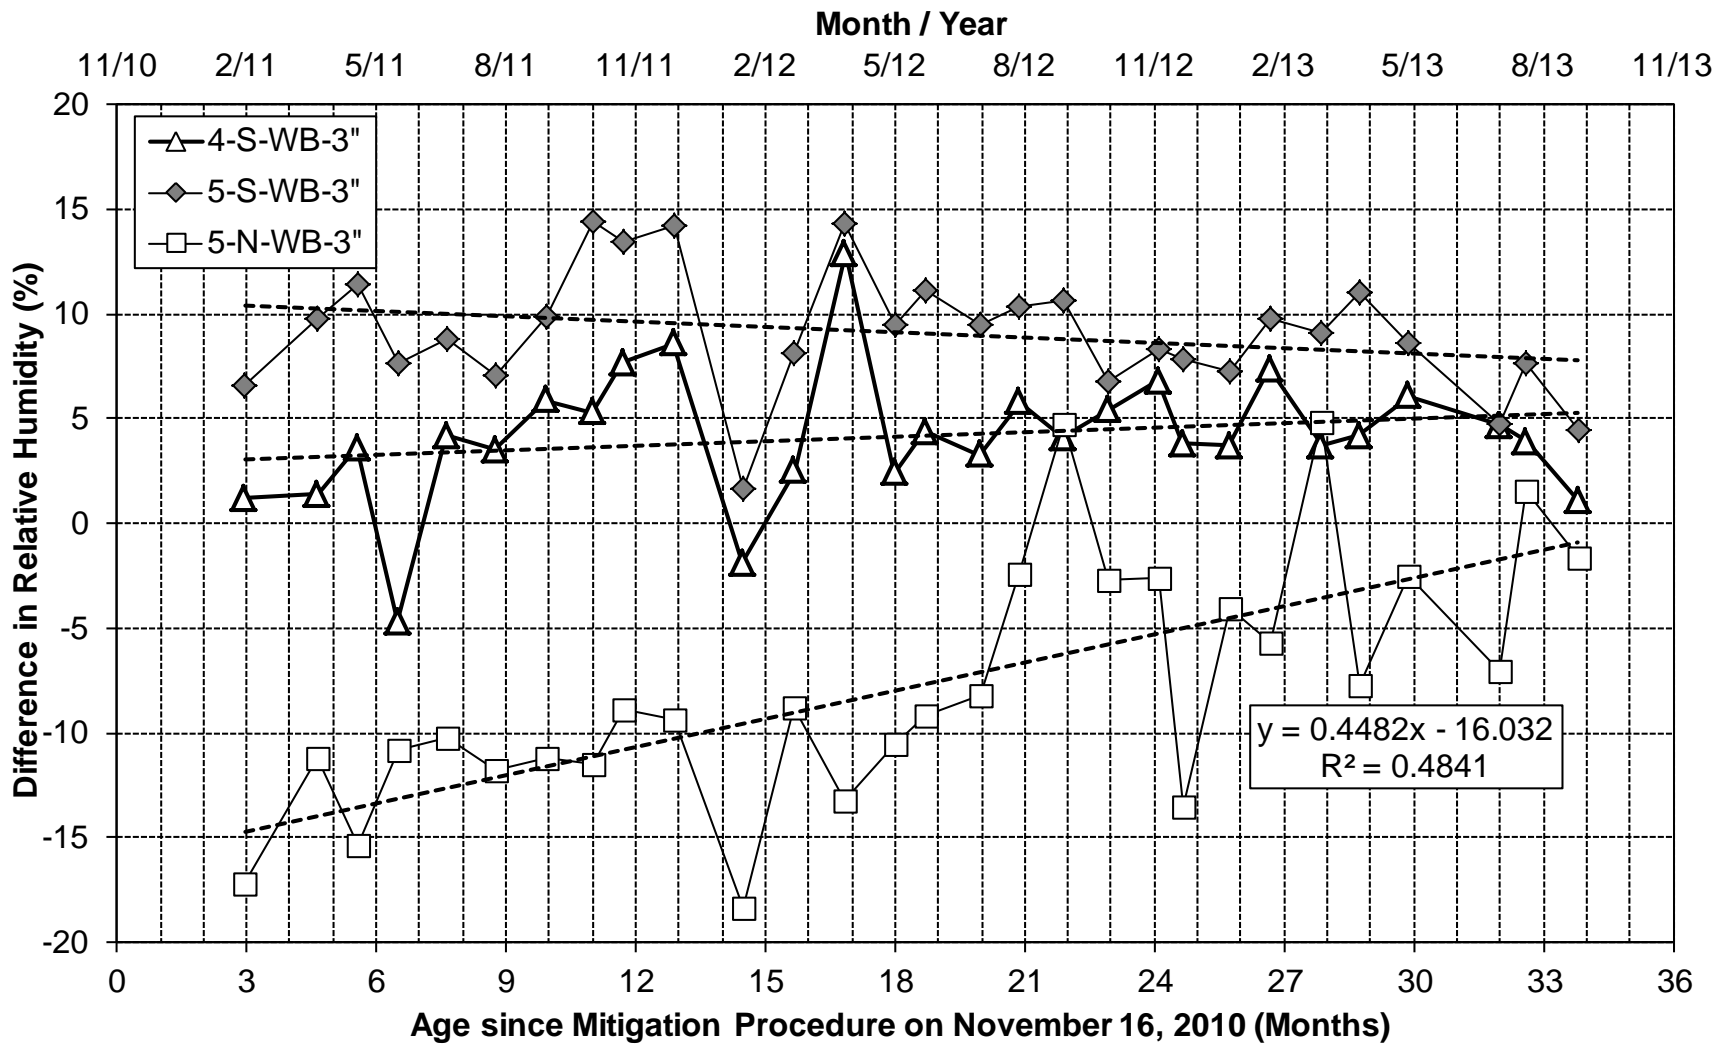
Figure 6.34. RH difference for West Bottom 3-inch depth

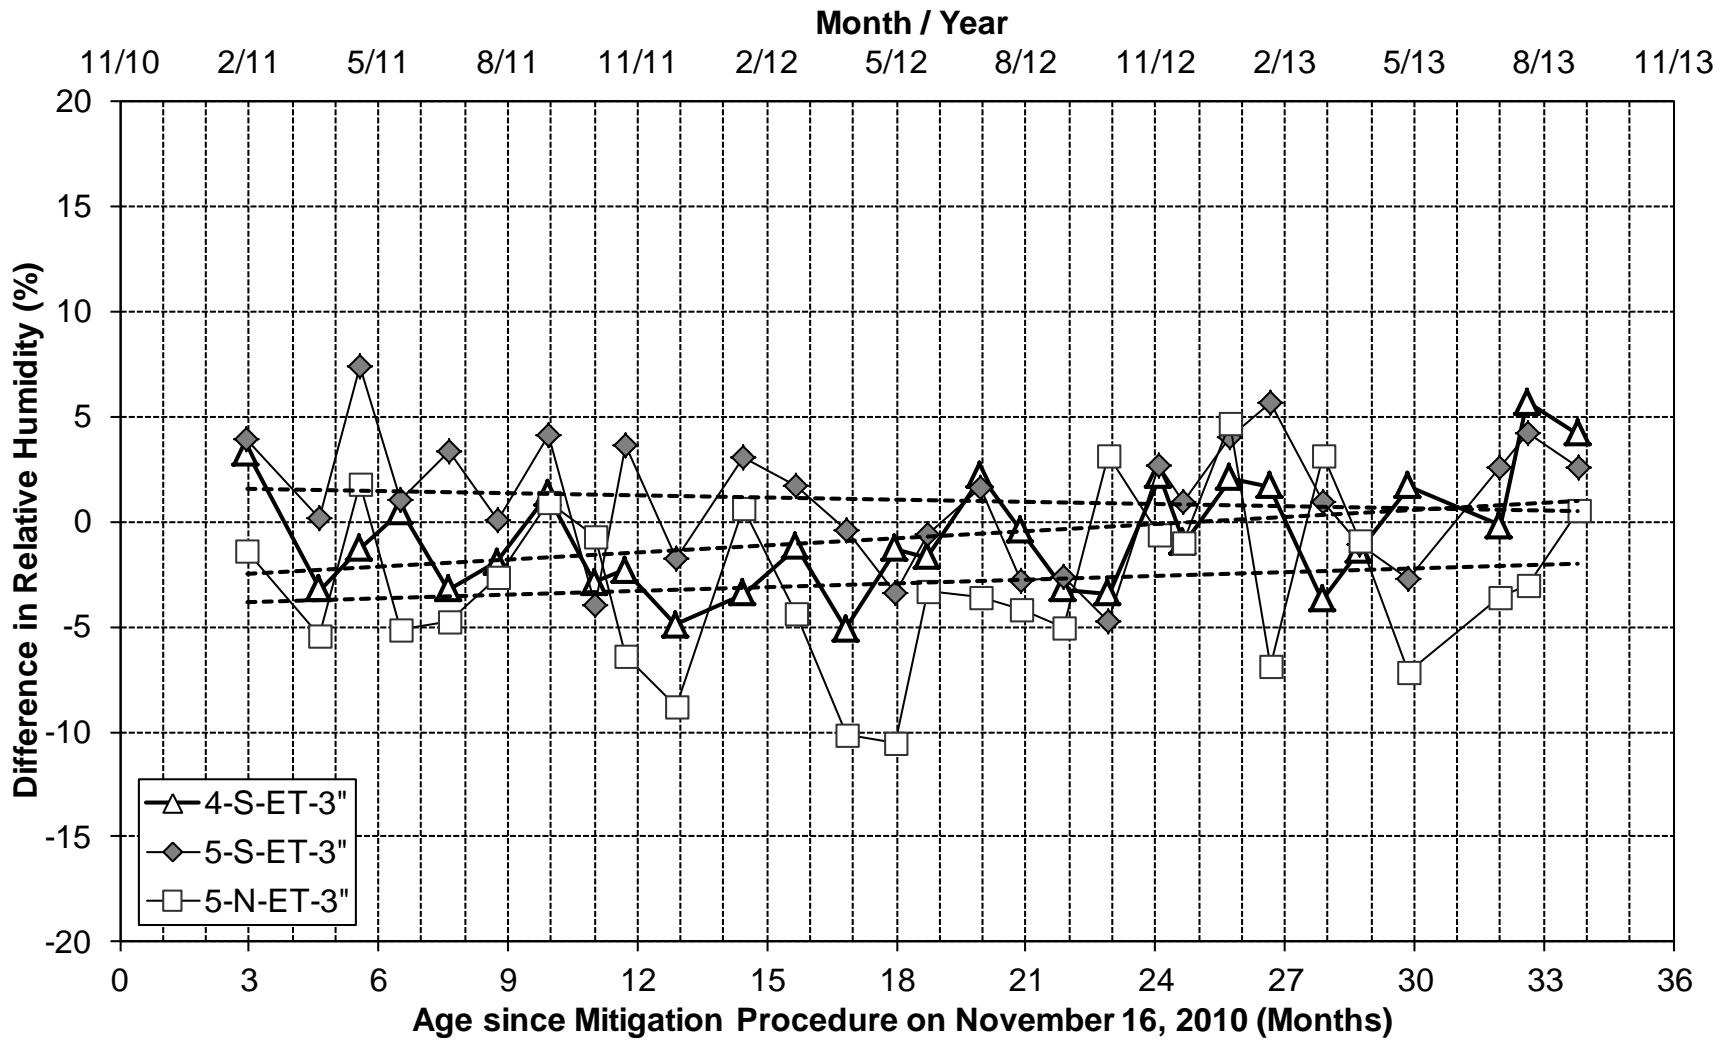
Figure 6.37. RH difference for East Top 3-inch depth

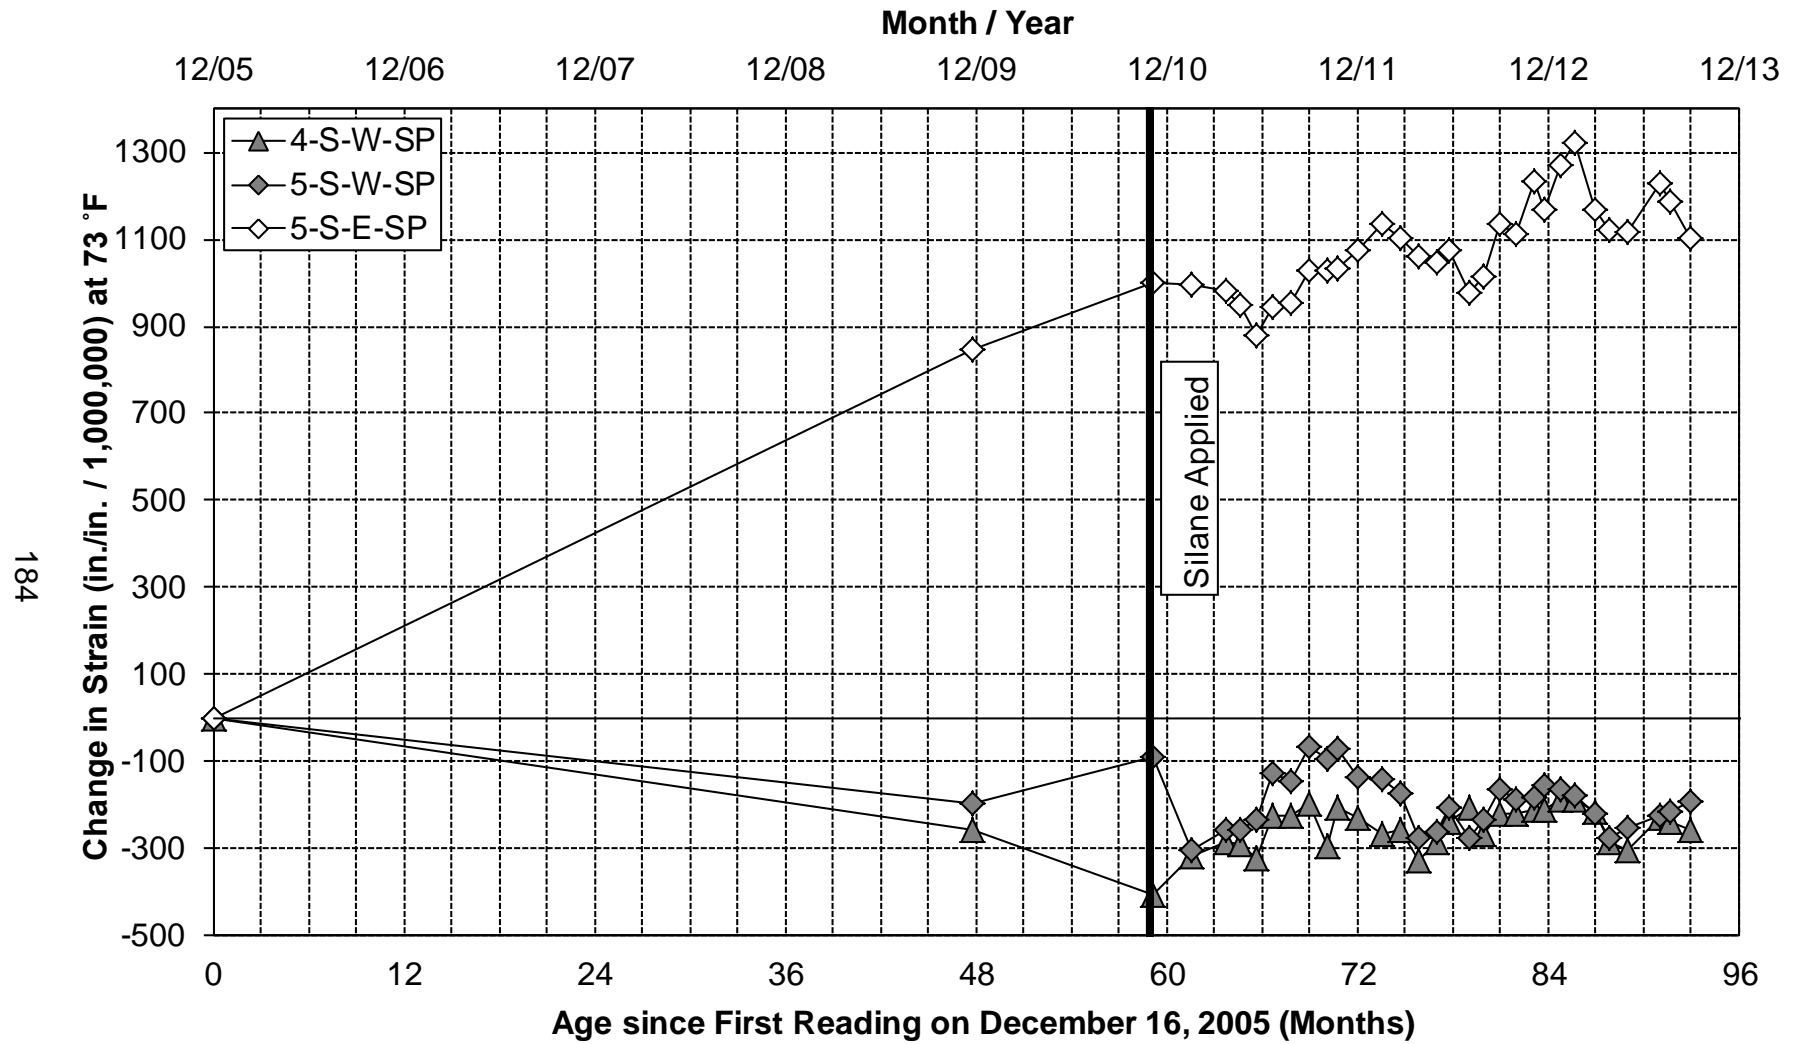
Figure 6.38. Change in concrete strain for Side Perpendicular since 2005

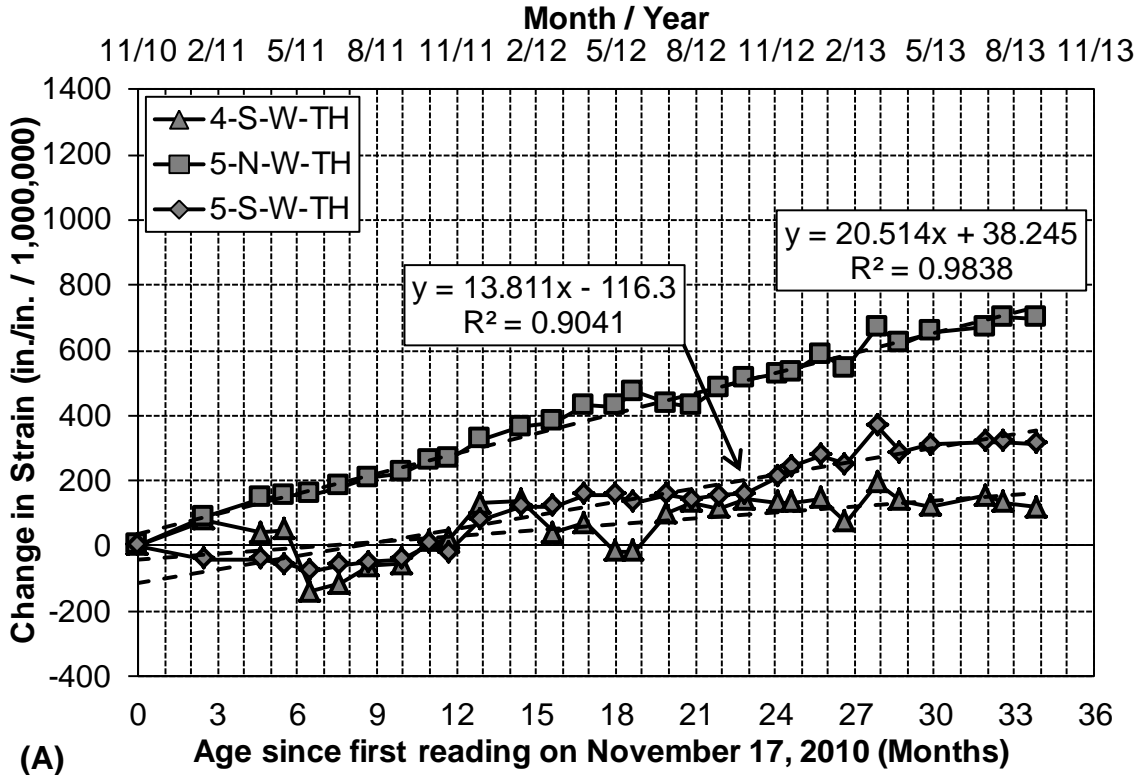
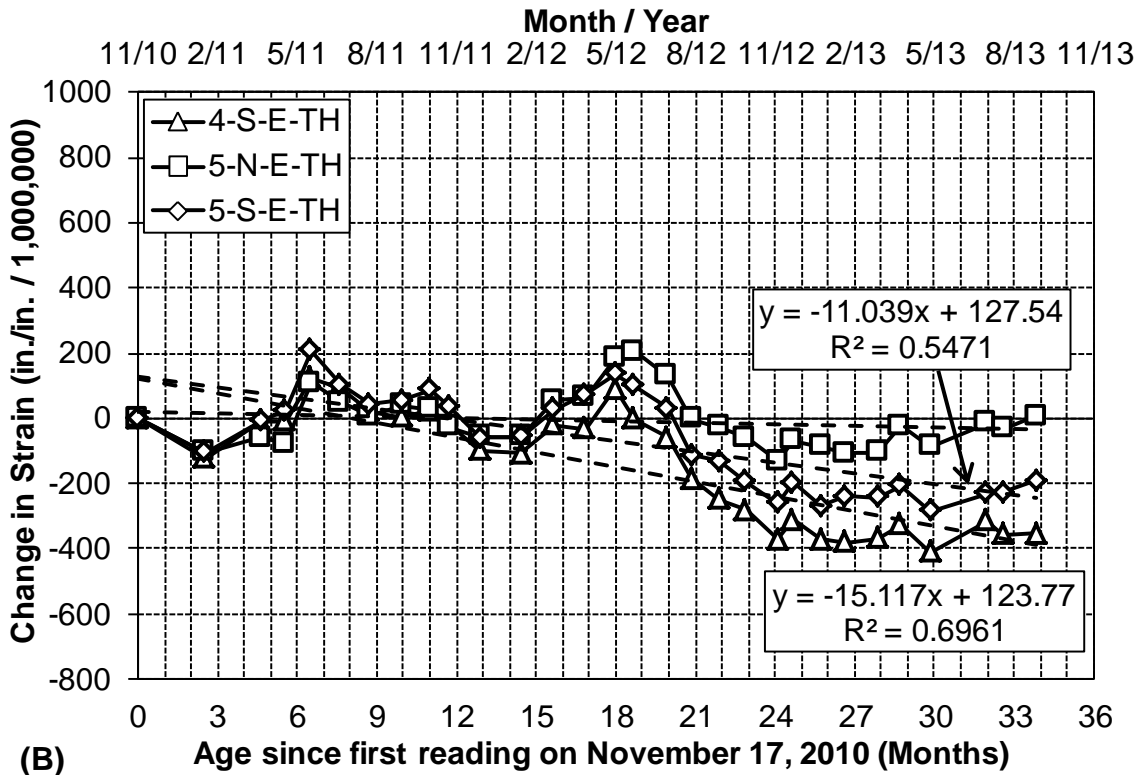
Figure 6.53. Strain difference for Top High at (A) west and (B) east

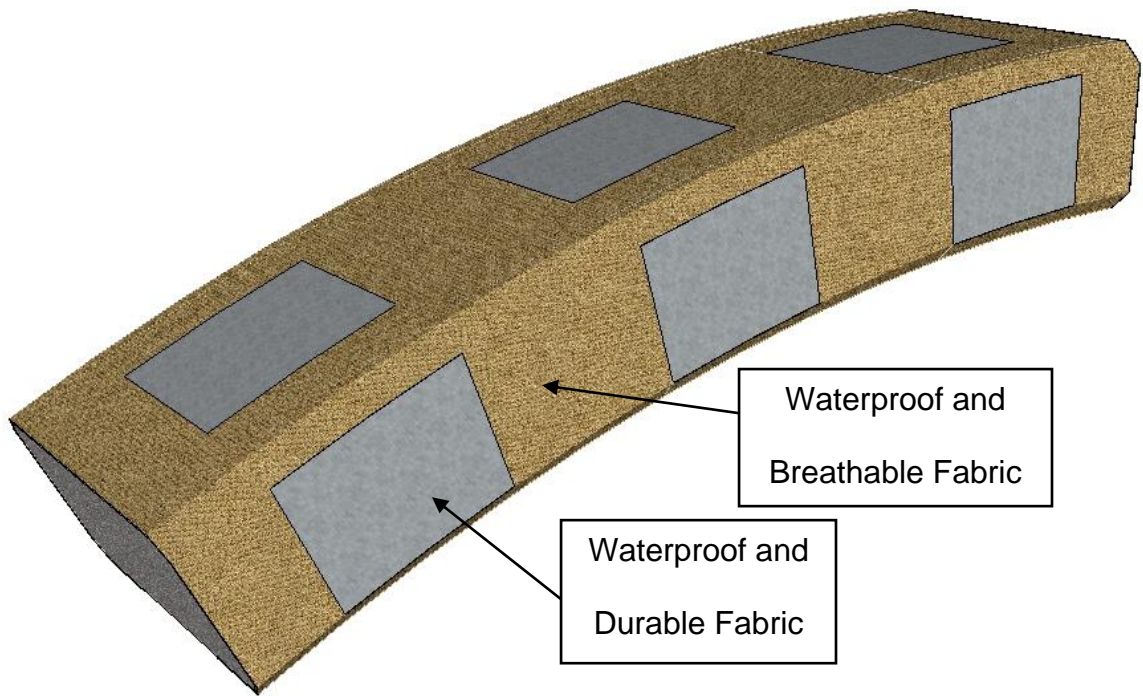
Figure 7.1. Fabric covered arch; top and side view

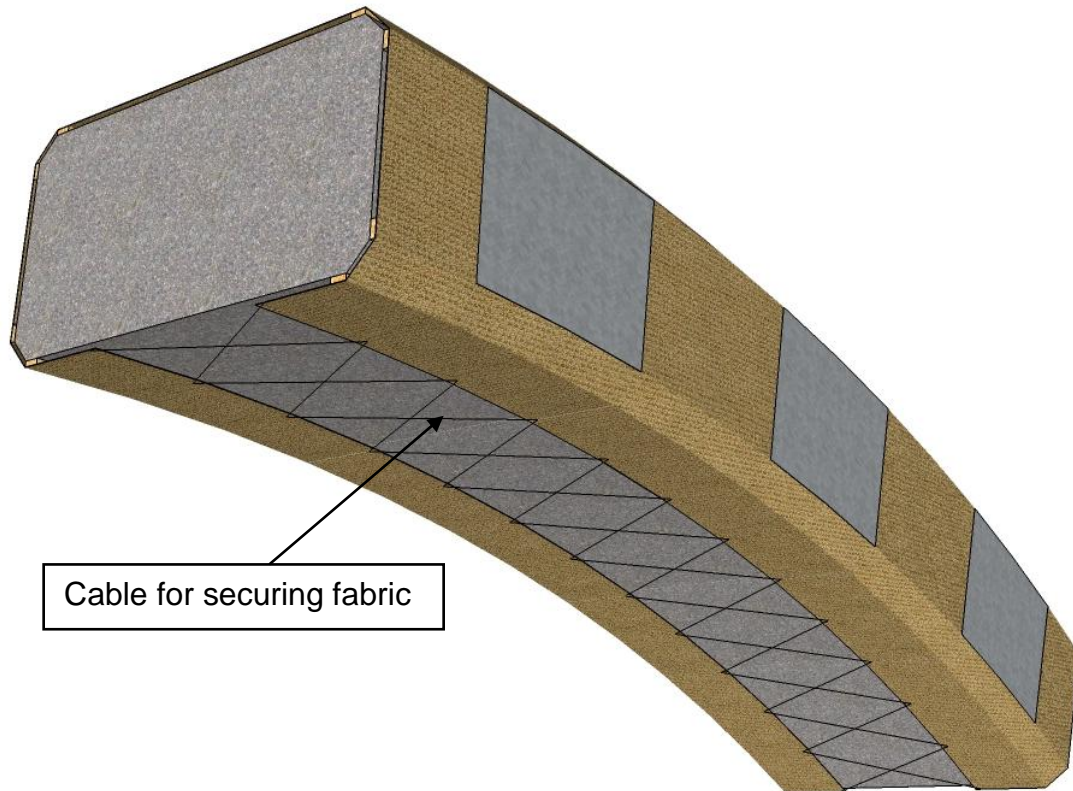
Figure 7.3. Bottom view of fabric secured around arch

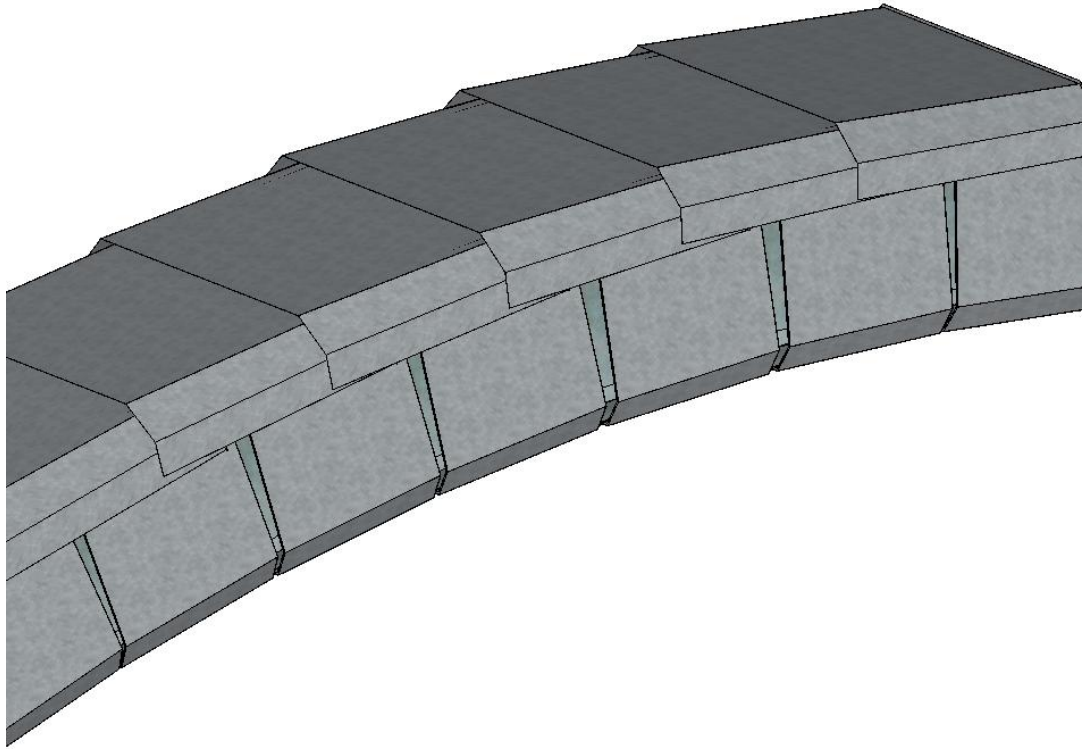
Figure 7.4. Ventilated cladding layout on arch

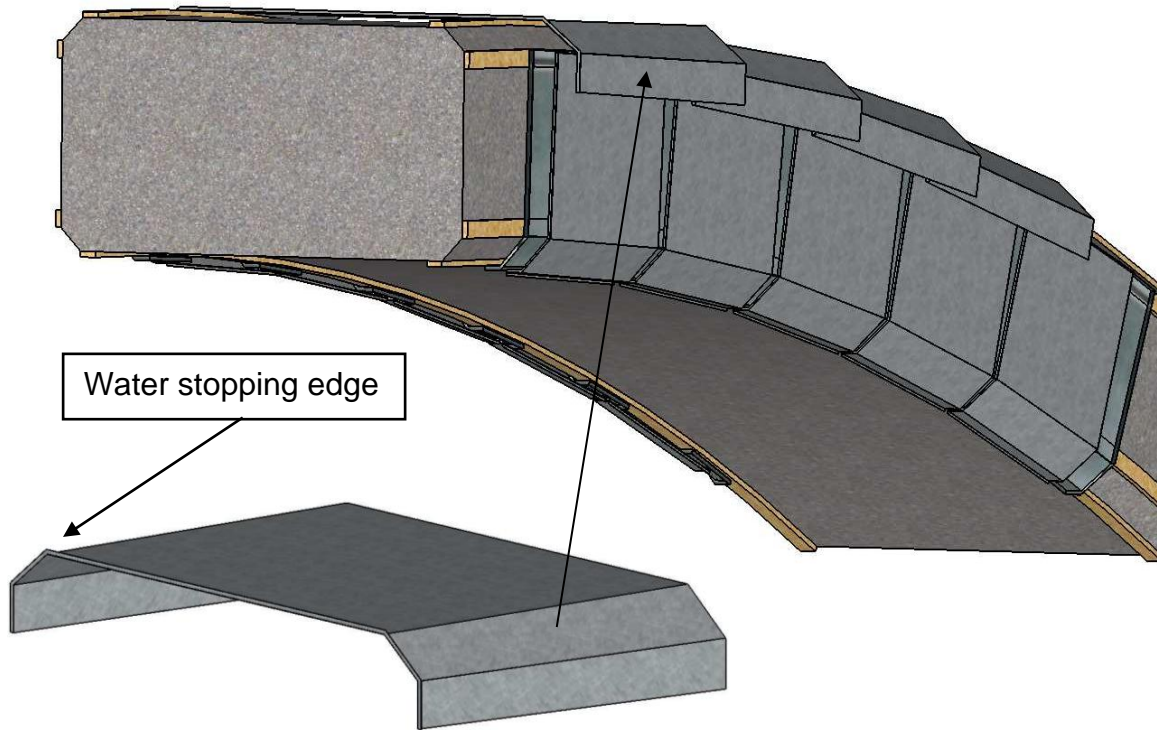
Figure 7.9. Layered top panels

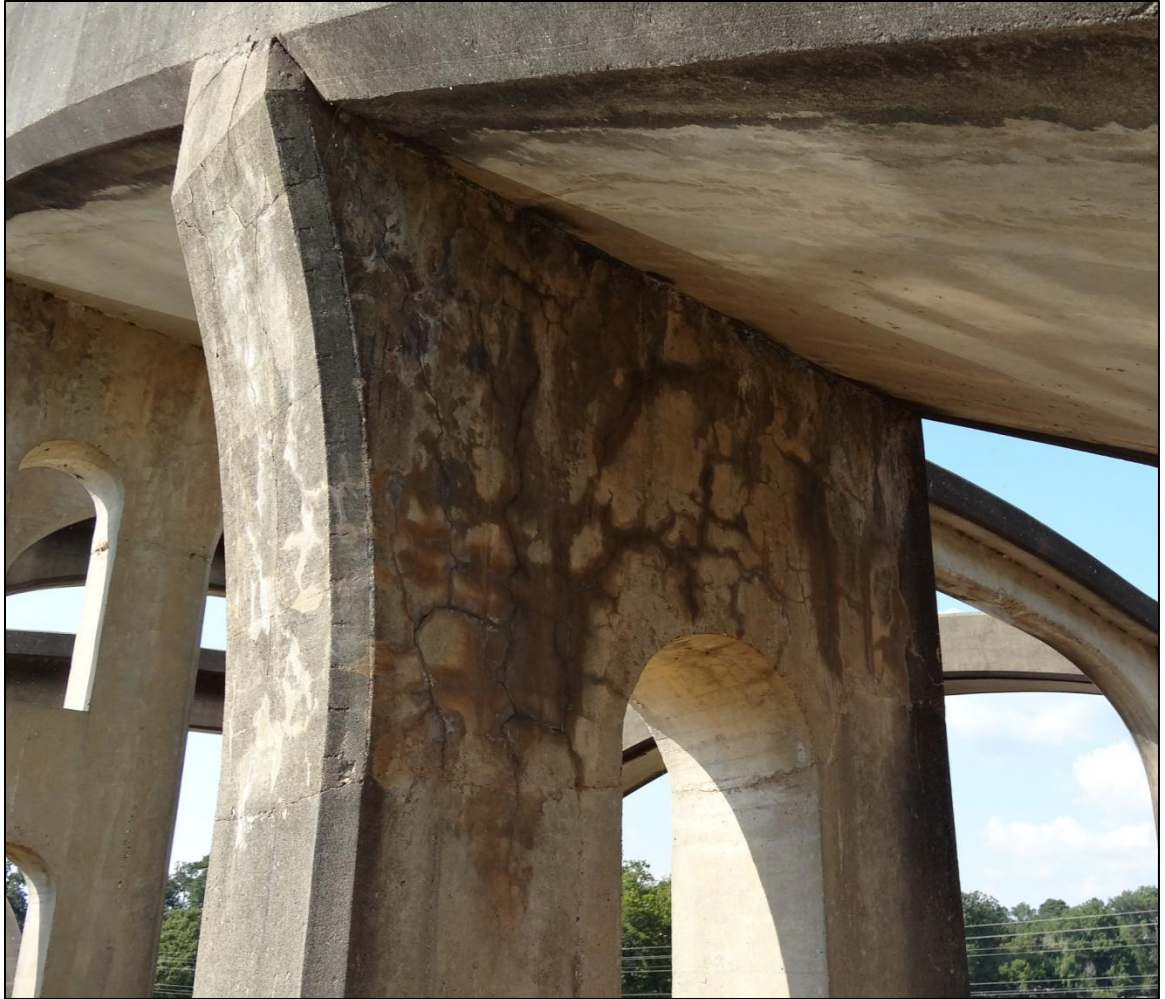
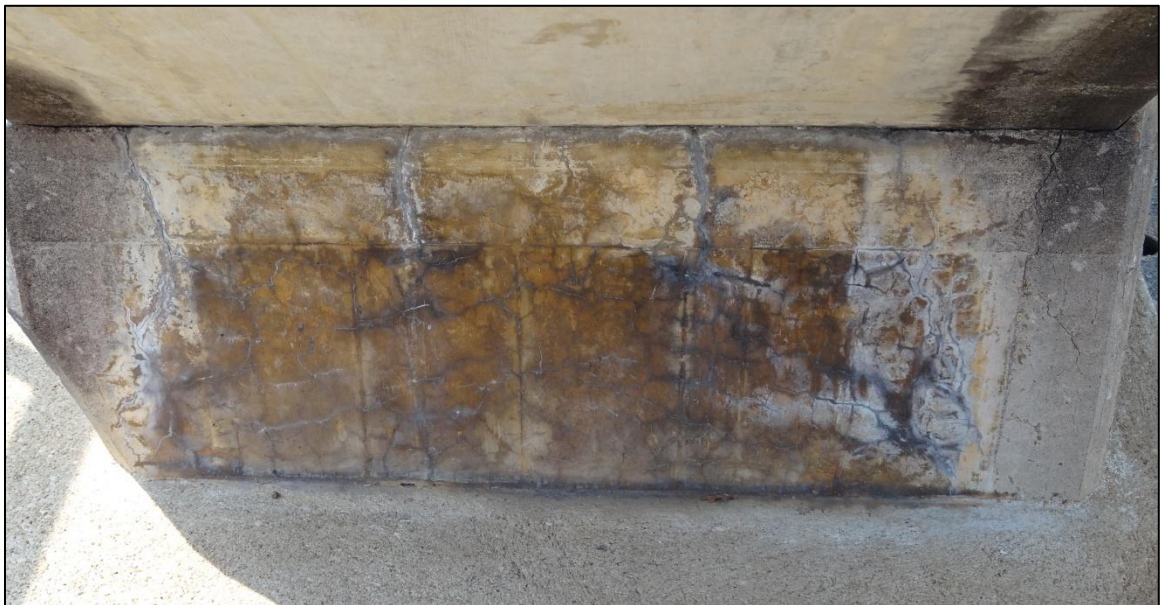
Figure 7.10. Examples of possible ASR in span 3

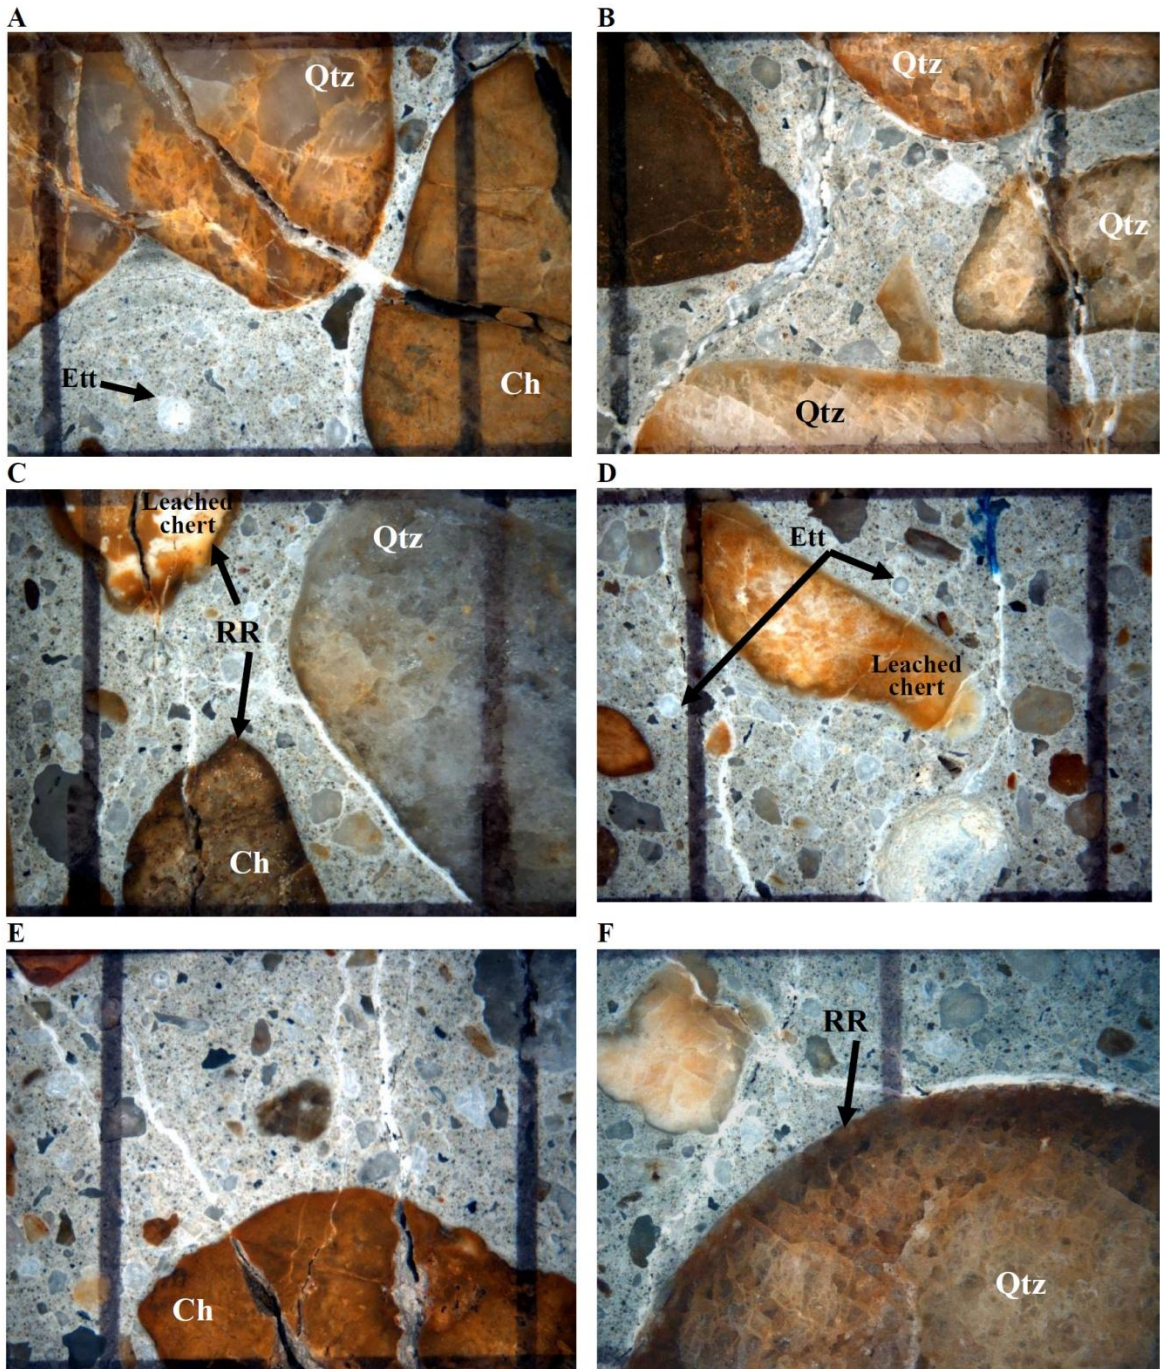
Figure B2: Micrographs of the polished core section 2A-South (distance between vertical lines = 1 cm)
 The micrographs show extensive cracking in the coarse aggregate particles and in the cement paste. The coarse aggregates mainly consist of chert (Ch) (sometimes partially leached/weathered) and quartzite particles (Qtz). Dark reaction rims (RR) are observed around some coarse aggregate particles. Concrete is not air entrained but some air voids are filled with ettringite (ett) (e.g. D). Cracks in the cement paste are often filled by ettringite (whitish and powdery deposits; also clear and waxy in luster) and alkali-silica reaction products, as illustrated in more details in Figure B3.

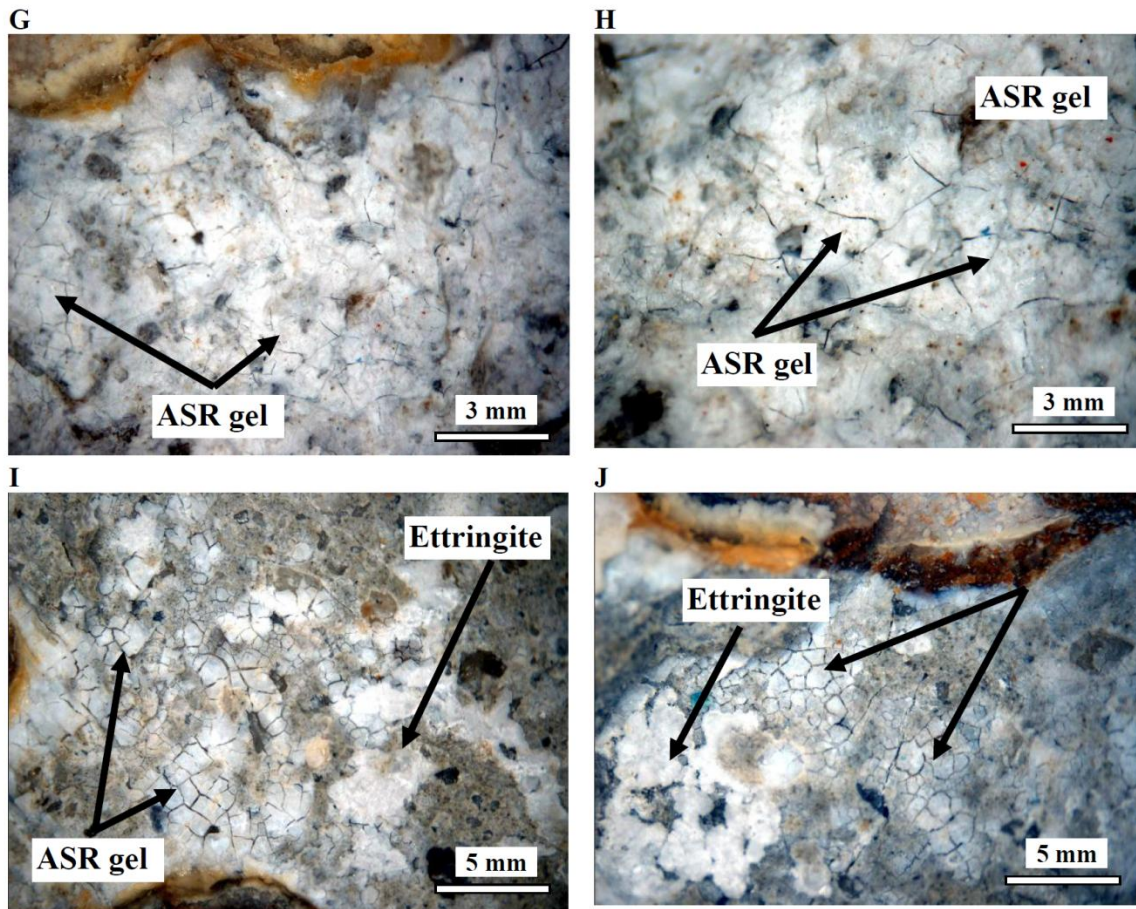
Figure B3: Micrographs of broken surfaces of the core 2A-South, as examined under the stereomicroscope. Figures B3-A and B3-B. Concrete surfaces broken along major cracks in the cement paste (core diameter = 3 inches (75mm)). Figure B3-C. The core broke along large cracks in the cement paste, thus exposing surfaces, both along cracks in the aggregates and the cement paste, largely covered by whitish secondary reaction products. Such products consist of ettringite and ASR gel (18x magnification). Figure B3-D. Whitish (powdery) reaction products (ettringite) covering large areas of the cement paste (20x magnification). Figure B3-E: Magnification (30x) of the reaction products illustrated in B3-D showing the needle-type microtexture of ettringite. Figure B3-F. Deposit of ettringite covering an aggregate particle. The deposit was found at the interface between an aggregate particle and the cement paste (as in Figure B2-C) and caused debonding of the aggregate particle when the concrete was broken for petrographic examination (20x magnification). Figures B3-G and B3-H. Deposits of ASR gel (showing typical “mud-crack” microtexture) covering large areas of the cracked cement paste (25x magnification). Figures B3-I and B3-J. Deposits of ASR gel and ettringite co-existing in the deteriorated concrete sample (18x magnification).

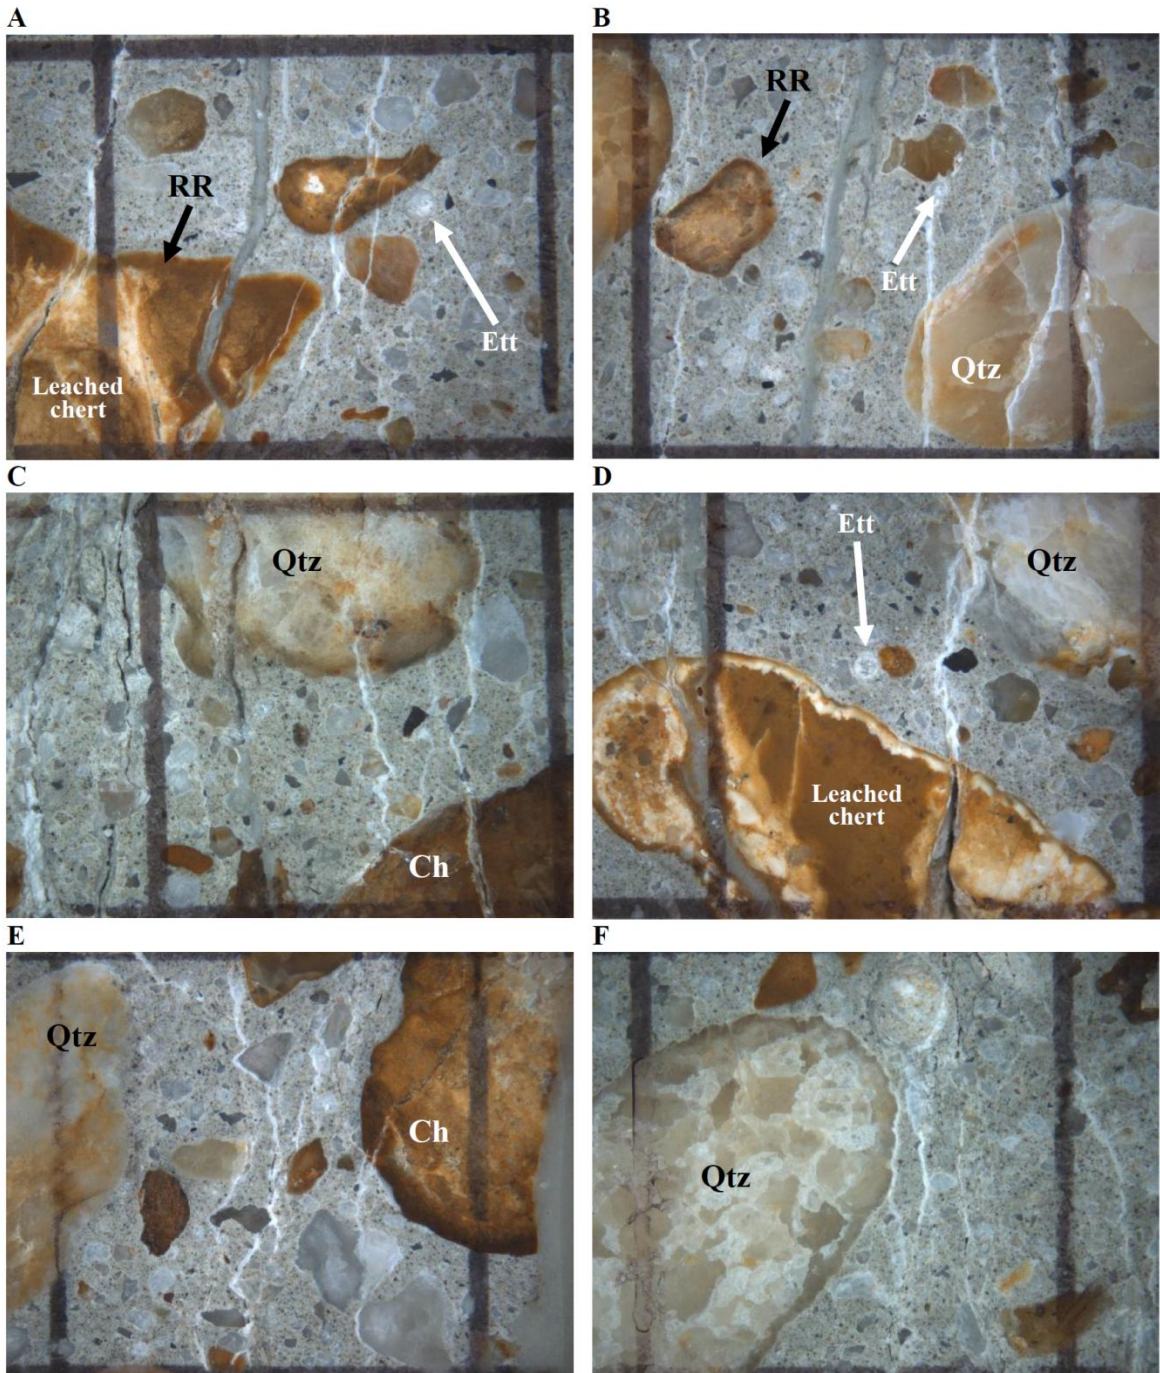
Figure B6: Micrographs of the polished core section 2A-North (distance between vertical lines = 1 cm). The micrographs show extensive cracking in the coarse aggregate particles and in the cement paste. The coarse aggregates mainly consist of chert (Ch)(sometimes partially leached/weathered) and quartzite particles (Qtz). Dark rims (RR) are observed around some coarse aggregate particles. Concrete is not air entrained but some air voids are filled with ettringite (ett) (e.g. B6-A, B6-B and B6-D). Cracks in the cement paste are often filled by ettringite (whitish and powdery deposits; also clear and waxy in luster) and alkali-silica reaction products, as illustrated in more details in Figure B7.
