**Effectiveness of Silane in Mitigating Alkali-Silica Reaction in the
Bibb Graves Bridge**

A thesis submitted to the Graduate Faculty of
Auburn University
In partial fulfillment of the
Requirements for the Degree of
Master of Science

Auburn, Alabama
December 14, 2013

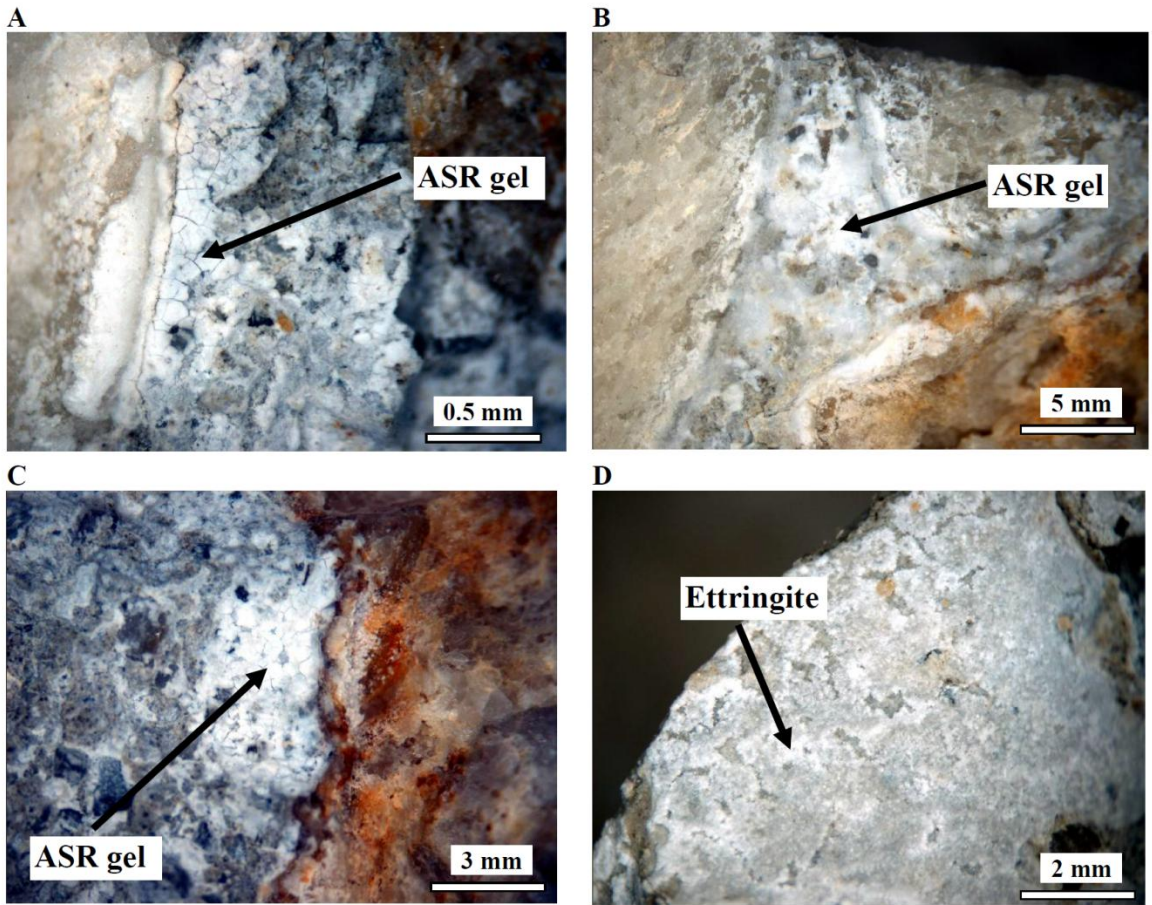
Figure B7: Micrographs of broken surfaces of the core 2A-North, as examined under the stereomicroscope. Figure B7-A to B7-C. Deposits of ASR gel (showing typical “mud-crack” microtexture) covering large areas of the cracked cement paste between aggregate particles. Figure B7-D. Deposit of ettringite in the mold of a debonded aggregate particle. The deposit was found at the interface between the aggregate particle and the cement paste (as in Figure B2-C) and caused debonding of the aggregate particle when the concrete was broken for petrographic examination.

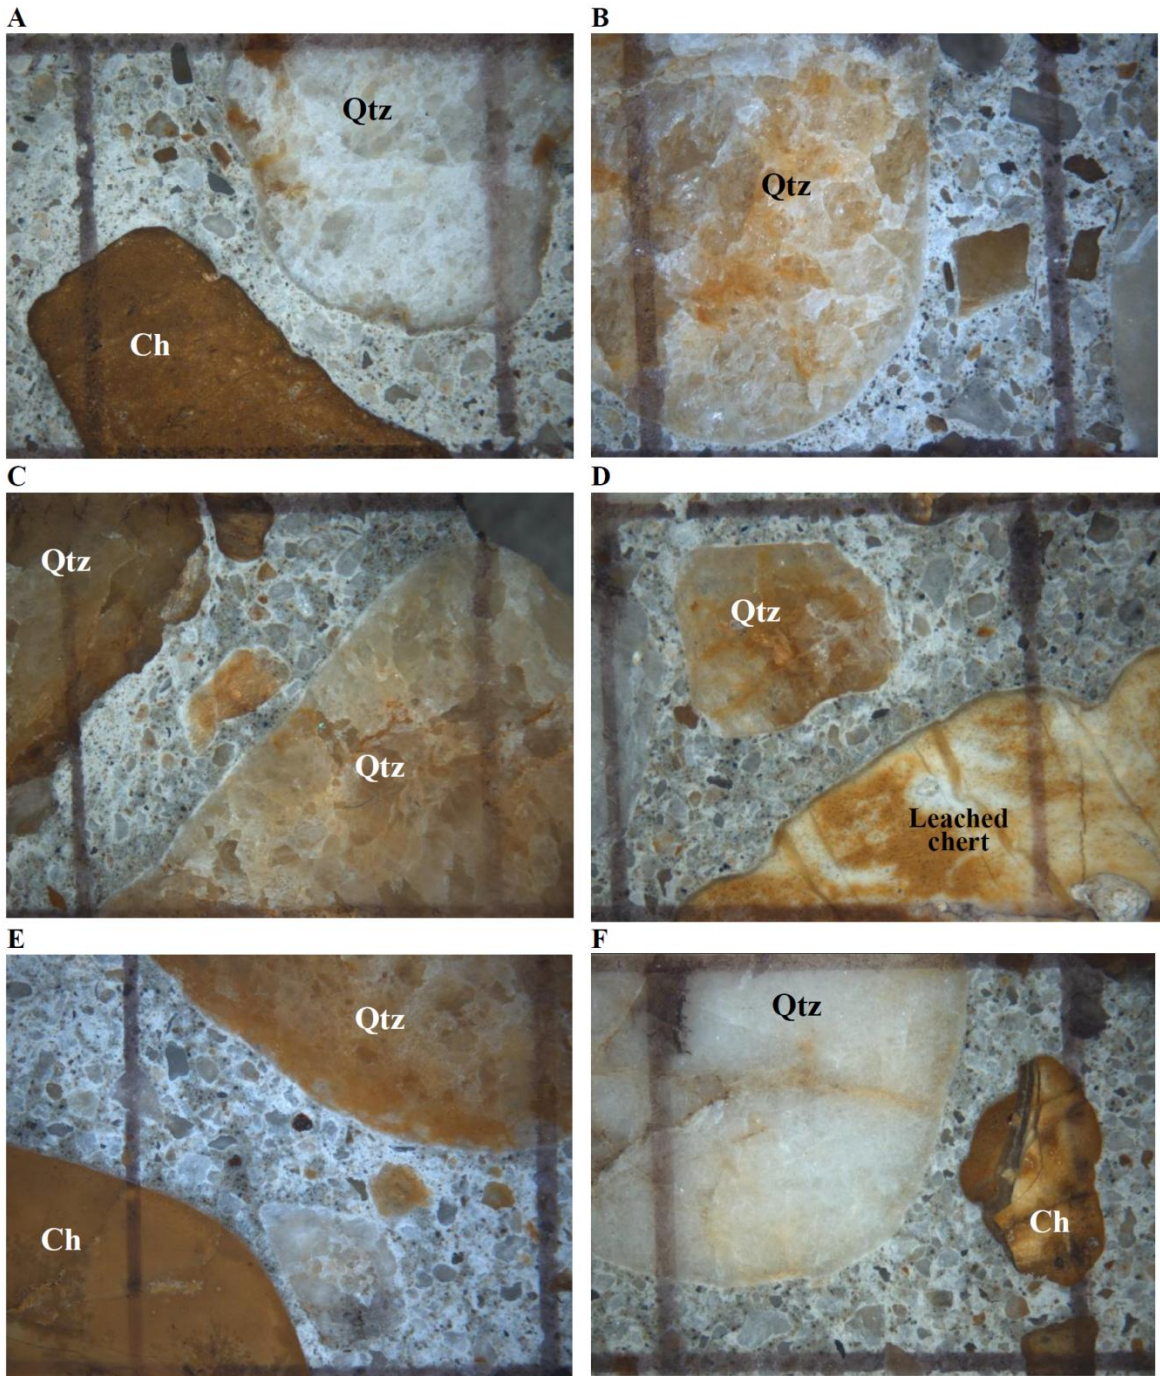
Figure B9: Micrographs of the polished core section 2B-South (distance between vertical lines = 1 cm). The micrographs show coarse aggregate particles that mainly consist of chert (Ch)(sometimes partially leached/weathered) and quartzite particles (Qtz). Very limited cracking is noticed in the cement paste.

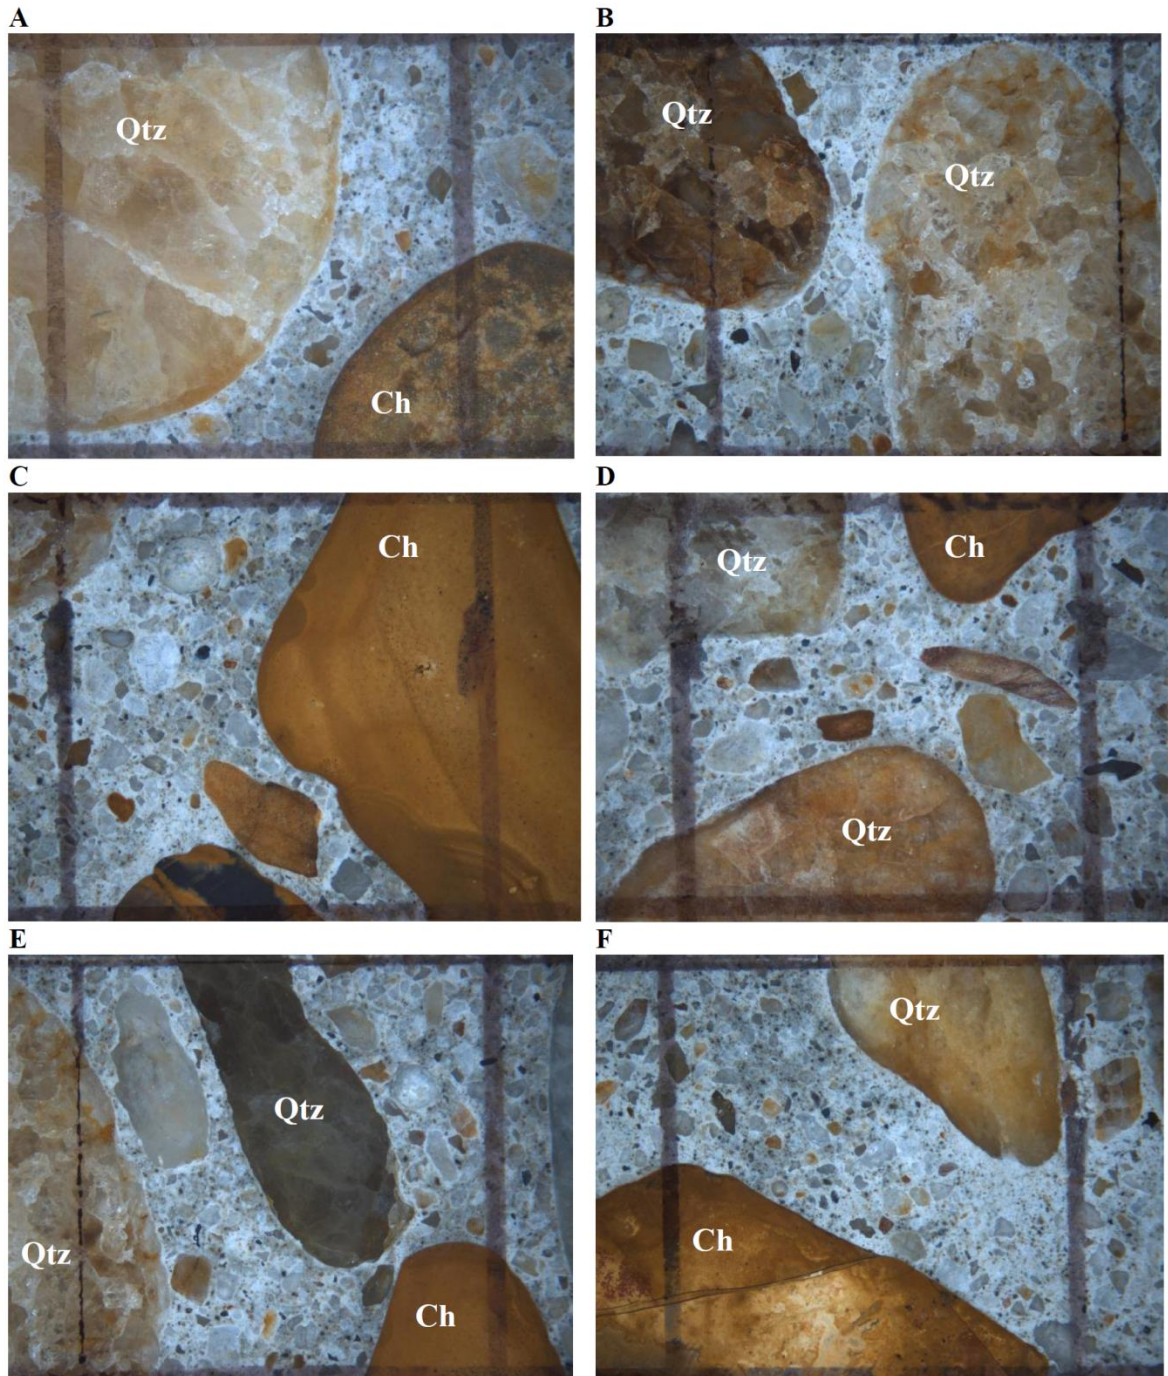
Figure B11: Micrographs of the polished core section 2B-North (distance between vertical lines = 1 cm).The micrographs show coarse aggregate particles that mainly consist of chert (Ch)(sometimes partially leached/weathered) and quartzite particles (Qtz). Very limited cracking is noticed in the cement paste.

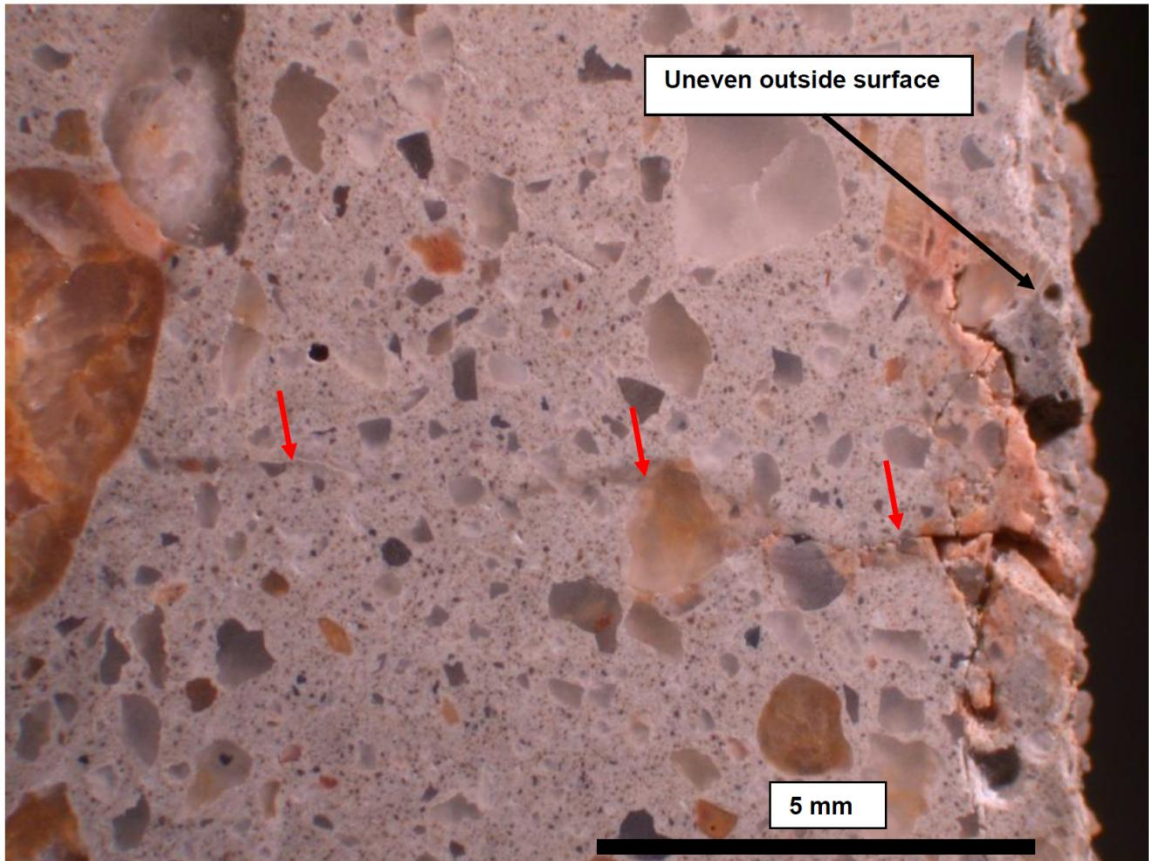
Figure 5. Core 1A-N - Narrow crack (arrows) and local paste carbonation in the outer region of the concrete. Outside surface is on the right. Carbonated paste is orange.

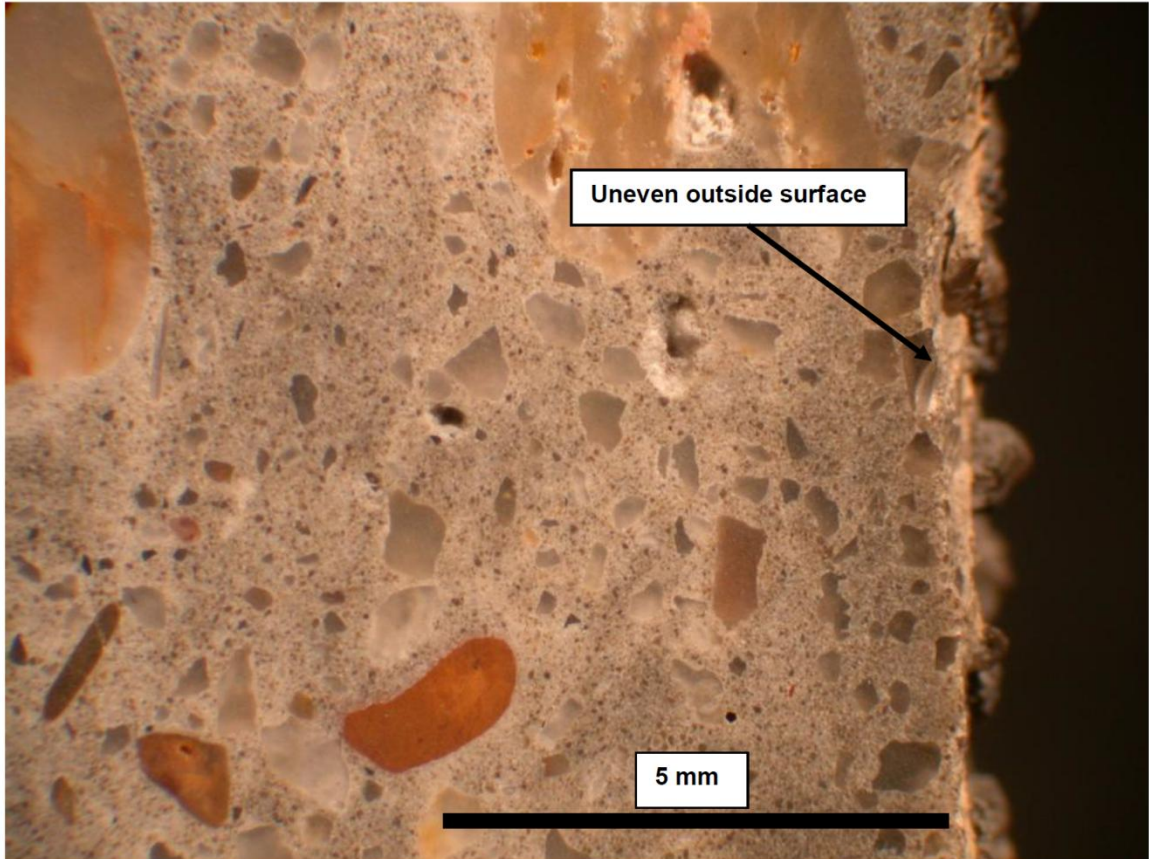
Figure 6. 1A-S - Mottled light gray to dark gray paste in the outer region of the concrete. Outside surface is on the right.

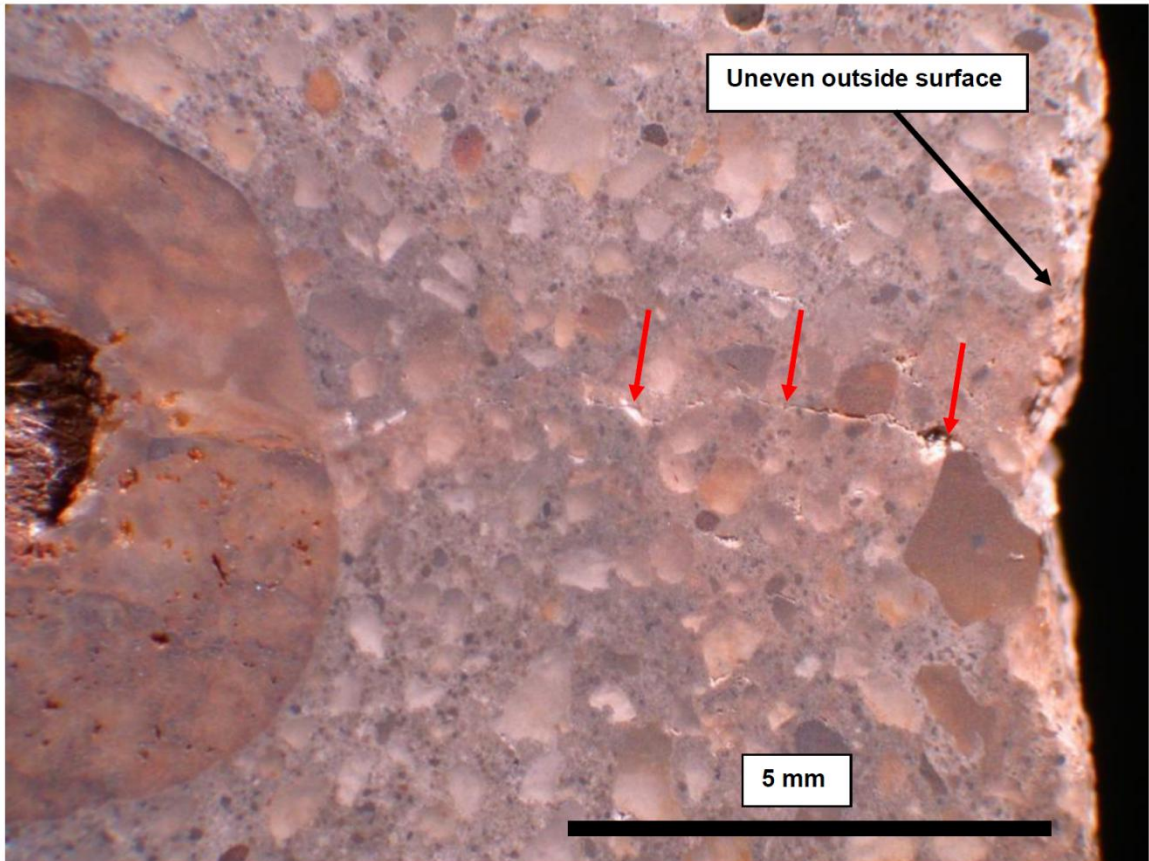
Figure 8. 1B-S - Narrow crack (arrows) in the outer region of the concrete. The crack extends from the outside surface to the aggregate particle on the left, but requires higher magnification to be seen. Outside surface is on the right. Patches of carbonated paste are pinkish orange.
