DOCUMENTATION OF THE RAPID REPLACEMENT
OF FOUR GDOT BRIDGE DECKS

A Thesis

Auburn University

Auburn, Alabama
May 11, 2006

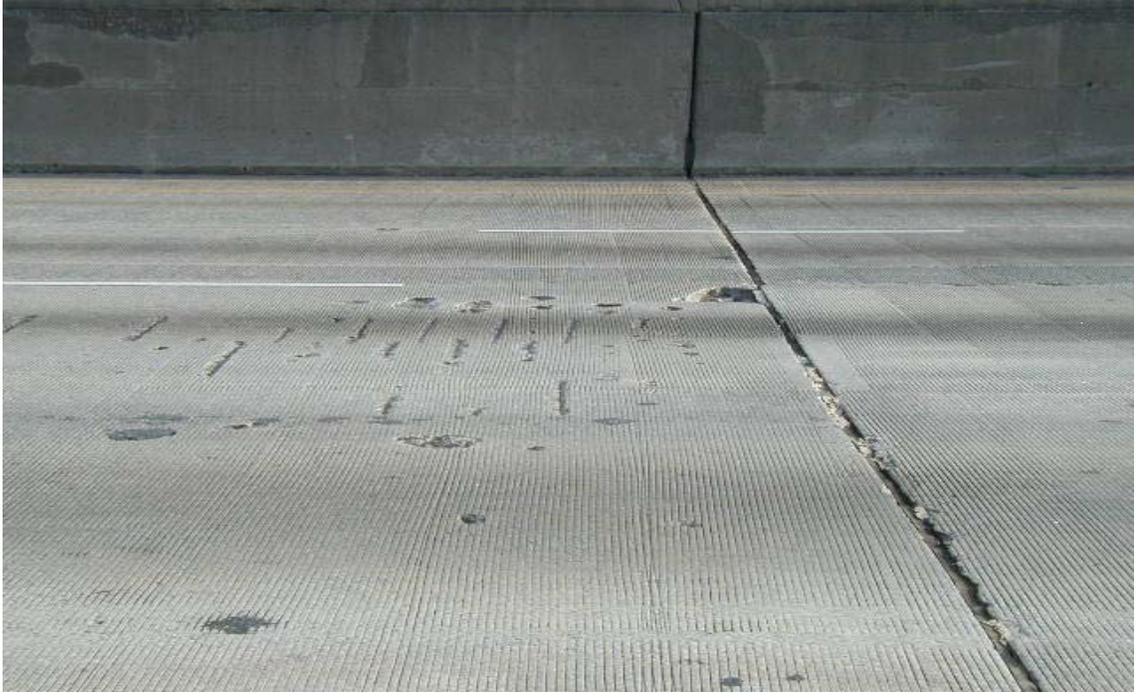
Fig. 2.21 Typical Spalling of Original Lanes (2)

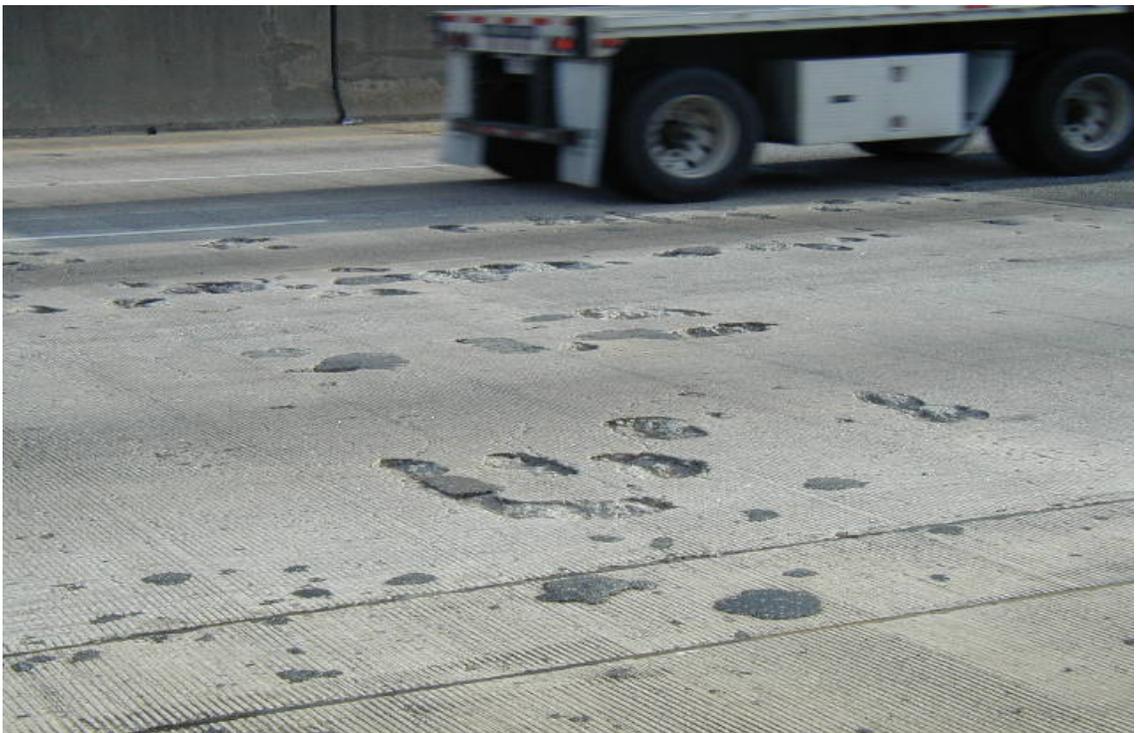
Fig. 2.22 Typical Deck Spalling of Lanes to be Replaced on Northbound Bridge (2)

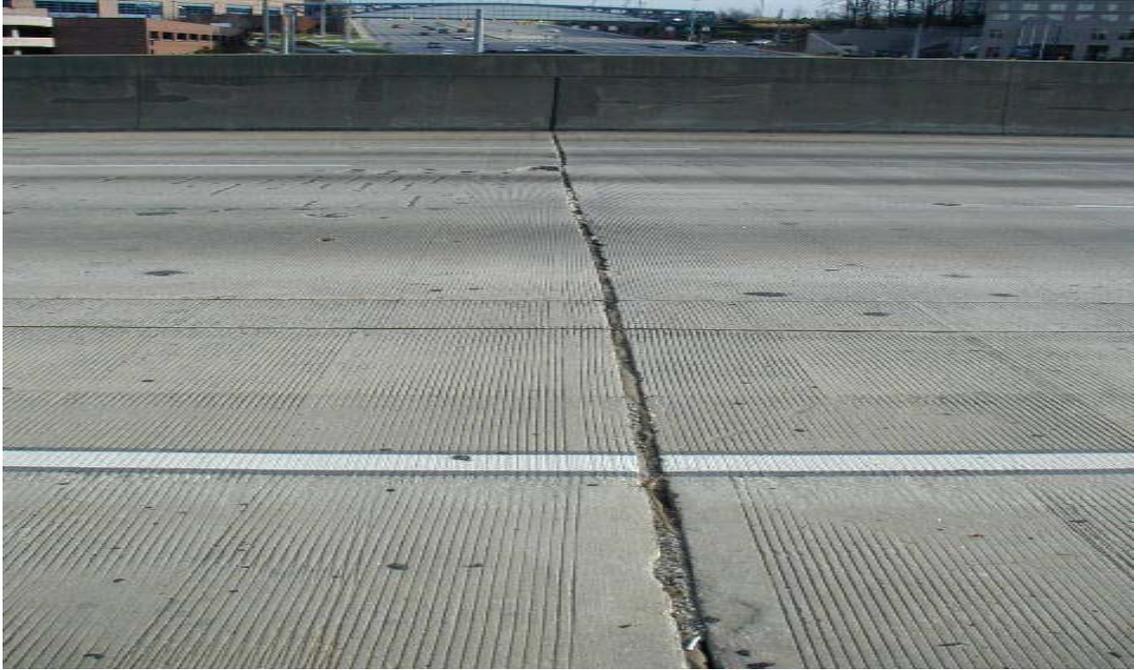
Fig. 2.23 Typical Transverse Joint on Northbound Bridge (2)

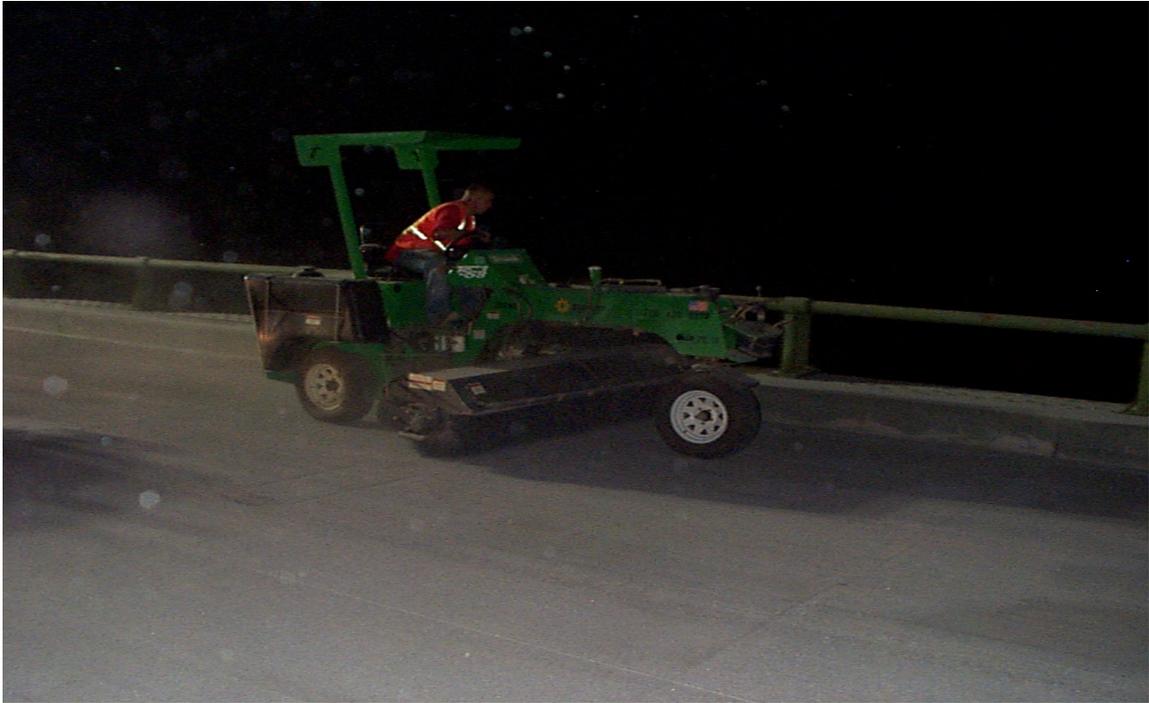
Fig. 3.47 Sweeping Deck Surface to Remove Any Loose Debris

Figures 3.46-3.53 show the deck preparation, application of the co-polymer overlay, and the resulting Flexogrid overlay. Figure 3.46 shows a test section that Poly-Carb performed to check the strength of the bond to the substrate. The test consisted of pipe caps that were epoxied directly to the concrete of the precast Exodermic panels and the Flexogrid overlay placed around these pipe caps. Once curing time was completed, the pipe caps were pulled perpendicularly to the concrete until a tensile failure between the concrete and pipe caps occurred. This tensile force was measured and recorded for each individual cap. The pull-off readings from the Longstreet Bridge ranged from 900-1200 psi. Figure 3.47 shows a sweeper being used to remove loose debris and dust

before the application of the first layer of the overlay. The sweeper was used after each layer application (2) to remove the excess fine aggregate. Figure 3.48 shows a rotary fine aggregate spreader used to broadcast the fine aggregate as it was conveyed from the Poly-Carb truck. Figure 3.49 shows a worker squeegeeing-on the epoxy as the Poly-Carb truck moves forward. Placement of the Flexogrid overlay consisted of a continuing process of application of the low viscosity crack sealer, squeegeeing of epoxy, and broadcasting of aggregate (see Figure 3.50). Note that the low viscosity crack sealer was applied in front of the Poly-Carb truck with a hand sprayer as it moved along the bridge. Figure 3.51 shows the finger joint located at midspan of the bridge with the first layer of overlay placed on one side. Note that the first layer of the overlay was placed on the other side of the finger joint on the night of the author's visit. A view of the first layer of the co-polymer overlay on approximately half of the bridge is shown in Figure 3.52. The finished 3/8" thick Flexogrid overlay is shown in Figure 3.53.

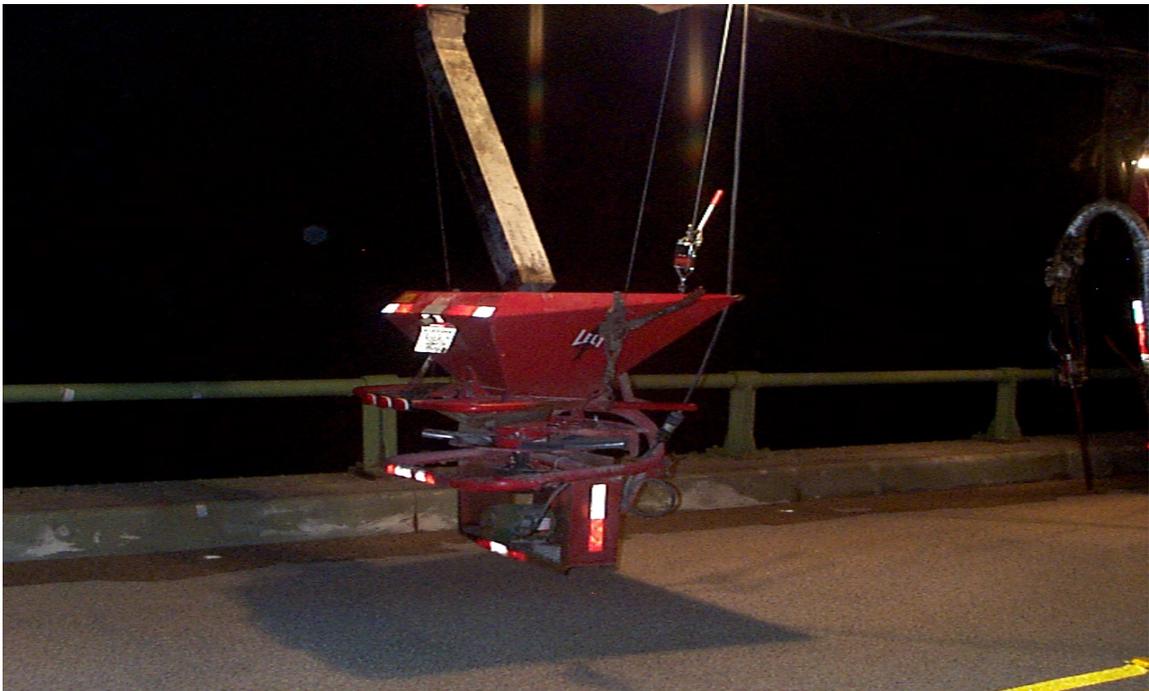
Fig. 3.48 Rotary Fine Aggregate Spreader

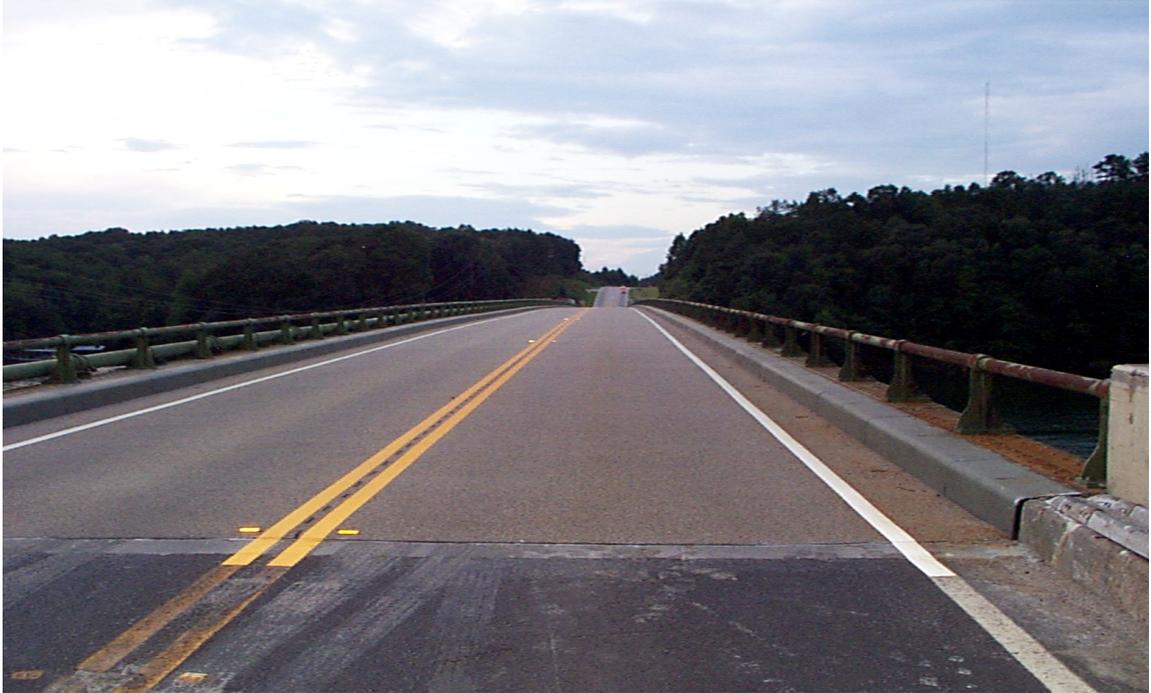
Fig. 3.53 Finished 3/8" Thick Flexogrid Overlay

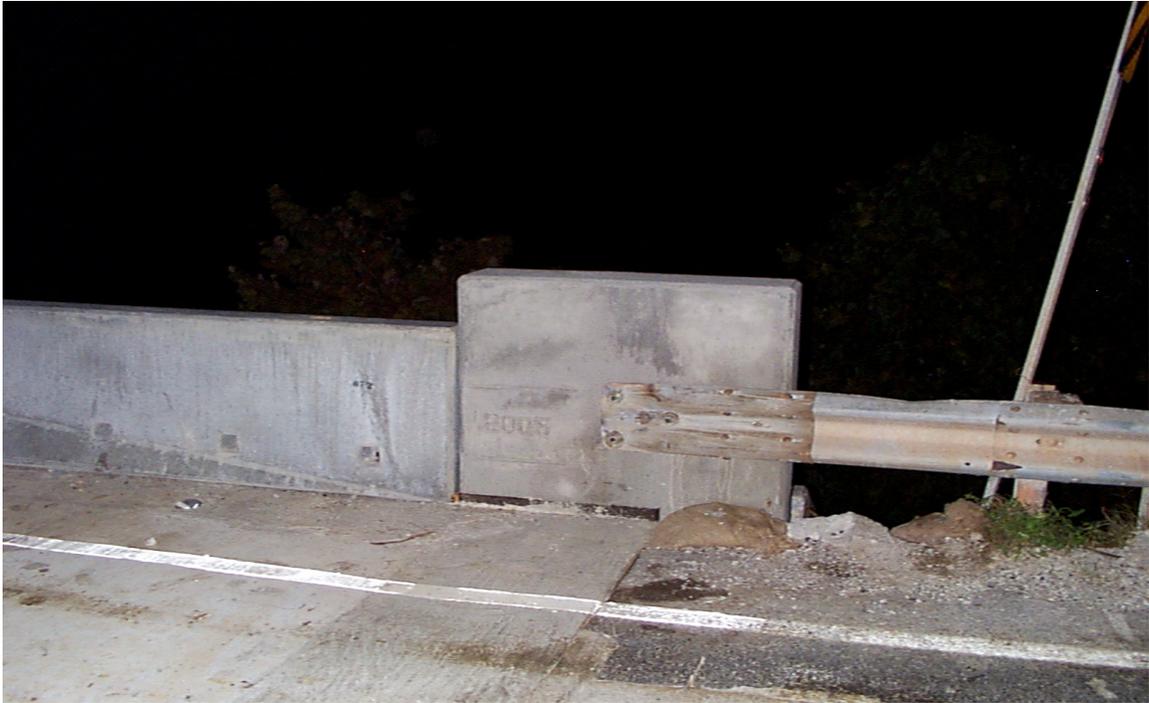
Fig. 4.26 Typical Bridge Endpost – Endpost CIP Before Deck Replacement (see Fig. 4.1)

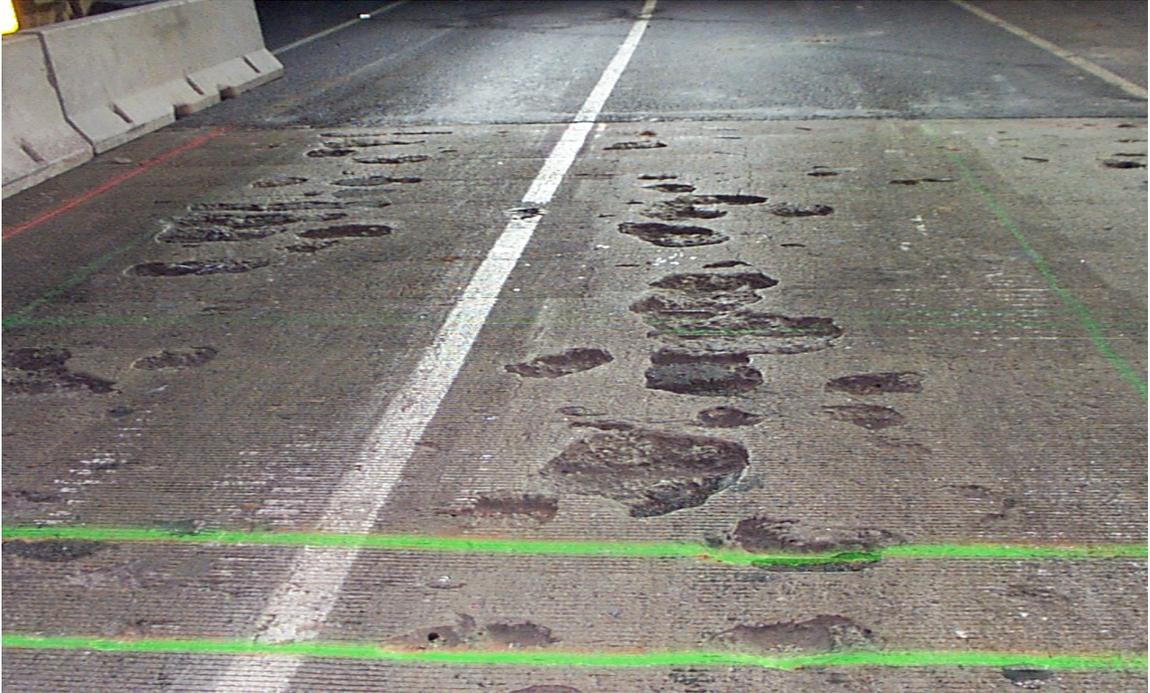
Fig. 5.2 Approach View of Typical Spalling of Original Travel Lanes

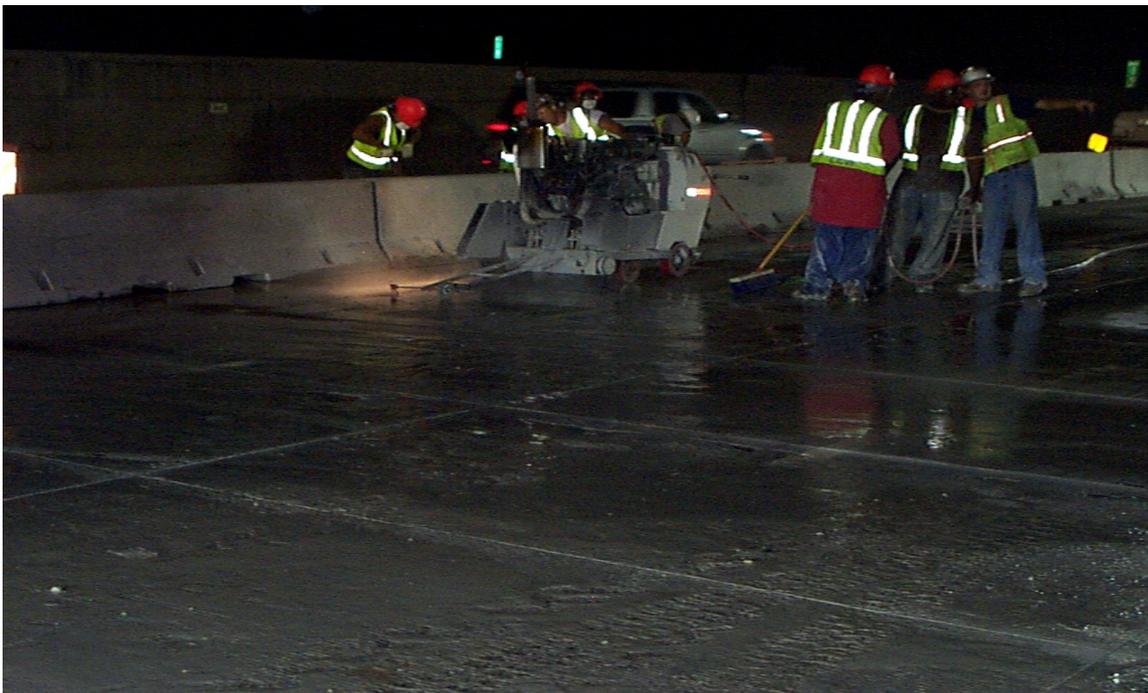
Fig. 5.7 Saw Cutting Grid Used for Deck Replacement

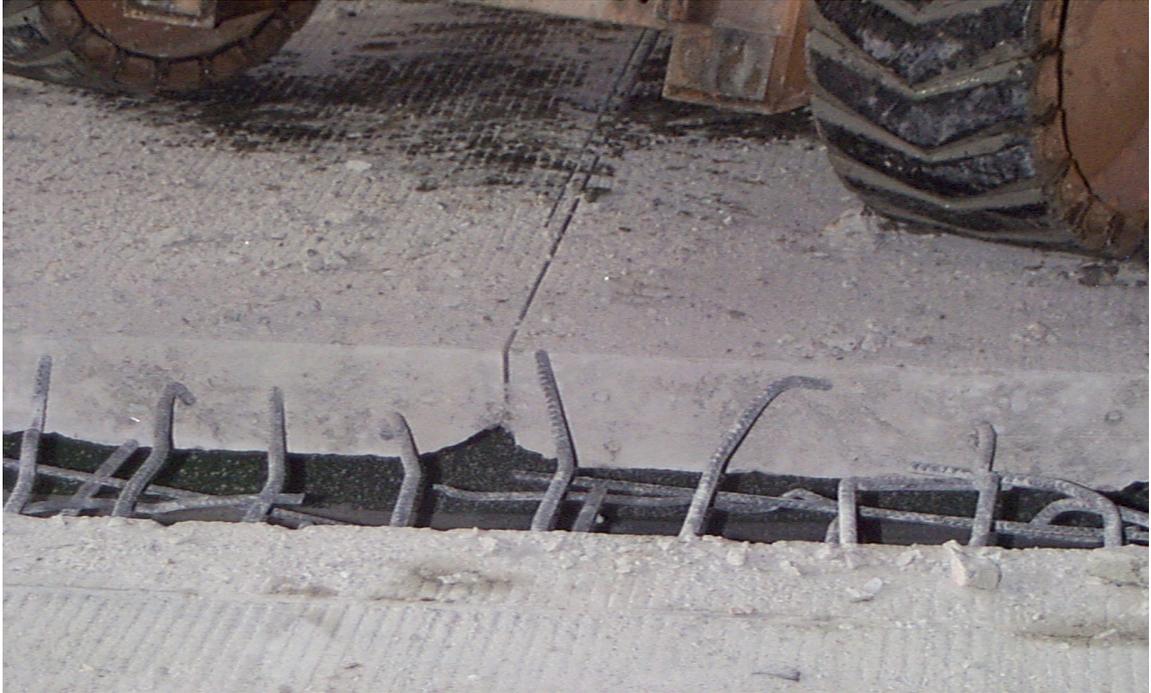
Fig. 5.8 Typical Depth of Transverse Saw Cuts

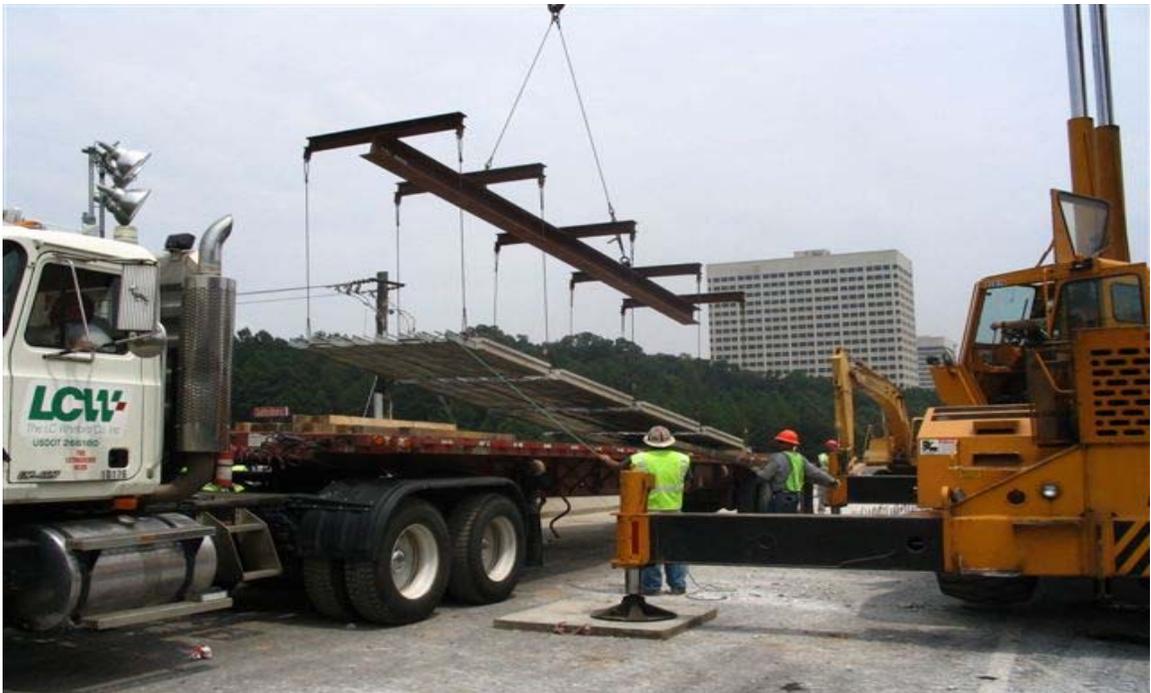
Fig. 5.25 Lift Spreader/Picking Beam Used During Deck Replacement Work

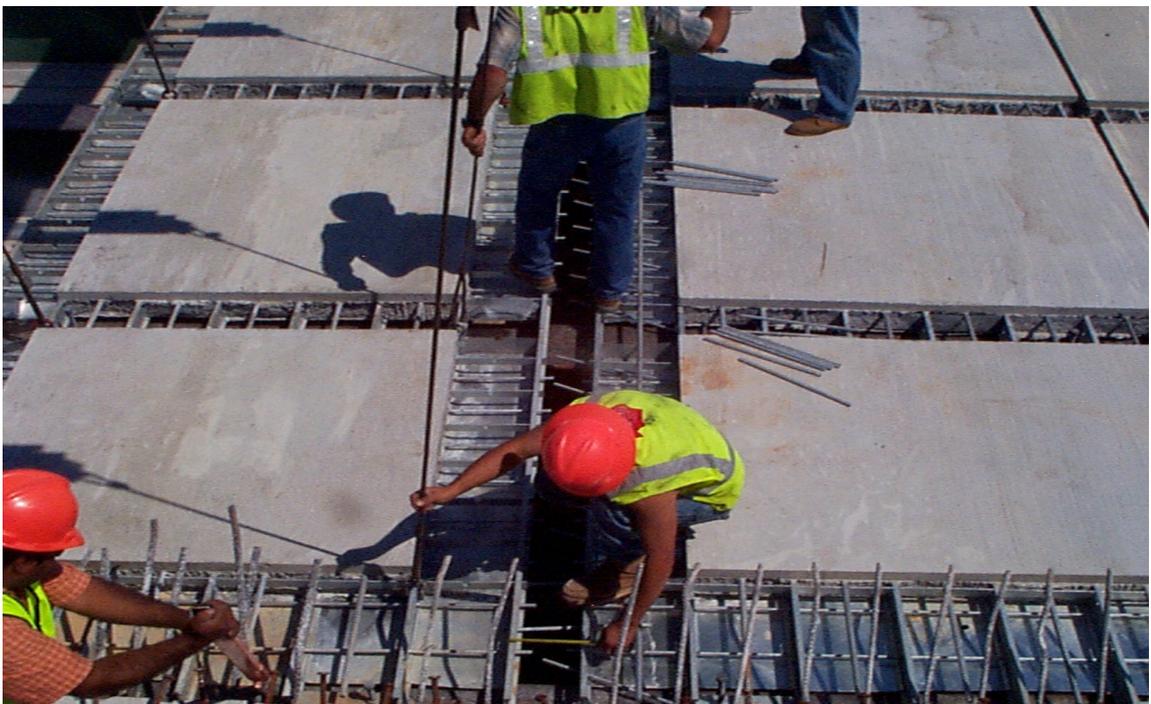
Fig. 6.17 Spacing of Exodermic Panels in Negative Moment Region

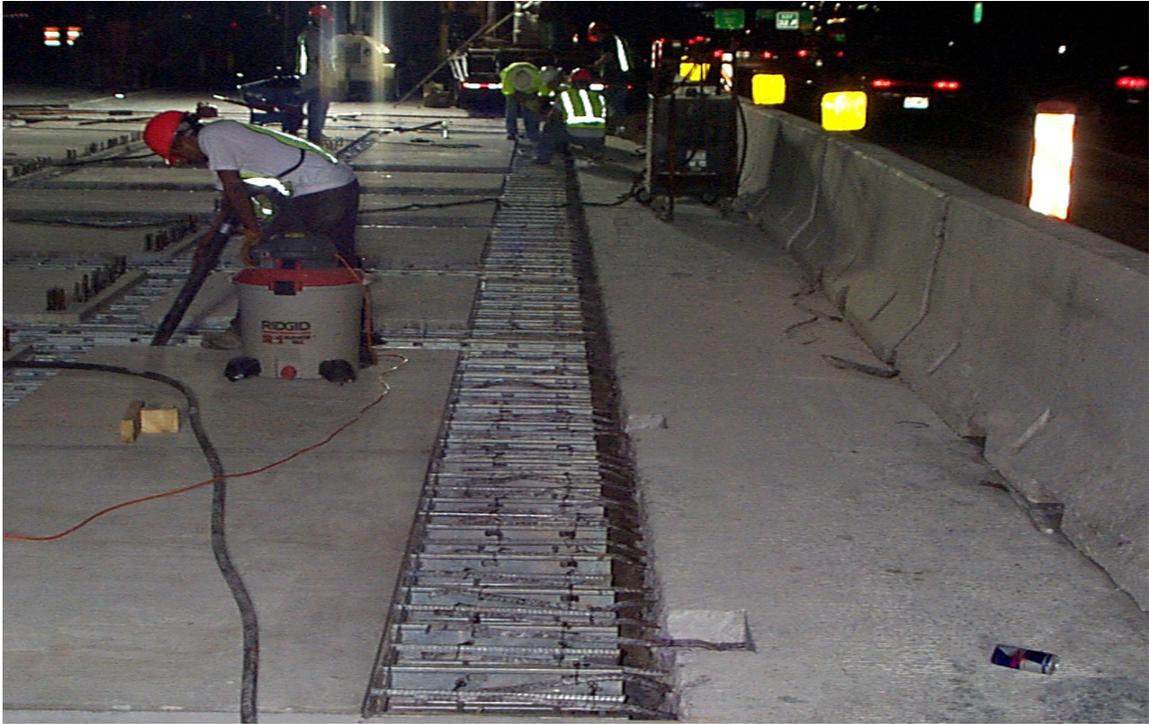
Fig. 6.26 Typical Longitudinal Joint

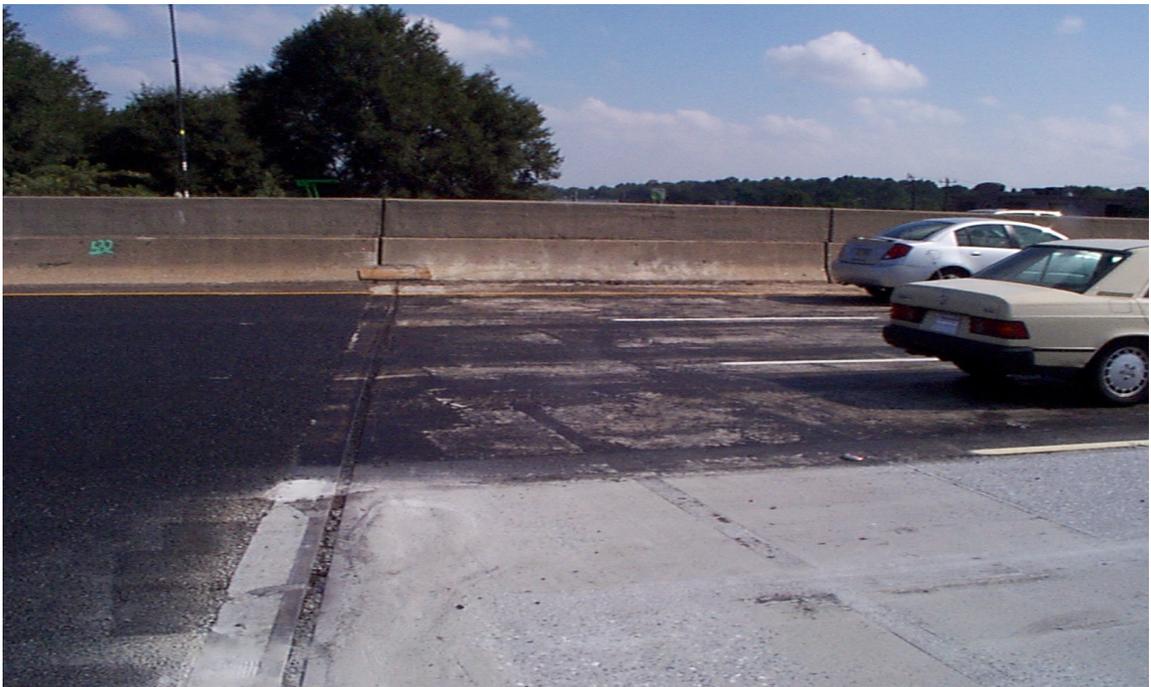
- 3. *Problem:*** The newly placed asphalt wearing surface on I-285 was smeared onto the new bridge deck surface as seen in Figure 7.13. This smeared asphalt increased the shot blasting and deck grinding time tremendously for the deck surface to meet the requirements of the copolymer overlay. The asphalt wearing surface was placed due to the lane shift implemented for deck replacement.

Fig. 7.13 Smearing of Newly Placed Asphalt Wearing Surface Onto New Deck Surface

Proposal for Improvement: Selection and design of any wearing surface placed onto the roadway that approaches a bridge with a possible overlay should consider the effects of this smearing and the resulting clean-up problem.
