**Field Evaluation of Near-Surface Mounted, Fiber-Reinforced Polymer Strips for  
Strengthening of a Continuous Reinforced Concrete Bridge**

A thesis submitted to the Graduate Faculty of  
Auburn University  
in partial fulfillment of the  
requirements for the Degree of  
Master of Science

Auburn, Alabama  
May 7, 2016

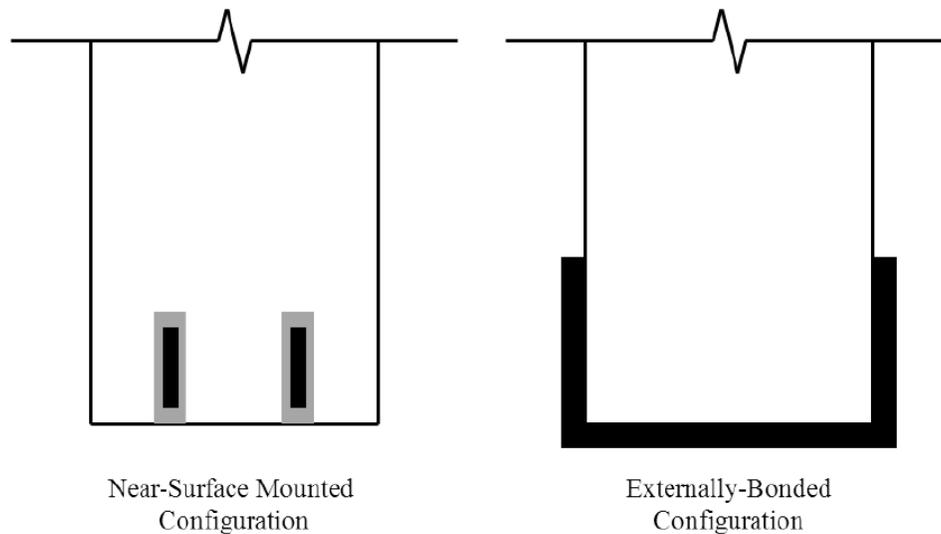
**Figure 1.2 Typical NSM and EB FRP Applications (Bertolotti 2012)**

NSM FRP provides greater protection from environmental conditions and improved bond quality when compared to EB FRP (Bertolotti 2012). External applications often apply to positive moment flexural strengthening of bridge girders due to unobstructed accessibility and ease of installation from beneath a bridge. EB FRP installations cover the member with FRP, resulting in a majority of the concrete no longer being exposed after a retrofit. However, for negative-moment flexural strengthening, a NSM FRP technique is often more appropriate. NSM FRP allows for embedment of FRP within the member while the concrete remains exposed. This is especially beneficial in a bridge deck retrofit for negative moment because it allows the deck surface to retain the traction of the concrete. Also, NSM FRP only involves work along the top

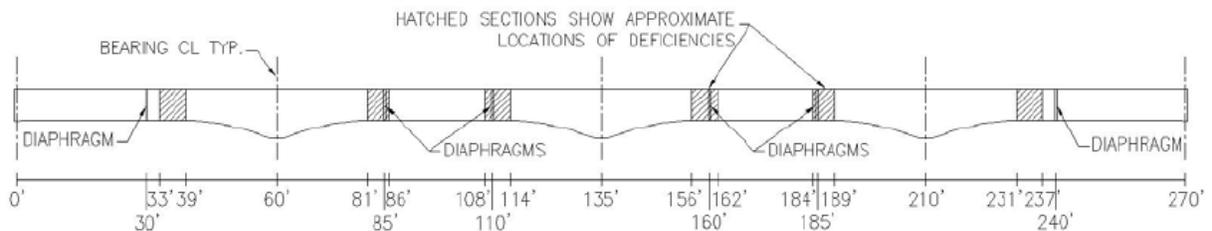
**Figure 1.3 Approximate Locations of Flexural Deficiencies in the Letohatchee Bridge**

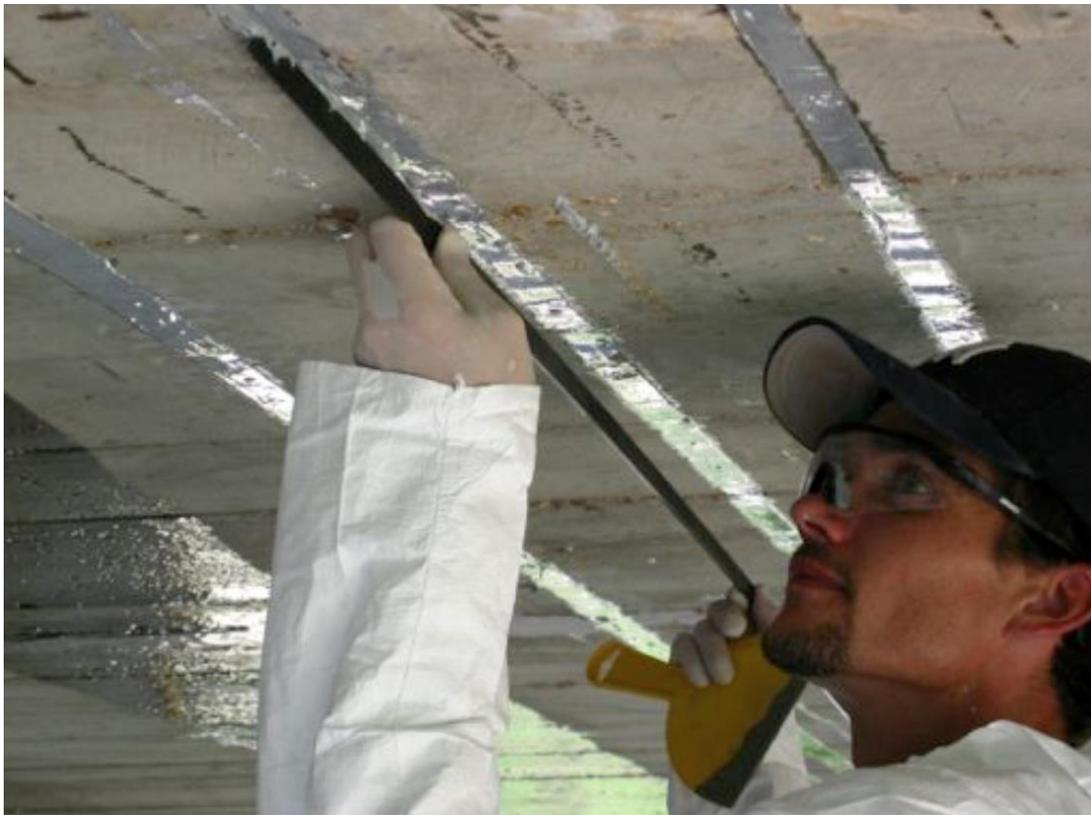
A newer method of FRP retrofit of structures is known as near-surface mounted FRP. NSM FRP refers to FRP strips or bars that are embedded below the surface of a structural member. Grooves are typically cut into a reinforced concrete member, and epoxy is placed into the groove, along with an FRP strip or bar. This method has not been documented as thoroughly as EB FRP, but it has steadily grown in use since the first NSM FRP retrofits in the 1990s (Parretti and Nanni 2004). Figure 2.5 shows a typical NSM FRP installation in a reinforced concrete bridge retrofit.

**Figure 2.5 Typical NSM FRP Installation (Hughes Brothers, Inc. 2011)**

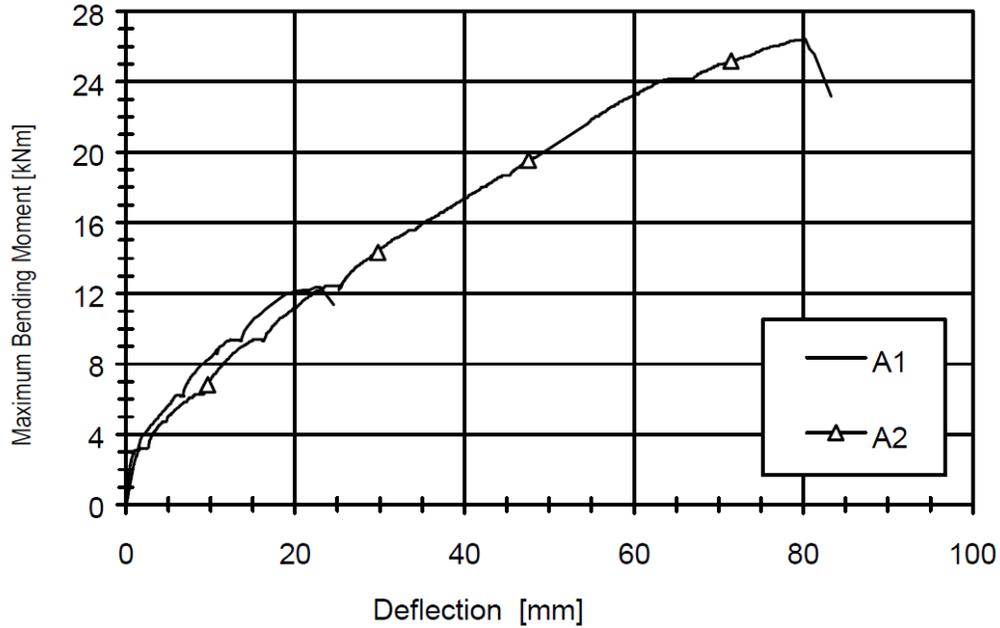
**Figure 2.6 Moment-Deflection Behavior of EB (A1) and NSM (A2) FRP Beams (Blaschko and Zilch 1999)**

Bond strength is very important because in EB FRP applications, bond strength typically limits the performance of the FRP retrofit. EB FRP is susceptible to bond failure before the FRP is able to reach tensile failure, which reduces the design strength of EB FRP applications. However, in NSM FRP applications, tensile strength of the FRP material often controls failure of the repair. Therefore, NSM FRP retrofits more efficiently utilize the FRP reinforcement than EB FRP retrofits (Jung et al. 2005).

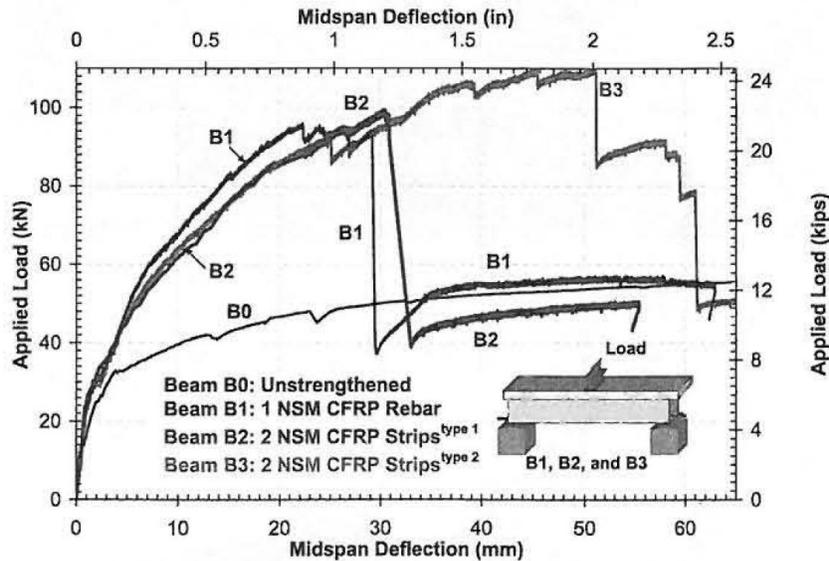
Load versus deflection results of the NSM FRP strengthened beams and the unstrengthened control beam are shown in Figure 2.7.

**Figure 2.7 Load Deflection Results of Unstrengthened and NSM FRP Strengthened Beams (El-Hacha and Rizkalla 2004)**

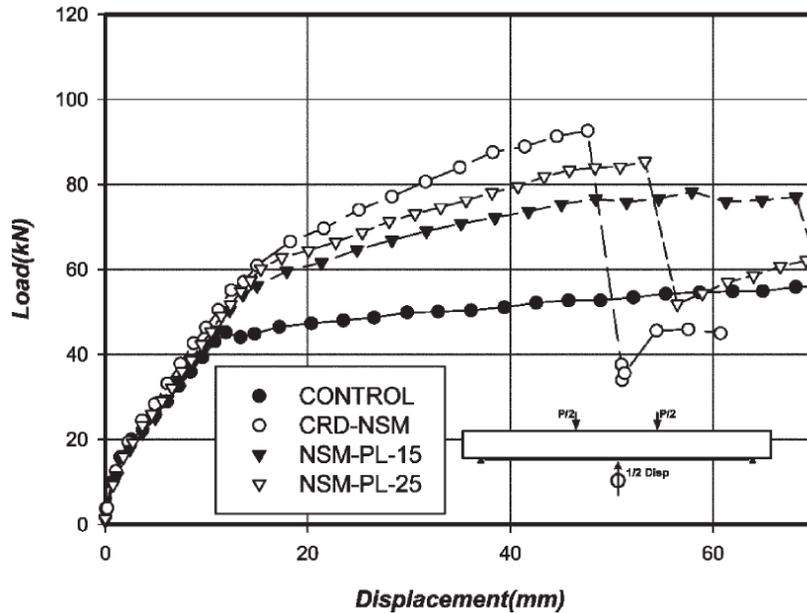
Beams that were strengthened with NSM FRP exhibited an increased ultimate load of 35–65%, when compared to the unstrengthened specimen. Figure 2.9 shows load-deflection results from the NSM FRP strengthened specimens.

**Figure 2.9 Load-Displacement Plot of NSM FRP Specimens (Jung et al. 2005)**

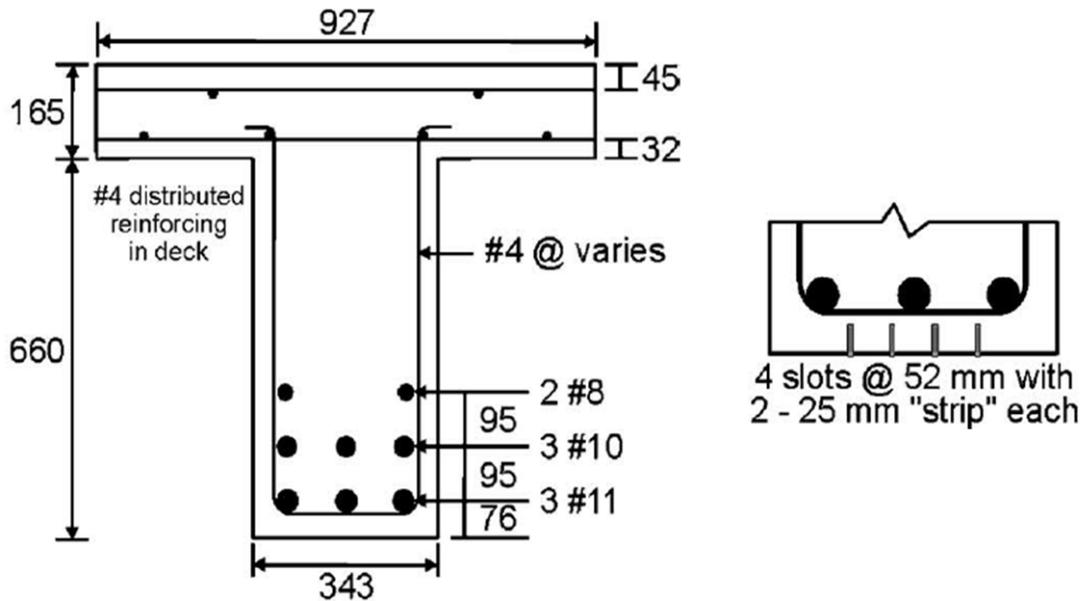
**Figure 2.10 Cherokee Creek Bridge Girder Cross Section and NSM FRP Layout (Aidoo, Harries, and Petrou 2006)**

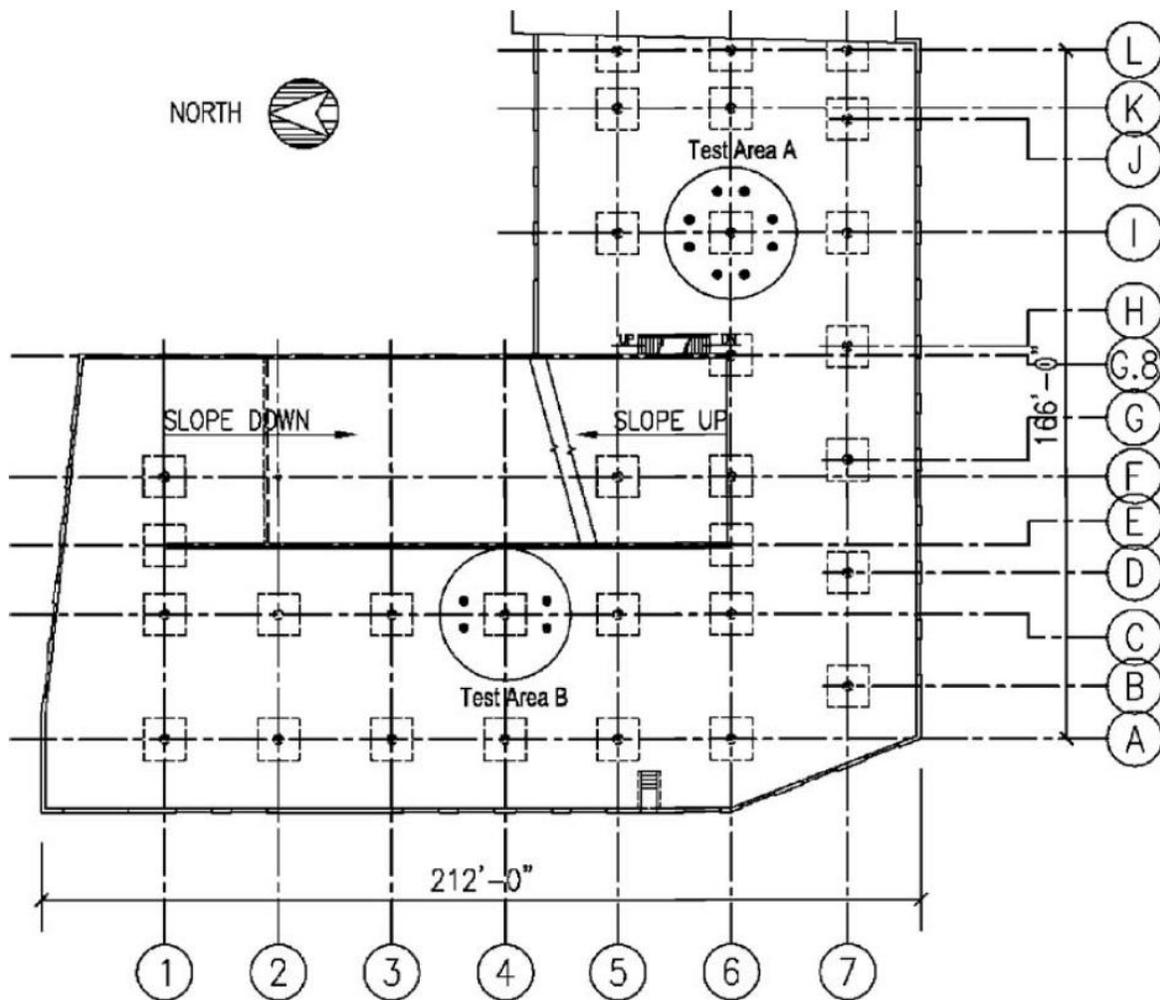
A two-way slab in a parking garage in Massachusetts was retrofitted with NSM FRP to provide negative-moment strengthening at columns. The garage was built in 1983, and was designed with 8 in. (0.2 m) thick two-way, reinforced concrete slabs with 10 ft x 10 ft x 4.25 in. (3.05 m x 3.05 m x 0.1 m) thick drop panels at interior columns. The parking garage layout is shown in Figure 2.11.

Figure 2.11 Parking Garage Layout and Test Locations (Tumialan, Vatovec, and Kelley 2007)

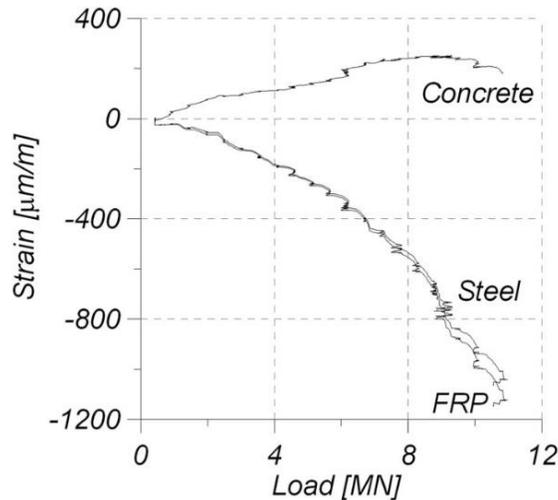
It was also observed that there was no failure in the FRP or in the epoxy bond between the concrete and FRP. The discrepancy in Figure 2.19 at low loads was attributed to development of shear deformation in the adhesive when the FRP strips begin to take some of the load. Figure 2.20 shows strains during the post-retrofit loading to failure.

**Figure 2.20 Strains During Post-Retrofit Failure Load Test of the Örnköldsvik Bridge (Bergström, Täljsten, and Carolin 2009)**

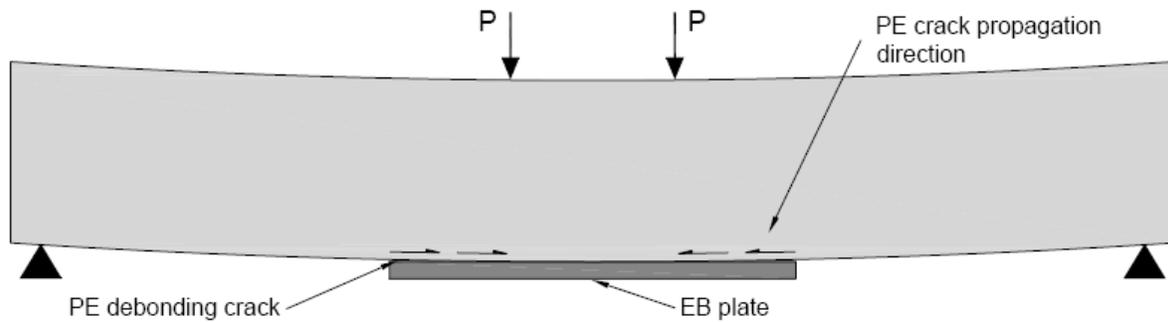
**Figure 2.24 Illustration of Plate-End Debonding Failure (Vasquez Rayo 2008)**

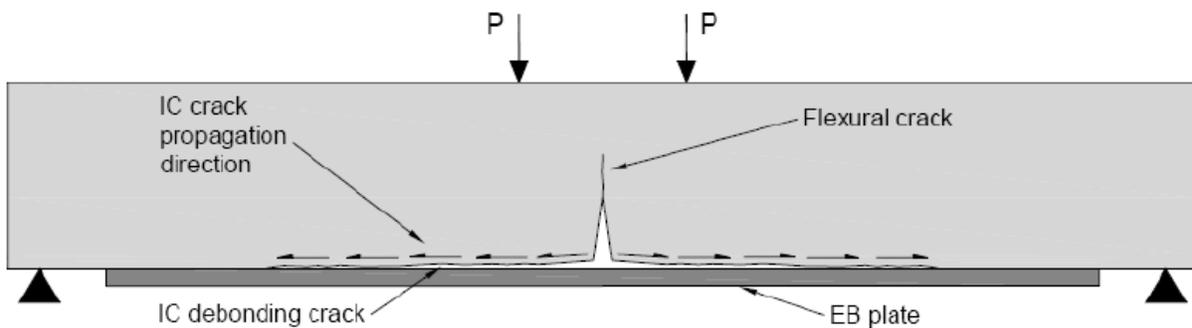
**Figure 2.25 Illustration of Intermediate Crack Debonding Failure (Vasquez Rayo 2008)**

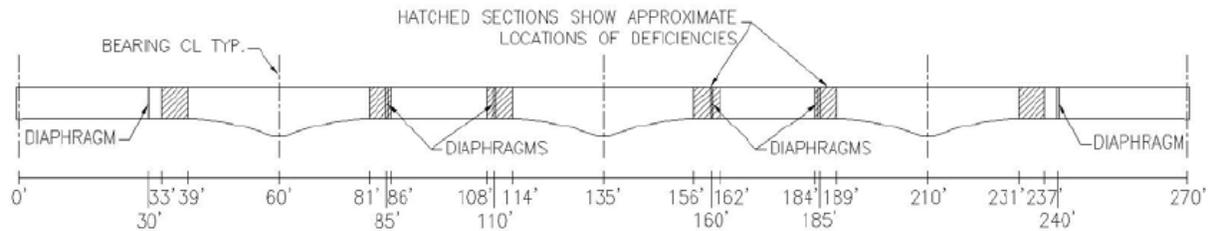
shows an elevation view of the Lethotatchee bridge with areas of deficiency indicated. Further detail on the Lethotatchee bridge deficiencies are documented in Chapter 3.

**Figure 2.26 Approximate Locations of Deficiencies in the Lethotatchee Bridge (Alexy 2009)**

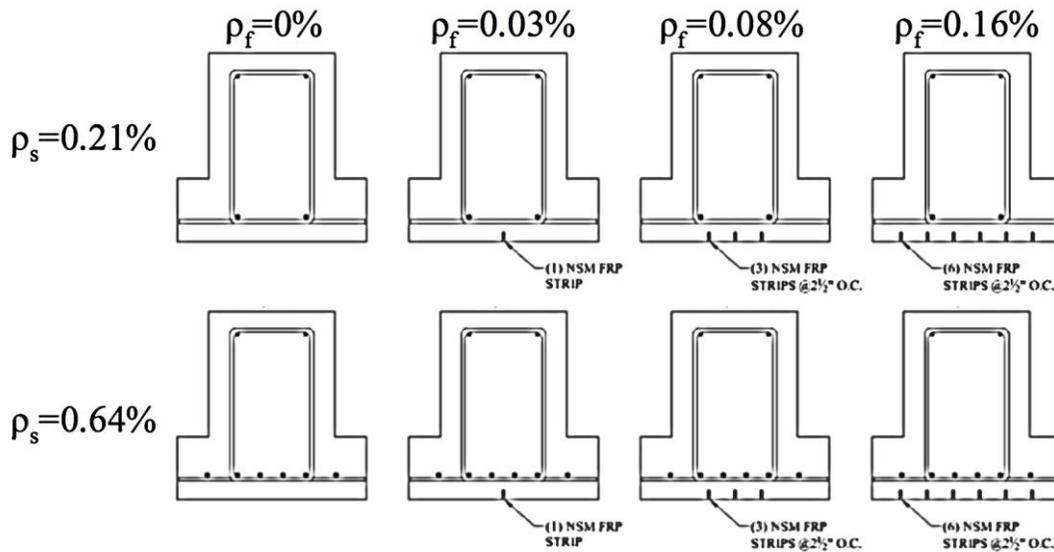
Bertolotti (2012) conducted a portion the laboratory testing program outlined by Alexy (2009). The testing program involved eight specimens fabricated with Grade 40 reinforcement and 3000 psi (20 MPa) concrete. The specimens were split into two groups based on steel reinforcement ratio ( $\rho_s$ ). In each group there was a control beam and the three remaining beams were strengthened with varying FRP reinforcement ratios ( $\rho_f$ ). Figure 2.27 shows the reinforcement ratios that were used in the laboratory testing program.

**Figure 2.27 Laboratory Testing Program Specimens (Adapted From Bertolotti 2012)**

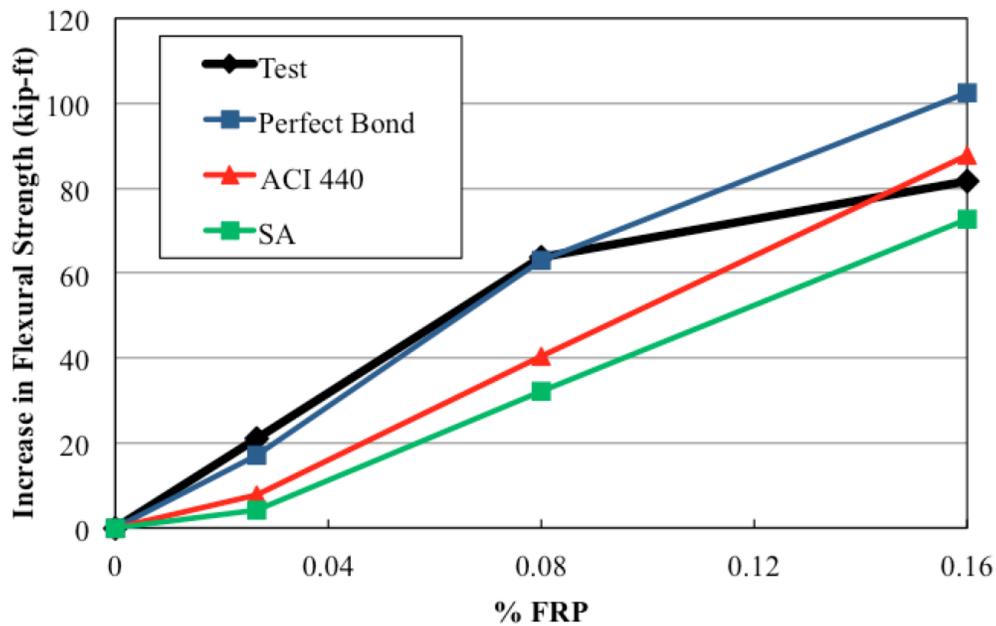
Bertolotti (2012) found that the increase in flexural strength and bond strength both outperformed the design predictions according to ACI 440 and Standards Australia (SA). The strengthened beams performed according to standard reinforced concrete flexural analysis expectations if a perfect bond condition was achieved. In consideration of the perfect bond condition, it is assumed that there is no bond failure. The increase in flexural strength and strain at failure for the beams with a steel reinforcement ratio of 0.21% is shown in Figure 2.28 and Figure 2.29, respectively.

**Figure 2.28 Increase in Flexural Strength at FRP Reinforcement Ratios for  $\rho_s=0.21\%$   
(Bertolotti 2012)**

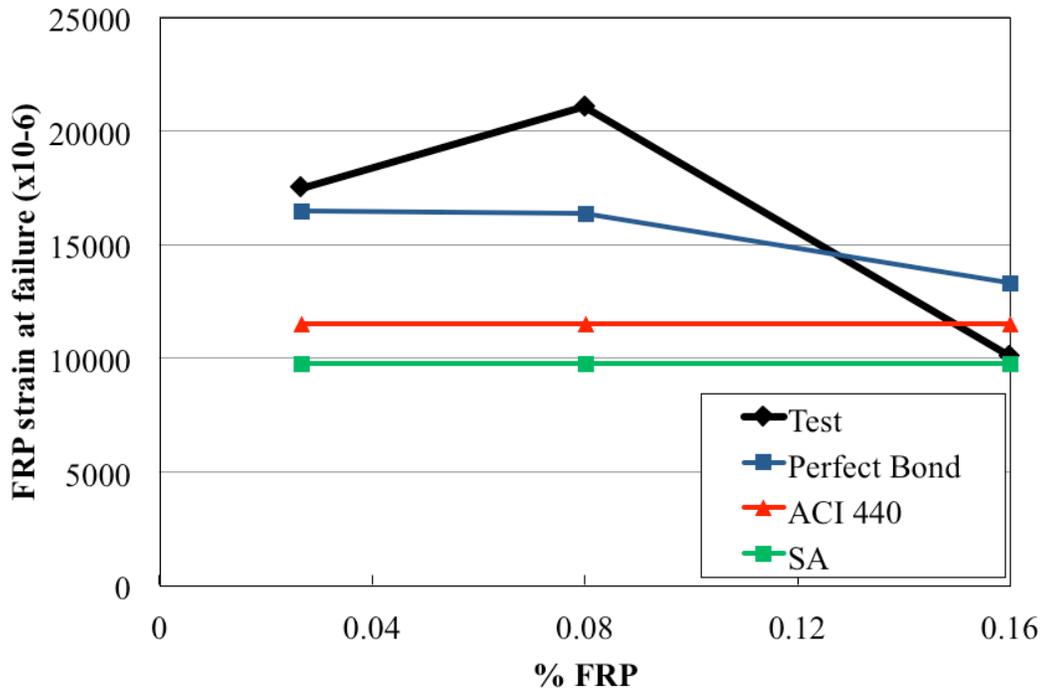
**Figure 2.29 FRP Strain at Failure at FRP Reinforcement Ratios for  $\rho_s=0.21\%$  (Bertolotti 2012)**

The results indicated that there was no bond degradation during the laboratory testing program, as all FRP reinforcement performed close to expectations of the perfect bond condition. Therefore, there was no evidence of IC-debonding failure mechanisms. Failure occurred due to crushing of the concrete in the test specimens with 0.03% and 0.08% FRP reinforcement ratios. However, there was a discrepancy in the data at the FRP reinforcement ratio of 0.16%. This was due to a shear failure in the beam before a flexural failure could be achieved. Figure 2.30 shows this beam and the shear failure that occurred during laboratory testing.

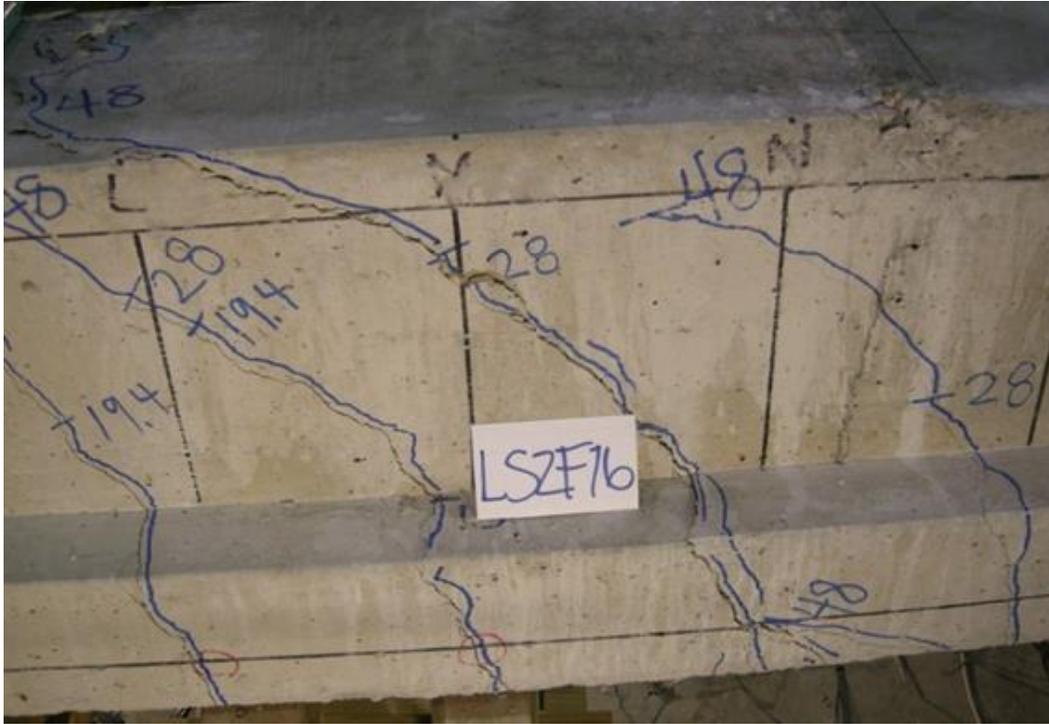
**Figure 2.30 Shear Failure of Beam with 0.21% Steel and 0.16% FRP Reinforcement Ratios (Bertolotti 2012)**

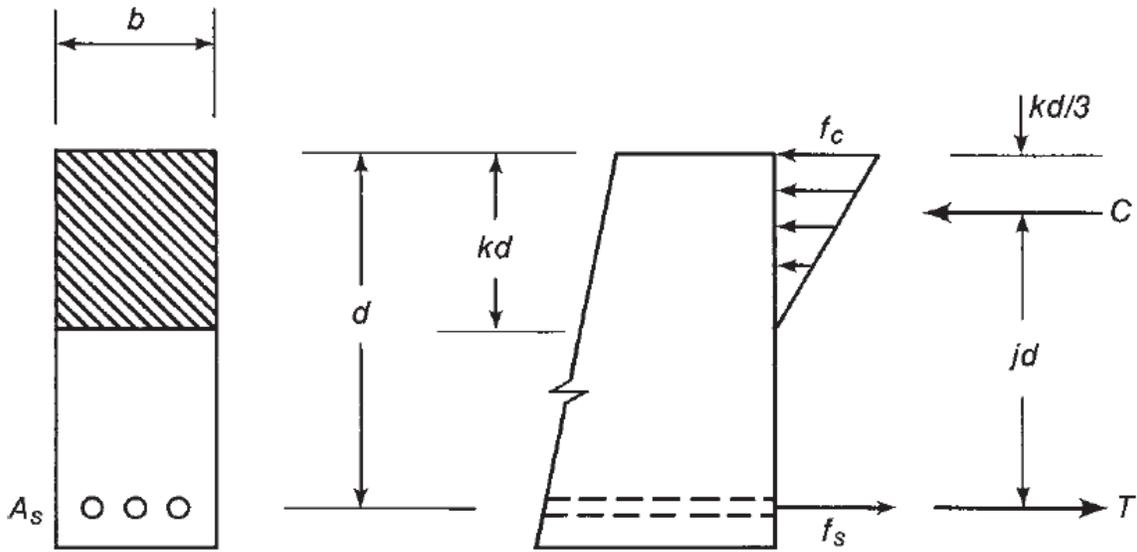
While there are no concrete stresses under service loads at cracks on the tension face, concrete develops compressive stresses on the opposite side of the neutral axis. Concrete compressive stresses under service loads exhibit linear behavior, from zero at the neutral axis to the maximum concrete compressive stress at the extreme compressive fiber. This phenomenon of reinforced concrete is known as linear-elastic behavior and is shown in Figure 2.31.

**Figure 2.31 Post-Cracking Linear-Elastic Stress Profile (Wight and MacGregor 2012)**

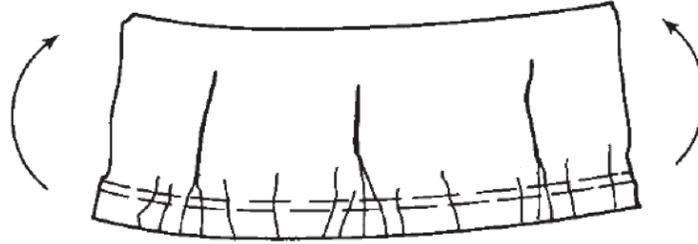
Therefore, tensile stresses in reinforced concrete cause cracking in the concrete. Typical flexural cracking of a reinforced concrete member is shown in Figure 2.32.

**Figure 2.32 Cracking Due to Bending Stresses (Wight and MacGregor 2012)**

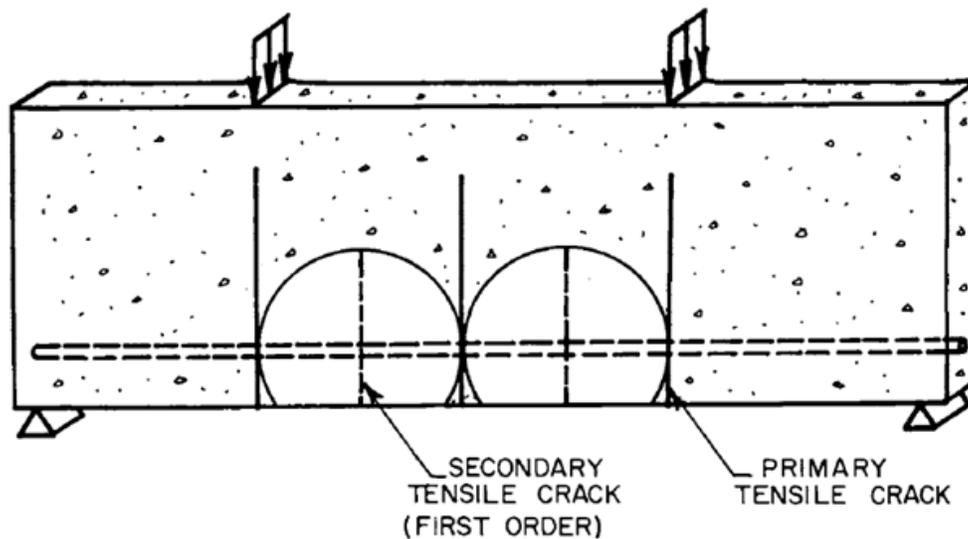
Broms (1965) tested reinforced concrete members in tension and flexure to study cracking patterns. He first states that cracking occurs when tensile stresses in concrete exceed the tensile capacity of the concrete. Broms also asserts that stress distribution of a cracked flexural member can be approximated according to linear-elastic theory. Cracking can be modeled by circular, high tensile stress areas, surrounded by areas of low compressive or tensile stresses, as show in Figure 2.33.

**Figure 2.33 Tensile Circles Demonstrating Mechanics of Tension Cracking in Flexural Members (Broms 1965)**

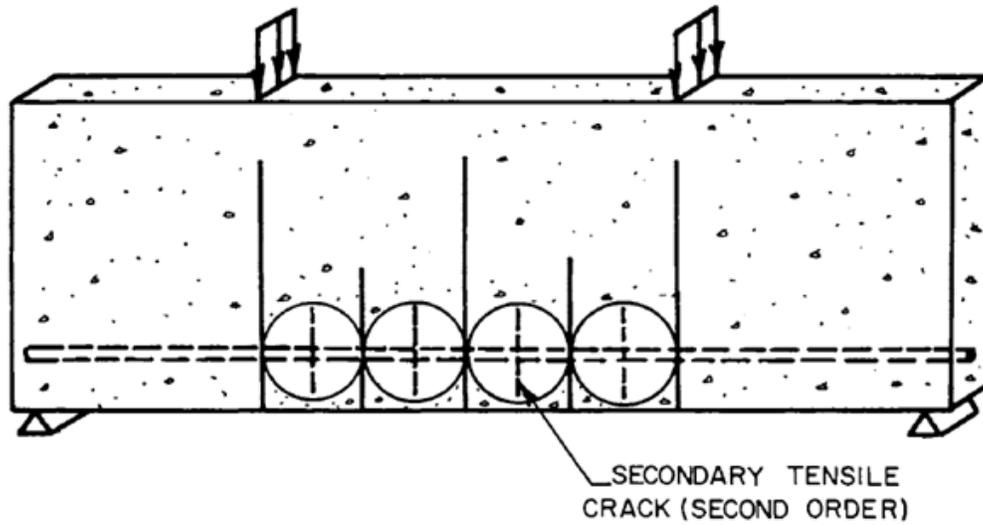
Further cracking will occur where the largest tensile stresses are located, or at midpoints between existing cracks. This phenomenon is further illustrated in Figure 2.34.

**Figure 2.34 Tensile Circles Demonstrating Mechanics of Tension Cracking in Flexural Members (Broms 1965)**

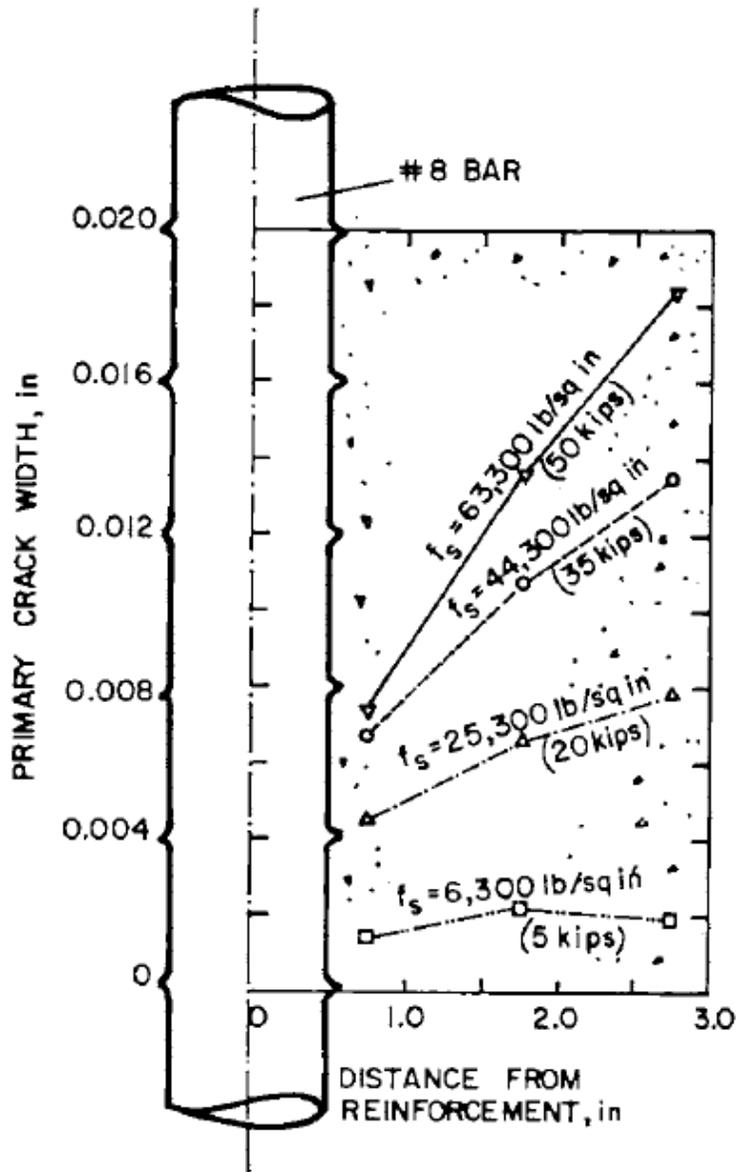
Broms also observed that crack width was larger at the level of the extreme tension fiber than at the level of the tension reinforcement. Crack widths of specimens observed in this test are shown in Figure 2.35.

**Figure 2.35 Primary Crack Width as Cracks Approach the Exterior Face (Broms 1965)**

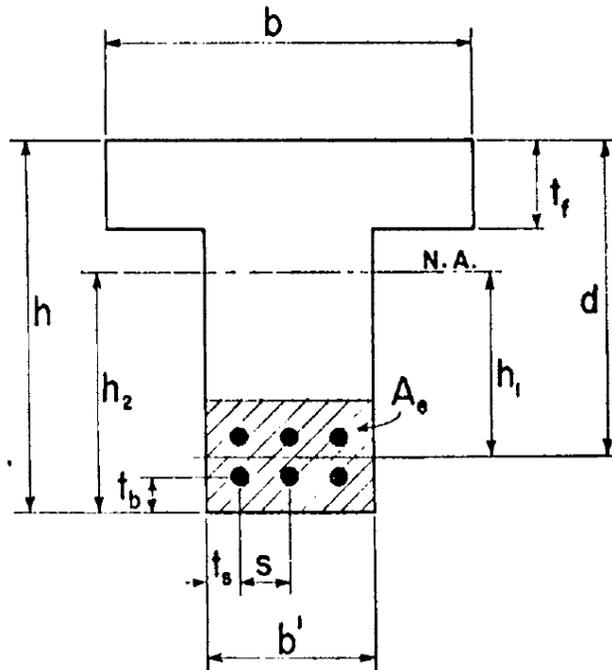
where  $w$  is the maximum tensile crack width at the centroid of the tensile reinforcement. The variables used in Broms's calculation of maximum crack widths are shown in Figure 2.36.

**Figure 2.36 Broms's Strain Equation Dimensional Notation (Gergely and Lutz 1968)**

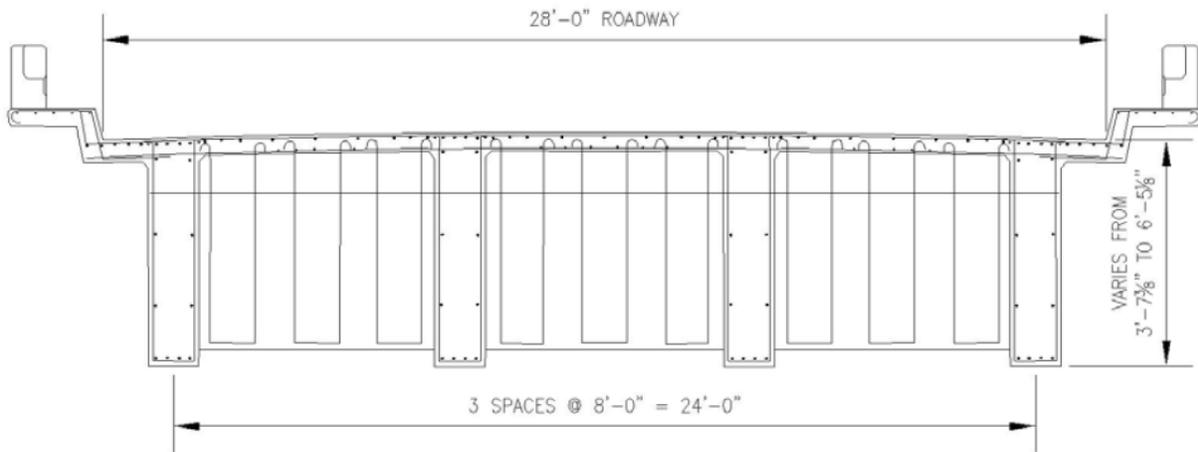
**Figure 3.4 Cross Section at an Interior Support (Alexy 2009)**

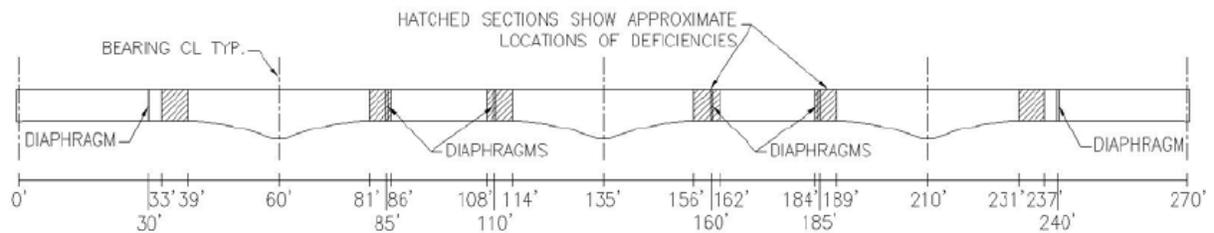
**Figure 3.7 Approximate Locations of Flexural Deficiencies in the Letohatchee Bridge (Alexy 2009)**

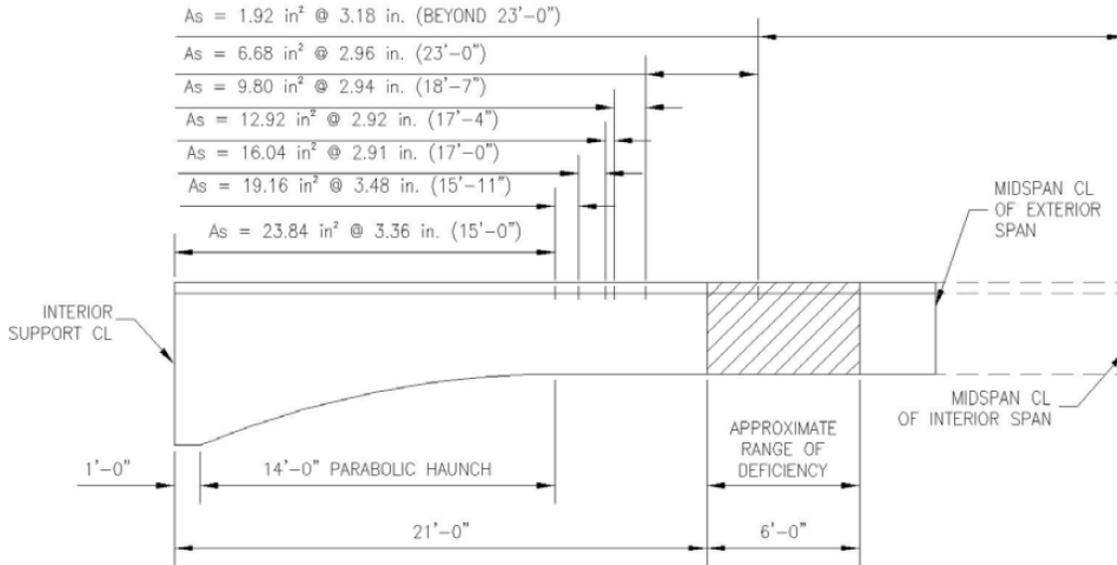
**Figure 3.8 Bar Termination Points and Deficient Region Location from Interior Supports (Alexy 2009)**

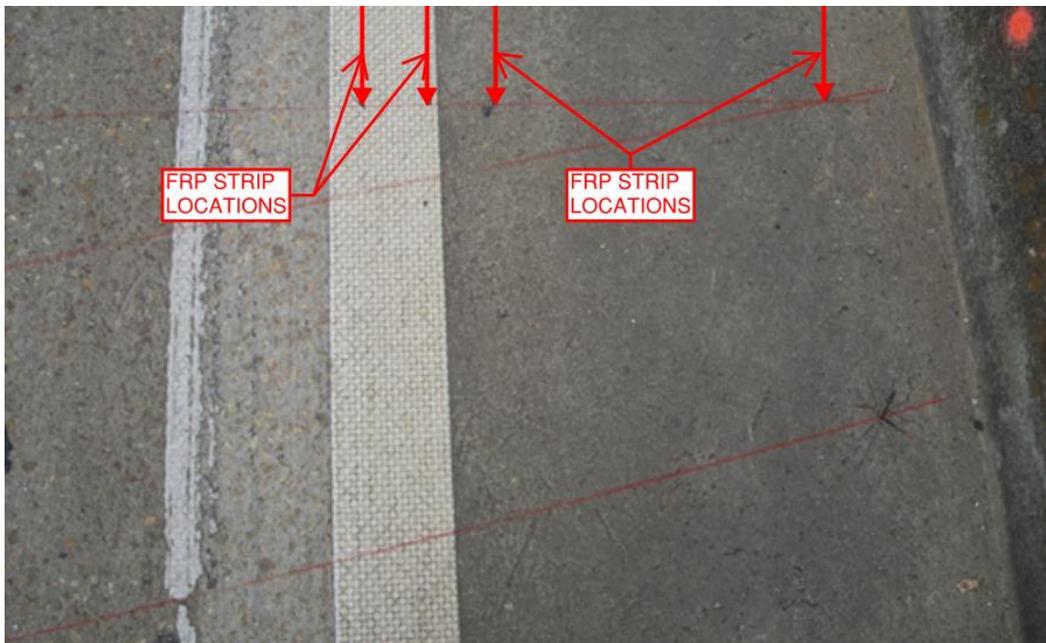
**Figure 4.7 FRP Strip Locations and Endpoints**

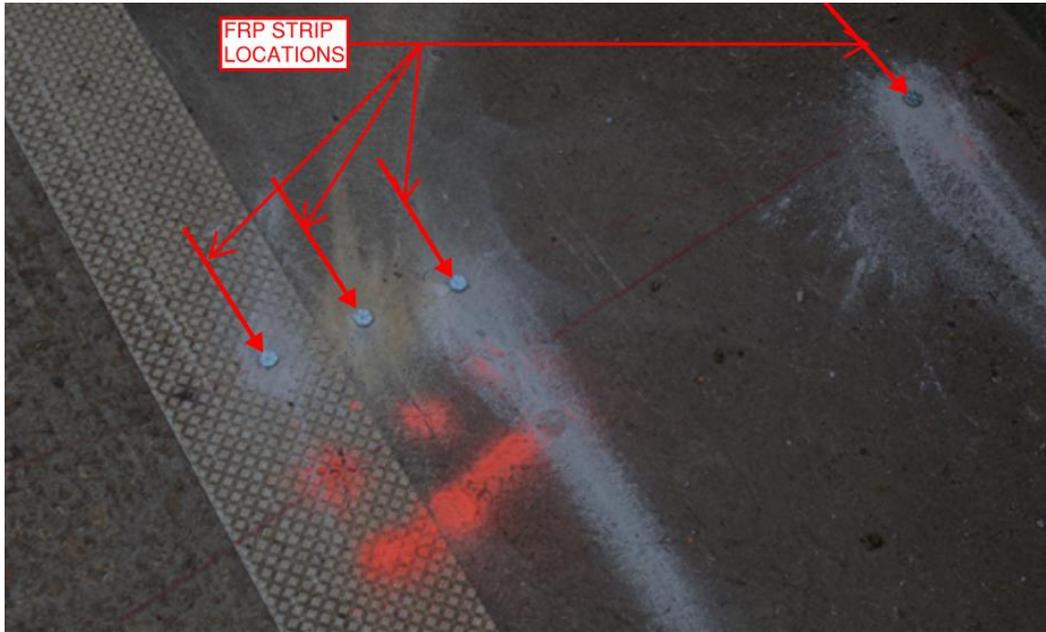
**Figure 4.8 Mag Nails Marking FRP Strip Locations**

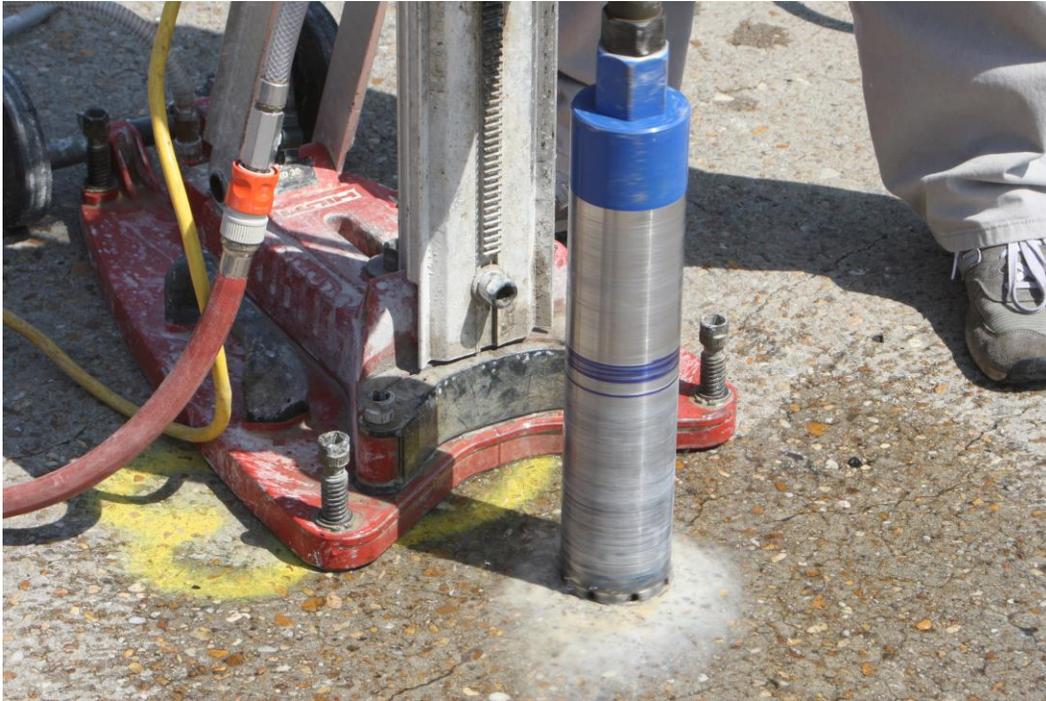
bridge conducted by ALDOT and the AU HRC on Thursday, May 9, 2013, as shown in Figure 4.9.

**Figure 4.9 Coring of the Letohatchee Bridge**

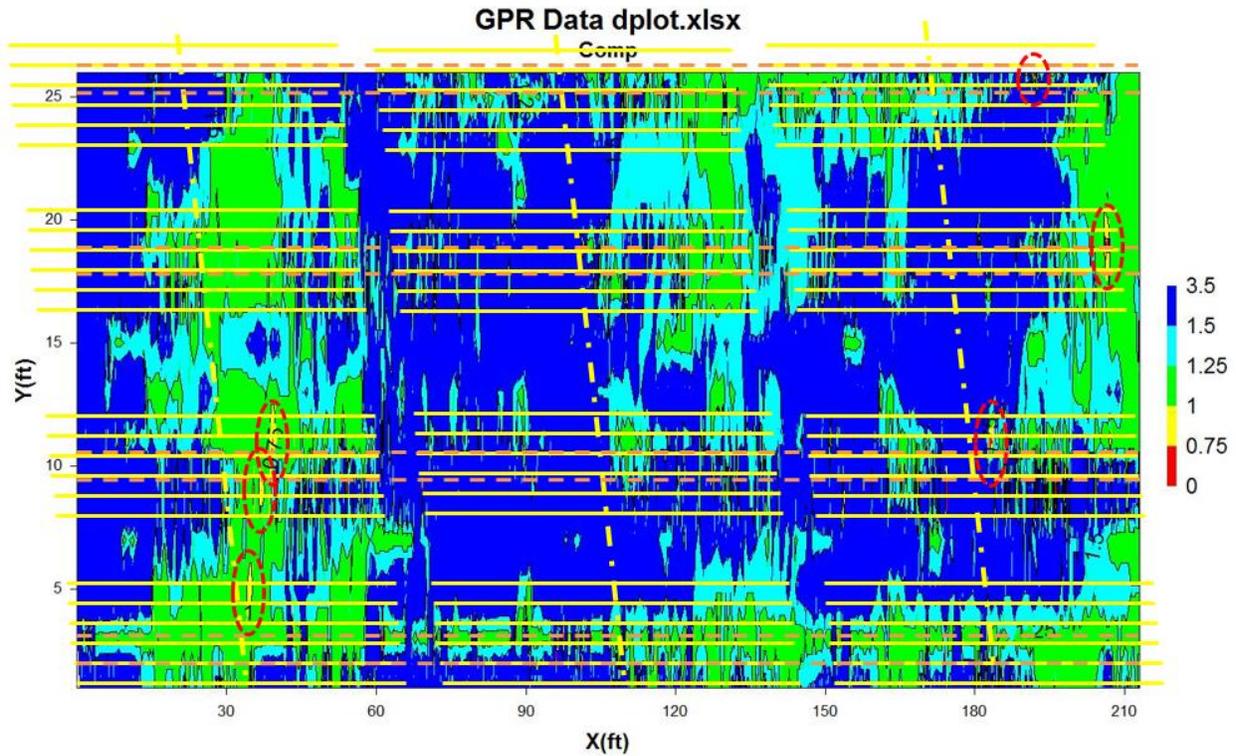
**Figure 4.10 Ground Penetrating Radar of the Letohatchee Bridge**

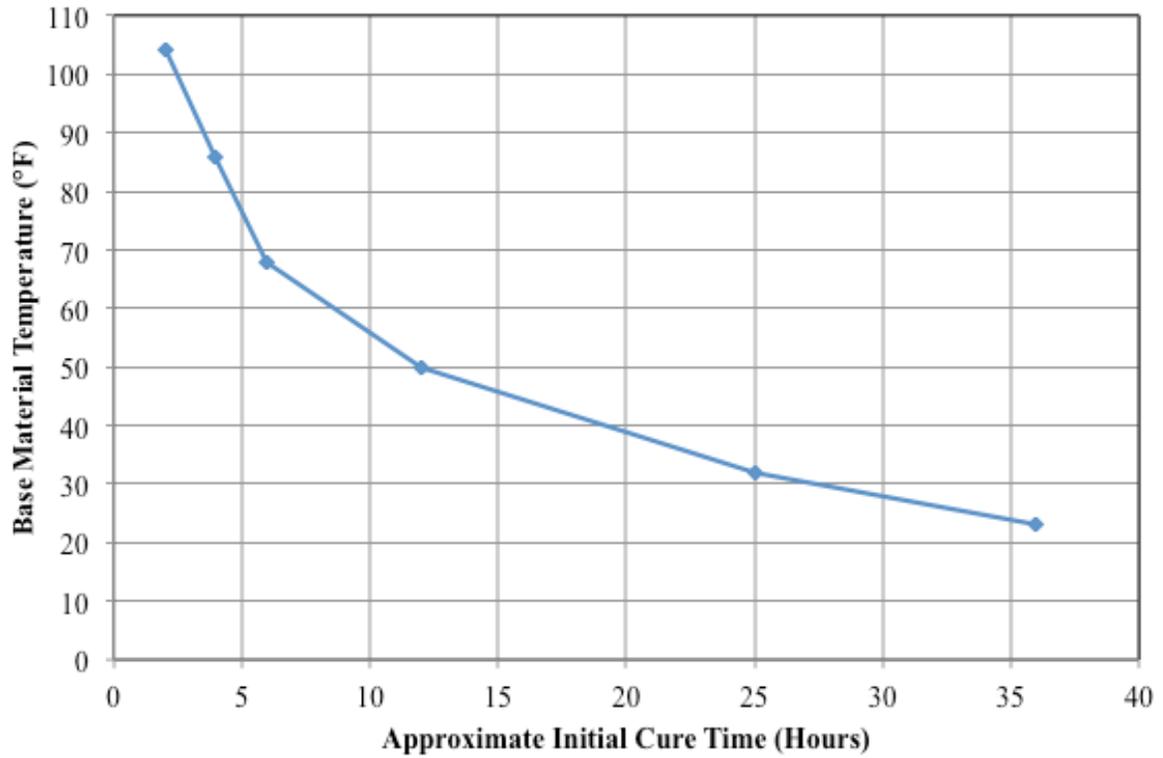
**Figure 4.36 Hilti HIT-RE 500 Initial Cure Time (Adapted from Hilti Inc. 2014)**

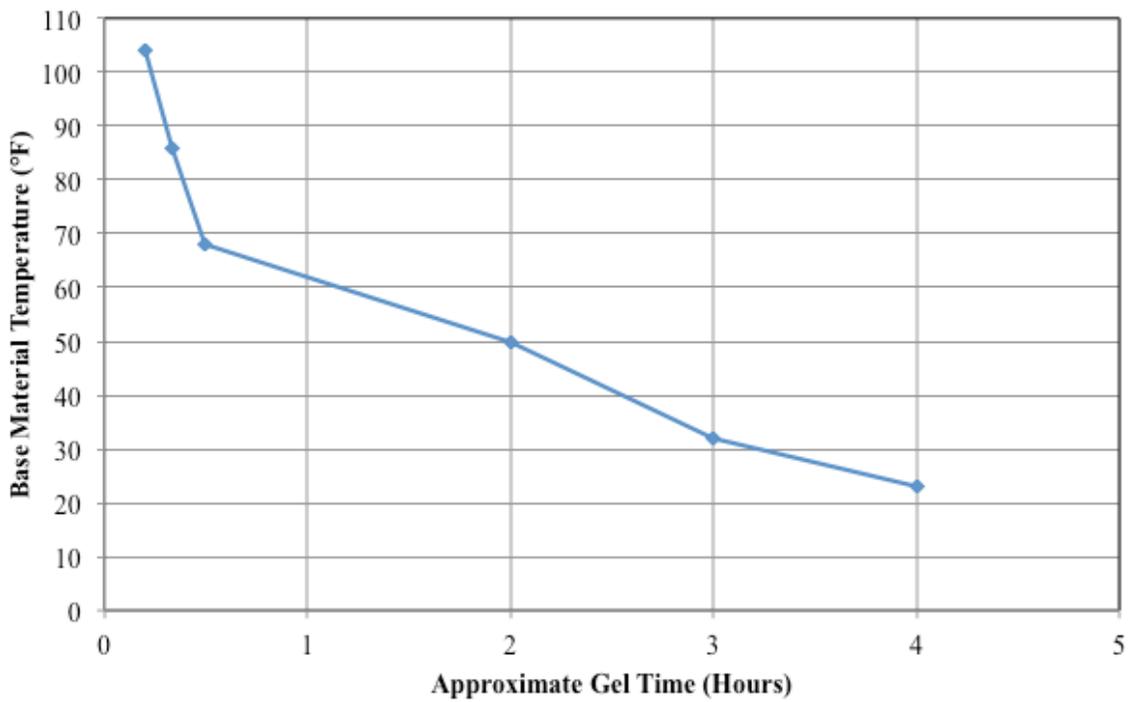
**Figure 4.37 Hilti HIT-RE 500 Gel Time (Adapted from Hilti Inc. 2014)**

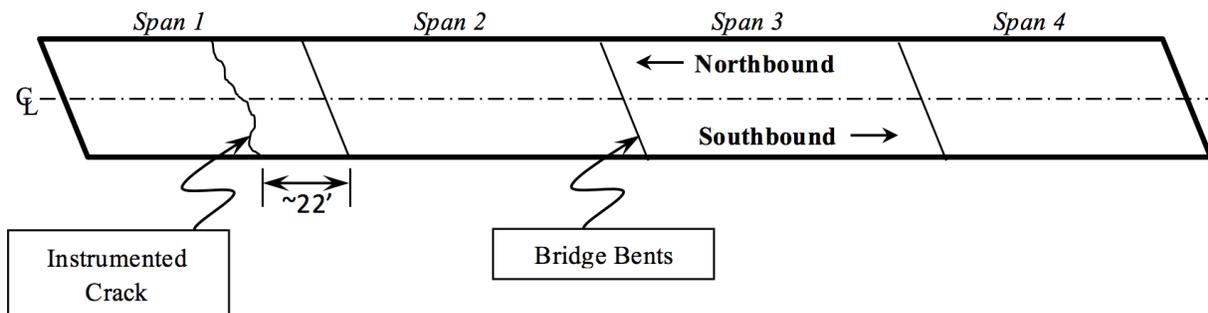
**Figure 5.2 Location of Instrumented Crack**

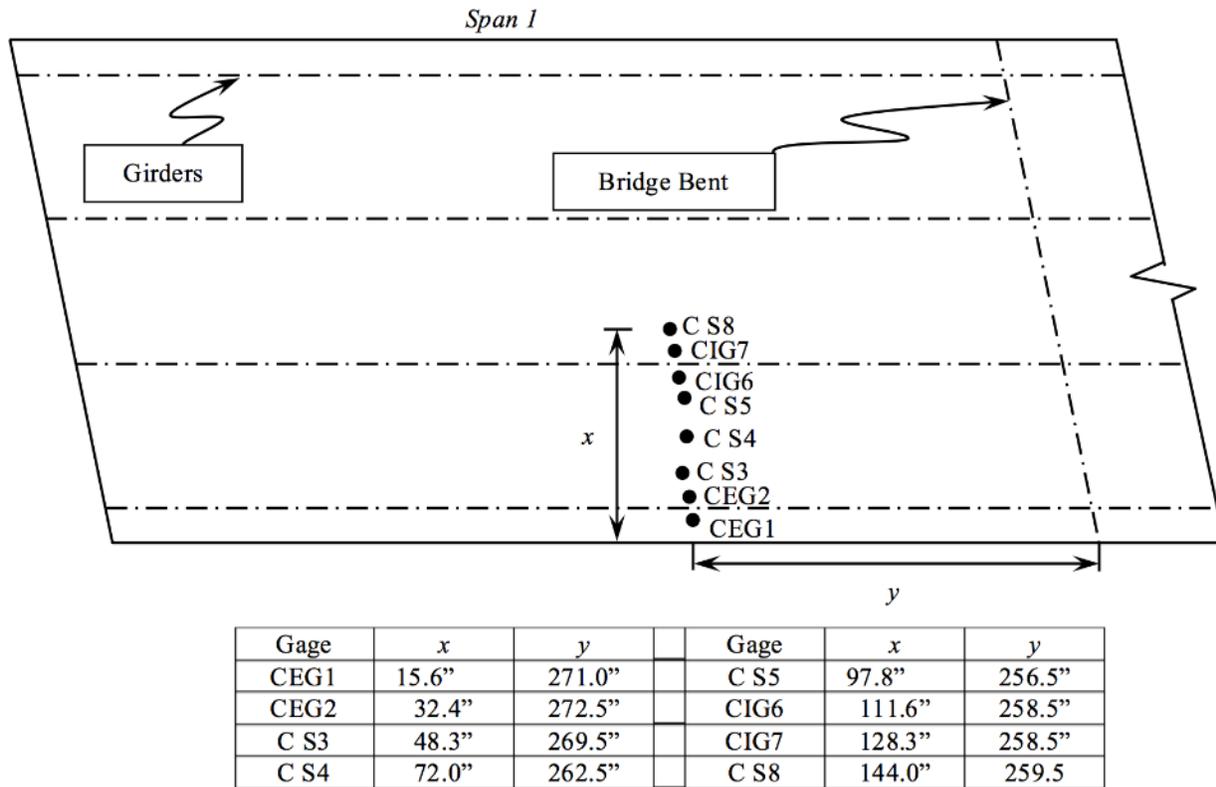
**Figure 5.4 Crack Opening Transducer Layout**

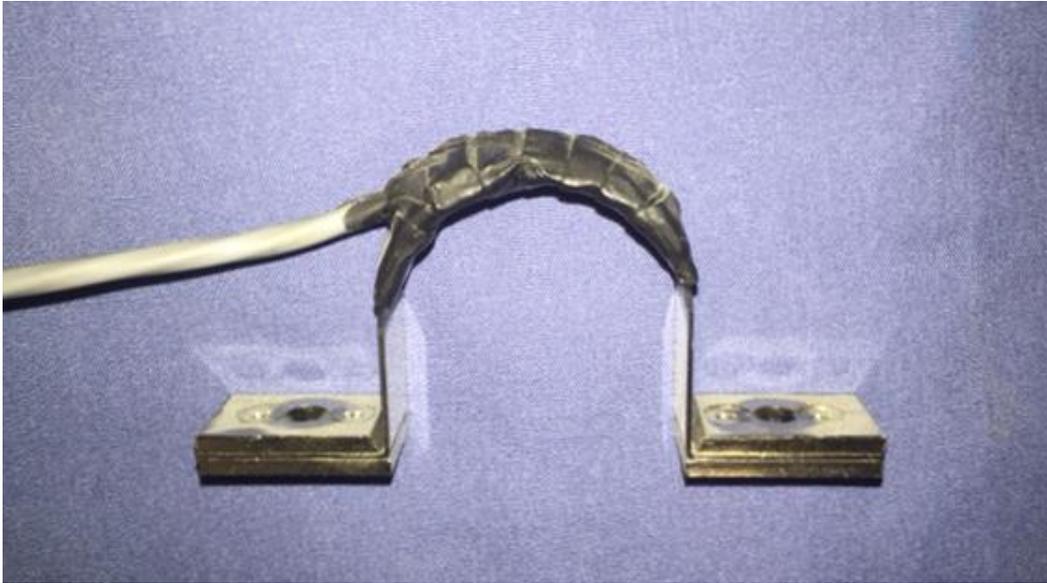
**Figure 5.19 Crack Opening Displacement Transducer**
