**Field Evaluation of Near-Surface Mounted, Fiber-Reinforced Polymer Strips for  
Strengthening of a Continuous Reinforced Concrete Bridge**

A thesis submitted to the Graduate Faculty of  
Auburn University  
in partial fulfillment of the  
requirements for the Degree of  
Master of Science

Auburn, Alabama  
May 7, 2016

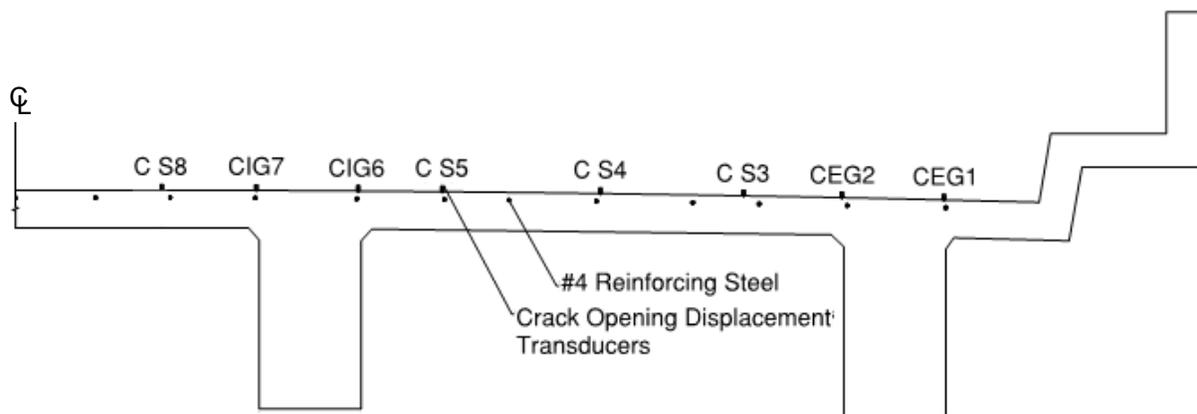
**Figure 5.20 Cross Section of Instrumented Lane with Transducers and Reinforcing Steel**

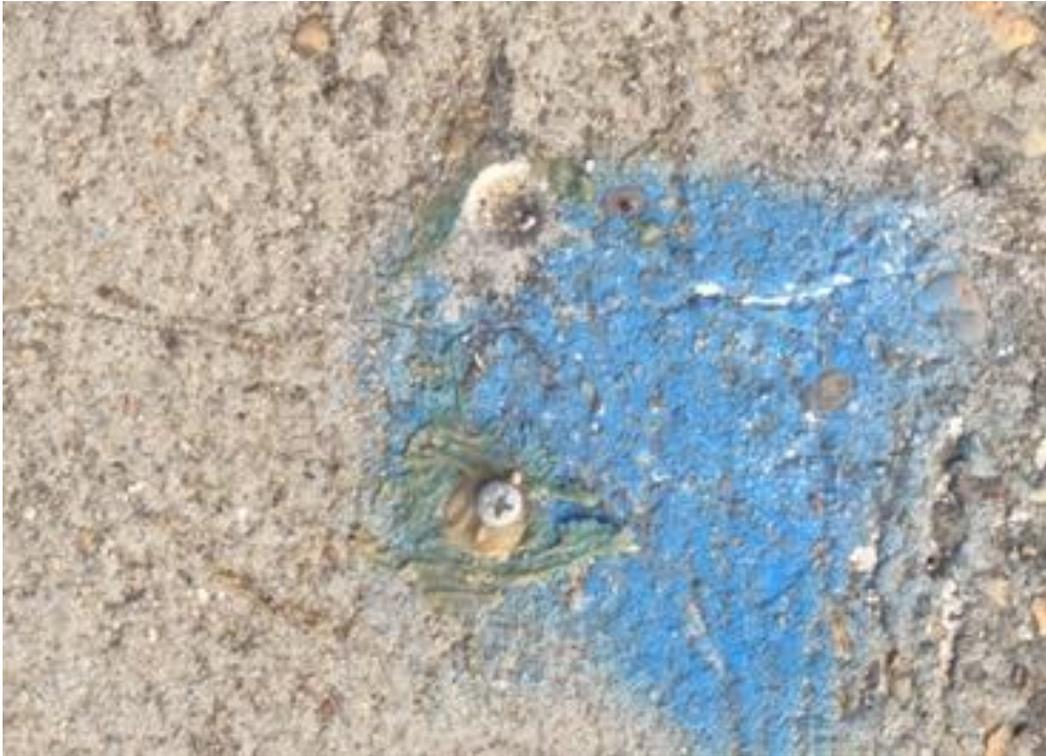
**Figure 5.22 Transducer Mount Damaged by Traffic**

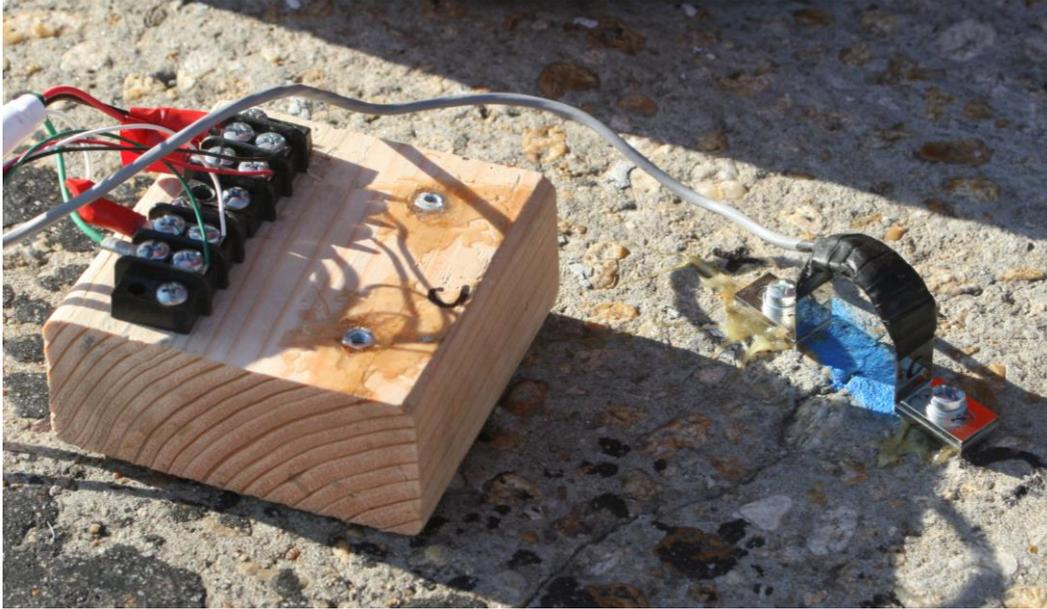
**Figure 5.23 Installed Crack Opening Displacement Transducer**

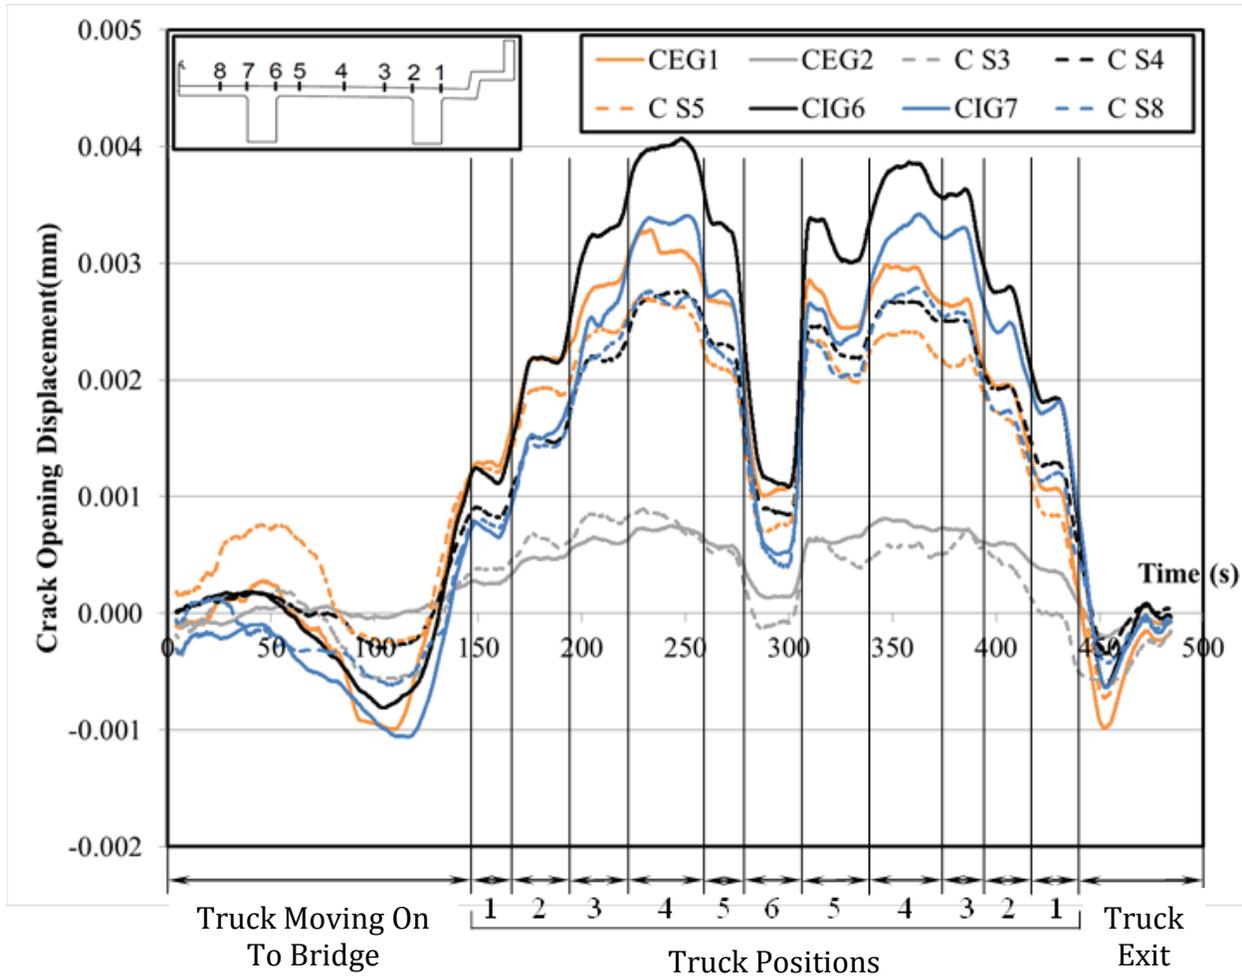
**Figure 5.29 Data from the First Test Sequence with LC-5 Load Truck Configuration**

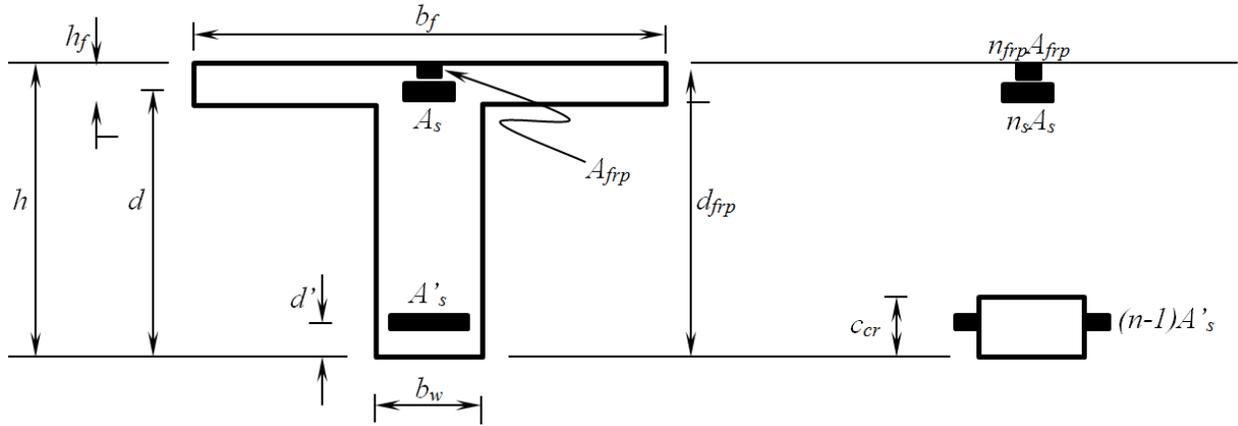
**Figure 6.1 Illustration of Cracked-Section Analysis**

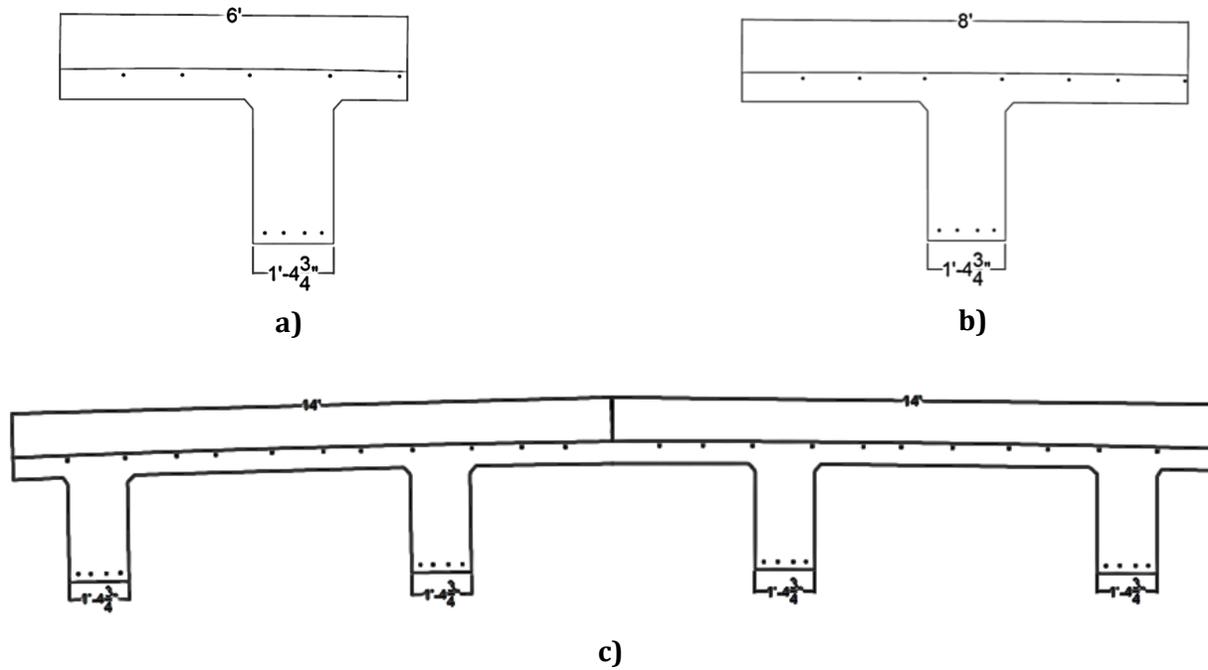
**Figure 6.2 Cross Sections Analyzed with Cracked Section Analysis of a) Exterior Girder, b) Interior Girder, and c) Full Bridge**

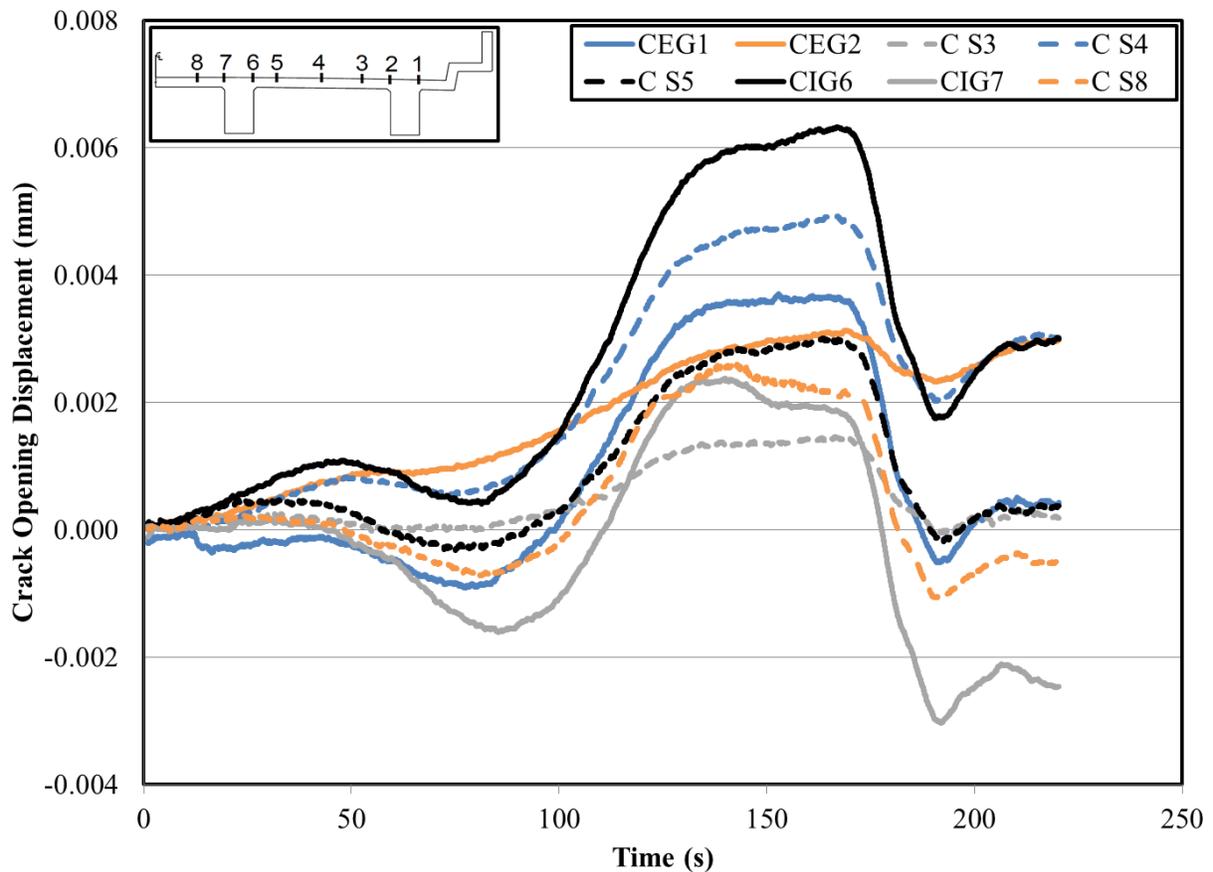
**Figure 6.3 Raw Data for all Transducers for One Test Run**

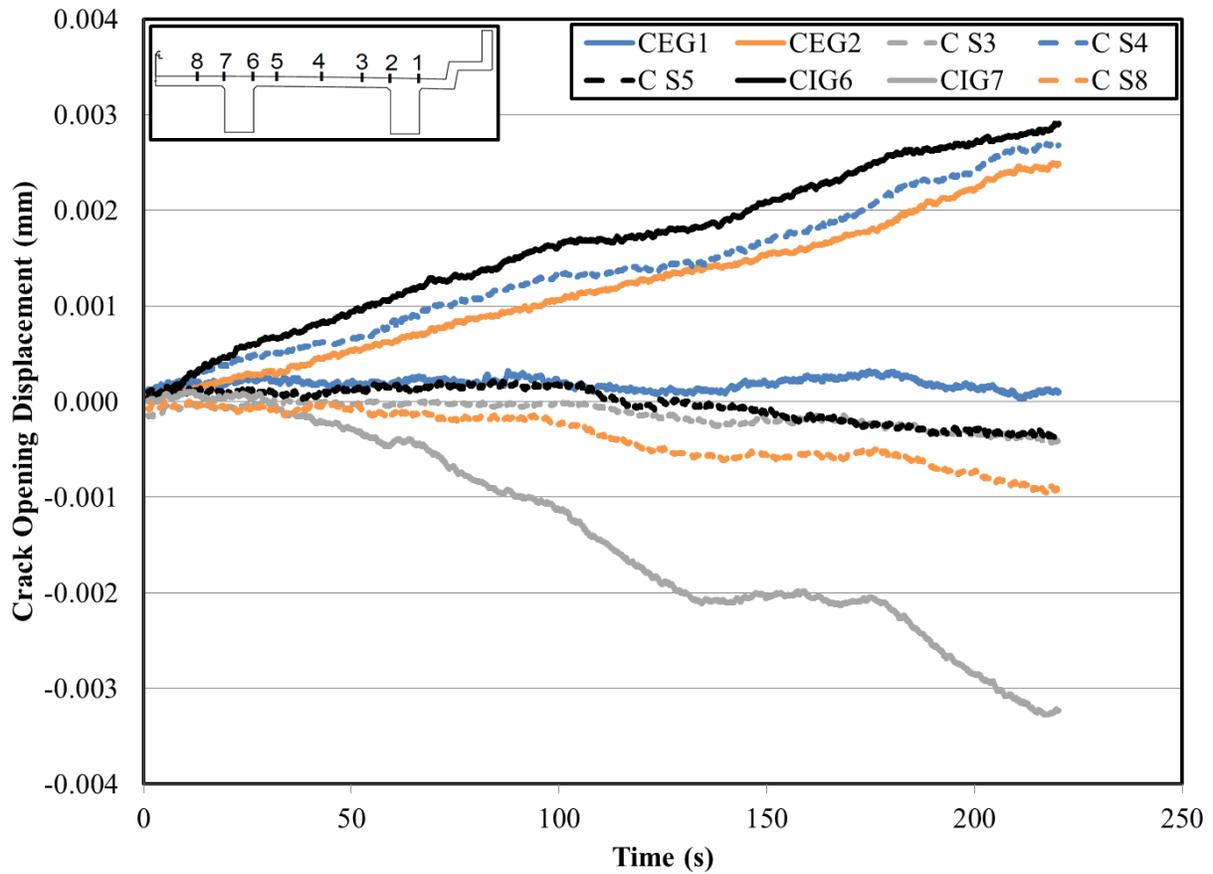
**Figure 6.4 Transducer Linear Drift without Loading on Bridge**

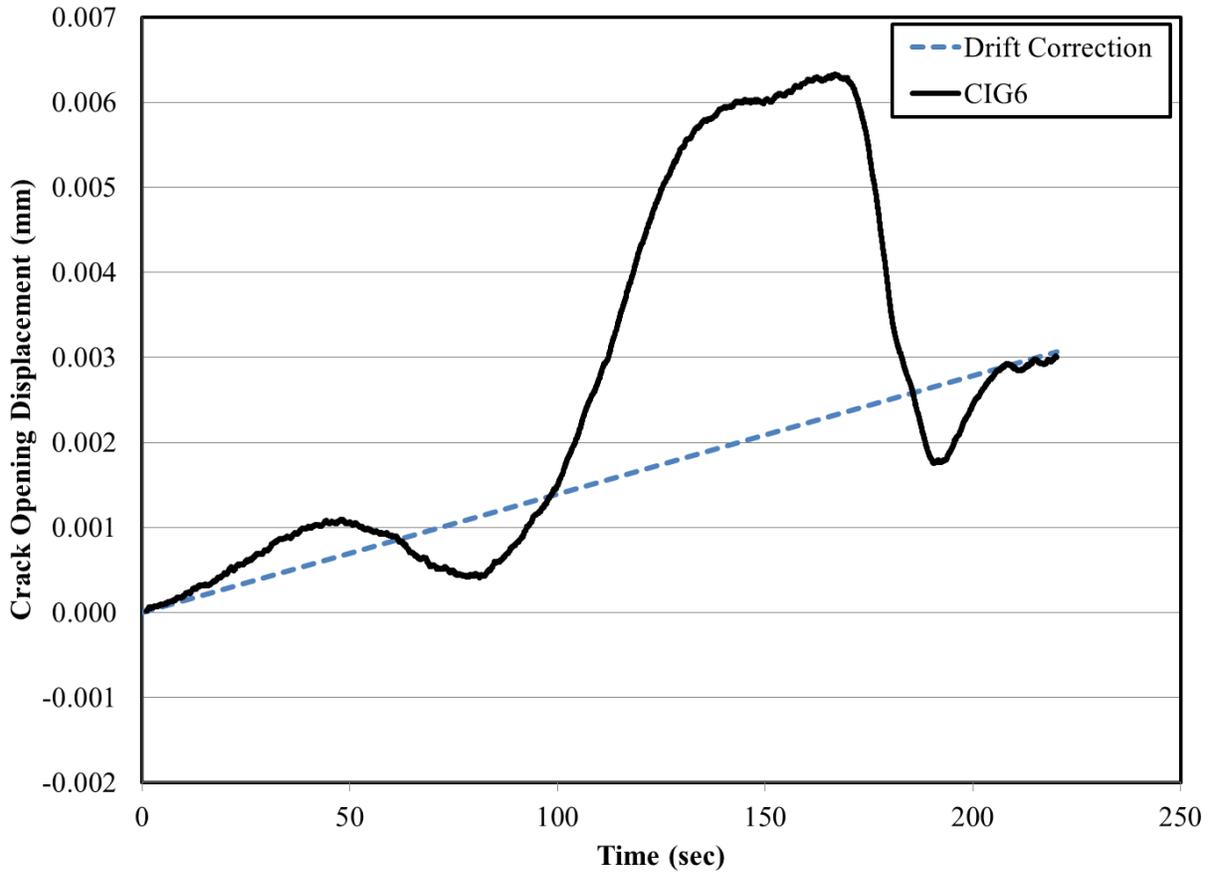
**Figure 6.5 Transducer CIG6 Raw Data from Pre-Retrofit Load Test on Sunny Morning**

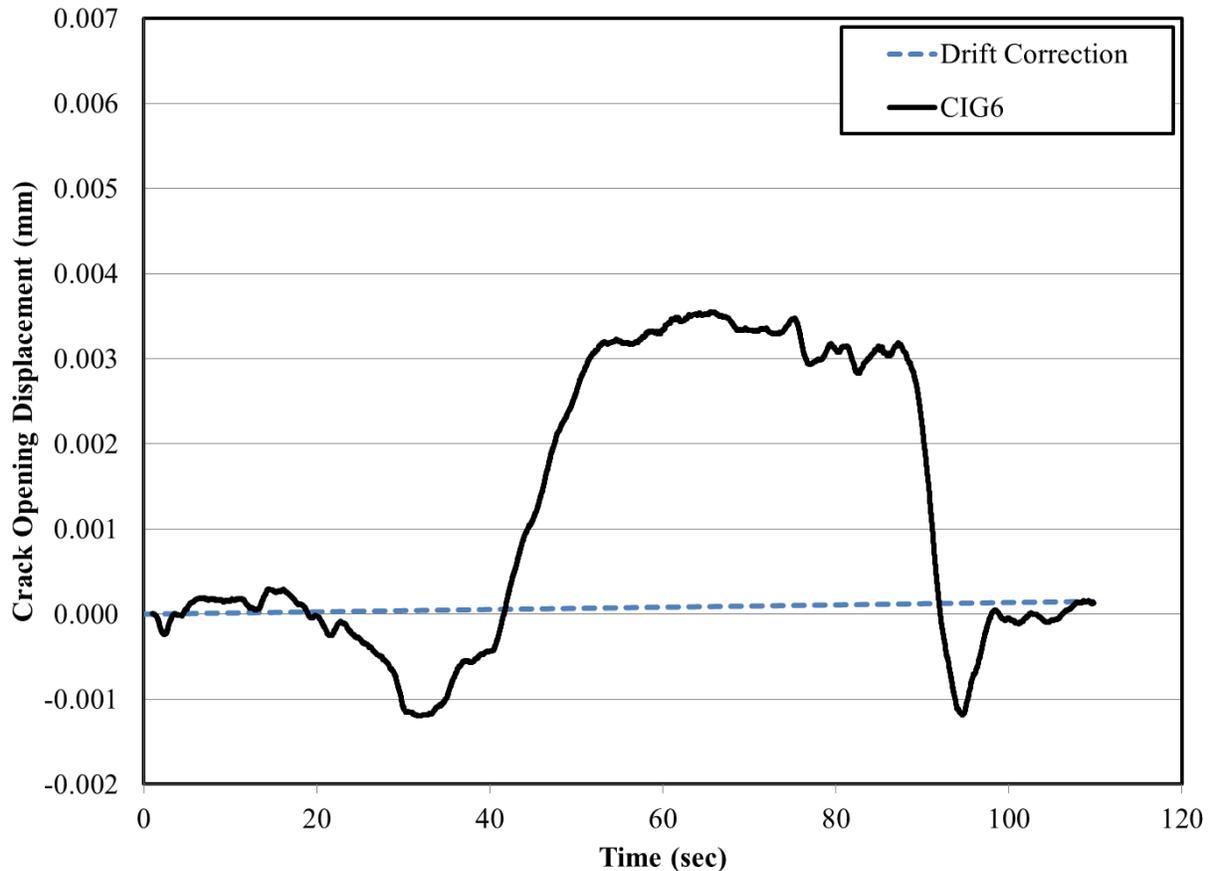
**Figure 6.6 Transducer CIG6 Raw Data from Post-Retrofit Load Test on Overcast Morning**

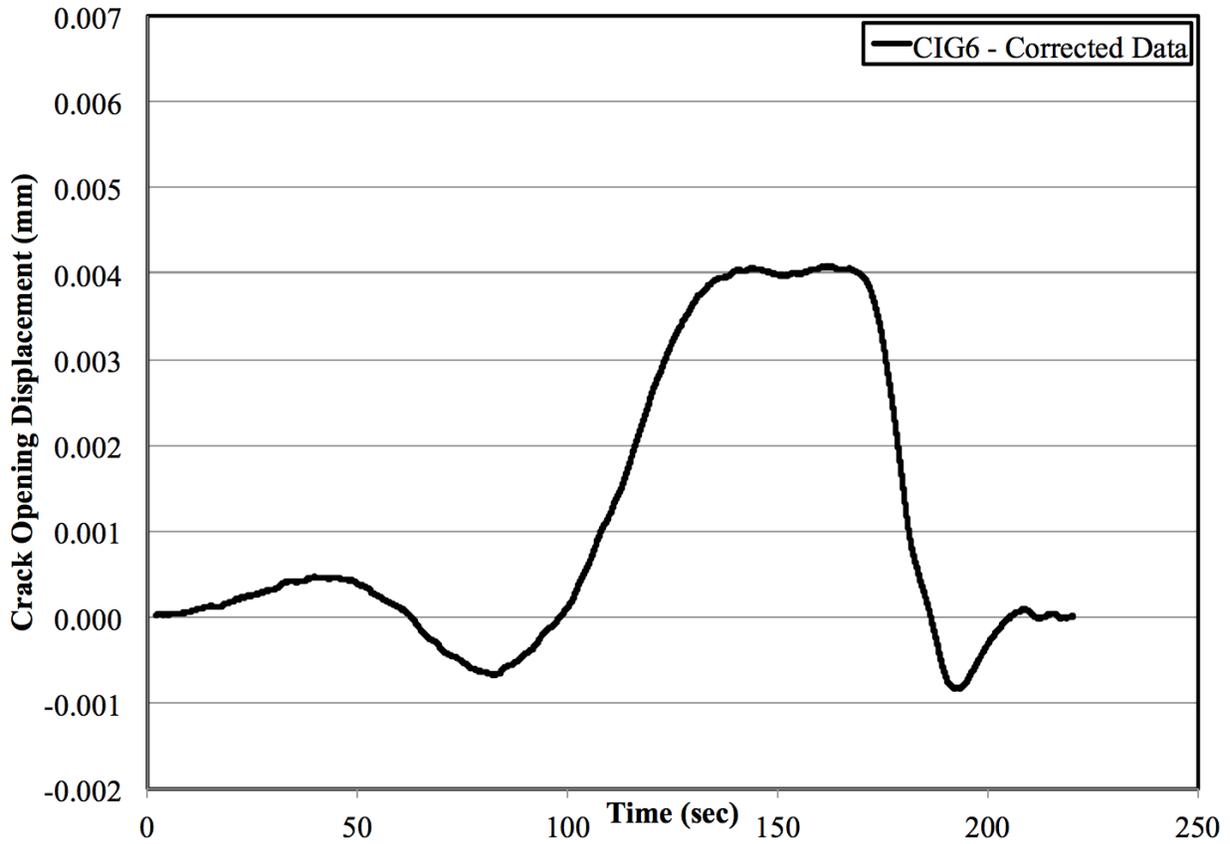
**Figure 6.7 Transducer CIG6 Corrected Data from Pre-Retrofit Load Test**

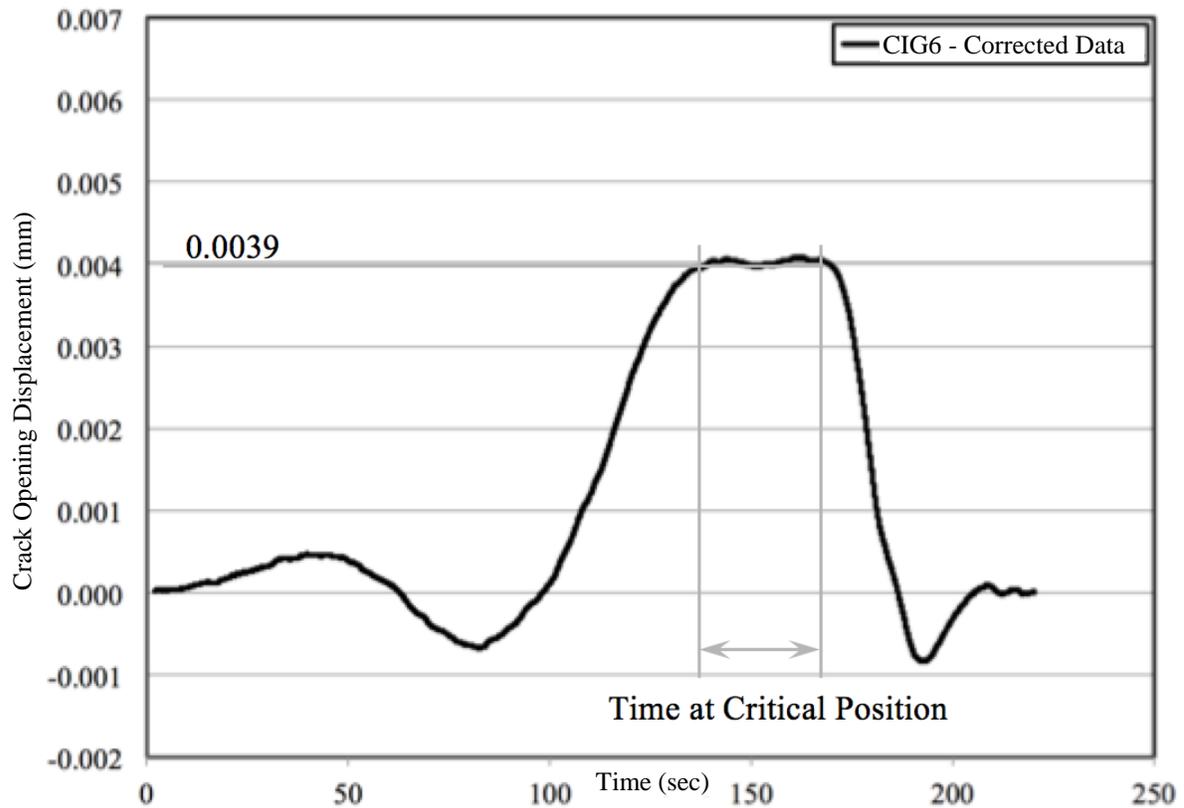
**Figure 6.8 Determination of Maximum Crack Opening Displacement for Transducer CIG6 for the Pre-Retrofit Load Test**

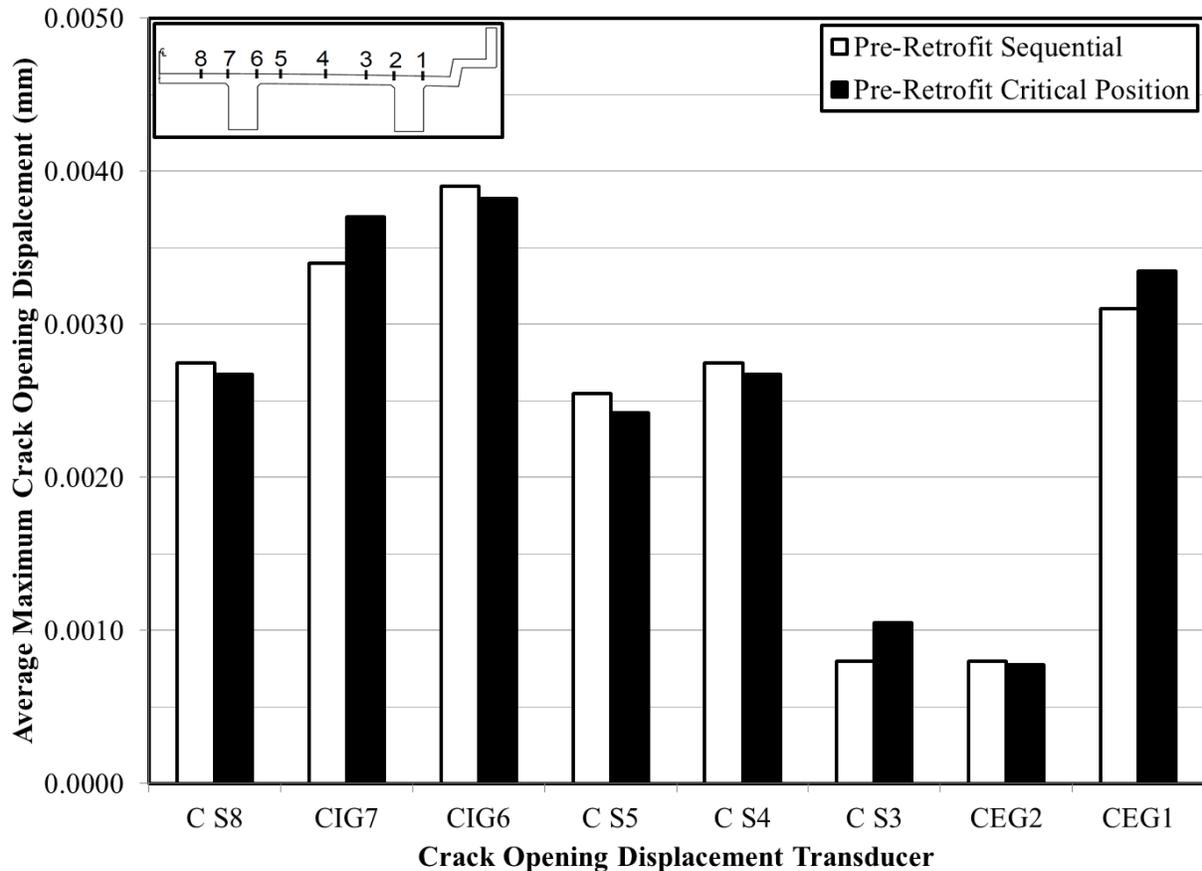
**Figure 6.9 Pre-Retrofit Maximum Average CODs for Sequential and Critical Position**

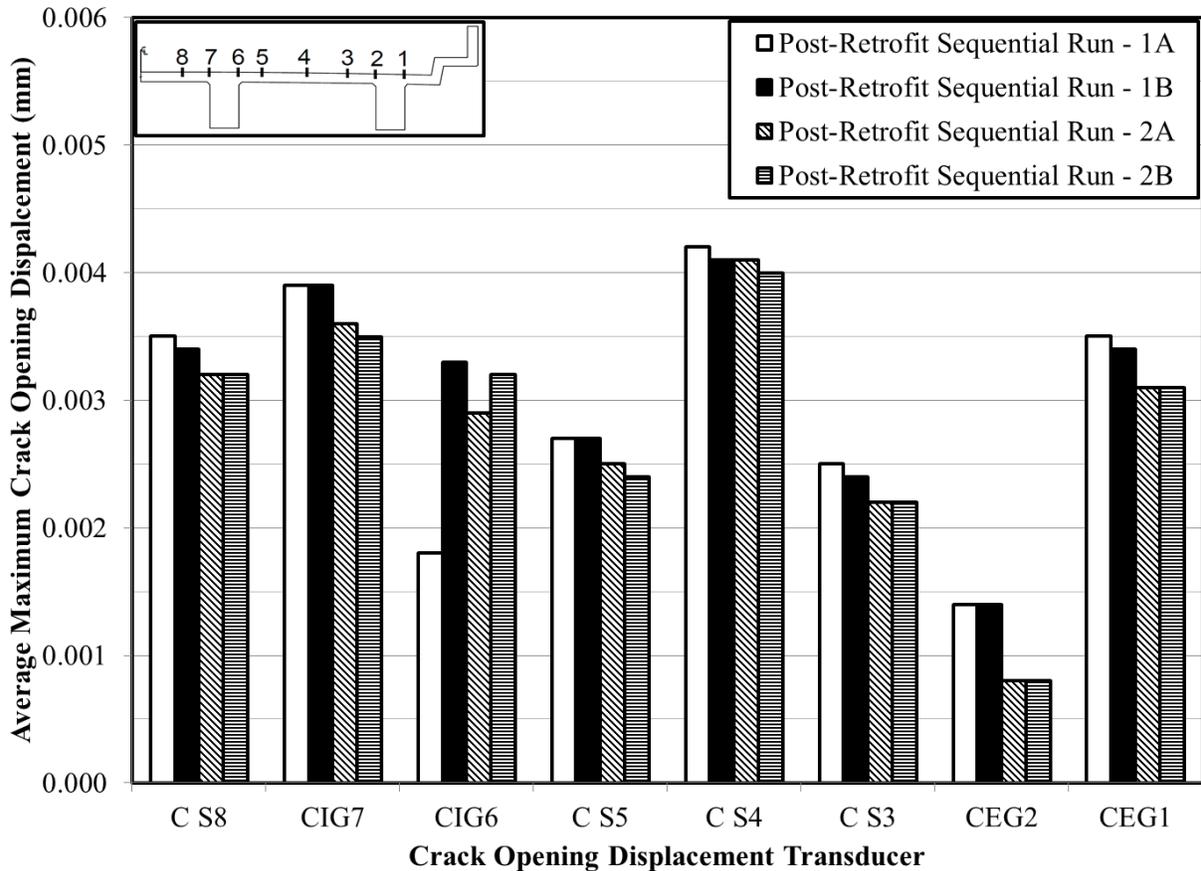
**Figure 6.10 Post-Retrofit Maximum Average COD for Sequential Runs with One Load Truck**

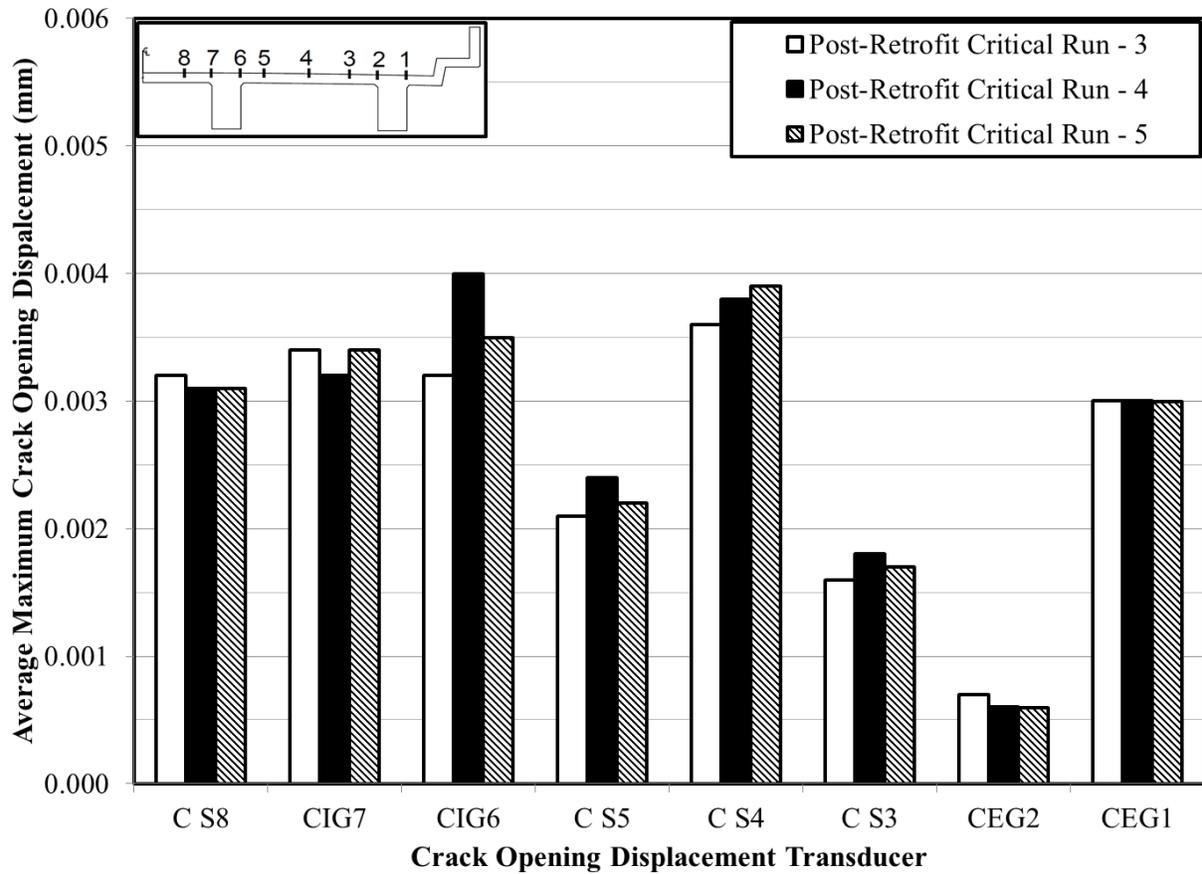
**Figure 6.11 Post-Retrofit Maximum Average COD for Critical Runs with One Load Truck**

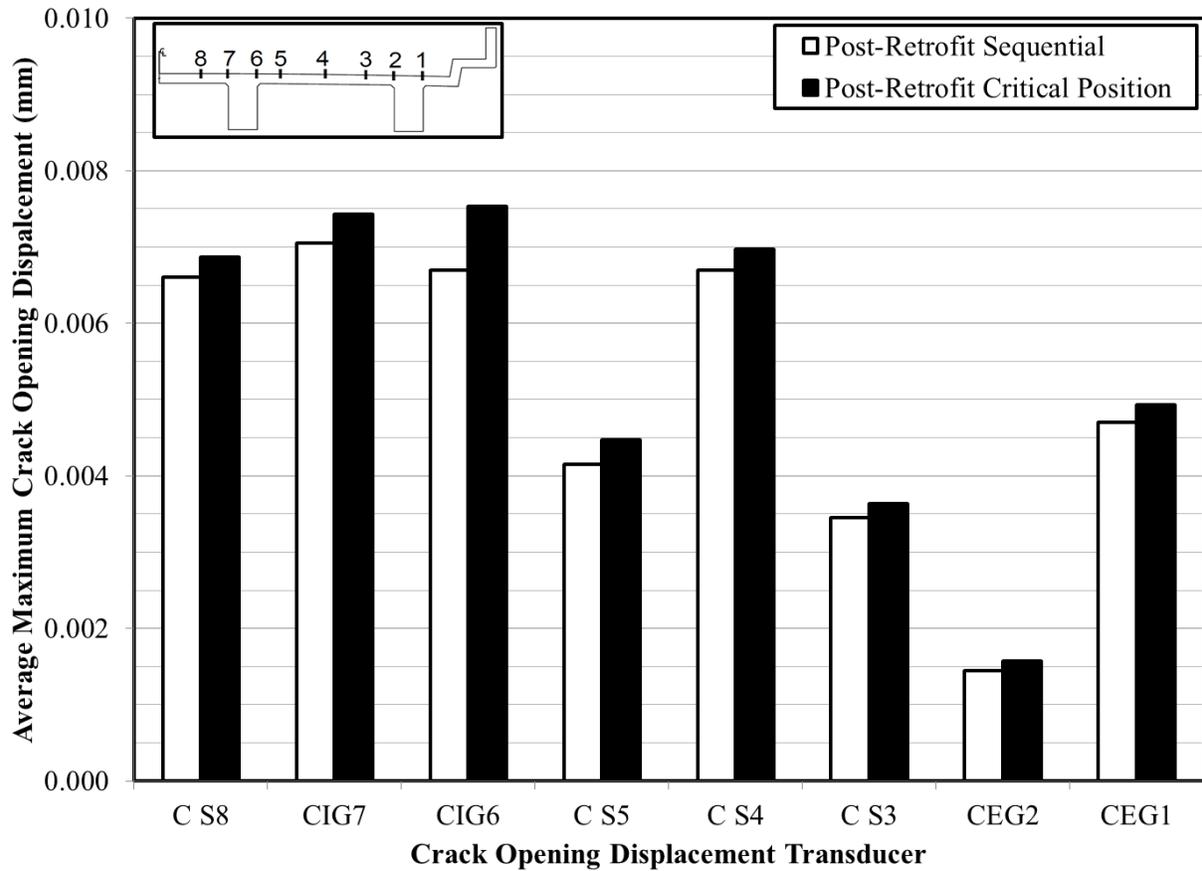
**Figure 6.12 Post-Retrofit Maximum Average COD for Critical Runs with Two Load Trucks**

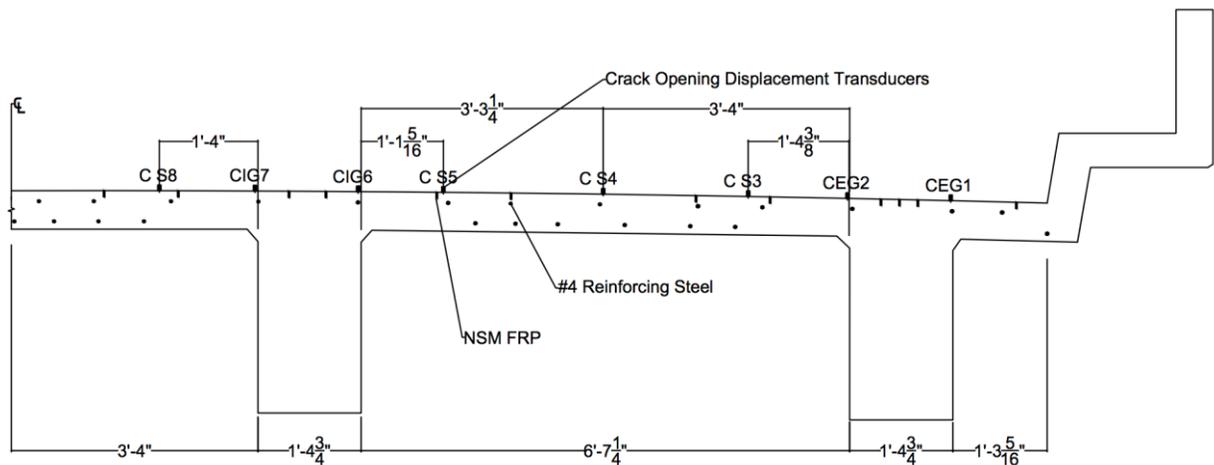
**Figure 6.13 Instrumented Cross Section of the Letohatchee Bridge**

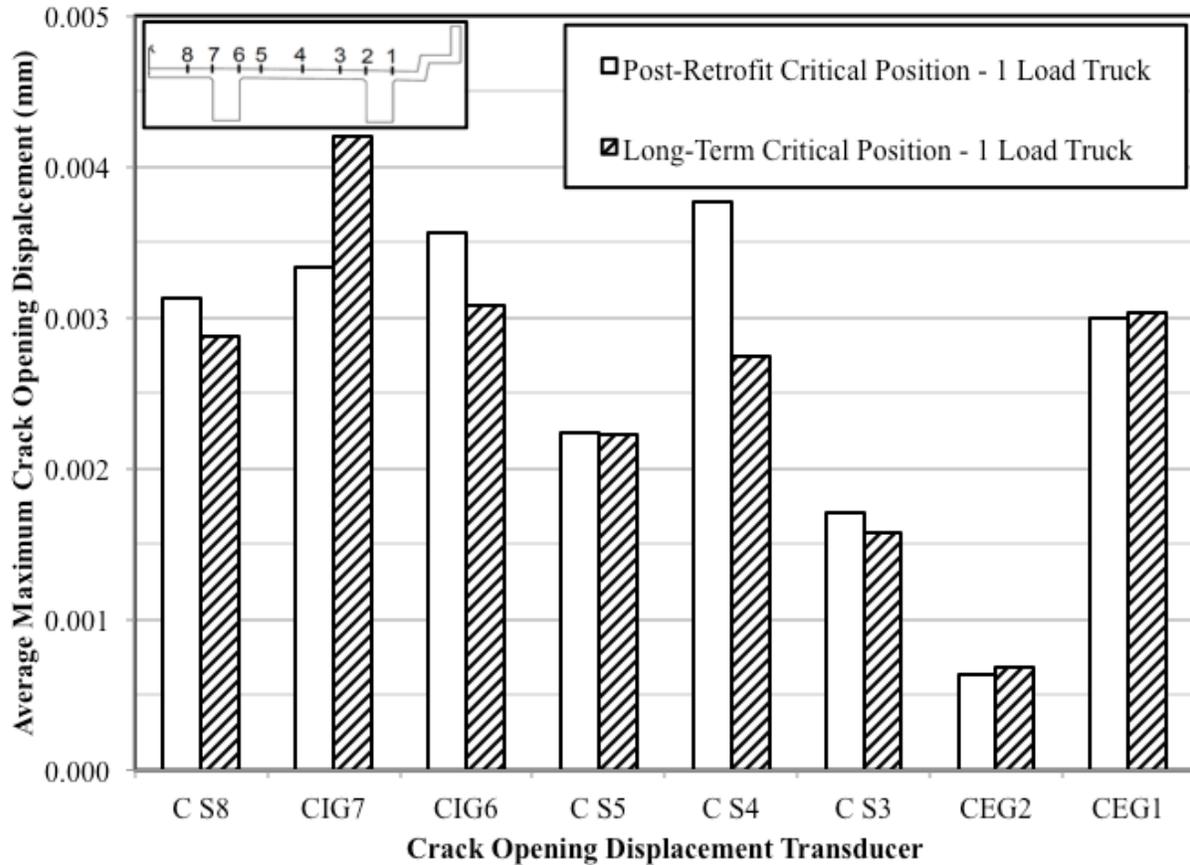
**Figure 6.14 Post-Retrofit and Long-Term Load Test Average Maximum CODs for Critical Position Runs**

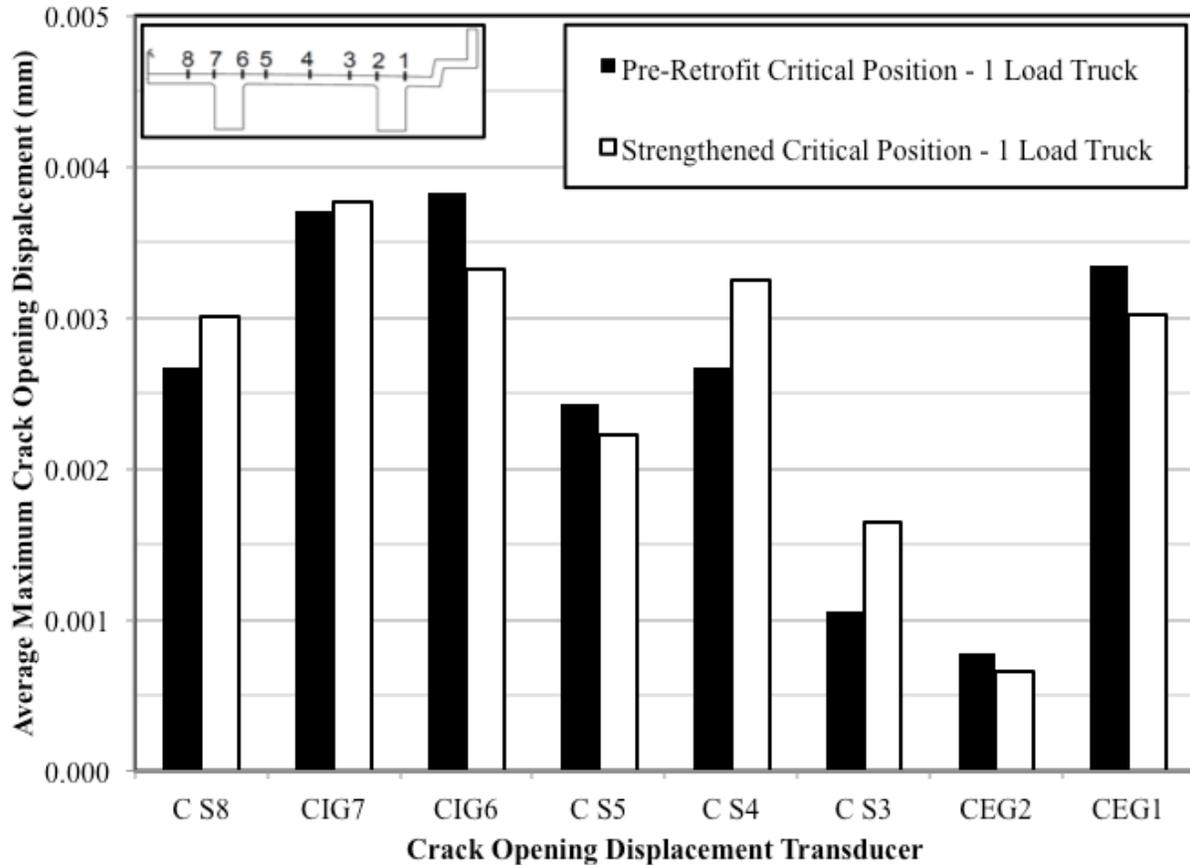
**Figure 6.15 CODs of the Pre-Retrofit and Strengthened Letohatchee Bridge**

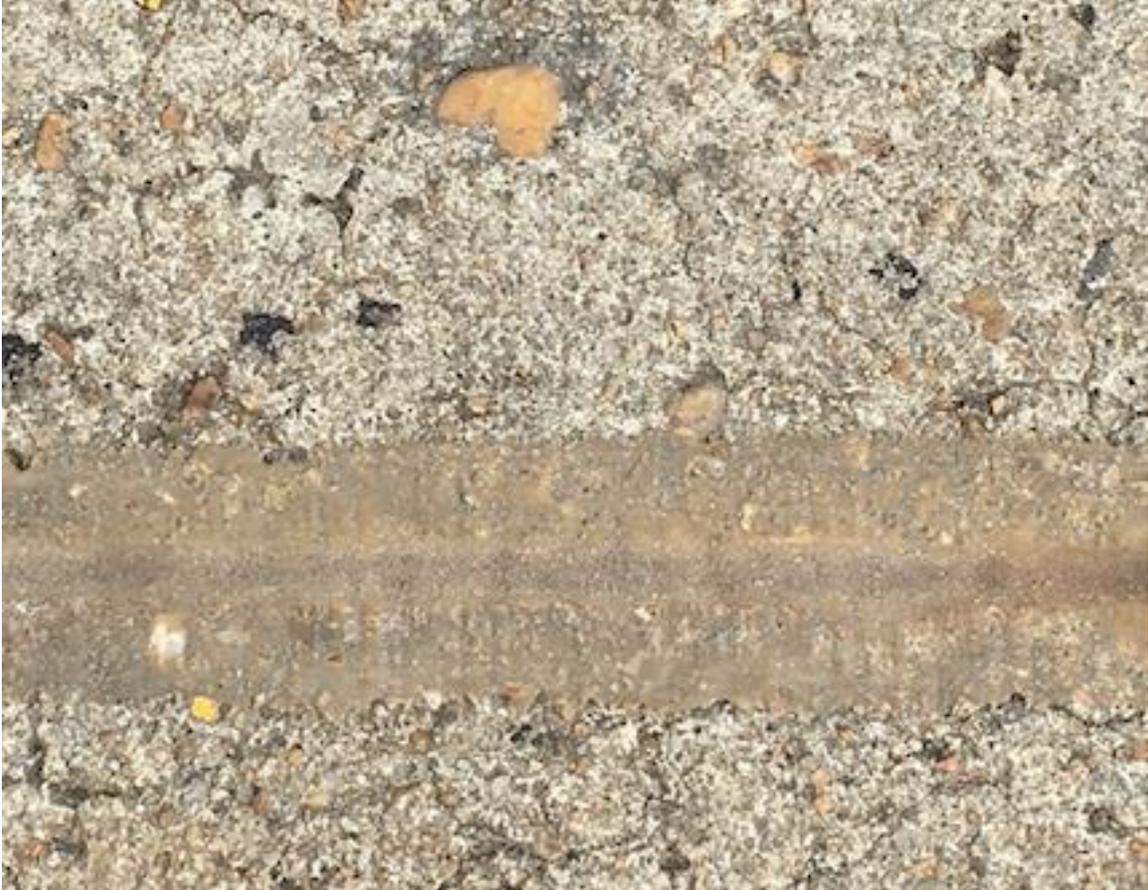
**Figure 6.16 Epoxy Showing No Degradation One Year After Installation**

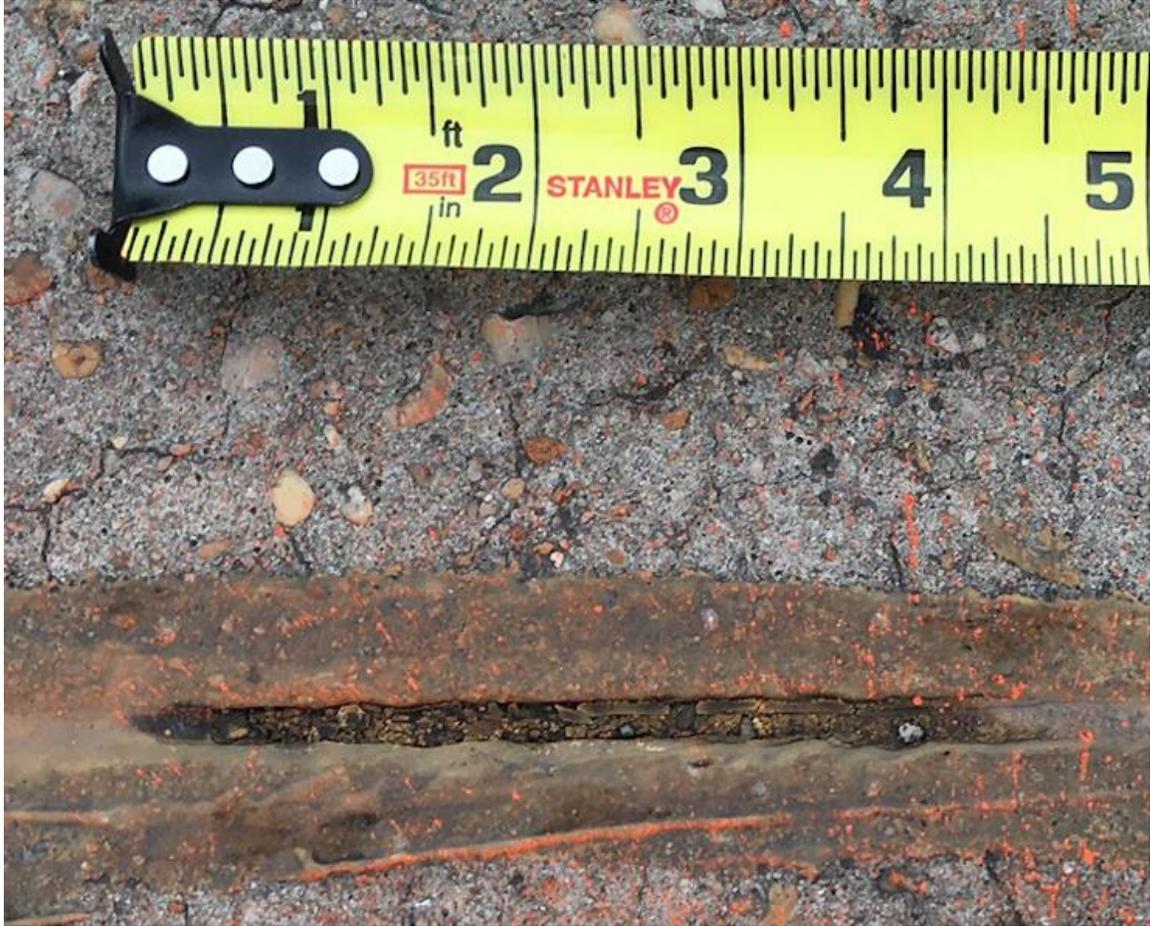
**Figure 6.17 Typical Area of Epoxy Degradation**

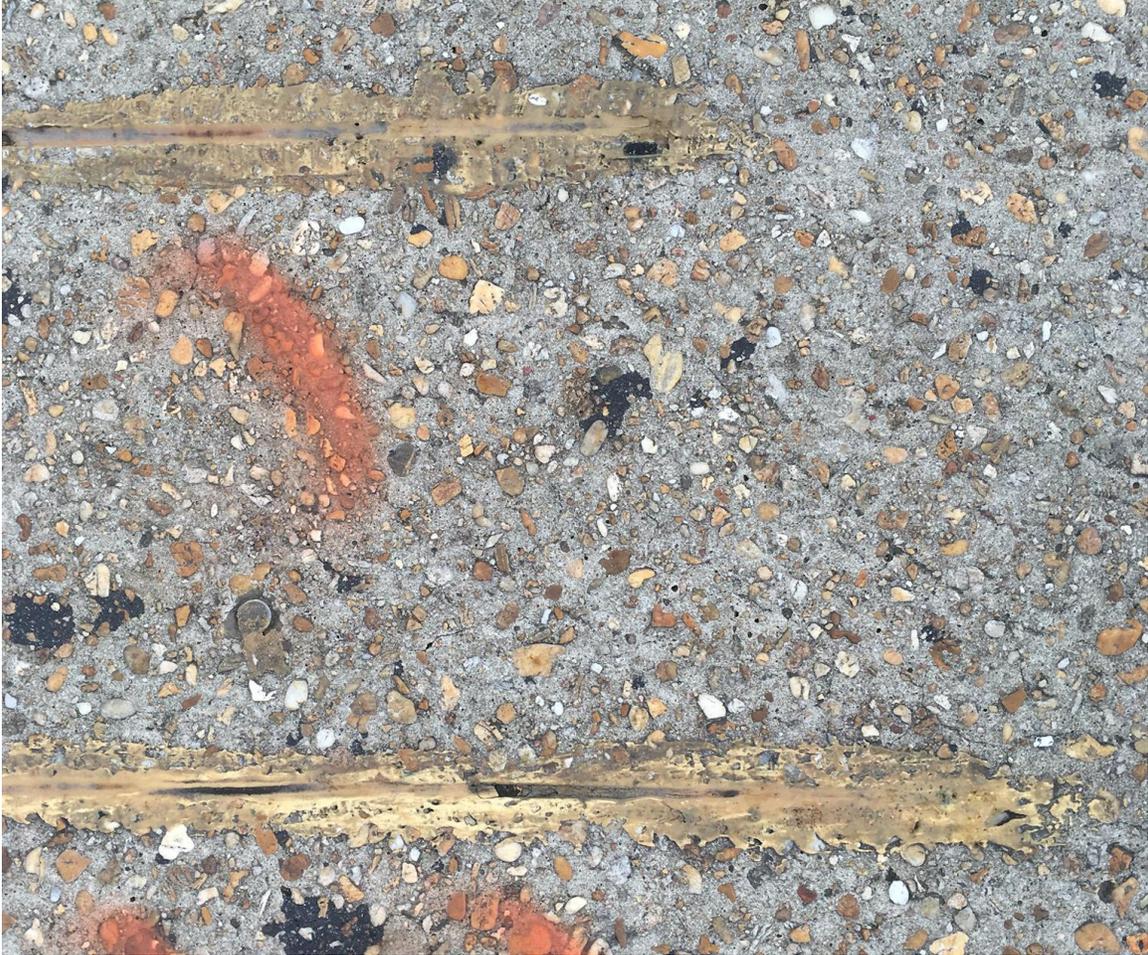
**Figure 6.18 Degradation of Epoxy Near Ends of Strips**

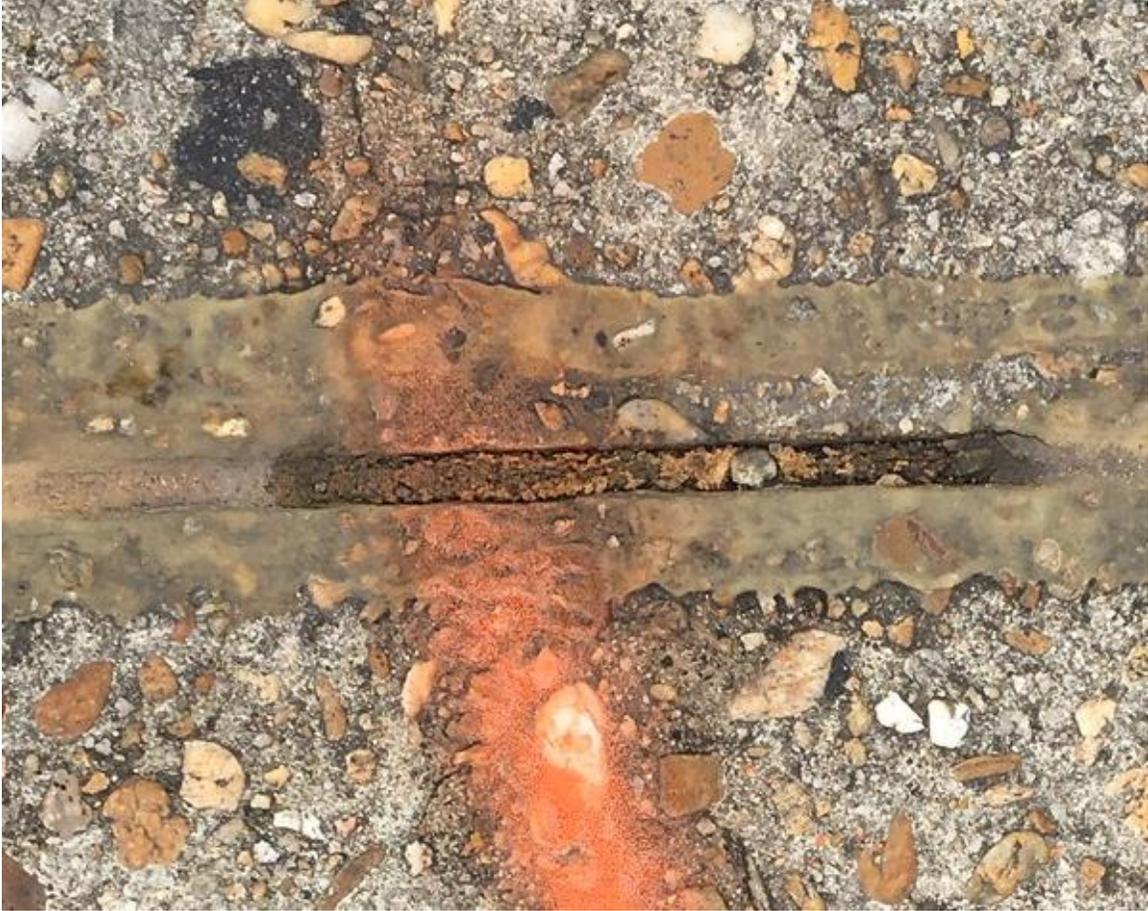
**Figure 6.19 Typical Epoxy Degradation**
