Experimental Testing of a Rotational Friction Connection for Use with Precast Concrete Cladding Panels in Metal Building Systems

A thesis submitted to the Graduate Faculty of
Auburn University
in partial fulfillment of the requirements for the Degree of
Master of Science in Civil Engineering

Auburn, Alabama
December 16th, 2017

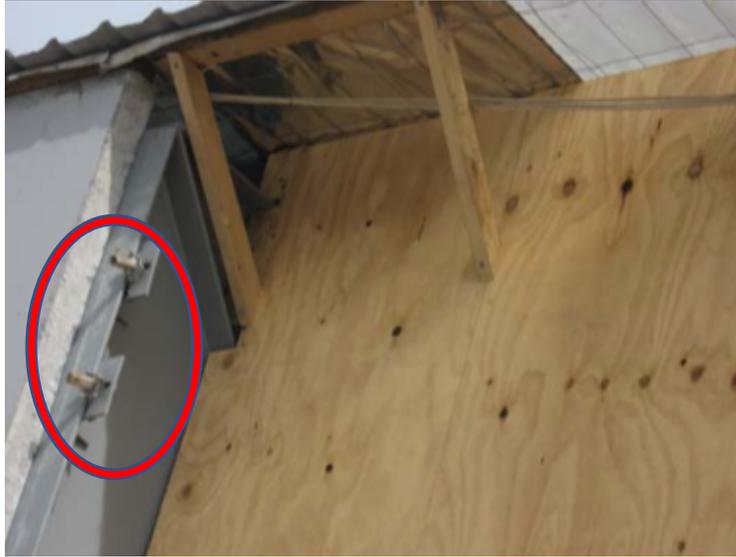
Figure 2-1: Concrete Anchor Connection Failure (Marshall 2012)

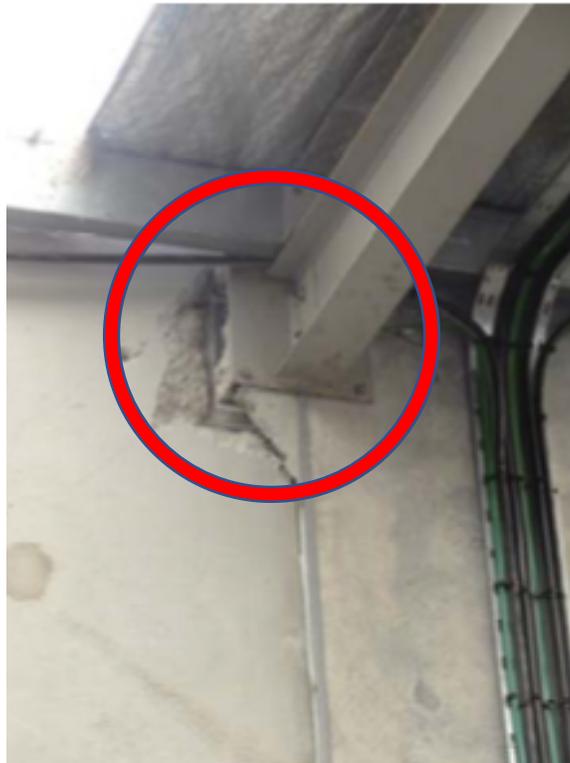
Figure 2-2: Damaged Connection at the Beam-to-Panel Interface (Marshall 2012)

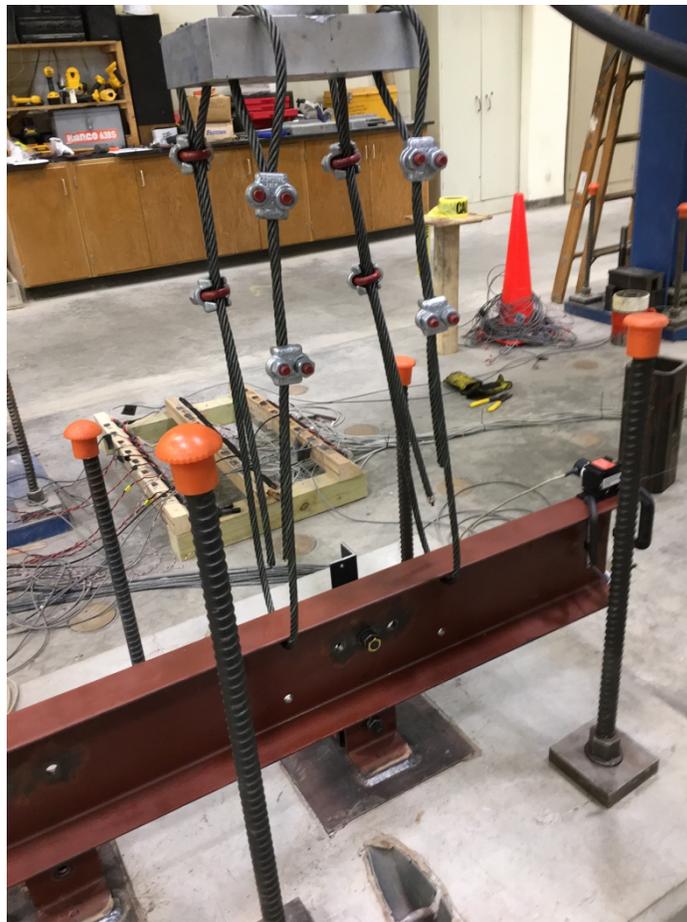
Figure 3-6: Experimental Setup for Application of Out-of-Plane Force

For biaxial and pullout testing, 1/2 in diameter holes were drilled near the top of the channel web, 6 inches in either direction of the hole being tested. Steel wire rope with a diameter of 7/16 in was placed through these holes and then connected to the vertical actuator to allow for the application of vertical force. The appropriate size wire rope clamps were then installed. Figure 3-6 shows the experimental setup for biaxial and pullout testing.

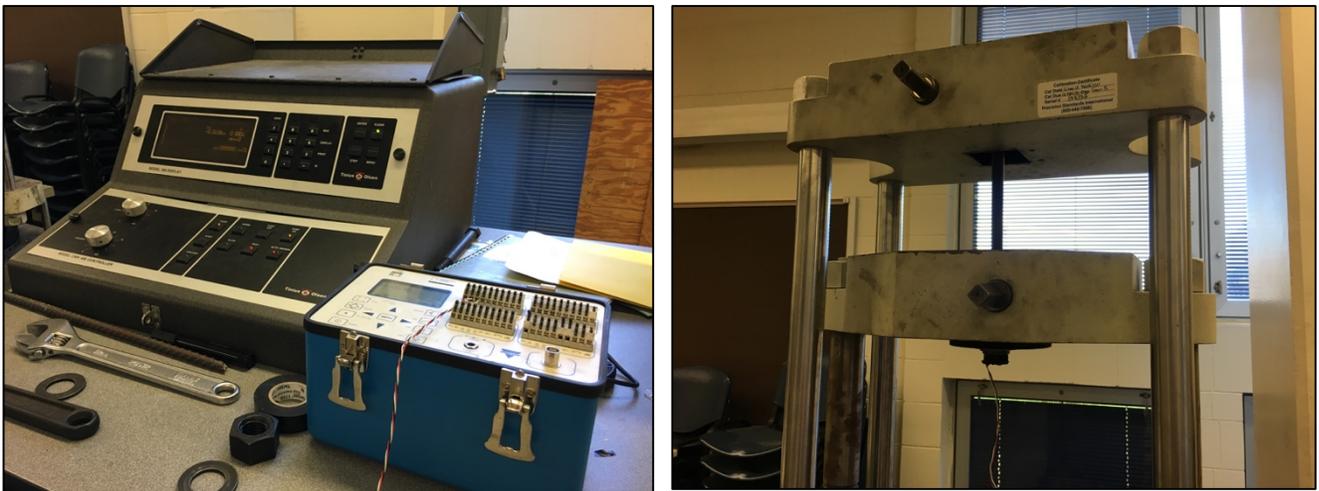
Figure 3-8: Experimental Setup for Bolt Calibration

accurately measure the force occurring. Finally, strain gages were installed into both bolts to measure the bolt tension throughout the experiment. Holes 2 mm in diameter were drilled into the center of the bolt heads, strain gages were placed inside, then epoxied. To ensure this was done properly, bolt calibration tests were performed using a *Tinius-Olsen Super "L" Hydraulic Universal Testing Machine* to incrementally load the bolts up to 35% of the yield stress in three separate trials and force versus strain plots were generated. A direct relationship between strain and tension was established and used to determine when bolts were fully pretensioned during installation in addition to the use of DTI squirting washers. The test setup for this calibration process and a representative sample of the results are shown in Figure 3-8 and Figure 3-9, respectively.

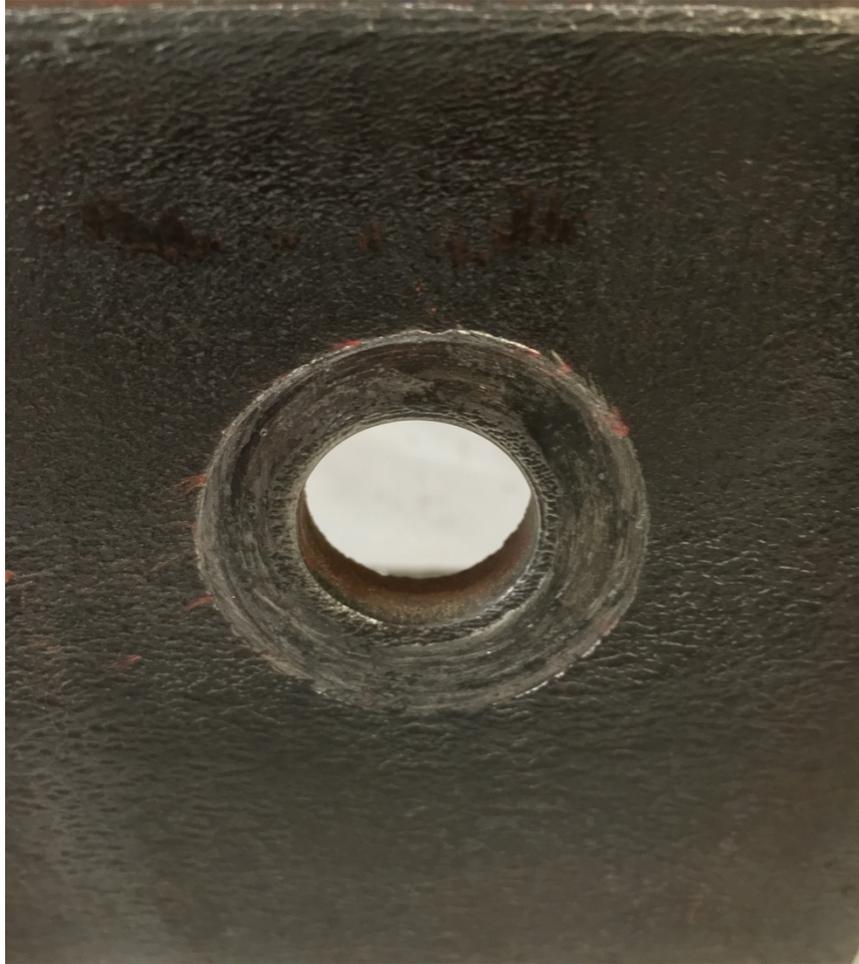
Figure 4-17: Damage on Interior Face of Angle after Three 100-Cycle Tests
