Theoretical Modeling and Lateral Load Testing of Driven Steel Pile Bridge Bents

A thesis submitted to the Graduate Faculty of
Auburn University
in partial fulfillment of the
requirements for the Degree of
Master of Science

Auburn, Alabama
May 4, 2019

Keywords: Lateral Load Tests, Deep Foundations, Driven Piles, Theoretical Modeling

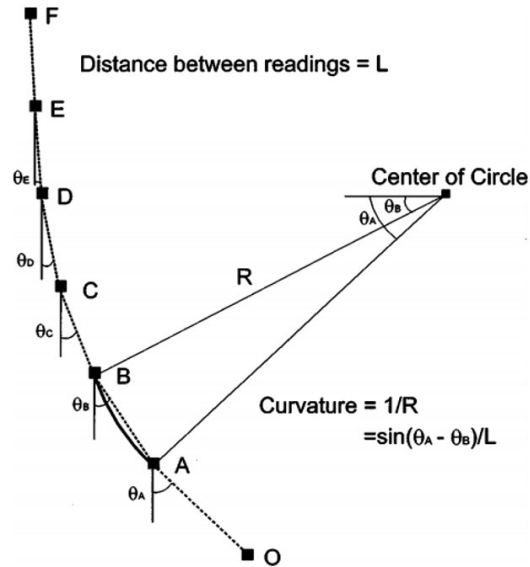
Inclinometer probes are used to determine the deflected shape of geotechnical structures. The inclinometer probe is comprised of two gyroscopes situated a fixed distance apart. Profiles are created by running the inclinometer probe down to the bottom of a casing attached to the geotechnical structure. The probe is pulled back up the casing and readings are taken at every two foot interval. Two gyroscopes measure the slope of the pile. The difference in slope between the two gyroscopes is used to calculate the average curvature at discrete points along the pile length. This is used to create a deflected shape profile for the piles. The profile is taken in one direction and then rotated 180 degrees to account for any error in the reading. Figure 2-15 illustrates the theory behind the data reduction used to calculate the deflected shape of the structural element. The readings are used to determine the radius to a reference circle, R . deflections are calculated by subtracting the initial observed R value for the unloaded condition from R values calculated under loaded conditions. This produces deflection profiles from the observed baseline test.

Figure 2-15 – Inclinator Theory (Ooi & Ramsey, 2003)

Deflected shape profiles for the structural elements are created by building a profile for the unloaded condition and creating a profile at each subsequent load. The deflected shape for each load case is created by calculating the difference in the shape of the subsequent load cases and the baseline case. The deflected shape can be used to calculate the corresponding bending moment profile for the tested structural element. These bending moment profiles can be used to calibrate analytical models to accurately reflect the actual behavior of the structural element.

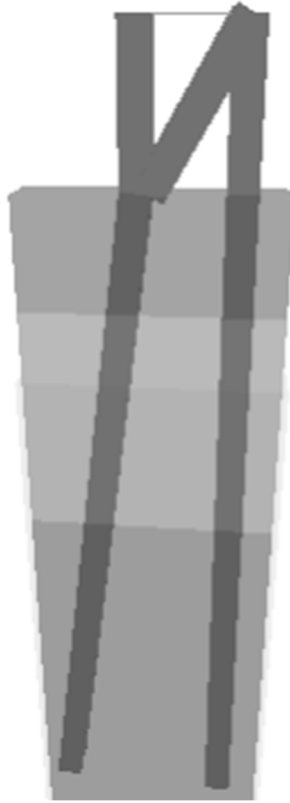
The Macon County Road 9 bent required a reaction bent to react against. The reaction bent was used to react the lateral loads in the bent during field load testing. The same soil profile used in the bent models was used to analyze the behavior of the reaction bent except the top clay layer was not replaced with rip-rap. The reaction bent featured two 35 feet long HP14x89 piles. The piles were oriented for weak axis bending in the direction of lateral loading. The two piles were driven in line with a 4 feet center to center spacing. The pile closest to the test bent was battered towards the second reaction pile with a 1.5/12 slope. A piece of pile cutoff was welded as a brace between the two reaction piles. Figure 3-17 shows the rendering of the FB Multiplier model of the reaction bent.

Figure 3-17 – FB Multiplier rendering of the Macon County Road 9 Bridge Reaction Bent

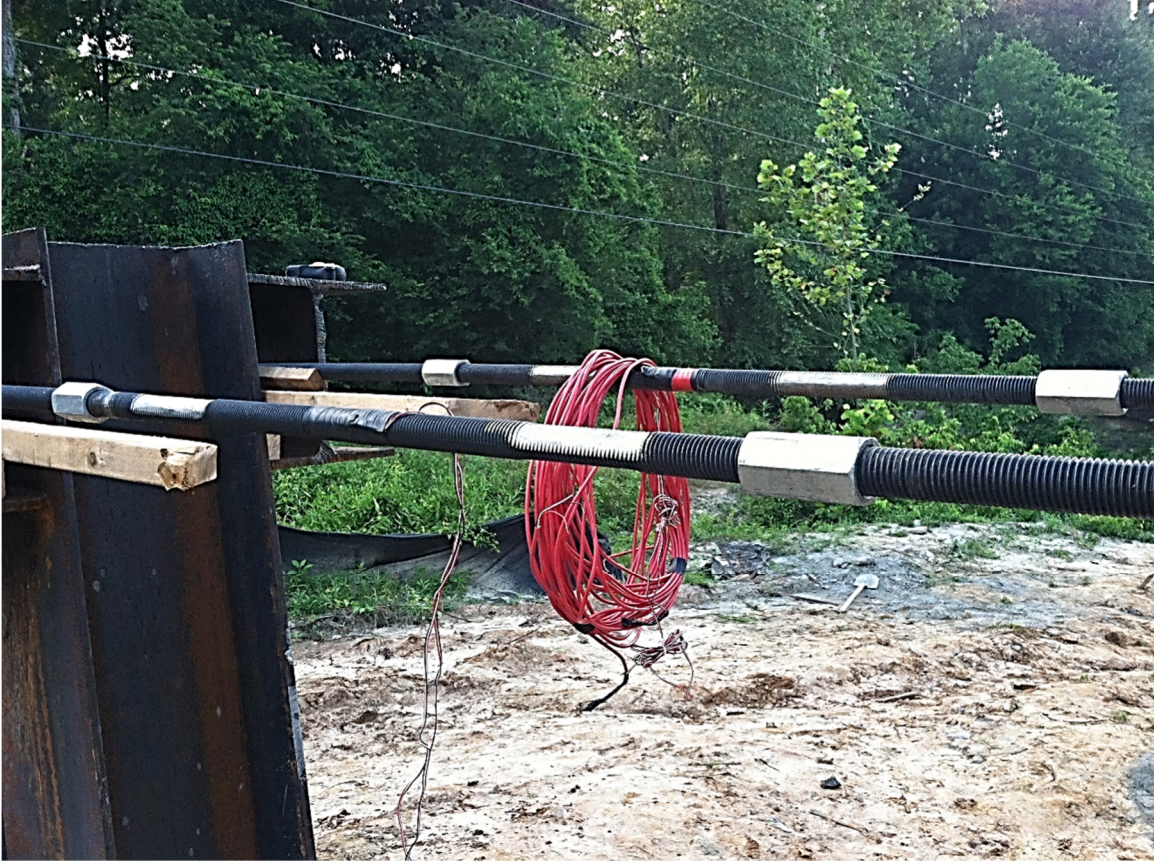
High strength threaded rods were used to apply lateral load to the test bents. Two small sections of threaded rod were instrumented with strain gages at two locations at the center of the segments. These two strain gages were used to measure the tension in the rods during testing. Each rod corresponded to the force supplied by one of the hydraulic jacks used to load the test bents. The rods were monitored during the tests to ensure that both jacks were supplying similar amounts of lateral load and that the loading condition remained symmetric. The rods were also used to calculate the amount of lateral force the bents were exposed to and to monitor the target loading schedule. The instrumented threaded rod segments were used for all the load tests conducted on the Macon County Road 9 Bent, the U.S. Highway 331 Bent, and the AUNGES test bents. Prior to use in load tests, the threaded rods were calibrated in the lab. Correction factors were used during testing for accurate load readings.

Figure 4-7 – Instrumented Threaded Rods prior to Load Testing

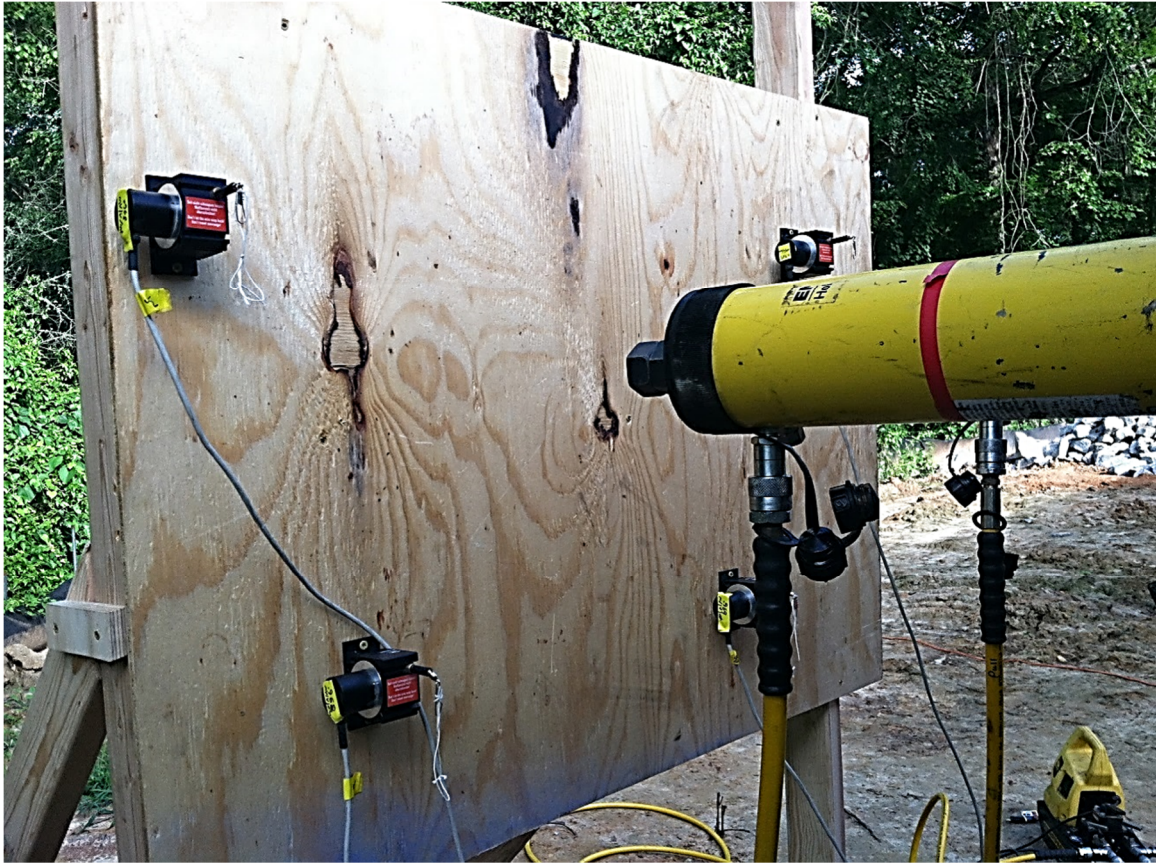
Wire pots were used during load test to measure the magnitude of deflection the bent caps experienced due to the application of lateral load. The wire pots utilize wire wound inside an instrumented housing. Hooks were anchored to the bent caps using drilled holes filled with epoxy. The wire pot housings were attached to a lumber frame that was anchored a short distance from the bent. The frame was rigid and anchored to the ground so that the wire pot housings remain fixed in place. The wire in the wire pots was extended and connected to the epoxied hooks. This initial distance served as the baseline measurement. As lateral load was applied to the bent, the wire would extend or retract. The data acquisition system recorded each measurement, and deflections were calculated based on changes from this initial measurement.

Figure 4-8 – Wire Pot Deflection Measurement Devices prior to Load Testing

The deflection measurements for the Macon County Road 9 bent and U.S. Highway 331 bent were used to ensure the bents did not experience excessive deflections that would result in permanent damage to the bents. The deflection measurements for each load test conducted were coupled with the load data from the instrumented threaded rods and load cells to create load versus deflection curves. The load versus deflection curves were compared to model predictions to assess the accuracy of preliminary models and to accurately calibrate the final models.

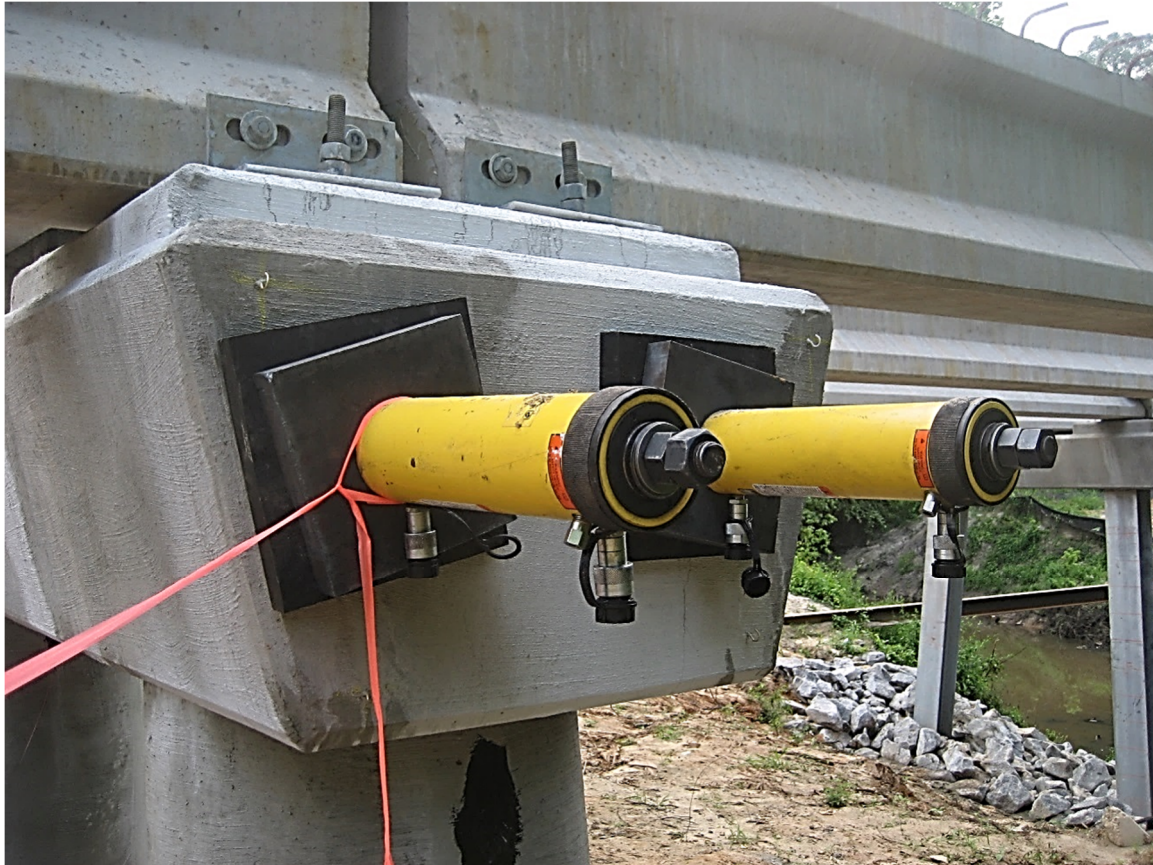
were tested using two RRH3010 Enerpac hydraulic jacks. The jacks were capable of applying a combined 60 ton (120 kip) load to the bent cap. This load capacity and jack stroke length was sufficient for the Shorter and Highway 331 bents since they were not pushed to failure.

Figure 4-9 – Enerpac RRH3010 Hydraulic Jacks

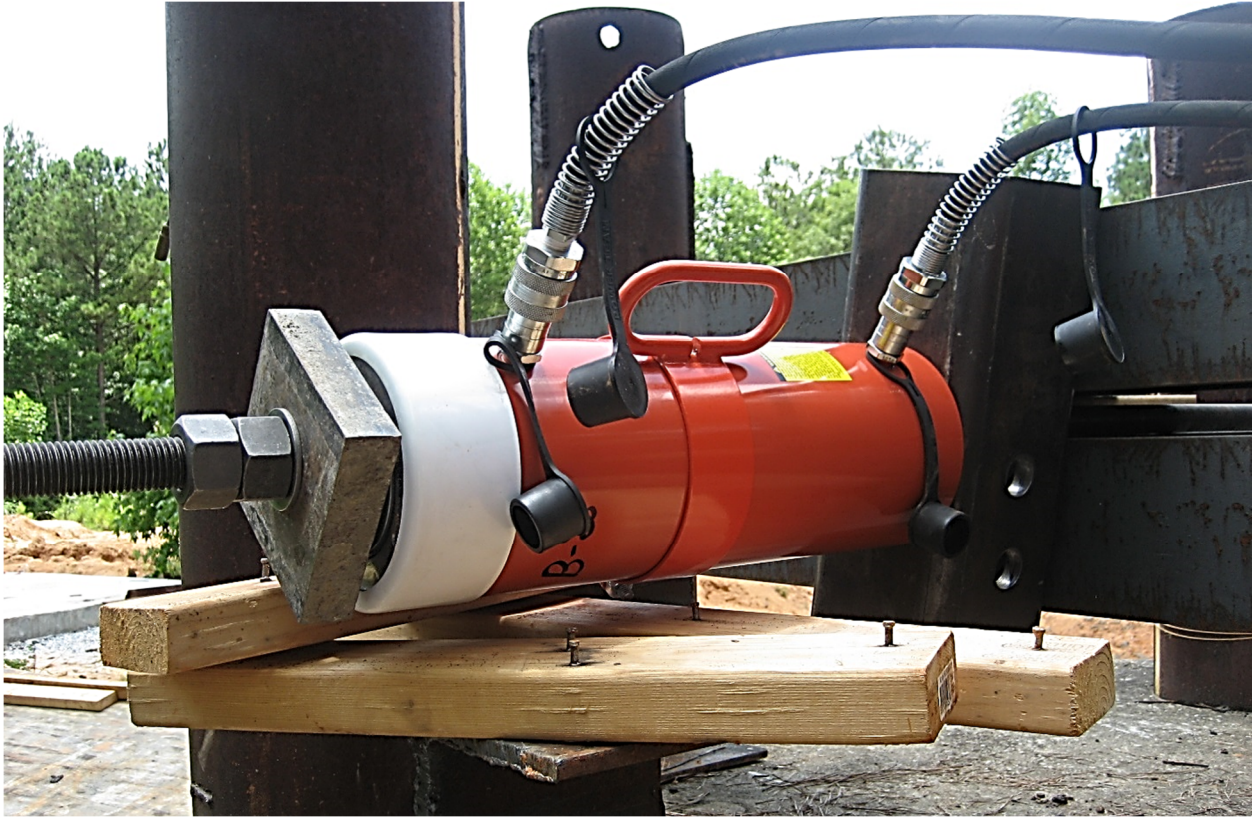
The AUNGES bents were designed to be tested to failure. Therefore, higher capacity jacks with greater stroke length were required to provide the necessary lateral load. Two Beerman PTRH6010 hydraulic jacks were used to load the test bents at the AUNGES. These jacks were both 60 ton jacks capable of applying 120 tons (240 kips) of lateral load. These jacks were chosen so that there would be sufficient capacity to induce failure in the piles.

Figure 4-10 – Beerman PTRH6010 Hydraulic Jack

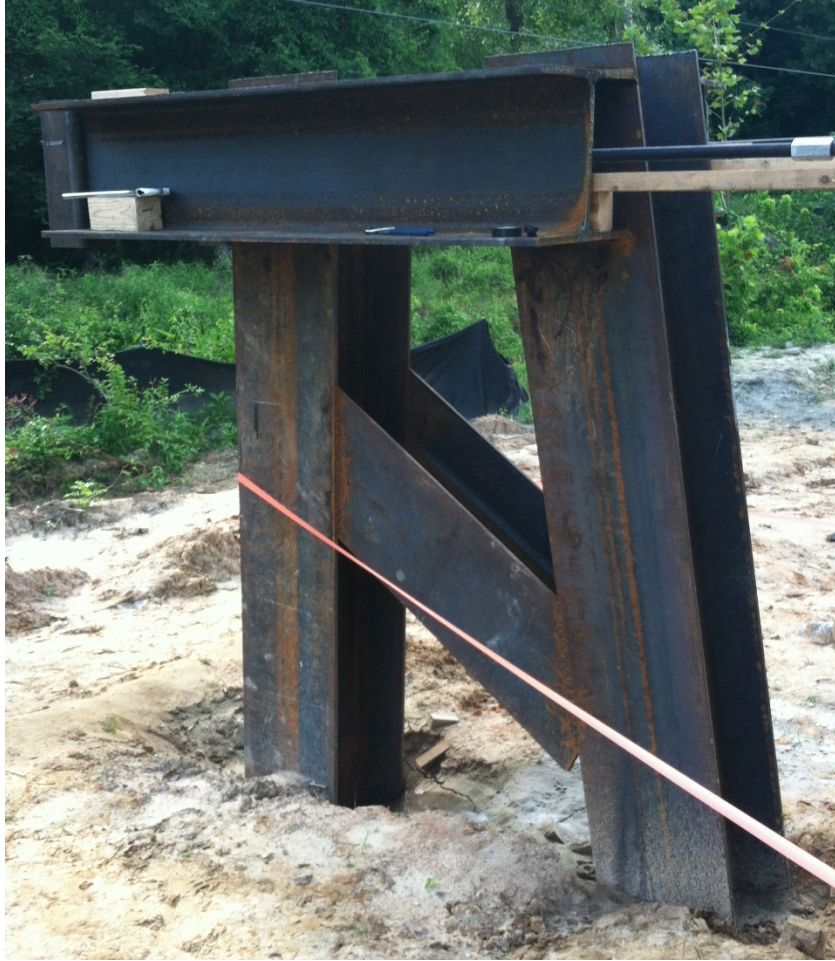
The piles for the reaction bent were driven at the same time as the piles for the test bent. This featured two piles driven with a slight batter 11 feet away from the test bent. Pile cut-off was welded between the two piles to serve as a brace when subjected to lateral loads. Pile cut-off was also welded to the sides of the reaction piles so that the reaction bent could be loaded. The threaded rod was passed through the cut-off sections and hollow tube steel with predrilled holes were placed onto the threaded rods. Nuts were used to hold the tubes in place. Figure 4-18 shows the completed reaction bent. Figure 4-19 shows the steel tube bearing against the pile cut-off welded to the sides of the reaction piles.

Figure 4-18 – Reaction Piles

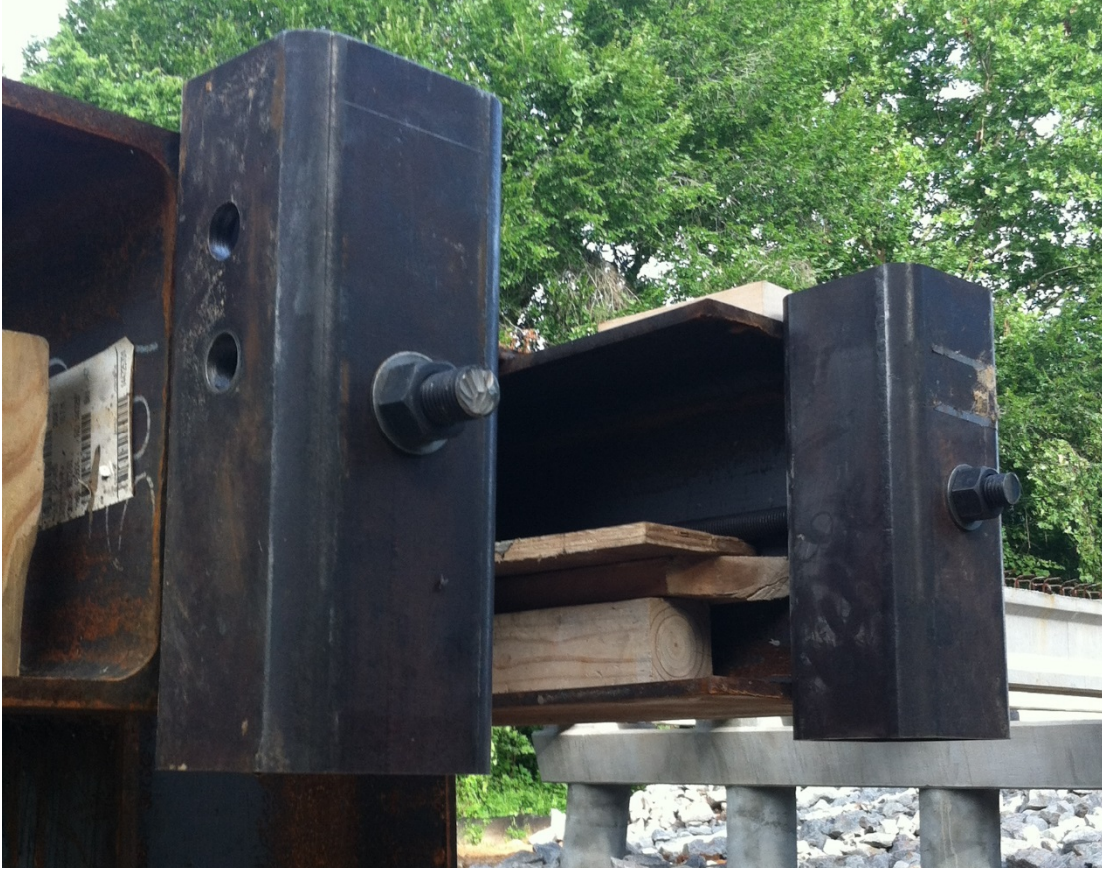
Figure 4-19 – Hollow Steel Tube Sections Bearing Against the Reaction Bent

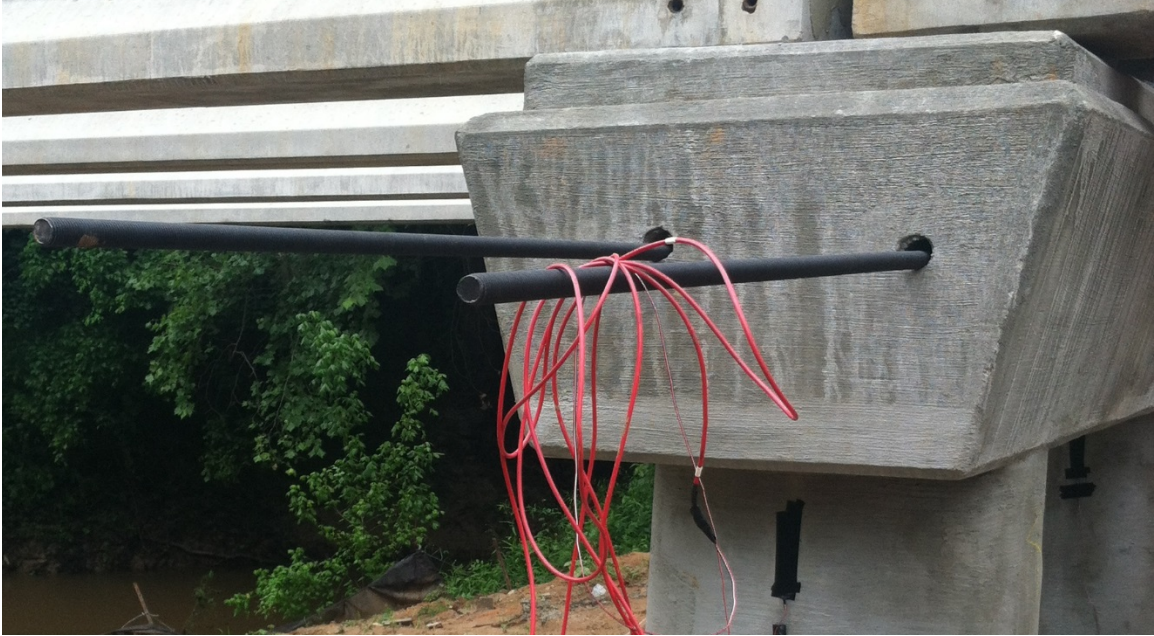
The threaded rod passed through the steel tube, through PVC sheathing cast into the bent cap, and out to the opposite side of the cap. An elastomeric bearing pad and a steel plate were placed onto the ends of the rods. These were included to evenly distribute the load from the jacks into the cap and to prevent localized failures such as crushing of the concrete. The jacks were then placed onto the ends of the rods and nuts were used to securely fix the jacks to the steel bearing plate.

Figure 4-20 – Threaded Rods Passing through PVC Sheathing in the Bent Cap

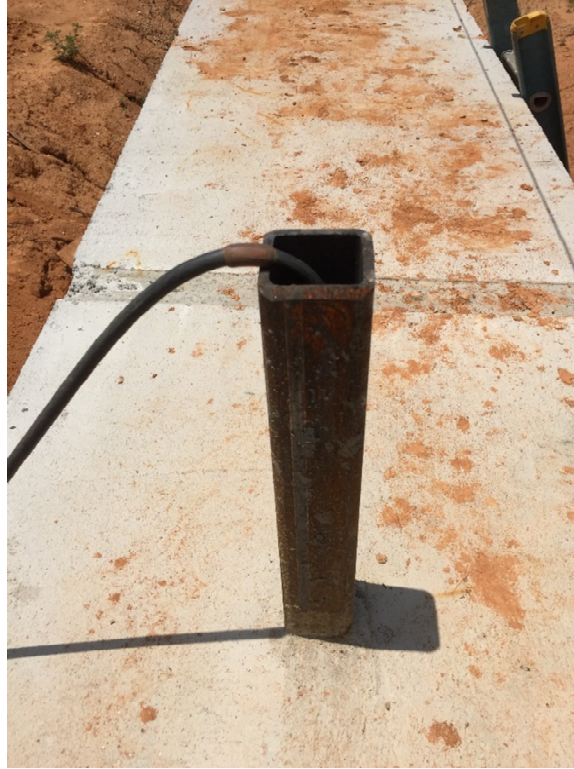
Pile 2 and Pile 3 were also fitted with 2.5 inch hollow tube steel to serve as tracks for inclinometer testing. Figure 4-38 shows the inclinometer casing at Pile 2 with inclinometer downhole.

Figure 4-38 – Inclinometer Downhole at Pile 2

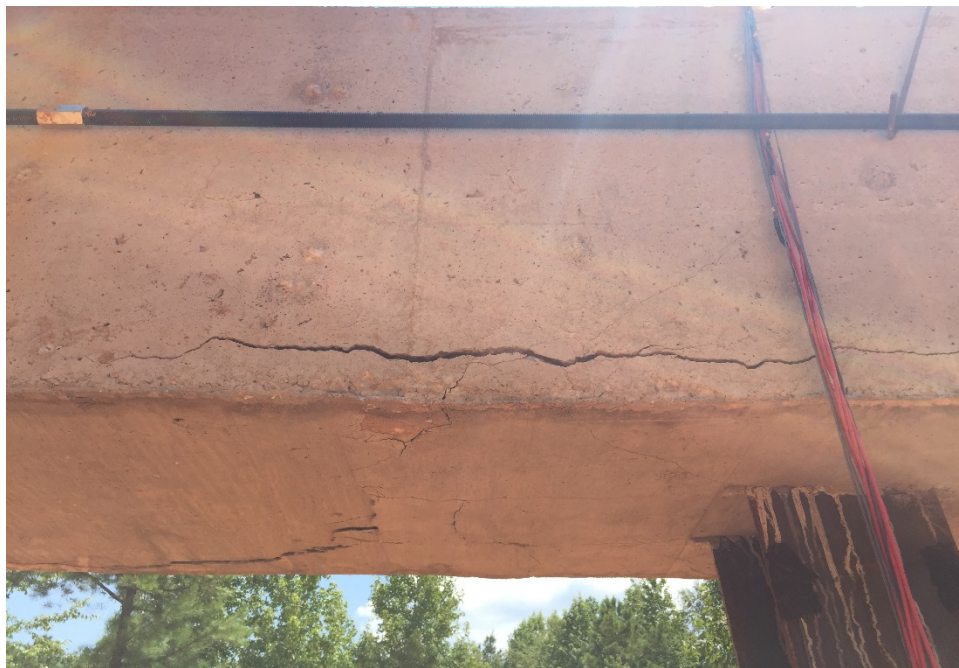
Figure 4-40 – Bent Cracking

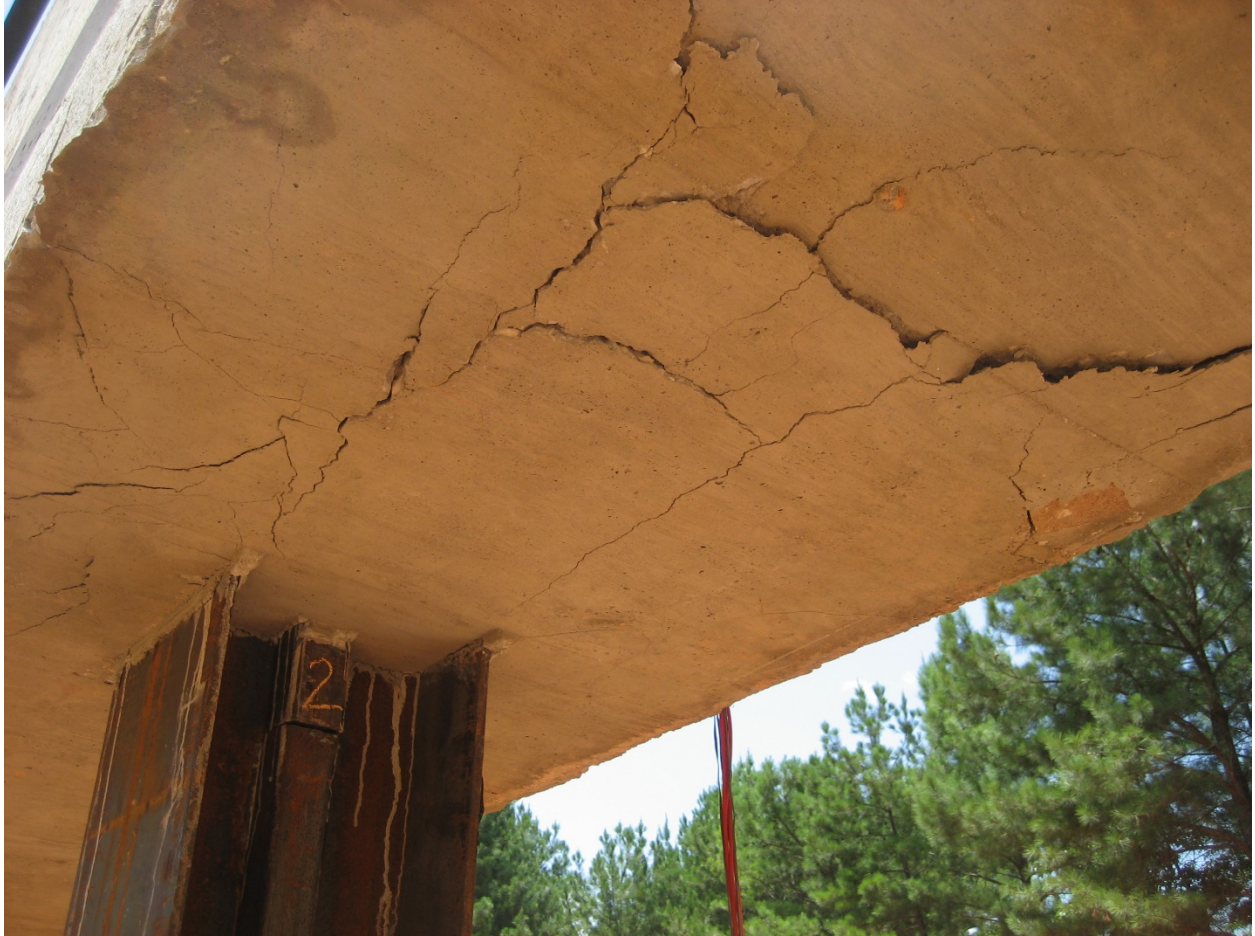
Figure 4-41 – Cracking below the Bent Cap

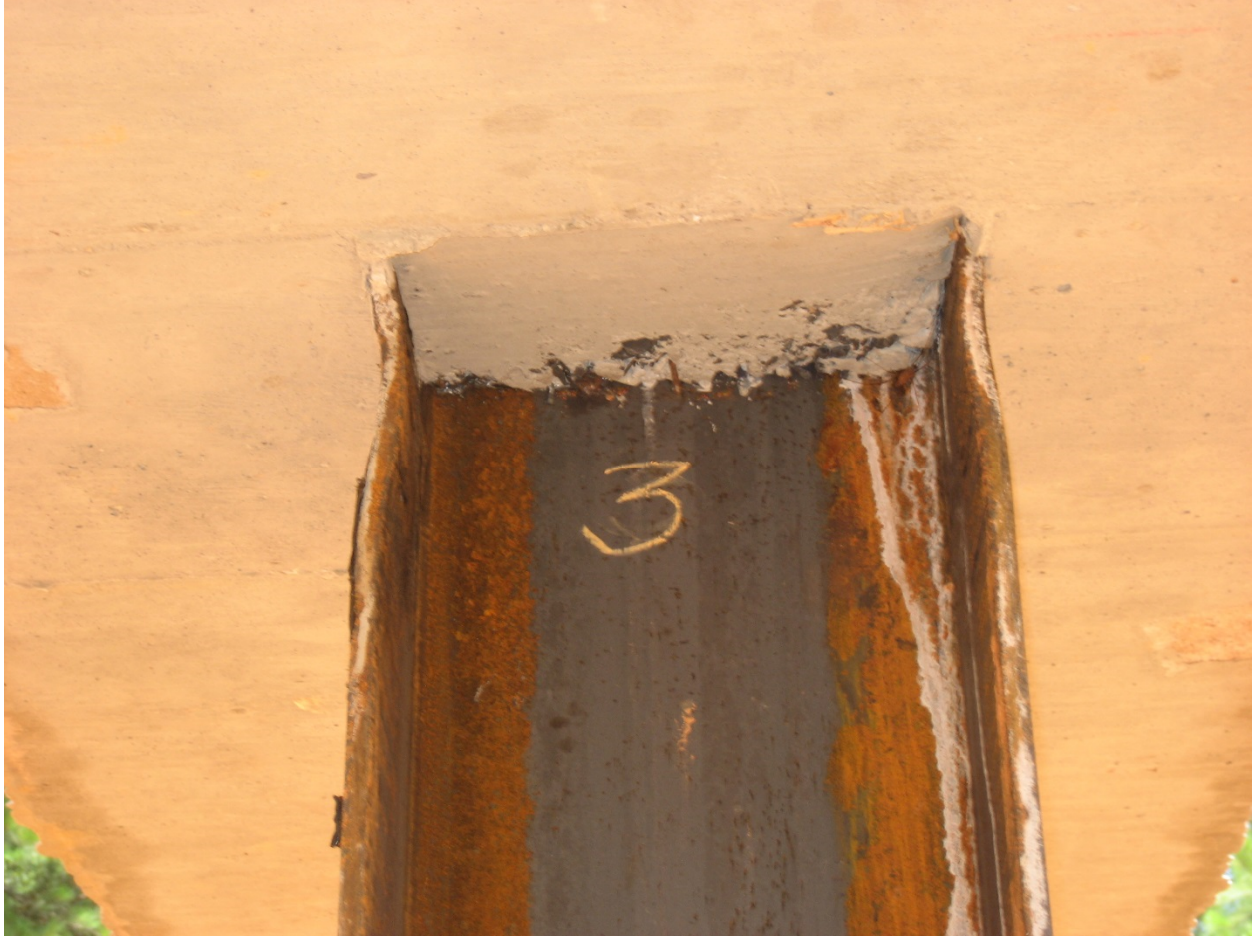
Figure 4-42 – Flange Buckling at Pile 3

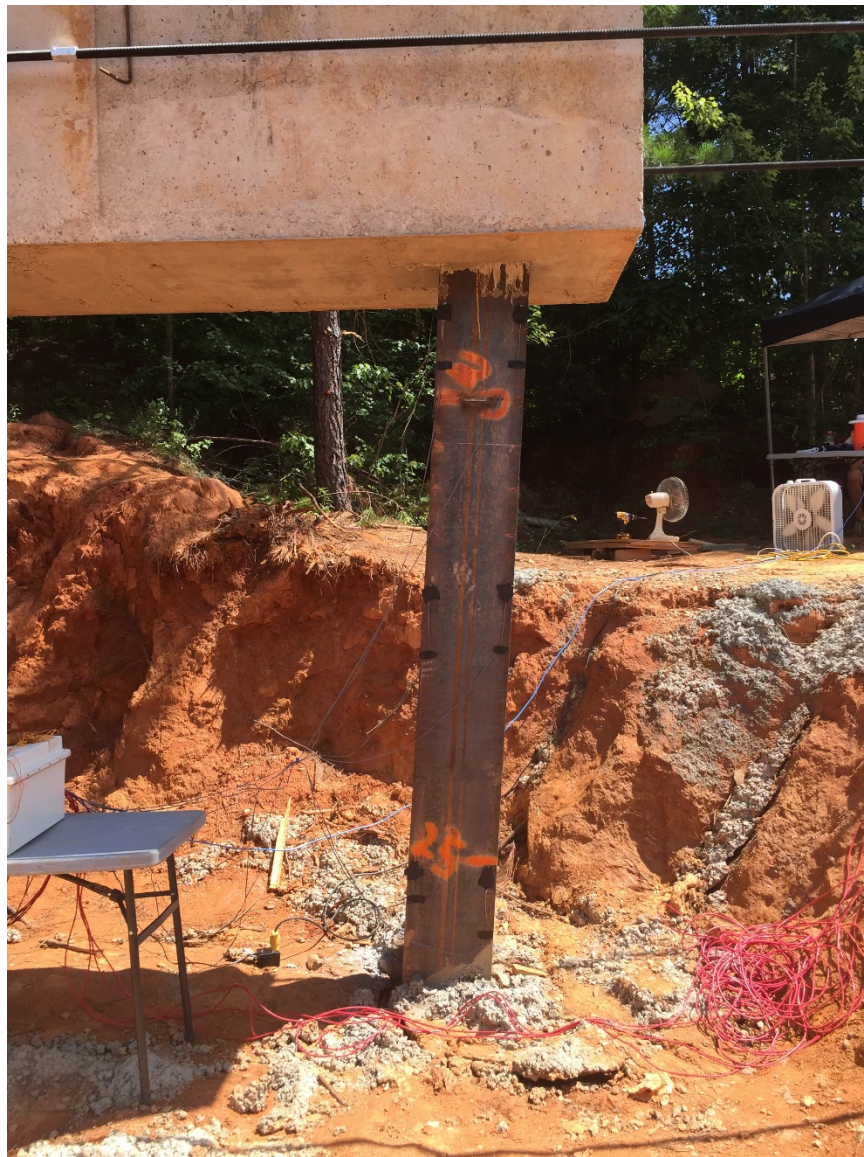
Figure 4-50 – Lateral Deflection Induced in Pile 5 during Field Load Testing

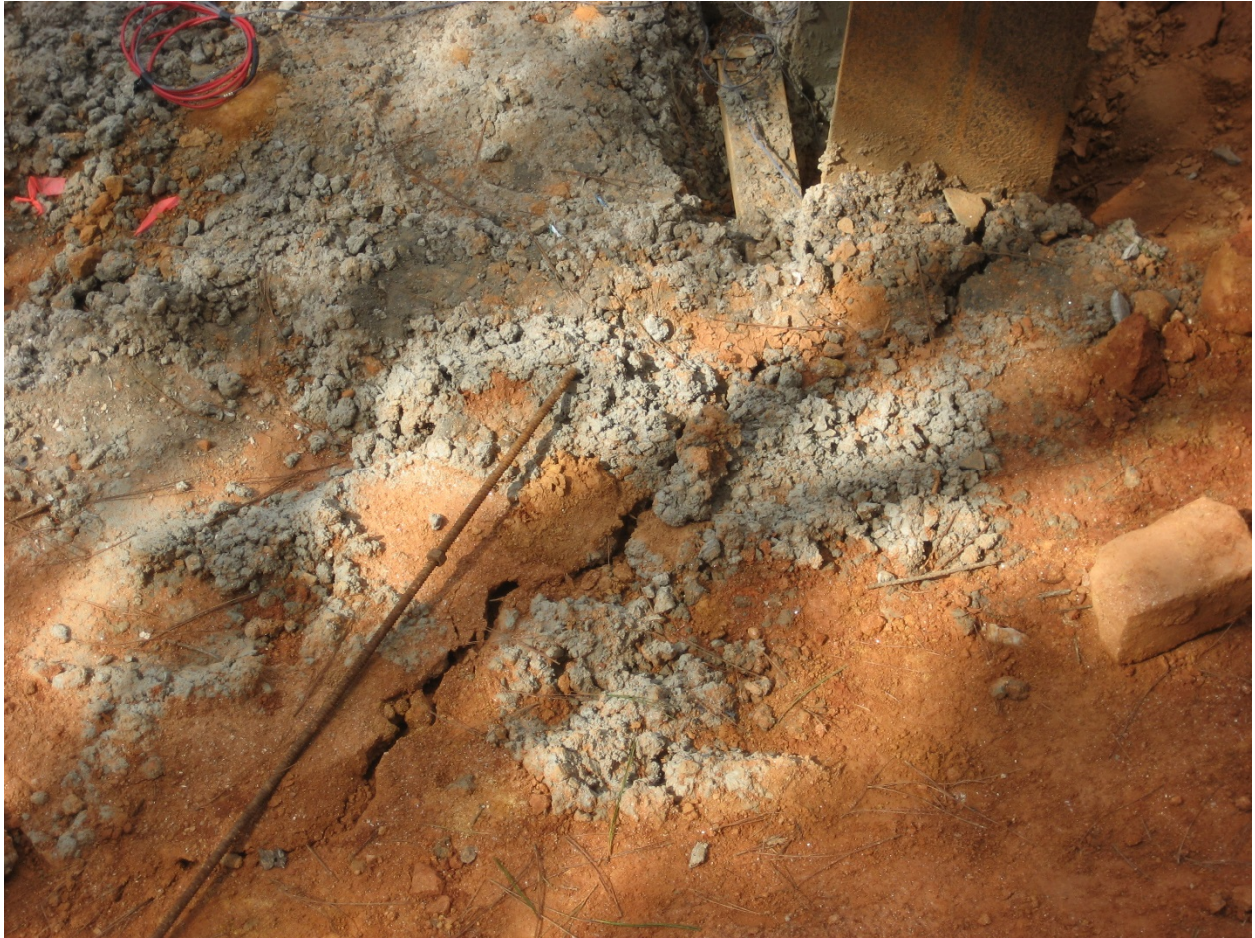
Figure 4-53 – Ground Crack Due to Lateral Load

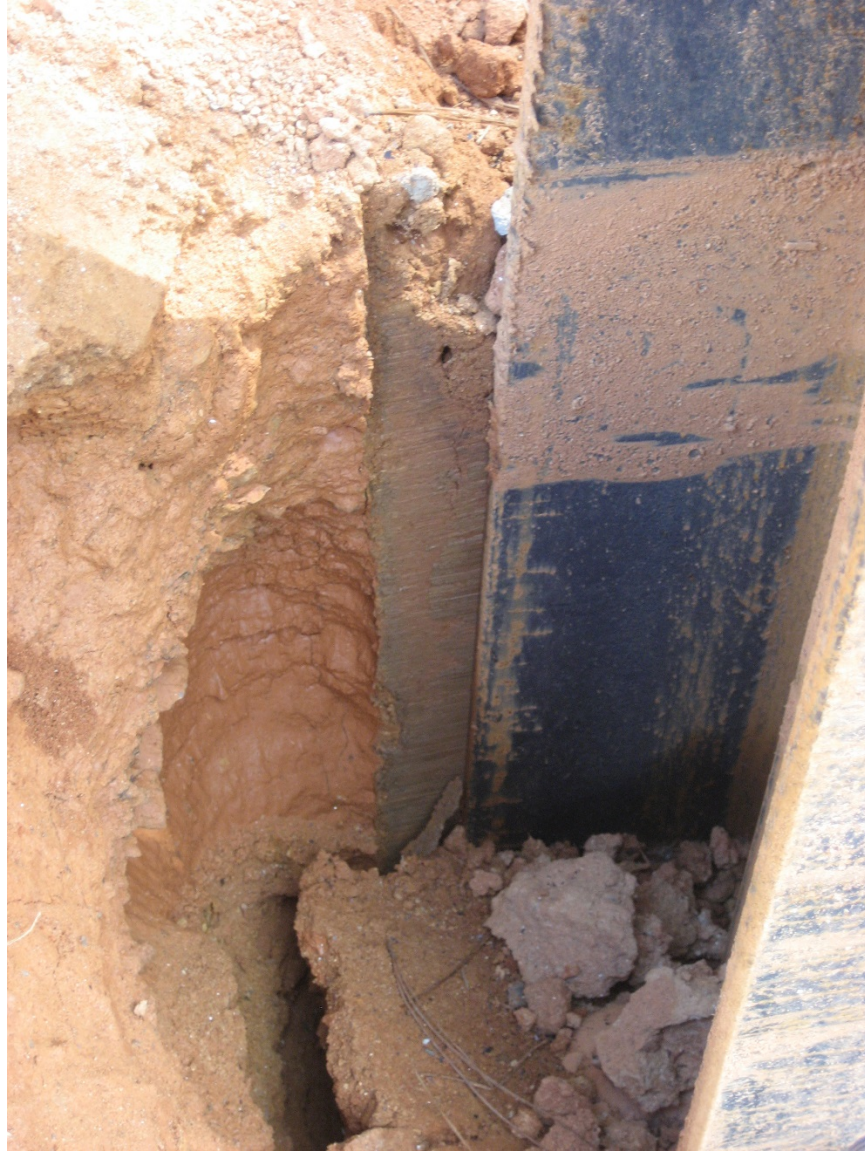
Figure 4-54 – Lateral Displacement of Test Pile
