**Evaluation of Nondestructive Test Methods  
for Concrete Bridge Deck Condition Assessment**

A thesis submitted to the Graduate Faculty of  
Auburn University  
in partial fulfillment of the  
requirements for the Degree of  
Master of Science

Keywords: ground-penetrating radar, impact echo, infrared thermography,  
half-cell corrosion potential, electrical resistivity, deterioration

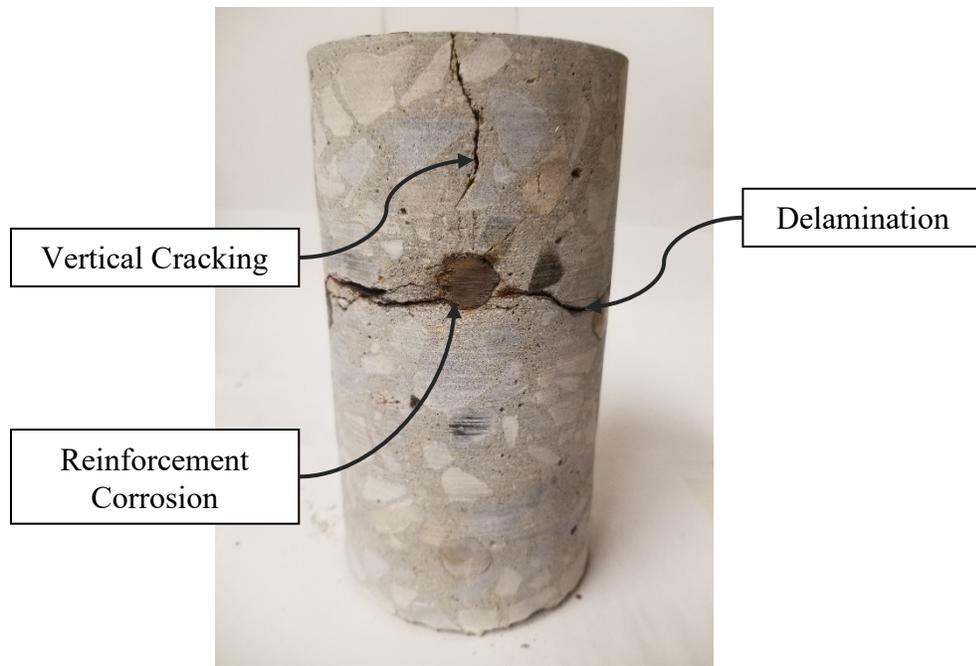
which exist on the same plane as the reinforcing steel. As the corrosion process continues, delaminations can propagate towards the surface and cause spalling. For this reason, it is advantageous to identify delaminations and corrosion as soon as possible. Like delaminations, vertical cracking can be caused by mechanisms other than corrosion. Plastic shrinkage, concrete deterioration, drying shrinkage, thermal effects, and loading can cause the concrete surface to crack, increasing concrete permeability and further heightening the risk of durability concerns (Mehta and Monteiro 2013). Typical corrosion-induced delaminations and vertical cracks from a concrete deck can be observed in Figure 2-2.

**Figure 2-2: Corrosion-Induced Delamination and Vertical Cracking in Concrete**

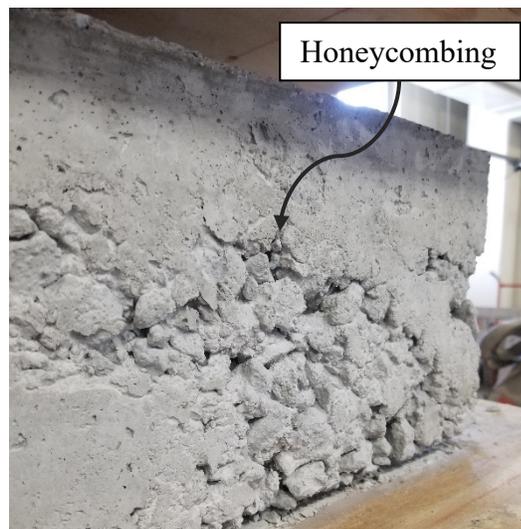
**Figure 2-3: Honeycombing in a Concrete Slab**

improper consolidation practices. Furthermore, when contaminated aggregates are mixed into concrete, the fine sediment attached to the aggregates may break free and combine to create clay balls which cause voids in concrete. Honeycombing occurs when concrete is inadequately consolidated, resulting in voids between nearby coarse aggregate (ACI 2018), giving the loosely connected network of aggregate the appearance of honeycombs. Honeycombing can be caused in reinforced concrete elements by many factors including (1) highly congested reinforcement, (2) low concrete workability, (3) insufficient cover to formed surfaces, (4) improper consolidation of fresh concrete, (5) leaking at joints, and (6) segregation during placement (Emmons 1993). Honeycombing can be observed in the side of the concrete slab, shown in Figure 2-3.

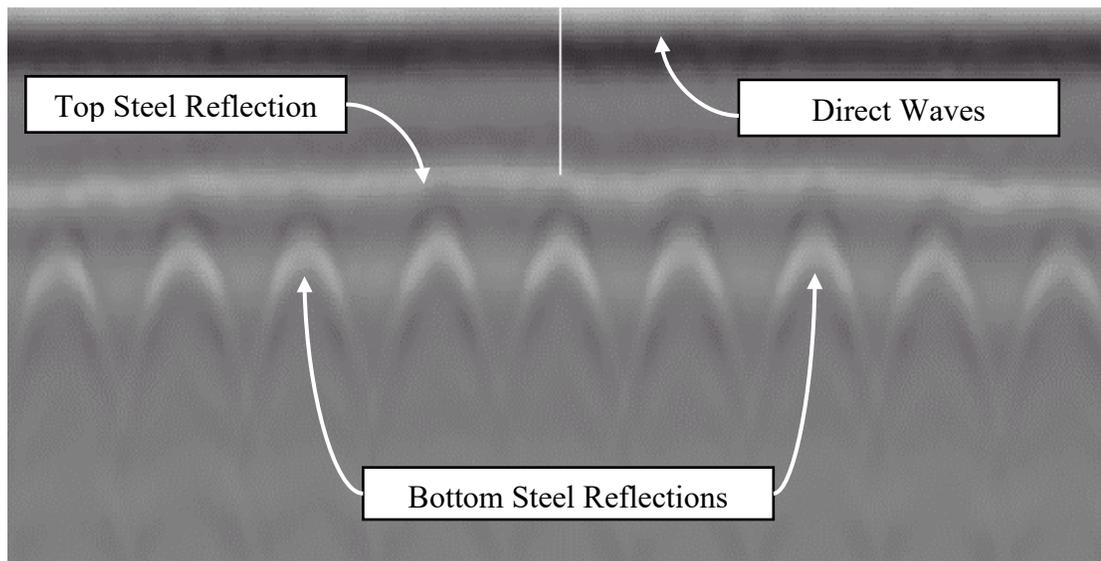
B-scans, of the deck, such as that in Figure 2-4. If the GPR antenna is positioned directly above a steel reinforcement and oriented such that it is pushed parallel to the reinforcement, a straight line is observed at the level of the reinforcement in a B-scan. The horizontal black and white lines shown at the top of the radar profile in Figure 2-4 corresponding to the direct air and direct ground waves. The direct air wave is the first wave that arrives at the receiver, immediately travelling through the air from the transmitter. Moreover, the direct ground wave is the second wave to arrive at the receiver, leaving the transmitter, travelling along the concrete surface, and returning to the receiver.

**Figure 2-4: GPR Scan of a Concrete Bridge Deck**

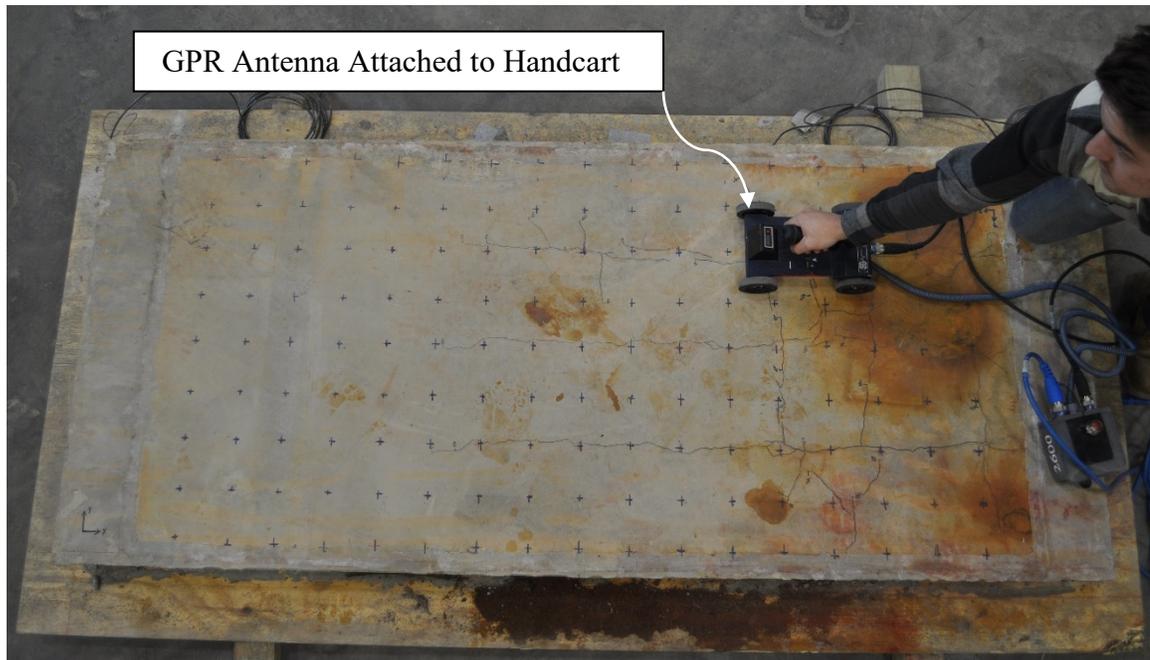
vehicle for air-coupled measurements at high speeds. Accordingly, much research conducted in the recent decades has focused on how best to correlate the results of GPR surveys with the true state of deterioration of bridge decks. A laboratory GPR survey of a fabricated concrete slab with a hand cart can be seen in Figure 2-5.

**Figure 2-5: GPR Evaluation of Deteriorated Laboratory Specimen**

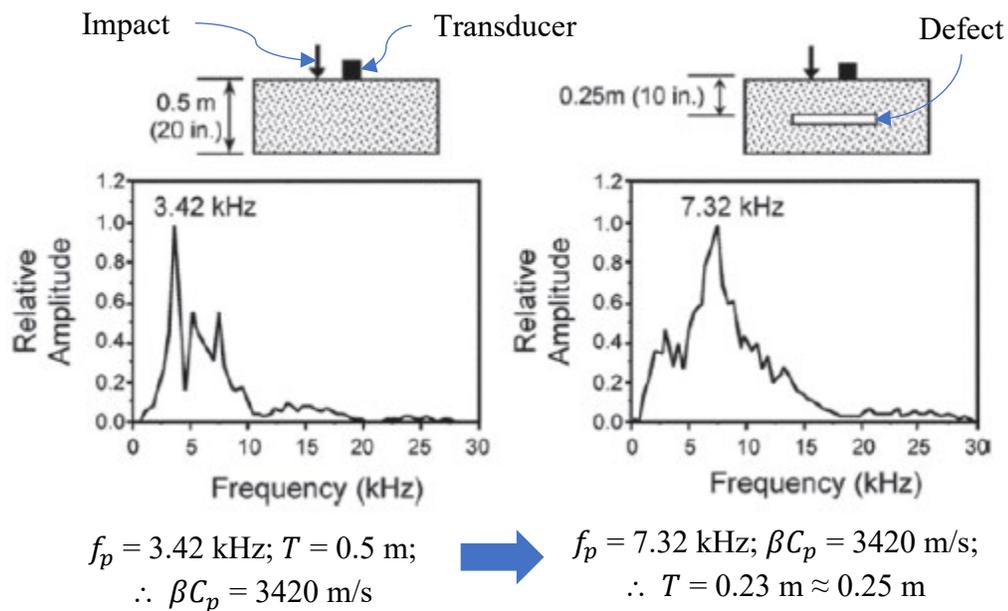
To accurately estimate the depth to a defect, one must confidently know the depth of the tested element to calibrate the P wave velocity. Once that has been determined, measurements may be taken at any point on the slab, peak frequencies can be identified, and the depth to the peak reflections may be calculated using Equation 2.2. A schematic illustrating the IE method can be seen in Figure 2-6.

**Figure 2-6: Validation of IE Method on Concrete Slabs (Adapted from ACI Committee 228 2013)**

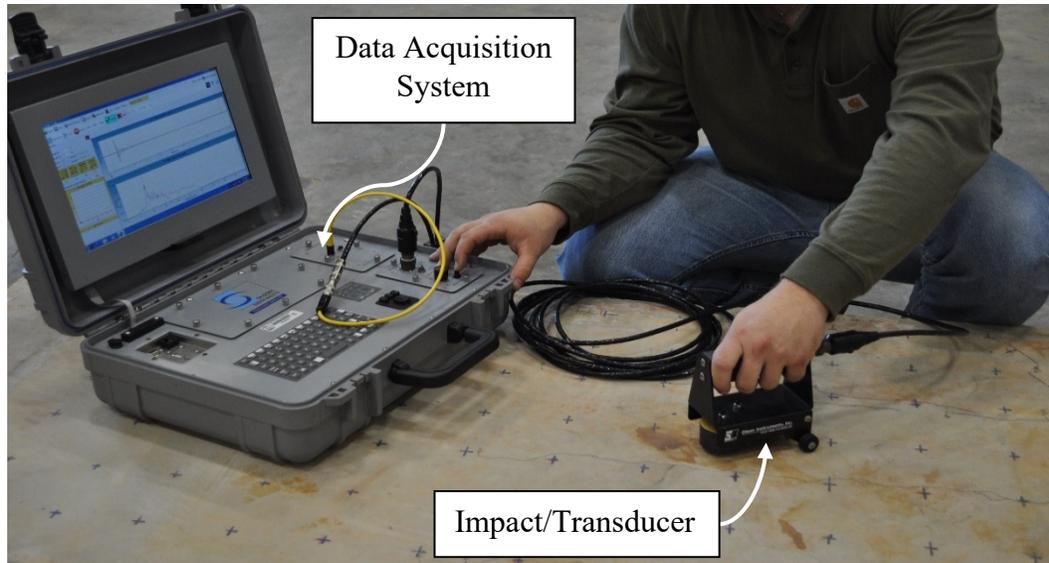
displacements resulting from impact and accompanying frequency spectra were displayed on the shown data acquisition system.

**Figure 2-7: IE Evaluation of Deteriorated Laboratory Specimen**

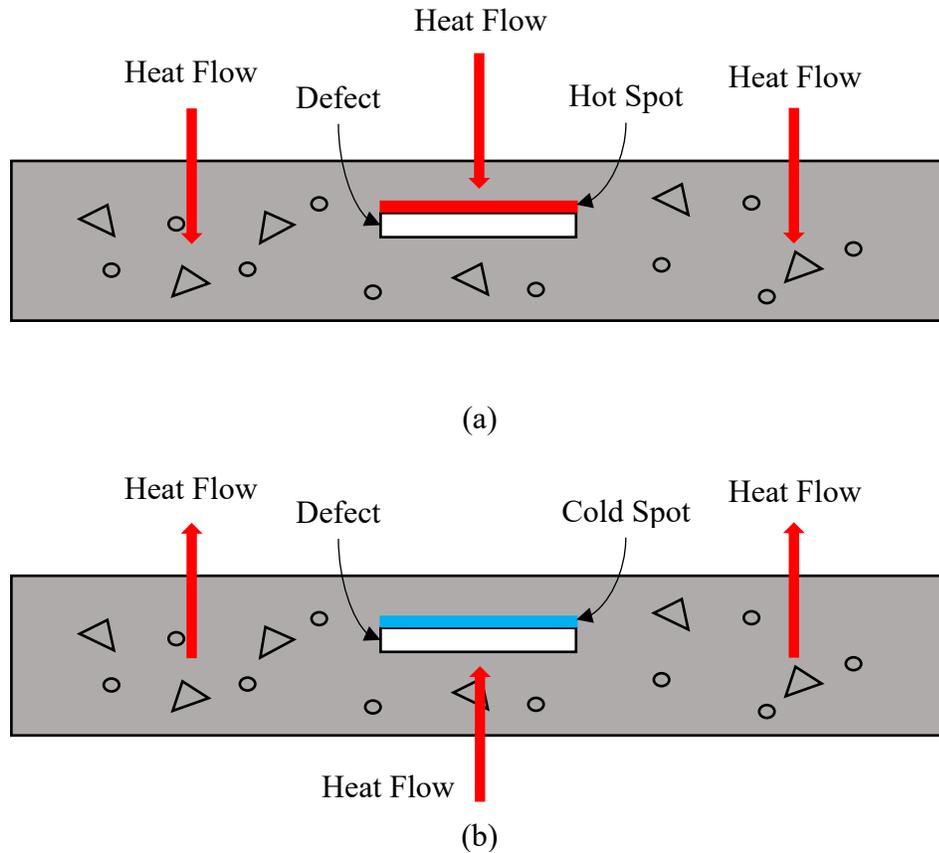
and “cold spots” during the evening when it is cooling. This behavior is illustrated in Figure 2-8.

**Figure 2-8: Effect of Defects on Deck Temperature Distribution during (a) Heating and (b) Cooling (Adapted from ACI Committee 228 2013)**

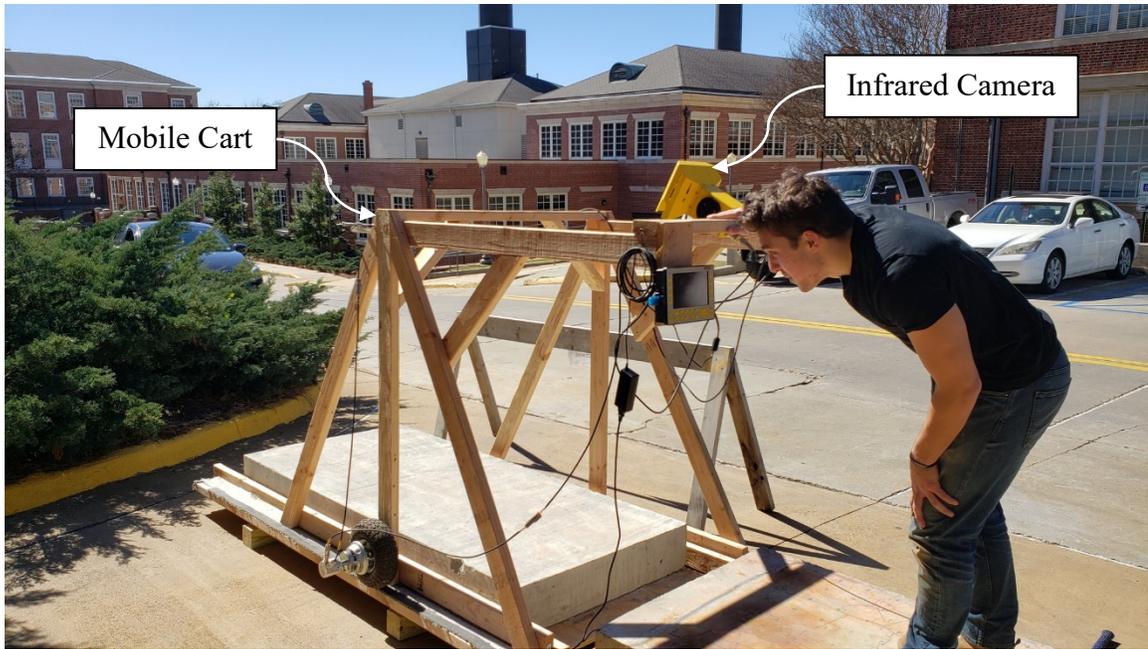
and sporadic cloud coverage can inhibit accurate condition assessment with IRT. An IRT evaluation of a laboratory concrete specimen with a novel cart can be seen in Figure 2-9.

**Figure 2-9: IRT Evaluation of Deteriorated Laboratory Specimen**

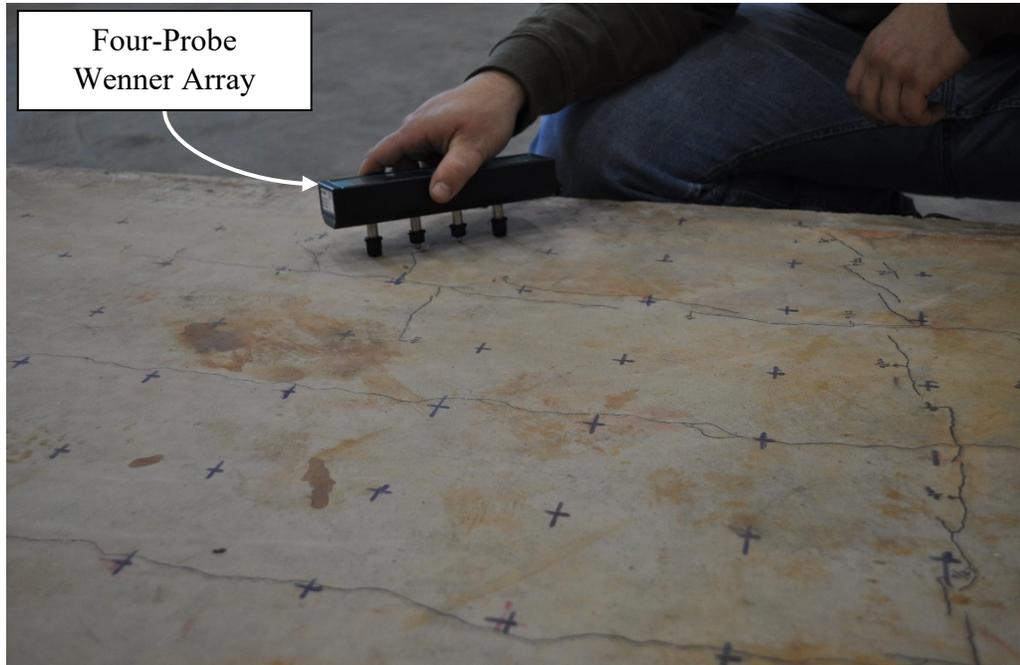
An ER evaluation of a concrete specimen distressed from corrosion can be seen in Figure 2-13.

**Figure 2-13: ER Evaluation of Deteriorated Laboratory Specimen**

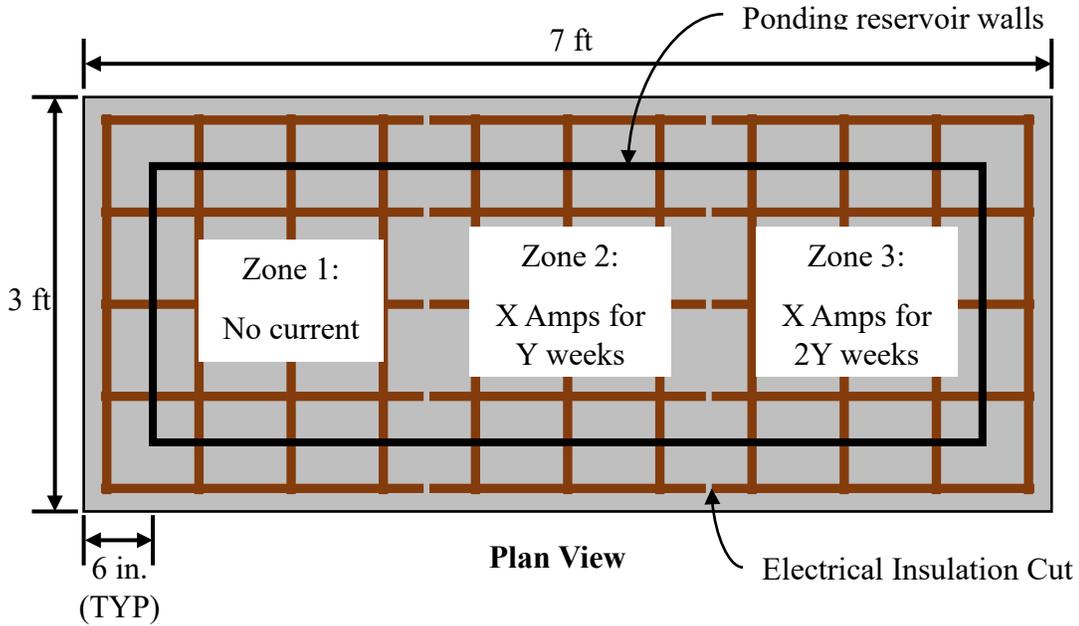
Zones 2 and 3; the cuts in the reinforcement mats mitigated flow of current between adjacent zones.

**Figure 4-1: Conceptual Plan View of Specimens C1 and C2**

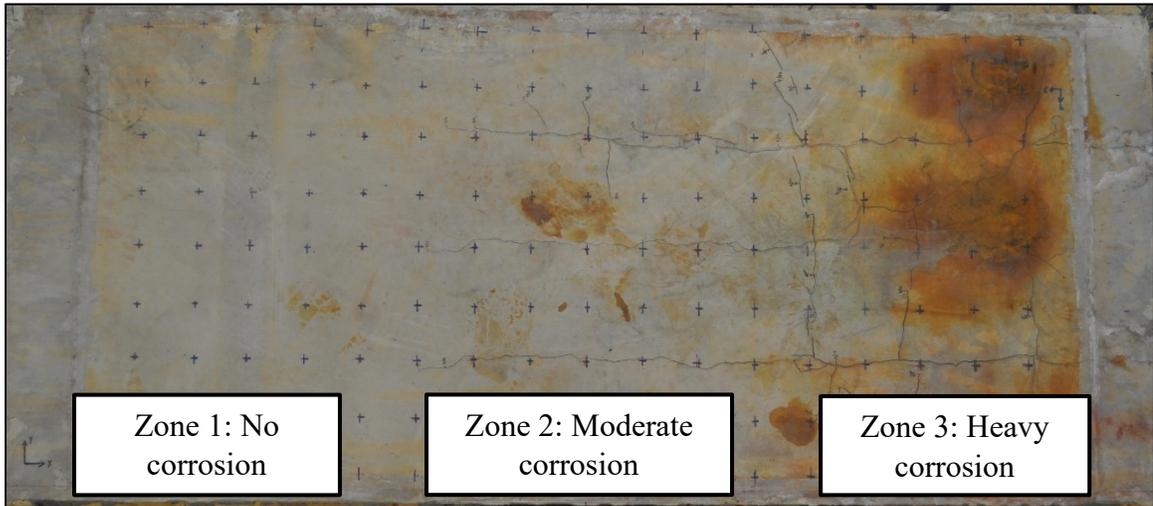
substantial surface staining from corrosion products traveling upwards through the cover layer, as seen in Figure 4-2. The location and quantity of corrosion products corresponded well with the hypothesized zones of corrosion.

**Figure 4-2: Plan View of Specimen C2 after Accelerated Corrosion.**

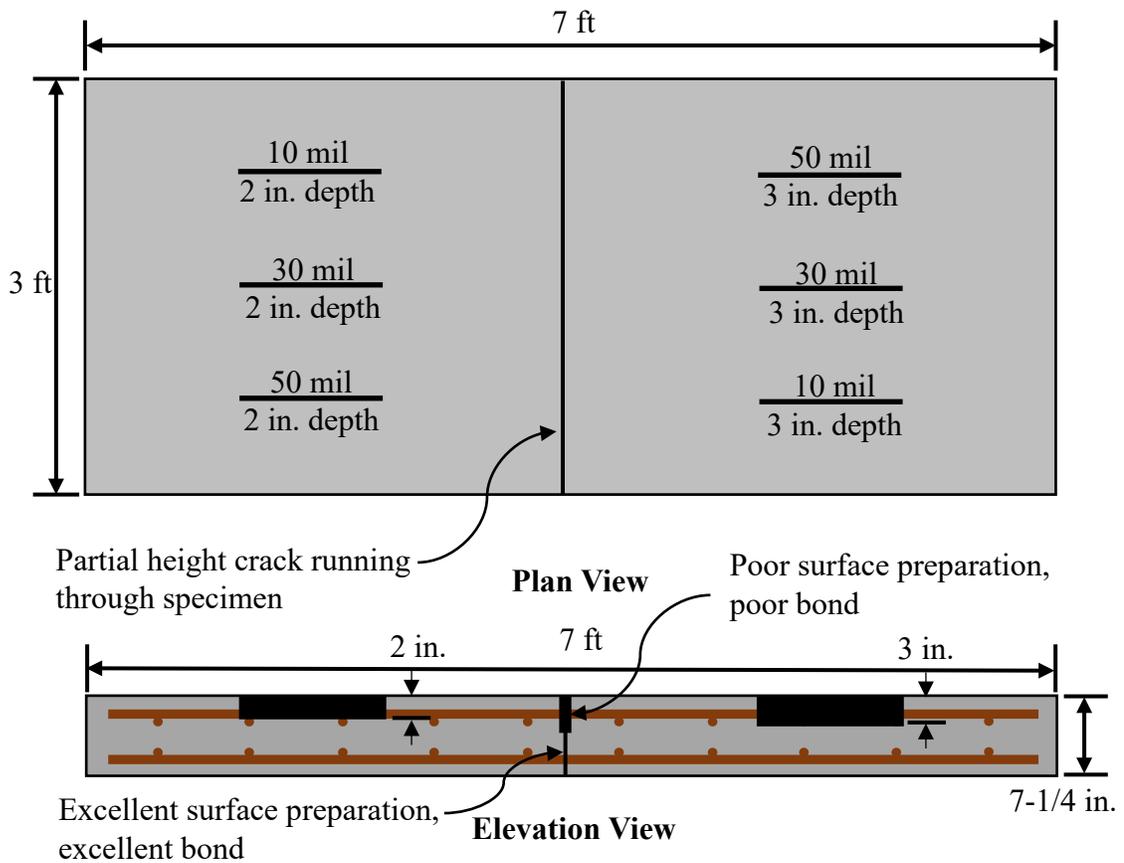
Specimen CR1 was designed to simulate vertical cracks of varying thicknesses, extents, and depths that might occur in an in-service bridge deck. In accordance with similar vertical crack simulation implemented by Lin et al. (2018), partial depth cracks of varying thickness were simulated using plastic sheeting, as can be observed in Figure 4-3. Furthermore, a partial depth crack spanning the width of the specimen was simulated by casting the right and left portions of the slab separately and forming the two together using a cold joint. The top of the contact interface of the two portions was poorly prepared to replicate cracking damage while the lower part was made to bond well together.

**Figure 4-3: Conceptual Views of Specimen CR1**

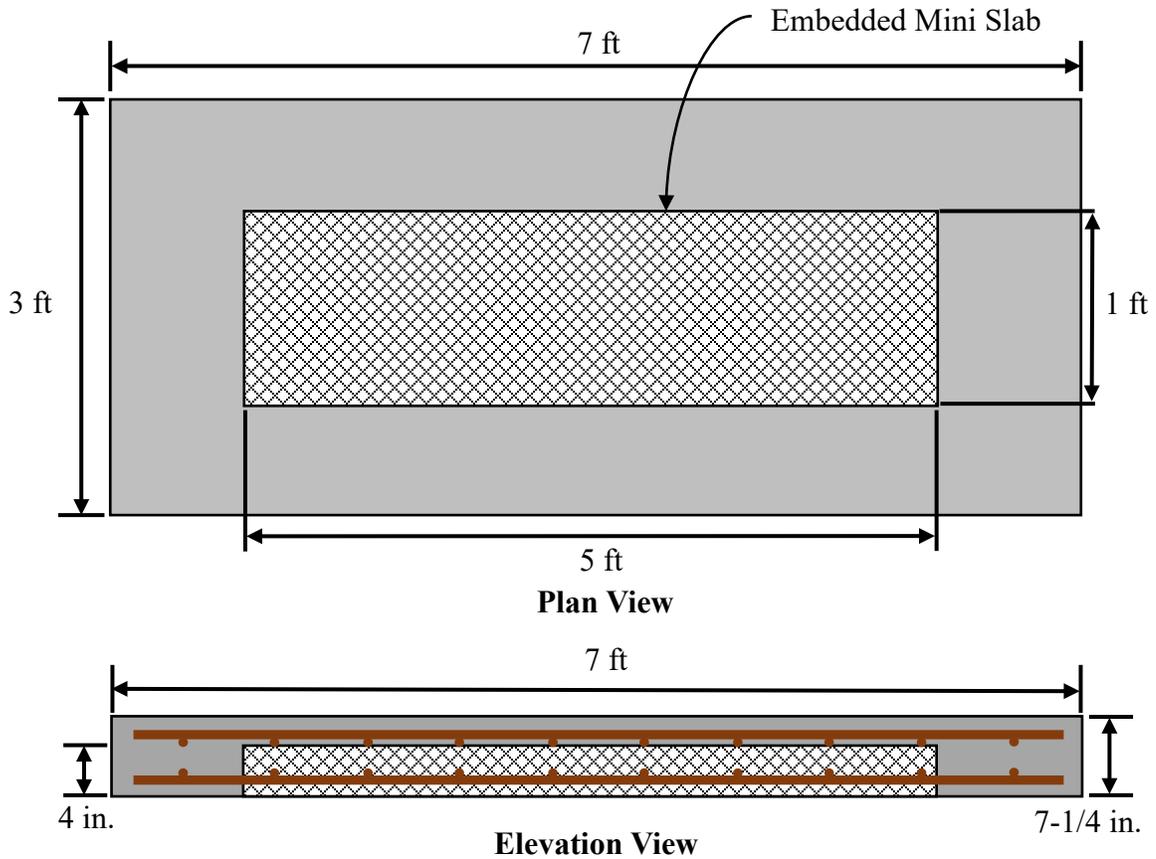
in. of cover to the topmost reinforcement was provided to be representative of a typical Alabama bridge deck.

**Figure 4-4: Conceptual Views of CTRL and DE Specimens**

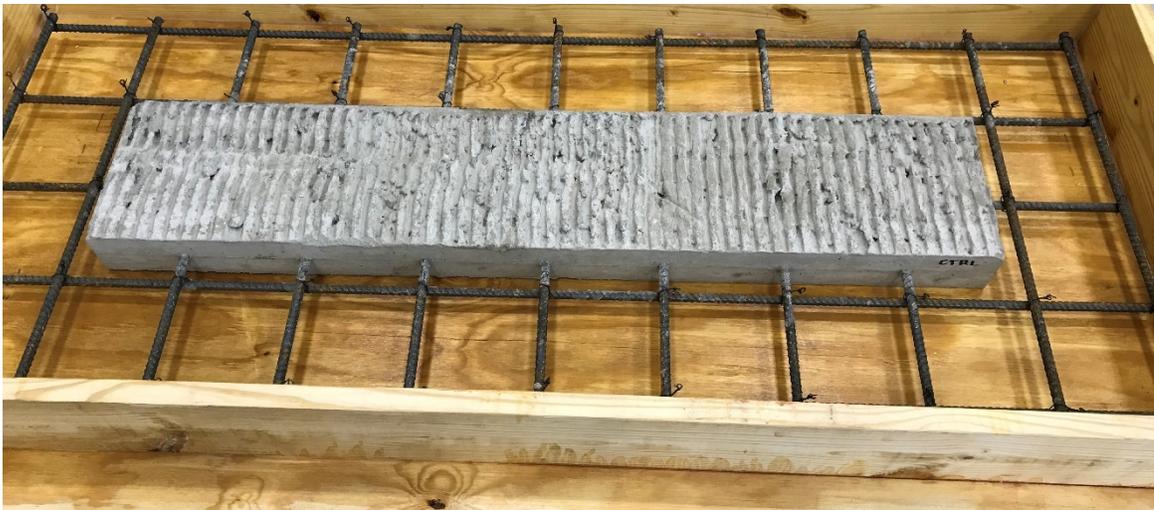
surrounding concrete, rather than the defects simulated in the miniature slabs of the DE specimens. Thus, if an NDT method indicated that there was a defect at the location of the miniature slab in the control specimen, it would make it difficult to claim that the NDT method responded to a simulated defect in a DE specimen. As with all miniature slabs fabricated for this study, the surface of the miniature slab of the control specimen was intentionally roughened to allow for improved bond with the surrounding concrete to be placed, as can be seen in Figure 4-5.

**Figure 4-5: Miniature Slab for Test Specimen CTRL**

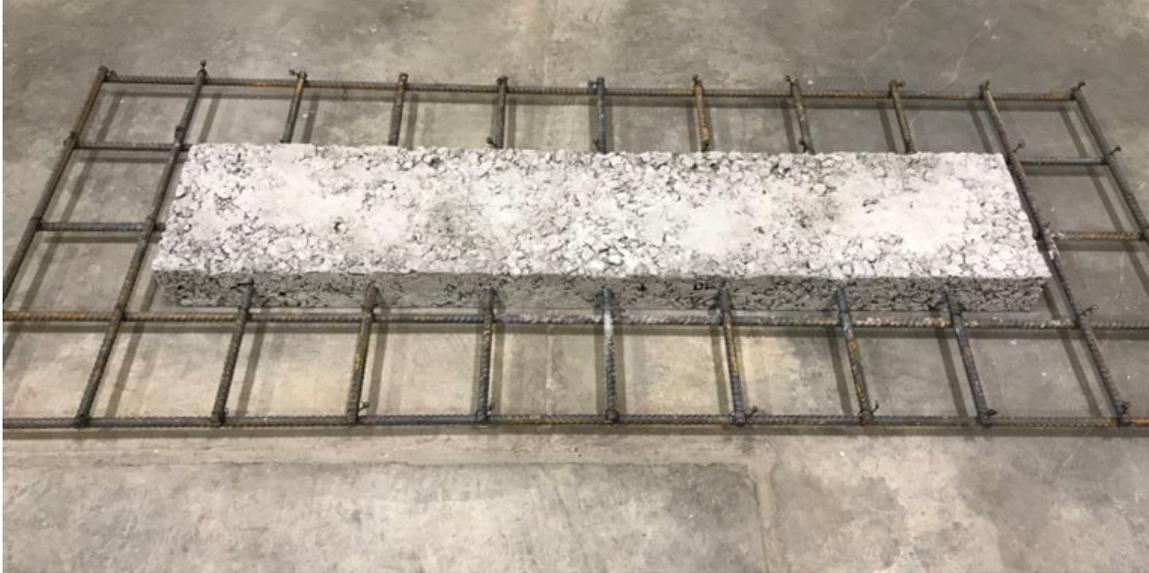
of Specimen DE3 was constructed using concrete with a high degree of honeycombing, as can be observed in Figure 4-6.

**Figure 4-6: Miniature Slab for Test Specimen DE3**

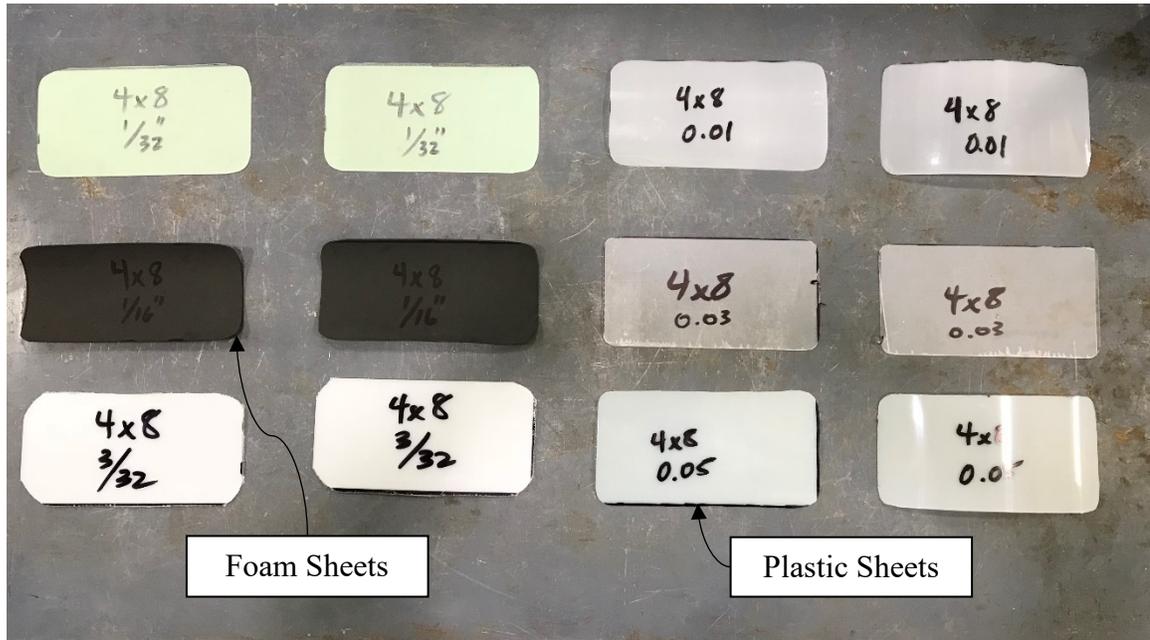
were fabricated with 4 in. by 8 in. plastic and foam sheets of varying thicknesses, as shown in Figure 4-7, to determine what is the thinnest detectable delamination for each NDT method.

**Figure 4-7: Plastic and Foam Inserts for Delamination Simulation**

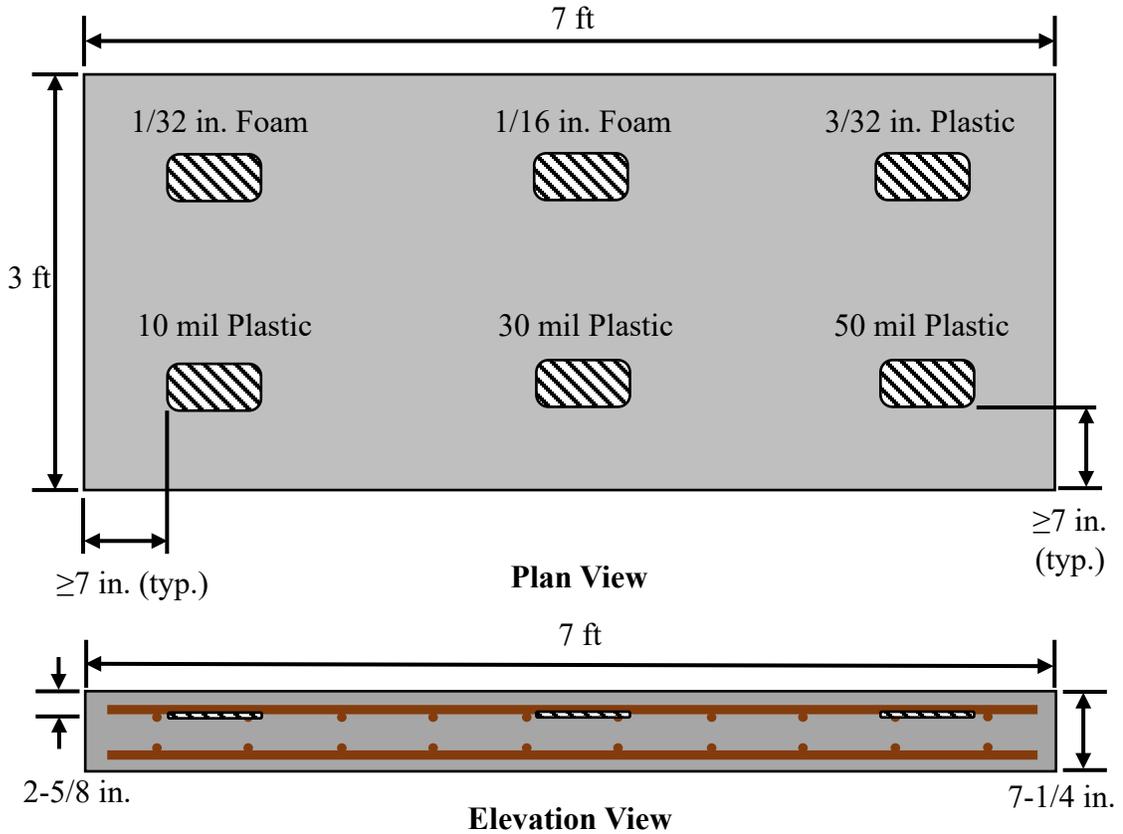
are termed “deep delaminations”. As can be observed in Figure 4-8, the depth to the shallow delaminations in Specimen DL1 was approximately 2-5/8 in.

**Figure 4-8: Conceptual Views of Specimen DL1**

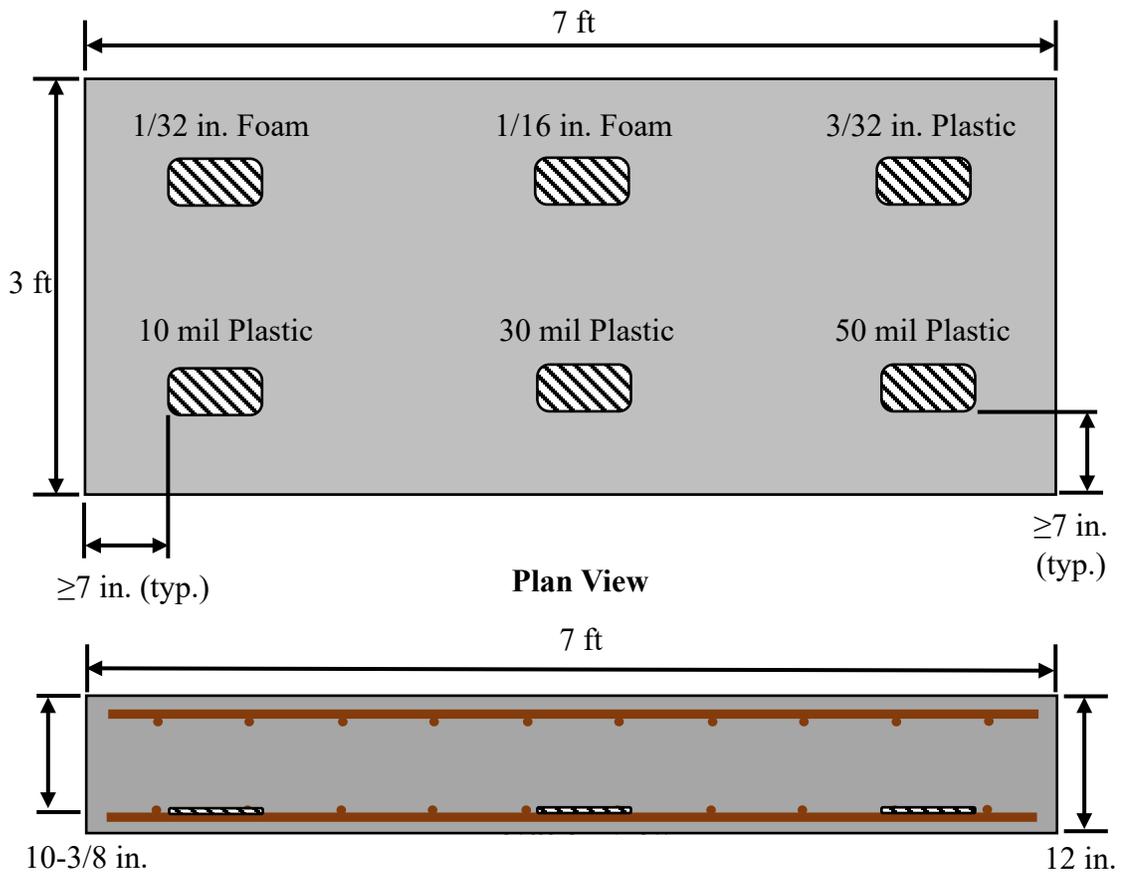
Delaminations placed in Specimen DL2, shown in Figure 4-9, were of the same in-plane dimensions and thicknesses as those from Specimen DL1. The two sets of delaminations differed only in depth; the deep delaminations in Specimen DL2 were placed 10-3/8 in. below the top surface rather than 2-5/8 in.

**Figure 4-9: Conceptual Views of Specimen DL2**

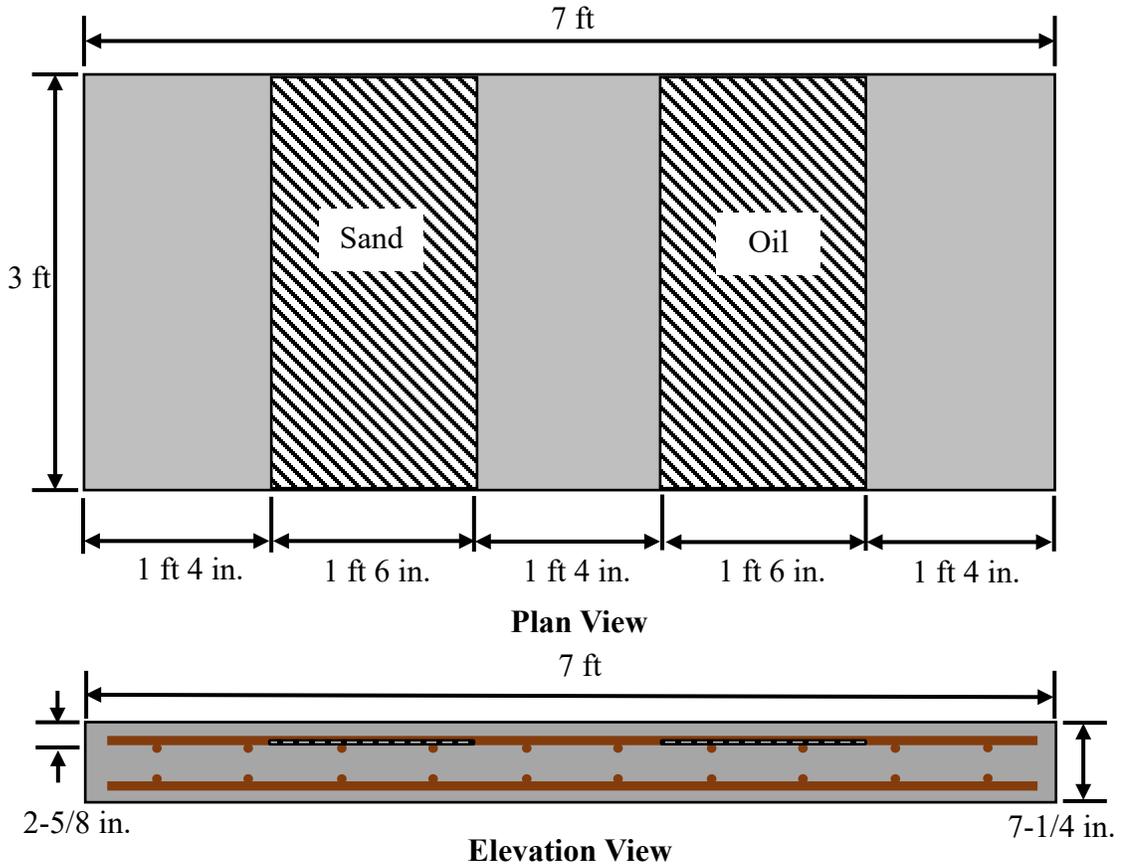
except that Specimen DL3 had shallow delaminations in a 7-1/4 in. thick slab while Specimen DL4 had deep delaminations in a 12 in. thick slab.

**Figure 4-10: Conceptual Views of Specimen DL3**

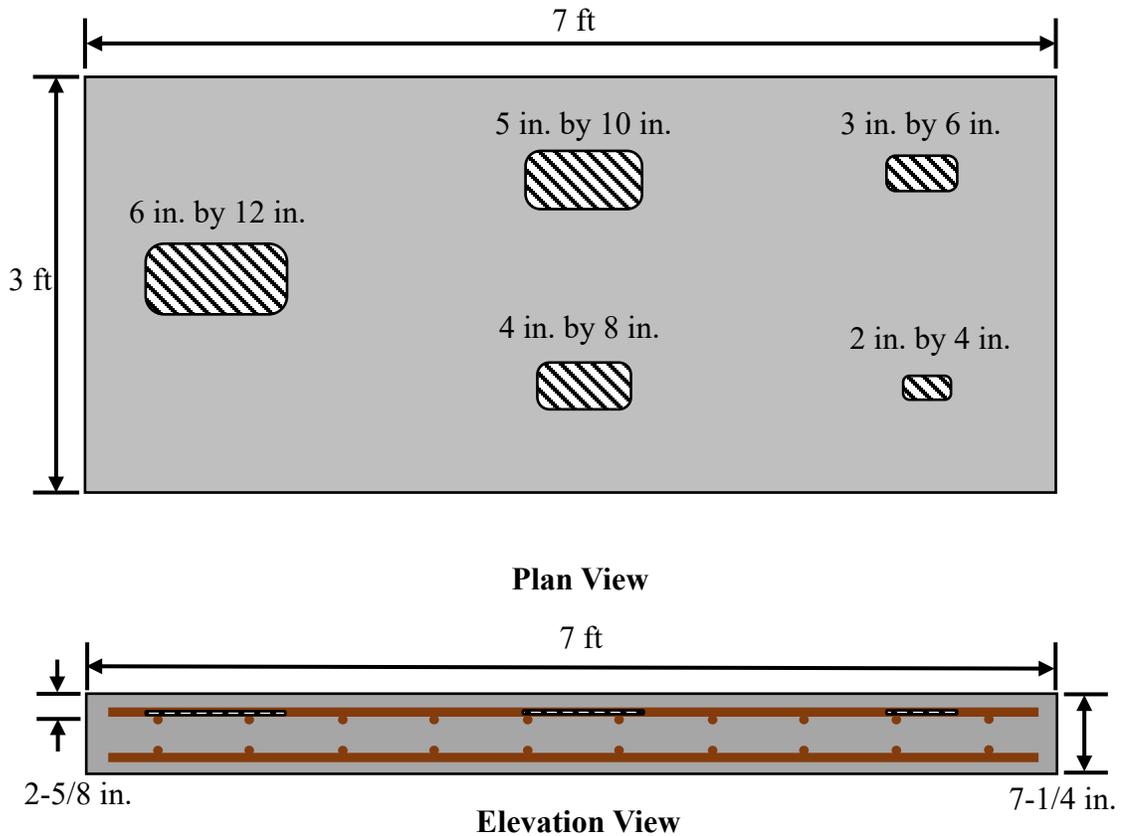
Apart from delamination depth and thickness, it was expected that the in-plane dimensions of a delamination would affect its detectability using NDT methods. To explore this notion, Specimens DL5 and DL6 were fabricated, respectively containing shallow and deep delaminations of varying areal extent. Shallow delaminations were placed in Specimen DL5, as can be observed in Figure 4-12, while deep delaminations were simulated in Specimen DL6. As in Specimens DL1–2, delaminations were simulated using plastic inserts that were pinched between perpendicular reinforcement in the top and bottom mats. Analogous to the relationship of Specimens DL2 and DL4 to DL1 and DL3 respectively, Specimen DL6 was the “deep counterpart” to Specimen DL5.

**Figure 4-12: Conceptual Views of Specimen DL5**

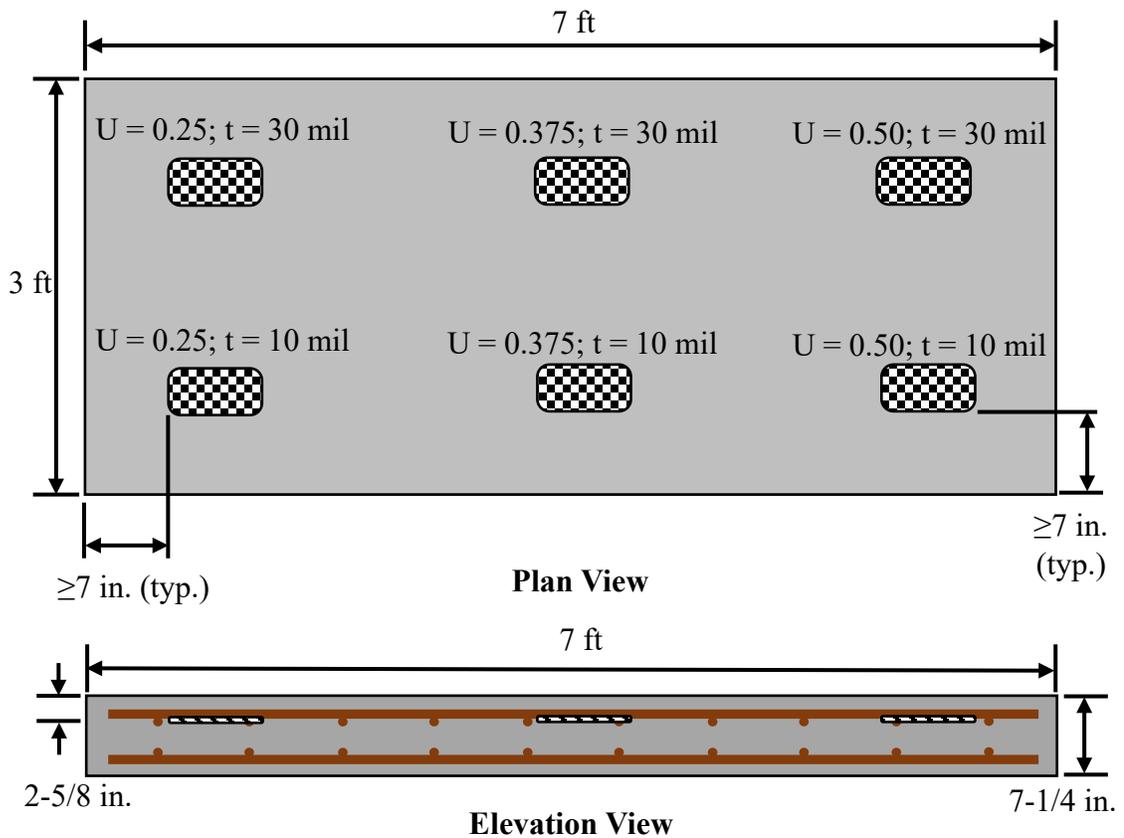
Lastly, Specimens DL7–8 were constructed to investigate the influence of unbonded fraction of area on delamination detectability. Inspired by work performed by Lin and Sansalone (1996), partially bonded delaminations were simulated in these two specimens using plastic inserts with checkerboard cuts to allow for concrete above and below the cuts to bond together, causing the partially bonded delaminations, as can be observed in Figure 4-13. Note that ‘U’ refers to the fraction of unbonded area (solid plastic) and ‘t’ refers to the thickness of the plastic inserts.

**Figure 4-13: Conceptual View of Specimen DL7**

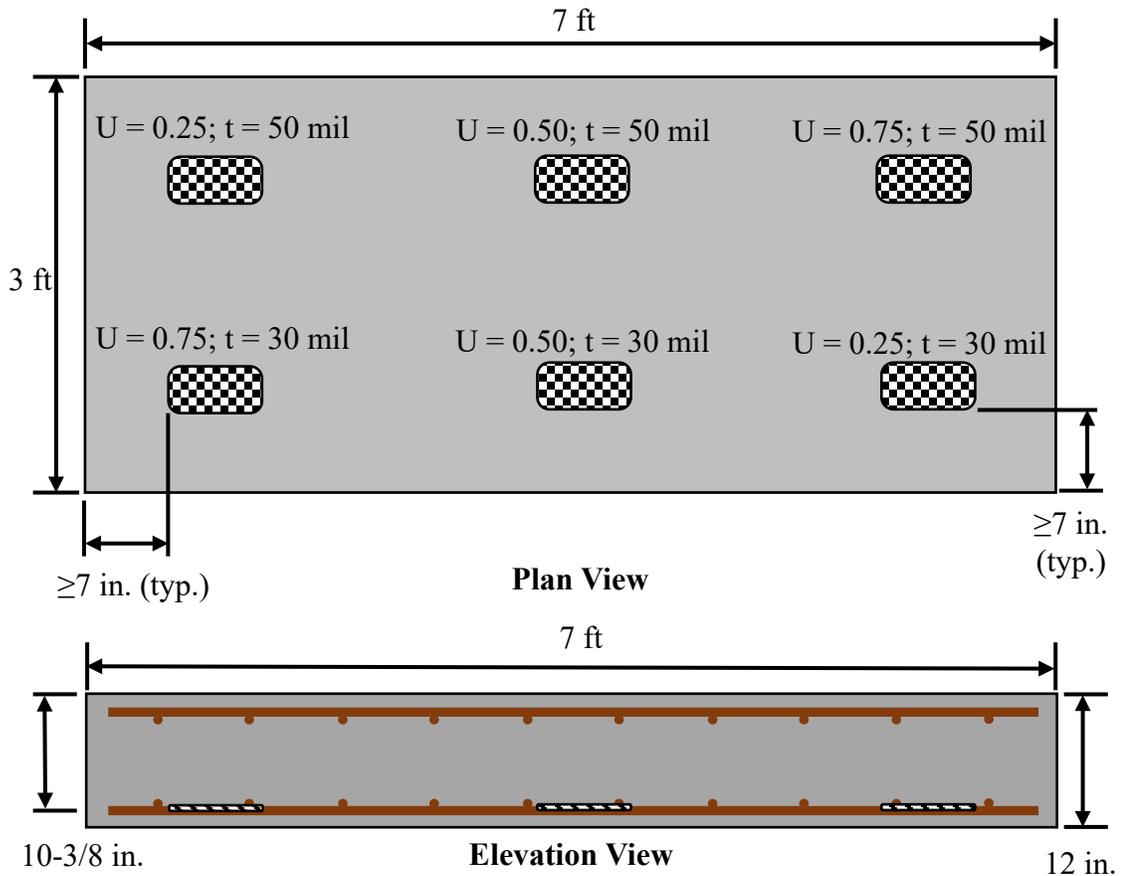
In both specimens, plastic inserts were also of varying thickness to explore the interdependence of delamination thickness and fraction of unbonded area on detectability. The thicknesses and unbonded fractions of the partially bonded delaminations in Specimen DL8, shown in Figure 4-14, were greater than those of Specimen DL7 as it was hypothesized that the greater depth to the deep delaminations would greatly attenuate incident NDT waves, thus requiring more severe defects to be detected.

**Figure 4-14: Conceptual Views of Specimen DL8**

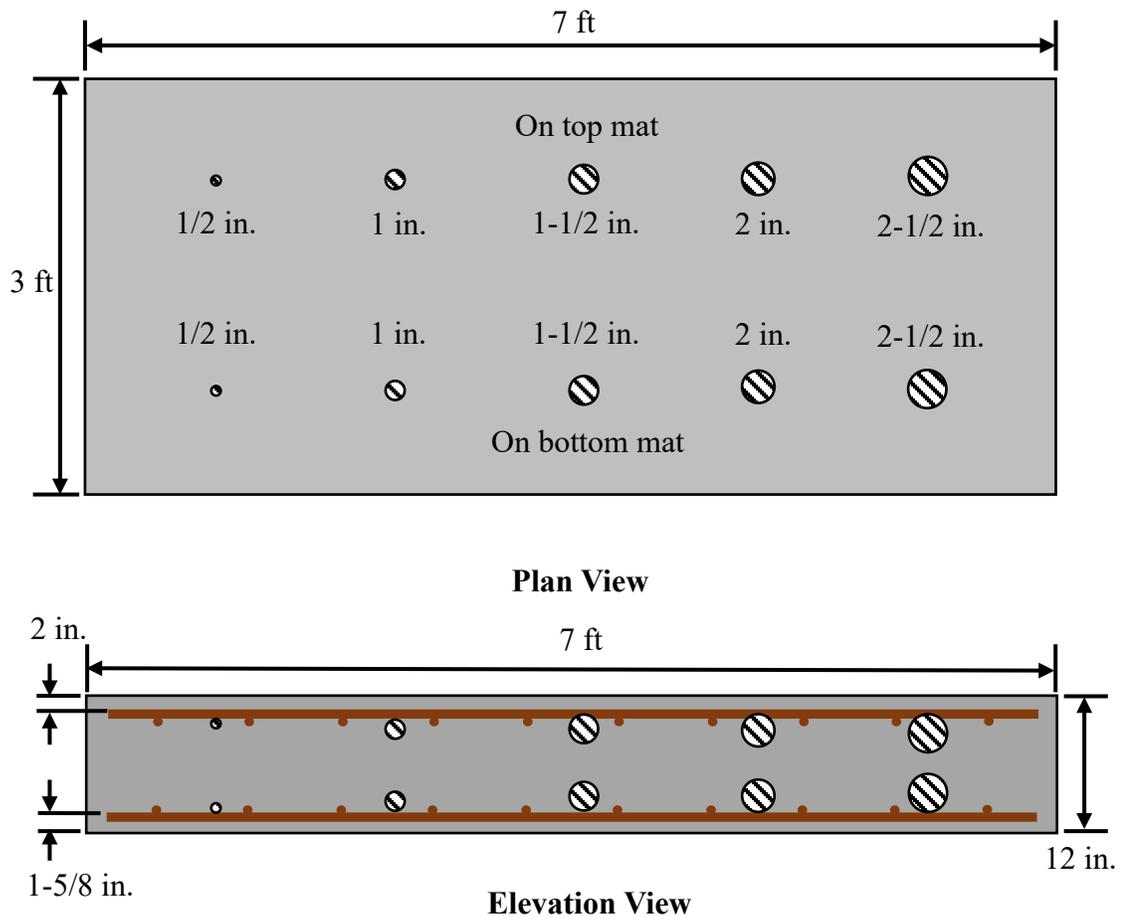
Test Specimens V1 and V2 were fabricated to evaluate the ability of NDT methods to identify voids in concrete bridge decks. Such voids can be the result of poor-construction practices and may be filled with either water or air. Similarly, voids in concrete may be the result of the use of unclean aggregates in concrete mixtures. During mixing, particulates on the aggregates are freed and agglomerate, forming balls of sediment. Such agglomerates can cause voids in concrete if placed in the bridge deck. Accordingly, the void specimens were built to be representative of these types of voids that may be found in a concrete bridge deck. Voids of diameters ranging between 1/2 in. to 2-1/2 in. were simulated in both Specimens V1 and V2, as can be observed in Figure 4-15. Furthermore, voids were placed on both the top and bottom reinforcement mats to explore the influence of depth on void detectability.

**Figure 4-15: Conceptual Views of Void Specimens**

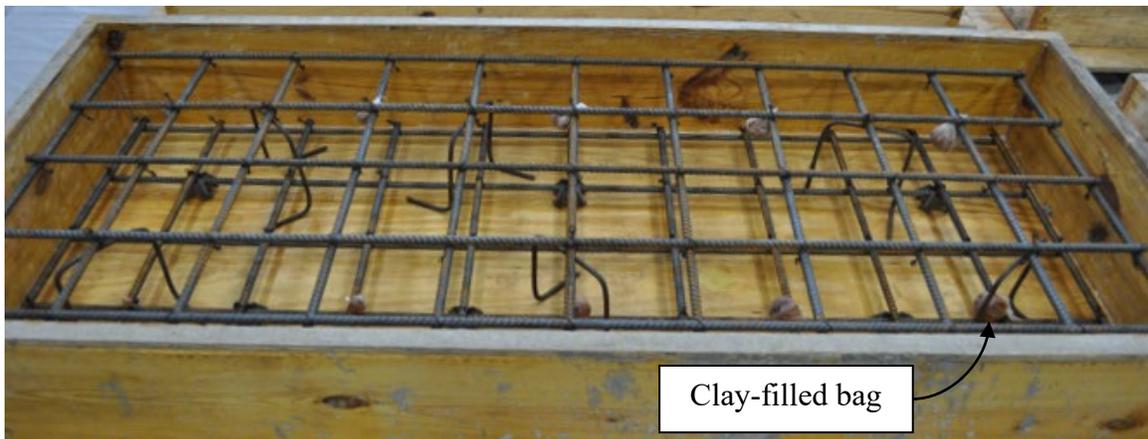
**Figure 4-17: Clay Void Installation in Specimen V2**

In Specimen V1, voids were placed in the concrete by filling balloons with water and tying them to the reinforcement mats, as can be observed in Figure 4-16. To simulate clays balls in concrete, plastic bags were loosely filled with clay and placed in Specimen V2 as shown in Figure 4-17. As in Specimen V1, the bags were tied to the top and bottom reinforcement mats to keep them in place during concrete placement.

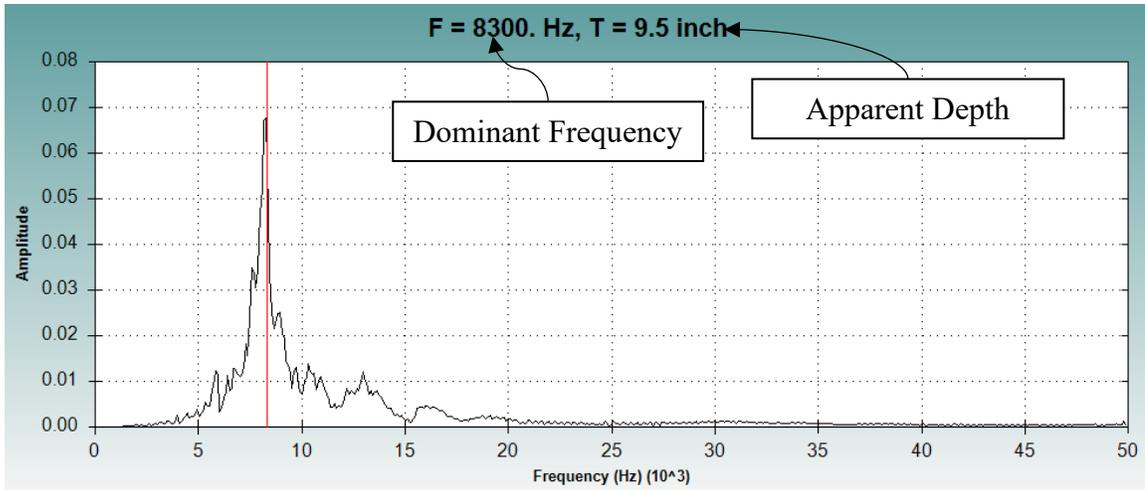
grid points. An auto-picking tool was used to select the dominant frequency excited during testing which was used to estimate the depth of response, as can be seen in Figure 4-18.

**Figure 4-18: Typical Frequency Response Data from an Impact-Echo Test**

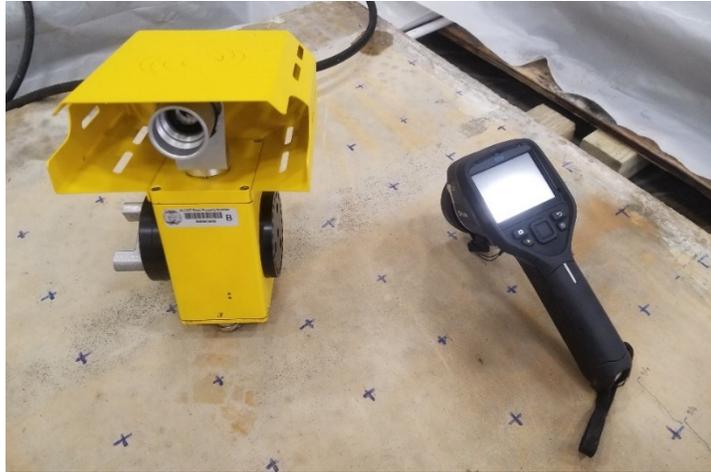
**Figure 4-19: MOBA MTPS-100 and FLIR E60 Thermal Cameras (Left to Right)**

To evaluate the capability of the infrared thermography method to detect defects in reinforced concrete bridge decks, two infrared cameras were used. Shown in Figure 4-19, a FLIR E60 handheld infrared camera was used to capture discrete thermal images of test specimens while continuous thermal profiles of the specimens were collected using a MOBA MTPS-100.

It was expected that both cameras would be capable of identifying surface temperature differentials typical of concrete bridge deck defects. As ASTM D4788 (2013) recommends using a thermal sensor with a minimum resolution of 0.2°C, the FLIR E60 possessed a sufficient resolution of about 0.05°C at 30°C (FLIR 2014) to fulfill ASTM guidance. With a thermal resolution of 0.1°C (MOBA 2014), the MTPS-100 also fulfilled the foregoing ASTM recommendation. Additionally, the FLIR E60 and MTPS-100 can

measure object temperatures in the range of  $-20^{\circ}\text{C}$  to  $+120^{\circ}\text{C}$  and  $0^{\circ}\text{C}$  to  $280^{\circ}\text{C}$  respectively which both cover the scope of typical surface temperatures of bridge decks.
