**Evaluation of Nondestructive Test Methods  
for Concrete Bridge Deck Condition Assessment**

A thesis submitted to the Graduate Faculty of  
Auburn University  
in partial fulfillment of the  
requirements for the Degree of  
Master of Science

Keywords: ground-penetrating radar, impact echo, infrared thermography,  
half-cell corrosion potential, electrical resistivity, deterioration

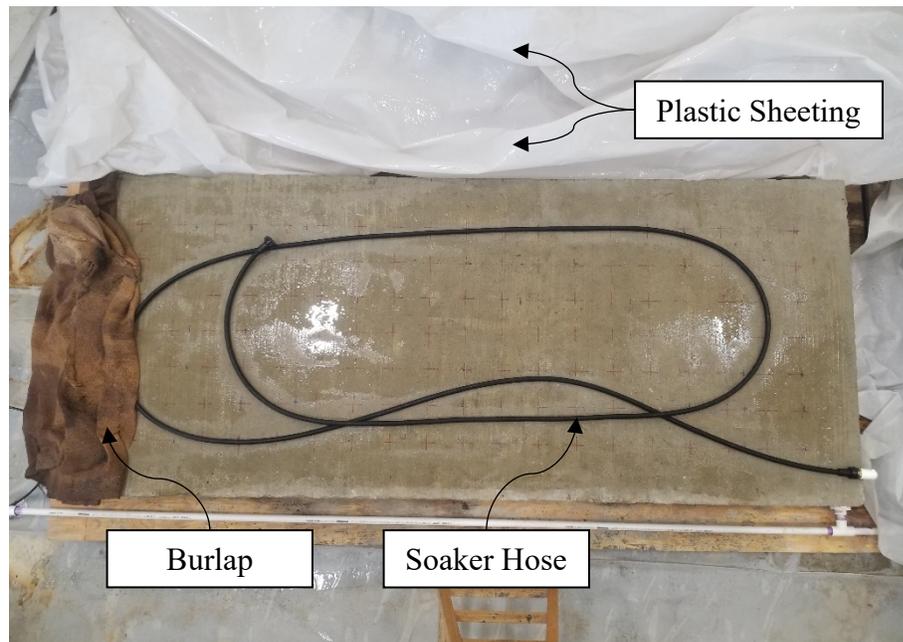
To evaluate the effects of moisture content on NDT measurements, six test specimens were selected to be moistened. Specimens C1, C2, DL1, DL3, DL7, and DE3 were selected as they were hypothesized to exhibit defects that could potentially affect NDT measurements differently when moistened. A PVC manifold was constructed that spanned among the six specimens. Soaker hoses were connected to the manifold and laid over each specimen. The hoses were then covered by saturated burlap and plastic sheeting, to mitigate evaporative losses. The hoses were then activated every 48 hours for three months before any NDT methods were used on the specimens. It was assumed that, at this time, the specimens were in a fairly moist state. This method of moistening the specimens can be seen in Figure 4-22.

**Figure 4-22: Ponding Program for Laboratory Specimens**

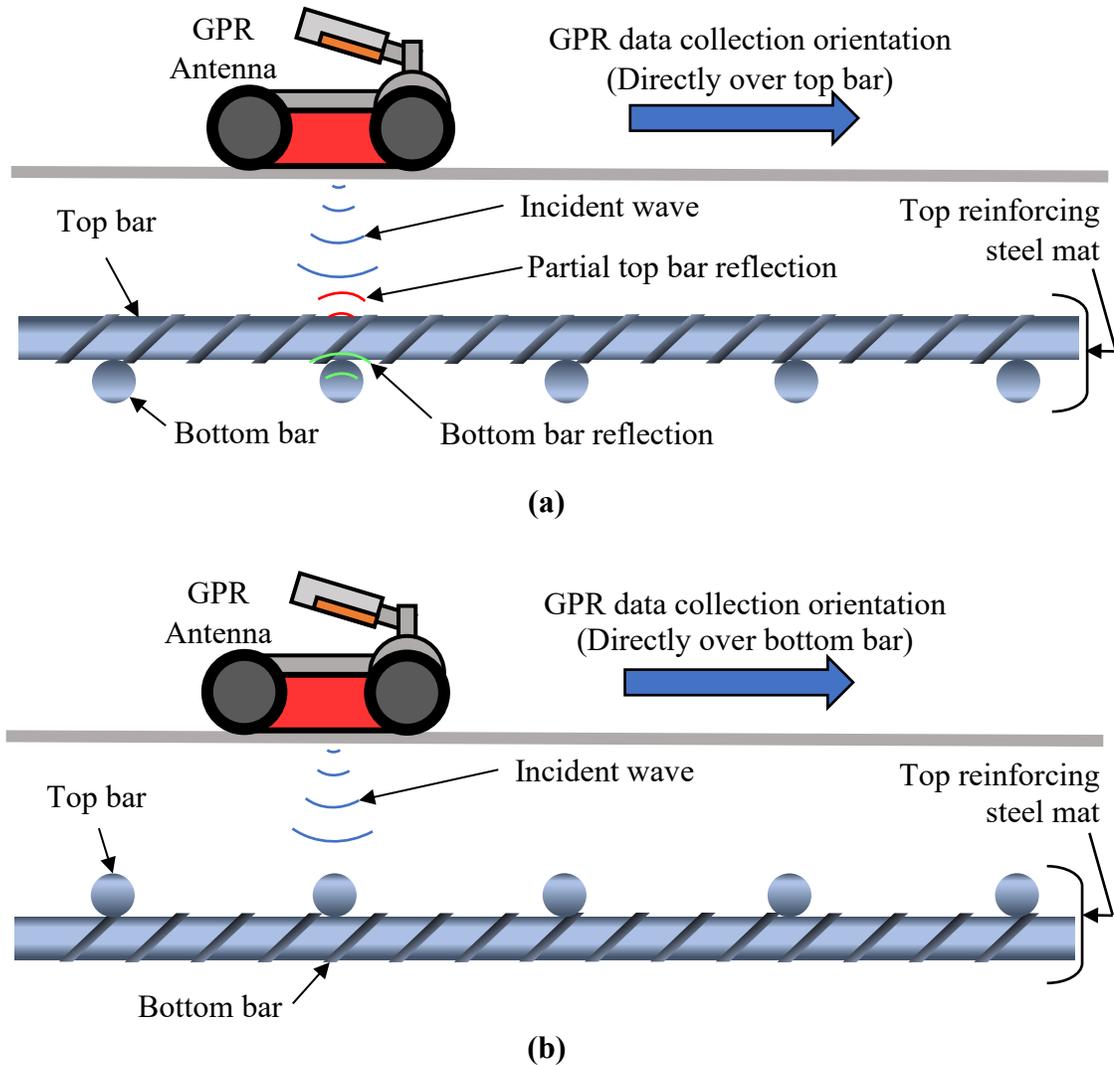
Nonetheless, it was hypothesized that inspection passes performed perpendicular to the bottom steel in the top mat may allow for the detection of defects at greater depths than could be detected by performing passes perpendicular to the top steel. As the concept of detecting defects with GPR is predicated on the argument that GPR waves are attenuated by the defects, data sampling at the bottom steel may allow for the detection of defects between the top and bottom steel in the upper mat. The ability to detect defects in this depth range may be significant, especially for corrosion induced delaminations which can originate at the level of the reinforcement.

**Figure 4-23: (a) Hypothesized Reinforcement Influence on GPR Data Collected Perpendicular to Bottom Bar and (b) Data Collected Perpendicular to Top Bar**

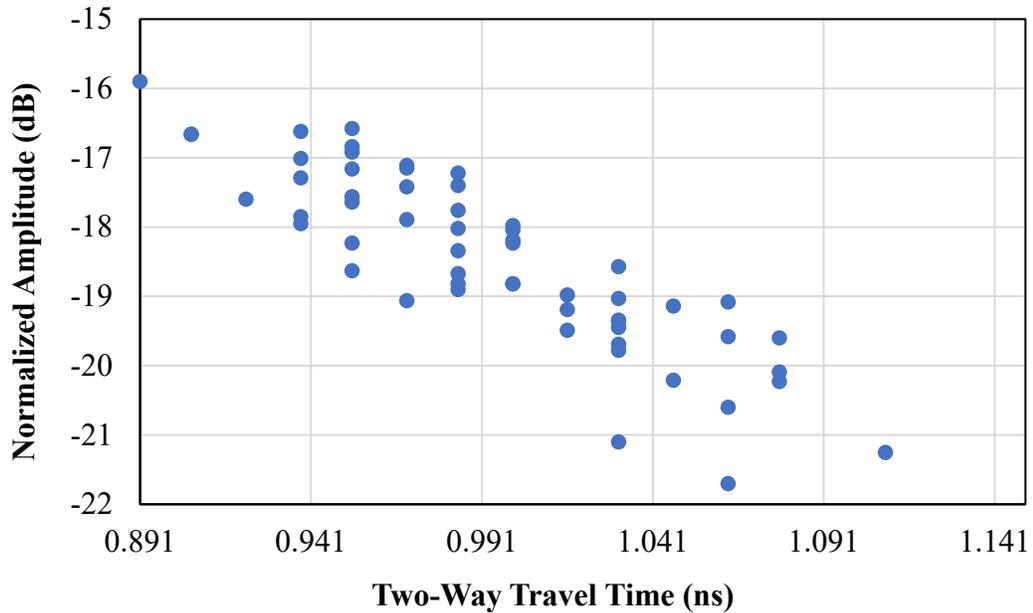
In this thesis, the depth-correction algorithm proposed by Barnes et al (2008) was implemented to assess whether such a technique allowed for increased correlation of GPR data with the true state of deterioration of the laboratory specimens. Given that the algorithm was tailored towards data collected perpendicular to the top steel in the top reinforcement mat, it was not applied to passes collected perpendicular to the bottom steel in the top mat. After collecting GPR data as described in 4.3.1, the two-way travel times and reflection amplitudes were exported to a data analyzation software. For specimens with significant cover depth variation, a linear relationship was observed between the normalized amplitude and the two-way travel time, as can be seen in the top layer GPR data from Specimen C2, shown in Figure 4-26.

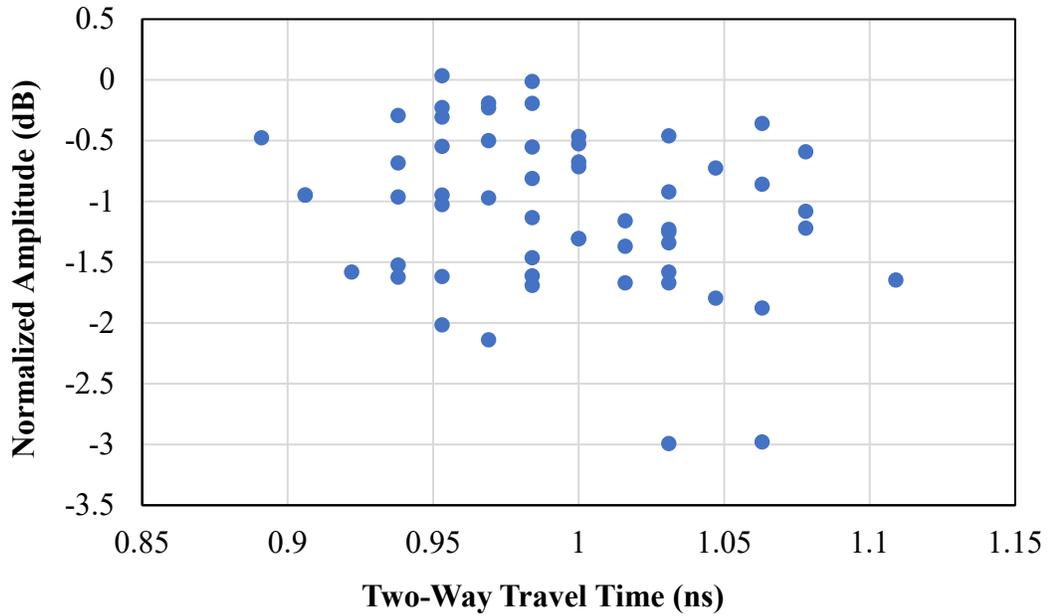
**Figure 4-27: Depth-corrected GPR Data for Test Specimen C2**

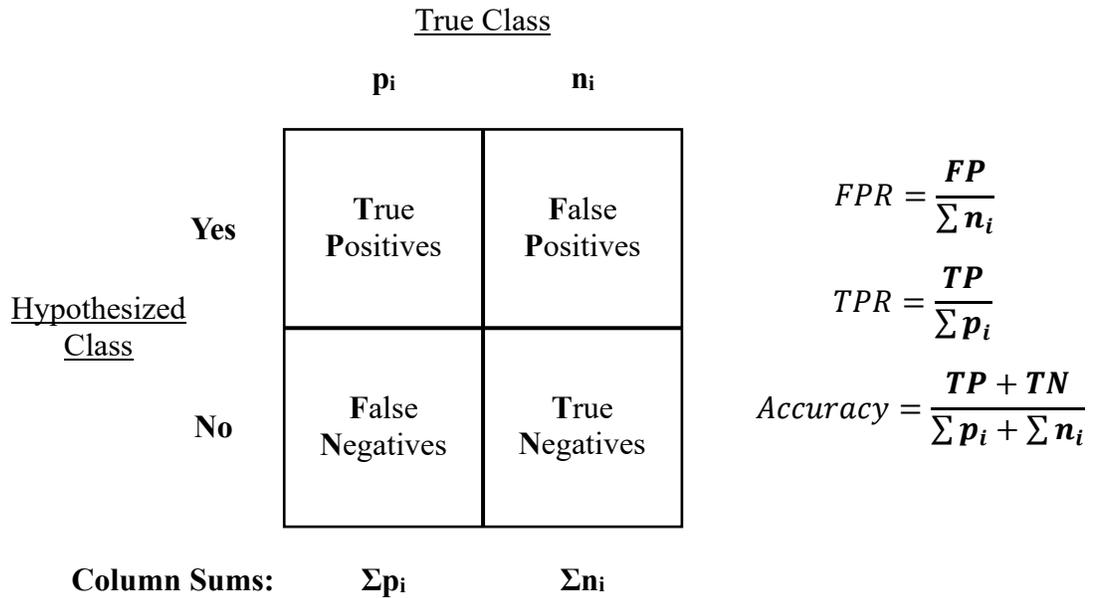
**Figure 4-28: Confusion Matrix and ROC Classifier Evaluation Metrics (Adapted from Fawcett 2006)**

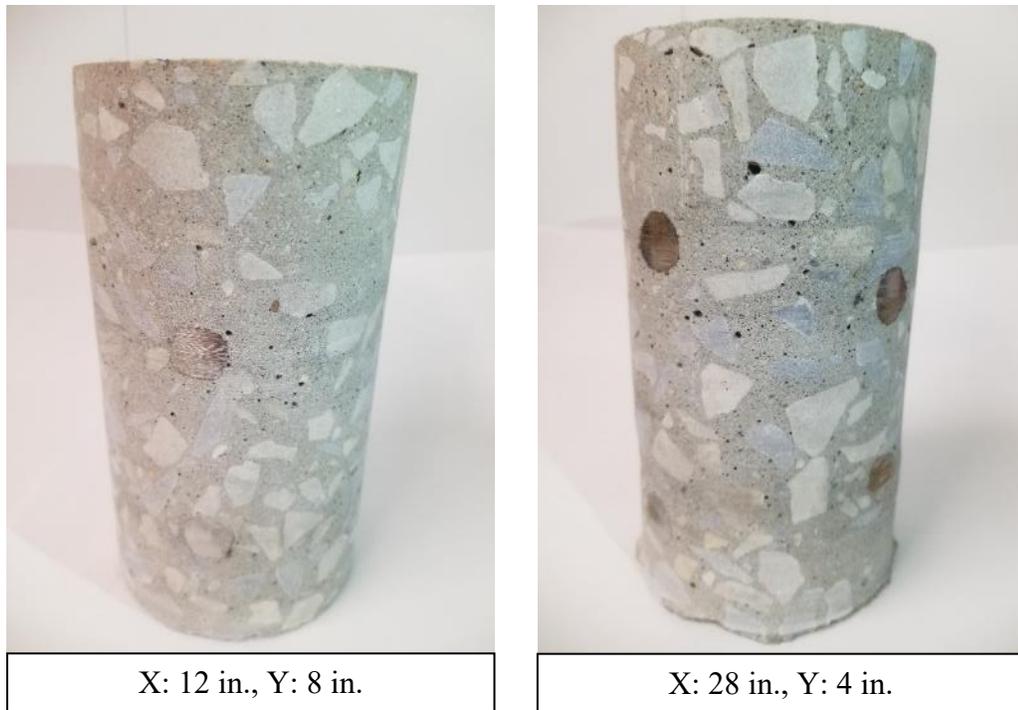
**Figure 4-32: Poor Delamination Simulation using Sand Layer in Specimen DL3**

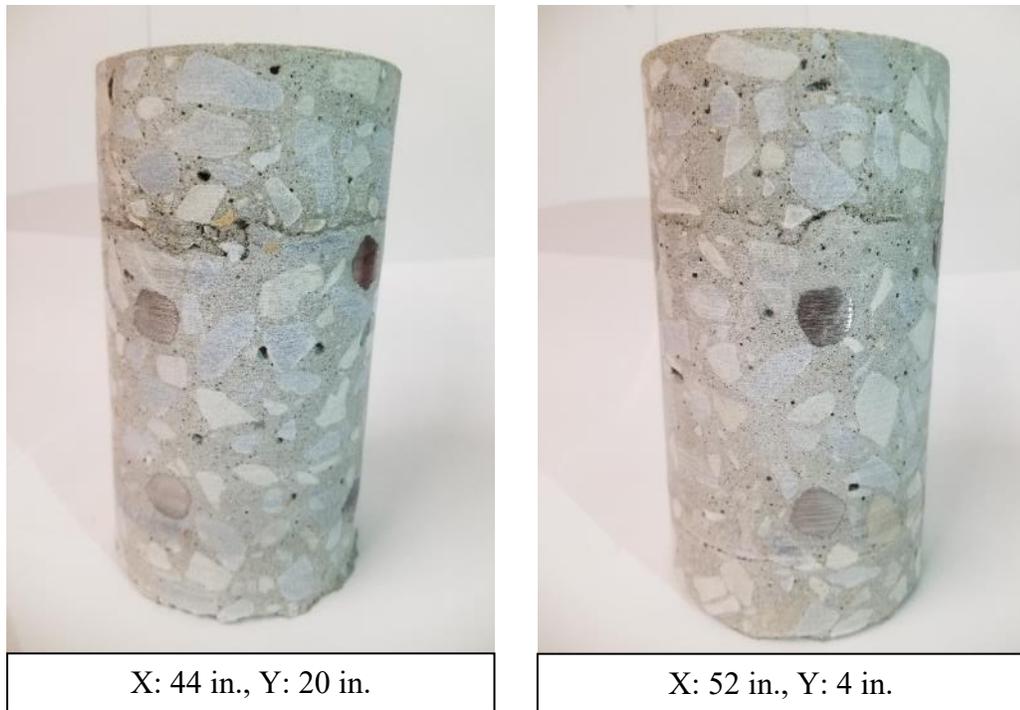
**Figure 4-33: Shallow Delamination Simulation using Oil Layer in Specimen DL3**

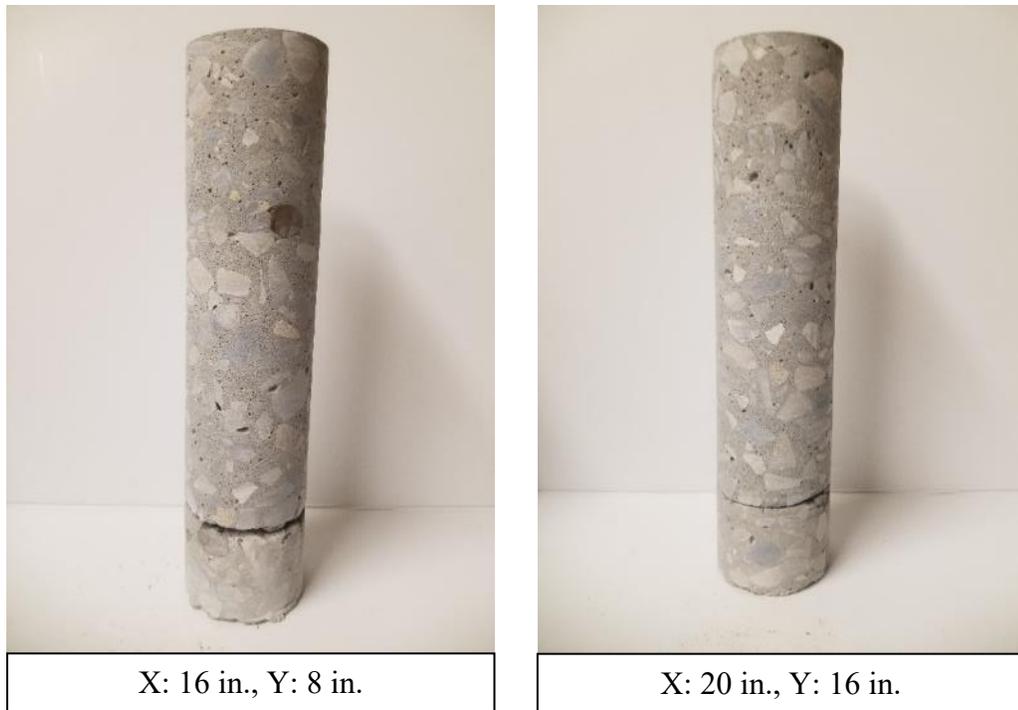
**Figure 4-34: Deep Delamination Simulation using Sand Layer in Specimen DL4**

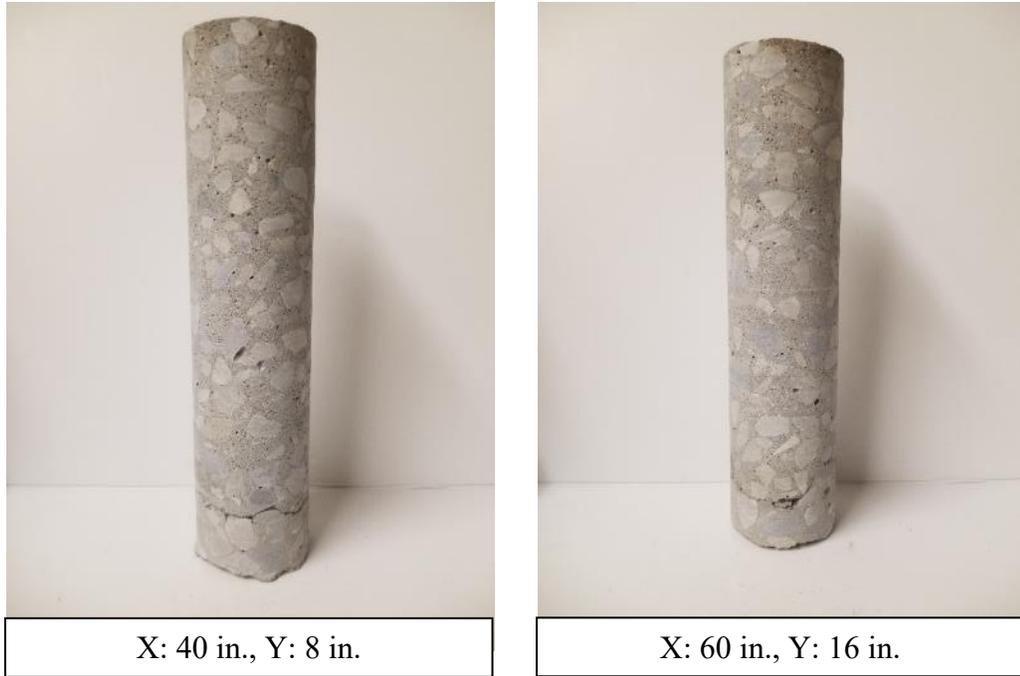
**Figure 4-35: Deep Delamination Simulation using Oil Layer in Specimen DL4**

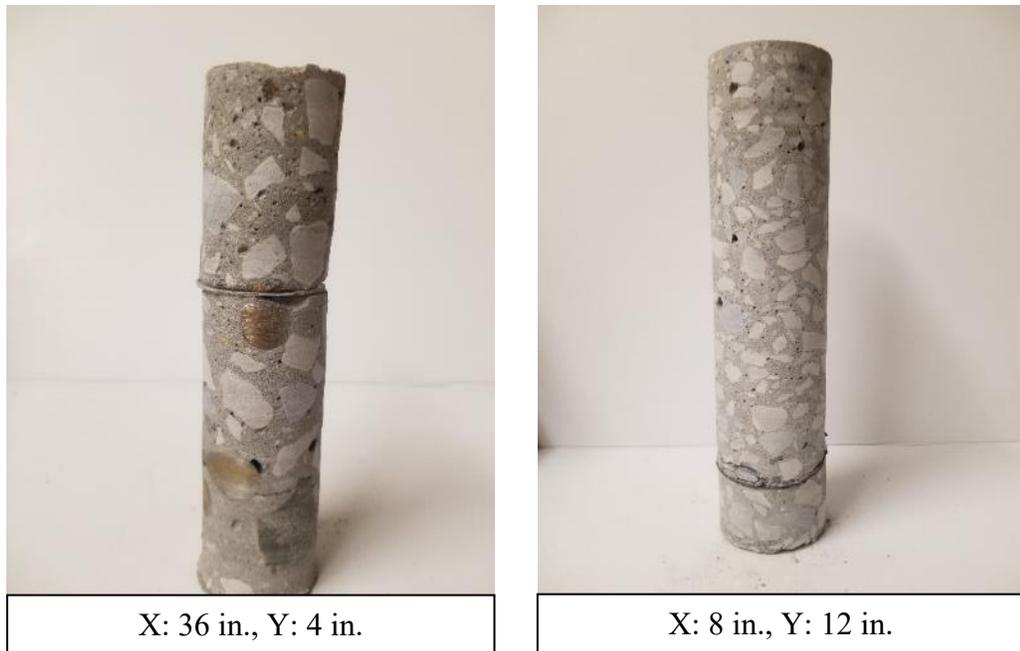
**Figure 4-36: Specimen DL5 Shallow Delamination (Left) and Specimen DL6 (Deep Delamination (Right))**

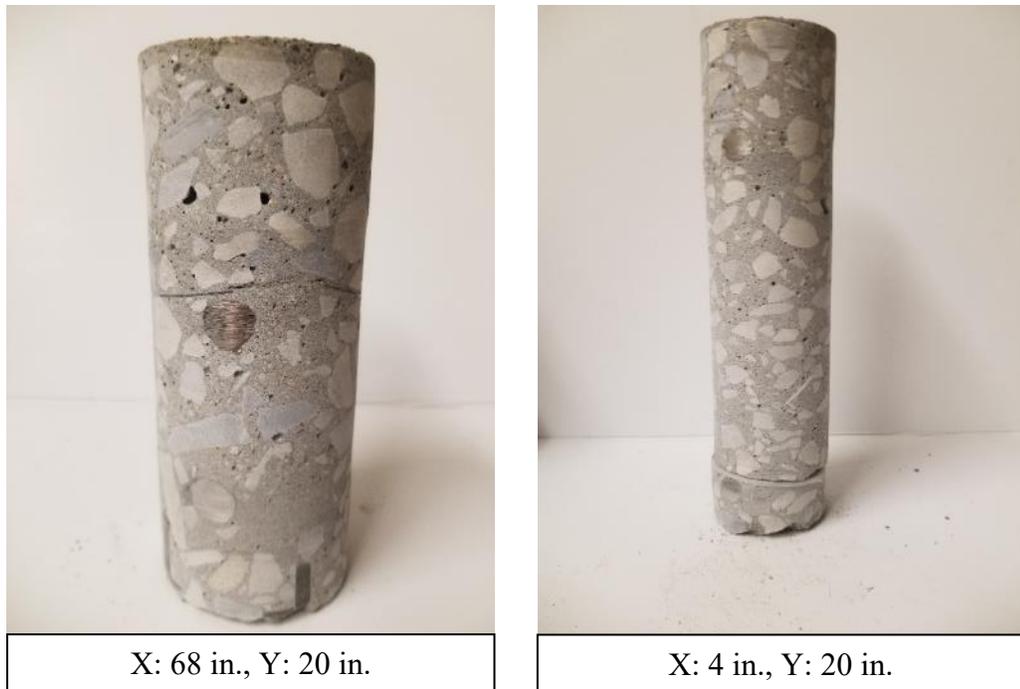
**Figure 4-37: Partially bonded Delaminations in Specimens DL7 (Left) and DL8 (Right)**

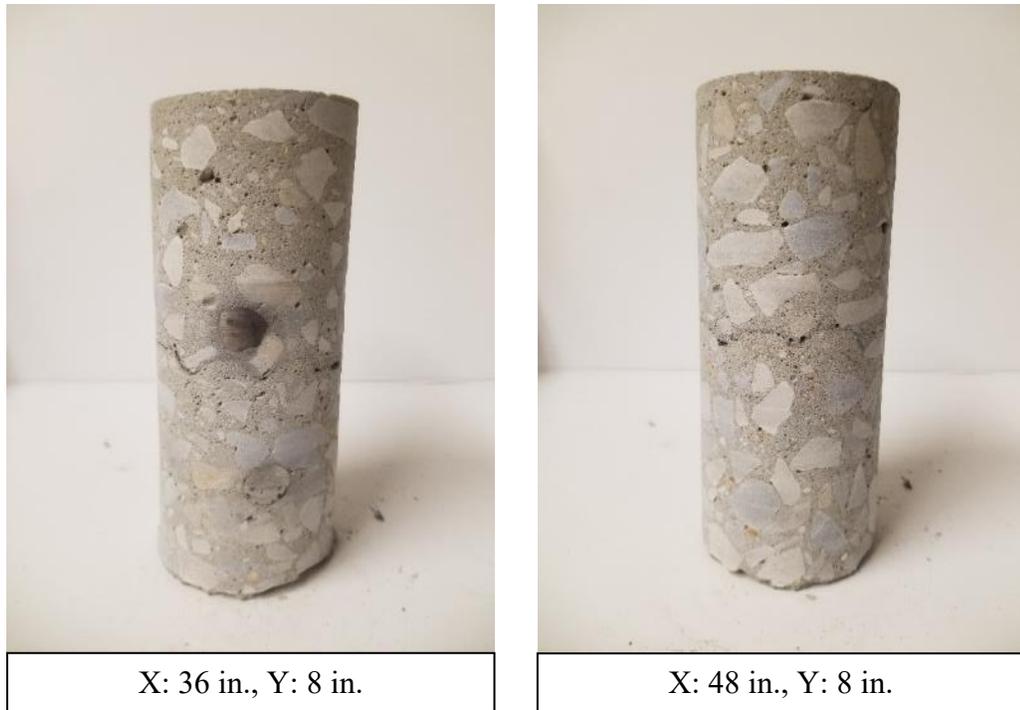
suggest there existed a defect over the miniature slab, it would have responded to the cold joint rather than an actual defect in the specimen.

**Figure 4-38: Cores Exhibiting Cold Joint in Specimen CTRL**

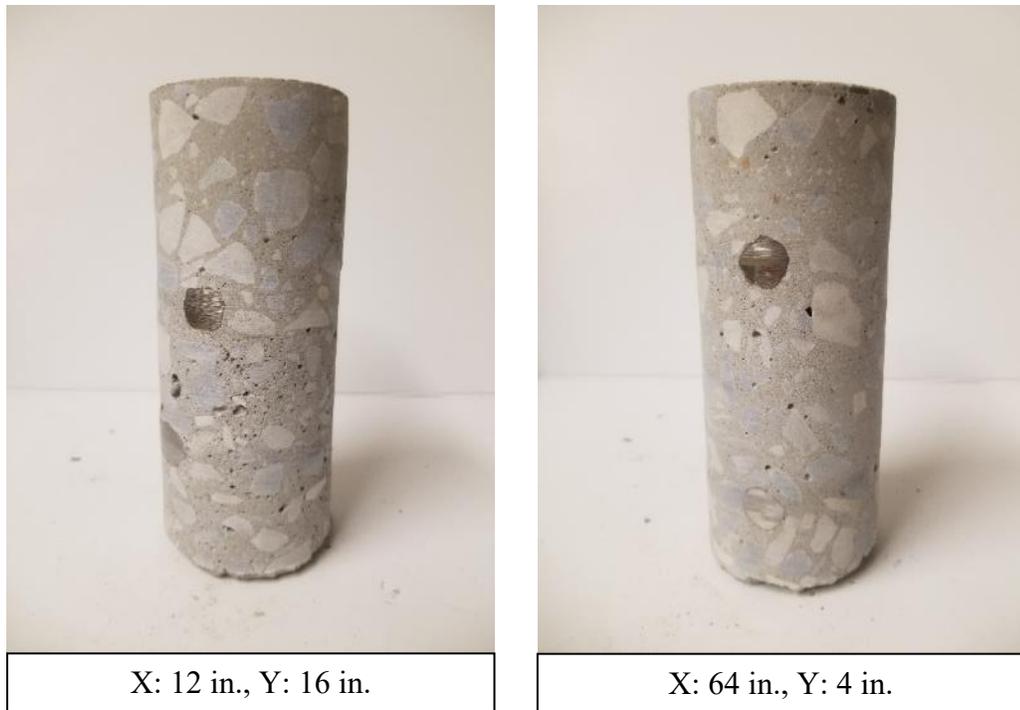
**Figure 4-39: Specimen DE2 Cores with (Left) and without (Right) Miniature Slab  
Concrete**

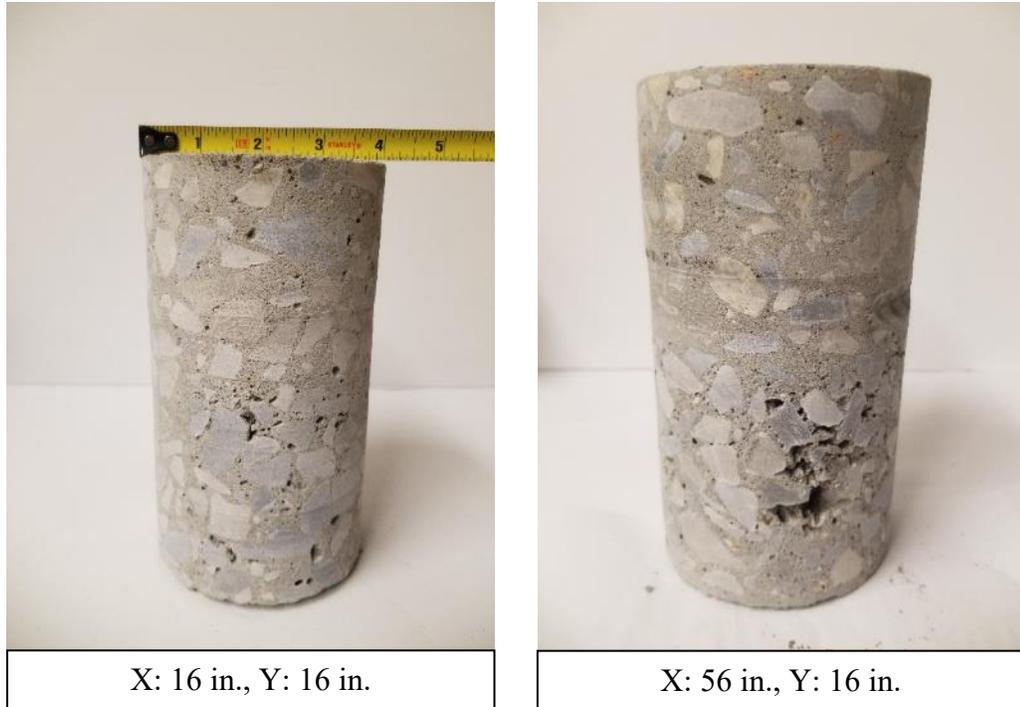
**Figure 4-40: Honeycombing in Miniature Slab Concrete of Specimen DE3**

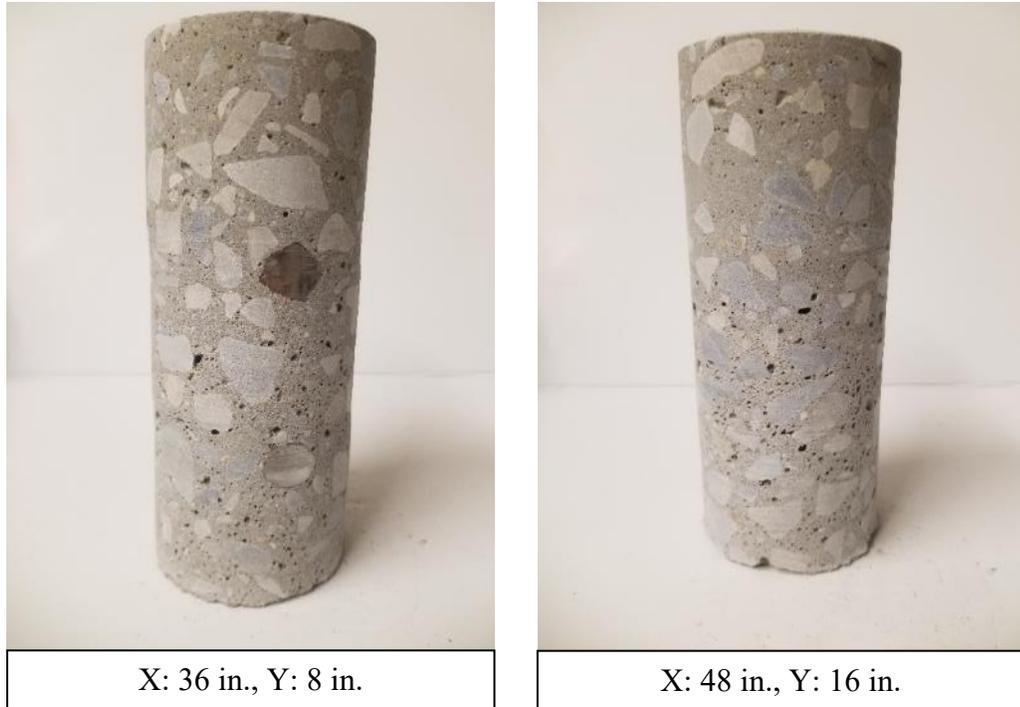
**Figure 4-41: Increased Air Content in Miniature Slab Concrete of Specimen DE4**

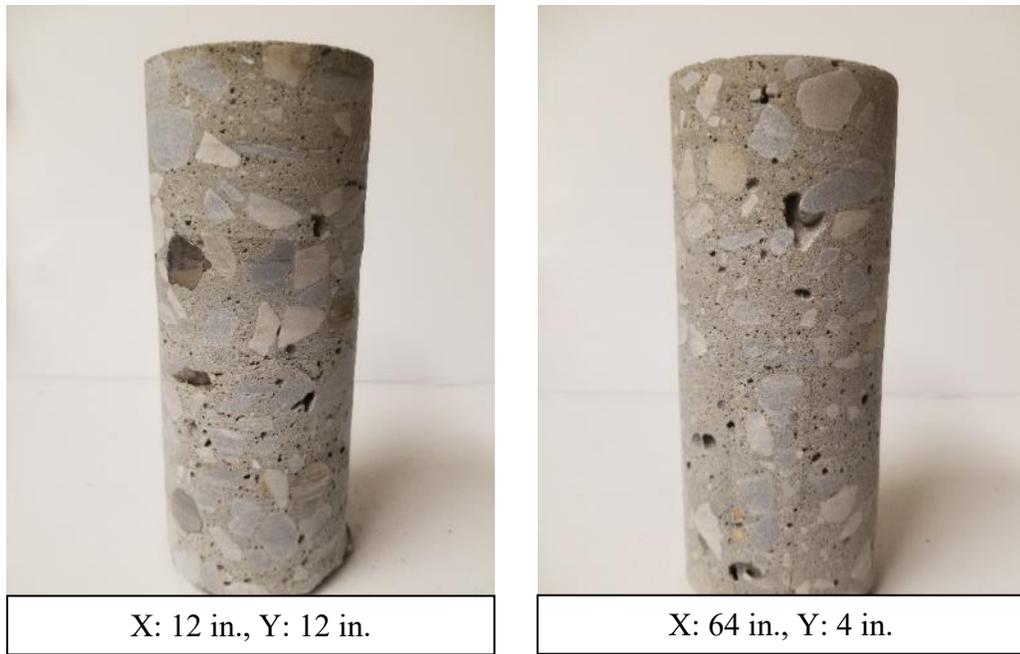
**Figure 4-42: Increased Air Content in All Concrete from Specimen DE5**

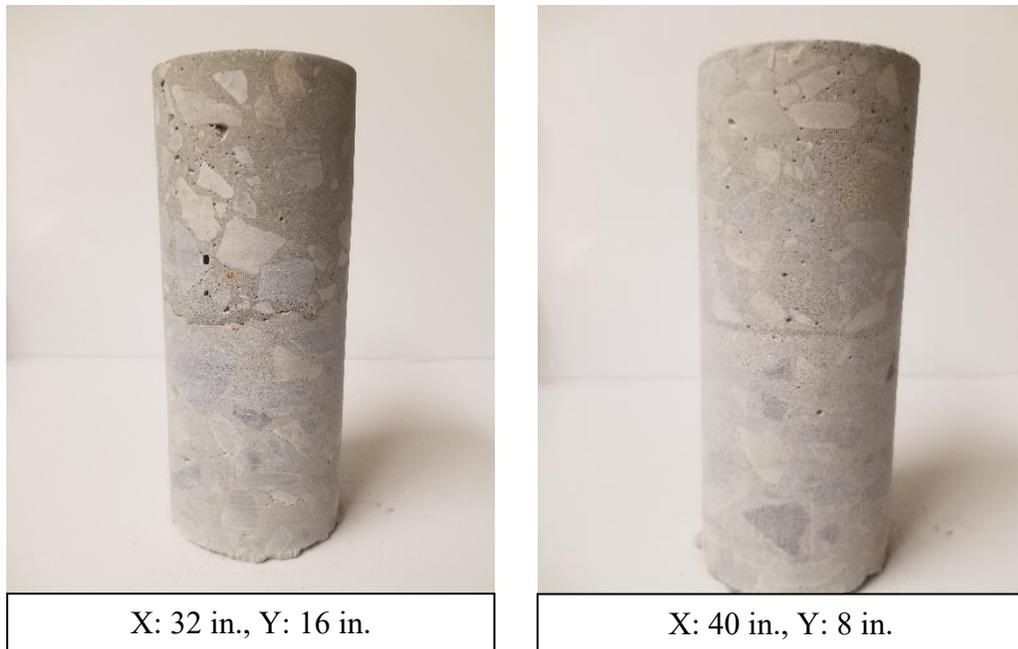
**Figure 4-43: Well-Consolidated Cores from Specimen PC1**

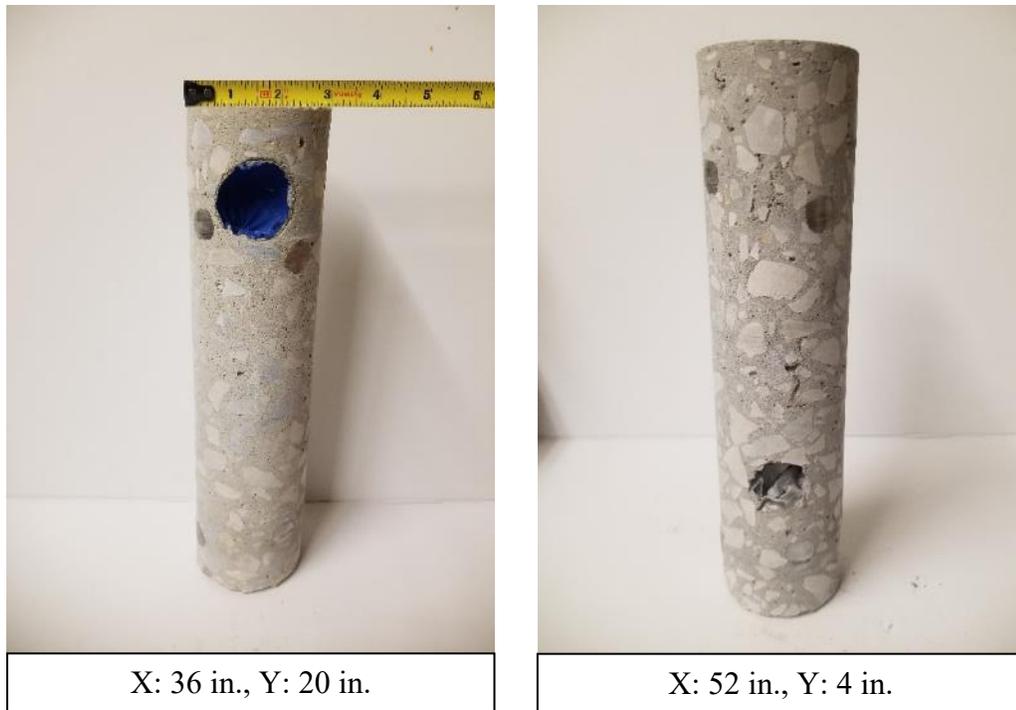
**Figure 4-45: Floated Voids in Specimen V1 (Left) and V2 (Right)**

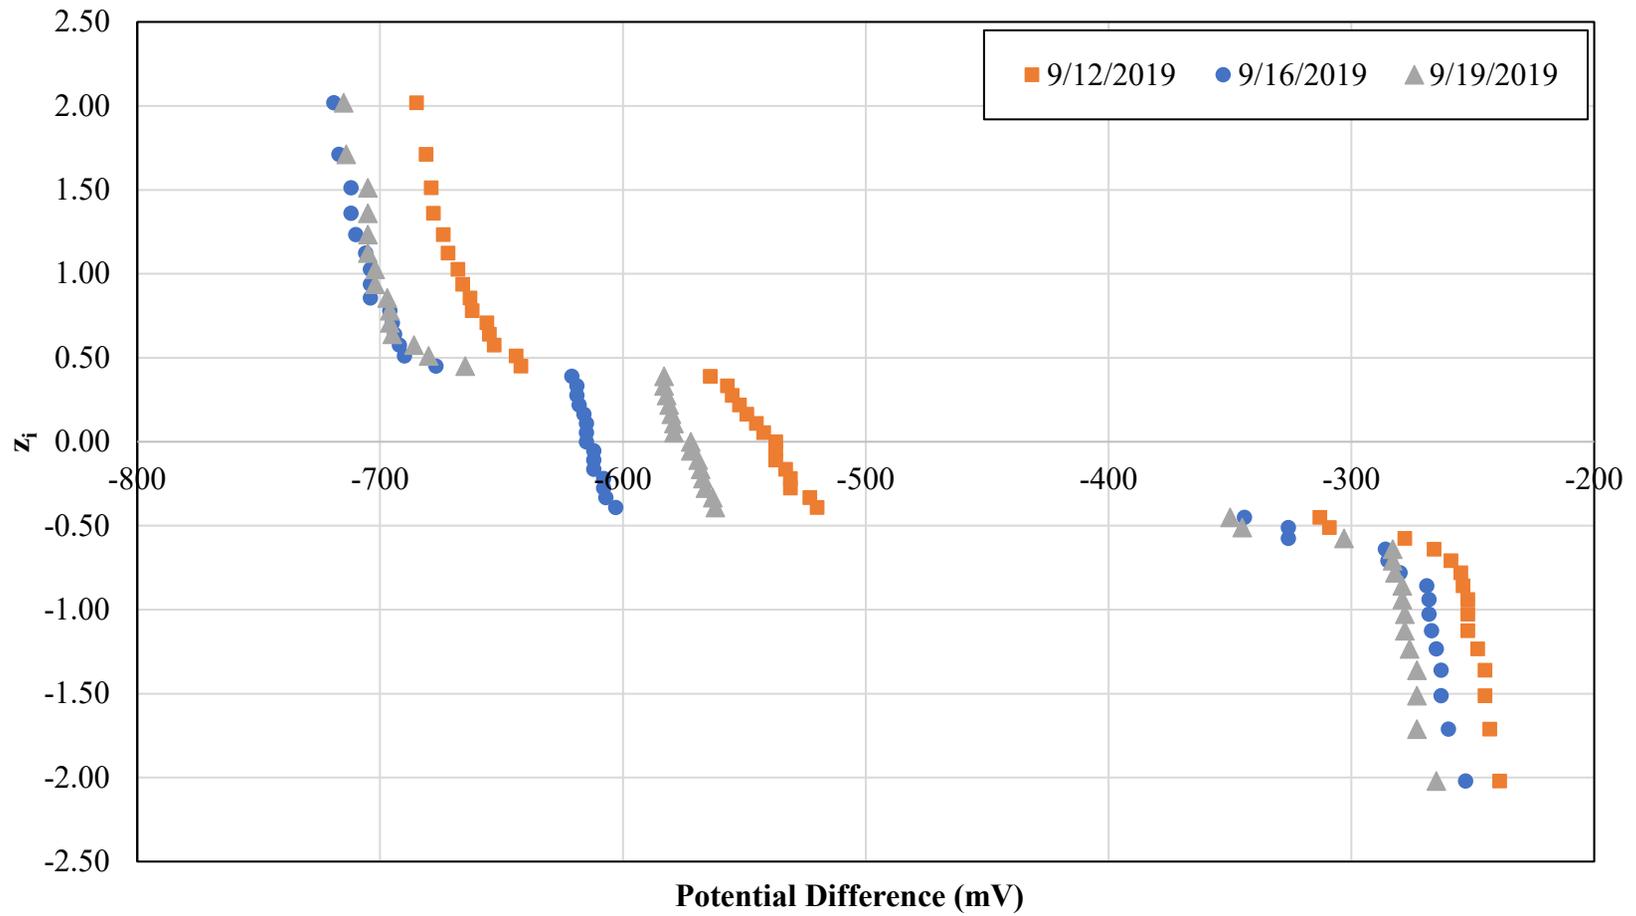
**Figure 4-99: Transformed Cumulative Probability Distributions of Specimen C1 Potential Measurements during Accelerated Corrosion**

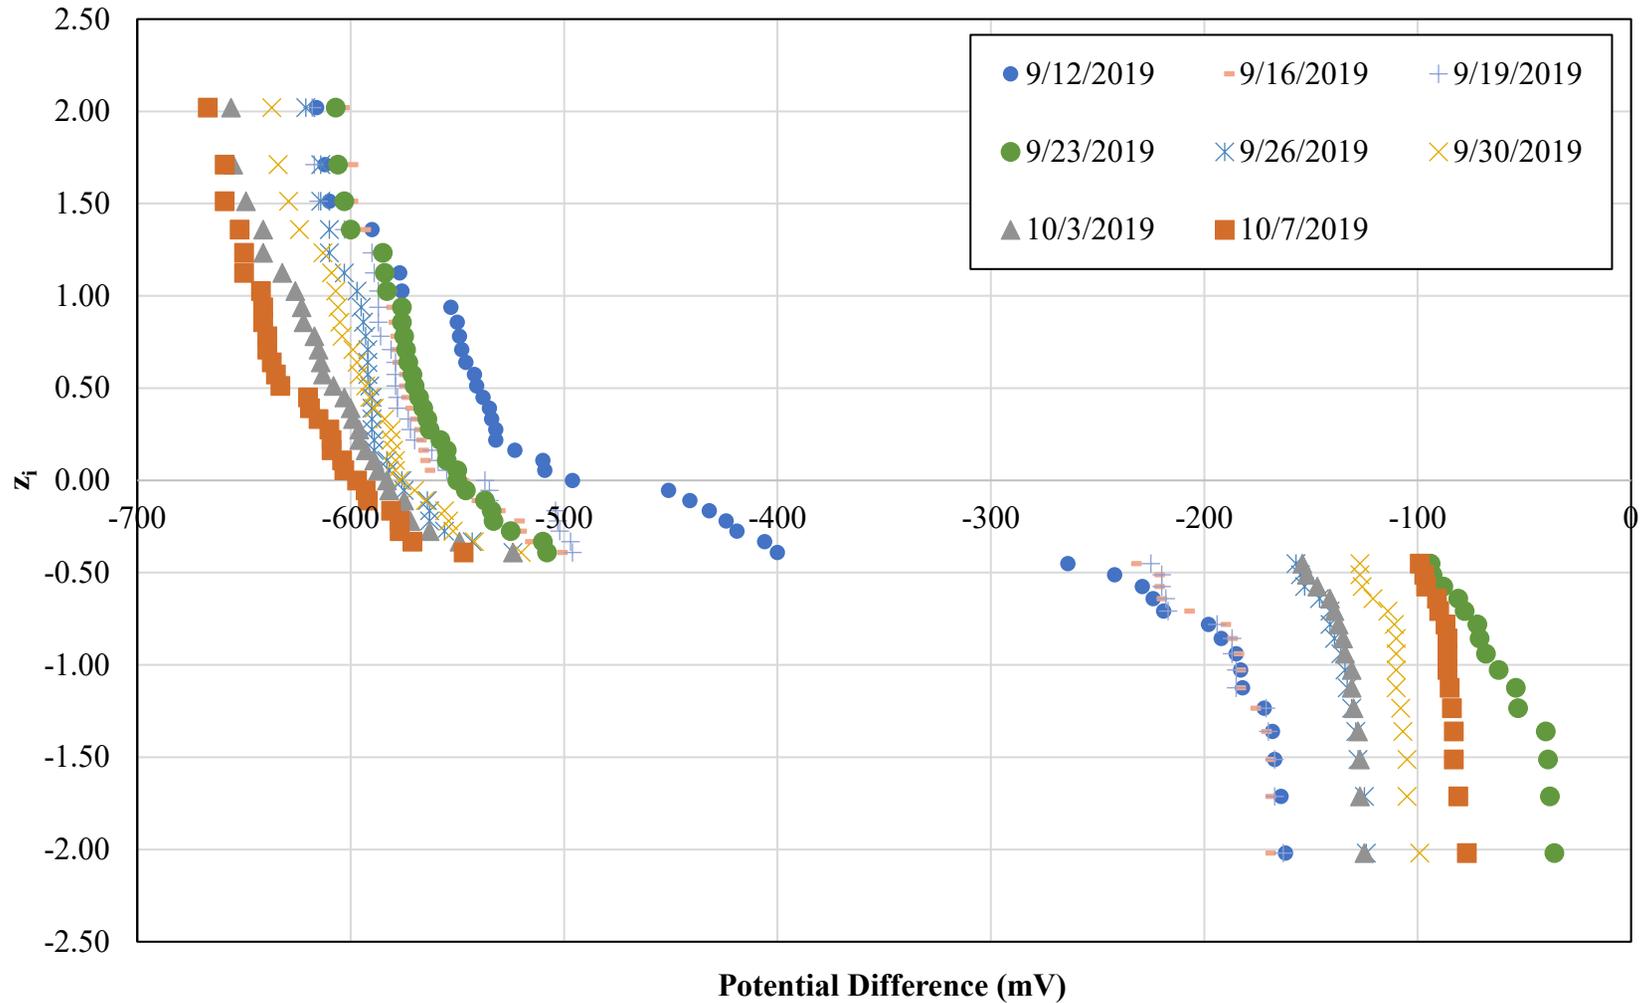
**Figure 4-100: Transformed Cumulative Probability Distributions of Specimen C2 Potential Measurements during Accelerated Corrosion**

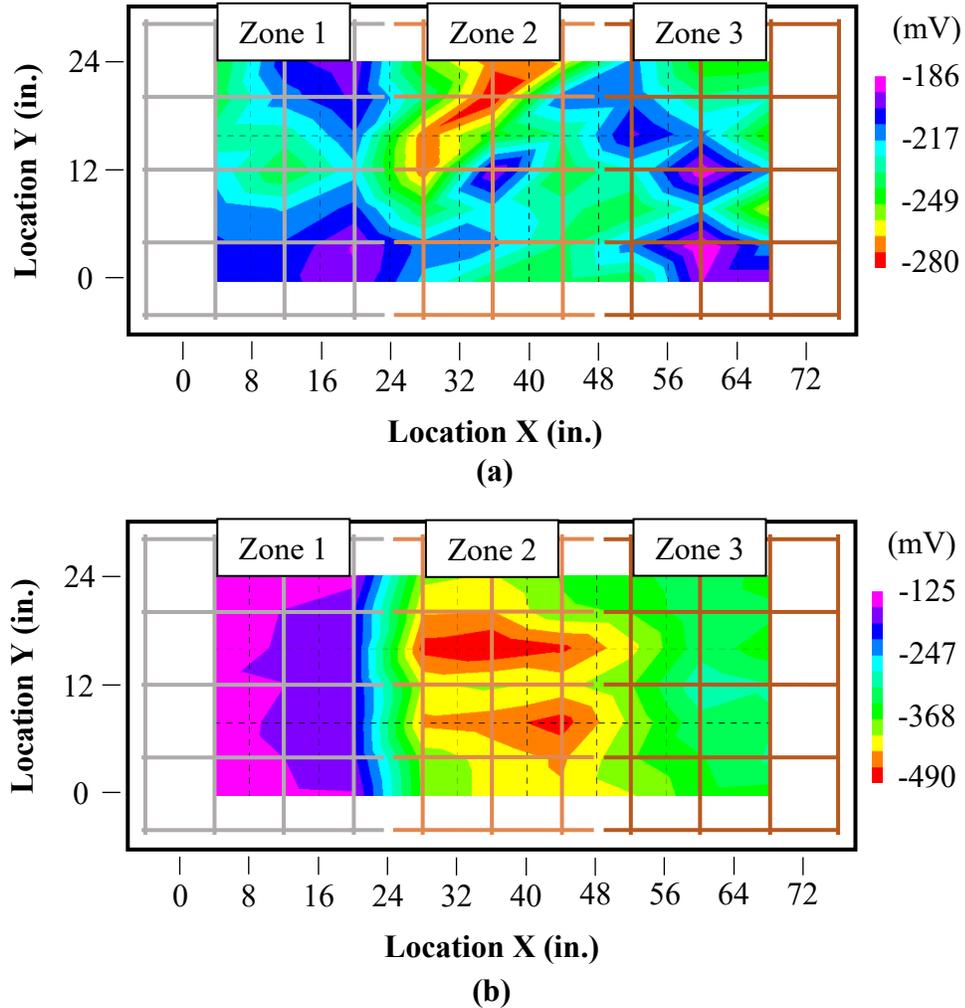
**Figure 4-102: HCP Contour Plots for (a) Specimen C1 and (b) Specimen C2 in Air-dried States (30 Minutes Pre-moistening)**

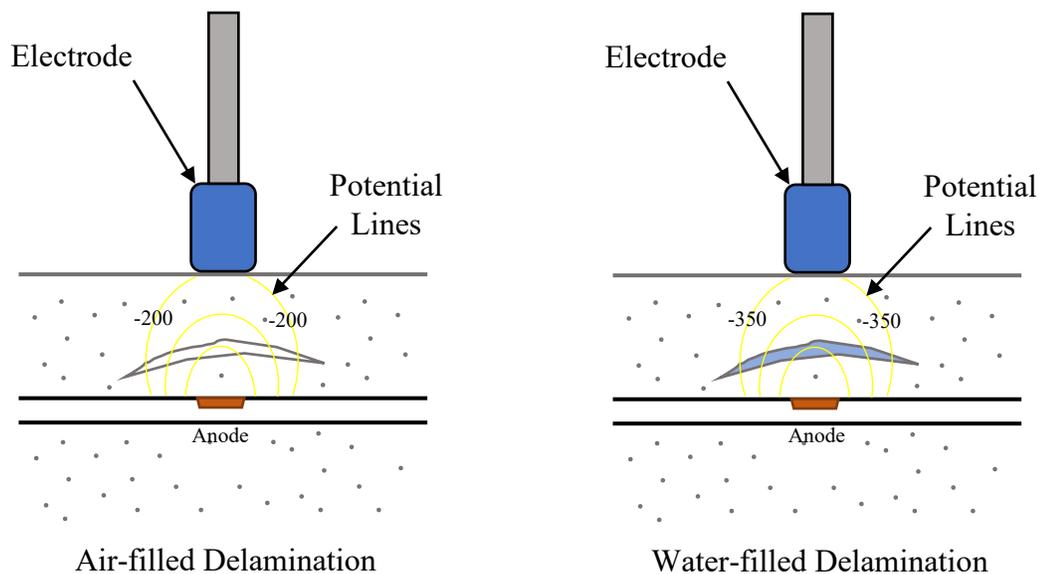
**Figure 4-103: Effect of Delaminations on Half-cell Potentials in Concrete Elements of Varying Moisture Content**

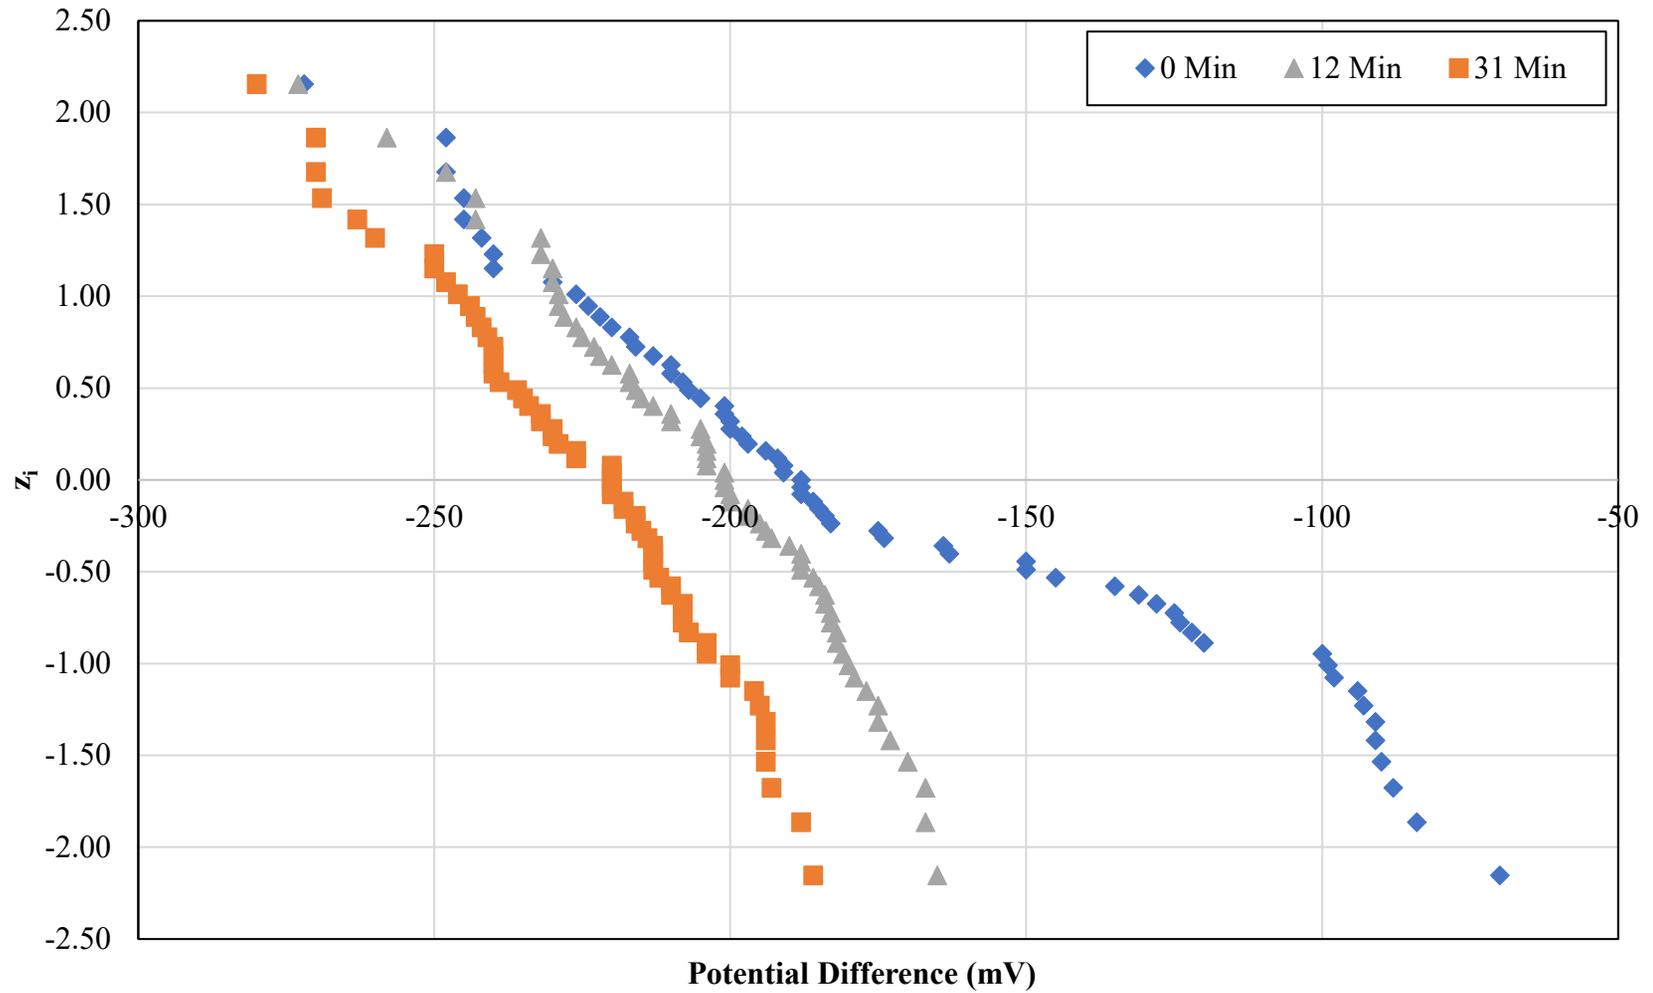
Figure 4-104: Air-dried HCP Measurements for Specimen C1 after Various Pre-moistening Durations

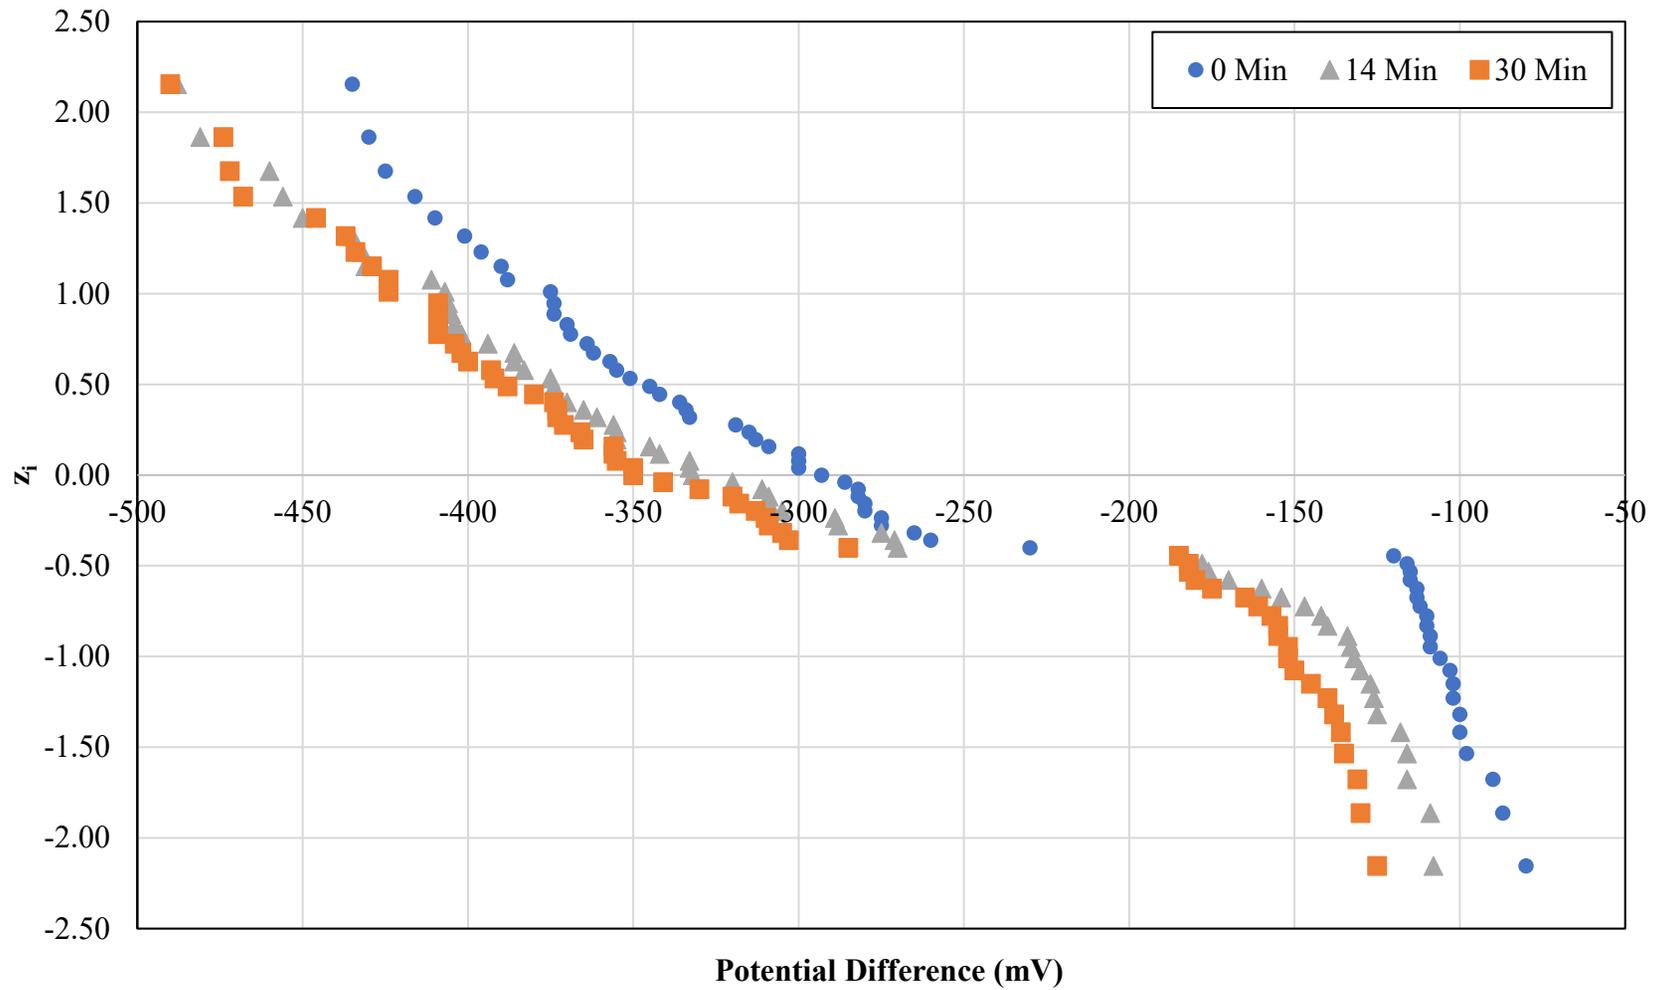
**Figure 4-105: Air-dried HCP Measurements for Specimen C2 after Various Pre-moistening Durations**

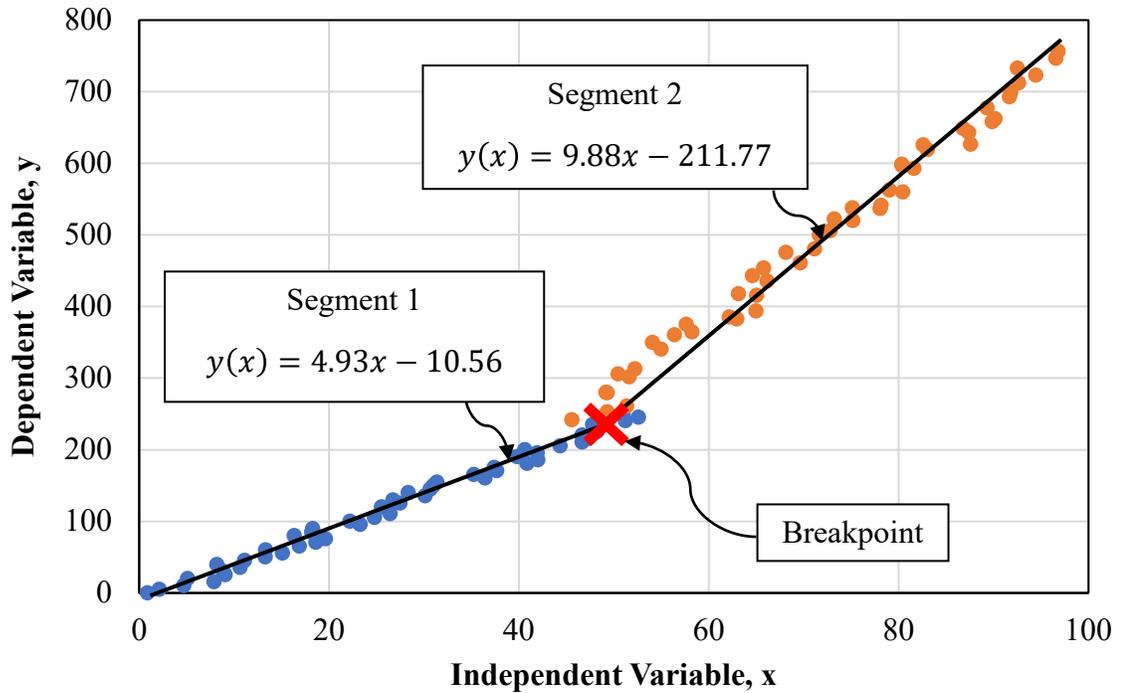
**Figure 4-106: Segmented Linear Regression for Two Linear Response Functions**
