**Evaluation of Nondestructive Test Methods  
for Concrete Bridge Deck Condition Assessment**

A thesis submitted to the Graduate Faculty of  
Auburn University  
in partial fulfillment of the  
requirements for the Degree of  
Master of Science

Keywords: ground-penetrating radar, impact echo, infrared thermography,  
half-cell corrosion potential, electrical resistivity, deterioration

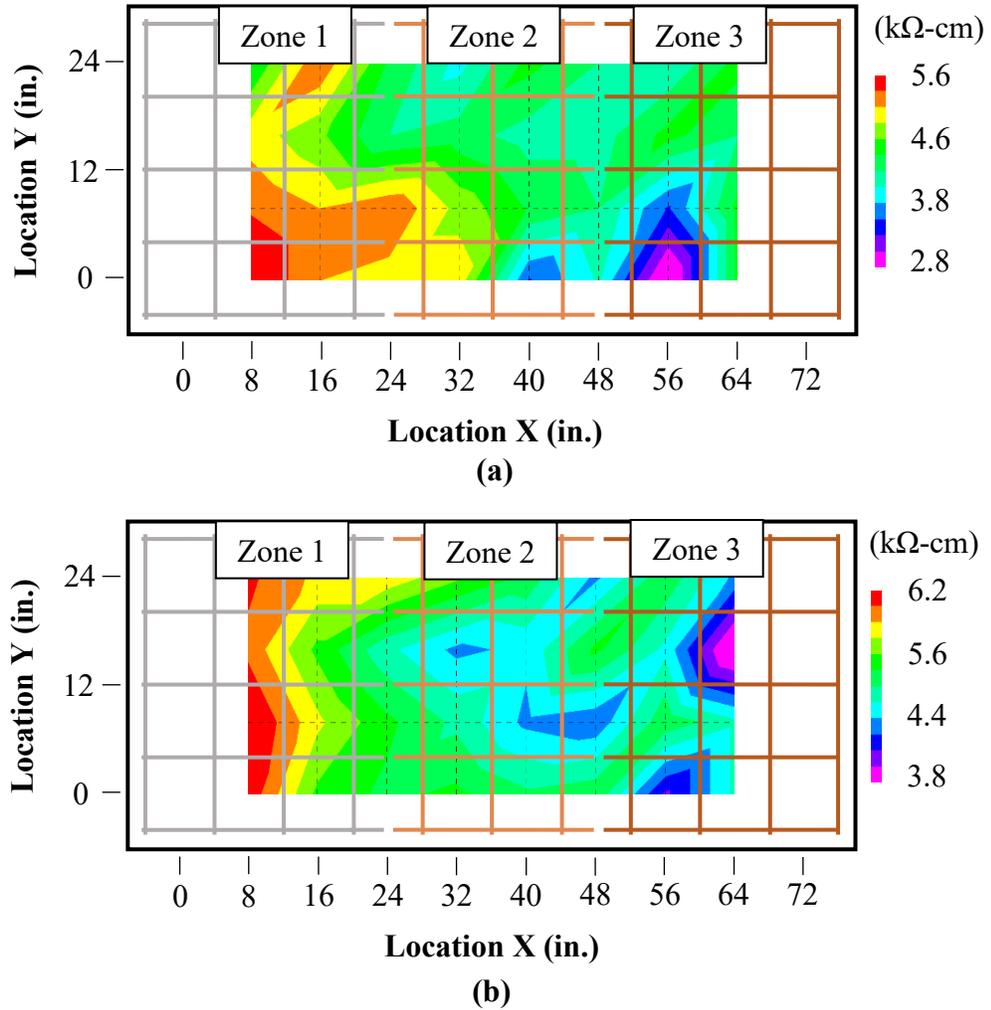
**Figure 4-107: ER Contour Plots for (a) Specimen C1 (09/19/19) and (b) Specimen C2 (10/07/19)**

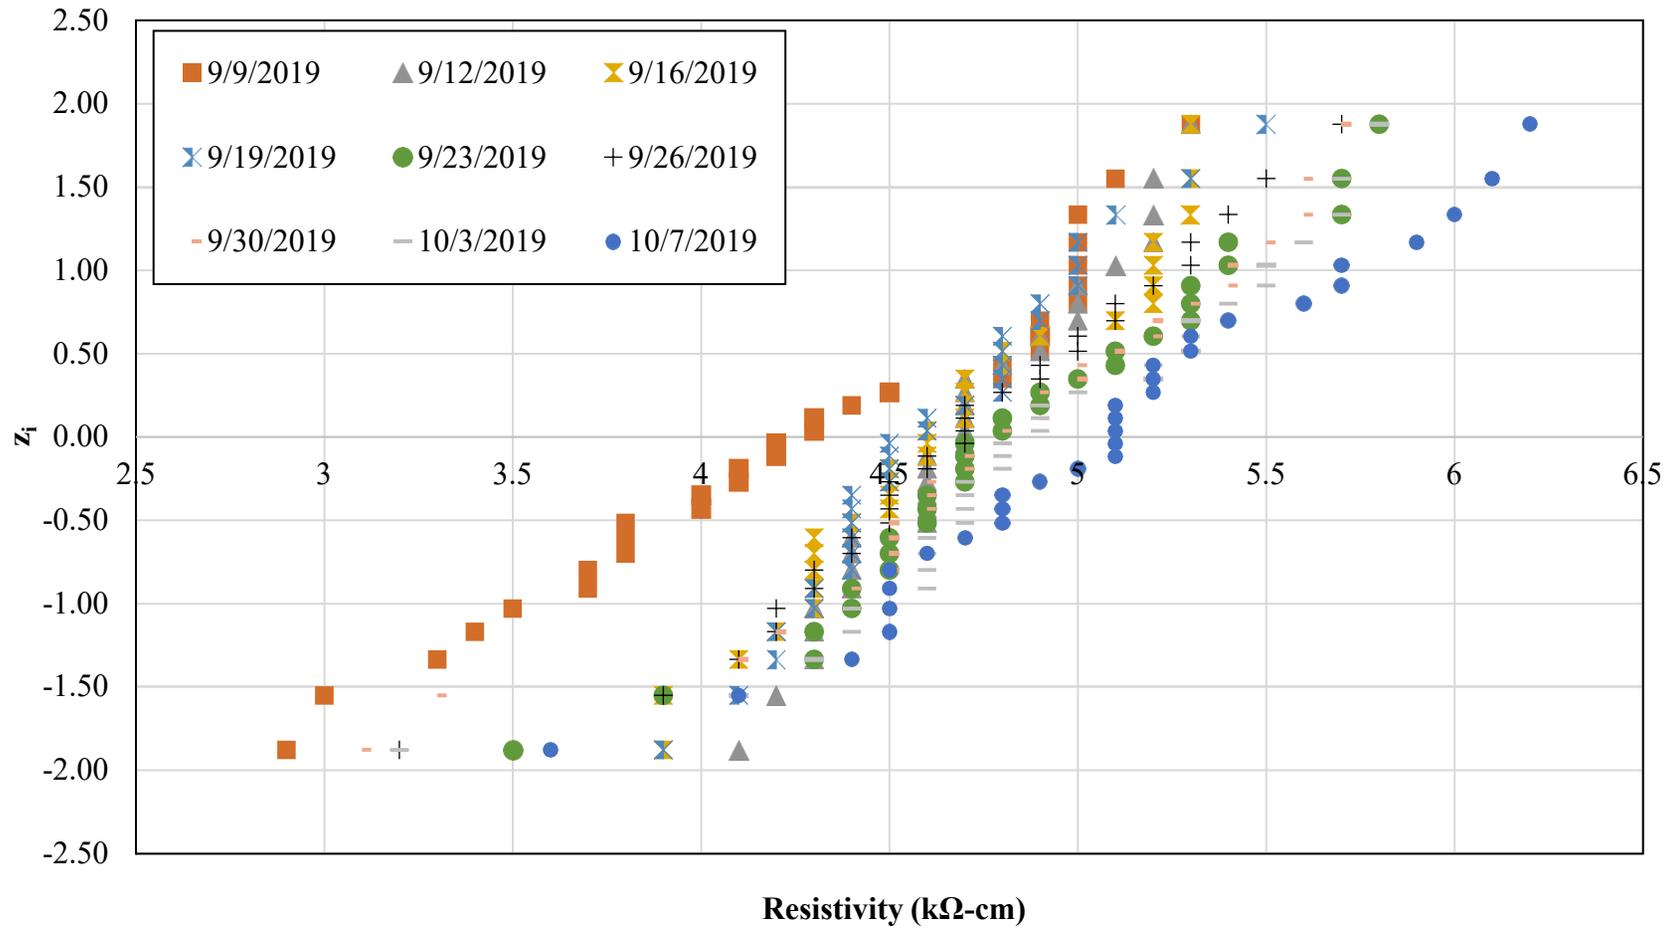
**Figure 4-110: Transformed Cumulative Probability Distributions of Specimen C2 Resistivity Measurements during Accelerated Corrosion**

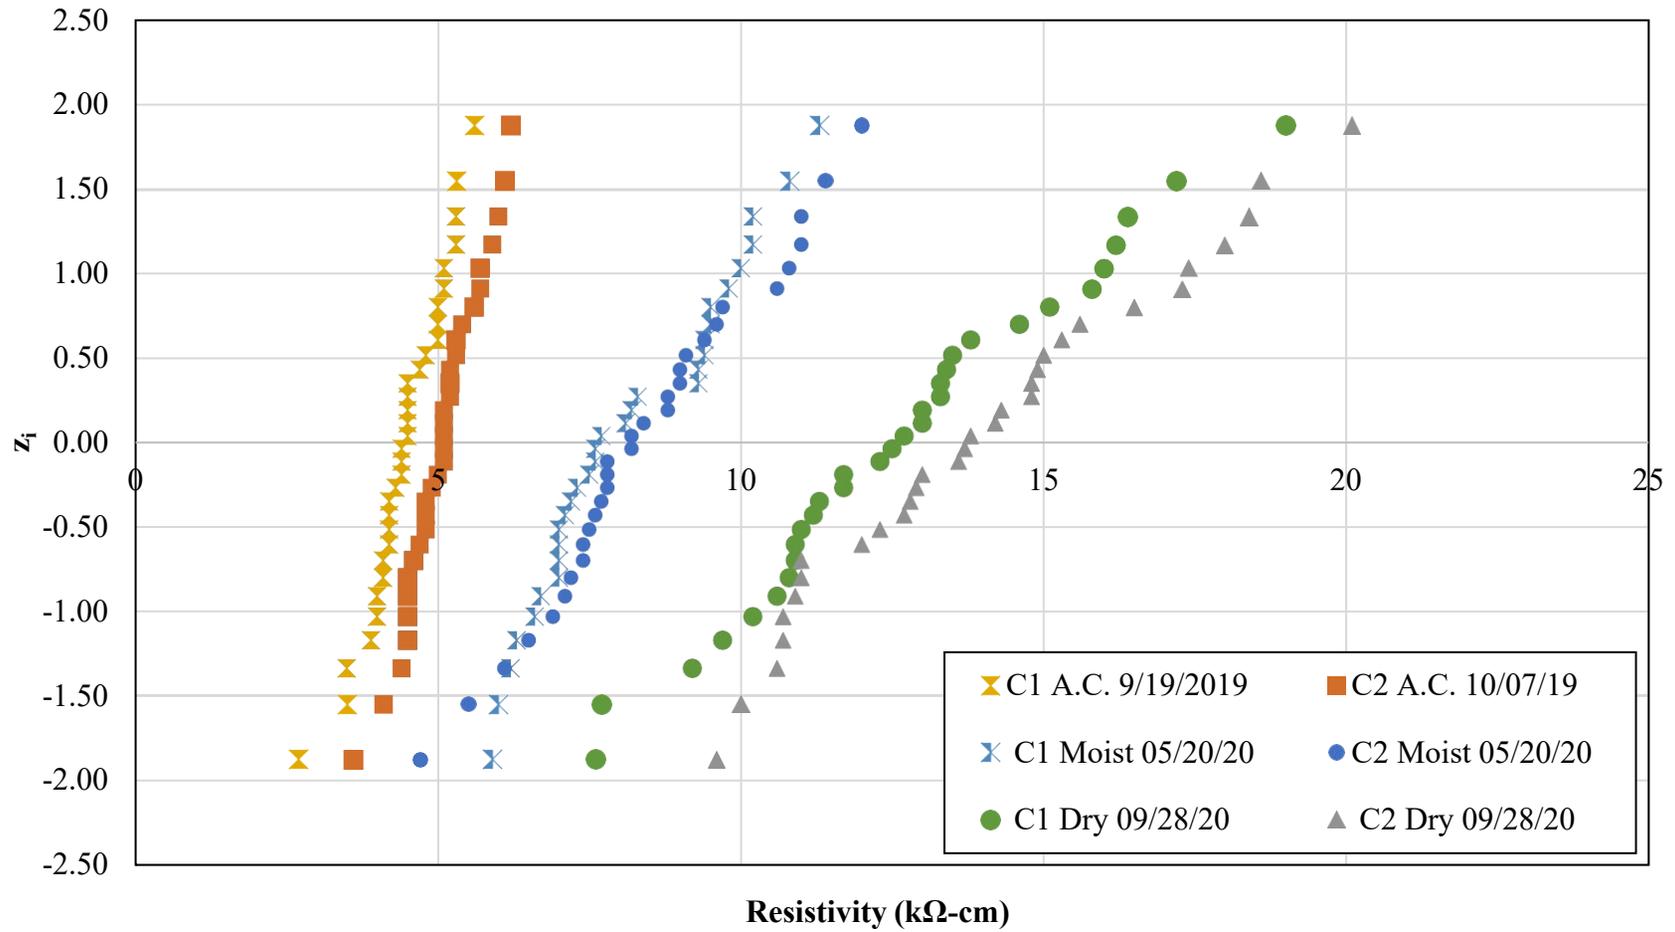
**Figure 4-111: Transformed Cumulative Probability Distributions of Specimens C1 and C2 Resistivity Measurements for Different Moisture Contents and Times**

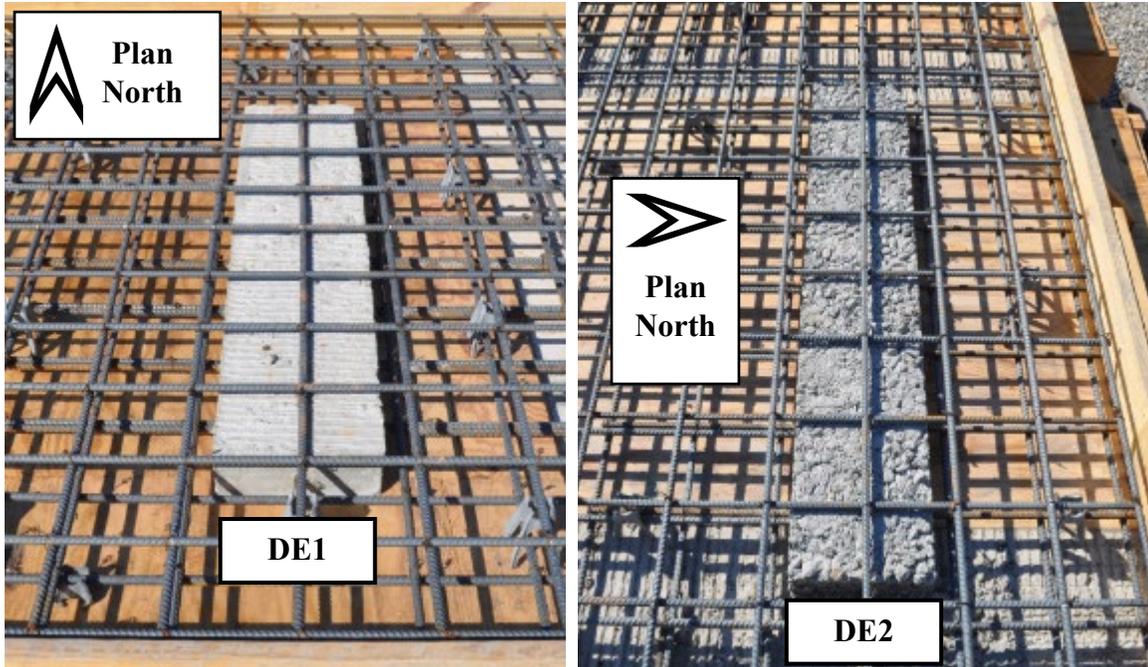
**Figure 5-4: Defect DE1 (Left) and DE2 (Right)**

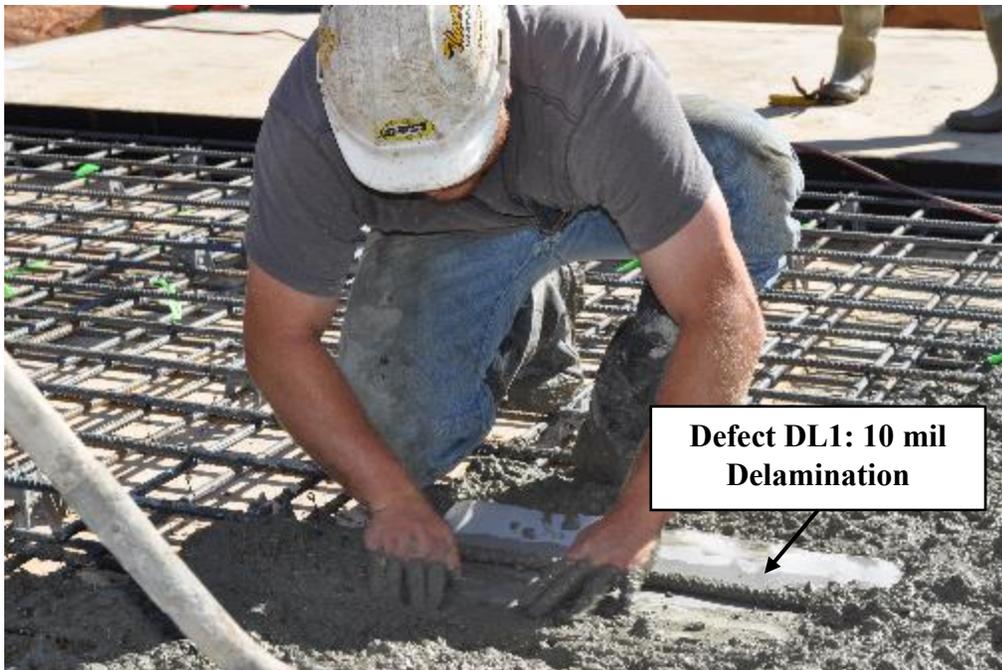
**Figure 5-5: Plastic Sheetting Delamination Simulation in Test Bridge**

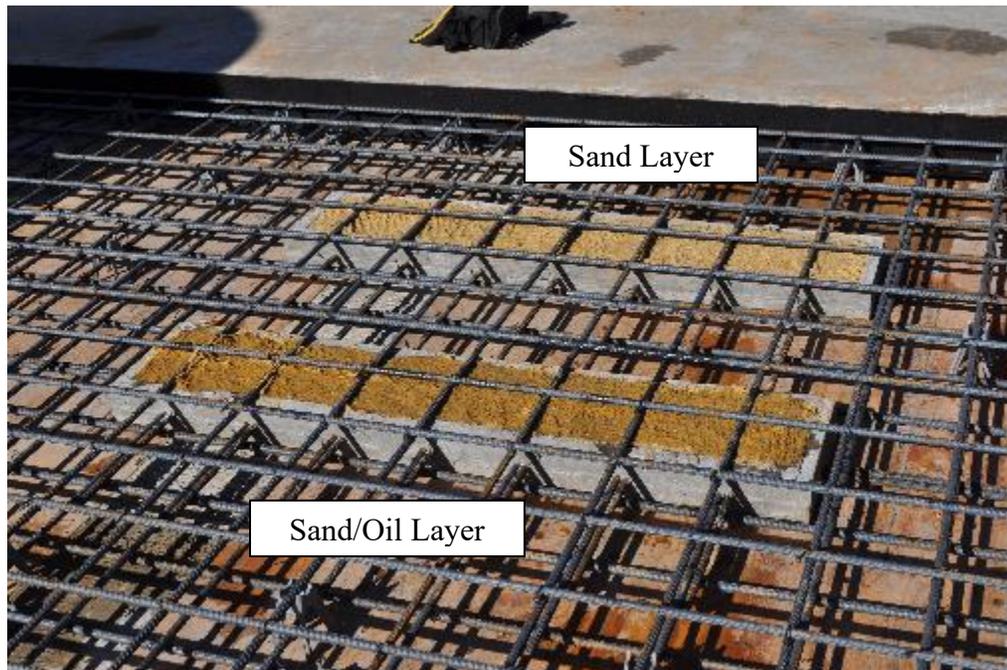
**Figure 5-6: Redeveloped Sand/Oil Delamination Simulation in Defect DL2**

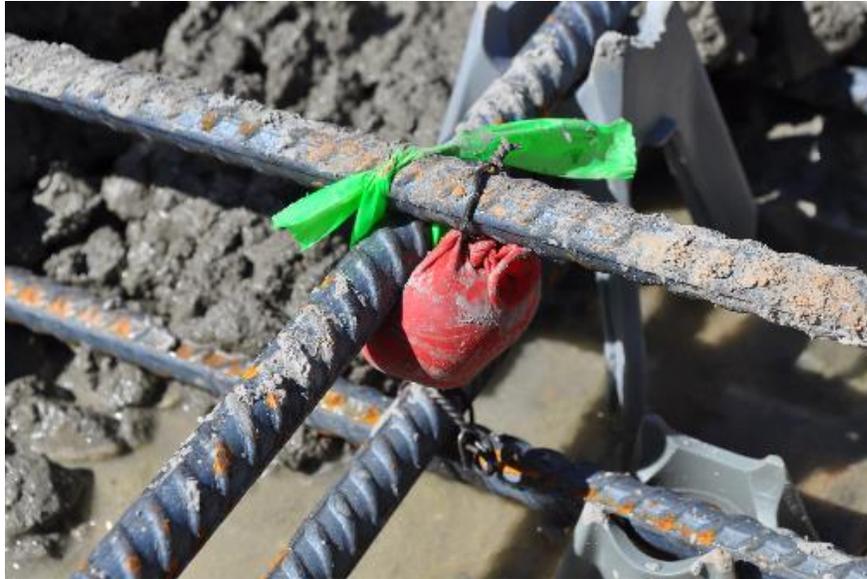
**Figure 5-8: Shallow Void Simulation in Defect V1**

Void simulation using clay-filled and water-filled balloons was successful in Phase 1 of this project, as verified through visual analysis of extracted cores. Thus, 1 in., 2 in., and 3 in. diameter shallow and deep voids were constructed in Defect V1 of the test bridge using the same simulation techniques. As can be observed in Figure 5-8, balloons were installed in their proper locations by tying them to either the upper or lower reinforcement mat. Balloons were more deliberately affixed to the reinforcement mats to mitigate the risk of them floating into the cover layer during placement. Concrete around the voids was

carefully consolidated using a vibrator to prevent the balloons from bursting open during concrete placement.

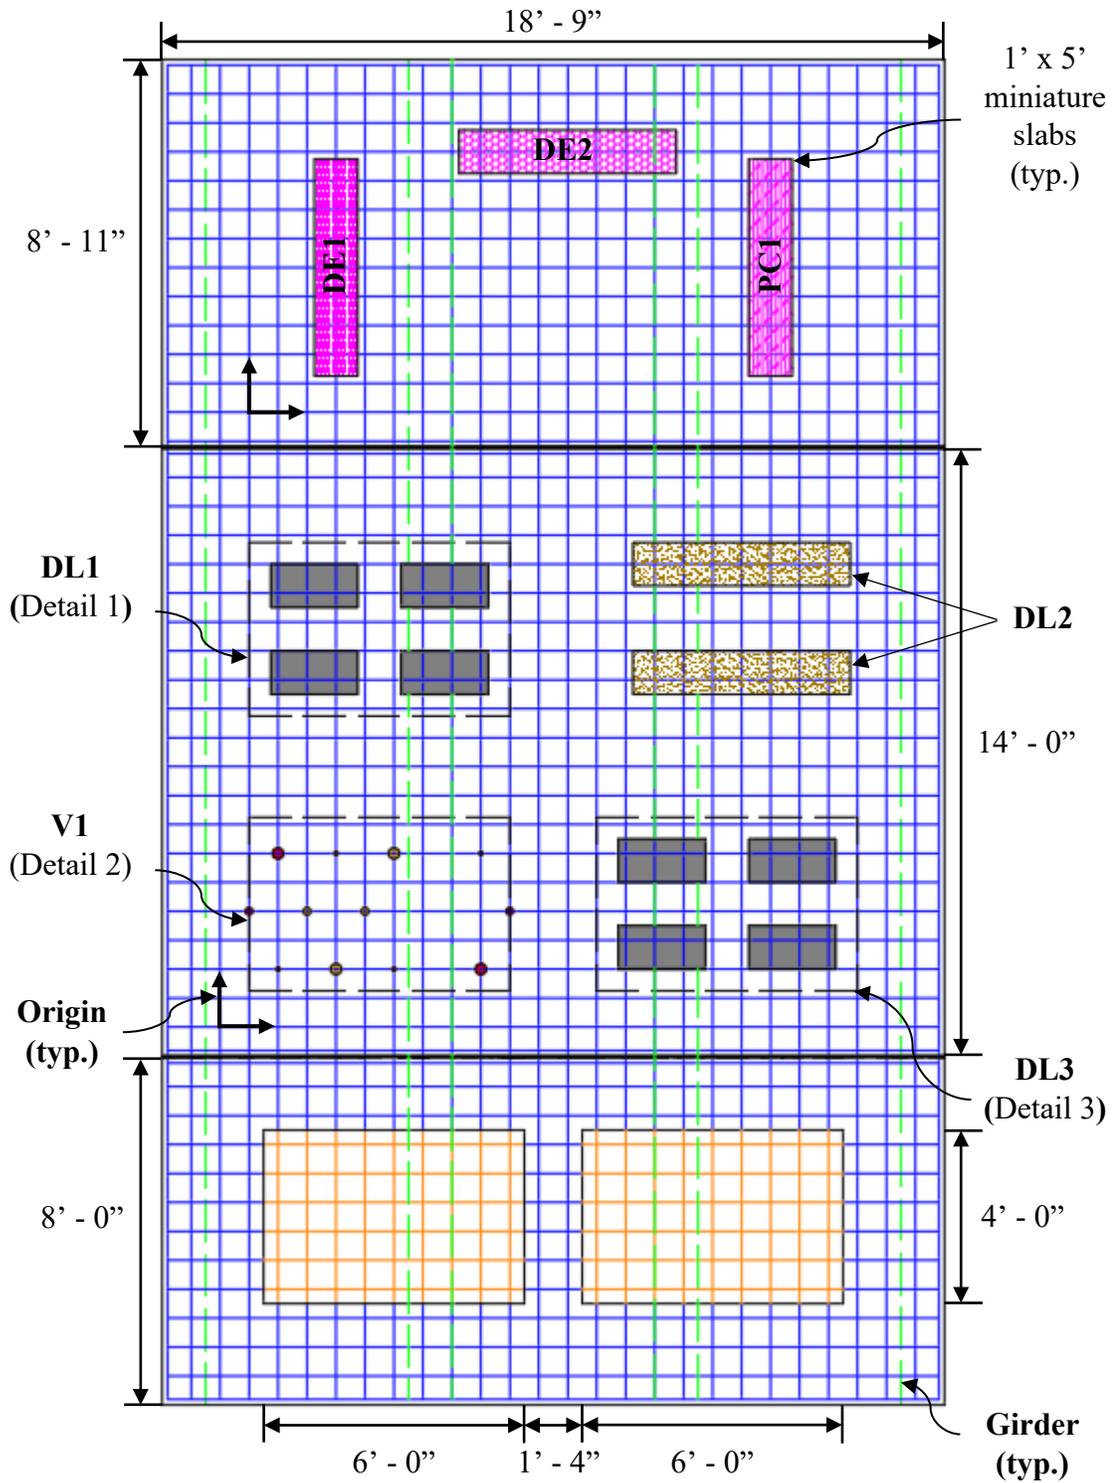
- Notes:** (1) Reinforcement spacing is 8 in. on center (shown as blue lines)  
 (2) Sections 1, 2, and 3 are shown from bottom to top of drawing

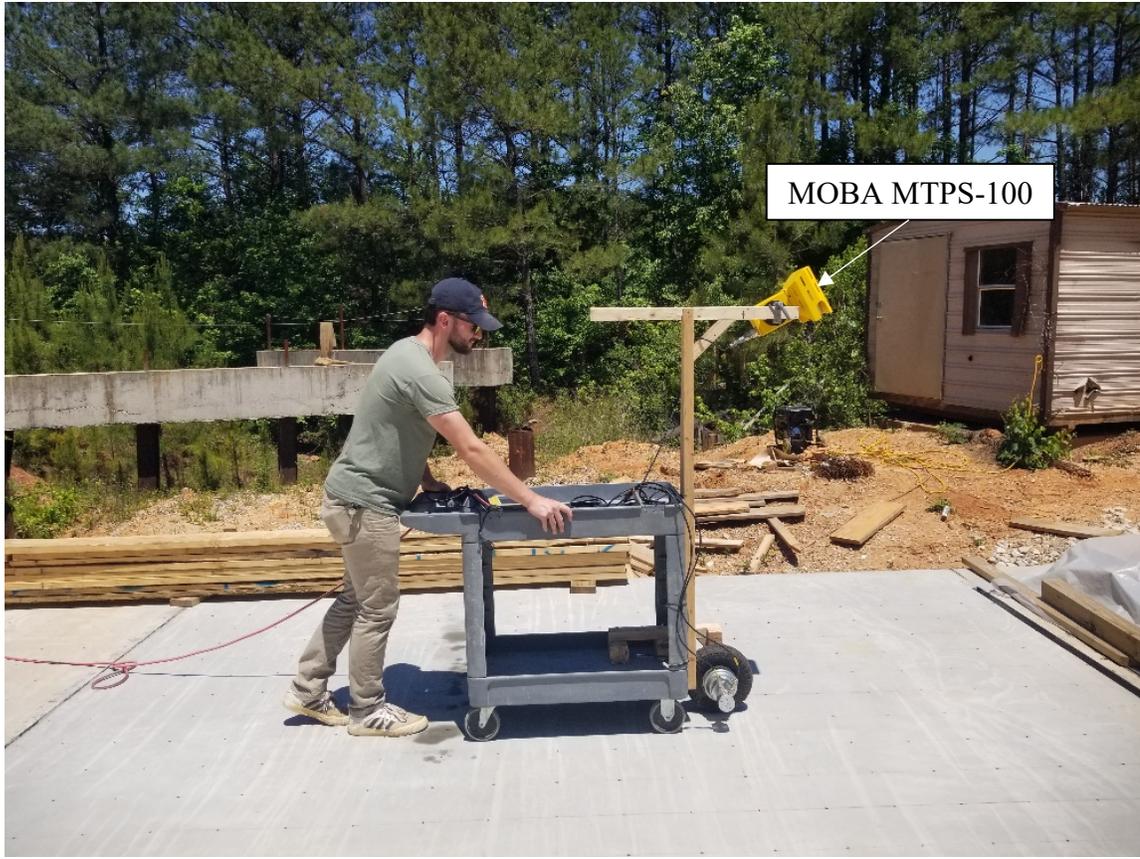
**Figure 5-12: IRT Evaluation of Bridge Deck using the MOBA MTPS-100 Cart System**

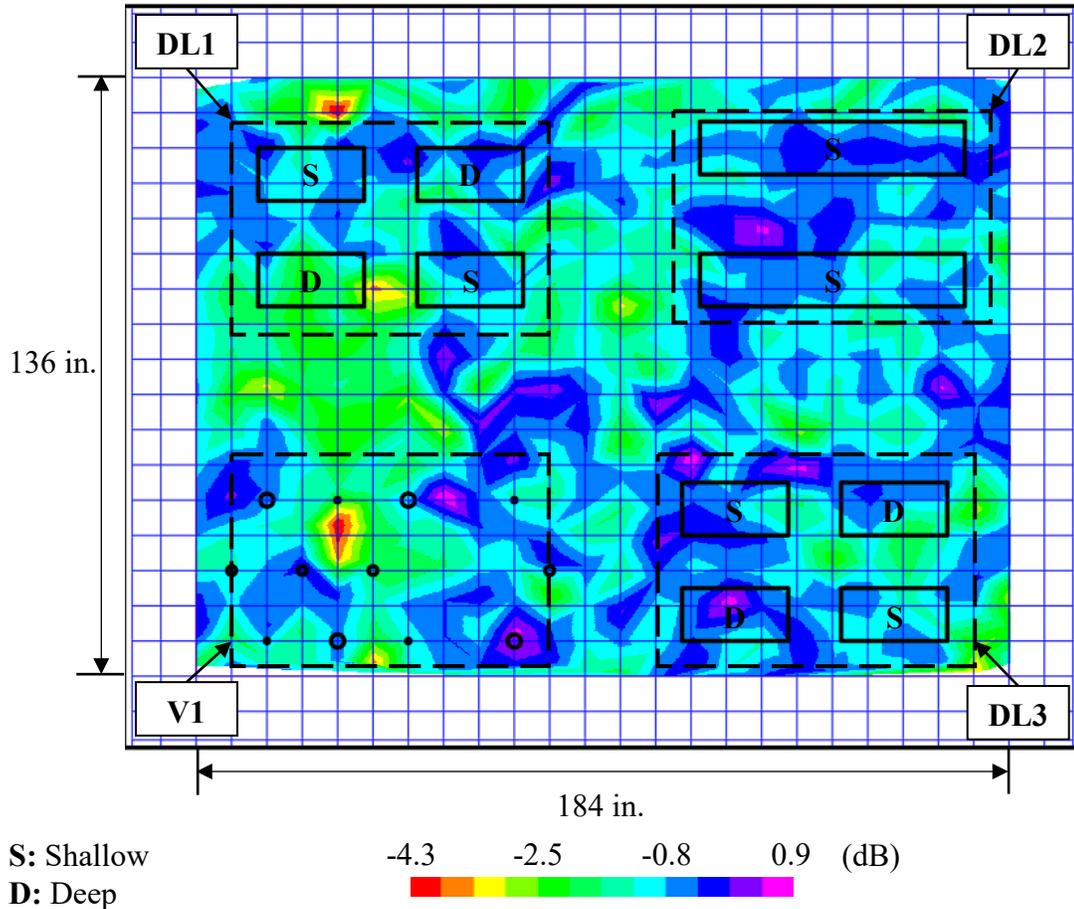
**Figure 5-14: Section 2 Spatial Contour Plot of GPR Data**

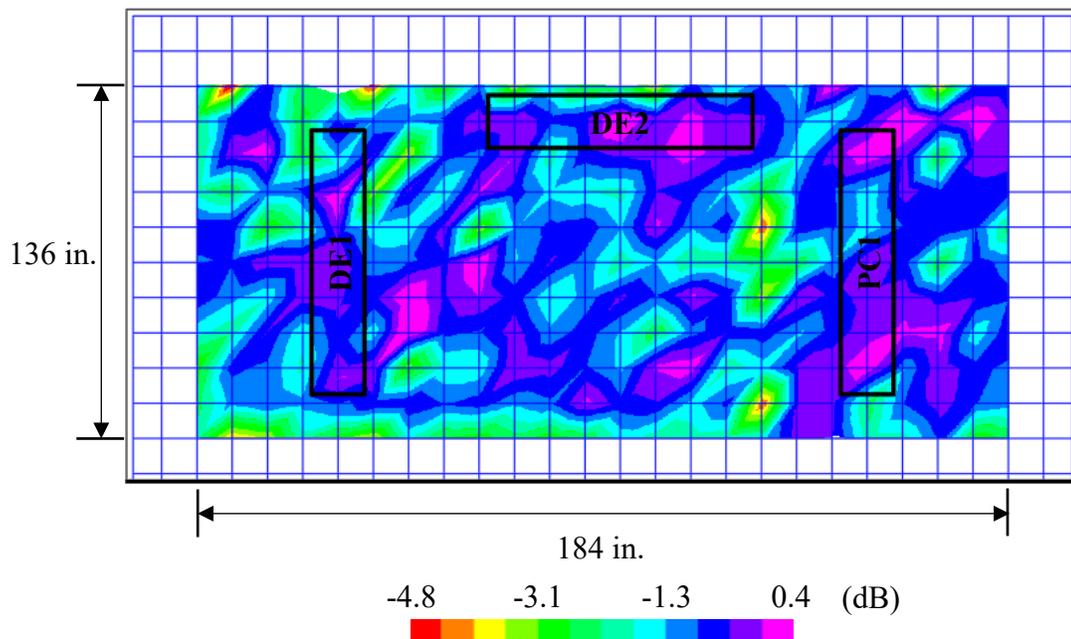
**Figure 5-15: Section 3 Spatial Contour Plot of GPR Data**

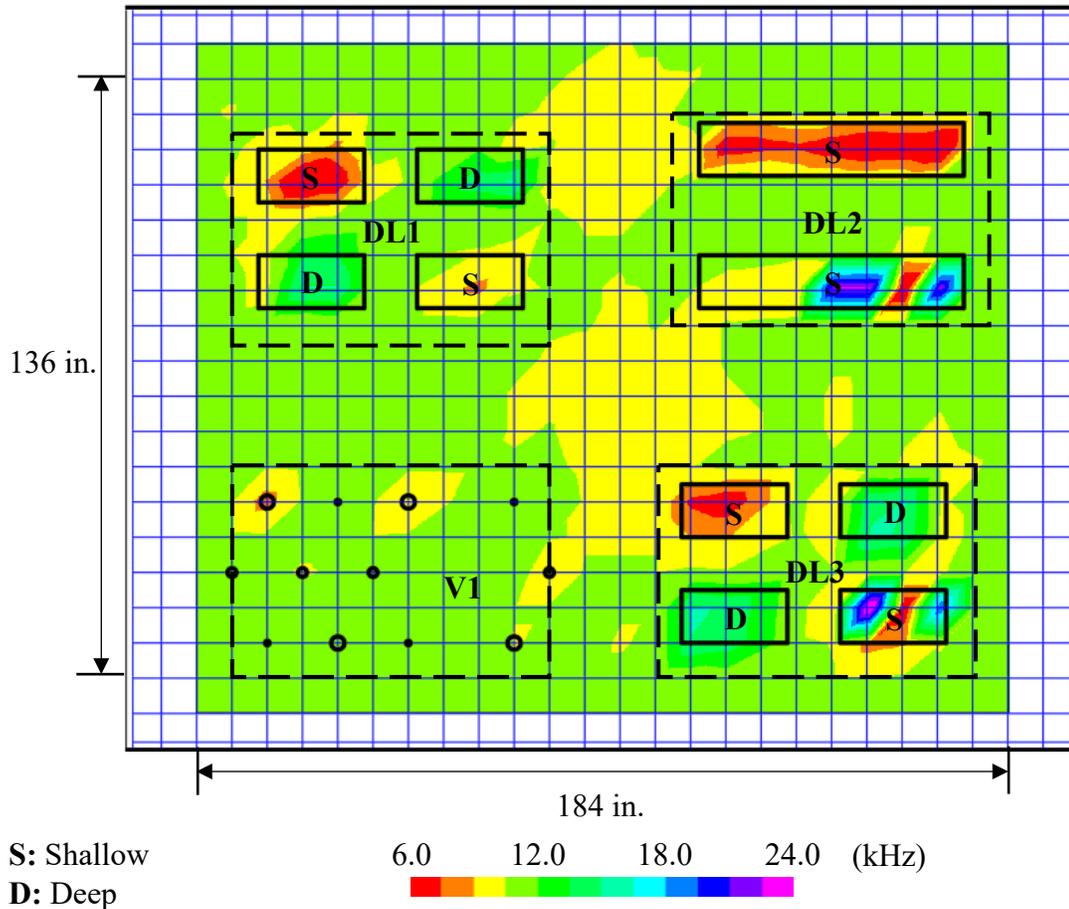
**Figure 5-16: Section 2 Spatial Contour Plot of IE Data**

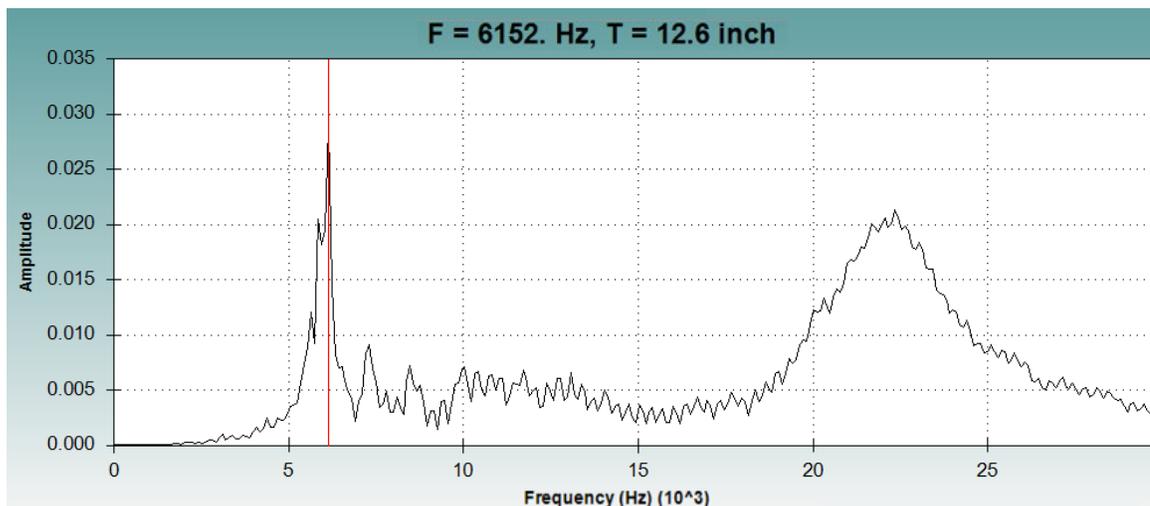
**Figure 5-17: Spectral Response Over Shallow Delamination Showing Two Pronounced Excited Frequencies**

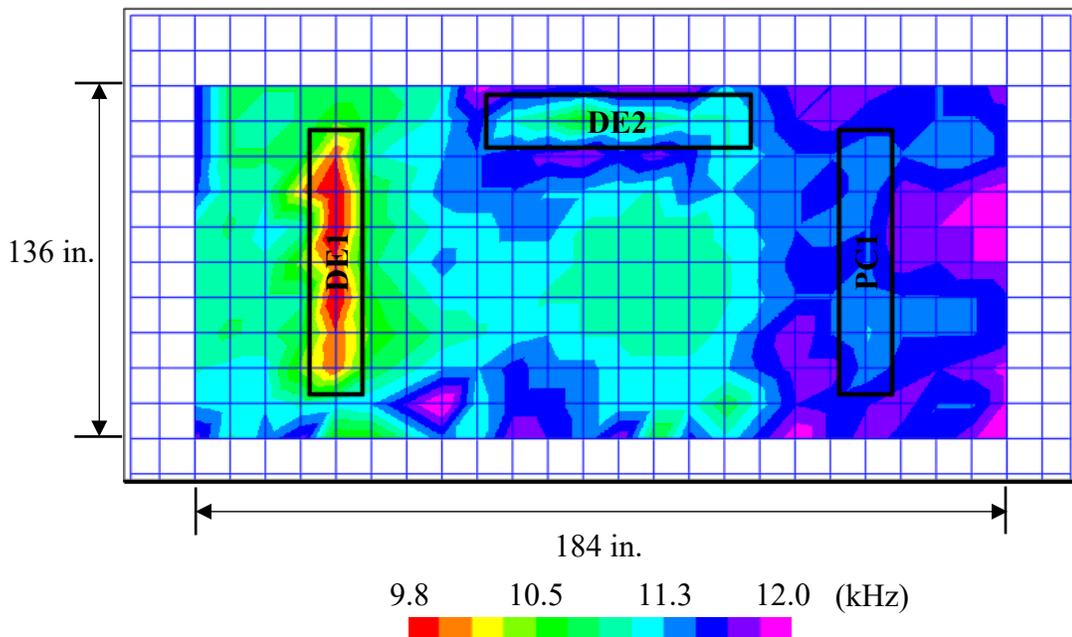
**Figure 5-18: Section 3 Spatial Contour Plot of IE Data**

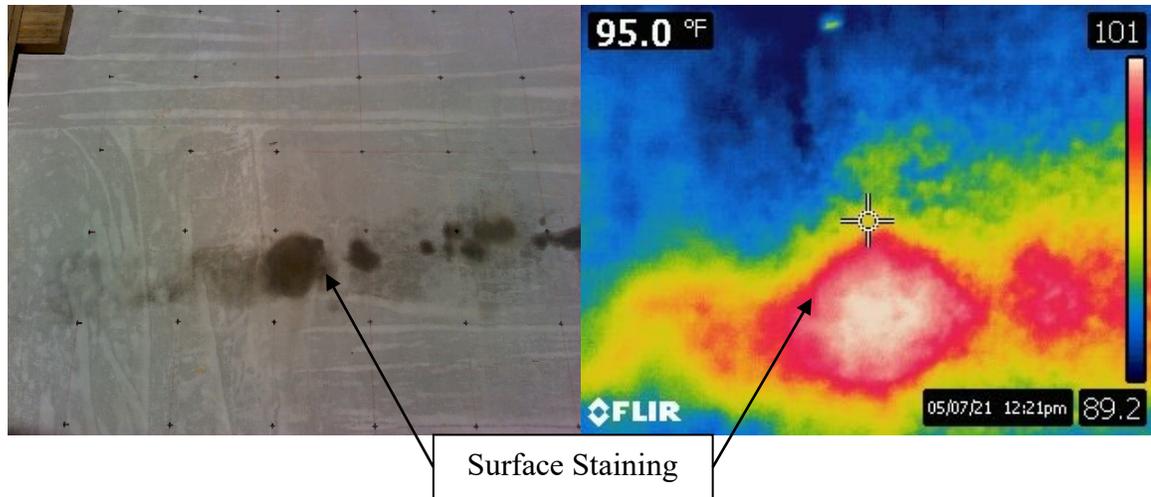
**Figure 5-20: Increased Estimated Surface Temperature from Staining at DL2**

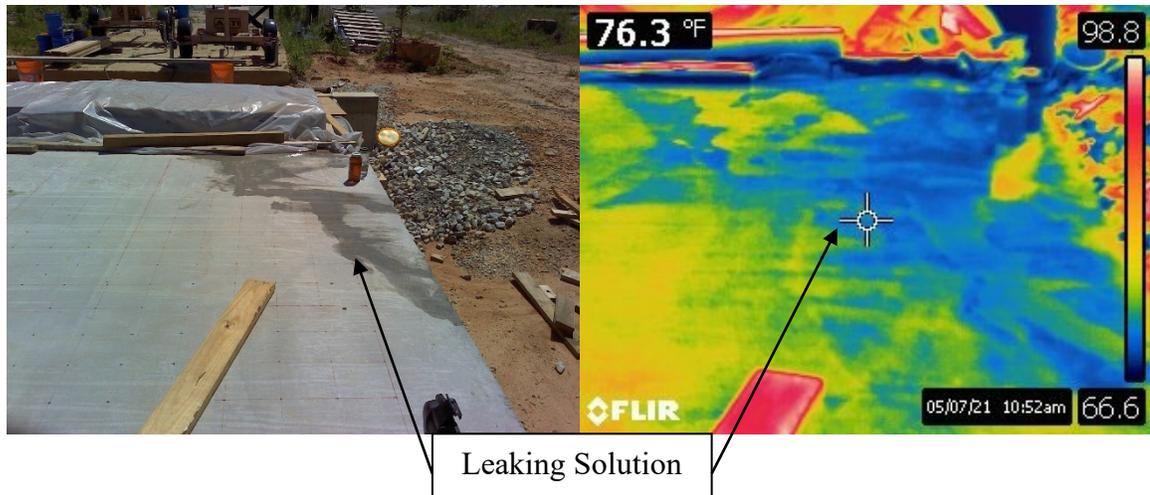
**Figure 5-21: Surface Cooling Caused by Leaking Sodium Chloride Solution**

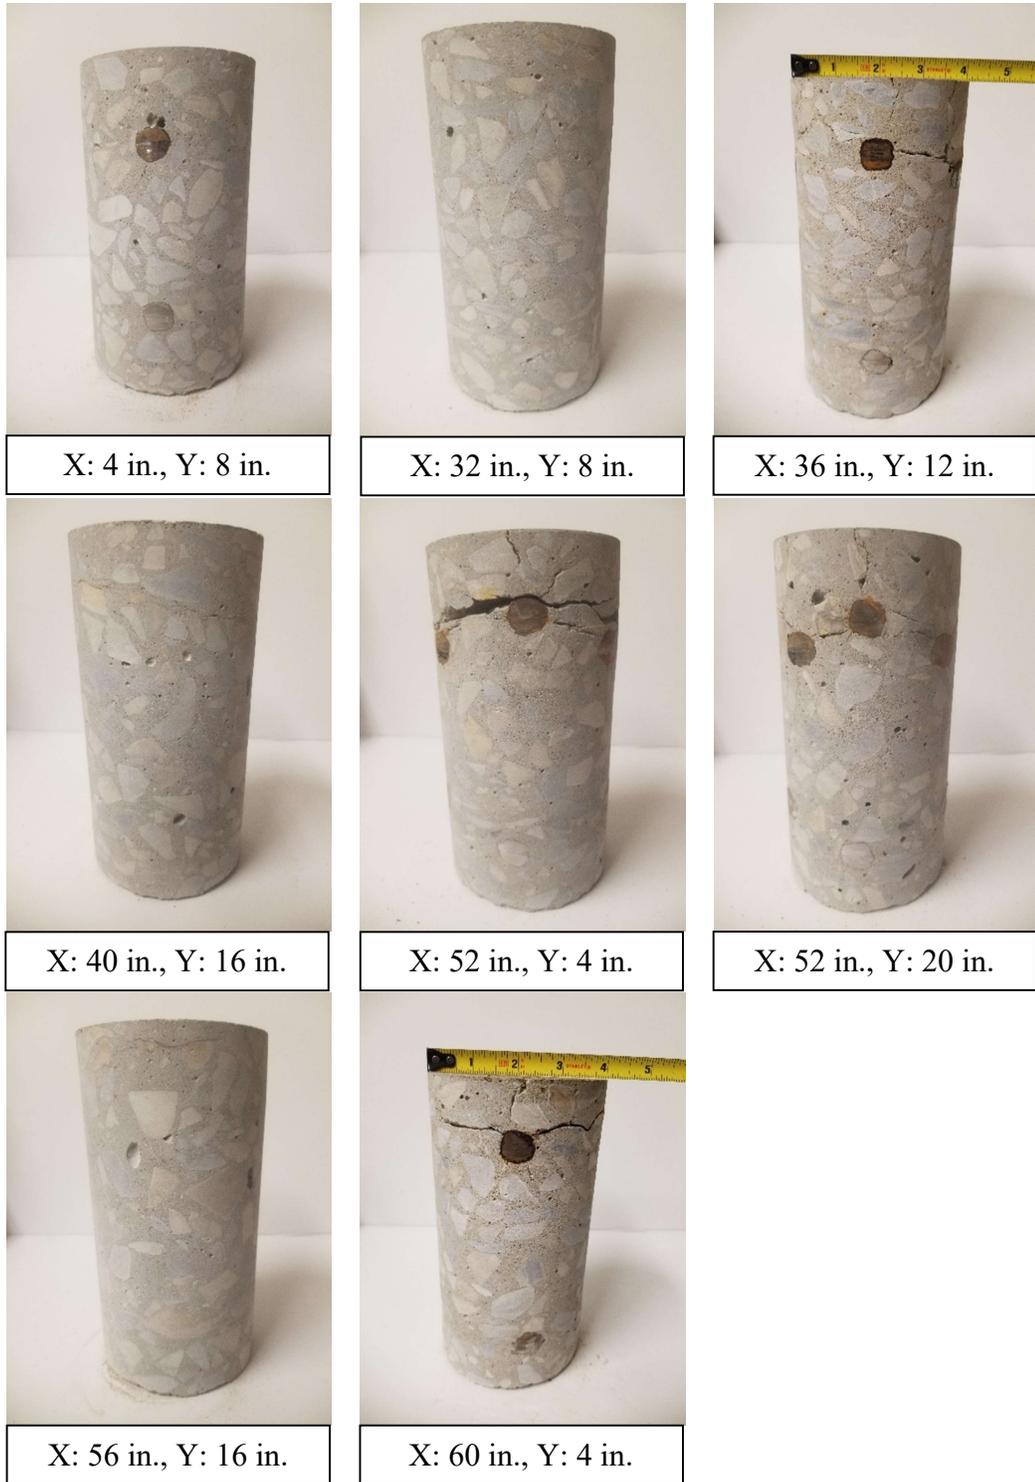
**Figure A1: Specimen C1 Extracted Cores**

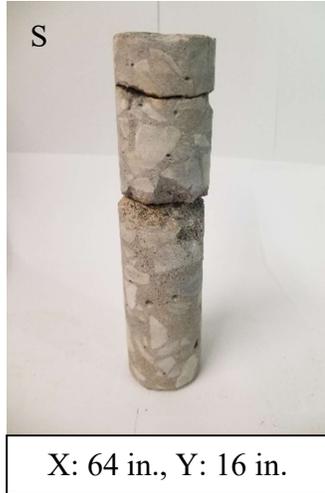
**Figure A3: Specimen C2 Extracted Cores (cont.)**

Two delamination planes were encountered during coring, as seen on the right.

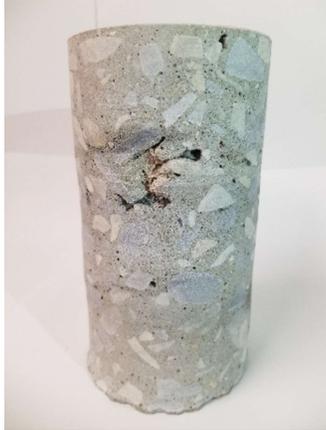
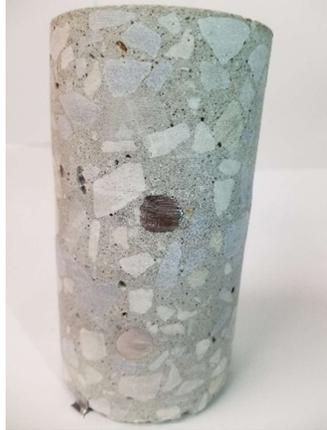
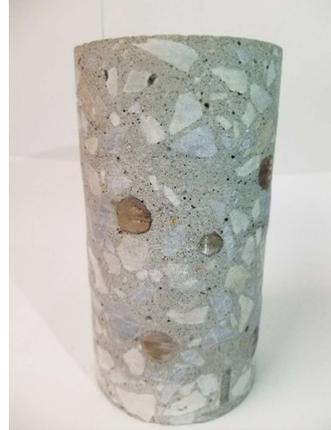
**Figure A6: Specimen DL3 Extracted Cores**

X: 20 in., Y: 16 in.

X: 36 in., Y: 8 in.

X: 68 in., Y: 4 in.

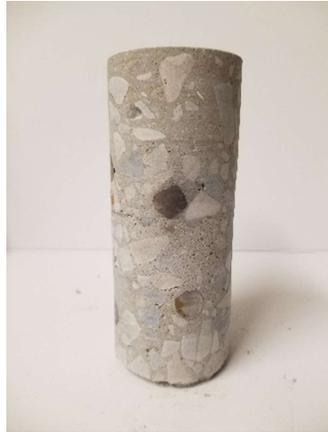
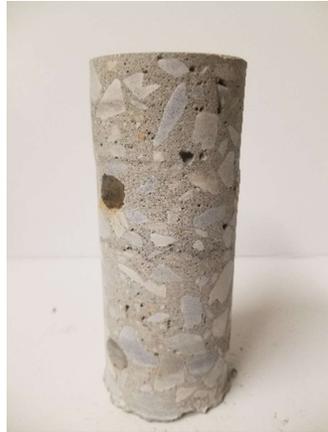
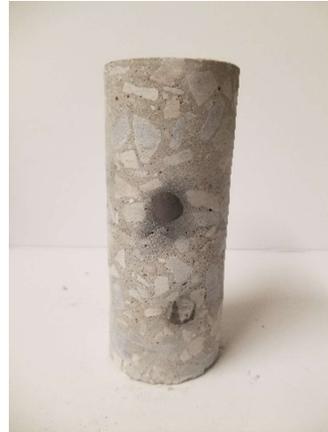
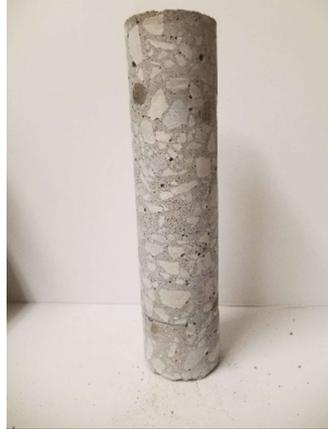
**Figure A12: Specimen CTRL Extracted Cores**

X: 12 in., Y: 12 in.

X: 24 in., Y: 12 in.

X: 36 in., Y: 16 in.

X: 48 in., Y: 16 in.

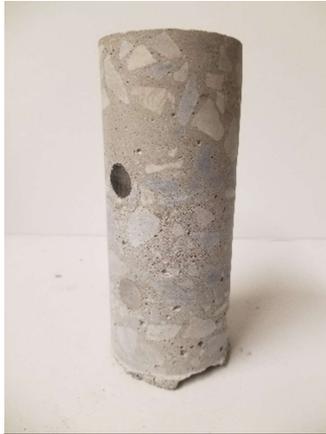
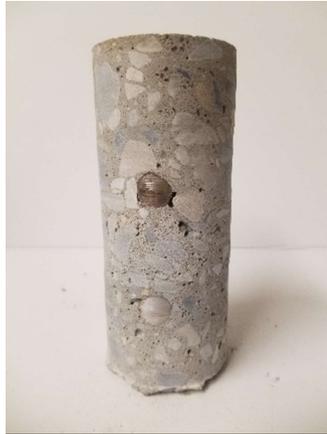
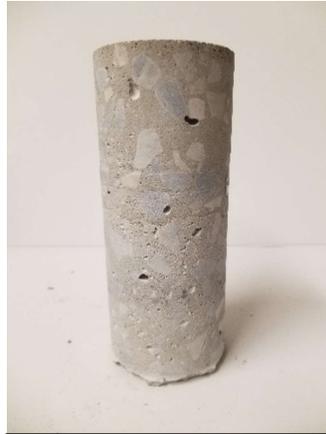
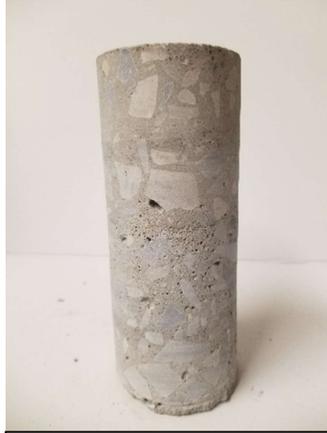
**Figure A13: Specimen DE2 Extracted Cores**

X: 28 in., Y: 16 in.

X: 36 in., Y: 16 in.

X: 44 in., Y: 16 in.

X: 56 in., Y: 12 in.

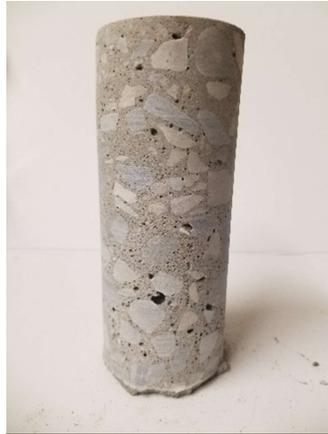
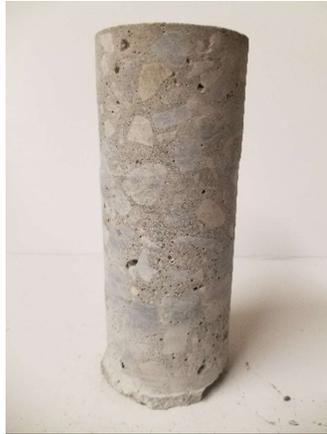
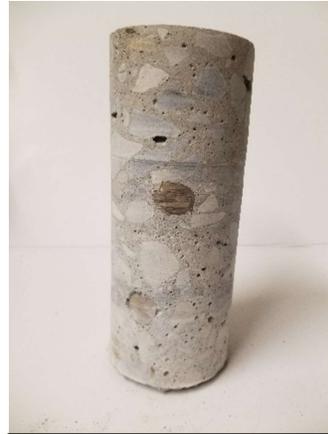
**Figure A16: Specimen DE5 Extracted Cores**

X: 24 in., Y: 16 in.

X: 36 in., Y: 8 in.

X: 44 in., Y: 16 in.

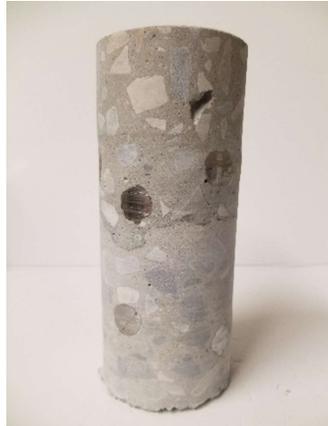
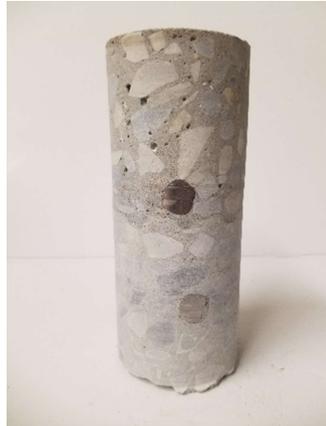
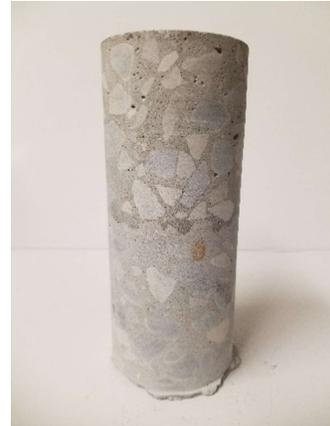
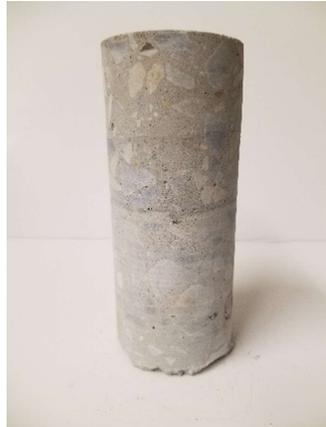
**Figure A17: Specimen PC1 Extracted Cores**

X: 12 in., Y: 12 in.

X: 20 in., Y: 8 in.

X: 32 in., Y: 8 in.

X: 48 in., Y: 12 in

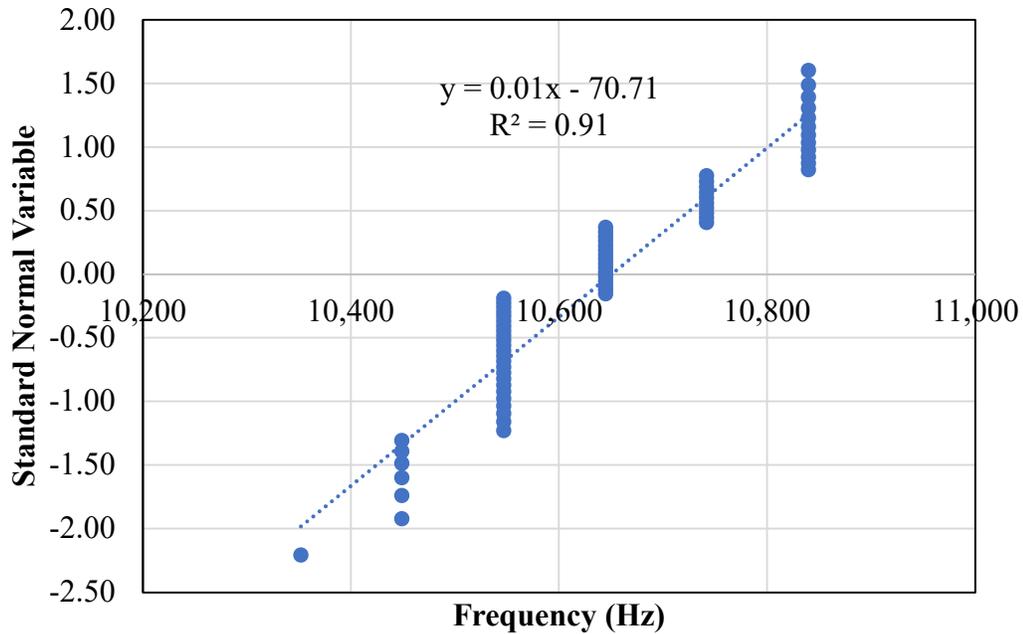
**Figure D1: Normal Distribution of Slab Thickness Frequencies**

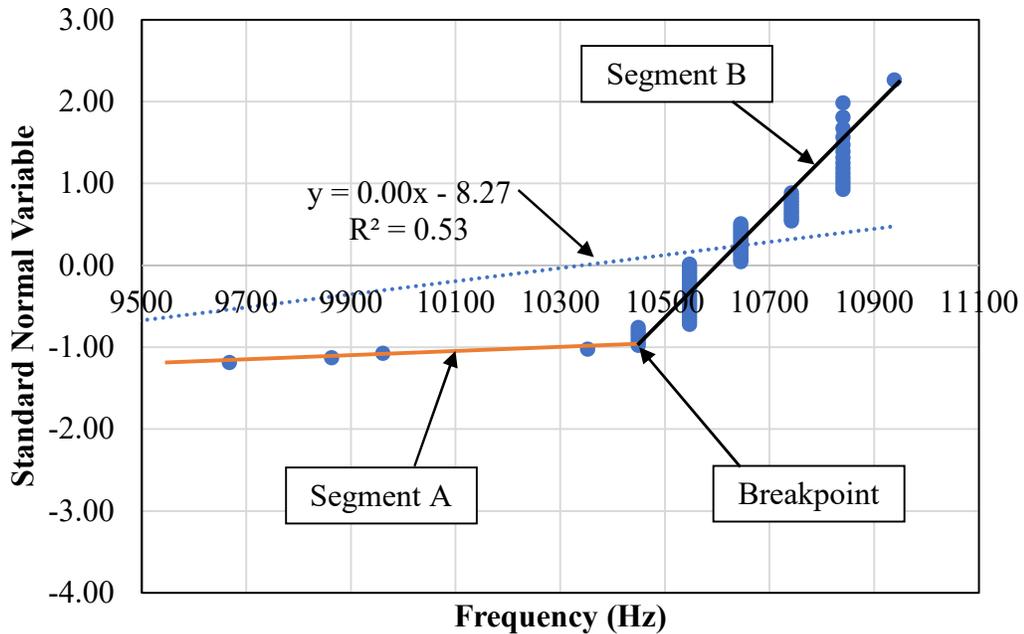
**Figure D2: Deck Thickness and Flexural Plate-Bending Frequencies from a Delamination Slab**
