**Evaluation of Nondestructive Testing Methods to Assess the Condition of Concrete
Bridge Decks**

A thesis submitted to the Graduate Faculty of
Auburn University
in partial fulfillment of the
requirements for the Degree of
Master of Science

Auburn, Alabama
August 7, 2021

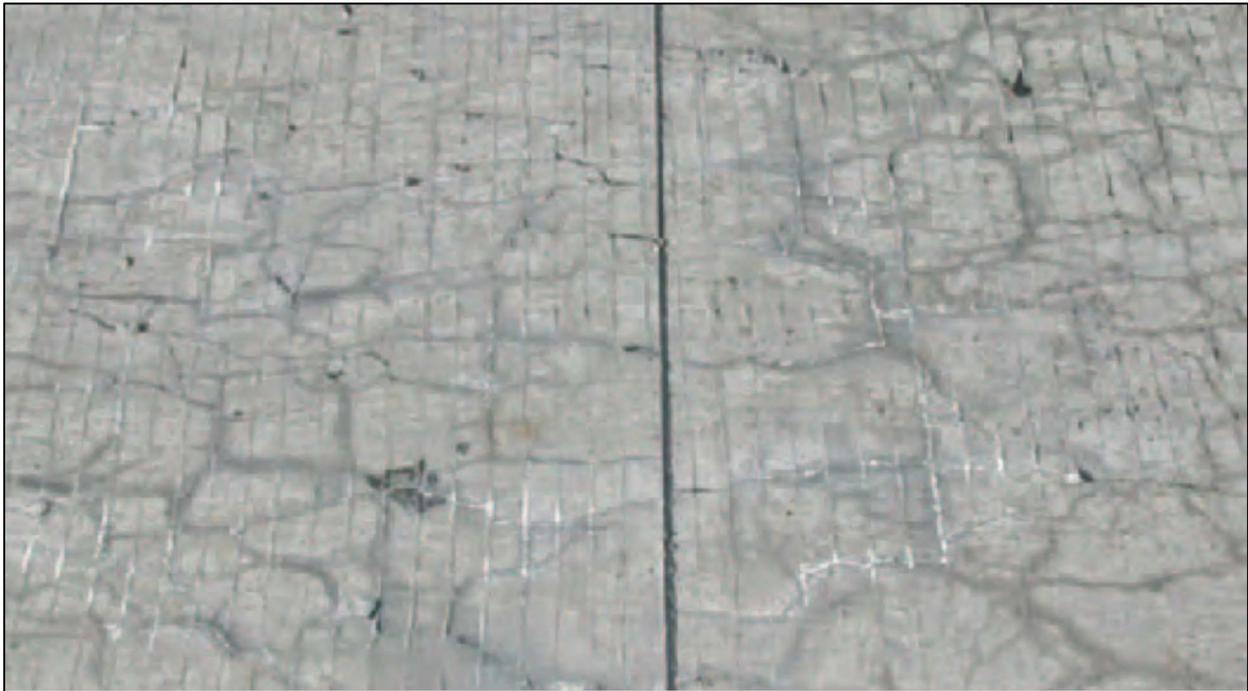
Figure 2-10: Surface cracking due to DEF distress (Taylor, Famy and Scrivener 2000)

ettringite formation (DEF), alkali-silica reaction (ASR), freeze-thaw cycles or plastic shrinkage (Gucunski, et al. 2013). DEF is a form of sulfate attack that is believed to mainly occur from a lack of heat control during the curing phase of concrete (Gucunski, et al. 2013). For DEF to occur, internal temperature of a plain portland cement specimen must be above approximately 160°F and the specimen must be kept moist almost permanently (Taylor, Famy and Scrivener 2000). Research suggests that monosulfate from clinker is intimately mixed with calcium-silicate hydrate (C-S-H) at the end of the heat treatment, and that if conditions are suitable for expansion, ettringite is then mixed with C-S-H (Taylor, Famy and Scrivener 2000). This formation of ettringite causes expansion within the concrete, resulting in empty cracks forming around the aggregates (Gucunski, et al. 2013). The effect of DEF can be observed in Figure 2-10.

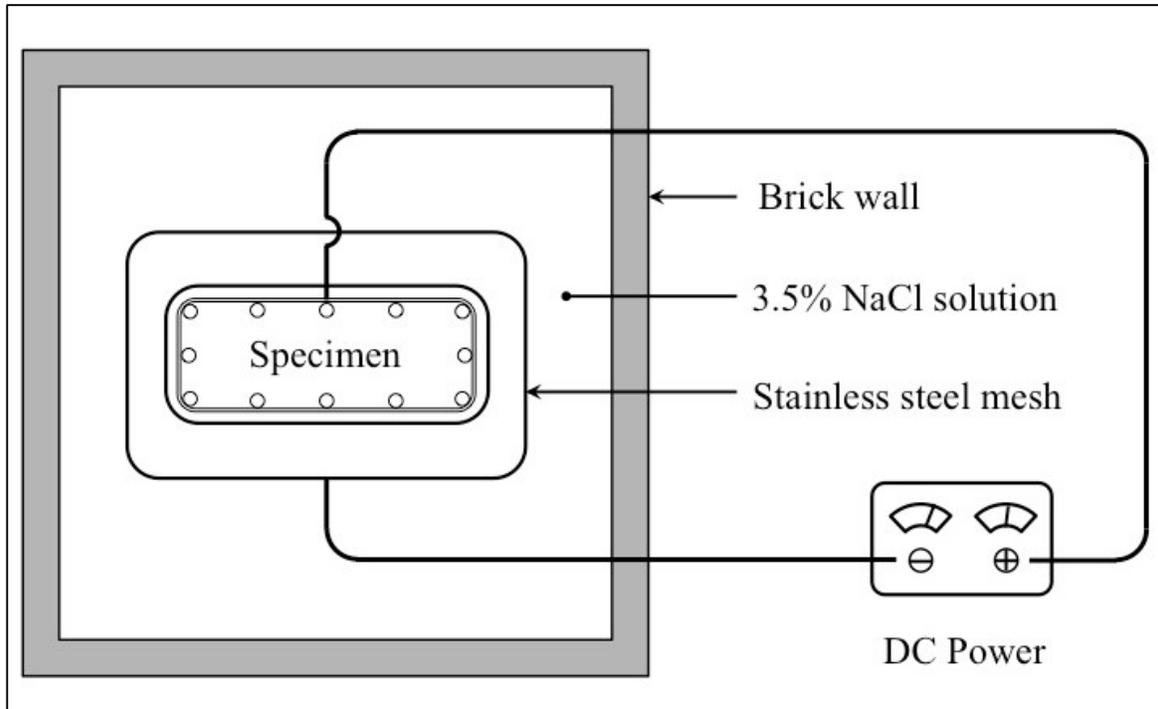
Figure 2-14: Accelerated corrosion setup (Adapted from Guo, et al. 2015)

Guo, et al. (2015) successfully employed accelerated corrosion techniques on four single shaft piers in order to investigate the seismic capacity of corroded bridge piers. Four columns measuring 10.5 ft (3.2 m) in height, including footing thickness, with a cross sectional area of approximately 10 × 24 in. (0.25 × 0.6 m) were constructed with 6,300 psi (43 MPa) strength concrete (Guo, et al. 2015). Twelve steel bars measuring 0.63 in. (16 mm) in diameter served as the longitudinal reinforcement, while 0.31 in. (8 mm) diameter bars served as rectangular ties in the column (Guo, et al. 2015). The clear cover to the first layer of reinforcing steel was 1 in. (25 mm) (Guo, et al. 2015). The reinforcing steel, both longitudinal and transverse, was set as the anode in the electrochemical reaction, while a stainless steel mesh surrounding the columns functioned as the cathode (Guo, et al. 2015). The bottom of each specimen was enclosed by a tank filled with 3.5 percent sodium chloride solution (Guo, et al. 2015). Specimens were designed to have corrosion levels corresponding to five percent, ten percent and fifteen percent steel loss (Guo, et al. 2015). A diagram of the accelerated corrosion process is shown in Figure 2-14.

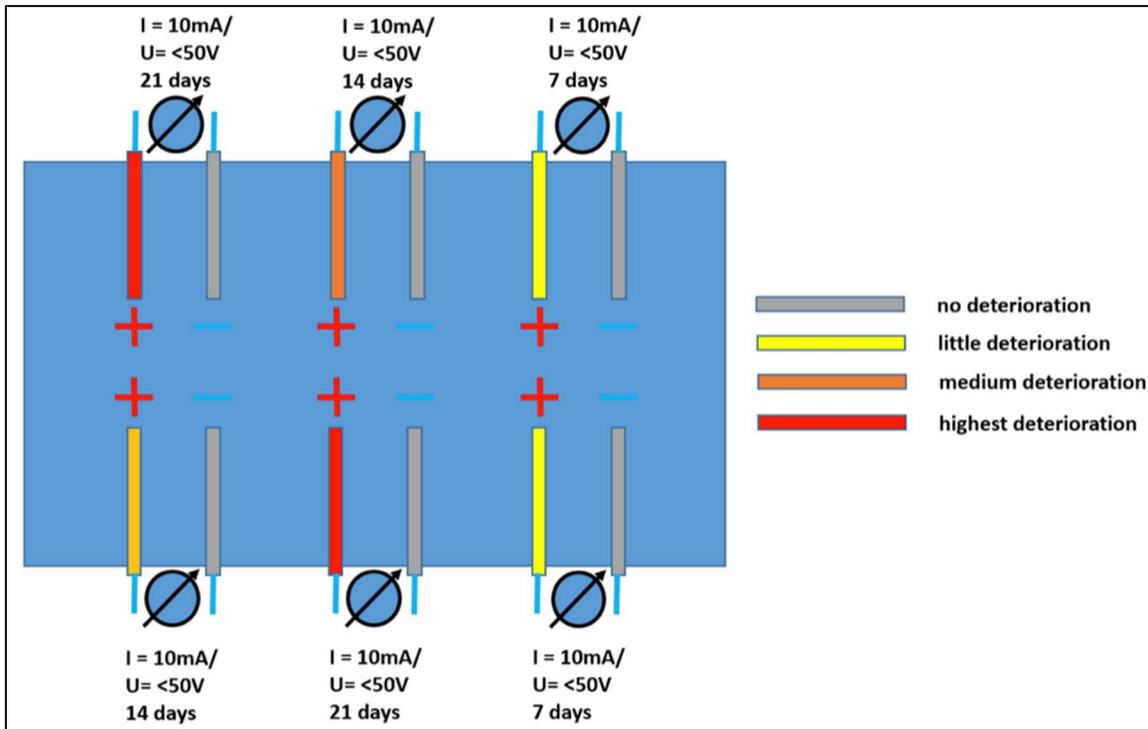
Figure 2-16: Accelerated corrosion setup (BAM Division 8.2 2018)

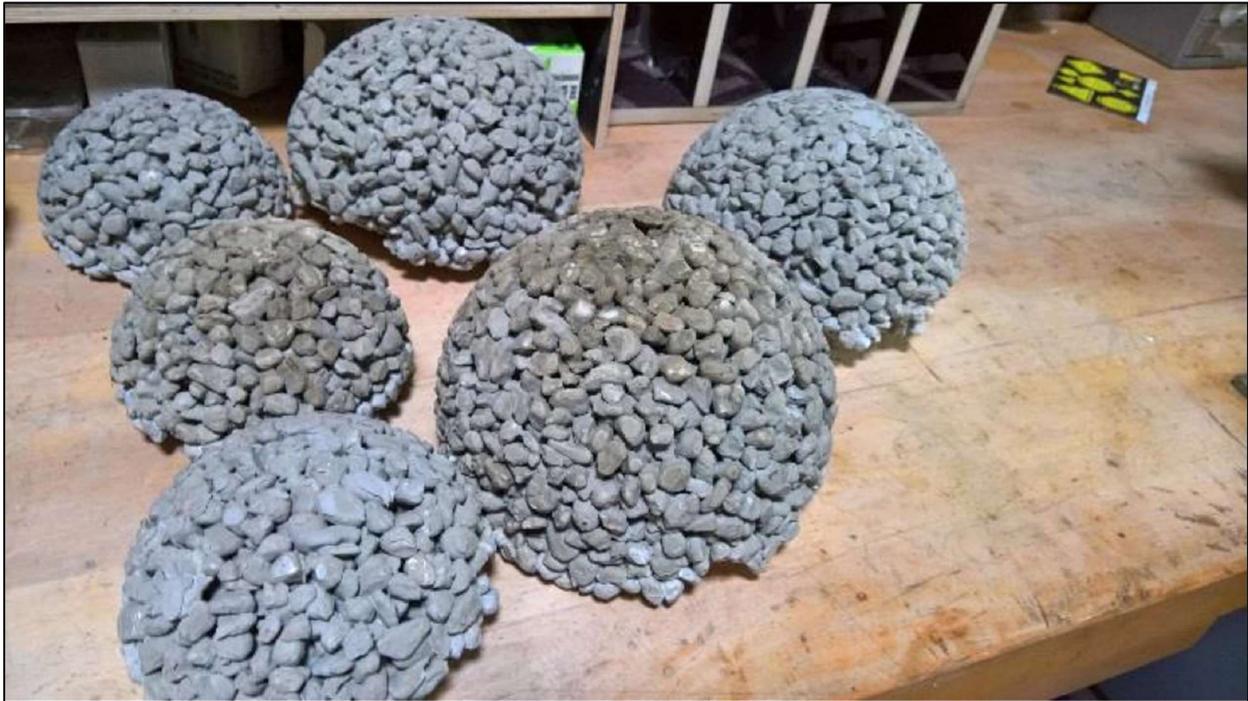
Figure 2-19: Honeycombed implants (BAM Division 8.2 2018)

The Federal Institute for Materials Research and Testing in Germany also used artificial honeycombing in an experiment to create a reinforced-concrete specimen with honeycombed regions in order to test their suitability for NDT detection. A concrete specimen was constructed with dimensions of $48 \times 48 \times 16$ in. ($120 \times 120 \times 40$ cm) (BAM Division 8.2 2018). The specimen was reinforced with a top and bottom layer of reinforcing steel, which consisted of 0.31 in. (8 mm) diameter steel bars spaced at 4 in. (10 cm) on center in both the longitudinal and transverse direction (BAM Division 8.2 2018). The clear cover from the surface to the first layer of reinforcing steel was 2 in. (5 cm) (BAM Division 8.2 2018). Nine honeycombs were comprised of a coarse-aggregate-rich concrete mixture (BAM Division 8.2 2018). The honeycombs were hemispherical in shape, each having a radius of 4 in. (100 mm) or 3 in. (75 mm) (BAM Division 8.2 2018). Photographs of some constructed artificial honeycombs are shown in Figure 2-19. All nine honeycombed regions could be detected using the ultrasound pulse-echo method.

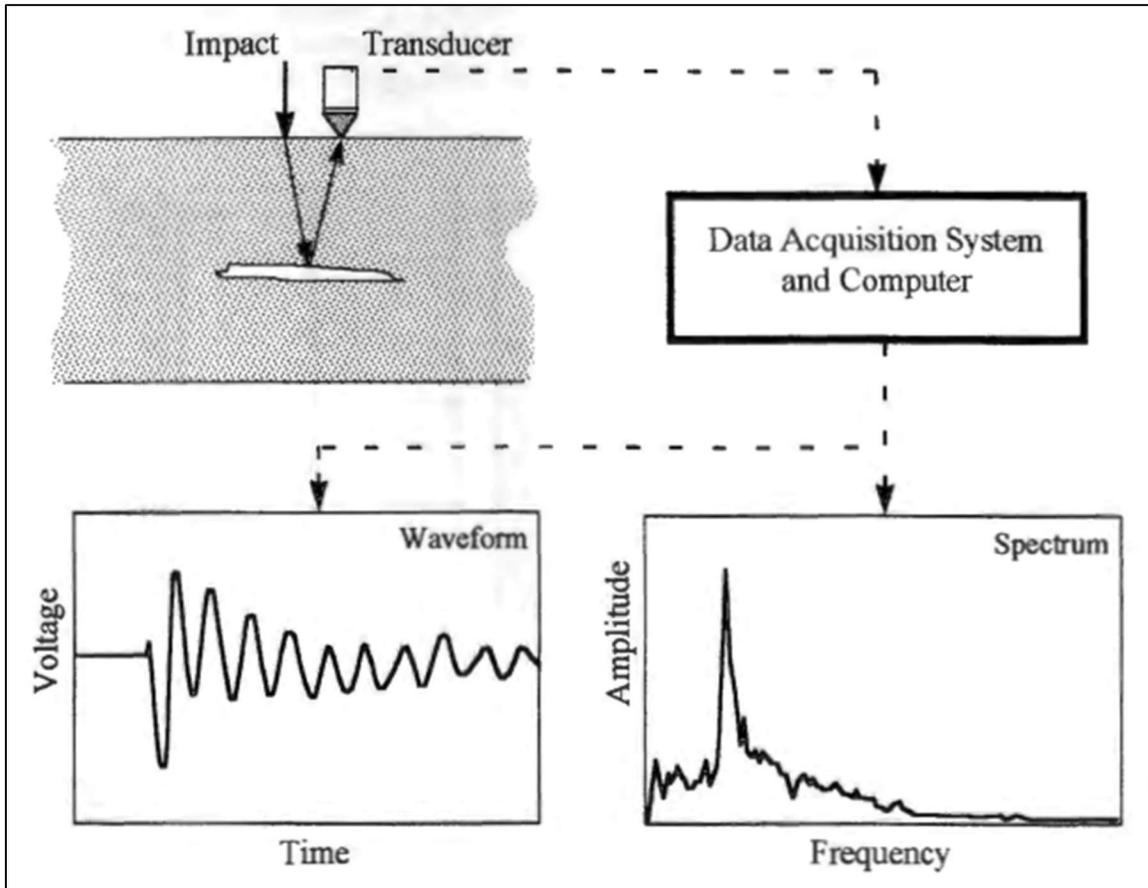
Figure 2-20: Simplified impact-echo method (Sansalone and Streett 1996)

The impact echo method is a nondestructive testing method that was developed in the mid-1980s, with field instruments becoming commercially available in 1992 (Sansalone and Streett 1996). The method is based upon an impact-generated stress pulse that propagates throughout the structure. This pulse travels into the body of the concrete structure as dilatational (P-) and distortional (S-) waves and travels along its surface as a Rayleigh (R-) wave (Cheng and Sansalone 1993). P-waves and S-waves may also be described as compression and shear waves, respectively (Sansalone and Carino 1989). The P- and S-waves travel into the concrete along hemispherical wave fronts and are reflected by internal interfaces, such as cracks or voids, and by the external faces of the structure (Cheng and Sansalone 1993). These reflections are monitored by a receiver or transducer located adjacent to the impact location. A diagram showing a simplified version of the impact echo is displayed in Figure 2-20.

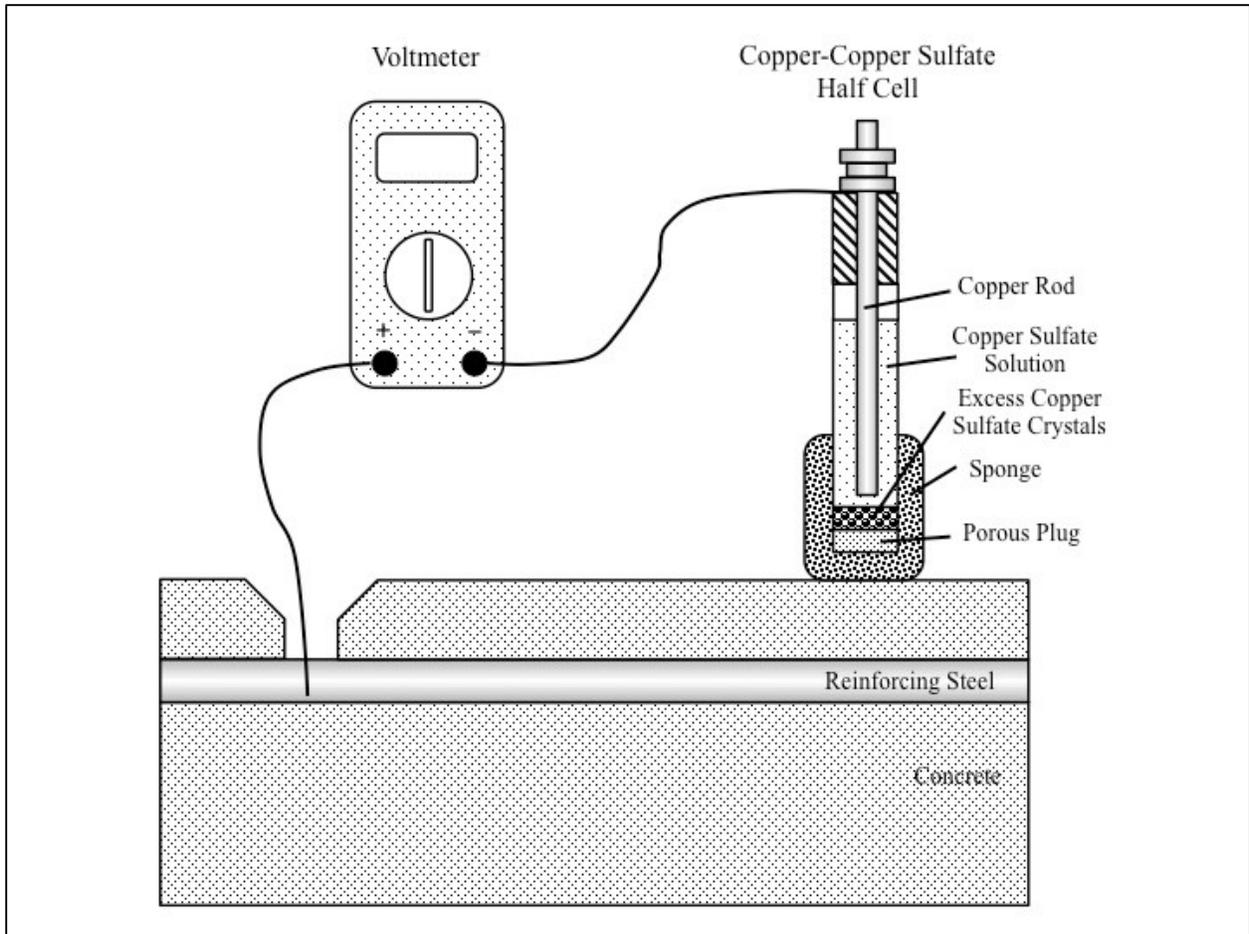
Figure 2-25: Simplified half-cell potential method (Adapted from ACI 228 2013)

The other half-cell is obtained by providing a reference cell. A reference cell is typically a portable copper/copper sulfate half-cell, which is composed of a copper bar submerged in a saturated solution of copper sulfate, placed on the surface of the concrete (Gucunski, et al. 2013). Each of these half-cells creates an electric potential, or a flow of electrons. This reference cell acts as a standard for measuring potential of the reinforcement half-cell. With a voltmeter, one can measure the potential difference between the half-cells and collect data corresponding to the probability of corrosion over the area of a reinforced-concrete structure. A diagram of a simplified half-cell potential test method is shown in Figure 2-25. A general standard to determine corrosion probability is presented in Table 2-1.

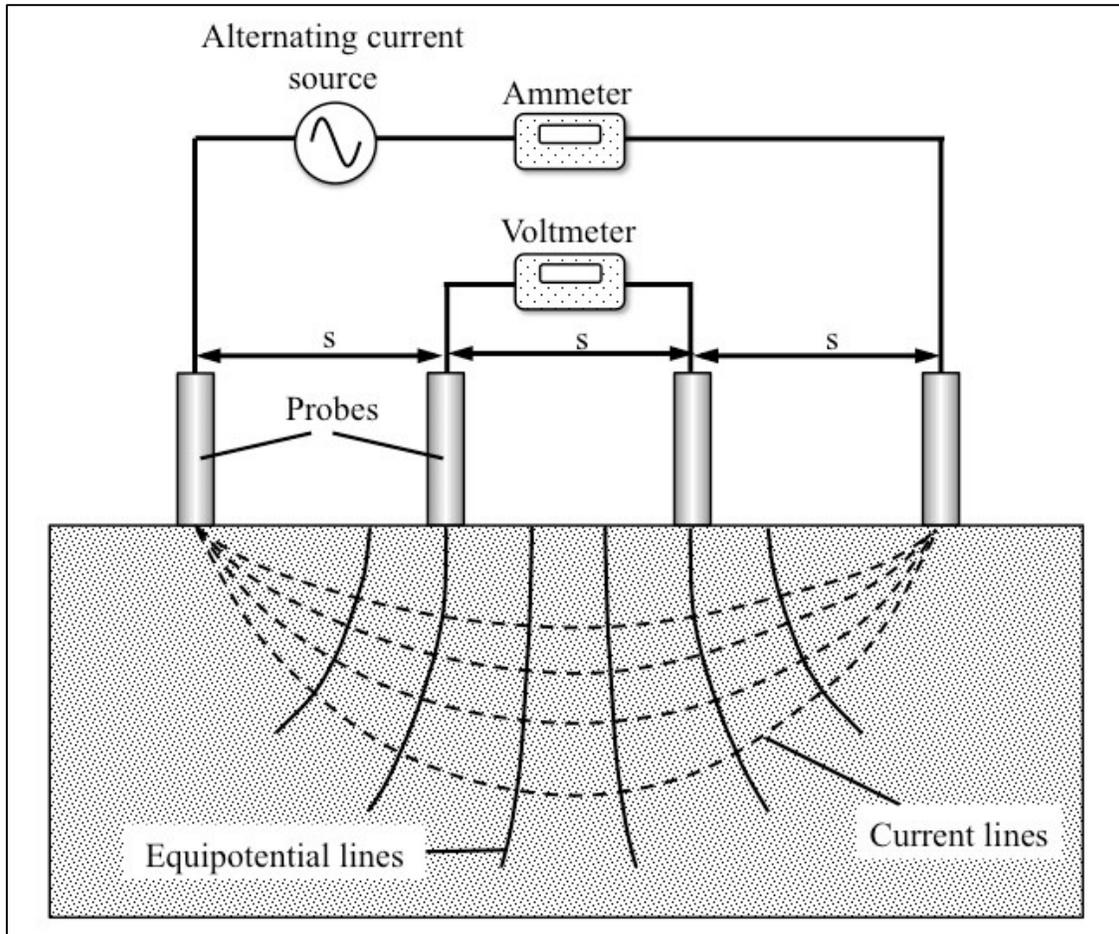
Figure 2-27: Surface resistivity principle (Adapted from ACI 228 2013)

The standard method for measuring the resistivity of a concrete structure is to perform a surface resistivity test on the in situ concrete. This process consists of applying a current to the concrete through electrodes and measuring the potential of the resulting electrical field from other electrodes (Gucunski, et al. 2013). The most common electrode configuration for a surface resistivity test for civil engineering applications is known as the Wenner setup, as shown in Figure 2-27 (Gucunski, et al. 2013).

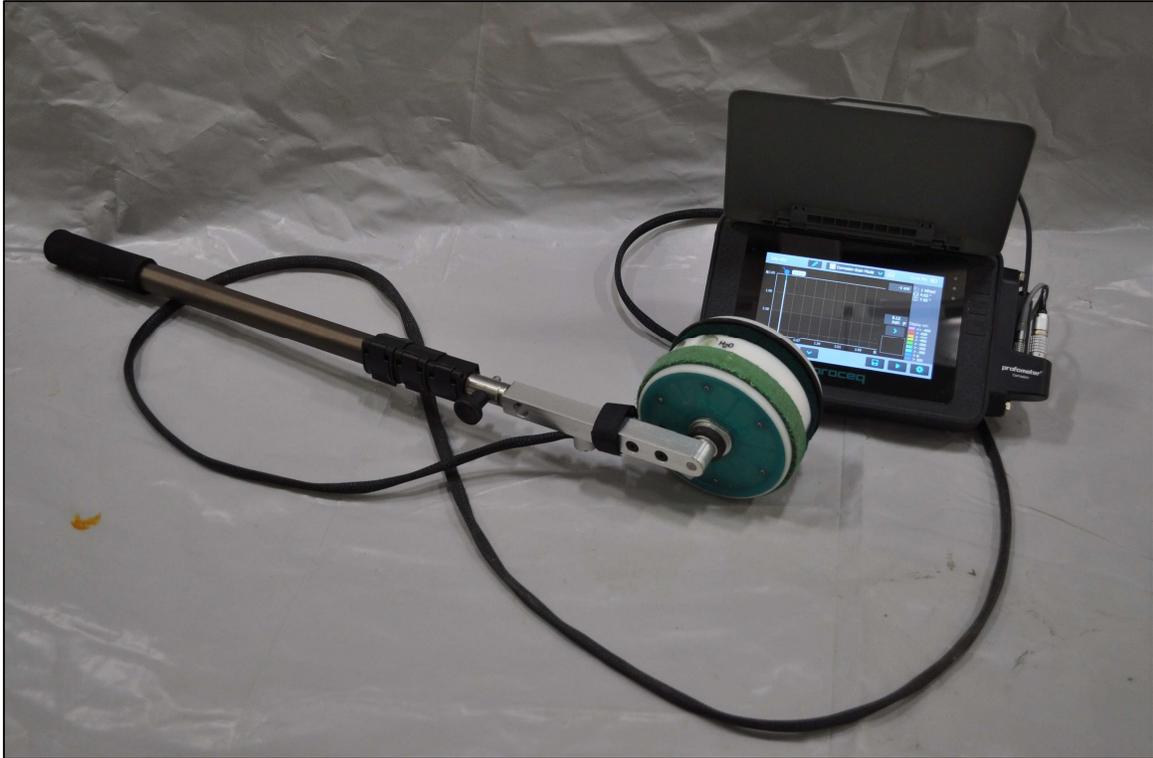
Figure 3-2: Proceq Profometer half-cell potential test equipment

The Proceq system for performing the half-cell potential test entailed rolling the wheel electrode along a line. The research team performed line-scans spaced at 6 in., which fell well within the limits for test spacing detailed in ASTM C876 (2015). Direct contact was made to the reinforcing steel by use of a bolt twisted into a threaded hole in the reinforcement. The concrete slabs returned relatively stable readings at a single location, but to ensure proper testing, the surfaces of the slabs were wetted. The distilled water compartment of the Proceq rolling wheel electrode, which applied water to the surface of the slab, allowed for water to be added to the surface as the test was performed. Data processing and reporting along each line-scan was performed within the software of the Proceq Profometer.

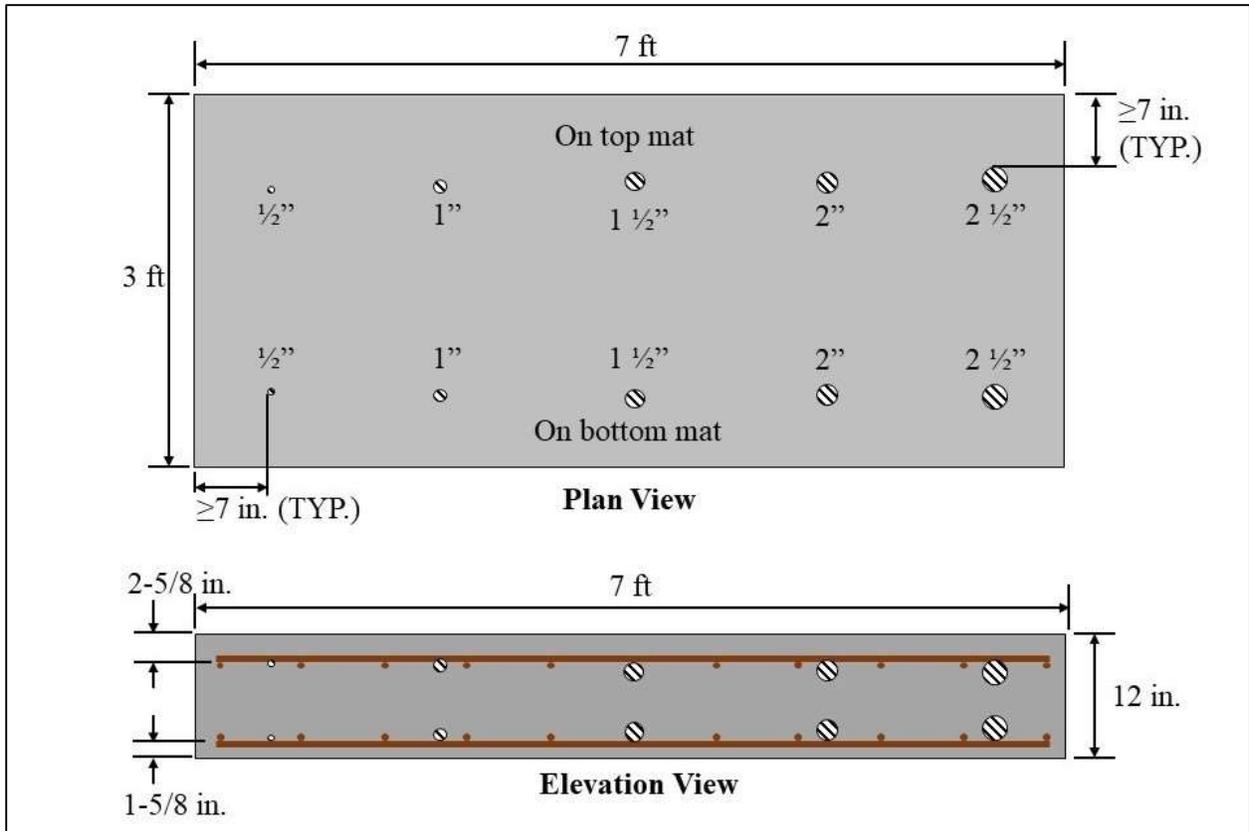
Figure 3-8: Diagram for Specimen V1

In order to investigate the detectability of these defects at both deep and shallow locations, this slab was constructed to be 12 in. thick. The voids were created using water-filled balloons with diameters between 0.5 and 2.5 in. that were tied to the reinforcing steel at locations shown in Figure 3-8. Deionized water was used to fill the balloons. In Figure 3-9, Specimen V1 is shown prior to placement of ready-mixed concrete. During the concrete placement and consolidation process, care was taken to ensure that the locations of the water-filled balloons were not altered.

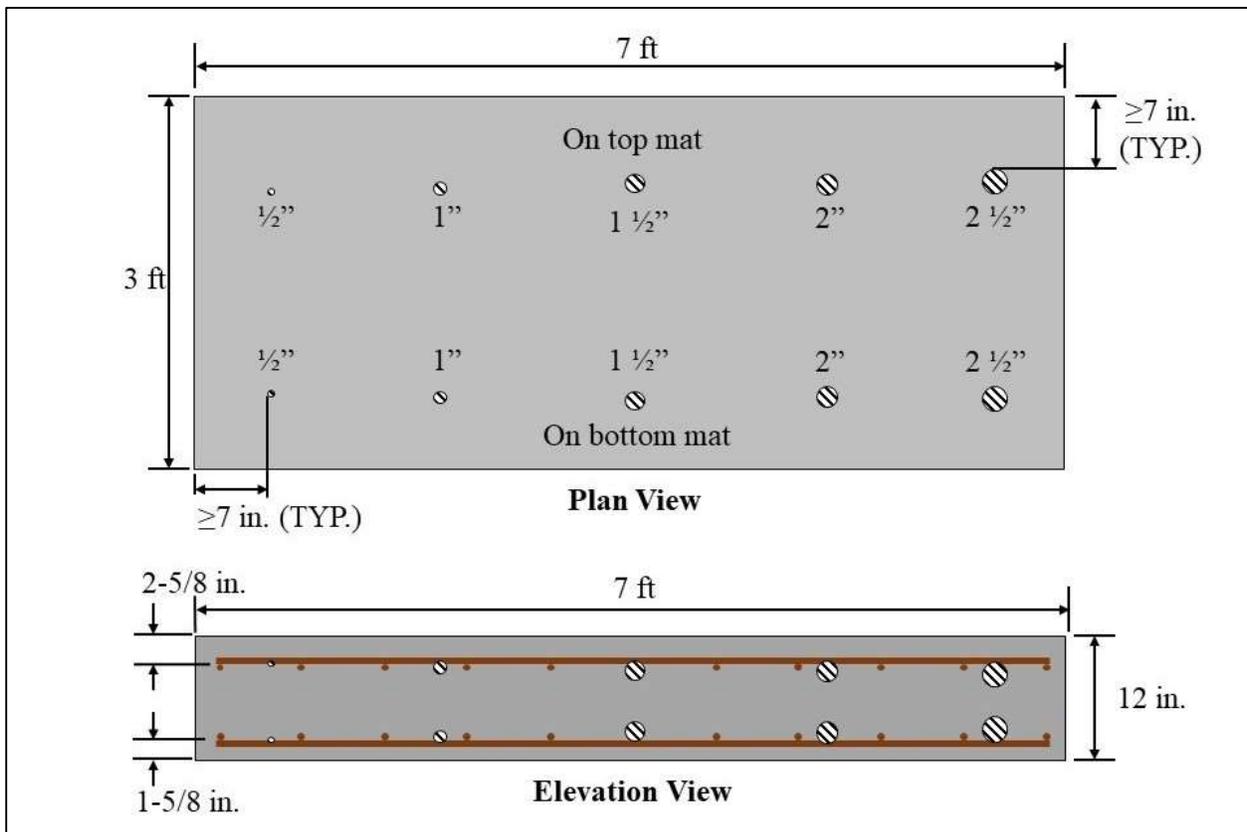
Figure 3-10: Diagram of Specimen V2

In order to investigate the detectability of these defects at both deep and shallow locations, this slab was constructed to be 12 in. thick. The voids were created using clay-filled balloons with diameters between 0.5 and 2.5 in. that were tied to the reinforcing steel at locations shown in Figure 3-10. Clay was used to fill the balloons. In Figure 3-11, Specimen V2 is shown prior to placement of ready-mixed concrete. During the concrete placement and consolidation process, care was taken to ensure that the locations of the clay-filled balloons were not altered.

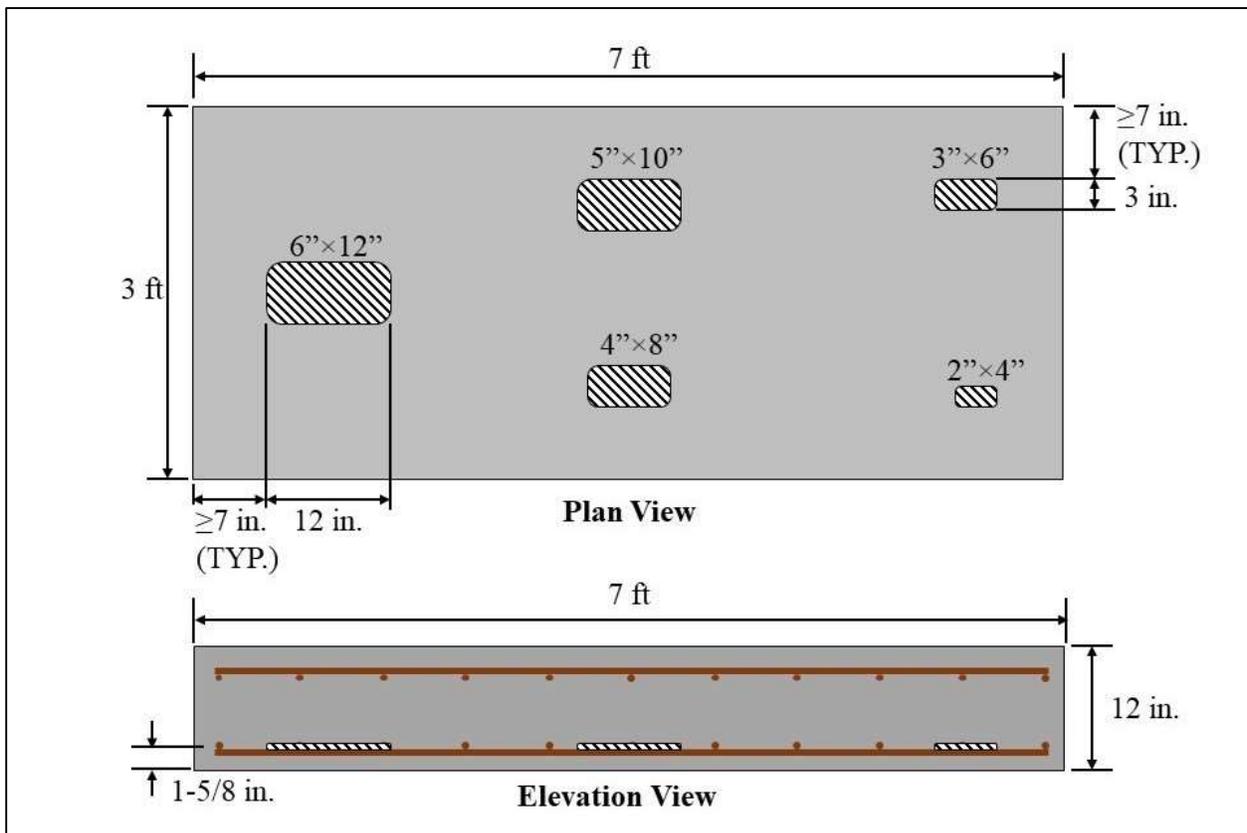
Figure 3-20: Diagram of Specimen DL6

In order to investigate the detectability of these delaminations at deep locations, this slab was constructed to be 12 in. thick. Delaminations were made from plastic sheets of varying plan dimension and a constant 30 mil thickness, as shown in Figure 3-20. In order to properly construct this specimen, concrete was placed into the formwork until the surface of the concrete was at the level of the bottom bars of the bottom reinforcement mat. All concrete in the formwork was then consolidated, after which the delaminations were placed between the longitudinal and transverse bars of the bottom of reinforcement mat. Additional concrete was then immediately placed above the in-place concrete and consolidated using a vibrator. Care was taken to ensure that vibratory consolidation did not alter the location of the artificial delaminations.

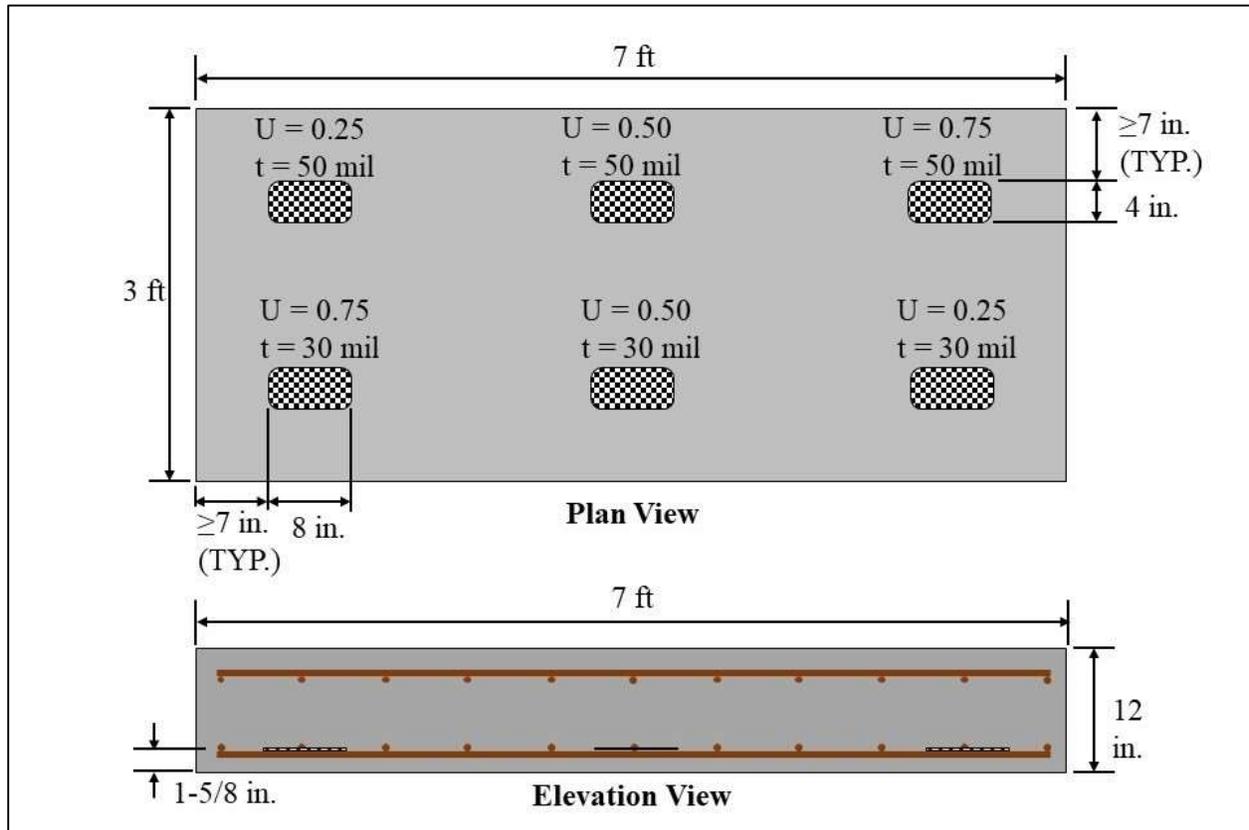
Figure 3-24: Diagram of Specimen DL8

was then immediately placed above the in-place concrete and consolidated using a vibrator. Care was taken to ensure that vibratory consolidation did not alter the location of the artificial delaminations.

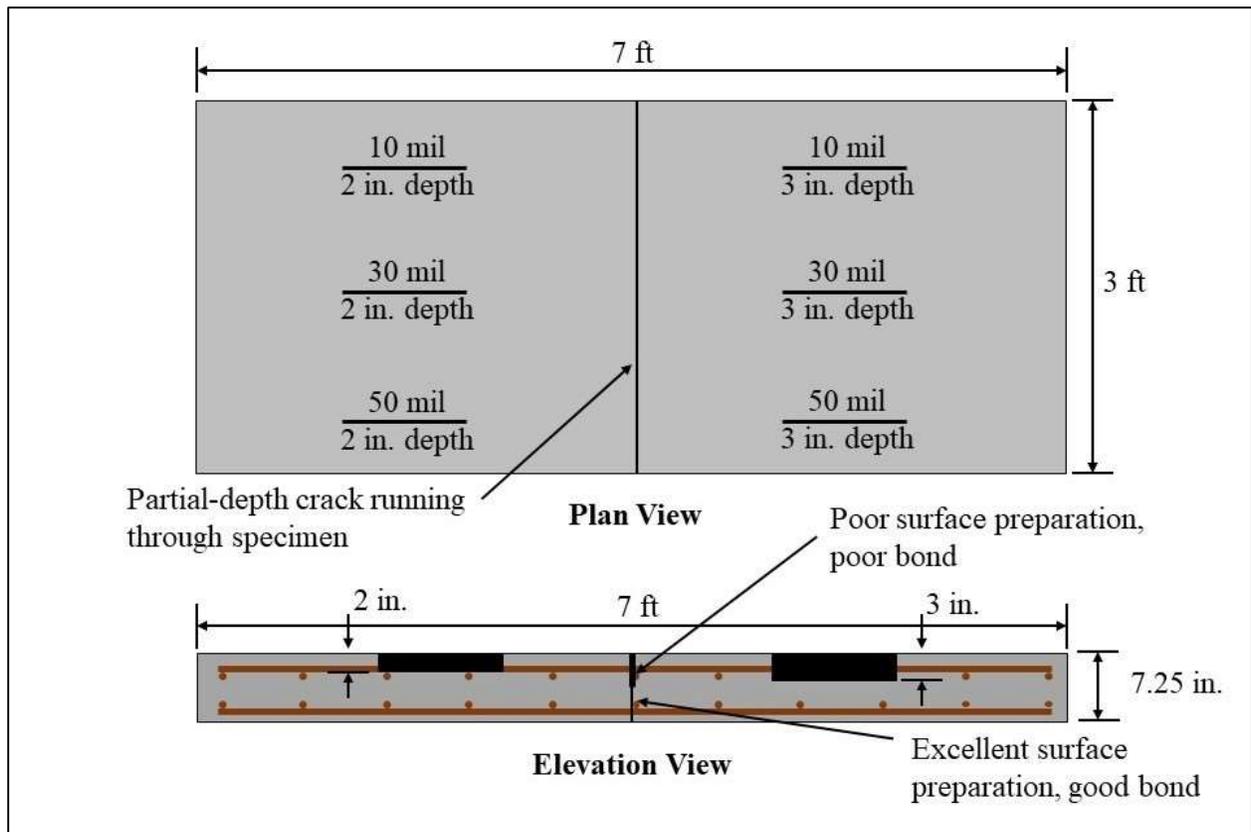
Figure 3-25: Diagram of Specimen CR1

cracks in this specimen measured 12 in. long. These plastic cracks were held vertically in place using a thin plastic string. In order to construct this specimen, a form bulkhead was placed midway along the longitudinal axis of the specimen. Concrete was placed into the formwork, measuring 3 × 3.5 ft, until the surface of the concrete was level with the top of the formwork. All concrete in the formwork was then consolidated, with care taken to ensure that vibratory consolidation did not adjust the location of the vertically oriented cracks. The concrete was allowed to partially set, after which the formwork bulkhead was removed and grease was applied to the top half of the concrete interface, as shown in Figure 3-27. Formwork was then placed around the uncast portion of the slab, and fresh concrete was subsequently placed there and consolidated, with care being taken to ensure that consolidation did not alter the location of the plastic cracks.

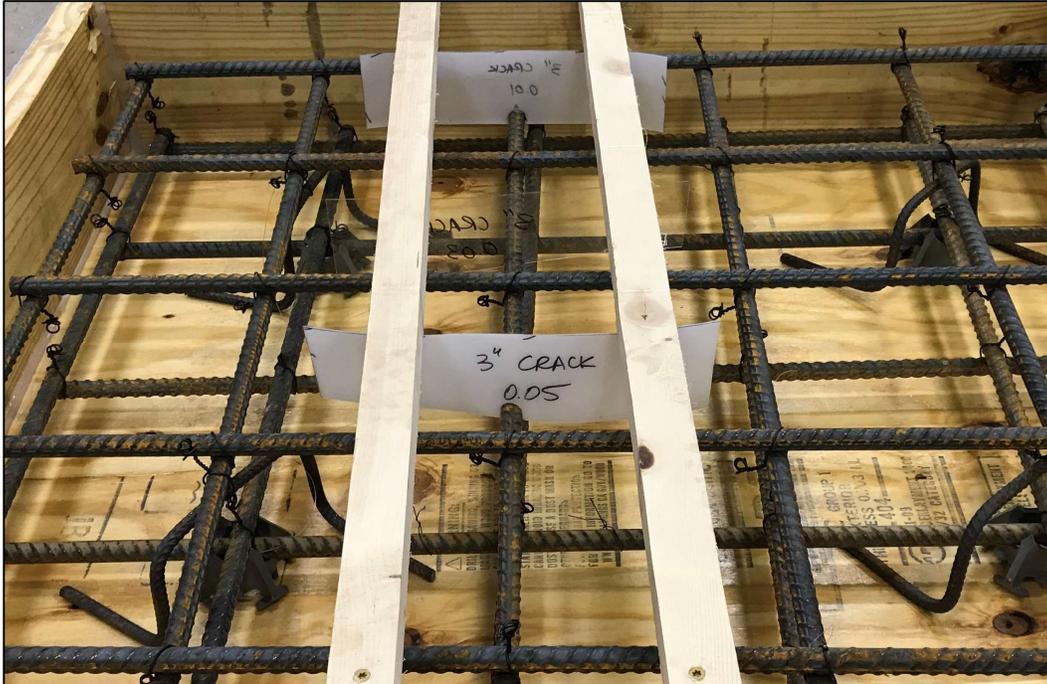
Figure 3-26: Plastic sheets representing vertical cracks

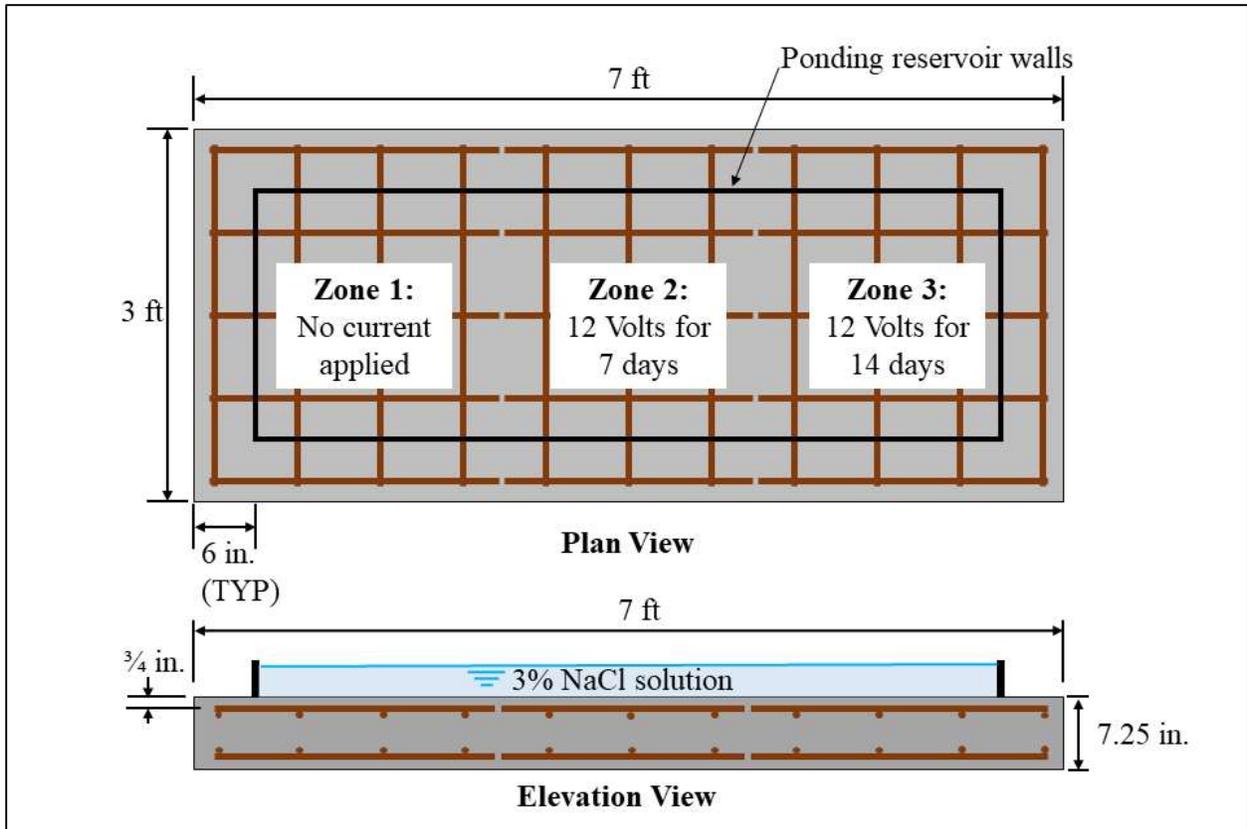
Figure 3-28: Diagram of Specimen C1

This slab, which had a concrete cover of $\frac{3}{4}$ " from the surface of the specimen to the top layer of reinforcing steel, served to test the detectability of corrosion-induced delaminations in the top reinforcement mat and was therefore constructed to be 7.25 in. thick. Corrosion was induced using accelerated corrosion techniques. The top reinforcement mat, which was the target for corrosion activity, was divided into three sections in the longitudinal direction, as shown in Figure 3-28. At the locations of rebar discontinuity, a rubber-based compound was applied to the ends of the reinforcing steel bars to in order to electrically isolate each section. Prior to casting, an insulated wire was attached to each section by a screw placed into a threaded hole in the reinforcing steel. After the specimen was cast and cured, the surface was ponded with a three percent sodium chloride solution for one week prior to the application of current, as shown in Figure 3-29. The ponding reservoir was constructed using 0.375 in. thick acrylic sheets. All joints were sealed and the reservoir was bonded to the concrete using a construction adhesive. To provide current to the system, standard 12 V batteries were connected to both Zone 2 and Zone 3, the former being connected for 7 days and the latter being connected for 14 days. The circuit was connected such that the reinforcing steel was connected to the positive post of the battery, while a stainless steel plate on the concrete surface, submersed in the sodium chloride solution, was connected to the negative post of the battery. Trickle chargers were connected to each battery in order to prevent significant current loss. Ponding was held constant throughout the application of current. Aside from times where the research team tested the specimen to measure corrosion progression, sodium chloride solution and current were continuously applied to the specimen. The research team notated the amount of time where the current source was disconnected and compensated for any time lost in order to ensure a full 7-day or 14-day current application.

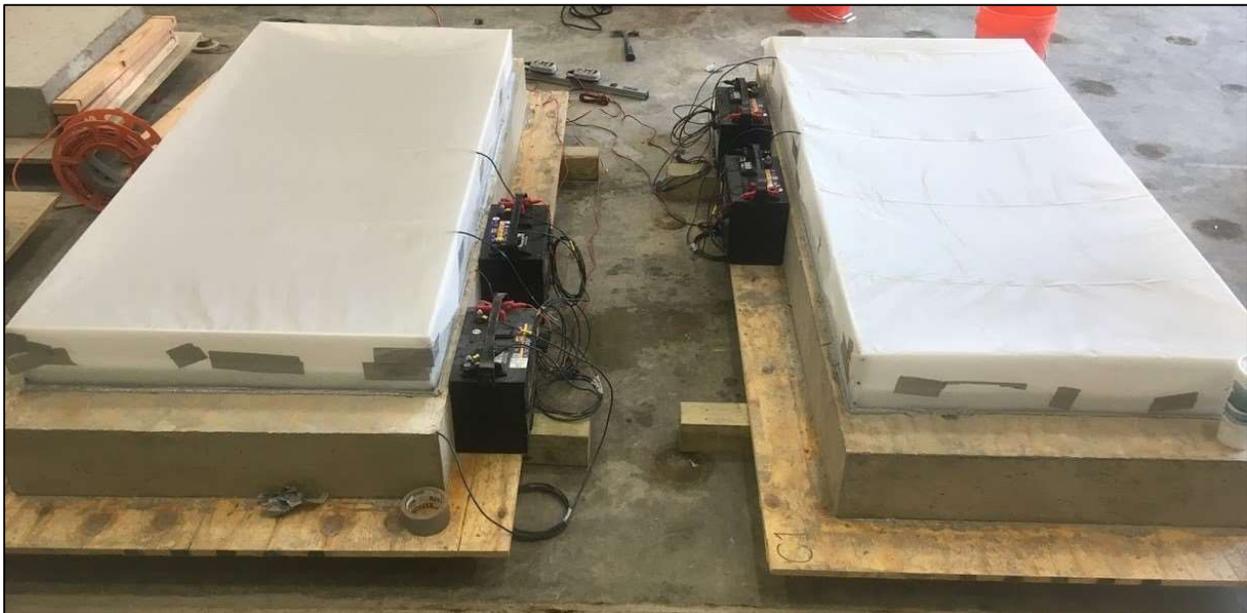
Figure 3-29: Corrosion specimens with ponding and current being applied

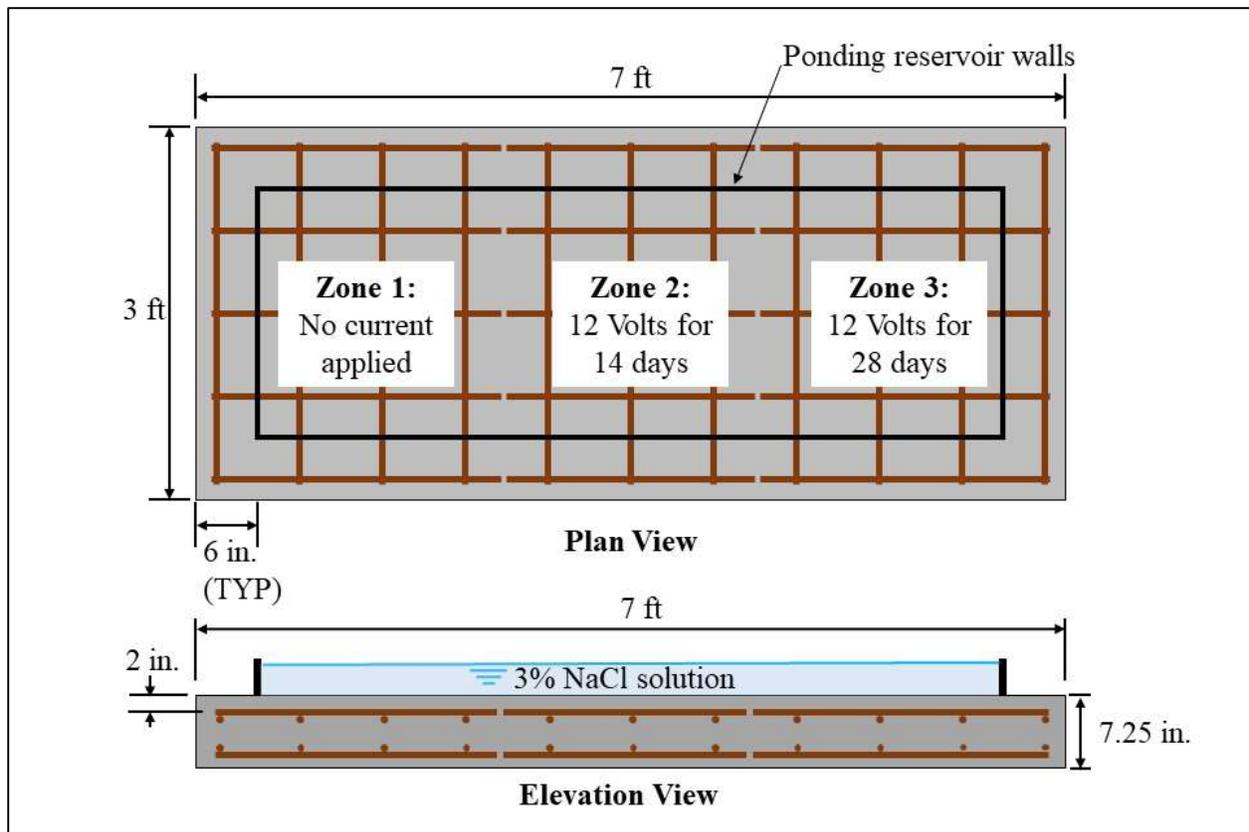
Figure 3-30: Diagram of Specimen C2

This slab, which had a concrete cover of 2” from the surface of the specimen to the top layer of reinforcing steel, served to test the detectability of corrosion-induced delaminations in the top reinforcement mat and was therefore constructed to be 7.25 in. thick. Corrosion was induced using accelerated corrosion techniques. The top reinforcement mat, the target for corrosion activity, was divided into three sections in the longitudinal direction, as shown in Figure 3-30. At the locations of rebar discontinuity, a rubber-based compound was applied to the ends of the reinforcing steel bars in order to electrically isolate each section. Prior to casting, an insulated wire was attached to each section by a screw placed into a threaded hole in the reinforcing steel. After the specimen was cast and cured, the surface was ponded with a three percent sodium chloride solution for one week prior to the application of current. The ponding reservoir was constructed using 0.375 in. thick acrylic sheets. All joints were sealed and the reservoir was bonded to the concrete using a construction adhesive. To provide current to the system, standard 12 V batteries were connected to both Zone 2 and Zone 3, the former being connected for 14 days and the latter being connected for 28 days. The circuit was connected such that the reinforcing steel was connected to the positive post of the battery, while a stainless steel plate placed at the concrete surface, submersed in the sodium chloride solution, was connected to the negative post of the battery. Trickle chargers were connected to each battery in order to prevent significant current loss. Ponding was held constant throughout the application of current. Aside from times where the research team tested the specimen to measure corrosion progression, sodium chloride solution and current were continuously applied to the specimen. The research team notated the amount of time where the current source was disconnected and compensated for any time lost in order to ensure a full 14-day or 28-day current application.

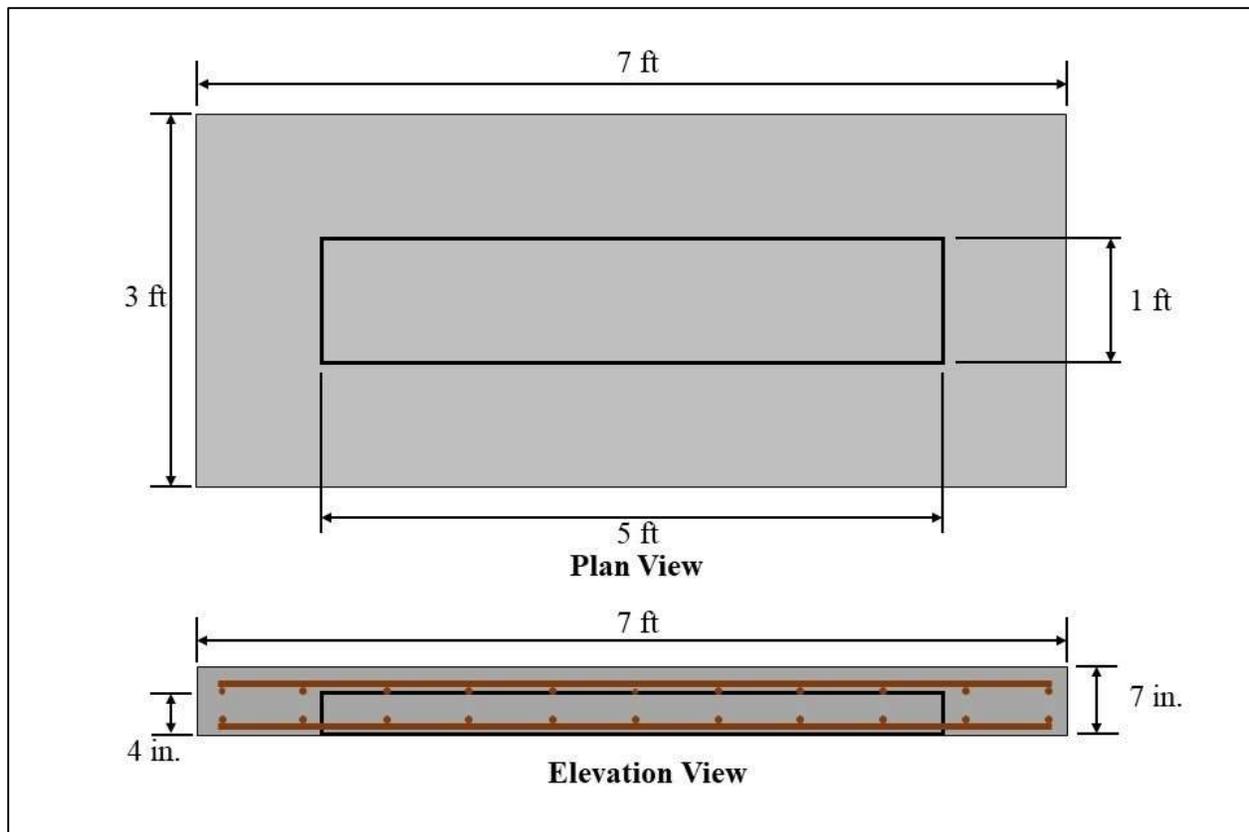
Figure 3-34: Diagram for Specimen CONTROL

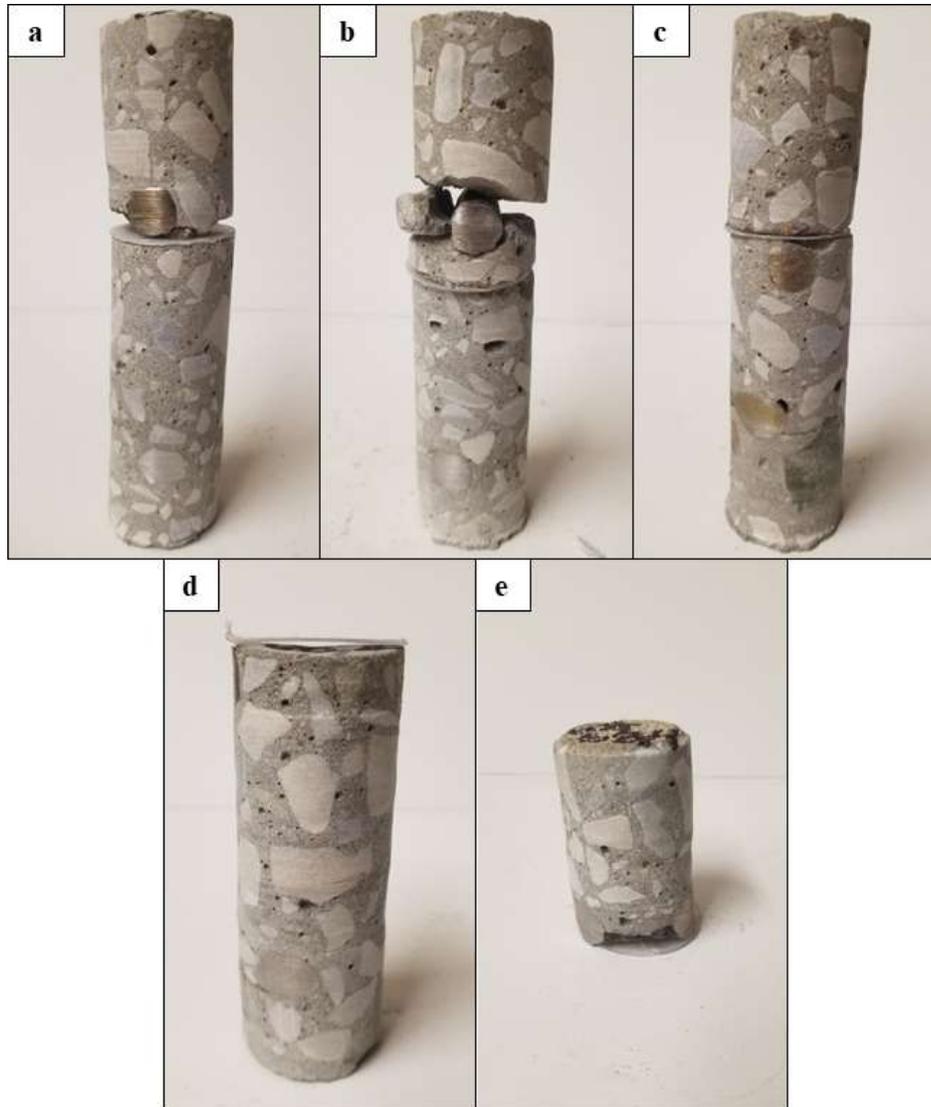
Figure 4-7: Cores taken from Specimen DL5

Cores taken from Specimen DL5 in the laboratory are shown in Figure 4-7. A core was extracted from each of the five delaminated locations within the specimen. The locations from which each core was extracted are shown in Table 4-7. Some cores were damaged due to spinning during the coring process. Therefore, only portions of some cores were recovered from some locations.
