**Evaluation of Nondestructive Testing Methods to Assess the Condition of Concrete
Bridge Decks**

A thesis submitted to the Graduate Faculty of
Auburn University
in partial fulfillment of the
requirements for the Degree of
Master of Science

Auburn, Alabama
August 7, 2021

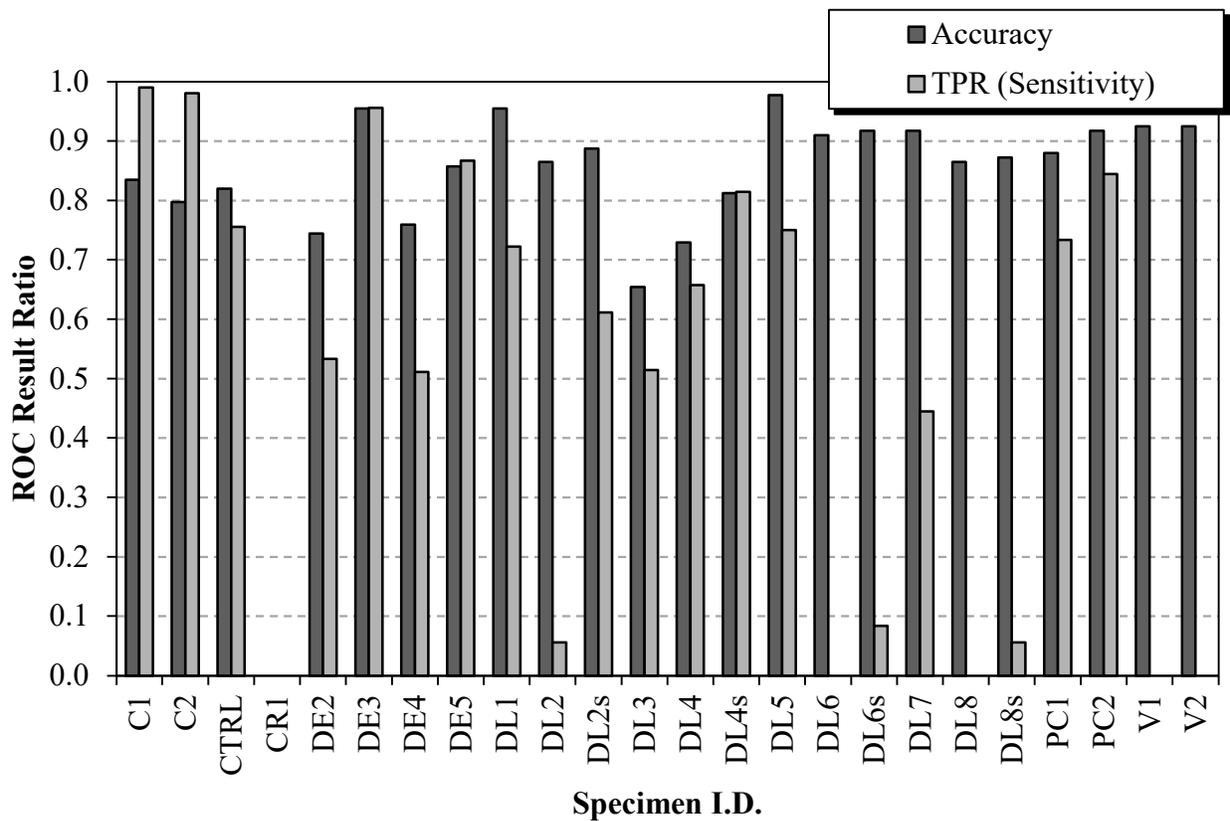
Figure 4-20: ROC analysis of impact-echo results

The ROC analysis results for the impact-echo data for each specimen is shown in Figure 4-20. The results of ROC analysis performed upon data evaluated for secondary peak waveforms are denoted with an “s” following the specimen identification. ROC analysis results for Specimen CR1 are zero, as no ROC analysis was performed on the data set. The subsections that follow Figure 4-20 present the surface contour plots and the respective defect layout, and results of ROC analysis, as well as a discussion of the results.

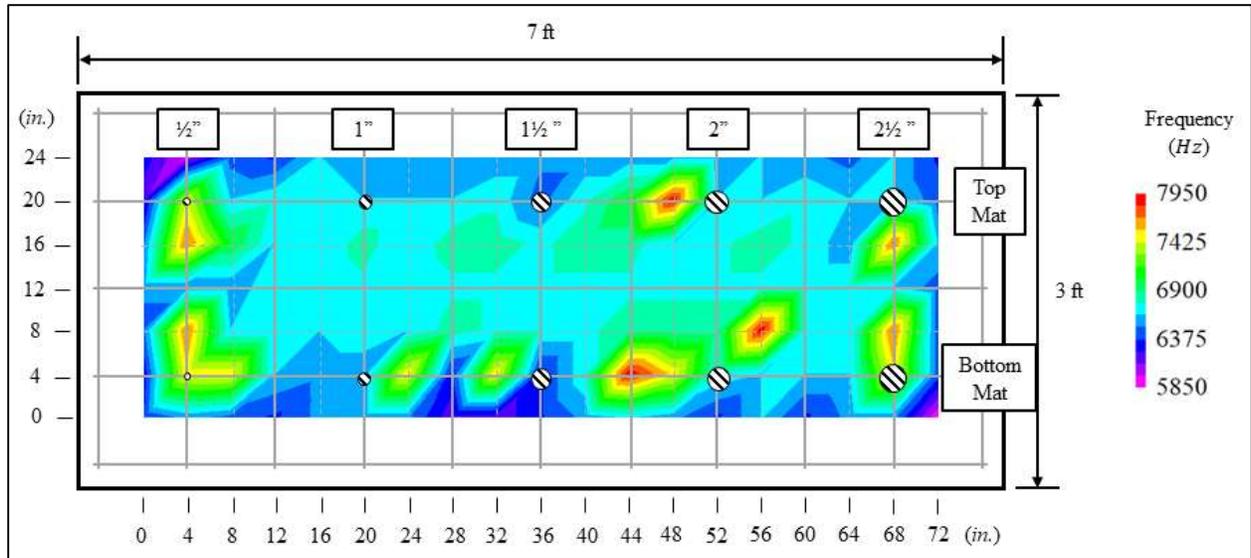
Figure 4-21: Impact-echo results for Specimen V1

A comparison between the known defect locations and the surface contour plot of the impact-echo results for Specimen V1 is shown in Figure 4-21.

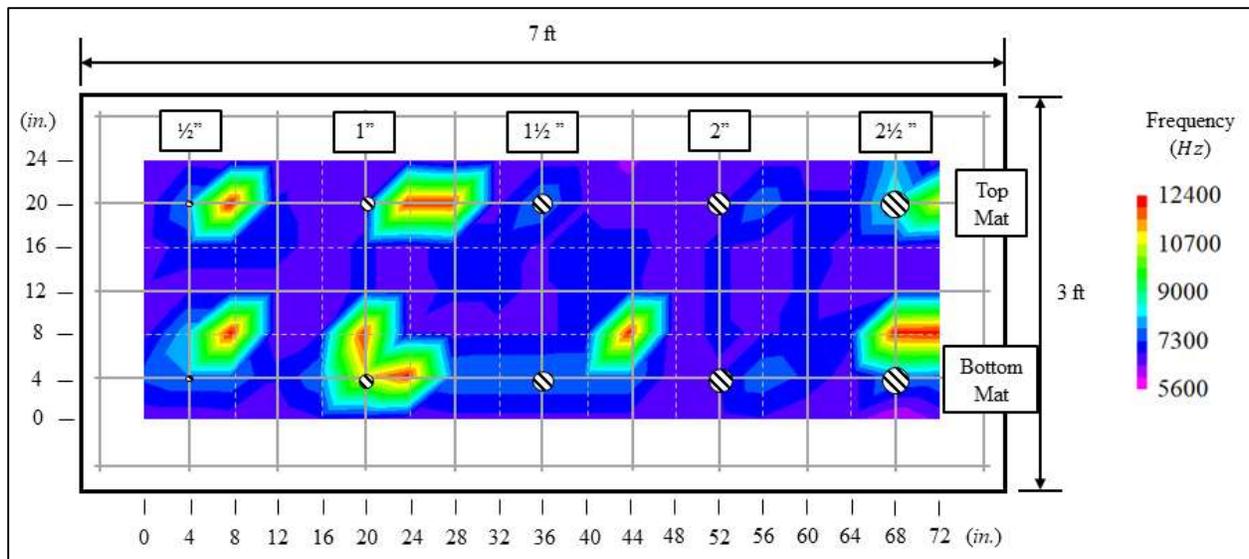
Figure 4-22: Impact-echo results for Specimen V2

A comparison between the known defect locations and the surface contour plot of the impact-echo results for Specimen V2 is shown in Figure 4-22.

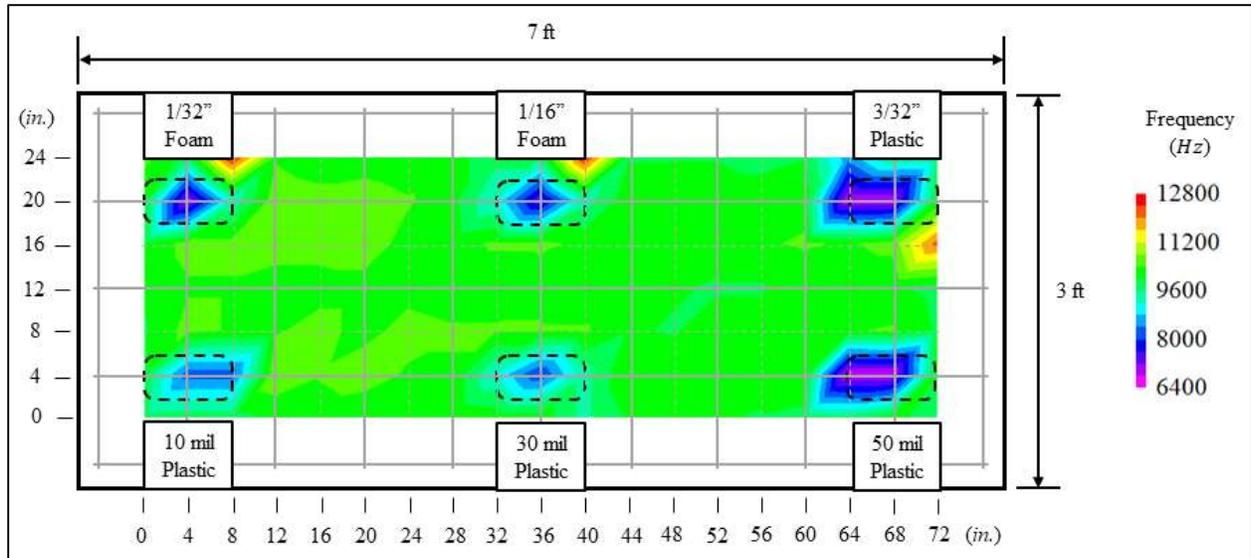
Figure 4-23: Impact-echo results for Specimen DL1

A comparison between the known defect locations and the surface contour plot of the impact-echo results for Specimen DL1 is shown in Figure 4-23.

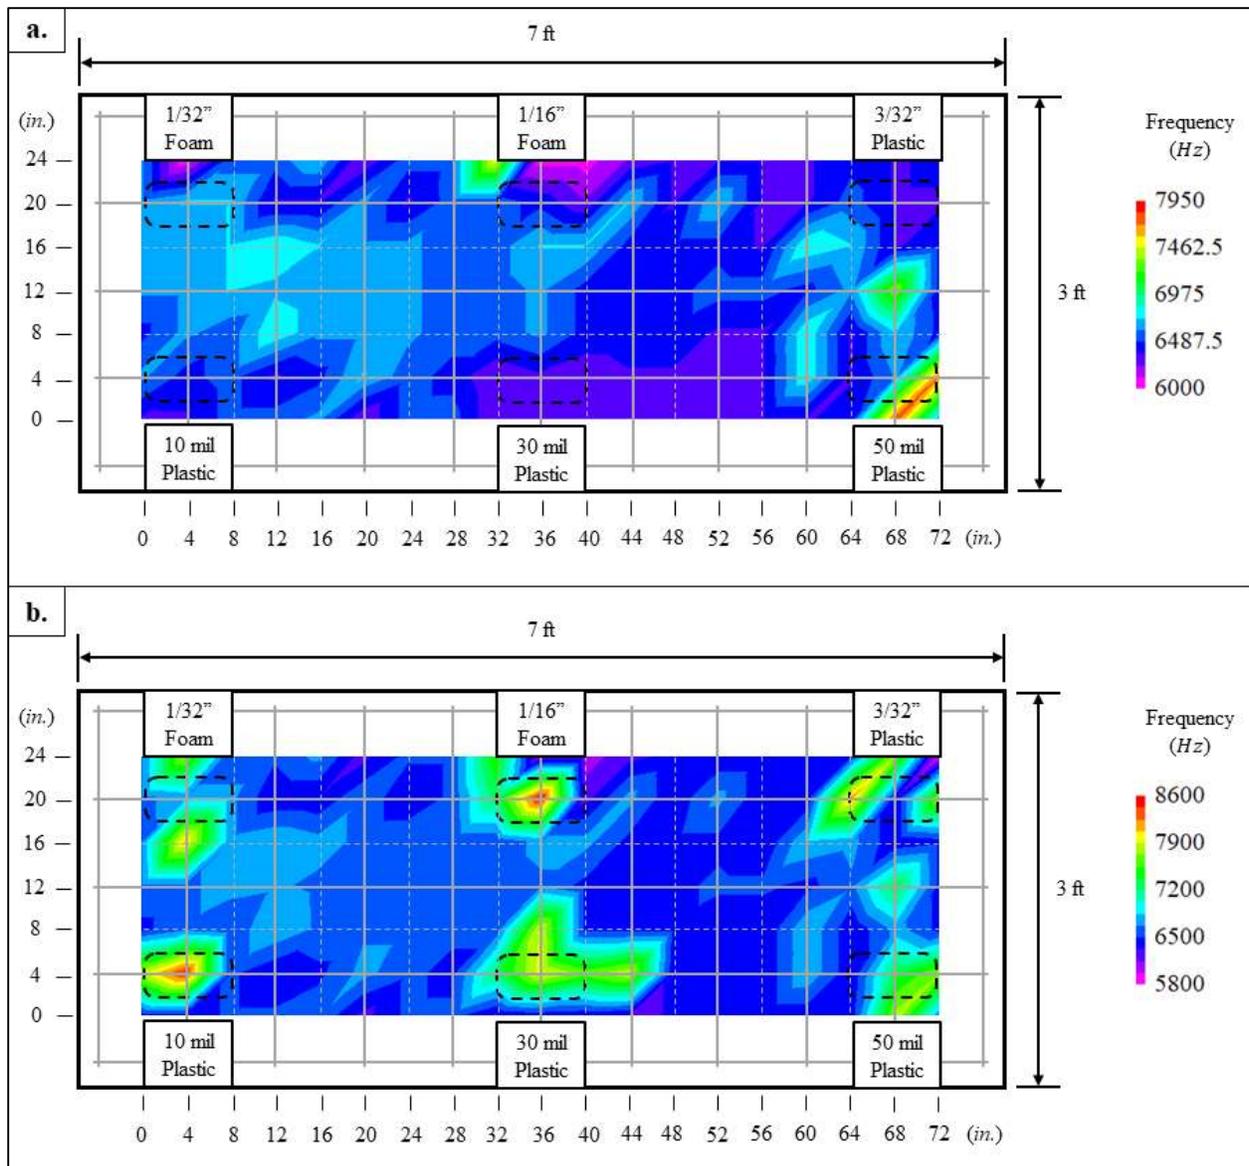
Figure 4-24: Impact-echo results for Specimen DL2; a) dominant frequencies, b) secondary peak frequencies

A comparison between the known defect locations and the surface contour plot of the impact-echo results for Specimen DL2 is shown in Figure 4-24.

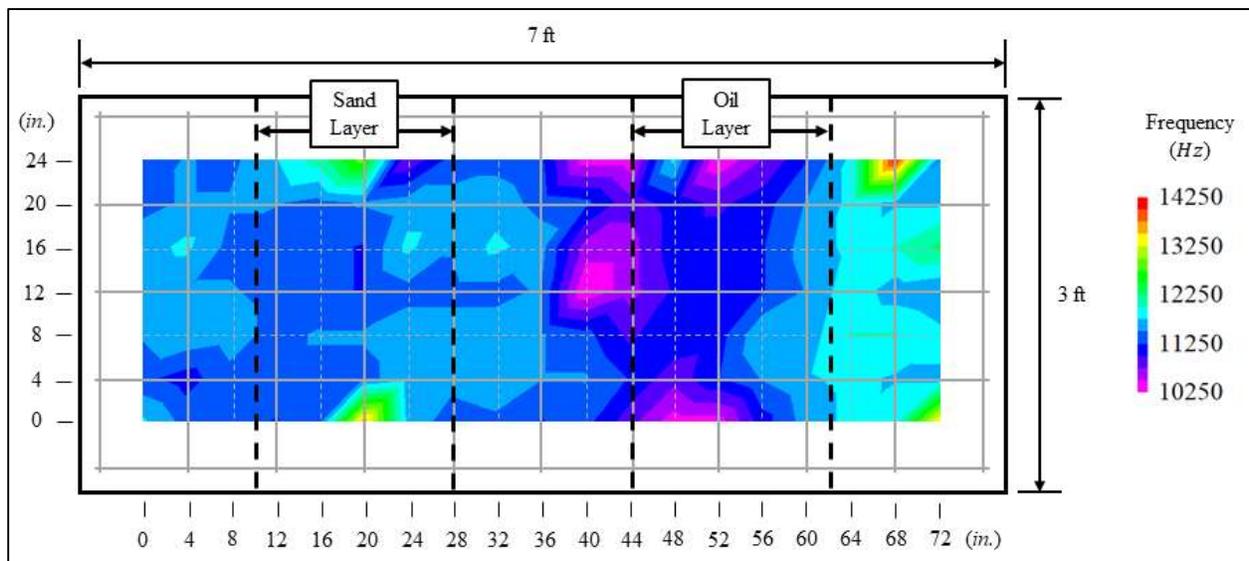
Figure 4-25: Impact-echo results for Specimen DL3

A comparison between the known defect locations and the surface contour plot of the impact-echo results for Specimen DL3 is shown in Figure 4-25.

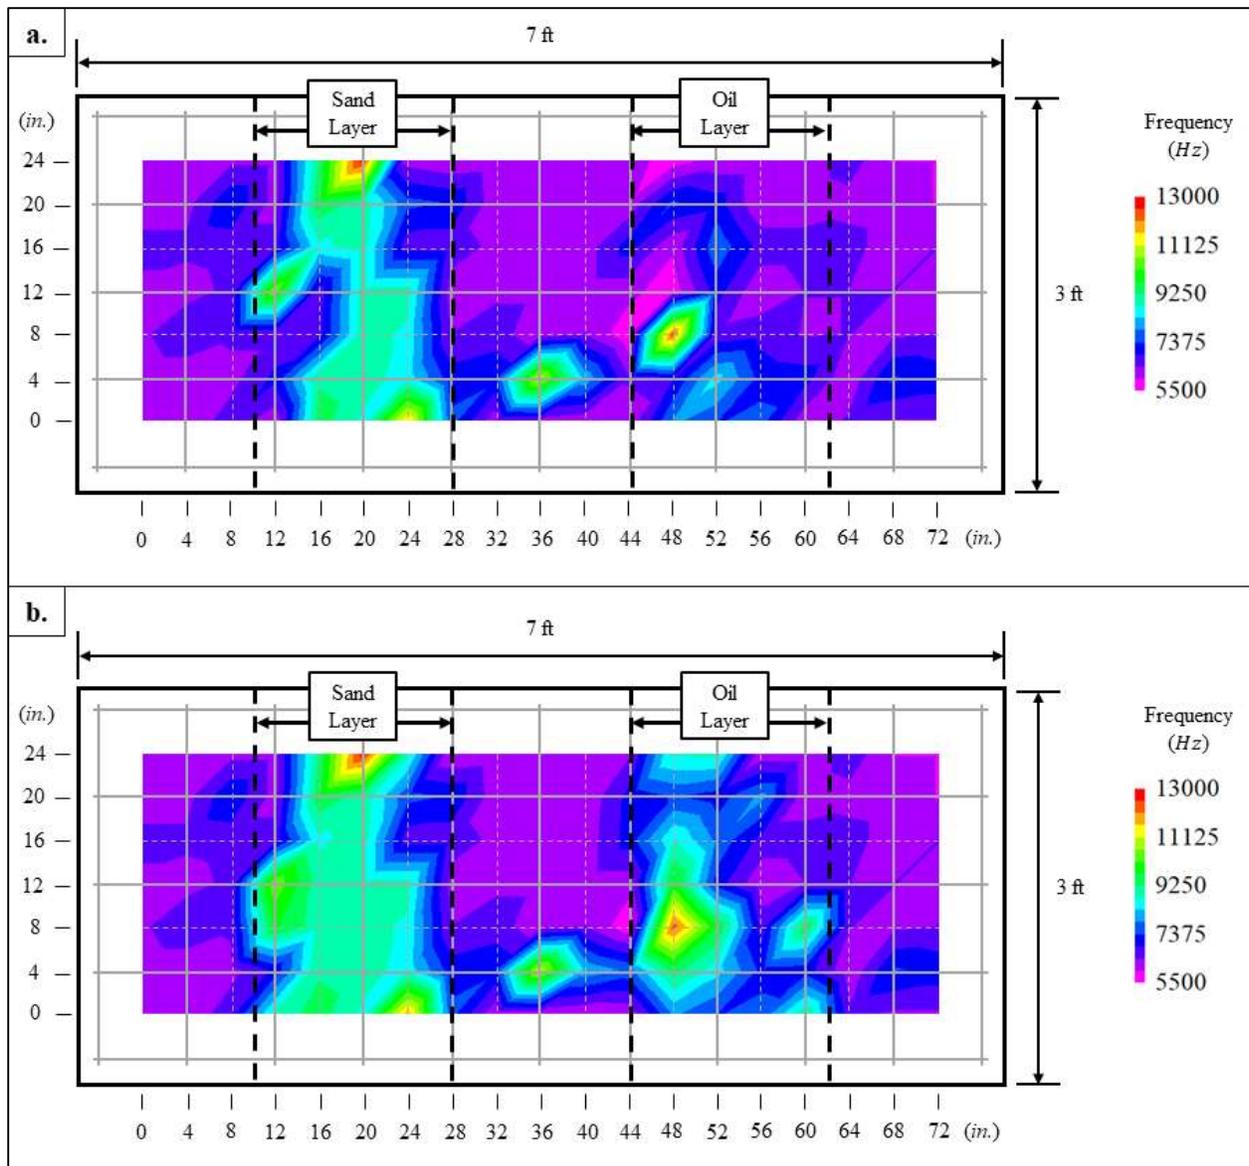
Figure 4-26: Impact-echo results for Specimen DL4; a) dominant frequencies, b) secondary peak frequencies

A comparison between the known defect locations and the surface contour plot of the impact-echo results for Specimen DL4 is shown in Figure 4-26.

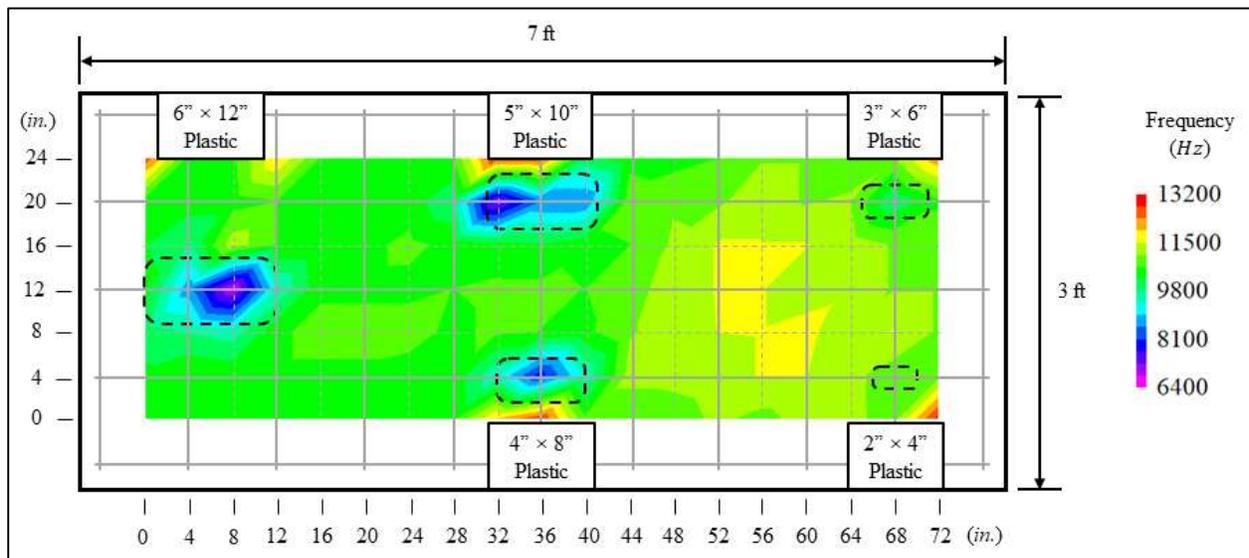
Figure 4-27: Impact-echo results for Specimen DL5

A comparison between the known defect locations and the surface contour plot of the impact-echo results for Specimen DL5 is shown in Figure 4-27.

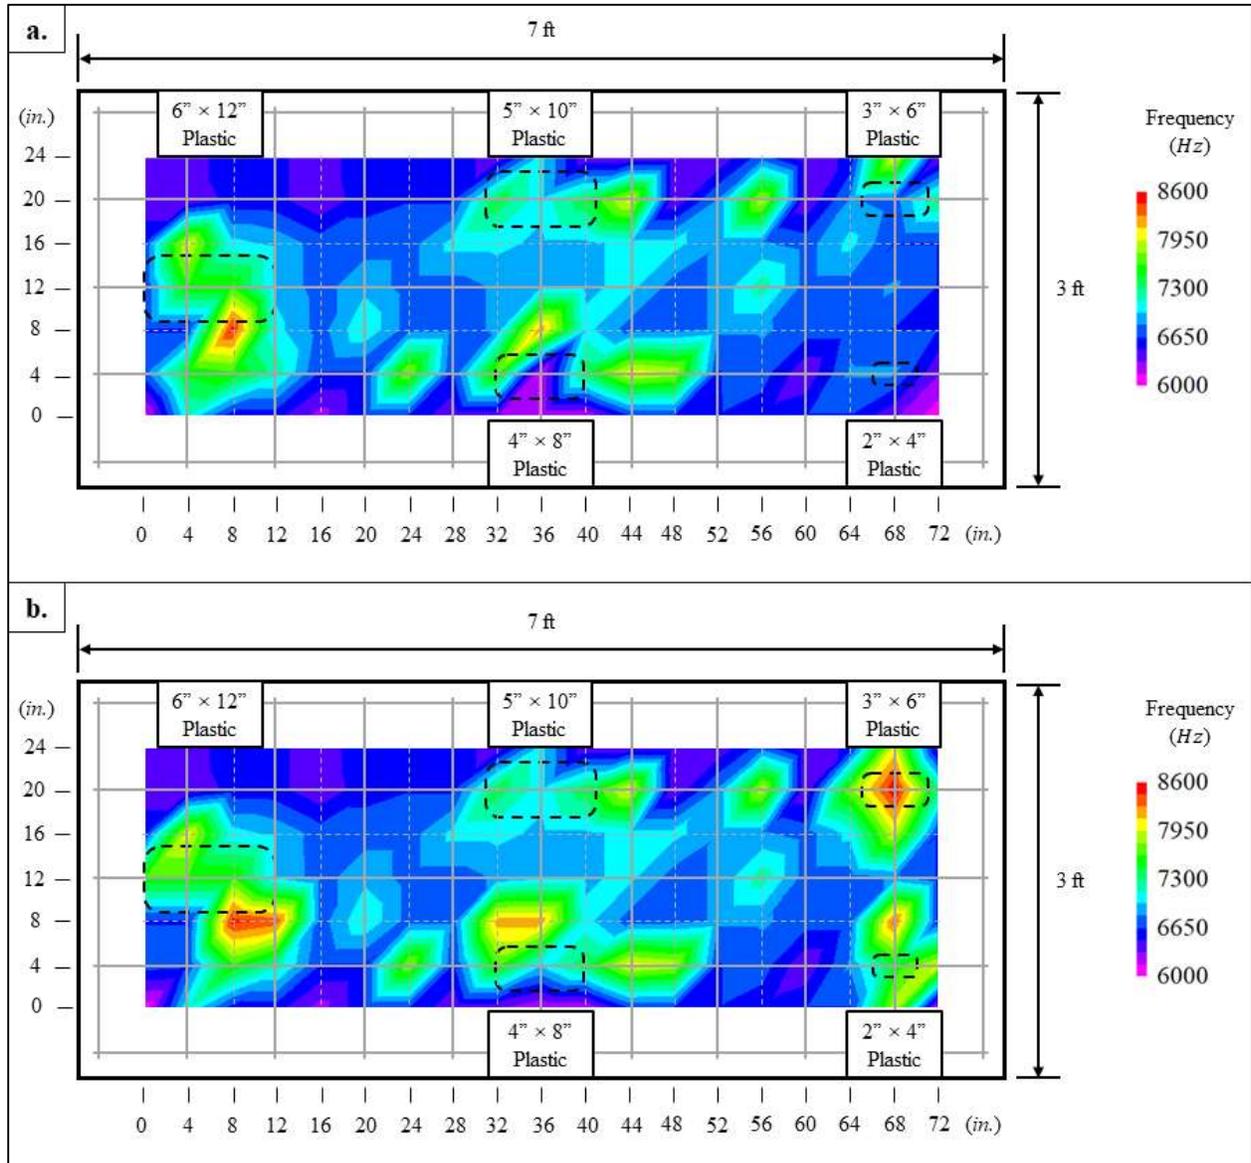
Figure 4-28: Impact-echo results for Specimen DL6; a) dominant frequencies, b) secondary peak frequencies

A comparison between the known defect locations and the surface contour plot of the impact-echo results for Specimen DL6 is shown in Figure 4-28.

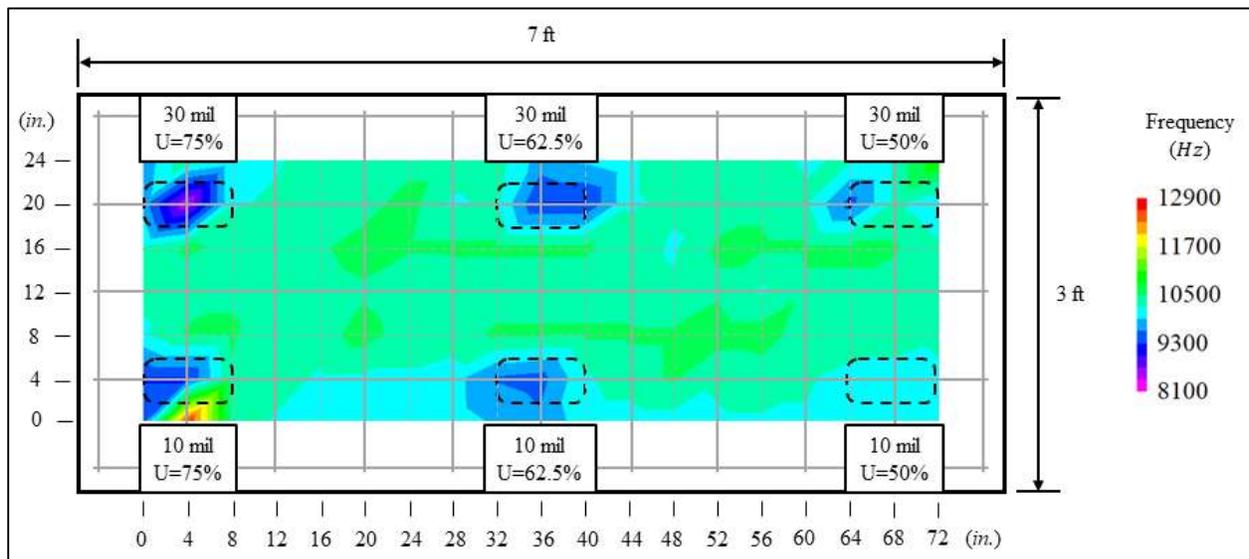
Figure 4-29: Impact-echo results for Specimen DL7

A comparison between the known defect locations and the surface contour plot of the impact-echo results for Specimen DL7 is shown in Figure 4-29.

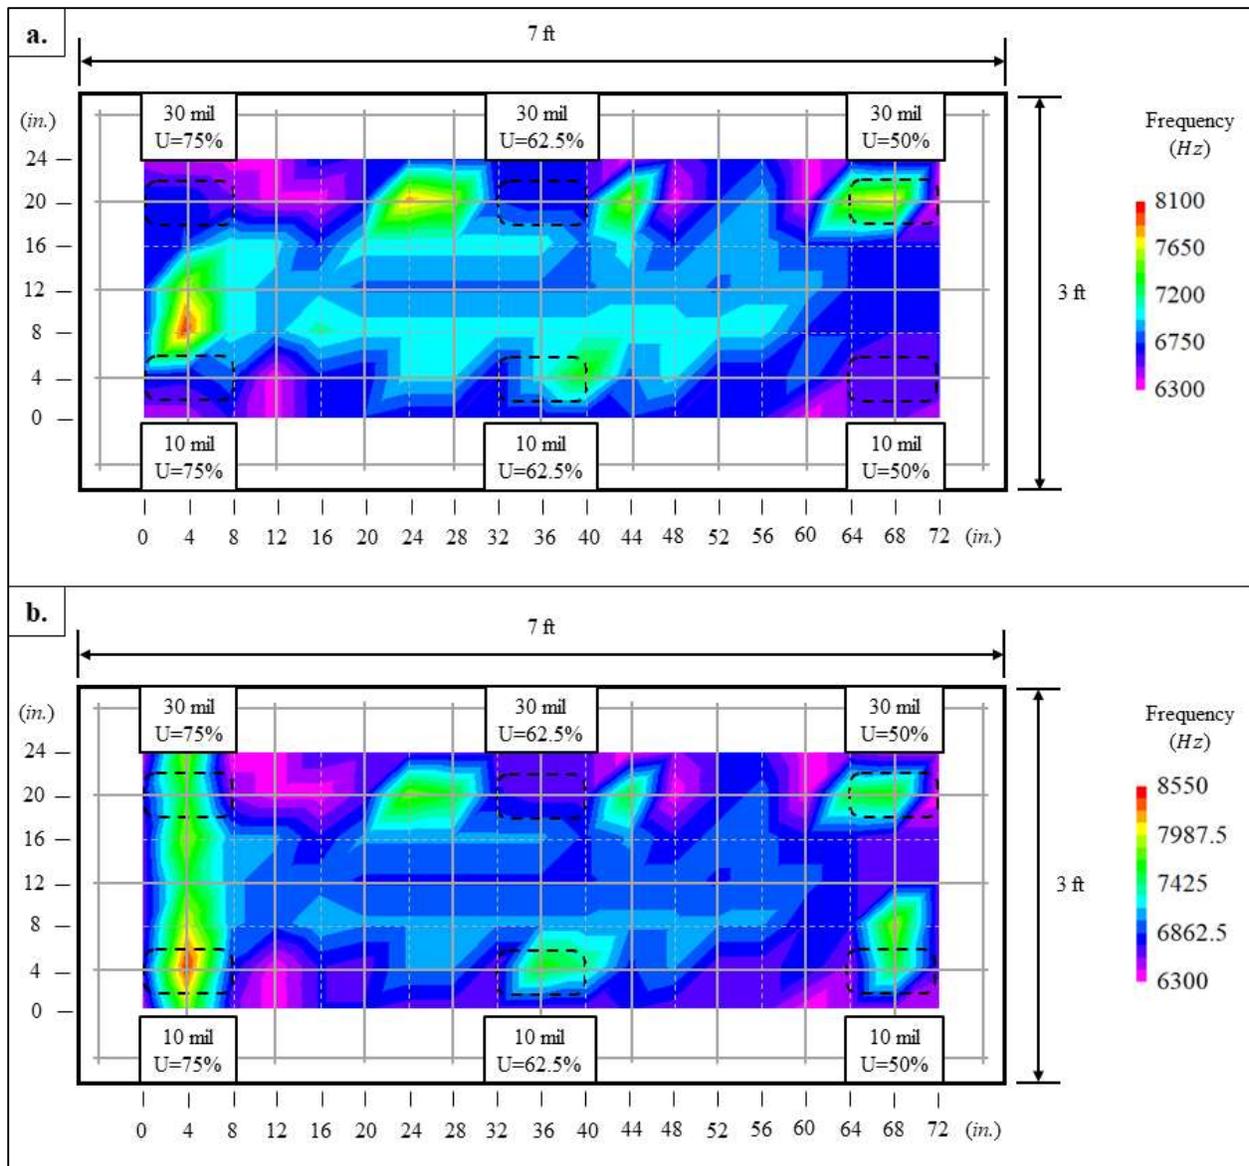
Figure 4-30: Impact-echo results for Specimen DL8; a) dominant frequencies, b) secondary peak frequencies

A comparison between the known defect locations and the surface contour plot of the impact-echo results for Specimen DL8 is shown in Figure 4-30.

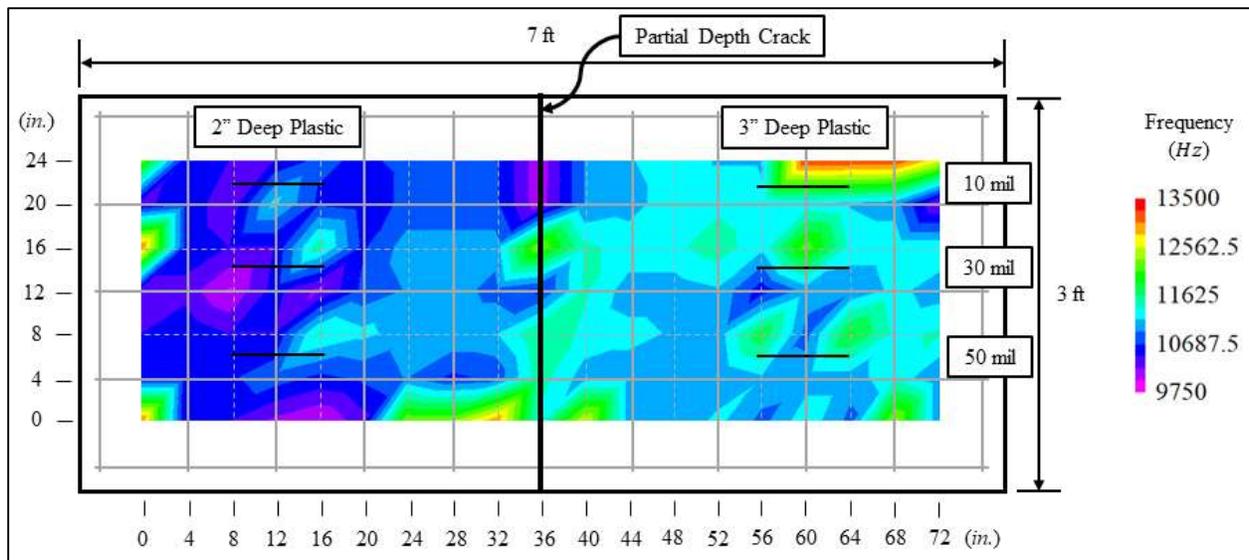
Figure 4-31: Impact-echo results for Specimen CR1

A comparison between the known defect locations and the surface contour plot of the impact-echo results for Specimen CR1 is shown in Figure 4-31.

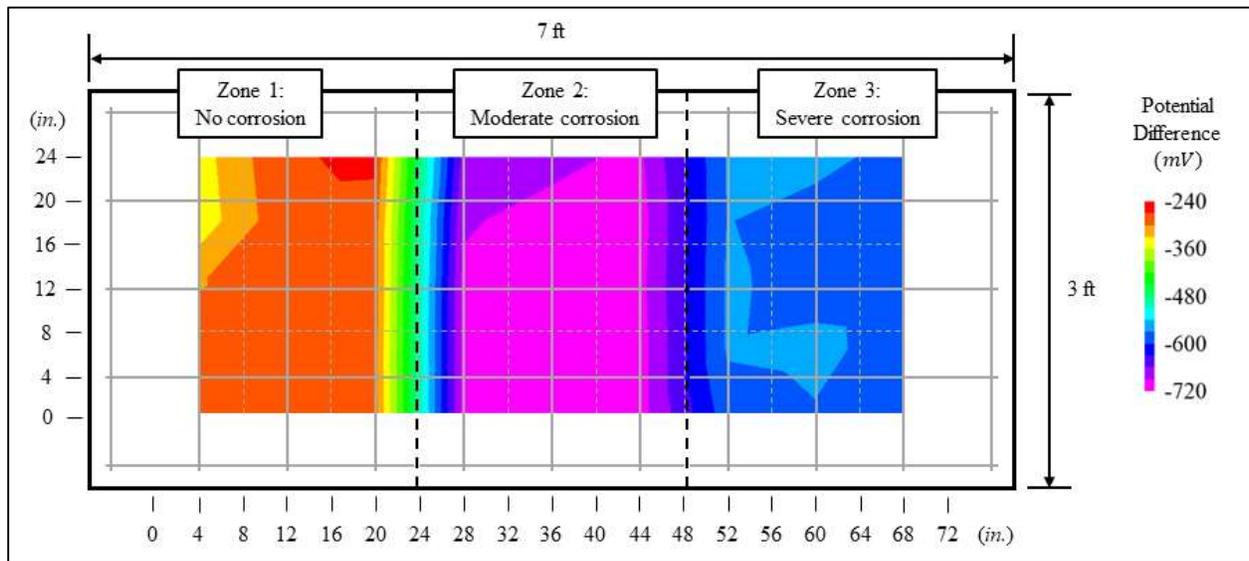
Figure 4-33: Half-cell potential results for Specimen C1

A comparison between the known defect locations and the surface contour plot of the half-cell potential results for Specimen C1 is shown in Figure 4-33.

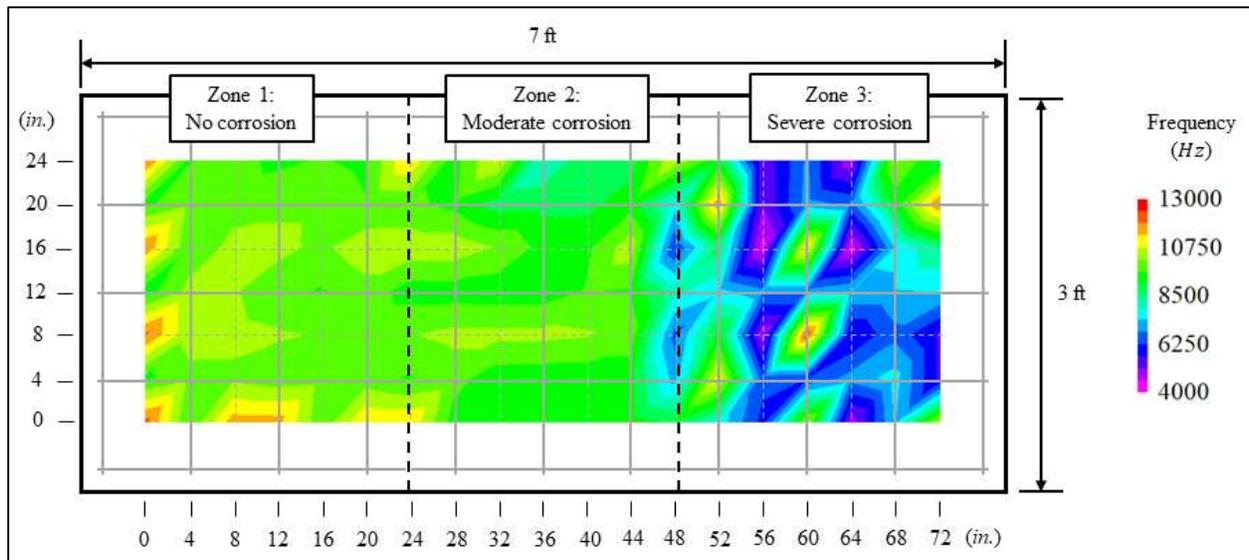
Figure 4-35: Impact-echo results for Specimen C2

A comparison between the known defect locations and the surface contour plot of the impact-echo results for Specimen C2, the corrosion specimen with 2 in. cover to the top layer of reinforcing steel, is shown in Figure 4-35.

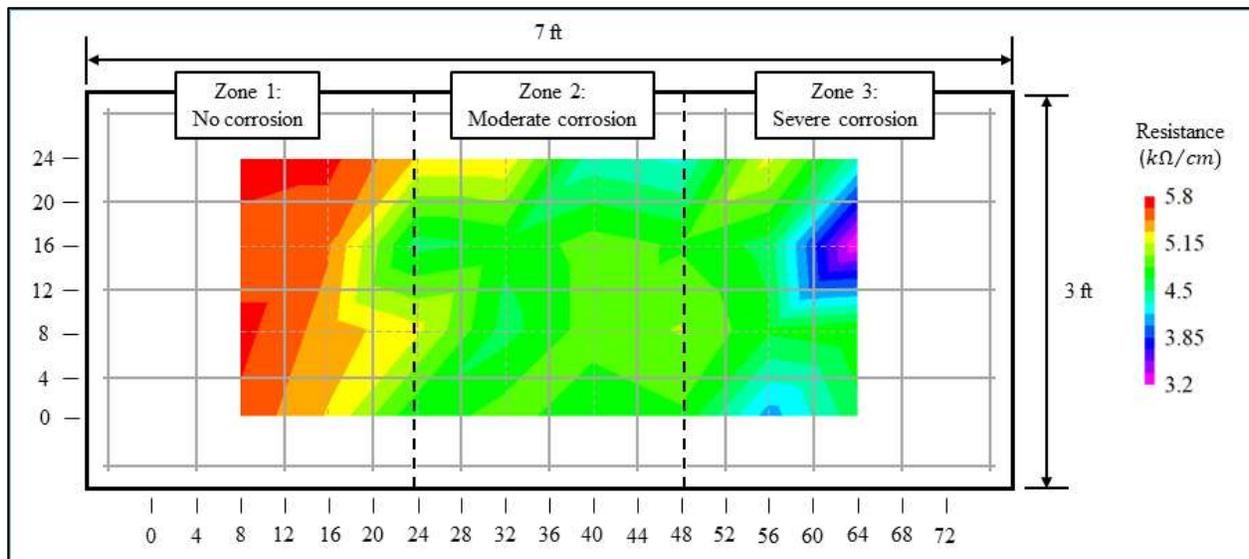
Figure 4-37: Surface resistivity results for Specimen C2

A comparison between the known defect locations and the surface contour plot of the surface resistivity results for Specimen C2 is shown in Figure 4-37.

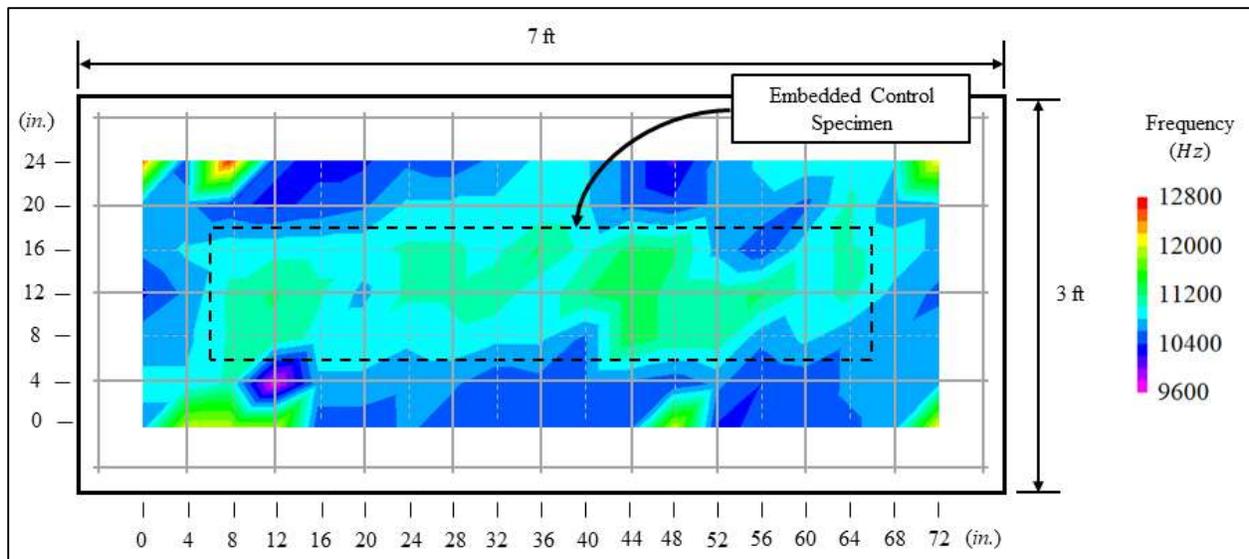
Figure 4-38: Impact-echo results for Specimen CONTROL

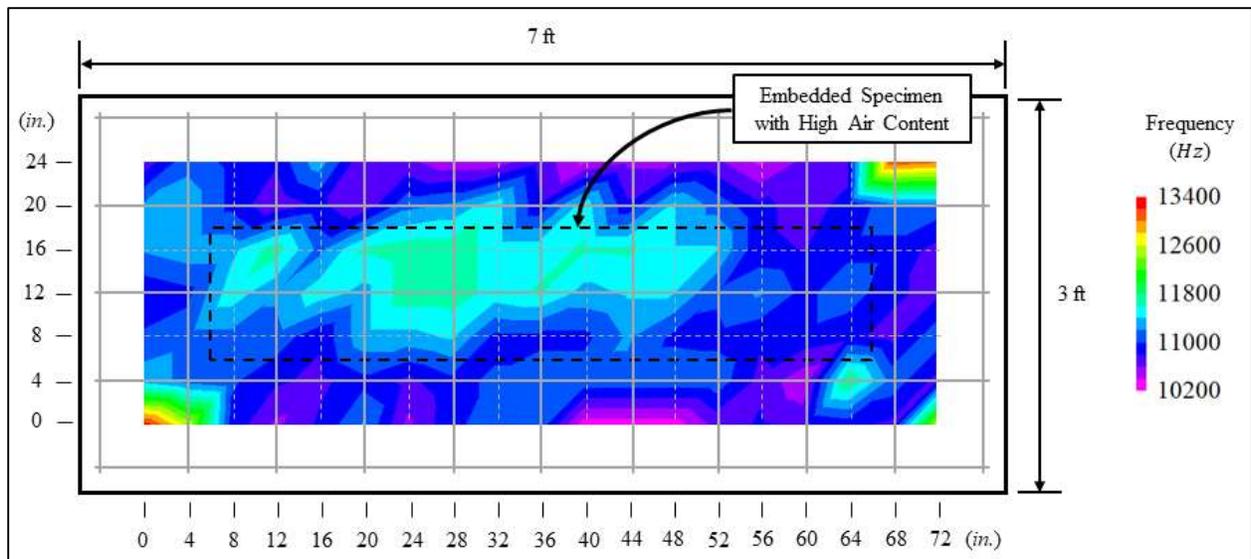
Figure 4-39: Impact-echo results for Specimen DE2

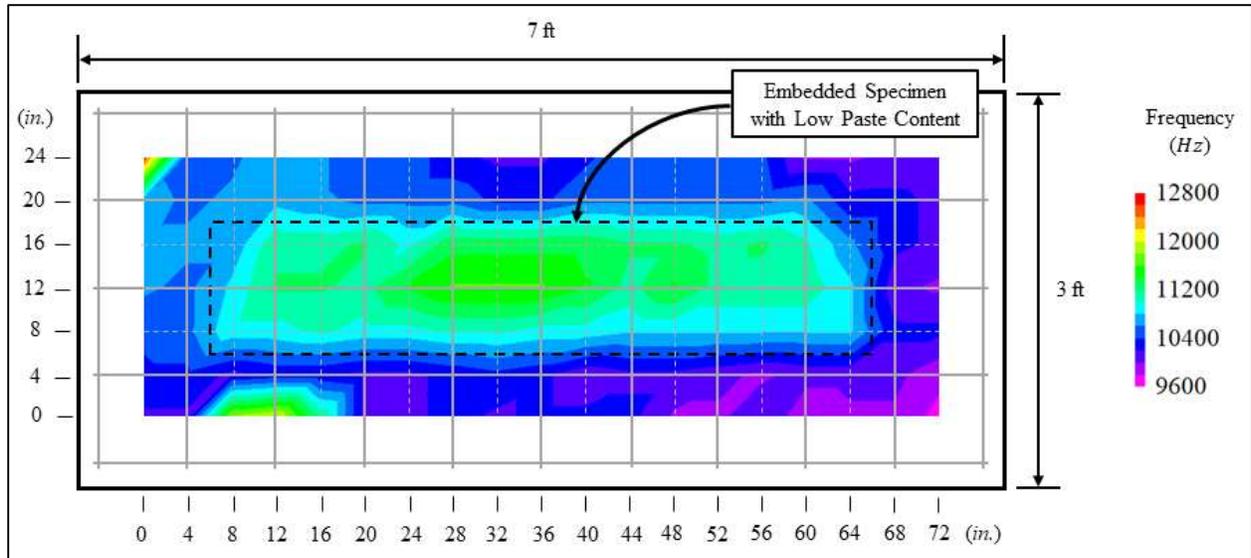
Figure 4-40: Impact-echo results for Specimen DE3

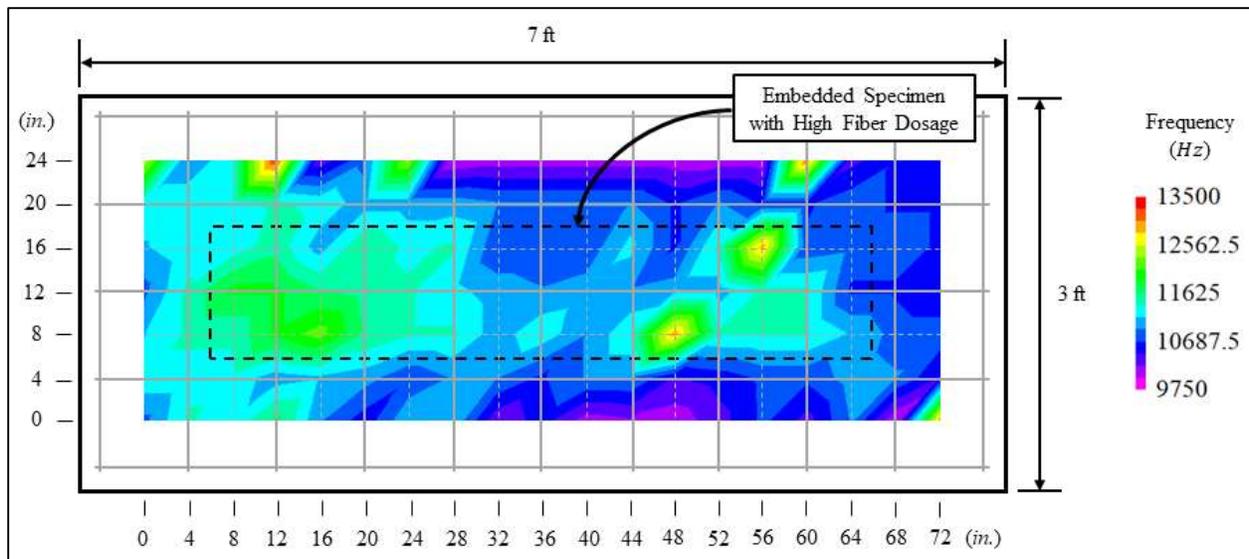
Figure 4-41: Impact-echo results for Specimen DE4

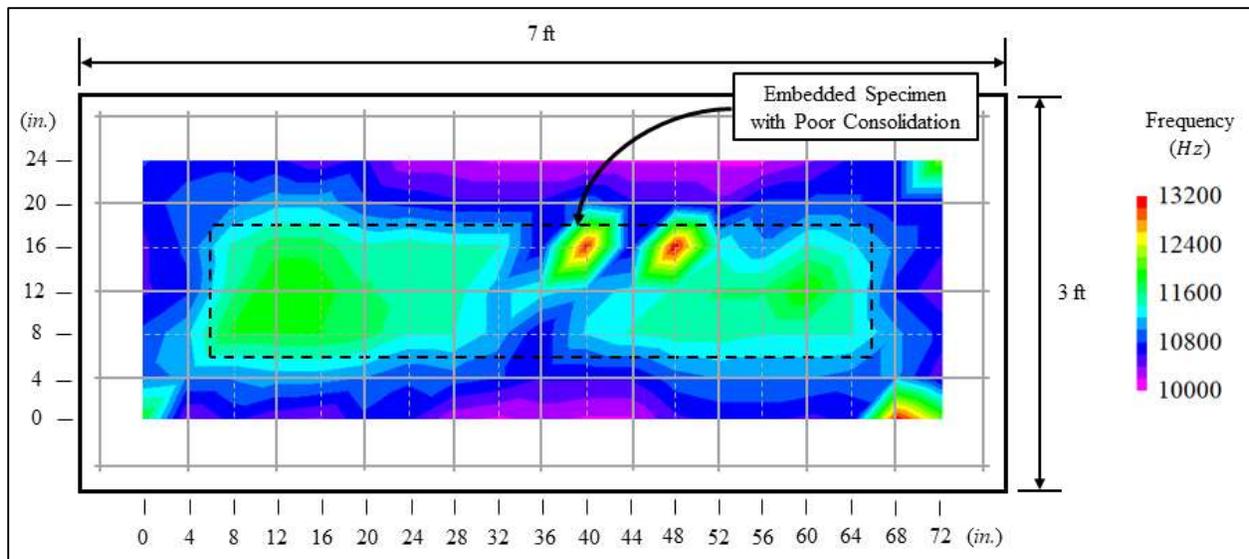
Figure 4-44: Impact-echo results for Specimen PC2

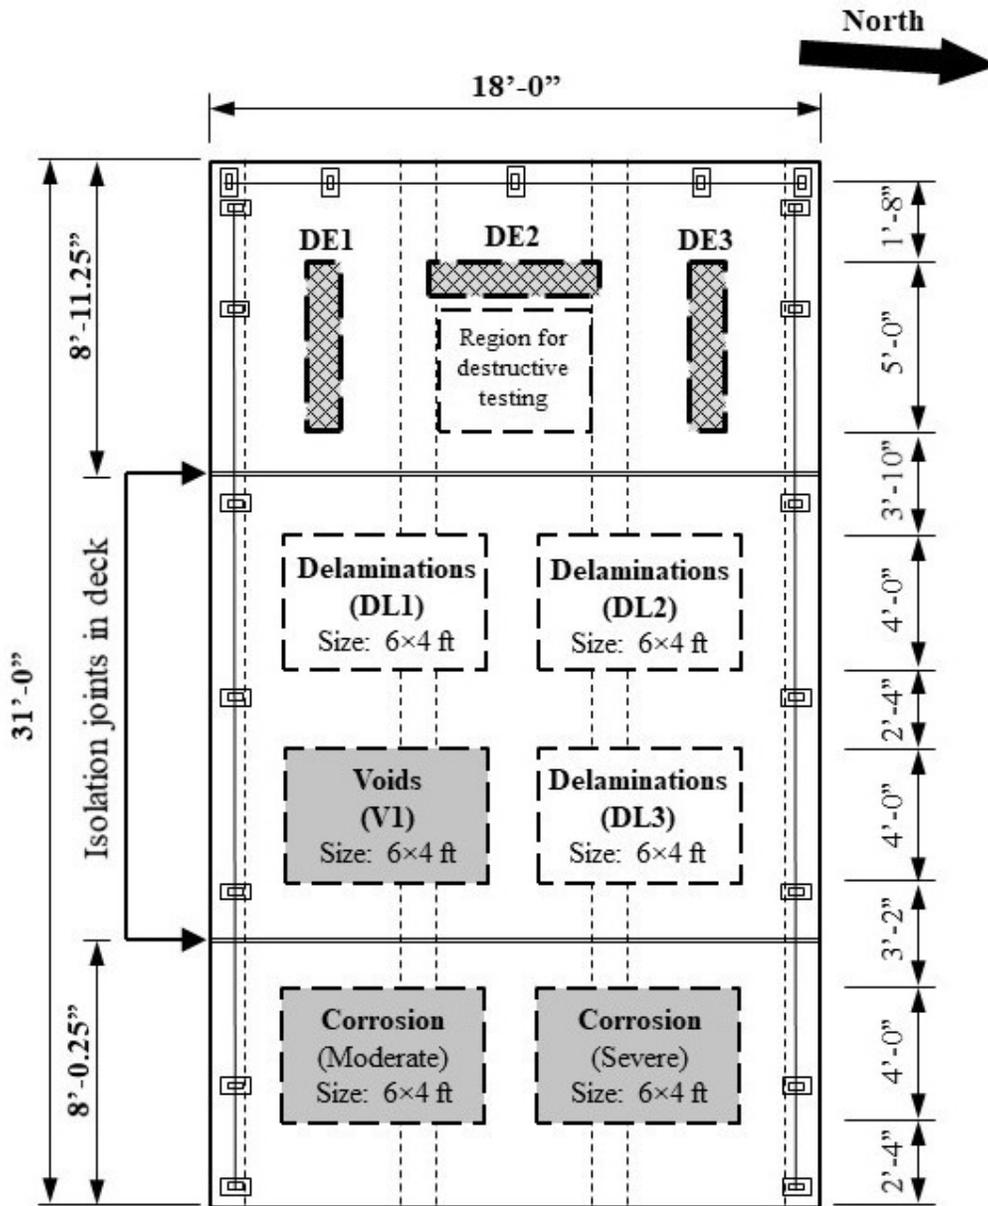
Figure 5-3: Preliminary design of defect layout for the NDT bridge (not to scale)

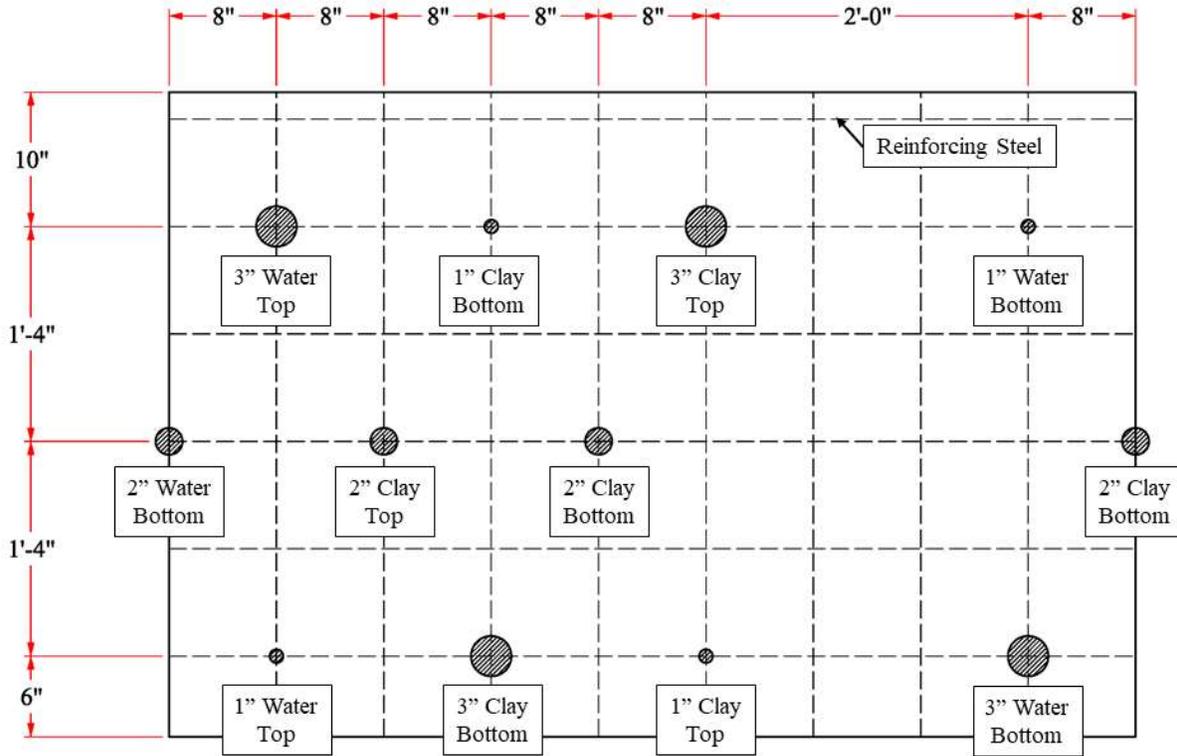
Figure 5-4: Layout of voids within Zone V1

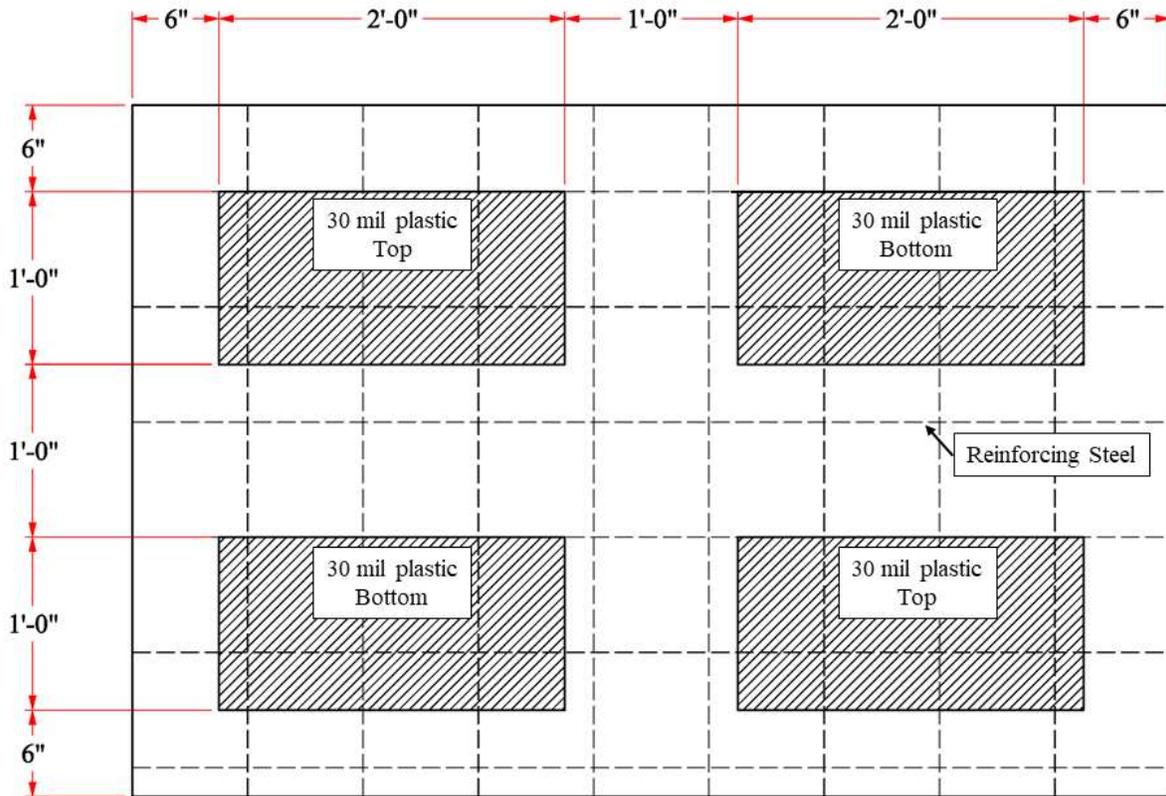
Figure 5-7: Layout of delaminations within Zone DL3

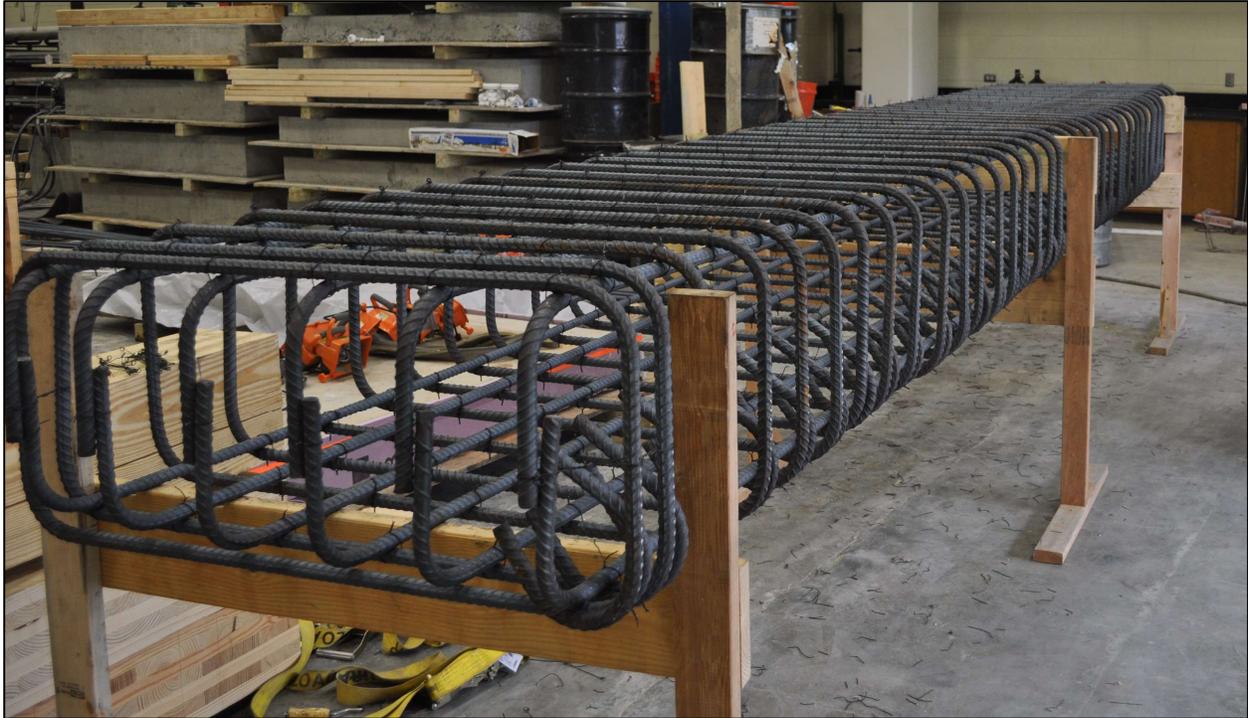
Figure 5-11: Tied reinforcing steel cage for the West-end footing
