**Evaluation of Nondestructive Testing Methods to Assess the Condition of Concrete
Bridge Decks**

A thesis submitted to the Graduate Faculty of
Auburn University
in partial fulfillment of the
requirements for the Degree of
Master of Science

Auburn, Alabama
August 7, 2021

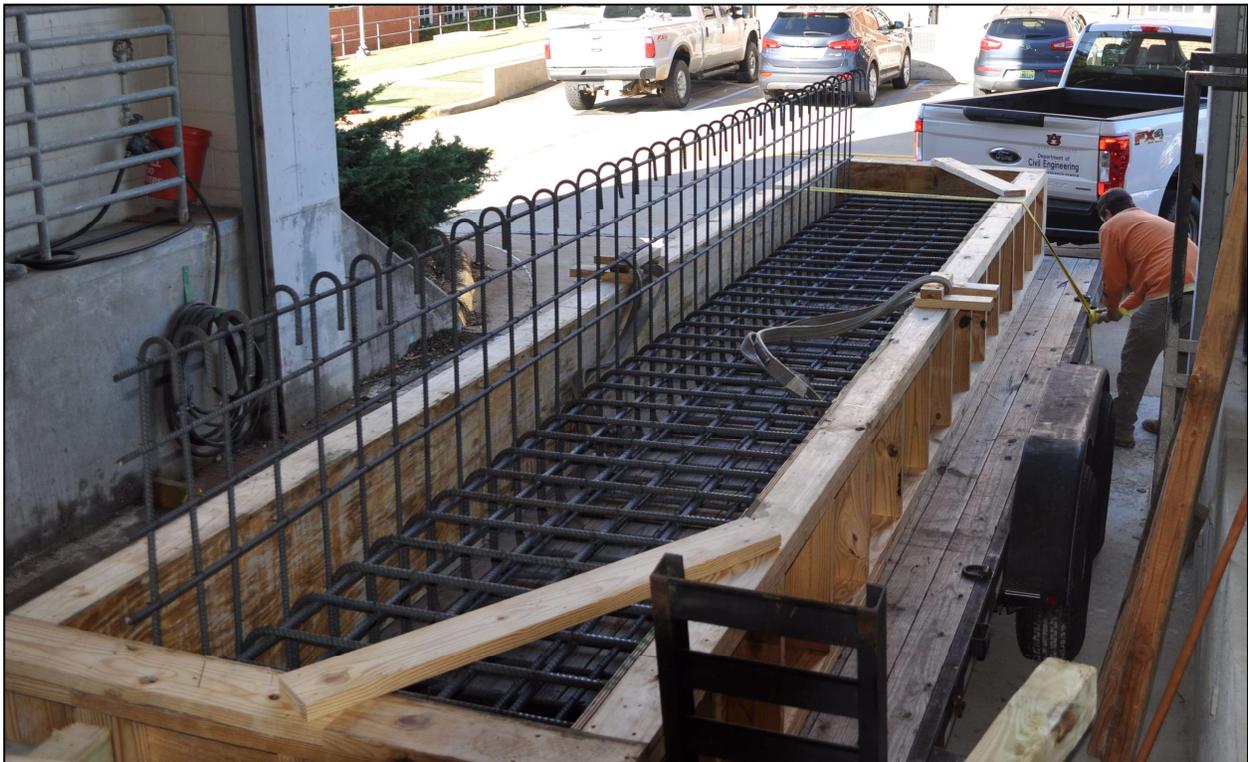
Figure 5-12: East-end footing and reinforcing steel cage loaded on the trailer

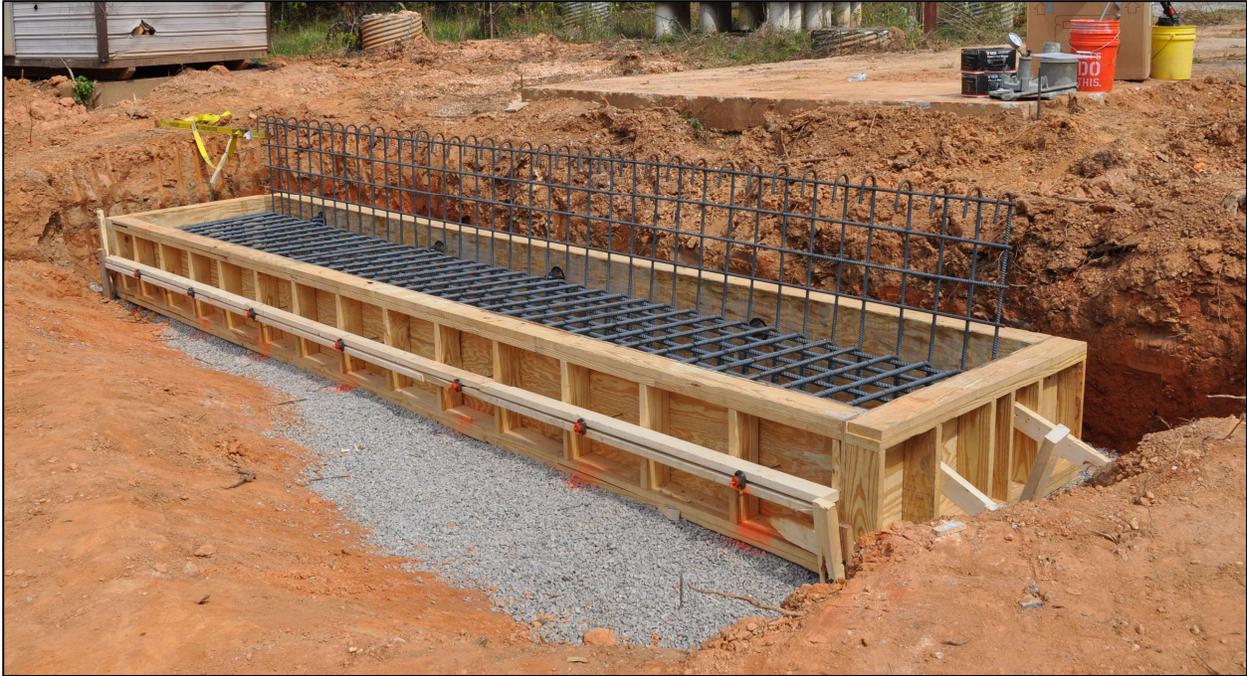
Figure 5-14: East-end foundation formwork and reinforcing steel

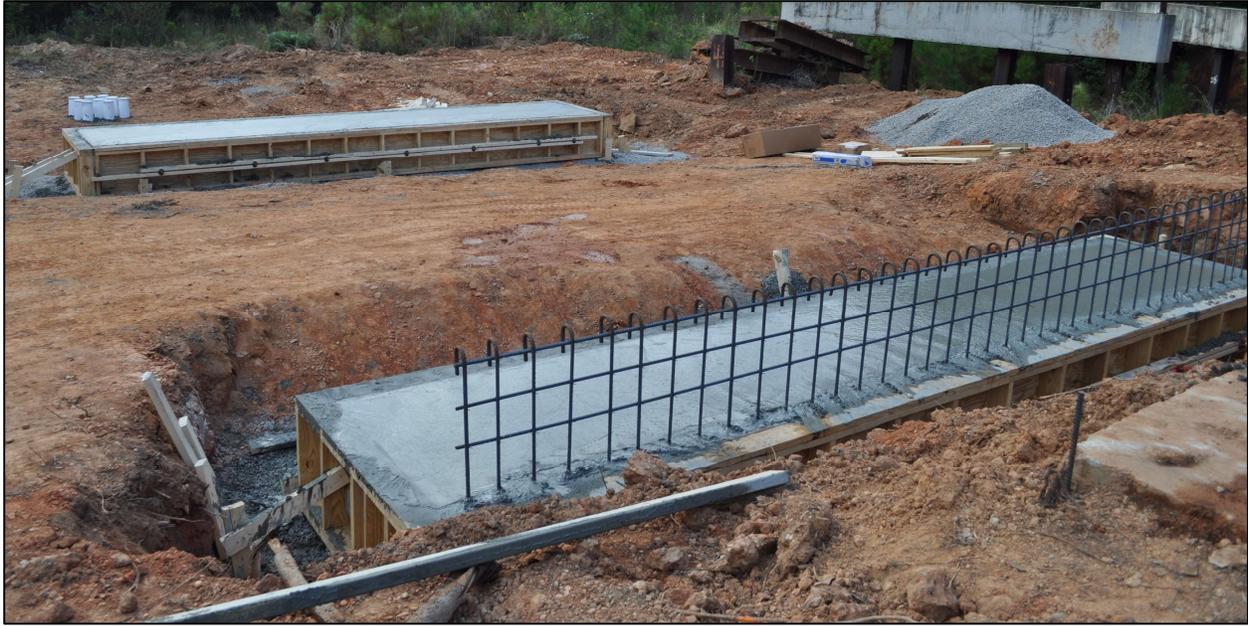
Figure 5-15: Both foundations after casting was complete

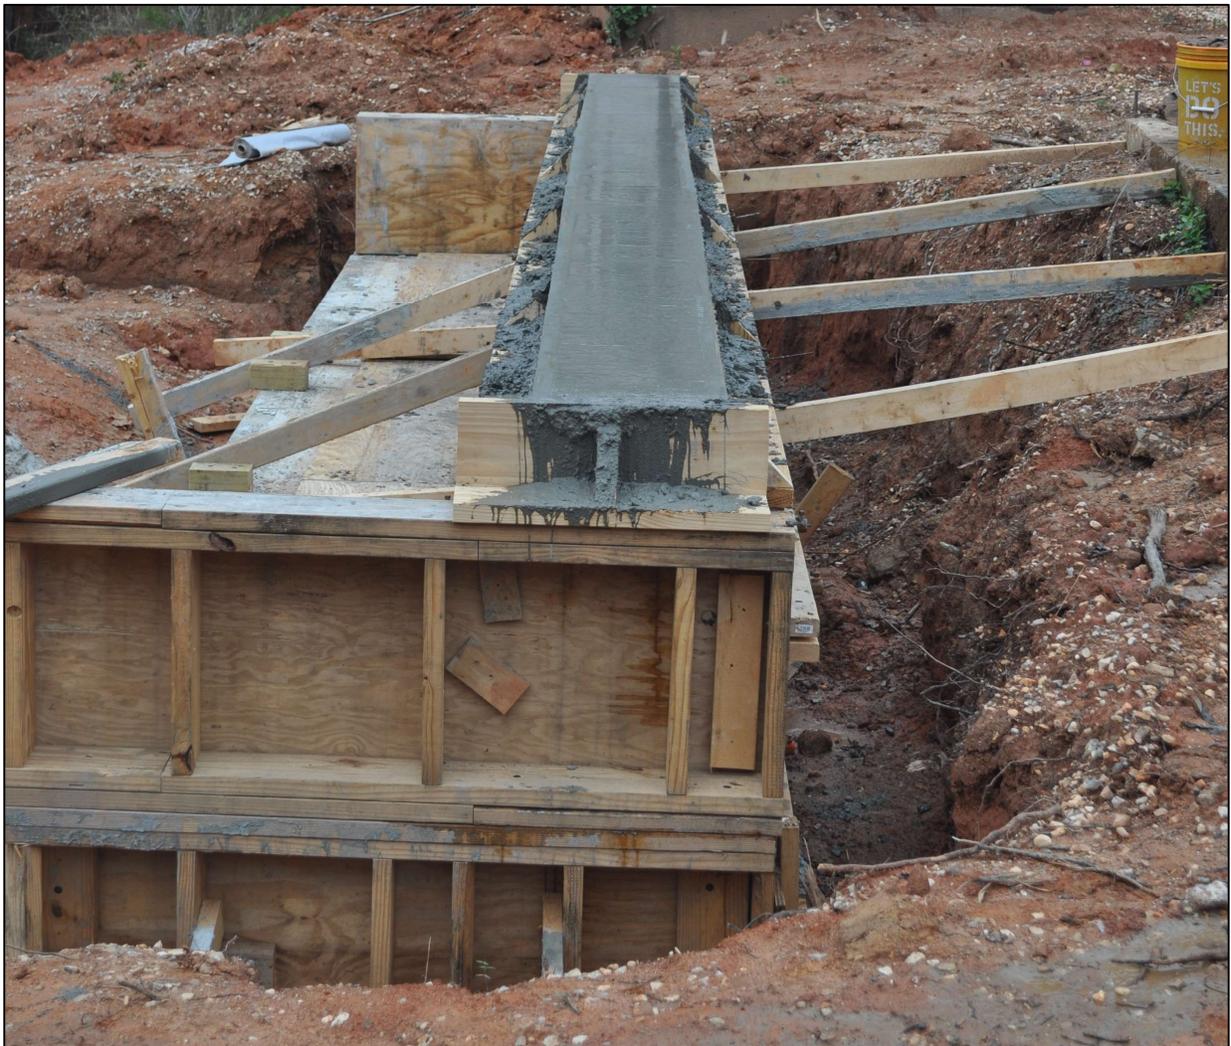
Figure 5-16: Retaining wall once casting was complete

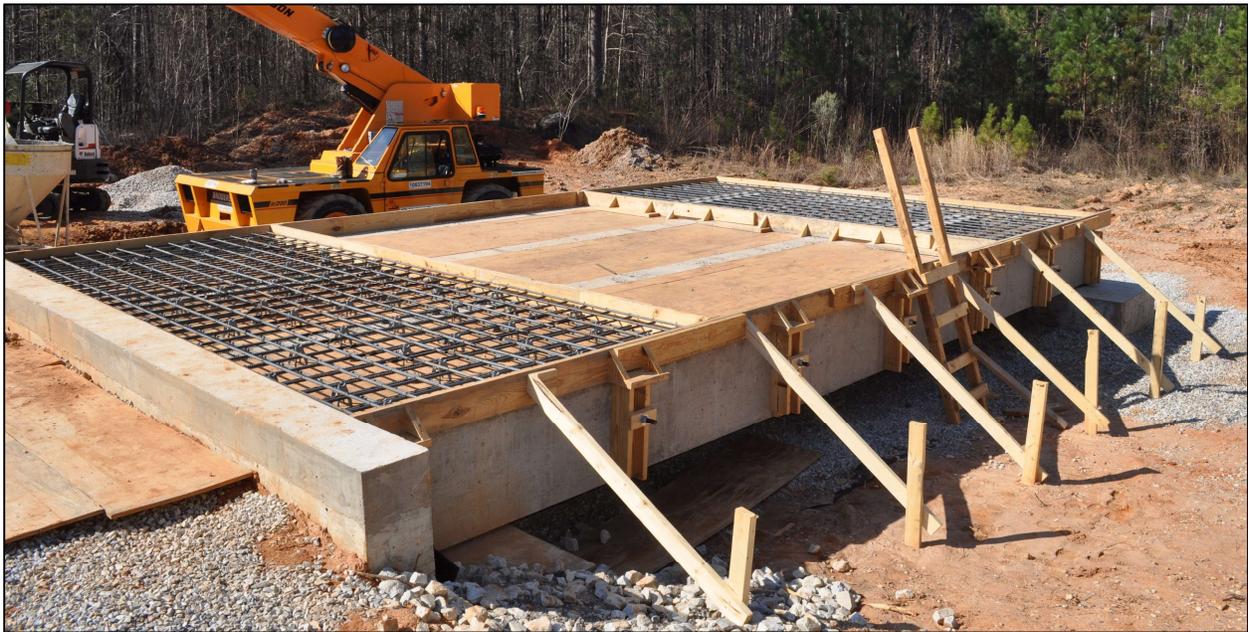
Figure 5-28: Facing southwest, the NDT bridge prior to the casting of the East-end and West-end bridge deck sections

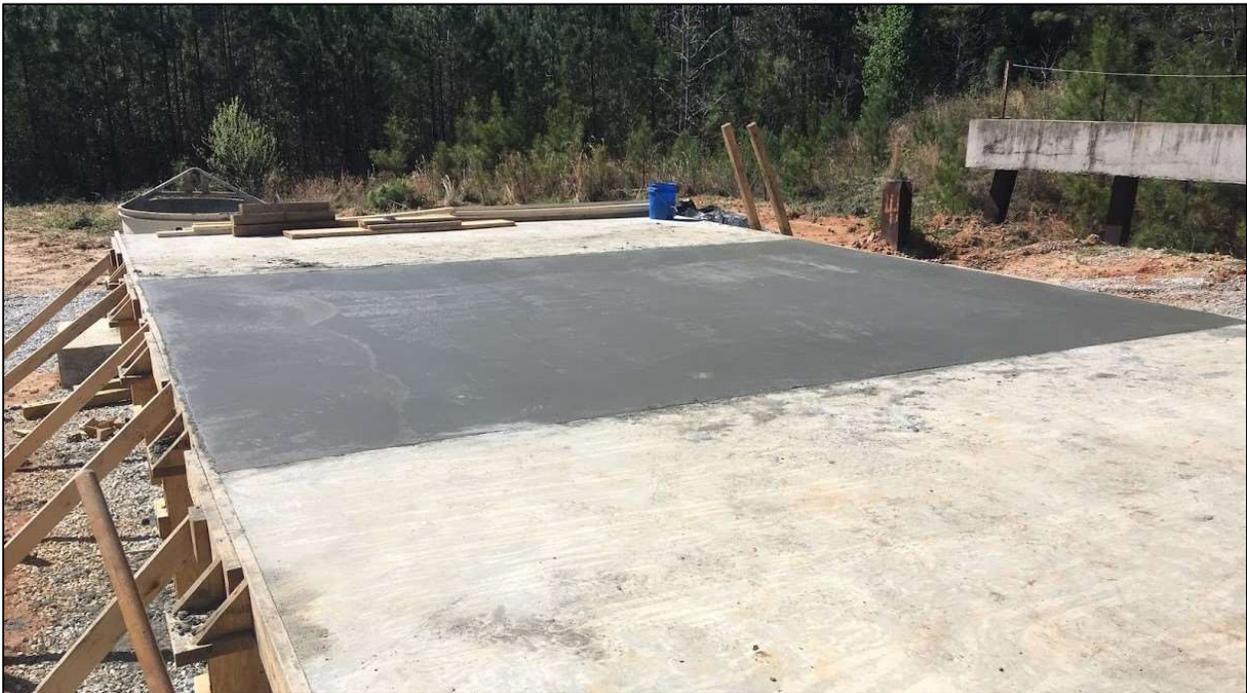
Figure 5-31: The NDT bridge deck after the middle section was cast

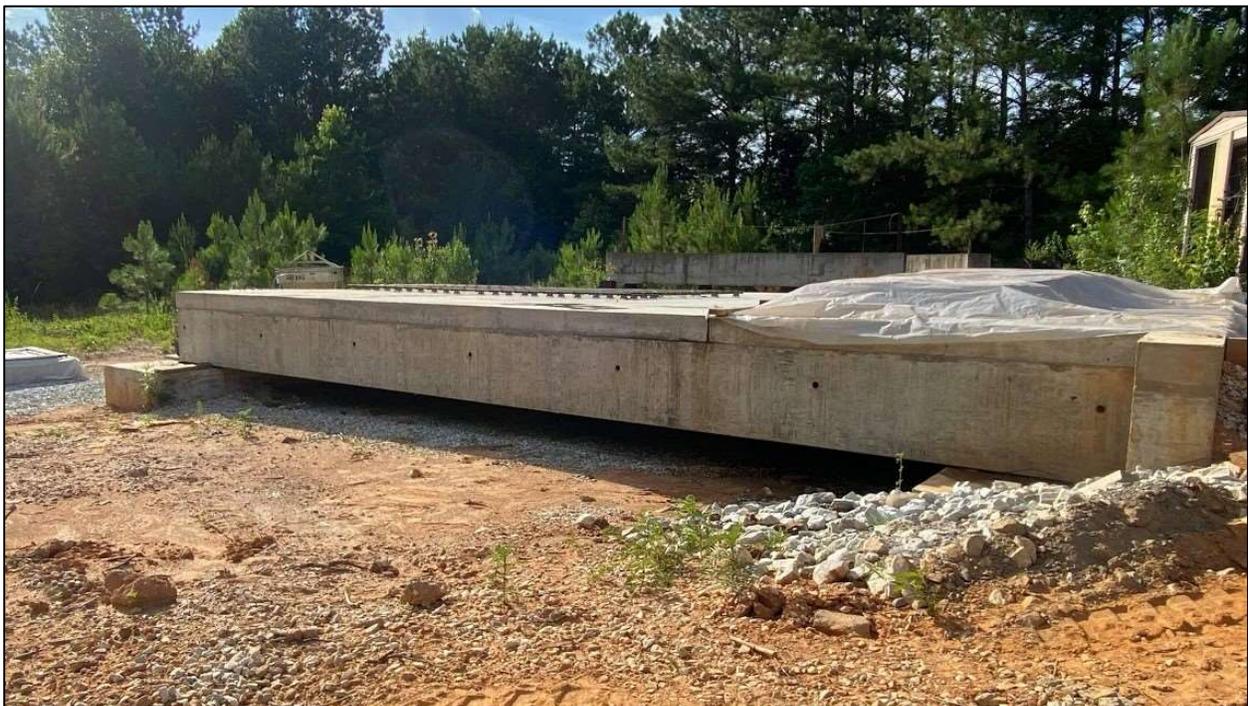
Figure 5-32: The NDT bridge once the slab formwork was removed; plastic is covering the corrosion ponds

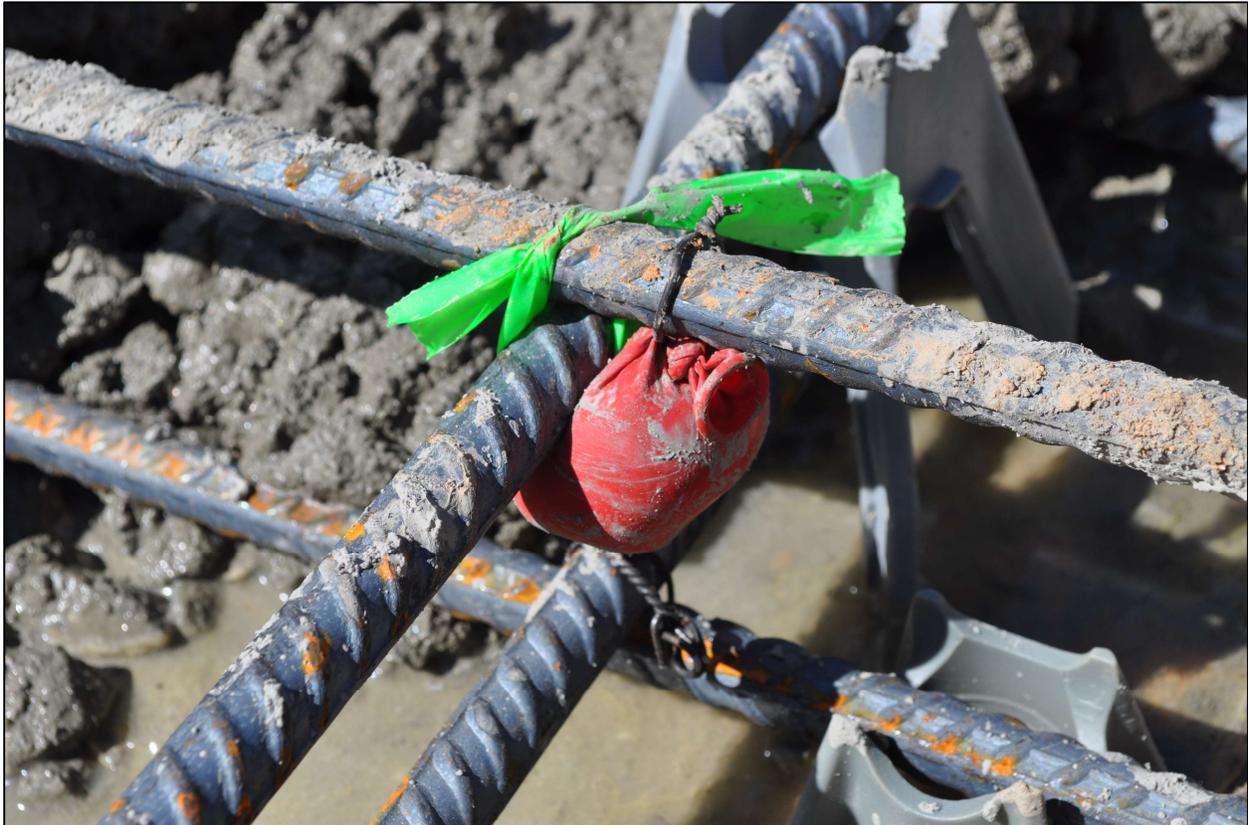
Figure 5-33: Clay void in place below the top reinforcing steel mat

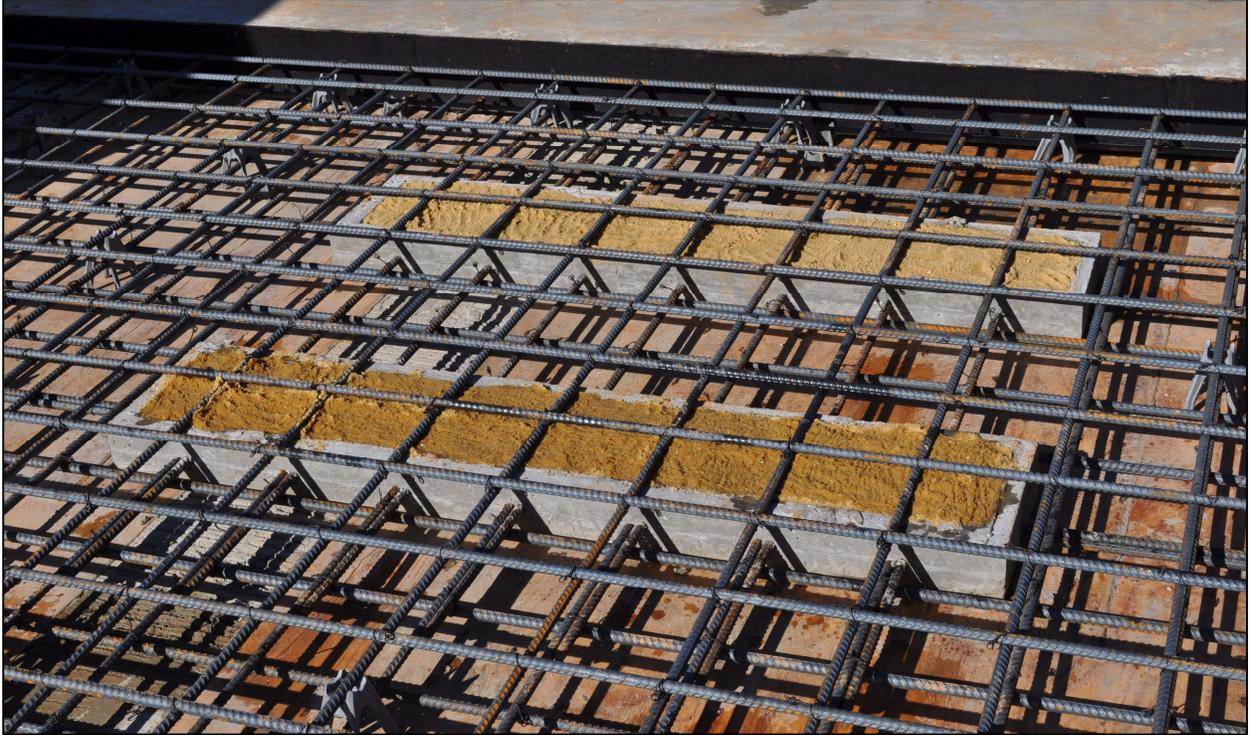
Figure 5-36: Sand layers in Zone DL2; sand with oil in foreground, sand in background

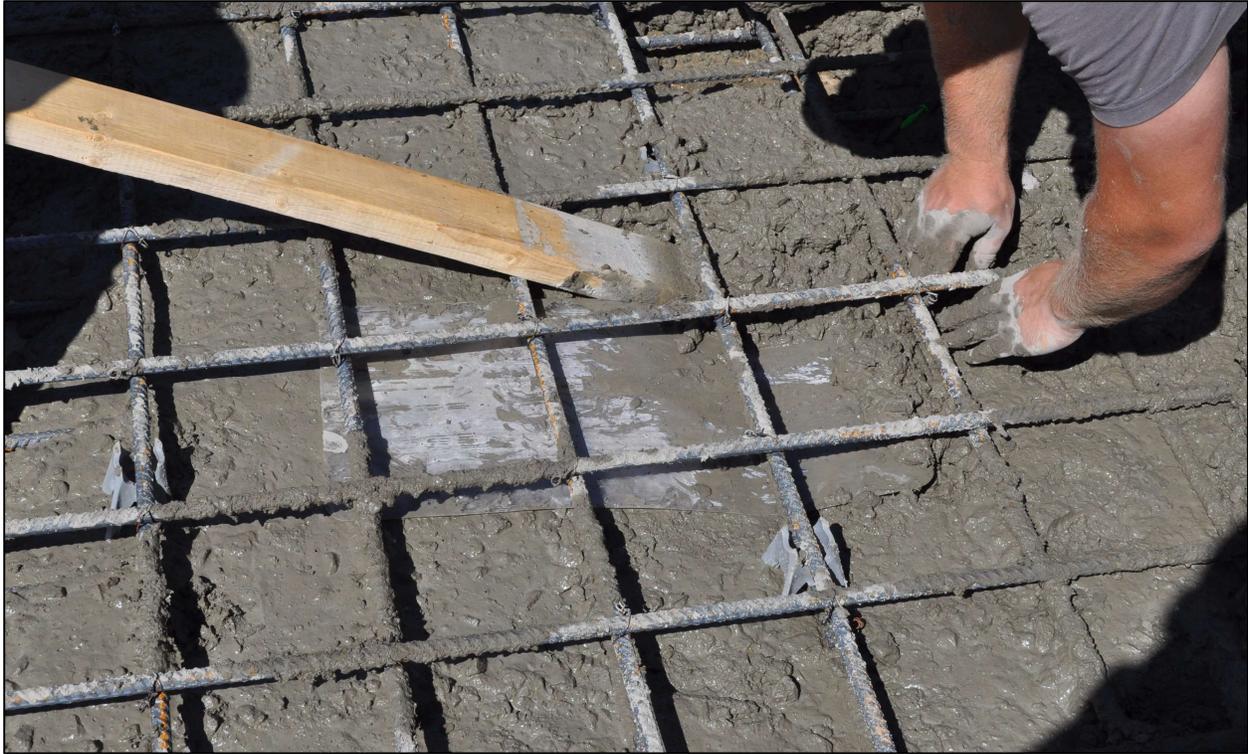
Figure 5-38: Placing a 30 mil plastic sheet between the bottom reinforcing bars in Zone DL3

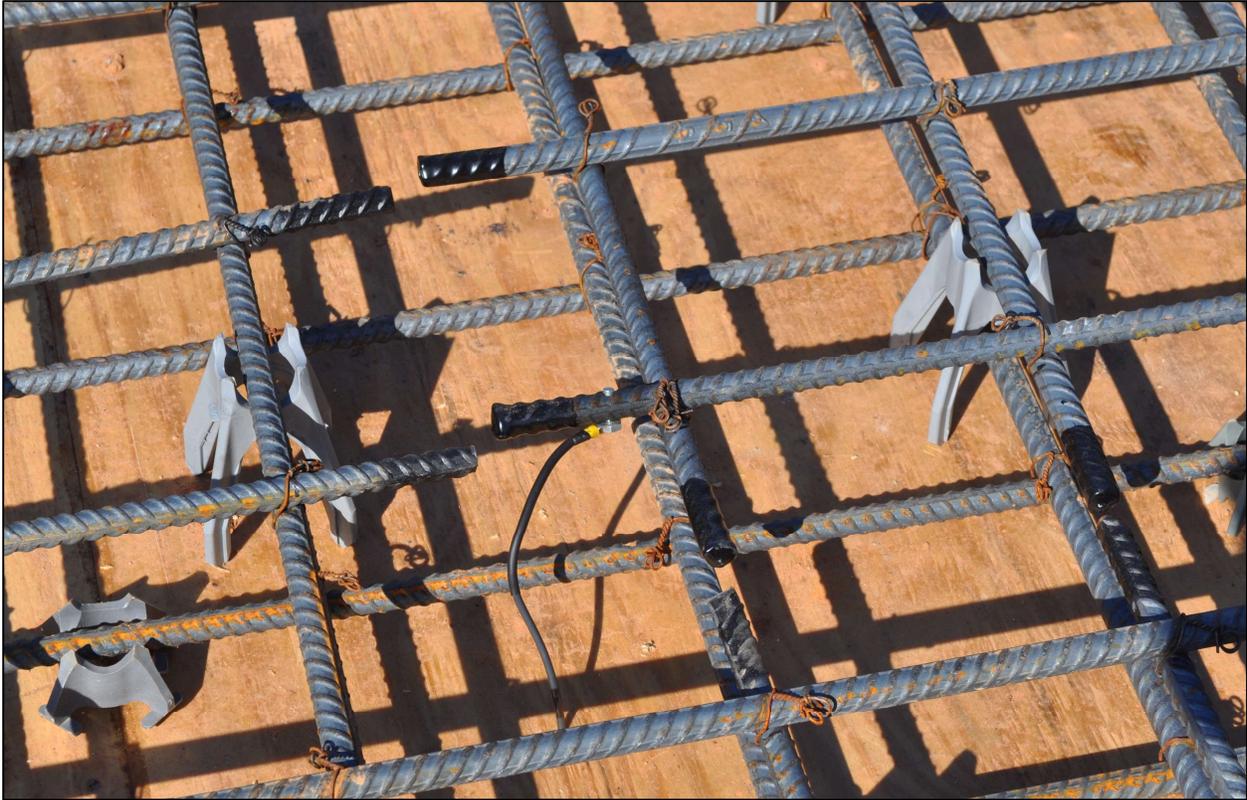
Figure 5-39: Discontinuous and electrically isolated rebar in the moderate corrosion section

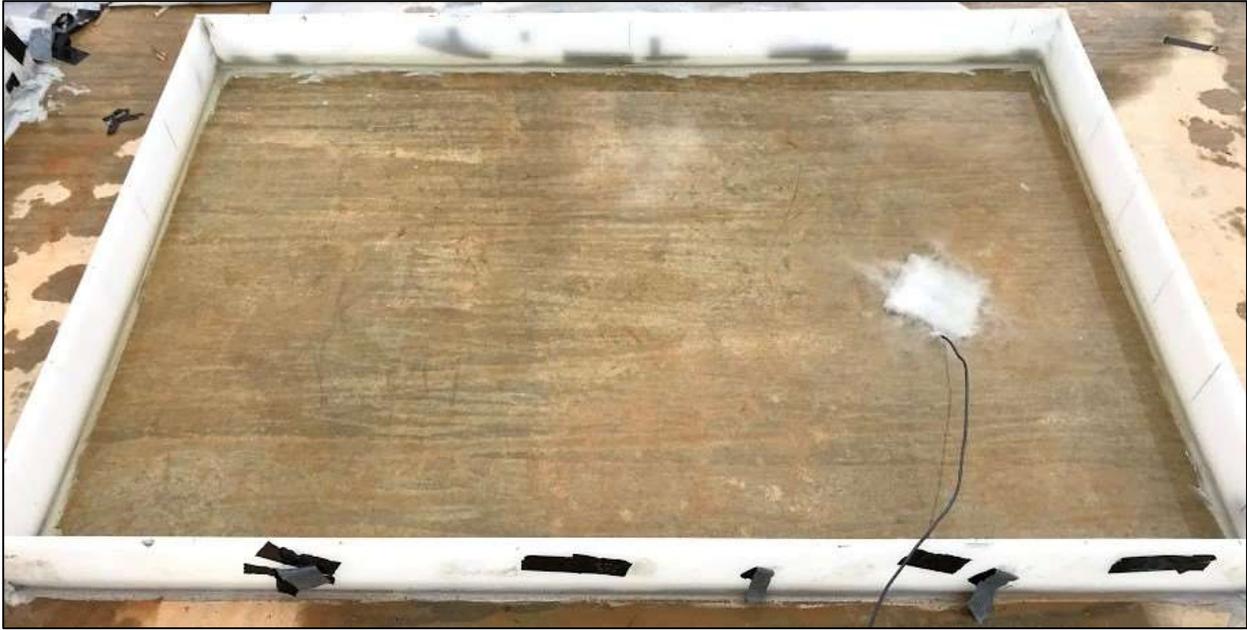
Figure 5-40: Pond walls filled with sodium chloride solution; submerged stainless steel plate

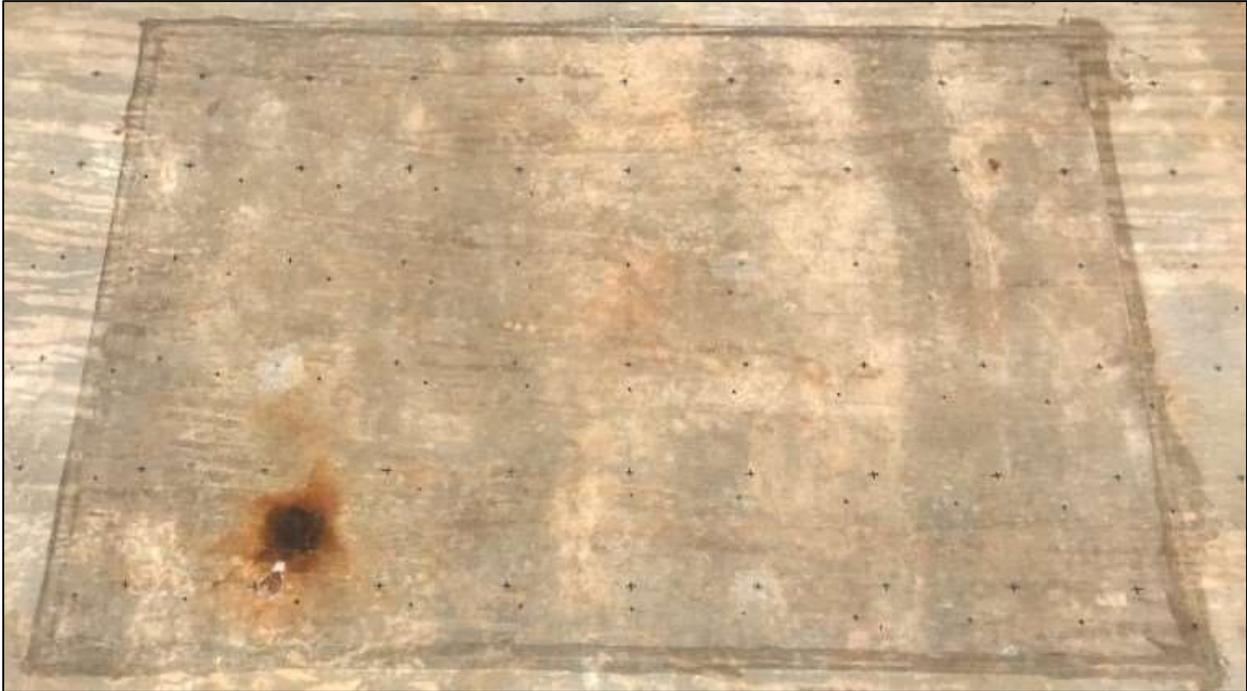
Figure 5-41: Zone C1, once the induced corrosion process was complete

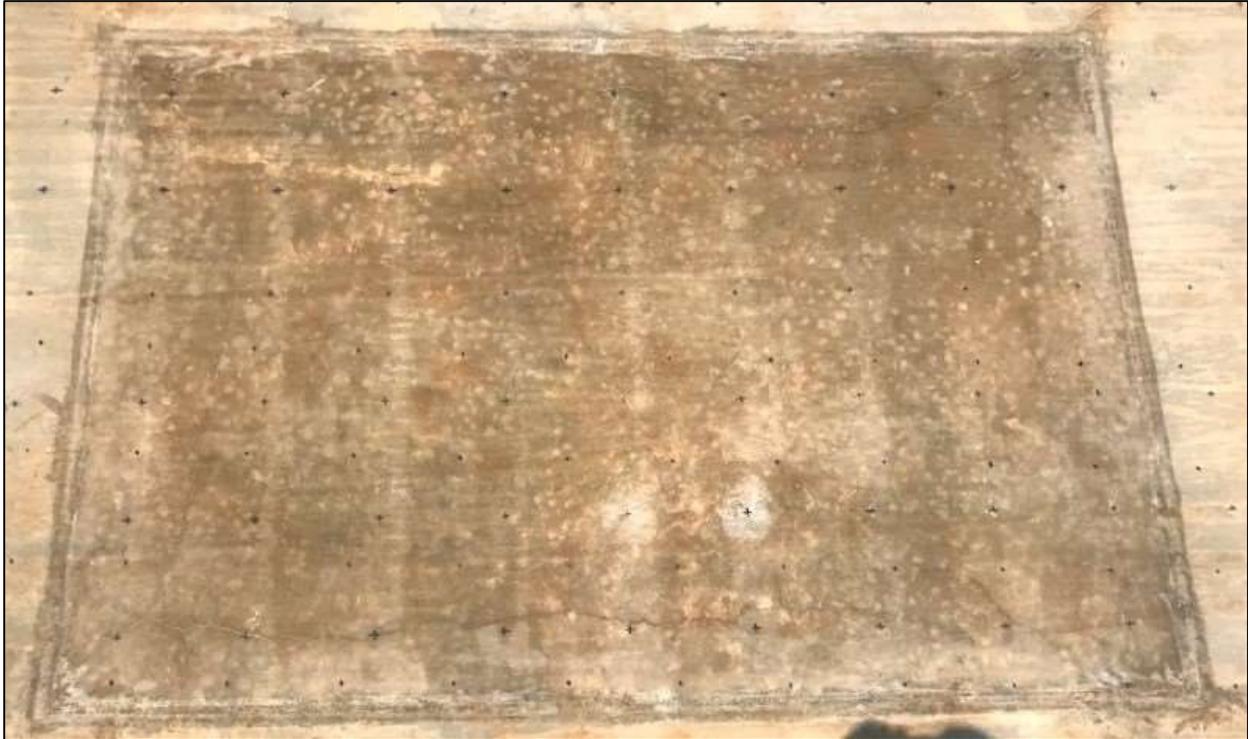
Figure 5-42: Zone C2, once the induced corrosion process was complete

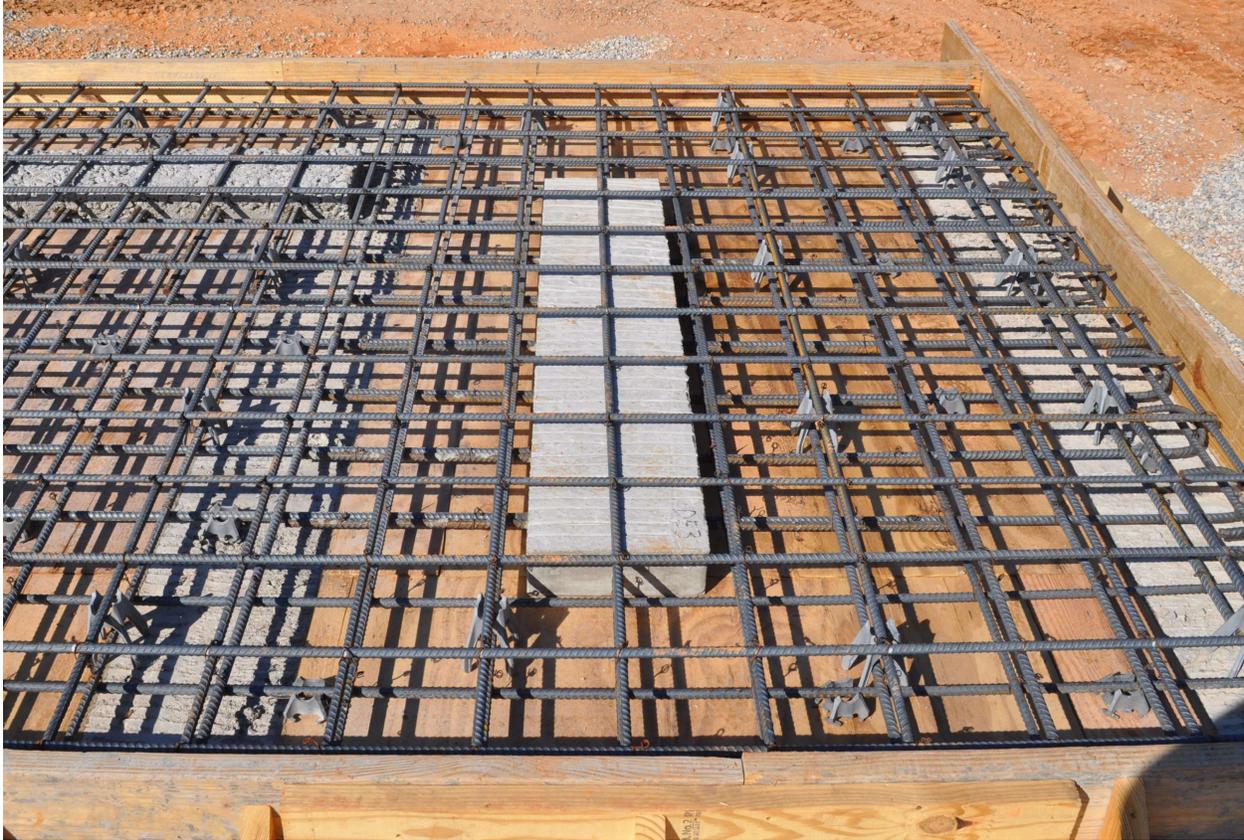
Figure 5-45: Low strength specimen in place at Zone DE3

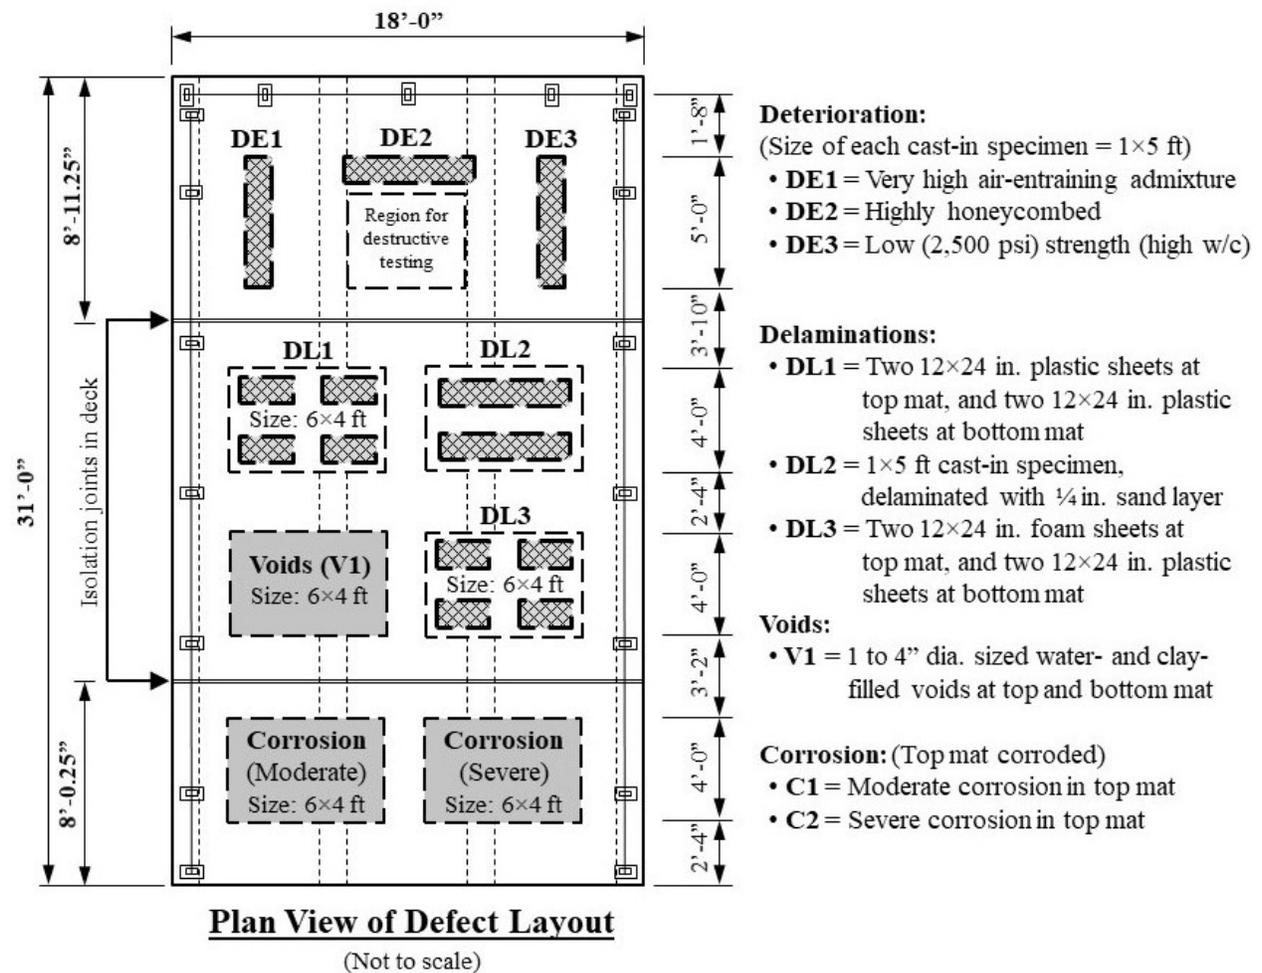
Figure 6-1: Summary of defects placed in the full-scale bridge deck NDT site

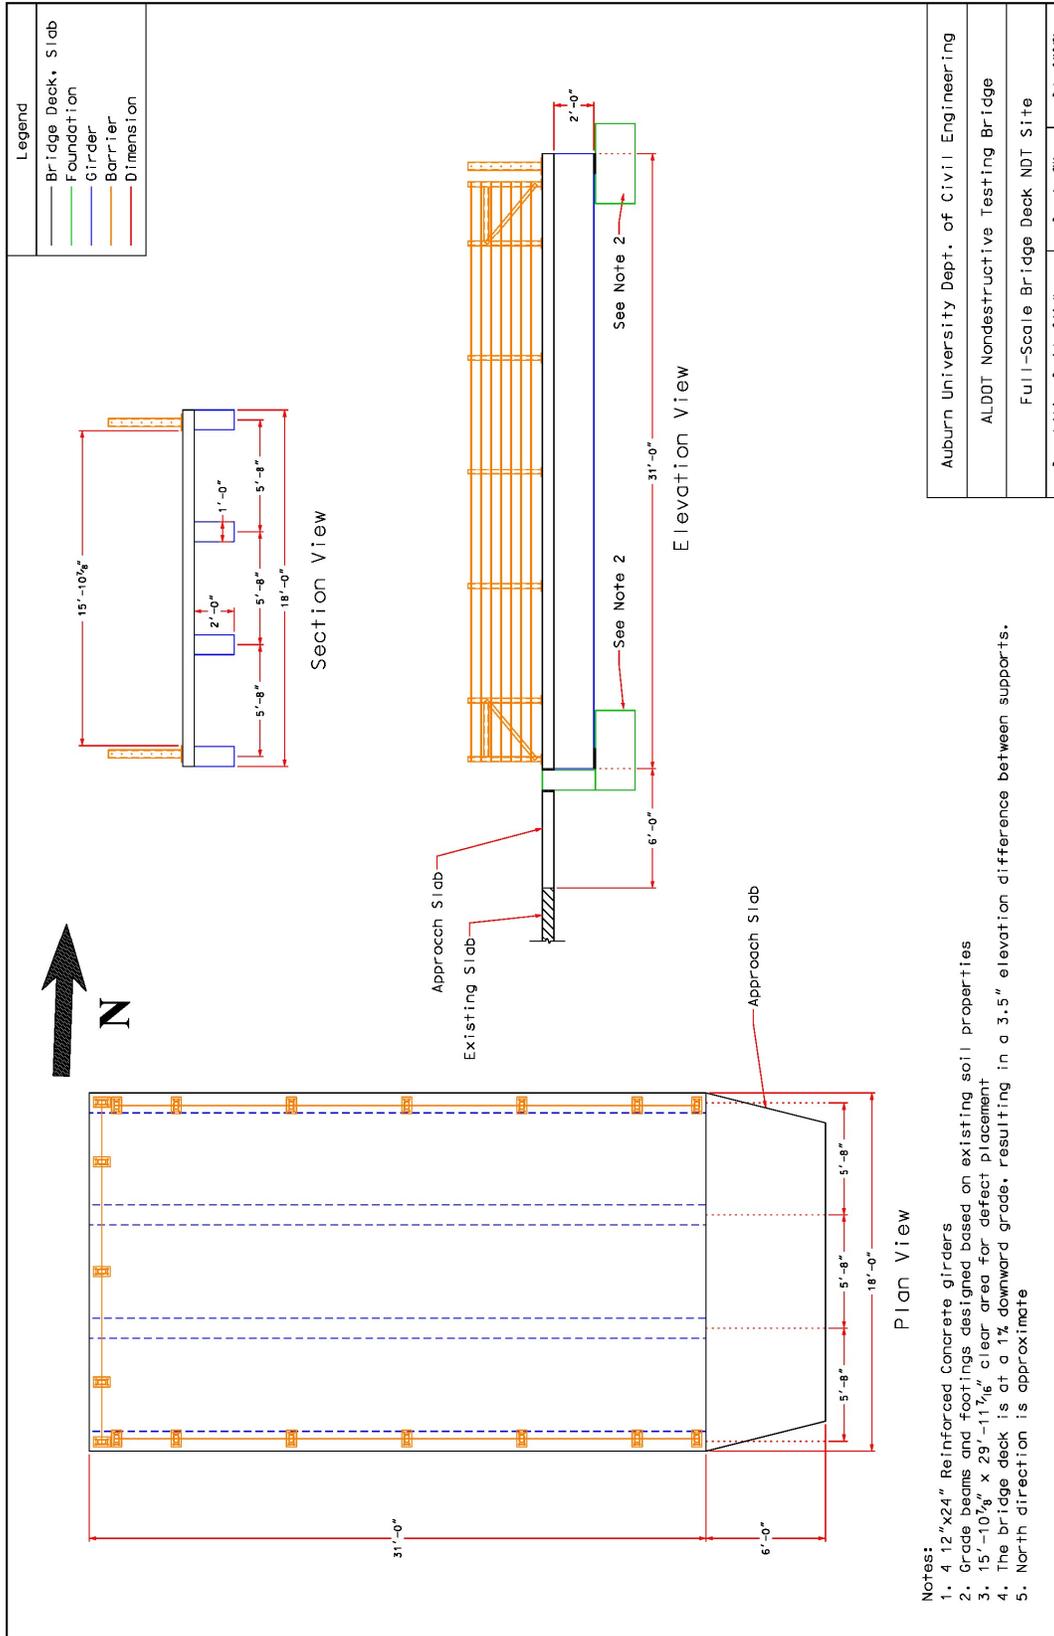
Figure B-1: Full-scale bridge deck NDT site design drawing

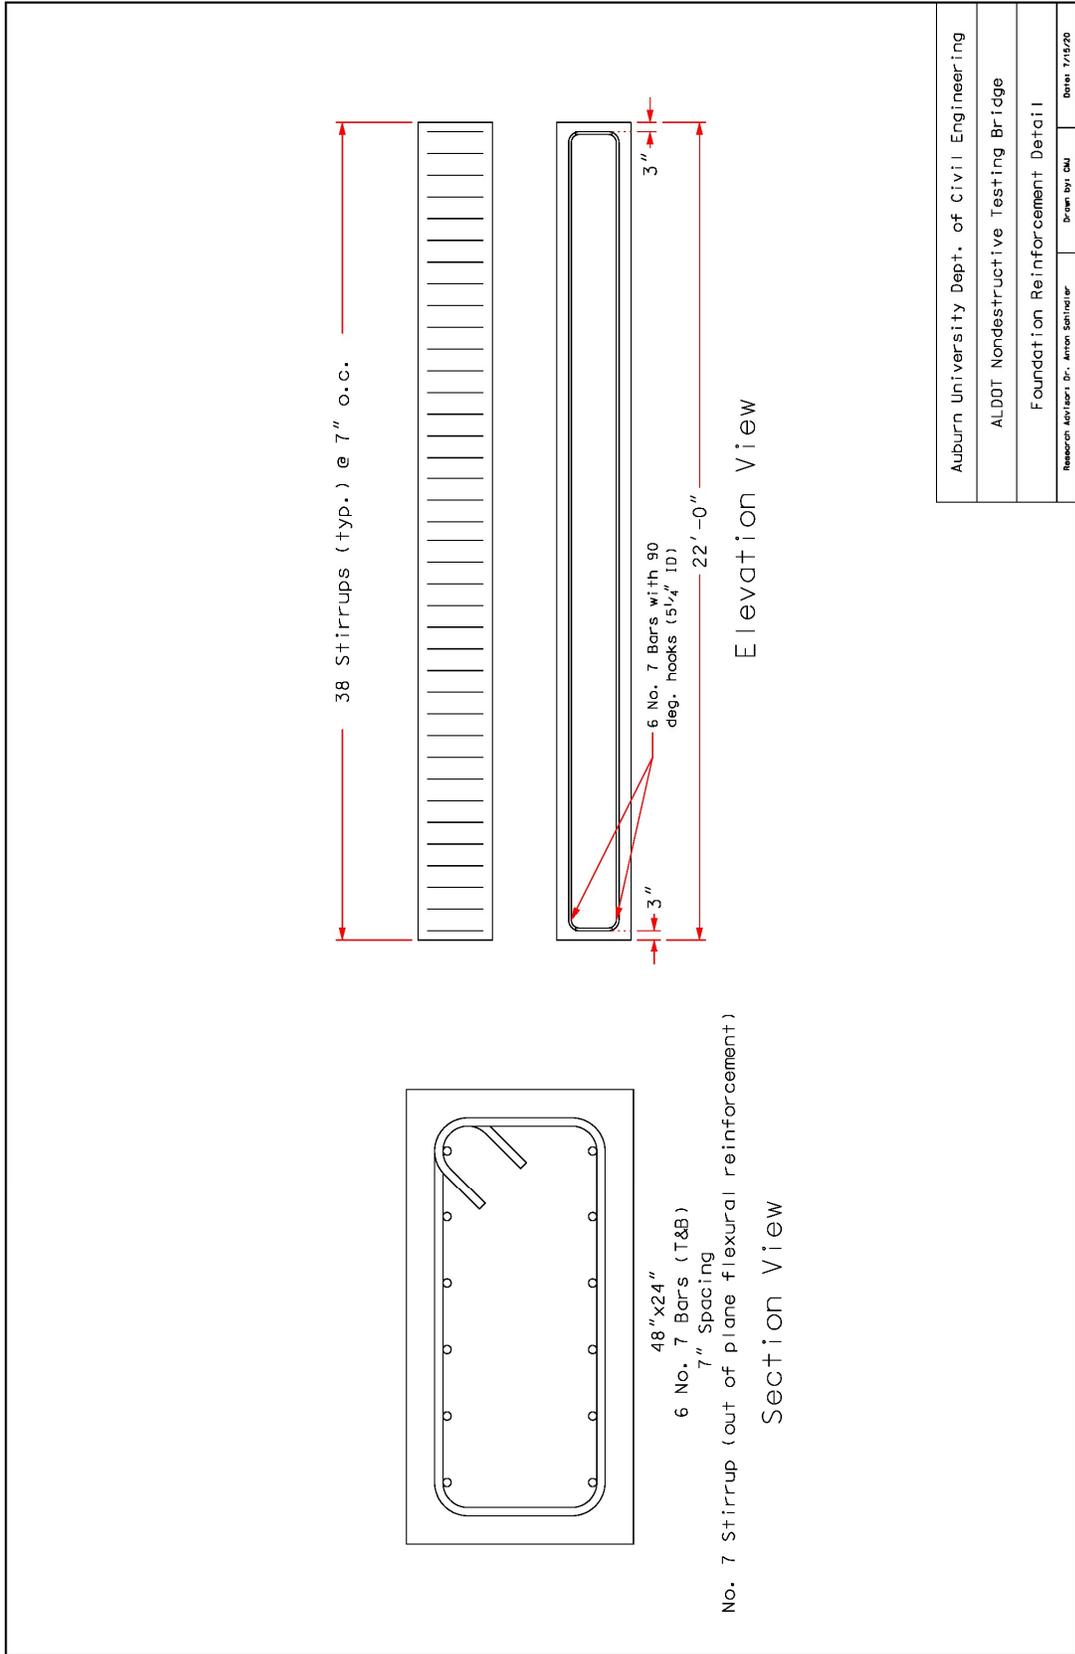
Figure B-2: Foundation reinforcement detail drawing

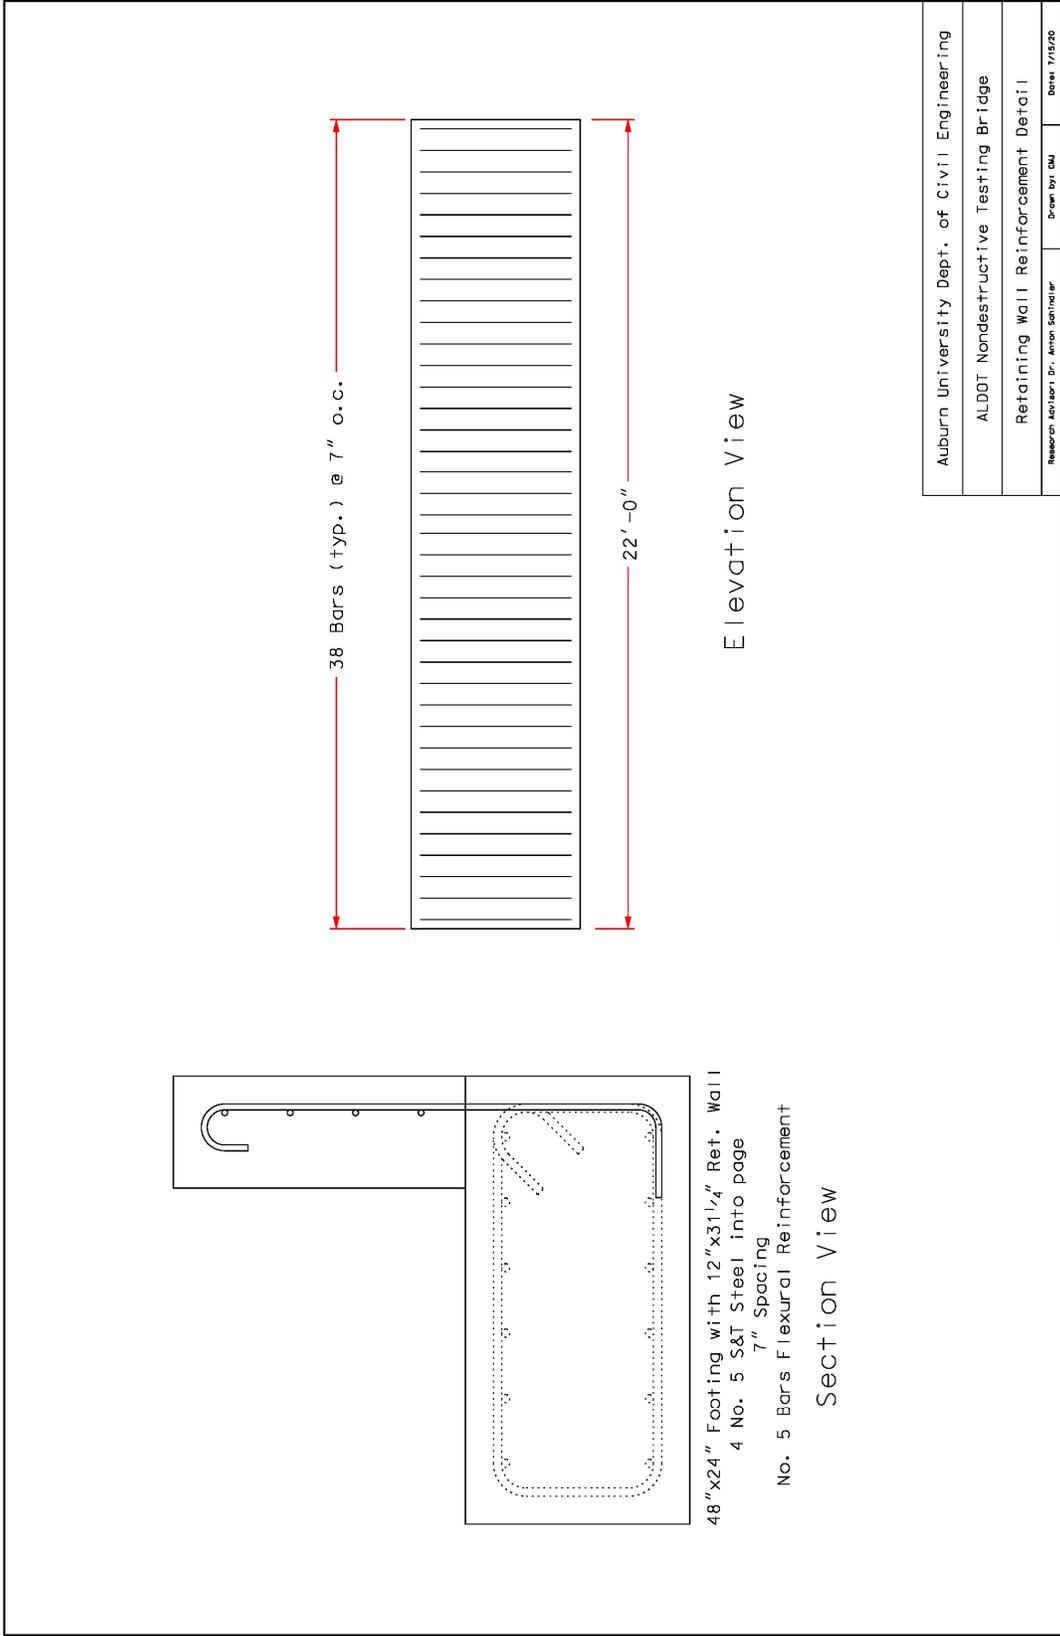
Figure B-3: Retaining wall reinforcement detail drawing

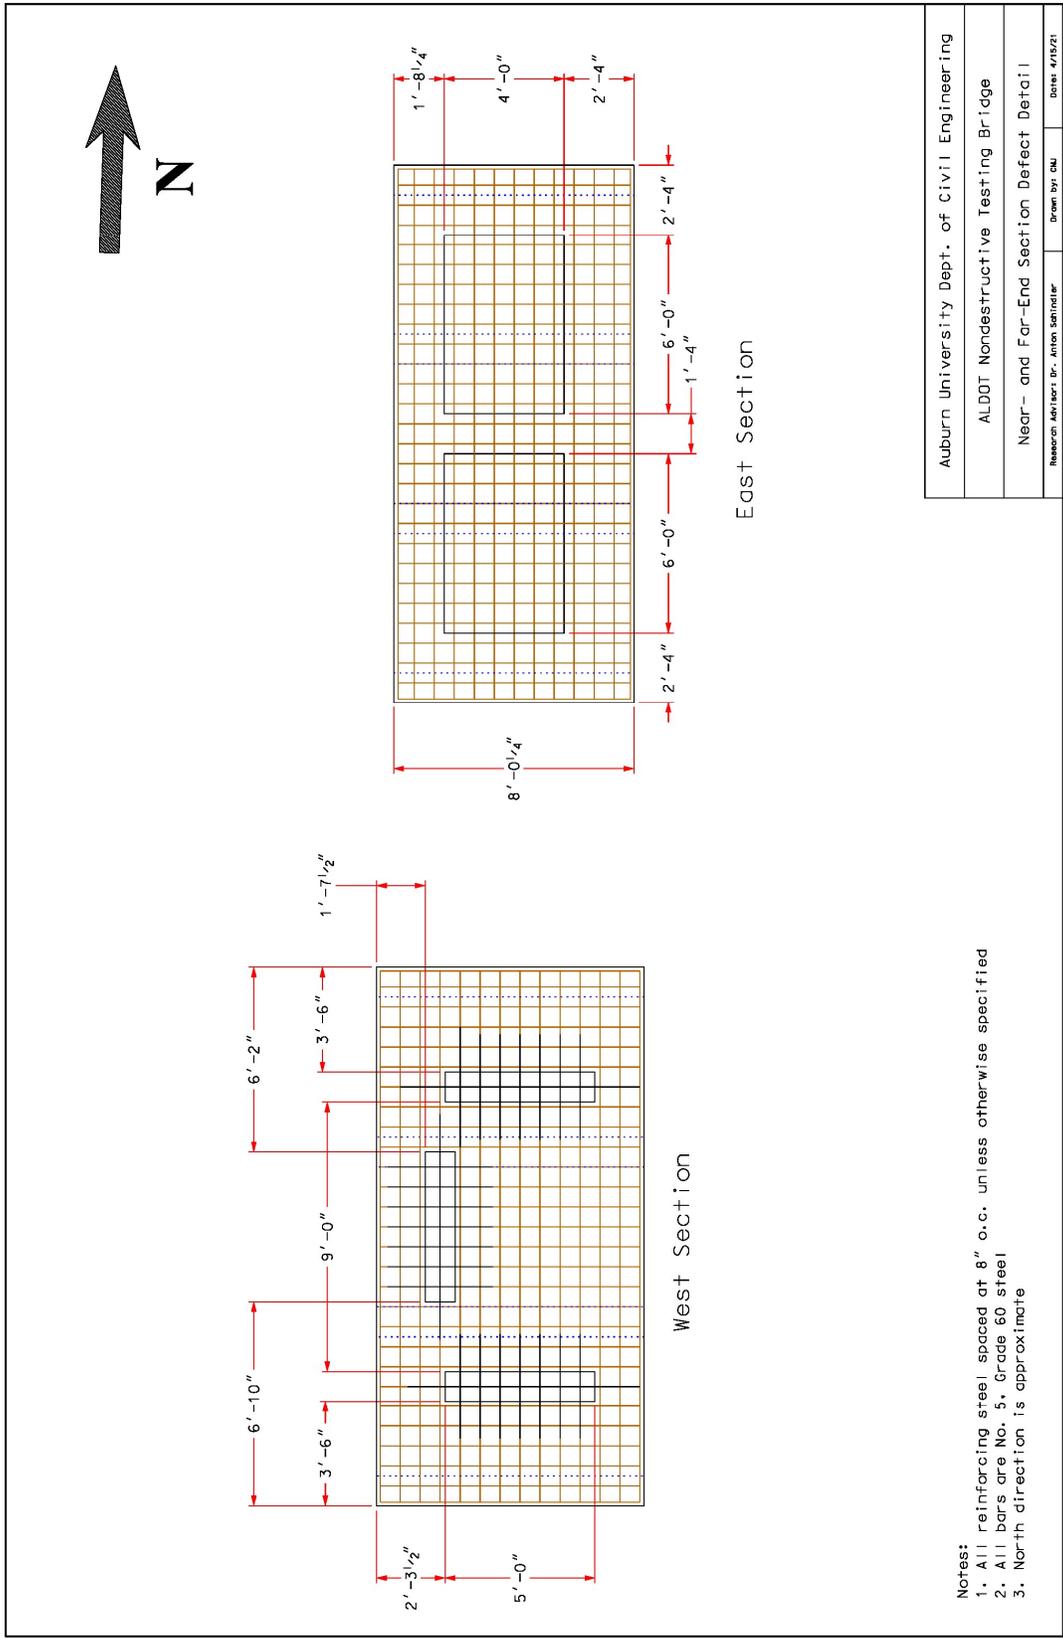
Figure B-6: East- and West-end section defect layout and dimensions
