**Evaluation of Nondestructive Testing Methods to Assess the Condition of Concrete
Bridge Decks**

A thesis submitted to the Graduate Faculty of
Auburn University
in partial fulfillment of the
requirements for the Degree of
Master of Science

Auburn, Alabama
August 7, 2021

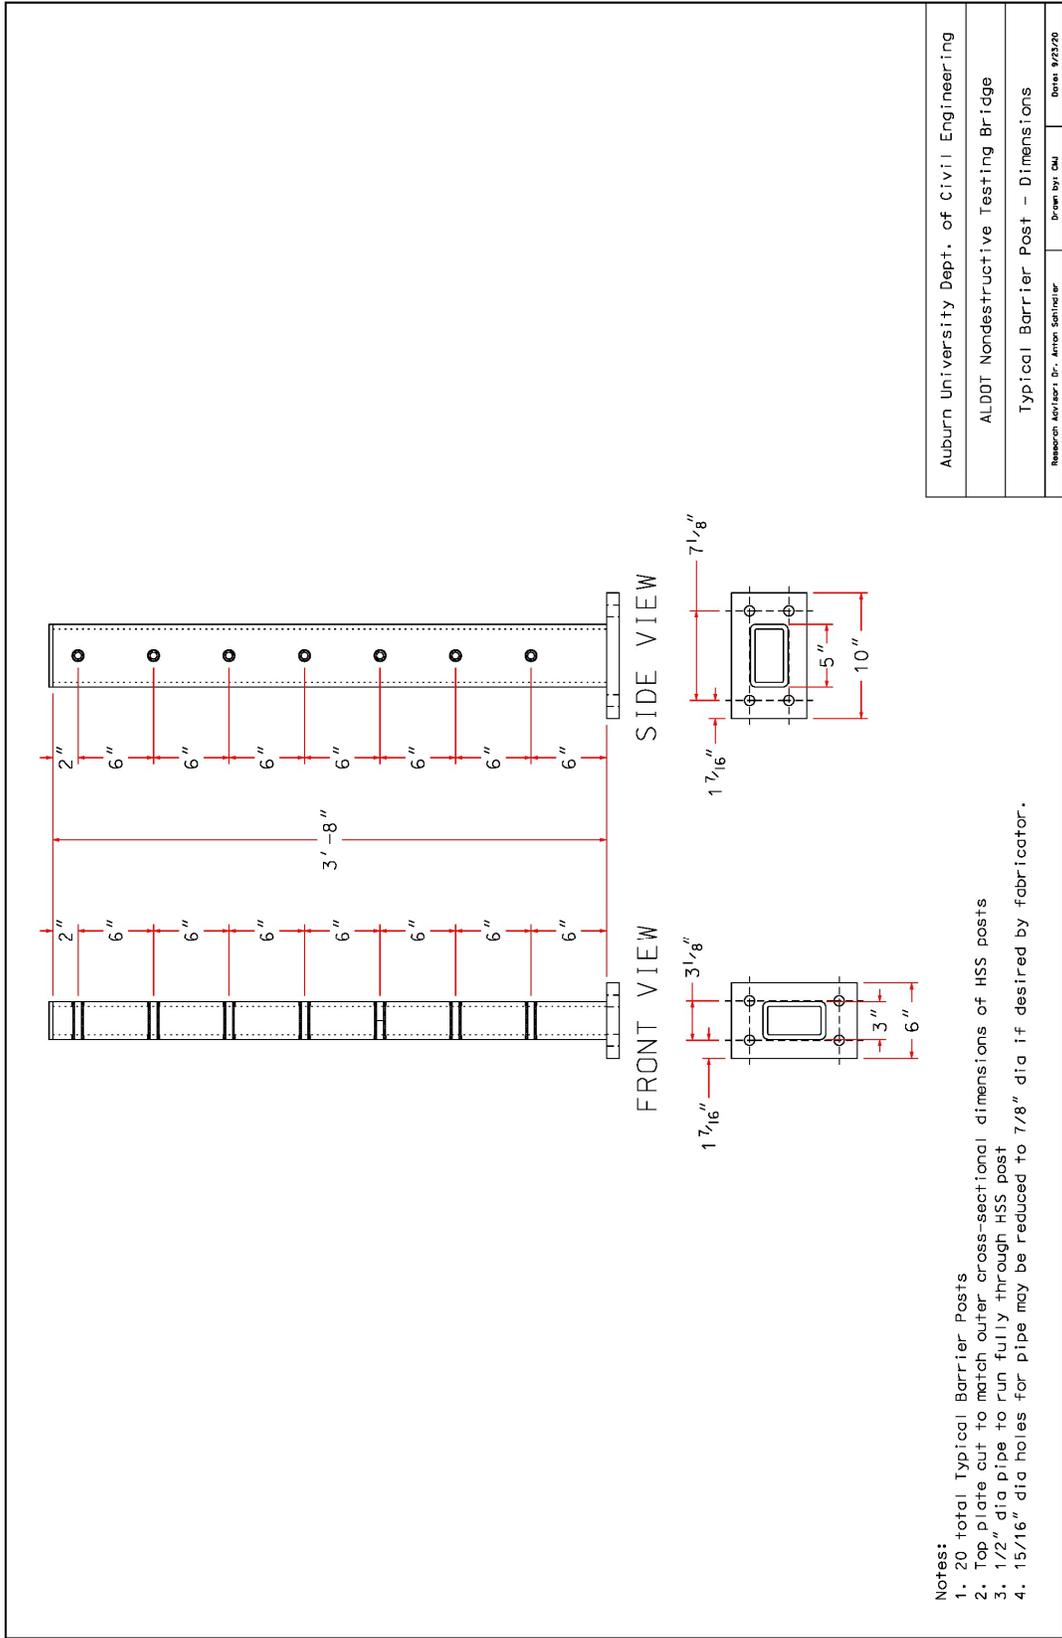
Auburn University Dept. of Civil Engineering
ALDOT Nondestructive Testing Bridge
Typical Barrier Post - Dimensions
Research Assistant, Dr. Armin Schnieder
Drawn by: DJJ
Date: 8/23/90
