**Finite Element Modelling of Large Area Maintenance Shelters and Comparison to  
Experimental Results**

A thesis submitted to the Graduate Faculty of  
Auburn University  
in partial fulfillment of the  
requirements for the Degree of  
Master of Science

Keywords: structural engineering, finite element modelling, large area maintenance shelter

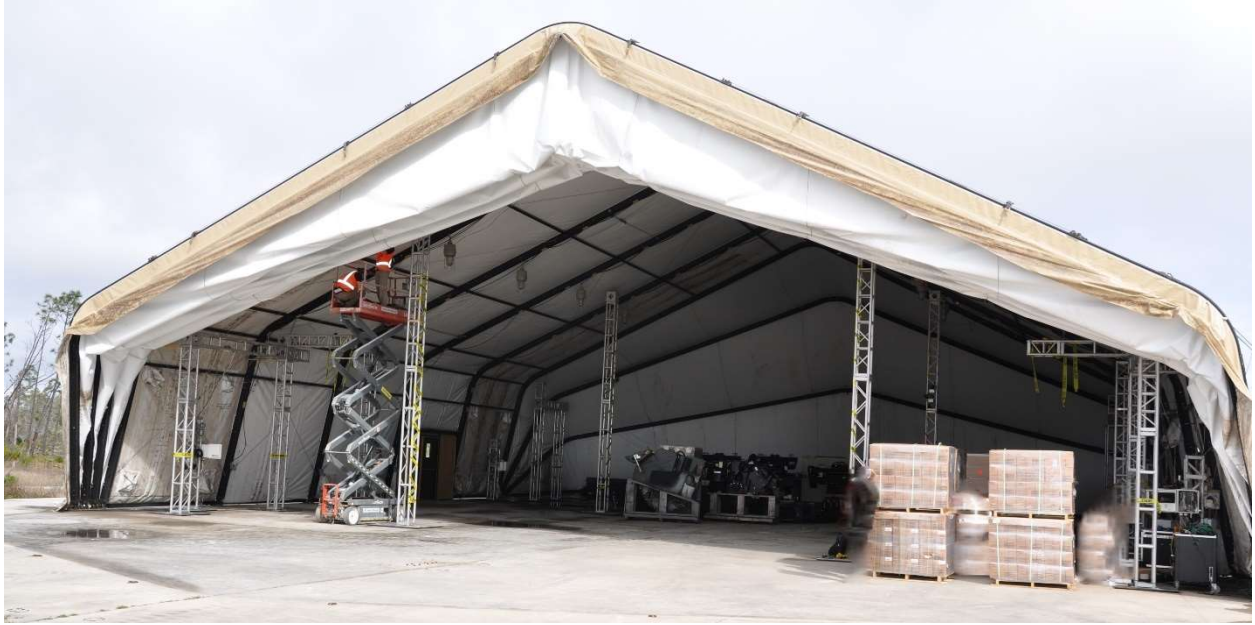
Figure 3.1-3. LAMS configuration with one end in the open position

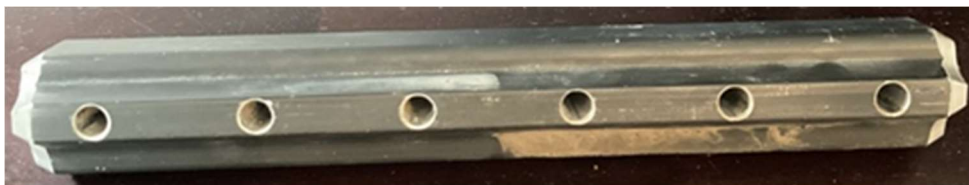
Figure 3.1-7. Side view of splice member

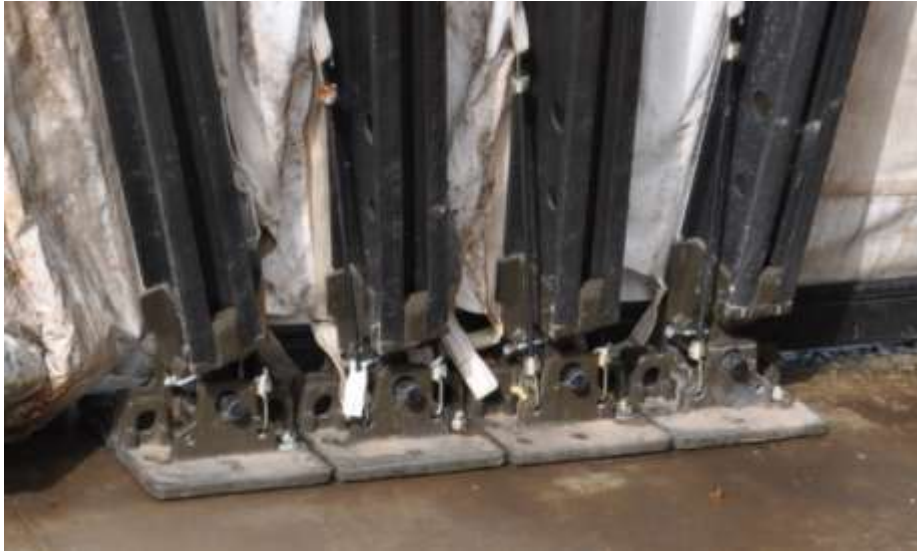
Figure 3.1-8. Base plate connections

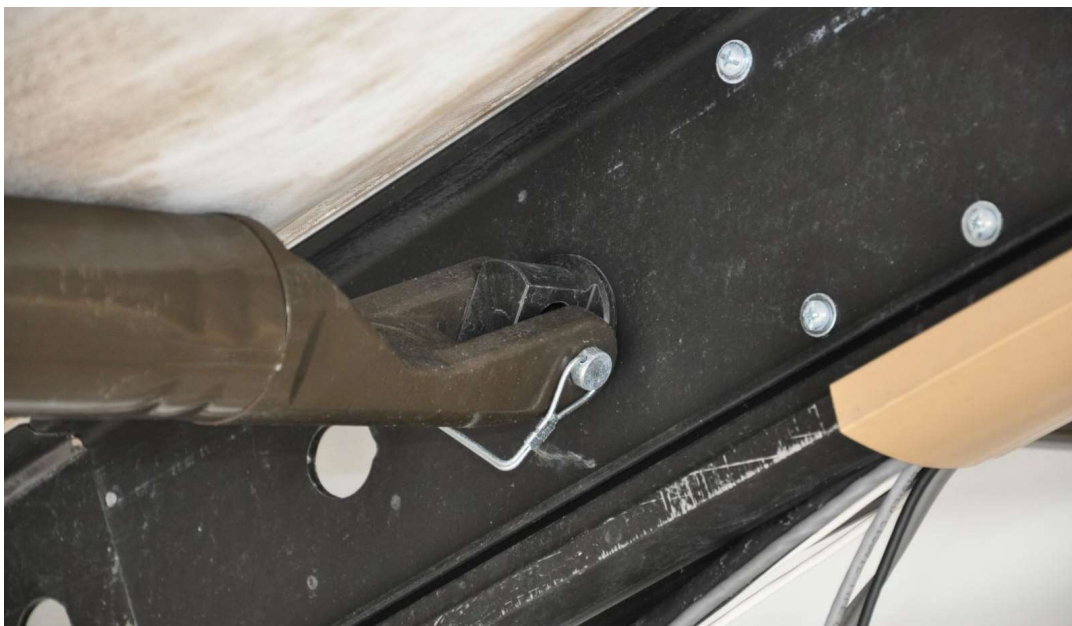
There are 13 purlin lines in the shelter that connect the six vertical arches. Each line consists of 5 purlins, for a total of 65 purlins. The purlins are connected to arches by a pin connection system. Figure 3.1-9 shows the connection of the purlins to the arches.

Figure 3.1-9. Purlin connection

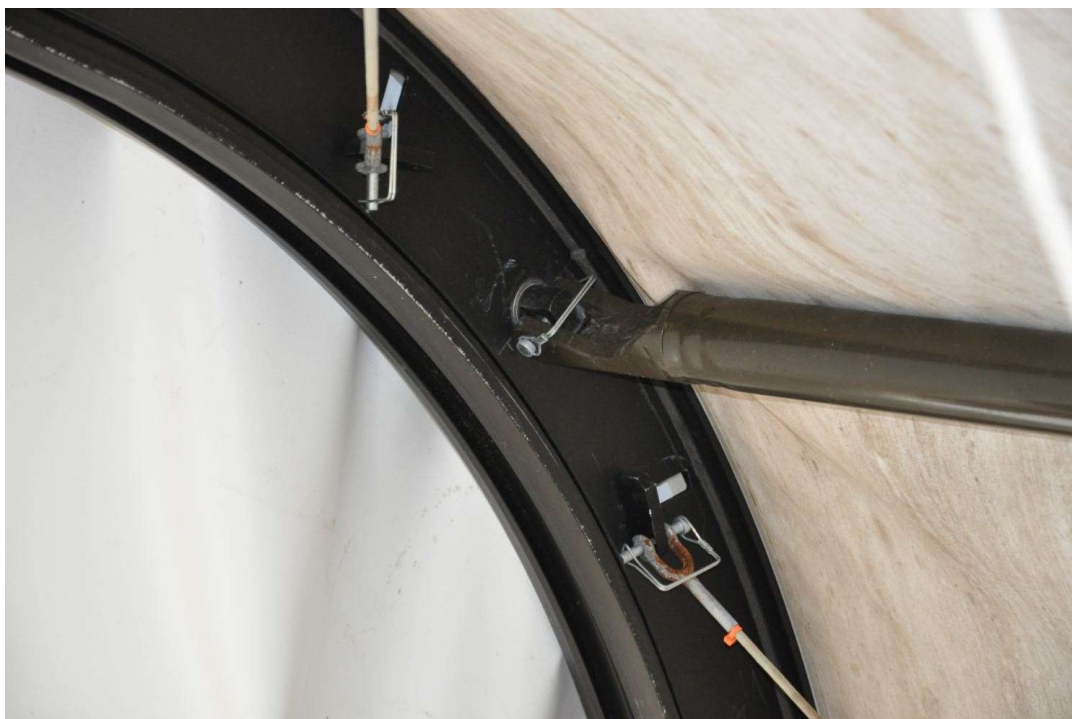
Figure 3.1-10. Purlin, roof, and wall cable connection

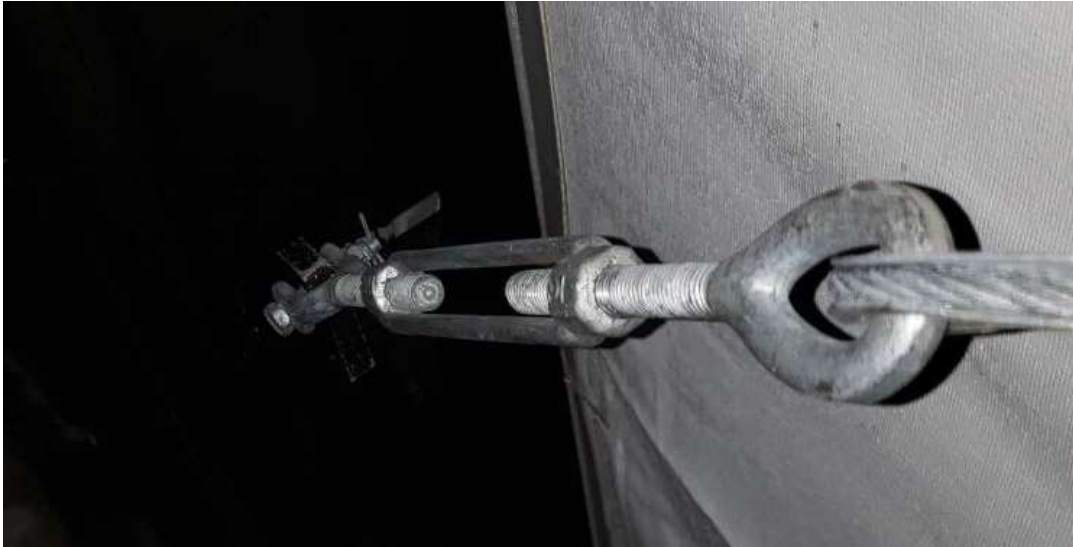
Figure 3.1-11. Wall cable connection to columns.

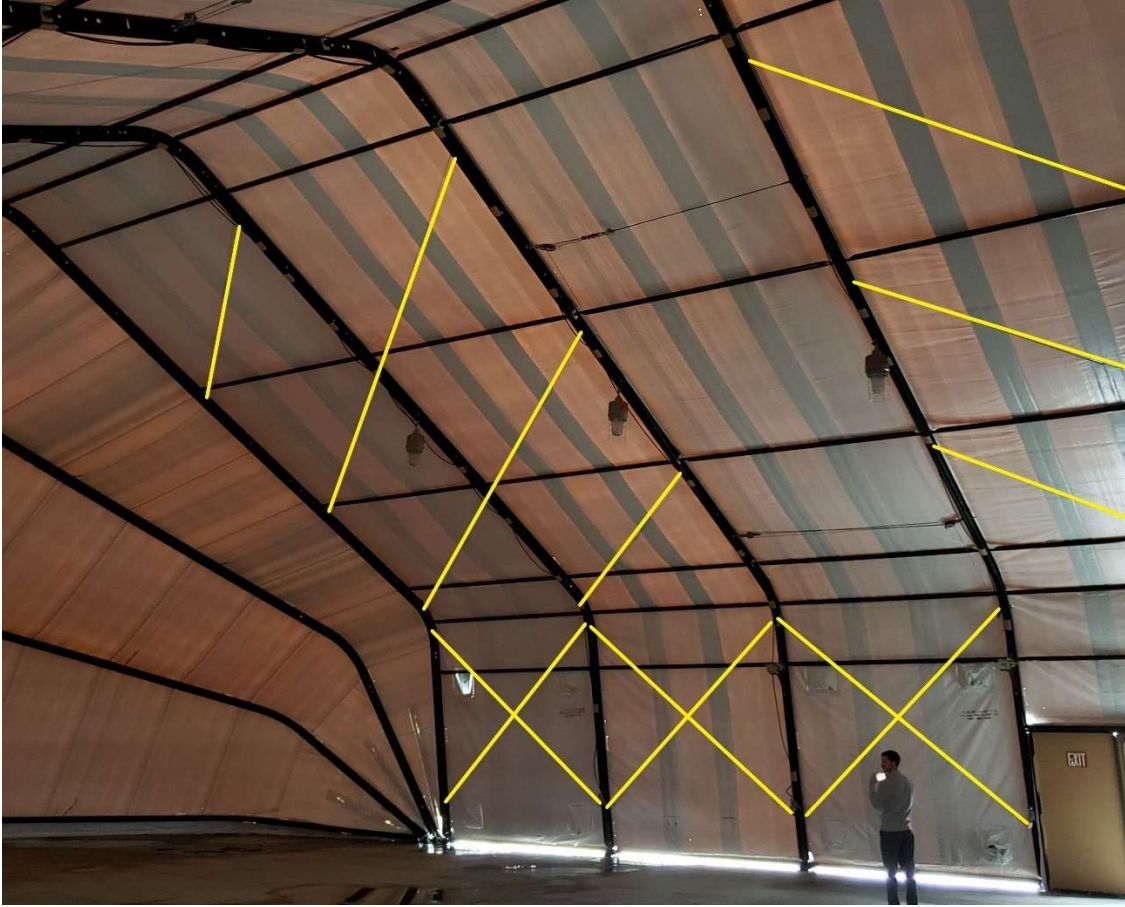
There are 24 roof cables and 16 wall cables in the shelter that connect the vertical arches. The roof cables consist of  $\frac{1}{4}$ -in diameter, 7x19 steel cables that are connected to the arches with a pin connection. The cables are attached between each frame line. The wall cables are also  $\frac{1}{4}$ -in diameter steel cables; however, they are connected to turnbuckles that connect to the arches. The distance between the cable and purlin connections along the frames is 8 inches. This is also the same distance between the baseplate connections and the wall cables. Figure 3.1-10 shows the connection of the purlins to the arches, along with the connection of the roof cables and arches. Figure 3.1-11 shows the connection of the arches to the wall cables. The interior configuration, including the vertical arches and purlins, can be seen in Figure 3.1-12. Figure 3.1-13 highlights the configuration of the wall and roof cables.

Figure 3.1-13. LAMS wall and roof cable configuration.

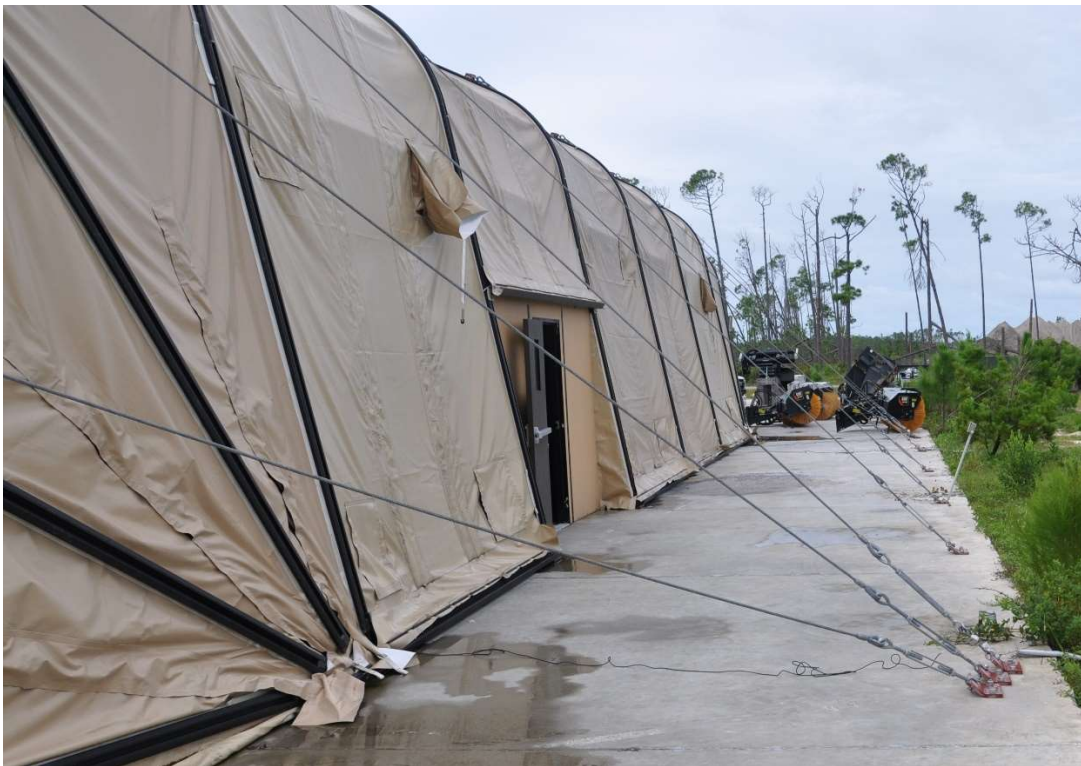
An exterior high wind kit is supplied along with the shelter. This kit includes (20) ½-in. diameter steel cables that attach to the arches near the eave and attach to base plates on each side of the shelter. The base plates are 10.73 feet away from the arch base plates and produce an angle of 45 degrees (Stiles, 2021). Without the high wind kit attached, the shelter is designed for 3-sec gust wind speeds up to 70 mph, and with the high wind kit, the shelter is designed for 90 mph gust wind speeds. Figure 3.1-14 shows the high wind kit attached to the LAMS at the in-service LAMS.

Figure 3.1-14. LAMS exterior high wind kit

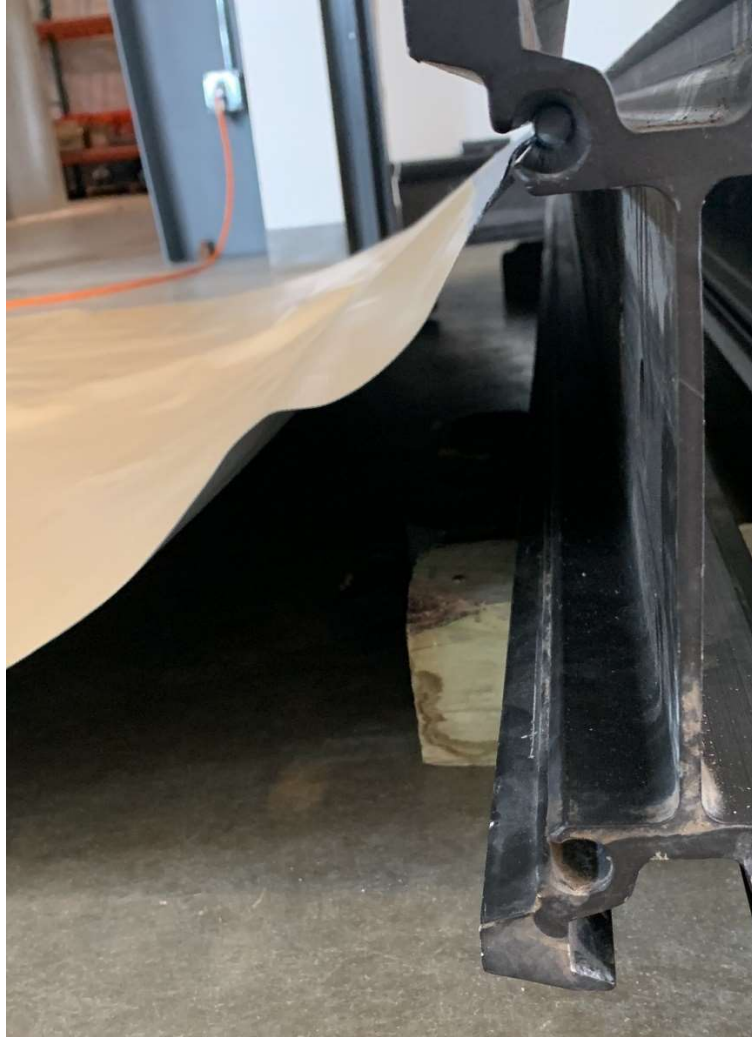
must be opaque (“blackout”) rather than translucent” (Clamshell Buildings, 2019). The reported typical fabric lifespans range from 15 to 25 years. Channels are designed in the aluminum rigid frame members that allow the fabric to be connected to the frames with a kedered attachment method. Inflatable chambers are present in the fabric to provide tensioning, with two in between each frame on the main framing system. The chambers are oriented in the same direction as the frames. When looking at the LAMS, it is clear to see that each fabric panel is relaxed, and not in total, uniform tension. An example of the kedered attachment of the fabric to the frames is shown in Figure 3.1-15.

Figure 3.1-15. Kedered fabric attachment to the framing members.
