**Mitigation of Alkali-Silica Reaction in the Bibb Graves Bridge**

A thesis submitted to the Graduate Faculty of  
Auburn University  
in partial fulfillment of the  
requirements for the Degree of  
Master of Science

The Bibb Graves Bridge in Wetumpka, AL has severe damage due to alkali-silica reaction (ASR) in two of its reinforced concrete arches. A mitigation procedure developed in the summer of 2010 by the FHWA, ALDOT, and Auburn University was implemented during the fall of 2010. The mitigation procedure included the application of a silane sealant, flexible sealant in the large cracks, and an epoxy flood coat to fill the small cracks on the tops of the arches.

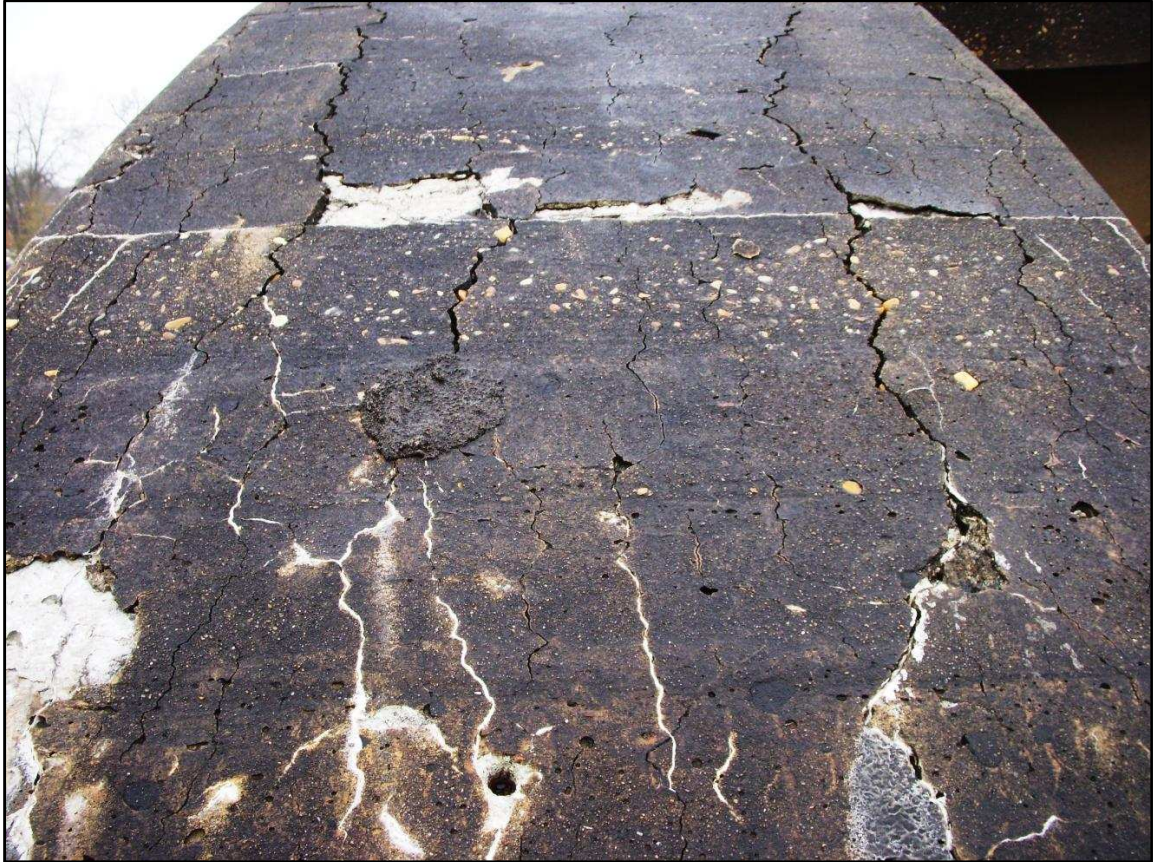
**Figure 1.2:** ASR-Induced cracking on the Bibb Graves Bridge

The Bibb Graves Bridge crosses the Coosa River in Wetumpka, Alabama. Built in 1931, the reinforced concrete bridge consists of seven spans with arches supporting a suspended roadway, as seen in Figure 1.1. The majority of the bridge is in sound condition; however, span 5 has severe cracking due to alkali-silica reaction (ASR). An example of ASR-induced cracking in one of the affected arches can be seen in Figure 1.2.

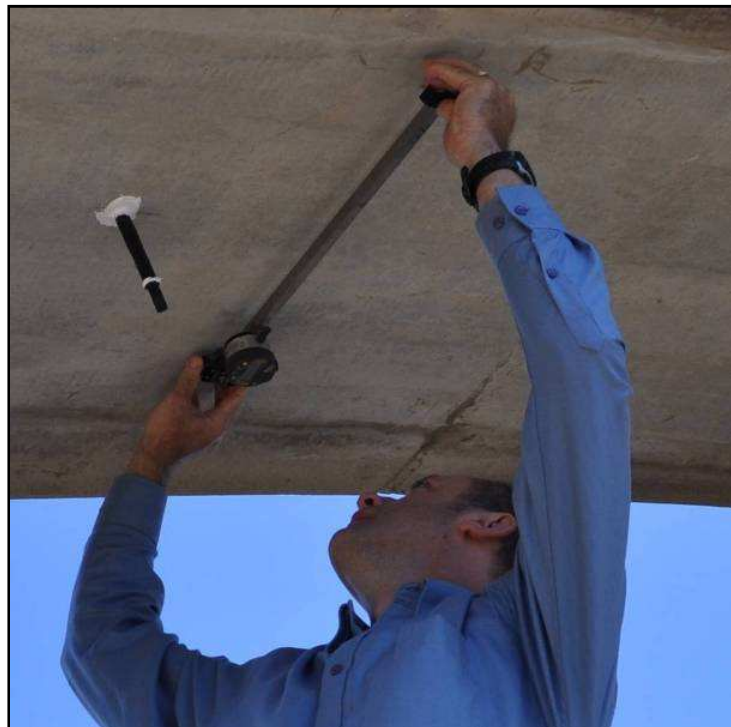
**Figure 1.3:** Concrete strain measurement being taken on the Bibb Graves Bridge

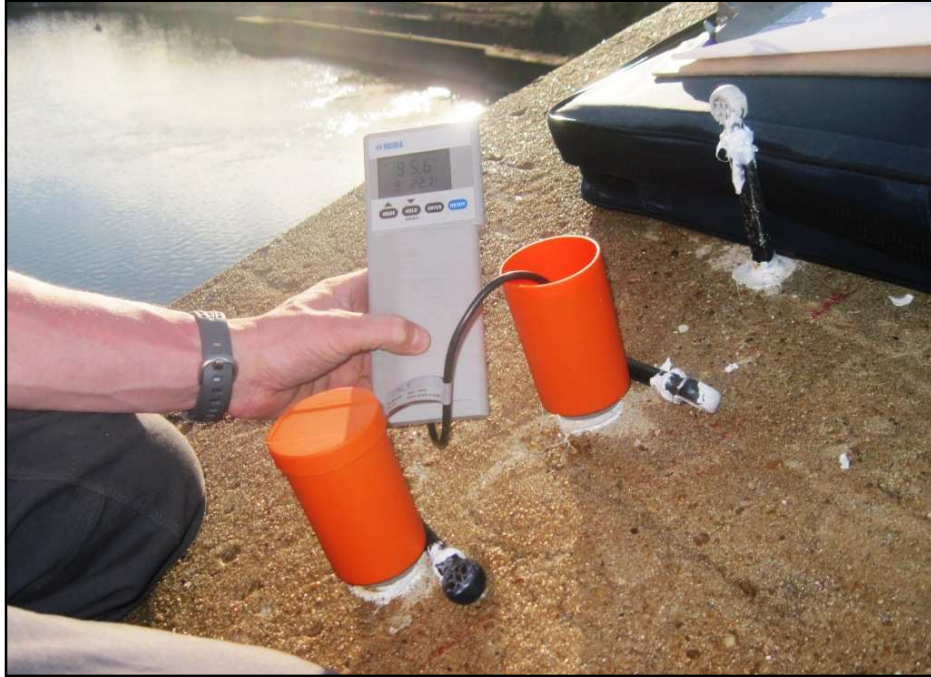
**Figure 1.4:** RH measurement being taken

Internal RH readings are taken monthly, as shown in Figure 1.4, to determine if the ASR mitigation procedure is effectively lowering the internal RH. Concrete strain and internal RH data have been collected since November 17, 2010.

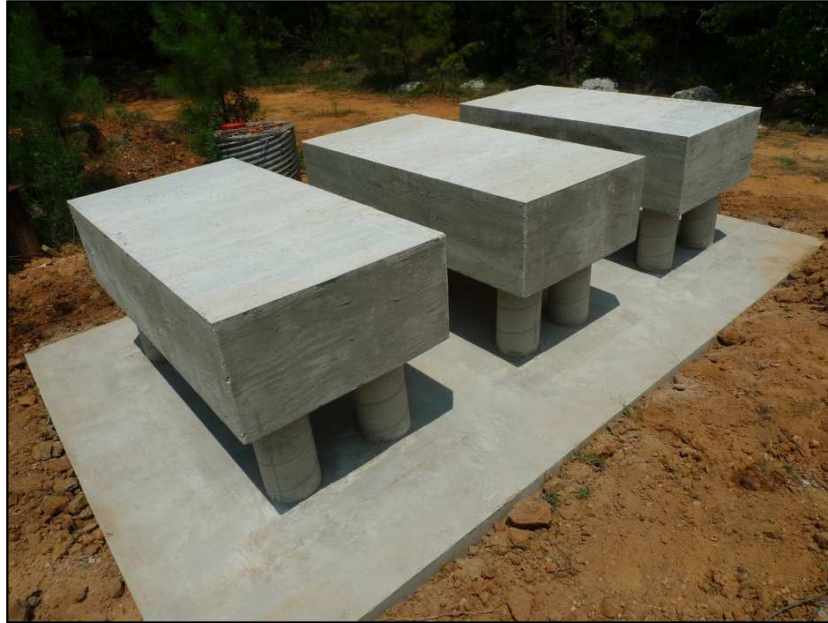
**Figure 1.5:** Arch test sections for finite-element analysis calibration

Due to the uncertainty of the time in which the ASR mitigation procedure should take effect, a moisture diffusion analysis of the arch cross section was performed. Using finite-element analysis, the moisture diffusion model was used to determine an upper and lower-bound time in which results should be seen if the ASR mitigation procedure is effective. To calibrate the finite-element model, three concrete arch test sections were constructed, as shown in Figure 1.5.

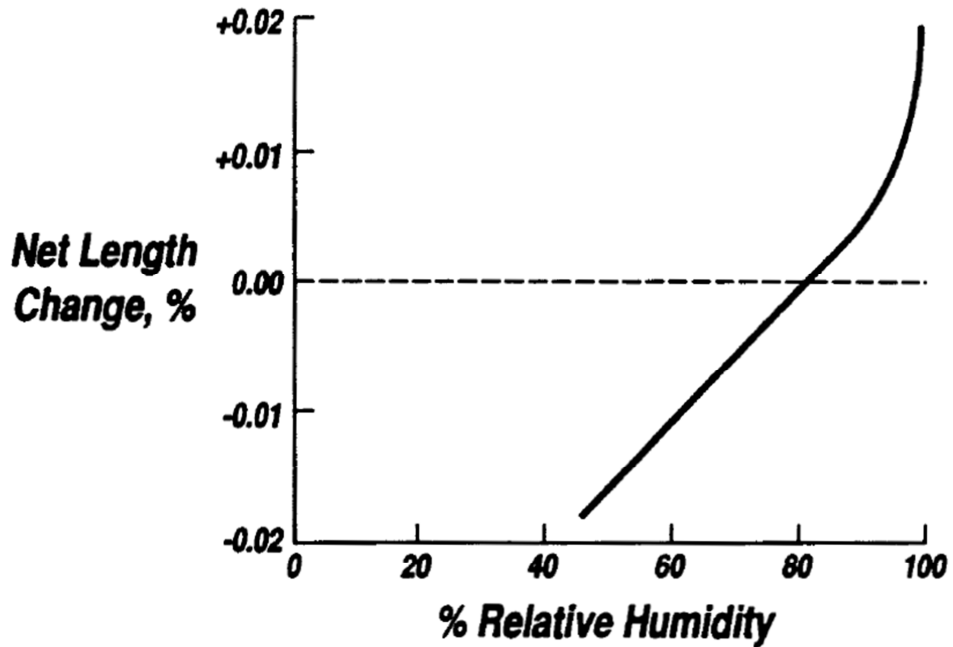
**Figure 2.1:** Threshold RH for expansion to occur due to ASR (Stark 1991)

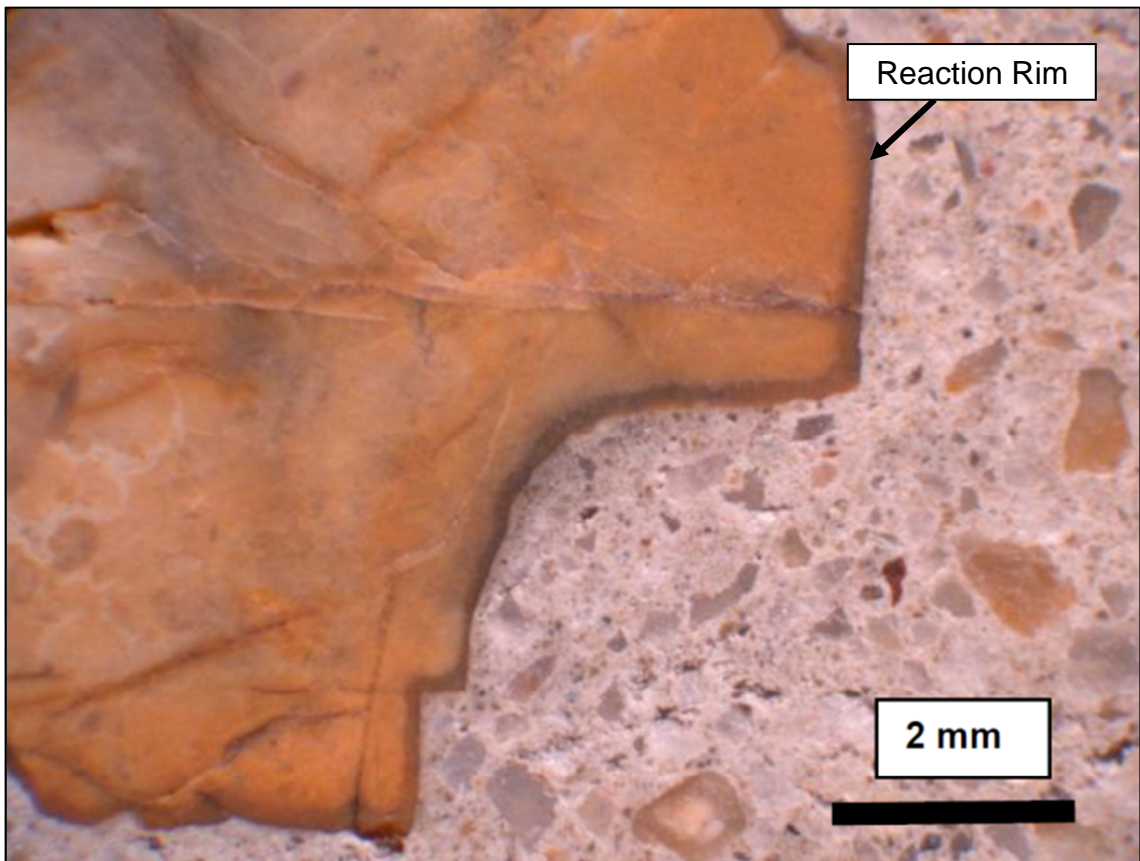
**Figure 2.3:** ASR reaction rim (WJE 2010)

In concretes that contain all of the reactive ingredients, ASR begins occurring immediately after water contacts the cement. One of the first indications is a discolored “reaction rim” within and around the aggregate particle, shown in Figure 2.3.

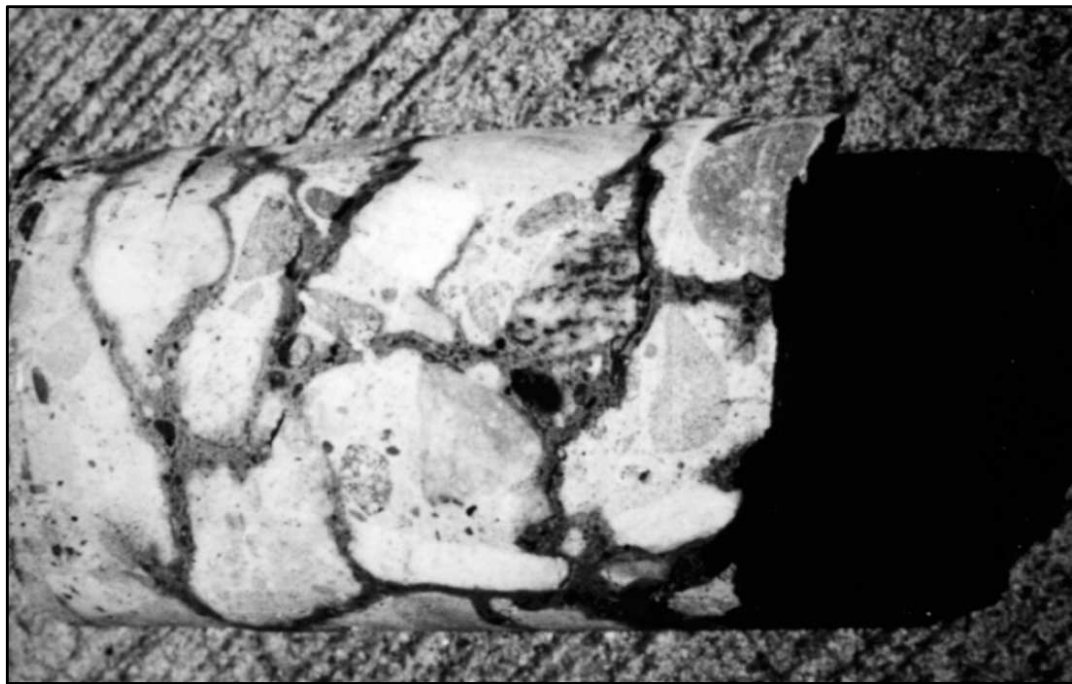
**Figure 2.4:** Bridge deck core showing vertical and horizontal cracks due to ASR.

Top of core to right (Forster et al. 1998)

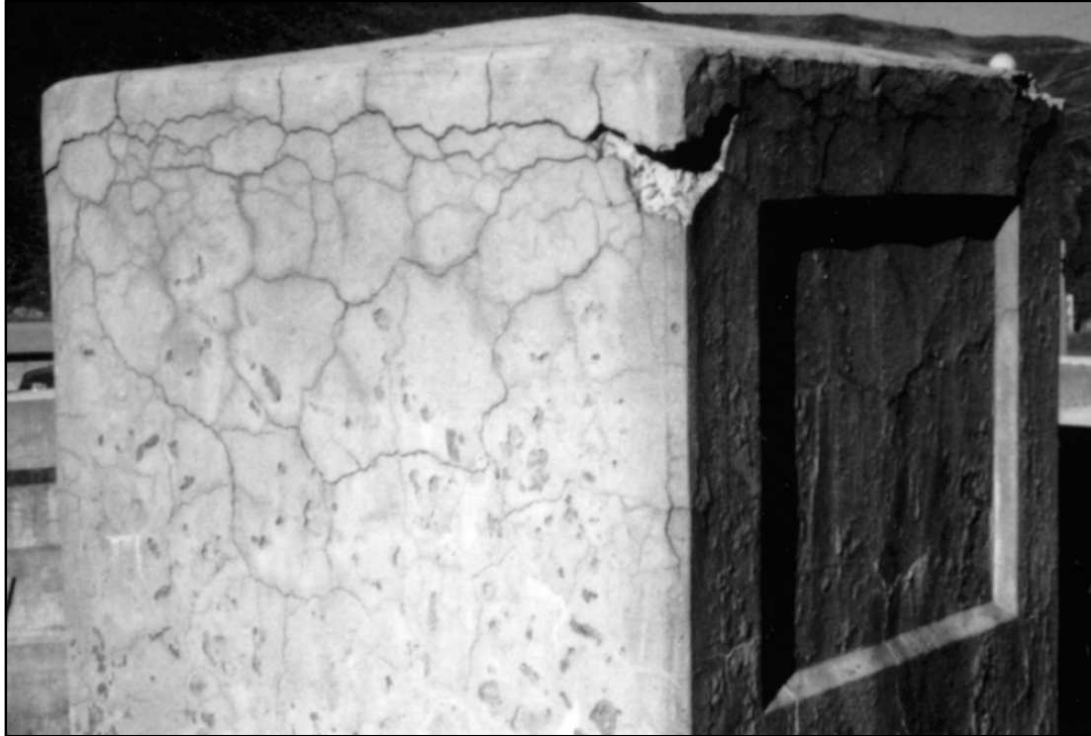
**Figure 2.5:** Typical “map-cracking” due to ASR (Forster et al. 1998)

Concrete deterioration caused by ASR is typically a result of excessive tensile stresses within the concrete due to differential volume change (Forster et al. 1998). The initial phase of deterioration is microcracking within the aggregate particles and cement paste matrix surrounding the aggregate particles. As the damage develops, microcracks propagate and surface cracks begin appearing. Unrestrained concrete cracking will be in all three dimensions within the structure, shown in Figure 2.4, and typical surface cracks appear in a polygonal pattern termed as “map-cracking” which is demonstrated in Figure 2.5 (Forster et al. 1998).

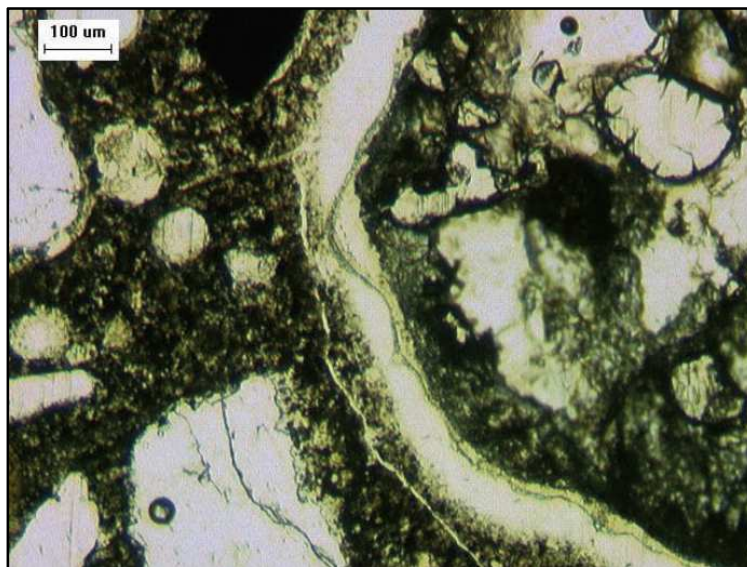
**Figure 2.8:** Thin section of concrete showing a crack highlighted by alkali-silica gel (Thomas et al. 2008)

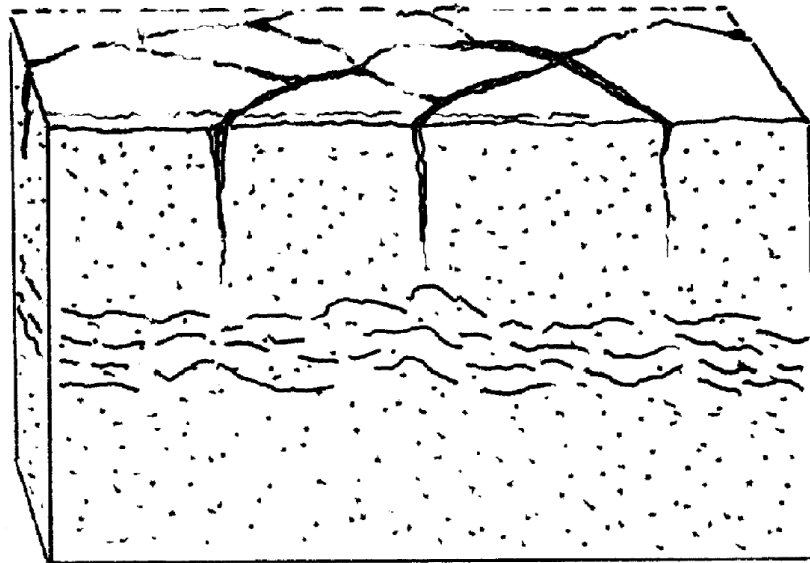
**Figure 2.9:** Sketch of a concrete slab subjected to ASR cracking with surface map-cracking, and subparallel internal cracks (Forster et al. 1998)

As microcracks propagate, the small cracks in the aggregates and cement paste matrix fill with additional alkali-silica gel, and this gel continues to swell in the presence of moisture, causing additional larger-scale cracking. Figure 2.9 is a sketch of a concrete slab with surface cracking due to ASR.

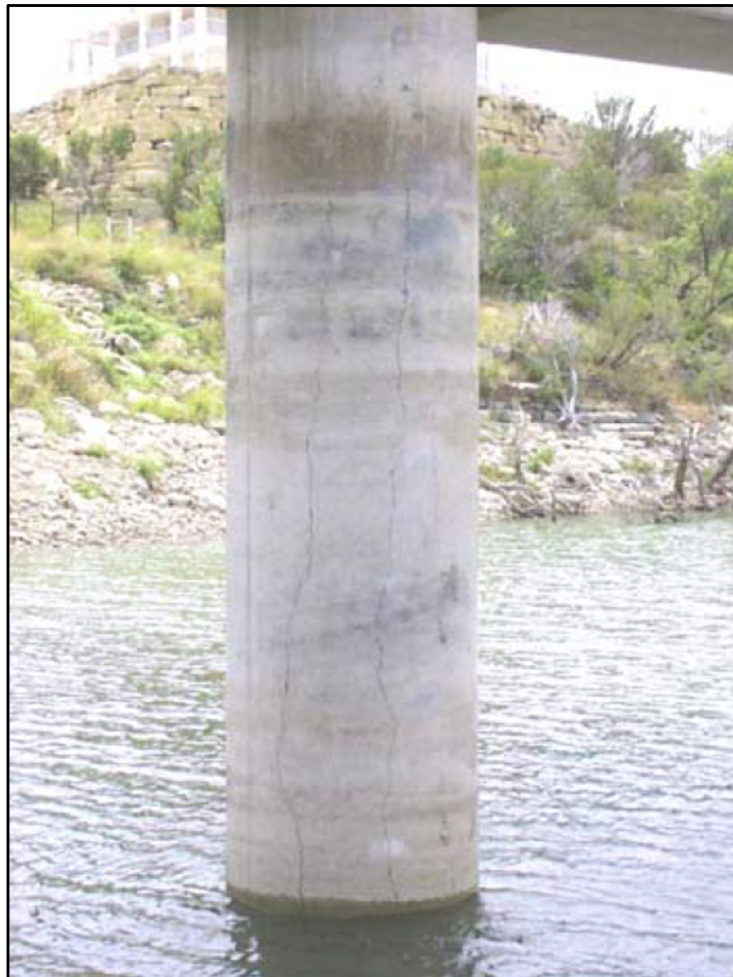
**Figure 2.10:** ASR-cracking orienting itself to underlying steel reinforcement

In reinforced concrete members the map-cracking pattern is less likely to appear; however, cracking will tend to orient itself to the underlying steel, or perpendicular to the direction of the confinement, as shown in Figure 2.10.

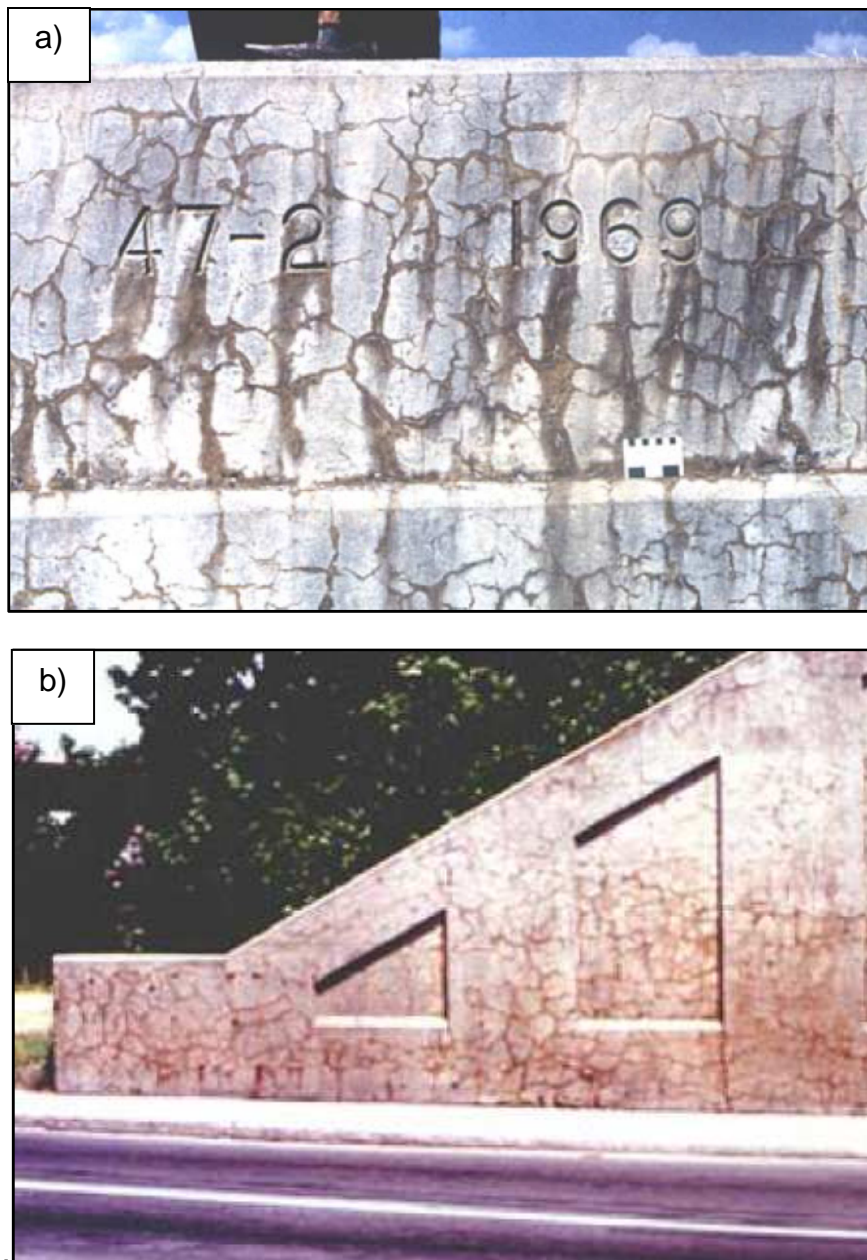
**Figure 2.11:** Examples of surface discoloration around cracks on a) a highway median barrier and b) a 25-year-old highway parapet wall (Fournier et al. 2004)

It is common for ASR-induced cracking to be highlighted by a broad brown area that gives the impression of permanent dampness, as shown in Figure 2.11 (Fournier et al. 2004).

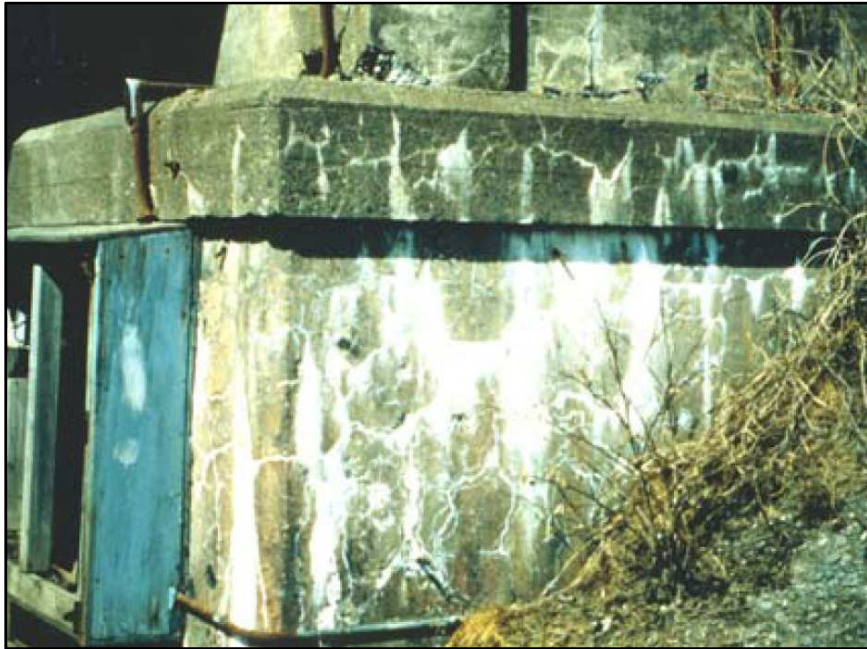
**Figure 2.13:** Example of efflorescence and alkali-silica gel exuding to the surface of a concrete foundation suffering from ASR (Fournier et al. 2004)

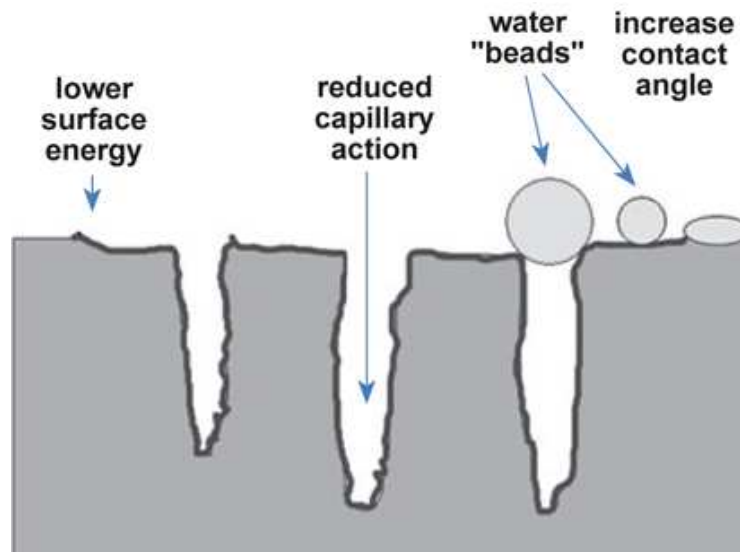
**Figure 2.18:** Representation of silane repelling water (Selley 2010)

energy (surface tension). The difference between these energies causes water to be more attracted to itself than to the substrate, and so the water has a tendency to stay in a spherical droplet shape. This is why water “beads” on a hydrophobic surface. Water beading is not an absolute measure of the ability to keep out water, but because water does not “wet-out” on a surface, the tendency for water to find and flow into small cracks in the surface is substantially reduced.

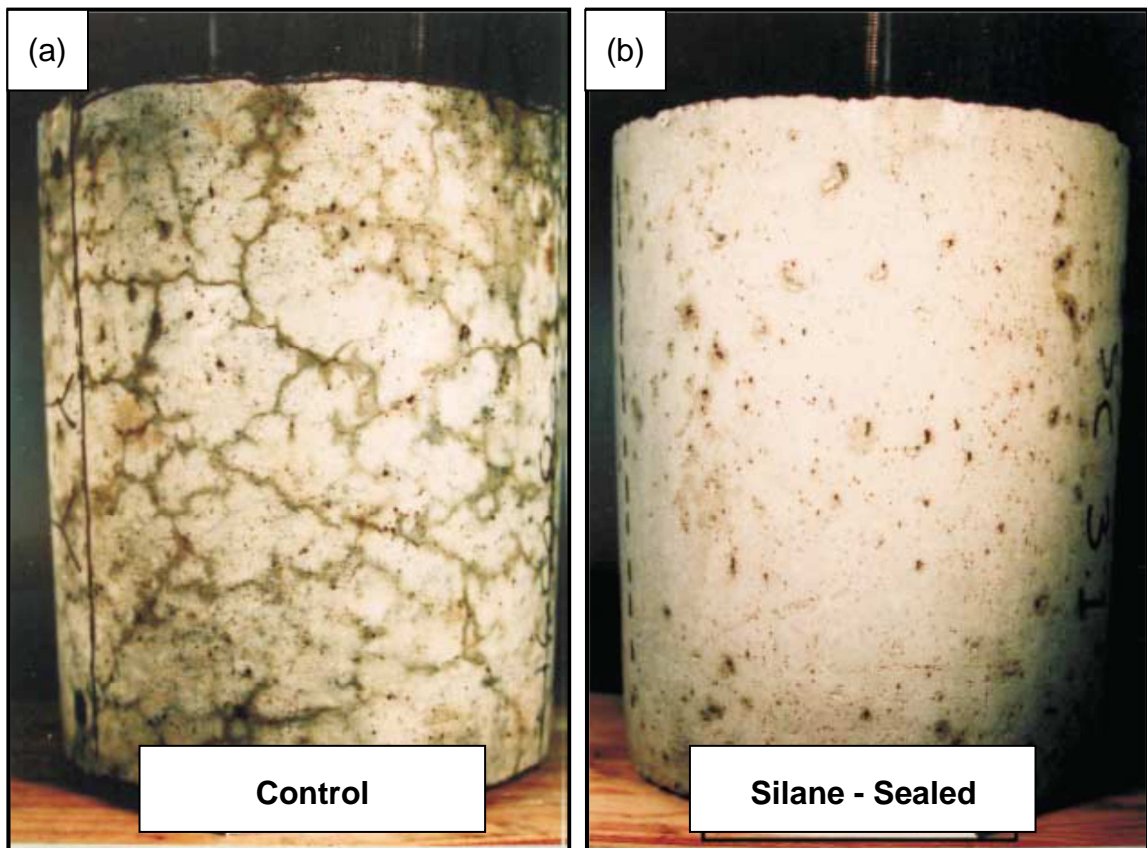
**Figure 2.20:** (a) Unsealed and (b) silane-sealed air-entrained concrete cylinders subjected to exposure cycle C4 after 1.5 years (Bérubé et al. 2002a)

Although the expansion measurements are powerful evidence alone, the absence of map cracking on the surface of the cylinders is quite striking when compared to the control specimens. The comparison between 1.5-year-old unsealed and silane-sealed cylinders subjected to the rigorous 14-day exposure cycle C4 can be seen in Figure 2.20.

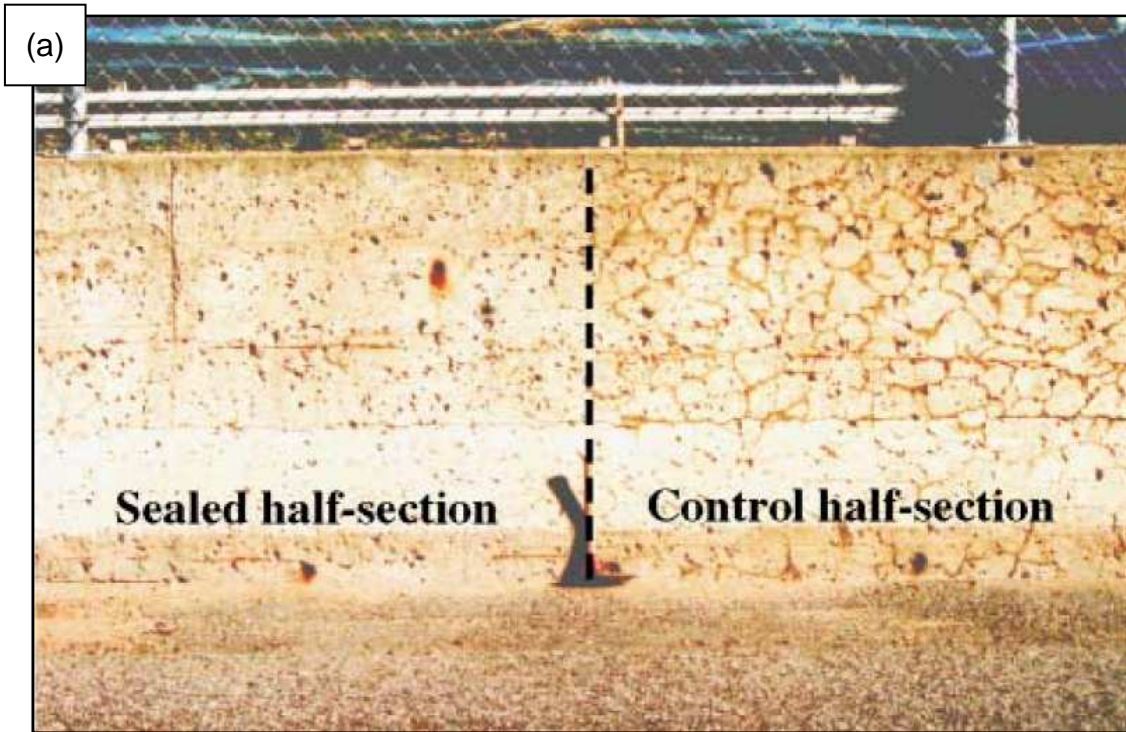
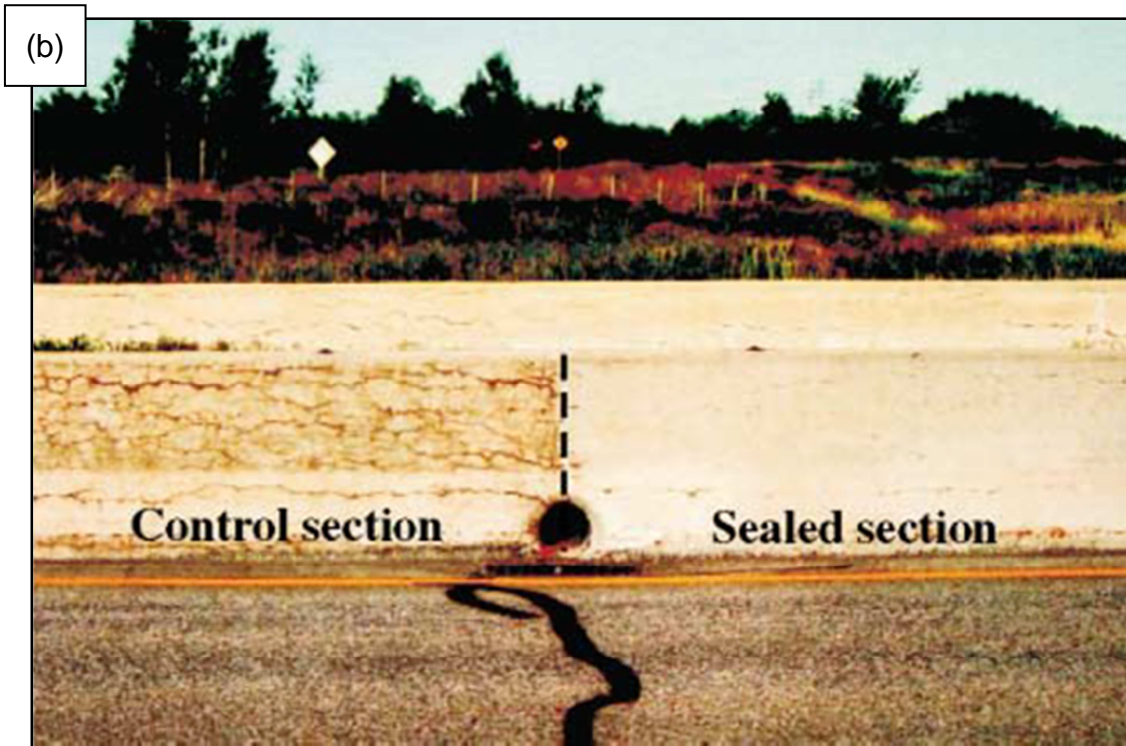
**Figure 2.21:** Examples of the unsealed and sealed highway median barriers 3 years after the application of silane sealants in (a) Montmorency and (b) Sainte-

In an additional study by Bérubé et al. (2002b), the previously discussed laboratory findings were validated in the field by applying silane and siloxane based products to highway median barriers showing various degrees of deterioration due to ASR. The highway median barriers, located in Montmorency and Sainte-Foy in Canada, were already exhibiting ASR related map cracking to various degrees. Two examples of the highway median barriers can be seen in Figure 2.21. At the time of silane application, the deterioration of the Montmorency highway median barriers was more severe than that of the Sainte-Foy median barriers, which had more severe map cracking. Therefore, it can be assumed that the median barriers in Montmorency would have likely been more permeable due to the presence of additional internal microcracking (Bérubé et al. 2002b).

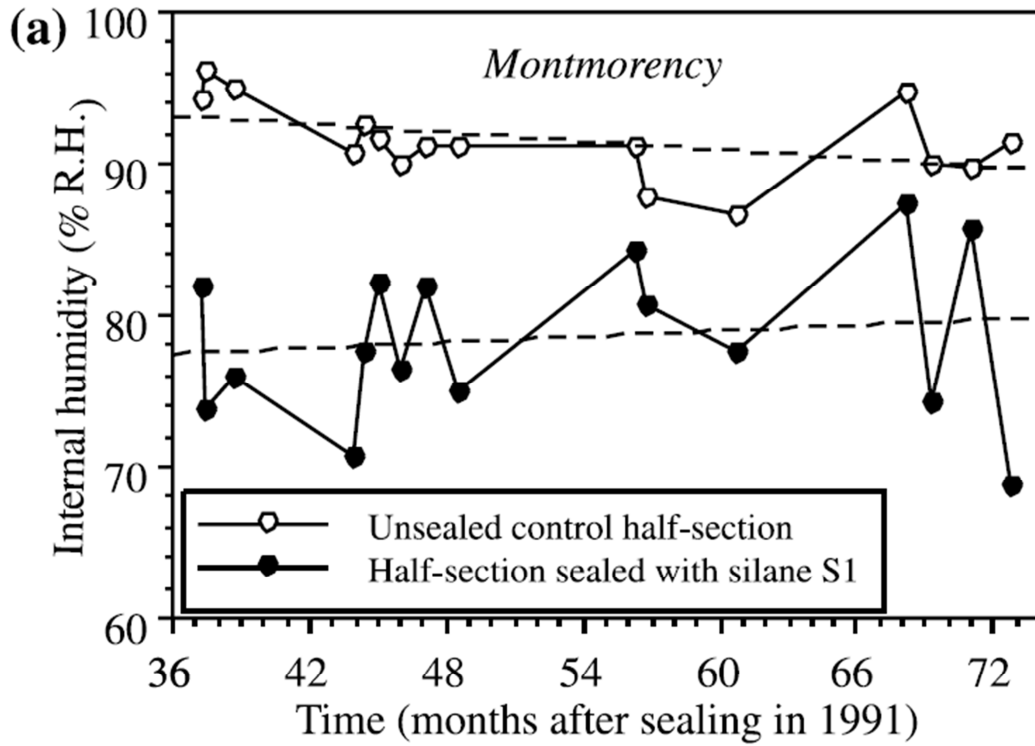
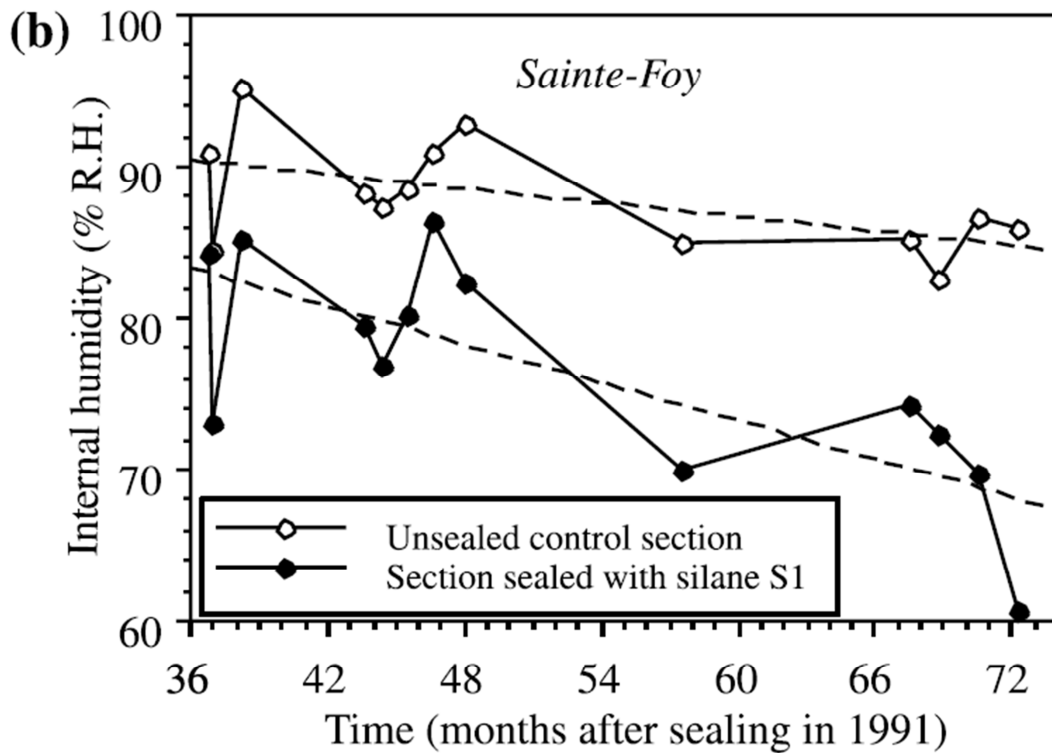
**Figure 2.22:** RH measured from 1994 to 1997 in highway median barriers in (a) Montmorency and (b) Sainte-Foy (Bérubé et al. 2002b)

From trends shown in the RH at both locations, it can be seen that *the higher the degree of deterioration due to ASR, the shorter the amount of time that a good sealer such as silane remains maximally effective*. In Figure 2.22a, the converging trend of the RH in the highway median barriers in Montmorency suggests that the silane, while still effective, had passed its point of maximum effectiveness. In Figure 2.22b, the diverging trend of the RH in the highway median barriers in Sainte-Foy suggests that the silane had not yet reached a point of maximum effectiveness (Bérubé et al. 2002b).

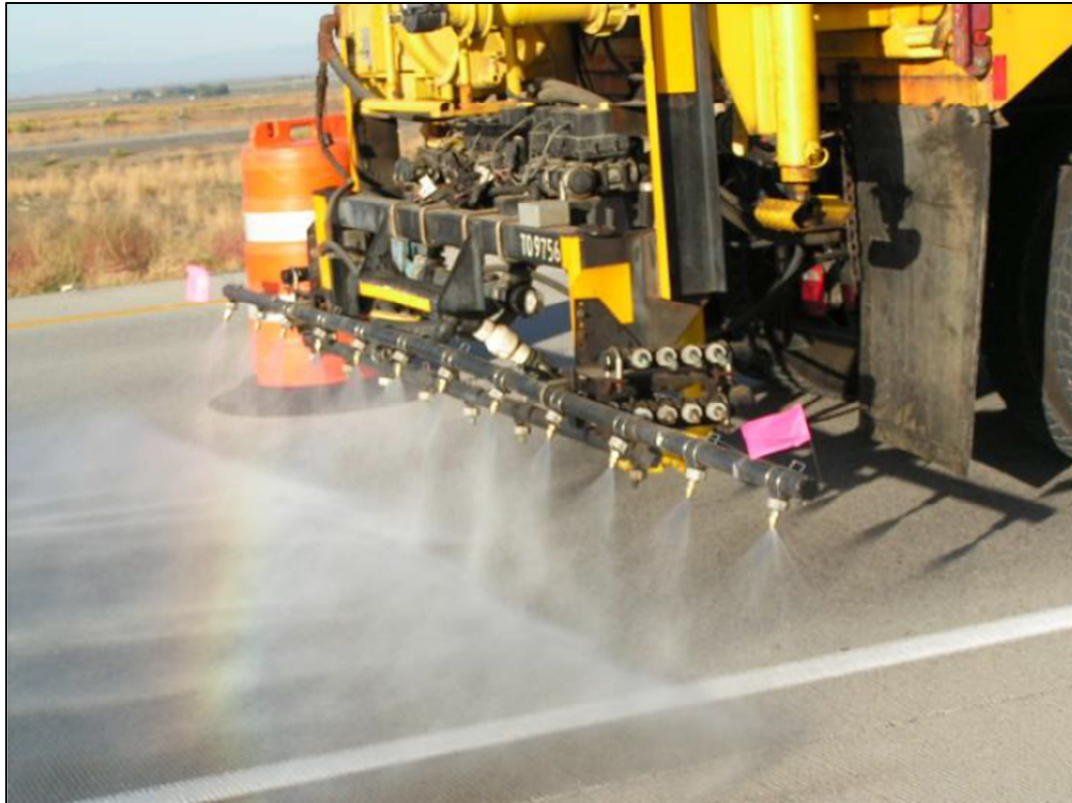
**Figure 2.23:** Topical application of lithium compounds (Fournier et al. 2010)

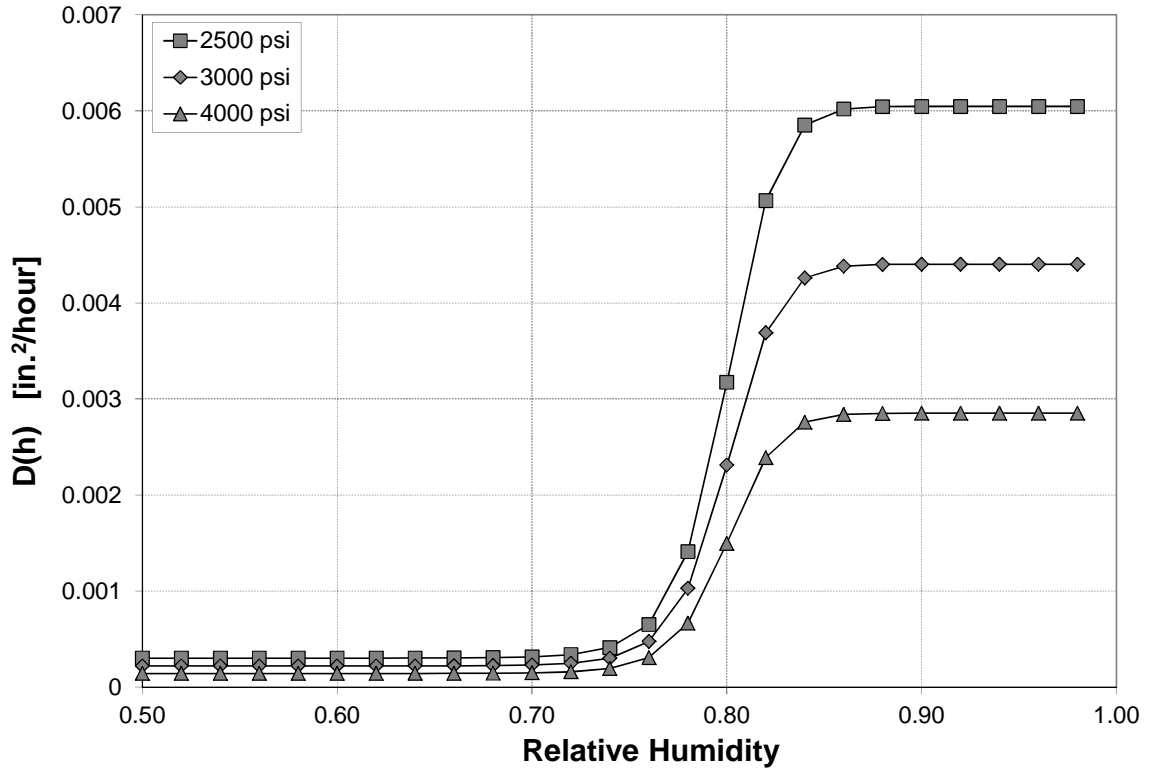
**Figure 2.24:** Diffusion coefficients for varying strength of concrete

This nonlinear diffusion coefficient produces an S-shaped curve that is shown in Figure 2.24. As the strength of the concrete decreases, the diffusivity of the concrete increases. Therefore, it should be expected that concrete with lower strength should allow moisture to mitigate through it faster than concrete with higher strength.

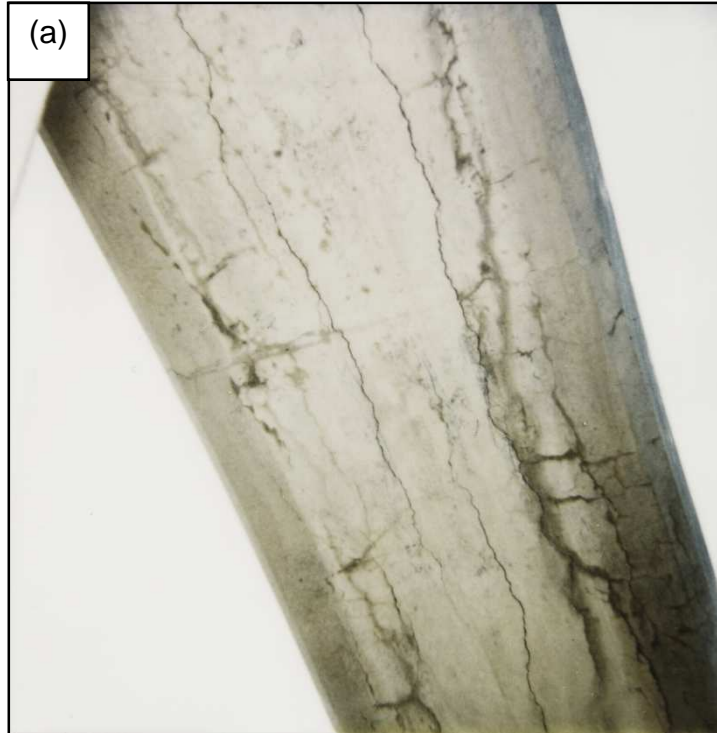
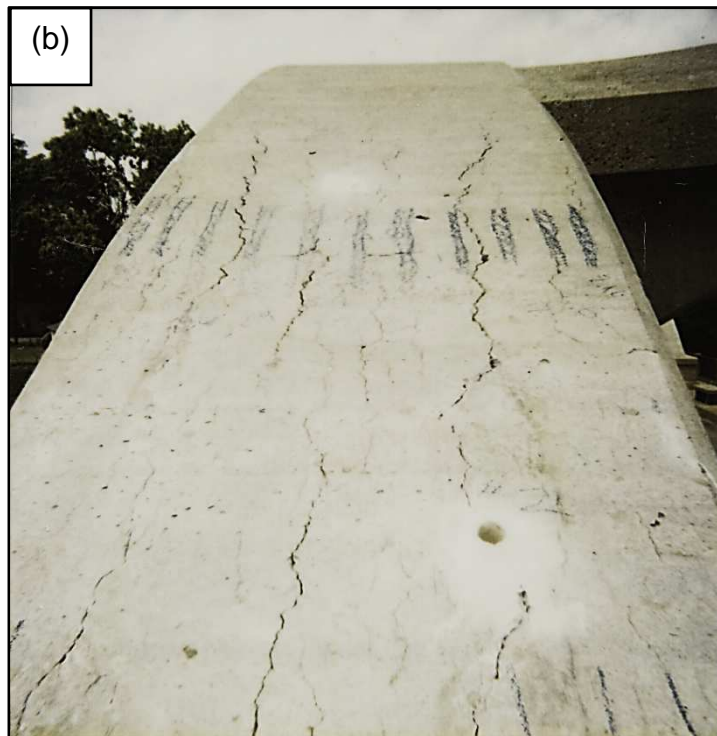
**Figure 3.9:** Examples of distress in the late 1990s on the  
a) top and b) bottom of a span 5 arch

The majority of the Bibb Graves Bridge is in sound condition; however, the two arches supporting the fifth span are severely cracked due to expansion caused by ASR. The presence of ASR in the Bibb Graves Bridge was first noted in the 1956 ALDOT report by Hester and Smith. Significant distress was first noticed in 1993 by Sergio Rodriguez, who was ALDOT's Concrete Engineer at the time. Two photographs of ASR distress, taken by Sergio Rodriguez, are shown in Figure 3.9. Figure 3.10a provides an example of an arch unaffected by ASR, and Figure 3.10b provides a view of a similar section of concrete on span 5 that is damaged by ASR.

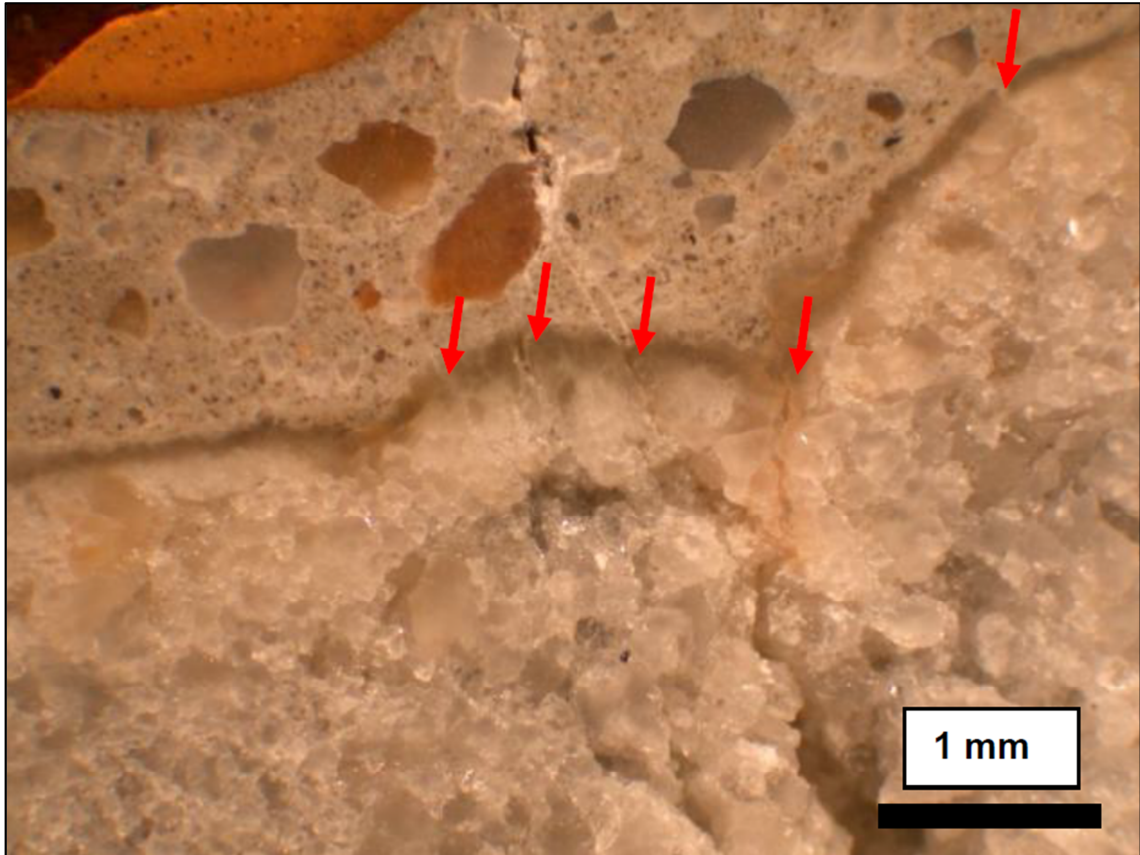
**Figure 3.12:** Core 1A – South: Typical dark glassy rim on white friable quartzite coarse aggregate particle. Arrows show ASR cracks in aggregate periphery (WJE 2010)

The concrete in all four samples was considered well consolidated. Coarse aggregate particles consist of siliceous gravel that is composed of quartzite and chert. Coarse aggregate particles were found to be rounded to sub-angular, mostly oblong in shape, and typically poorly graded, with the exception of core 1B-South. Dark rims were commonly observed around coarse aggregate particles, as shown in Figure 3.12. The fine aggregate consists of natural siliceous sand that is mainly composed of quartz, quartzite, chert, iron oxides, mica, and small amounts of limestone and a slag-like material. Paste properties were good except in the locations where the concrete was in distress.

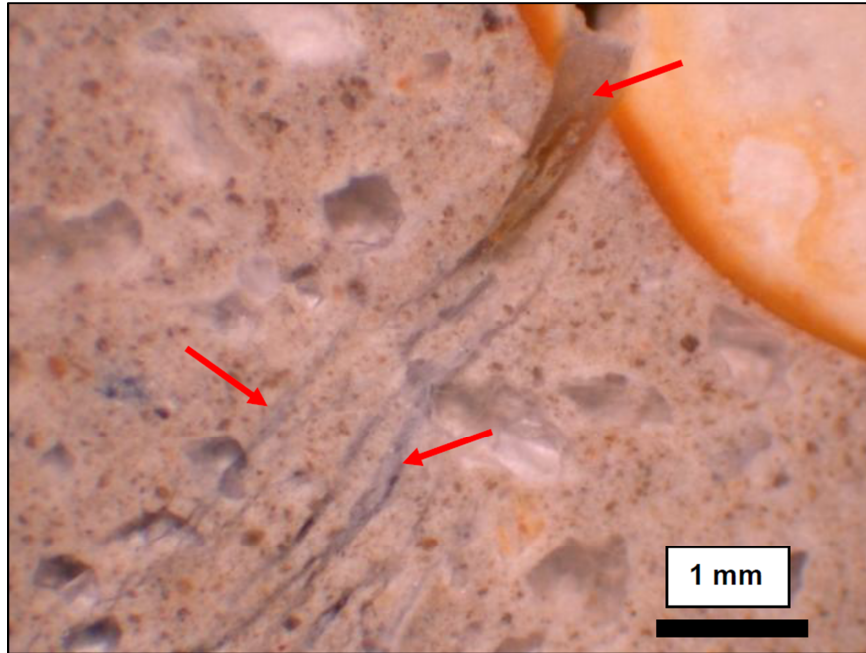
**Figure 3.13:** Crack at periphery of quartzite aggregate particle (top right) and multiple veinlets, indicated with arrows, filled with ASR gel (WJE 2010)

Cores 1A – South and 1A – North contained major amounts of secondary deposits in voids and fractures. ASR gel was most commonly found in cracks within the outer portion of aggregate particles, as shown in Figure 3.13. ASR gel was found to be less prominent than ettringite. An example of ettringite formation in a microcrack is shown in Figure 3.14. No such deposits were found in cores 1B – South and 1B – North.

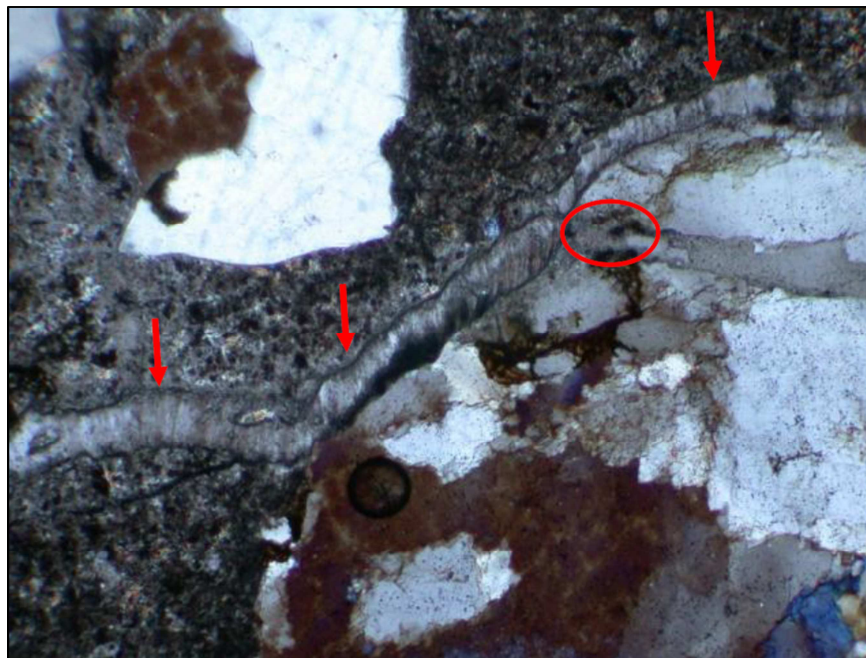
**Figure 3.14:** Core 1A – South: Microcracks filled with ettringite, shown with arrows. Small amount of gel at outside edge of crack in aggregate is circled.

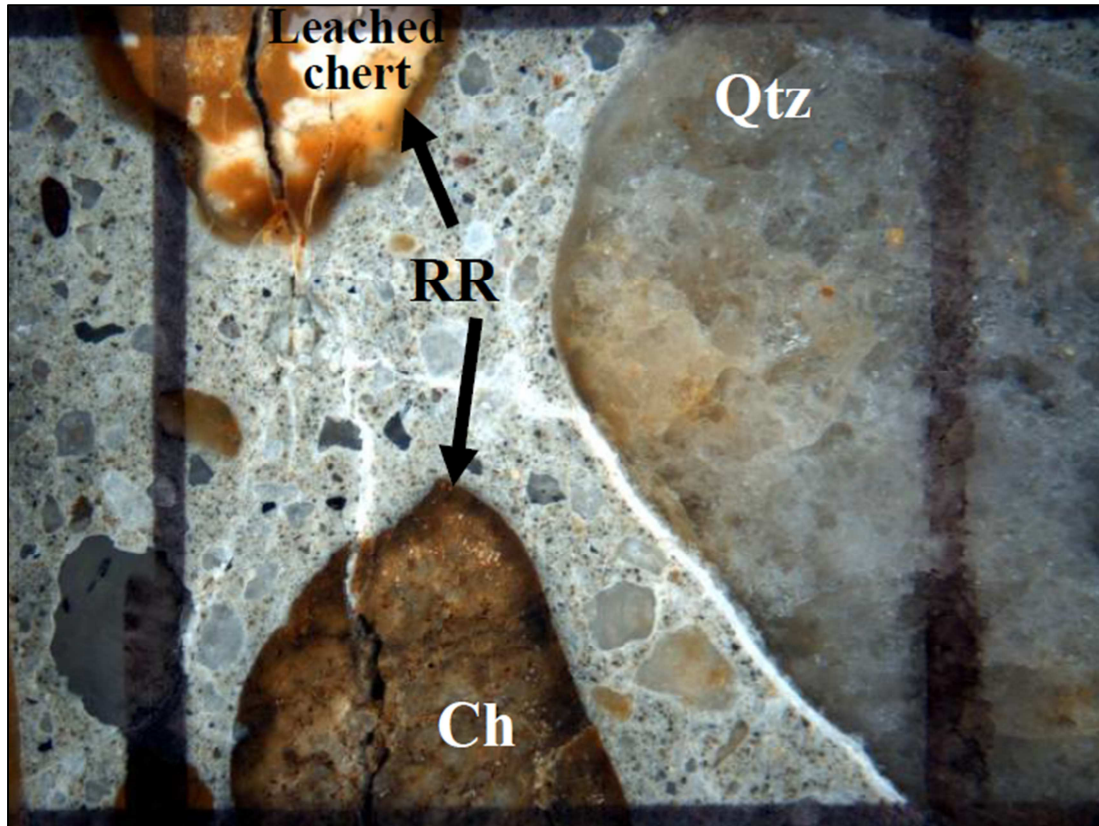
**Figure 3.15:** Reaction rims (RR) surrounding chert (CH) coarse aggregates  
(The Transtec Group 2010)

Core 2A-South and 2A-North obtained a DRI of 1430 and 1081, respectively, which is, “indicative of a very high degree of damage in the concrete” (The Transtec Group 2010). Dark reaction rims around coarse aggregate particles were observed in both samples, as shown in Figure 3.15. No significant ASR was found in Core 2B-South and 2B-North.

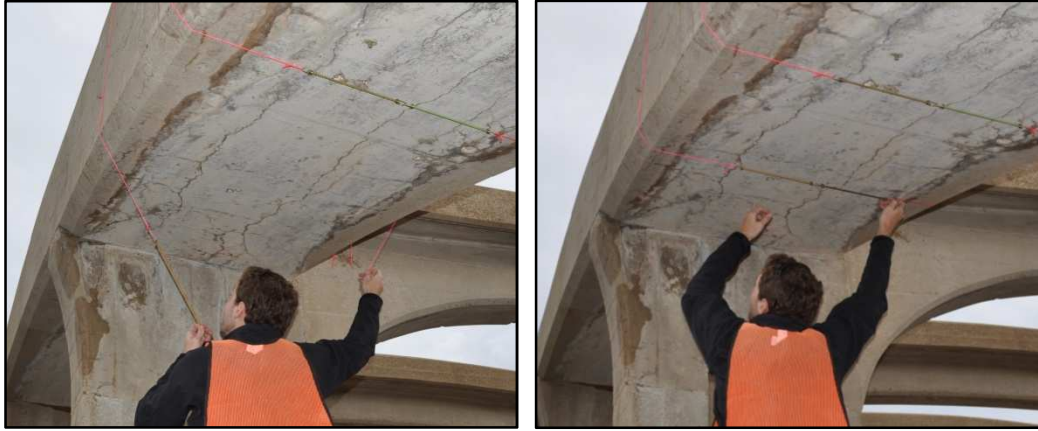
**Figure 3.16:** Installation of grid lines for crack survey
