**Mitigation of Alkali-Silica Reaction in the Bibb Graves Bridge**

A thesis submitted to the Graduate Faculty of  
Auburn University  
in partial fulfillment of the  
requirements for the Degree of  
Master of Science

The Bibb Graves Bridge in Wetumpka, AL has severe damage due to alkali-silica reaction (ASR) in two of its reinforced concrete arches. A mitigation procedure developed in the summer of 2010 by the FHWA, ALDOT, and Auburn University was implemented during the fall of 2010. The mitigation procedure included the application of a silane sealant, flexible sealant in the large cracks, and an epoxy flood coat to fill the small cracks on the tops of the arches.

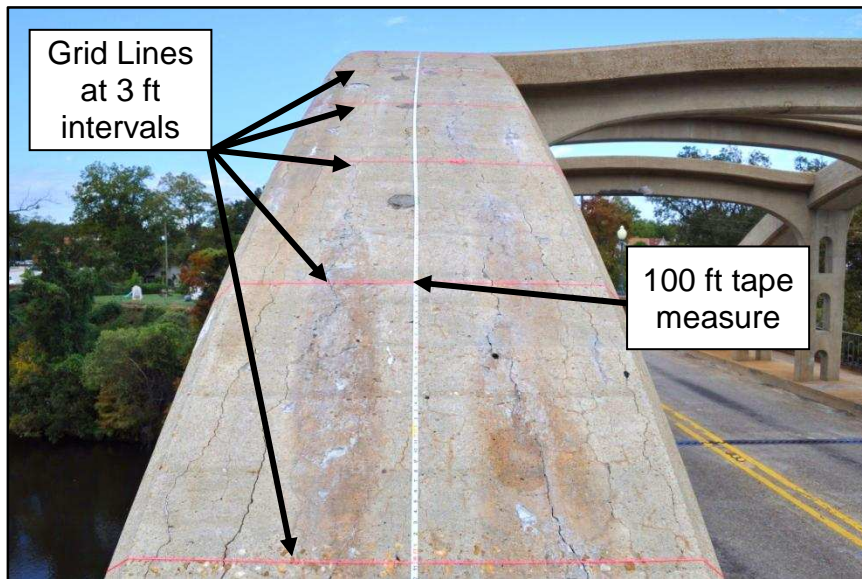
**Figure 3.17:** Crack mapping grid system after installation

The installed grid system is shown in Figure 3.17. Once the grid system was in place, the cracks were then hand-drawn to scale on grid paper, and the crack widths were recorded. The cracks were measured at the widest point along their length, between the two grid lines, using a crack width gauge, as shown in Figure 3.18. The results of the crack mapping are shown in Figures 3.19 to 3.24.

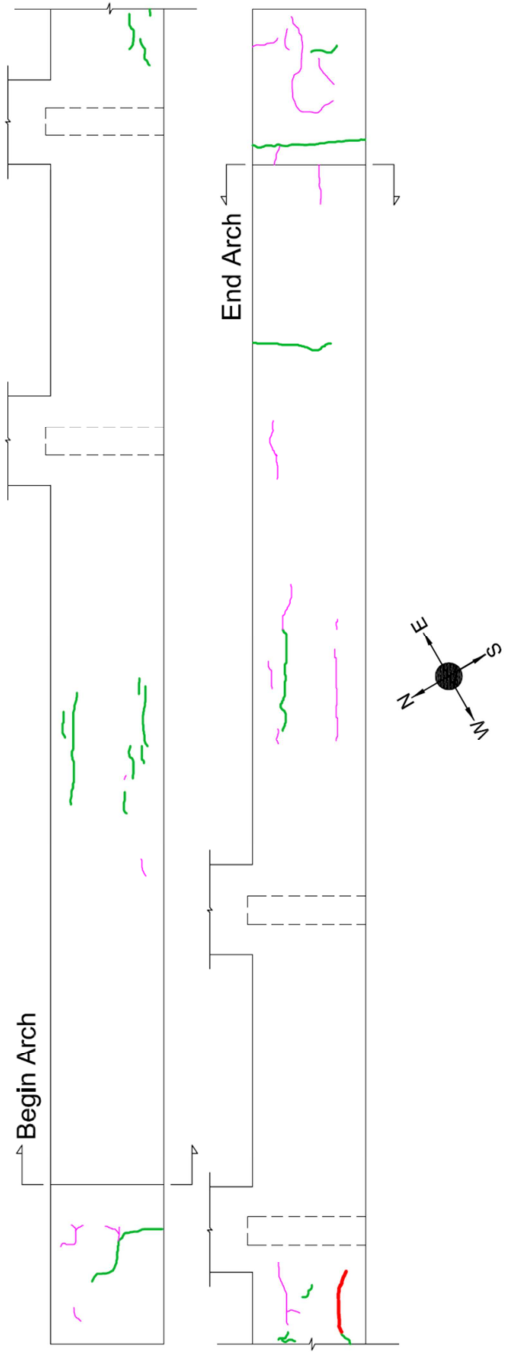
**Figure 3.19:** Crack-mapping survey. November 5, 2010.

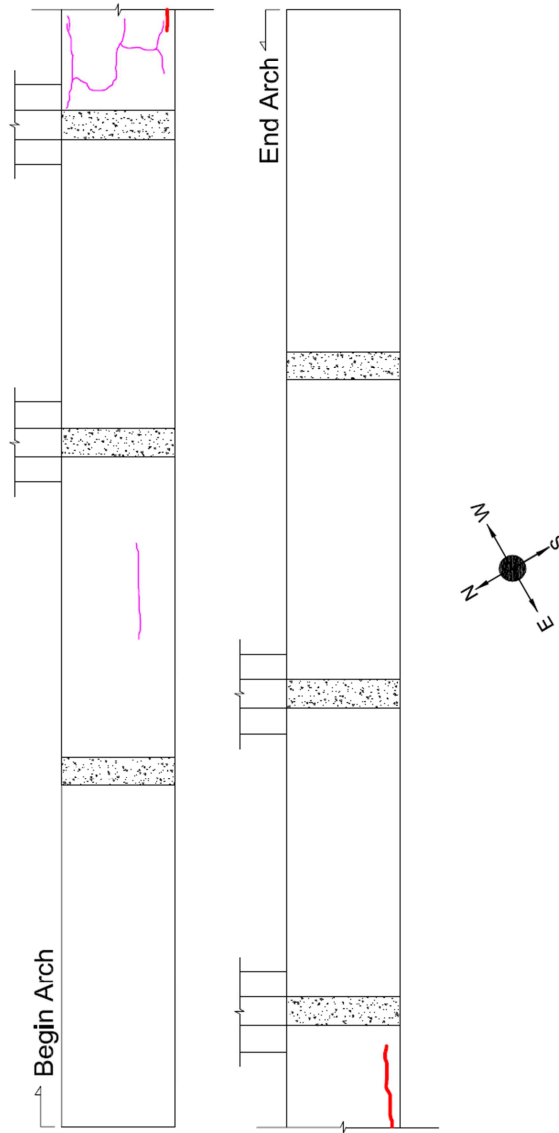
**Figure 3.20:** Crack-mapping survey. November 5, 2010.

Span 4 – South Arch – Bottom View

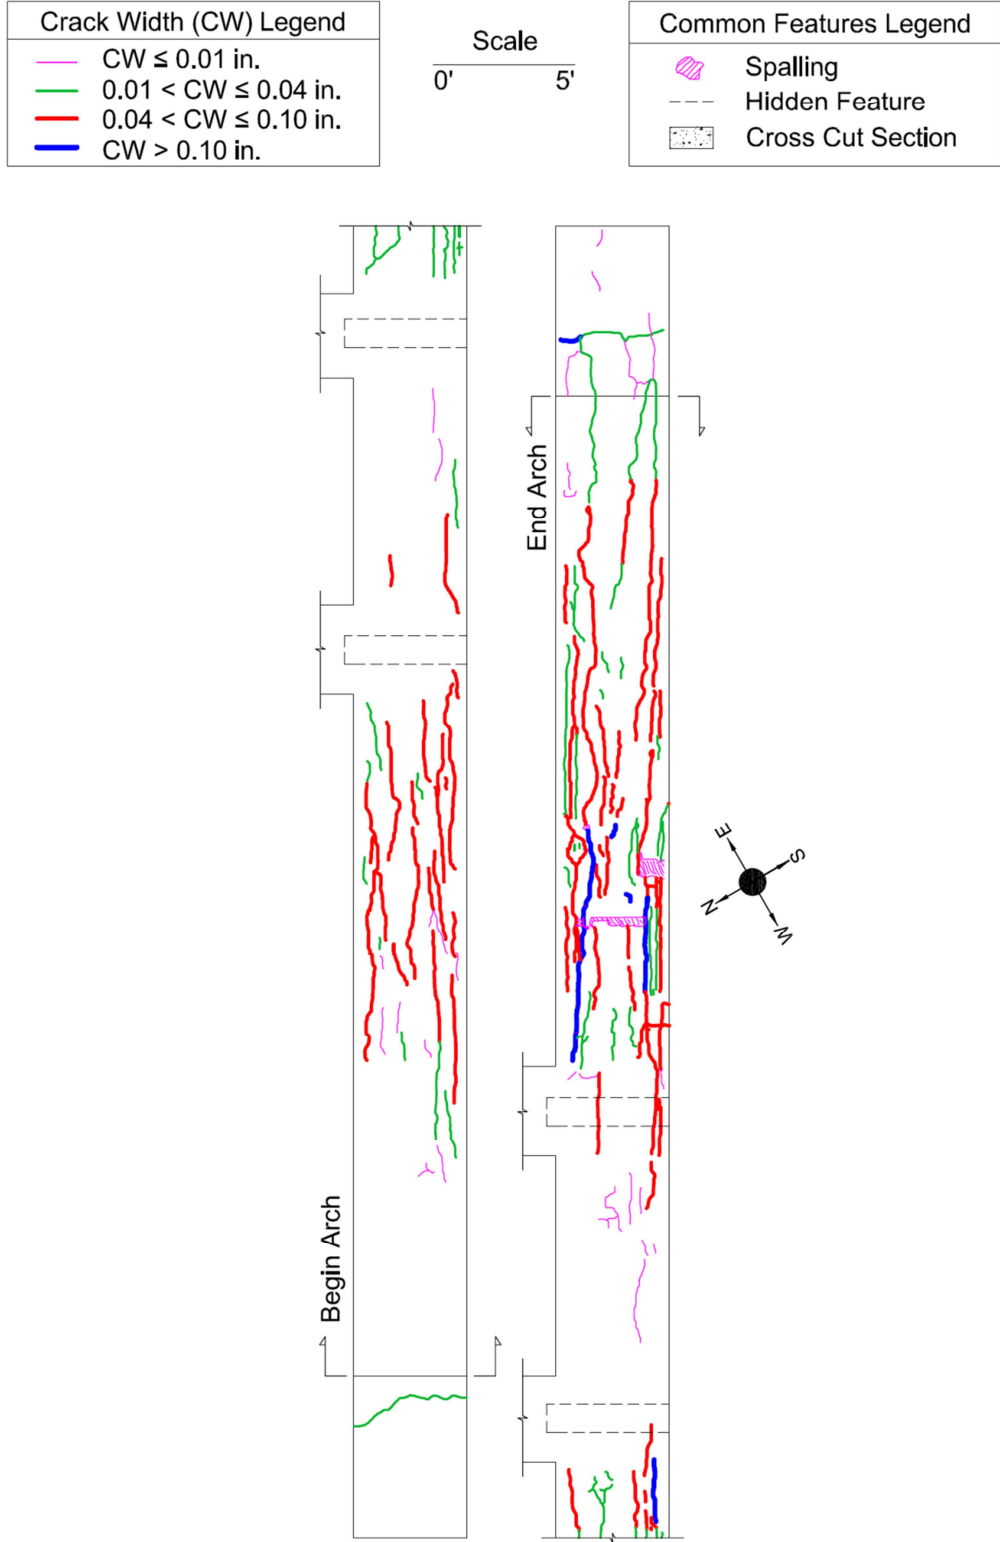
**Figure 3.21:** Crack-mapping survey. November 4, 2010.

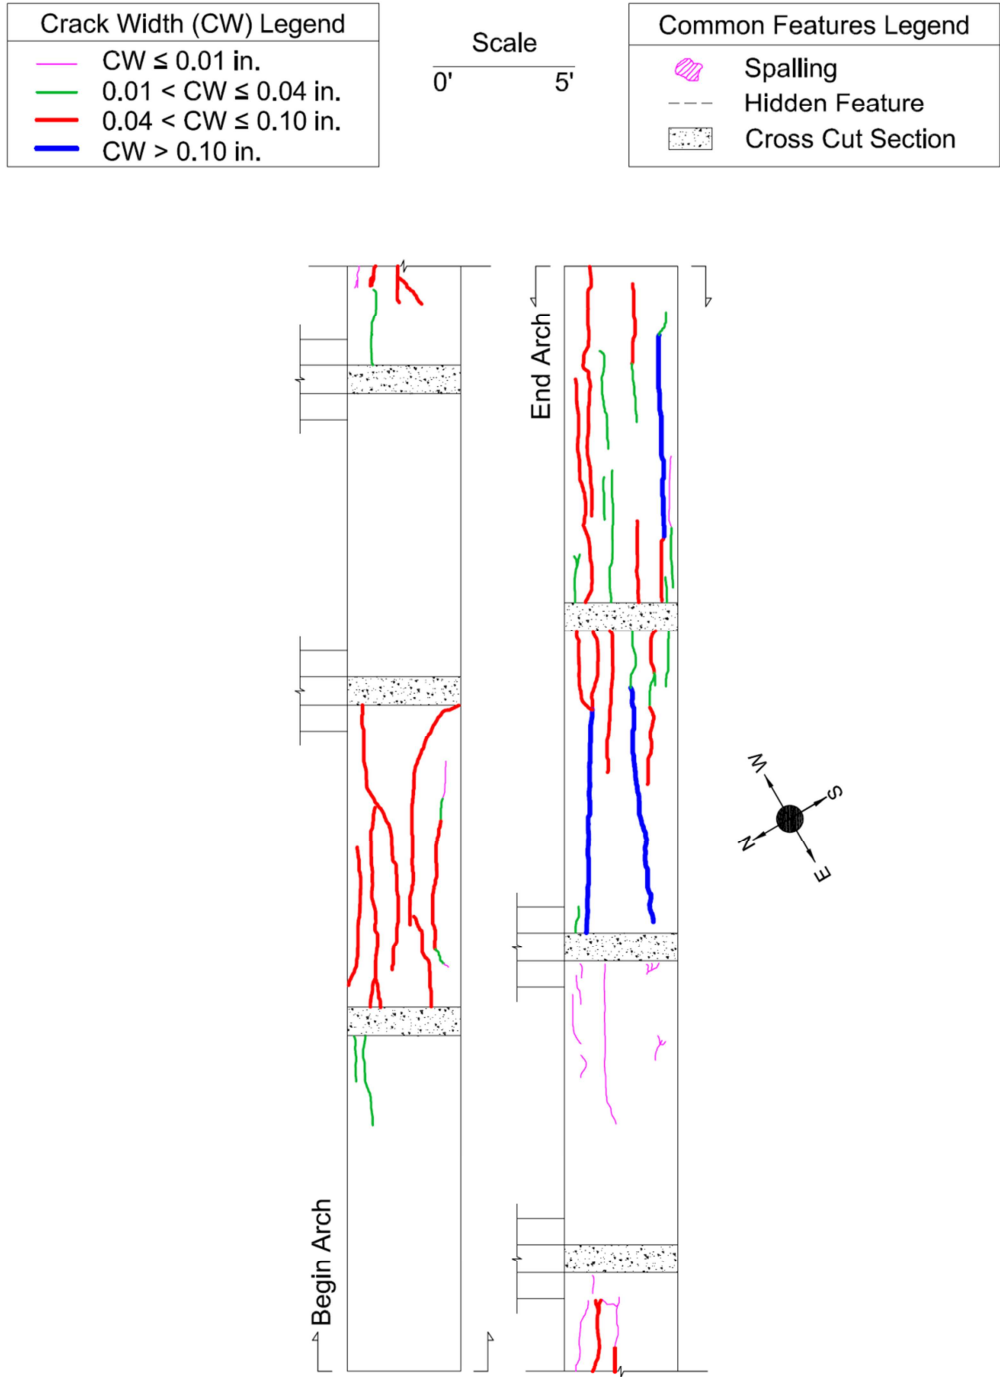
**Figure 3.22:** Crack-mapping survey. November 4, 2010.

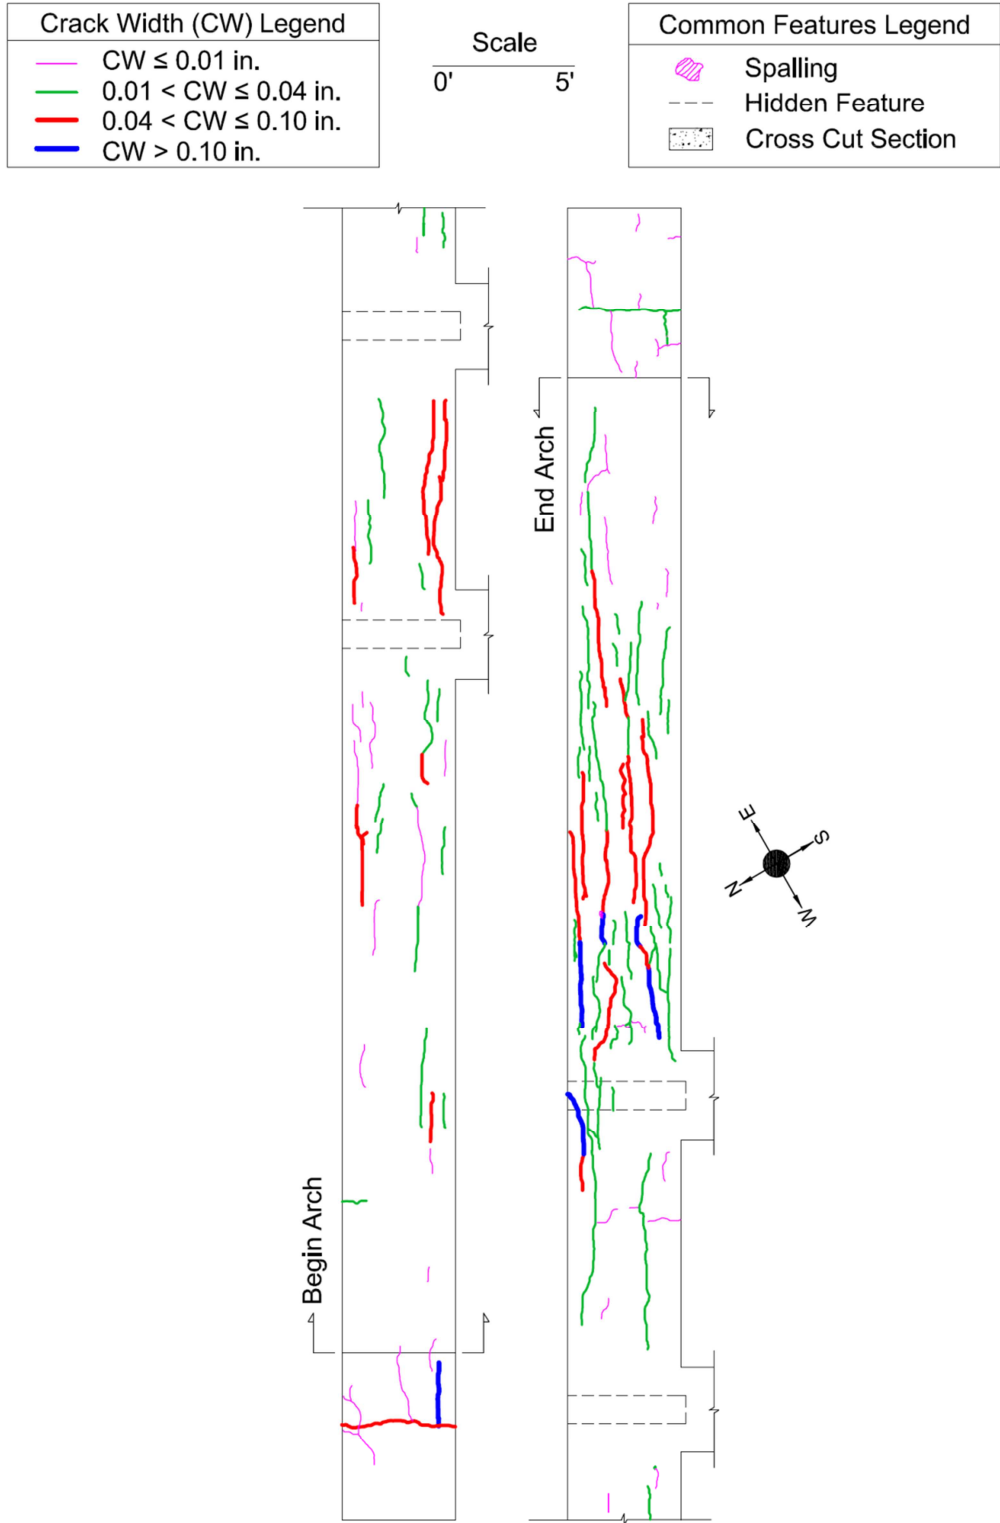
**Figure 3.23:** Crack-mapping survey. November 4, 2010.

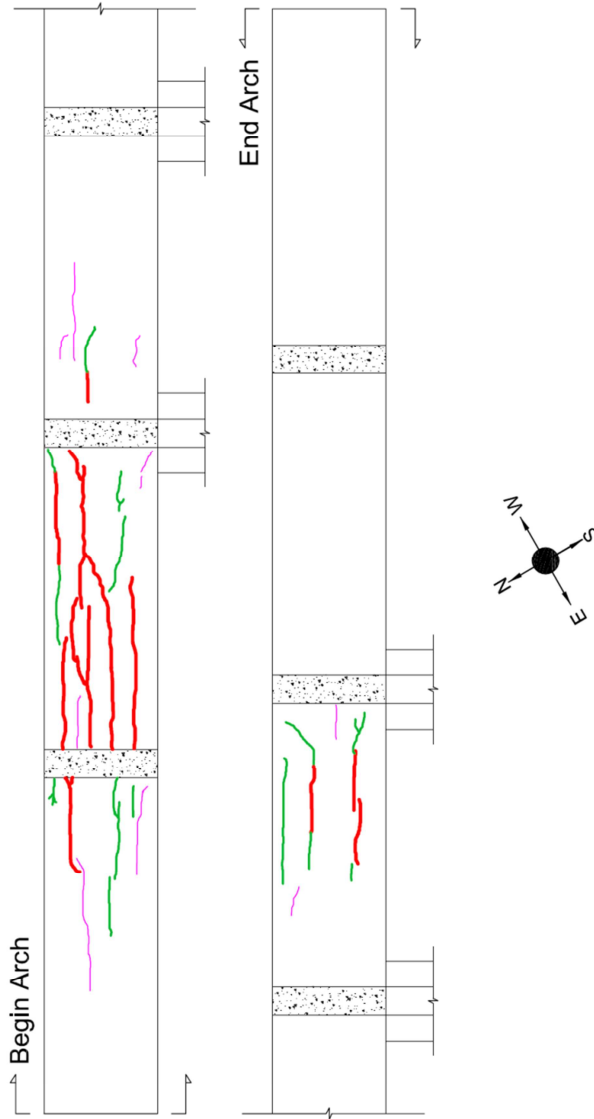
**Figure 3.24:** Crack-mapping survey. November 4, 2010.

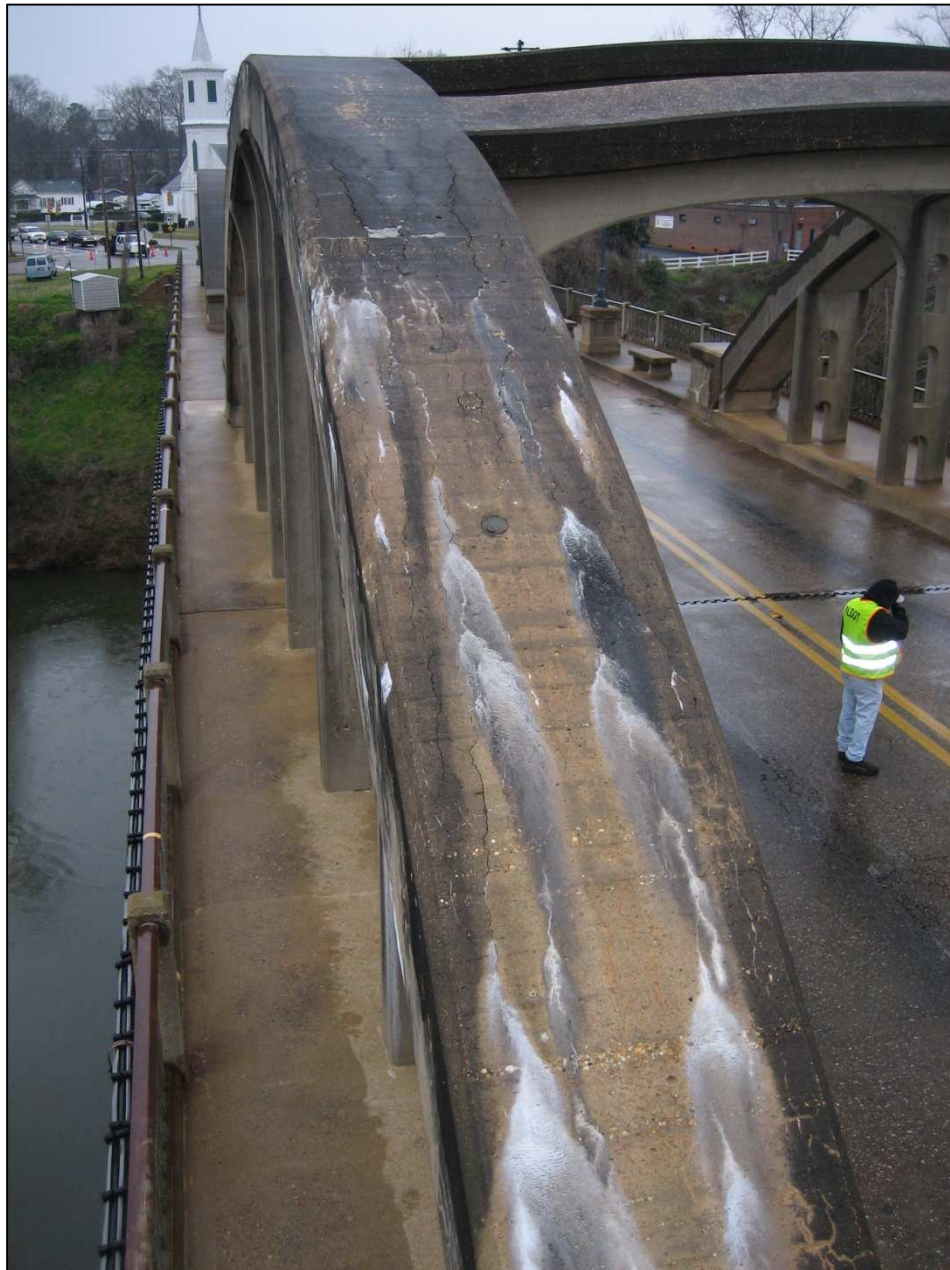
**Figure 3.25:** Severe distress due to ASR on the eastern side of the southern arch of span 5 on 3-11-2008

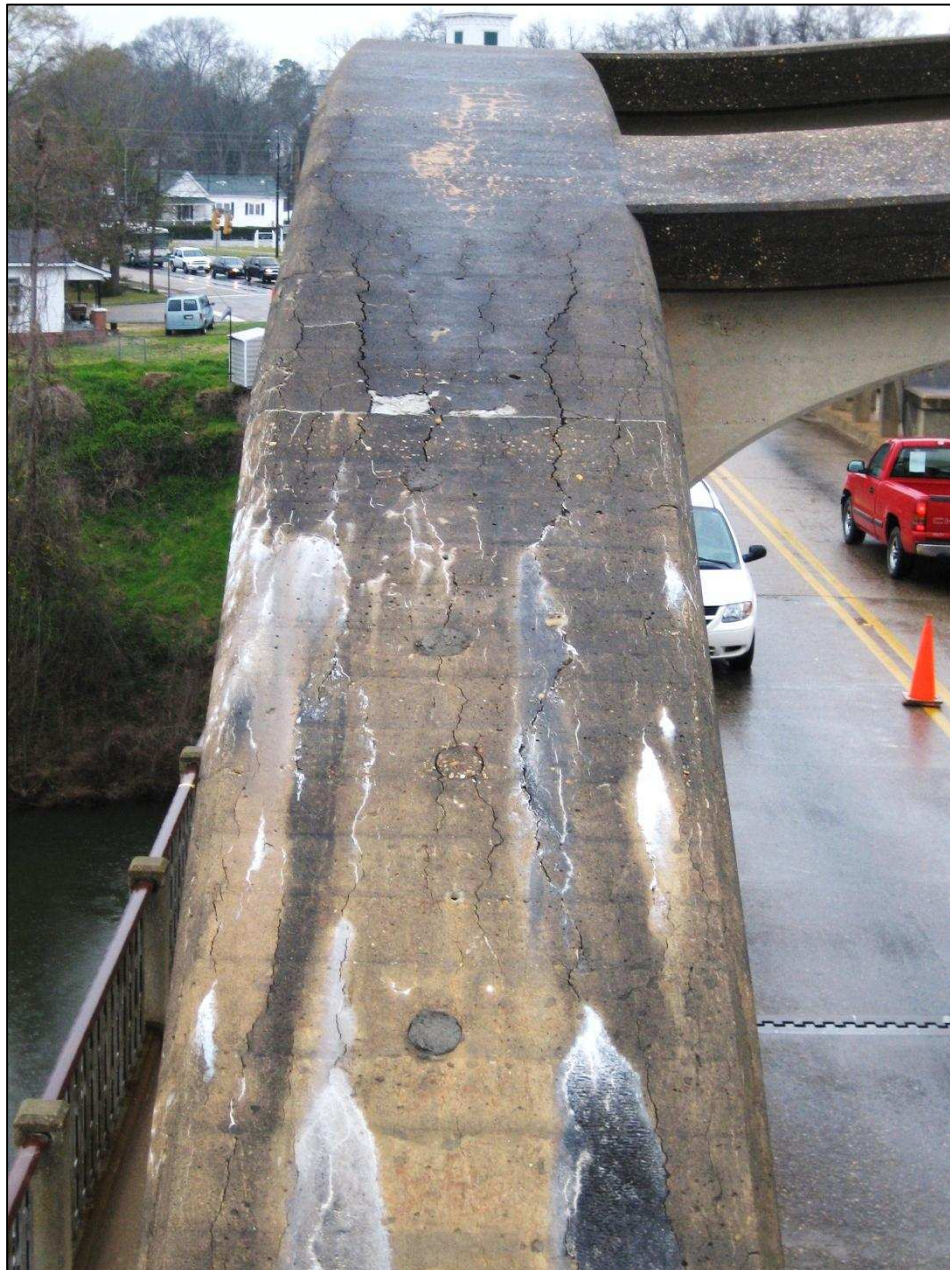
**Figure 3.26:** A closer view of the severe distress due to ASR on the eastern side of the southern arch of span 5 on 3-11-2008

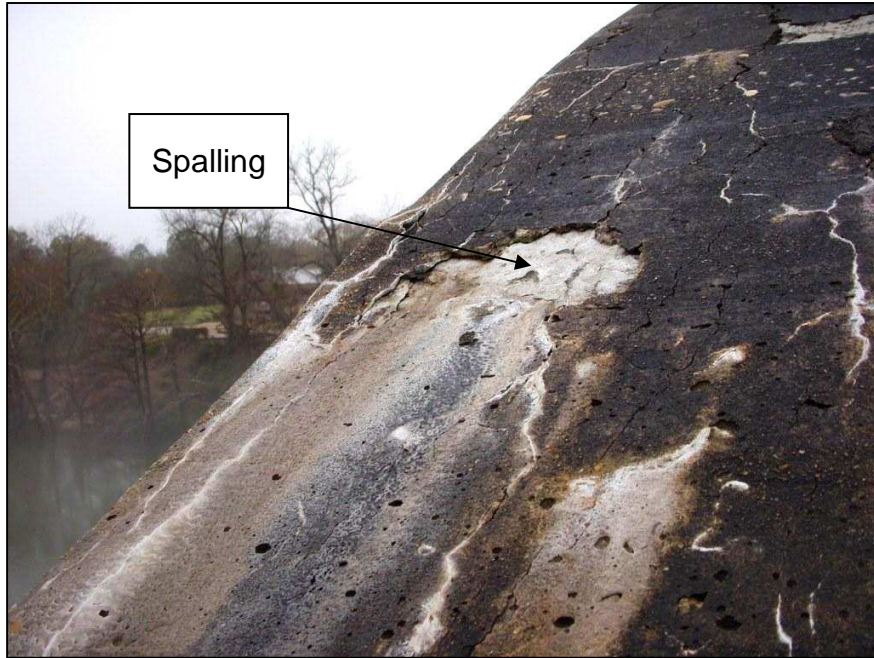
**Figure 3.27:** An example of spalling on span 5 on 12-14-2009

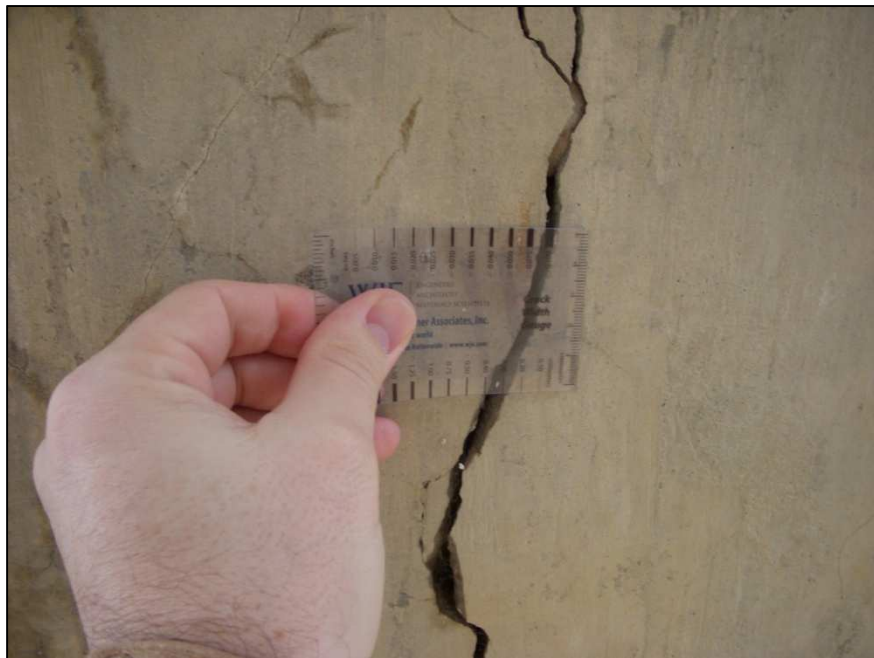
**Figure 3.28:** Severe cracks greater than 0.1 inches on 3-11-2008

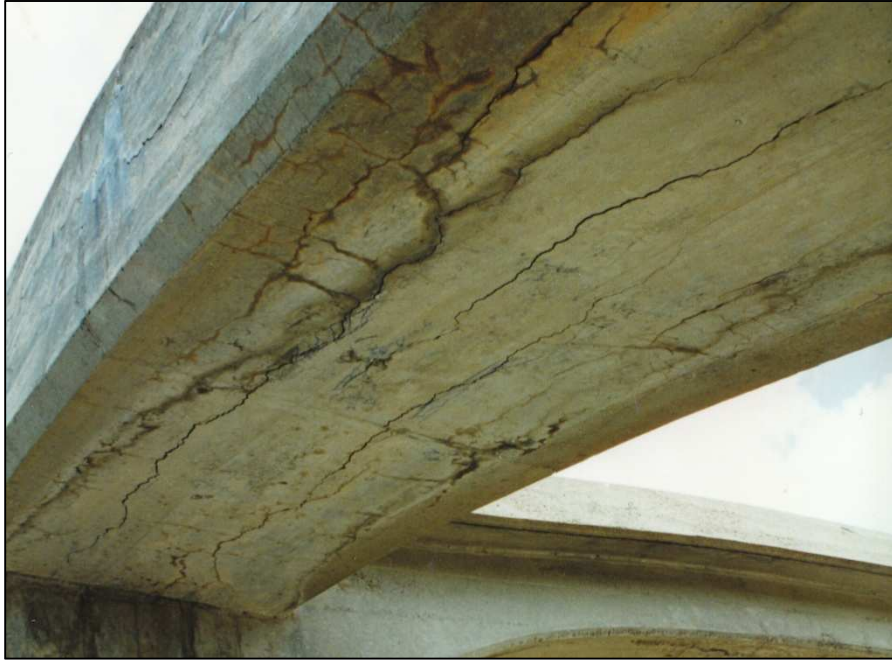
**Figure 3.29:** Severe cracks on the bottom of the arch on 3-11-2008

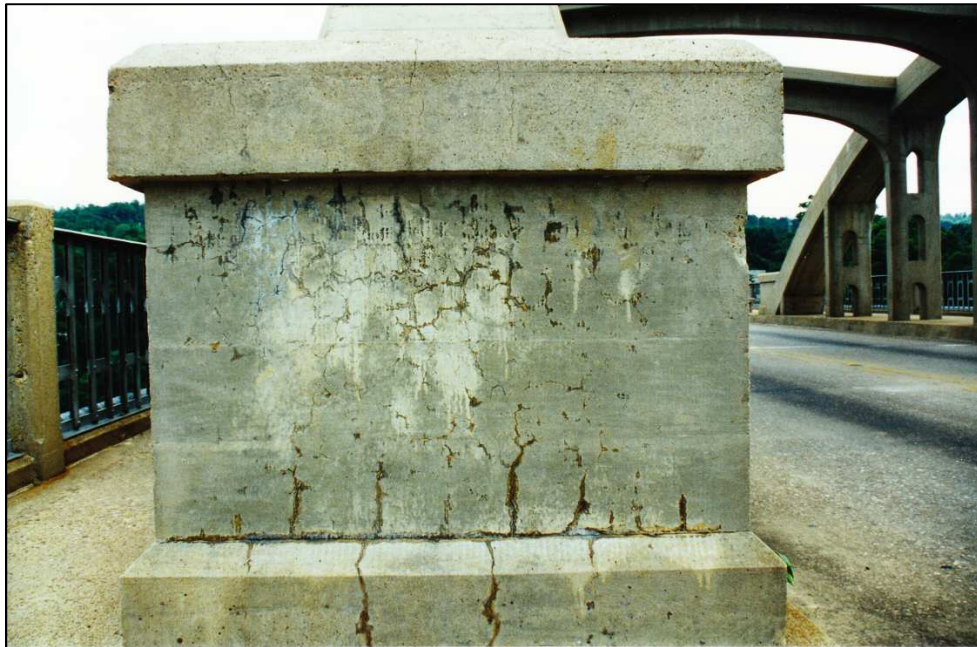
**Figure 3.30:** Map-cracking on the abutment of span 5

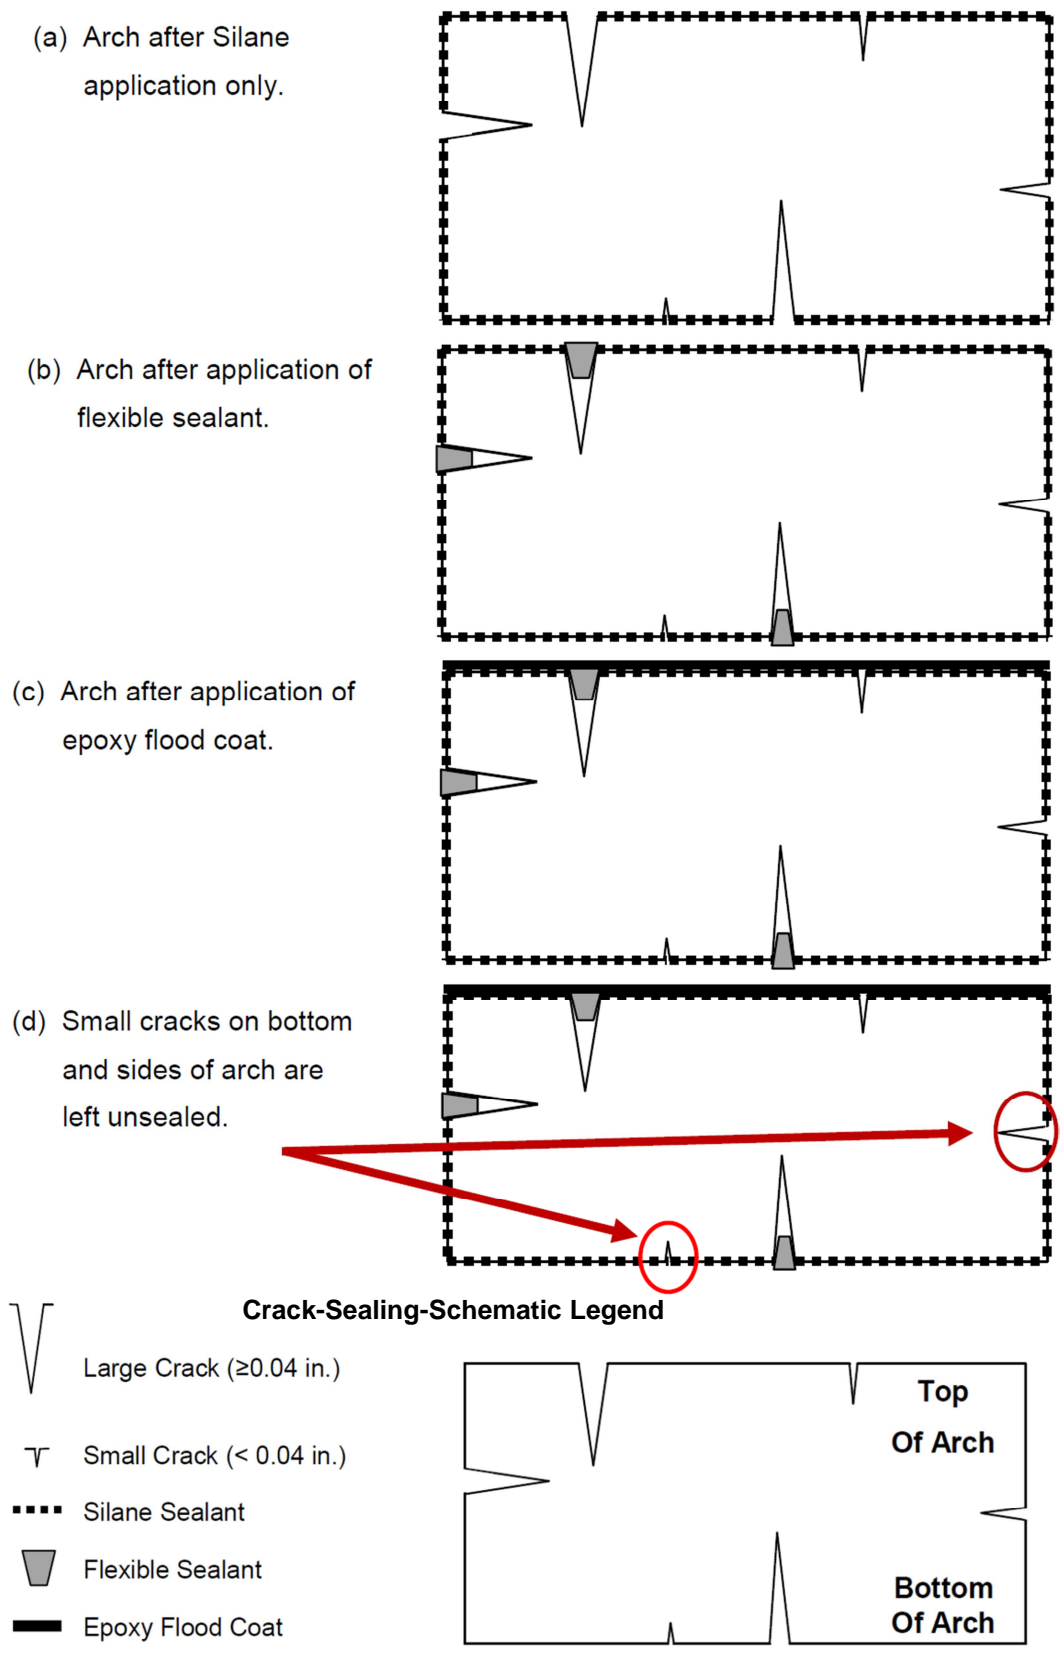
**Figure 4.2:** Schematic of the ASR mitigation procedure applied

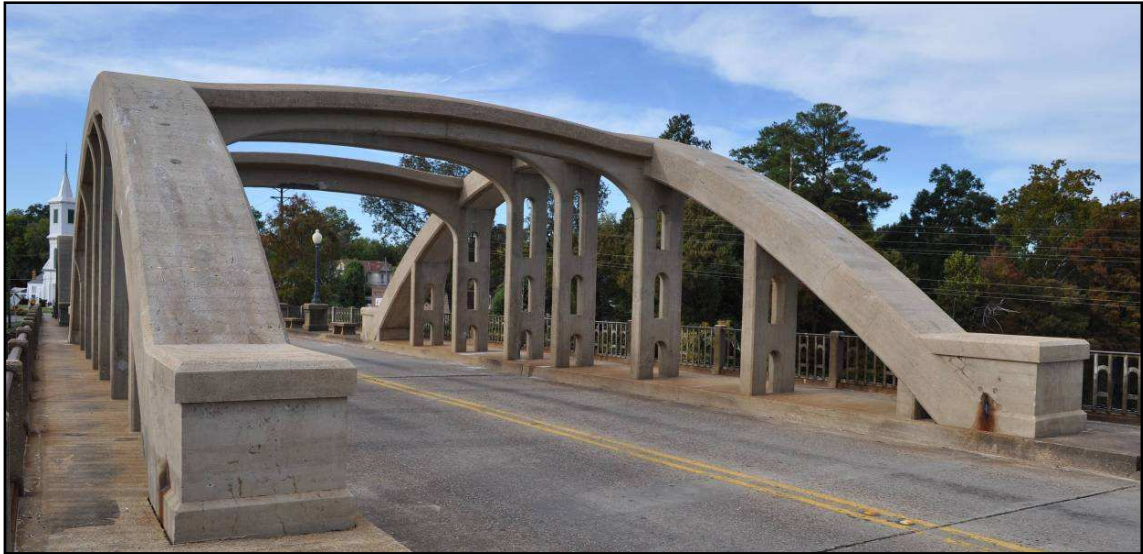
**Figure 4.5:** Water-blasted arches prepared for ASR mitigation procedure

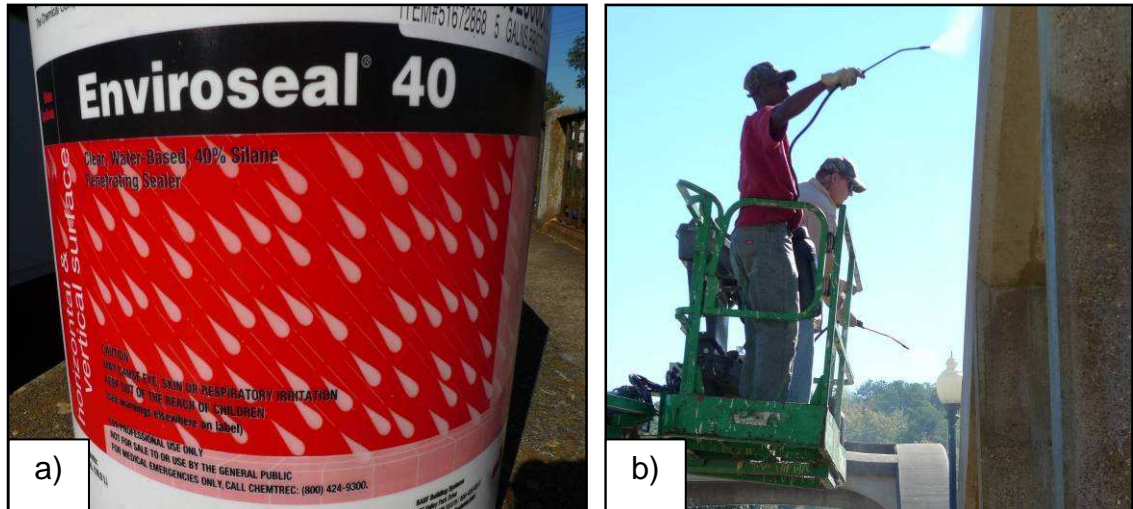
**Figure 4.6:** (a) Water-based silane sealant and (b) application of silane

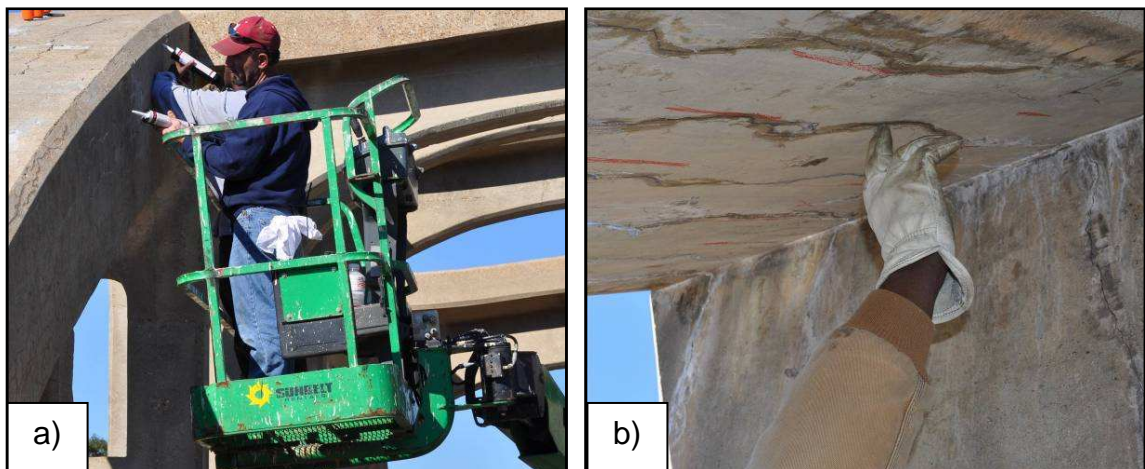
**Figure 4.7:** (a) Application of flexible sealant and (b) smoothing sealant by hand

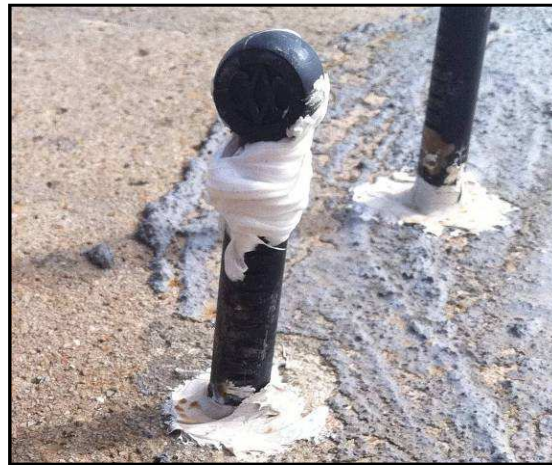
**Figure 5.1:** RH tube with plug installed and tube sealed with a flexible silicone sealant

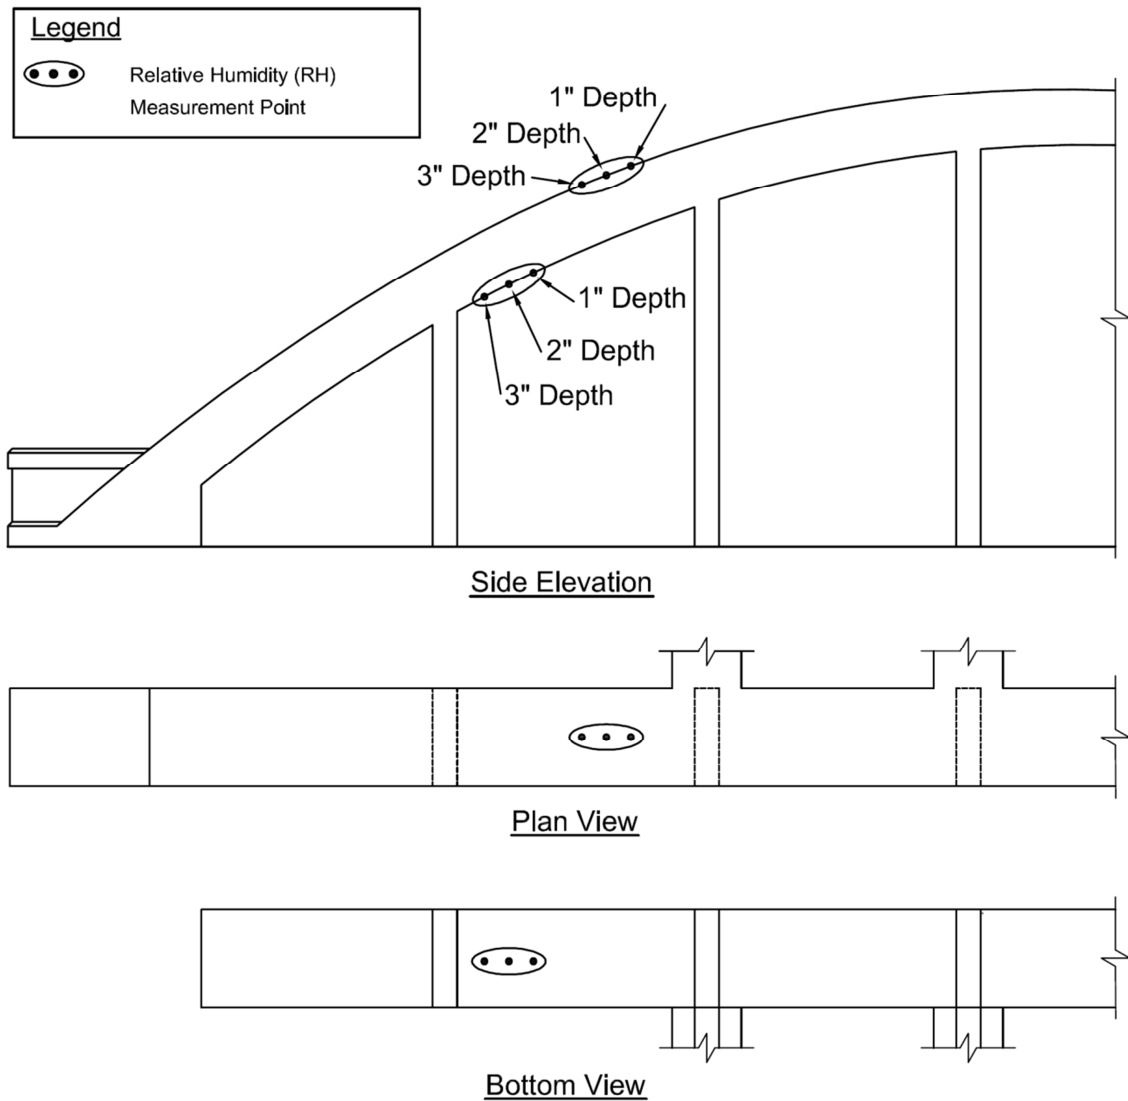
**Figure 5.6:** RH measurement locations for all arches

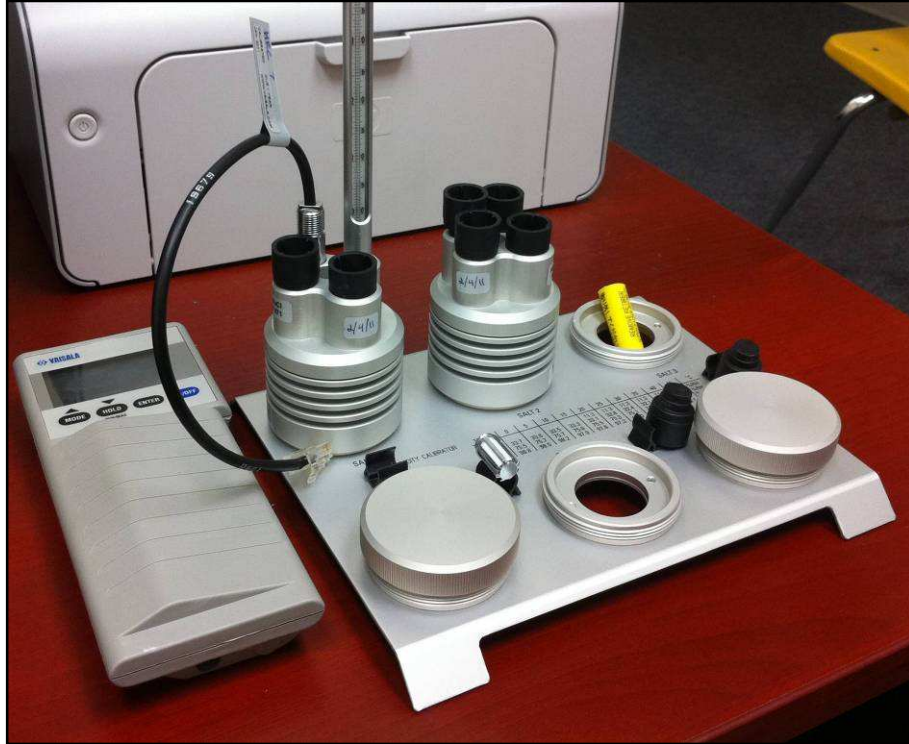
**Figure 5.7:** Vaisala's Humidity Probe Calibrator, HMK15

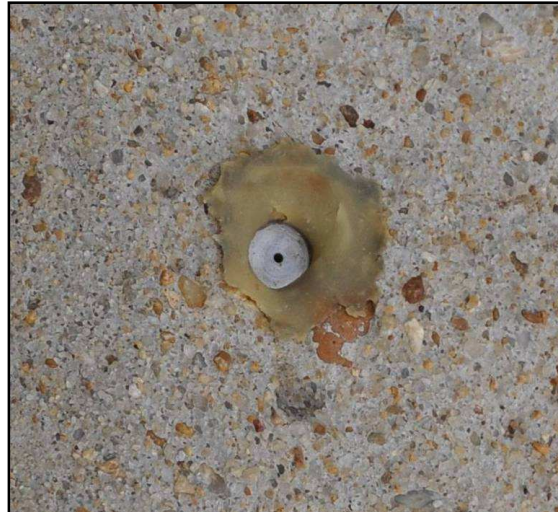
**Figure 5.8:** Example of installed DEMEC stud in the Bibb Graves Bridge.

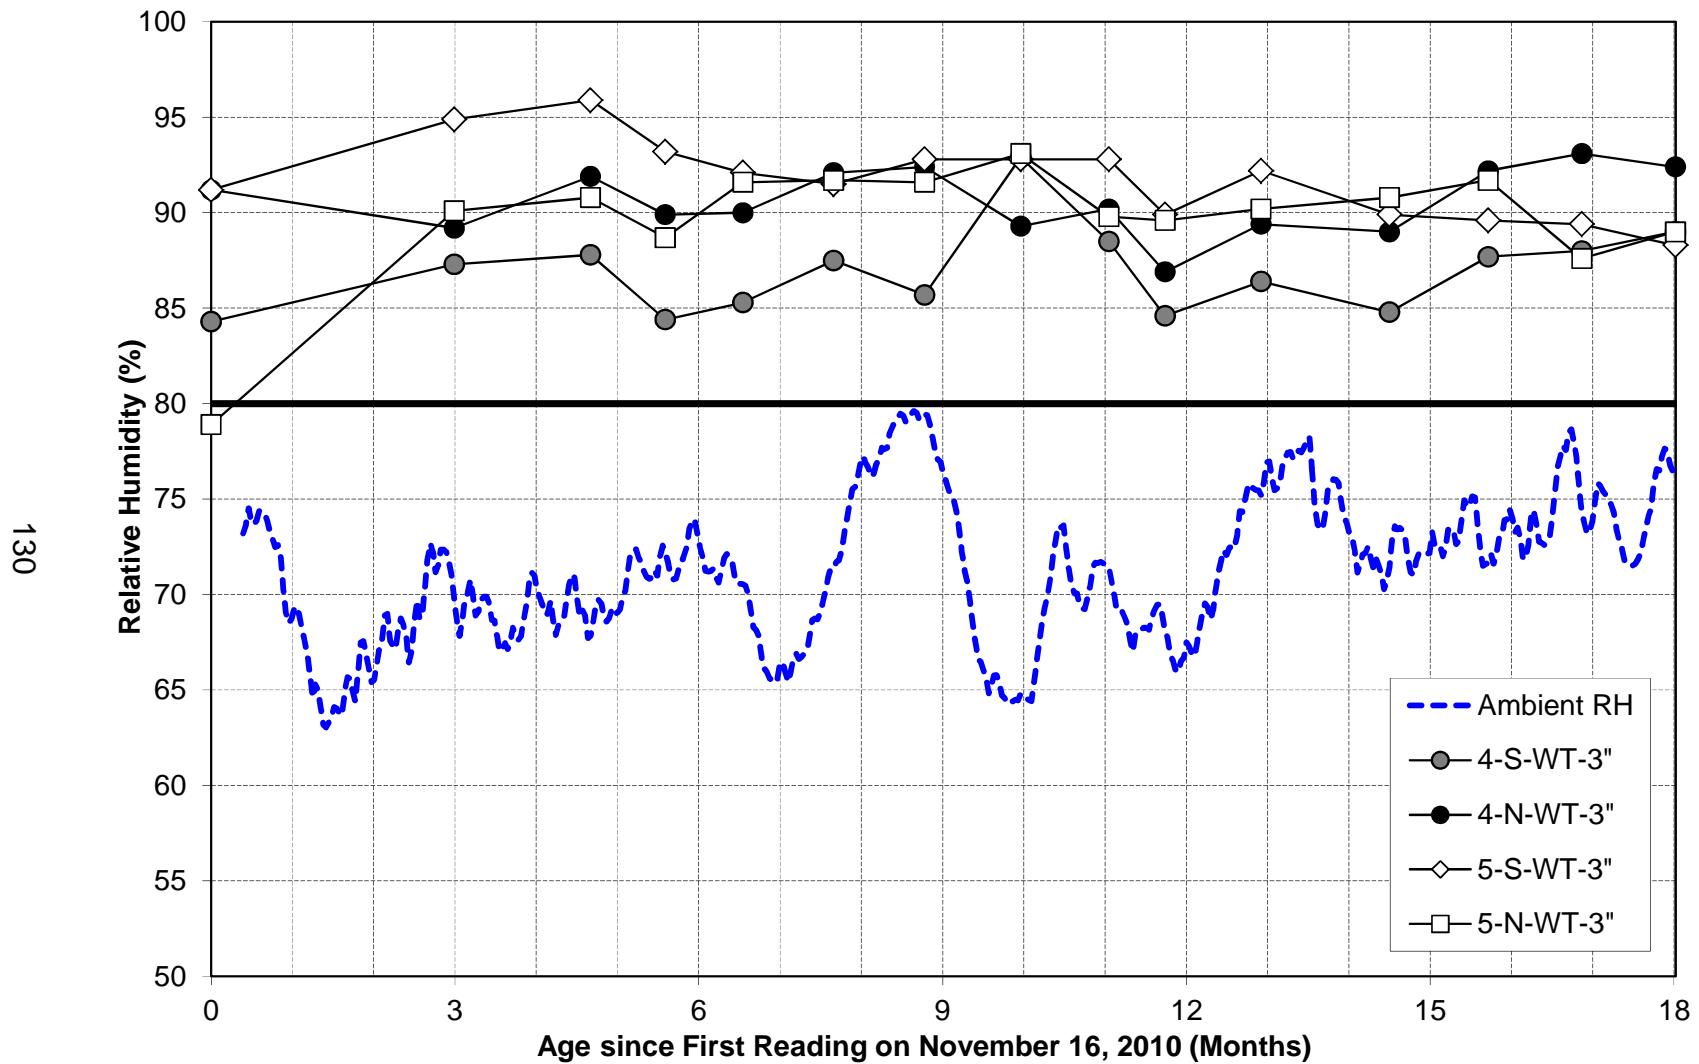
Figure 6.10: RH measurements, West Top, 3-inch depth

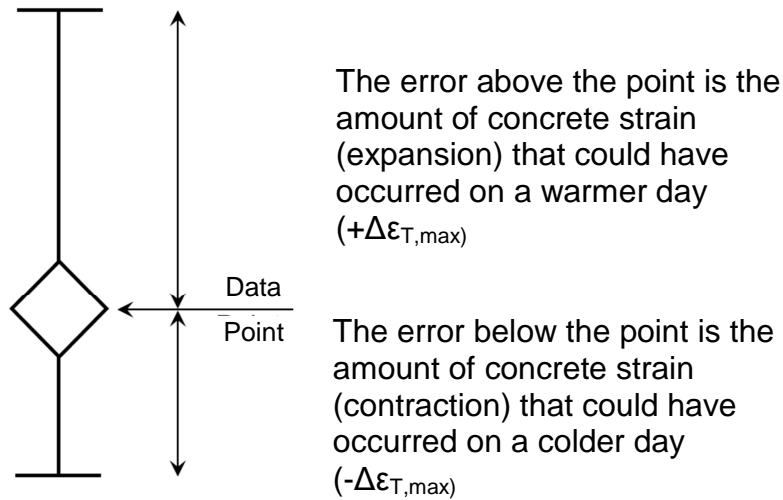
**Figure 6.15:** Temperature effect error bar for a 70 °F day

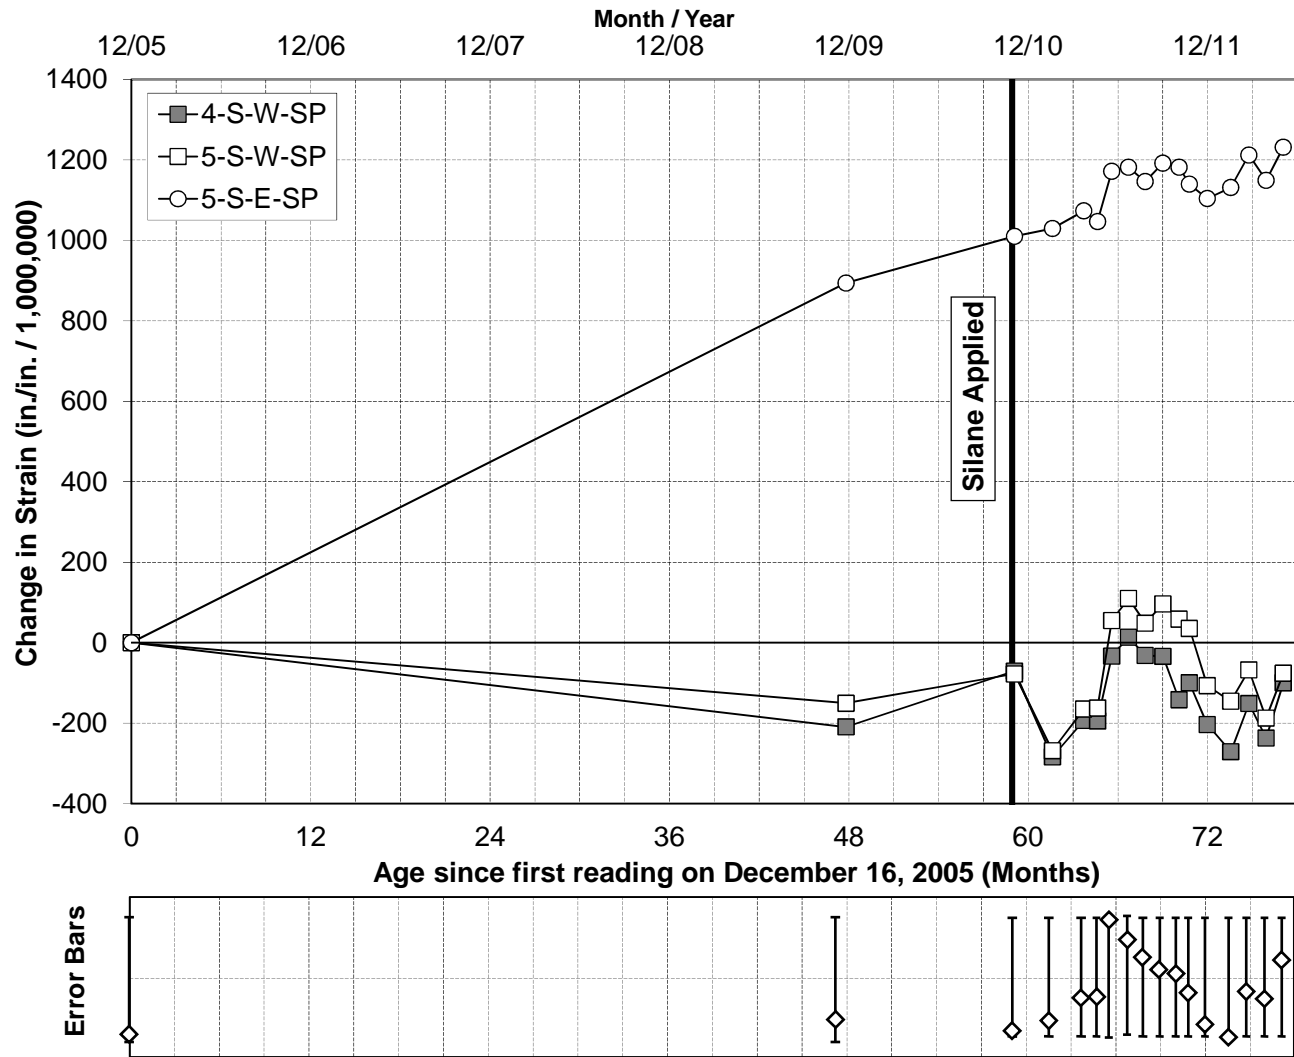
Figure 6.16: Change in concrete strain for Side Perpendicular since 2005
