**Mitigation of Alkali-Silica Reaction in the Bibb Graves Bridge**

A thesis submitted to the Graduate Faculty of  
Auburn University  
in partial fulfillment of the  
requirements for the Degree of  
Master of Science

The Bibb Graves Bridge in Wetumpka, AL has severe damage due to alkali-silica reaction (ASR) in two of its reinforced concrete arches. A mitigation procedure developed in the summer of 2010 by the FHWA, ALDOT, and Auburn University was implemented during the fall of 2010. The mitigation procedure included the application of a silane sealant, flexible sealant in the large cracks, and an epoxy flood coat to fill the small cracks on the tops of the arches.

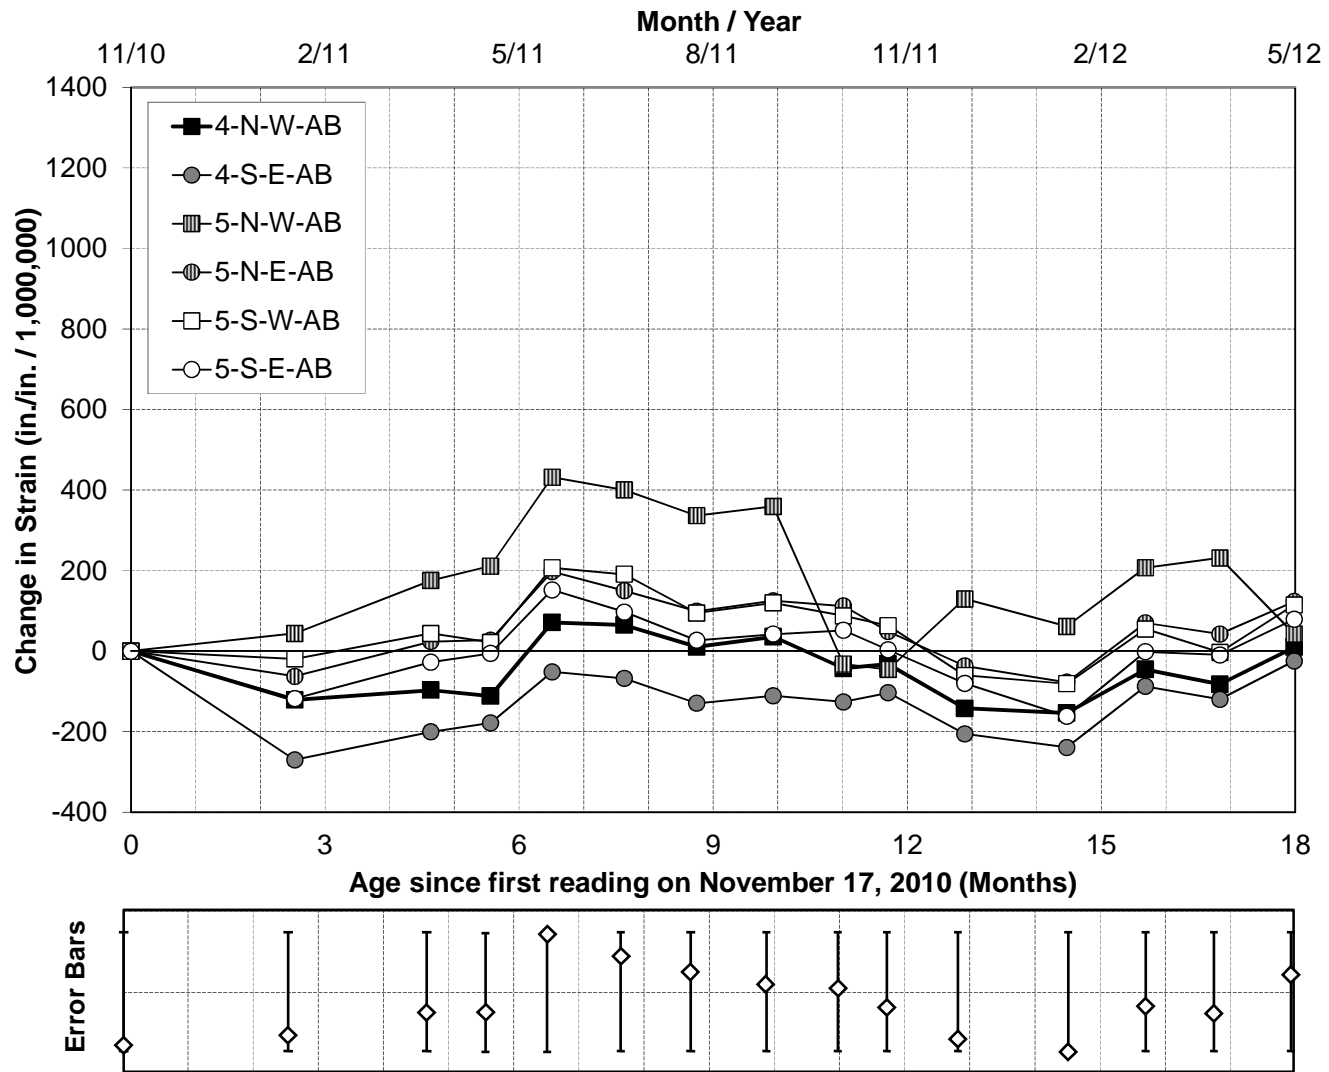
**Figure 6.25:** Change in concrete strain for Abutment since 11/2010

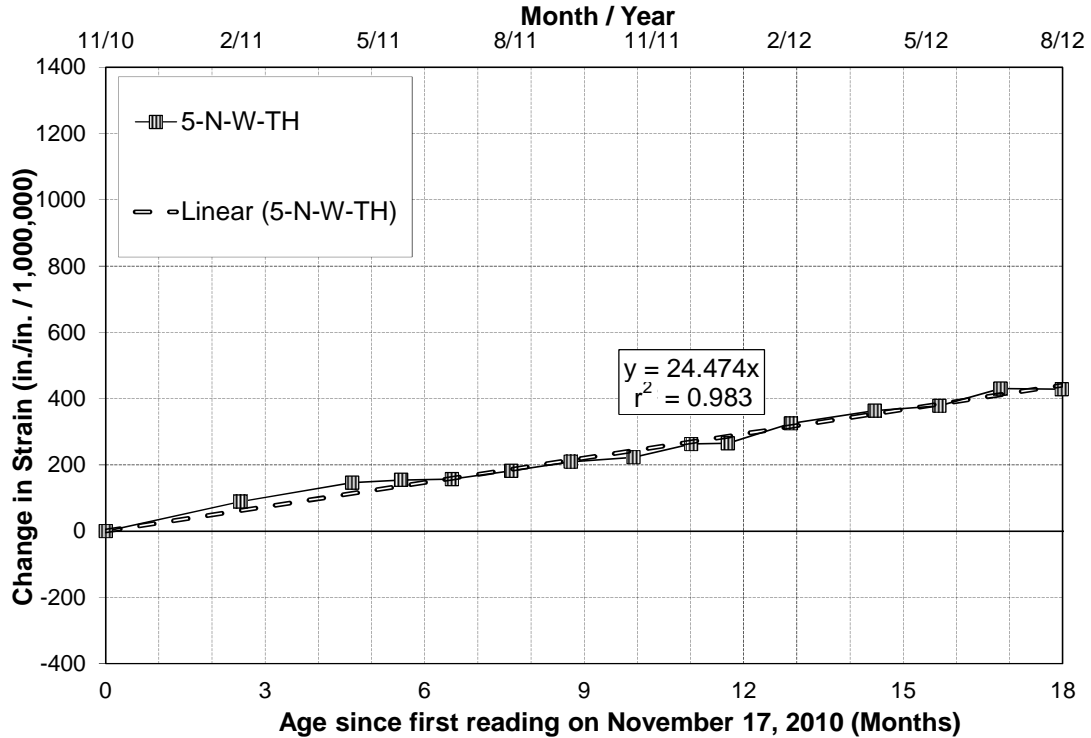
**Figure 6.29:** Concrete strain difference plot for TH measurement location

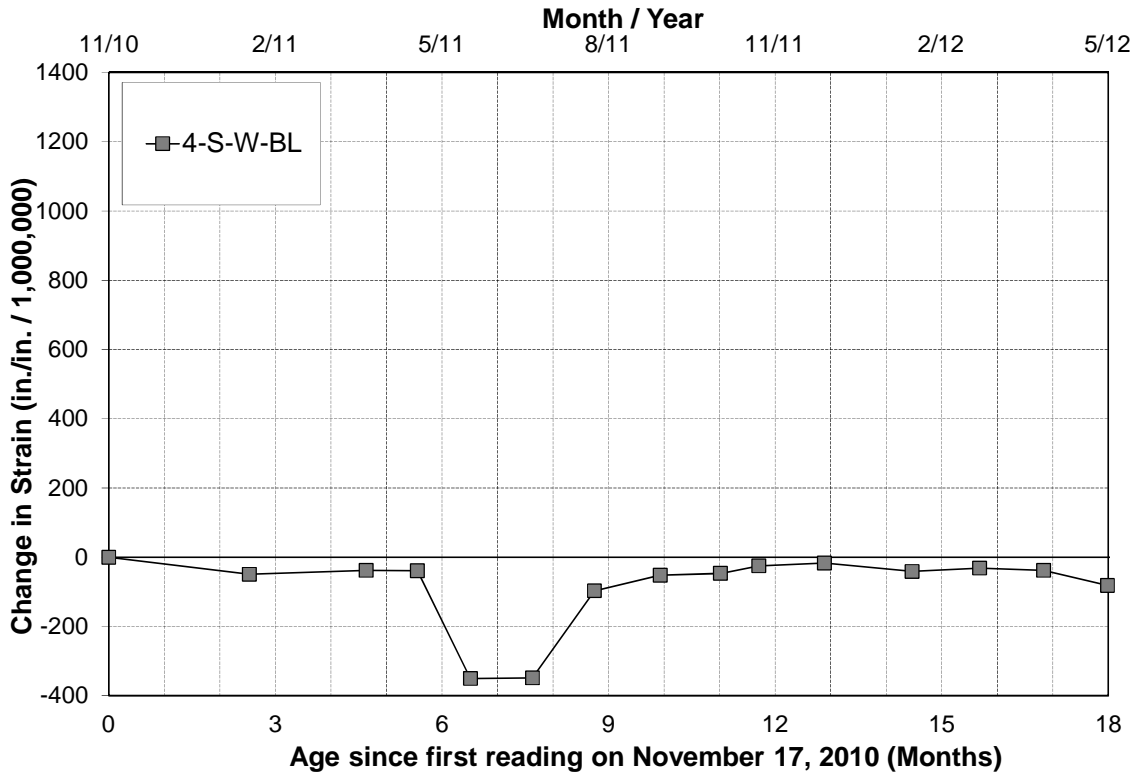
Figure 6.30: Concrete strain difference plot for BL, with  $r^2 < 0.5$

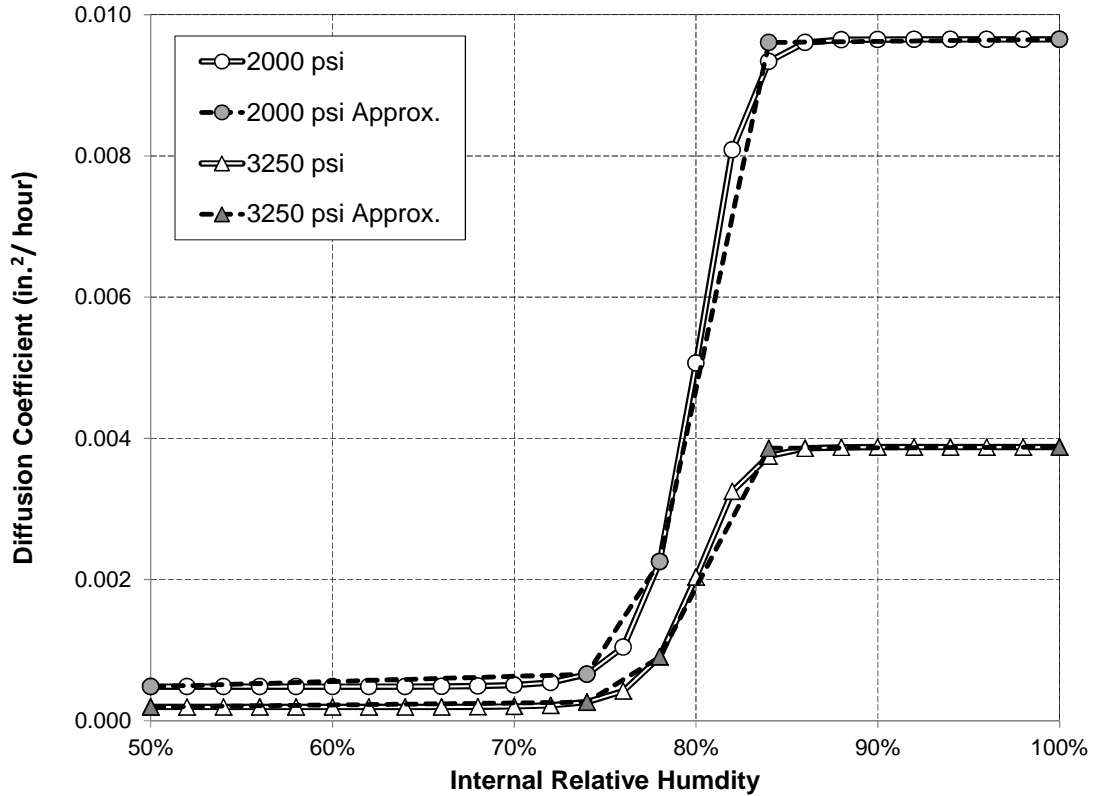
**Figure 7.2:** Multilinear approximation of the moisture diffusion coefficient

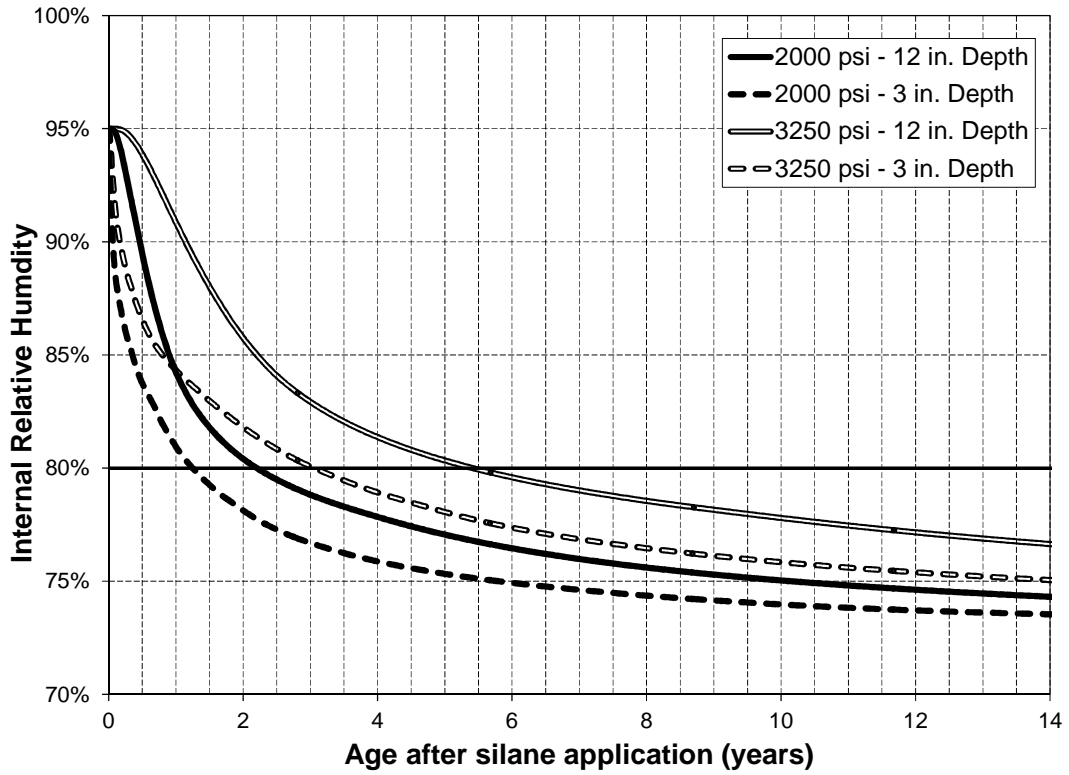
Figure 7.4: Moisture loss in concrete coated with silane only

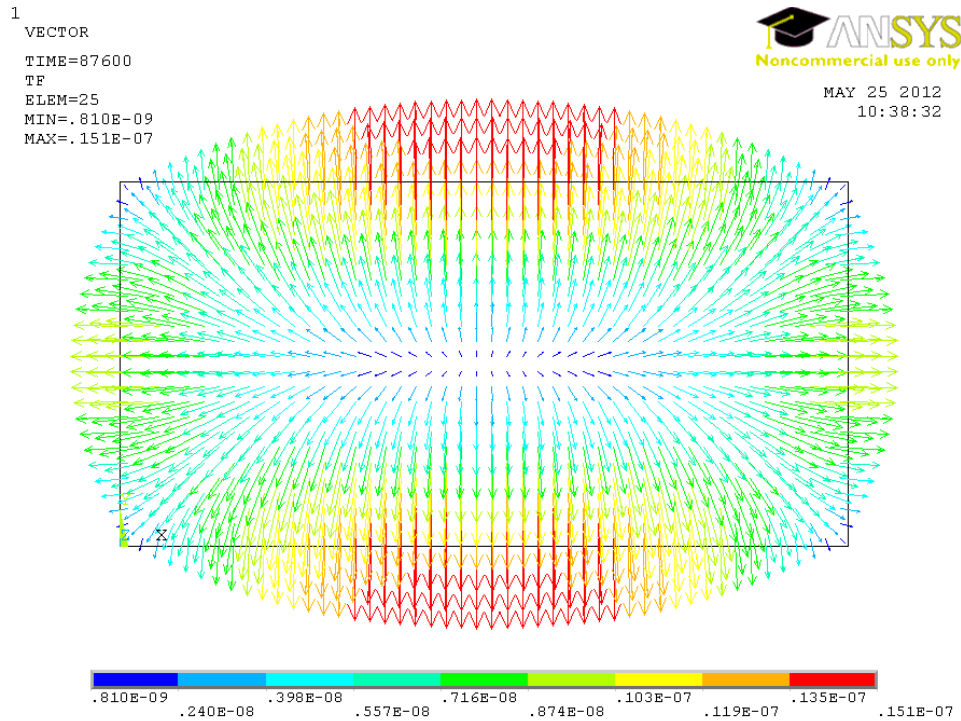
Figure 7.5: Moisture flux at 10 years for 2,000 psi concrete and no epoxy flood coat

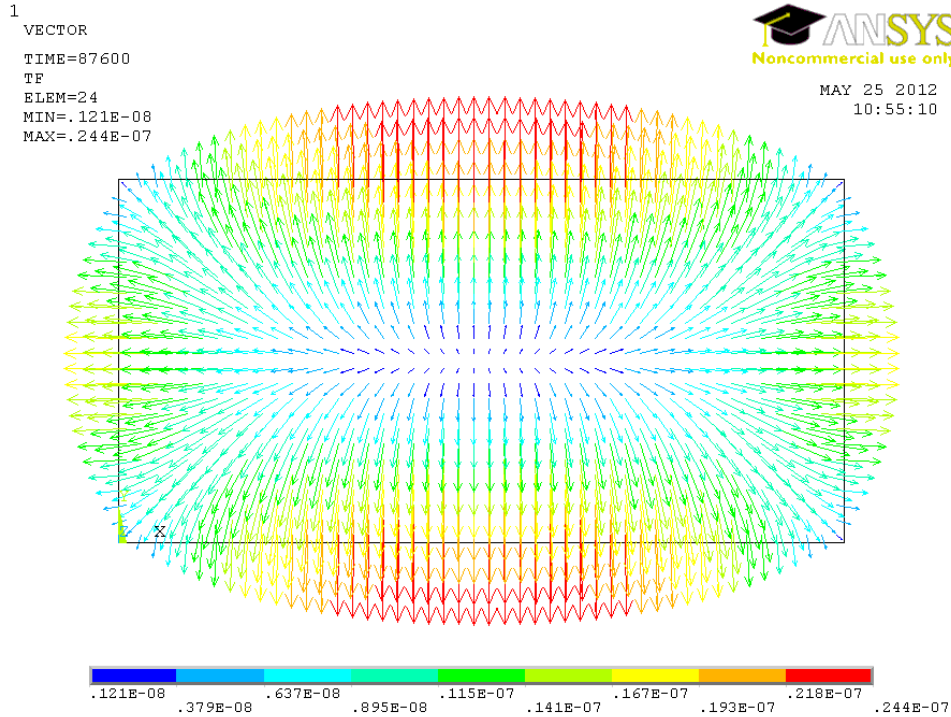
**Figure 7.6:** Moisture flux at 10 years for 3,250 psi concrete and no epoxy flood coat

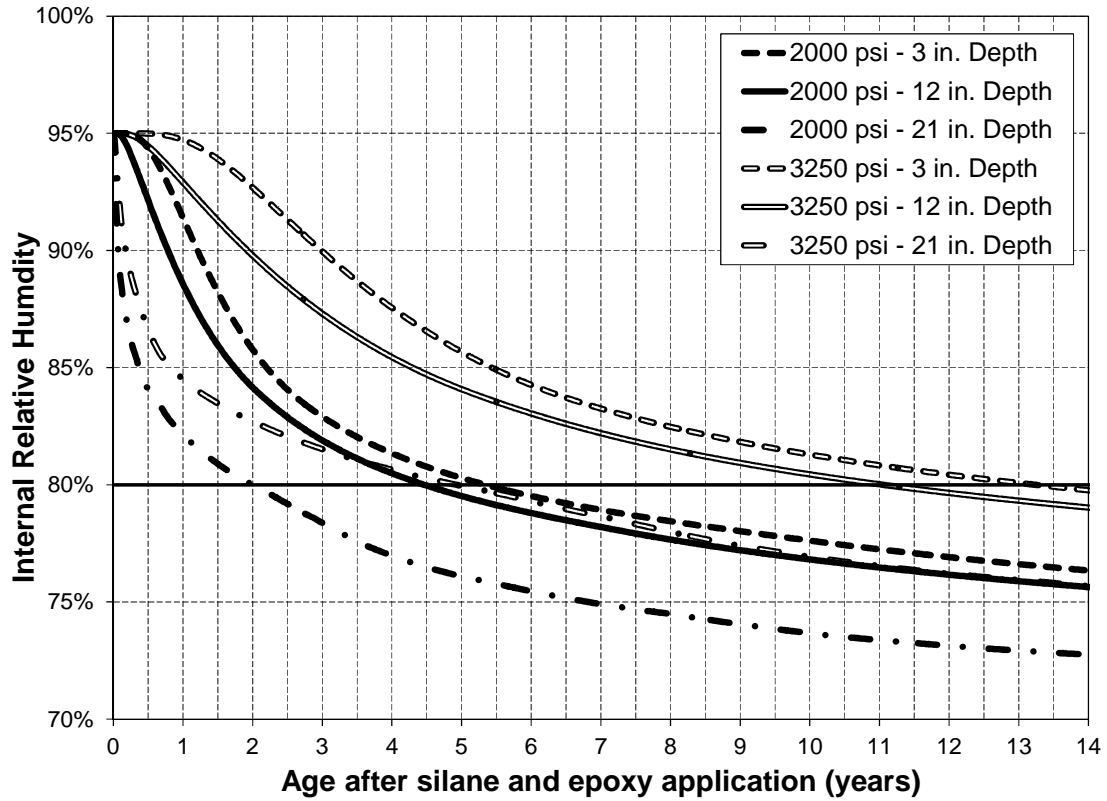
Figure 7.7: Concrete RH change when coated with an epoxy flood coat

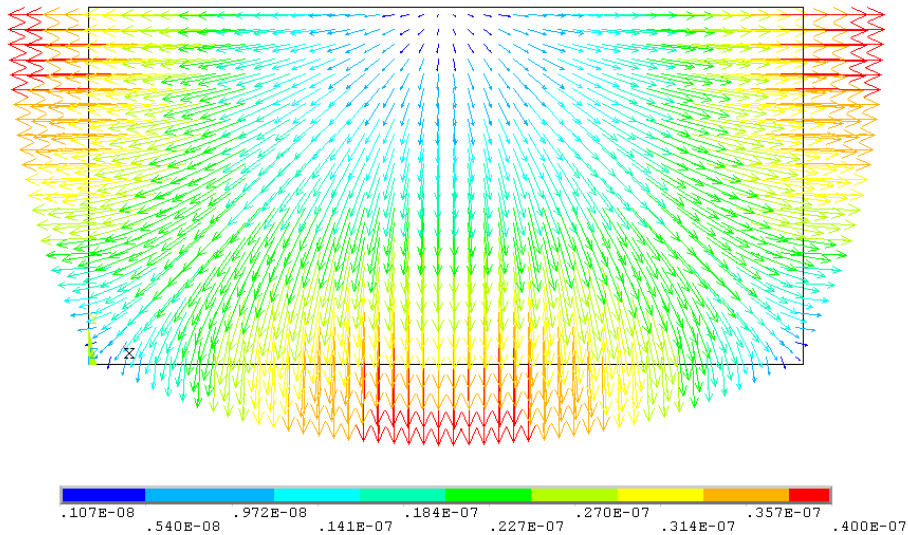
Figure 7.8: Moisture flux at 10 years for 2000 psi concrete with an epoxy flood coat

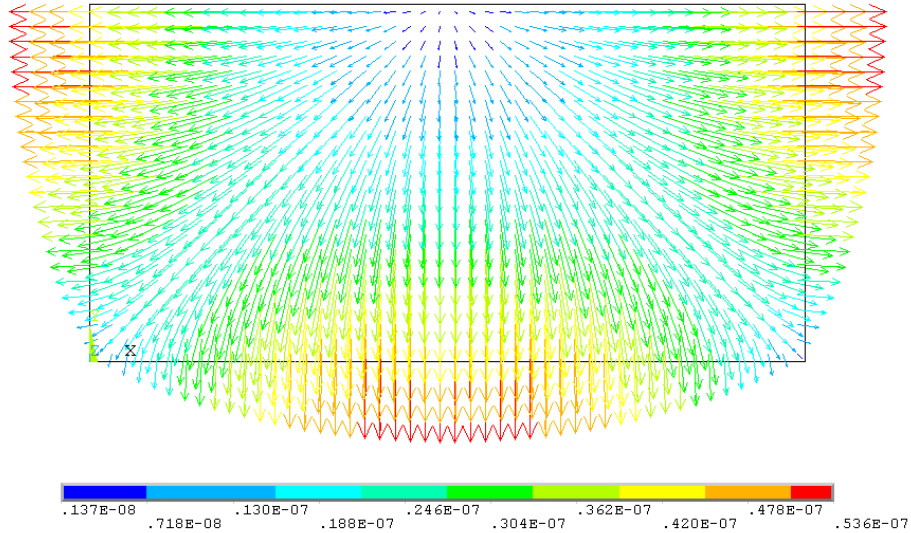
**Figure 7.9:** Moisture flux at 10 years for 3250 psi concrete  
 with an epoxy flood coat

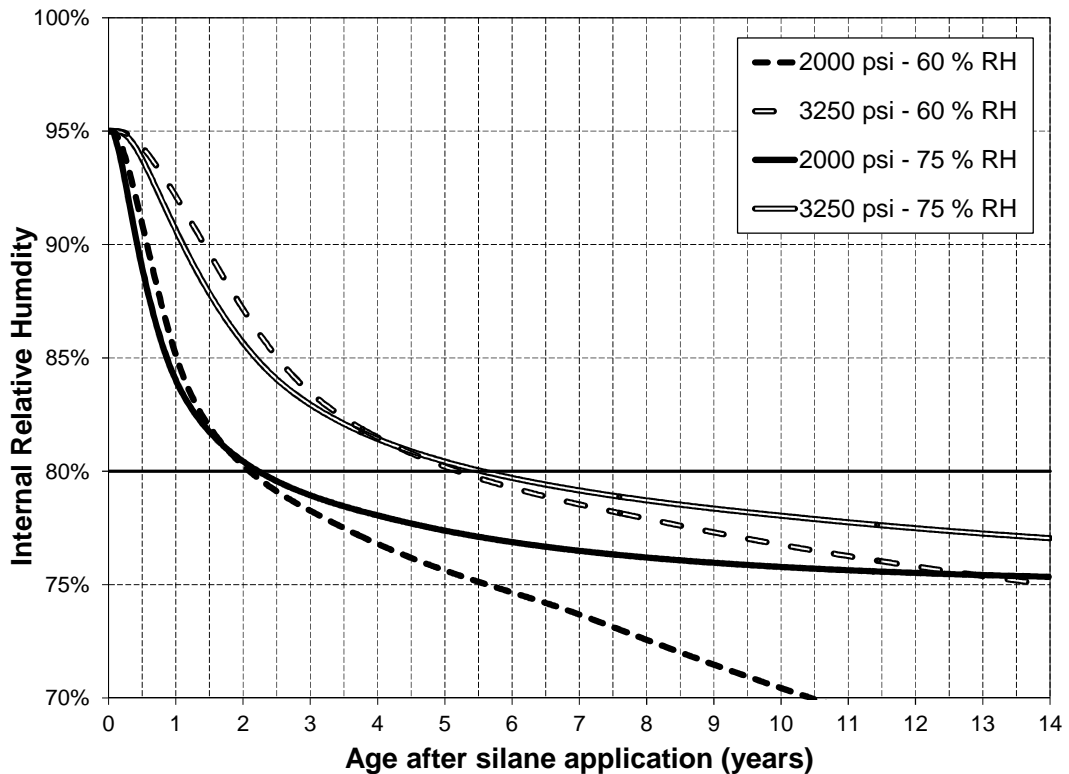
**Figure 7.10:** Moisture diffusion with steady state ambient RH, with silane only

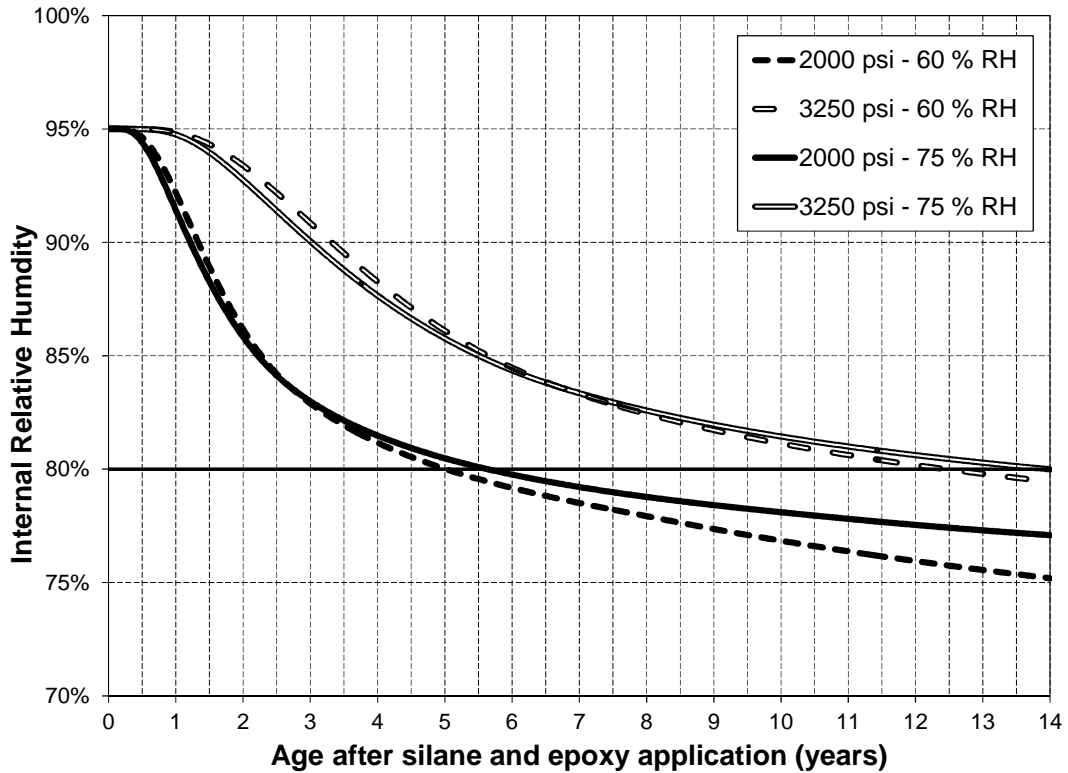
**Figure 7.11:** Moisture loss with steady state ambient RH, with silane and an epoxy flood coat

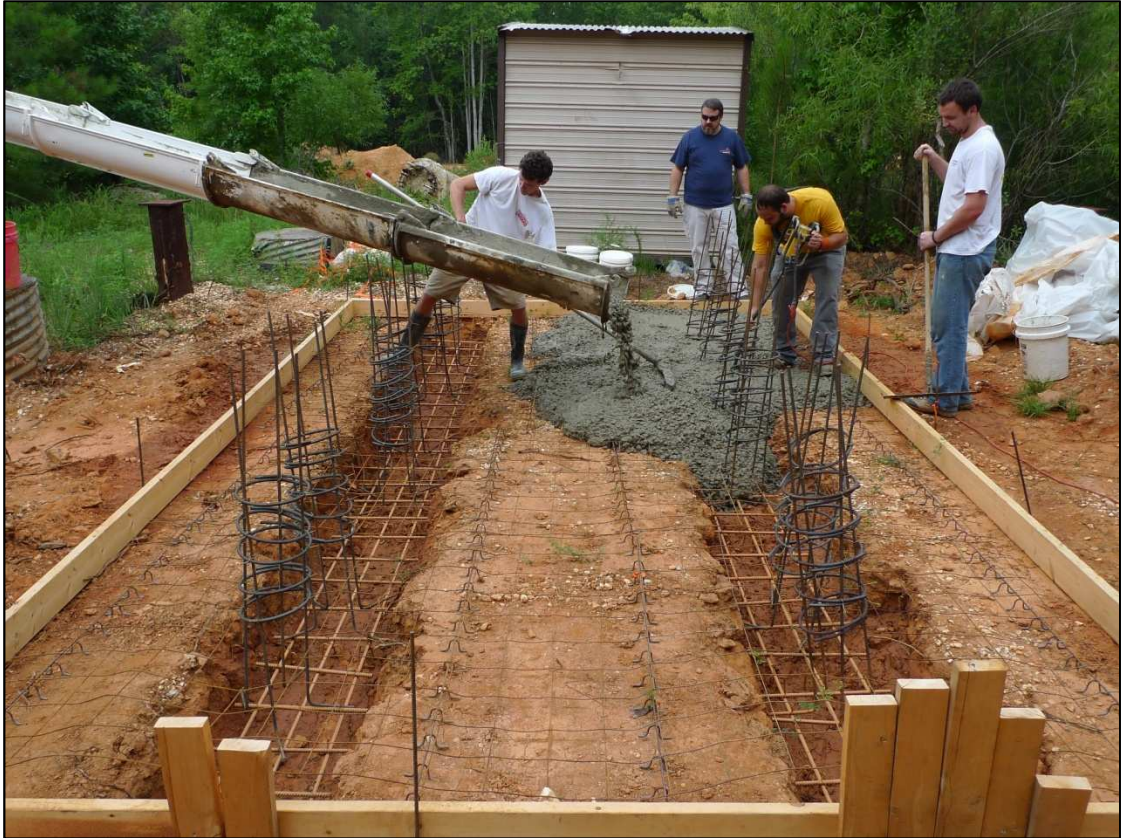
**Figure 7.13:** Construction of strip footings and slab on grade
