Scour Potential of Cohesive Soils

A thesis submitted to the Graduate Faculty of
Auburn University
in partial fulfillment of the
requirements for the Degree of
Master of Science

Auburn, Alabama
August 3, 2013

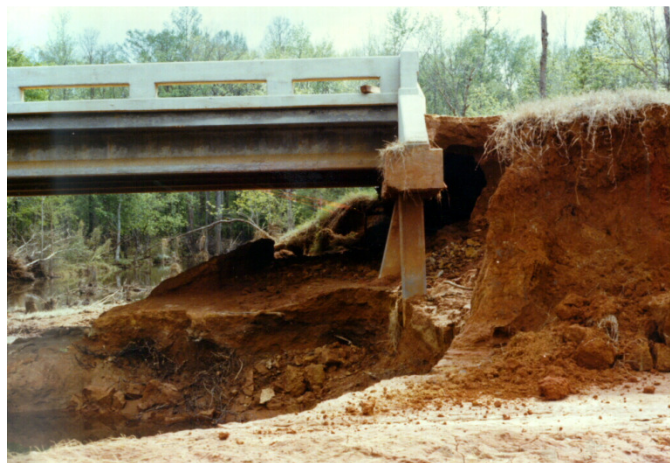
Figure 1-1. Example of Bridge Scour

In 2009, according to the Federal Highway Administration (FHWA), there were approximately 603,000 bridges in the National Bridge Inventory. Of these 603,000 bridges, roughly 83 percent span water (Lagasse et al. 2007). With such a large number of bridges crossing water, scour can be a major concern with accelerated flow conditions such as flooding. Between 1961 and 1976, over 50 percent of the 86 major bridge failures were due to scour (Murillo 1987). More recently, from 1989 to 2000 just over fifteen percent of all bridge failures were due to scour (Wardhana and Hadipriono 2003). From these numbers it is evident that scour is a serious issue in bridge design and maintenance. When scour does occur, remediation measures are extremely costly, due to potential instabilities in the bridge and river bed, as shown in Figure 1-1. Estimates of scour are an important step in the bridge design process, as the estimated depth of scour is a driving force in the foundation system selection and penetration depth.

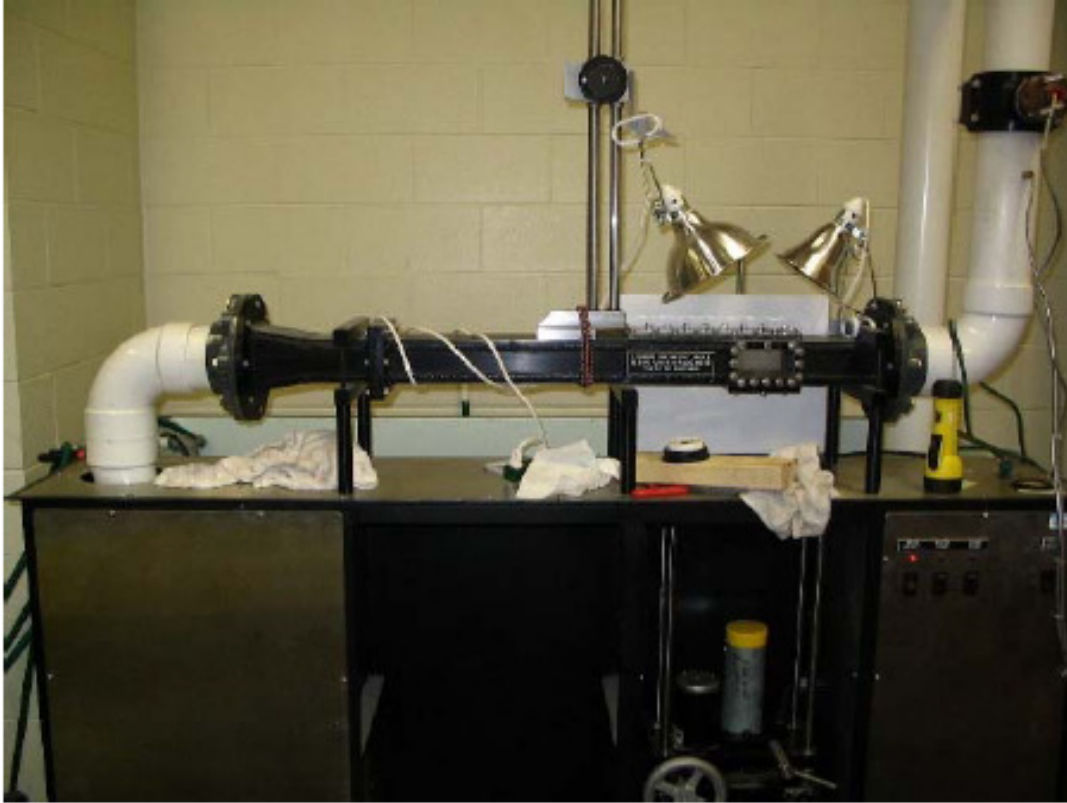
Figure 2-1. Erosion Function Apparatus

The quality of the SRICOS prediction is based on the results from the EFA test that is performed on site specific samples. The Erosion Function Apparatus is a closed-channel, flume-like machine equipped with a pump and a stepping motor (Briaud et al. 2001b). The bottom of the flume has a circular opening for testing a Shelby tube sample with a diameter of 76.2 mm. A watertight seal is created between the Shelby tube and the flume by an O-ring. The cross section of the rectangular flume is 101.6 mm x 50.8 mm. The total length of the flume measures 1.22 m. The pump is regulated by a valve on the front of the EFA, and generates velocities ranging from 0.1 to 6 meters per second (m/s). The Shelby tube is held flush at the bottom of the flume during testing. A piston attached to the stepping motor protrudes the sample from the Shelby tube into the flume in 1 mm increments (Briaud et al. 2001b). The EFA can be viewed in Figure 2-1 below. The EFA is instrumented with a thermistor and a paddle flow meter to electronically monitor the temperature and flow rate using a computer.

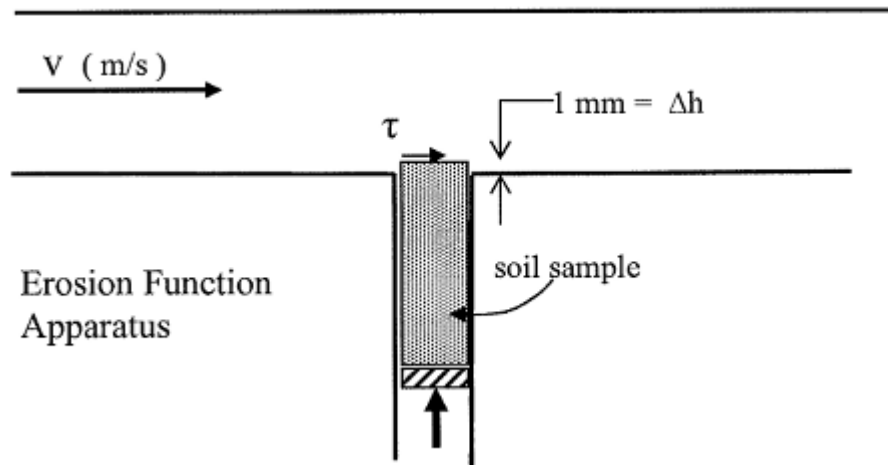
Figure 2-2. Schematic of EFA Test

The first step in performing an EFA test proposed by Briaud is to place the sample in the EFA, fill the flume with water and wait an hour to mimic stream conditions. Next the flume velocity is set to 0.3 m/s and the sample was advanced 1 mm into the flume. The EFA is equipped with a viewing glass so that a technician can observe the erosion of the sample. After the sample is advanced 1 mm, as shown in Figure 2-2, the technician measures how much time it takes for the 1 mm sample protrusion to erode. After 1 mm has eroded, or after one hour of testing, the sample is advanced to the 1 mm protrusion location and the velocity increased is to 0.6 m/s. The erosion of the sample is again monitored, and the time for the current 1 mm protrusion to erode is recorded. The sample is sequentially advanced and the erosion timed for velocities of 1 m/s, 1.5 m/s, 2.0 m/s, 3/0 m/s, 4.5 m/s, and 6 m/s (Briaud et al. 2001b). A schematic of a prepared EFA test is shown in Figure 2-2 (Mobley 2009).

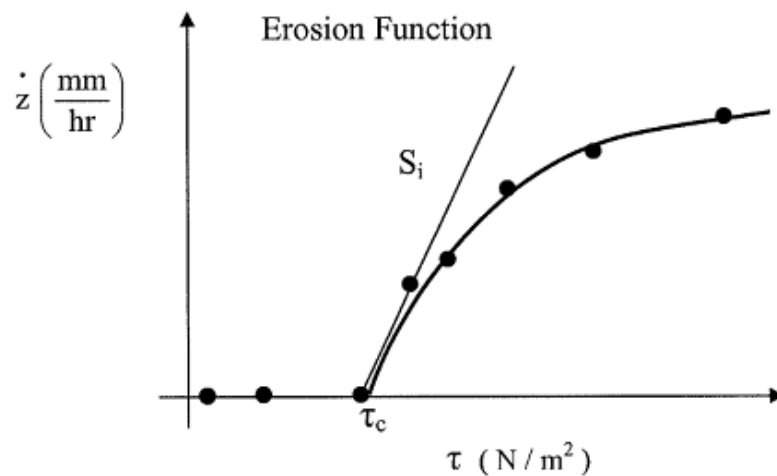
Figure 2-3. Typical Erosion Function

The results from the EFA are used to create an erosion function, which is used in the scour calculations of the SRICOS method. An example of an erosion function can be viewed in Figure 2-3 (Mobley 2009). The erosion function is a derived from a velocity versus erosion rate relationship that is created from the EFA data. An erosion function shows the relationship between erosion rate (z) and shear stress (τ) for a given soil. Velocity is related to shear stress by using the geometry of the flume, density of water, and friction factor obtained from a Moody Chart. It is imperative the erosion function encompass all shear stresses expected in the stream bed during design flood conditions.

Other than the relationship between shear stress and erosion rate, an erosion function provides two critical values that are used in scour predictions. The critical shear stress (τ_c) is the bed shear stress at which scour first occurs (Mobley 2009). The critical shear stress is found by observation while performing an EFA test. During erosion testing flow is gradually increased until erosion begins. This velocity is converted to a shear stress, recorded, and plotted on the erosion function. The initial erodibility (S_i) measures the rate of scour just after the critical shear stress is reached. The initial erodibility is calculated by drawing a line tangent to the erosion function through the critical shear stress (Crim 2003). Generally, initial erodibility is higher in sands compared to cohesive soils.

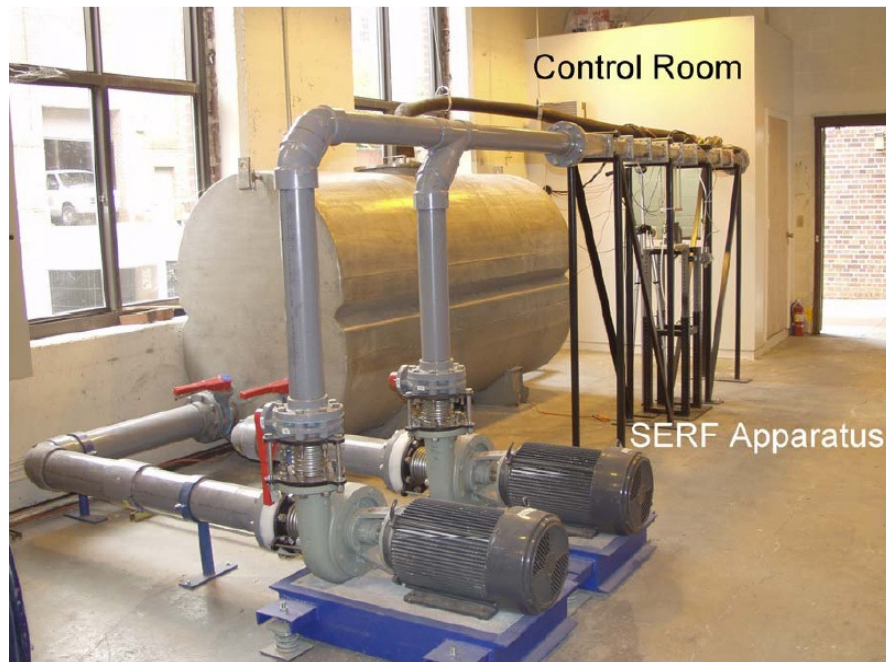
Figure 2-5. Sediment Erosion Rate Flume (SERF)

The Sediment Erosion Rate Flume (SERF) is the second apparatus created at the University of Florida for the purpose of measuring relationships between erosion rate and shear stress. The SERF functions similar to the EFA. Like the EFA, the SERF uses a flume with a rectangular cross section, a water pump, a reservoir, and a stepping motor. The SERF does have a larger water capacity than the EFA, as it utilizes two pumps and has an 1100 gal reservoir. The SERF is much more automated than the EFA, using multiple instruments and a Labview program. Images of the SERF are shown in Figure 2-5 and Figure 2-6.

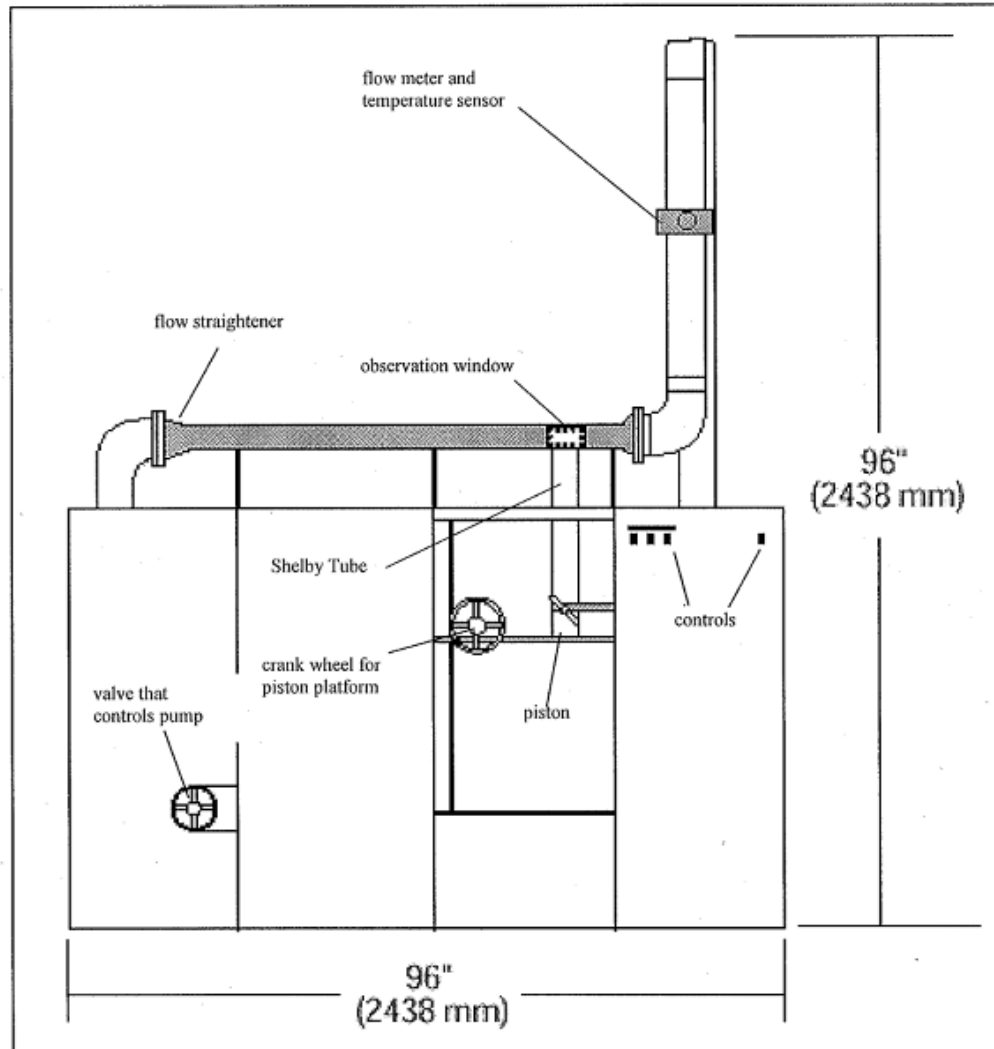
Figure 3-1. Schematic Showing Important Components of the EFA

As stated earlier, the Erosion Function Apparatus is the device Briaud (1999) created at Texas A&M University in order to collect the scour rates used to construct erosion functions. These erosion functions were used to estimate the depth of scour over the design life of a bridge. Figure 2-1 shows an image of an EFA. Figure 3-1 shows a schematic of an EFA featuring all of the integral components used for erosion testing (Crim 2003). The EFA contains a reservoir, a pump, and a flume. Water is pumped from the reservoir, through the flume, and across the sample during testing before being recirculated back into the reservoir. The valve on the front of the EFA is used to regulate the flow velocity during testing. A flow straightener is used to develop a full flow condition before the water flows over the soil sample.

The EFA is instrumented with a flow meter and temperature sensor in order to monitor flow velocity and water temperature during testing. The sample tube is positioned in the flume using the crank wheel attached to the piston platform. The piston platform is then locked into place so that the sample tube positioning does not change during testing. A motor is attached to the piston and the sample can be brought to the proper elevation in the flume by using a control switch. During testing, scour is observed through the observation window. Other controls shown in Figure 3-1 include a power switch to the EFA, a power switch to the pump, and a power switch to a sump pump, which is located in the reservoir.

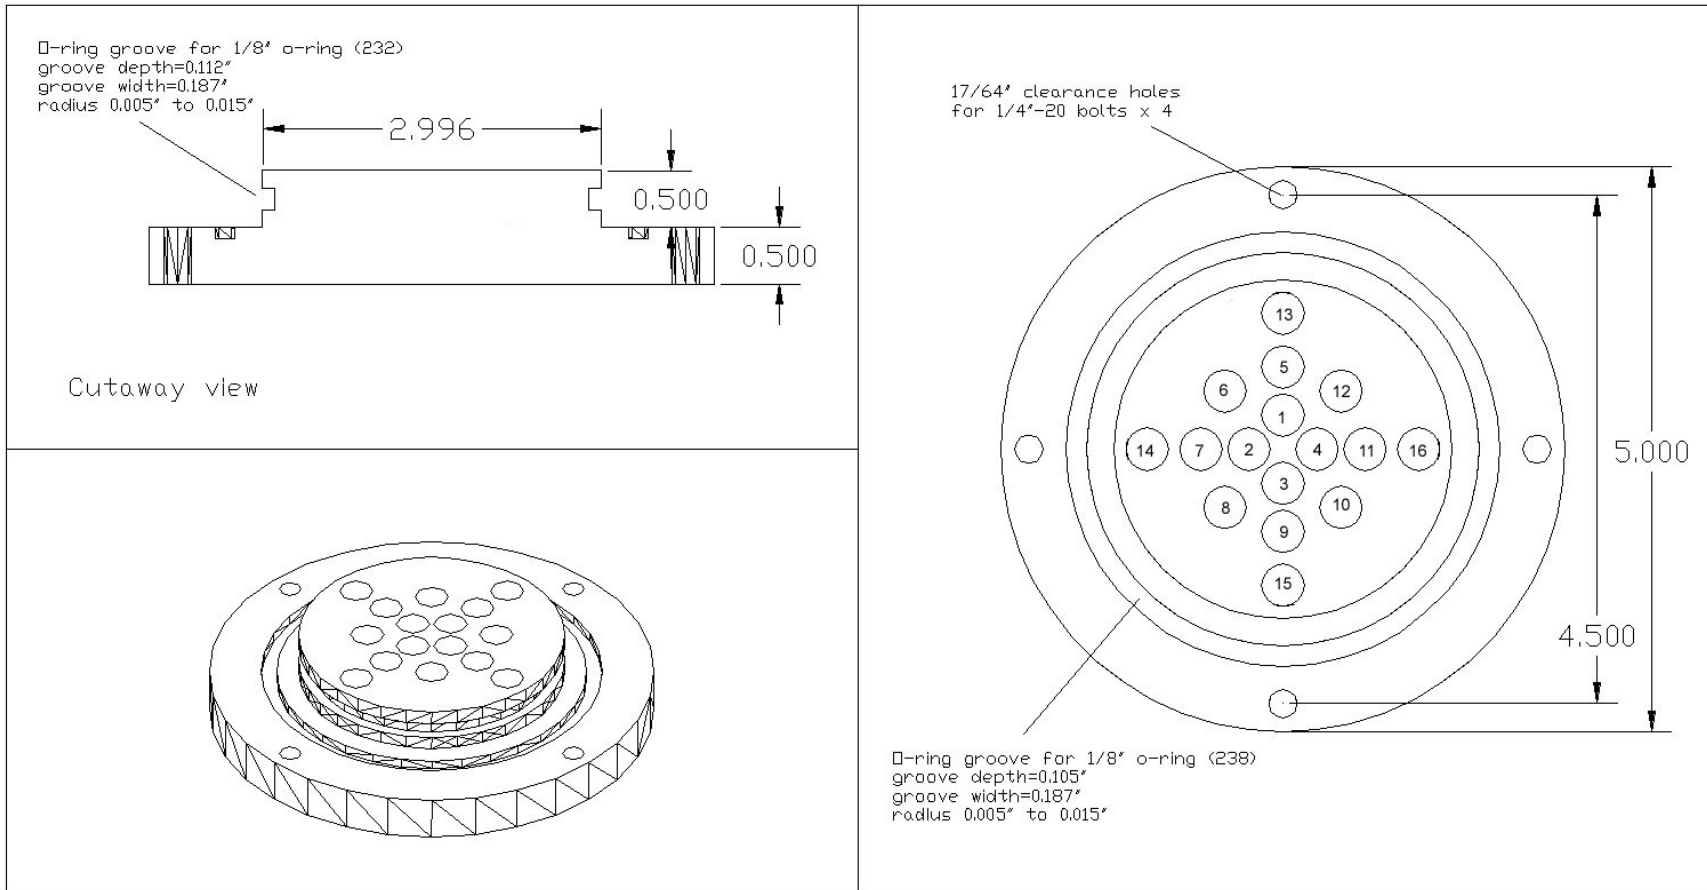
Figure 3-3. Auburn Ultrasonic Sensor Schematic

Similar to the work performed by Sheppard et al. (2005) at the University of Florida, an ultrasonic sensor was designed and installed on Briaud's Erosion Function Apparatus at Auburn University. The SERF created by Sheppard and Bloomquist was designed to not only assist in calculating erosion rates, but to obtain a pattern of erosion. The ultrasonic sensor on the SERF consists of twelve transducers. Eight of the transducers are used in measuring scour of a 7.3 cm sample, while all twelve transducers are used to measure scour of a 9.5 cm sample. The design criteria for the EFA ultrasonic sensor was to create a similar array of transducers that will measure scour in cohesive soils, instead of rock, and consist of a tight grouping of transducers creating a clearly mapped soil surface. This ultrasonic sensor was designed and created with the help of Seatek and consists of sixteen transducers. The sensor is connected to a stainless steel housing, and mounted to the top of the flume of the EFA above the location of the test sample. A schematic of the ultrasonic sensor designed by Seatek is shown below in image 3-3.

The transducers function at 5 MHz, with a physical diameter of 0.5 cm and an acoustic footprint of 0.8 cm at a distance of 5 cm (Jette 2010). The ultrasonic sensor was set into an aluminum cover, which replaced the original acrylic cover of the EFA. The ultrasonic sensor was sealed to the aluminum cover by using two O-rings. Careful considerations were made to ensure that the ultrasonic sensor was flush with the bottom on the EFA aluminum cover. The ultrasonic sensor could not protrude from the EFA cap, as this would result in irregular flow conditions. The ultrasonic sensor also could not be raised above the EFA cap, as the transducers must be submerged to function properly. The ultrasonic sensor is able to collect data from 16 different points across the area of a Shelby tube soil sample (71.12 mm). Also 12 data points can be obtained from standard rock coring soil samples, which is convenient if a soil formation is too stiff to be sampled by pushing Shelby Tubes.

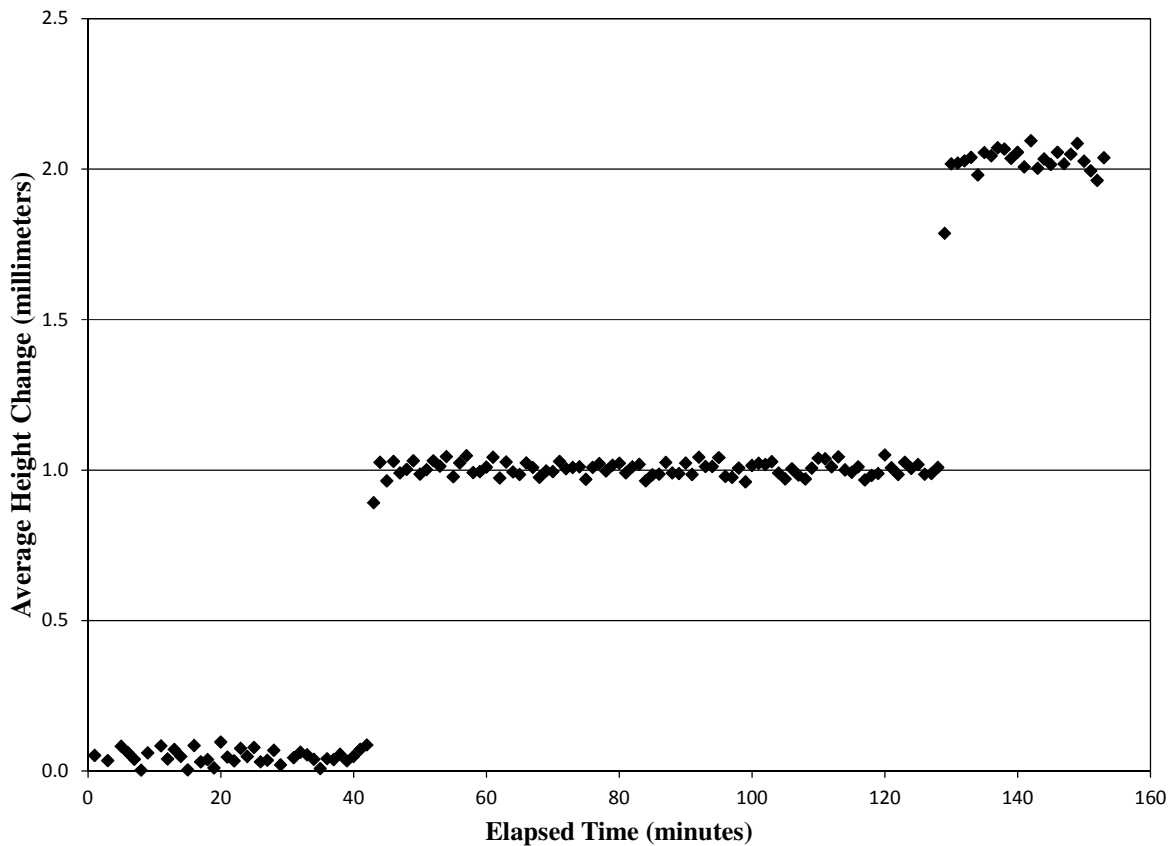
Figure 3-10. Sensor Verification Test

produced the expected results, as one millimeter jumps are observed at 42 and 128 minutes. It is important to notice that variation in these readings were small, with a maximum of 0.08 mm from the target distance. These small variations could be attributed to variations in errant scans or temperature corrections.

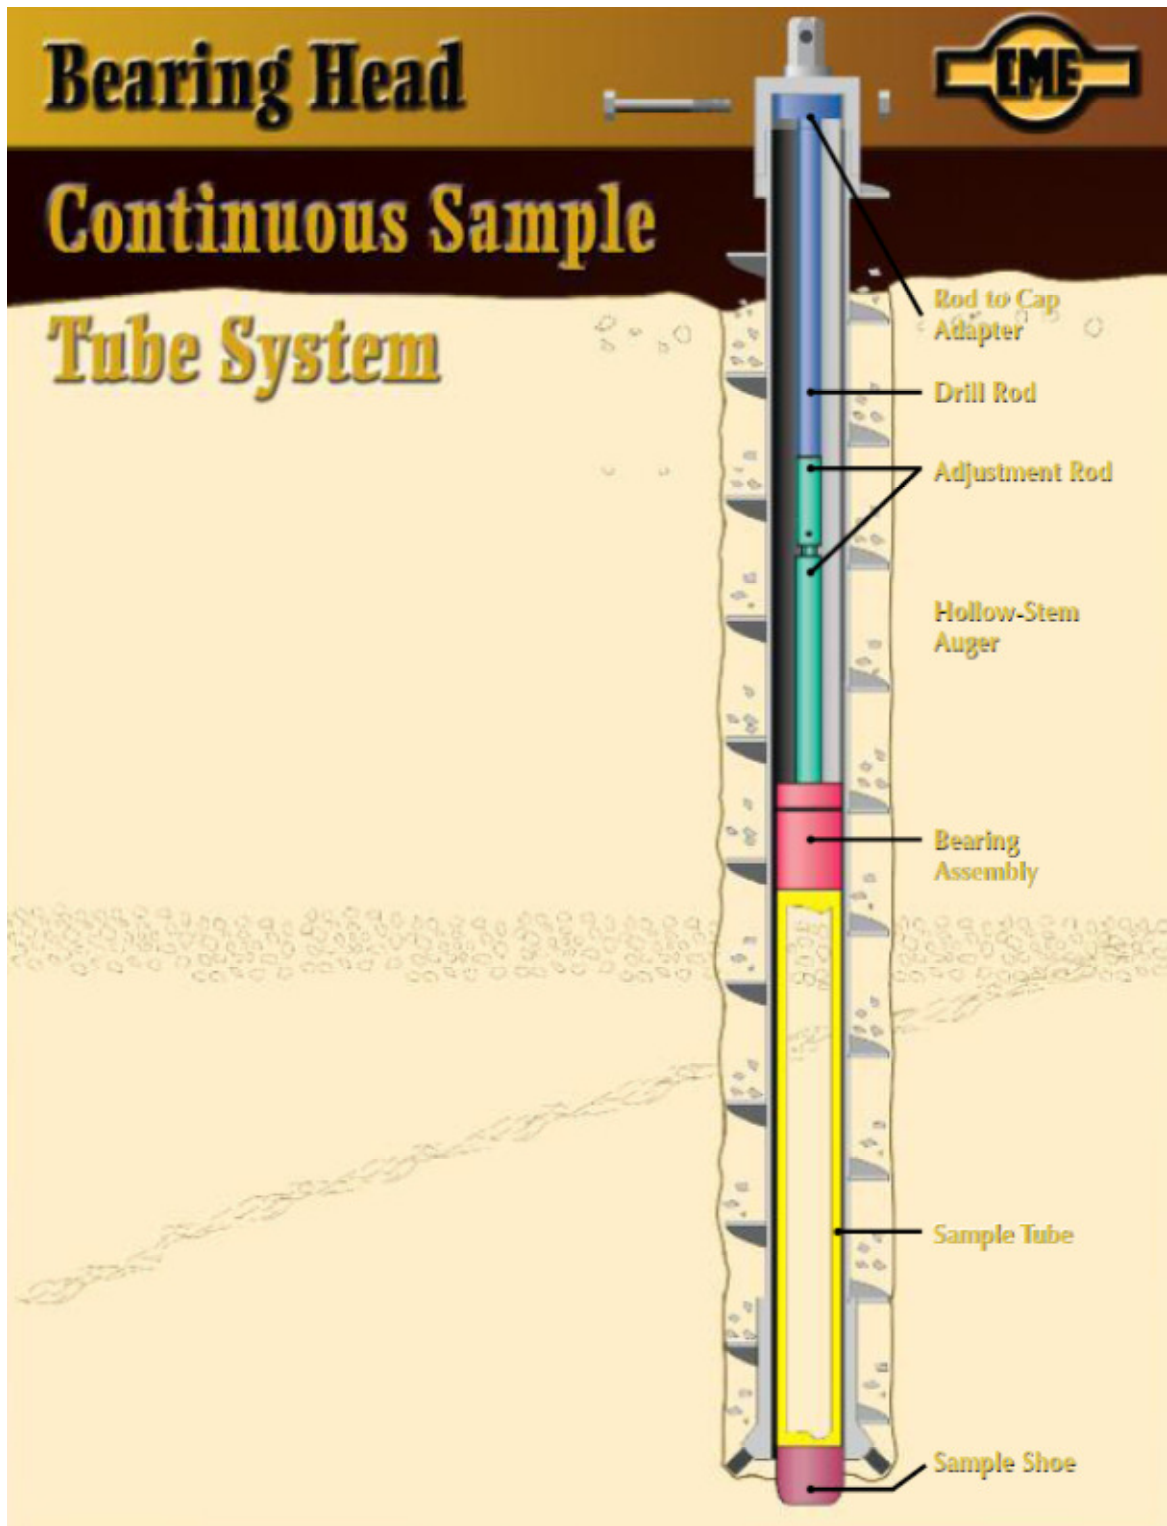
Figure 3-11. CME Continuous Sampling System

During a typical sampling trip ALDOT geologists located possible drilling sites containing the target formations. ALDOT geologists also determined the depth where the target formation was reached. Once the target formation was confirmed from drill cuttings and split spoon samples, a Standard Penetration Test (SPT) was performed to obtain the SPT N value for each formation. Typically two to three standard penetration tests were performed in each formation depending on the approximate depth of the formation provided by the ALDOT geologist. Once the SPT was completed, the AW rod was removed from the boring and a hollow stem auger was used to the depth of the previously drilled hole. Typically a Shelby Tube was pushed inside the hollow stem auger to ensure that any loose cuttings would not be sampled. Sampling was then performed as described above with the CME continuous sampling system. Typically 2-3 continuous samples were gathered in each formation resulting in 4-6 sample tubes. It was believed that obtaining 1.5-2.3 m of each formation would be sufficient for both EFA testing and geotechnical testing. After collection, sample tubes were capped and taped to maintain field moisture conditions. Since EFA and geotechnical testing could take place months after sampling, samples were stored in a curing room to preserve field moisture conditions. Sample tubes were also marked according to depth and formation prior to storage.

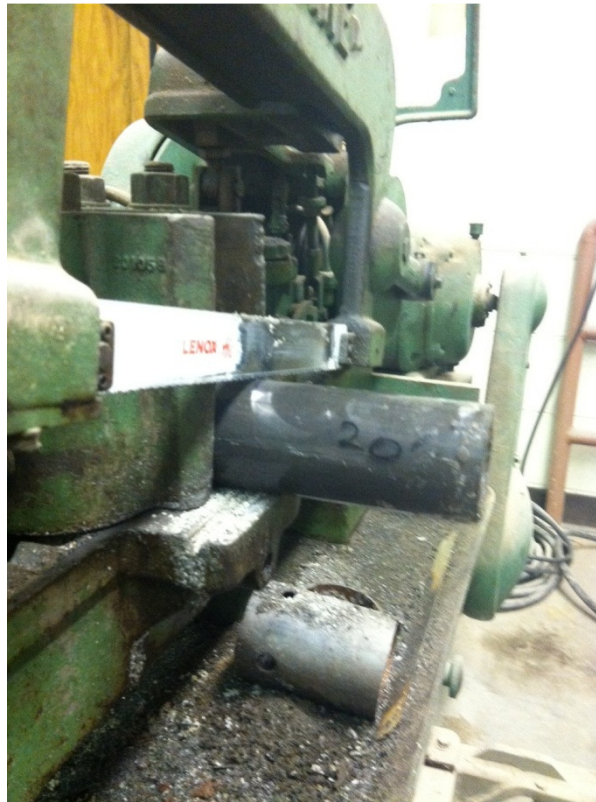
Figure 3-12. Automatically Advancing Hacksaw Cutting Sample Tube

A testable EFA sample was not cracked radially or longitudinally with a length of at least 101 mm. It was important that testable sections were not cracked as cracks would have induced shear planes that would alter the results of testing. A typical sample tube had an outside diameter of 63.5 mm, an inside or sample diameter of 57.2 mm, and a length of 762 mm. The pushing arm of the EFA could accommodate a sample tube length up to 457 mm. An automatically advancing hacksaw was used to cut the sample tubes to accommodate the dimensions of the EFA. A testable section for the EFA was located and marked on the sample tube. The section was then loaded into the saw and clamped to ensure that a square cut was made. It was important the clamp was not so tight to distort the acrylic tube. Figure 3-12 below shows a sample section being cut with the automatically advancing hacksaw.

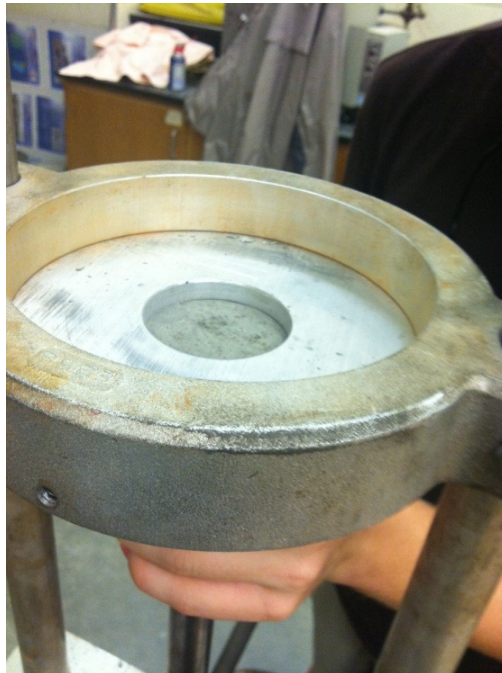
Figure 3-13. Extruding Sample

Once the sample section was cut, the sample was extruded approximately 5 mm in order to prepare the surface for testing. Using a spatula the surface of the sample was cleaned of any loose debris. The sample was also cut level with the sample tube, and the surface was smoothed with the spatula. At times a wire saw was used along with a spatula to prepare the surface for testing. Figure 3-13 shows the sample being extruded, and Figure 3-14 shows the sample surface being prepared for testing.

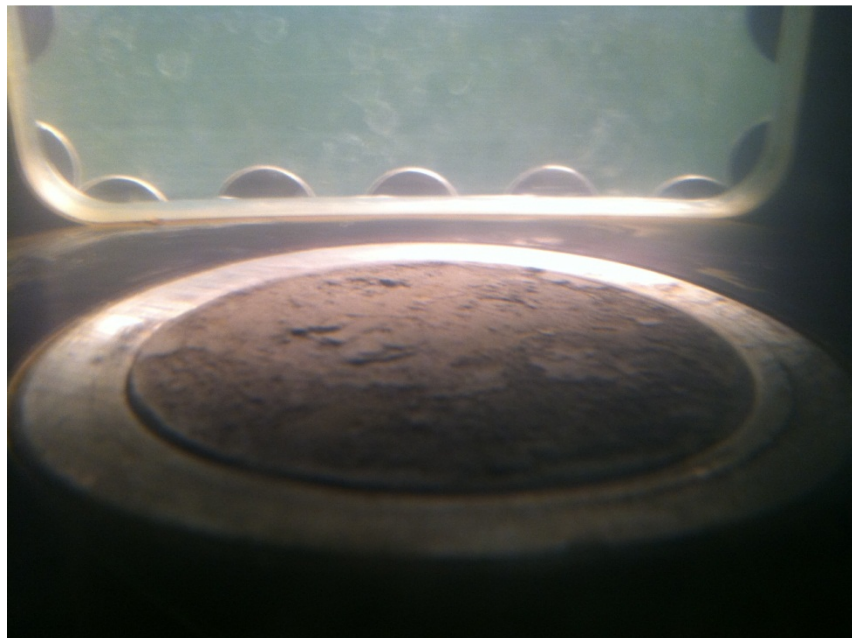
Figure 3-16. Soil Sample in EFA Level with Base of Flume

10. Using the stepping motor, the sample was advanced through the base plate until the sample is level with the base of the flume. Figure 3-15 shows the soil plunger being pushed against the base of the soil sample, and Figure 3-16 shows the sample pushed level with the base of the flume.

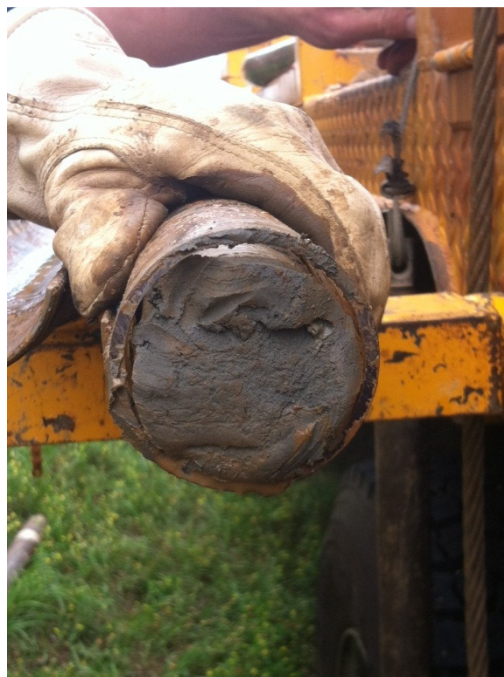
Figure 4-2. Bucatunna Clay Sample Smaller Radially than Sample Tube

The continuous sample from 4.11 m to 5.64 m was determined to be unusable for EFA testing. The top of the sample was not usable as it had a plug missing from the Standard Penetration test taken above. The sample gathered from 4.11 to 5.64 m was also smaller radially than the sample tube at the base of the sample as shown in Figure 4-2.

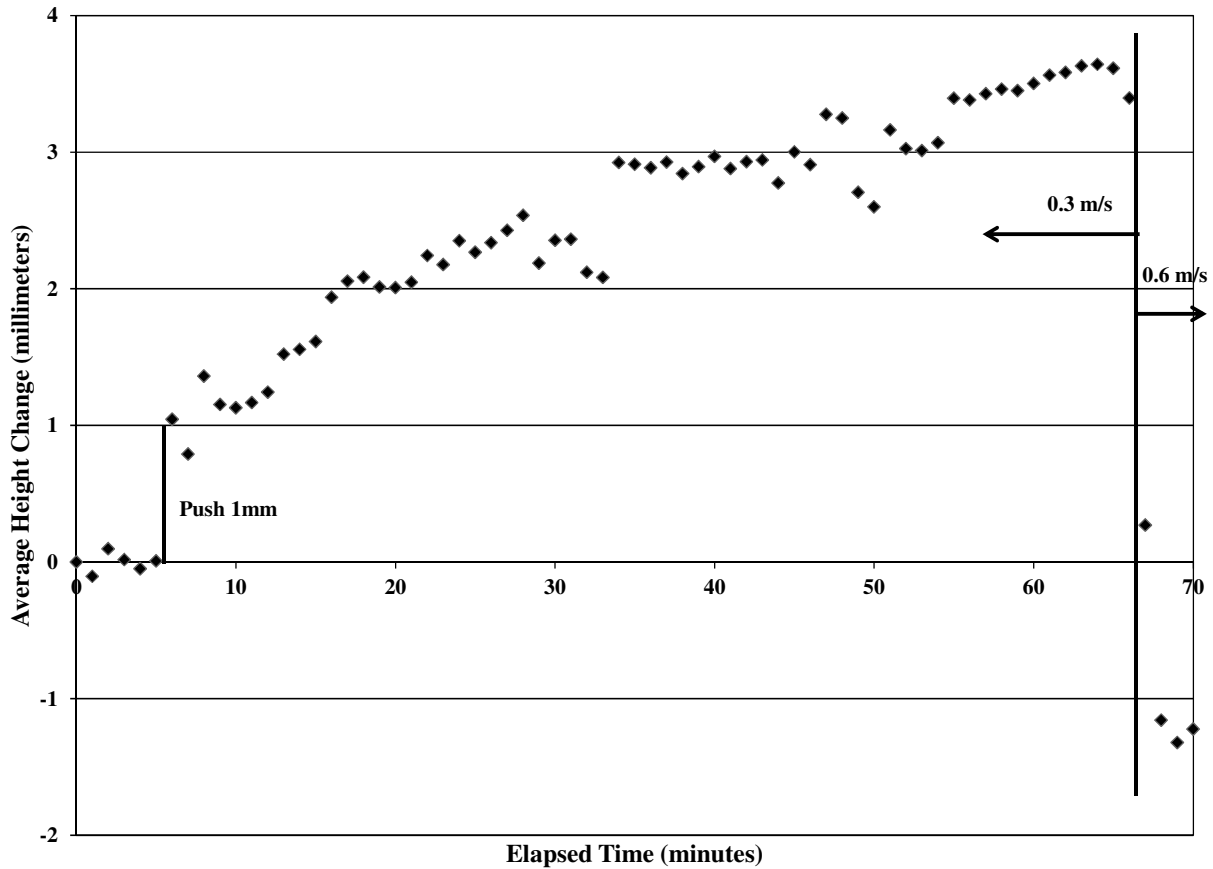
Figure 4-3. “Bucatanna 27.0_1” Results

The Bucatunna Clay was the first formation tested at Auburn University using the ultrasonic sensor and data acquisition system. In total 32 EFA tests were performed on the Bucatunna Clay formation with 27 tests providing results for determining a scour rate versus velocity relationship. The first sample used for EFA testing was located at approximately 8.22 m below the ground surface. The first test titled “Bucatunna27.0_1” was performed to determine a starting velocity for testing. The data collected from “Bucatunna27.0_1” is shown below in Figure 4-3.

The “Bucatanna 27.0_1” test specimen began at a starting velocity of 0.3 m/s, and was advanced 1mm into the flume after approximately 5 minutes. This can be viewed in the bump at the five minute mark in Figure 4-3, and further proves the validity of the ultrasonic sensor. The “Bucatanna 27.0_1” sample actually showed a net gain in height over the next hour while the velocity was held at 0.3 m/s. This seemed odd that the sample was actually rising into the flume as the shear stress was applied to the sample, but this movement was visually confirmed. After one hour, no scour was observed and the sample had raised an average of 2.5 mm. It was believed that this swelling was due to the Bucatanna Clay being a swelling clay formation, and this issue would be confirmed during geotechnical testing. Once the flume velocity was increased to 0.6 m/s the “Bucatanna27.0_1” sample scoured drastically, as shown in Figure 4-3.

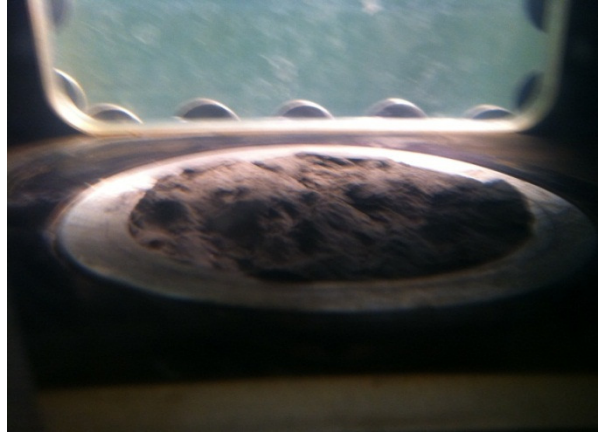
Figure 4-4. “Bucatumna 23.0_4” After Erosion Occurred

The final test performed on the Bucatunna Clay formation was aimed at determining the critical shear velocity of the formation. Since previous tests on the Bucatunna Clay formation was scour resistant, and actually swelled, at 0.3 meters per second and scoured at 0.6 m/s, the critical shear velocity was located between the two velocities. The test titled “Bucatanunna 23.0_4” was started with a flume velocity of 0.3 m/s and gradually increased until scour was observed. The flume velocity was held between 0.35 and 0.4 m/s for approximately 15 minutes, and again swelling was observed instead of scour. Slowly the flume velocity was increased between 0.45 and 0.5 m/s. At this velocity a large chunk eroded from the sample. Figure 4-4 below shows the sample immediately after erosion occurred. This image agrees with the ultrasonic sensor, while portions of the sample are located above the base of the flume, the majority of the sample has eroded in deep pockets below the flume. From this test it was determined that the threshold velocity was 0.45 m/s.

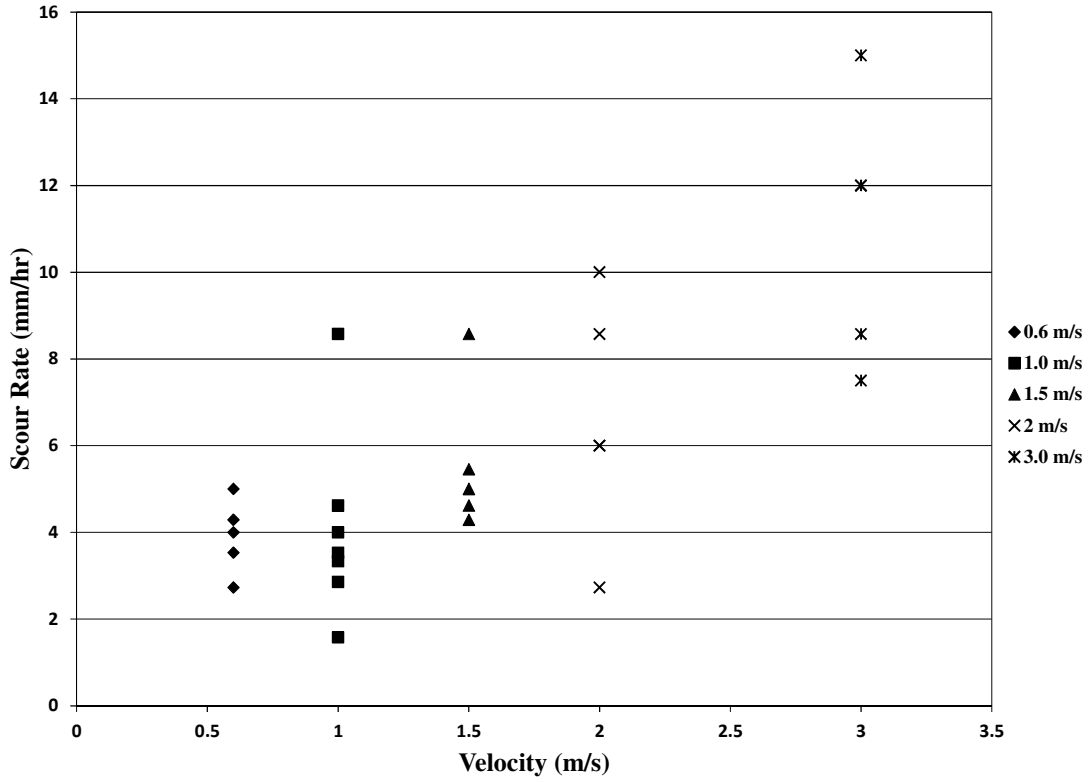
Figure 4-5. EFA Tests Results, Bucatunna Clay

As previously stated a total of 27 EFA tests were performed on the Bucatumna Clay formation at five different velocities. Figure 4-5 below shows the all of the results for the EFA test results with respect to scour rate and flume velocity. For the most part the data sets are tightly bunched with similar scour rates at each velocity interval. Figure 4-6 below shows the drawn-in velocity versus scour rate curve for the Bucatumna Clay formation as derived from the mean scour rate at each velocity.

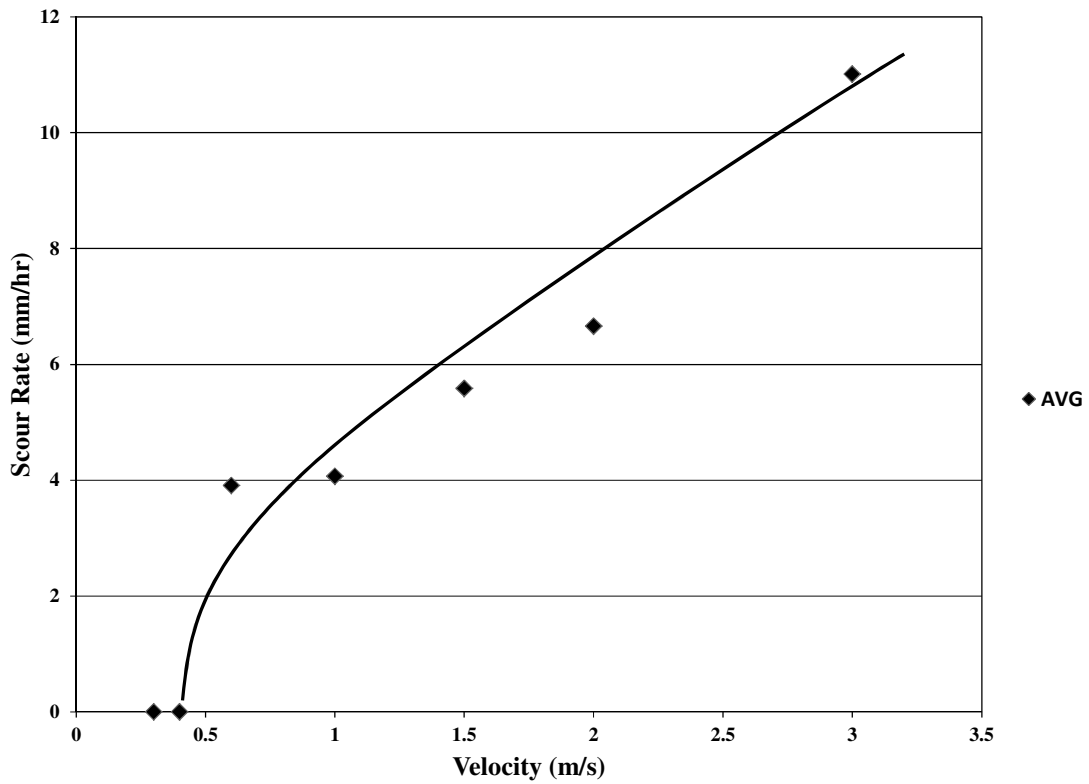
Figure 4-6. Bucatunna Clay Velocity versus Scour Rate

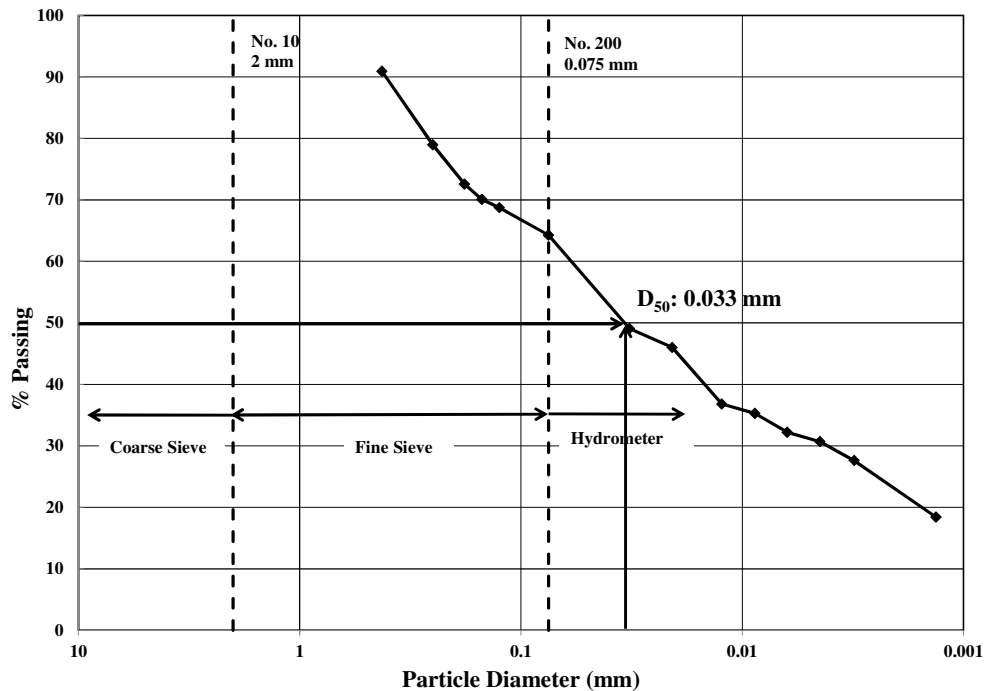
Figure 4-7. Bucatunna Clay Grain Size Distribution

As part of the scope of this research several common geotechnical index tests were performed on the Bucatunna Clay formation. Two initial moisture contents were taken to obtain the insitu moisture content of the formation prior to EFA testing. These tests yielded moisture contents of 49.5 and 46.2 percent, with an average of 47.9 percent. Using ASTM D421, several kilograms of the soil obtained during sampling was processed and oven dried. Using this processed soil, a full grain size distribution was performed on the formation following ASTM D422. The results of the grain size analysis are shown in Figure 4-7. Since this research revolved around fine-grained materials, a coarse sieve analysis was not performed as the maximum particle size diameter for this formation was approximately 0.43 mm. From the grain size analysis the mean particle diameter (D_{50}) was calculated to be 0.033 mm. Approximately 65 percent of the sample passed the number 200 sieve, classifying the formation in the silt and clay family.

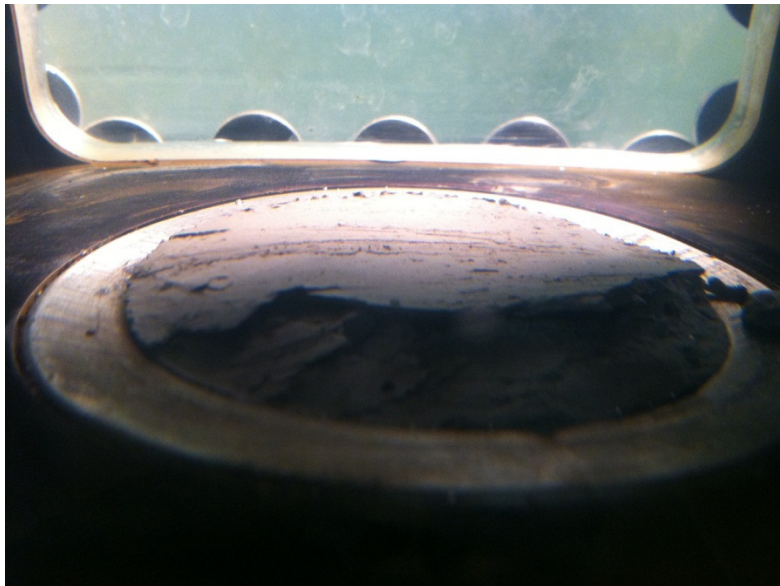
Figure 4-8. “Yazoo Clay 18.5_1” Test Failure Wedge

The first test performed on the Yazoo Clay formation was used to help determine the starting test velocity and was titled “Yazoo Clay 18.5_1”. The “Yazoo Clay 18.5_1” test started with a flume velocity of 0.3 m/s, and scour was not observed. After one hour the flume velocity was increased to 0.45 m/s and immediately a wedge of the sample scoured away. This wedge developed shortly after the test was started and grew in size throughout the test, and image of this wedge can be viewed in Figure 4-8. However, since this method of failure had not yet been observed a second test titled “Yazoo Clay 18.5_2” was performed starting at a flume velocity of 0.45 m/s.

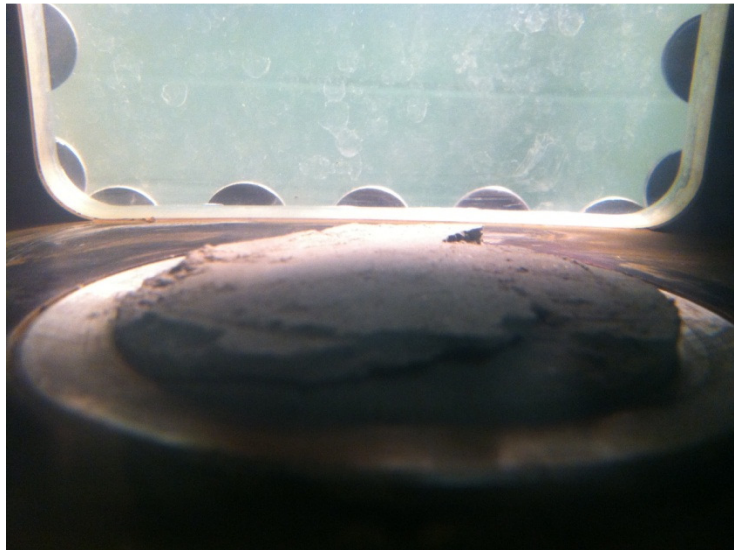
Figure 4-9. “Yazoo Clay 18.5_2” Test Swelling and Cracking

m/s. During this time the test sample rose and average of 1.75 mm, and developed a large crack in the center of the sample as shown in Figure 4-9. After the test sample was exposed for 25 minutes at a flume velocity of 1.0 m/s, the sample scoured well below the bottom of flume as shown in Figure 4-10. The test results showing the gradual swell in the “Yazoo Clay 18.5_2” test can be viewed in Figure 4-11. The test was analyzed and it was determined that the testing regiment should be started at a flume velocity of 1.0 m/s.

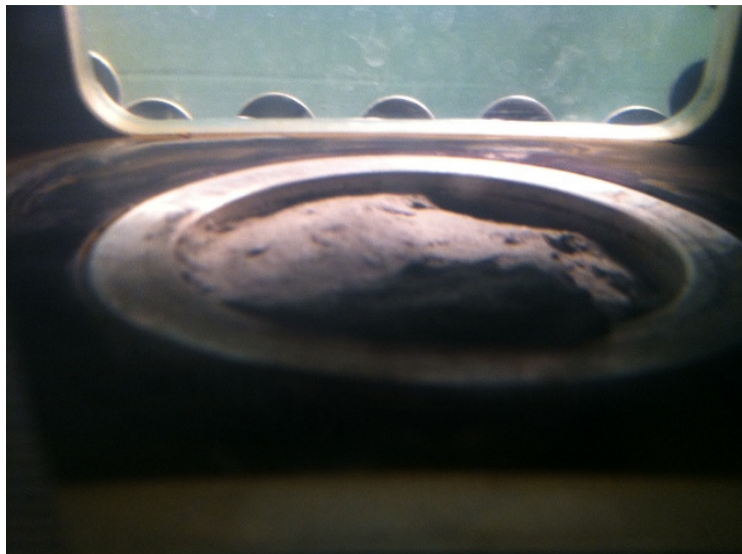
Figure 4-10. “Yazoo Clay 18.5_2” Test After Failure

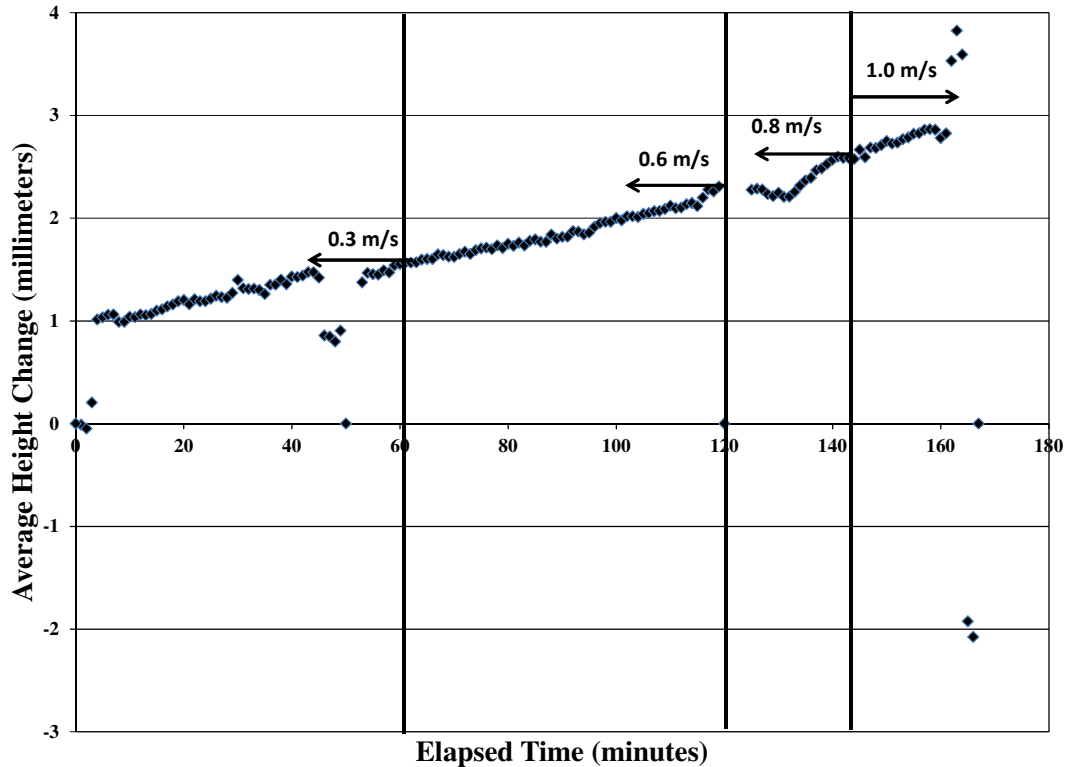
Figure 4-11. “Yazoo Clay 18.5_2” Test Results

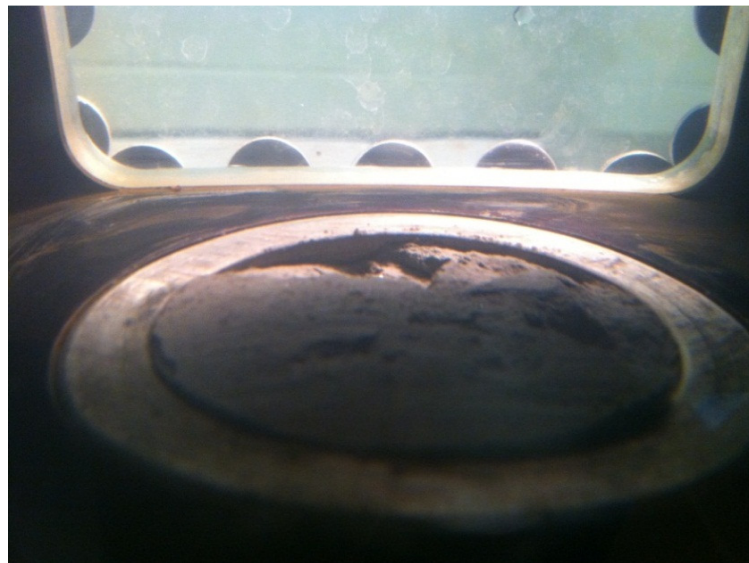
Figure 4-12. “Yazoo Clay 18.5_9” Test Scoured Area from Front

Since the two samples that were tested at a flume velocity of 1.5 m/s showed smaller amounts of scour than the tests at 1.0 m/s, the testing schedule was continued at a flume velocity of 2.0 m/s. Overall the average scour rate of the two tests performed at a flume velocity of 1.5 m/s was 0.70 mm/hr. A summary of these two tests is shown in Table 4-7.

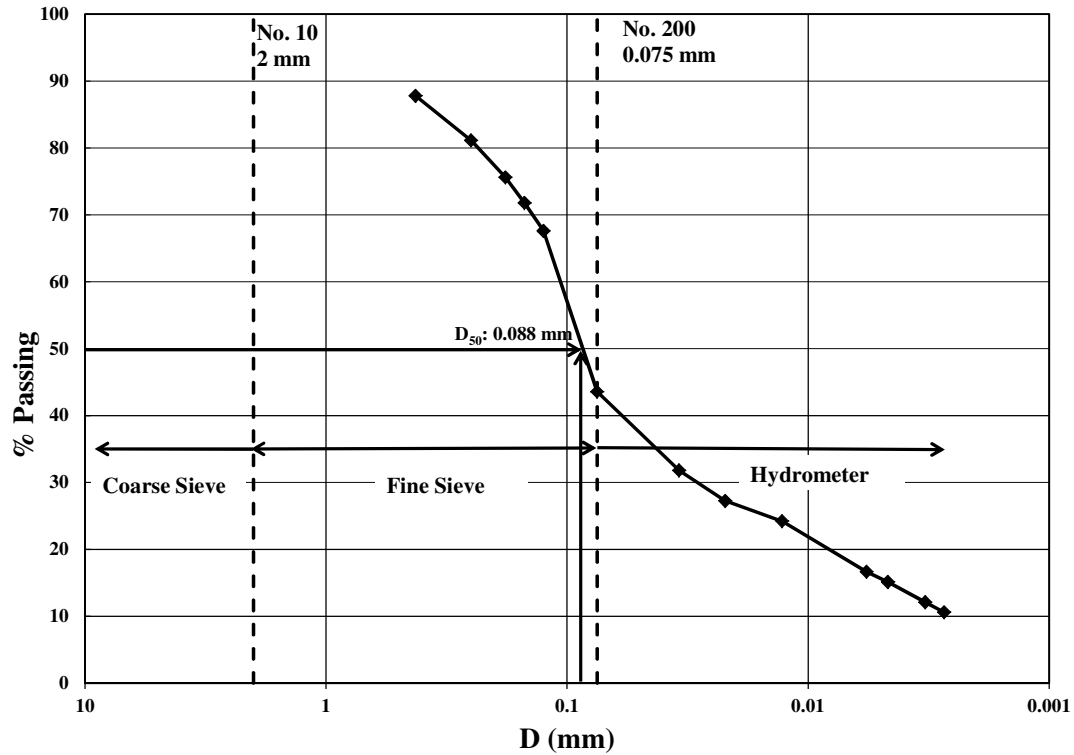
Figure 4-14. Yazoo Clay Formation Grain Size Distribution

Atterberg limits were performed to complete the soil classification and geotechnical testing of the Yazoo Clay formation. The liquid limit was determined to be approximately 57, and the formation was determined to be non-plastic. Using these values along with the information gathered from the grain size distribution, the sample was classified as a non-plastic silty sand (USCS Classification SM).

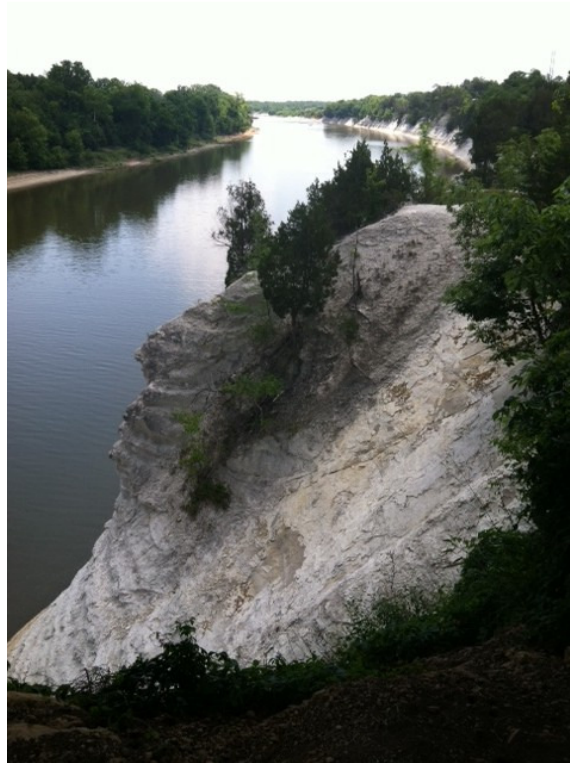
Figure 4-15. Demopolis Clay Formation Sampling Location

The Demopolis Chalk formation was sampled on May 5, 2012 in Sumter County, Alabama. An ALDOT geologist classified the Demopolis Chalk formation as a very stiff light gray chalk. The Demopolis Chalk formation was sampled beside a bridge crossing the

Tombigbee River. An outcrop of the formation could be viewed in the bluffs comprising the river bed. These bluffs were approximately 15 m above the river, entirely comprised of the Demopolis Chalk formation. These bluffs can be viewed below in Figure 4-15.
