Scour Potential of Cohesive Soils

A thesis submitted to the Graduate Faculty of
Auburn University
in partial fulfillment of the
requirements for the Degree of
Master of Science

Auburn, Alabama
August 3, 2013

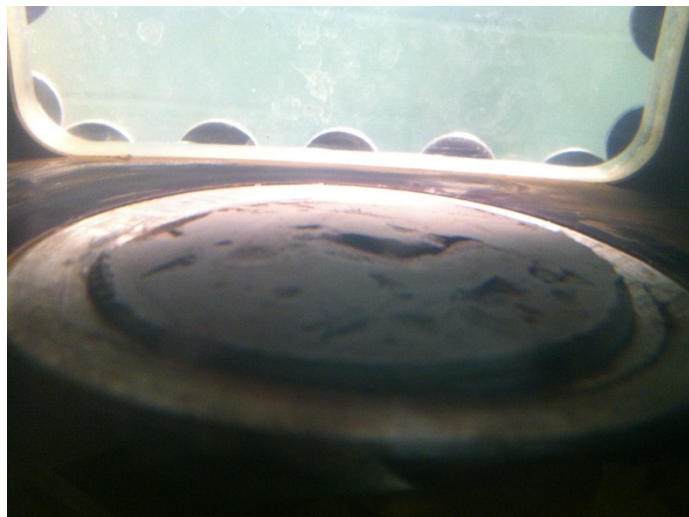
Figure 4-16. “DemopolisChalk19.0_5” After Testing

The results of all five tests may be viewed in Appendix C. This was the first sample tested in this study that did not exhibit any scour behavior with the set testing regiment. In case future testing of the Demopolis Chalk formation is necessary, the remaining testable section of the formation was sealed and placed into a curing chamber to preserve field moisture conditions.

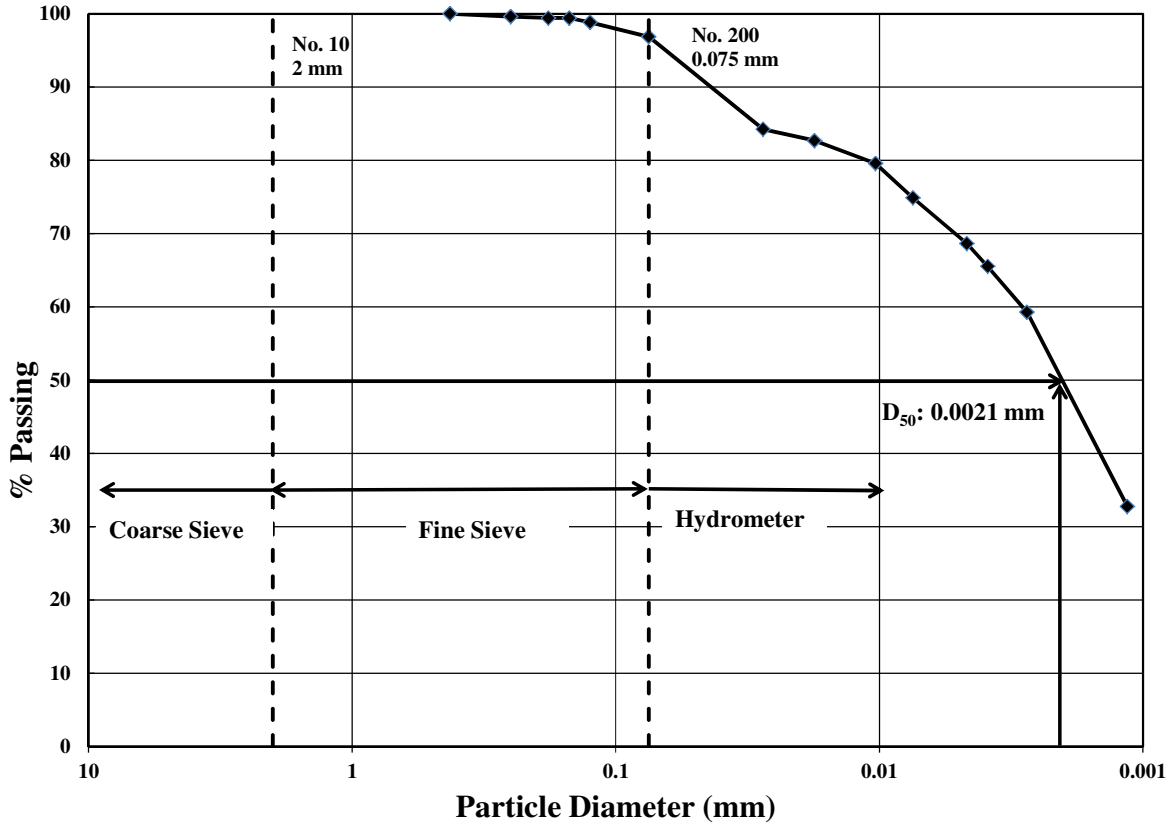
Figure 4-17. Demopolis Chalk Formation Grain Size Distribution

analysis on the Demopolis Chalk showed that the formation consisted of very fine-grained particles with approximately 97 percent of the sample passing the number 200 sieve. From the grain size analysis the mean particle diameter was calculated to be 0.021 mm.

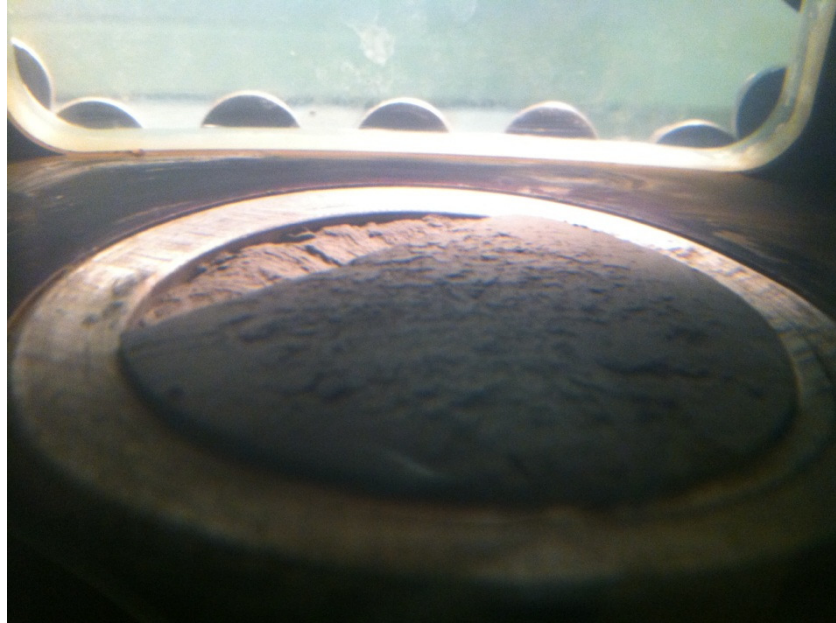
Figure 4-18. “MoorevilleChalk22.0_7” After Testing

Two EFA tests were performed at a flume rate of 1.5 m/s on the Mooreville Chalk formation. The first of these two tests was titled “MoorevilleChalk22.0_7” and resulted in one third of the volume of the protrusion being scoured away by one large chunk in the upstream portion of the sample. The final result of this test can be viewed below in Figure 4-18. The second test performed at a flume velocity of 1.5 m/s resulted in no measurable amount of scour. The only scour was that occurred during this test was witnessed visually and consisted of the rounding off of the front edges of the sample similar to that witnessed in testing the Demopolis Chalk formation.

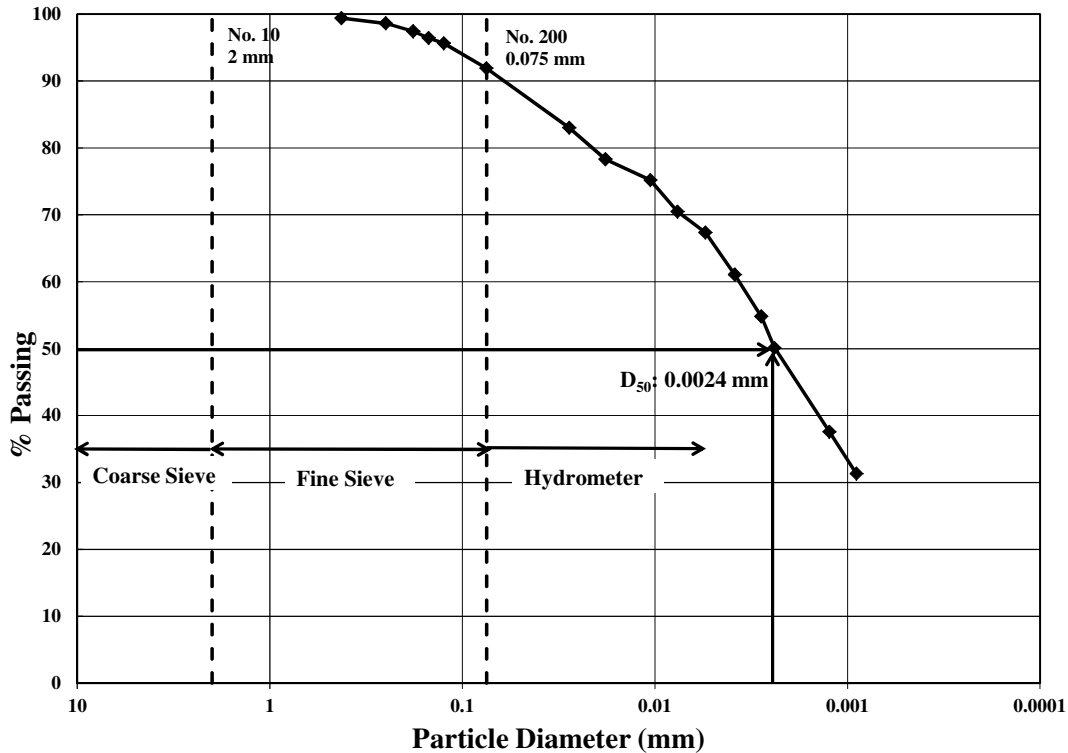
Figure 4-19. Mooreville Chalk Formation Grain Size Distribution

Two initial moisture contents were taken to obtain the insitu moisture content of the Mooreville Chalk formation. These tests yielded moisture contents of 21.9 and 24.9 percent, with an average of 23.4 percent. Using soil processed by following ASTM D421, a full grain size distribution was performed on the formation following ASTM D422. The results of the grain size analysis can be viewed below in Figure 4-19. The grain size analysis on the Mooreville Chalk showed that the formation consisted of very fine-grained particles with approximately 92 percent of the sample passing the number 200 sieve. From the grain size analysis the mean particle diameter (D_{50}) was calculated to be 0.024 mm. The mean particle diameter and percent of the Mooreville Chalk sample passing the number 200 sieve mirrored that of the Demopolis Chalk formation. Also after 24 hours in the Hydrometer both formations had at least thirty percent of the sample still in solution.

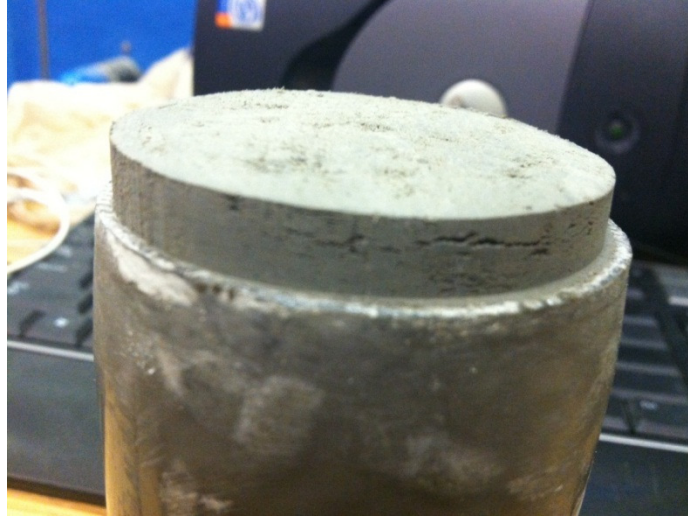
Figure 4-20. Prairie Bluff Chalk Formation Cracking Example 1

The first test on the Prairie Bluff Chalk formation started at a flume velocity of 1.0 m/s. The protrusion into the flume was calculated to be 1.51 mm or fifty percent higher than the height specified by Briaud. After fifty minutes a large mass chunk scoured away, the volume of the scoured section was approximately equal to five times the volume of the protrusion. It was noted during testing that the sample seemed dry and loose in some areas, and that the large scoured volume started from the loose areas of the sample. Another EFA test was performed at a flume velocity of 1.0 m/s, with a total protrusion of 1.85 mm. No scour was observed during this test, suggesting that the flume velocity should be increased for future tests. The idea that the test samples that had altered tubes and been manually advanced were exposed to differing stress states than initially intended during EFA testing was confirmed during testing of the Prairie Bluff Chalk formation. It was thought that these samples were exposed to shear or torsional forces during extruding. This idea was reinforced by cracking on the edges of the advanced sample as viewed in Figure 4-20 and Figure 4-21. These shear and torsional forces could have been developed through an eccentricity between the bowed sample tube and the extruder advancing the sample. It is unknown if these forces negatively influenced EFA testing. It was noted that these cracks that developed in the EFA sample created shear planes for scouring to occur that would not naturally exist in a stream bed.

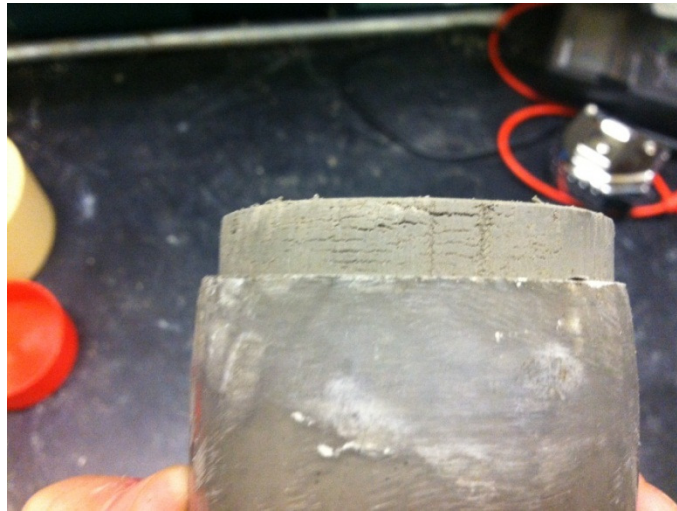
Figure 4-21. Prairie Bluff Chalk Formation Cracking Example 2

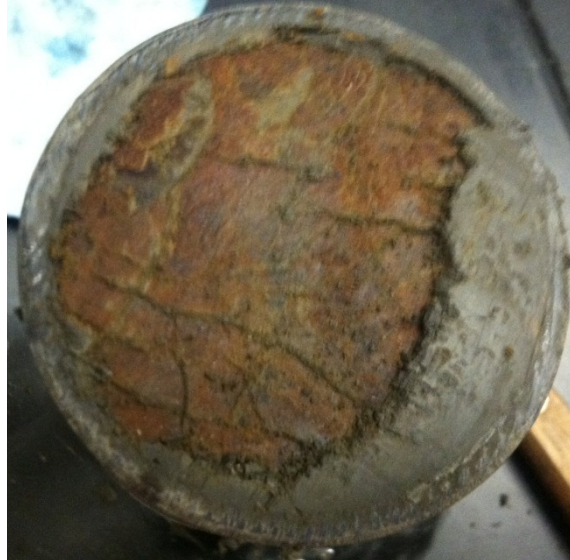
Figure 4-23. Porter’s Creek Clay Formation Scoured along Weathered Planes

During testing of the Porter’s Creek Clay formation it was noted that weathered planes existed within the tested samples. It was also noted that scour typically started on or around these weathered planes, which appeared to be planes of weakness with respect to scour resistance. As a result of these weathered lines and planes in the prepared sample four EFA tests were abandoned immediately following advancement into the flume. All four of these tests had large mass scouring occur at the location of the weathered planes immediately following the push. The volume of scour was not measured by the ultrasonic sensor as scour occurred very quickly before a scan from the sensor could be performed. Visually the volume of scour in these four instances was greater than the one millimeter protrusion into the flume. An image of these weathered lines and planes can be viewed below in Figure 4-23. When the weathered lines were noticed in split spoon samples during sampling the ALDOT geologist confirmed that this weathering pattern was quite common in samples from the Porter’s Creek Clay formation.

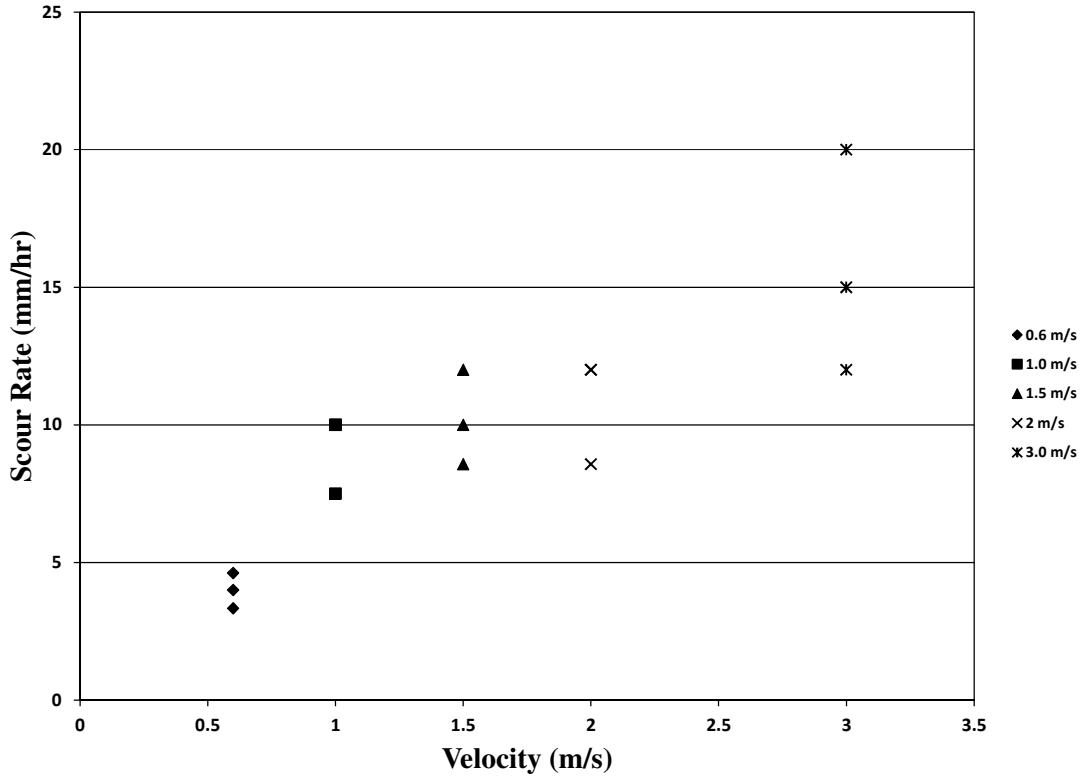
Figure 4-24. EFA Test Results, Porter's Creek Clay Formation

The last test performed on the Porter’s Creek Clay formation was intended to determine the threshold velocity, which scour first occurs. From previous tests it was determined that the threshold velocity, or critical shear velocity, was between 0.3 and 0.6 m/s. The velocity during the first test performed on the Porter’s Creek Clay formation typically ranged from 0.3 to 0.35 m/s. The velocity for the final test on the formation, titled “Porter’s Creek Clay 18.75_1”, was started at 0.4 meters per second. At first surface scouring began to occur, at a reduced rate of that observed in the samples tested at 0.6 m/s. After about ten minutes small flakes began to scour away from the specimen, while the flume velocity ranged from 0.4 to 0.42 m/s. This scouring was substantial enough for the threshold velocity to be established at 0.4 m/s. It should be noted that the threshold velocity obtained is not an exact number. Previous work at Auburn University involved the calibration of the flow meter located in the EFA. This work showed at velocities less than 0.5 m/s the flow meter could have a margin of error of approximately ten percent (Mobley, 2009). The total results for the testing of the Porter’s Creek Clay formation can be viewed in Figure 4-24, with the averaged results in Figure 4-25.

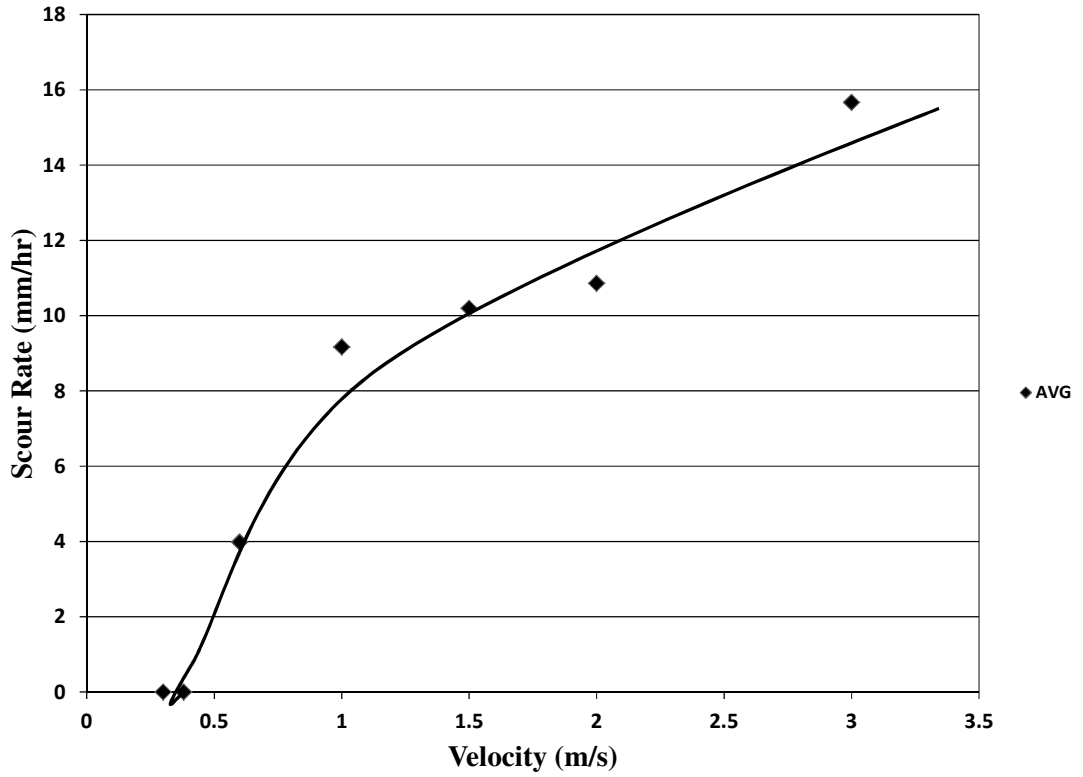
Figure 4-25. Porter's Creek Clay Velocity versus Scour Rate

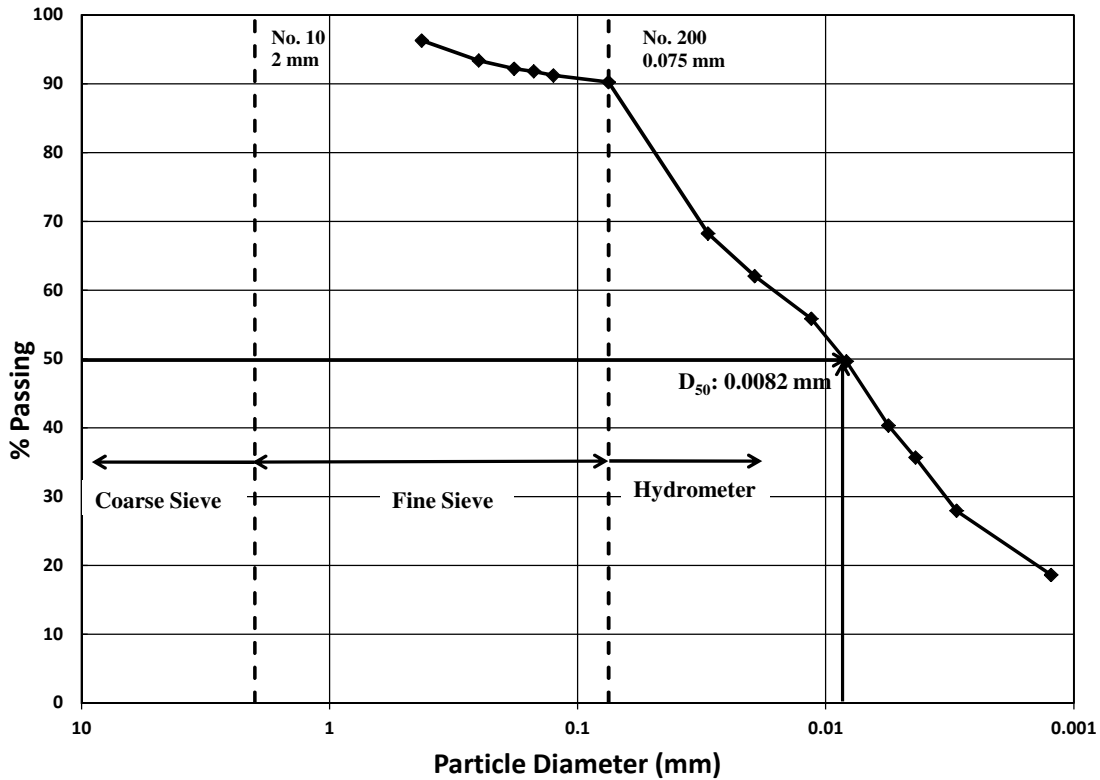
Figure 4-26. Porter's Creek Clay Formation Grain Size Distribution

Atterberg limits were performed to complete the soil classification and geotechnical testing of the Porter's Creek Clay formation. The liquid limit was determined to be approximately 62, and the plastic limit was determined to be approximately 53, resulting in a plasticity index of 9. Using these values along with the information gathered from the grain size distribution, the sample was classified as an elastic silt (USCS Classification MH).

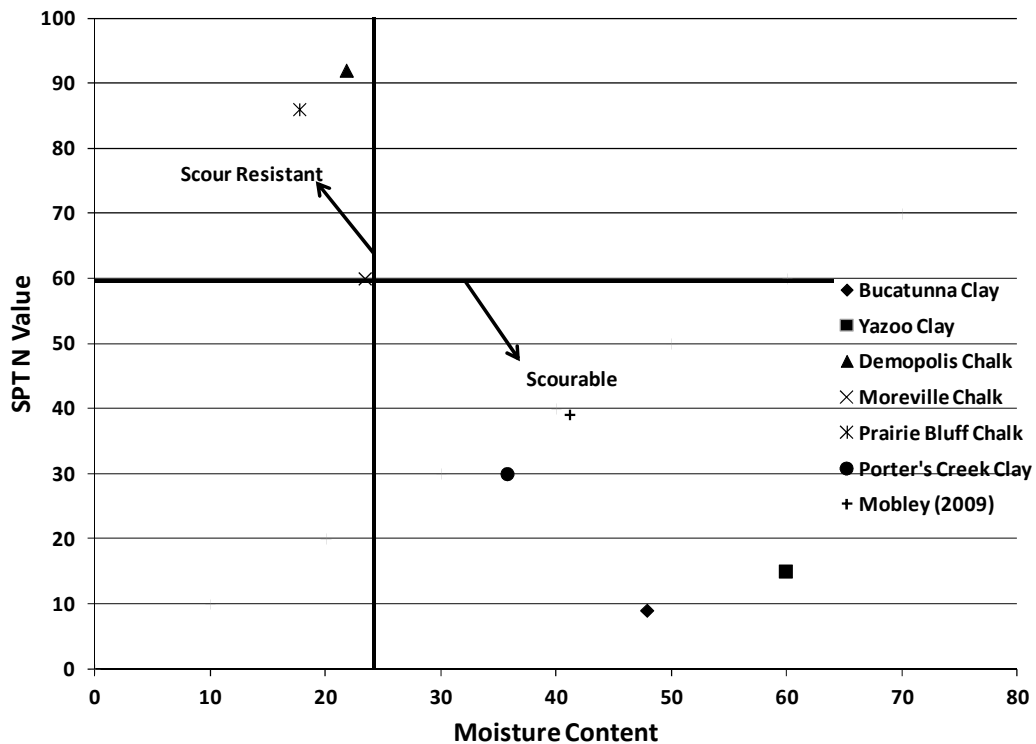
Figure 5-1. Scour Observation using Moisture Content and SPT N Value

An observation was made with the scour test results and the geotechnical index parameters using the moisture content and SPT N value. In Figure 5-1 below, a horizontal and vertical line are drawn, and approximately intersect at a moisture content of 23 percent and an SPT N value of 60. All of the formations falling down and to the right of this intersection, the Bucatunna Clay formation, the Yazoo Clay formation, and the Porter's Creek Clay formation all scoured during testing. The formations up and to the left of the intersection, the Demopolis Chalk formation, the Mooreville Chalk formation, and the Prairie Bluff Chalk formation were scour resistant. This observation combined all three aspects of this study in sampling, EFA testing, and geotechnical testing. The SPT N value was obtained during sampling, the scour data was obtained during EFA testing, and the moisture content was collected during geotechnical testing. Additionally, one data point from Mobley (2009) was added to this data set and also follows this observation.

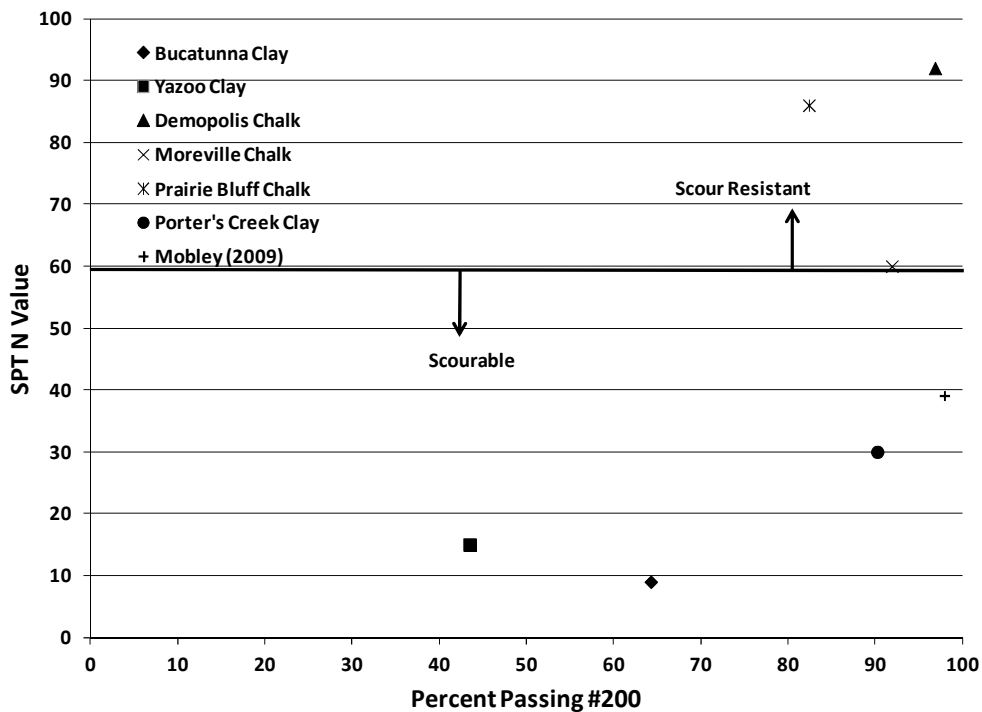
Figure 5-2. Scour Observation using Percent Passing #200 and SPT N Value

Similarly, an observation was also made between SPT N Value and the percent of particles passing the number 200 sieve. Figure 5-2 shows this observation, as all of the formations falling below the line scoured during testing and all the formations plotted above the line were scour resistant. Similar to Figure 5-1, data from Mobley (2009) was added to this plot. Mobley (2009) observed scour in this sample with a SPT N value of 39 and 98 percent of the sample passing the #200 sieve, which follows the observation in Figure 5-2. This observation between scour parameters, SPT N value, and grain size is further described by Figure 5-3.
