**Ex-Vivo Biomechanical Testing of a Tendon Implant Device for the Repair of Equine
Flexor Tendon Lacerations**

A thesis submitted to the Graduate Faculty of
Auburn University
in partial fulfillment of the
requirements for the Degree of
Master of Science

Auburn, Alabama
August 3, 2013

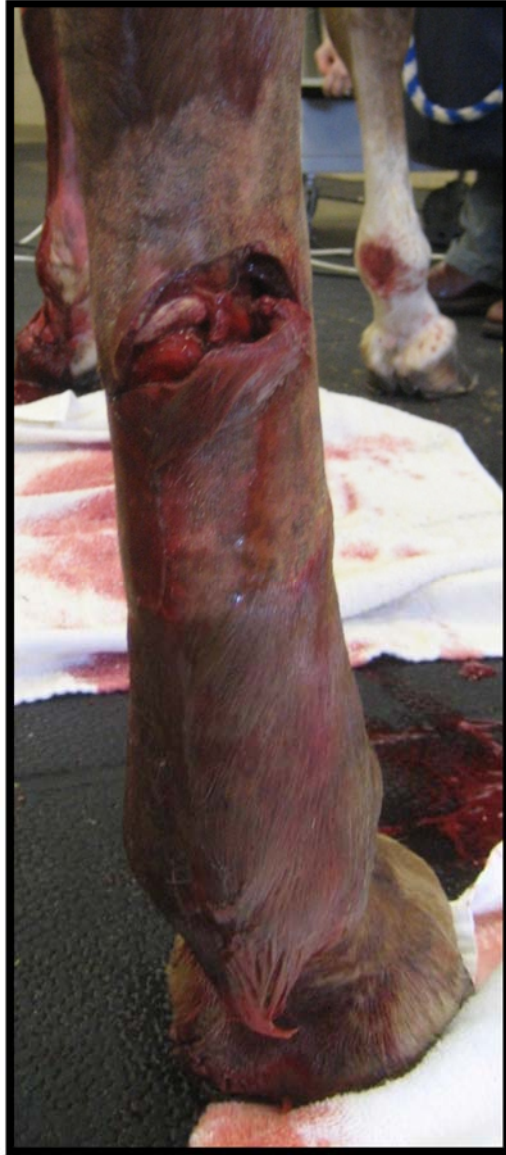
Figure 1: Flexor tendon laceration

Superficial digital flexor tendon repairs in horses need to support loads of up to 3600 N and strain rates of 2-4% at a walk, without external coaptation.^{2,6-8} (Figure 1) The three loop pulley (3LP) has been shown to be superior in terms of strength and failure characteristics of the suture patterns currently used in clinical equine practice.⁹⁻¹² The pattern uses a single strand of suture that crosses the flexor tendon laceration six times, forming three loops (Figure 2). However, the 3LP withstands only 1/3 of the normal weight bearing load.^{6,9} Therefore repairs are typically supported with some form of external coaptation for 4 to 6 weeks postoperatively to allow some tendon strength to return before subjecting the repair to full loads.⁹⁻¹² (Figure 3)

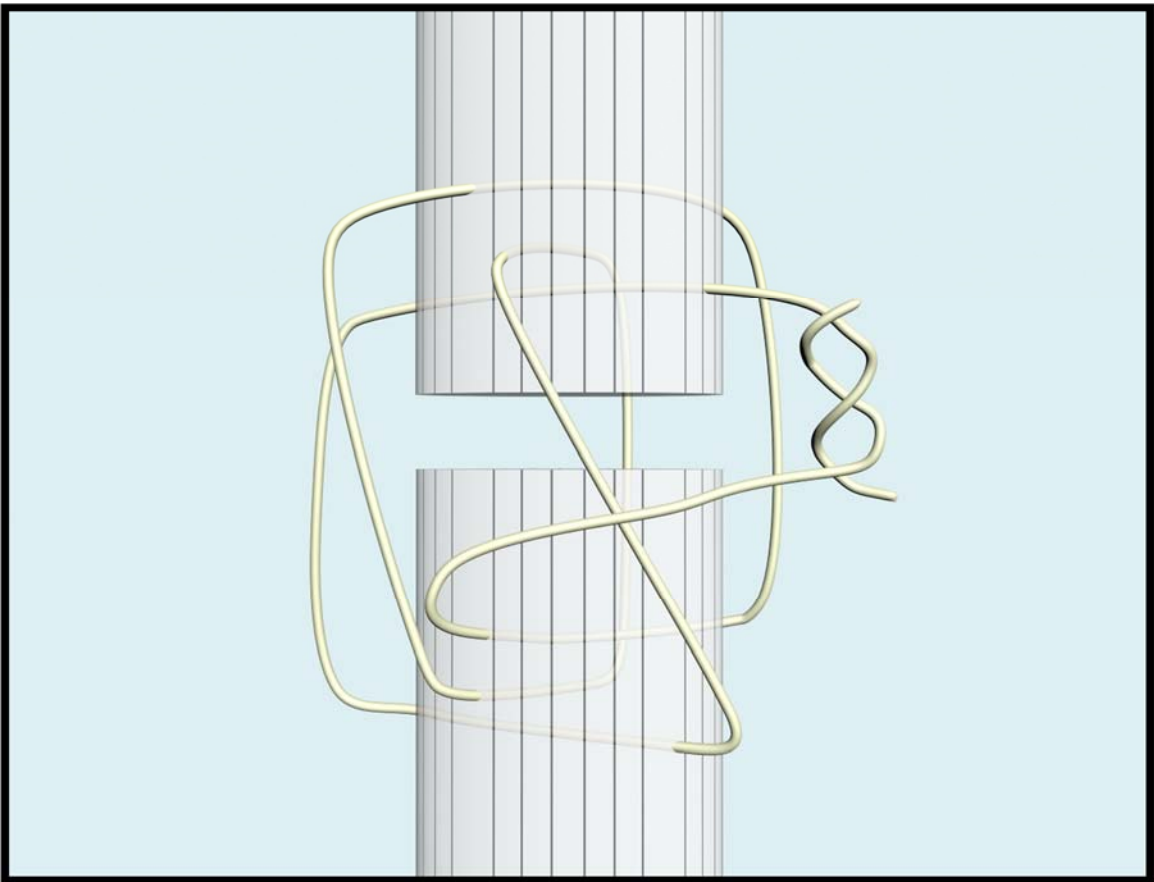
Figure 2: Three loop pulley suture pattern

The two traditional suture patterns used in studies evaluating healing in sutured versus un-sutured tendon lacerations are the three loop pulley (3LP) (Figure 2), or the locking loop (LL) (Figure 8). Both of these suture patterns have been examined in controlled experimental studies for their mechanical properties in equine tendons.^{9,11,12} Adair compared the 3LP to the LL pattern sutured with either #1 polypropylene or #1 polydioxanone and found the 3LP pulley withstood a greater load to failure than the LL regardless of the material used in all tendons evaluated.¹² Adair did not evaluate the load to 2 mm gap formation in any of the repairs in his study but he did note that the 3LP formed a larger gap (2.97 cm)

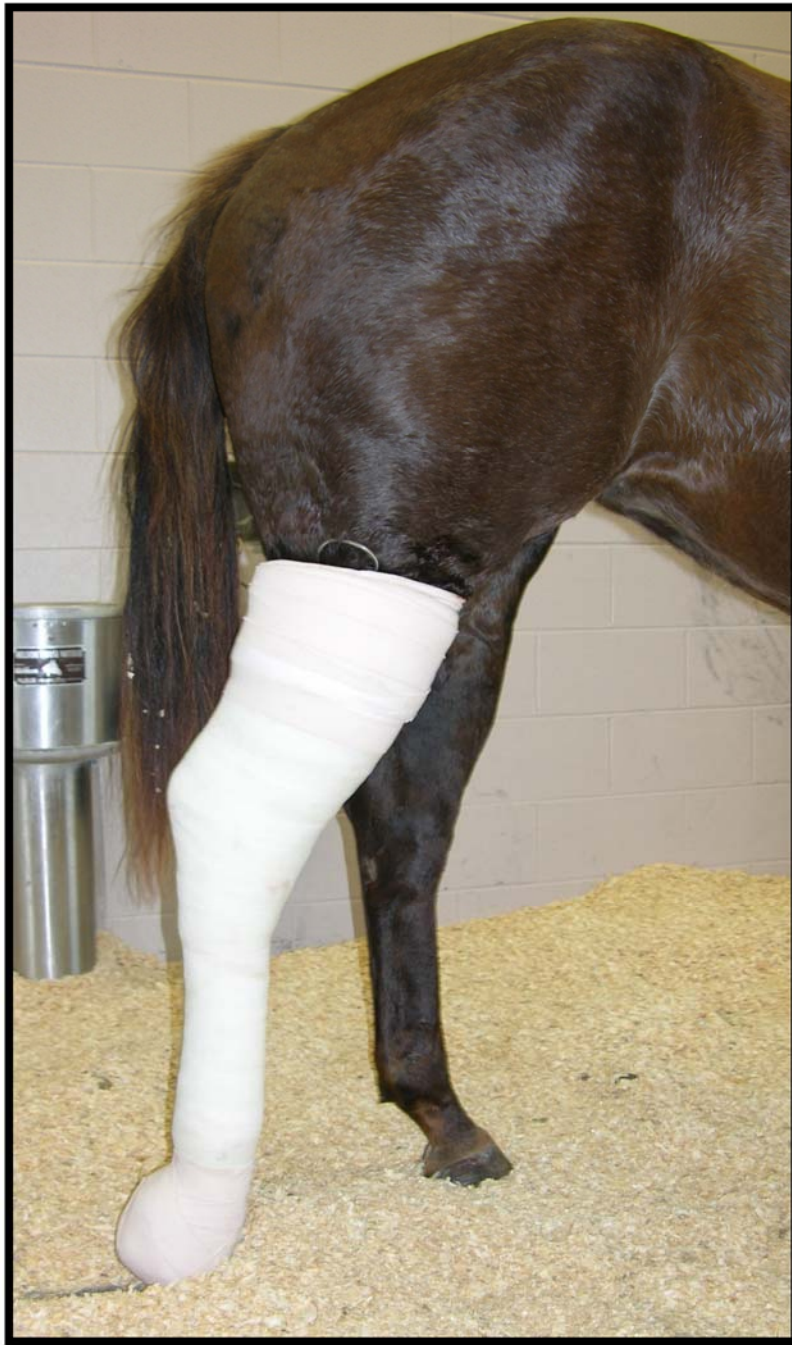
Figure 3: Tendon laceration in full limb external coaptation or cast

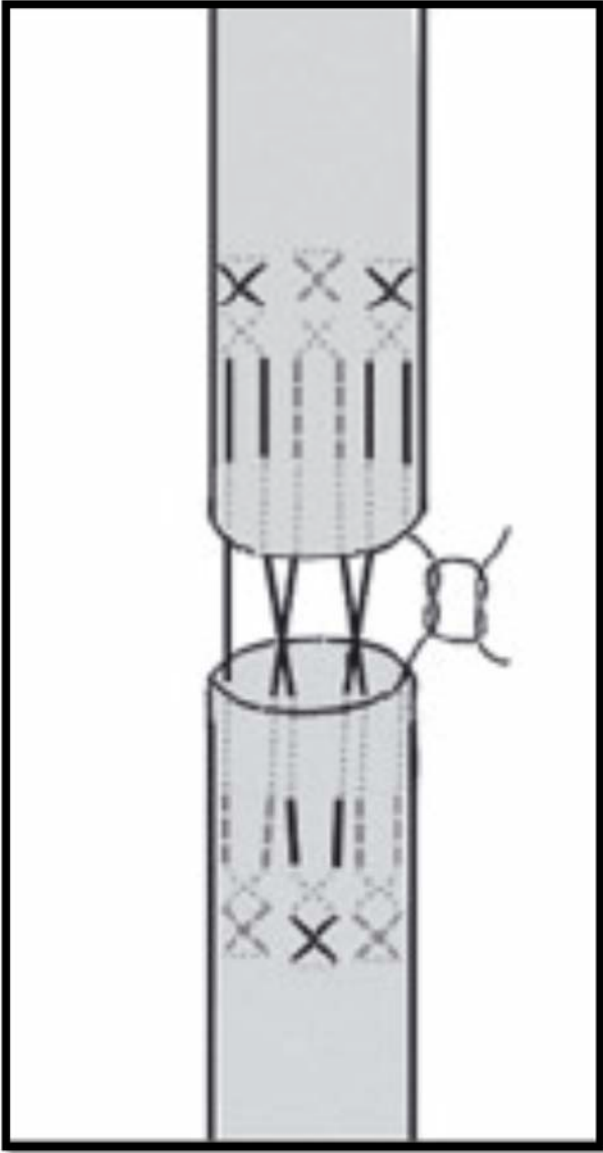
Figure 4: Six-strand Savage suture pattern (Everett, 2010) Used under Fair Use guidelines

A six-strand version of the Savage technique (Figure 4) has also been evaluated by Everett, et al.¹⁸ in comparison to the 3LP. The study was performed on cadaveric equine superficial digital flexor tendons. This study did not use an epitenon suture and performed the repairs using 2 polydioxanone. Everett used a distraction rate of 25 mm/sec. This study found the six-strand Savage had a higher ultimate load to failure (421 N) than the 3LP (193 N). However, the two suture patterns had similar resistance to 3 mm gap formation of 102 N for the Savage pattern and 109 N for the 3LP. Similar to the previous study the authors concluded that there may be some limitations to the use of the suture pattern in in-vivo trials because the pattern may affect blood flow and that the overall strength of the pattern was not strong enough to resist gap formation in standing horses.¹⁸

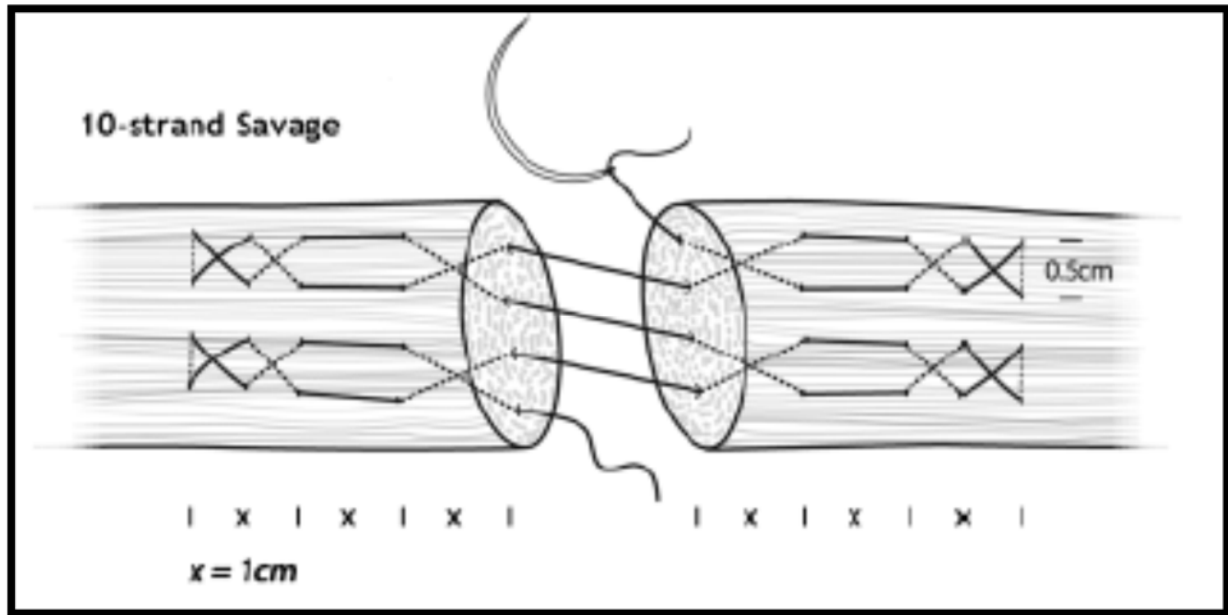
Figure 5: Partially completely ten-strand Savage (Smith, 2010) Used under Fair Use guidelines

Smith evaluated a ten-strand version of the savage suture technique (Figure 5) with or without a Lin-locking epitenon suture in an ex vivo study using equine superficial digital flexor tendons.¹⁹ A distraction rate of 8.5 mm/sec was used in this study. Smith carried out the repairs using either 2 polydioxanone or 2 polyglactin 910 suture and compared them to the 3LP sutured using one of the two suture materials. All Savage suture patterns failed by suture breakage at the

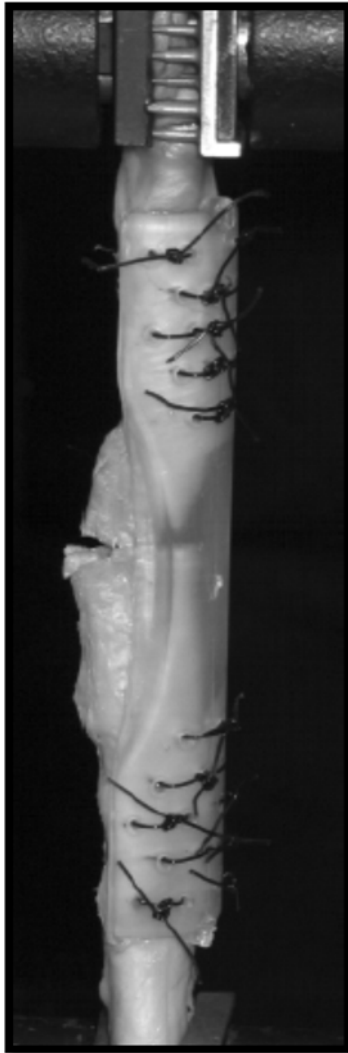
Figure 6: Bioabsorbable tendon plate placed within an equine deep digital flexor tendon
(Jenson, 2005) Used under Fair Use guidelines

Jenson et al. developed a bioabsorbable tendon plate (Figure 6) and evaluated its strength in comparison to the 3LP with 2 polydioxanone in repair of equine deep digital flexor tendon (DDFT) lacerations in vitro.¹⁴ The plates were made from poly-L-lactic acid and shaped to conform to the mid-metacarpal palmar surface of an adult DDFT. Each plate had sixteen holes in the proximal and distal third of the plate for a total of 32 holes in each plate. The holes were used to place five

simple interrupted full thickness sutures and two figure-of-8 full thickness sutures at each end of the plate using 2 polydioxanone. The peak force for failure of plated tendons was 1507.8N, which was significantly ($P>0.05$) higher than those repaired with the 3LP (460.9N). The plates failed by pulling out of the tendon. The authors noted that they had concerns over how the apparatus would be accepted into biological tissue. They felt that the nature by which the plate was attached to the damaged tendon with circumferential sutures could limit tendon healing by vascular compromise, harboring sepsis, inducing adhesions or reducing normal tendon motion. To date there have been no published reports of the in-vivo use of these tendon plates.

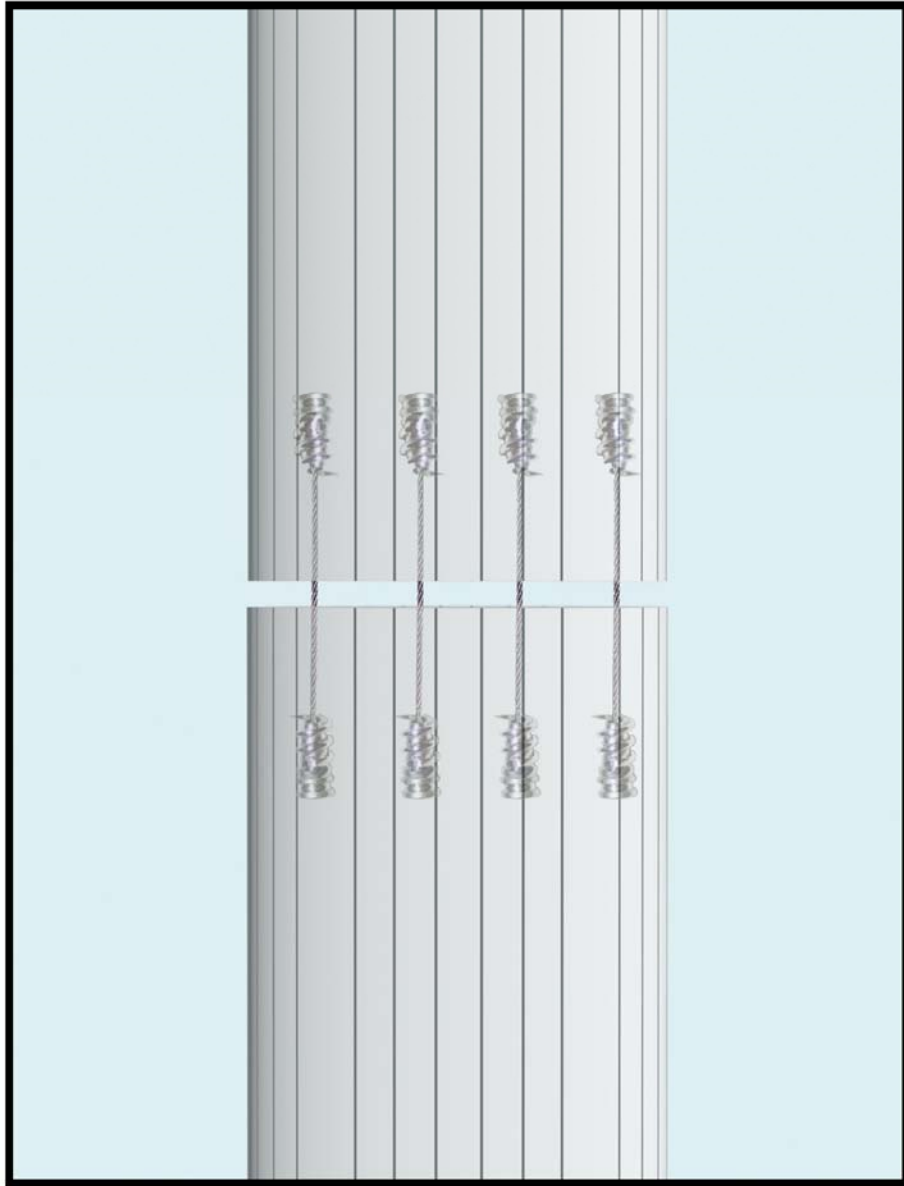
Figure 7: Stainless steel suture and anchor system

The stainless steel suture was cut and the paratenon closed routinely with 4-0 polydioxanone in a simple continuous pattern. A total of four stainless steel sutures were placed, evenly distributed in the superficial digital flexor tendon (Figure 7). A single surgeon (EB) performed all repairs.

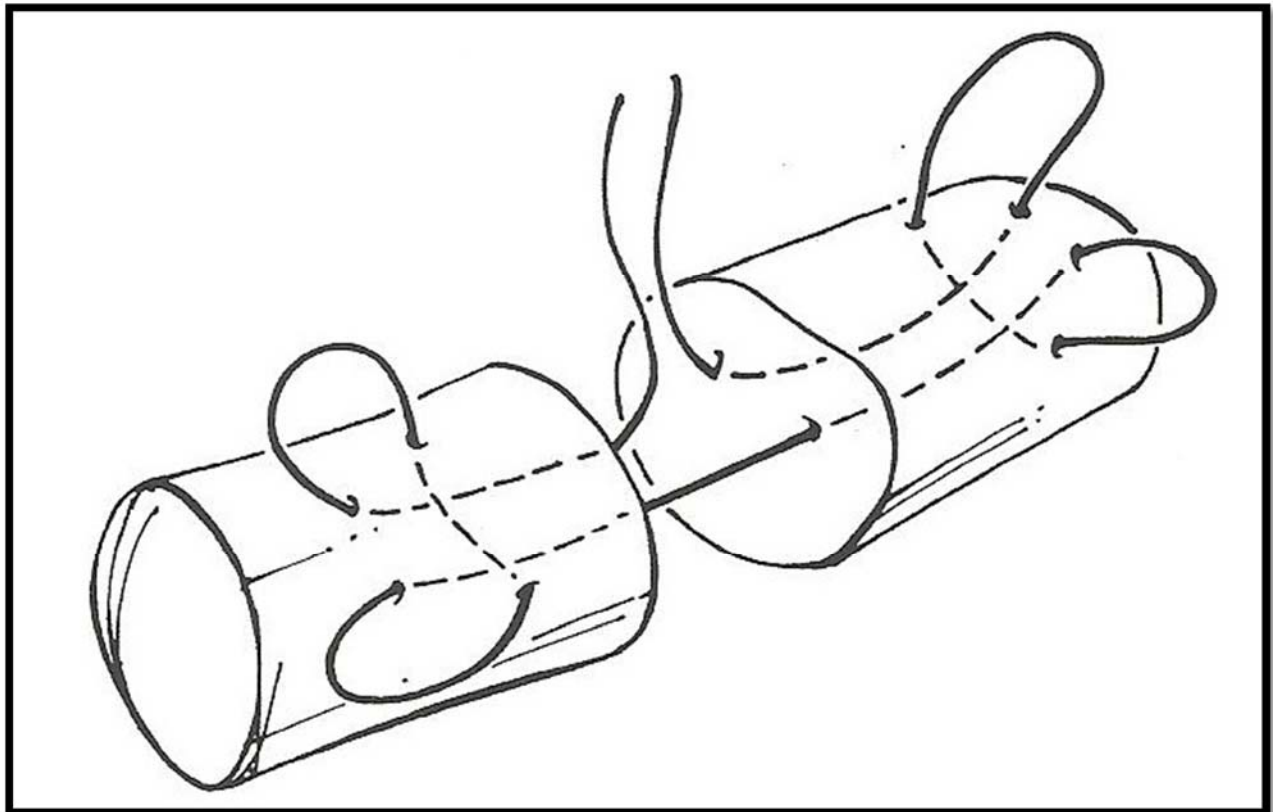
Figure 8: Locking- loop suture pattern (Adair, 1989) Used under Fair Use guidelines

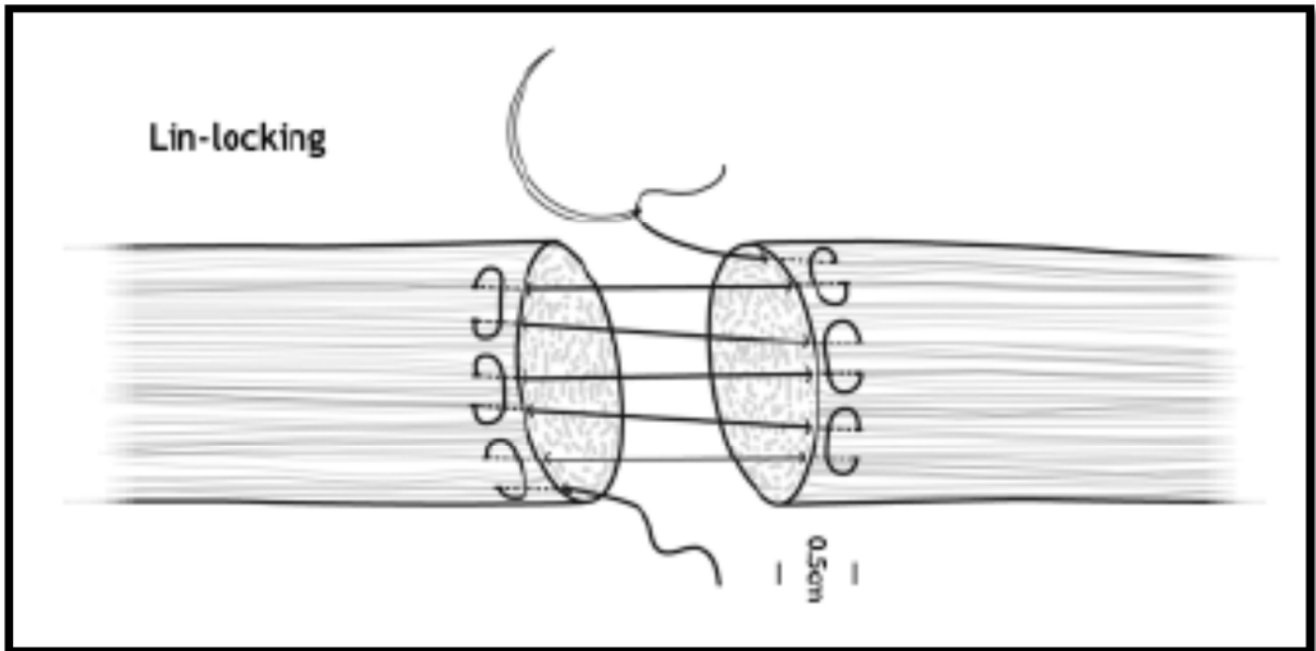
Figure 9: Lin-locking epitenon suture (Smith, 2010) Used under Fair Use guidelines

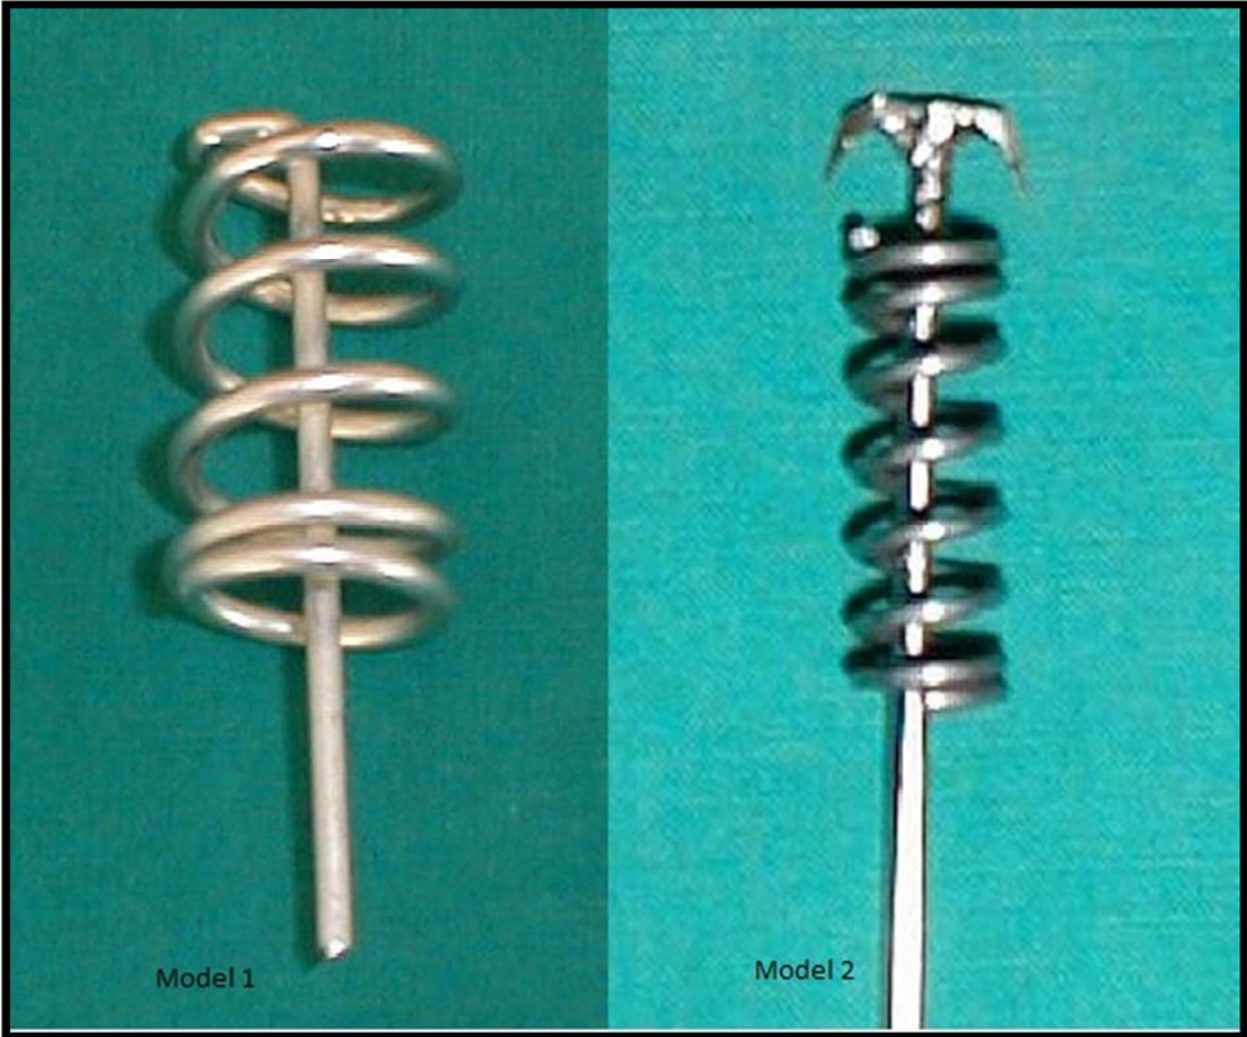
Figure 10: Intra-tendinous stainless steel implants designed by Erol, et al. (Erol, 2007)
Used under Fair Use guidelines

In the early 2000's human studies started to investigate tendon laceration repair methods that utilize implants placed entirely within the tendon.¹⁵⁻¹⁷ Erol examined two variations of a stainless steel coil surrounding a wire placed within sheep tendons.¹⁶ (Figure 10) Model 1 was formed of a single 5-turn spiral coil of 0.8 mm wire. The coil was formed out of one end of the wire turned back and wrapped around itself. Model 2 had two separate pieces of wire. A 7-turn spiral coil of 0.8 mm wire formed in the same fashion as Model 1 with an additional T shaped wired attached to the proximal end of the spiral. The T shaped component

was made of 1.5 mm wire. The diameter and distance between the spirals was the same for each model, but the value was not stated in the paper. This study tested the implants in lacerated cadaveric sheep Achilles tendons compared to a LL suture repair. It found that Model 2 withstood a higher tensile force to ultimate failure (28 Kilogram-Force or 274 N) than the LL technique (22 Kilogram-Force or 216 N) when distracted at a rate of 20 mm/sec.

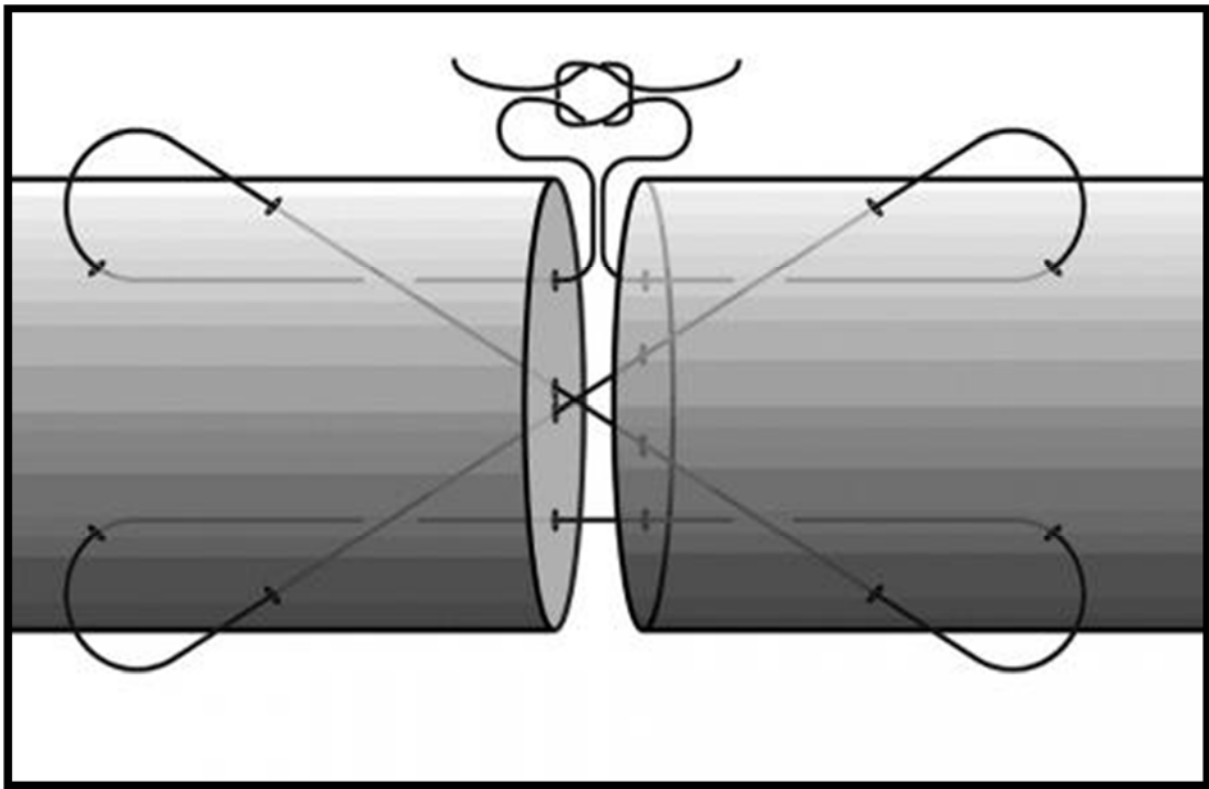
Figure 12: Four-strand cruciate suture pattern. (Hirpara, 2010) Used under Fair Use guidelines

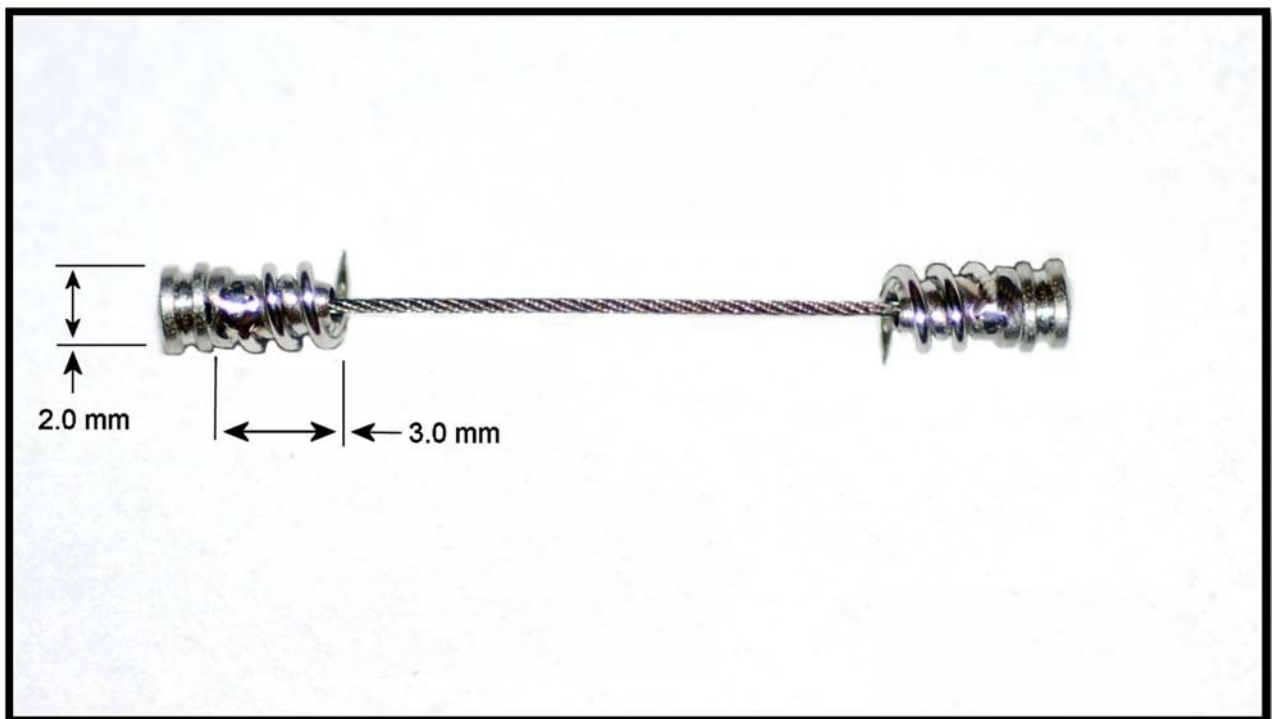
Figure 13: Stainless steel anchors and suture system

The stainless steel SA system (Teno Fix Tendon Repair System, Ortheon Medical, Columbus, OH) was placed as described by Su et al in 2005.²² The SA system consists of a 2-0 multifilament stainless steel suture and two stainless steel anchors (Figure 7). Placement was accomplished by making a small stab incision through the paratenon at a distance 2 cm proximal and distal from the severed end

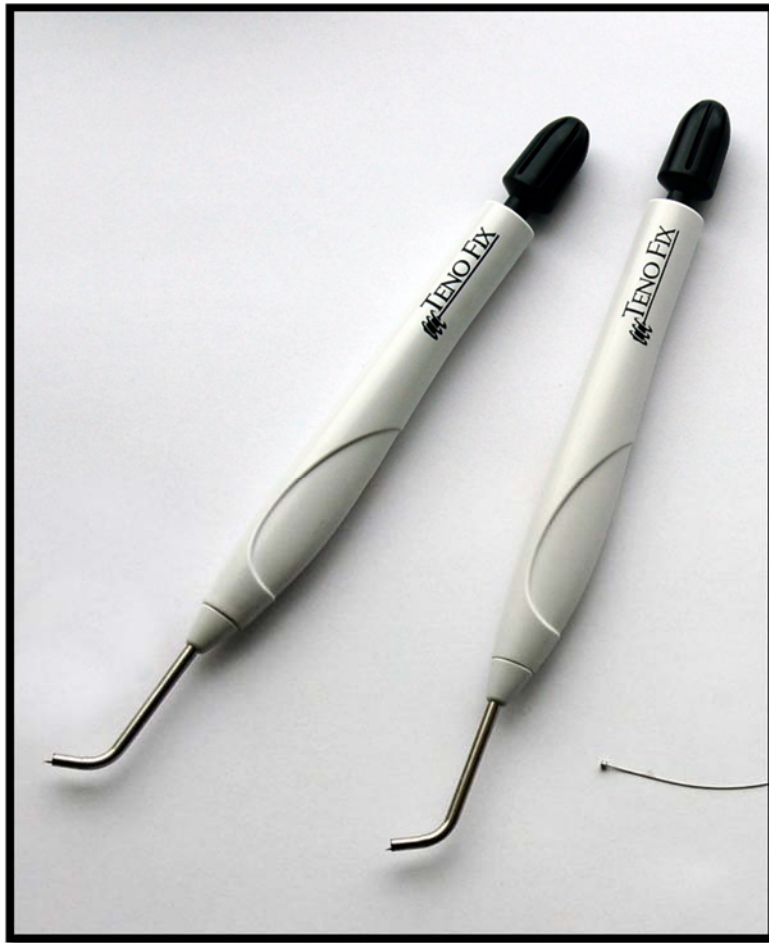
Figure 14: Obturator of stainless steel and anchor system

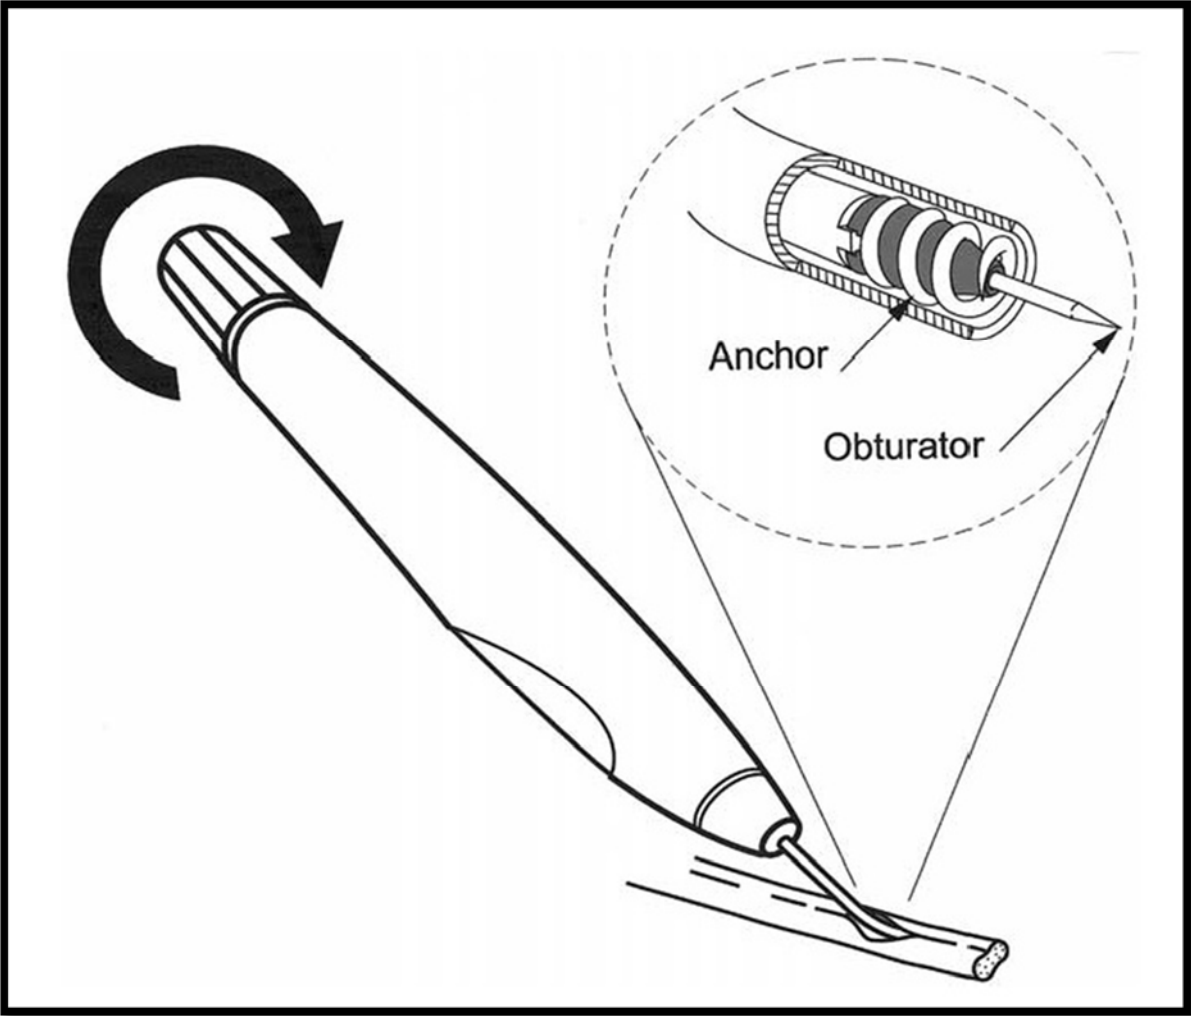
Figure 15: Obturator twisting the anchor into place within the tendon end

fascicles.^{26,27} It is the collagen fibers that are gathered in the SA repair anchor as it is twisted into place in the tendon.^{20,22}

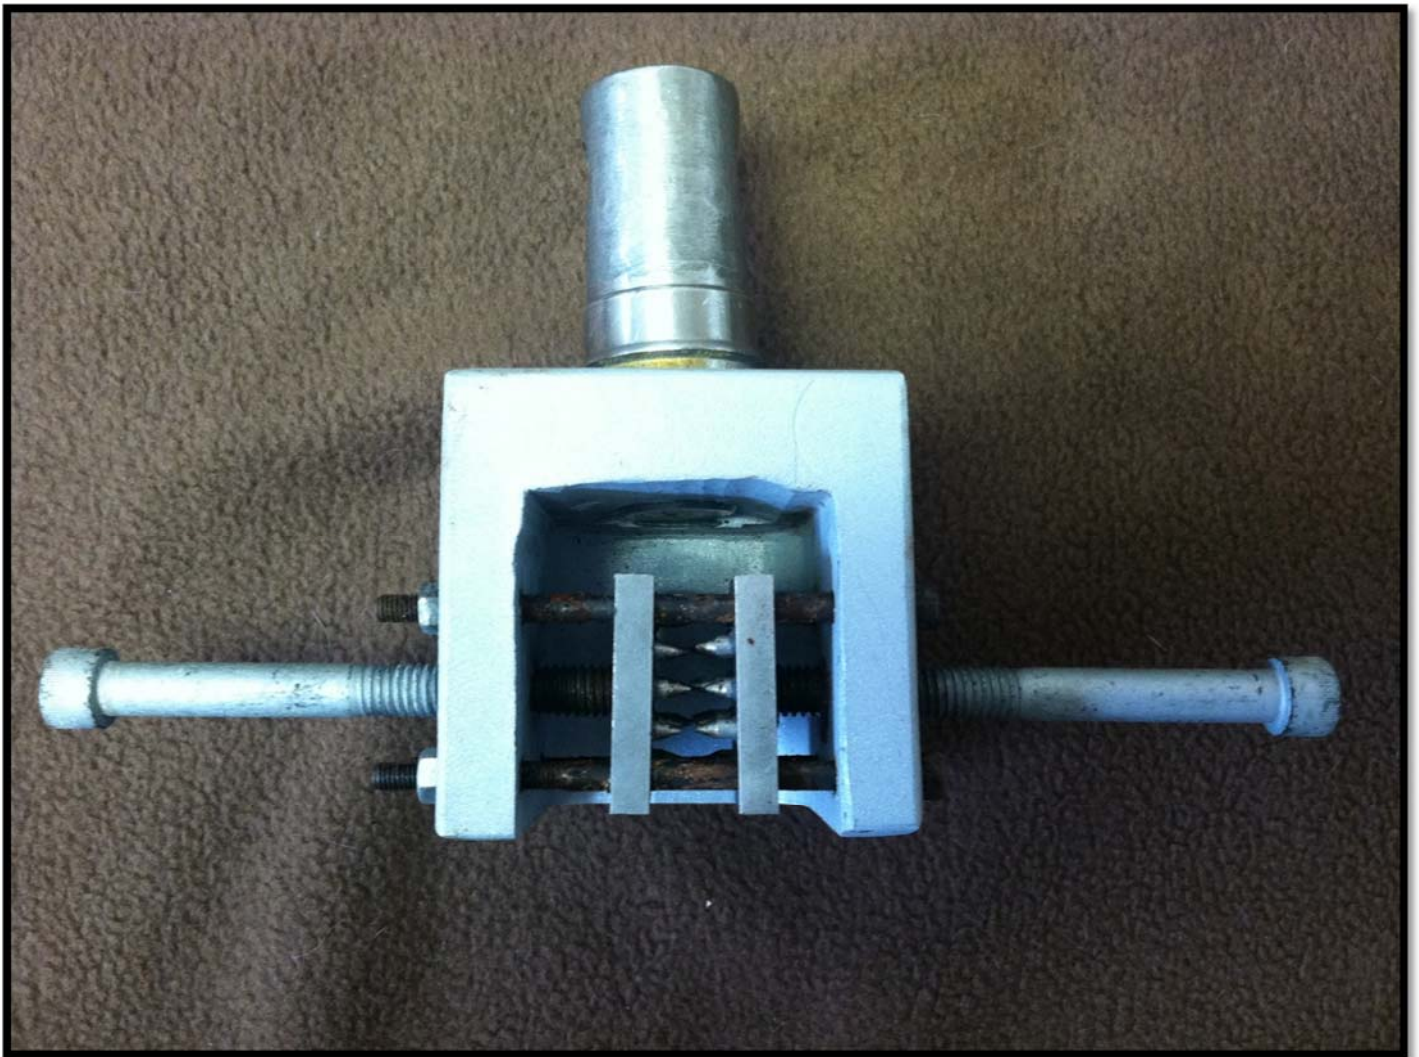
Figure 16: Clamps used to secure tendons to the tensile testing machine

No grip failure or slippage of the tendons occurred during tendon testing, and all tendons completed the testing phase immediately after sutured repair.

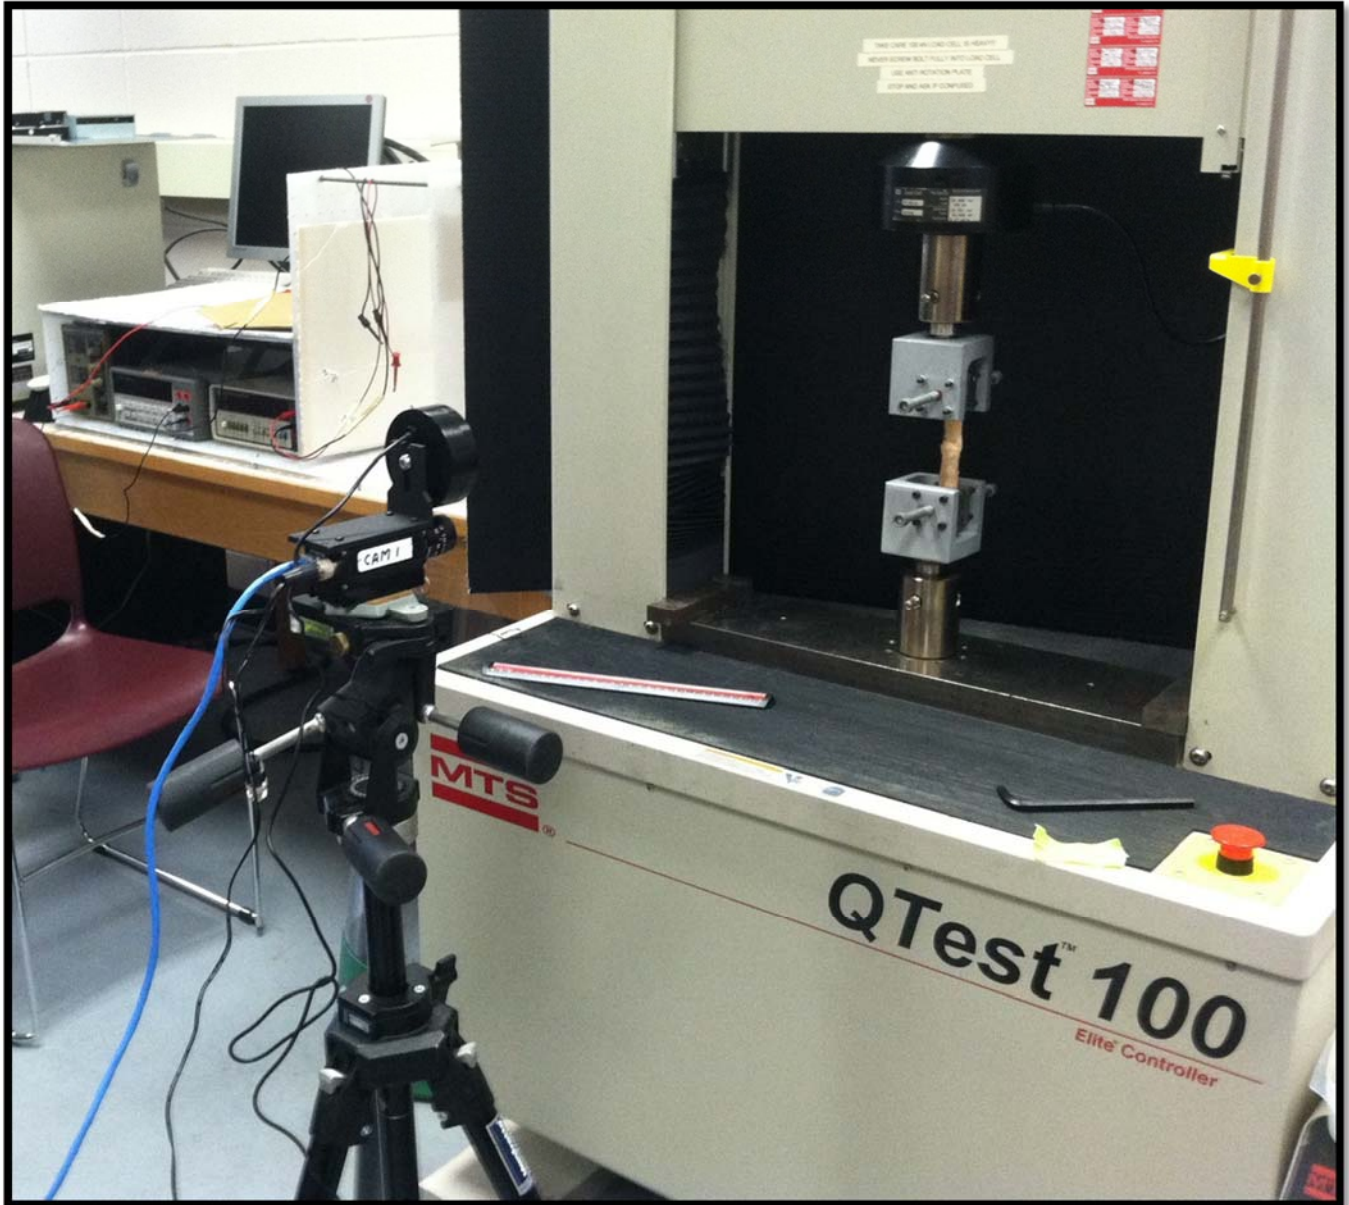
Figure 17: Testing set-up with Q-Test 100 and high speed camera in place

Immediately after repair the tendons were transported to the laboratory in phosphate buffered sodium chloride for testing. An electromechanical materials testing machine (Q Test 100, MTS, Eden Prairie, MN) coupled with a high speed

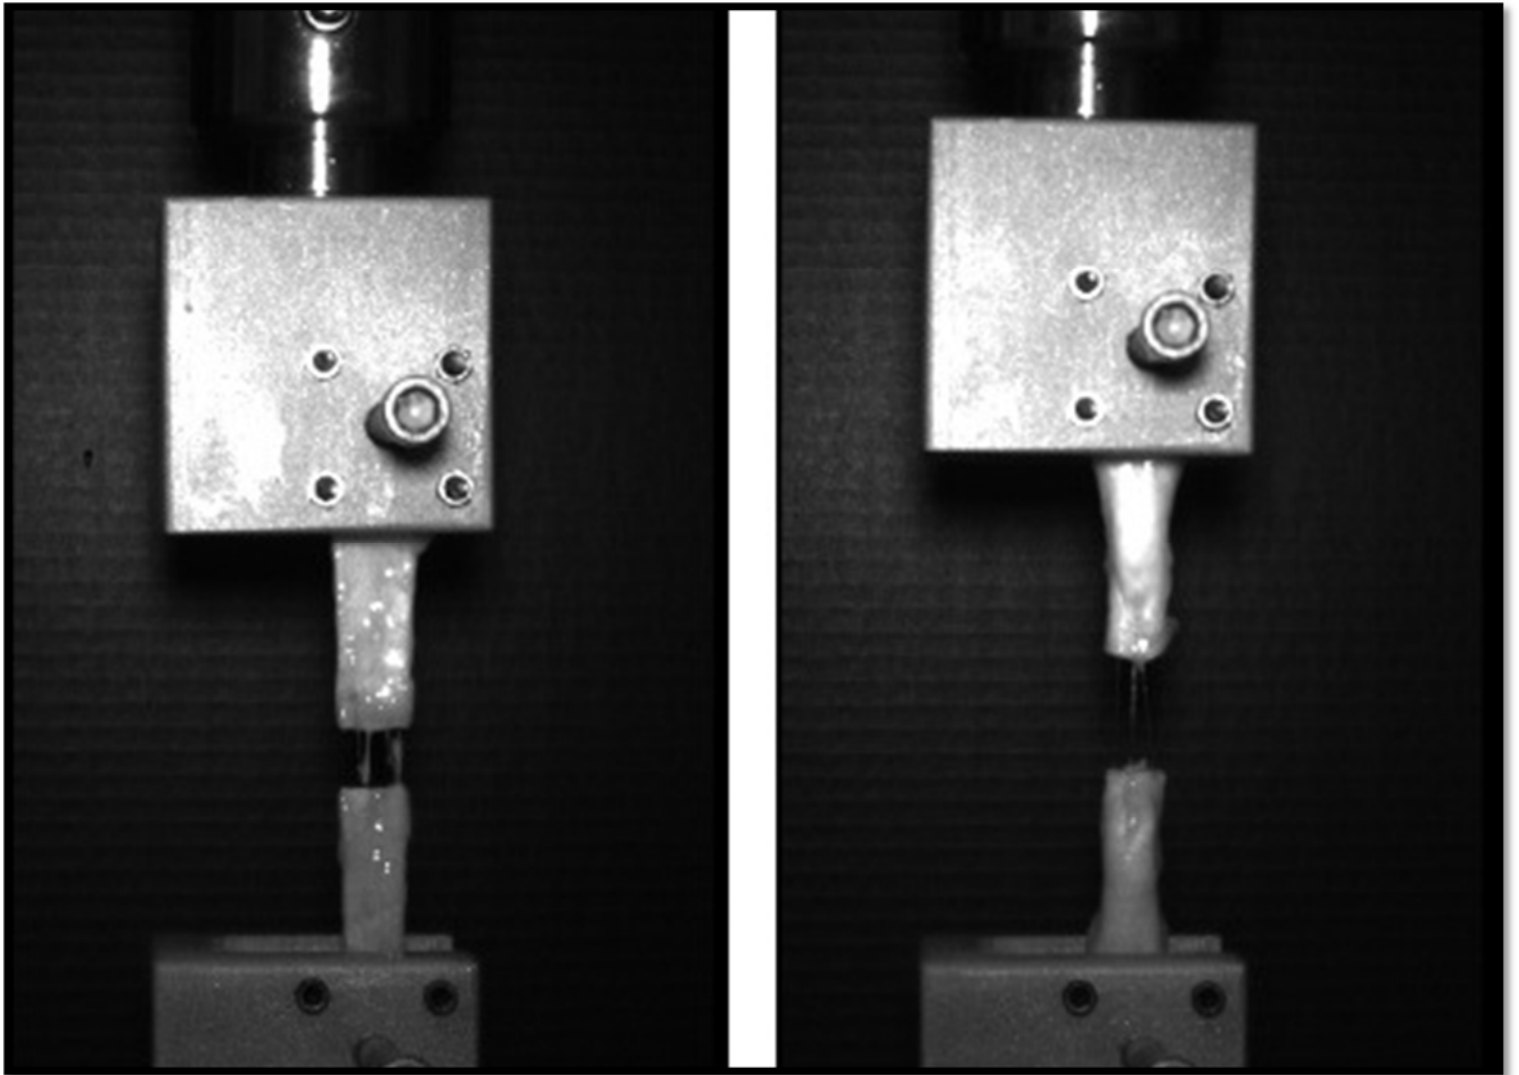
Figure 18: Gap at failure for the SA (left) and 3LP (right) repairs

The mean +/- SD ultimate failure load for the 3LP repair (363.5 N +/- 83.7 N) was significantly stronger than the SA repair (132.4 N +/- 26.8 N, $P = 0.0001$). The mode of failure was suture pull-out for all 3LP repairs, and anchor pull-out for all of the SA repairs. The gap at failure for the SA repair (6.8 mm +/- 1.3 mm) was significantly smaller than for the 3LP repair (19.1 mm +/- 3.2 mm, $P = 0.000005$). (Figure 18)

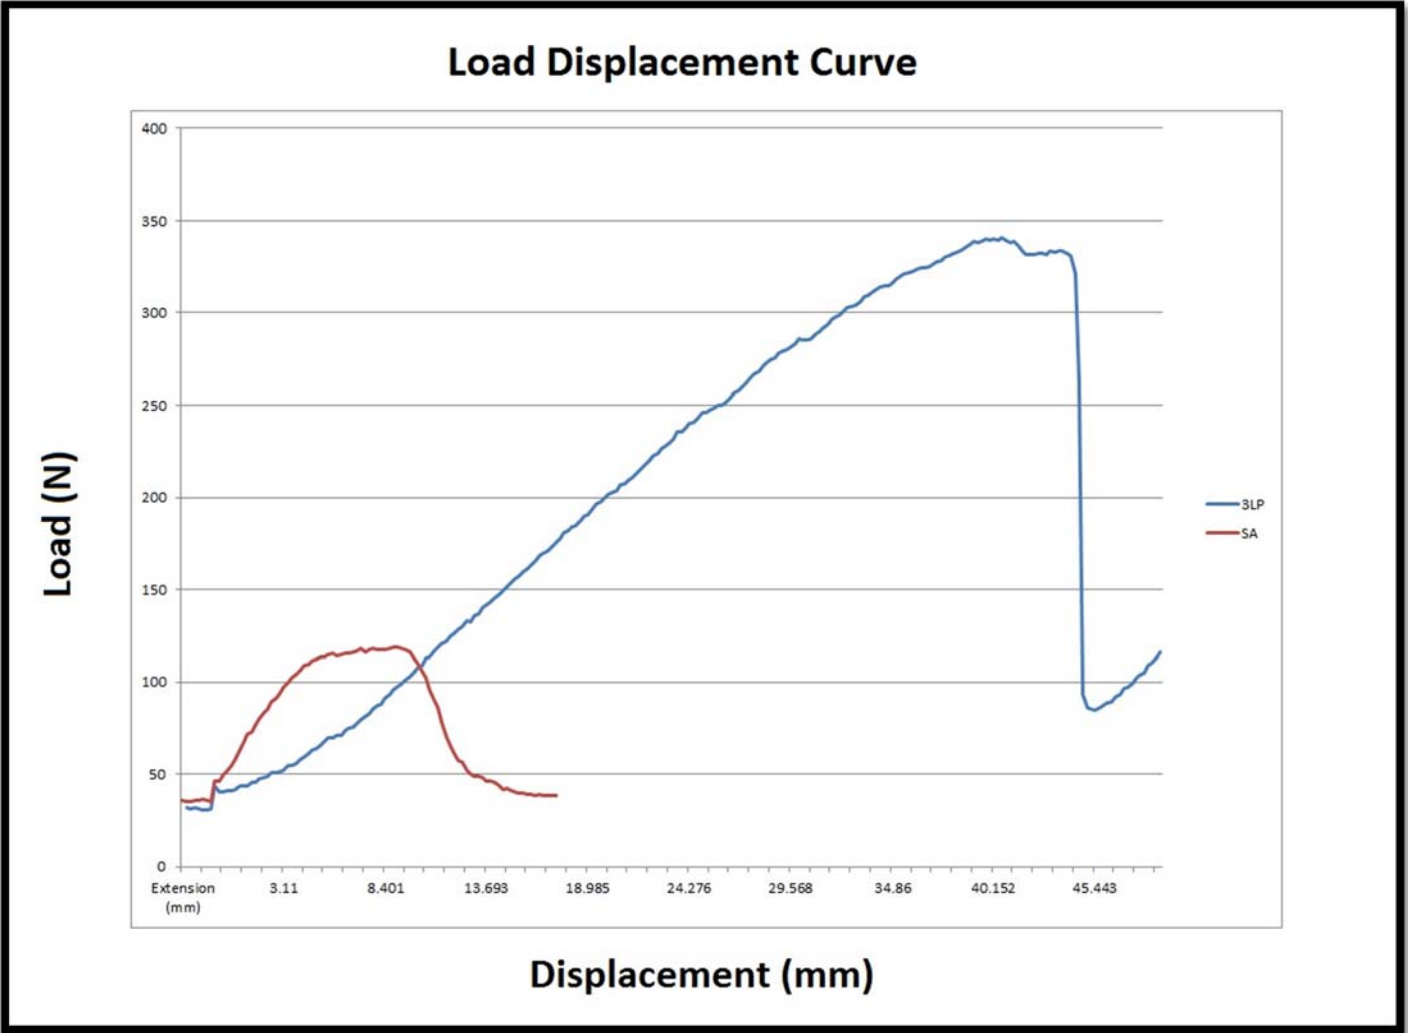
Figure 19: Example of a load versus actuator displacement for SA (blue) and 3LP (red). Horse #6 is pictured.

The load versus actuator displacement was plotted for each of the tenorrhaphy patterns to produce a load displacement curve. (Figure 19) These curves show the SA repair is not as strong as the 3LP as displacement increases after a 2 mm gap at the tendon ends. However, it appears that the SA repair is stiffer during initial testing as evidenced by the steeper slope of the displacement curve.
