**Moisture Content Monitoring using a Nuclear Moisture Gauge
and Preliminary Findings at Alabama Highway 5**

A thesis submitted to the Graduate Faculty of
Auburn University
in partial fulfillment of the
requirements for the Degree of
Master of Science

Auburn, Alabama
May 6, 2017

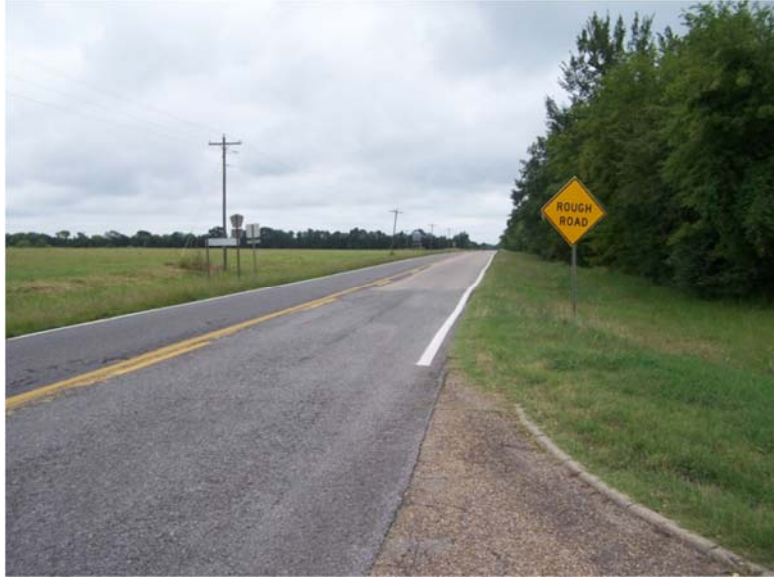
Figure 1: Distresses Pavement at AL-5 (Herman 2015)

It is easy to see the effects of these expansive clay soils on farm-to-market roads in portions of southern and western Alabama. Farm-to-market roads were established in Alabama by the “Farm to Market Act” of 1943 which allotted one cent of the state gasoline tax to be used for the construction of county roads and bridges (ARBA 2017). In many cases, these roads were constructed directly on the existing subgrade. This combined with large amounts of truck traffic causes a significant amount of distress to the pavement surface as the subgrade shrinks and swells. This distress is especially evident along Alabama Highway 5 (AL-5) where rutting, longitudinal cracks, and patching are prevalent along much of the road. To maintain a safe riding surface, resurfacing of the road is necessary on an almost annual basis. Pictures of this distress is shown in Figure 1 and Figure 2.

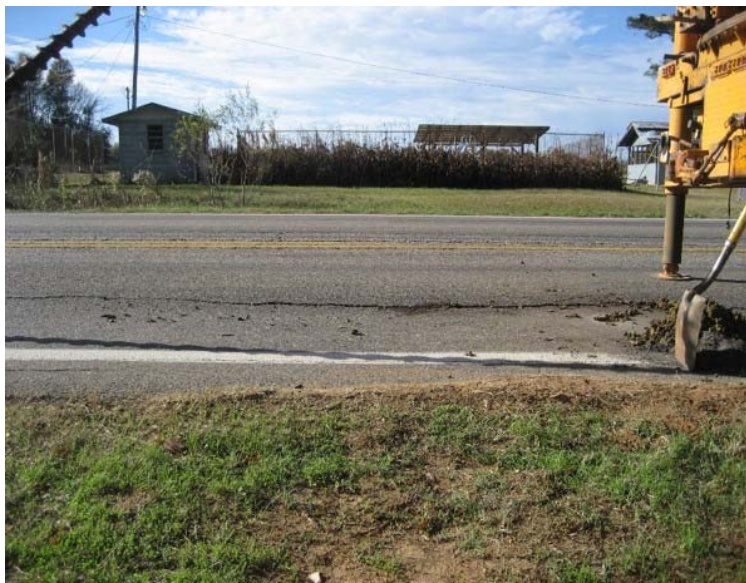
Figure 2: Longitudinal Cracking at AL-5 (Herman 2015)

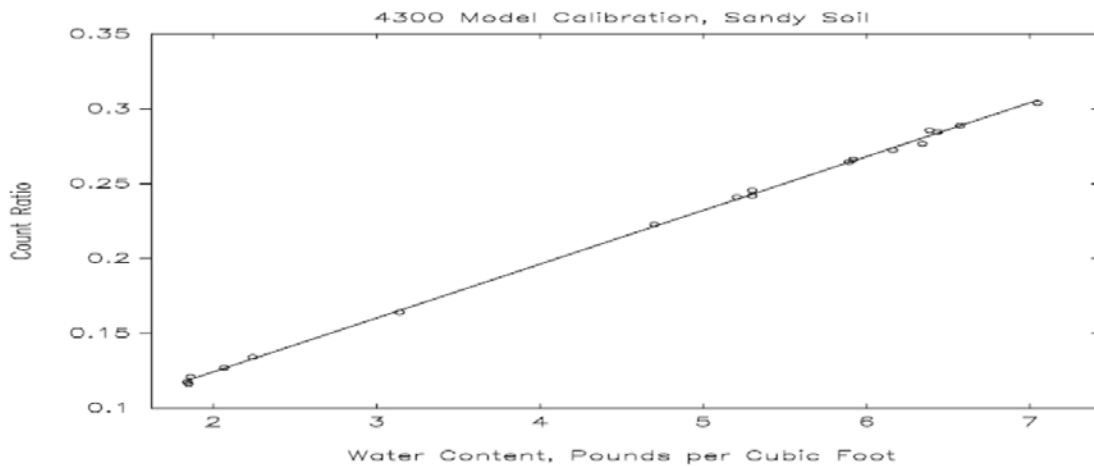
Figure 11: Typical Field Calibration Curve (Troxler 2006)

The count rate in a standard material is typically given the name “standard count”. In many cases the standard material is contained within the shield. Water can also be used as a standard material. It is recommended that the stability of the neutron moisture gauge be checked by taking readings in the standard prior to taking readings in the soil. (IAEA 2002) Using the count ratio, a calibration curve can then be created for various soils. An example of a calibration curve is shown in Figure 11.

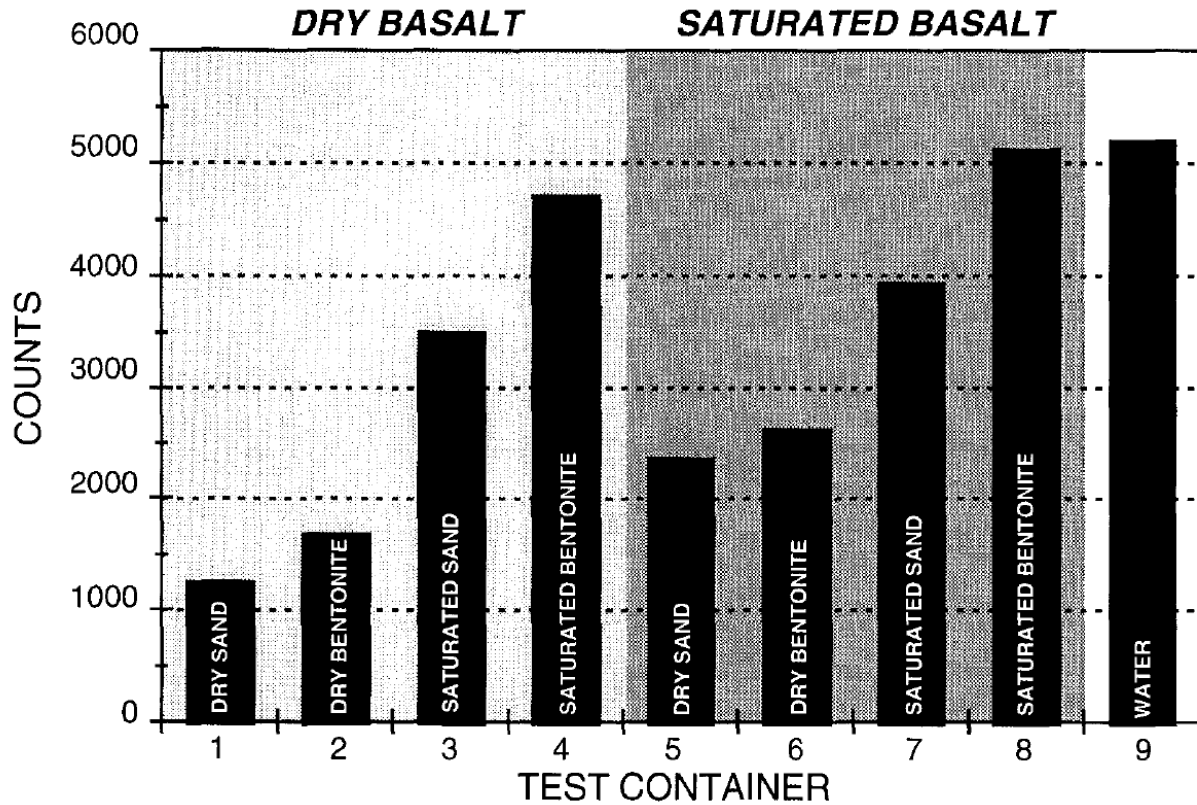
Figure 12: Test Container Neutron Counts for various annular space fills (Bishop and Porro 1997)

When a different material other than the existing soil is used to fill the annular space around the access tube, Bishop and Porro (1997) state that it is “impossible to determine the moisture content of either material from a single reading.” This is because the soil and the fill have different moisture holding capacities (Bishop and Porro 1997). However, relative changes in water content of the soil can still be achieved as shown in Figure 12. This graph shows that when a dry sand is used to fill the annular space between the soil and the access tube, changes in water content of the surrounding soil can be detected. It also shows, in every case, that the hydroprobe is capable of detecting changes in water content through the PVC pipe and annular materials (Bishop and Porro 1997). Additionally, Kramer et al. (1990) showed that the hydroprobe was able to detect changes in moisture content when the access tube was installed using grout to fill the annular space between the tube and the soil.

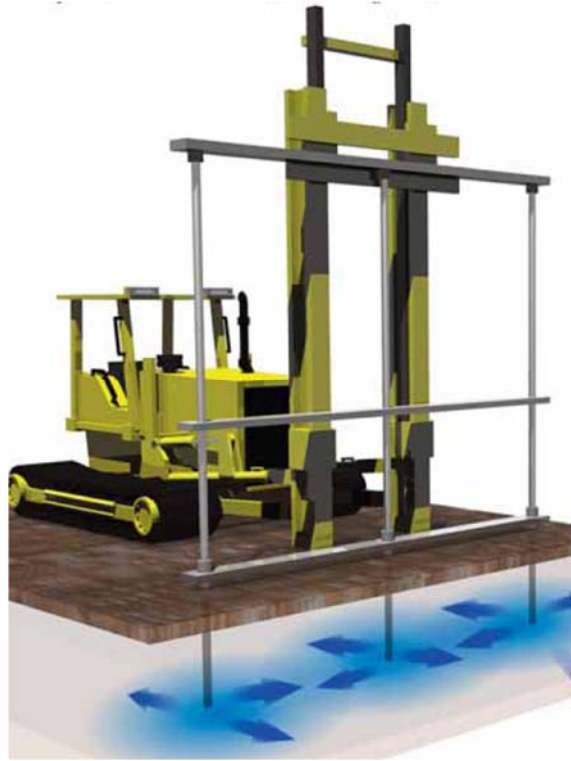
Figure 14: Typical Injection System (Hayward Baker 2010)

The lime slurry pressure injection (LSPI) method was developed to provide a better alternative to the drill-hole technique (Nelson and Miller 1992). The LSPI method consists of pumping lime slurry into a subgrade using an injection vehicle equipped with injection pipes. Injections are made at 12 to 18-inch intervals to a total depth extending through the active zone. At each interval, slurry is pumped until refusal or until a target pressure is achieved. Injection depths can range from three to ten feet, and are typically spaced at five-foot grid patterns (Little 1995). Figure 14 illustrates a typical injection vehicle.

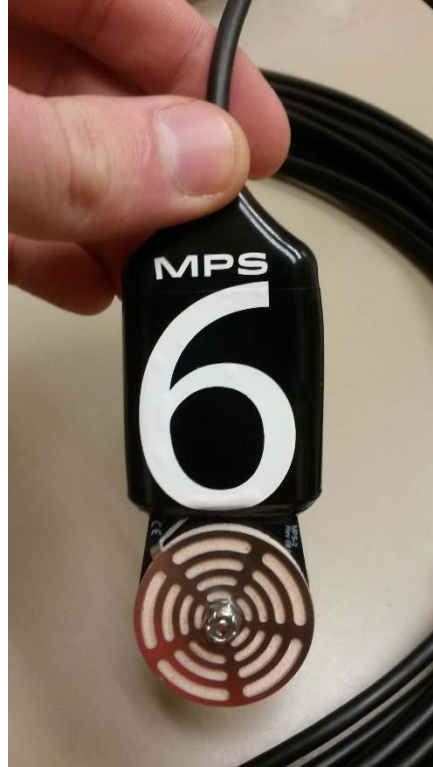
Figure 23: Decagon Devices MPS5 Suction Sensor (Jackson 2016)

To measure matric suction, the MPS6 from Decagon Devices was used. The sensor works by placing the ceramic disks in hydraulic contact with the soil. This allows the suction in the ceramic disks to equalize with the surrounding soil suction. The moisture content of the ceramic disk is then measured using a dielectric technique similar to that of the GS1. Finally, the moisture characteristic curve of the ceramic disk is used to correlate water content to matric suction. Factory calibrations were used for this device (Jackson 2016). A picture of this sensor is shown in Figure 23.

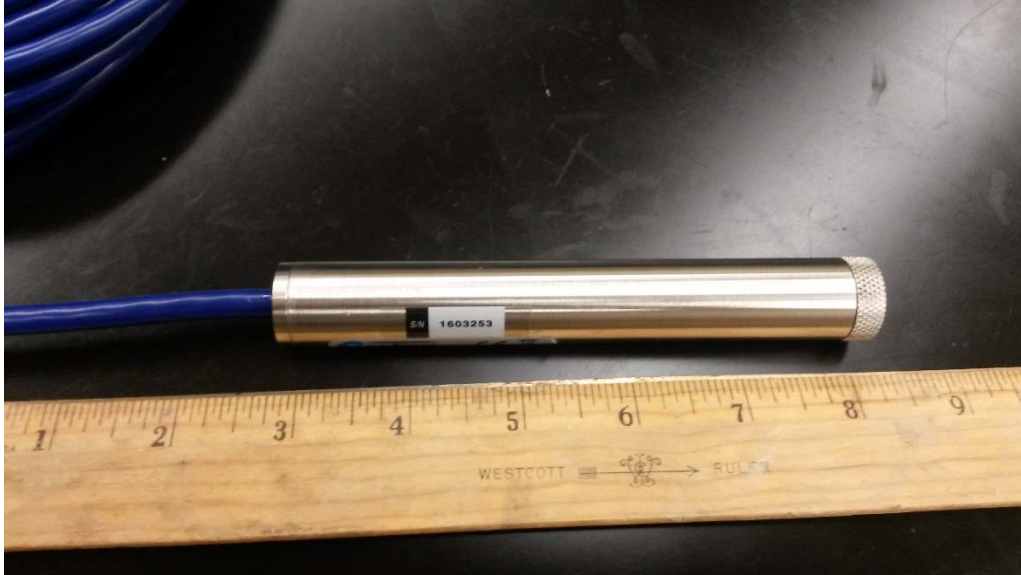
Figure 24: Geokon 4500S Vibrating Wire Piezometer (Jackson 2016)

Geokon 4500S vibrating wire piezometers were installed to measure positive pore pressures. The sensors were individually calibrated by Geokon. (Jackson 2016) A picture of this sensor is shown in Figure 24.

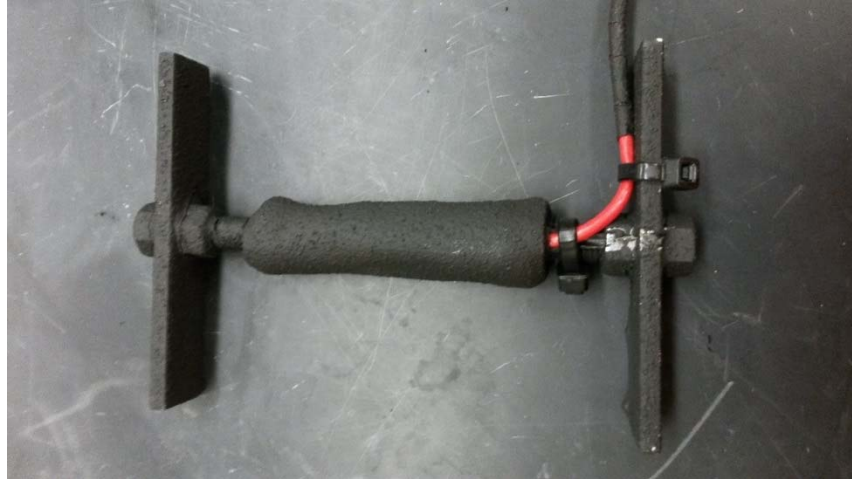
Figure 25: CTL ASG-152 Asphalt Strain Gauge (Jackson 2016)

In an attempt to measure the level of pavement distress, asphalt strain gauges were installed in the pavement. Two types of asphalt strain gauges were used throughout the project. Due to time and availability constraints, the ASG-152 by CTL group was used in Test Section 1 to monitor the sand blanket. In all other sections less expensive asphalt strain gauges manufactured by CTL were used. The two strain gauges are shown in Figure 25 and Figure 26. Both gauges incorporate a full Wheatstone bridge circuit with four active 350 ohm strain gauges mounted on a 6/6 nylon rod. The gauges were calibrated by the manufacturer. (Jackson 2016)

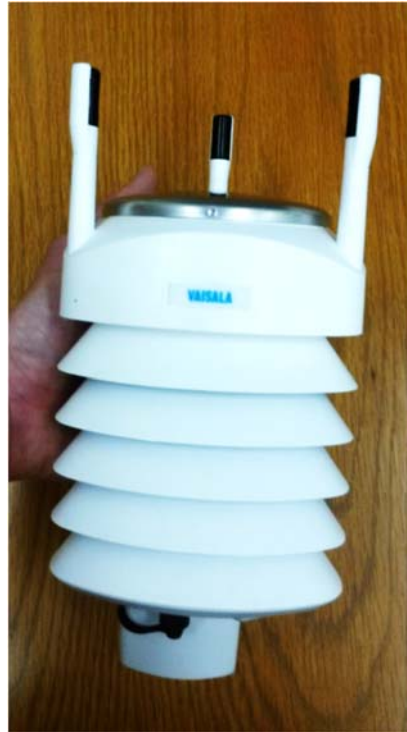
Figure 29: Campbell Scientific WTX520 Weather Sensor (Jackson 2016)

One Campbell Scientific WTX520 weather sensor was installed. The weather sensor is capable of measuring air temperature, barometric pressure, wind speed and direction, relative humidity, and precipitation. The weather sensor is shown Figure 29.

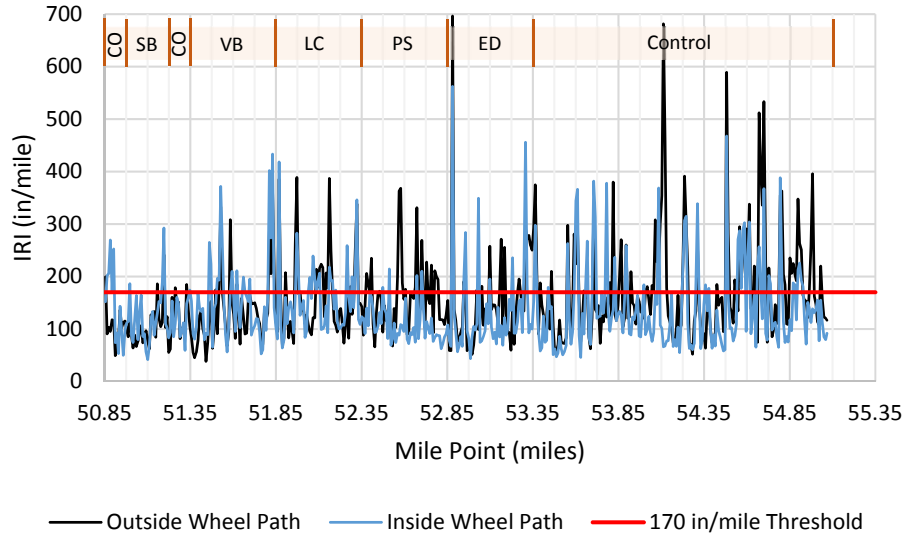
Figure 32: IRI Survey – North Bound Lane – 05/31/2014

From two IRI surveys before construction, IRI values were shown to be well in excess of the failure threshold of 170 inches/mile defined by the FHWA (Herman 2015). The results of the IRI surveys dated May 31, 2014 and November 05, 2014 are shown in Figure 32 thru Figure 35.

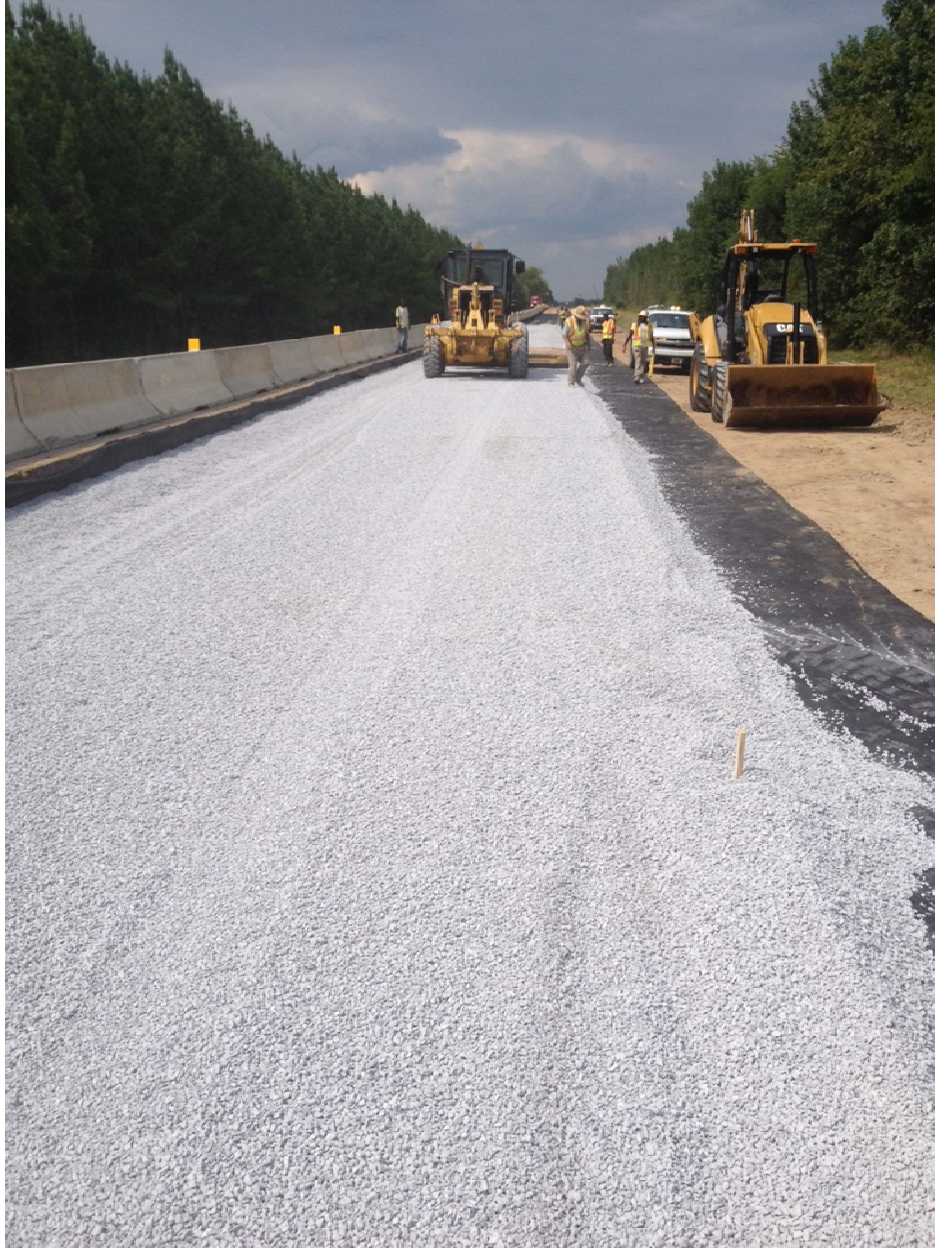
Figure 38: North Bound Lane – Application of Sand Blanket

Construction of the sand blanket began on 7/10/15 and the base course of asphalt was placed on 10/29/15. Since it was required that the road remain open to traffic, temporary traffic signals were installed and one lane was constructed at a time. A trench was first dug to install the drain along the edge of pavement. The trench was lined with a geotextile fabric and backfilled with the sand blanket material as shown in Figure 37. The installation of the 6 inch sand blanket layer is shown in Figure 38. Figure 39 shows the tack coat being applied to the granular base in the north bound lane. During the construction, water could be seen flowing out of the drain from the sand blanket following a rain as shown in Figure 40. Upon completion of both lanes, a final wearing course was paved as shown in Figure 41.

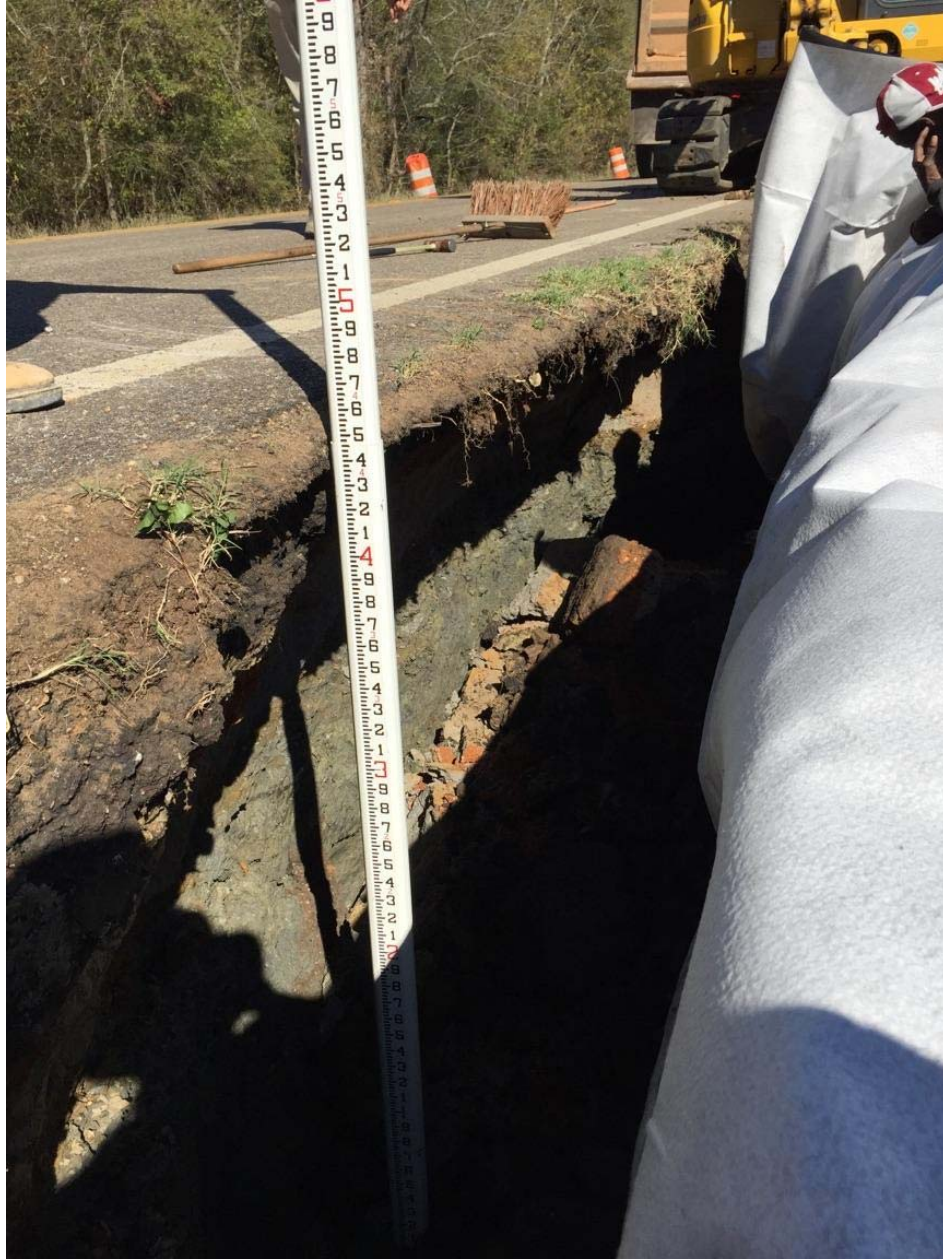
Figure 43: Trench Cave-in – Vertical Barriers

deep trench without the sidewalls collapsing resulted in the abandonment of the 10 feet deep vertical barriers. Instead, 6 feet deep barriers were placed along the entirety of the Test Section. An example of a collapse while attempting to dig the 10 feet trench is shown in Figure 43. An image of the open trench is shown in Figure 44. After excavation, the trench was lined and backfilled with a fine sand as shown in Figure 45 and Figure 46. A layer of asphalt was then paved directly over the sand as shown in Figure 47 and Figure 48.

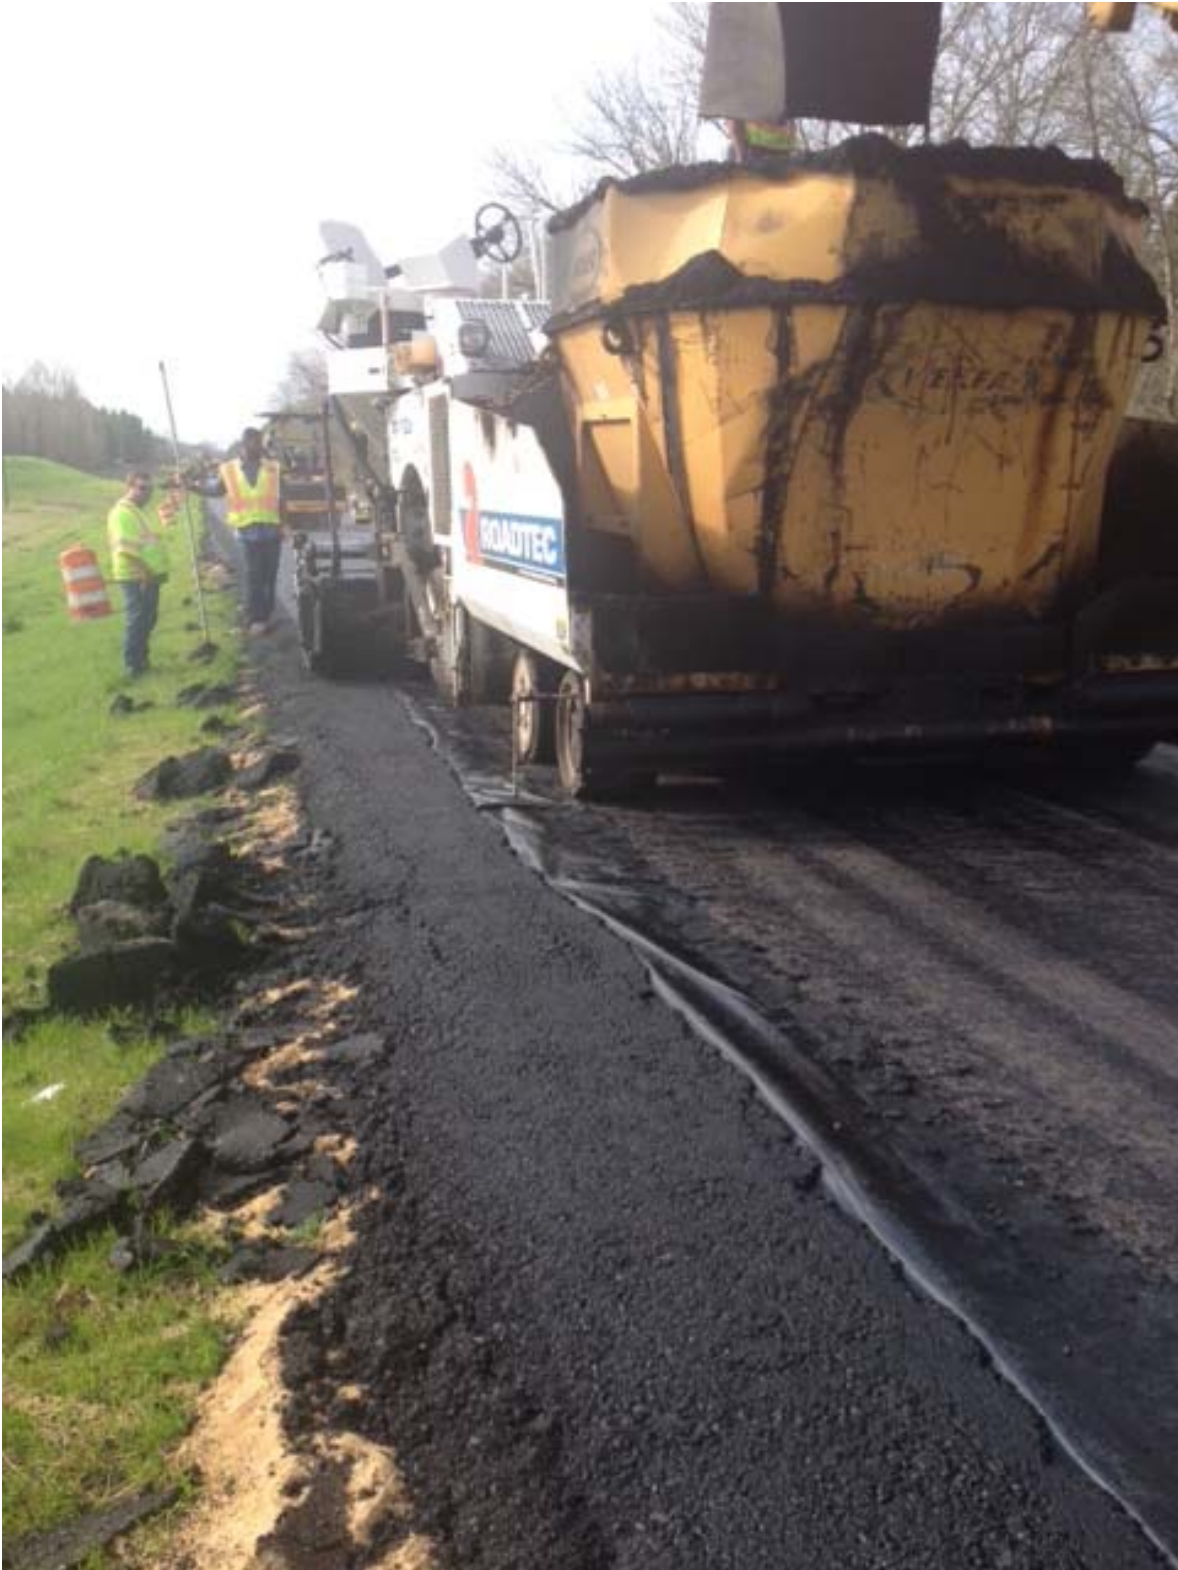
Figure 49: Leveling of Pavement over Vertical Barriers

As shown in Figure 49, the geosynthetic was folded over on the top creating ripples and folds in the material. The leveling course of asphalt was then placed on top of this geosynthetic.

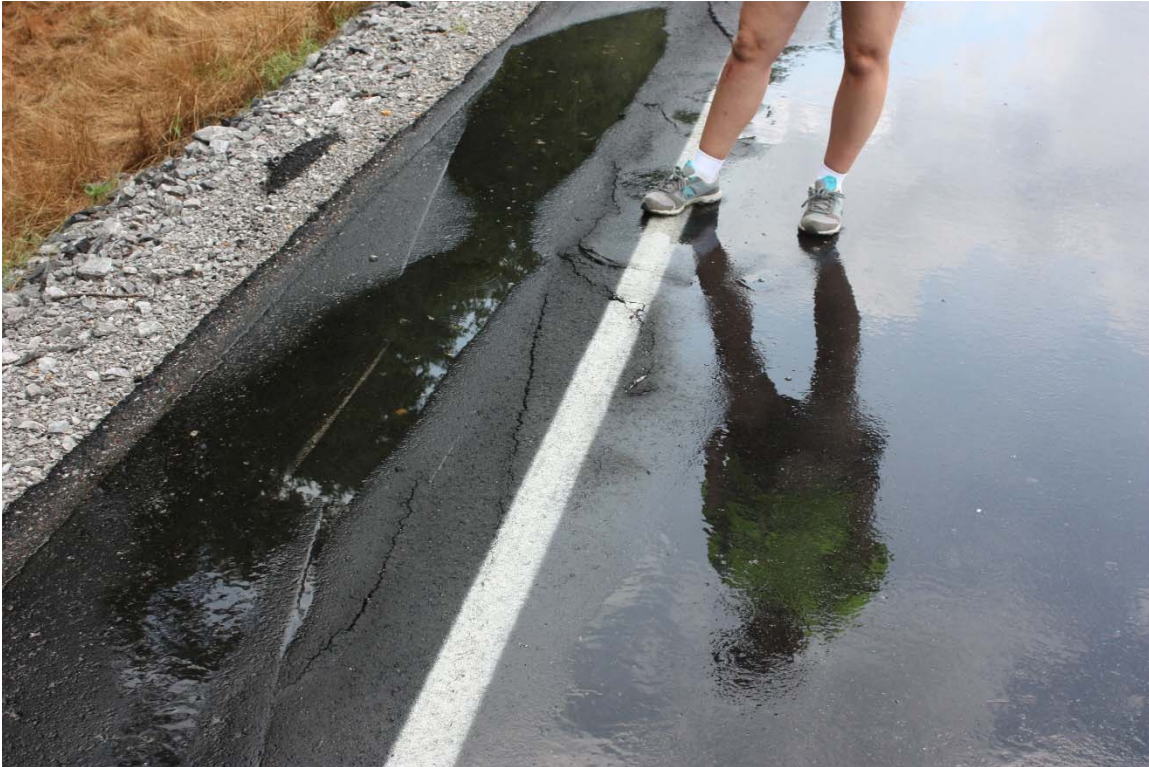
Figure 50: Cracks along shoulder above Vertical Barriers

After the base course of asphalt was placed on top of the vertical barrier test section, cracking, rutting, and spalling was observed directly above the vertical barriers. In some places, the geosynthetic protruded through the base course. Pictures of this can be seen in Figure 50 through Figure 53. Poor construction practice and compaction efforts were most likely to blame.

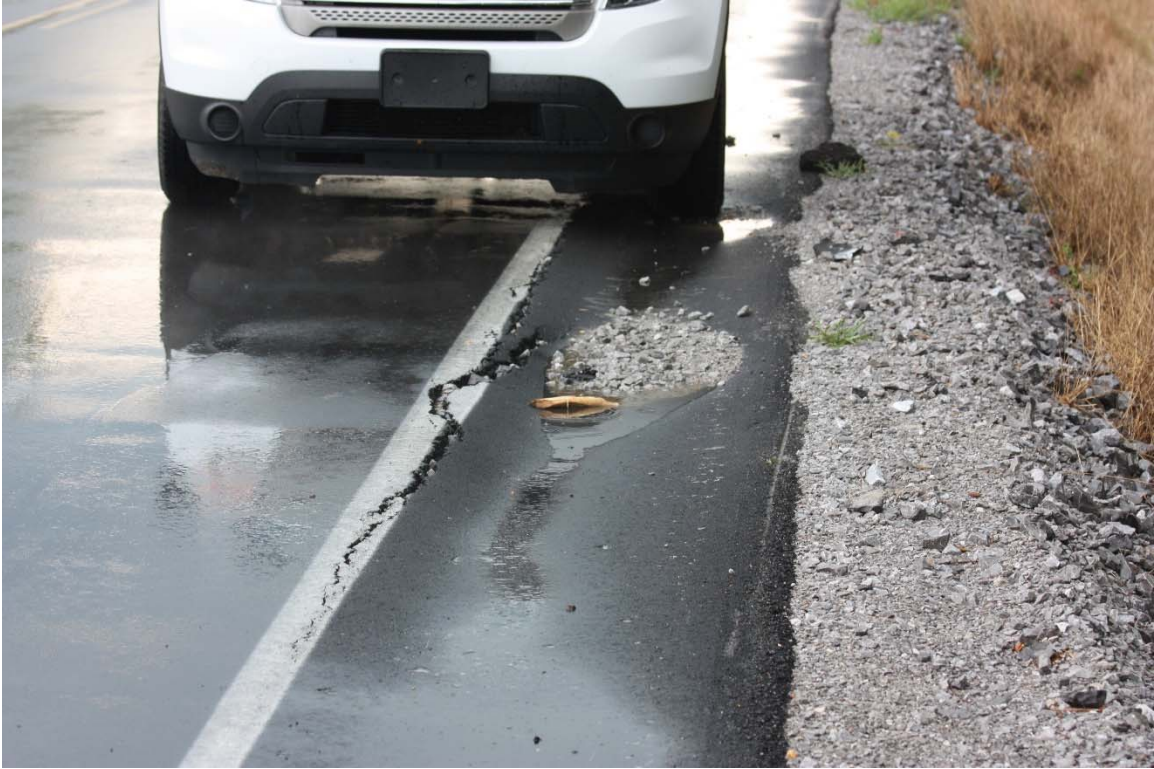
Figure 51: Rutting Observed above Vertical Barriers

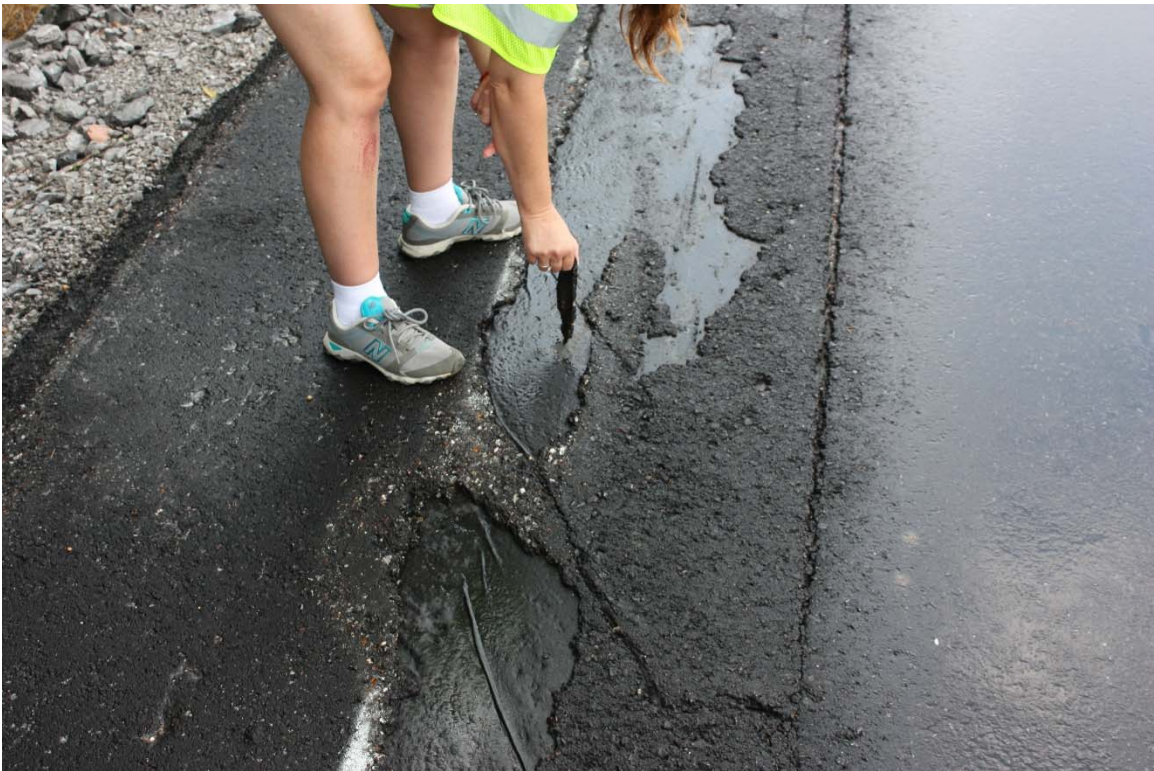
Figure 52: Asphalt Spalling above Vertical Barriers

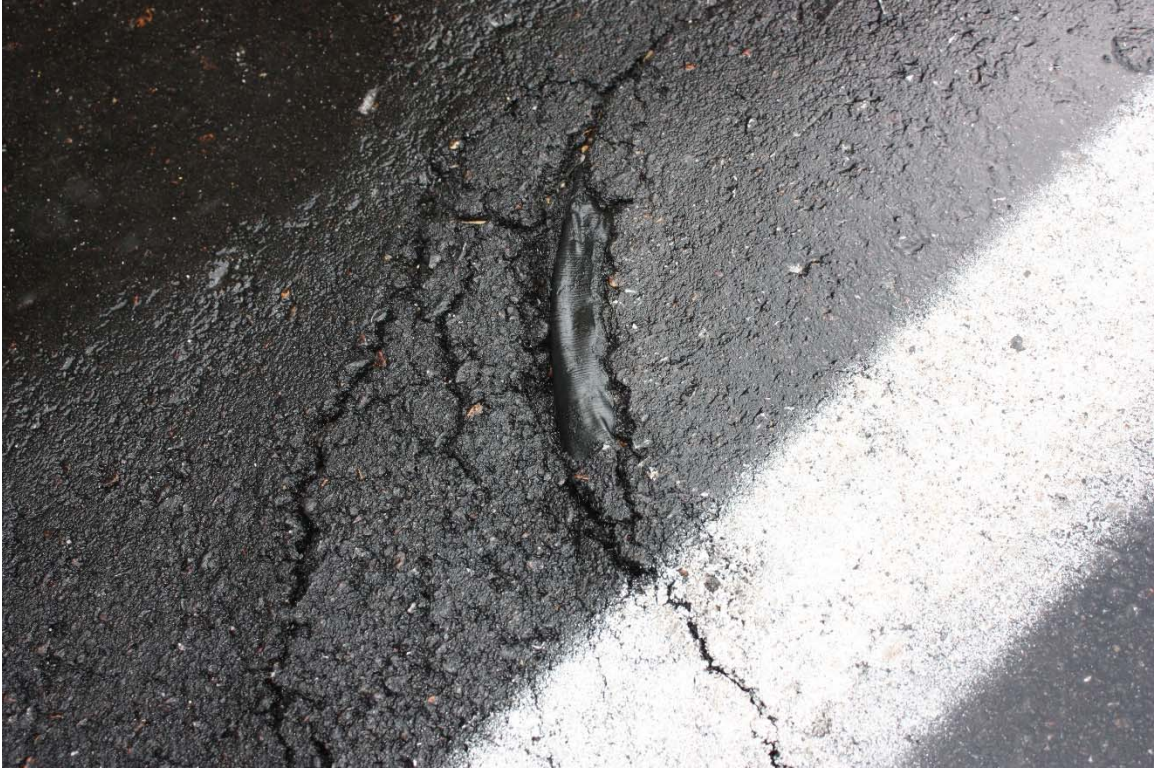
Figure 53: Geosynthetic protruding through base course of asphalt

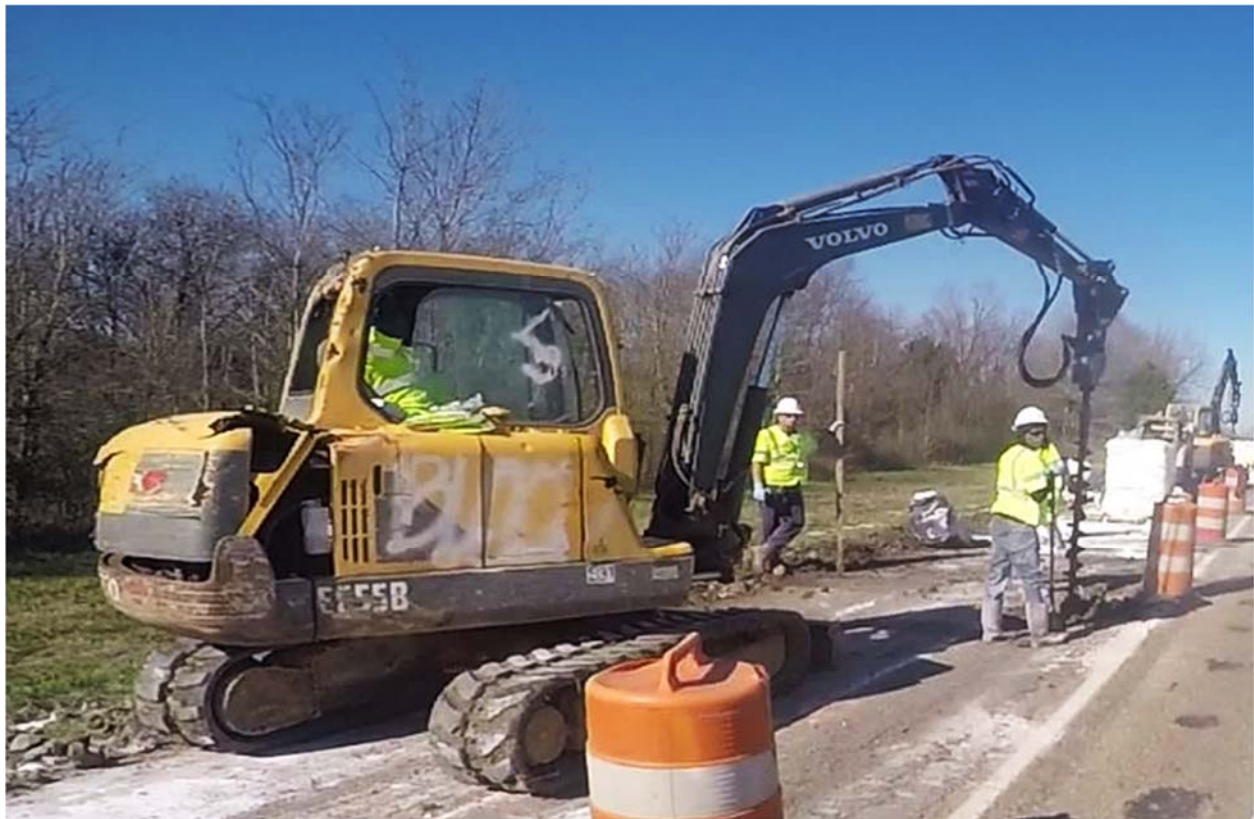
Figure 56: Drill Used for Lime Column Installation

Construction of the lime column test section began 11/4/15 and was completed on 2/4/16. The installation of the lime columns turned out to be very quick and efficient due to the ability to mount an auger to a small track hoe as shown in Figure 56 and Figure 57. The lime columns were drilled and then dry packed with lime as shown in Figure 58. Each hole was then patched

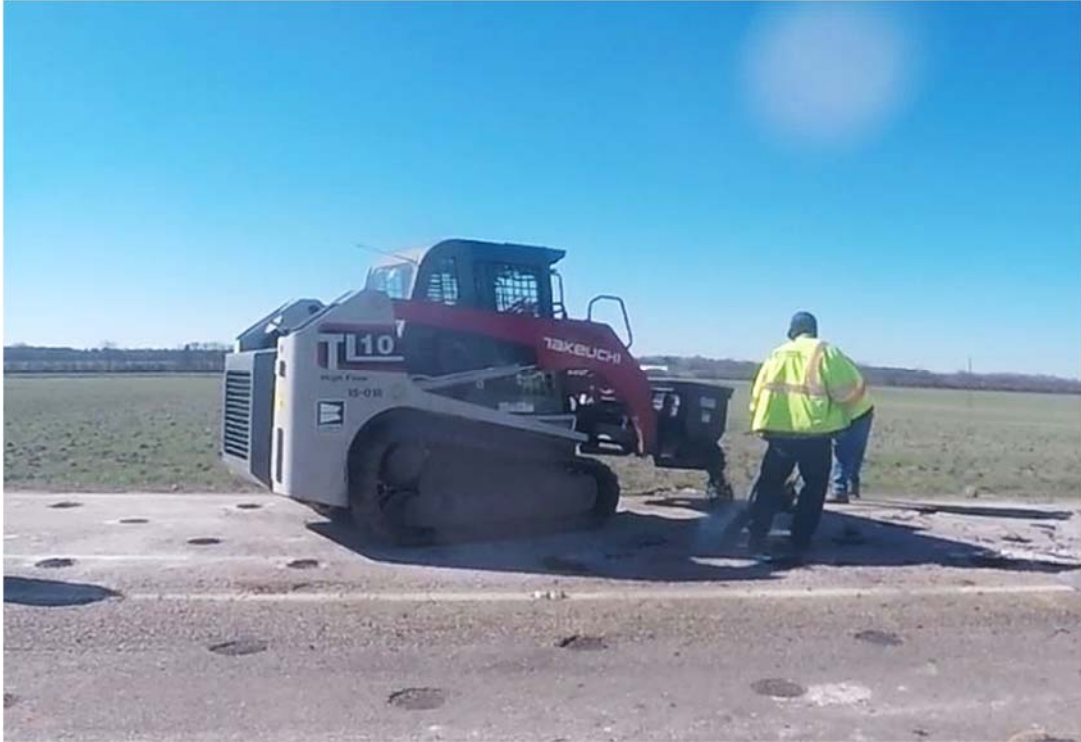
Figure 59: Pouring Asphalt into Lime Column Holes

with asphalt by pouring in hot asphalt from a bucket on a skid steer as shown in Figure 59. The asphalt was compacted and rolled as shown in Figure 60 and Figure 61.

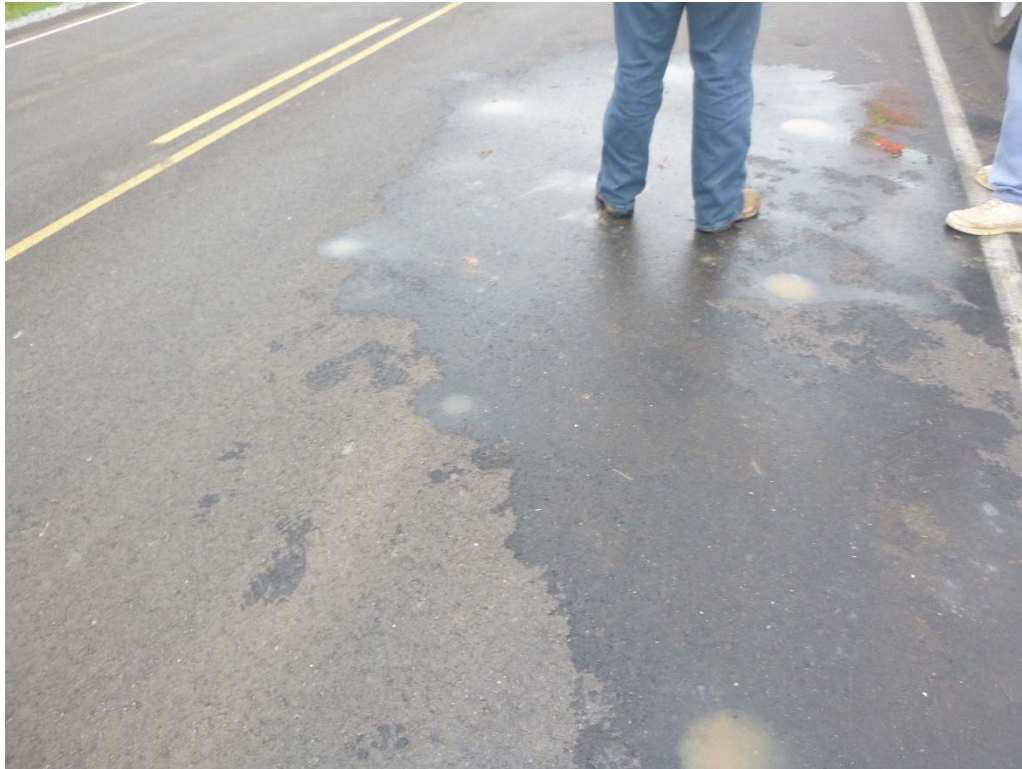
Depressions in the base course of the asphalt at the location of the lime columns as shown in Figure 62 were discovered. In one extreme case, a void reached the asphalt surface creating a hole in the pavement roughly a foot deep as shown in Figure 63. These depressions are most likely due to poor compaction of the asphalt cap at the top of the hole.

Figure 62: Lime Columns Reflected Through Base Course and Holding Water

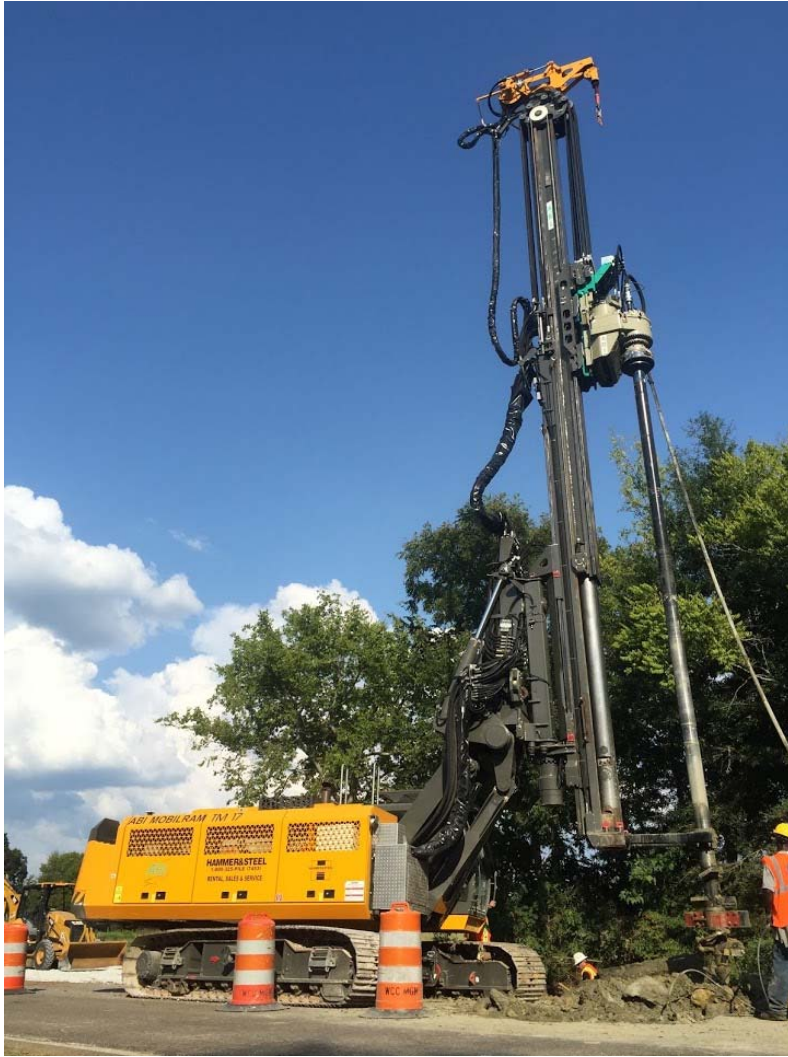
Figure 71: Deep Mix Column Drill Rig

A field validation program was completed on August 28, 2015. An image of the drill rig and batch plant used is shown in Figure 71 and Figure 72. During the installation of test columns, a variety of challenges and problems were discovered which ultimately led to the cancellation of the deep mixed column Test Section. For completeness, these challenges will be described in detail. First, due to the sheer size of the mix plant and drill rig, a substantial work platform had to be constructed adjacent to the road. As production of the deep columns continued, the platform would have to be moved and reconstructed causing extensive delays in the construction sequence.

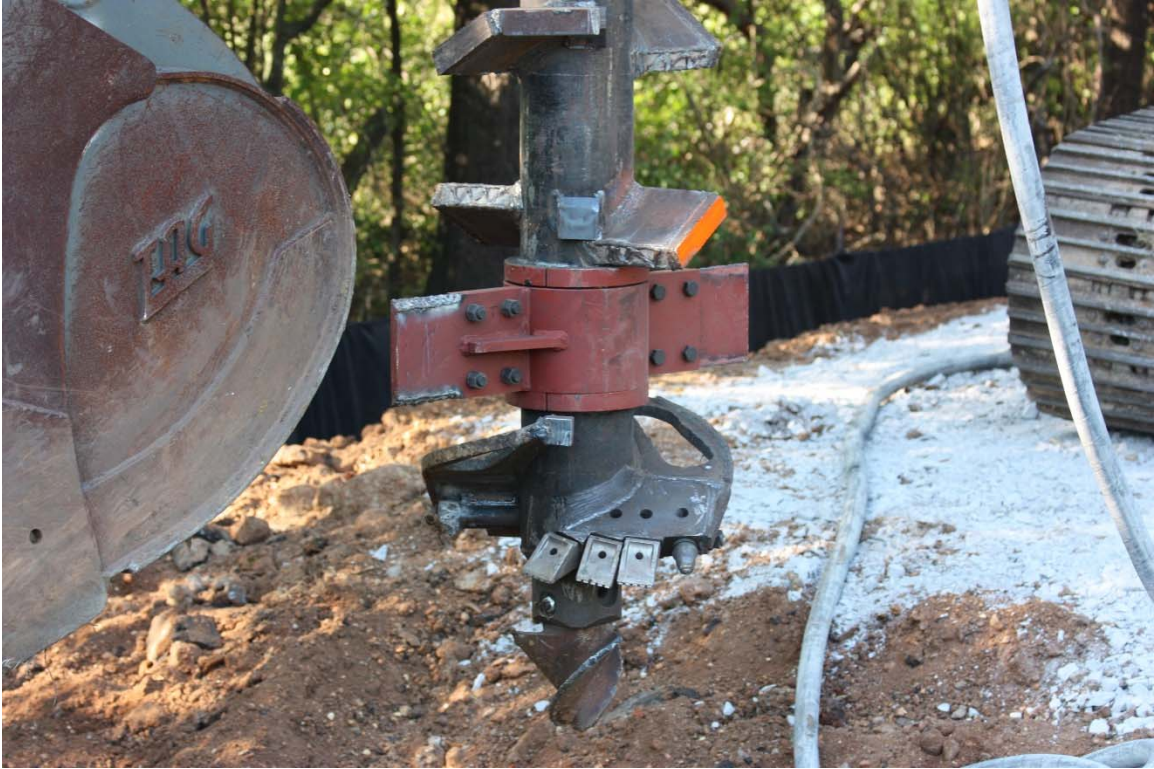
Figure 73: Drill Bit used for Deep Mix Column Installation

In addition to this, the original intent was for the columns to be directly drilled through the pavement surface. However, the drill bit used, shown in Figure 73, was not capable of coring through the asphalt pavement. Therefore, a rectangular section of pavement was cut and the asphalt was removed so that the test columns could be installed. Due to the inability of the drill bit to penetrate the asphalt, the entirety of the asphalt pavement would have to be removed and replaced in sections as columns were installed. This was determined to be highly impractical and would cause delays and increase costs.

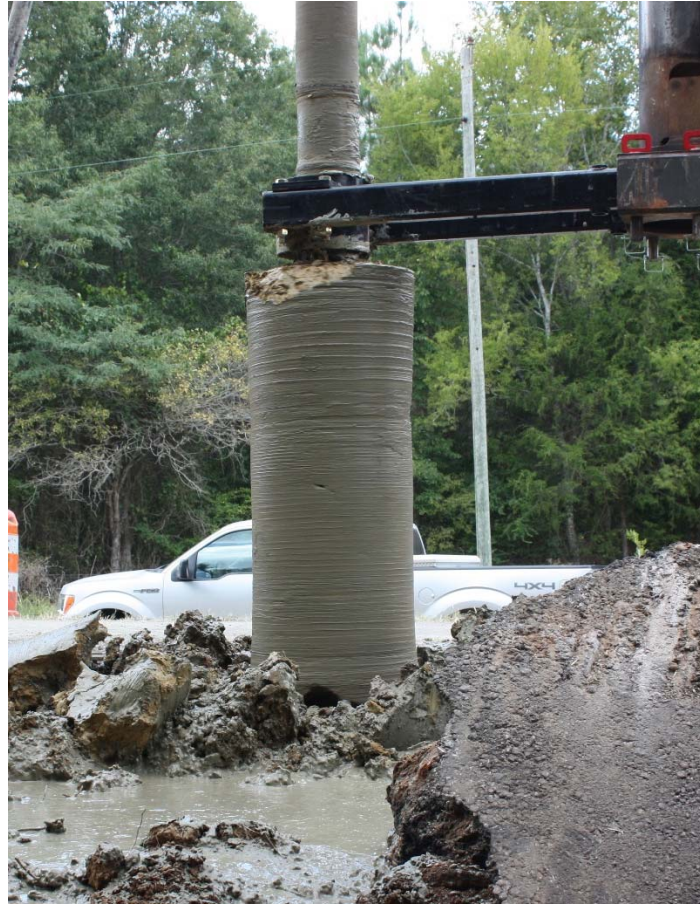
Figure 74: Extracted Column of Soil from Deep Mix Column

During the installation of the test columns, different cement dosage and slurry ratios were used. It was found that the method could not properly mix the cement slurry into the highly plastic clays at AL-5. As the drill was raised out of the hole a column of soil was extracted as well as shown in Figure 74. After breaking up this column of soil, it was discovered that the cement was not mixing into the soil. This can be seen in Figure 75. In this photo the gray color is the cement slurry mixture and the tan/brown is the in-situ soil. It was concluded by the contractor that the drill bit they were using was not appropriate for the type of soil at AL-5. For these reasons, deep mix columns were abandoned and Test Section 7 was used as another control section.

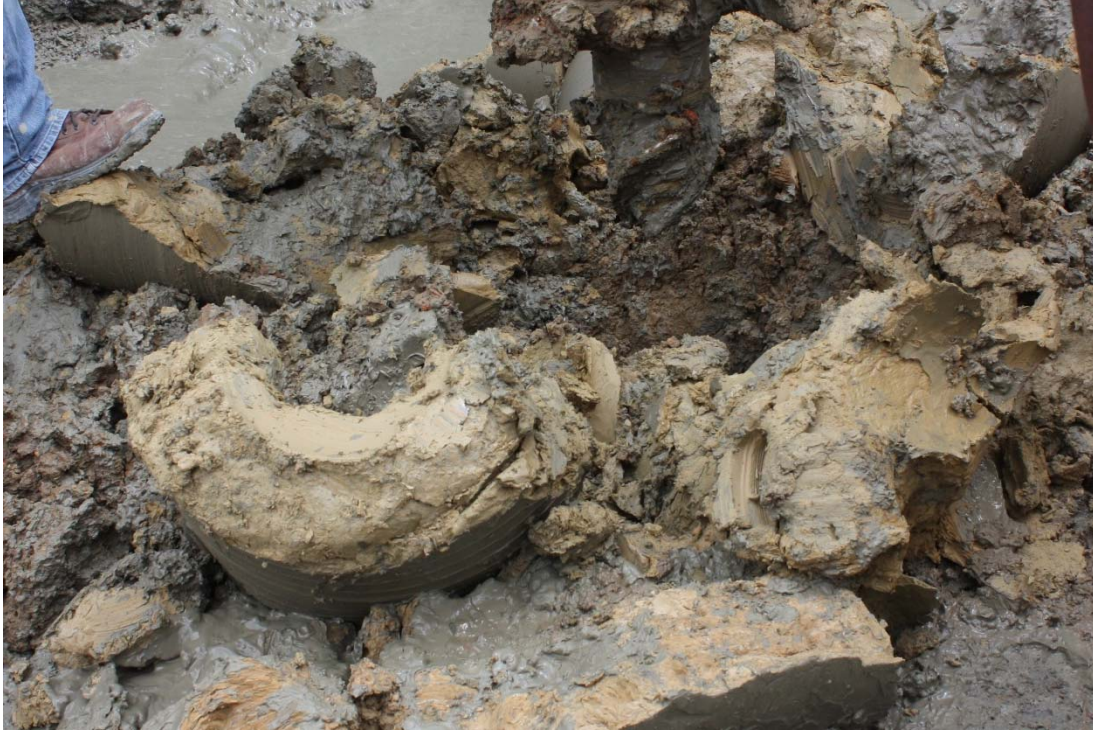
Figure 75: Clumps of soil showing lack of cement mixing

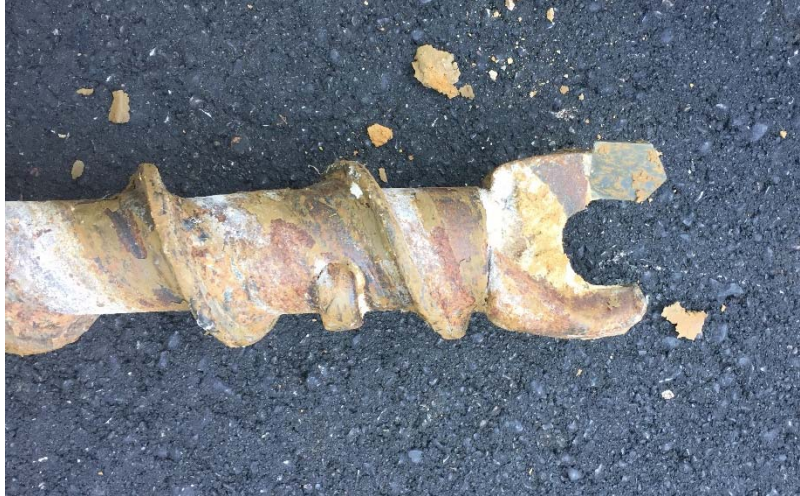
Figure 77: Auger and Bit used for Installation

Another option in the literature was to drill a bore hole the same diameter as the pipe and then push the pipe into place. This would provide good contact between the pipe and soil while allowing easy installation of the pipe. However, due to the small size of the PVC pipe, finding a set of augers with a 1.9 inch diameter was not possible. The smallest set of augers ALDOT was able to acquire were 2 inch in diameter with a 2-1/4 inch bit. A picture of the augers and bit is shown in Figure 77 for reference. This created a small annular void between the pipe and the soil which could affect the readings. As mentioned previously, Bishop and Porro (1997) were able to show that filling this annular void with sand made it possible to determine fluctuations in moisture content of the surrounding soil. Because of their findings, it was decided to fill the annular void with filter sand.
