**Moisture Content Monitoring using a Nuclear Moisture Gauge
and Preliminary Findings at Alabama Highway 5**

A thesis submitted to the Graduate Faculty of
Auburn University
in partial fulfillment of the
requirements for the Degree of
Master of Science

Auburn, Alabama
May 6, 2017

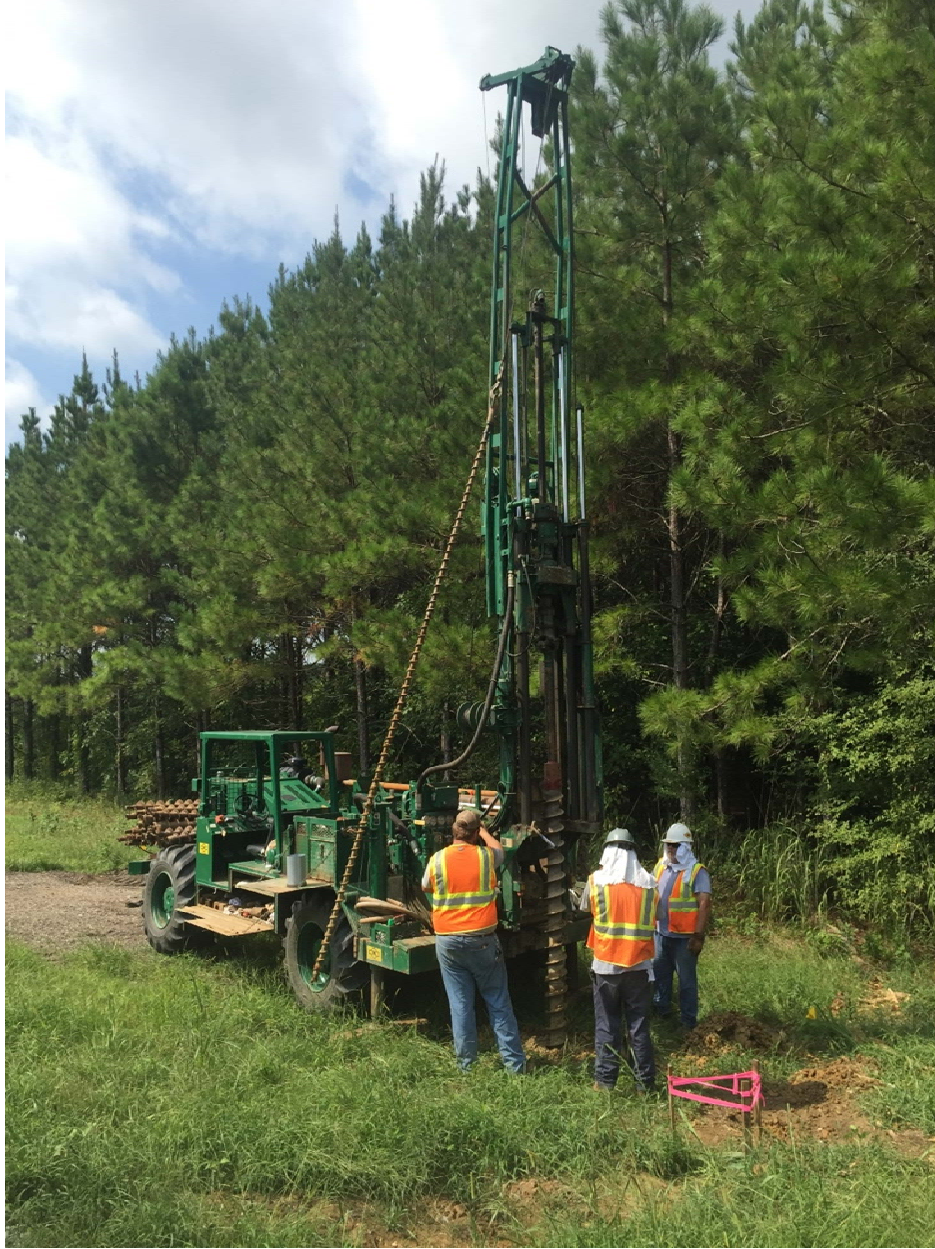
Figure 78: ATV Drill Rig used for Hydroprobe Installation

Using the auger, a 10 feet 2 inch deep hole was drilled and the PVC pipe was lowered into place. An image of the drill rig is shown in Figure 78. To prevent water from infiltrating the access tube, the bottom of the PVC pipe was sealed with a rubber stopper and a PVC cap before lowering into place as shown in Figure 79. Under normal circumstances, it is recommended to leave the access tube sticking out above the ground two to three feet. However, for obvious reasons this was not possible due to traffic. Instead the top of the access tube was terminated inside a waterproof manhole flush with the road and ground surface as shown in Figure 80. The manhole cover was secured in place with a quick setting grout. An additional rubber stopper was used to seal the top of the tube within the manhole cover. A cross section of the completed access hole is shown in Figure 81.

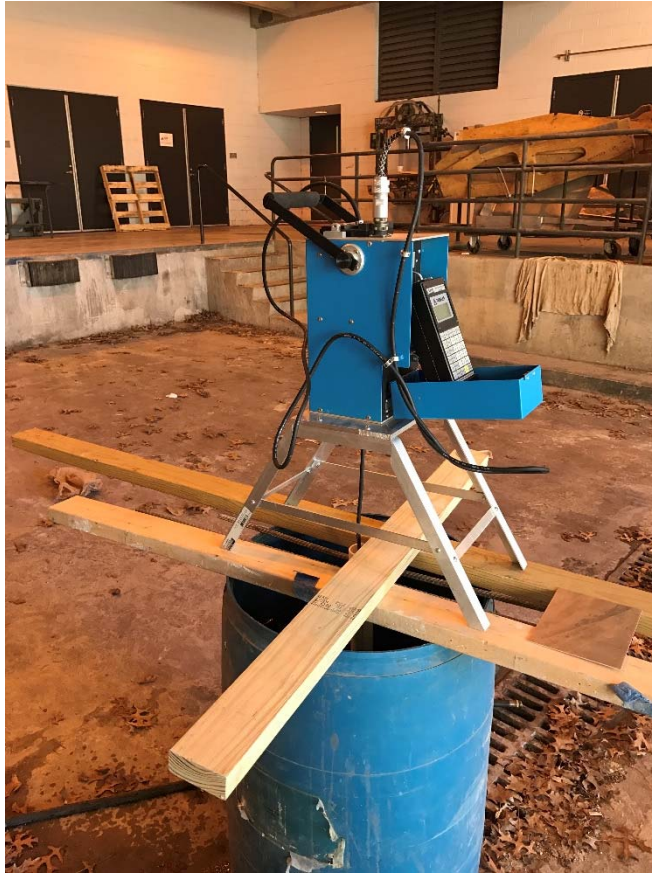
Figure 82: 55-Gallon Barrel Water Test Setup

To determine the effects of the PVC pipe on the gauge readings, Troxler (2006) recommended the following procedure. A section of PVC pipe was sealed at the bottom and positioned in the center of a 55-gallon barrel full of water. The probe was then lowered to the middle of the barrel and numerous readings were taken to obtain the average count. This average count was then compared to the corresponding point on the factory calibration curve. An image of this setup is shown in Figure 82.

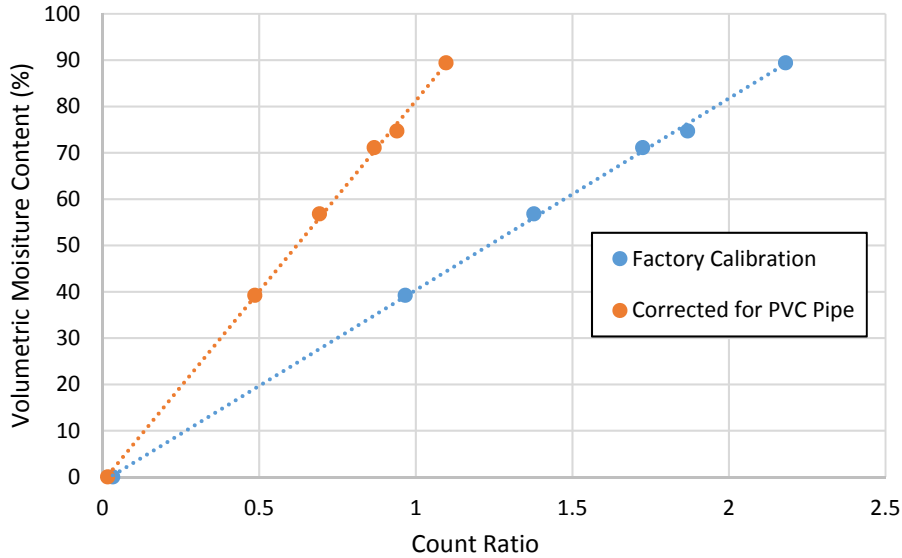
Figure 83: Calibration Correction for PVC

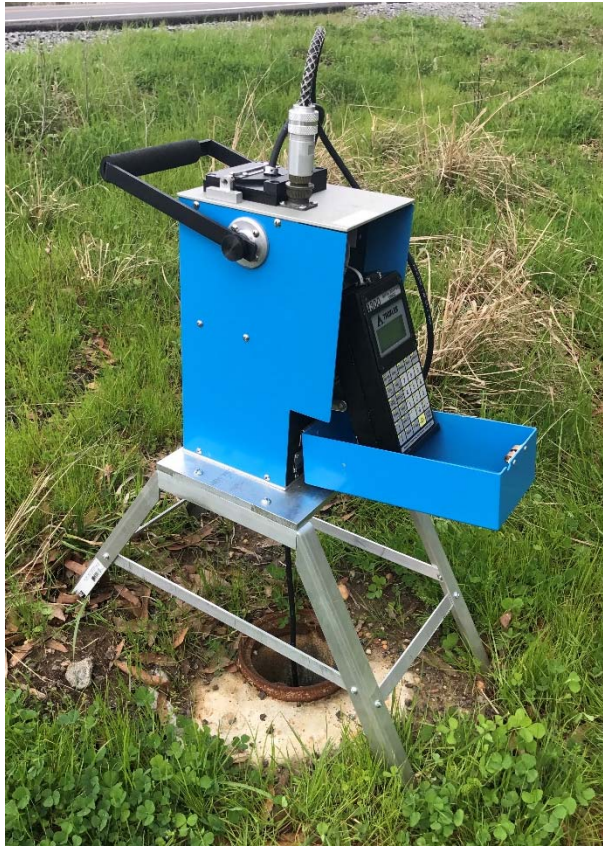
Figure 84: Hydroprobe Stand

To ensure accurate readings, the standard count must be obtained daily. Typically, the standard count is taken with the moisture gauge sitting on top of the access tube extending out of the ground two to three feet. By doing this, the standard count obtained is consistent across all access holes. Due to the top of the access tube being below the ground surface this was not possible. The manufacture noted that it would be acceptable to place the hydroprobe on the ground to take readings as long as the standard count was taken on a surface that would not affect the standard count. To ensure consistency across the project, a stand was developed to allow the hydroprobe to sit roughly a foot above the ground surface or road. The stand was made of aluminum as it is a material which does not affect the hydroprobe reading. A photo of this stand in use is shown in Figure 84.

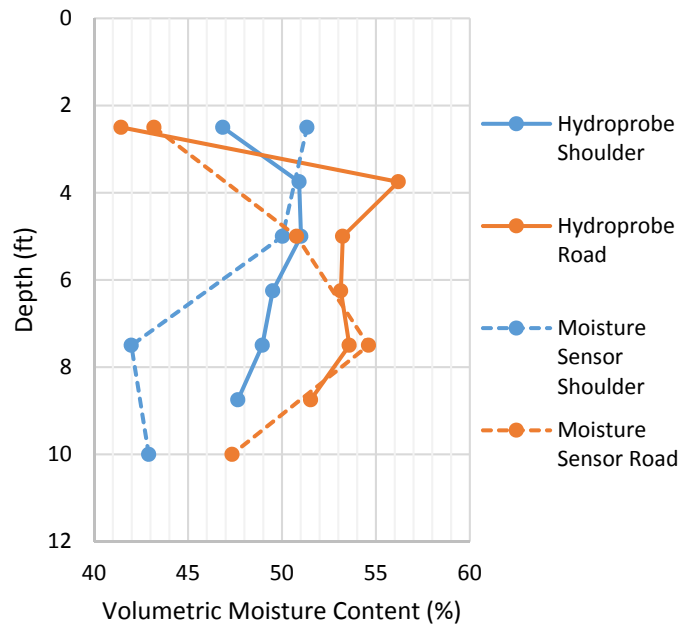
Figure 88: Baseline Hydroprobe Readings – Paved Shoulder

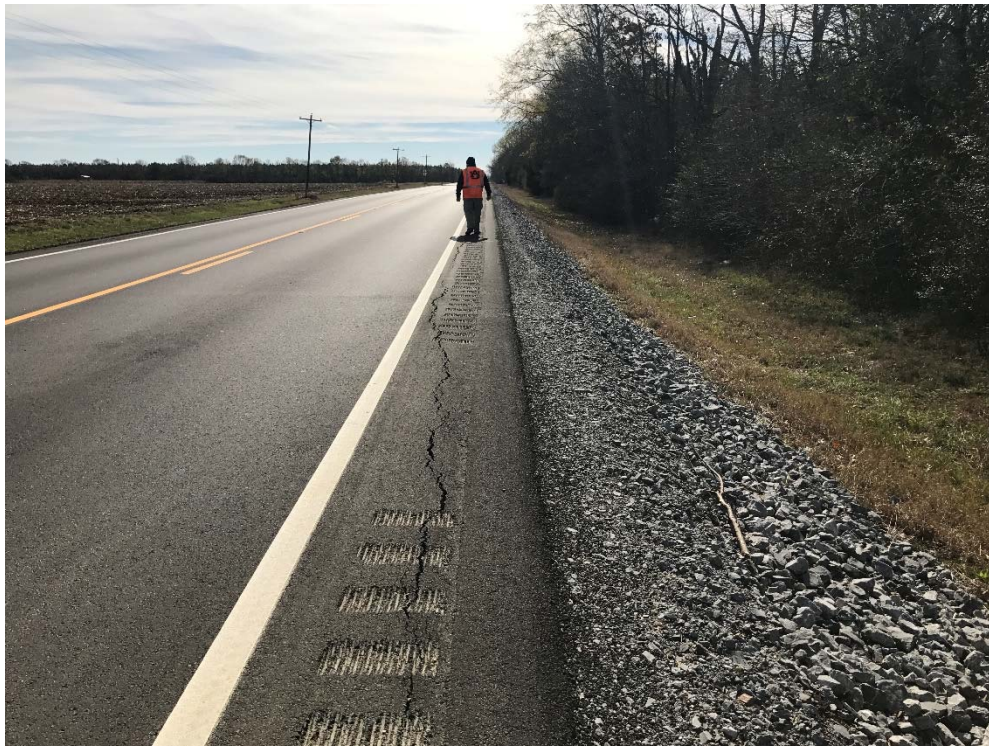
Figure 91: Longitudinal Crack in Vertical Barrier Test Section
