**INVESTIGATION OF DEFLECTION BASINS TO IDENTIFY STRUCTURAL
DISTRESSES WITHIN FLEXIBLE PAVEMENTS**

A dissertation submitted to the Graduate Faculty of
Auburn University
in partial fulfillment of the
requirements for the Degree of
Doctor of Philosophy

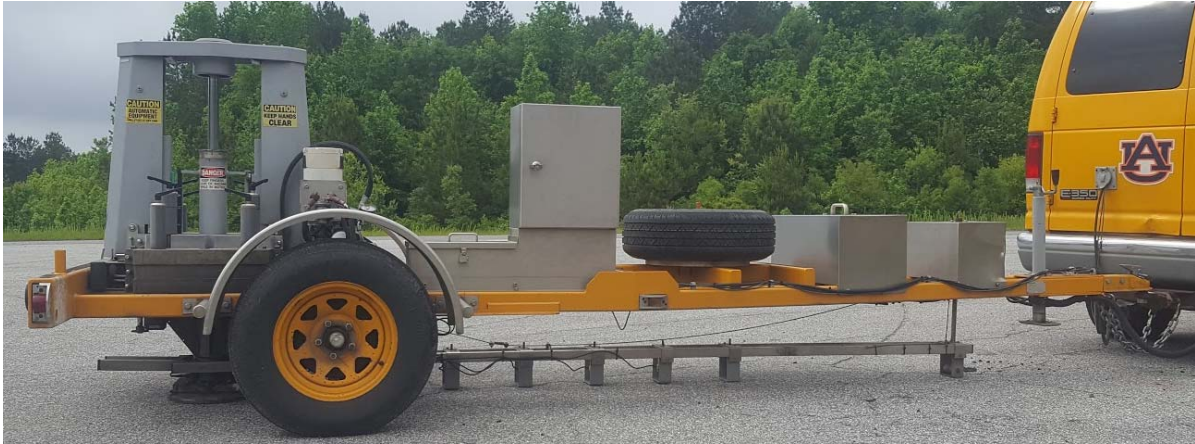
Figure 1.1 – Dynatest Model 8000 FWD.

The FWD is a NDT tool that is used by many agencies to assess in-situ structural characteristics of pavements. The FWD, shown in Figure 1.1, operates by dropping a weight onto a rubber plate placed on the pavement surface and measuring the subsequent deflections of the pavement with sensors at various distances away from the drop. It is able to accurately replicate the loading from a moving vehicle wheel in magnitude and duration (Huang, 2004). The load level of an FWD drop is a result of the height at which the weight is dropped (i.e., greater drop height results in higher load level). Figure 1.2 schematically shows an FWD setup with nine sensors (D_0 through D_8) at increasing distances away from the center of the load plate. The term “deflection basin” is generally used to describe the deformed area measured by the sensors.

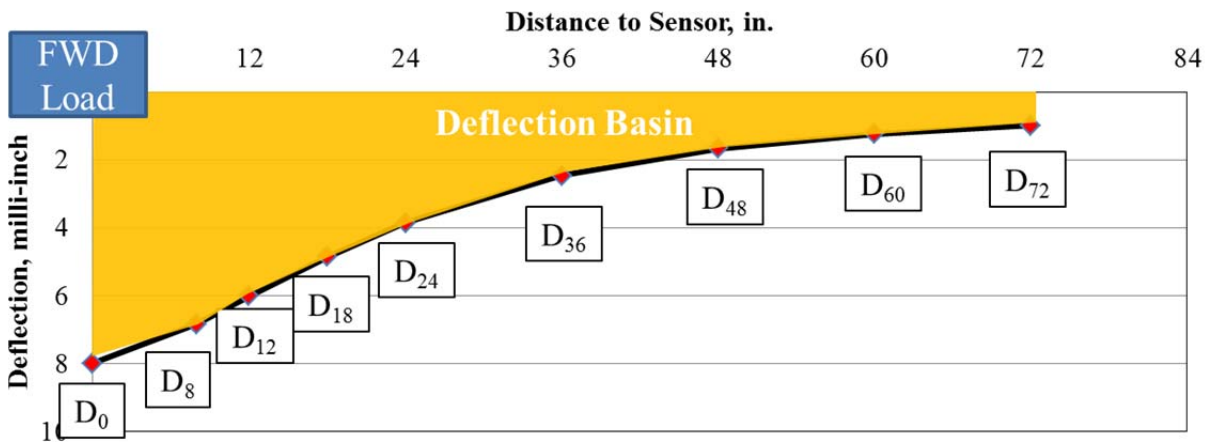
Figure 1.2 – FWD testing schematic.

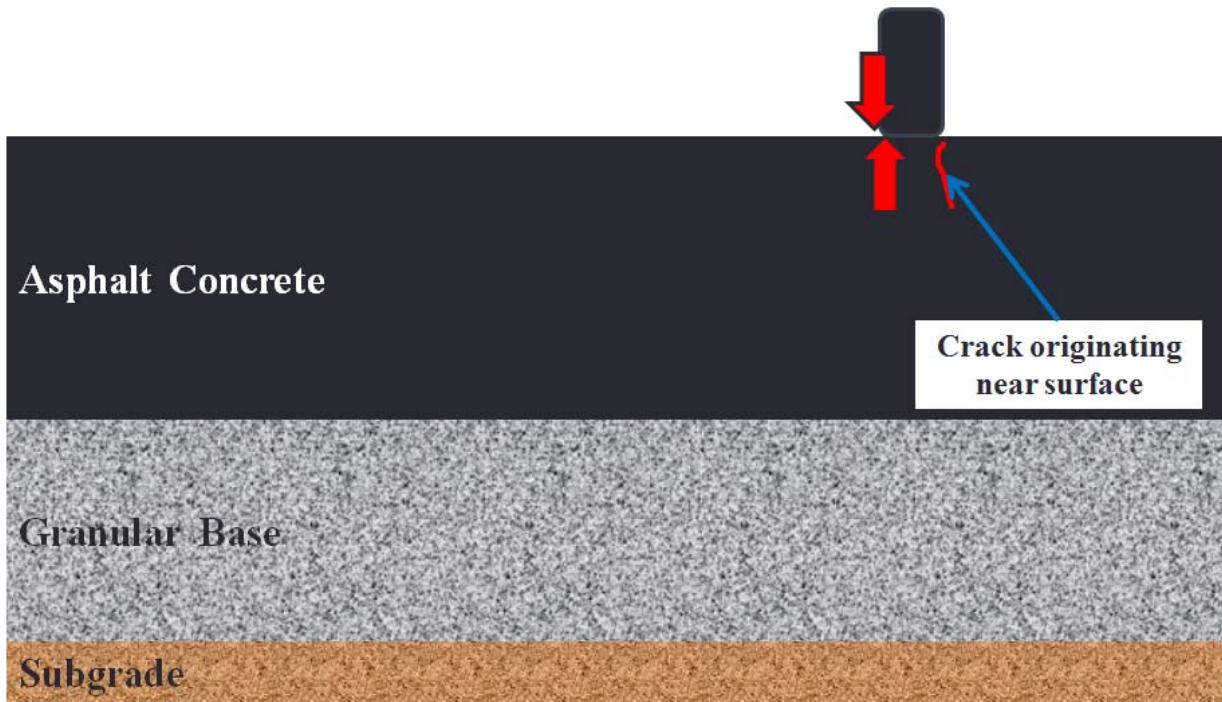
Figure 2.3 – TDC diagram with cracking due to shear stress at edge of tire.

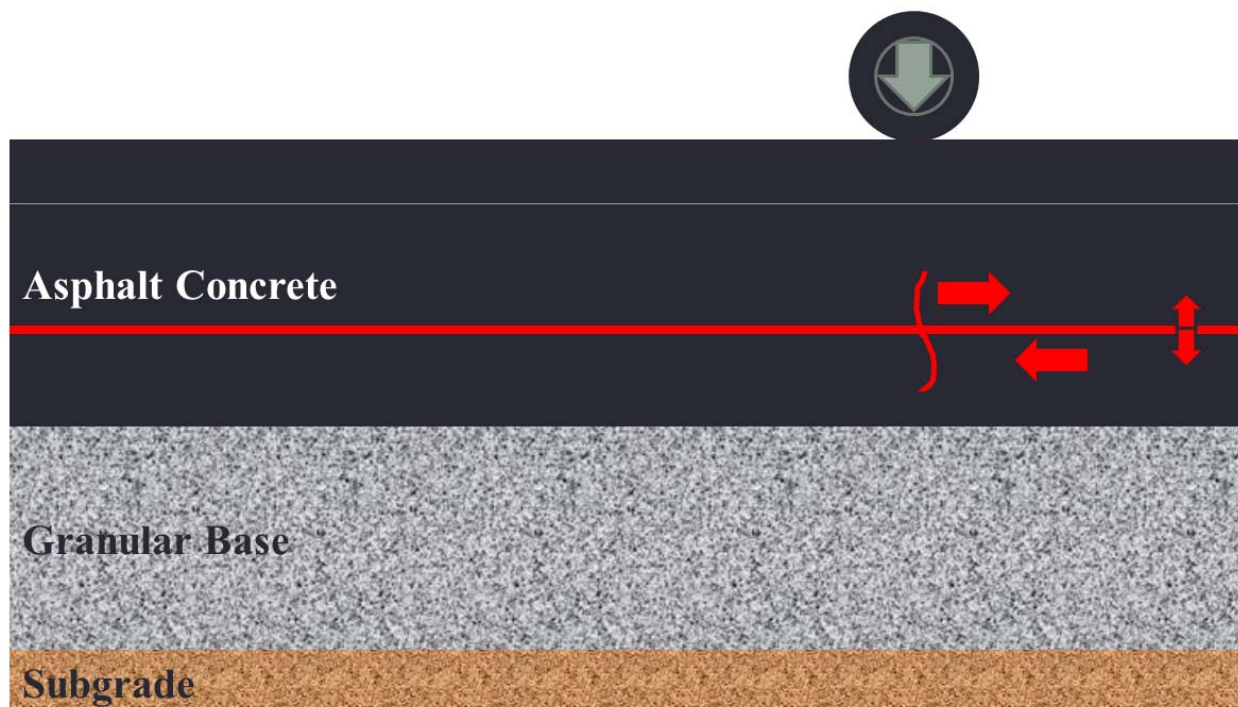
Figure 2.5 – Delamination diagram.

Delamination is a result of shear and tensile forces at the interfaces between AC layers (Mohammad et al. 2012). A schematic of these forces, along with a crack originating from the delamination location, is shown in Figure 2.5. After layer delamination occurs, the pavement layers begin to behave independently instead of acting as a single structure. Delamination often results in rapid failure and requires complete removal of the delaminated layer. If the surface layer is delaminated, tearing and “crescent” shaped cracking is visible on the pavement surface (Brown et al., 2009). In Figure 2.6, it can be seen that the top of the “crescent” is pointing in the direction of traffic. When delamination occurs at AC layer interfaces lower in the structure, the cracking visible on the surface often appears more like fatigue cracking because fatigue cracking is occurring at the bottom of the layer directly above the delaminated interface due to excessive bending under wheel loads.

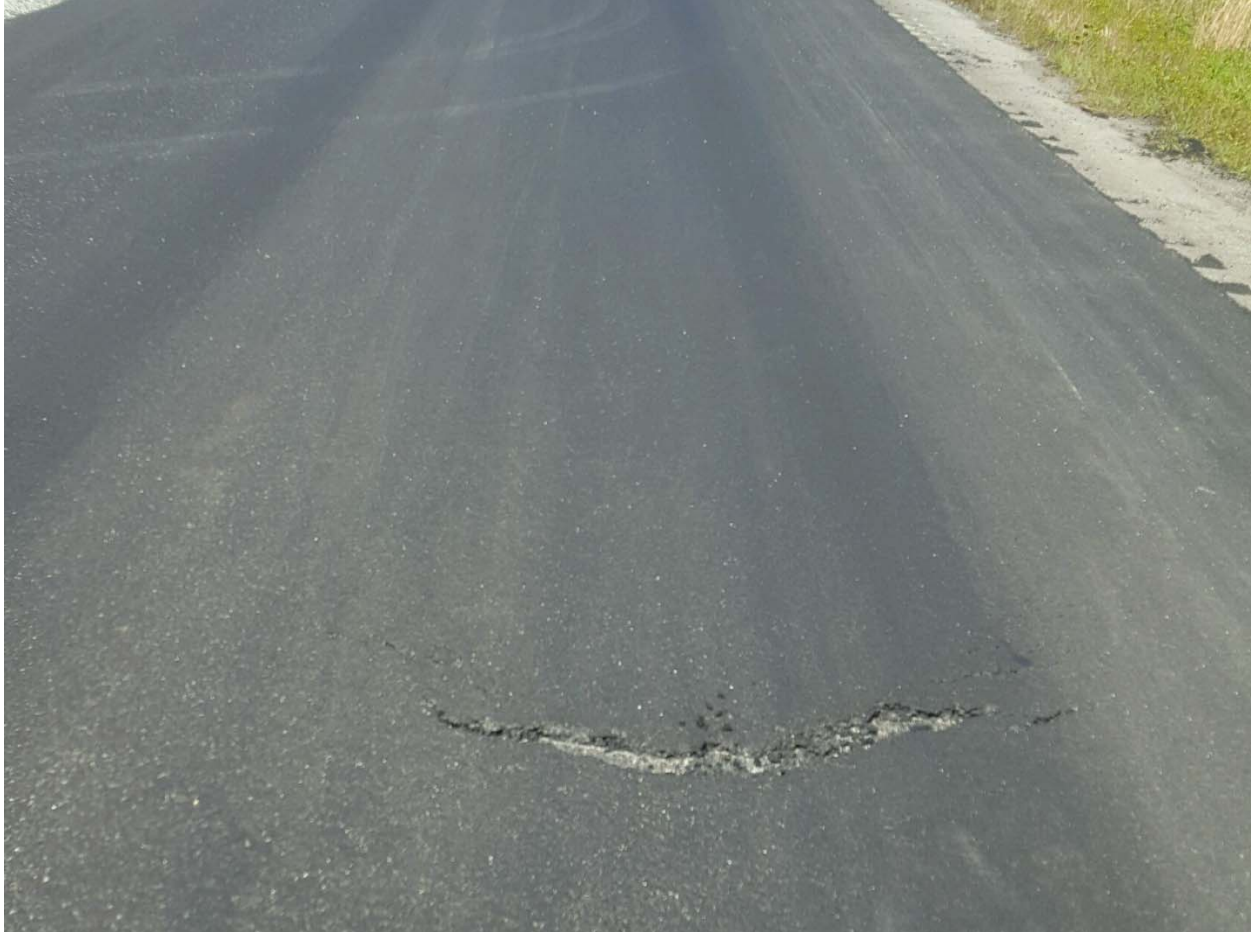
Figure 2.6 – Crescent shaped cracking resulting from delamination of the surface layer.

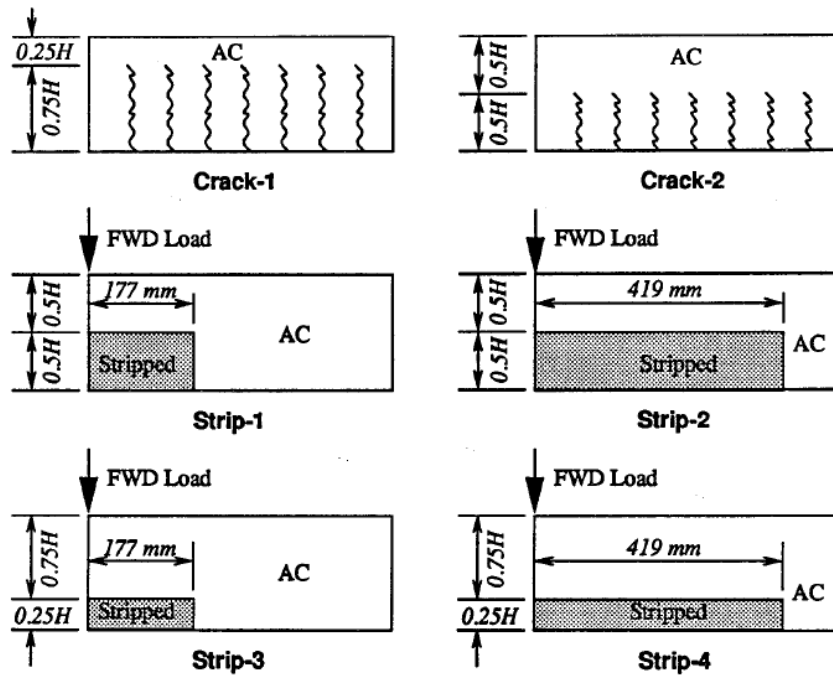
Figure 2.13 – Distress conditions considered in FE modeling (Kim et al., 1999).

Discontinuities in the AC from cracking or stripping were also investigated in the FE simulations. Bottom-up cracking was simulated in a FE model by using interface elements to represent cracks in the AC. Simulations were conducted with cracks 152 mm apart and cracks propagating through 75% and 50% of the AC, as shown in Figure 2.13. Stripping was also considered in separate FE models with extents shown in Figure 2.13. The stripped portion of the AC was represented by using a reduced elastic modulus; however, the amount of modulus reduction was not reported (which would have been of particular interest to the modeling conducted in this research). The distressed pavement simulations were compared to intact pavement simulations and the changes in deflection basins due to the simulated distress were investigated but the sensitivity of individual DBPs to simulated distress was not reported (as it was for change in moduli or thickness).

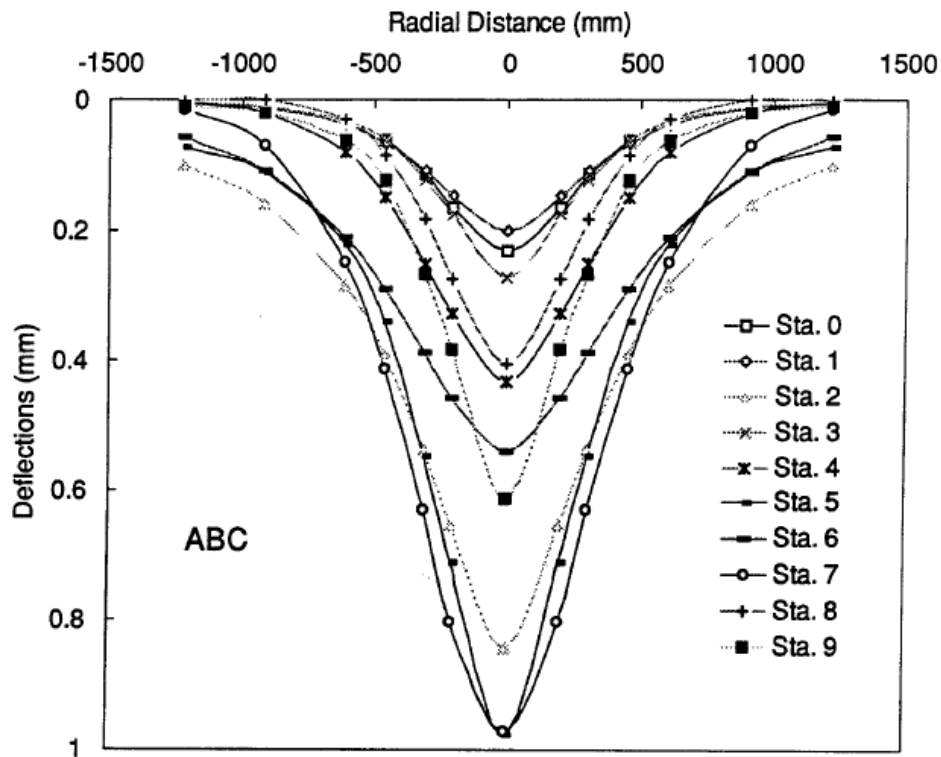
Figure 2.14 – Deflection basin variability within section (Kim et al., 1999).

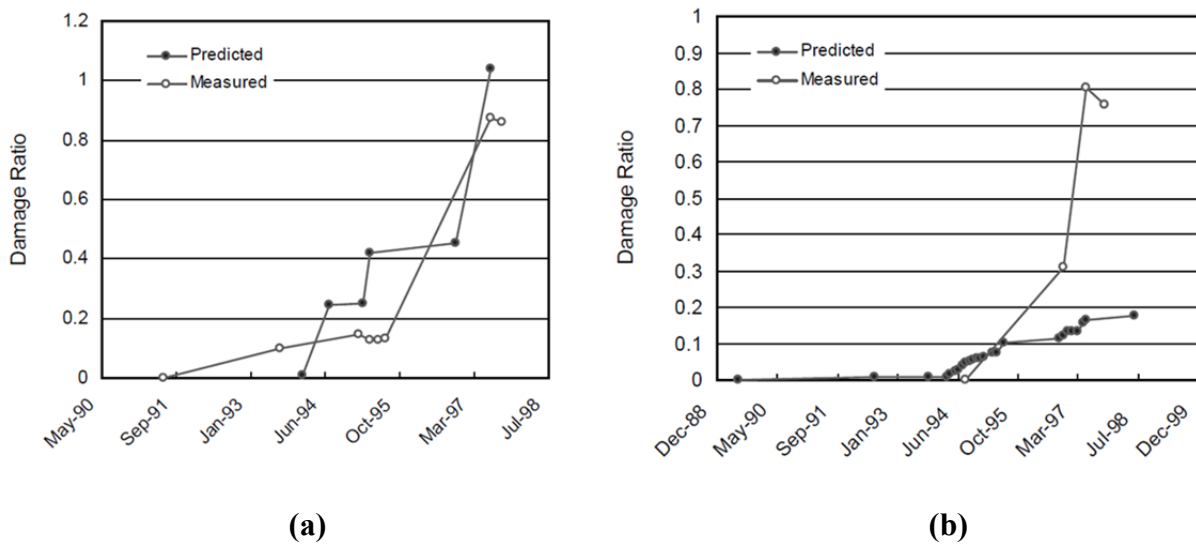
Figure 2.16 – Predicted and measured fatigue cracking from sites (a) in wet- no freeze region and (b) wet – freeze region (Park and Kim, 2003)

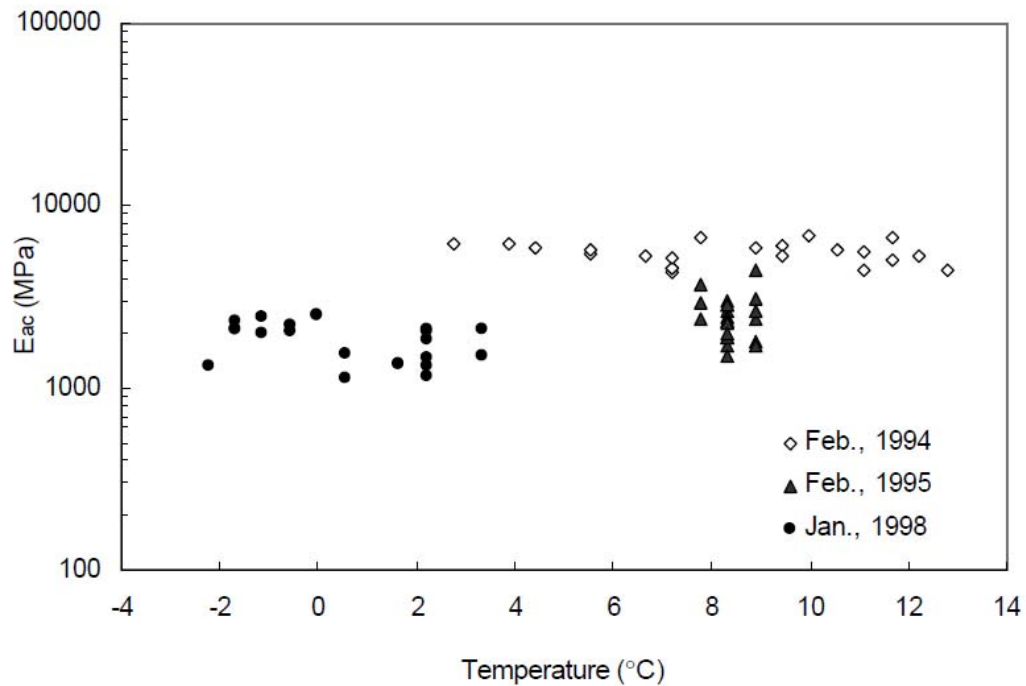
Figure 2.17 – AC Modulus from aggregate base pavement in Arizona (Xu et al., 2003)

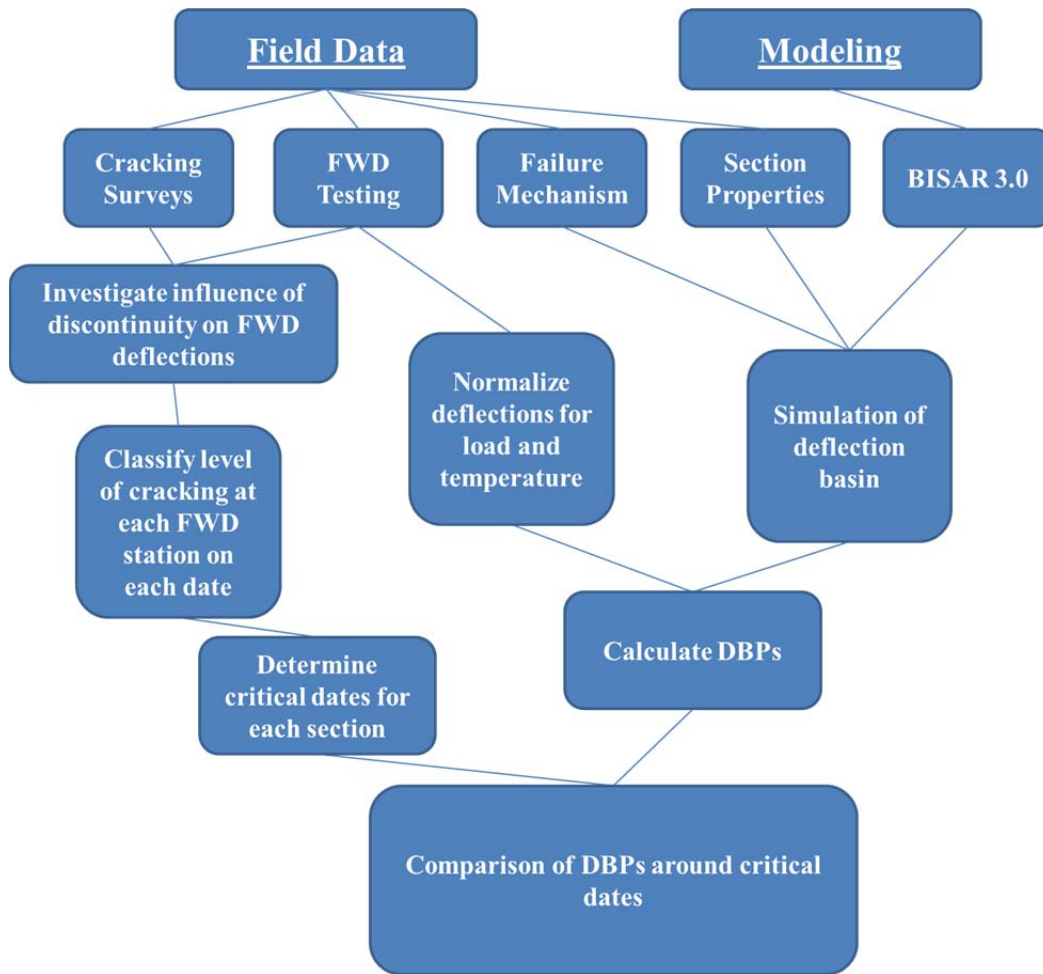
Figure 3.1 – Flowchart of methodology.

The methodology to scrutinize deflection basins on flexible pavements that developed cracking is summarized in Figure 3.1 and fully described in the following subsections. Modeling and field data from the NCAT Test Track were used for each section analyzed. The field data for each section consisted of FWD testing, cracking surveys, section properties from construction quality control and laboratory testing, and the failure mechanism documented in previous reports. The FWD testing data were normalized using regression equations to account for the effect of load and pavement temperature. Each section was modeled in BISAR 3.0 (Bitumen Stress Analysis in Roads), using laboratory measured moduli and surveyed layer thicknesses, to determine the theoretical effect of the documented cracking type on the FWD deflection basins. Delamination, top-down cracking (TDC), and bottom-up fatigue cracking (BUFC) were the cracking mechanisms considered. The level of cracking at each FWD station over time was quantified based on a sub-investigation that was conducted to determine the horizontal distance at which a discontinuity began to affect the measured deflections. Finally, the DBPs calculated from the BISAR simulations were compared to DBPs from normalized FWD data.

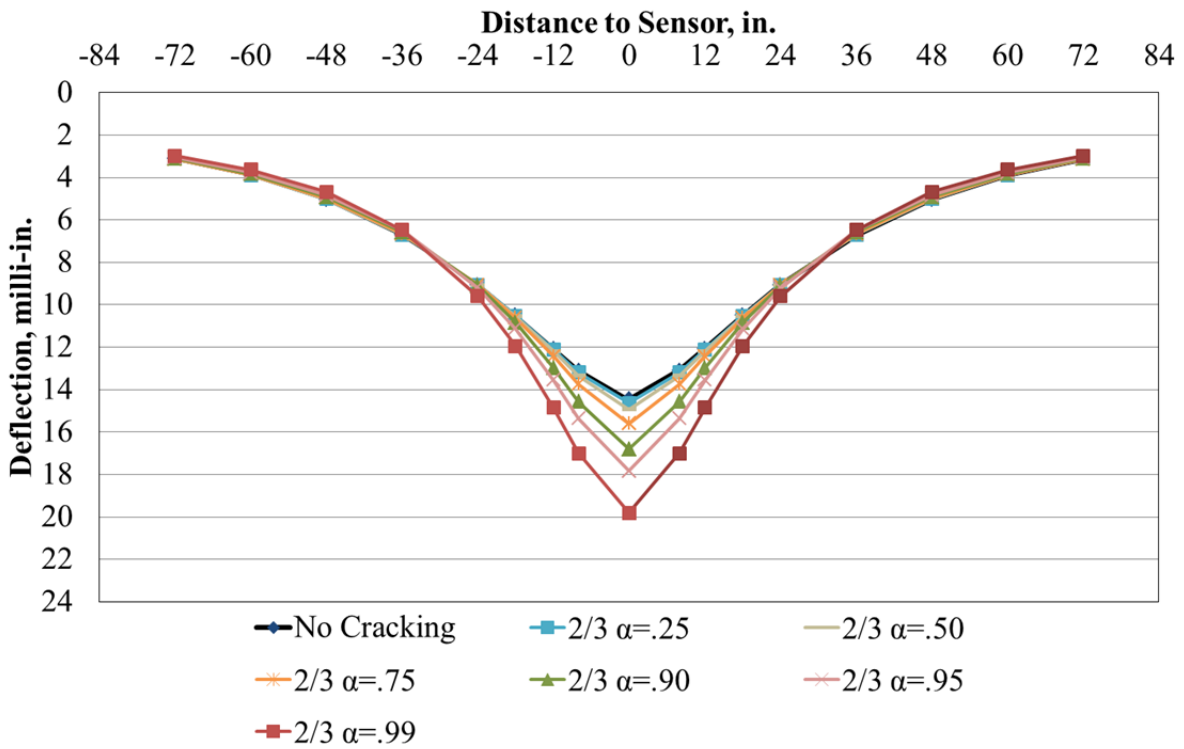
Figure 3.4 – BISAR simulated deflection basin with varying slip at interface 2/3.

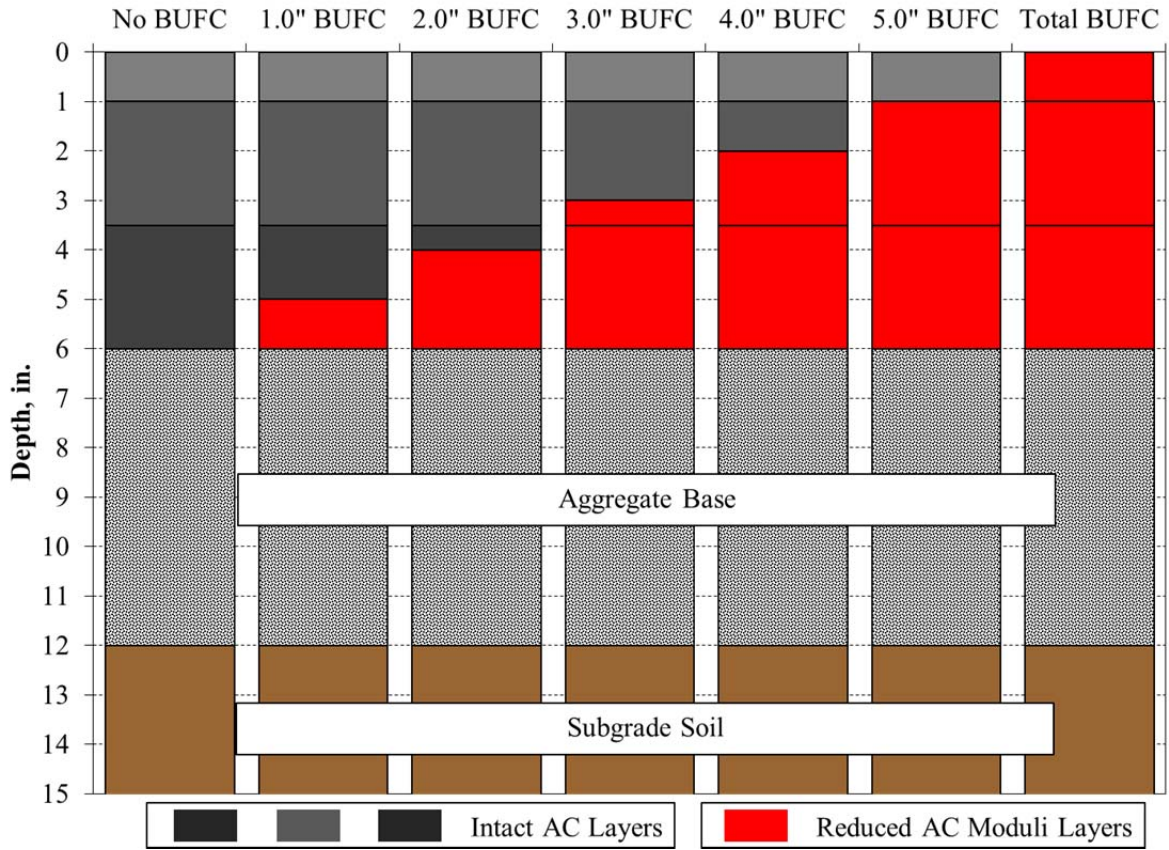
Figure 3.5 – Example cross-sections used to model BUFC.

Figure 3.5 shows the simulations used to model BUFC in BISAR. Although the discontinuities in the pavement created by cracking directly violate the underlying assumption of homogeneity in linear-elastic modeling, it is still useful to estimate how the deflection basin will change as a result of BUFC. This was simulated by lowering the moduli (E_{AC}) of the “cracked” layers in BISAR. The AC moduli were reduced to 25 and 50% of their original value. The “cracked” layer was increased in 1 inch increments to simulate the impact on the deflection basin as BUFC propagates toward the surface. A modulus reduction to 25% was initially modeled, shown in Figure 3.6, because it was believed that there is a significant reduction in modulus with cracking but since the material is still confined, the modulus should still be on the same magnitude as the intact state. Additionally, a modulus reduction of 50% was tried and is shown in Figure 3.7. A 50% modulus reduction was utilized because it has been used as a failure threshold in laboratory bending beam fatigue testing (AASHTO T321-07). The BUFC model was further refined in the Fatigue Cracking Developmental Group (Chapter 6) when DBPs from sections with BUFC were scrutinized. It can be seen in Figure 3.6 and 3.7 that, as expected, the deflections at sensors within 18 inches of the load increase as the thickness of the simulated fatigue cracking increases.

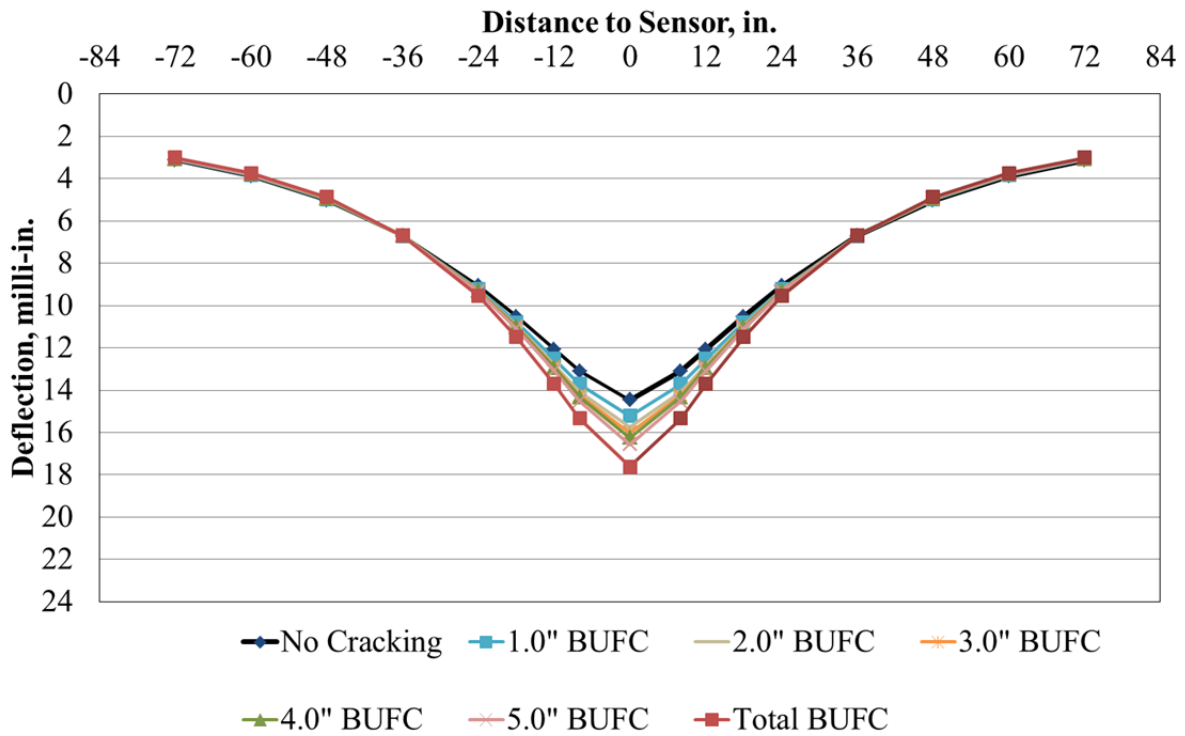
Figure 3.7 – BISAR BUFC simulation (E_{AC}=50%).

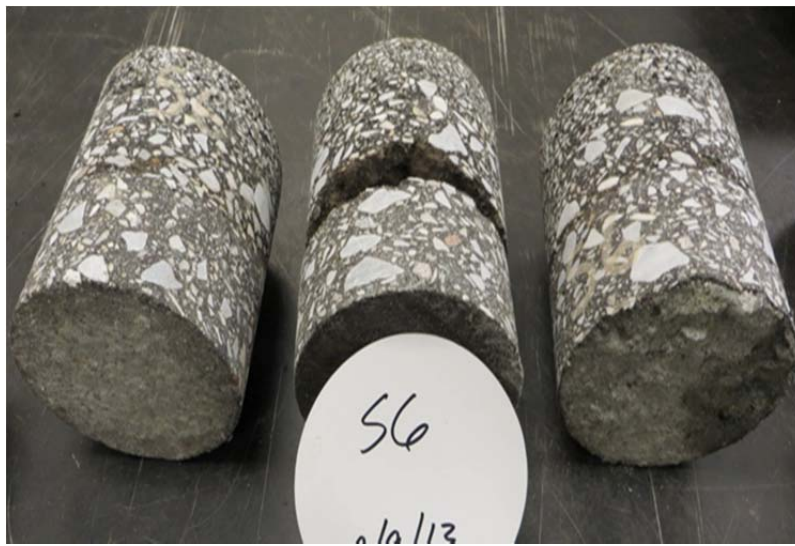
Figure 4.10 Cores taken from 2012-S6 in September 2013 (Vrtis et al., 2015).

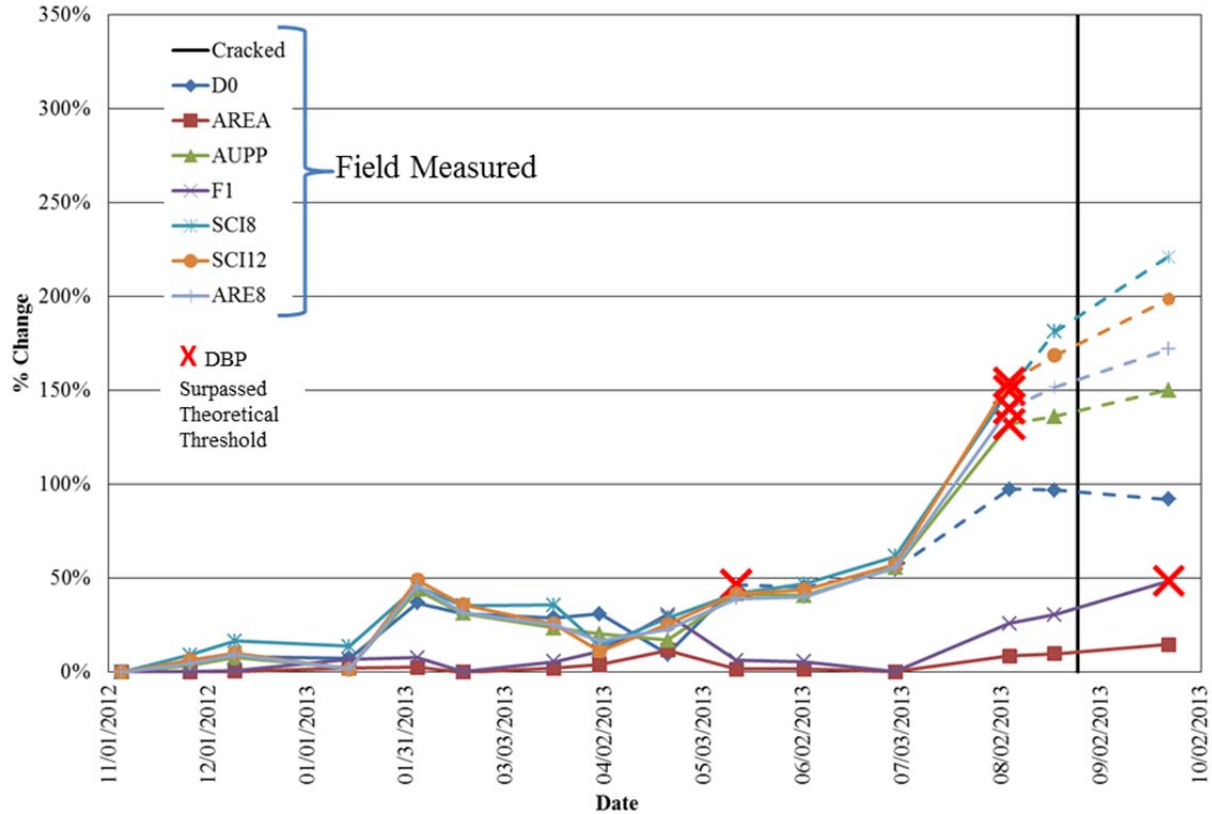
Figure 4.11 – Percent Change in DBPs over time for S6-3.

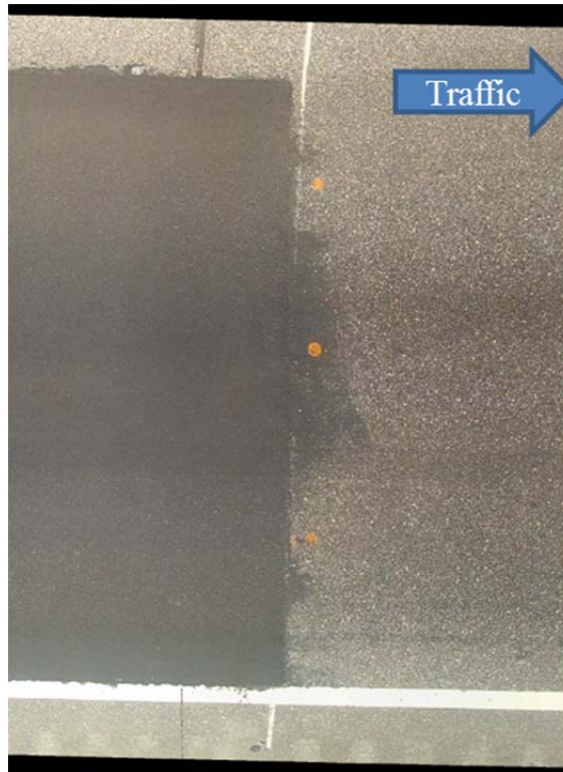
Figure 6.4 – Patch near RL#1 in 2009-N10

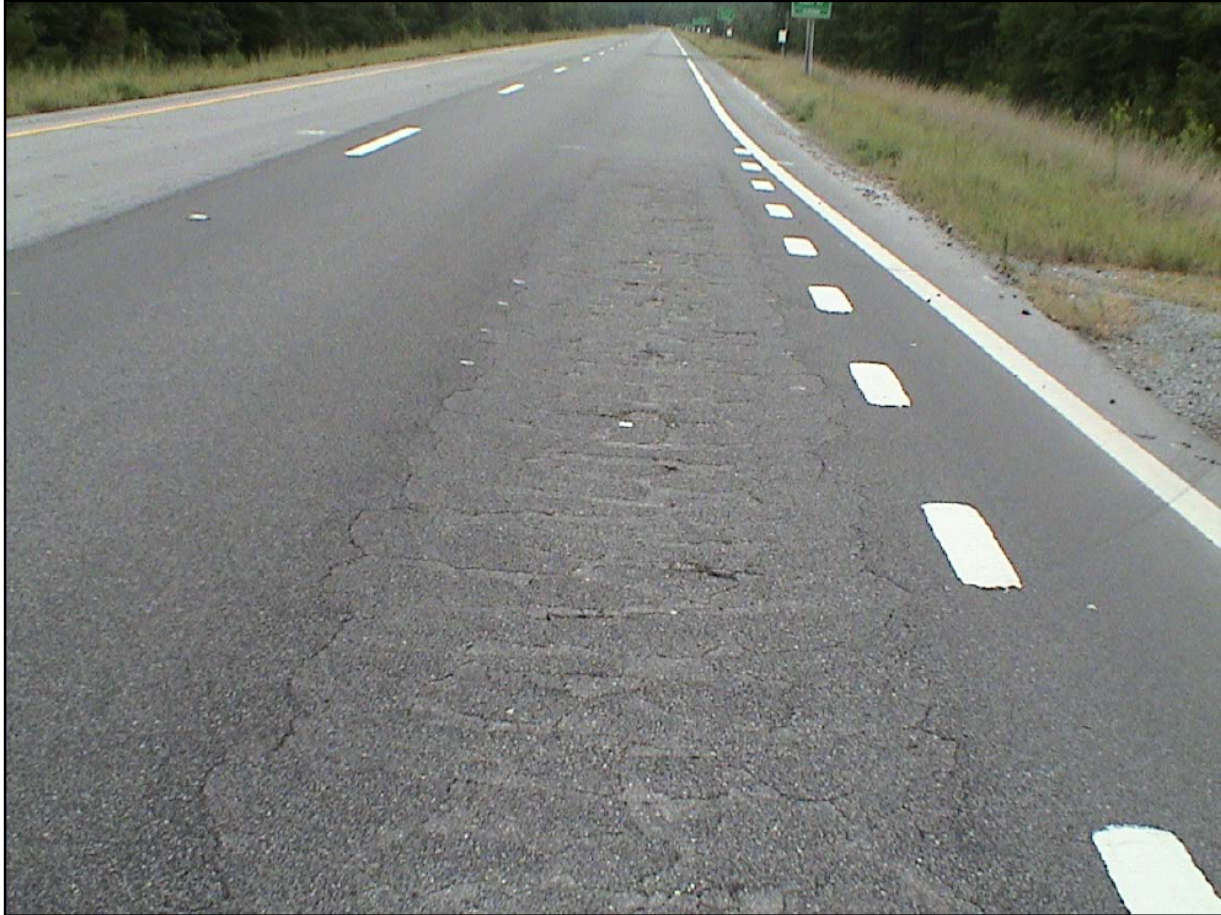
Figure 6.13 – Fatigue cracking in 2003-N1 (Priest and Timm, 2006)
