Design of Lateral Support for Non-Integral Wing Walls of Culverts

A thesis submitted to the Graduate Faculty of
Auburn University
in partial fulfillment of the
requirements for the Degree of
Master of Science

Auburn, Alabama
December 16, 2017

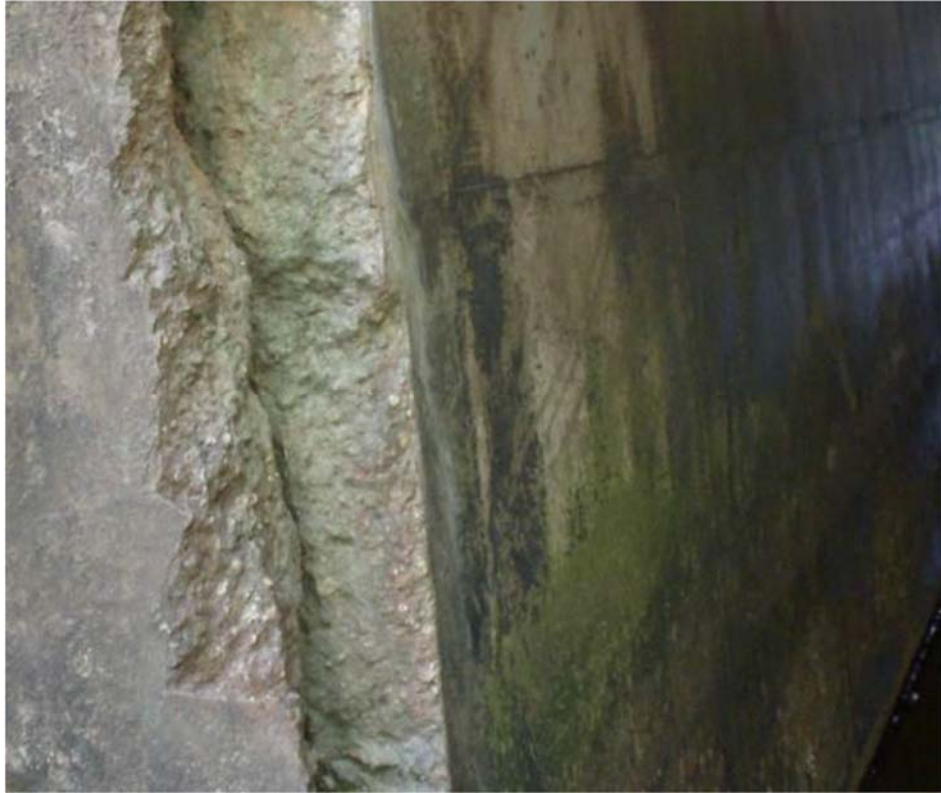
Figure 1-1: Distress at Wing Wall Connection to Culvert (Minton, 2012)

Traditionally, cast-in-place reinforced concrete box culverts are built integrally with their wing walls resulting in a monolithic structure. While this design is expedient due to being less formwork intensive, it results in a concentration of stress where the wing wall joins the culvert. As the structure settles, the difference in weight as well as bearing area of the two components leads to a differential settlement between the culvert barrels and the wing walls. This differential settlement, which can be exacerbated by scour, poor construction, and the out-of-plane flexibility of the wall, causes a moment to occur at the aforementioned concentration of stress. To explain this, the wing wall is considered to be a cantilevered beam which transfers moment to the body of the culvert. The flexure which results from the differential settlement creates tensile stresses in the extreme fibers which, in turn, lead to cracking, as shown in [Figure 1-1](#). Depending on which element settles more quickly, this distress can occur at either the bottom or top of the junction and proliferate from there. This cracking reduces the effective cover of the reinforcement and can lead to a host of issues, such as corrosion, spalling, and in extreme cases, failure of the wing wall.

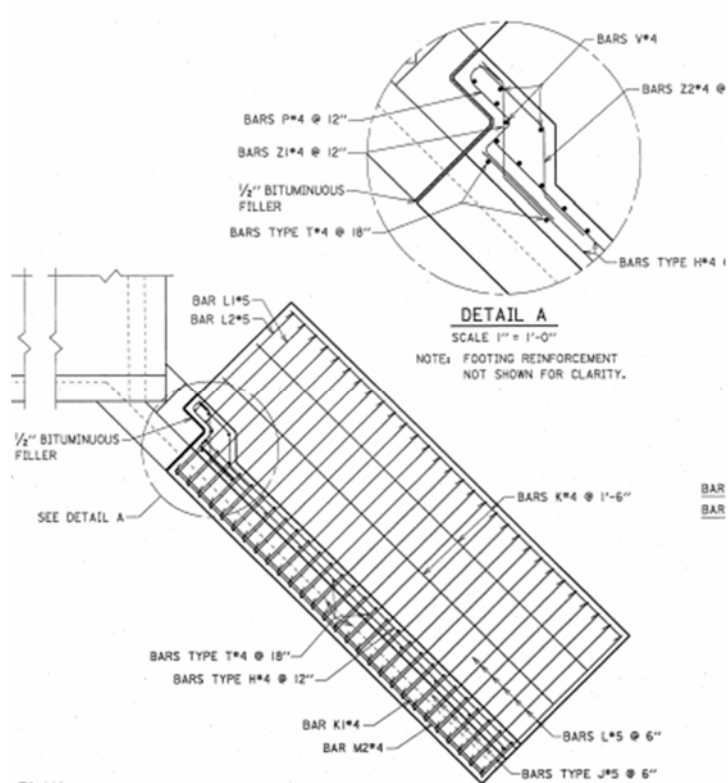
Figure 1-2: Proposed Wing Wall Detail

In order to mitigate this recurring problem, an alternative design, shown in [Figure 1-2](#) and [Figure 1-3](#), was proposed by Alabama Department of Transportation (ALDOT). In the proposed design, the wing wall is entirely separated from the culvert and supported on its own foundation. This allows for the two components to settle and deflect independently, eliminating the issues associated with differential settlement. To ensure the two structural elements continued to perform jointly in resisting the loads associated with backfill, a tab was added to each corner of the body of the culvert to serve as a horizontal bearing support for the wing walls. In this way, the wing walls still benefit from the lateral stiffness of the culvert, but restraint is removed from what was previously a concentration of stress. The result is a decrease in the probability of significant cracking, meaning a design with improved durability and longevity.

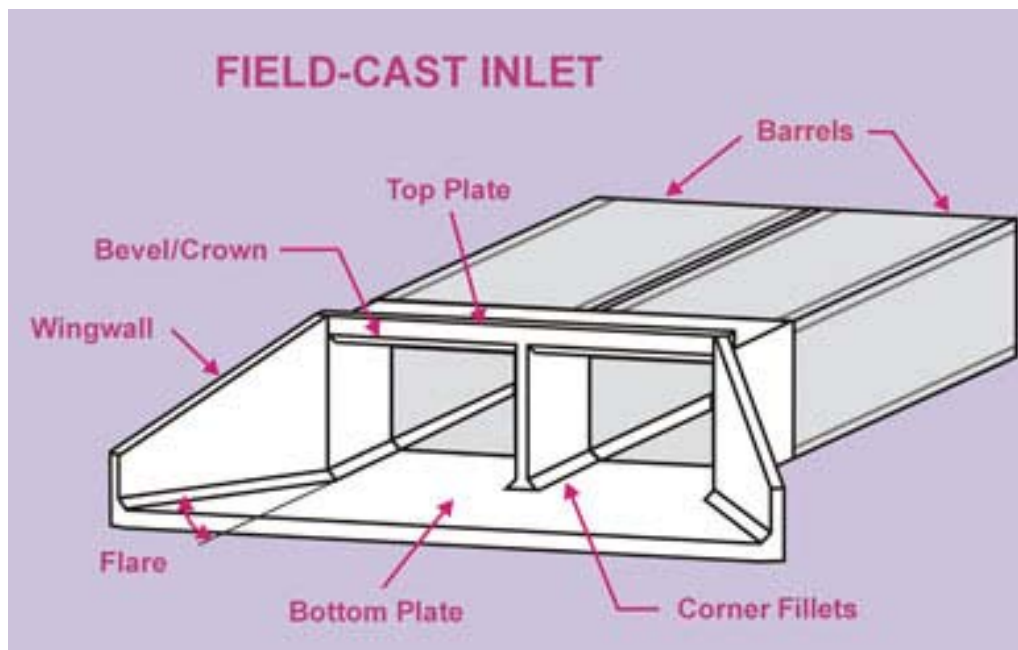
Figure 2-4: Components of a Box Culvert (Kerenyi, Jones, Goeden, & Oien, 2005)

The primary components of a cast-in-place reinforced concrete box culvert are shown in Figure 2-4, which serves to provide context for the nomenclature used throughout this thesis.

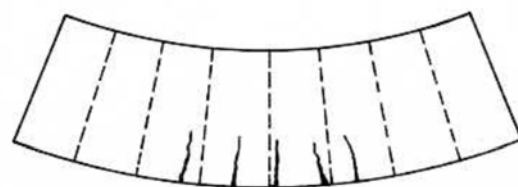
Bending deformation with cracking due to direct tensile strain

Shear deformation with cracking due to diagonal tensile strain

Figure 2-6: Structural damage due to settlement (Burland & Wroth, 1974)

Ahmed, et al. (2002) found that soil settlement is the largest factor that leads to cracks in culverts. Figure 2-6 depicts how settlement can lead to damage in concrete structures. Figure 2-7 shows how differential settlement of the wing wall and culvert can lead to distress at the wing wall support. The dotted line in this figure represents the original location of the wing wall prior to settlement. As previously stated, the disparity of the masses of the culvert and wing walls, coupled with the difference in bearing areas, leads to a potential for differential settlement. This causes a concentration of stresses at the juncture of the culvert and wing walls, as well as throughout the wing walls. This is exacerbated by the disparity between the flexibility of the two members, as this juncture restrains the wing walls tendency toward out-of-plane deflection.

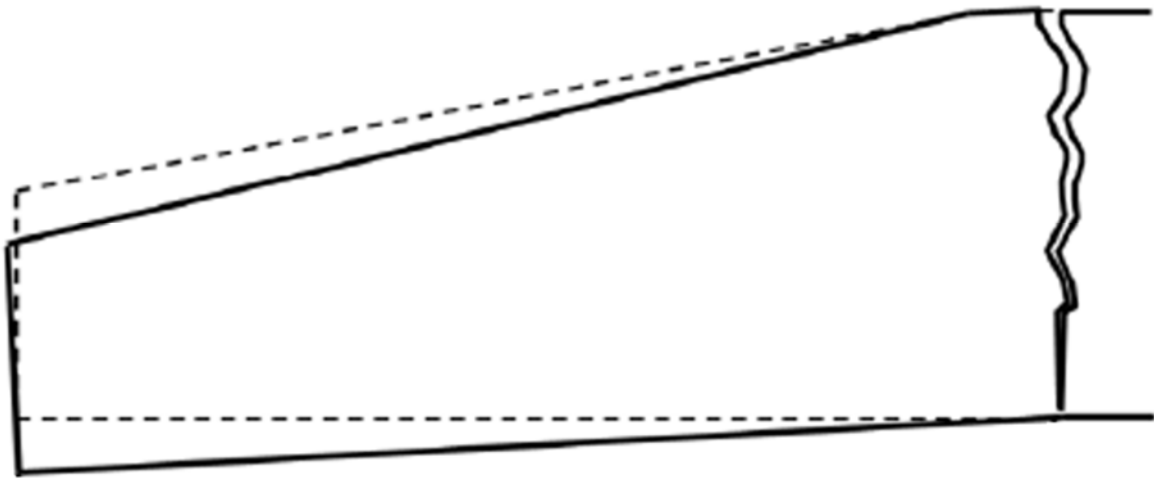
Figure 2-7: Distress in support of wing wall (Minton, 2012)

The separation of the wing wall and culvert through their foundation allowed for the free rotation of the wing walls with respect to the culvert. This removal of the restriction on motion alleviated the stresses associated with differential settlement as well as any possible stresses from drying shrinkage.

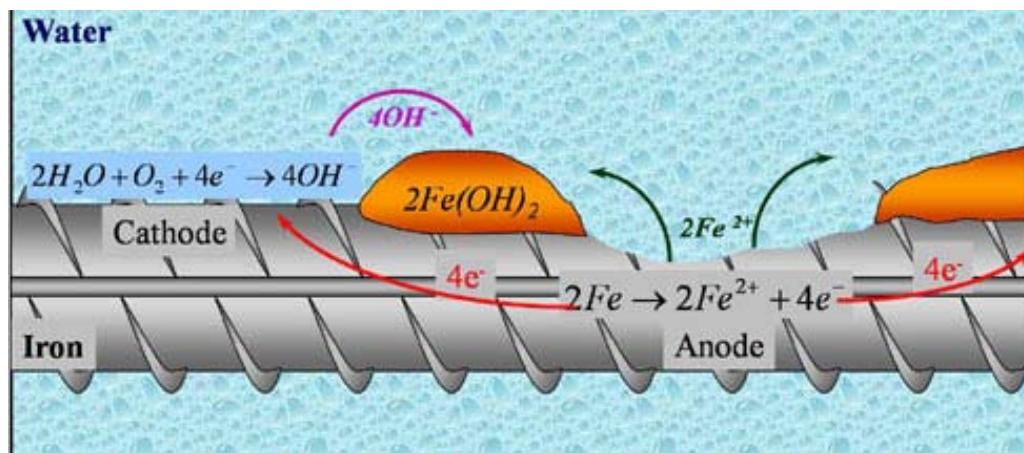
Figure 2-8: Reduction in Steel Section (Portland Cement Association, 2014)

While corrosion causes precipitates that increase the volume of the reinforcing steel, the diameter of the effective bar is reduced due to loss of effective bar cross-section, as shown in [Figure 2-8](#), thus reducing the overall capacity of the member. Furthermore, the cracking and spalling that occur in the concrete reduce the effective cross section of the concrete which also reduces the compressive strength of that member (Emmons, 1993).

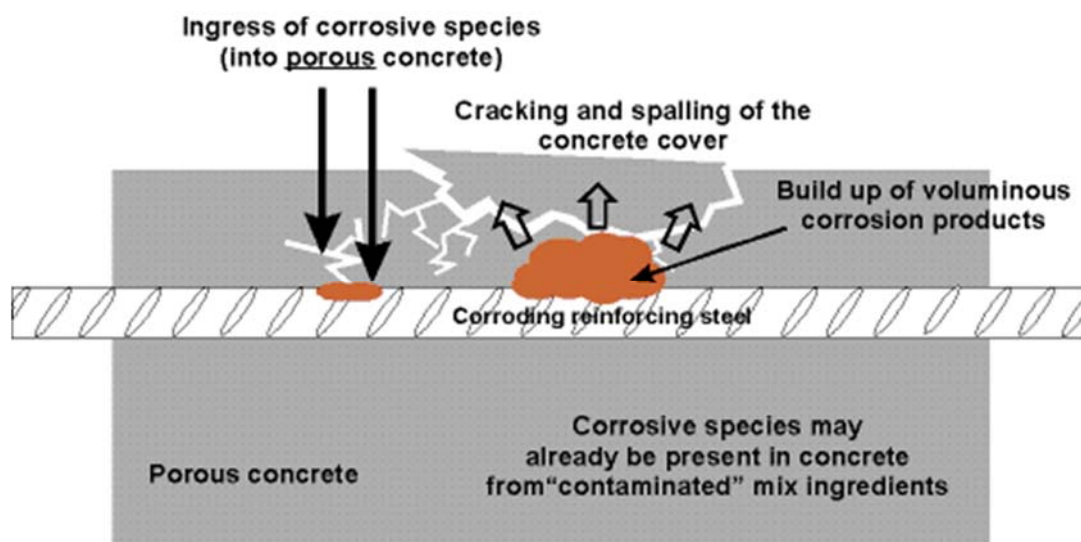
Figure 2-9: Embedded Metal Corrosion (Tullmin, 2001)

Excessive cracks in a concrete structure increase the amount of reinforcing steel exposed to corrosive environments and thus accelerate the deterioration of the overall structure, which illustrates one of the reasons that led to the redesign central to this research project.

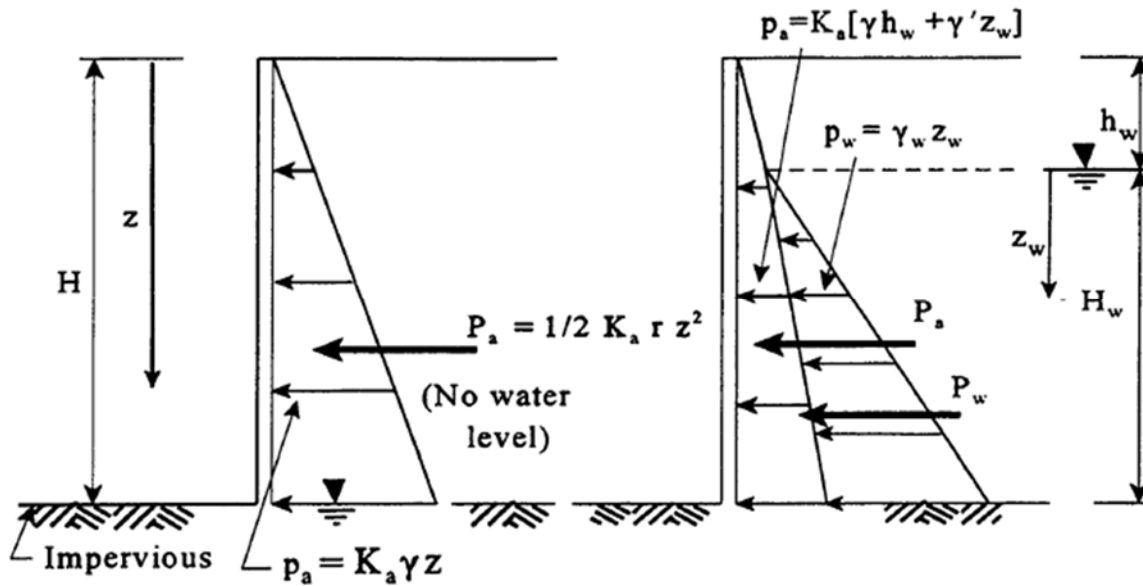
Figure 2-11: Lateral Pressures for Static Groundwater Case (FHWA, 1999)

It is typical to specify that a free draining backfill be used and to design the structure to include weep holes, which provide a path through the retaining structure for the water to drain and thus relieve the wall of the hydrostatic pressures that would otherwise build up along the face of the structure. In some instances, however, economic considerations lead to the use of locally sourced cohesive backfill without free draining properties and these hydrostatic pressures must then be accounted for in the design of the structure. In some cases, these hydrostatic pressures can far exceed the lateral earth pressure. It may also be undesirable to allow water to drain through the structure due to the impact on the settlement of adjacent structures (FHWA, 1999).

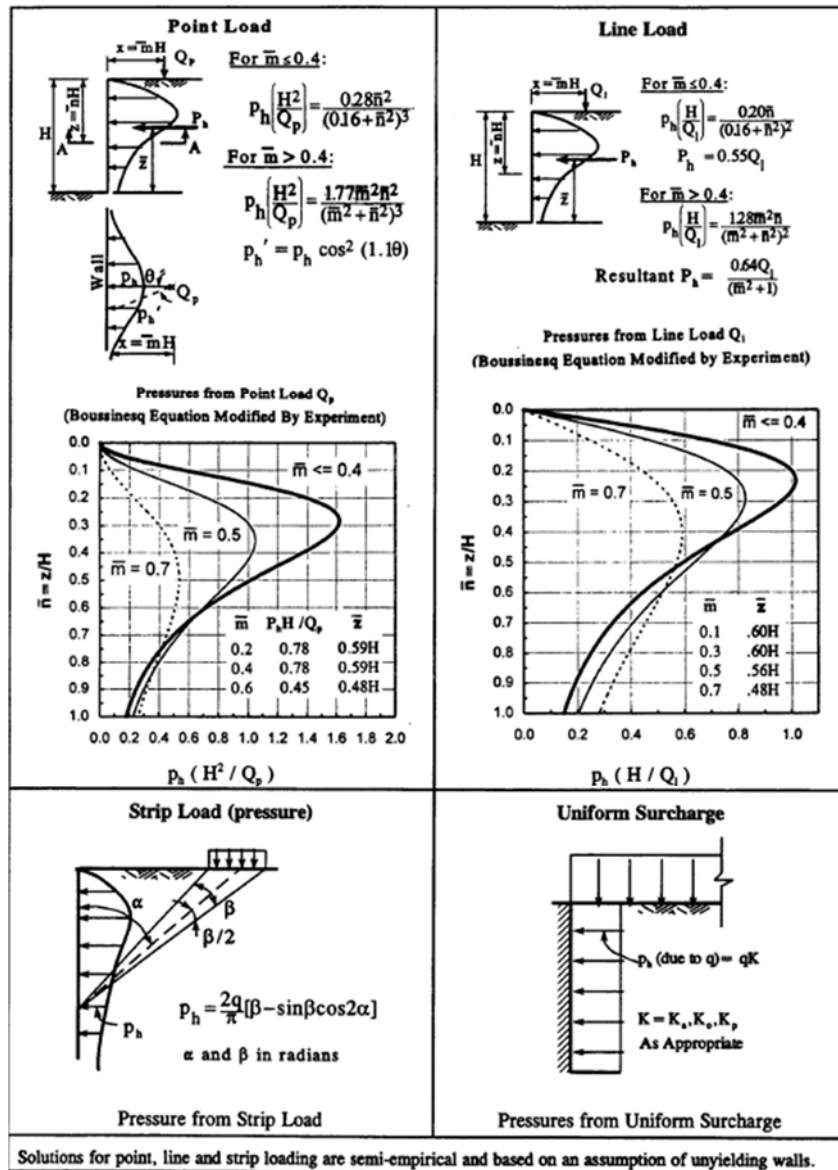
Figure 2-12: Lateral Pressure Due to Surcharge Loads (FHWA, 1999)

highways, electric/communications towers, and construction equipment. Note that these methods were developed with the assumption of an unyielding wall which is conservative and yields nearly double the values calculated in an elastic half space, thus their applicability may vary from project to project (FHWA, 1999).

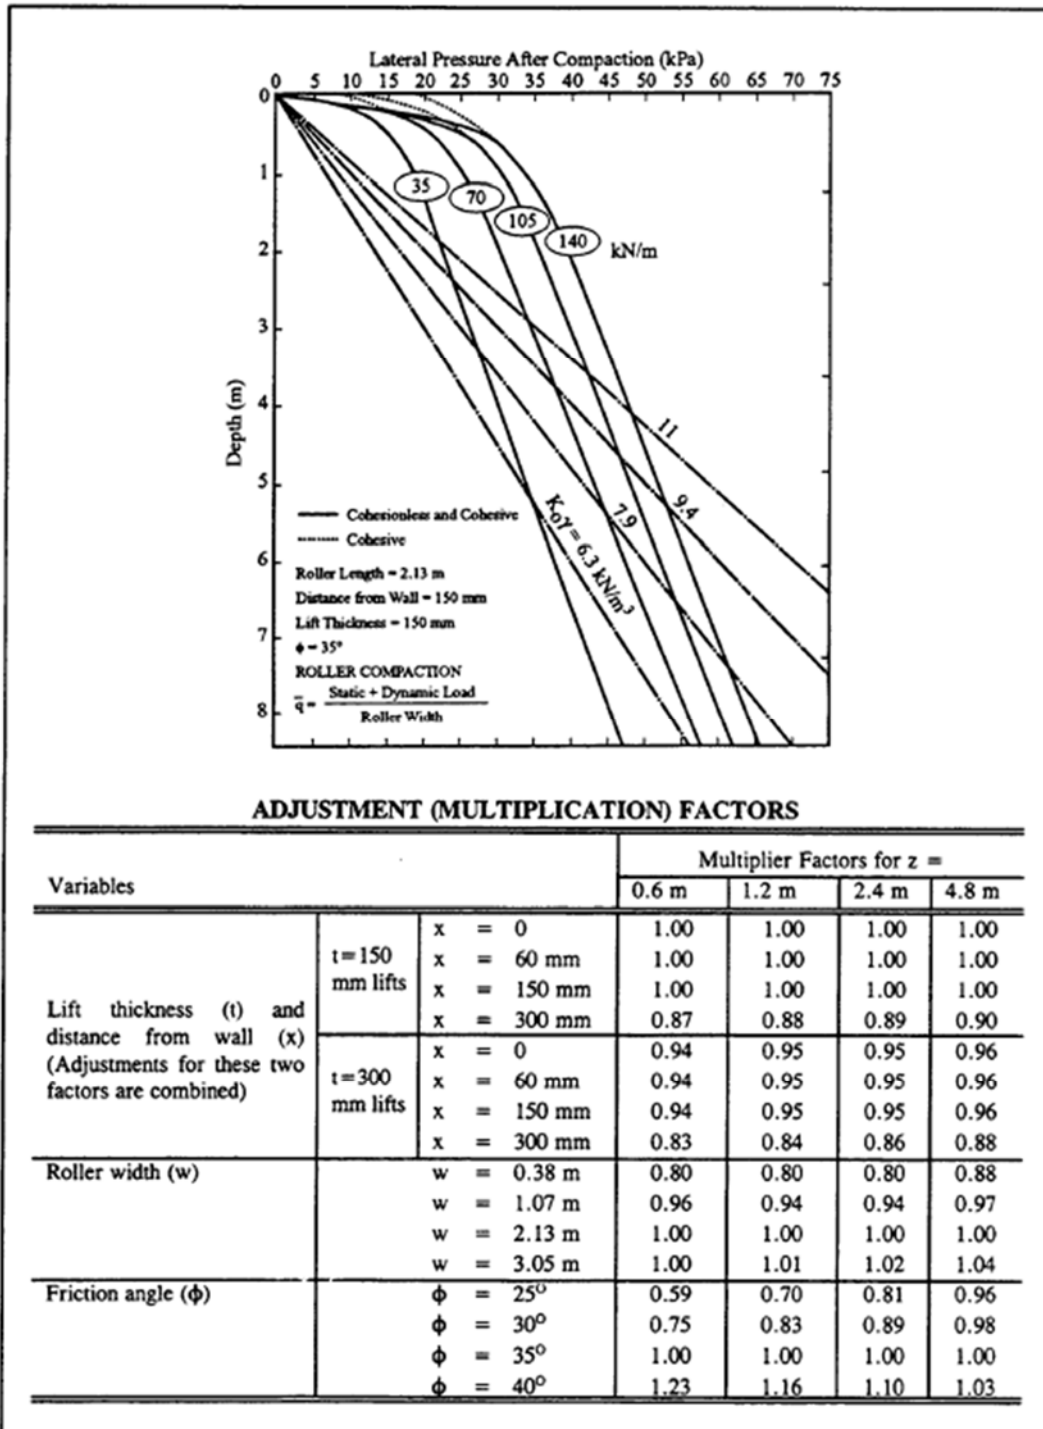
Figure 2-13: Earth Pressures due to Compaction with Rollers (FHWA, 1999)

This increase of lateral load is most pronounced at the ground surface and by a depth of 18 feet, it has typically become negligible. This is evident in [Figure 2-13](#), taken from Section 2.7 of the FHWA Retaining Wall Manual and used to calculate the impact of compaction on the magnitude of the lateral load. The dash-dot lines in [Figure 2-13](#) represent the value of the At-Rest Earth Pressure and the solid lines represent the increased values due to compaction. The circled numbers on the solid lines are the values of \bar{q} calculated using the equation given in the lower left corner of the chart. For values of \bar{q} not given, it is appropriate to interpolate. The dotted lines near the top of the chart are representative of the fact that the impact of compaction is slightly larger for cohesive soils near the surface. The table in the bottom portion of [Figure 2-13](#) gives multiplication factors for corrections that account for varying lift thickness, distance of compactor from the wall, roller width, and friction angle of the compacted soil. As with the surcharge load calculations, this method is based upon the assumption of a rigid wall and is therefore conservative (FHWA, 1999).

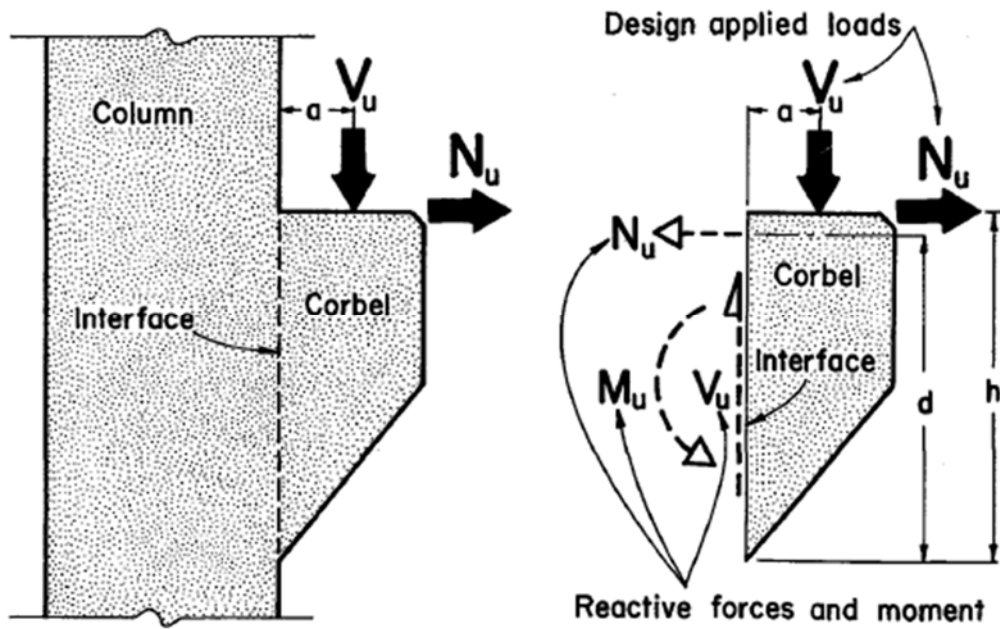
Figure 2-18: Corbel as a free body diagram (Mattock, 1976)

1. The ratio of a_v/d must not exceed 1. The magnitude of N_c must not exceed the magnitude of V . Distance d shall be measured at support.
2. Depth at outside edge of bearing area shall not be less than $0.5d$.
3. Section at face of support shall be designed to resist simultaneously a shear V_u , a moment M_u , calculated as $[V_{av} + N_c(h-d)]$, and a horizontal tensile force N_u . These forces are shown in a Free Body Diagram below in [Figure 2-18](#). As shown, distance h shall be measured at the face of support. [Figure 2-19](#) gives a diagram of typical corbel reinforcement to resist these loads.

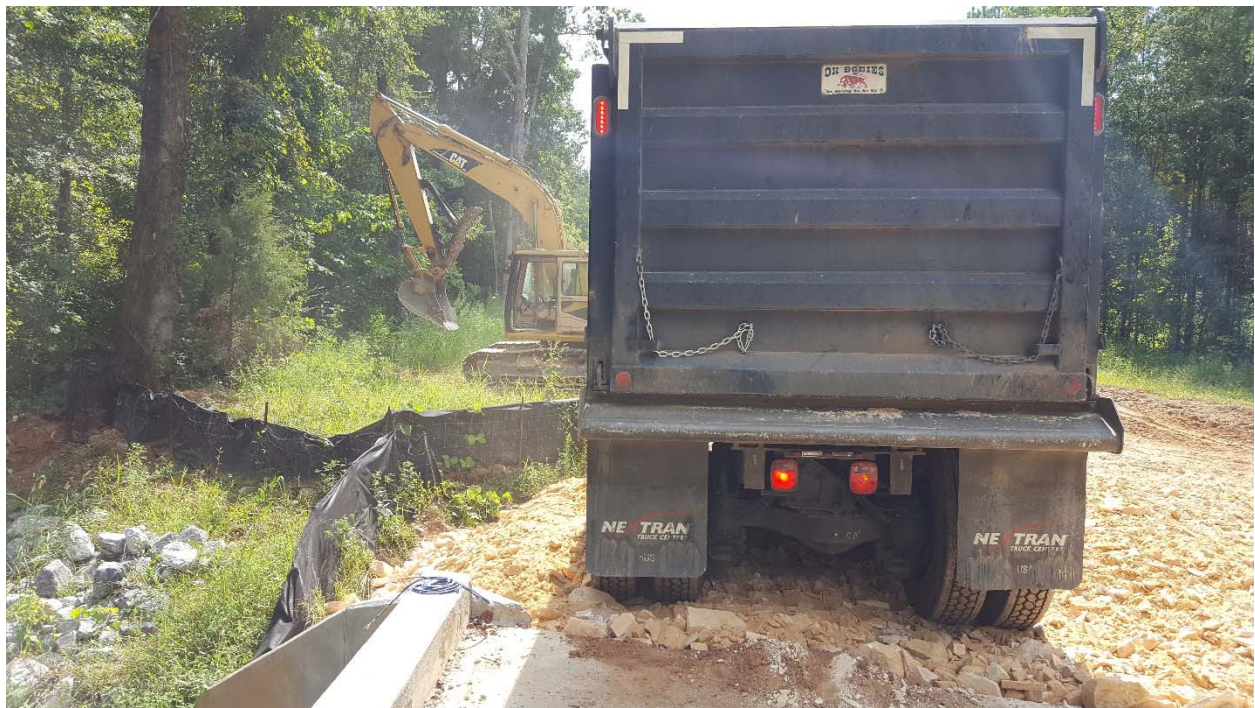
Figure 3-16: 40 ton truck placed near tab

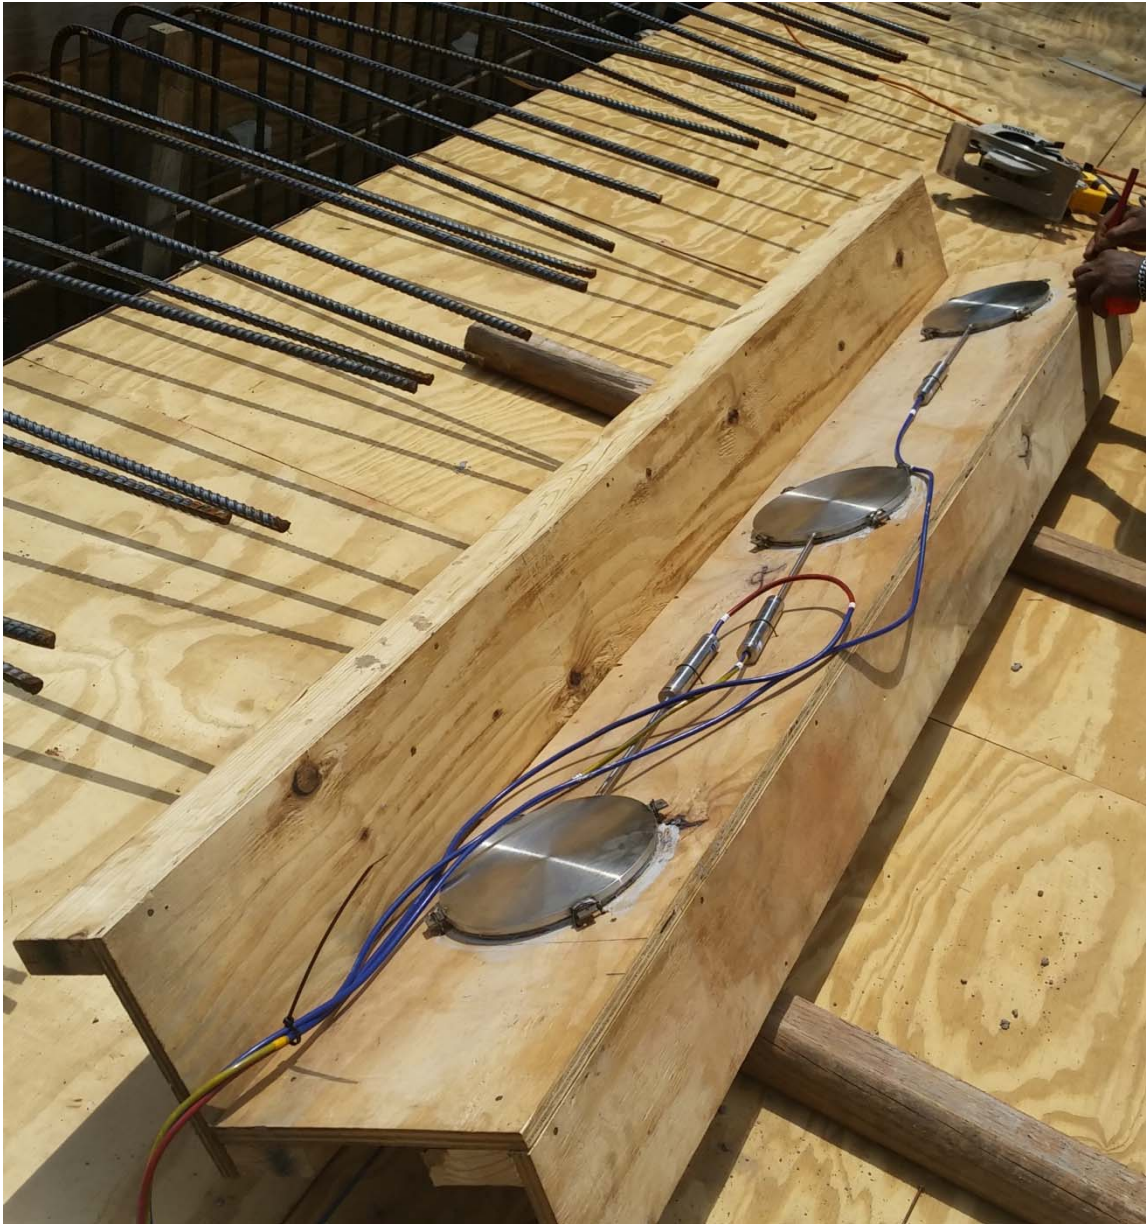
Figure 4-3: Formwork prepared for embedded installation of pressure cells

The embedded method of installation required that the pressure cells be attached to the formwork, as shown below in Figure 4-3, so that they could be completely embedded in to the concrete of the tab, as shown be below Figure 4-4. The cells were attached using steel wire so that the wire could be cut when it came time to remove the formwork. Plastic cable ties were used to ensure the cables would follow an appropriate path to the top of the tab.

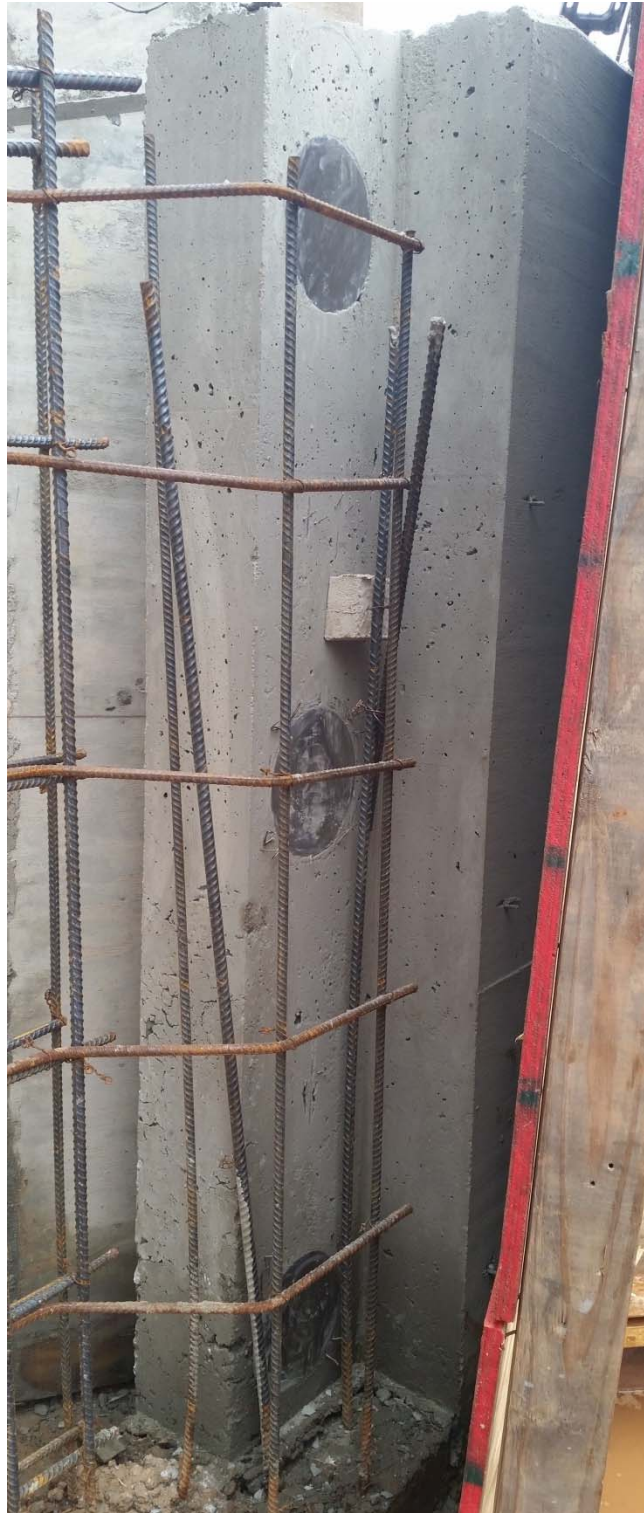
Figure 4-4: Pressure cells embedded in culvert tab

This method proved to be labor intensive due largely to the difficulty associated with the added care necessary to place the formwork with attached pressure cells while navigating through already placed reinforcing steel. There was also an increase in the difficulty of removing said formwork.

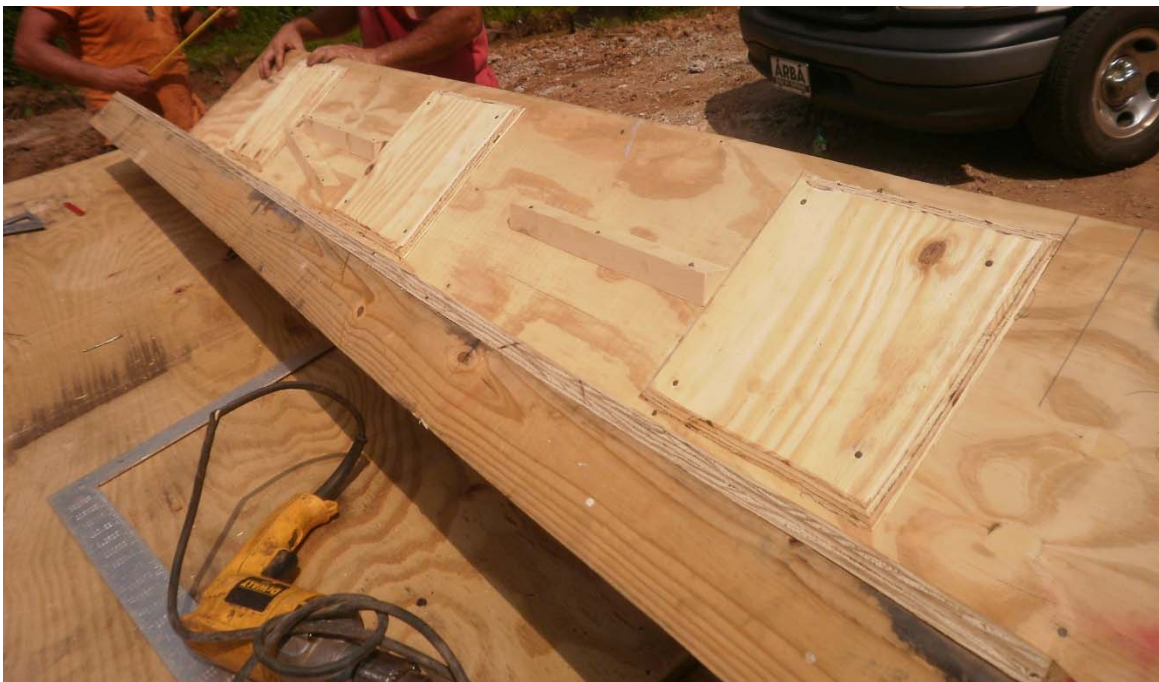
Figure 4-5: Formwork with block-outs for post installation

The post-construction method of pressure cell installation, shown above in [Figure 4-2](#), involved using block-outs on the formwork, shown below in [Figure 4-5](#), in order to create recesses in the hardened concrete of the tab, shown below in [Figure 4-6](#), into which the cells could be installed using concrete screws. The cables were attached to the perimeter of the cells using zip ties to ensure that the cables would not pass in front of the cells and affect pressure measurements.

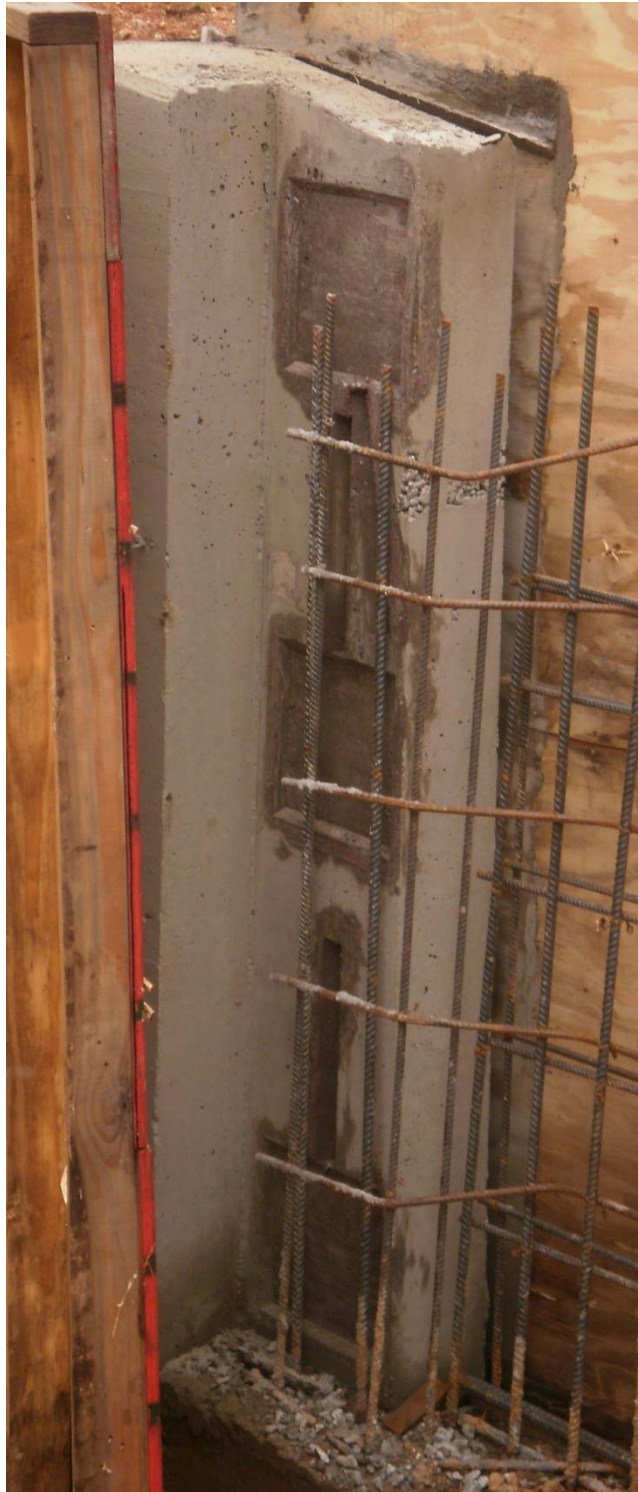
Figure 4-6: Recesses in tab for post installation

The method of post-construction installation allowed for reusability of formwork and resulted in an easier construction process overall in comparison to the embedded method of installation. An added benefit of this method was that, unlike the embedded cells, the post installed cells protruded a slight amount beyond the face of the tab which increased the likelihood of contact with the wing wall registering as pressure on the cells. For these reasons, it was decided that the post-construction installation method was the better choice; thus, it was utilized for all subsequent installations on this project.

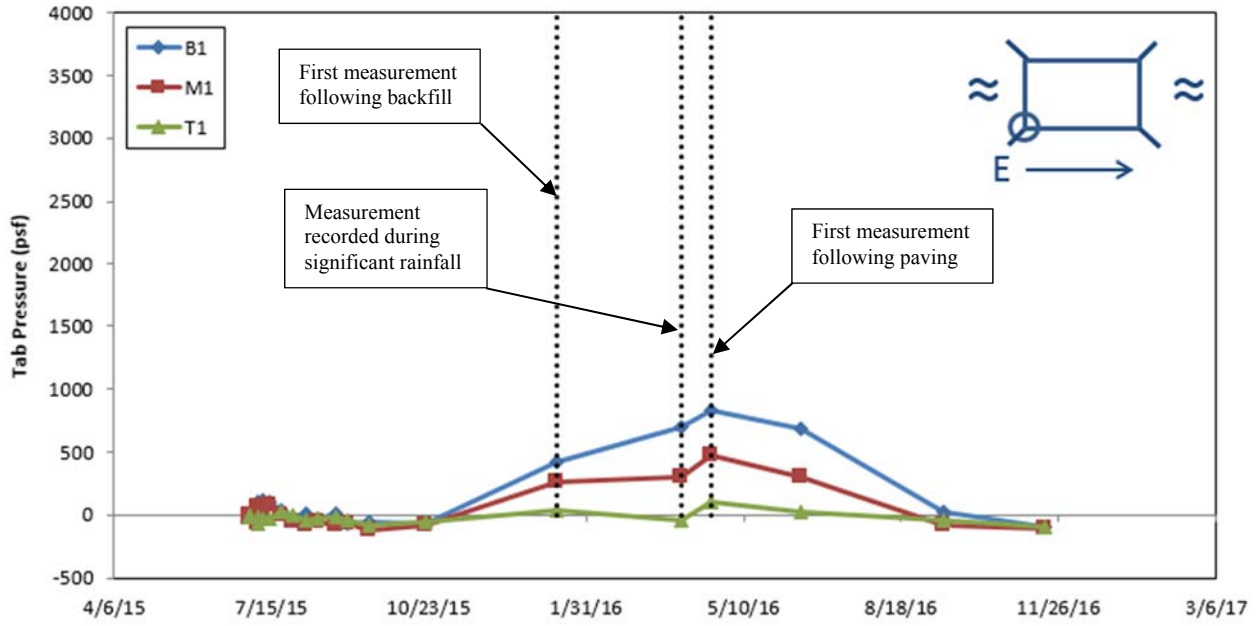
Figure 5-1: Chambers County Tab 1, Pressure versus Time

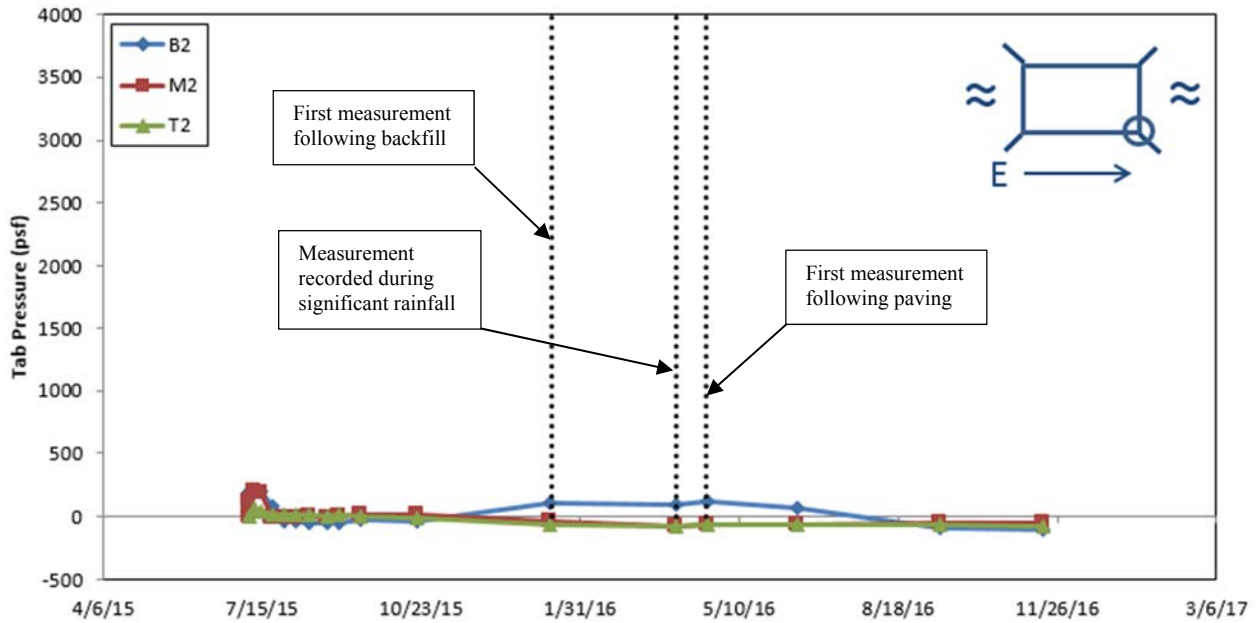
Figure 5-2: Chambers County Tab 2, Pressure versus Time

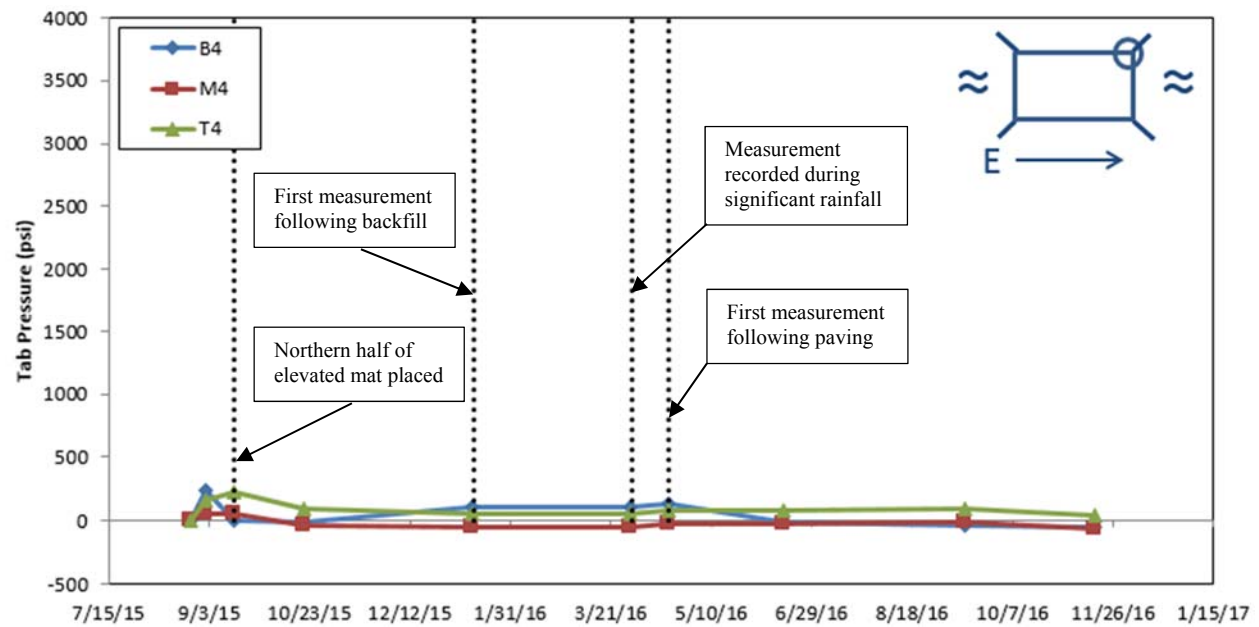
Figure 5-4: Chambers County Tab 4, Pressure versus Time

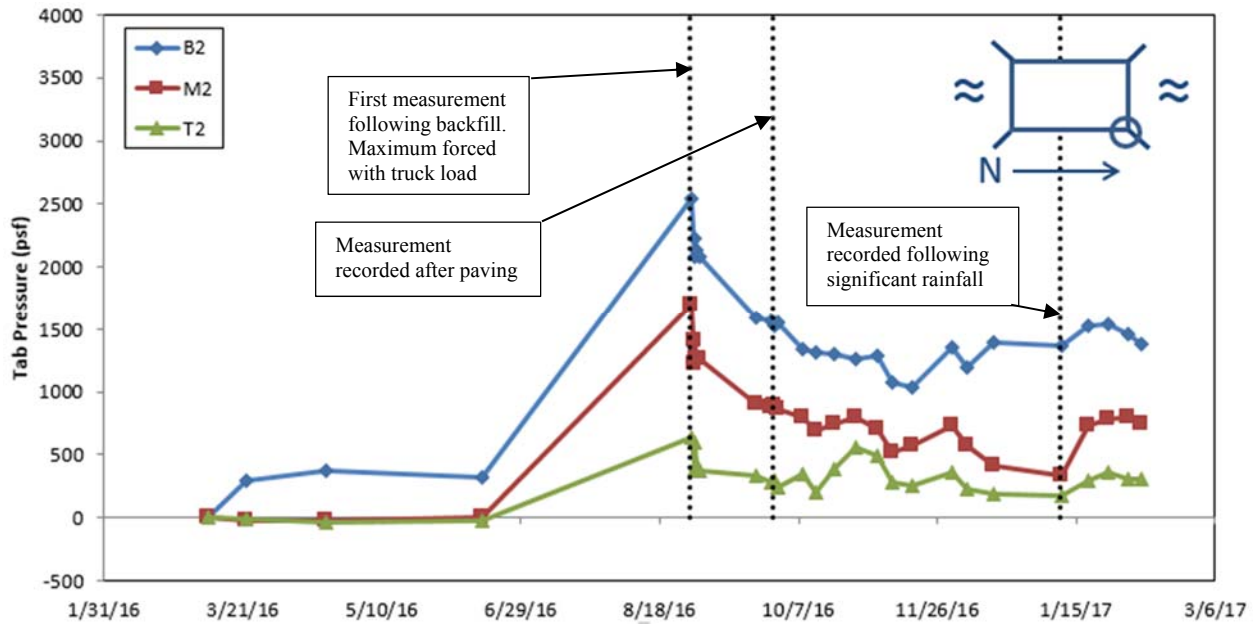
Figure 5-6: Lee County Tab 2, Pressure versus Time

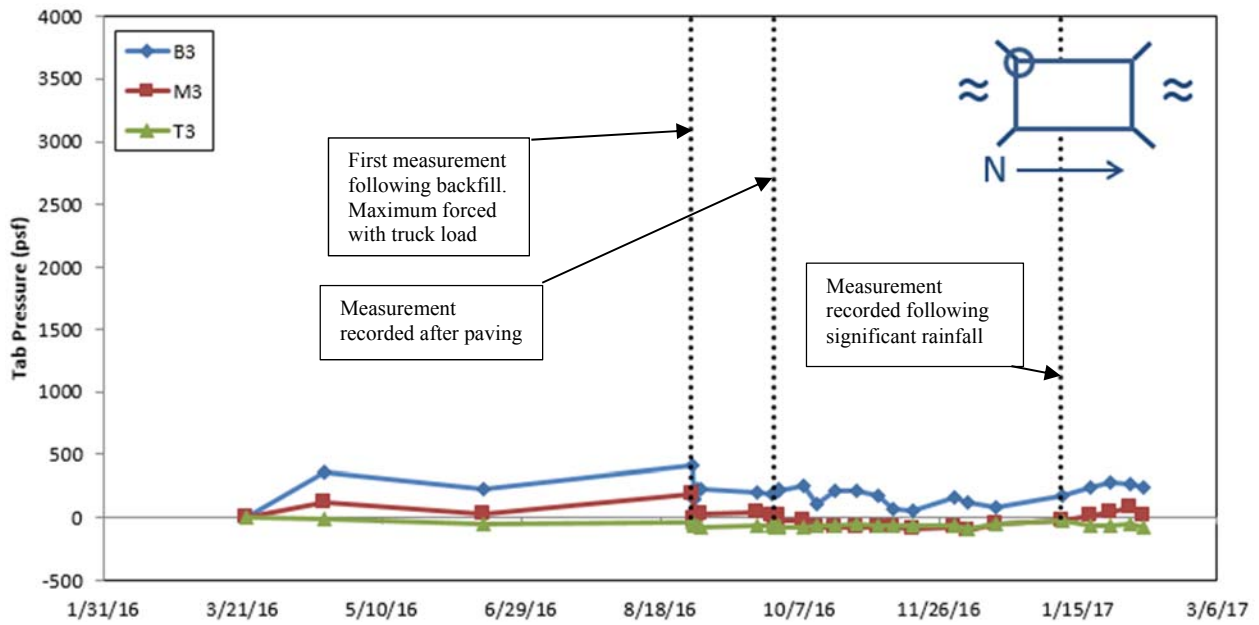
Figure 5-7: Lee County Tab 3, Pressure versus Time

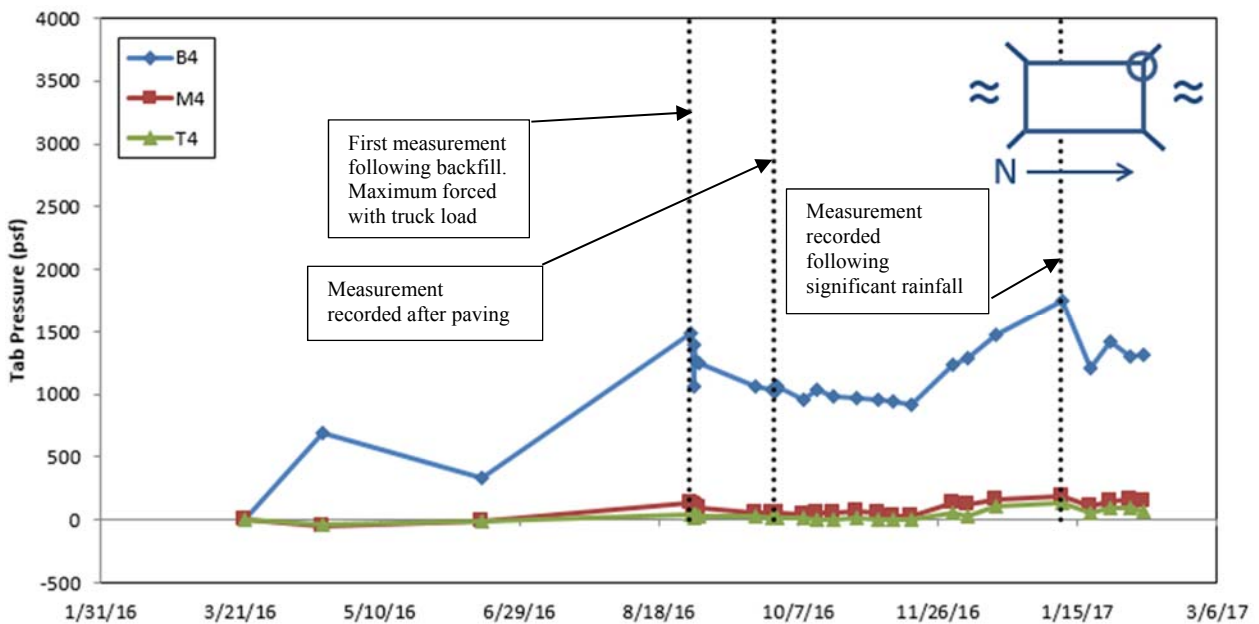
Figure 5-8: Lee County Tab 4, Pressure versus Time

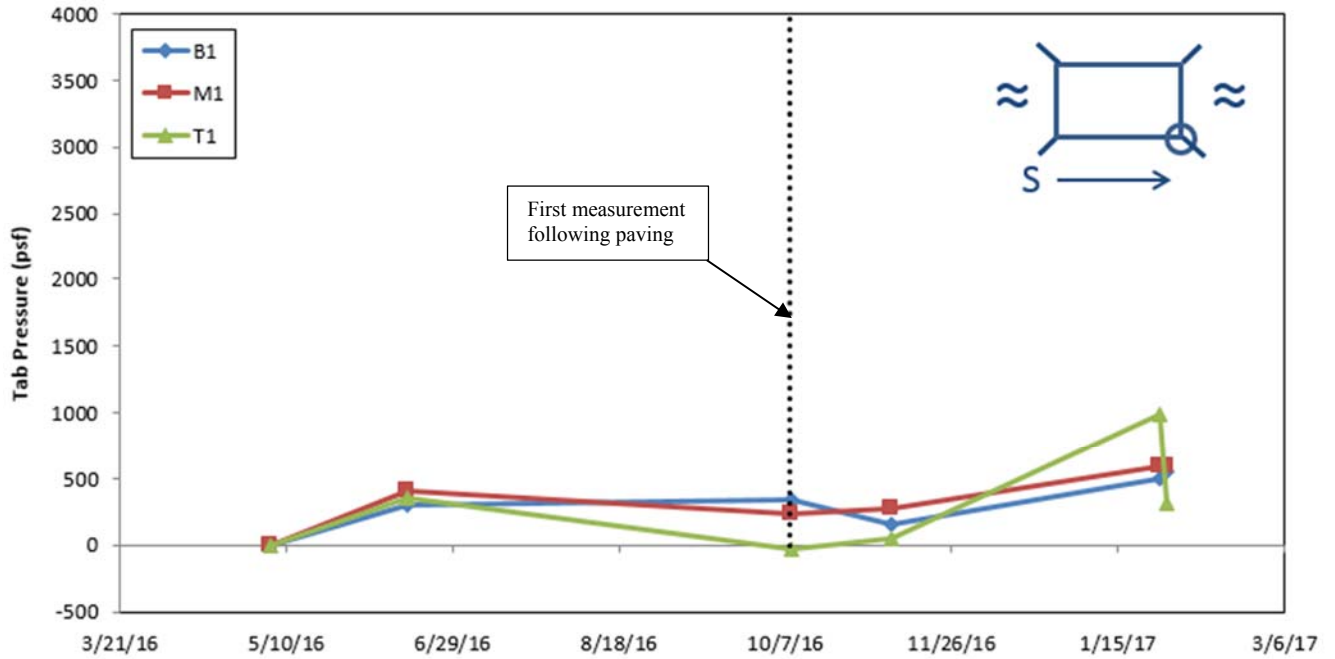
Figure 5-9: Coosa County Tab 1, Pressure versus Time

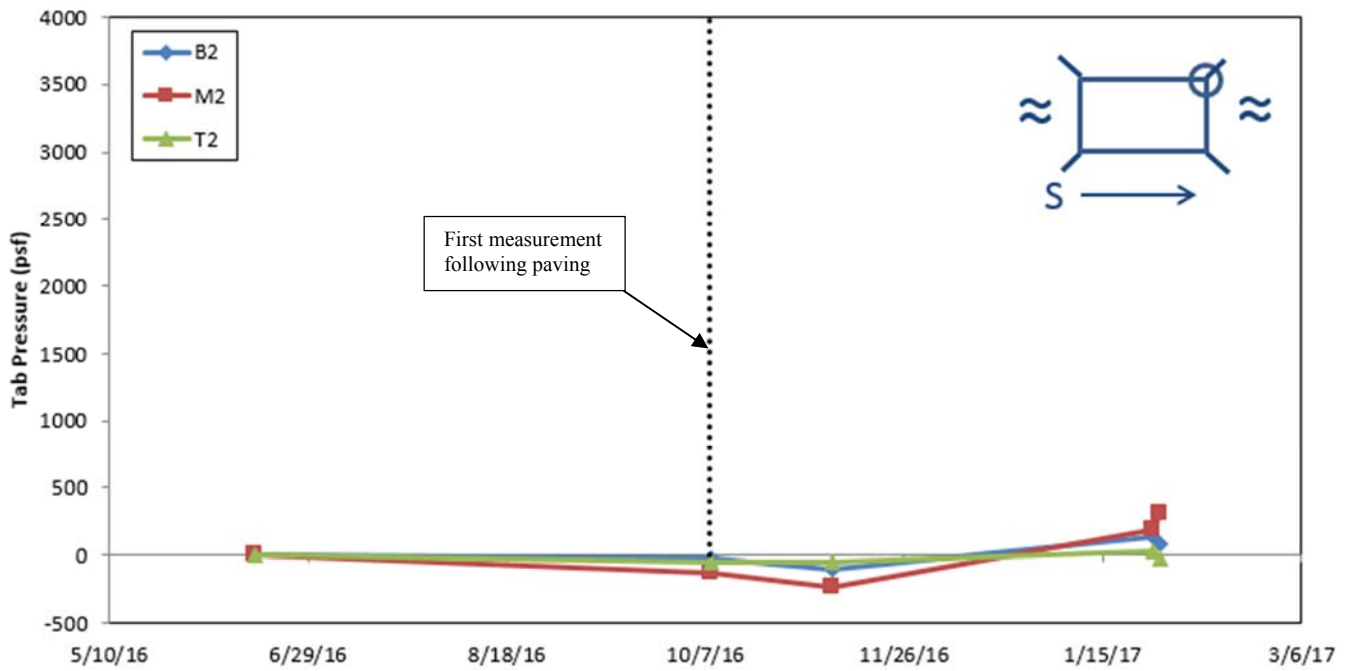
Figure 5-10: Coosa County Tab 2, Pressure versus Time

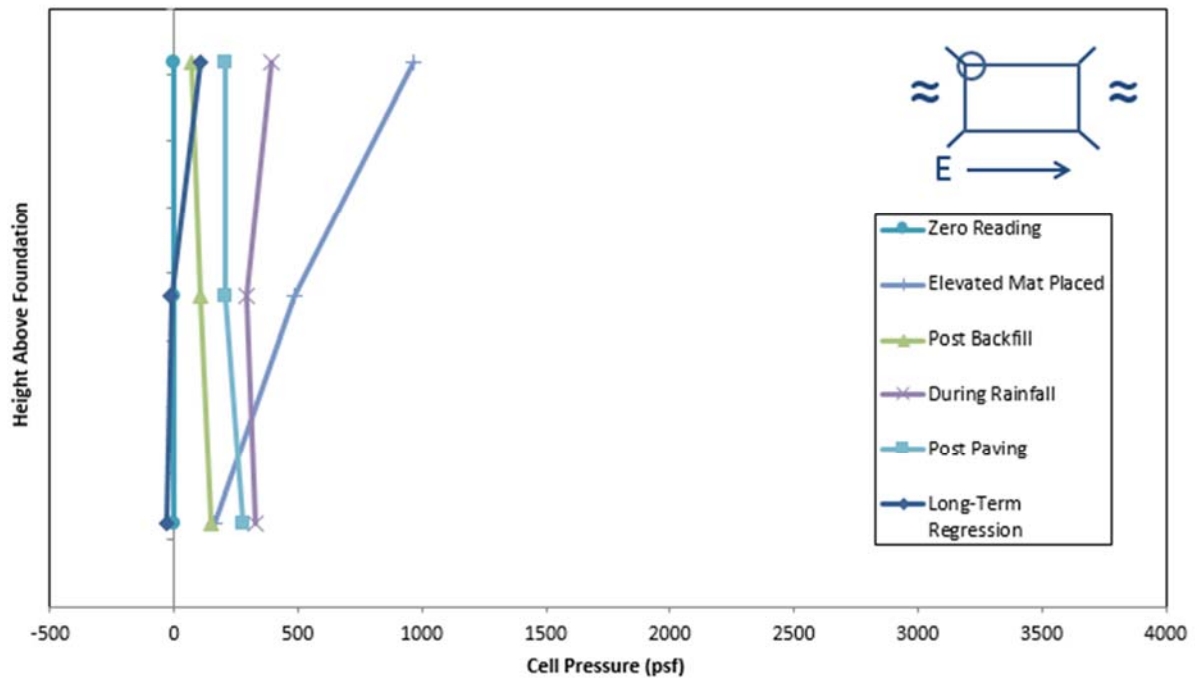
Figure 5-13: Chambers County Tab 3, Pressure versus Height
