Design of Lateral Support for Non-Integral Wing Walls of Culverts

A thesis submitted to the Graduate Faculty of
Auburn University
in partial fulfillment of the
requirements for the Degree of
Master of Science

Auburn, Alabama
December 16, 2017

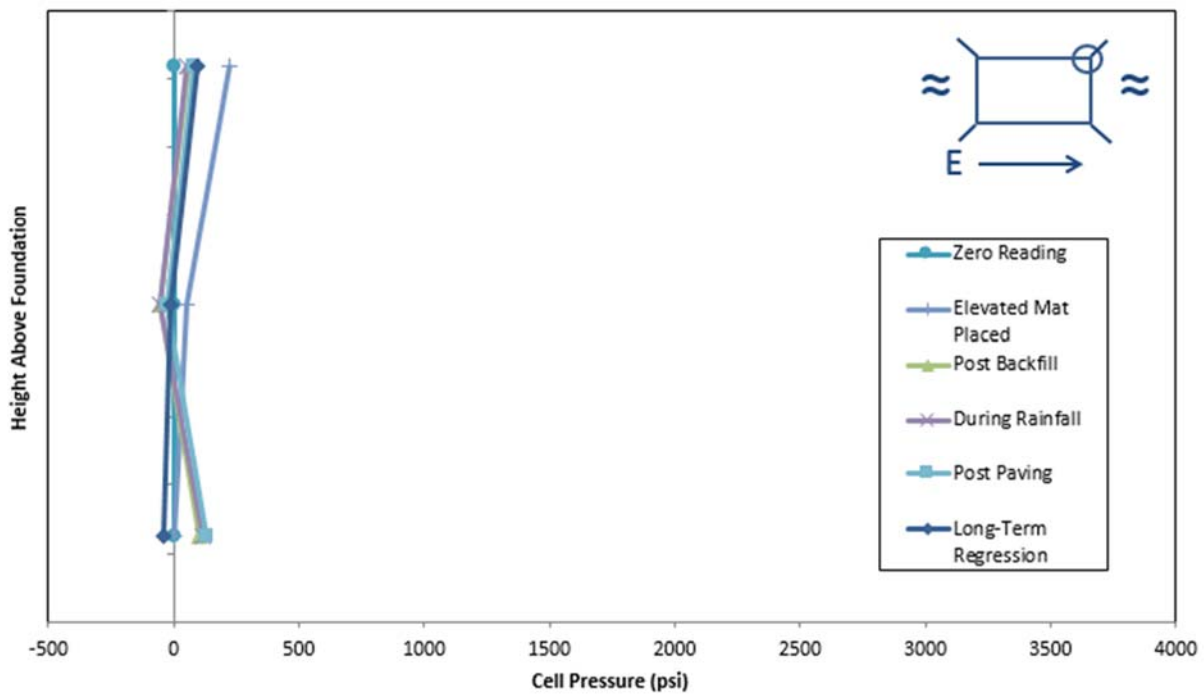
Figure 5-14: Chambers County Tab 4, Pressure versus Height

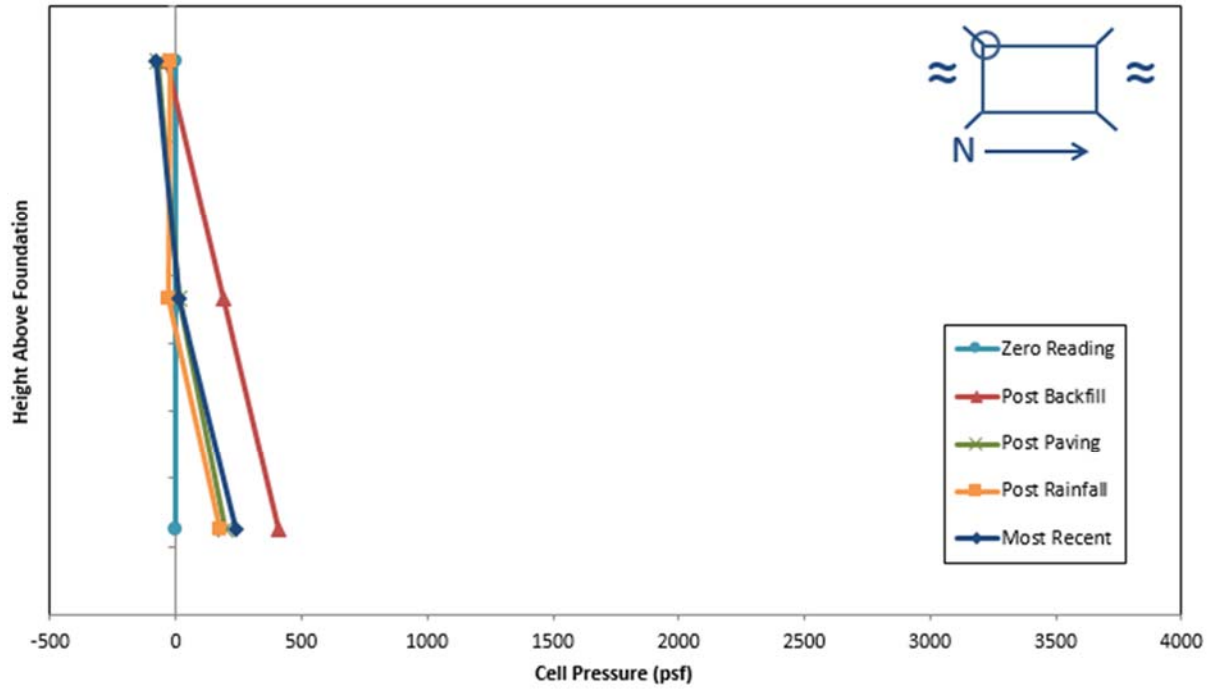
Figure 5-17: Lee County Tab 3, Pressure versus Height

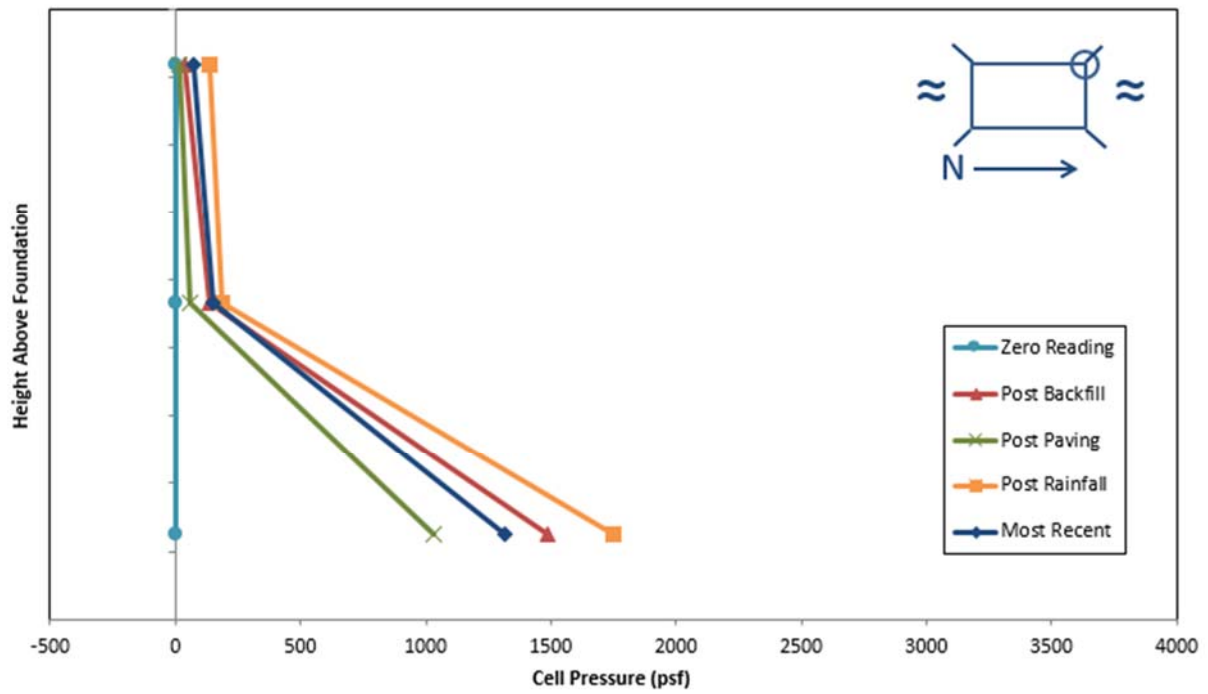
Figure 5-18: Lee County Tab 4, Pressure versus Height

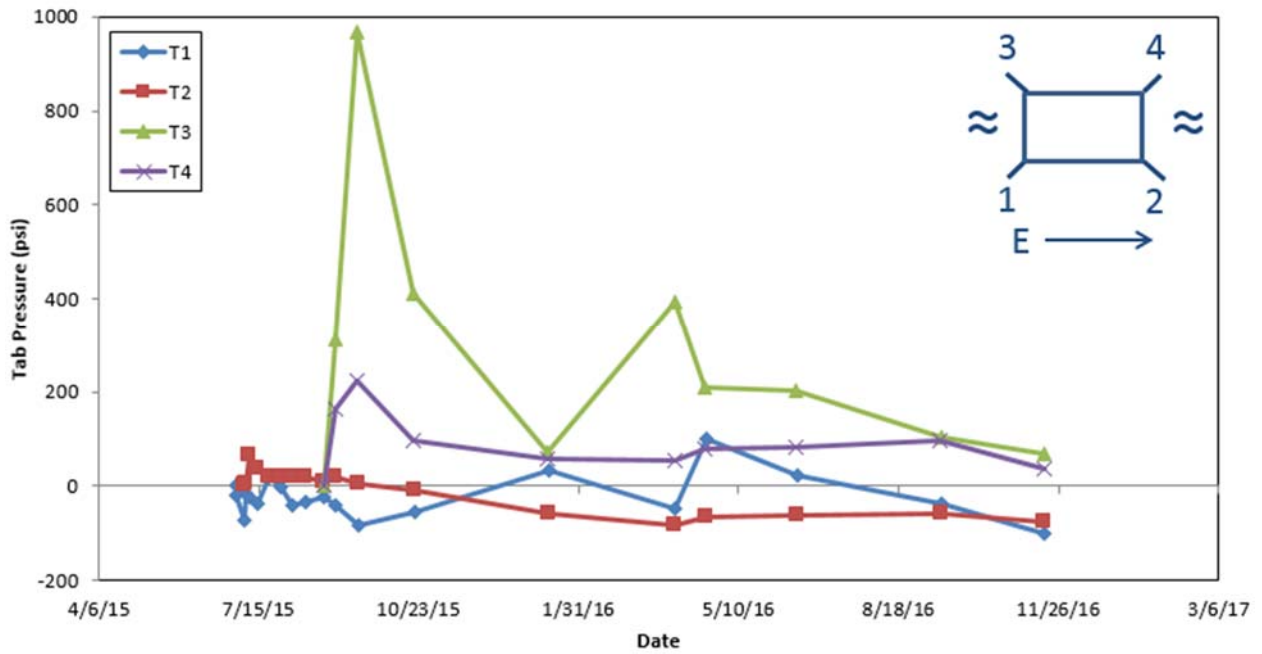
Figure 5-23: Chambers County Top Cells

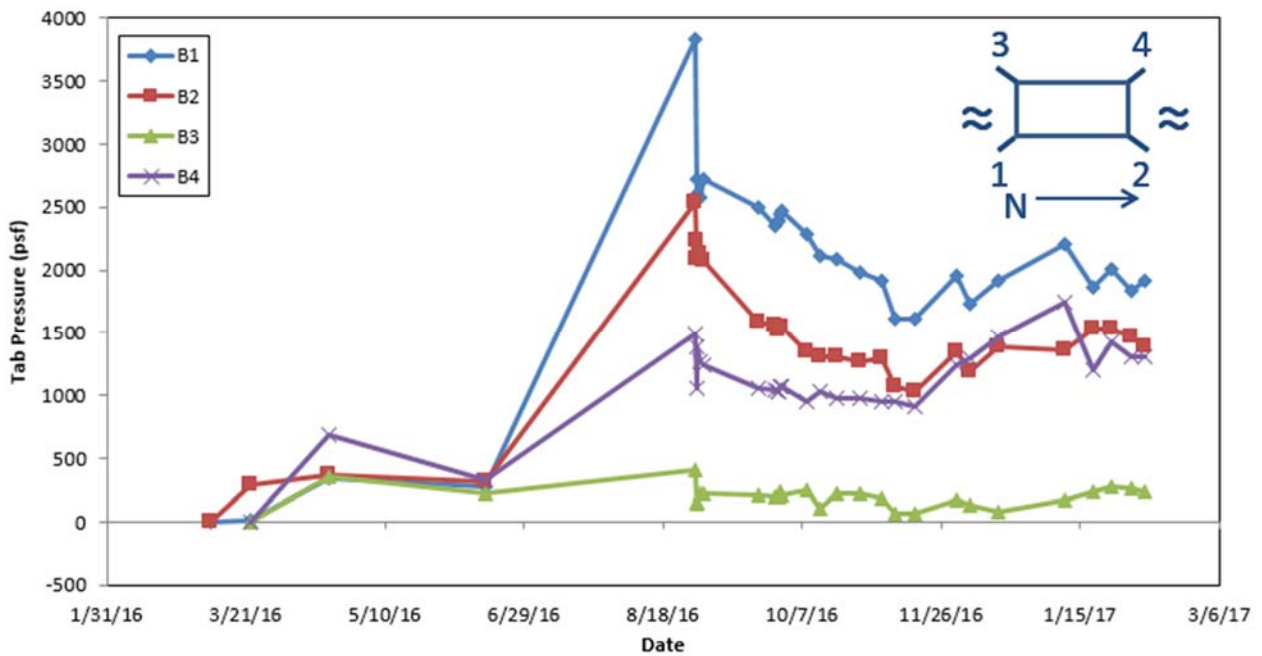
Figure 5-24: Lee County Bottom Cells

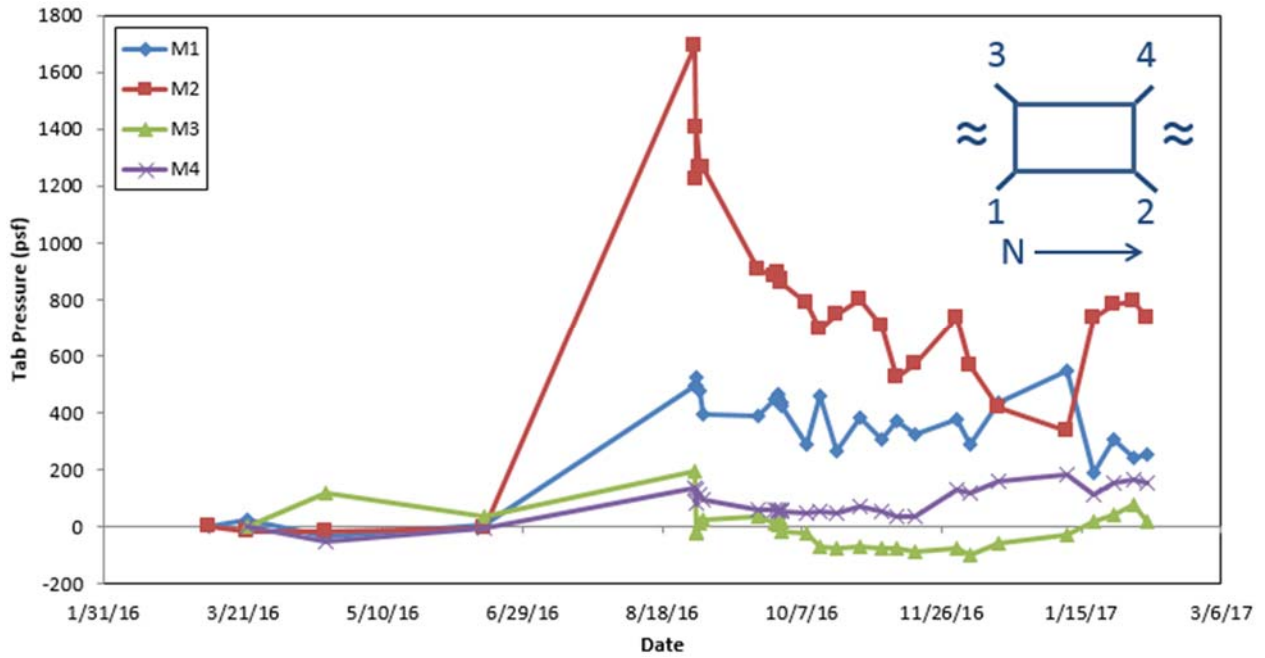
Figure 5-25: Lee County Middle Cells

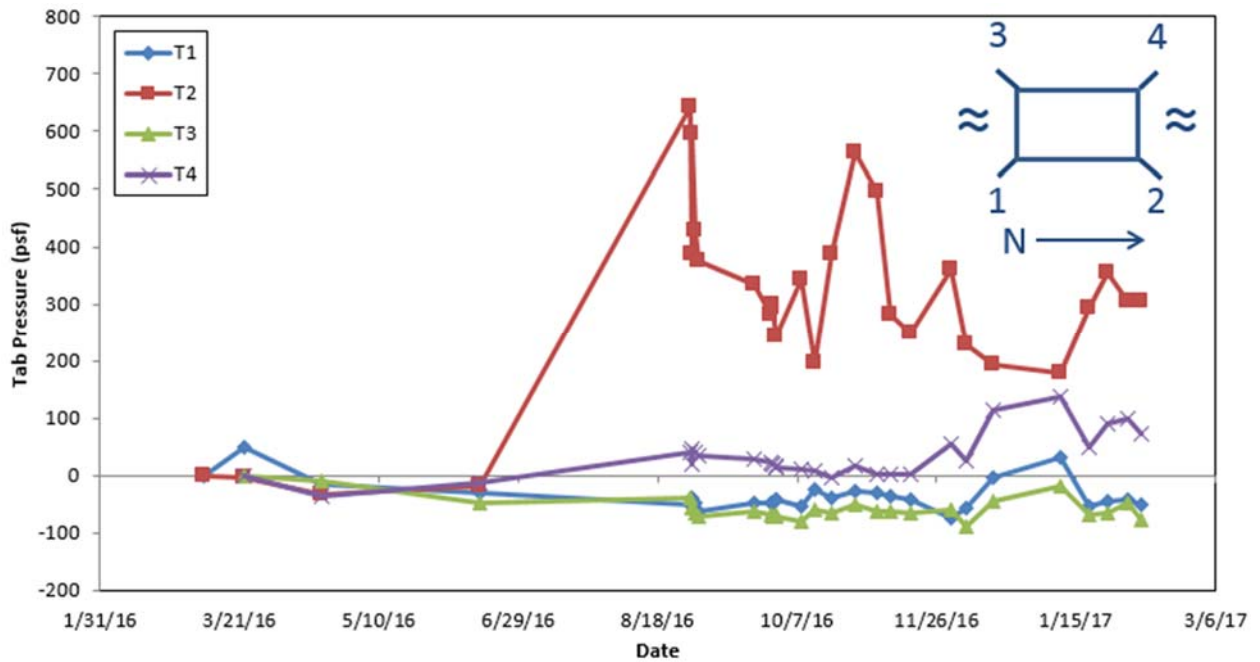
Figure 5-26: Lee County Top Cells

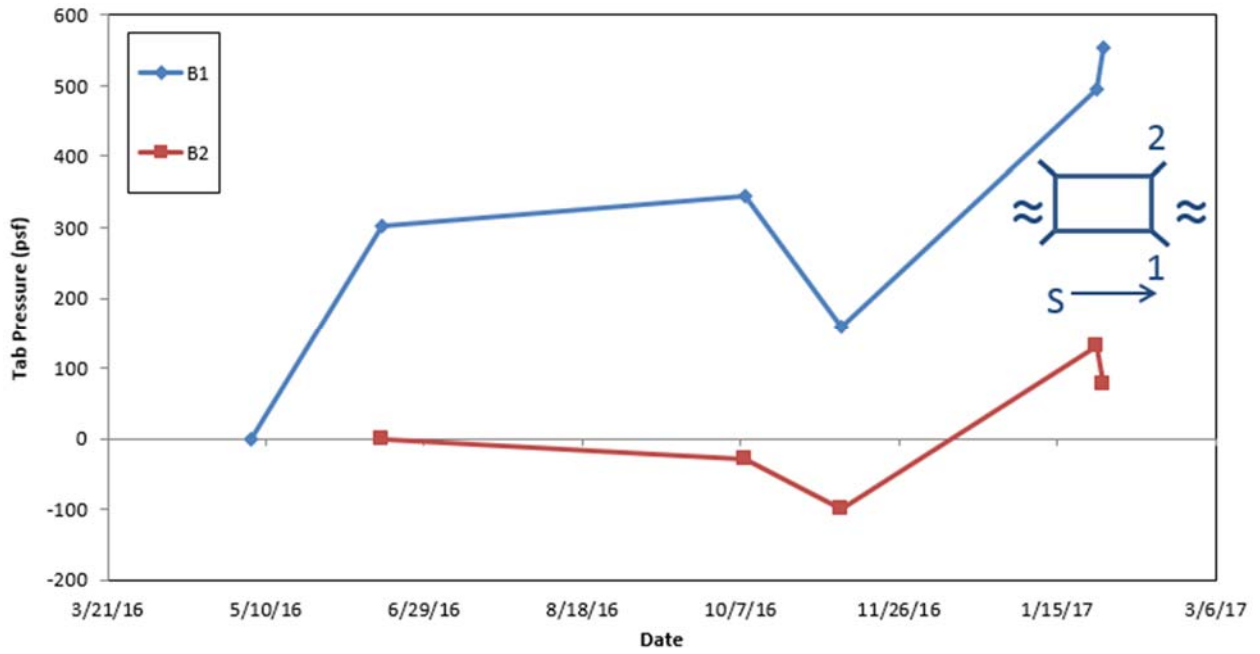
Figure 5-27: Coosa County Bottom Cells

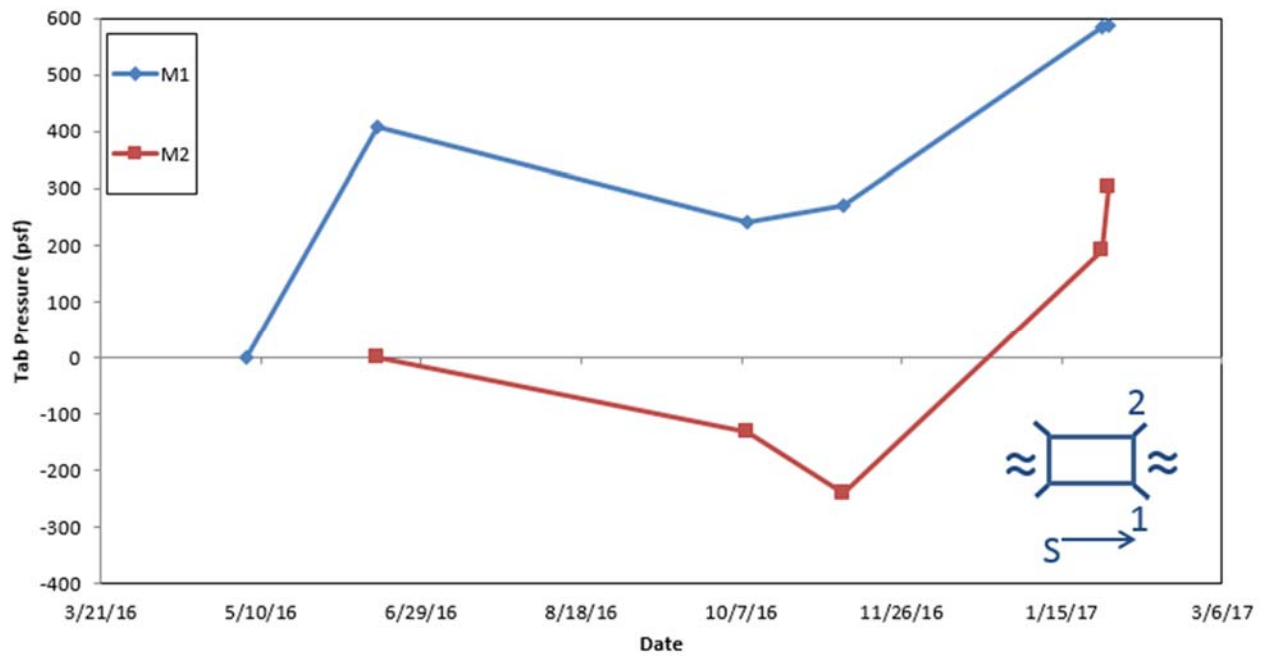
Figure 5-28: Coosa County Middle Cells

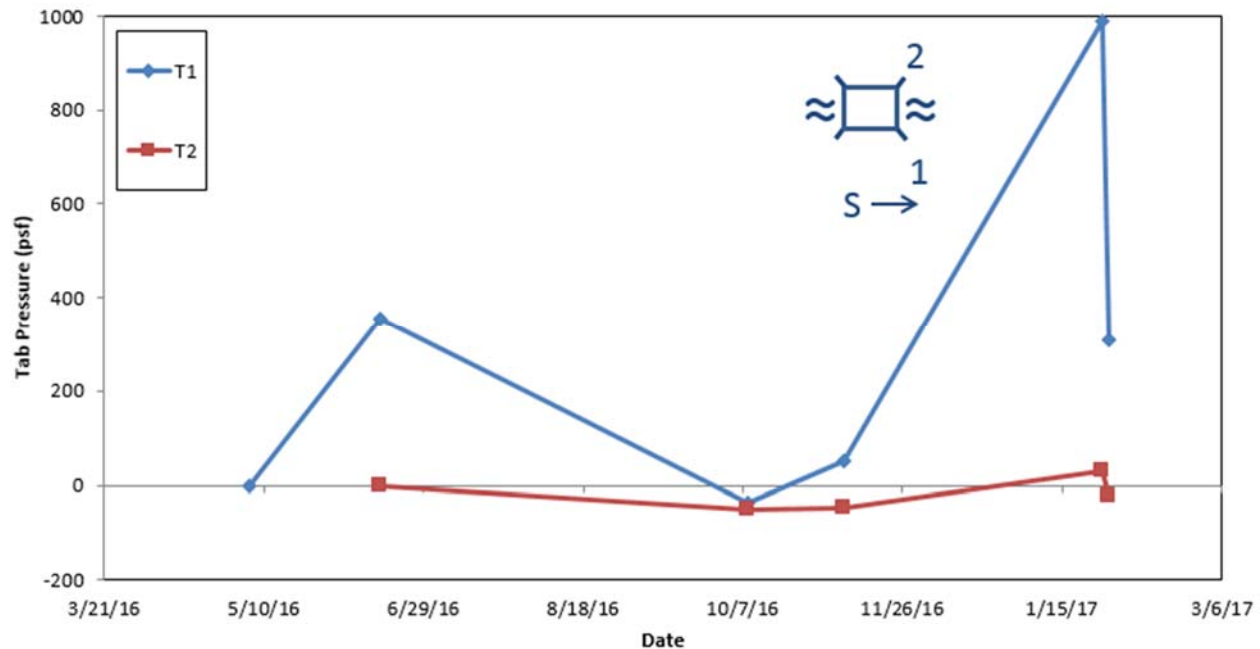
Figure 5-29: Coosa County Top Cells

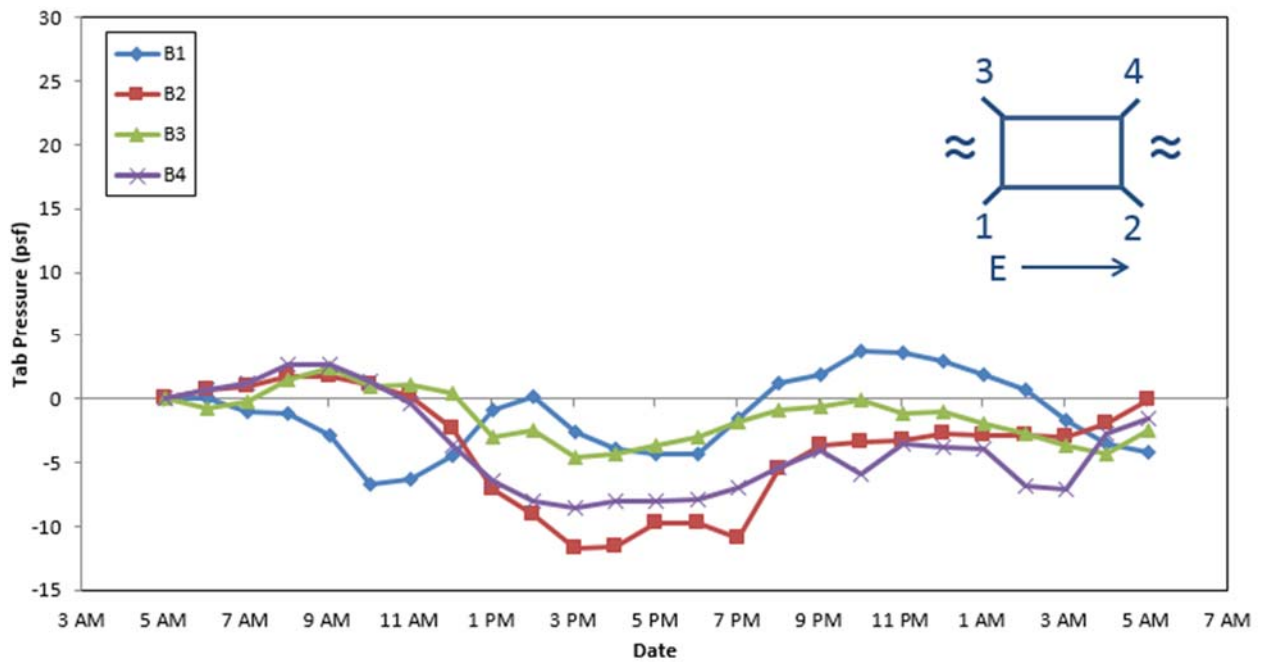
Figure 5-34: Chambers County Bottom Cells, 24-Hour Cycle

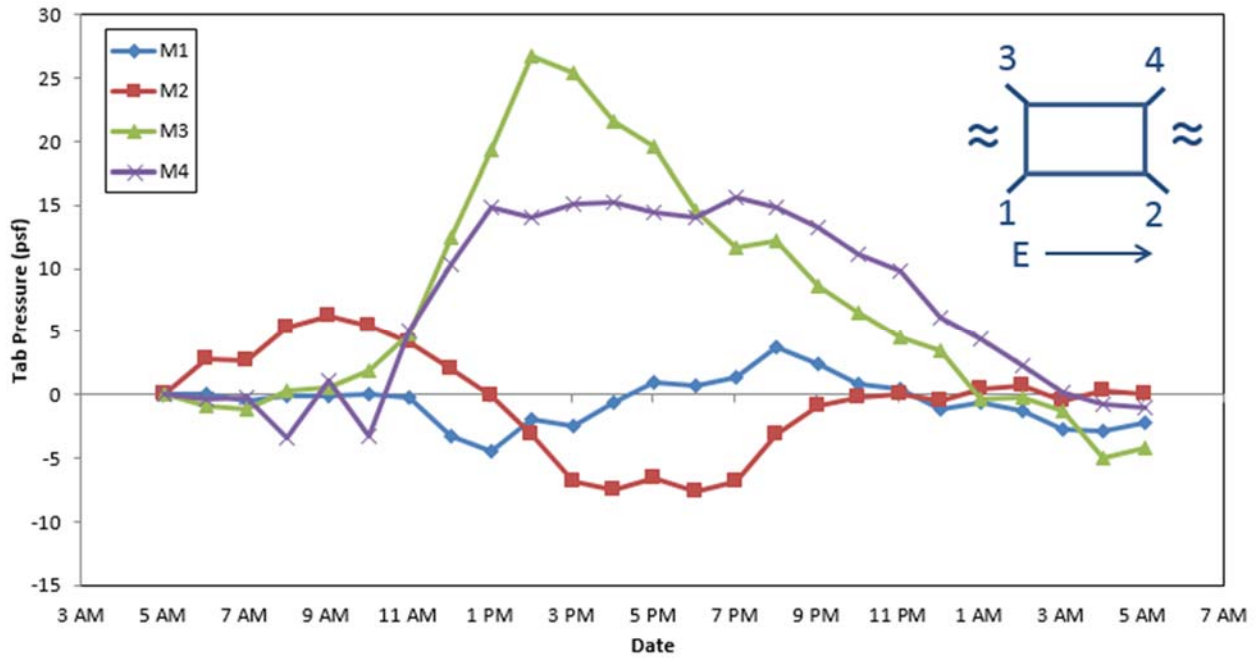
Figure 5-35: Chambers County Middle Cells, 24-Hour Cycle

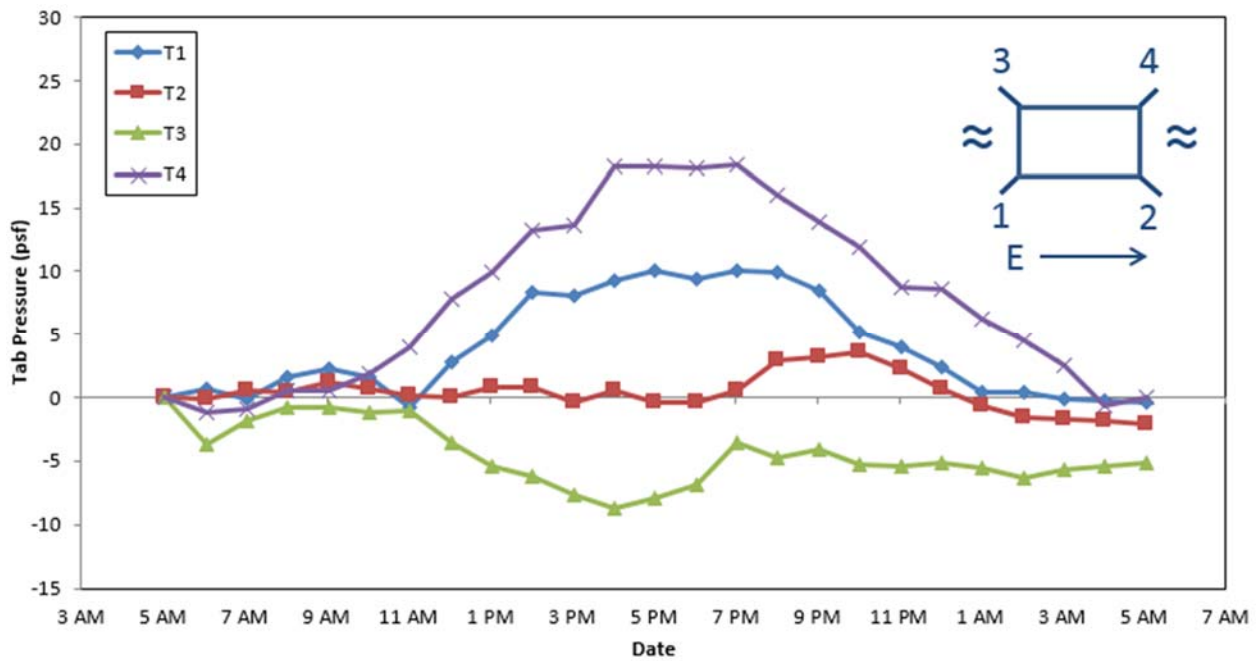
Figure 5-36: Chambers County Top Cells, 24-Hour Cycle

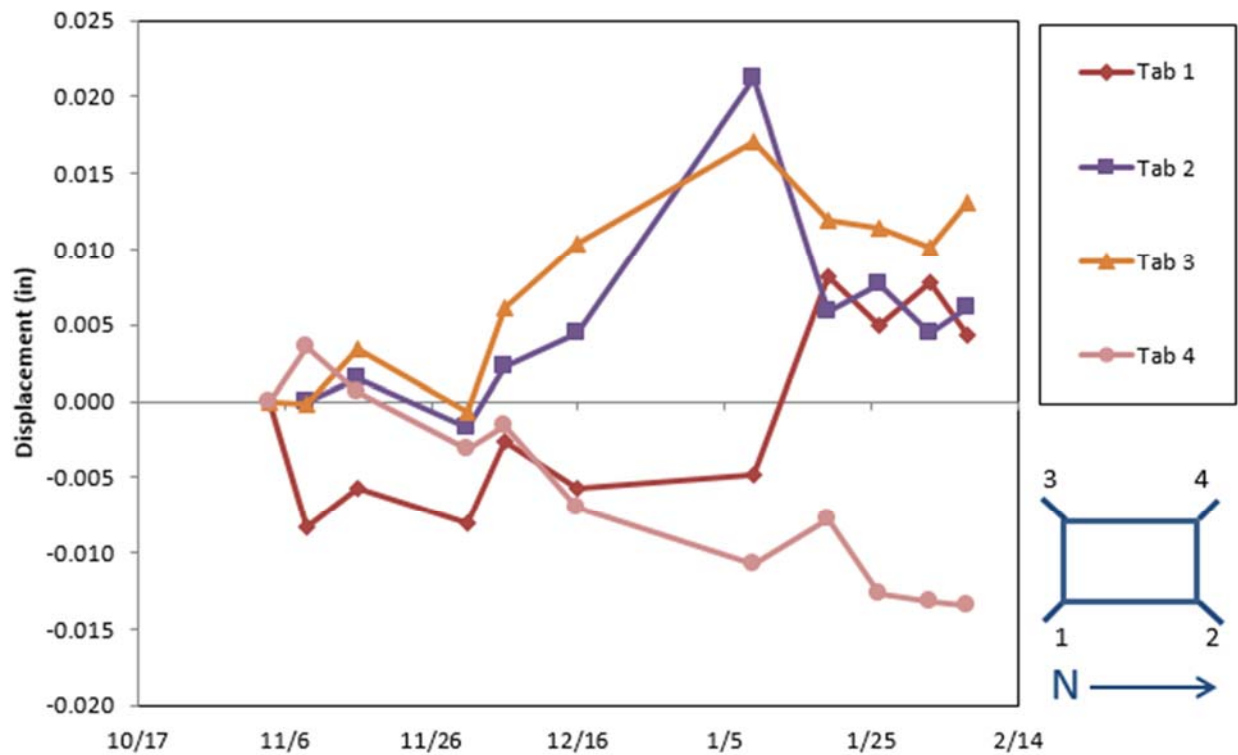
Figure 5-37: Lee County Gap Width

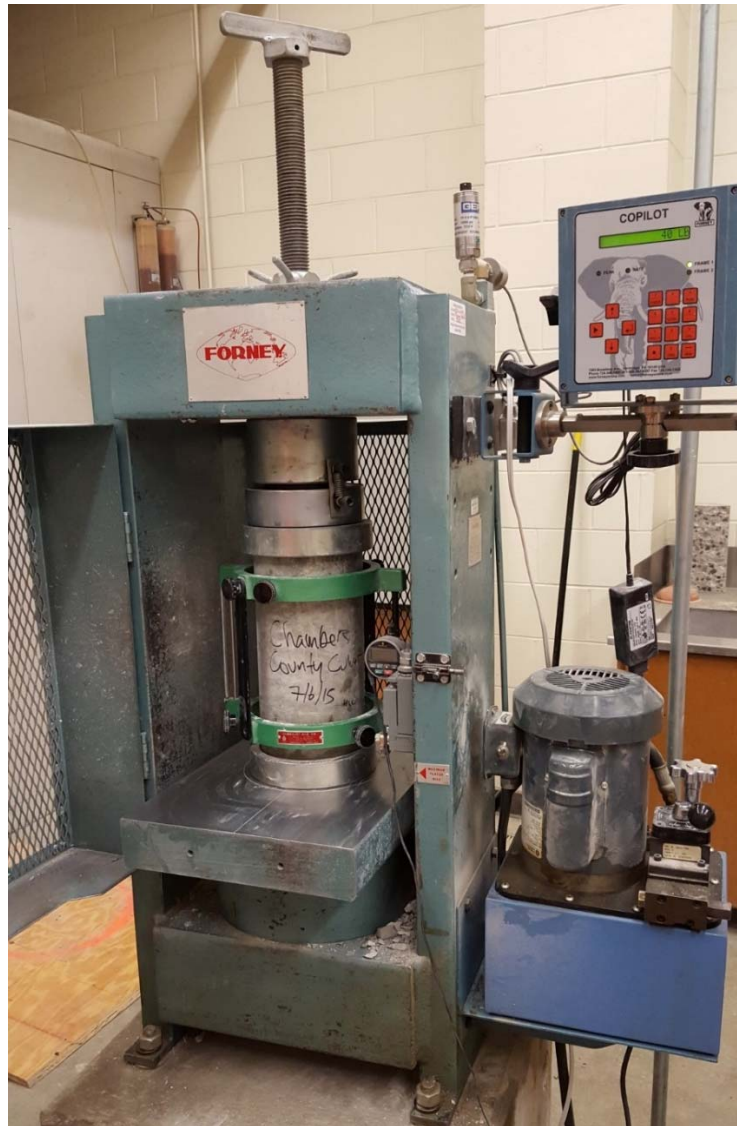
Figure 5-38: Modulus of Elasticity testing

Once a group of cylinders had aged to 28 days, they were removed from the moist curing room, their surface was wiped dry, and they were tested per the standards set forth in ASTM C649. A picture of the test set up with a cylinder and compressometer is shown below in [Figure 5-38](#).

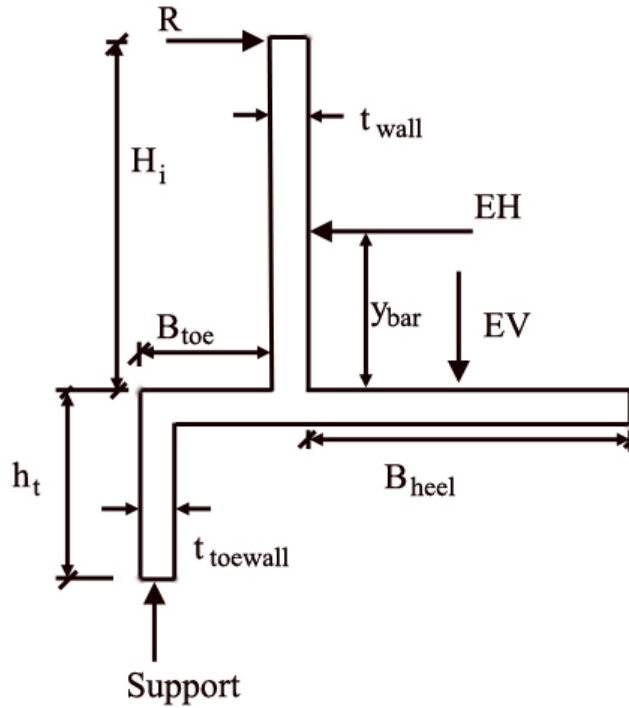
Figure 6-1: Wing Wall Free-Body Diagram

To estimate the loads acting upon the tab, it was necessary to first estimate the resultant forces caused by the lateral earth pressure acting upon the wing wall. These were determined using the following procedure, referencing the free-body diagram given in [Figure 6-1](#):

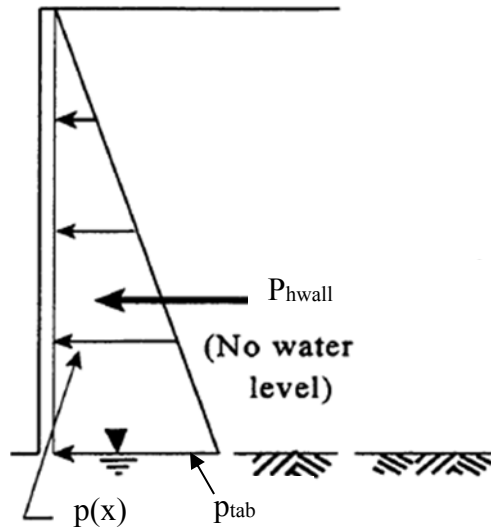
Figure 6-3: Wing Wall Translation Tab Loading

$$p_{tab} = \frac{2 * P_{hwall}}{h_i} \qquad \text{Equation 6-6}$$

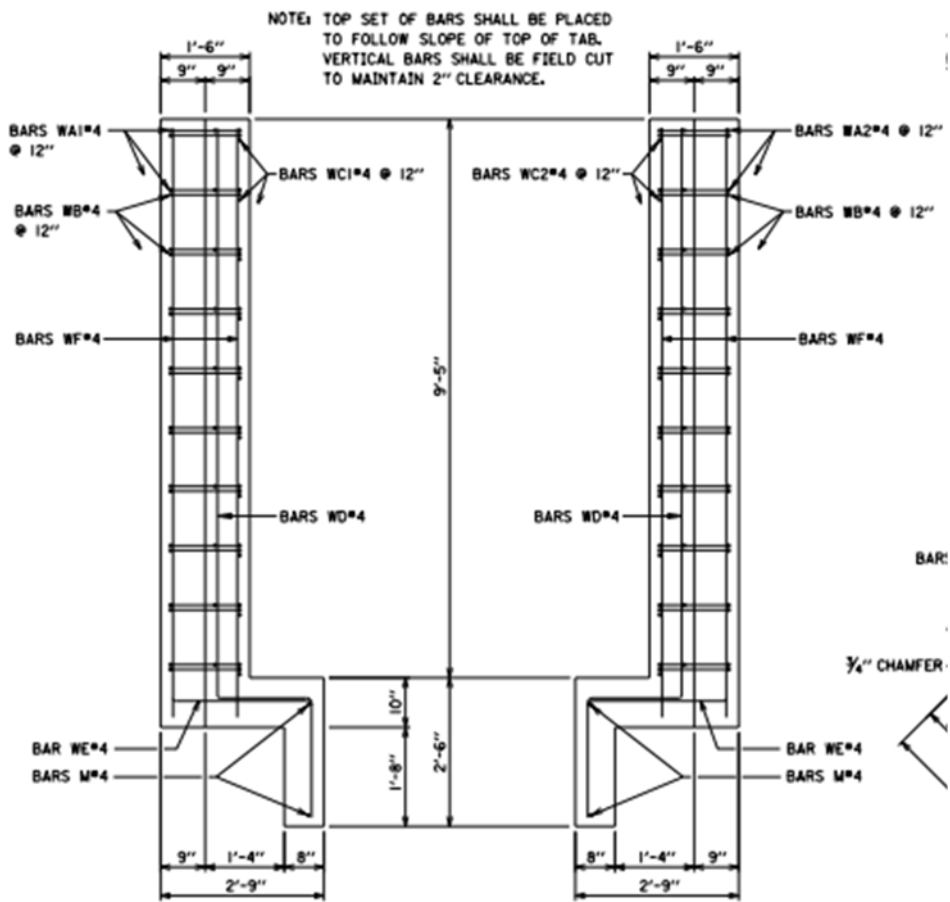
Figure 6-6: Wall Tab Detail End View

As can be seen in [Figure 6-5](#) and [Figure 6-6](#), the area of shear resisting reinforcement, A_{vf} , comprised four legs of a #4 bar, which amounted to 0.8 in^2 . No stirrups were used, which is reasonable considering the narrowness of the member, but a value for A_n of 0.4 in^2 , or half of the bars active in shear, was used in order to determine the amount of steel that was active in resisting tension, A_{st} , per the provisions given in Section 2.5.1. Moment-resisting reinforcement comprised two legs of a #4 bar, thus A_s was taken 0.4 in^2 .
