Analysis of the D'Olive Creek Watershed: Identifying the Local Drivers That Have led to Stream Degradation

A thesis submitted to the Graduate Faculty of
Auburn University
in partial fulfillment of the
requirements for the Degree of
Master of Science

Auburn, Alabama
May 5, 2018

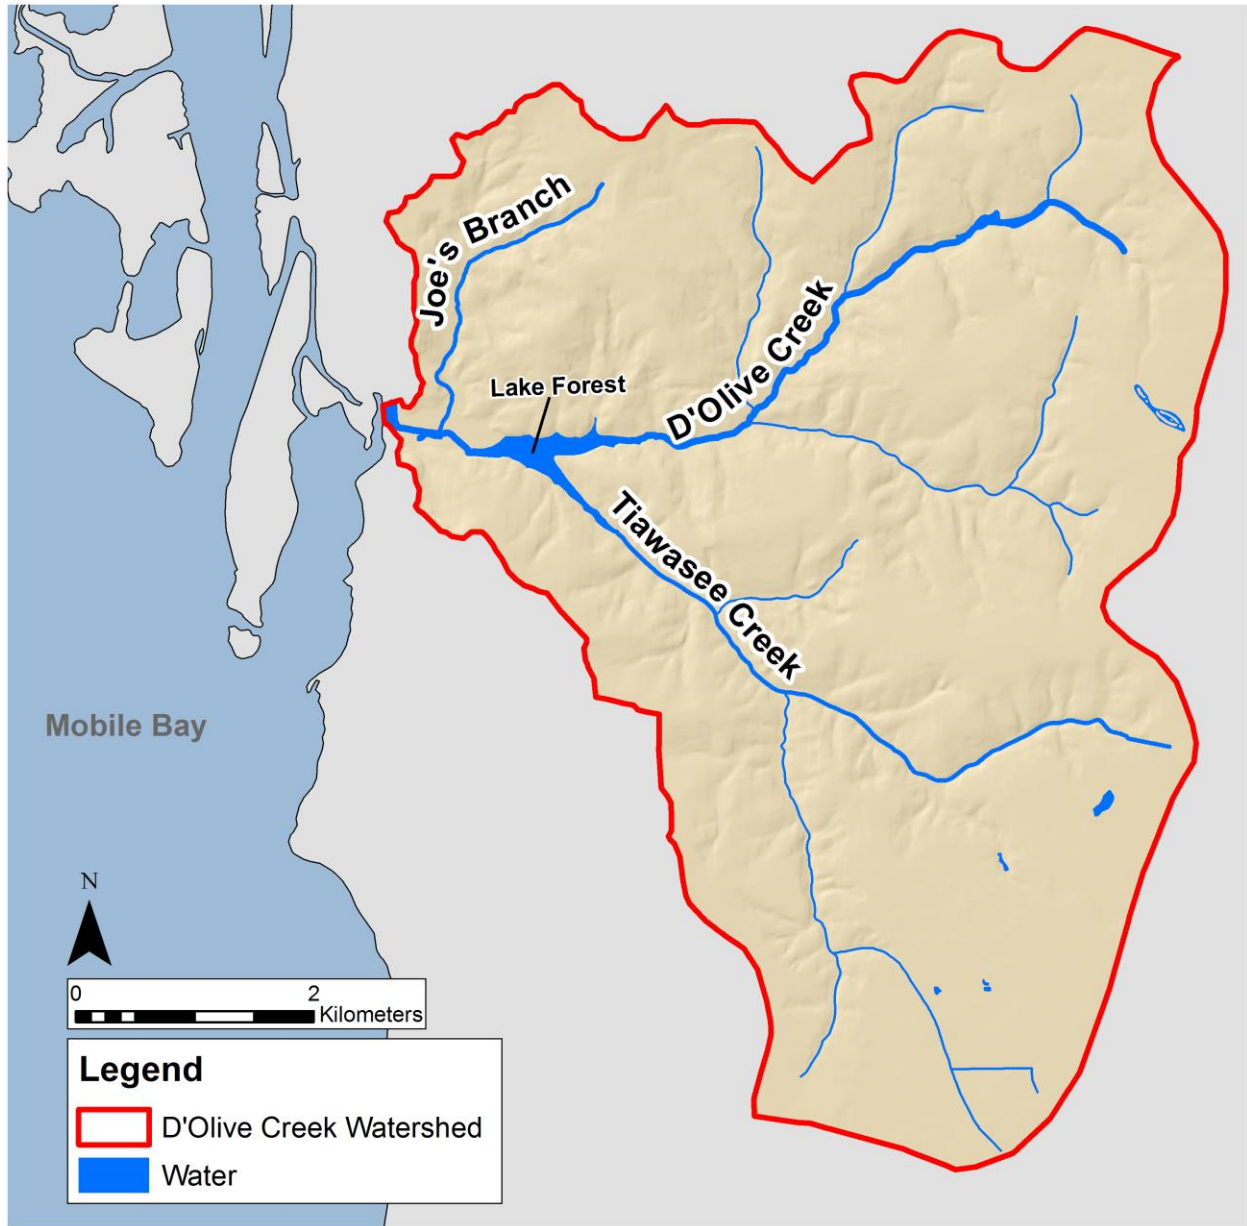
Figure 3: The D'Olive Creek Watershed and its stream network.

D'Olive Creek is named after Louis D'Olive, a French settler who first visited the area in the early 1800s. The D'Olive Creek Watershed covers approximately 32 sq. km along the eastern side of Mobile Bay (Figure 3). The watershed was mostly underdeveloped until the late 1960s (Coffee, 2010). Significant amounts of urban development have occurred in this area since the 1970s and have had negative environmental effects: erosion, sedimentation, and pollution (Coffee, 2010). Based on the intense growth that the D'Olive Creek Watershed has experienced, there is a strong possibility that the area could reach a 100% build-out condition by 2020 (Coffee, 2010). Analyzing watershed characteristics will aid in reaching a 100% build-out condition that minimizes environmental impact.

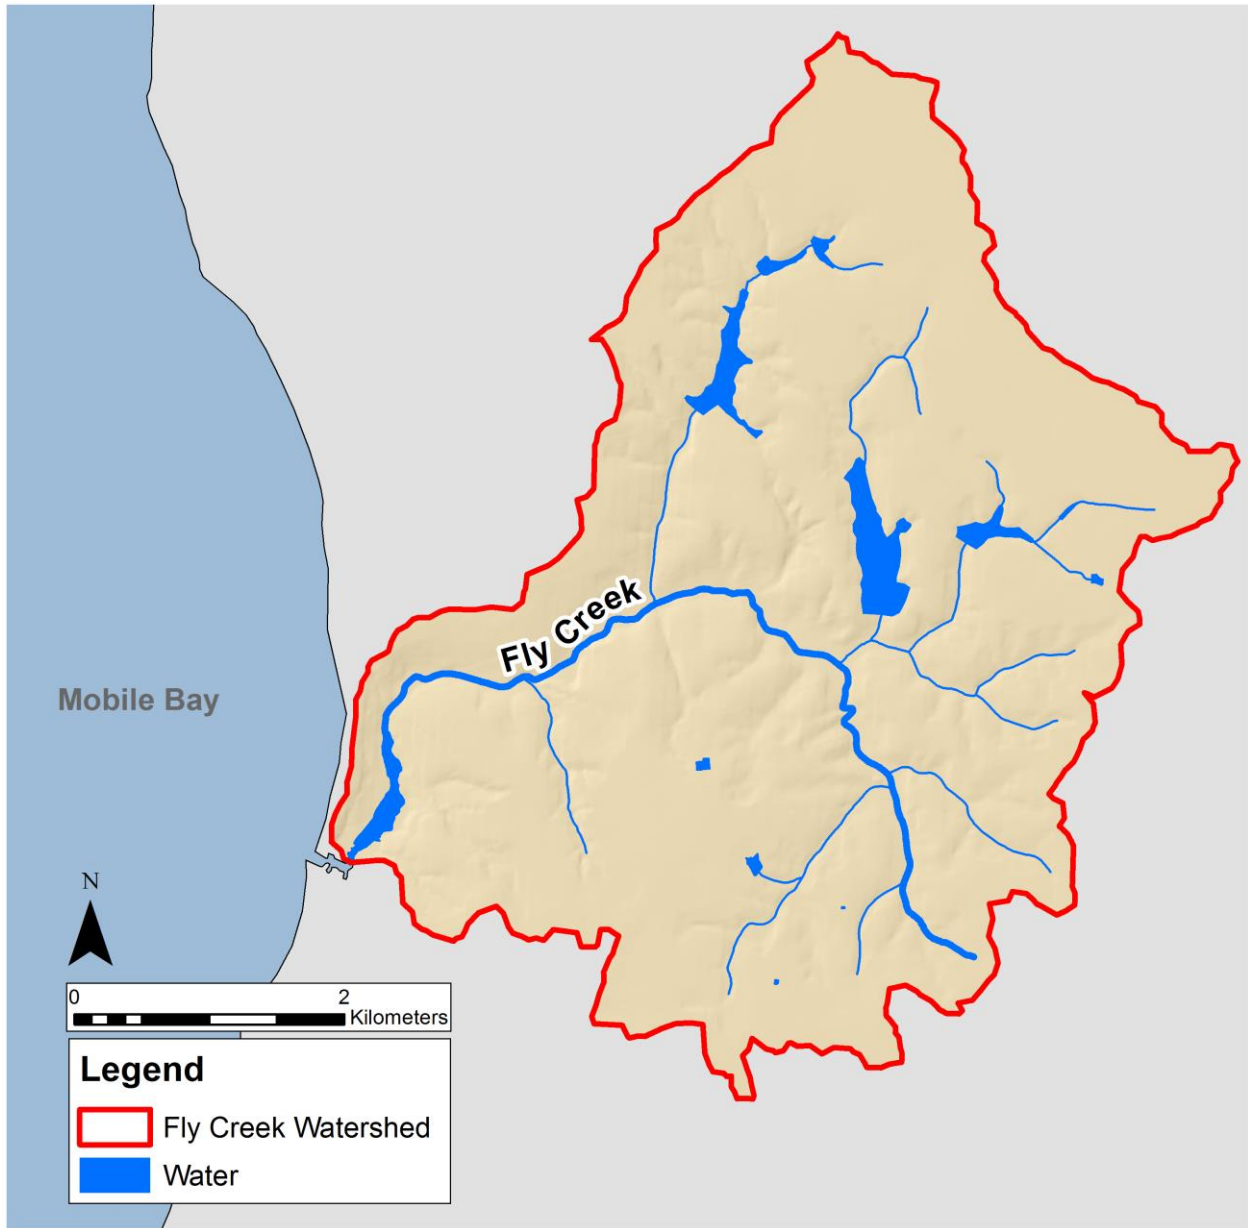
Figure 4: The Fly Creek Watershed and its stream network.

The Fly Creek Watershed lies along the eastern side of Mobile Bay (Figure 4) and covers approximately 20 sq. km. Similar to the D'Olive Creek Watershed, the Fly Creek Watershed is recognized by the Mobile Bay NEP as being quite ecologically significant. Although the importance of the watershed is well-known, the Mobile Bay NEP currently has no official watershed management plan under development for Fly Creek. Nevertheless, watershed restoration and related activities are occurring in the area and a number of stakeholders are participating: industry, citizen groups, academia, federal, state, and local agencies.

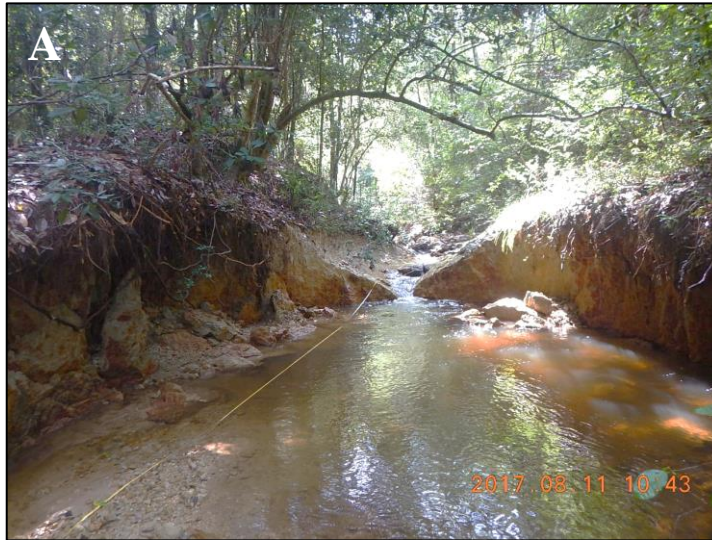
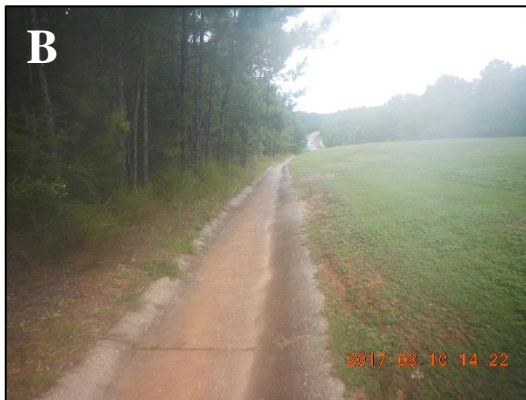
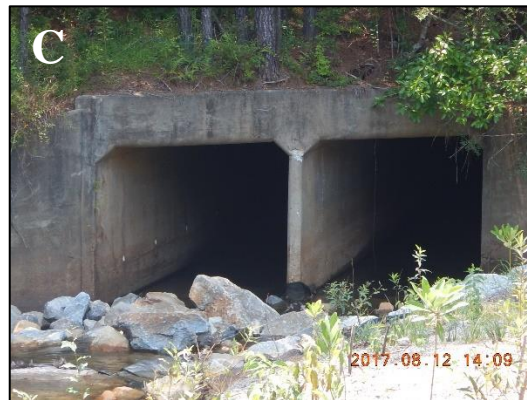
Figure 6 A, B, and C:
Reference images of the impaired location
A) Looking upstream at the impaired tributary;
B) Concrete channel located upstream of site;
C) Culvert located upstream of site.

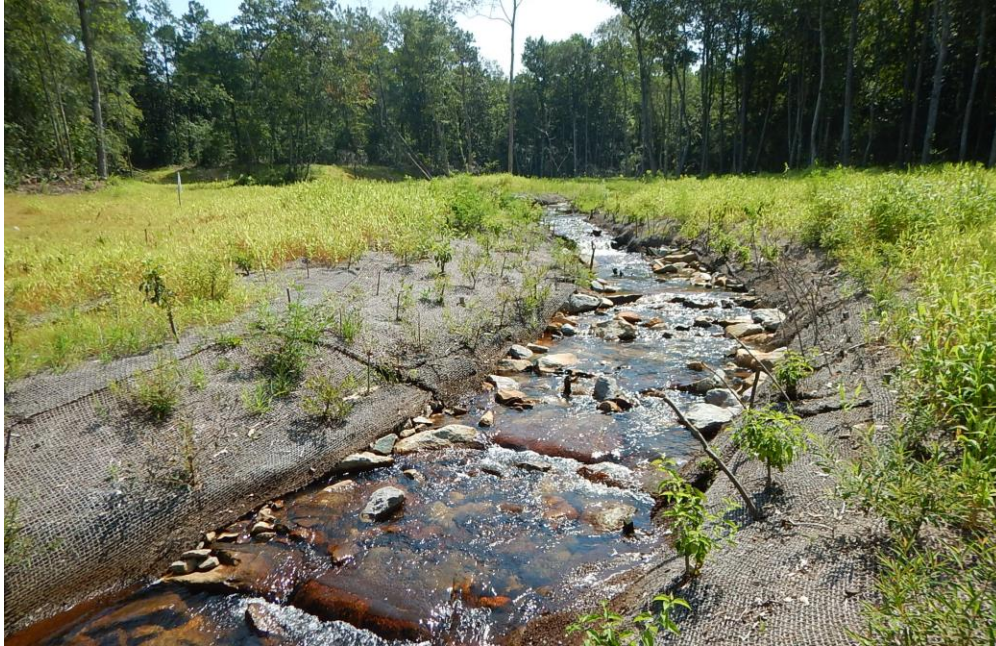
Figure 7: The use of rock material (e.g. boulders) and riparian vegetation to modify flow dynamics at the restored site, following a hybrid natural channel design and modified hydraulic design method (Rosgen, 1994).

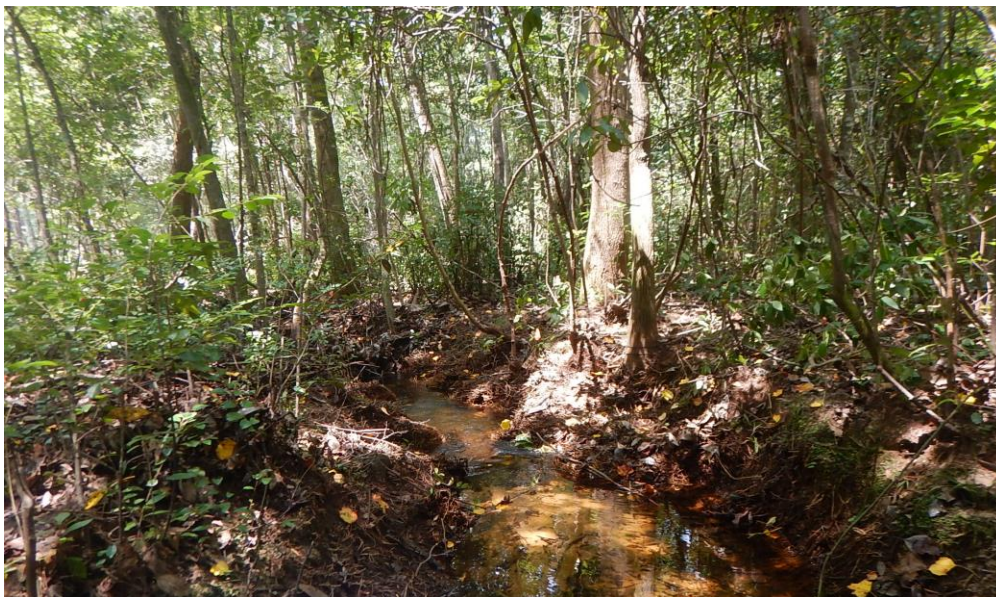
Figure 8: Looking upstream towards forested area at the reference tributary.

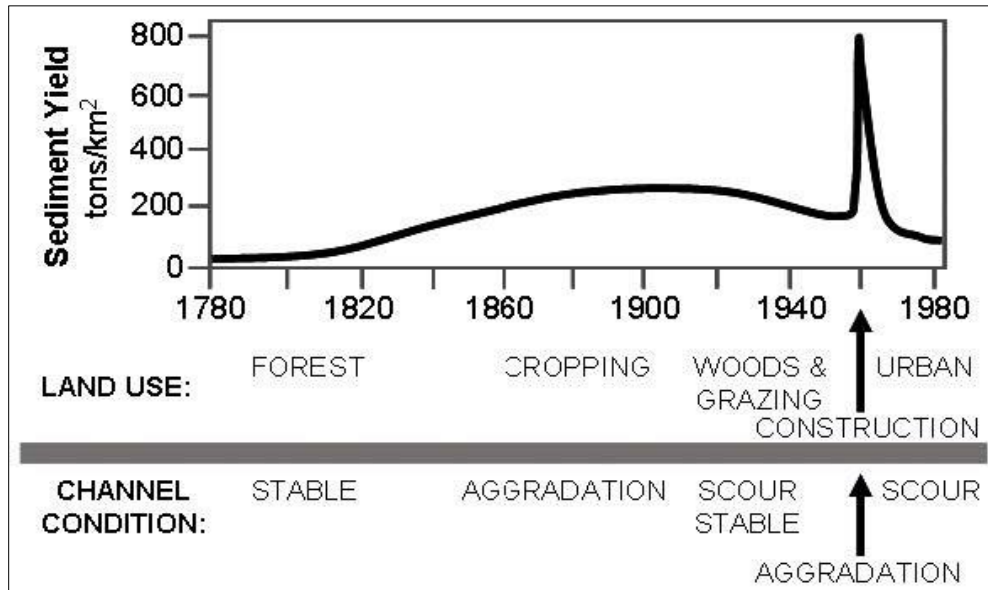
Figure 10: Change in sediment yield through time as land use changes, from Wolman (1967) and modified by Lord et. al (2009).

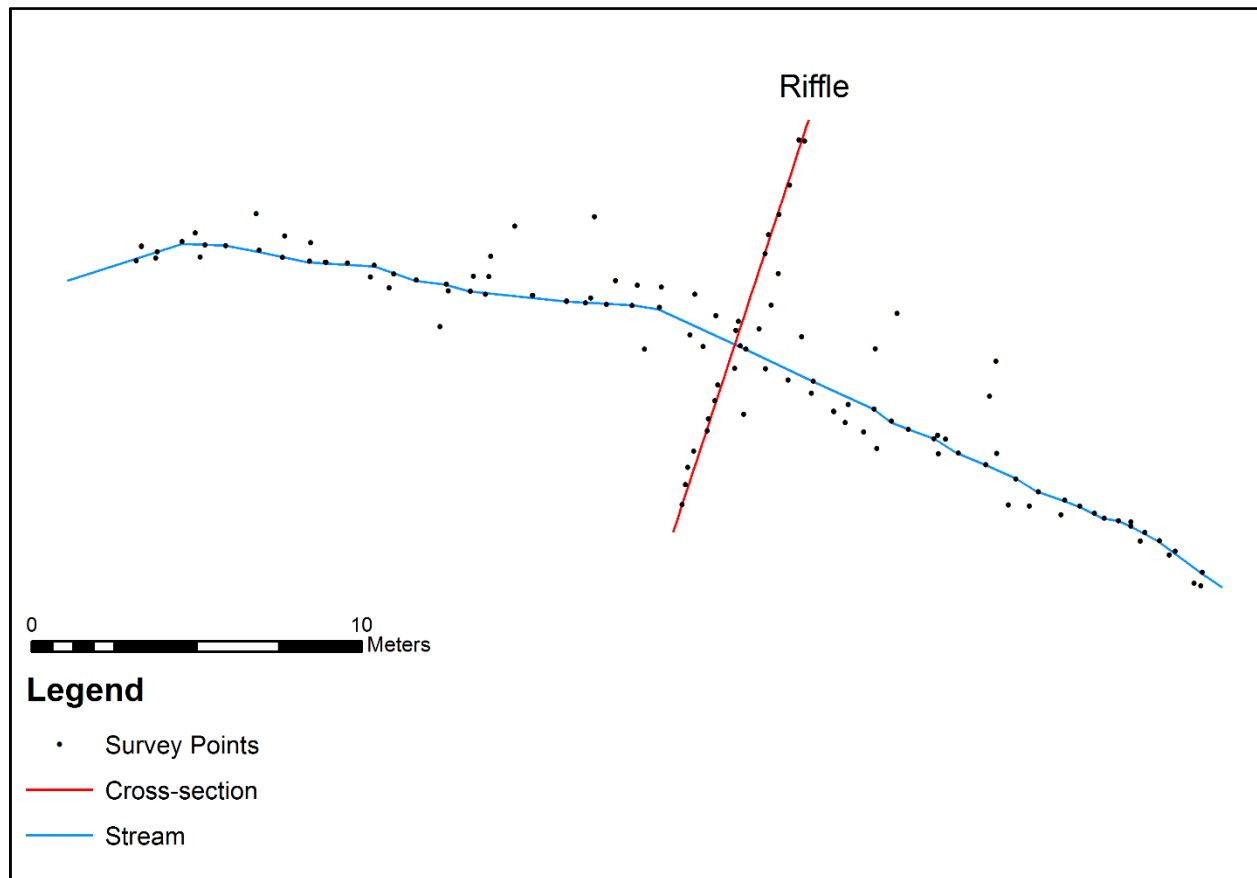
Figure 13: Longitudinal and cross-section survey points of impaired site.

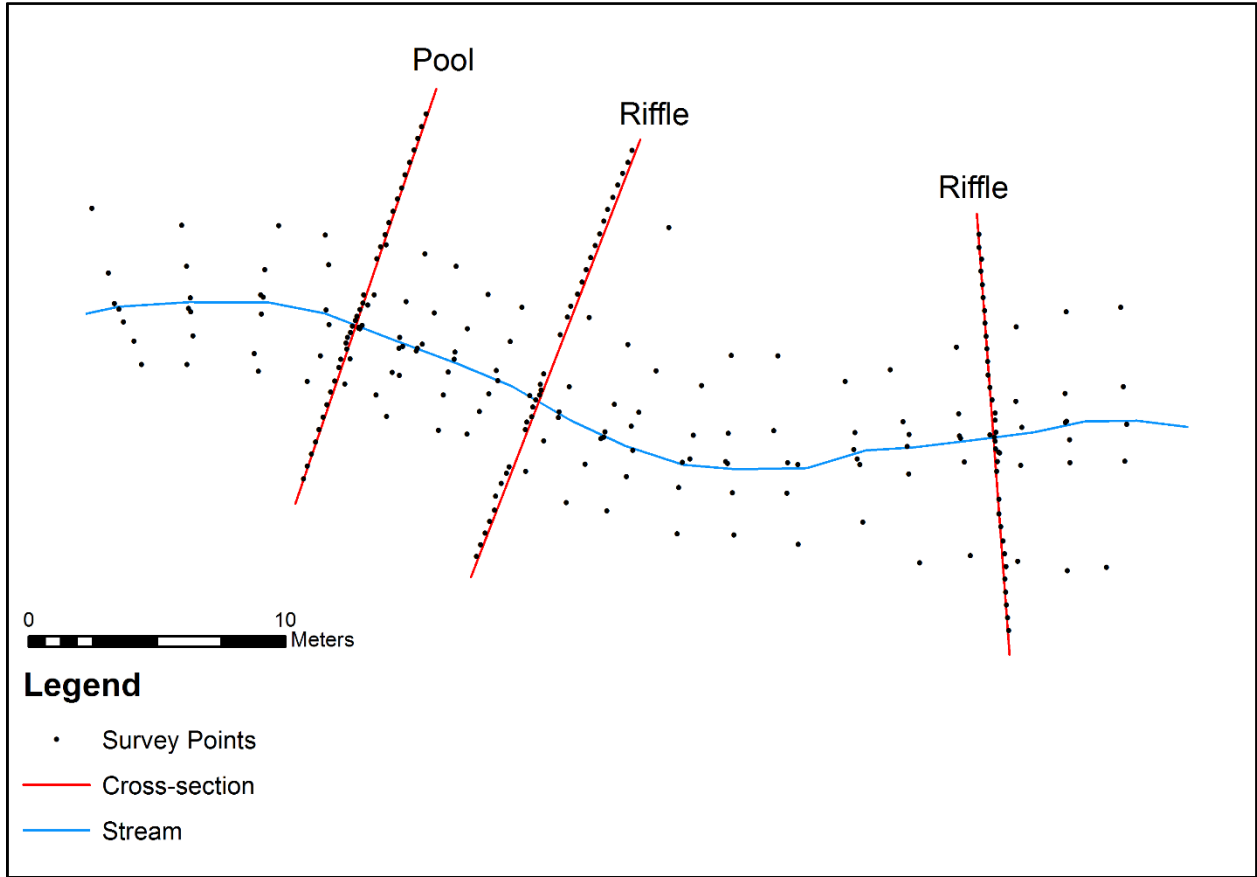
Figure 14: Longitudinal and cross-section survey points of restored site.

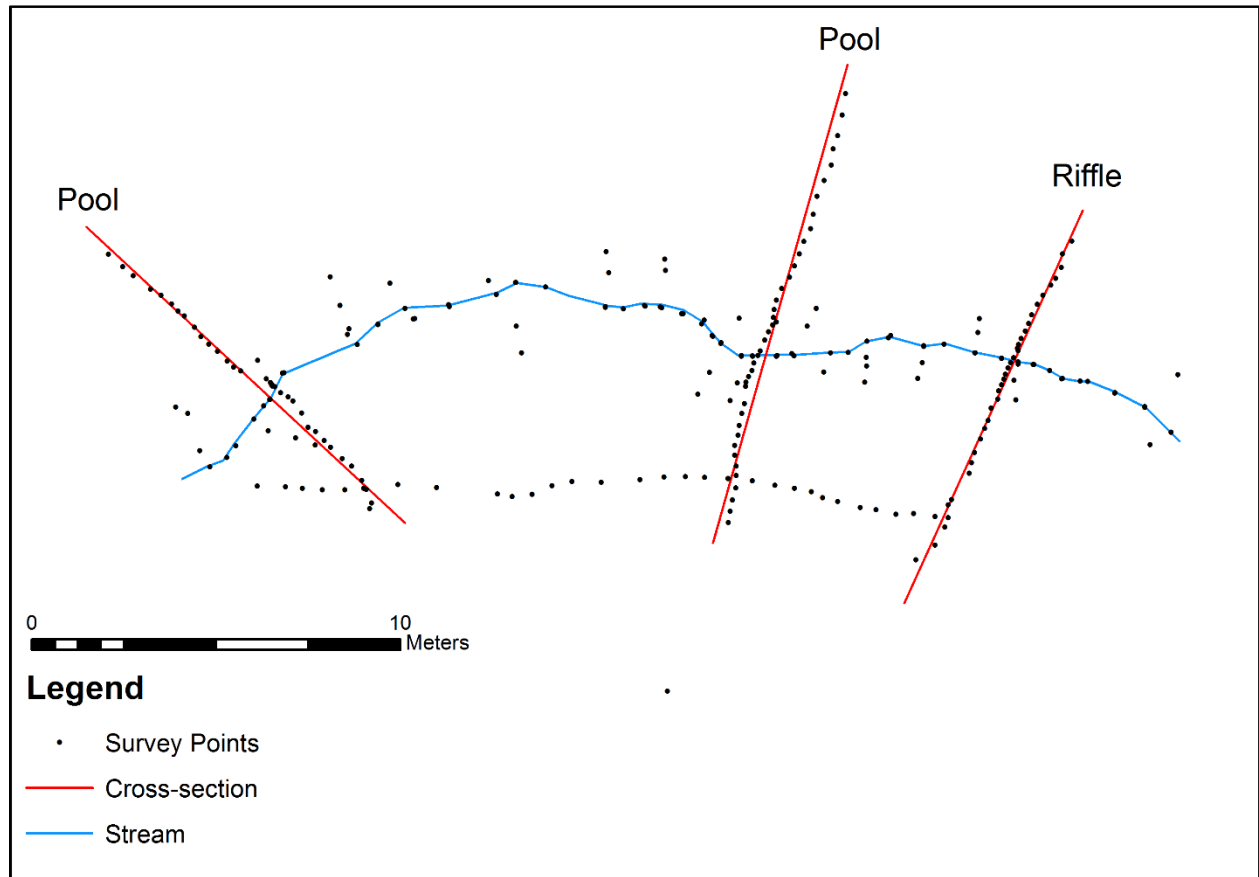
Figure 15: Longitudinal and cross-section survey points of reference site.

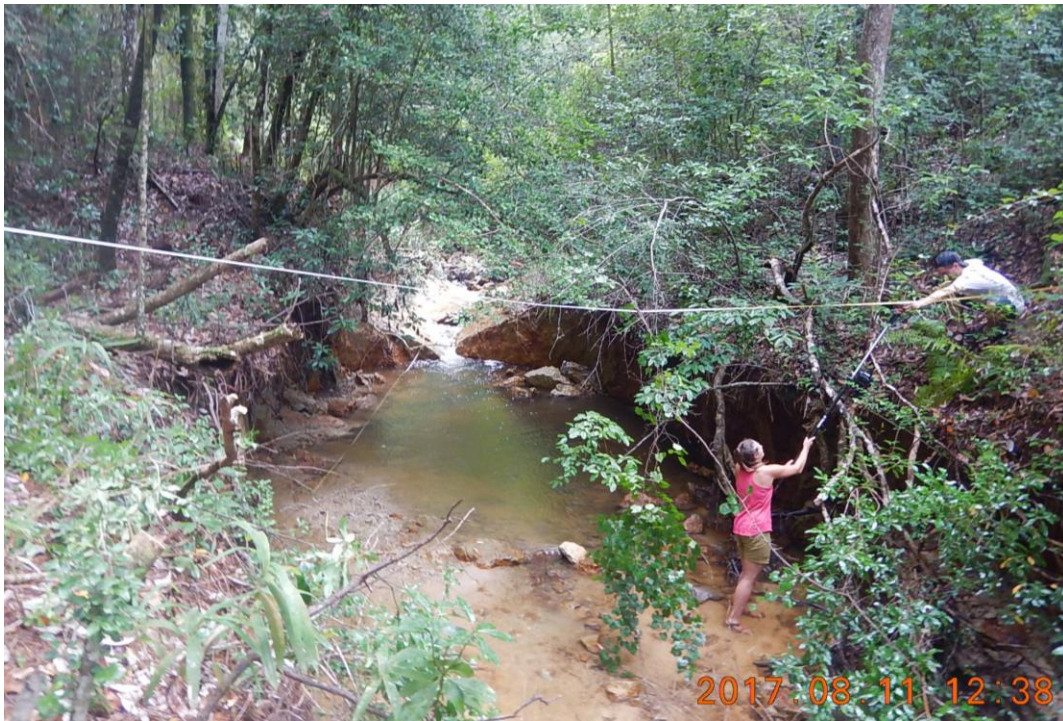
Figure 27: Cross-section at the impaired site along which the vegetation analysis was performed.

The impaired cross-section (Figure 27) had at least four classes of vegetation >20%; 5-20% of total cover represented by invasive exotic vegetation (*Cinnamomum camphora*); <30% of streambank had evidence of a deep, binding root mass; high flows (> 2X bankfull) not able to enter floodplain (deeply entrenched); <10% of cross-section had exposed soil surface. Collective quantitative analysis of vegetation data for the impaired site equaled 50/100.

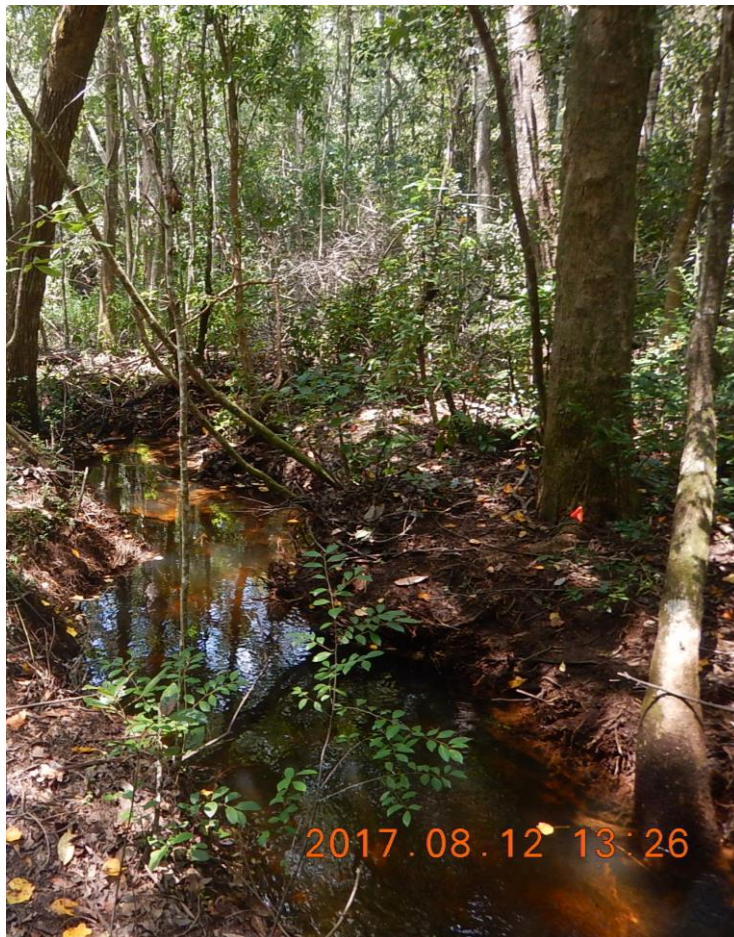
Figure 29: Vegetation diversity along the streambank resulting in root masses along the reference tributary.

All three cross-sections at the reference site had at least four classes of vegetation >20%; 5-20% of total cover represented by invasive exotic vegetation; 30-60% of streambank had evidence of a deep, binding root mass (Figure 29); high flows (> bankfull) able to enter the floodplain; vegetated buffer width >15.24 m; clear mix of wetland and non-wetland habitats (evidence of pooling water). Exposed soil surface varied at each cross-section from 5 to 25%. Collective quantitative analysis of vegetation data for the reference site equaled 86/100.

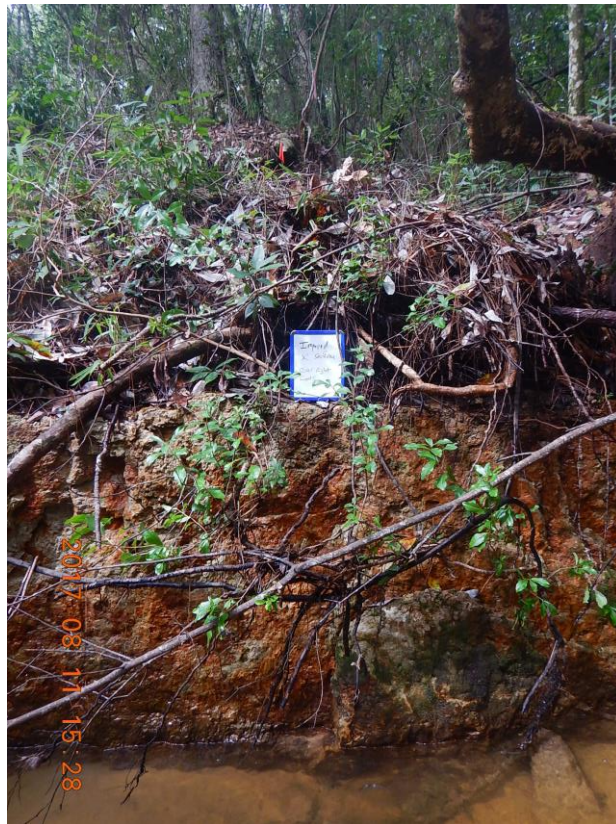
Figure 30: Example of bank incision at the impaired site. This type of incision is common in urban areas and is associated with hydrologic changes related to impervious surfaces (i.e. stream flashiness).

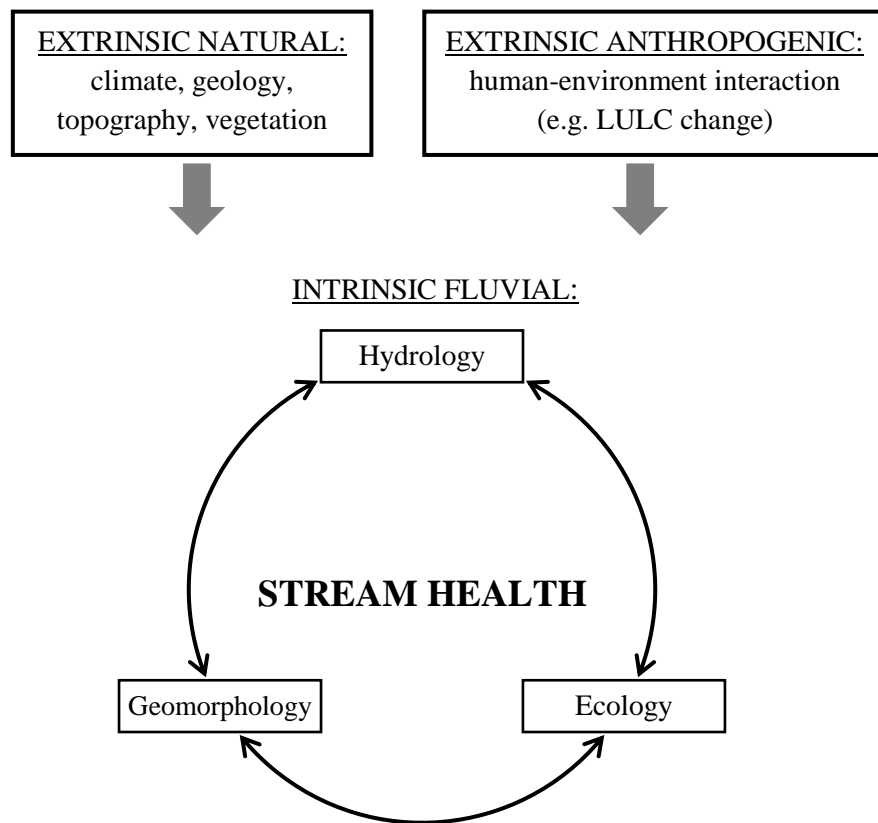
Figure 31: Three major categories that affect stream health in urban environments: extrinsic natural, extrinsic anthropogenic, and intrinsic fluvial.

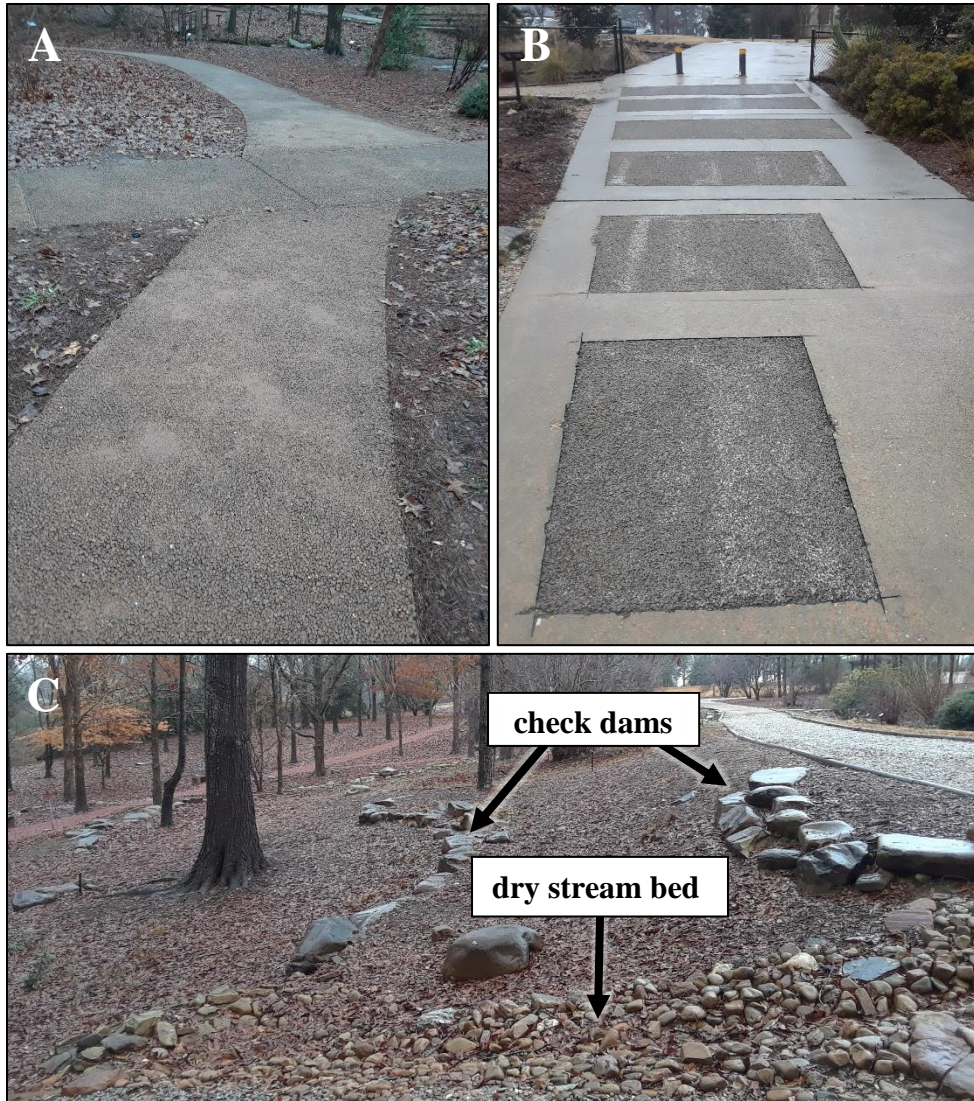
Figure 32 A, B, and C:
BMP examples at the Donald E. Davis Arboretum, Auburn University
A) Pervious concrete sidewalk;
B) Pervious concrete inserted into an impervious concrete sidewalk;
C) BMP apparatus installed across the landscape to mitigate runoff before it enters a downhill stream.

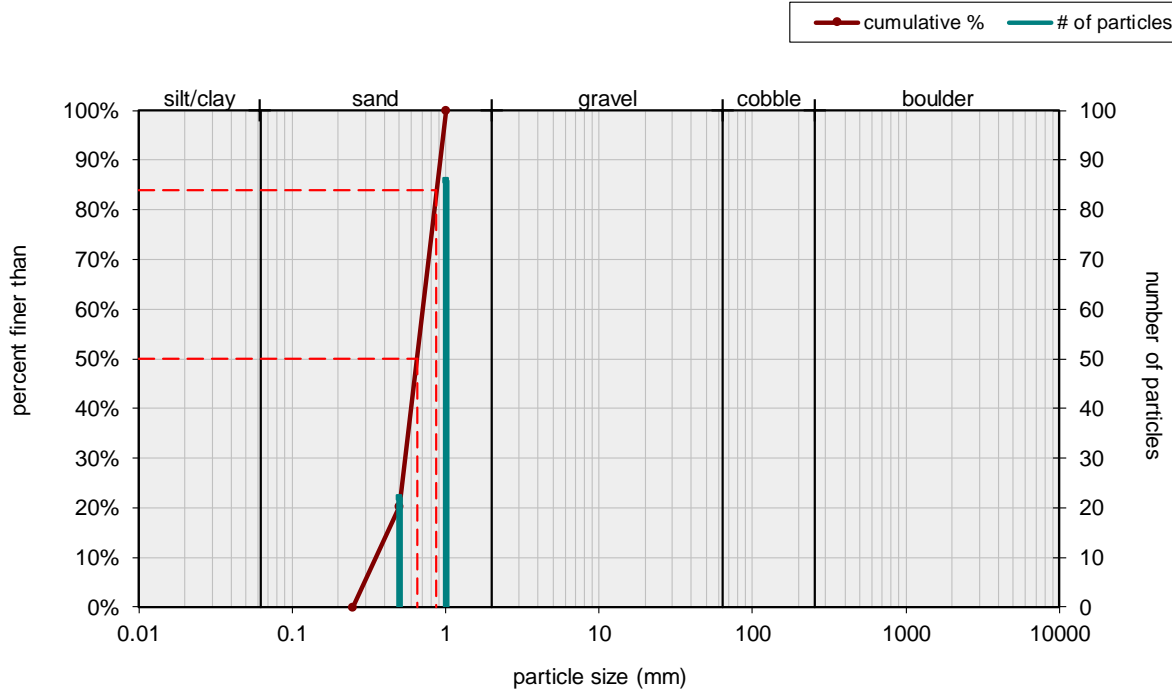
Reference Site - Riffle

Size (mm)		Size Distribution		Type	
D16	0.43	mean	0.6	silt/clay	0%
D35	0.57	dispersion	1.4	sand	100%
D50	0.65	skewness	-0.05	gravel	0%
D65	0.74			cobble	0%
D84	0.87			boulder	0%
D95	0.96
