FINITE-ELEMENT MODELING OF A DAMAGED PRESTRESSED
CONCRETE BRIDGE

A Thesis

Auburn University

Auburn, Alabama
May 10, 2007

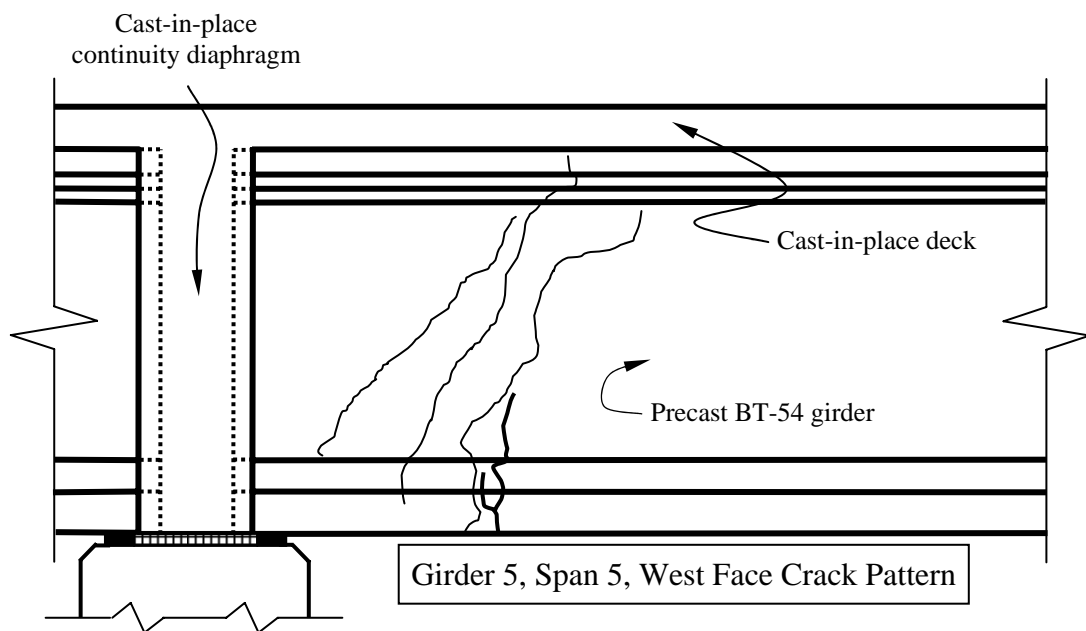
Typical crack widths ranged from 0.002 in. to 0.25 in. Figure 3.1 presents the pattern of cracking found in 1994 in one 54-in. girder of Span 5 (Barnes et al. 2006). Many of the cracks were inclined and as a result intersected transverse reinforcing bars. These inclined cracks were limited to a width of approximately 0.06 in. In the bottom flange, however, the cracks were vertical and therefore crossed only the longitudinal prestressing strands. These larger cracks (widths up to 0.25 in.), such as those found on the girders shown in Figure 3.2, were visible from the ground (Barnes et al. 2006).

Figure 3.1 Typical Pattern of Cracking in End Region of Precast Girder (Barnes et al. 2006) Note: The bolder line on the bottom-flange cracks indicates a greater crack width.

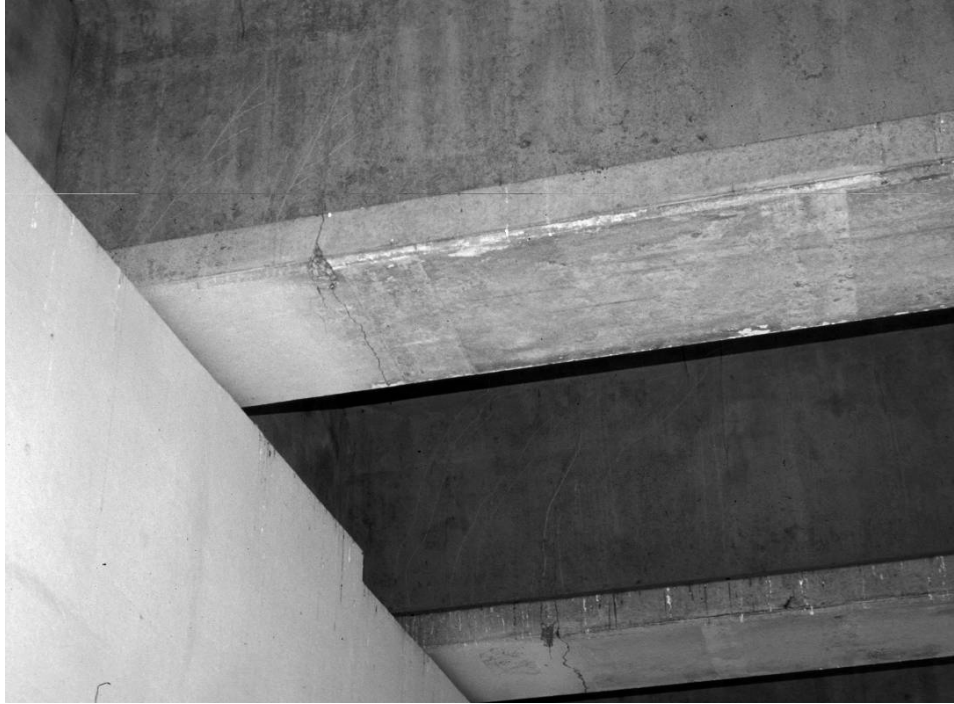
Figure 3.2 Cracked Pretensioned Bulb-Tee Girders (Barnes et al. 2006)

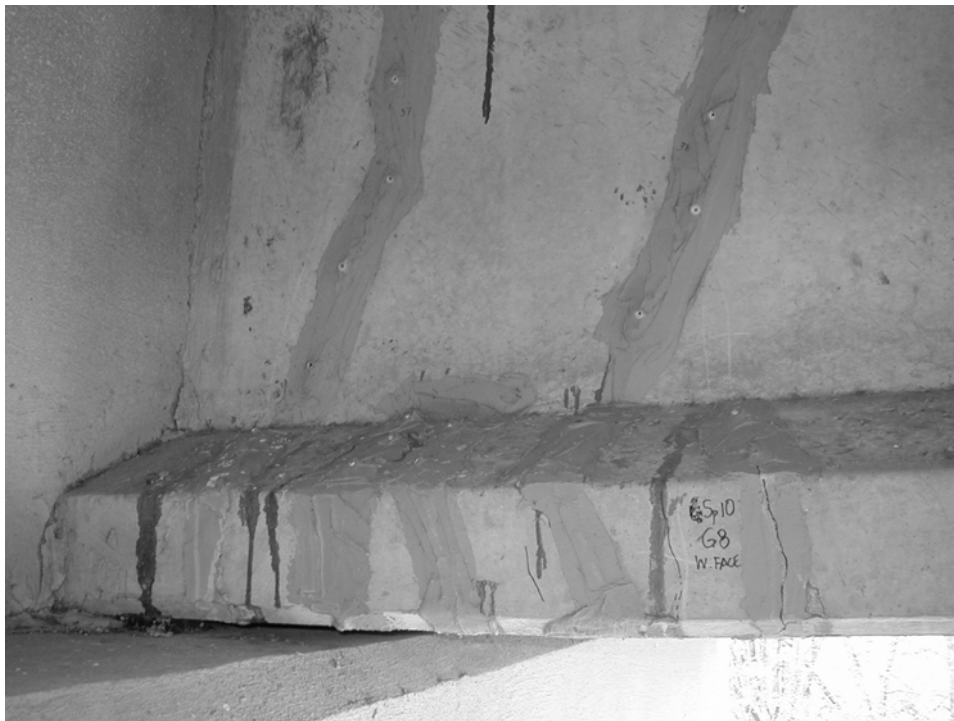
Figure 3.3 Epoxy-Injected Cracks

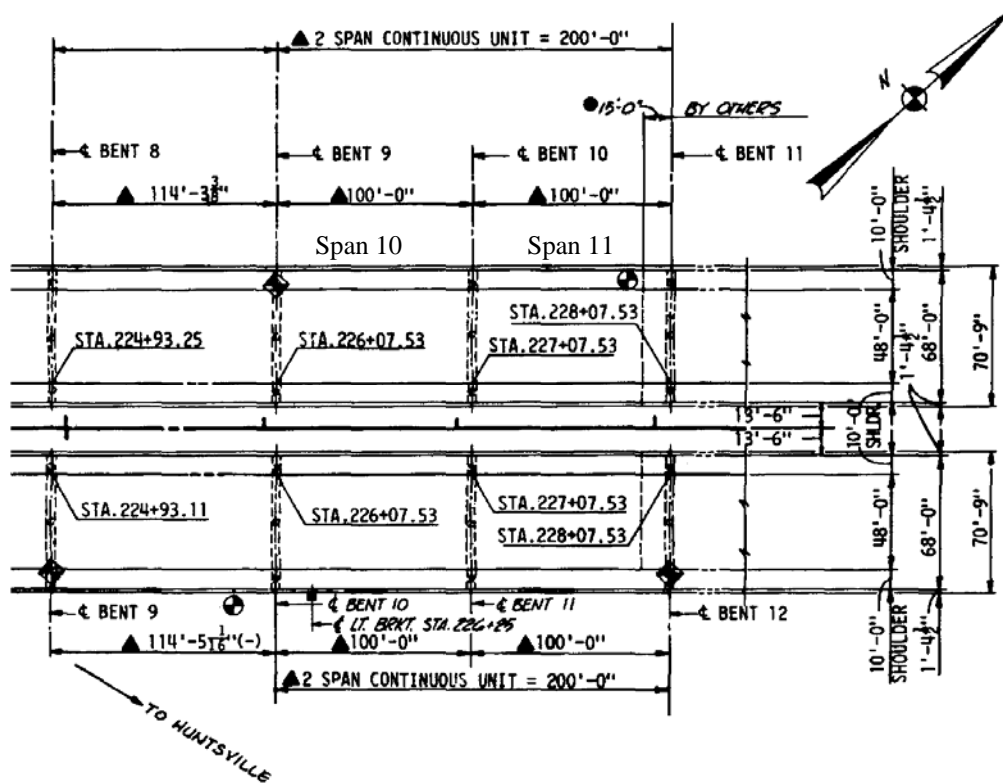
Figure 3.6 Plan View of the Two-Span Continuous Unit (ALDOT 1987)

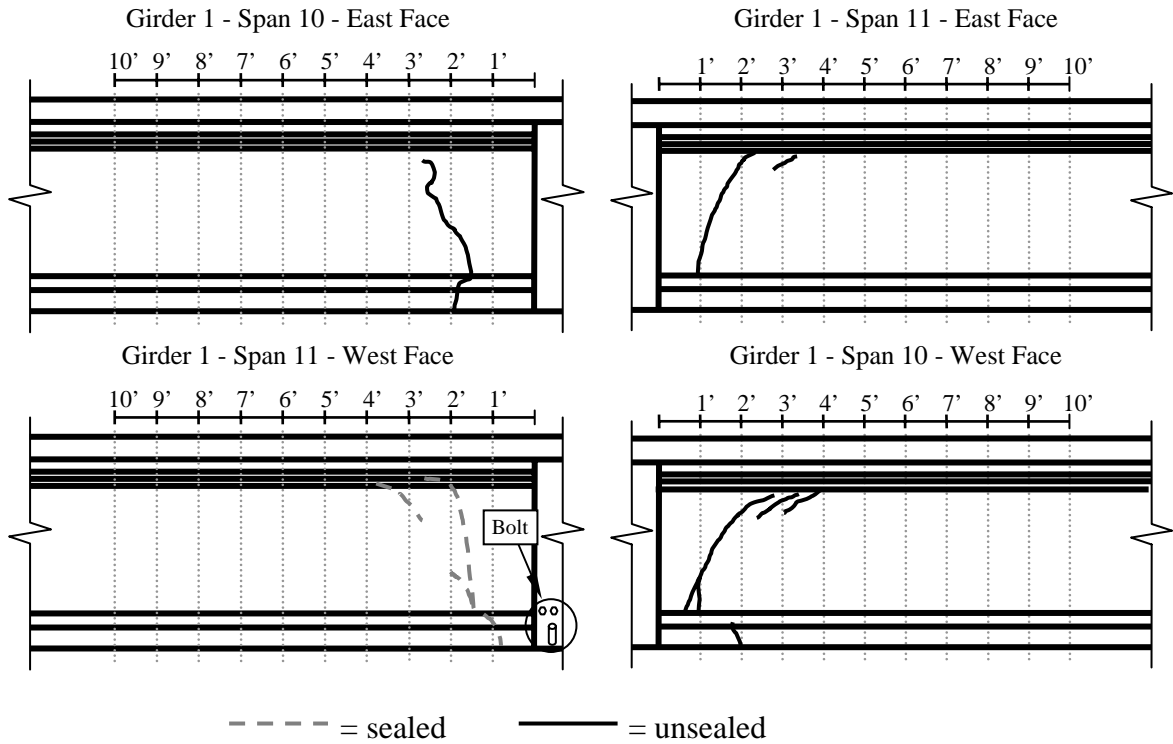
Figure 3.13 Girder Line 1 Cracking (Fason and Barnes 2004)

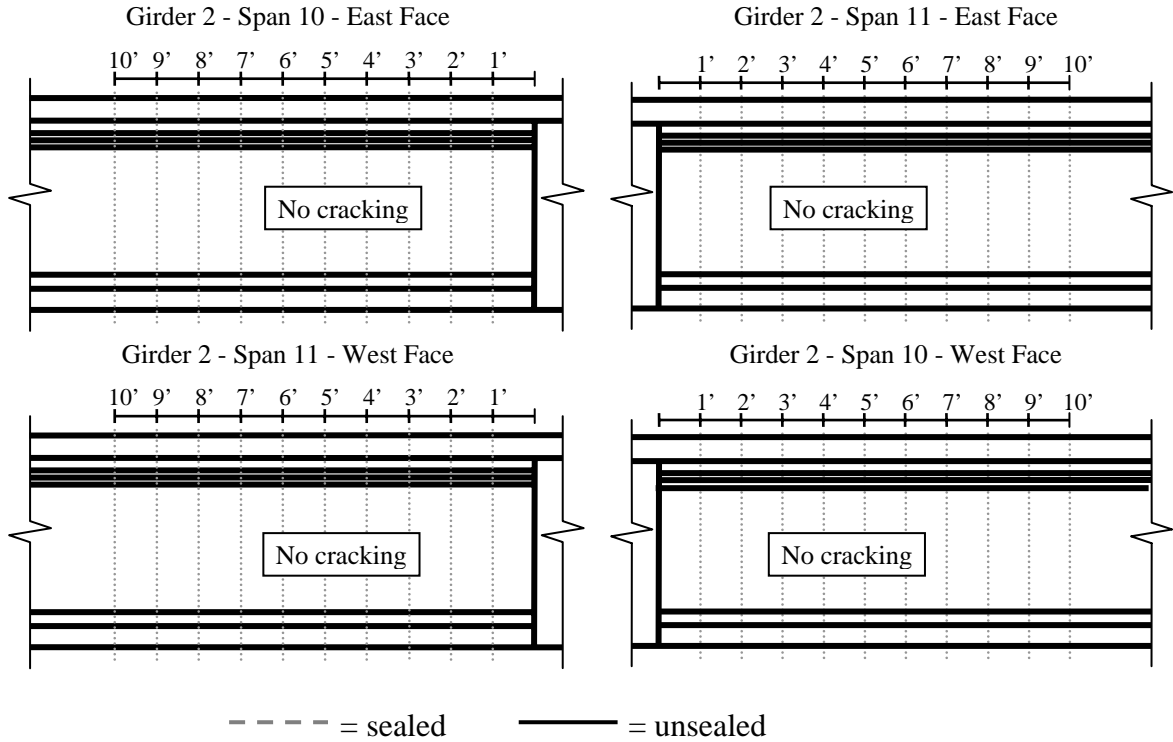
Figure 3.14 Girder Line 2 Cracking (Fason and Barnes 2004)

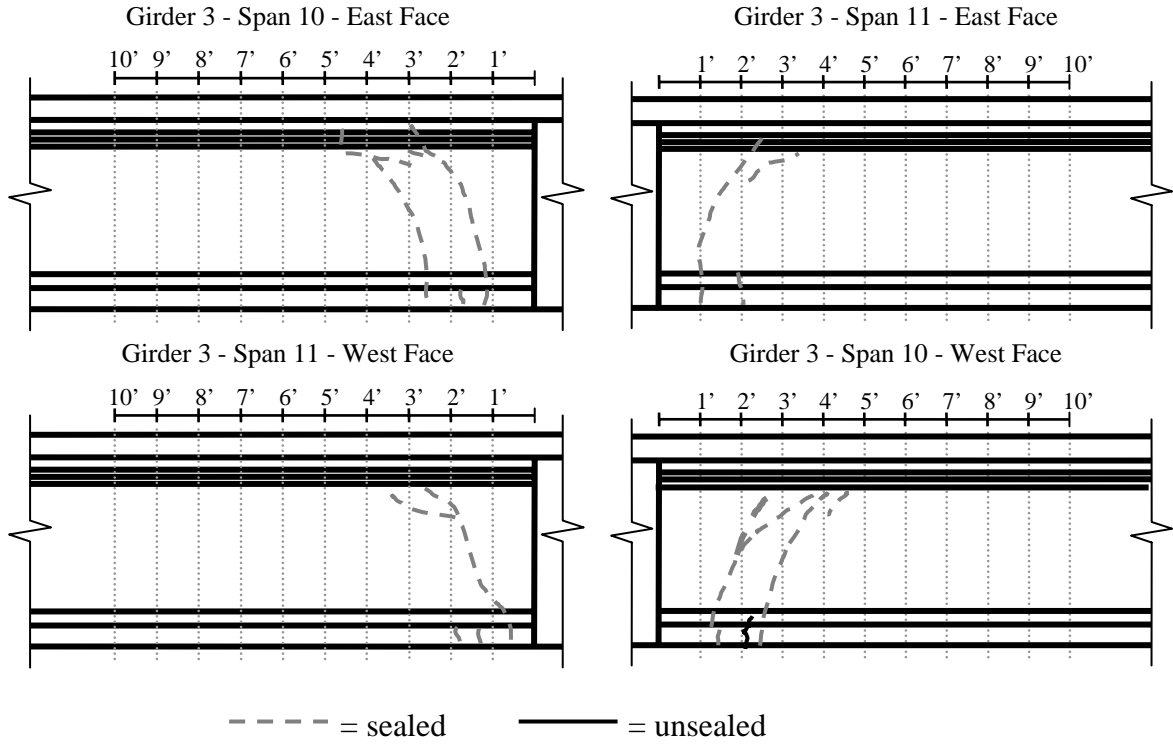
Figure 3.15 Girder Line 3 Cracking (Fason and Barnes 2004)

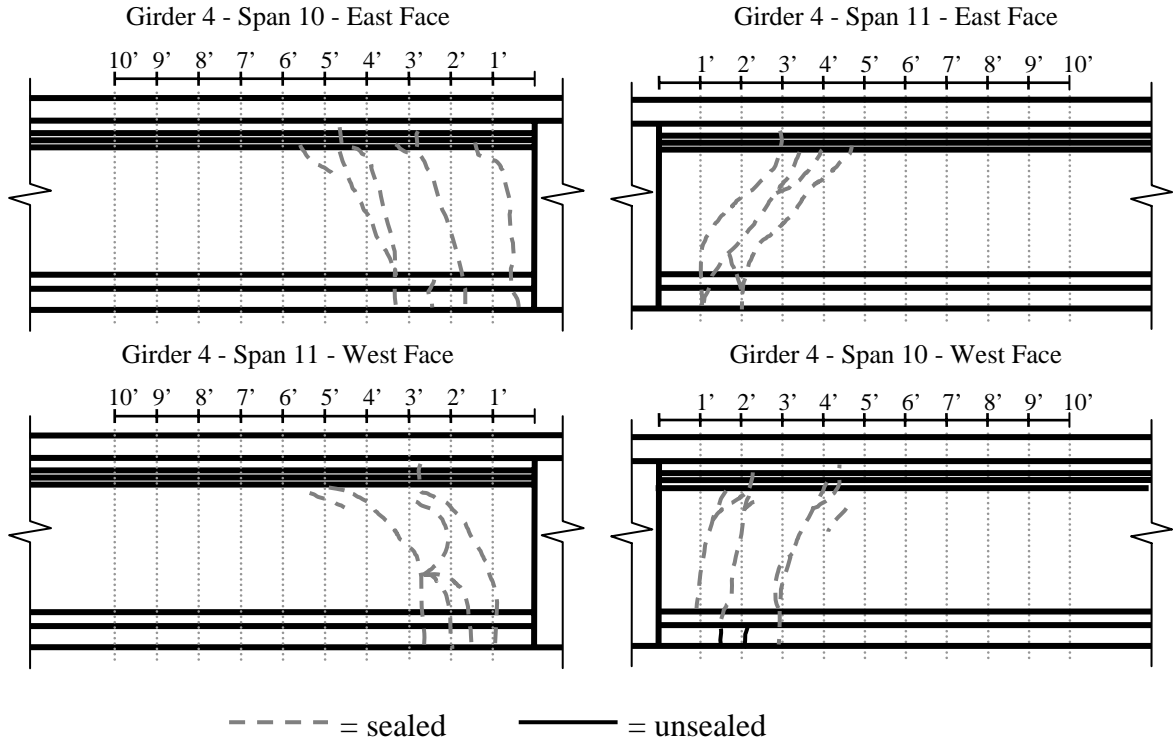
Figure 3.16 Girder Line 4 Cracking (Fason and Barnes 2004)

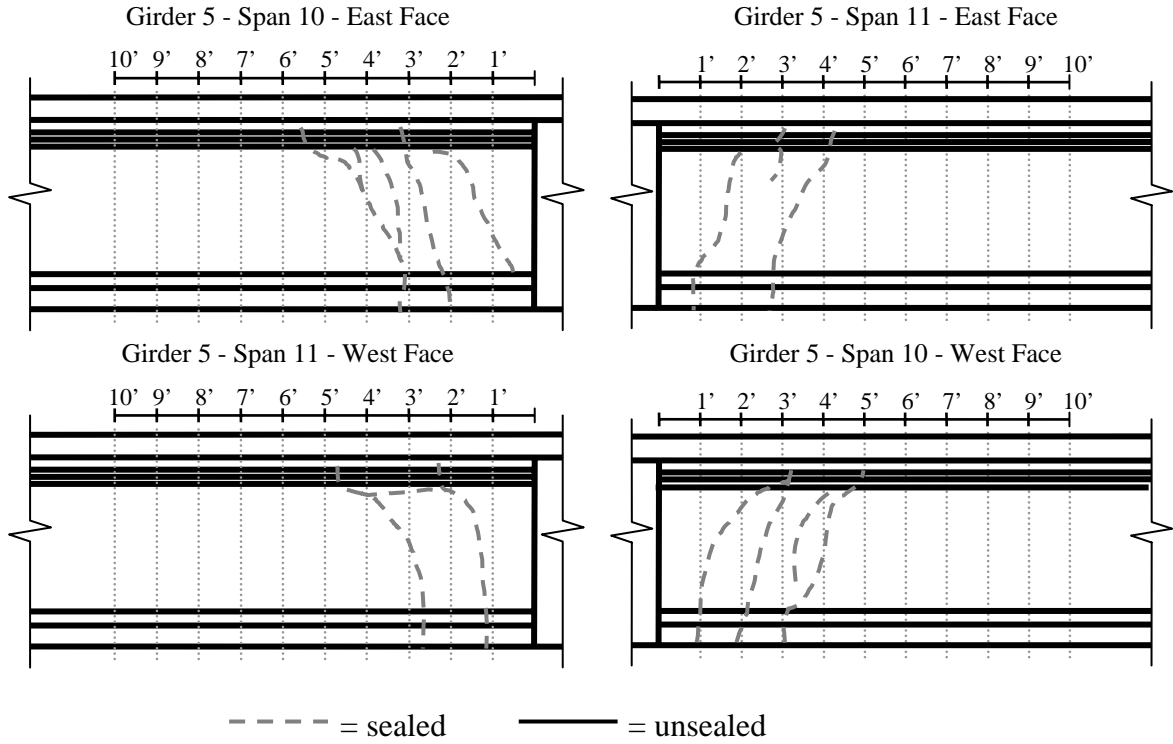
Figure 3.17 Girder Line 5 Cracking (Fason and Barnes 2004)

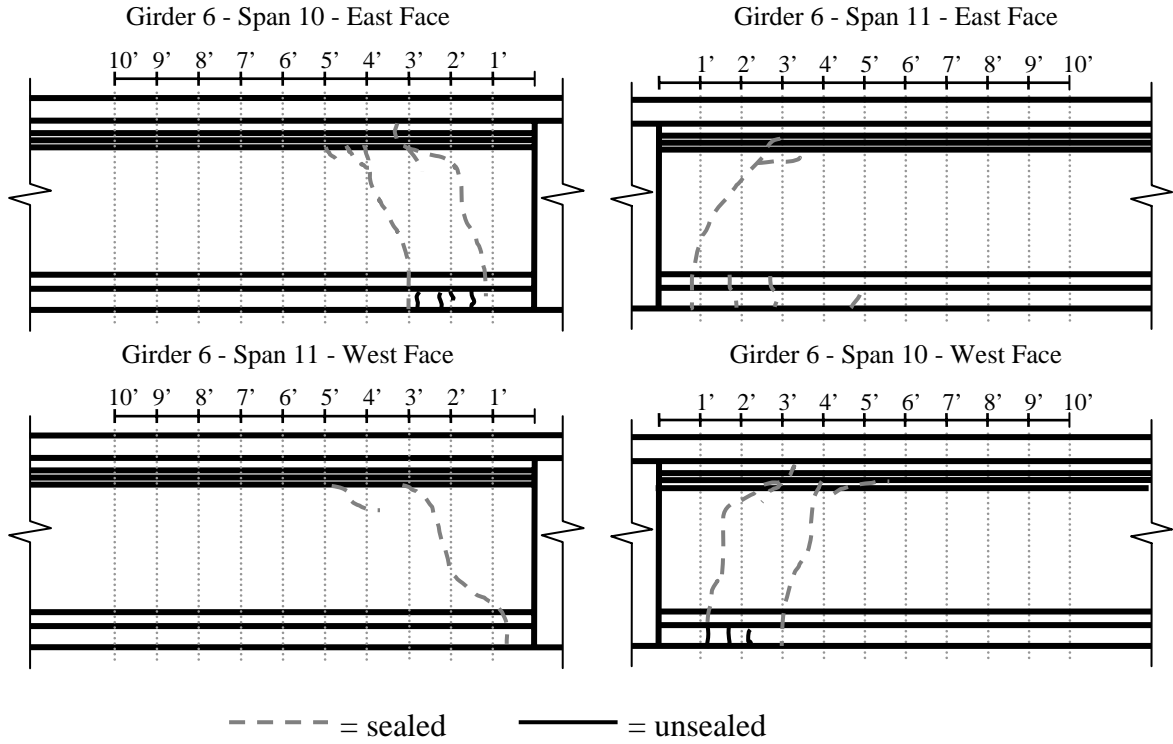
Figure 3.18 Girder Line 6 Cracking (Fason and Barnes 2004)

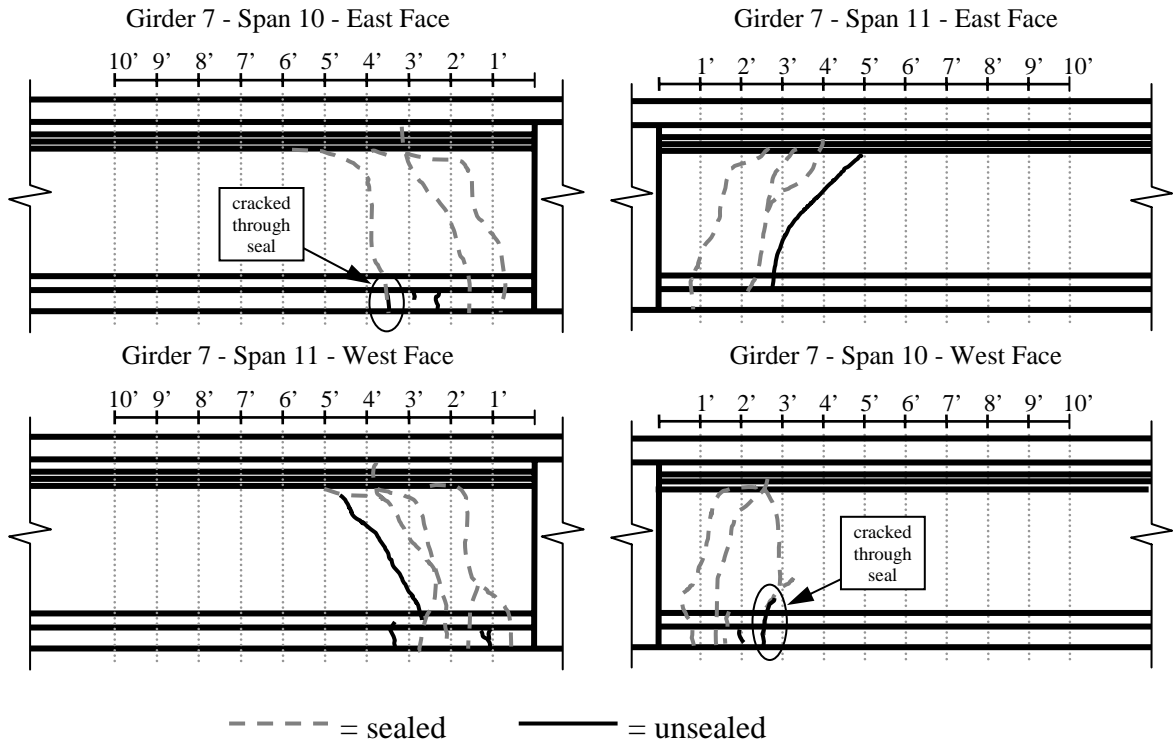
Figure 3.19 Girder Line 7 Cracking (Fason and Barnes 2004)

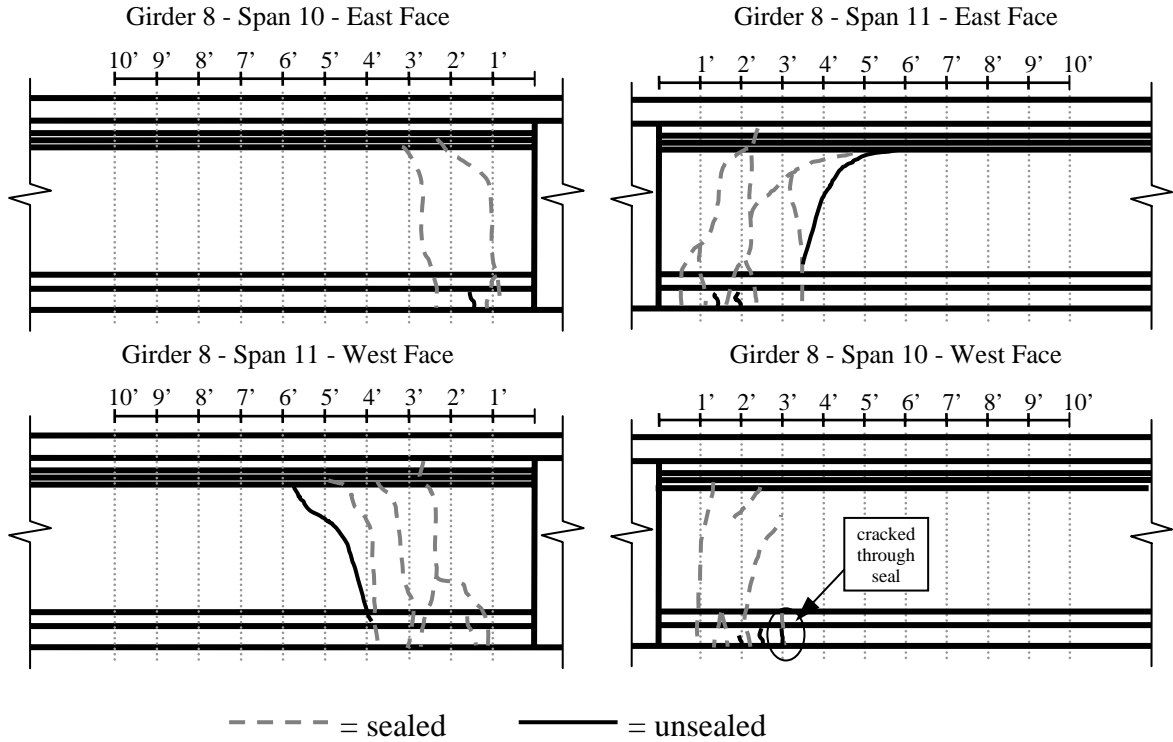
Figure 3.20 Girder Line 8 Cracking (Fason and Barnes 2004)

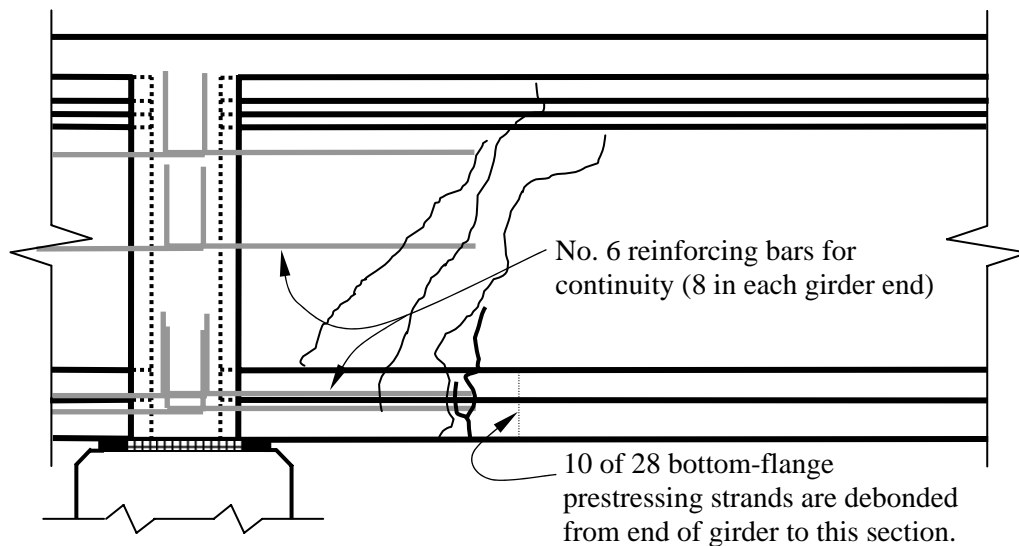
The question which then remains is: why did the cracking occur within the girder itself rather than at the joint between the girder and the diaphragm where the largest tensile stresses occur? The answer is a twofold contribution from the reinforcement details, which are shown in Figure 3.22. First is that of the reinforcing bars used to establish continuity. There is both a relatively weak plane at the end of the continuity bars and a stress concentration at such a discrete transition point. The second contribution is from the debonding of the prestressing strands which occurs shortly past the end of the reinforcing bars for continuity. The increased tension found just behind these debonding points combined with the increased stress resulting from the reinforcement bars for continuity to produce cracked girders rather than separation of the girder from the diaphragm. Careful attention to reinforcing details can prevent such cracking from occurring (Barnes et al. 2006).

Figure 3.22 Cracked Girder with Continuity Reinforcement Details (Barnes et al. 2006)

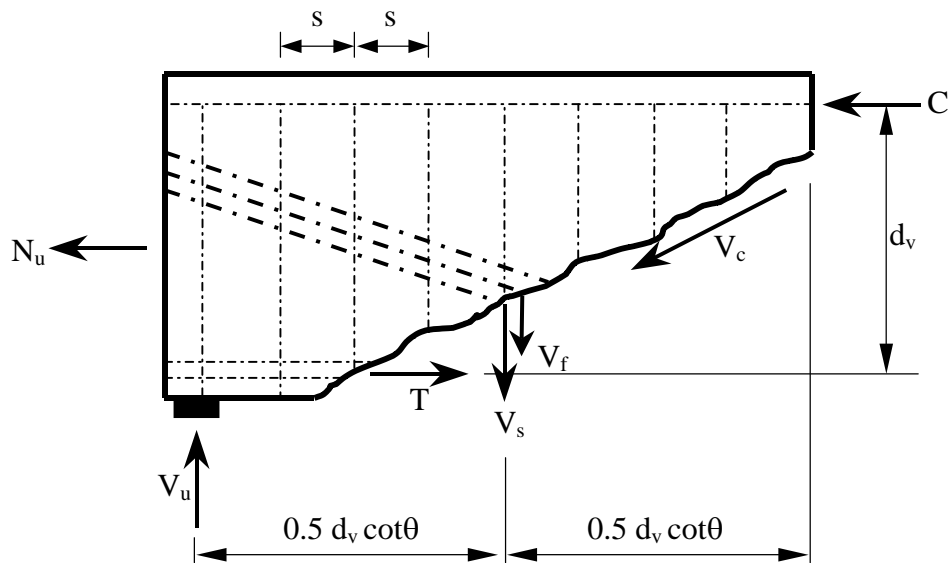
Referring to Figure 3.23, the loss of shear resistance is less straightforward. Though the lack of effective prestress force in the end regions results in a decrease of the concrete contribution to web-shear cracking resistance, there is still sufficient transverse reinforcement in these regions to compensate. This is likely attributable to the conservative standard reinforcing details employed in the girder design. However, the bottom flange tensile reinforcement is inadequate to effectively resist the longitudinal component of the diagonal tension, T , resulting from shear-critical loading (Barnes et al. 2006).

Figure 3.23 Influence of Shear on Required Bottom-Flange Tensile Resistance (Barnes et al. 2006)

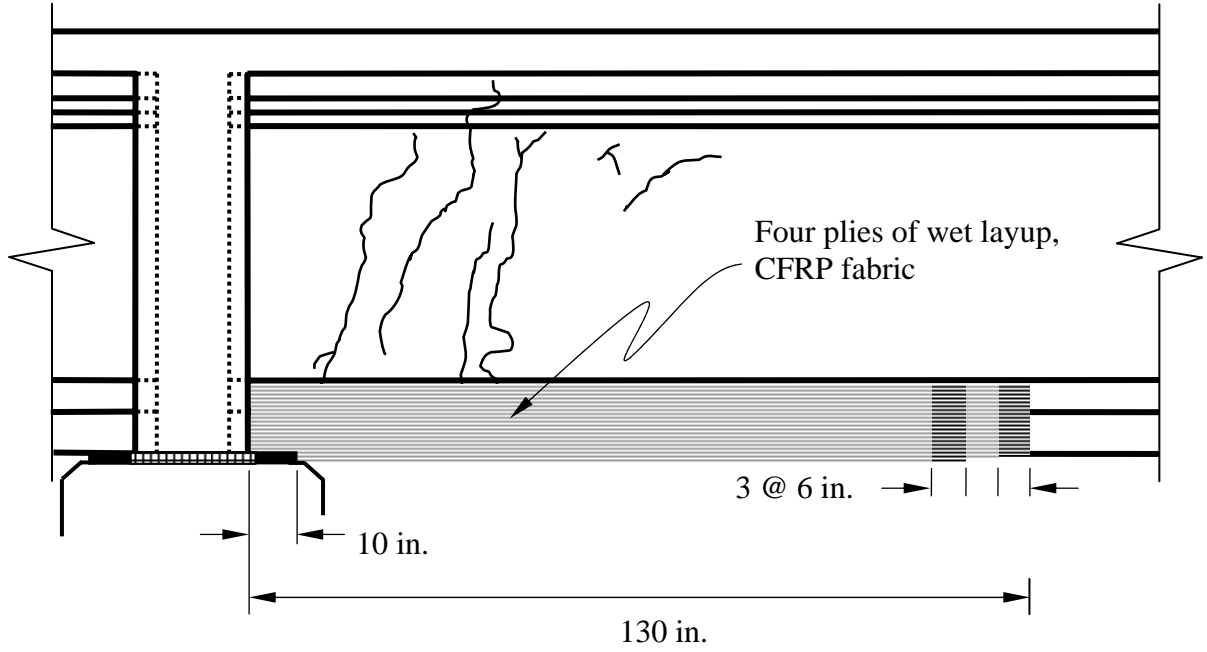
The FRP product chosen for the repair discussed in this investigation is the Tyfo SCH-41 composite manufactured by Fyfe Co. This product is a “wet lay-up system comprised of Tyfo SCH-41 reinforcing fabric and Tyfo S epoxy” (Swenson 2003). The reinforcing fabric is comprised of unidirectional carbon fibers backed with a glass veil to increase and support fabric stability during installation. The epoxy is a “two-part adhesive used to both saturate the composite fabric and bond the fabric to the concrete.” Installation of the FRP repair system is expected in early 2007. Load testing to assess the behavior of the repaired spans will follow the FRP installation (Barnes et al. 2006).

Figure 3.24 Longitudinal Configuration Profile for FRP (Barnes et al. 2006)

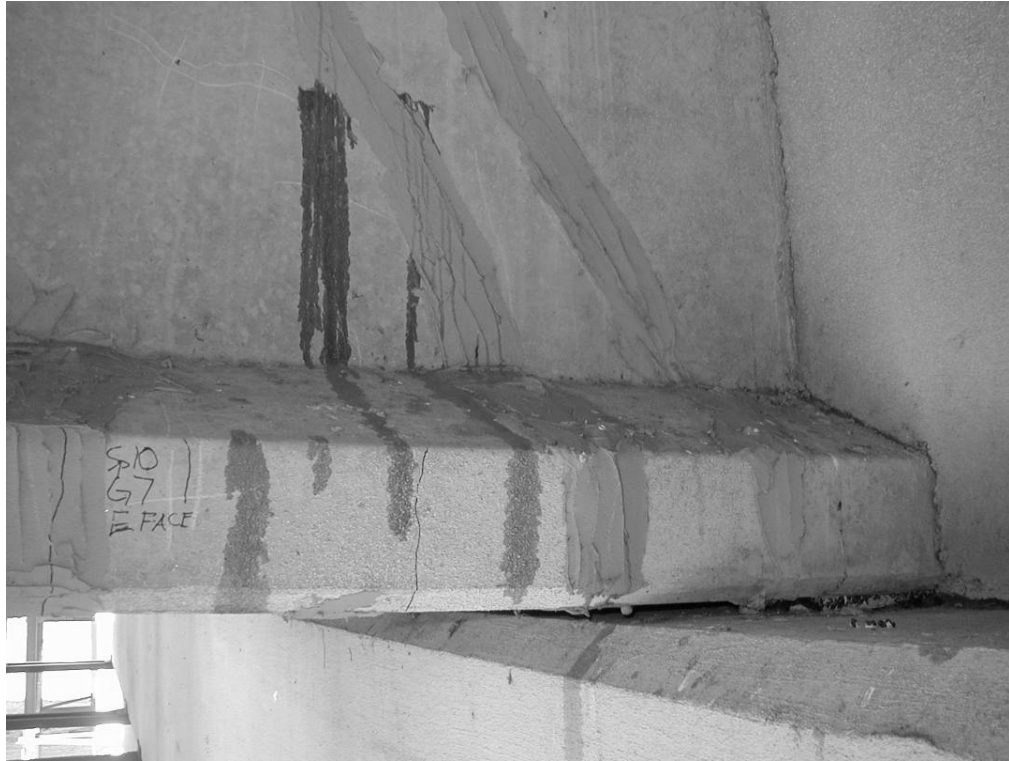
Figure 4.12 Girder 7 Span 10 East Face

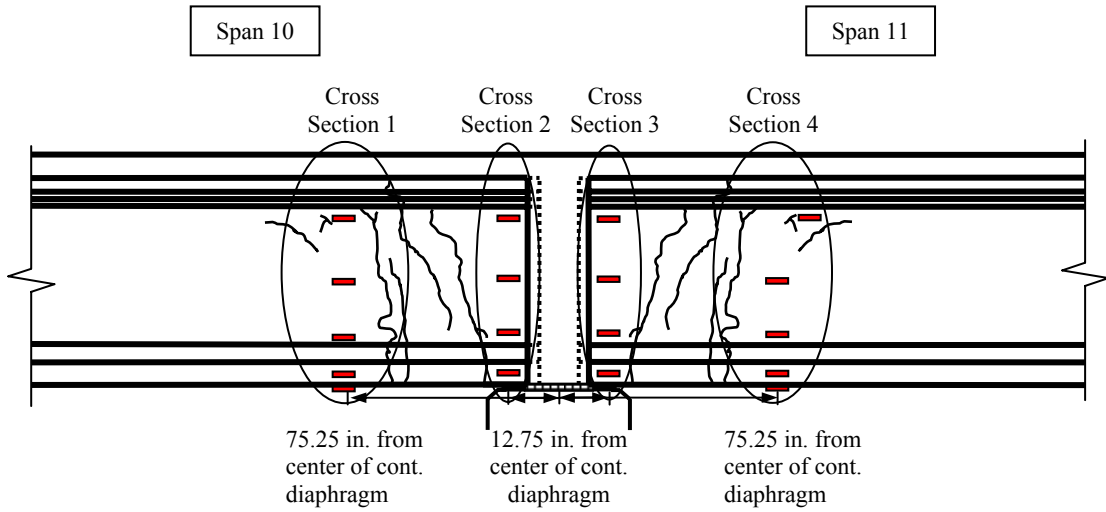
In order to get more comprehensive data in the cracked region, Cross Sections 1–4 each had six strain gauges as depicted in Figures 4.21 and 4.22. Cross Sections 5–8 only had gauges located on the bottom of the girder. The primary purpose of the gauges along the bottom of the girder was to better determine the overall behavior of the girders, particularly the manner in which the damaged regions affected the distribution of bending moments within the structure.

Figure 4.20 Approximate Locations for Cross Sections 1 through 4

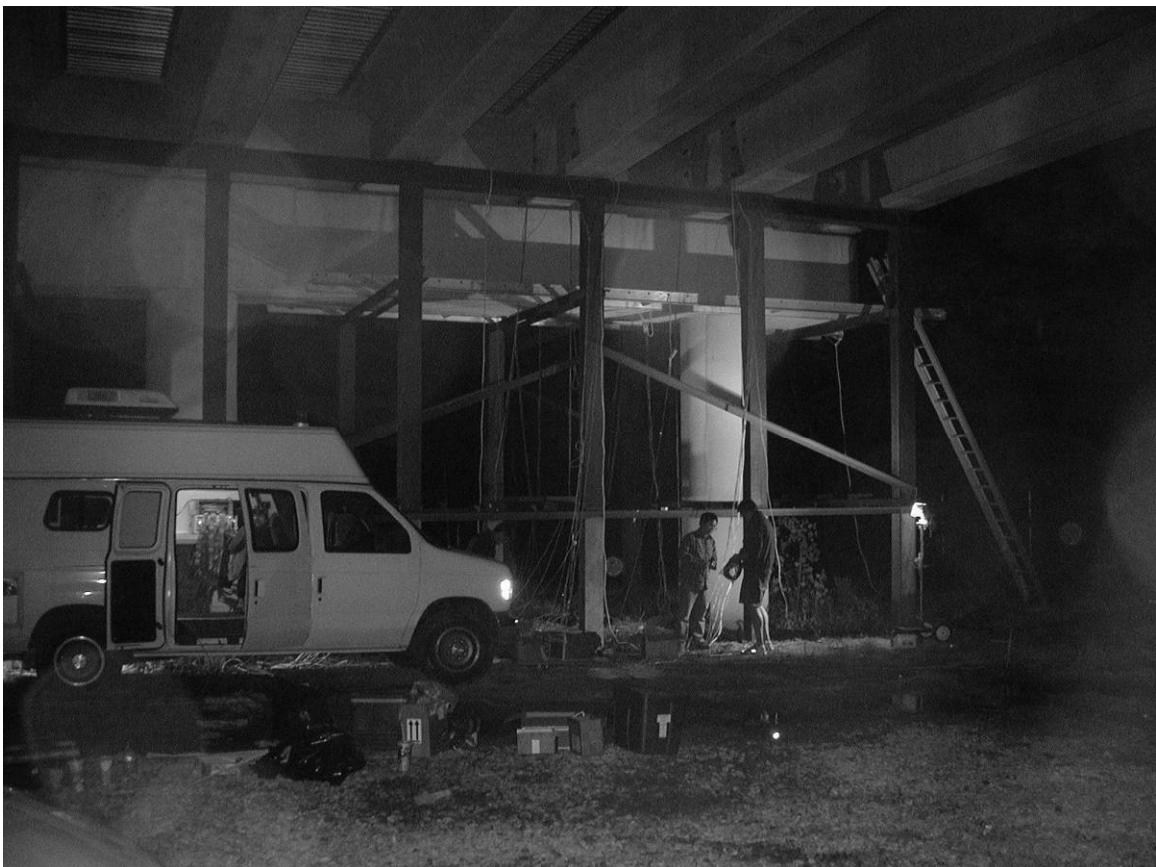
Figure 4.25 Van Setup during Testing

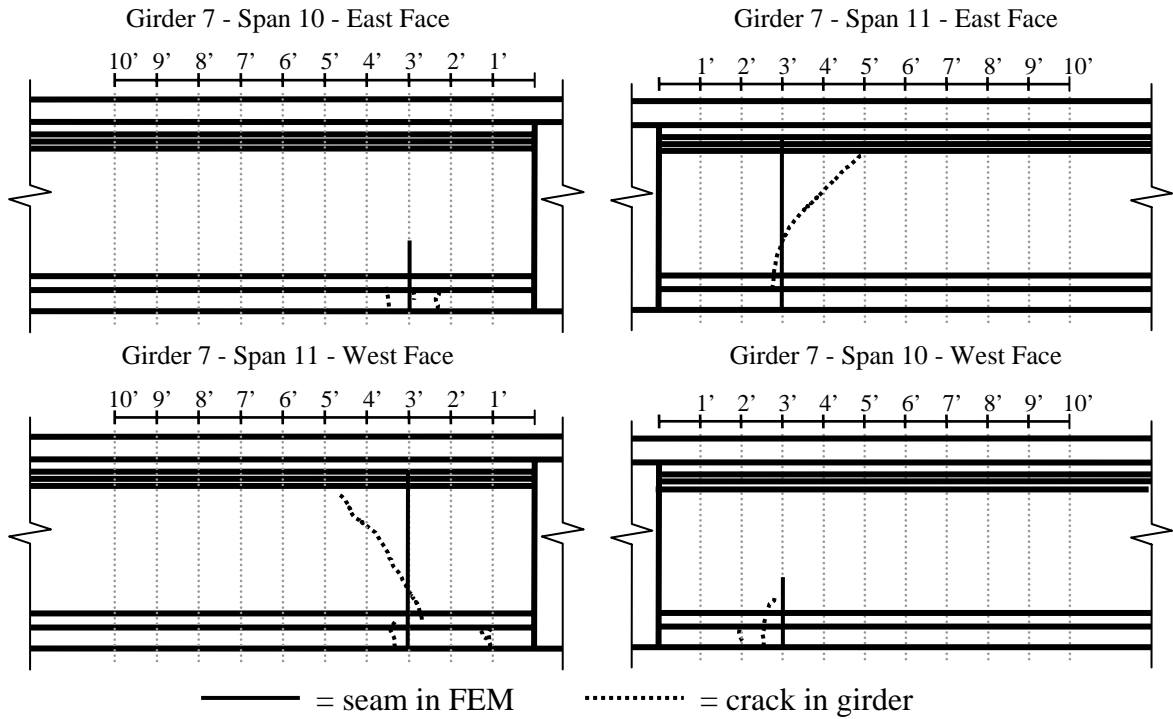
Each girder has a maximum of four Seams. One Seam could be located along the face of the continuity diaphragm to represent the cracking of the continuity diaphragm. This Seam could be located on either one or both spans. In addition to that, there could be one Seam located between 18 to 48 inches from the face of the continuity diaphragm on one or both spans to represent the cracking in the girder. Because each cracked girder end contains only one major crack, only one Seam was inserted at a location that was central to the location of the cracks present on each face of the girder.

Figure 5.17 Girder Line 7 Cracks with Seams Superimposed (Fason and Barnes 2004)

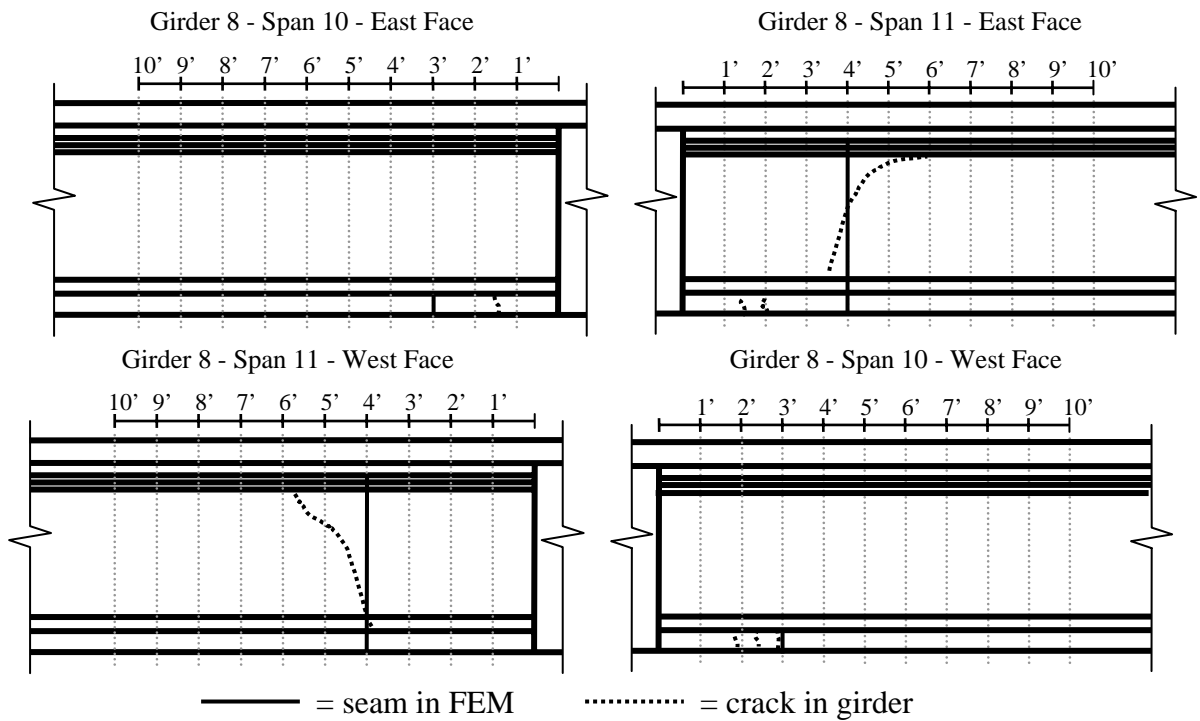
Figure 5.18 Girder Line 8 Cracks with Seams Superimposed (Fason and Barnes 2004)

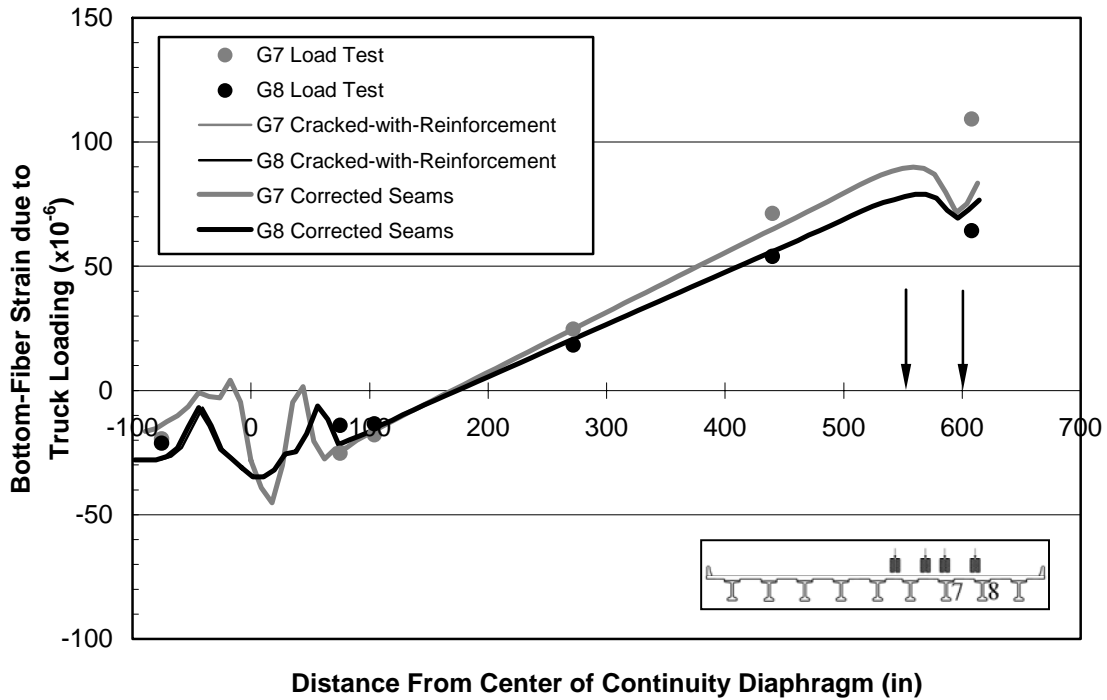
The final *Pre-Repair* model differs from the *Cracked-with-Reinforcement* model in only one way. After beginning to model the FRP repair on the *Cracked-with-Reinforcement* model, an error in modeling the Seams explained in Section 5.10 and identified in Table 5.2 was discovered. While the Seams away from the face of the diaphragm were all defined correctly, the Seams which were supposed to be present in some of the girders at the face of the continuity diaphragm had not been defined. It was judged that because the inclusion of the Seams would not affect the global behavior of the bridge—which is demonstrated through the bottom-fiber strain results depicted in Figure 5.21, where the results of the two models overlap one another—the decision to use the *Cracked-with-Reinforcement* model, as opposed to the *Uncracked* or *Cracked* models, would not be affected. As a result, the Seams were corrected in only two models—the *Pre-Repair* model and the *Post-Repair* model. The *Pre-Repair* model was then used to compare the current analytical behavior of the bridge with the expected behavior predicted by the *Post-Repair* model.

Figure 5.21 Comparison Between Models with and without Correctly Defined Seams

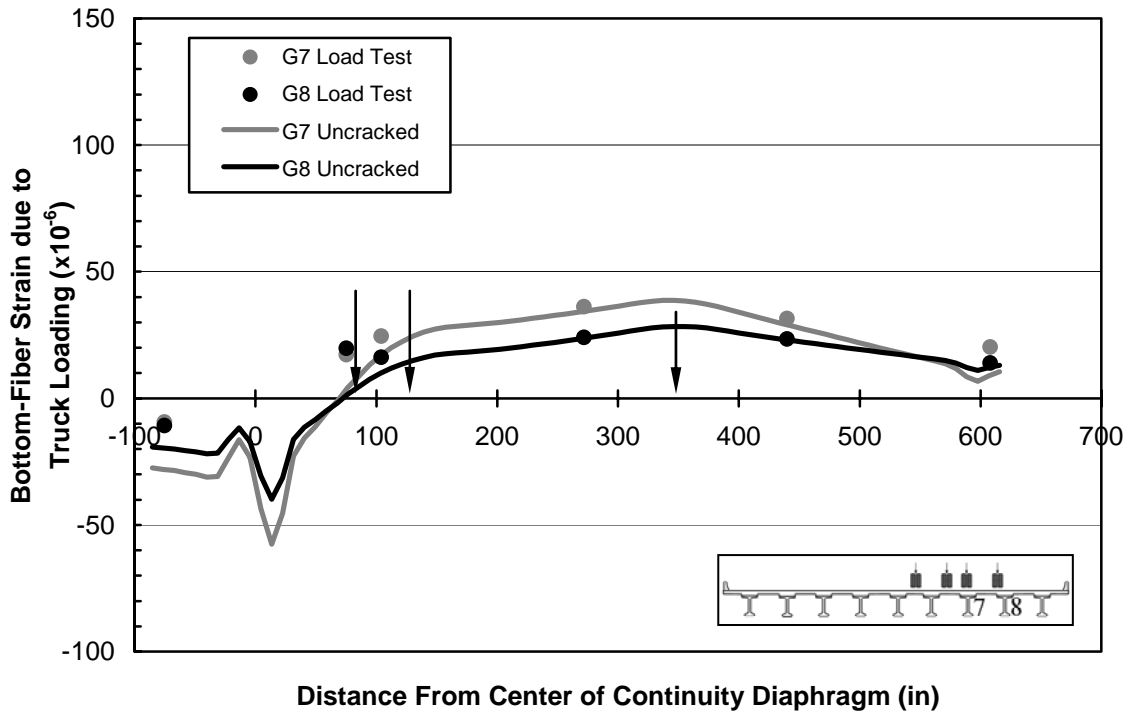
The *Uncracked*-model results generally exhibit more compression (or less tension) strain at the girder bottom fiber than was measured in the load tests. This is particularly evident at the cross sections near the cracked regions. The discrepancy is pronounced for the load positions near midspan (A9 and C9). This indicates that the girder bending moments in the actual structure are less negative than in the *Uncracked* model. Thus, this model overestimates the continuity of the cracked-girder system.

Figure 6.1 Bottom-Fiber Strain Data for the Uncracked Bridge Model—A7 Load Position

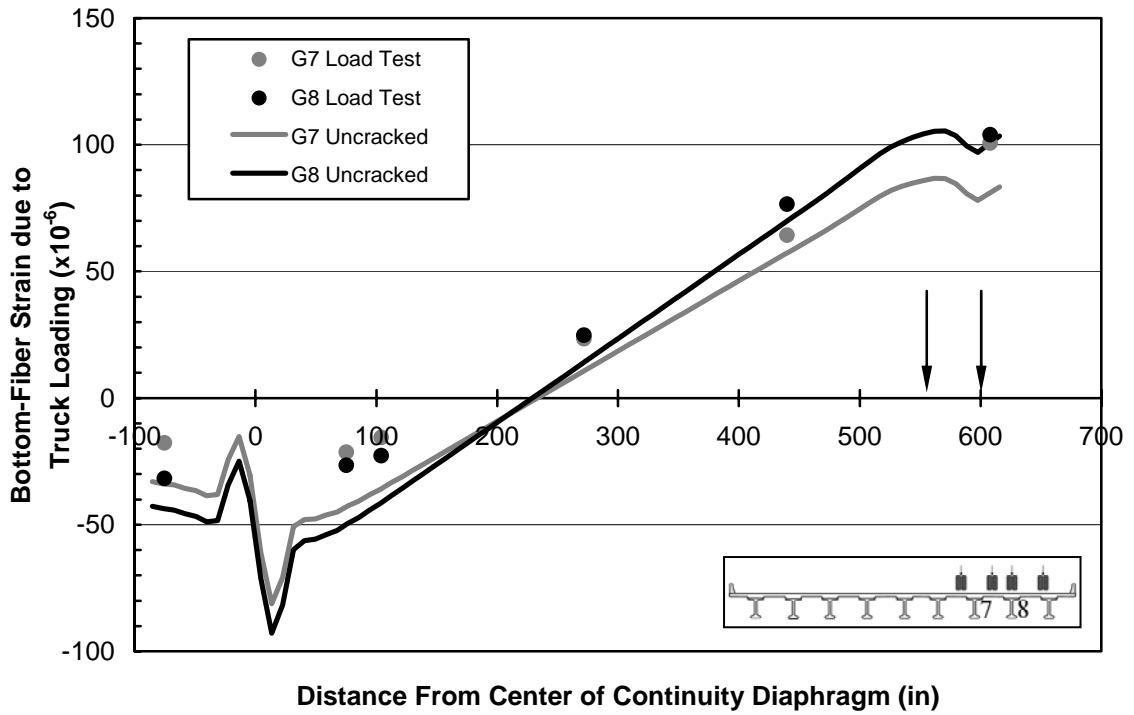
Figure 6.4 Bottom-Fiber Strain Data for the Uncracked Bridge Model—C9 Load Position
