FINITE-ELEMENT MODELING OF A DAMAGED PRESTRESSED
CONCRETE BRIDGE

A Thesis

Auburn University

Auburn, Alabama
May 10, 2007

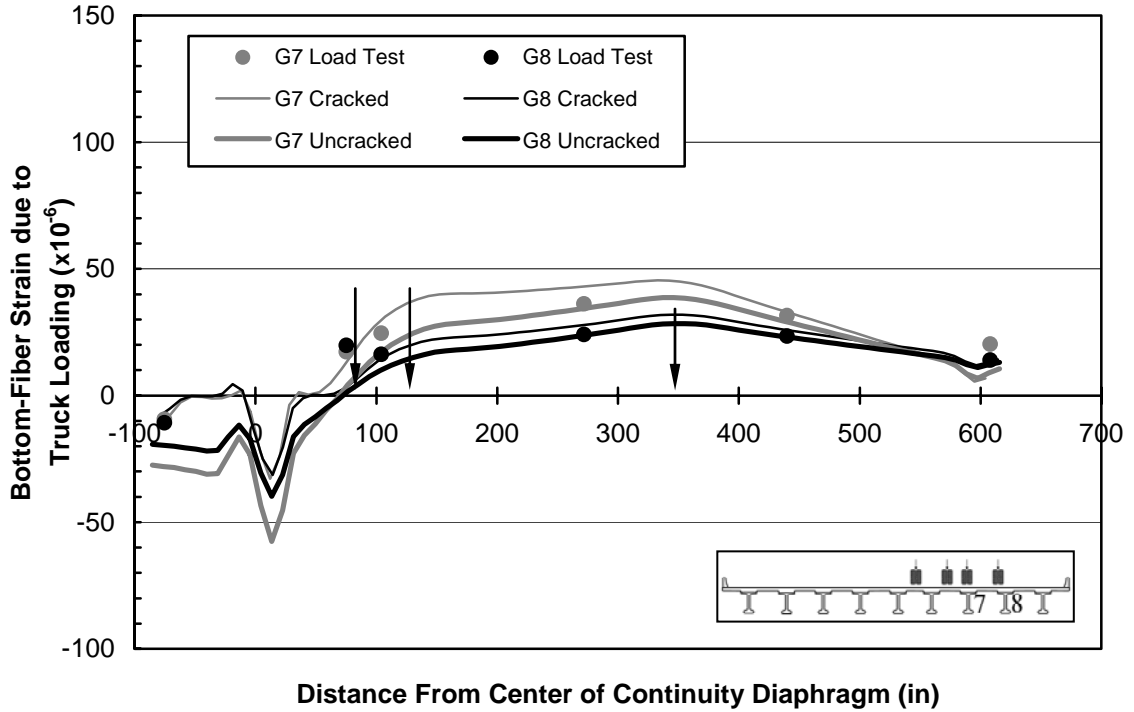
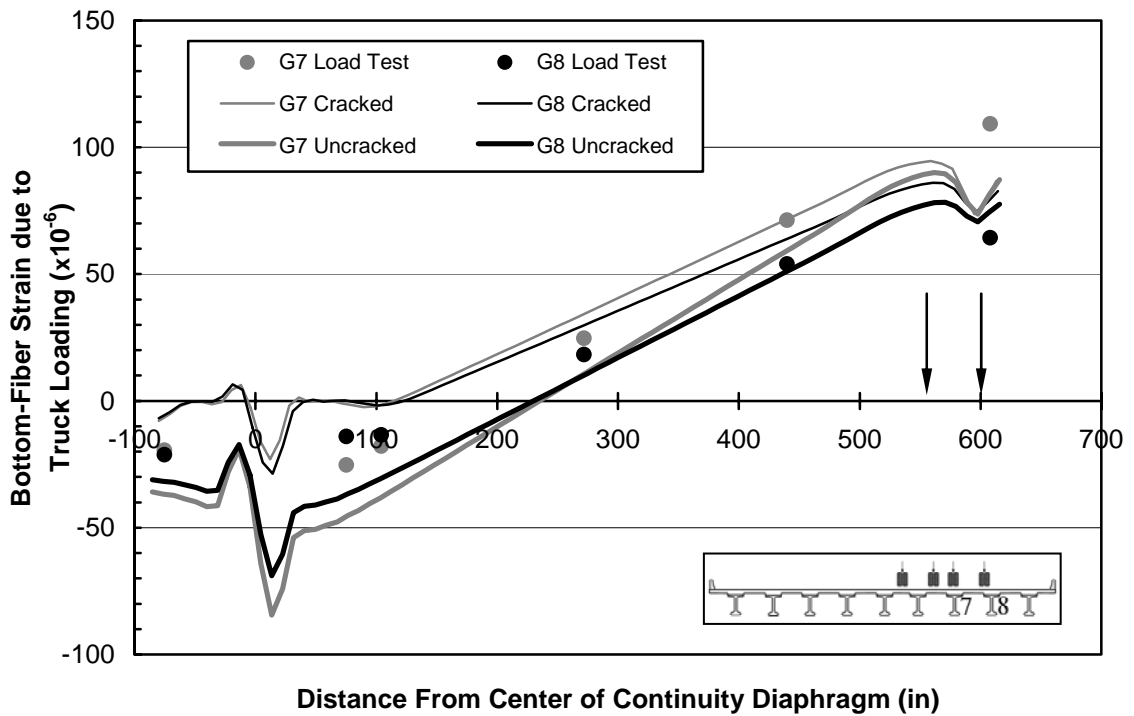
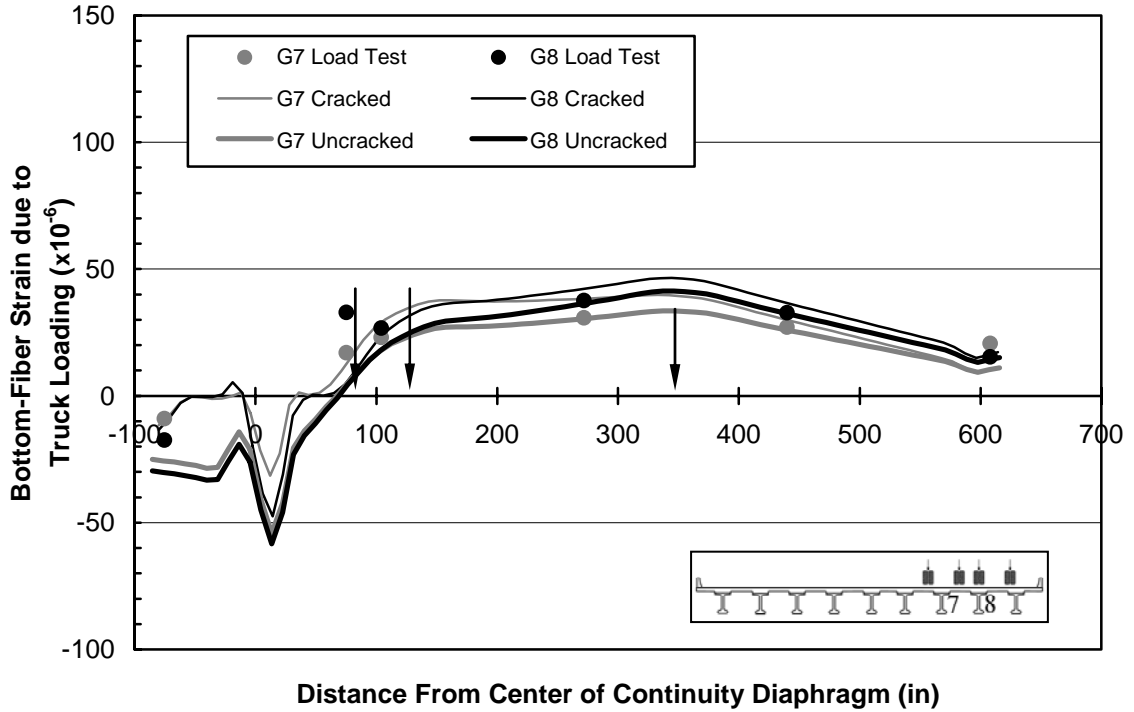
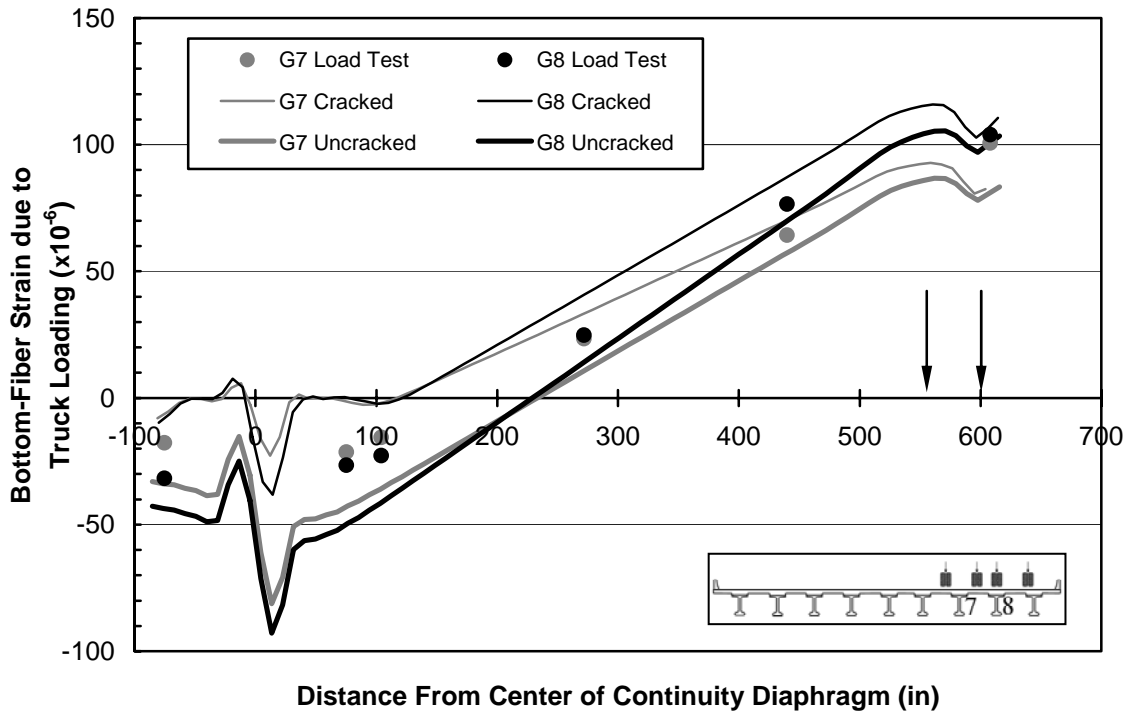
The seams were created as explained in Section 5.9, and the seam locations are detailed in Table 5.2. The effect of a seam is to create independent nodes along the two faces of the seam; this allows each side of the seam to move independently of the other side, somewhat like a tear in a piece of paper. This model represents the worst-case scenario—the bridge behavior if the steel that crosses these cracks does not contribute to the superstructure’s resistance to applied loads. This would be the case if all of the steel crossing each crack had fractured, or if the bond between the prestressing reinforcement and concrete had deteriorated to the extent that no stresses can be transferred from the concrete to the steel.

Figure 6.5 Bottom-Fiber Strain Data for the Cracked Bridge Model—A7 Load Position

Figure 6.6 Bottom-Fiber Strain Data for the Cracked Bridge Model—A9 Load Position

Figure 6.7 Bottom-Fiber Strain Data for the Cracked Bridge Model—C7 Load Position

Figure 6.8 Bottom-Fiber Strain Data for the Cracked Bridge Model—C9 Load Position

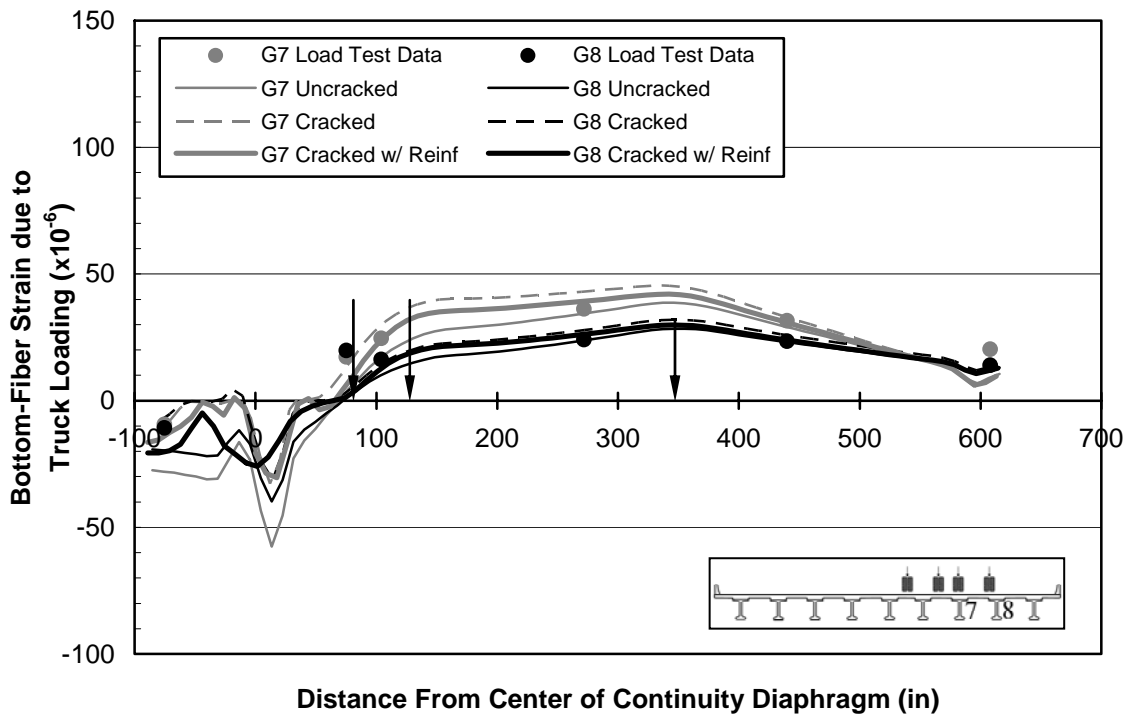
After comparative evaluation of both the strain and deflection results, it was determined that—of the three—the *Cracked-with-Reinforcement* model best represents the bridge behavior.

Figure 6.9 Bottom-Fiber Strain Data for the Model Refinement—A7 Load Position

When looking at Figures 6.9 through 6.12, there is a noticeable discrepancy between the experimental value of Girder 7 strain at midspan and the corresponding FEM results. Although the *Cracked-with-Reinforcement* model best represents the strain results at the other strain gauge locations, the discrepancy at this location is large regardless of which FEM is employed. In order to investigate whether this discrepancy is related to overestimating the influence of the midspan diaphragms, a comparison FEM without midspan diaphragms was created. Apart from the omission of these diaphragms, this model was identical to the *Cracked-with-Reinforcement* model. Comparisons between the results of these two models, along with the corresponding load test results, are depicted in Figures 6.17 through 6.20, with the divergent point labeled as ‘A’.

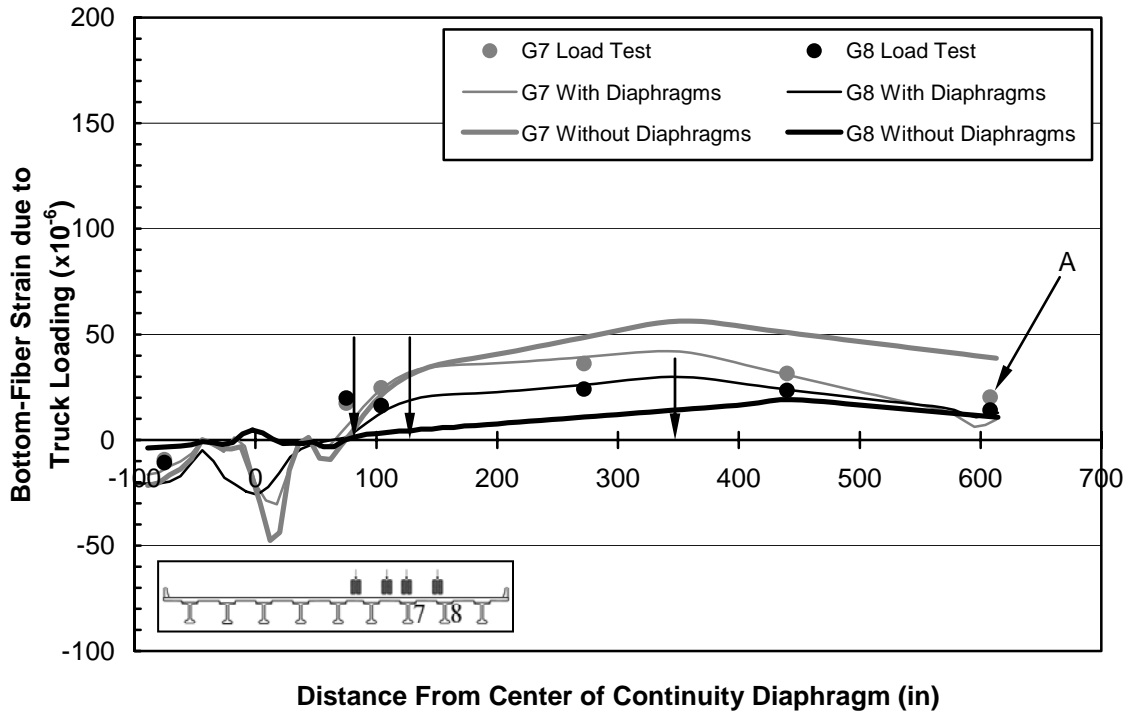
Figure 6.17 Comparing the Models with and without Diaphragms—A7 Load Position

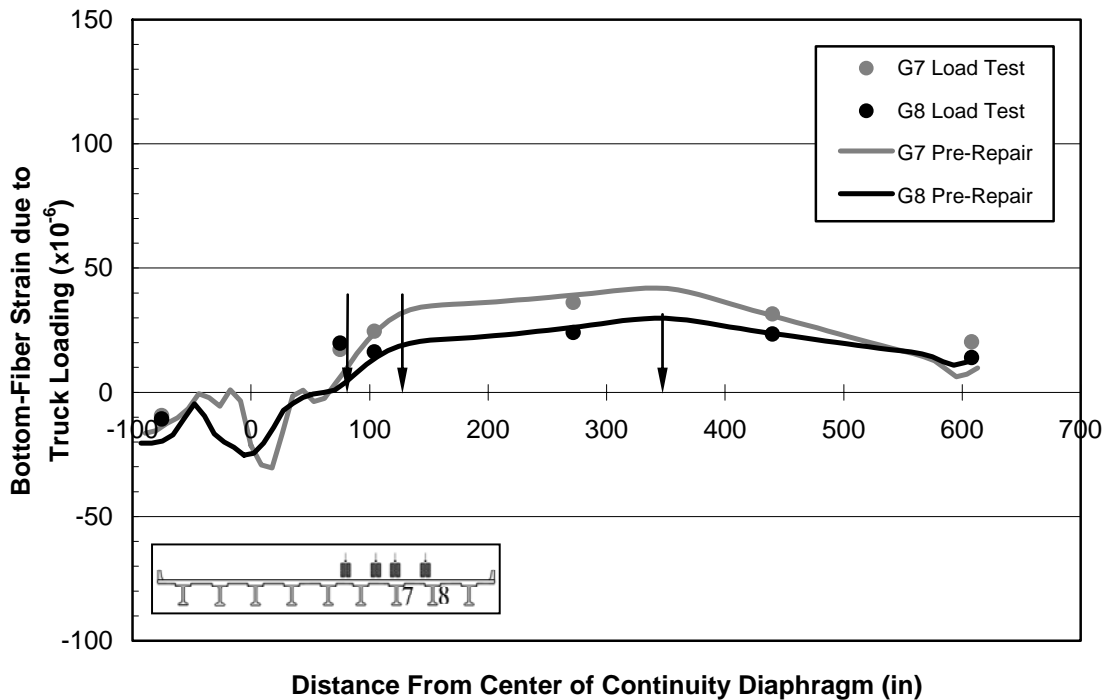
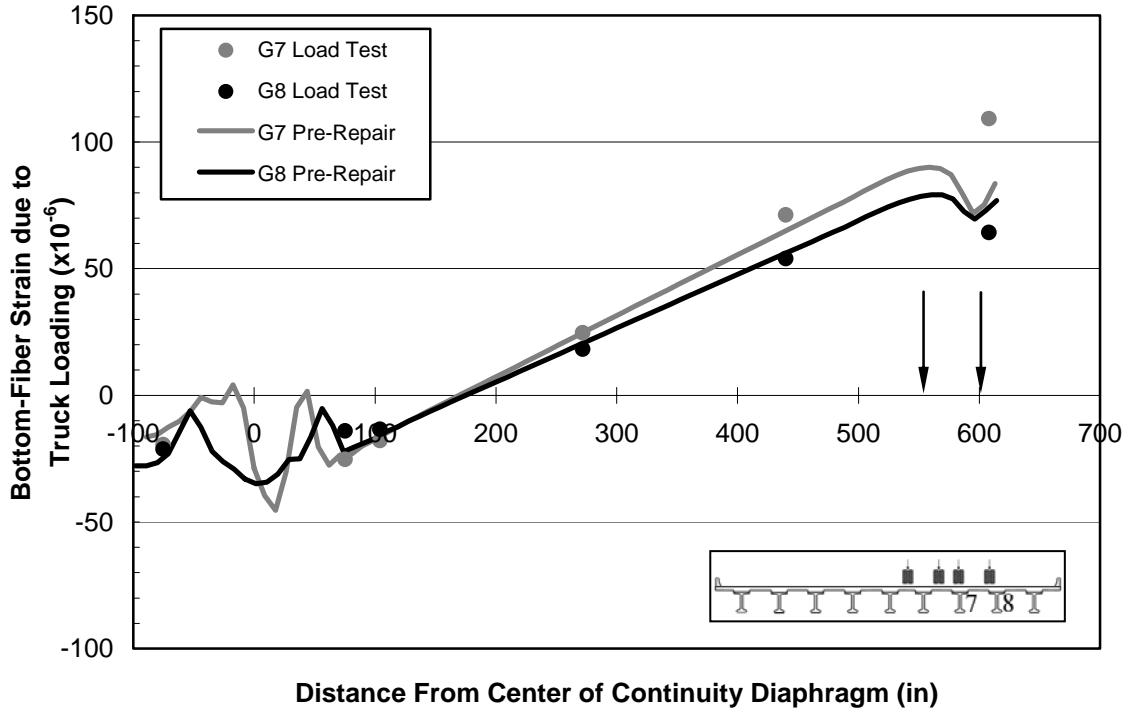
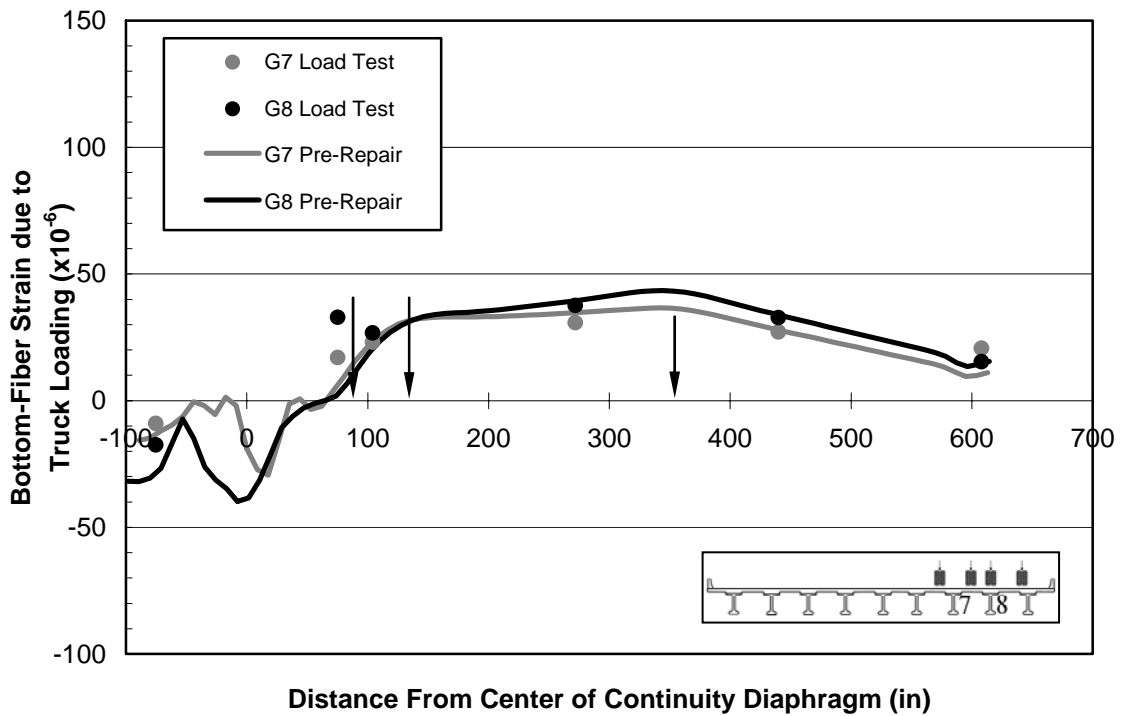
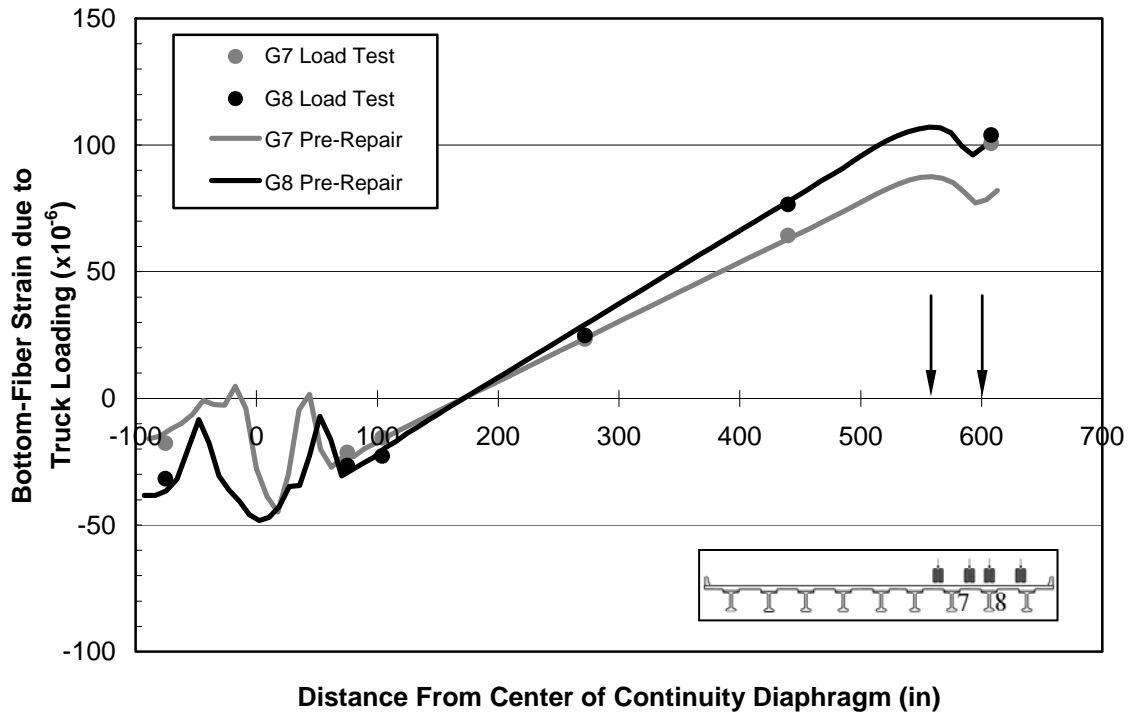
Originally, the *Cracked-with-Reinforcement* model was selected as the final pre-FRP repair model. Section 5.14.4 details the changes that were made to it to produce the *Pre-Repair* model—seams along the face of the continuity diaphragm, which were not included in the *Cracked-with-Reinforcement* model, were added to create the final *Pre-Repair* model. Figures 6.21 through 6.24 show the analytical results of this model compared to the experimental results. The next step was to model the effects of the fiber-reinforced polymer repair on the damaged structure.

Figure 6.21 Bottom-Fiber Strain Data for the Pre-Repair Model—A7 Load Position

Figure 6.22 Bottom-Fiber Strain Data for the Pre-Repair Model—A9 Load Position

Figure 6.23 Bottom-Fiber Strain Data for the Pre-Repair Model—C7 Load Position

Figure 6.24 Bottom-Fiber Strain Data for the Pre-Repair Model—C9 Load Position

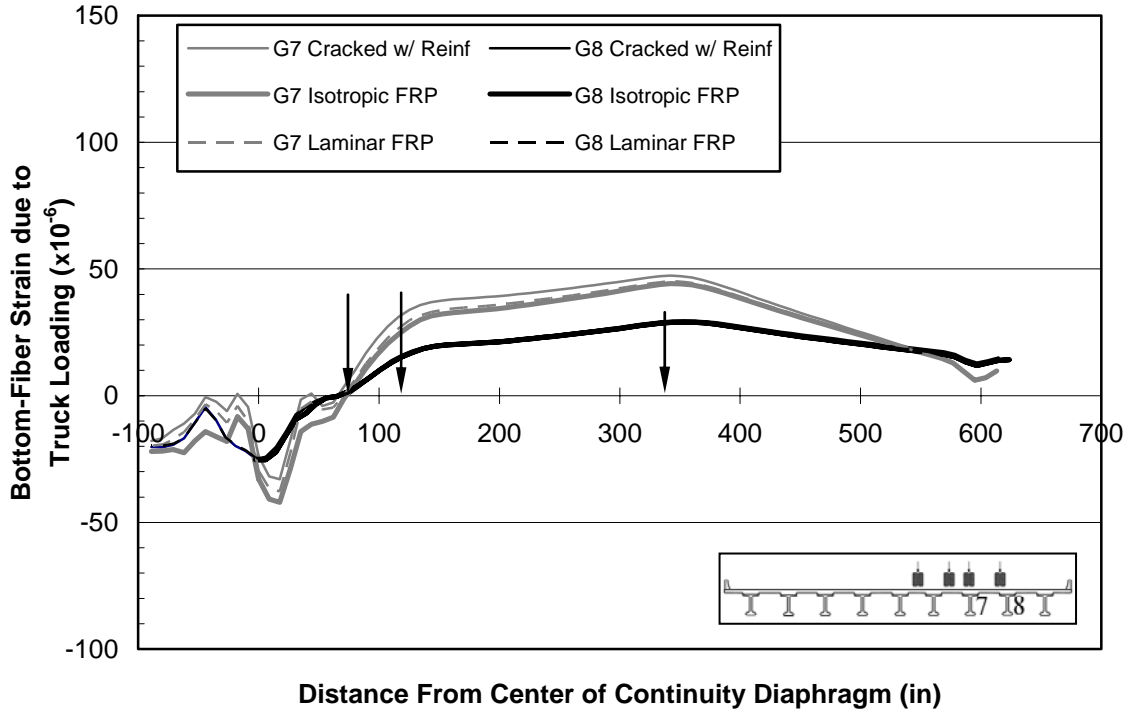
The FEMs for the *Post-Repair* model were created by adding the fiber-reinforced polymer repair—created as explained in Sections 5.16.2 and 5.16.3—to the *Pre-Repair* model. Figures 6.25 through 6.28 present a bottom-fiber longitudinal strain comparison between models with isotropic FRP and laminar FRP. Section 5.16 presents the details of these FRP modeling options.

**Figure 6.25 Bottom-Fiber Strain Data for the Isotropic v. Lamina FRP Models—
A7 Load Position**

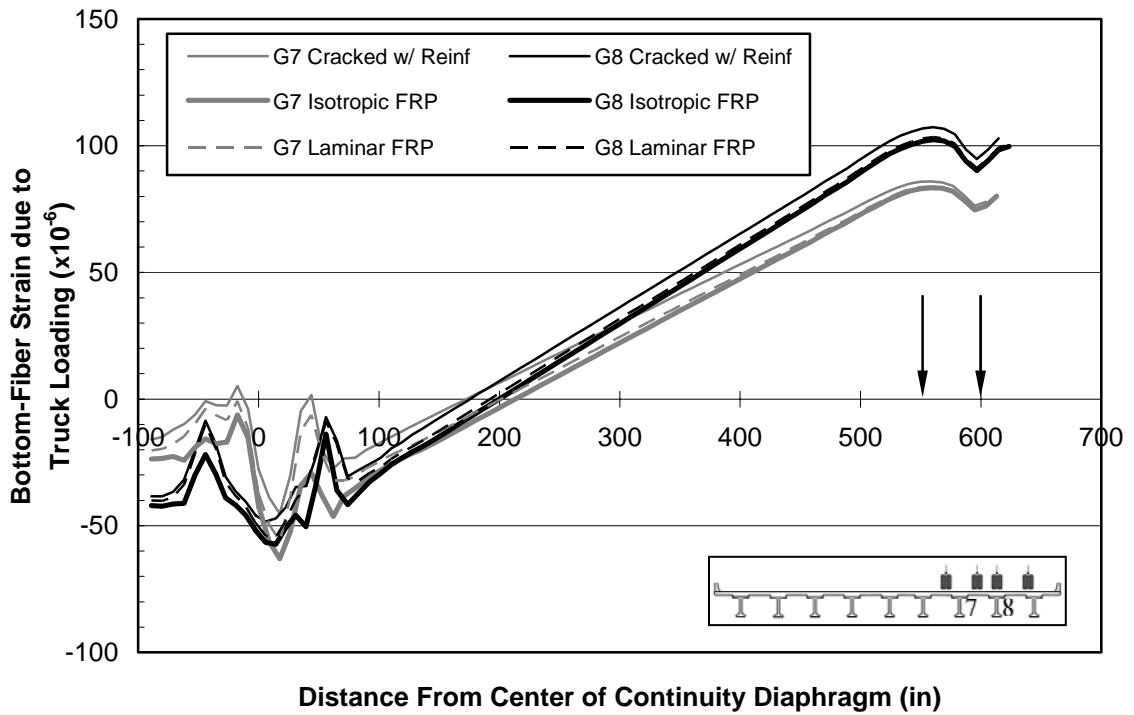
Figure 6.28 Bottom-Fiber Strain Data for the Isotropic v. Lamina FRP Models—C9 Load Position

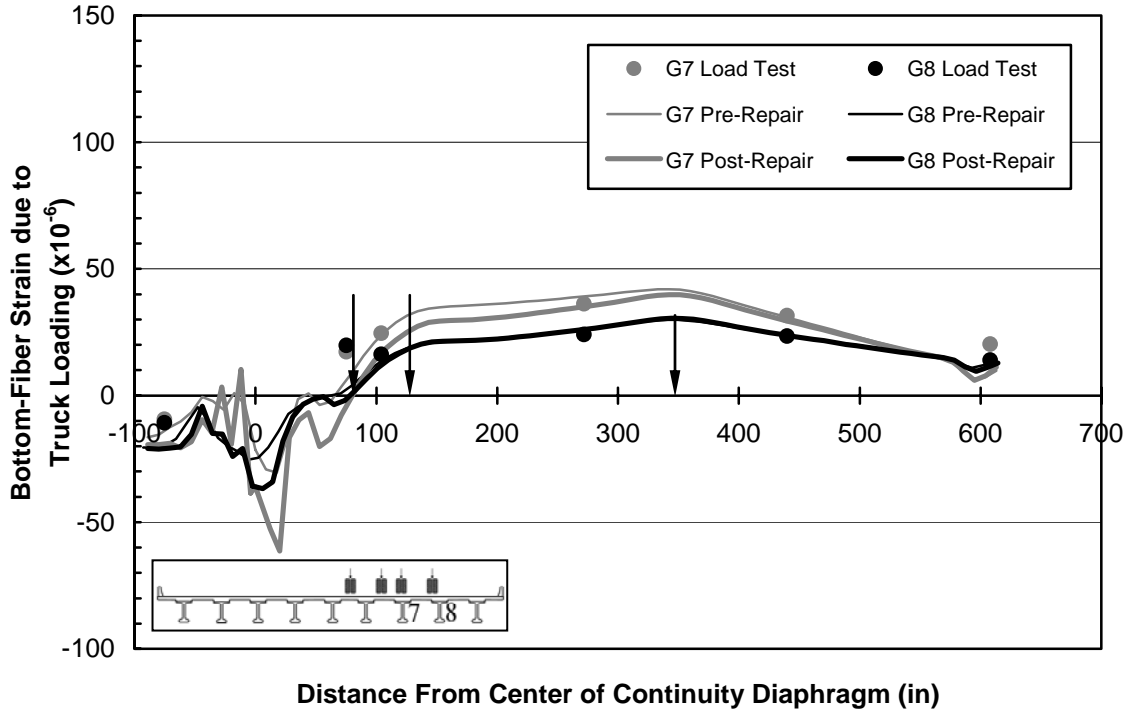
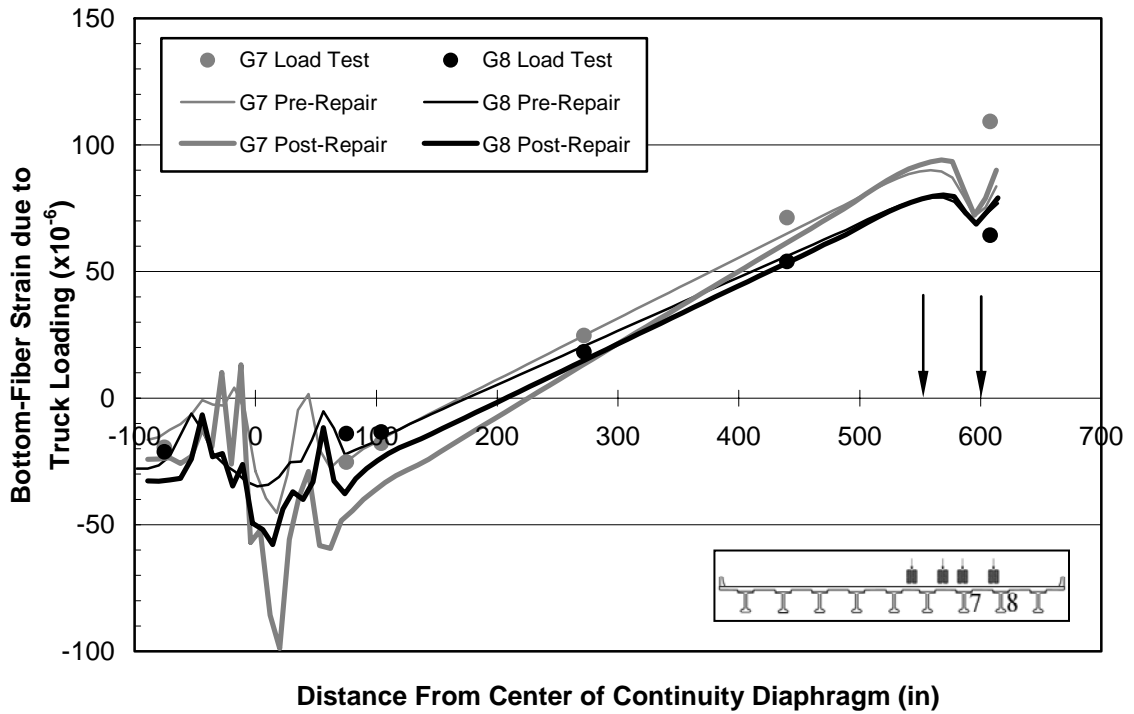
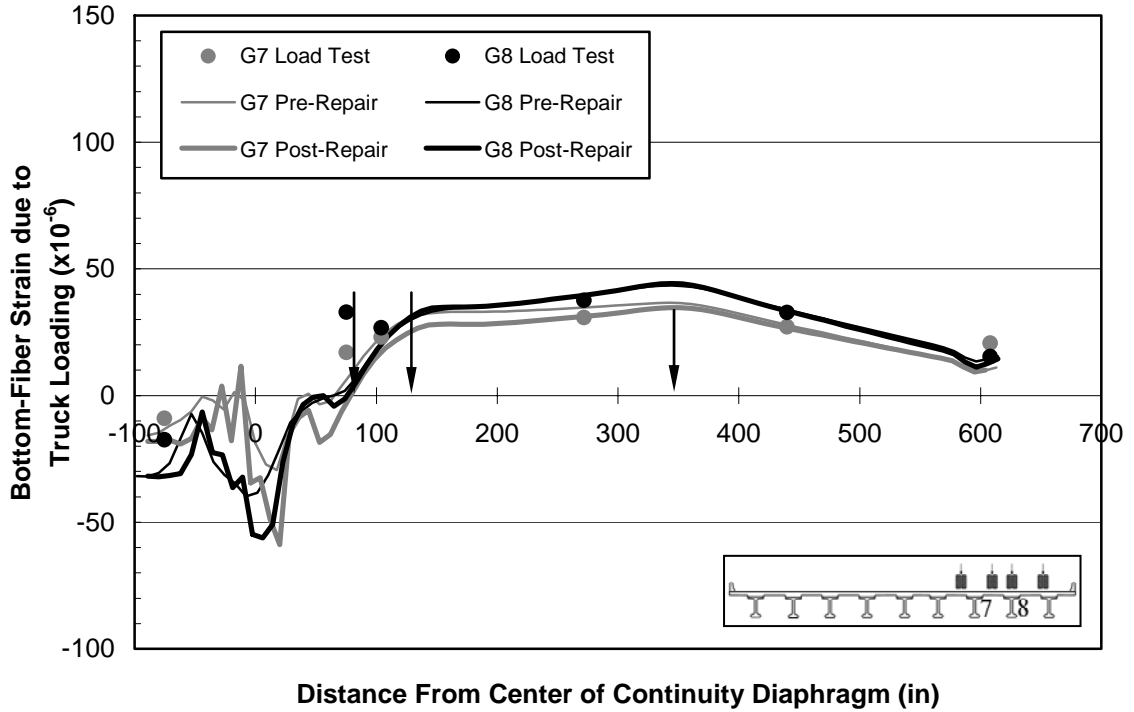
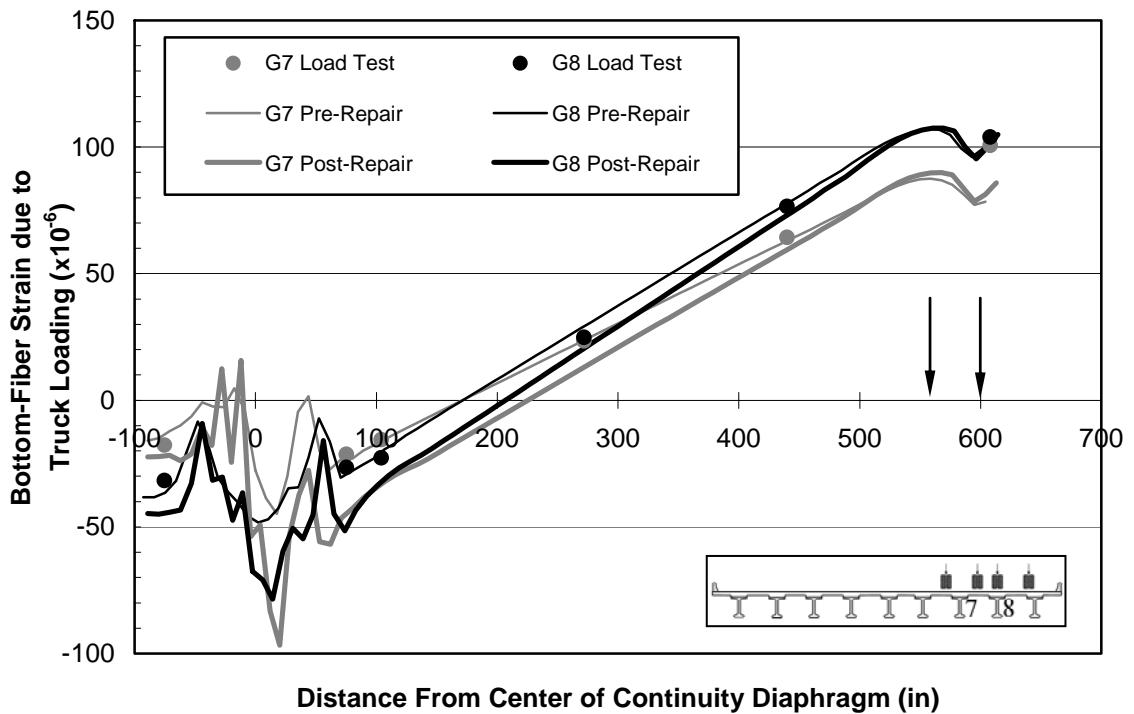
Not surprisingly, the FRP has the greatest effect on the resulting strains near the cracked region. For all four load positions, there is between 0 and 25×10^{-6} in./in. increase in compressive strain at the location of the Seams. It is interesting to note that for all four load positions, the repair acts to decrease the predicted deflection more at the midspan of the loaded girder—regardless of the longitudinal position of the load trucks—than at any other location. This effect is more evident at the A9 and C9 Load Positions than at the A7 and C7 Load Positions. The repair appears to be equally effective for both Girder 7 and Girder 8.

Figure 6.29 Bottom-Fiber Strain Data for the Pre- v. Post-Repair Models—A7 Load Position

Figure 6.30 Bottom-Fiber Strain Data for the Pre- v. Post-Repair Models—A9 Load Position

Figure 6.31 Bottom-Fiber Strain Data for the Pre- v. Post-Repair Models—C7 Load Position

Figure 6.32 Bottom-Fiber Strain Data for the Pre- v. Post-Repair Models—C9 Load Position

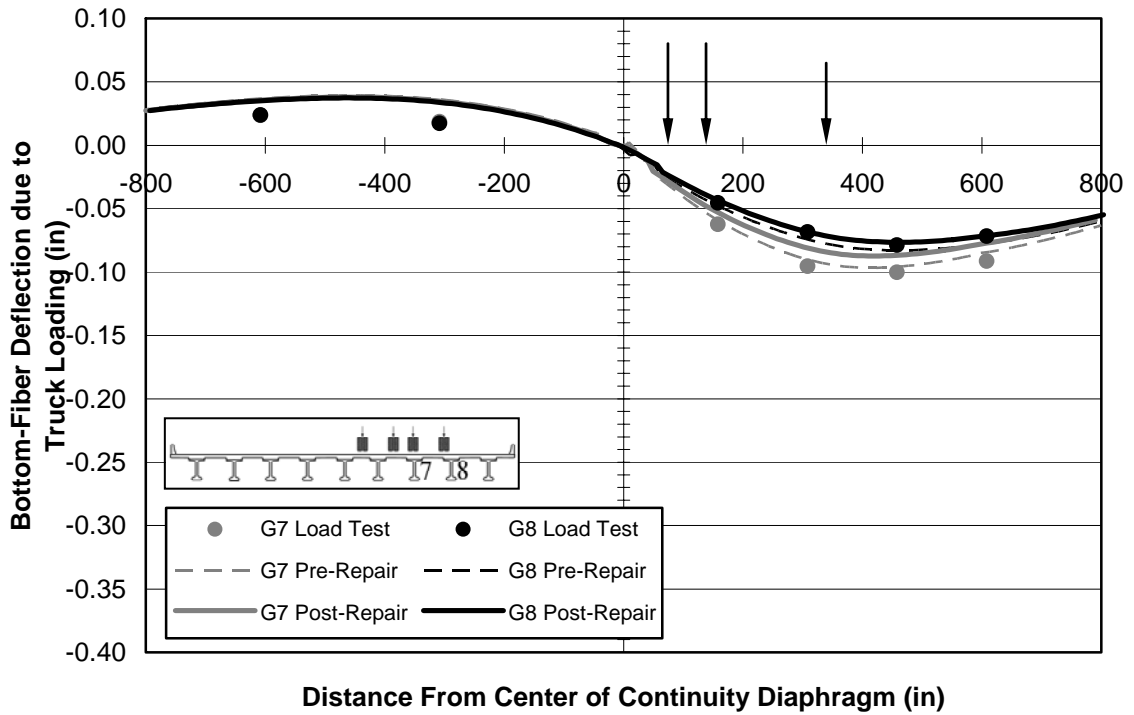
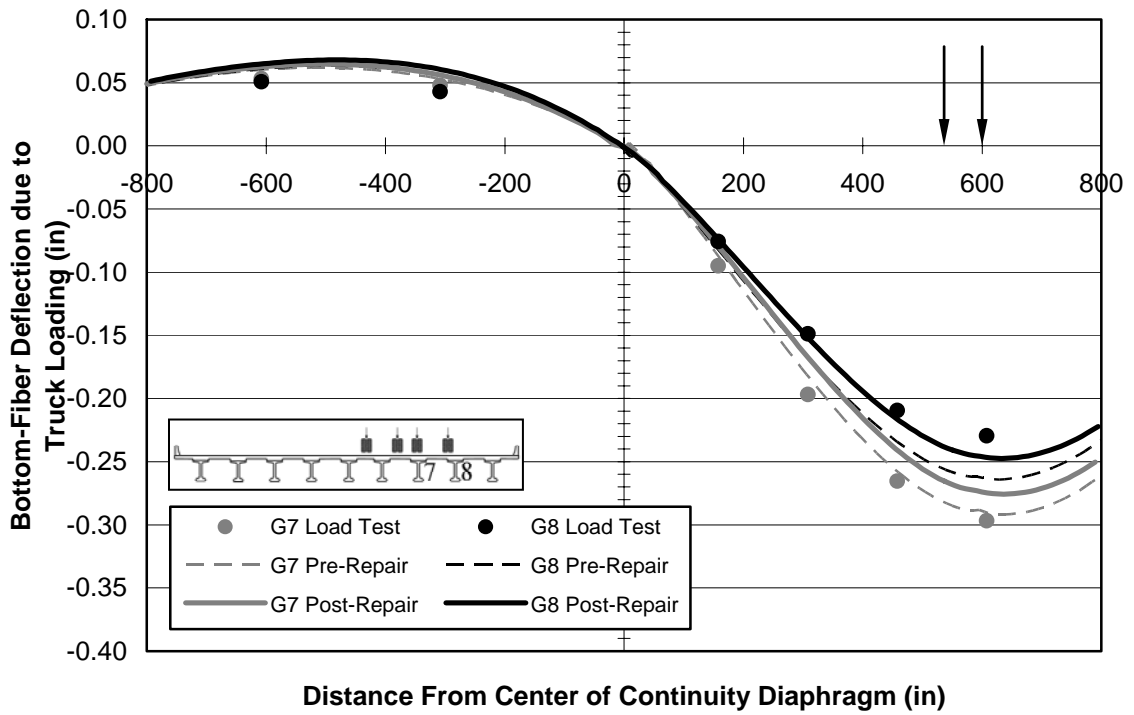
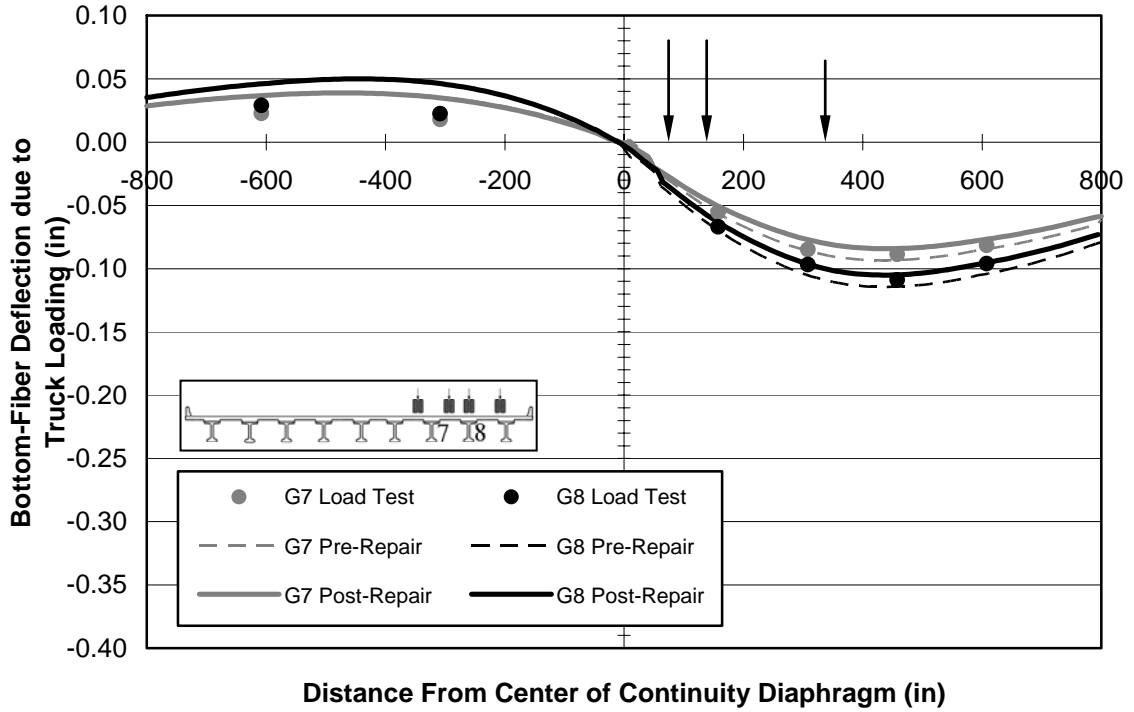
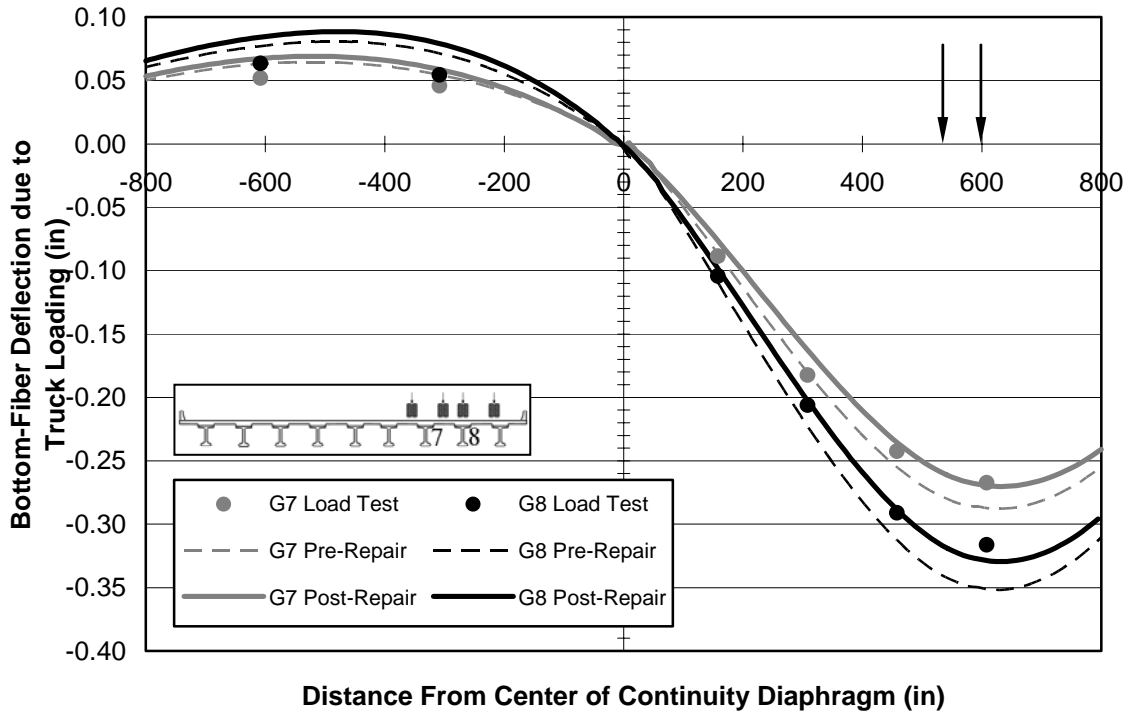
Figure 6.33 Bottom-Fiber Deflections for the Pre- v. Post-Repair Models—A7 Load Position

Figure 6.34 Bottom-Fiber Deflections for the Pre- v. Post-Repair Models—A9 Load Position

Figure 6.35 Bottom-Fiber Deflections for the Pre- v. Post-Repair Models—C7 Load Position

Figure 6.36 Bottom-Fiber Deflections for the Pre- v. Post-Repair Models—C9 Load Position
