FINITE-ELEMENT MODELING OF A DAMAGED PRESTRESSED
CONCRETE BRIDGE

A Thesis

Auburn University

Auburn, Alabama
May 10, 2007

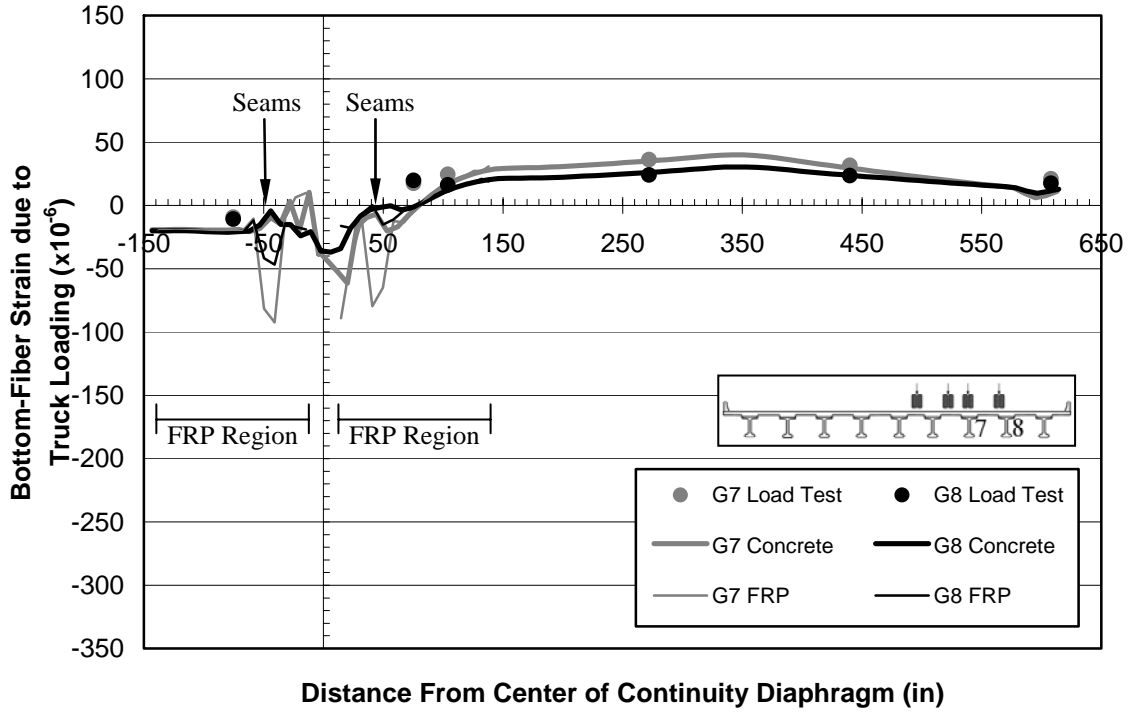
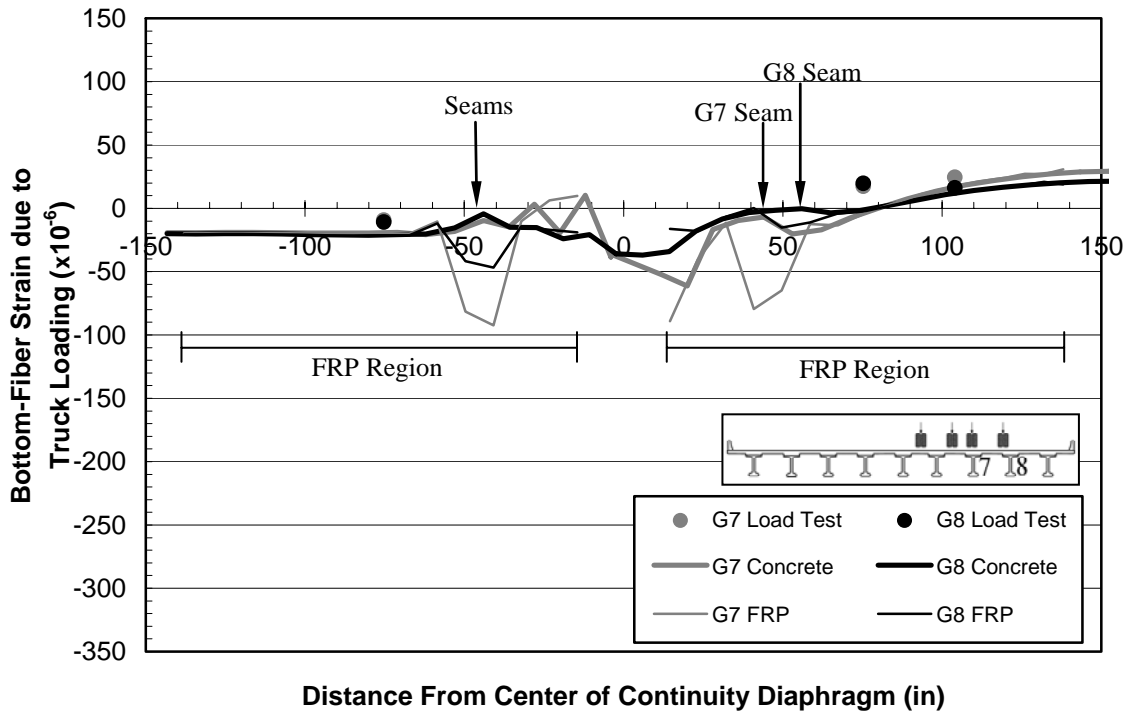
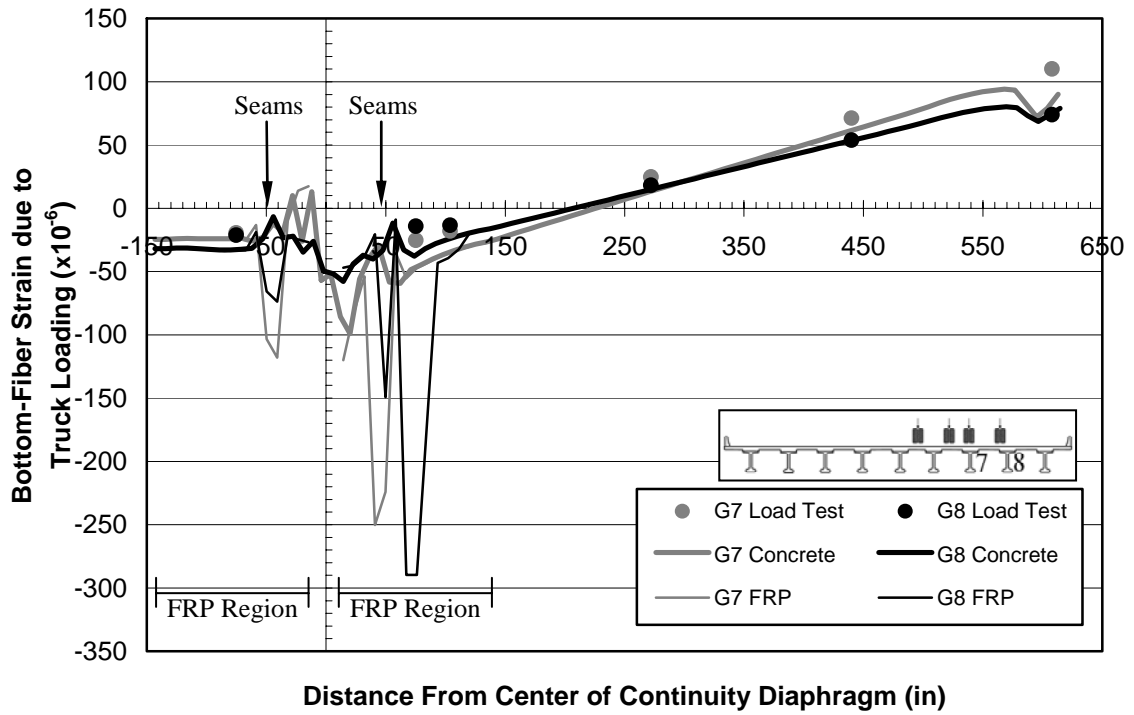
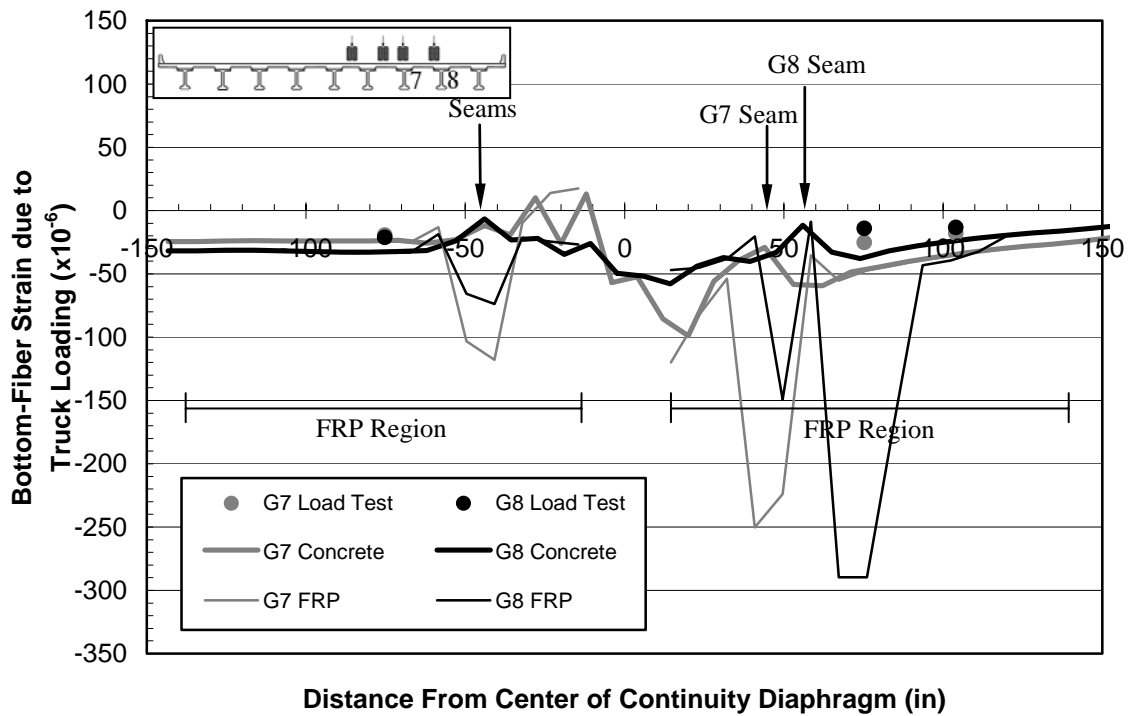
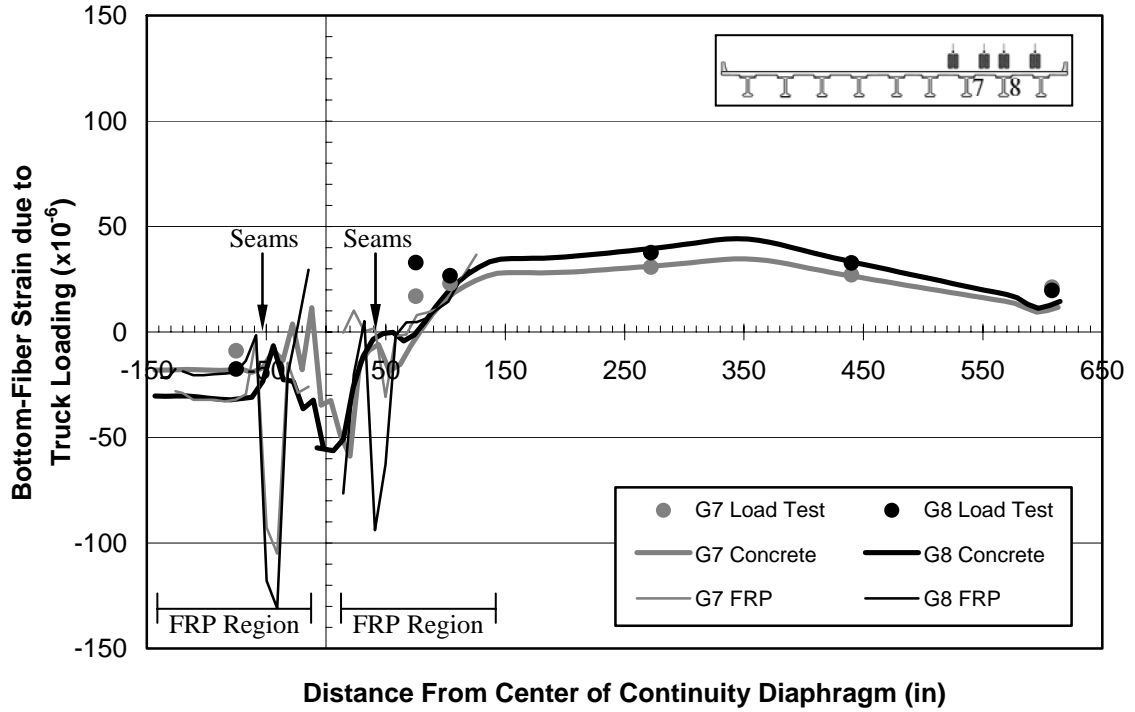
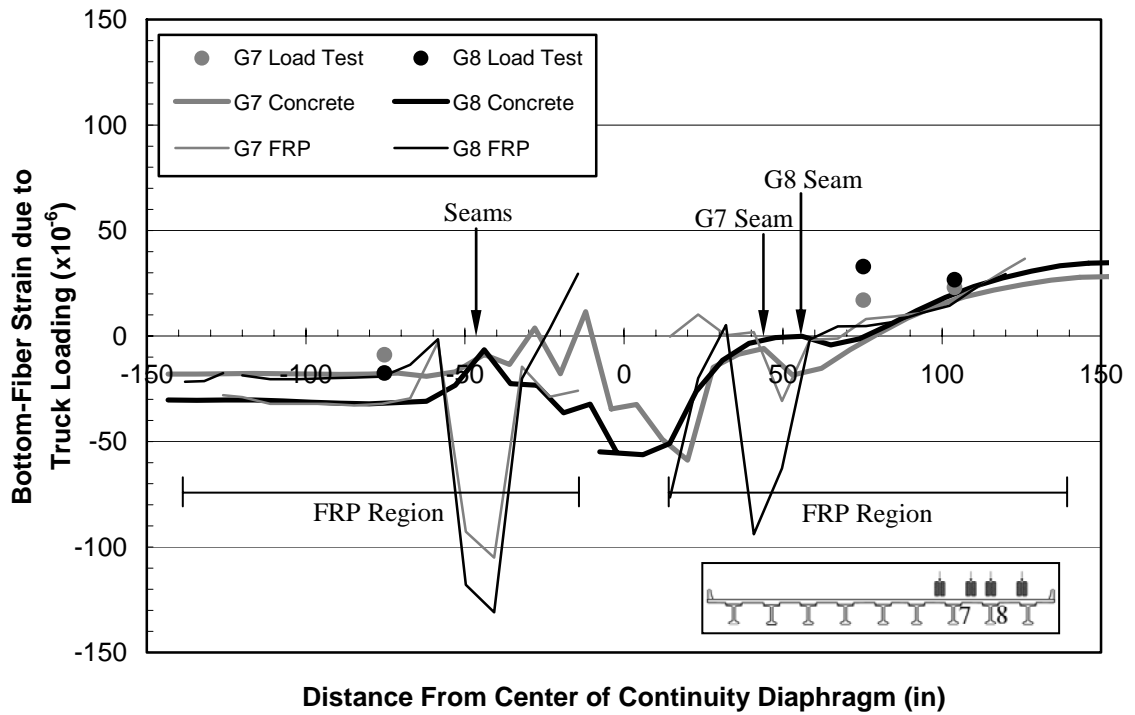
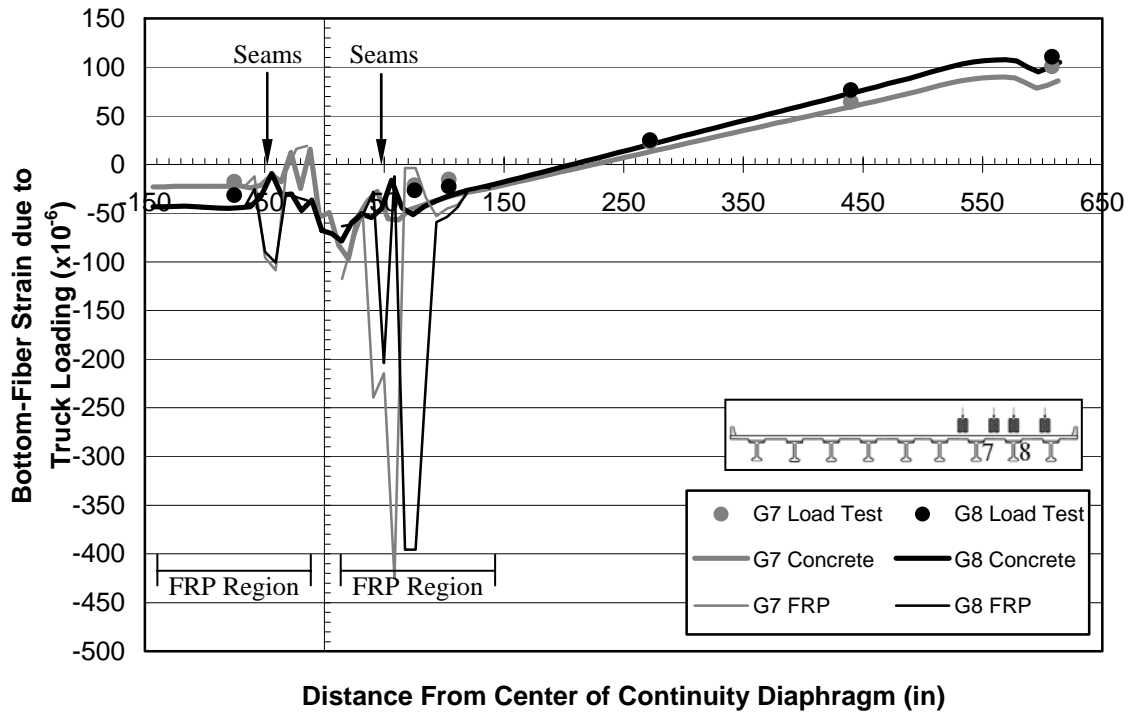
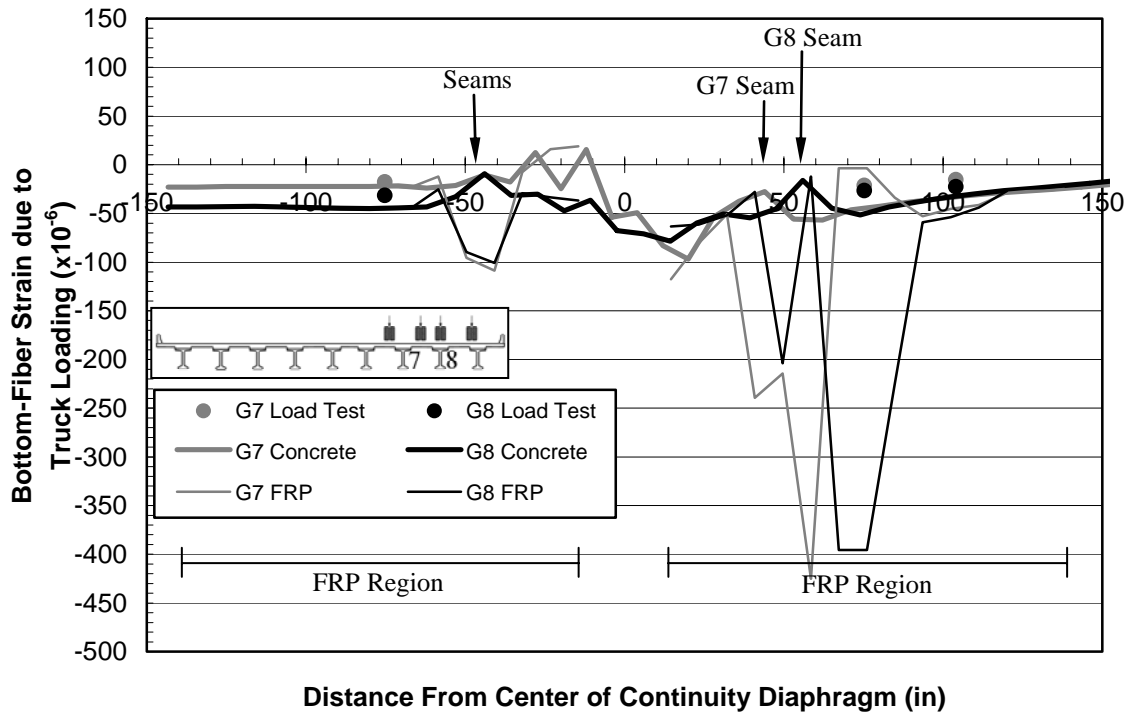
Figure 6.37 Bottom-Fiber Strain Data for the Concrete v. FRP for the Post-Repair Model—A7 Load Position

Figure 6.38 Bottom-Fiber Strain Data for the Concrete v. FRP for the Post-Repair Model (close-up view)—A7 Load Position

Figure 6.39 Bottom-Fiber Strain Data for the Concrete v. FRP for the Post-Repair Model—A9 Load Position

Figure 6.40 Bottom-Fiber Strain Data for the Concrete v. FRP for the Post-Repair Model (close-up view)—A9 Load Position

Figure 6.41 Bottom-Fiber Strain Data for the Concrete v. FRP for the Post-Repair Model—C7 Load Position

Figure 6.42 Bottom-Fiber Strain Data for the Concrete v. FRP for the Post-Repair Model (close-up view)—C7 Load Position

Figure 6.43 Bottom-Fiber Strain Data for the Concrete v. FRP for the Post-Repair Model—C9 Load Position

Figure 6.44 Bottom-Fiber Strain Data for the Concrete v. FRP for the Post-Repair Model (close-up view)—C9 Load Position

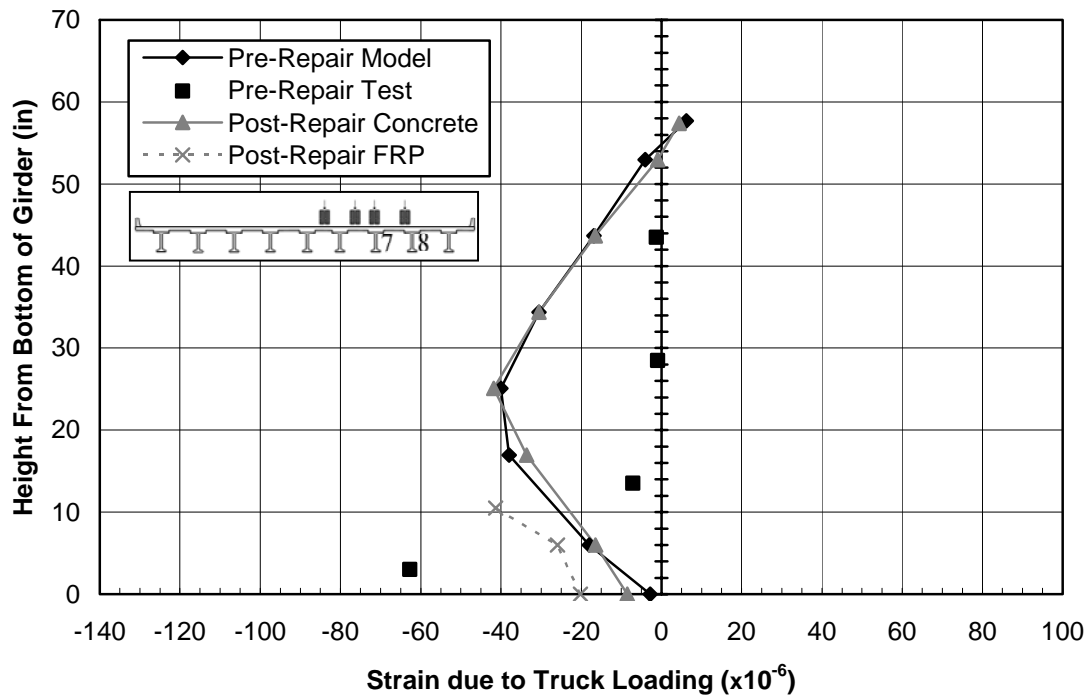
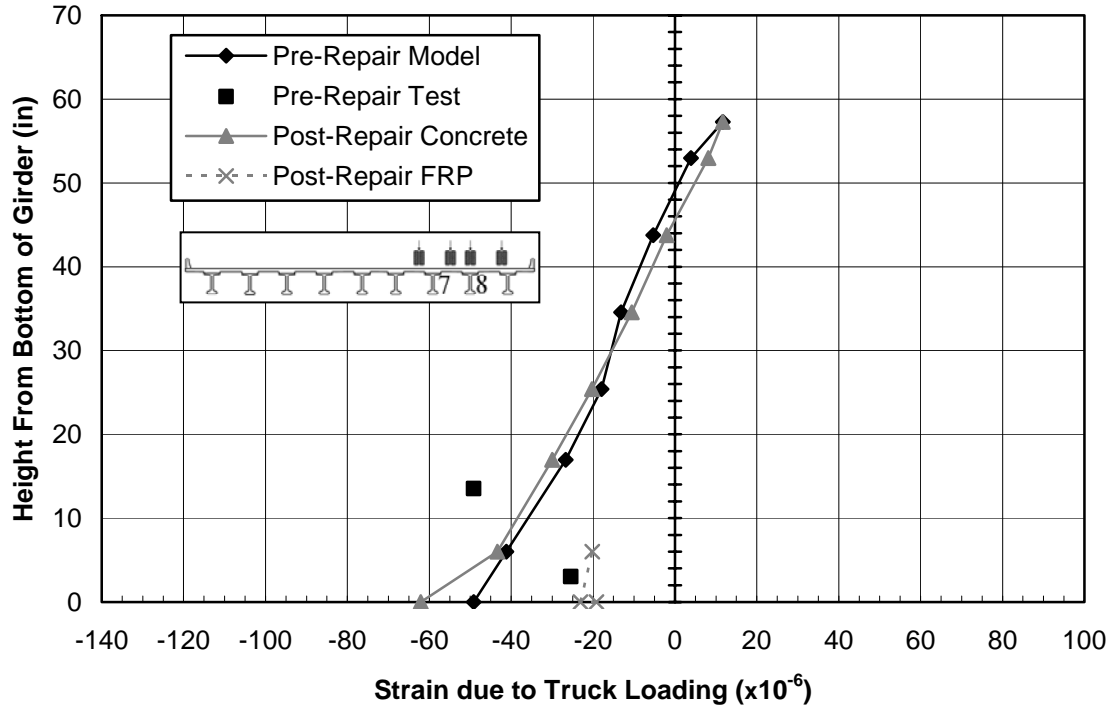
Figures 7.1 and 7.2 provide a good example of how the girder-section strain profile measurements are not so useful. These illustrate the strain values at various depths on one face of a specific cross section of a girder. These figures are from Cross Section 2—which is 4.75 in. from the face of the continuity diaphragm on Span 10—and Cross Section 3—which is 4.75 in. from the face of the continuity diaphragm on Span 11—respectively. Figure 7.1 shows the strain along the East face of Girder 7 for the A7 (near cracked region) Load Position, and Figure 7.2 shows the strain along the West face of Girder 8 for the C9 (midspan) Load Position. From these figures, it is apparent that the FEM results predict a strain profile quite different from that which was measured during the bridge testing. Other profiles can be seen in Appendices D–G.

Figure 7.1 Strain Profile—A7 Load Position, Section 2, Girder 7, East Face

Figure 7.2 Strain Profile—C9 Load Position, Section 3, Girder 8, West Face

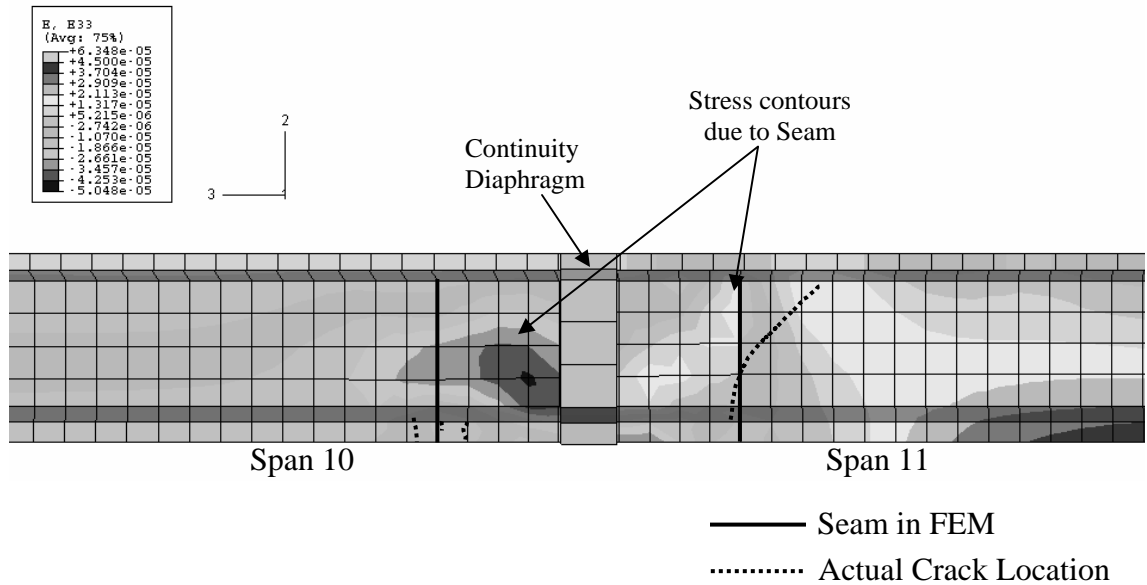
By evaluating the strain contours of the ABAQUS *Cracked-with-Reinforcement* model shown in Figure 7.3, the reason for the disparity becomes apparent. The stress contours that result from the modeled seam are significantly different from the stress contours that are present on the real structure as a result of the crack groups—which are illustrated in Figures 3.6–3.14. In addition to the fact that multiple cracks are modeled as one seam, the cracks on the physical structure tend to run in a more diagonal fashion along the girder than was used in the seam approximations. Because the stresses and strains within this cracked region change drastically over a relatively small distance, this deviation from the actual cracking pattern causes the FEM results within that cracked region to be significantly different from the load test results.

Figure 7.3 Longitudinal Strain Contours for the Cracked-with-Reinforcement Model, A7 Load Position, Girder 7, East Face

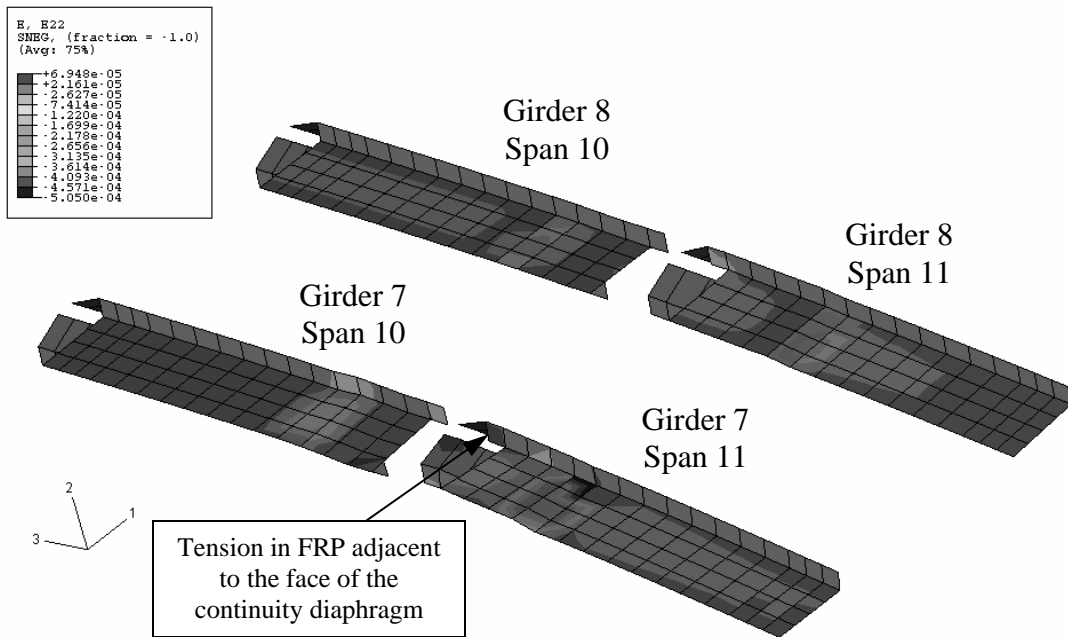
Figure 7.5 Strain Contours in FRP for Load Position A9

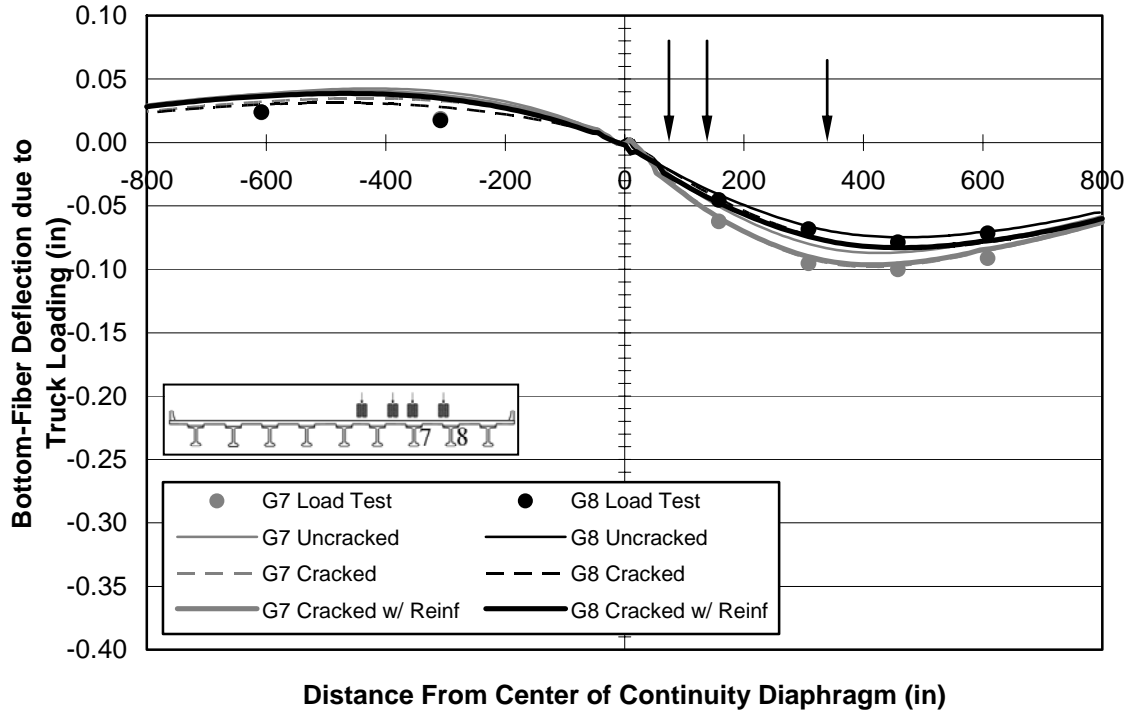
Figures B.1 through B.4 show the comparison between the experimental deflections and the analytical deflections for each of the *Uncracked*, *Cracked*, and *Cracked-with-Reinforcement* models. The deflection results of the *Pre-Repair* model are compared with those of the *Post-Repair* model in Figures B.5 through B.8.

Figure B.1 Bottom-Fiber Deflections for the Model Refinement—A7 Load Position

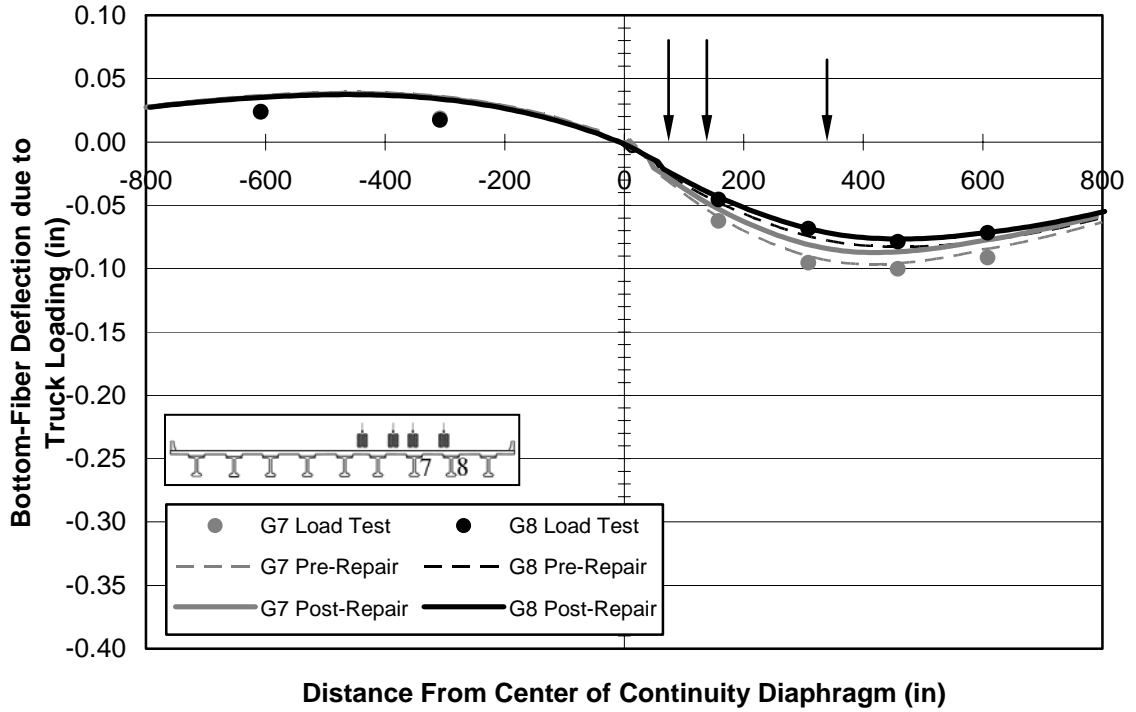
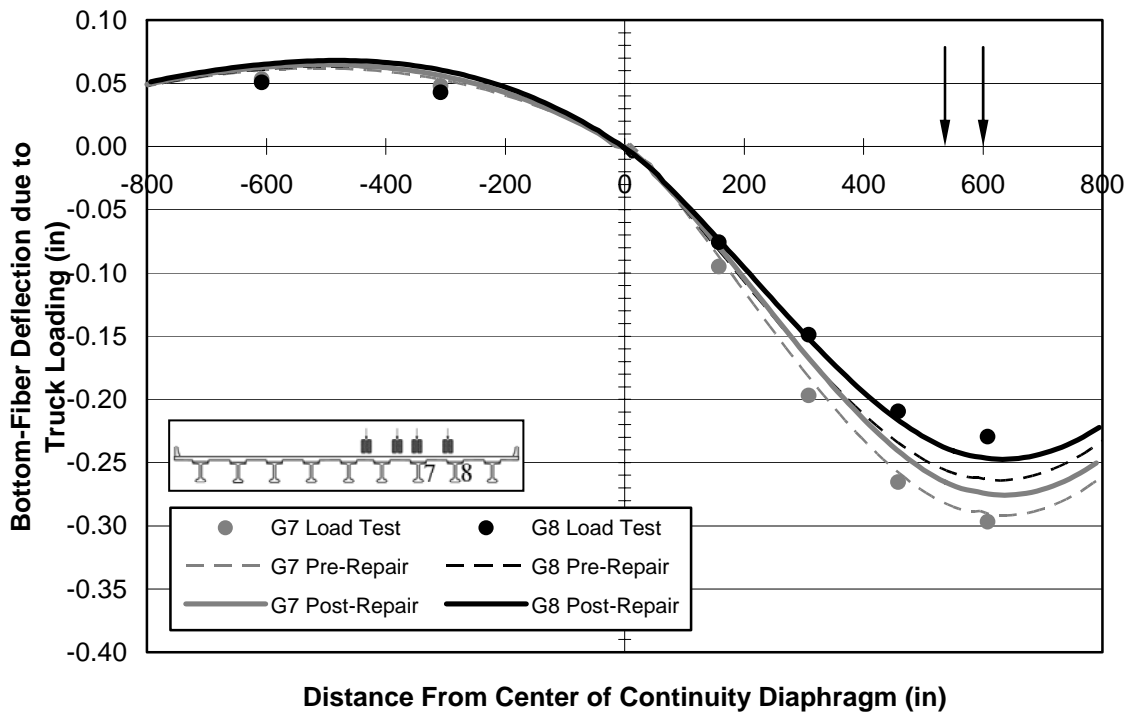
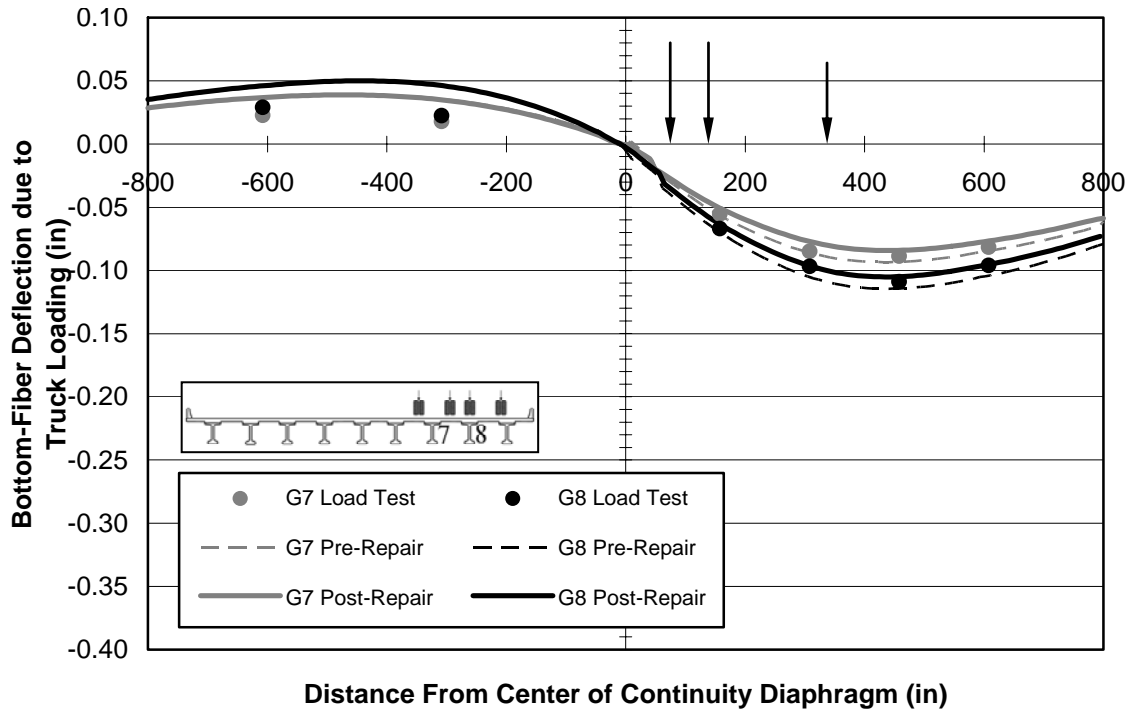
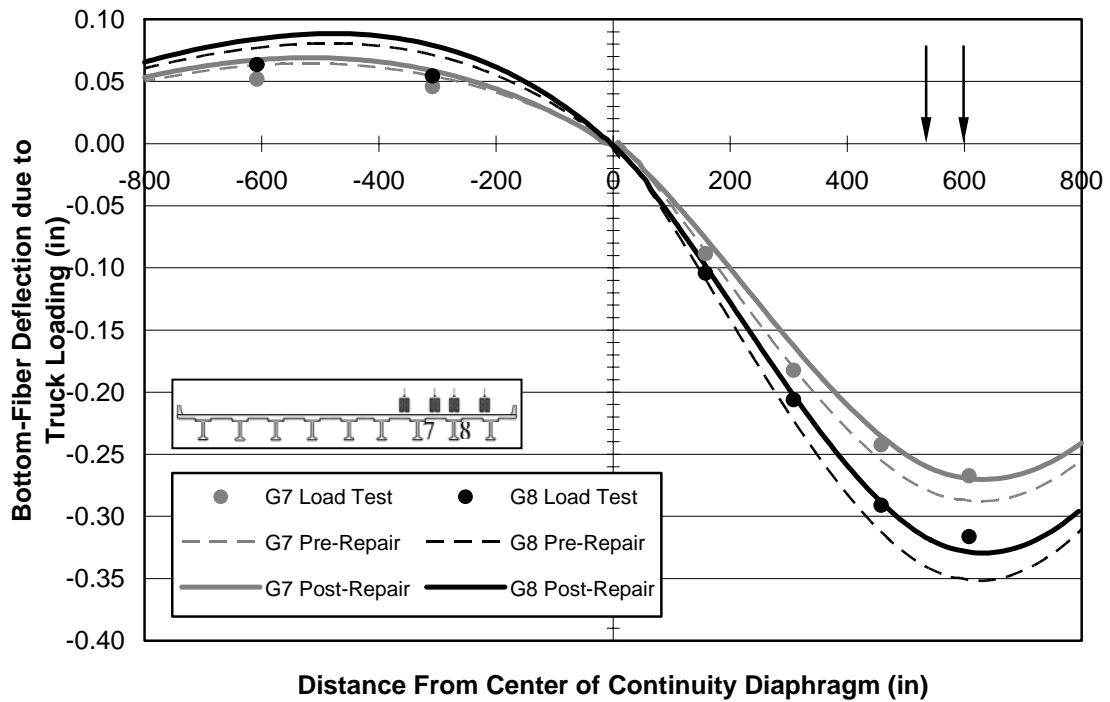
Figure B.5 Bottom-Fiber Deflections for the Pre- v. Post-Repair Models—A7 Load Position

Figure B.6 Bottom-Fiber Deflections for the Pre- v. Post-Repair Models—A9 Load Position

Figure B.7 Bottom-Fiber Deflections for the Pre- v. Post-Repair Models—C7 Load Position

Figure B.8 Bottom-Fiber Deflections for the Pre- v. Post-Repair Models—C9 Load Position

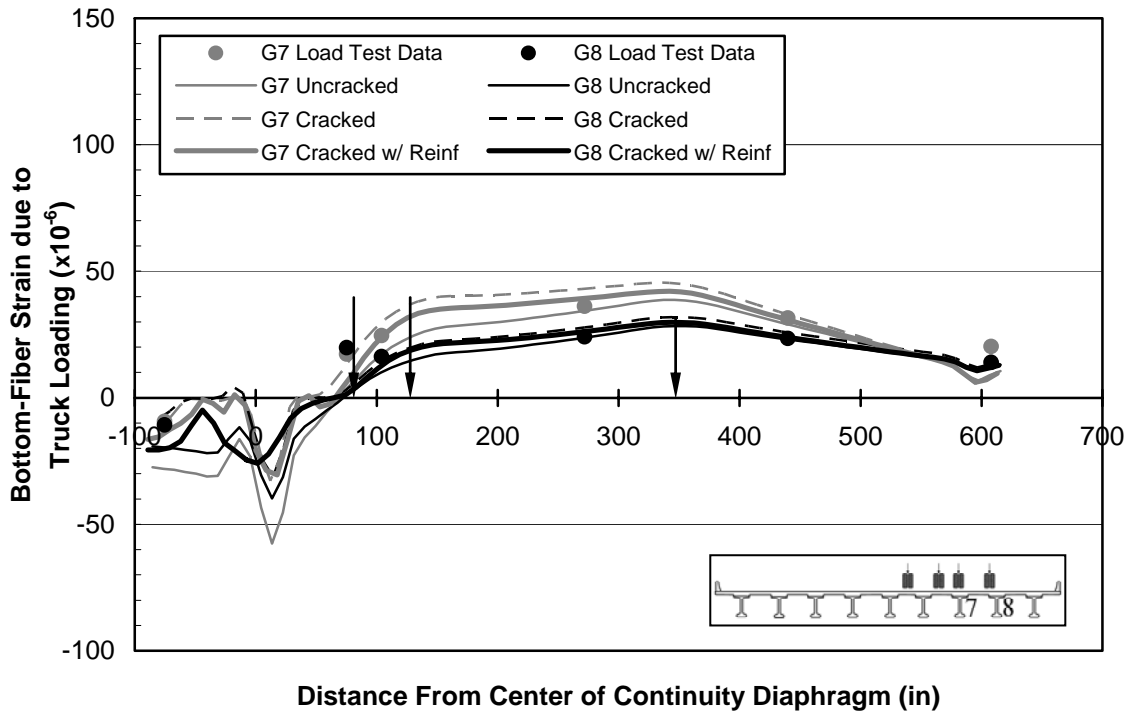
Figure C.1 Bottom-Fiber Strain Data for the Model Refinement—A7 Load Position

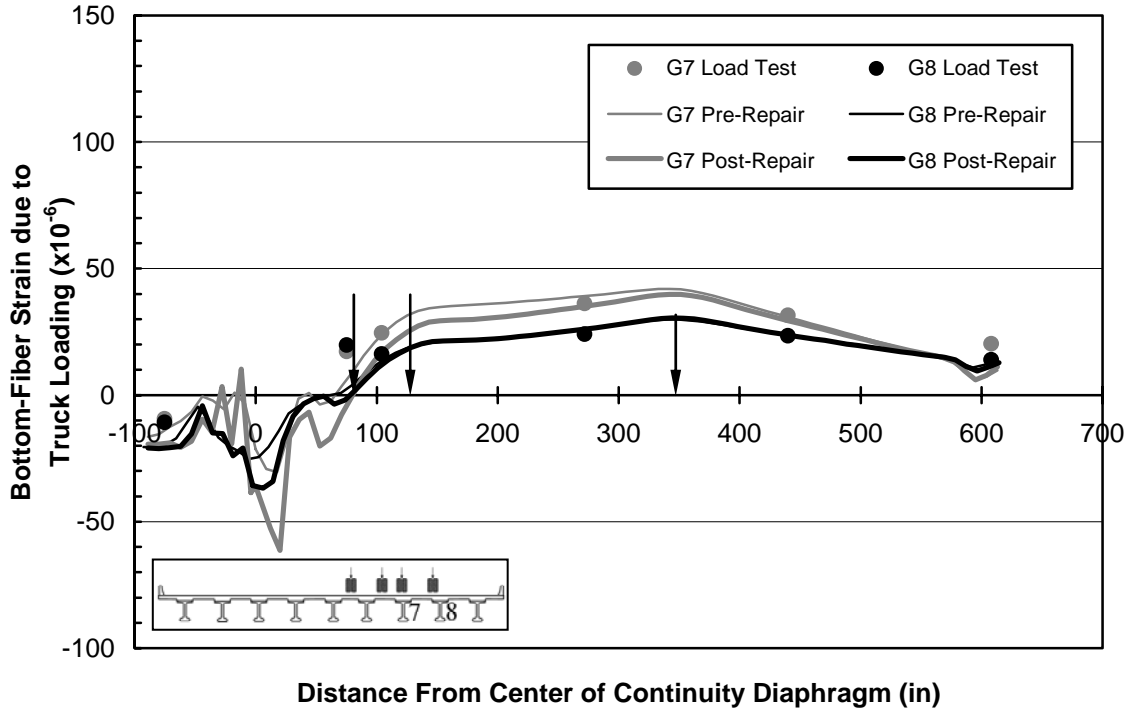
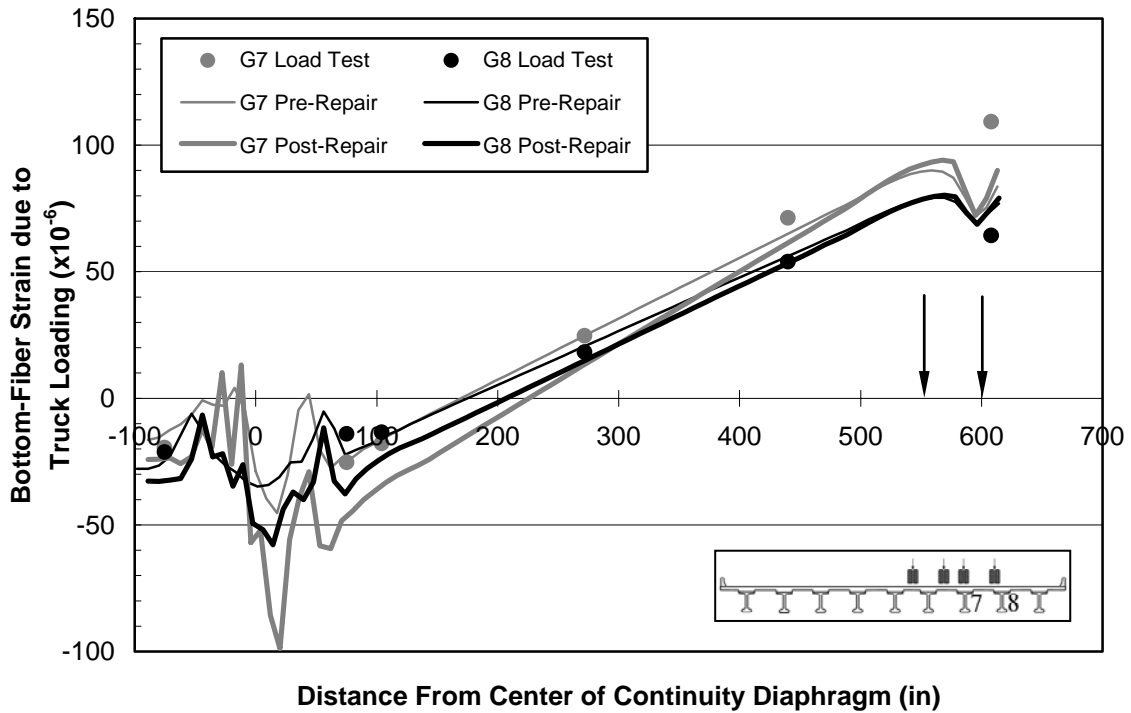
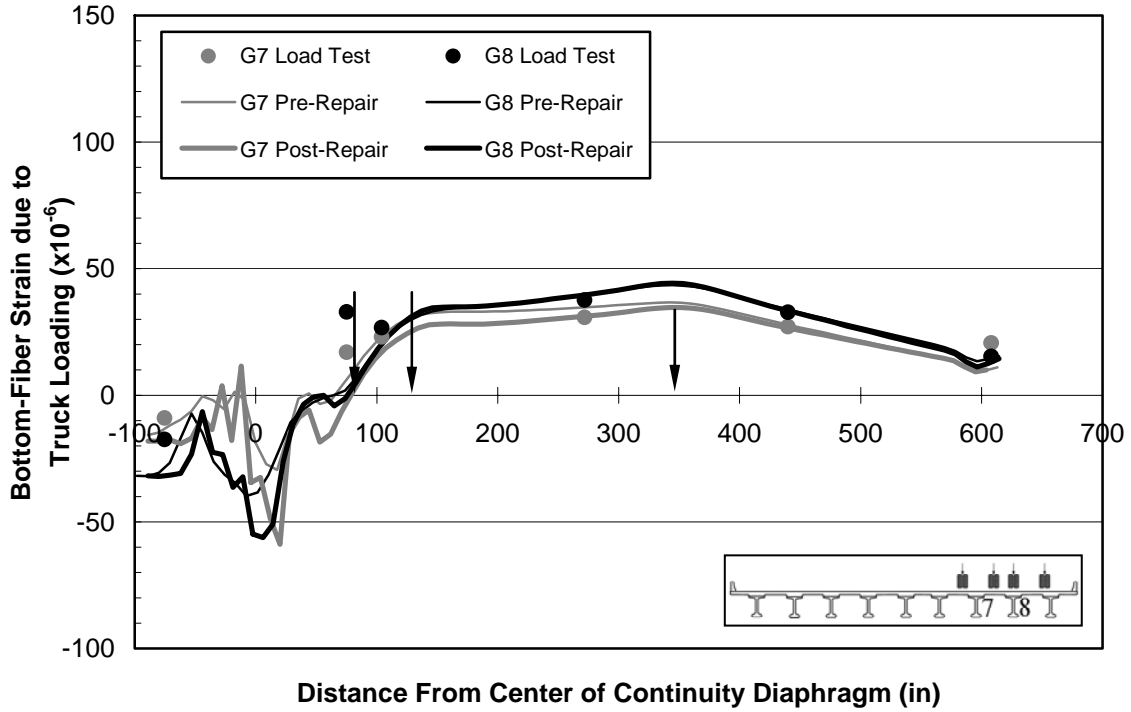
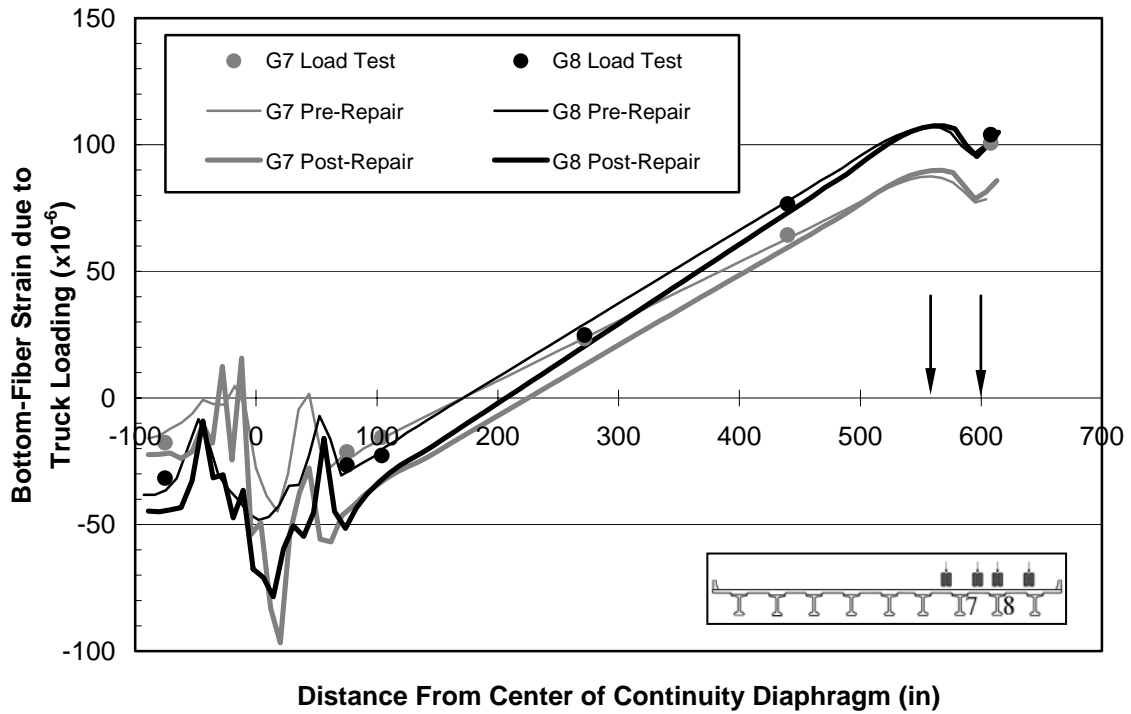
Figure C.5 Bottom-Fiber Strain Data for the Pre- v. Post-Repair Models—A7 Load Position

Figure C.6 Bottom-Fiber Strain Data for the Pre- v. Post-Repair Models—A9 Load Position

Figure C.7 Bottom-Fiber Strain Data for the Pre- v. Post-Repair Models—C7 Load Position

Figure C.8 Bottom-Fiber Strain Data for the Pre- v. Post-Repair Models—C9 Load Position

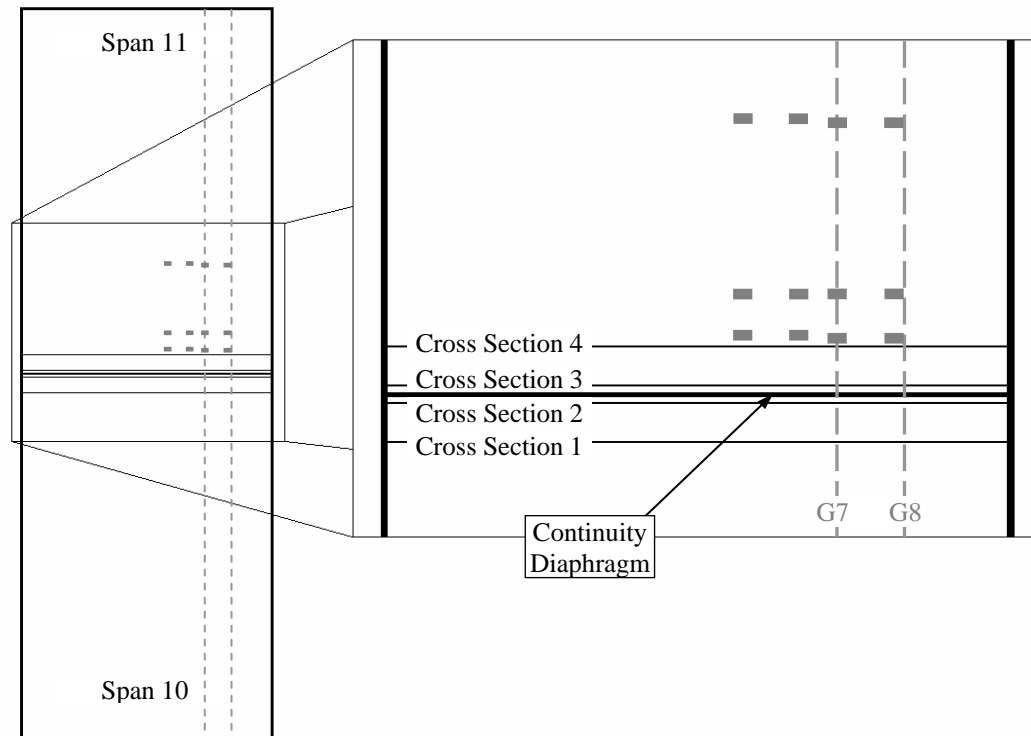
Figure D.1 Strain Profile Cross Section Locations for Load Position A7

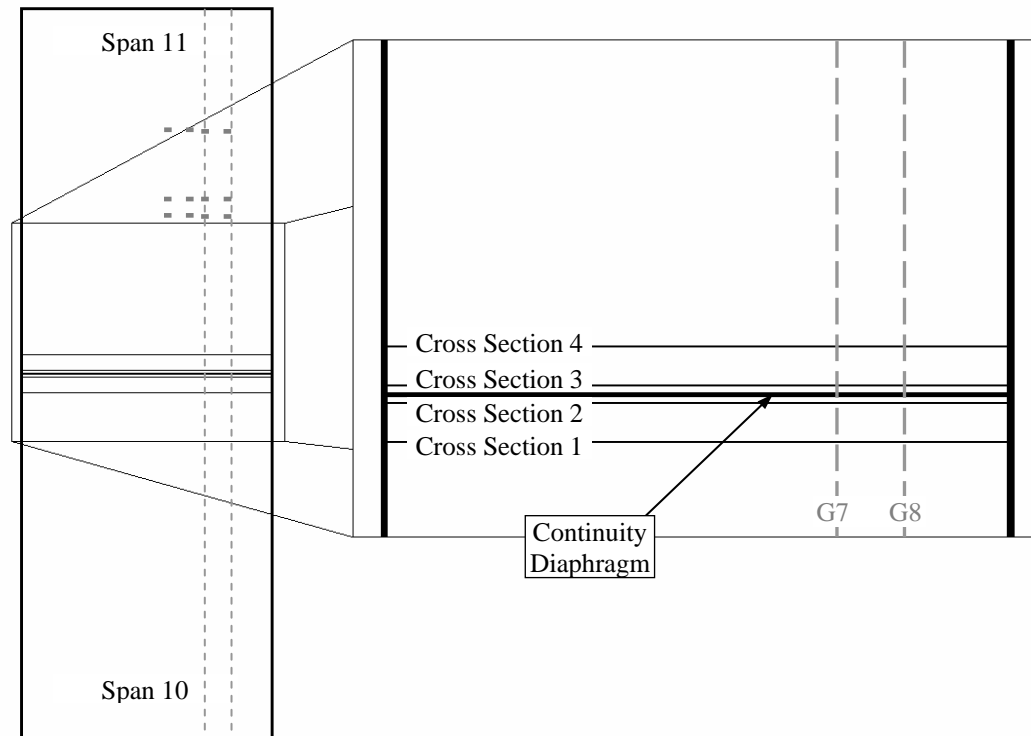
Figure E.1 Strain Profile Cross Section Locations for Load Position A9

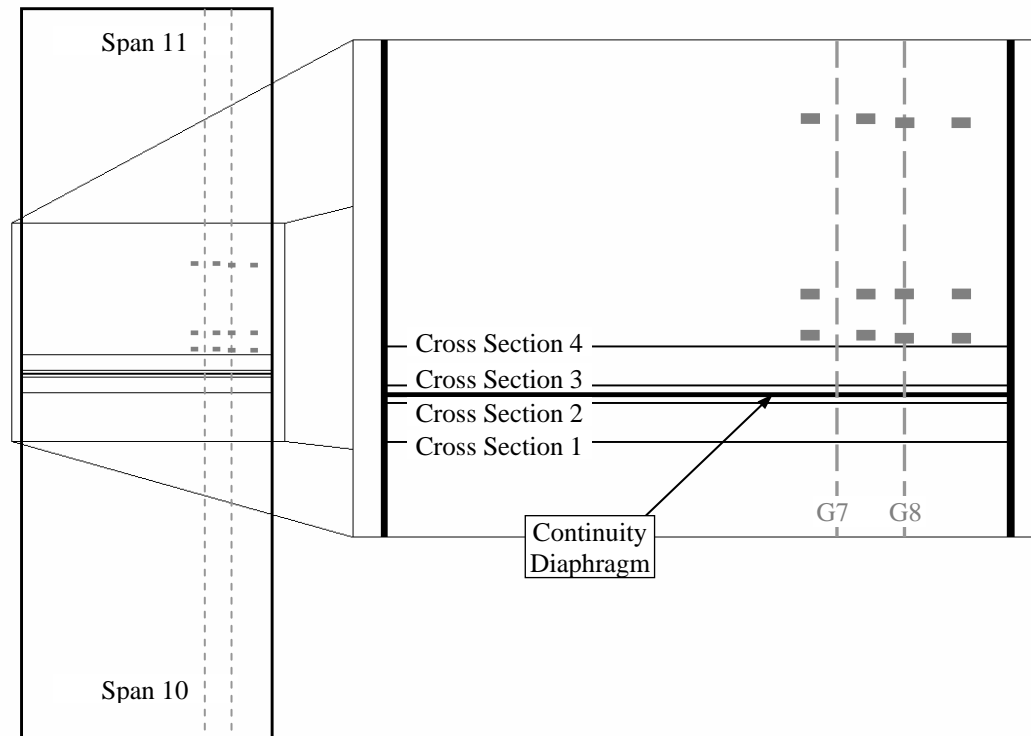
Figure F.1 Strain Profile Cross Section Locations for Load Position C7

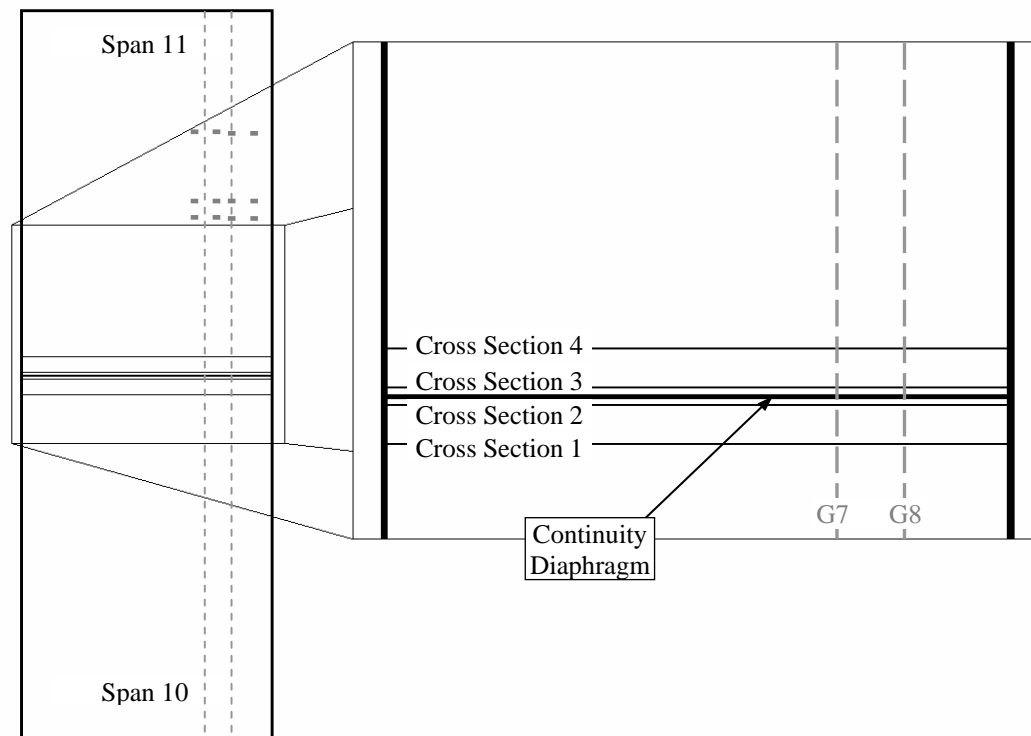
Figure G.1 Strain Profile Cross Section Locations for Load Position C9
