**Drained Residual Strength of Expansive Soils Causing
Pavement Distress along Alabama Highway 5**

A thesis submitted to the Graduate Faculty of
Auburn University
in partial fulfillment of the
requirements for the Degree of
Master of Science

Keywords: expansive clays, ring shear, drained residual strength

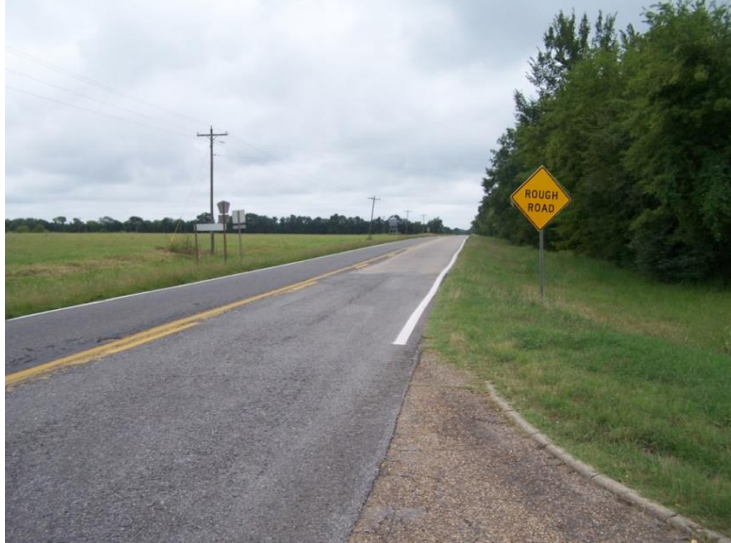
Figure 1: Distress Pavement at AL-5 (Herman 2015)

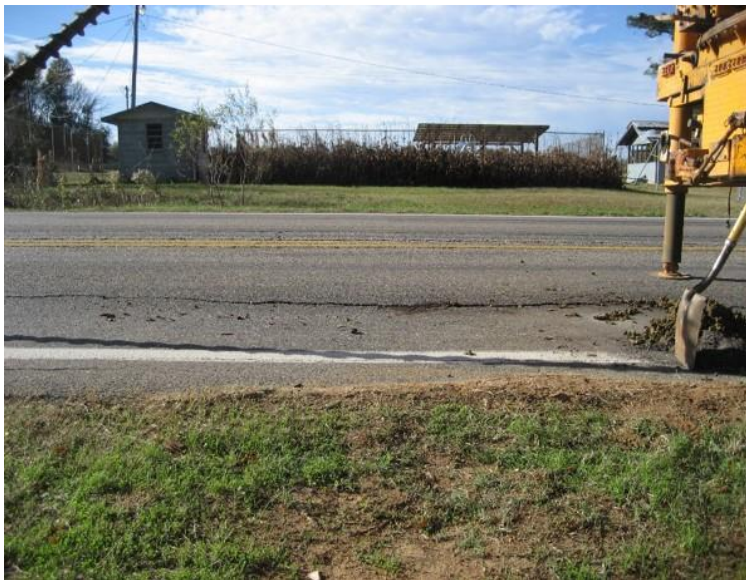
Figure 2: Longitudinal Cracking along AL-5 (Herman 2015)

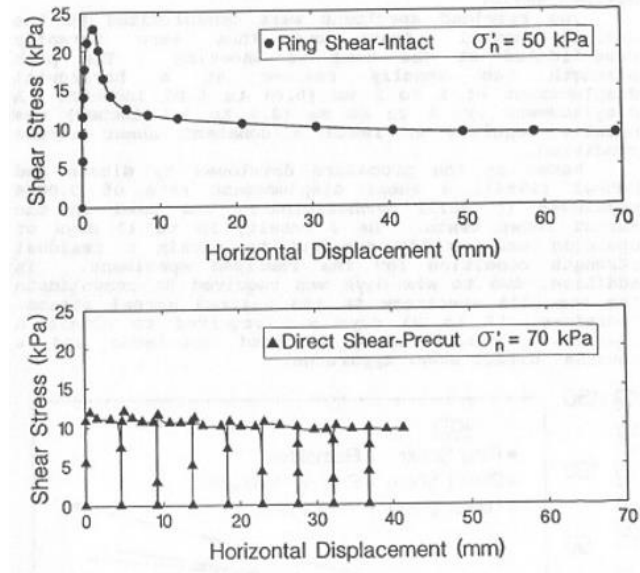
Figure 16: Shear Stress versus Horizontal Displacement Curves for Ring Shear and Direct Shear Tests (Stark and Eid 1992)

The remolded specimens in the direct shear test resulted in a failure envelope much higher than the other tests. Since the duration of the direct shear tests are longer than the duration of a ring shear test, this direct shear method should not be used to measure the residual strength of the soil in order to save time if a ring shear apparatus is available (Stark and Eid 1992). The precut, remolded specimens used in the direct shear testing generally had good agreement with the ring shear testing. However, the ring shear apparatus better illustrates the slow decrease in strength after the peak strength is obtained as shown in Figure 16 (Stark and Eid 1992).

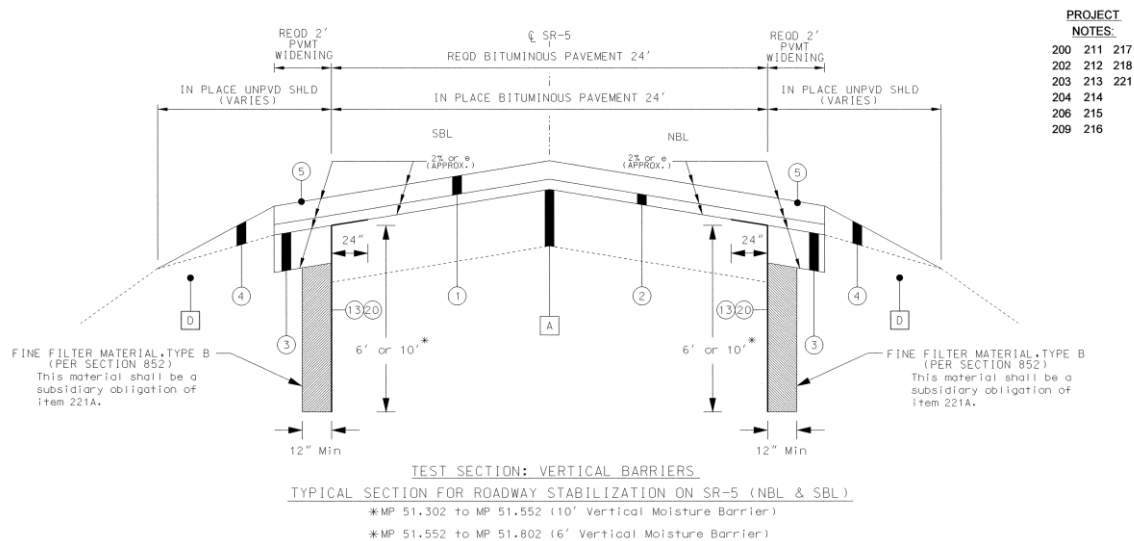
Figure 29: Vertical Barriers Cross Section (ALDOT 2015)

Vertical moisture barriers (VB) are in trenches along the edge of the pavement and consist of sheets of impervious geomembrane. The purpose of the geomembrane is to limit the amount of lateral flow of water into and out of the subgrade. Nelson and Miller (1992) say that it is normally impractical to install vertical barriers the entire depth of the active zone, but rather a depth of one-half to two-thirds of the active zone will suffice. Figure 29 shows the typical cross-section for the vertical barriers test section. Ten-foot barriers were supposed to be constructed on the north side of the Test Section and six-foot barriers on the south side of the Test Section; however, the soils began to cave in when the ten-foot trench was constructed. Therefore, only six-foot trenches were placed along the entire Test Section. Figure 30 shows the final construction of the vertical barriers test section. After the base course of asphalt was placed on the vertical barriers, cracking, rutting, and spalling developed above the vertical barriers. In some places, the geosynthetic protruded through the asphalt. These issues were likely caused by poor construction practice and compaction efforts and can be seen in Figure 31 and Figure 32.

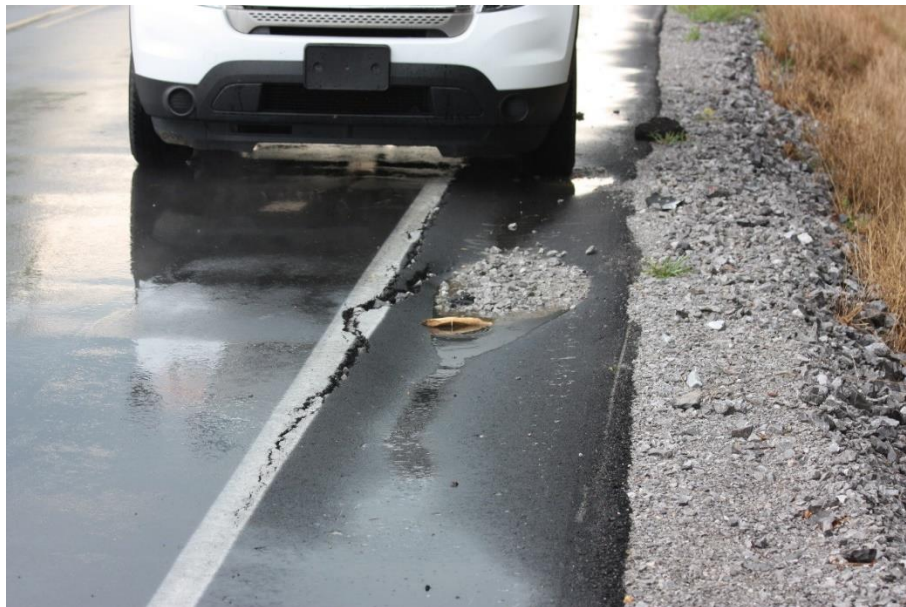
Figure 31: Cracking and Rutting Observed above Vertical Barriers

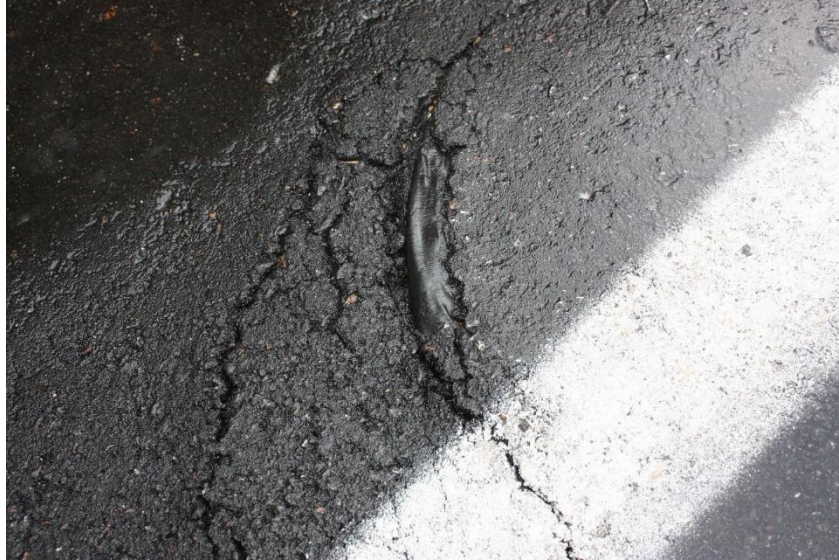
Figure 32: Geosynthetic Protruding Through Base Course of Asphalt

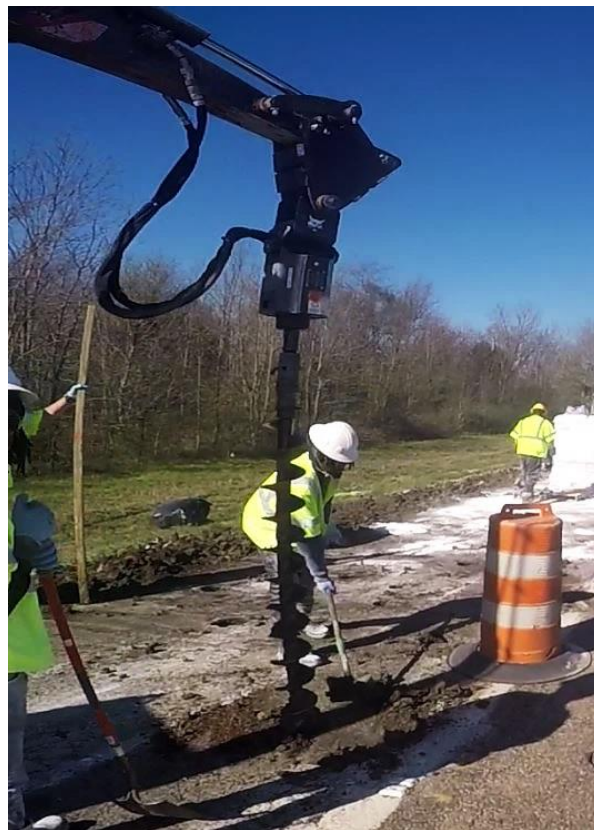
Figure 36: Auger used for Lime Column Installation

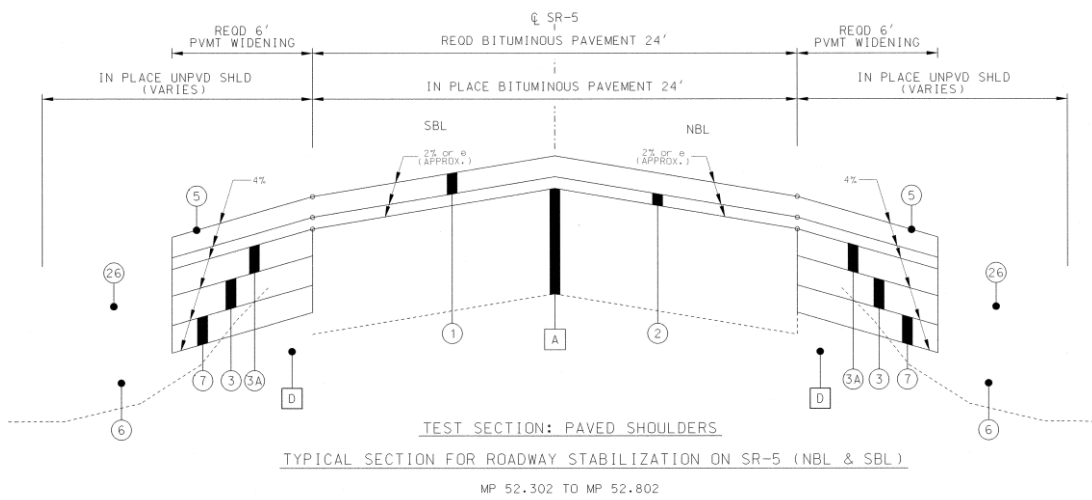
Figure 39: Paved Shoulder Cross Section (ALDOT 2015)

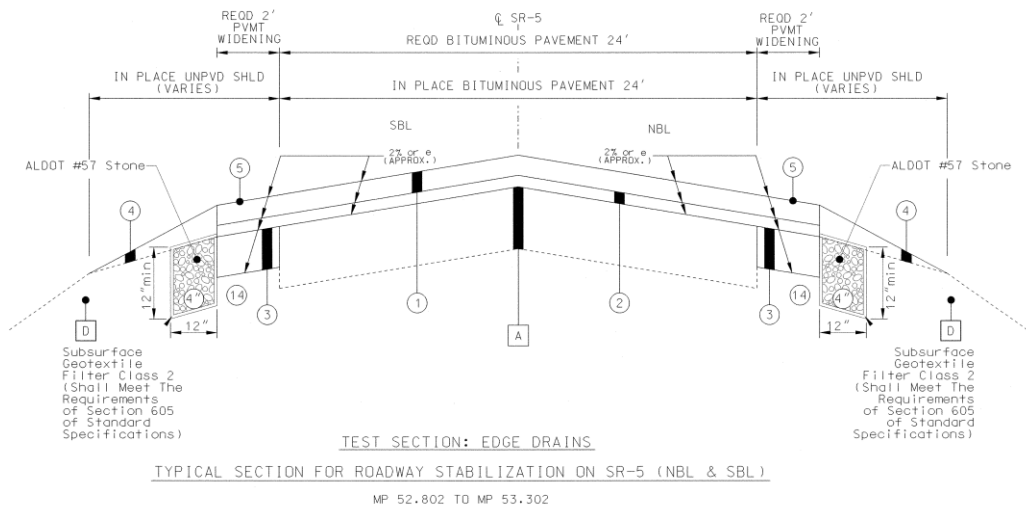
Figure 41: Edge Drain Cross Section (ALDOT 2015)

Edge drains (ED) were installed at the edge of the pavement in order to stabilize the moisture content of the subgrade. Heaving of the pavement would be reduced if the moisture content of the subgrade was more stable. Figure 41 illustrates the cross-section for the edge drain Test Section. A picture of the edge drains after being backfilled with #57 stone is shown in Figure 42.

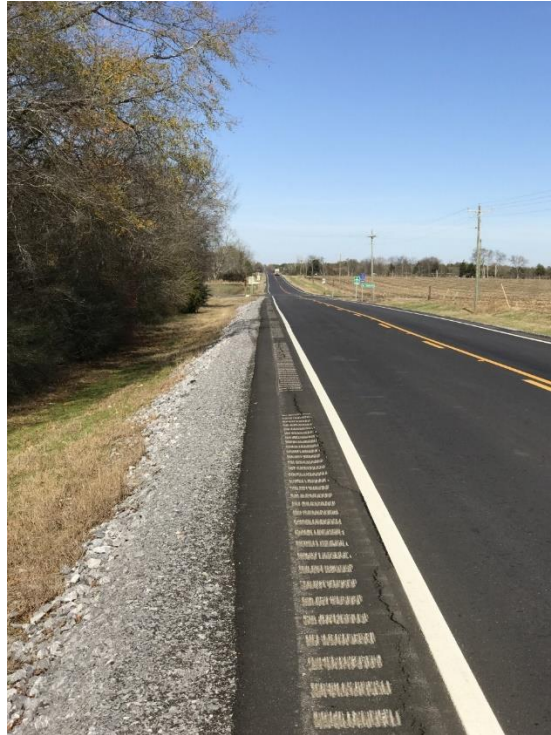
Figure 104: Longitudinal Crack in Vertical Barrier Section December 2016

first section to experience cracking. These cracks were observed on a site visit on December 15th, 2016 and can be seen in Figure 104.

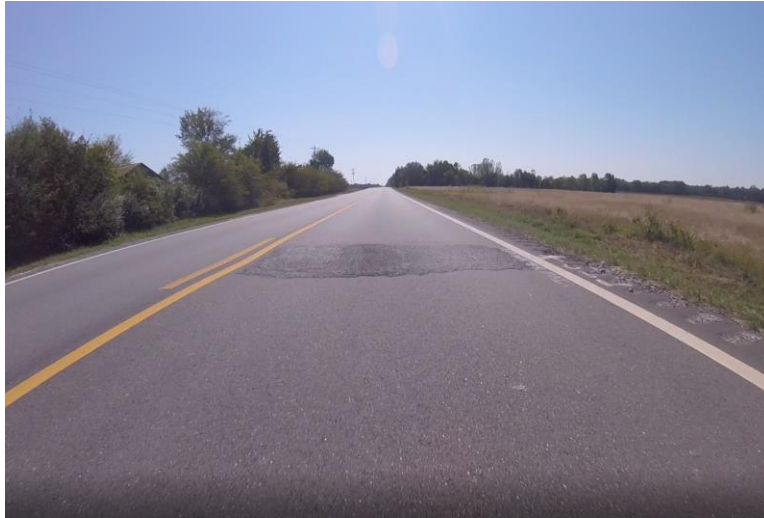
Figure 105: Location of IRI Spike (Culvert Patch) in Southbound Lime Columns Section September 2017

The research site was visited in September 2017. The roadway was still smooth with no signs of heaving due to the subgrade. A small patch of asphalt had been placed over a culvert in the lime columns test section resulting in an increase in the IRI at that mile point. The patched roadway is shown in Figure 105.

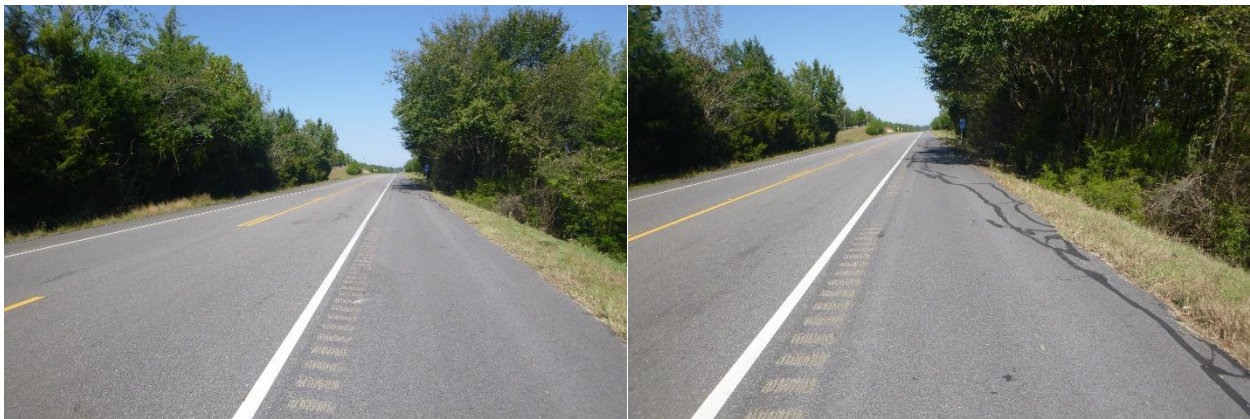
Figure 108: Paved Shoulder Section of AL-5 in Dallas County December 2017

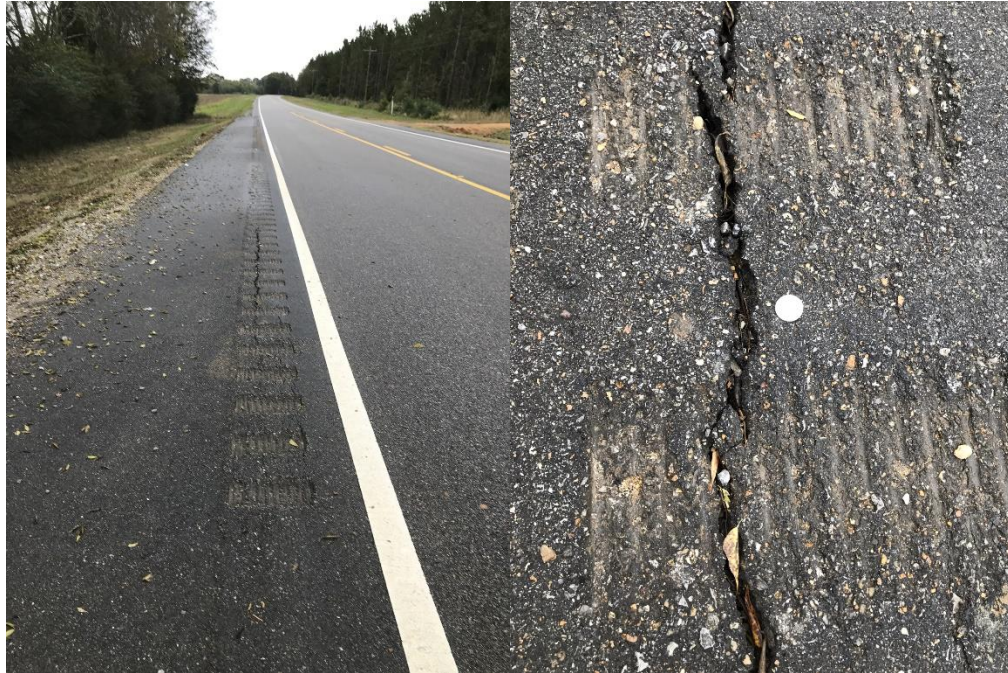
Figure 109: Cracks in Paved Shoulder Test Section November 2018

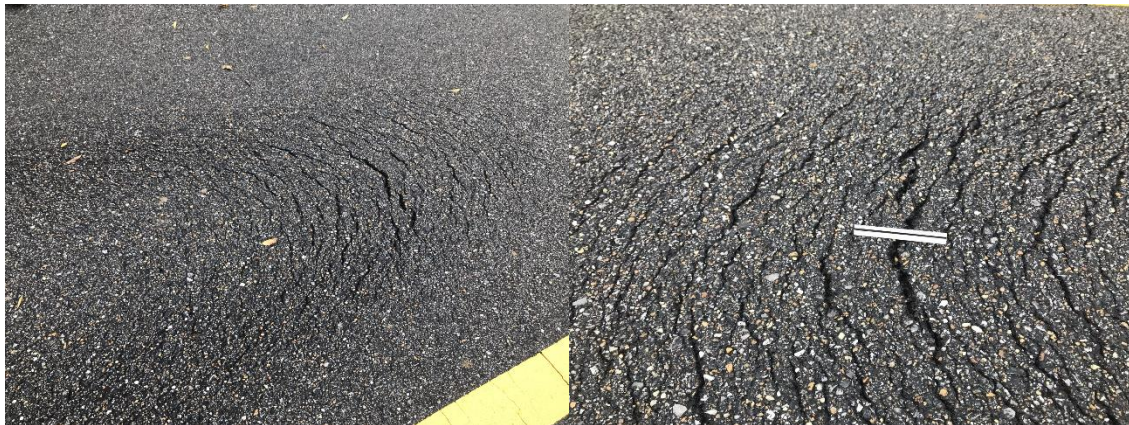
Figure 110: Paved Shoulder Test Section Travel Lane November 2018

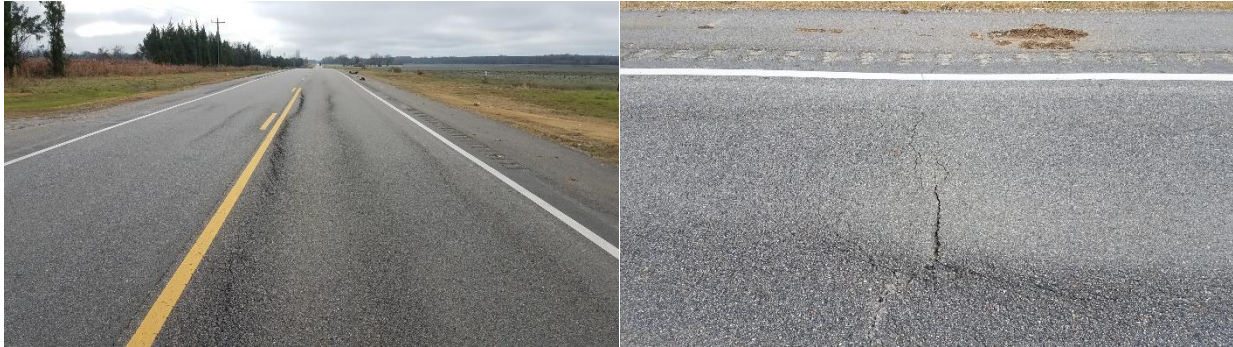
Figure 111: Pavement Distress and Cracks in Paved Shoulder Test Section December 2018

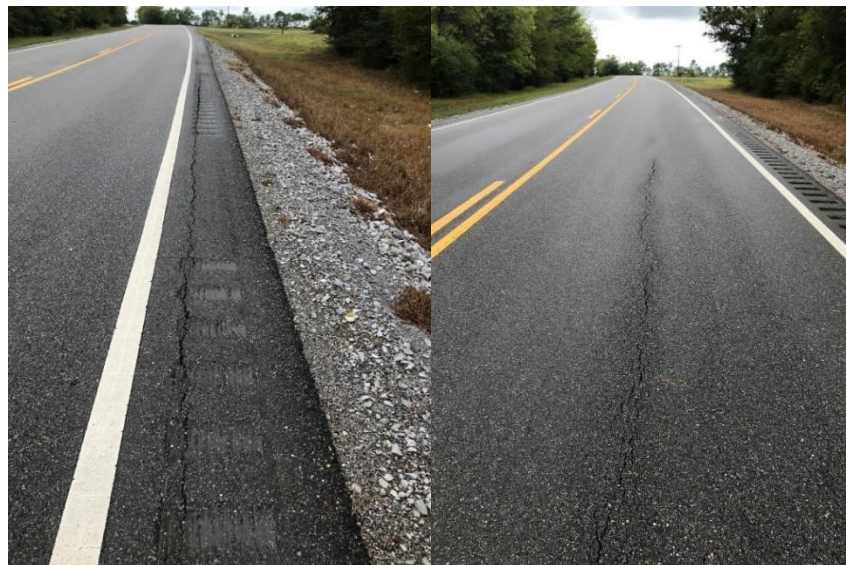
Figure 114: Shoulder and Lane Cracking in the Edge Drain Test Section October 2019

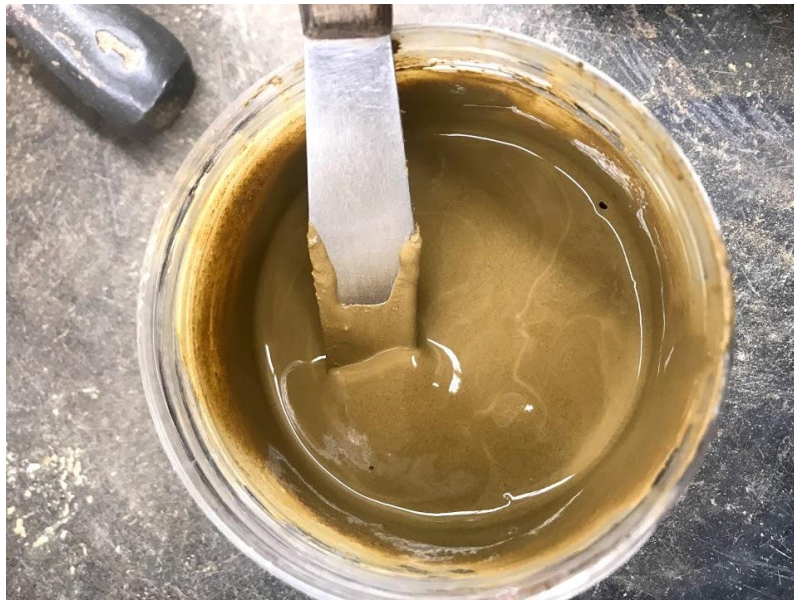
Figure 119: Sand Blanket Material Prepared to Liquid Limit

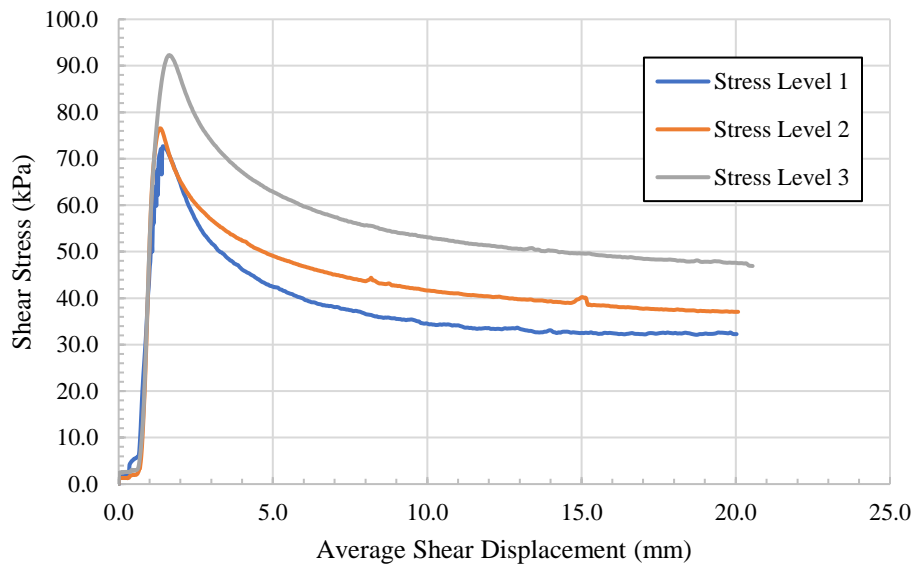
Figure 124: Shear Stress versus Average Shear Displacement for Sand Blanket (B1.5)
