**A Study of Driver Behavior at Access Points with Restricted Left Turn Movements: Case Studies in Alabama**

A thesis submitted to the Graduate Faculty of  
Auburn University  
in partial fulfillment of the  
requirements for the Degree of  
Master of Science

Auburn, Alabama  
August 6, 2022

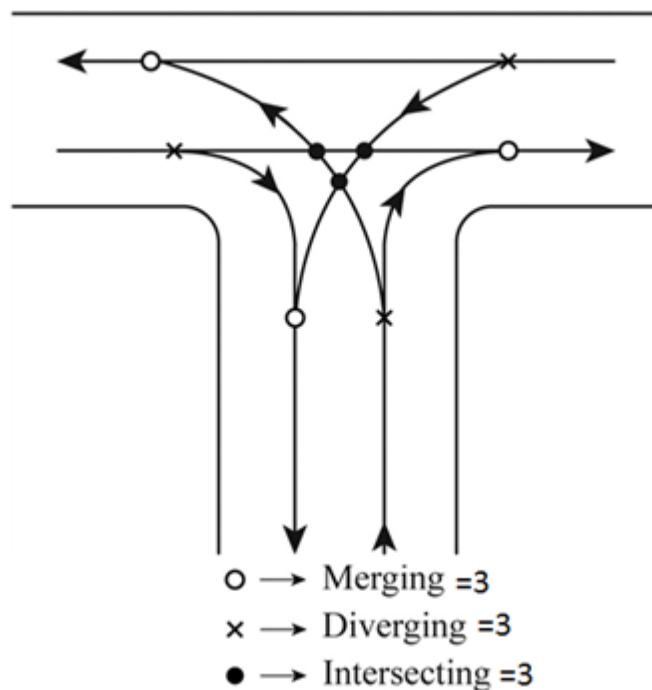
As can be seen in **Figure 1**, there are a total of 9 conflict points at a three-way intersection.

**Figure 1 Three-leg Intersection with No Restrictions (7)**

- Provide countermeasures to reduce illegal left turns at unsignalized accesses on roadways.
- Provide countermeasures for reducing the number of times a motorist drives on the wrong side of a channelizing island at unsignalized accesses on roadways.
- Determine the scope of the illegal left turns
- Reduce the number of conflicts, as illustrated in **Figure 1** and **Figure 2**

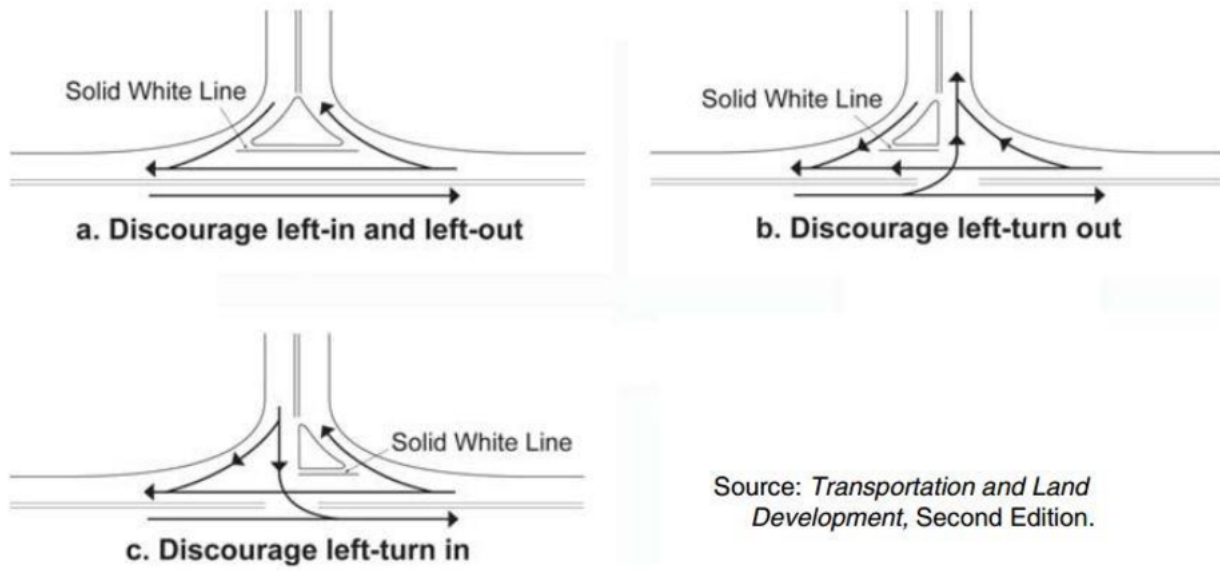
These are reduced when there are restricted left turn designs, as seen in **Figure 2**. Left turn crashes tend to be more severe because they involve a T-bone type of impact.

**Figure 2 Various Conditions and Conflict Points for Three-leg Intersections (8)**

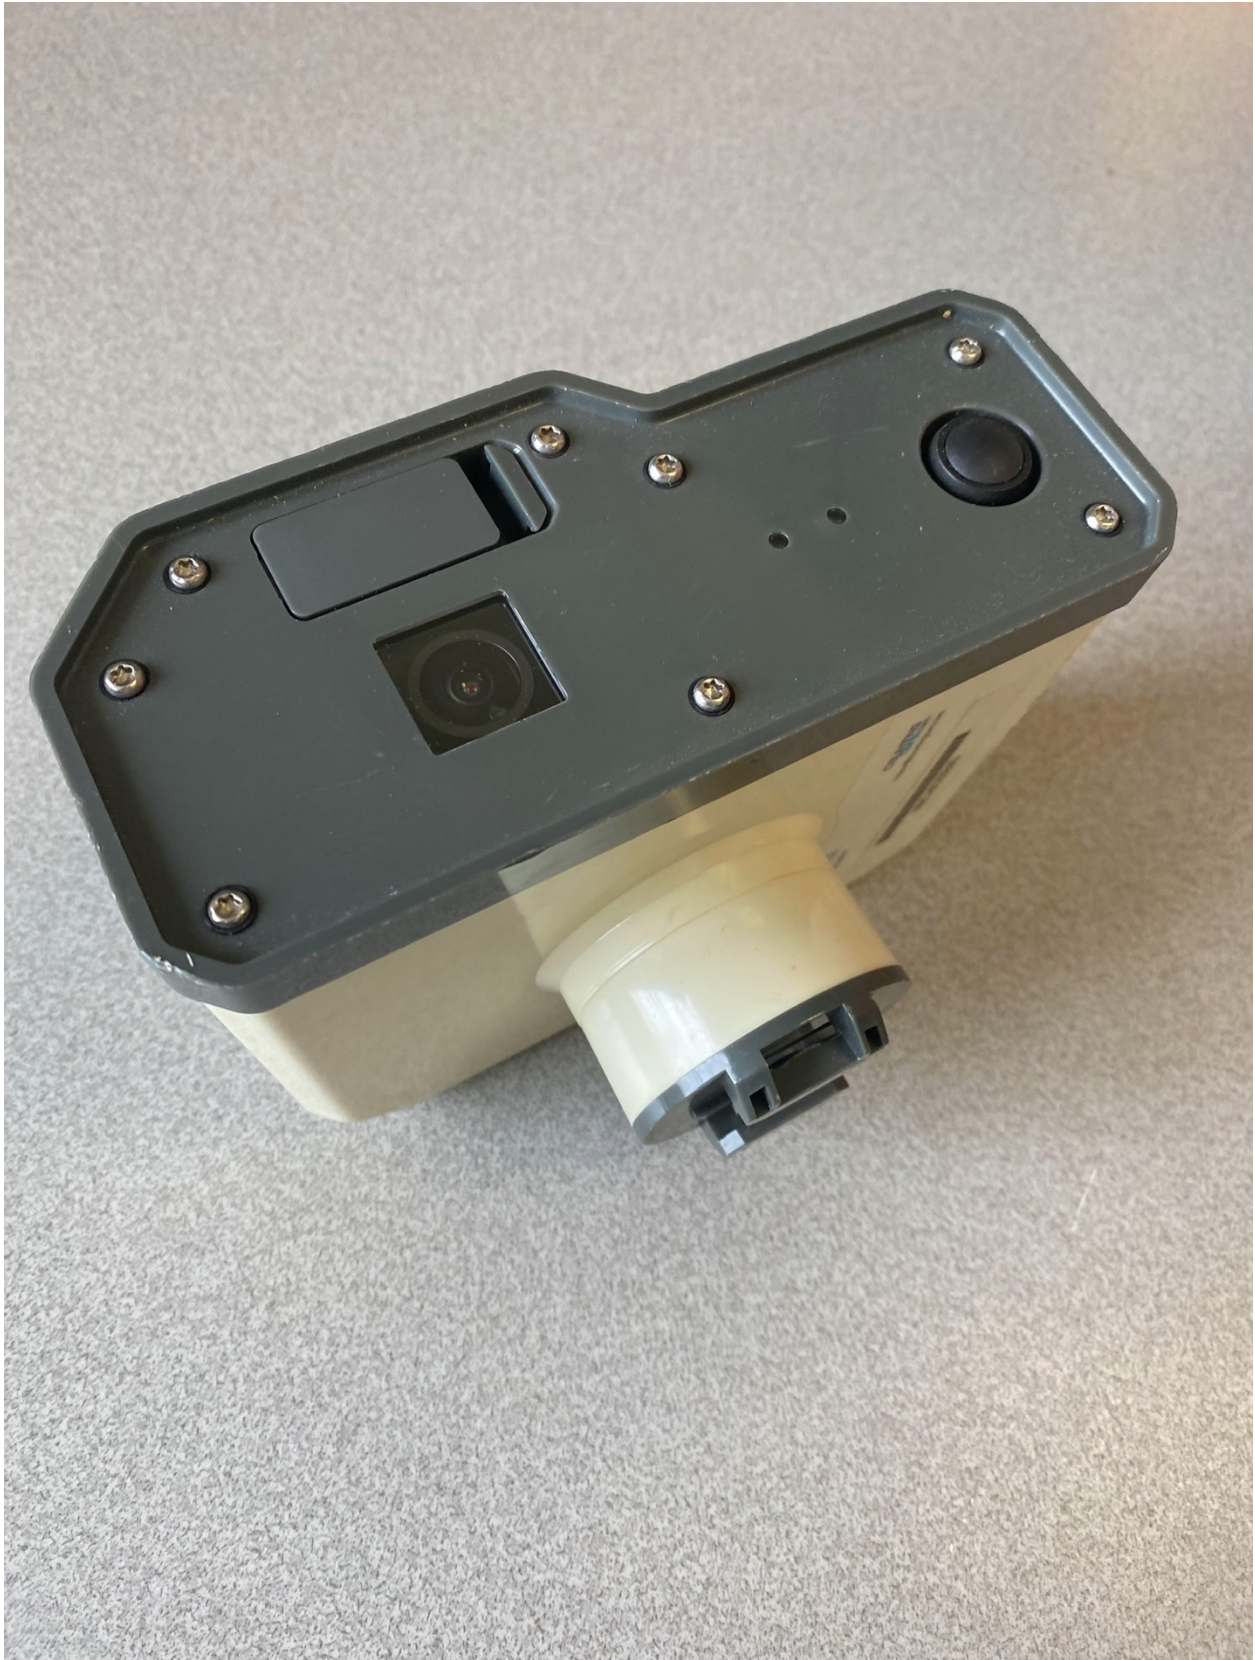
**Figure 3 A Portable Camera used to record Illegal Left Turns**

The research team installed portable traffic cameras mounted near the respective locations. The videos were recorded for 72 hours during the three weekdays (Monday to Thursday). The videos were analyzed by observing the driver behavior and their actions when approaching the restricted left turn. The total number of vehicles that approached the restricted left turn were counted as well as the number of vehicles that made an illegal left turn. This would give a ratio of the drivers that would make an illegal left turn. Other abnormalities such as driving on the wrong side of the channelized island were noted.

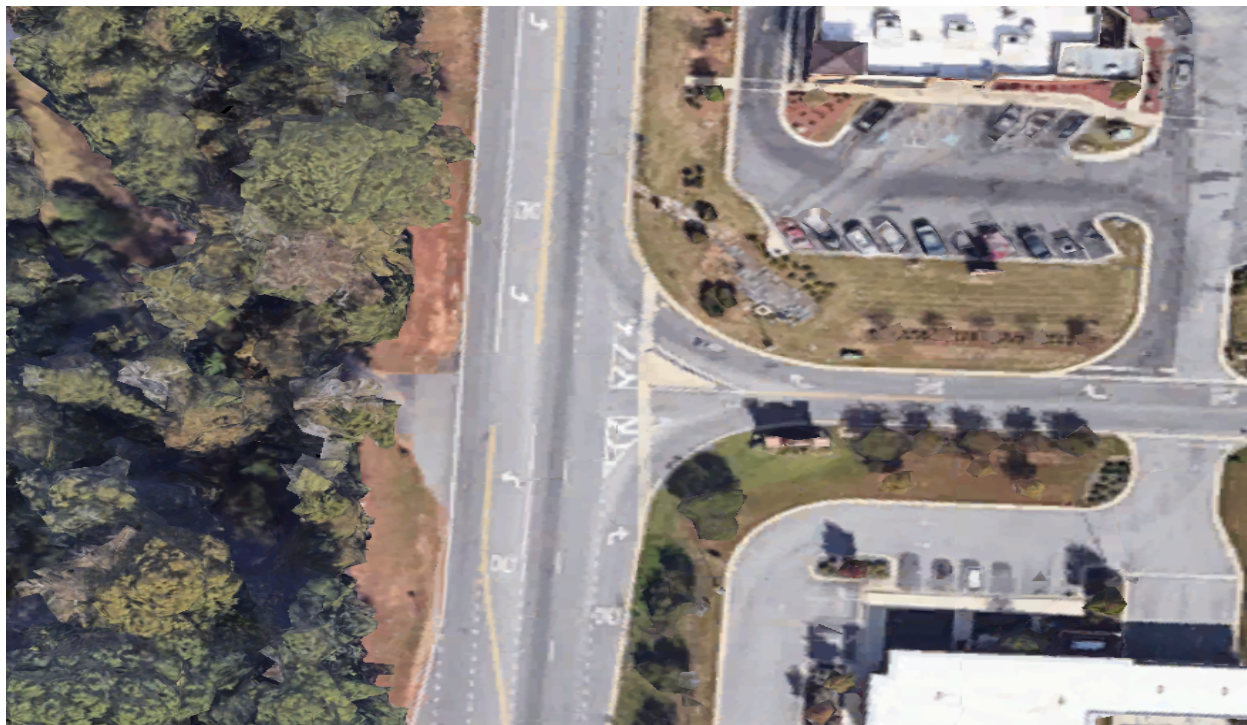
North College Street is a two-lane principal arterial having auxiliary lanes, with a speed limit of 50 miles per hour at the grocery store entrance. The grocery store entrance has one lane coming out of the store. This lane is designed for right out only traffic. Traffic coming into the store is allowed to turn in from both the north and southbound directions. Channelized island, right-turn only sign, and lane use arrows are installed on the minor road to restrict left-turns from driveways. **Figure 4** and **Figure 5** show this location from an aerial and ground view respectively.

**Figure 4 Aerial view of North College Street at the Grocery Store Entrance (27)**

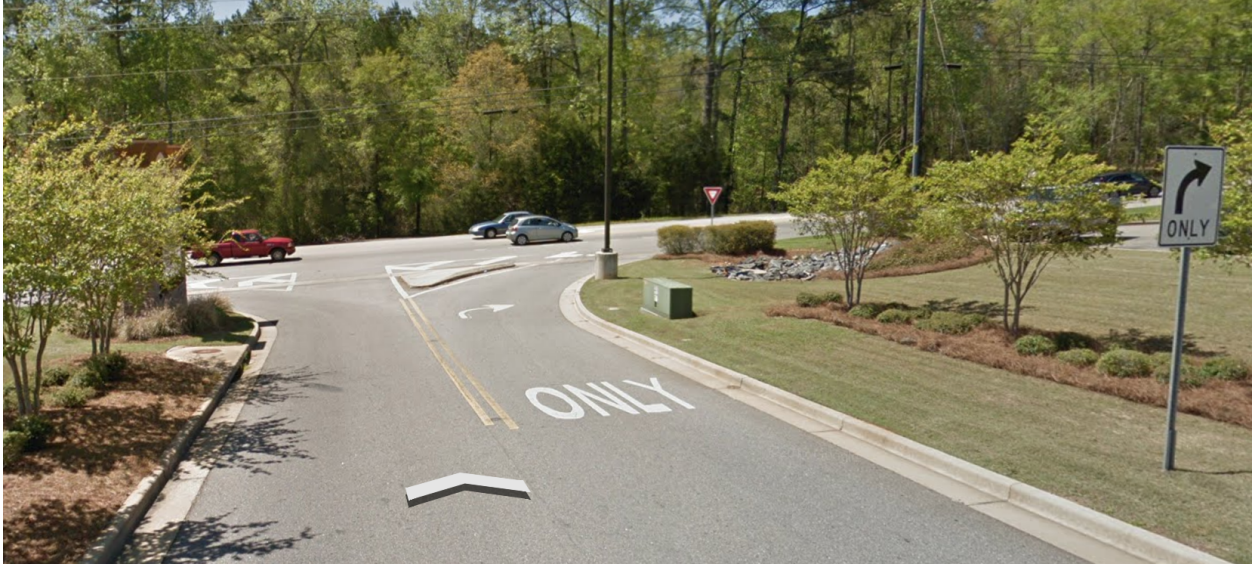
**Figure 5** Ground view of North College Street at the Grocery Store Entrance (27)

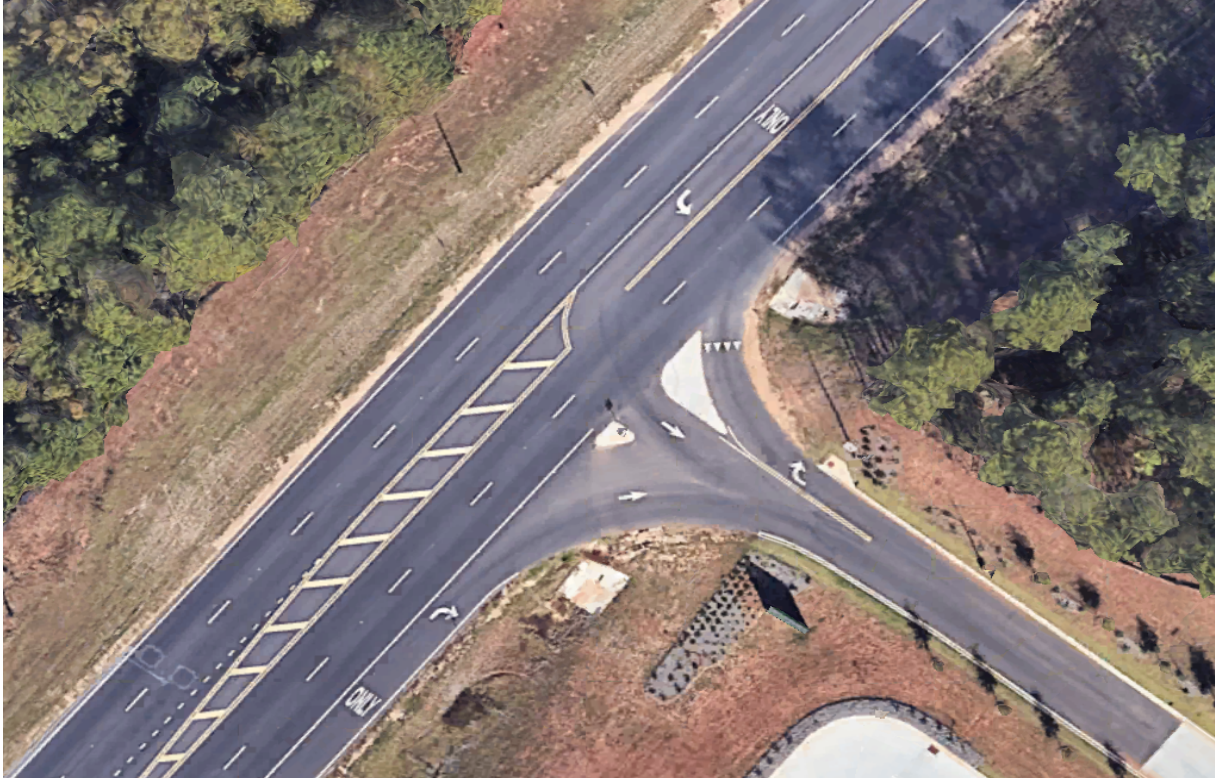
Shug Jordan Parkway is a four-lane undivided principal arterial, with a speed limit of 55 miles per hour. There is only one lane for traffic exiting the gas station. There is a channelized island encouraging people to turn right out of the gas station. There is a DNE sign and a lane use arrow on the pavement to deter people from driving on the wrong side of the channelized island.

**Figure 6**Aerial view of Shug Jordan Parkway at the Gas Station Entrance (27)

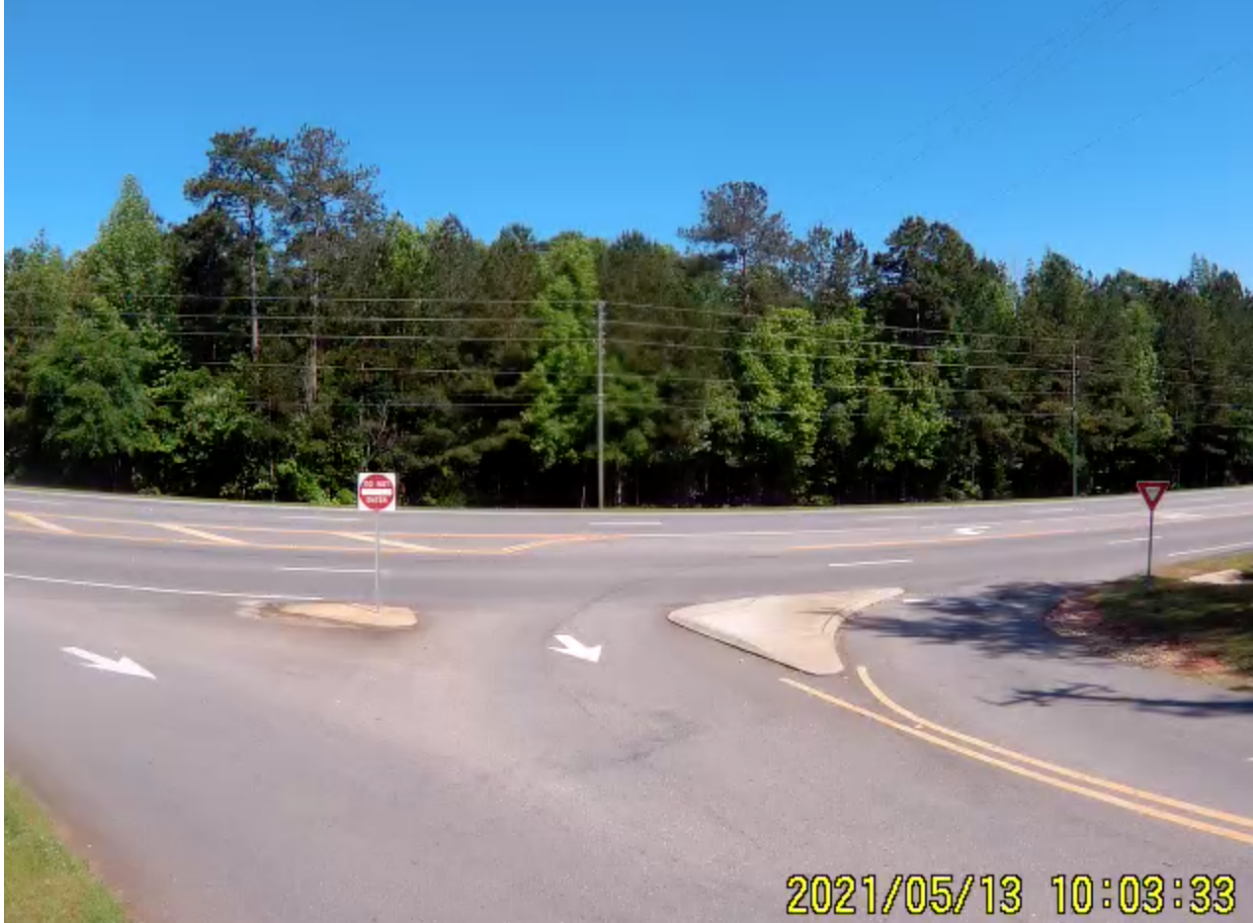
**Figure 7** Ground view of Shug Jordan Parkway at the Gas Station Entrance

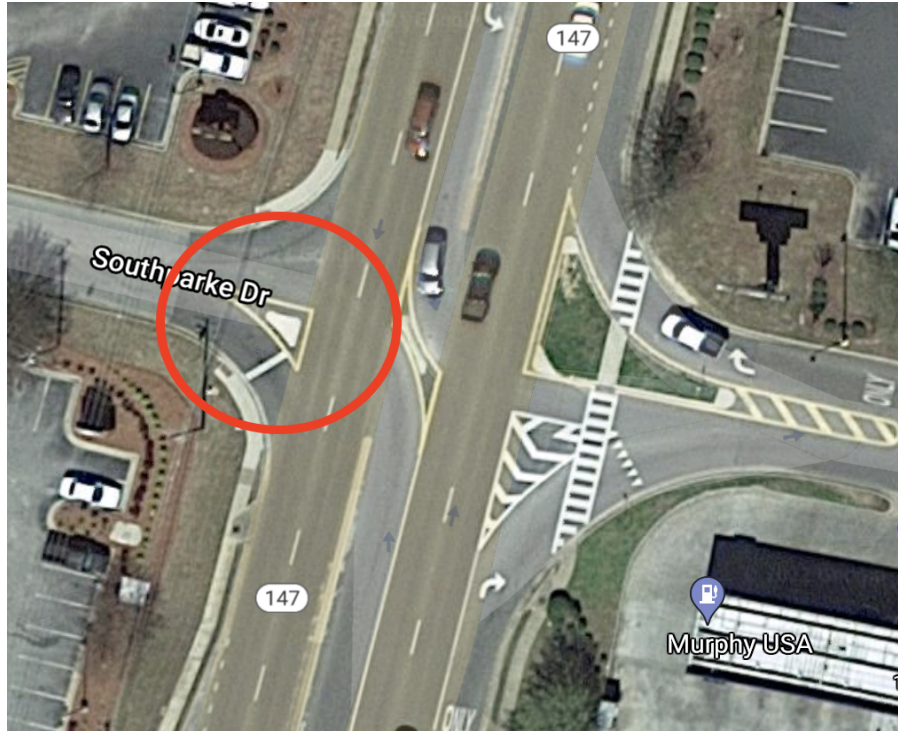
South College Street is a four-lane undivided principal arterial, with a speed limit of 45 miles per hour. The entrance at Restaurant is a right-in-right-out only access design. There is a raised concrete median separating the two directions of traffic flow on the South College Street. **Figure 8** and **Figure 9** show this location from an aerial and ground view respectively.

**Figure 8 Aerial view of South College Street at Southparke Drive (27)**

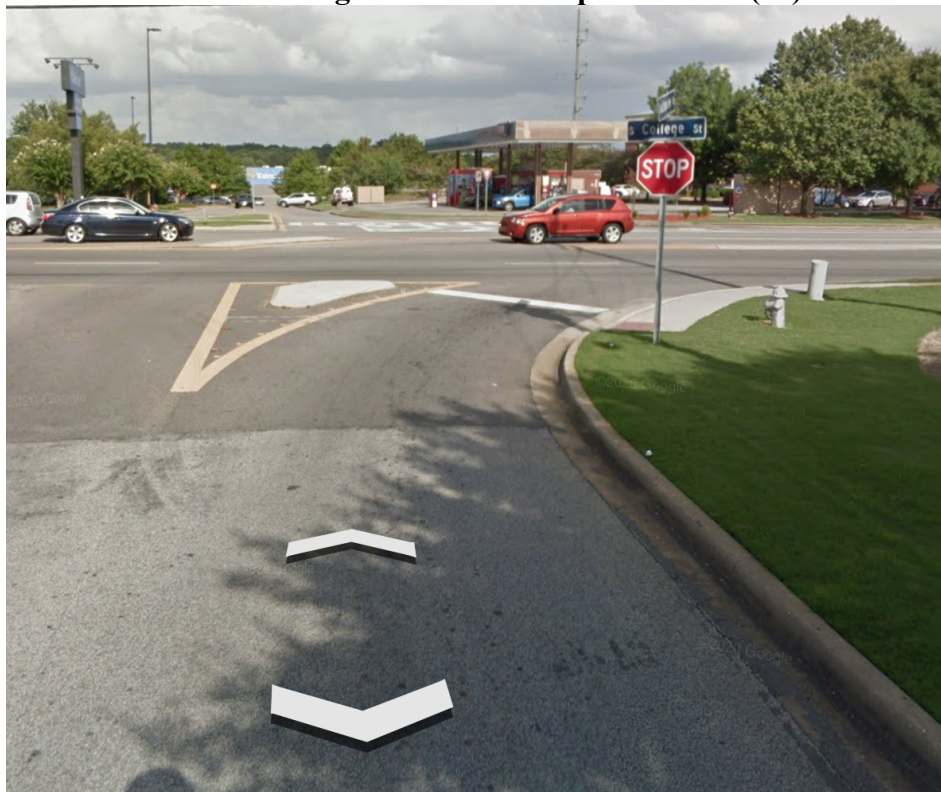
**Figure 9 Ground view of South College Street at Southparke Drive (27)**

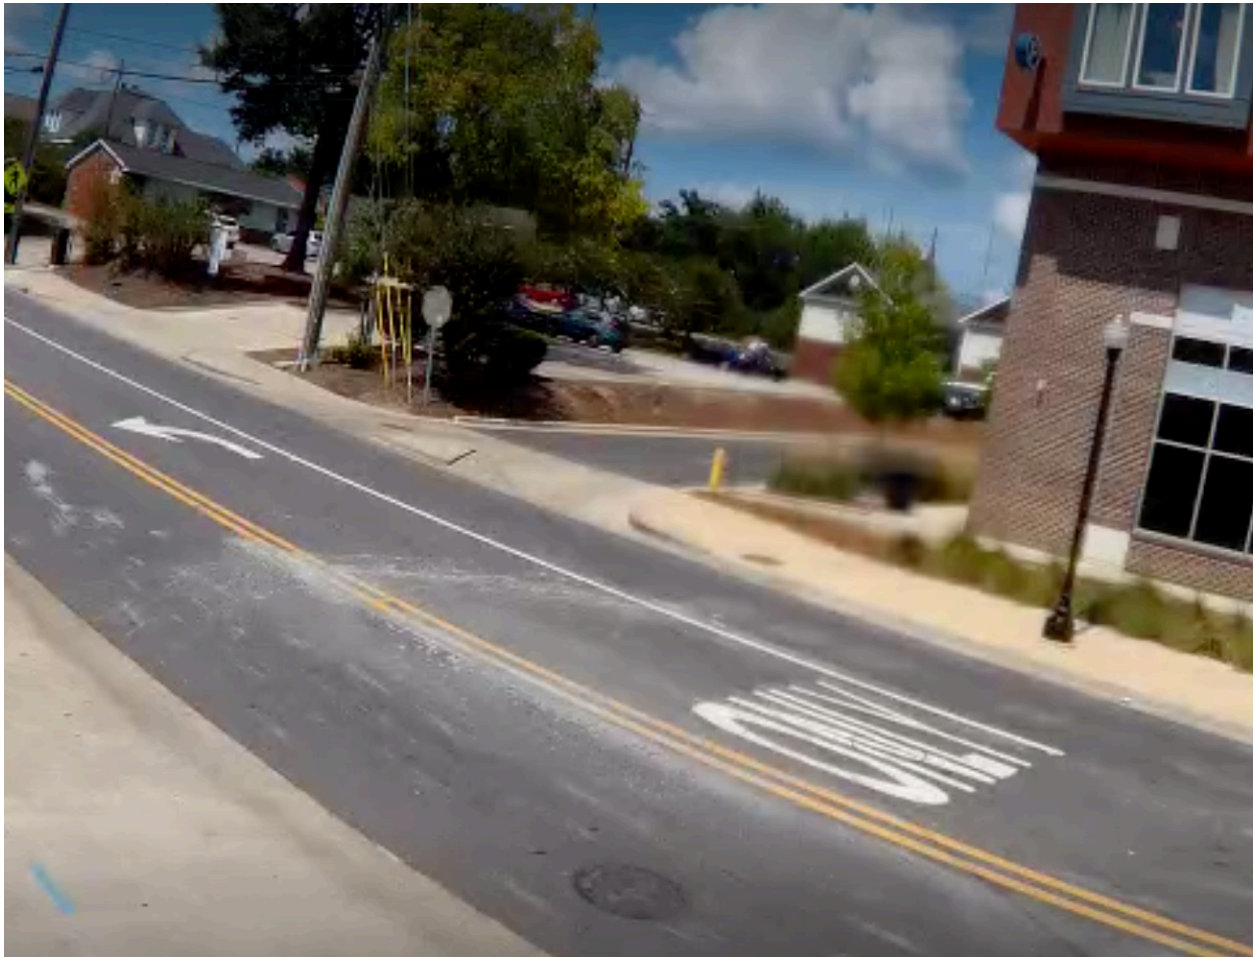
Glenn Avenue is an east-west undivided minor arterial, with a speed limit of 25 miles per hour. The entrance to the apartment is a right-in-right-out only access design. **Figure 10** shows this location from a ground view.

**Figure 10 Ground view of Glenn Avenue at the Apartment Entrance**

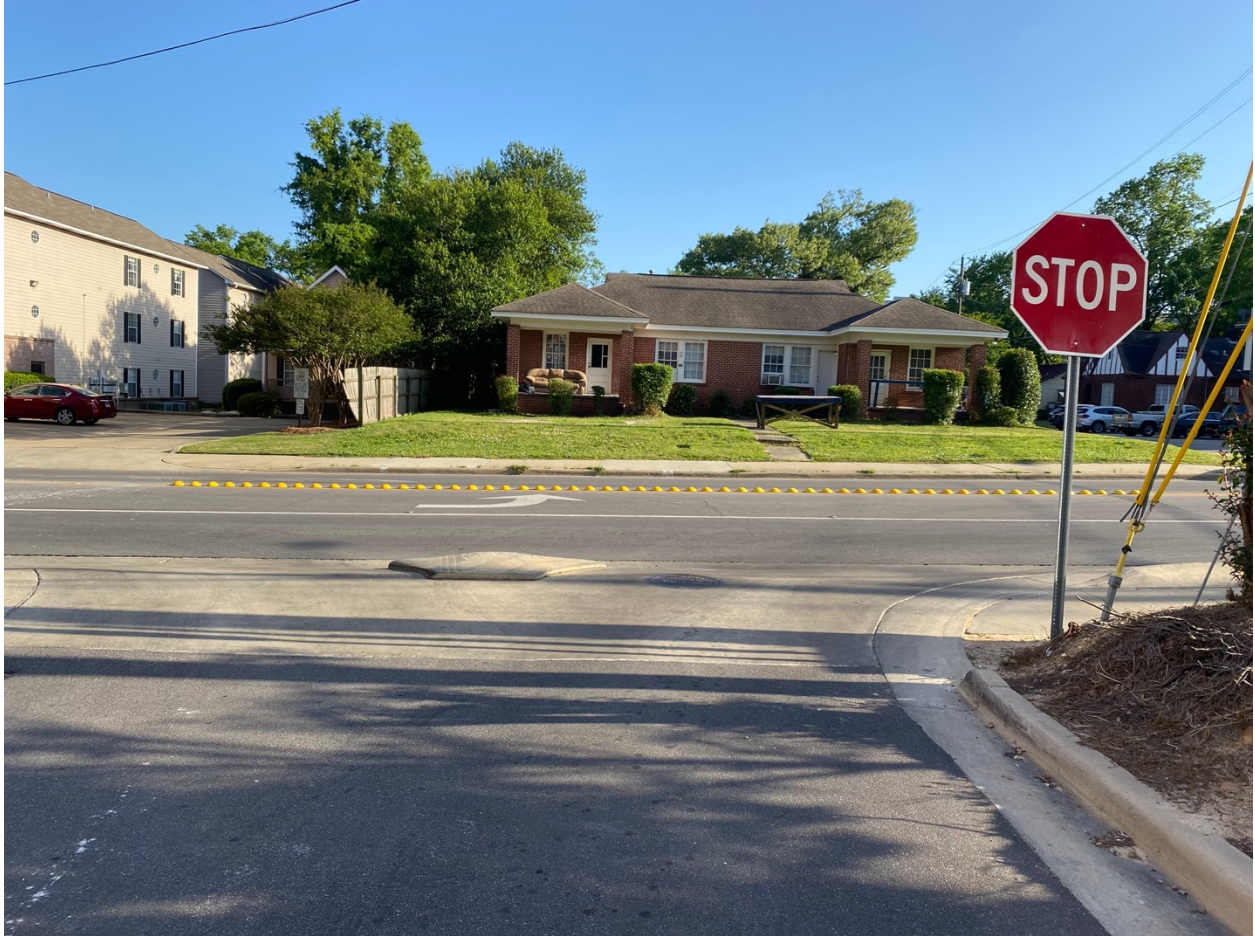
**Figure 11 Alternate Ground view of Glenn Avenue at the Apartment Entrance**

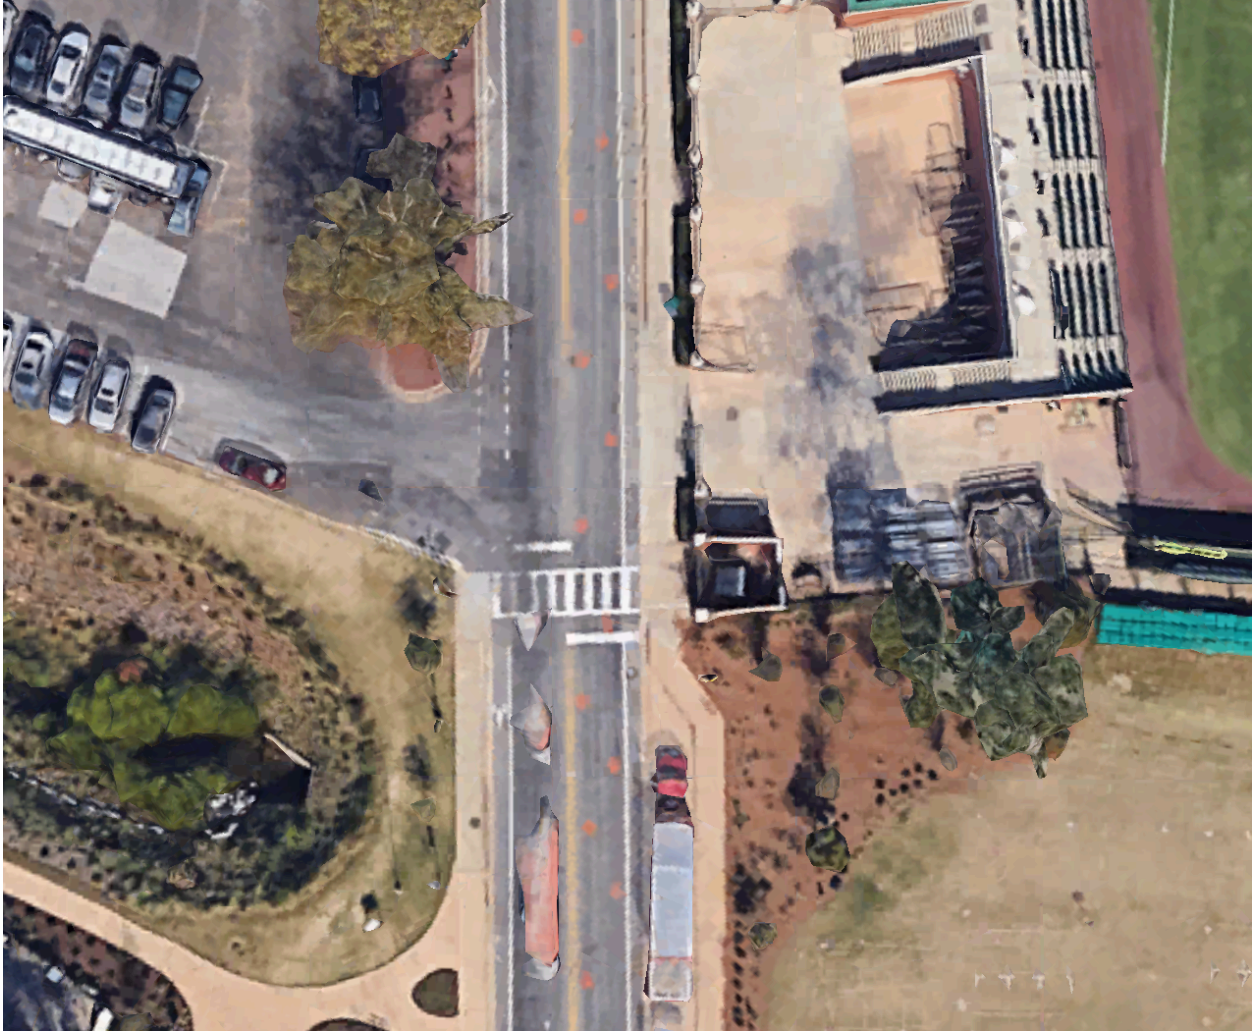
Donahue Drive is a two-lane undivided minor arterial, with a speed limit of 25 miles per hour. The exit is a right-out only access design. **Figure 12** and **Figure 13** show this location from an aerial and ground view respectively.

**Figure 12 Ariel view of Donahue Drive at the Entrance near Baseball Ballfield (27)**

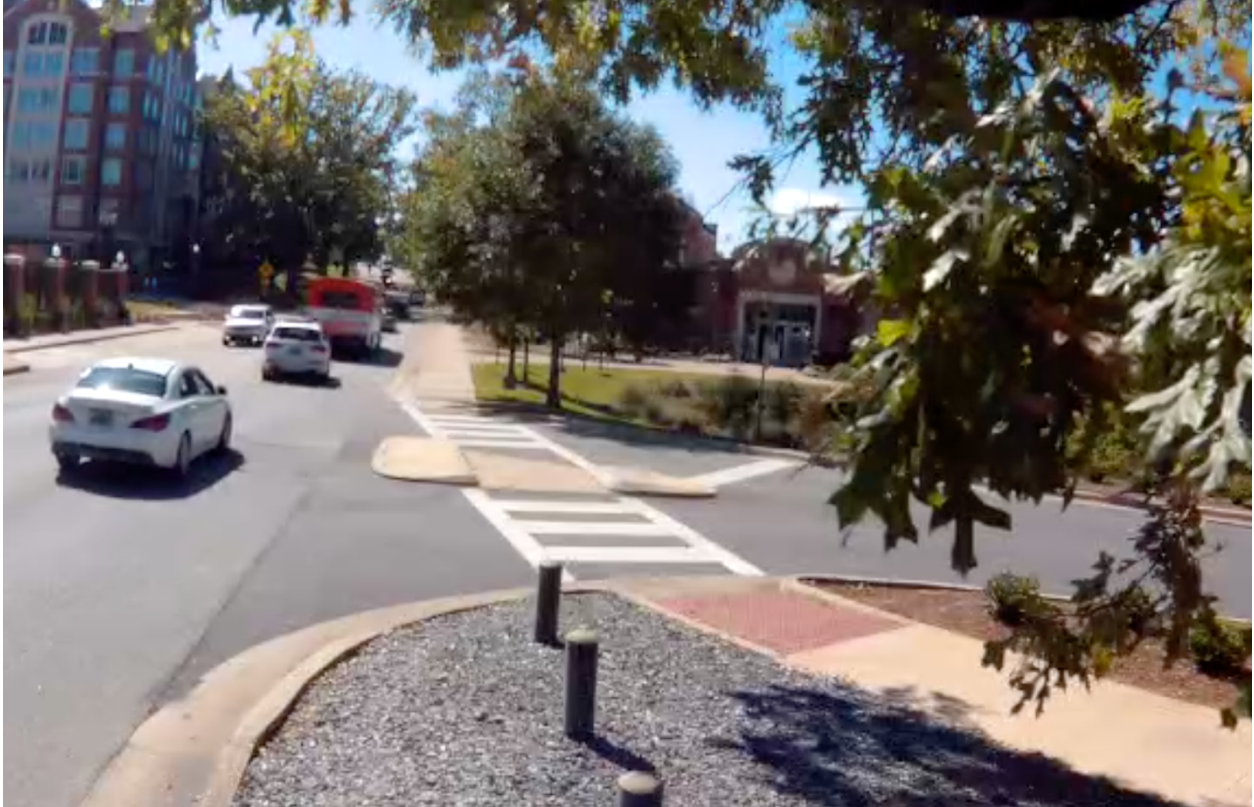
**Figure 13 Ground view of Donahue Drive at the Entrance near Baseball Ballfield**

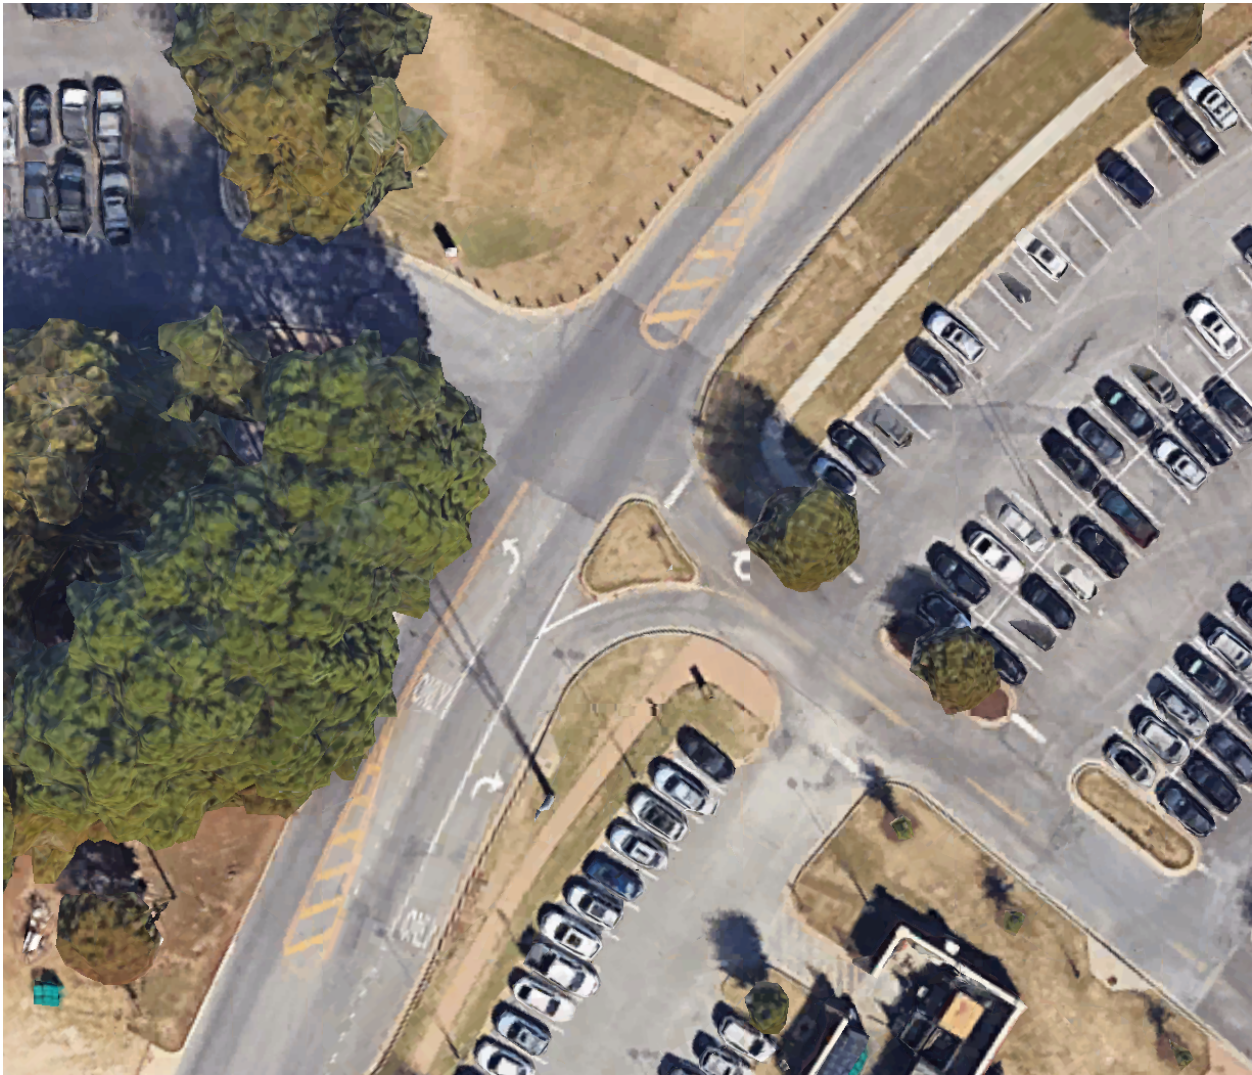
Wire Road is a two-lane undivided local roadway, with a speed limit of 20 miles per hour. The entrance is a right-in-right-out only access design. **Figure 14** and **Figure 15** show this location from an aerial and ground view respectively.

**Figure 14** Ariel view of Wire Road at the Entrance near War Eagle Way (27)

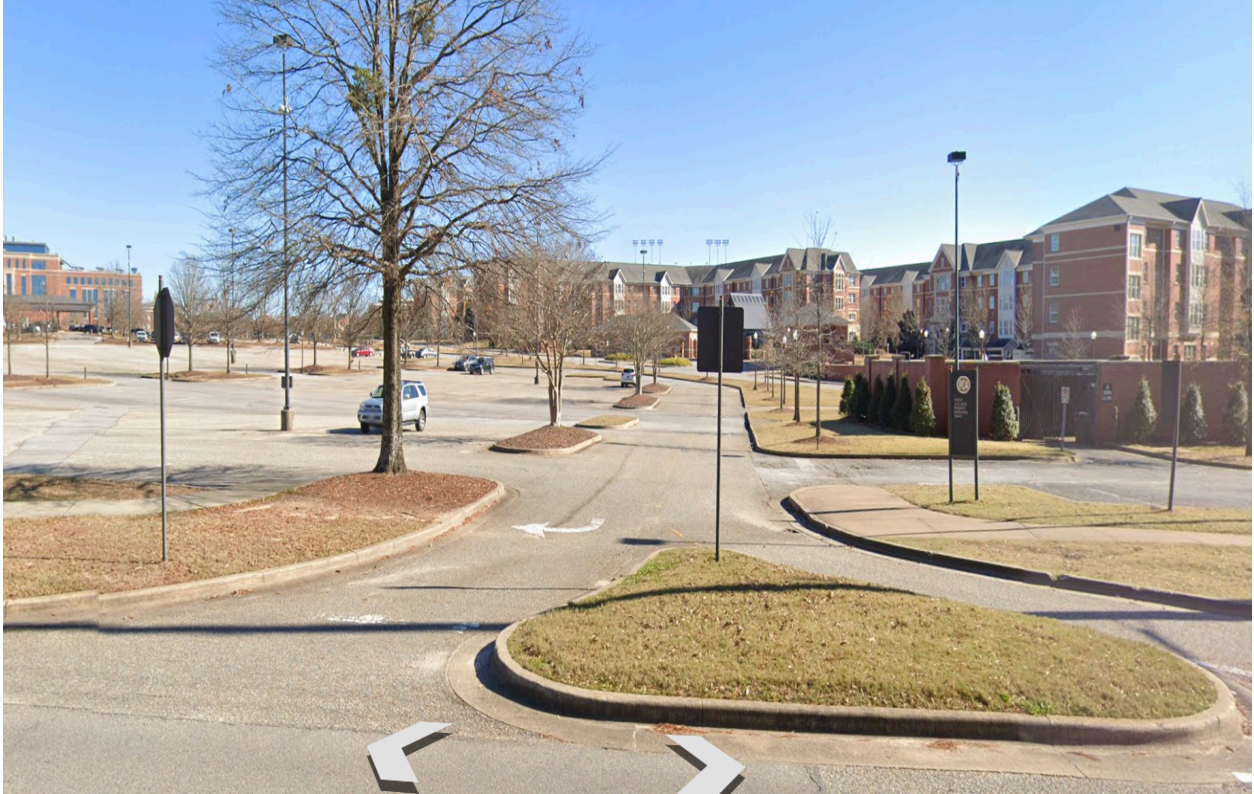
**Figure 15 Ground view of Wire Road at the Entrance near War Eagle Way (27)**

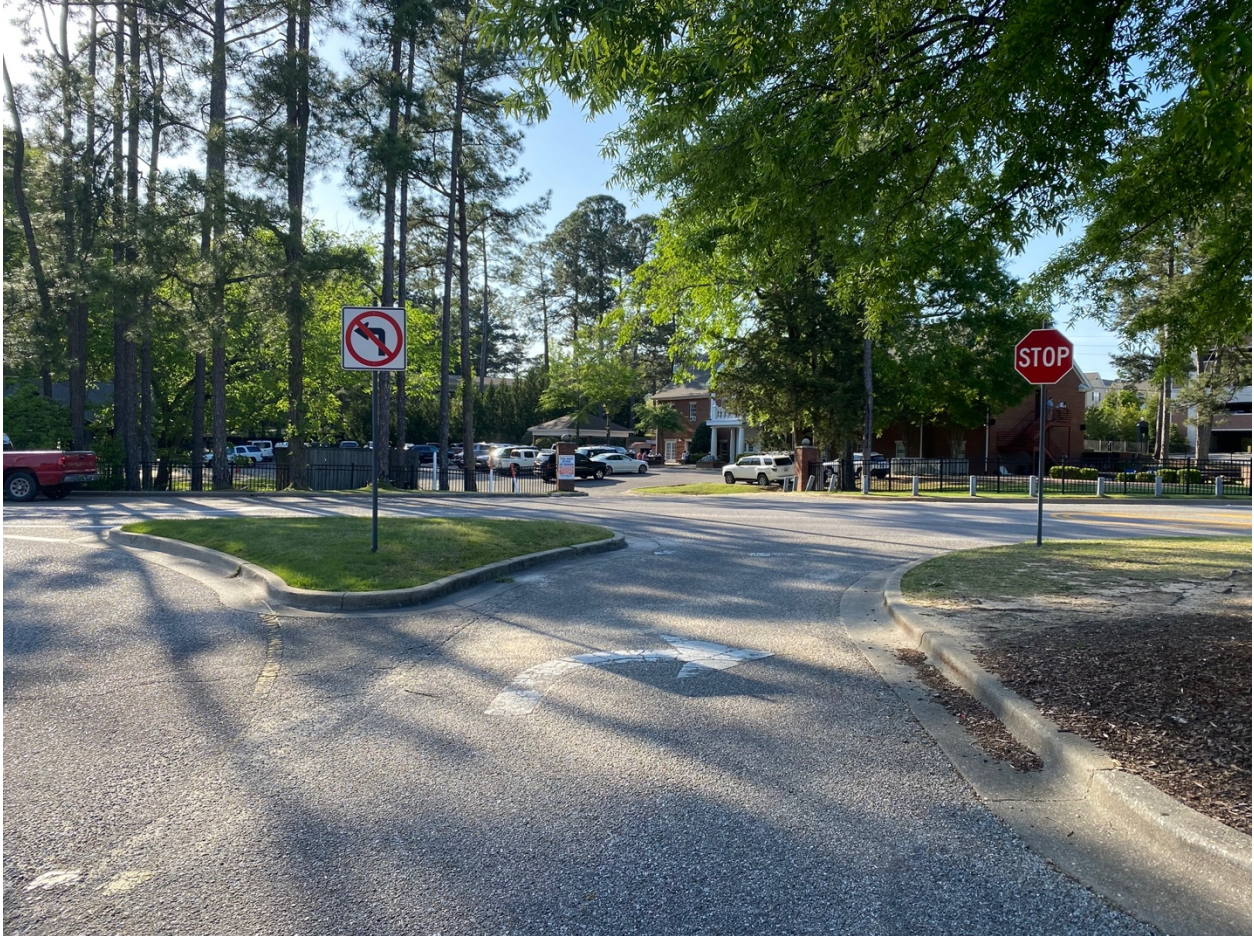
**Figure 16 Alternate Ground view of Wire Road at the Entrance near War Eagle Way**

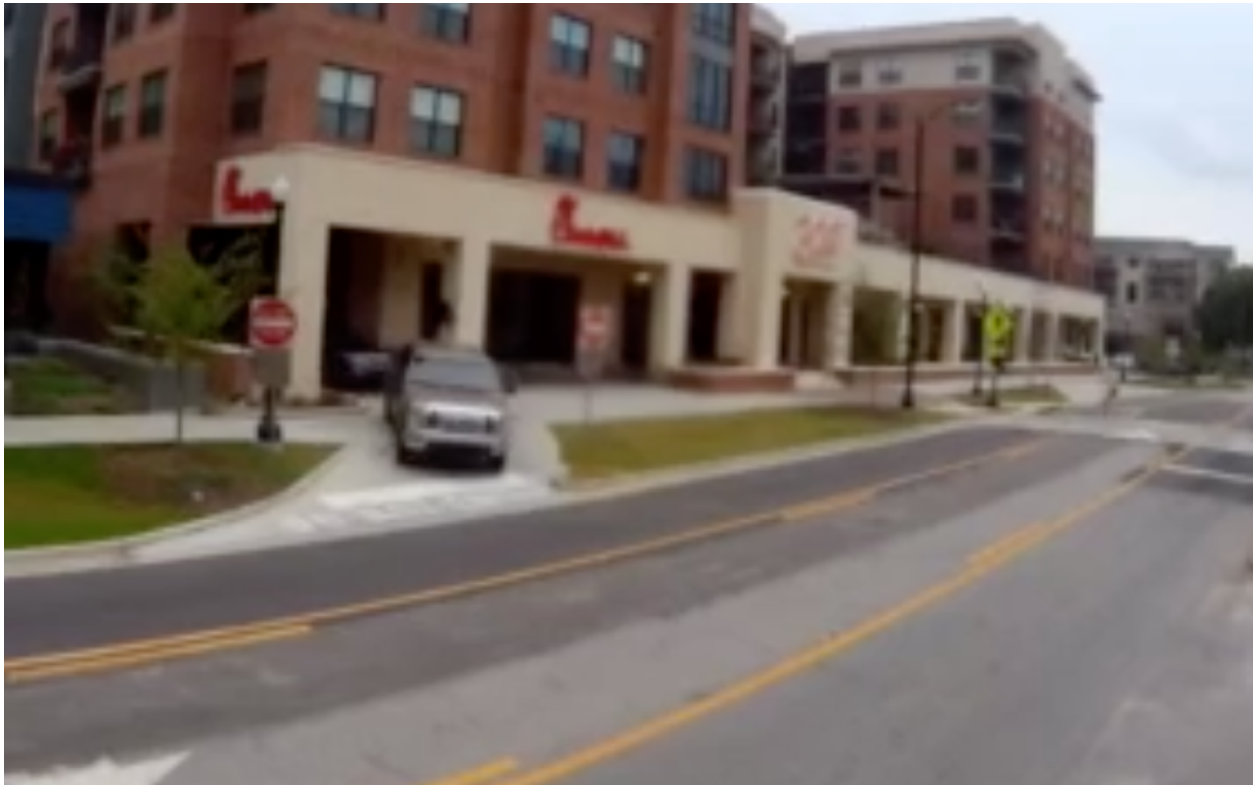
Magnolia Avenue is a three-lane undivided minor arterial with a two-way-left-turn-lane, with a speed limit of 25 miles per hour. The exit at the Restaurant is a right-out only access design. **Figure 17** shows this location from a ground view.

**Figure 17 Ground view of Magnolia Avenue at the Restaurant Exit**

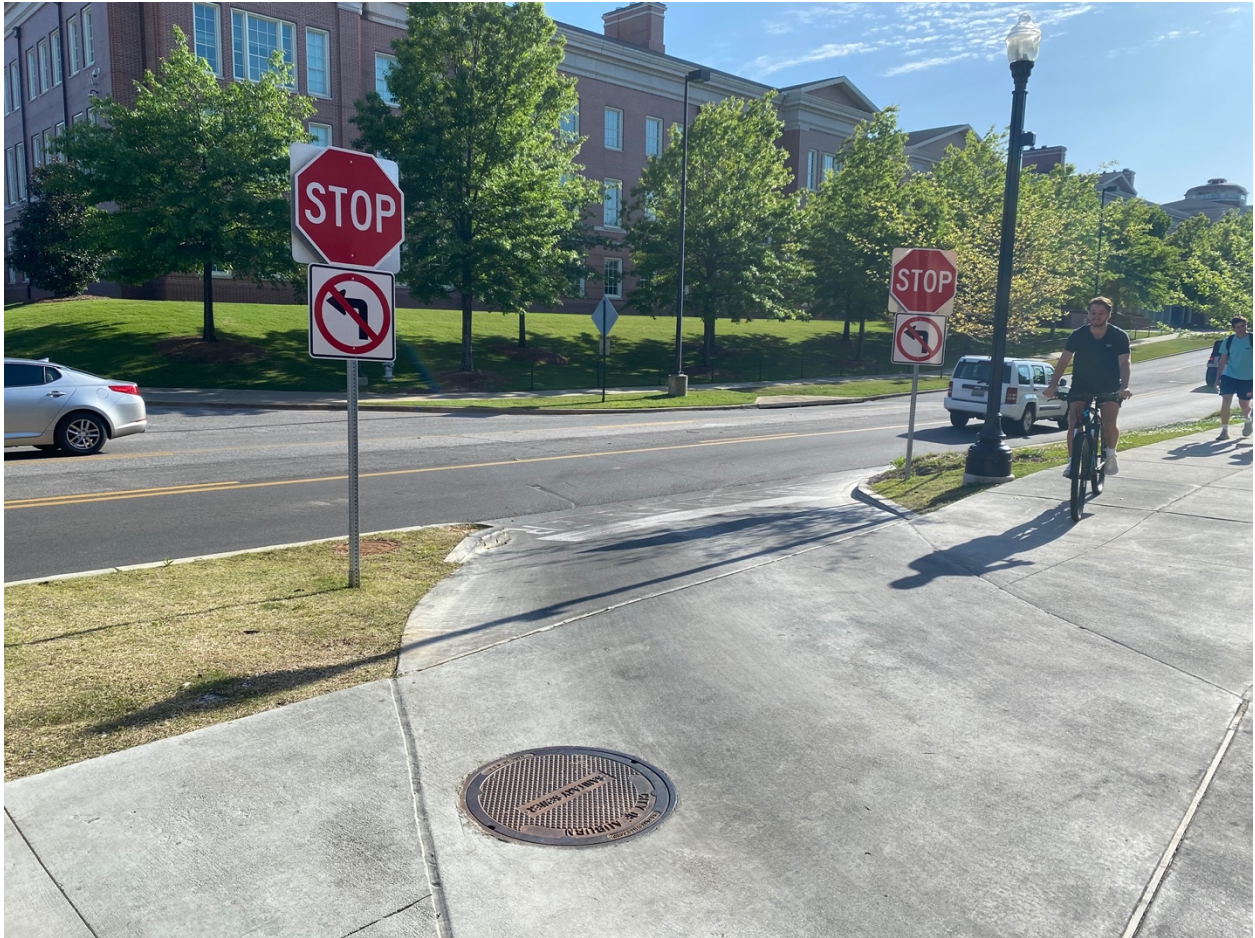
**Figure 18 Alternate Ground view of Magnolia Avenue at the Restaurant Exit**

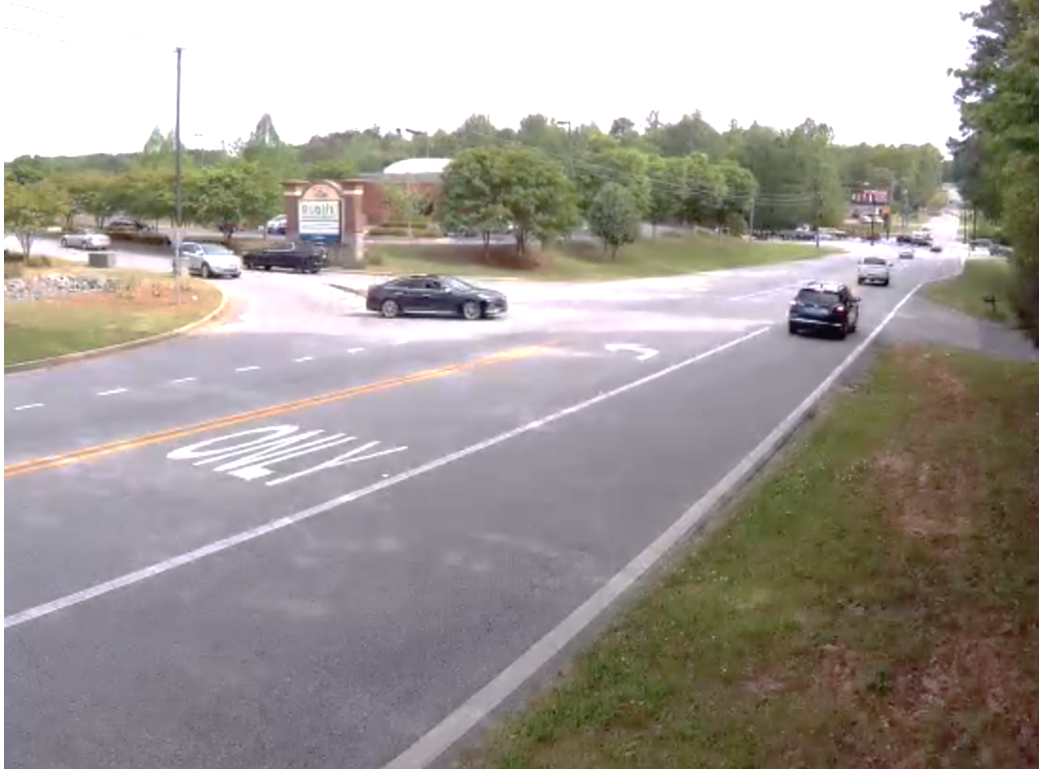
From the grocery store entrance location on North College St, it was found that roughly 1 in every 3 vehicles made an illegal left turn. **Table 2** represents a sample of vehicles that approached the restricted left turn in 30-minute periods. In addition, it was also determined that 1 in 20 vehicles that made an illegal left turn made the left turn from the wrong side of the channelized island. Also, there was a close conflict in approximately 1 out of every 33 vehicles turning out of the grocery store access. A close conflict was defined when vehicles made an illegal left turn and would interfere with cars on the major road. As shown in **Figure 19**, an illegal left turn can be found at this location. In addition, in **Figure 20**, an example can be seen of a vehicle driving on the wrong side of the channelized island.

**Figure 19** Illegal left turn onto N. College Street at the Grocery Store entrance location

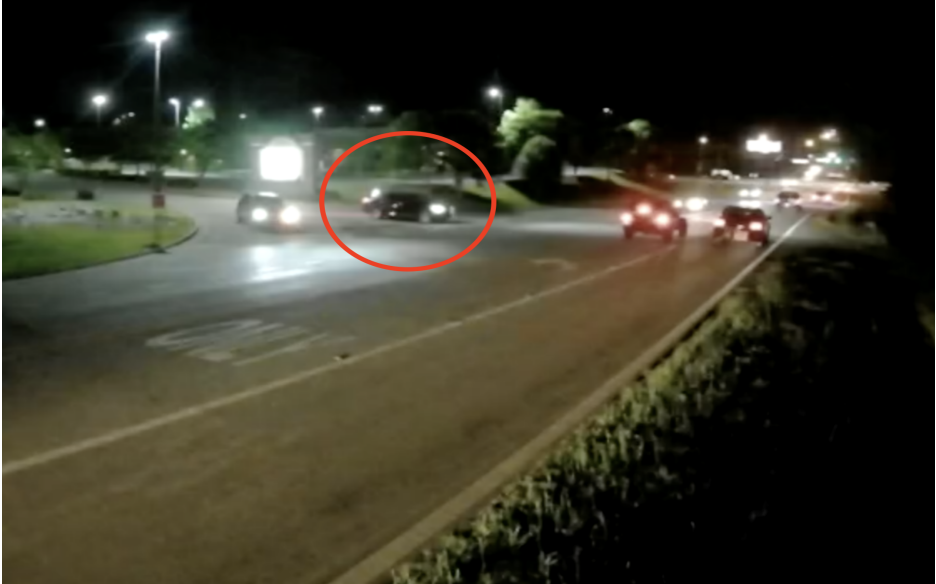
**Figure 20** Vehicle on the wrong side of the channelized island at the Grocery Store entrance location

The behaviors were analyzed by reviewing the videos recorded by portable traffic cameras. Driver behavior in this study was defined by the vehicles' actions that were taken at the restricted left turn. While making an illegal left turn, the driver's behavior showed vehicles yielding at the channelized island and making a large J turn to go around the channelized island and turn left, as shown in **Figure 21**. In addition, when there were no pavement markings and few signs to direct drivers, there were behaviors of driving on the wrong side of the channelized island as shown in **Figure 20**.

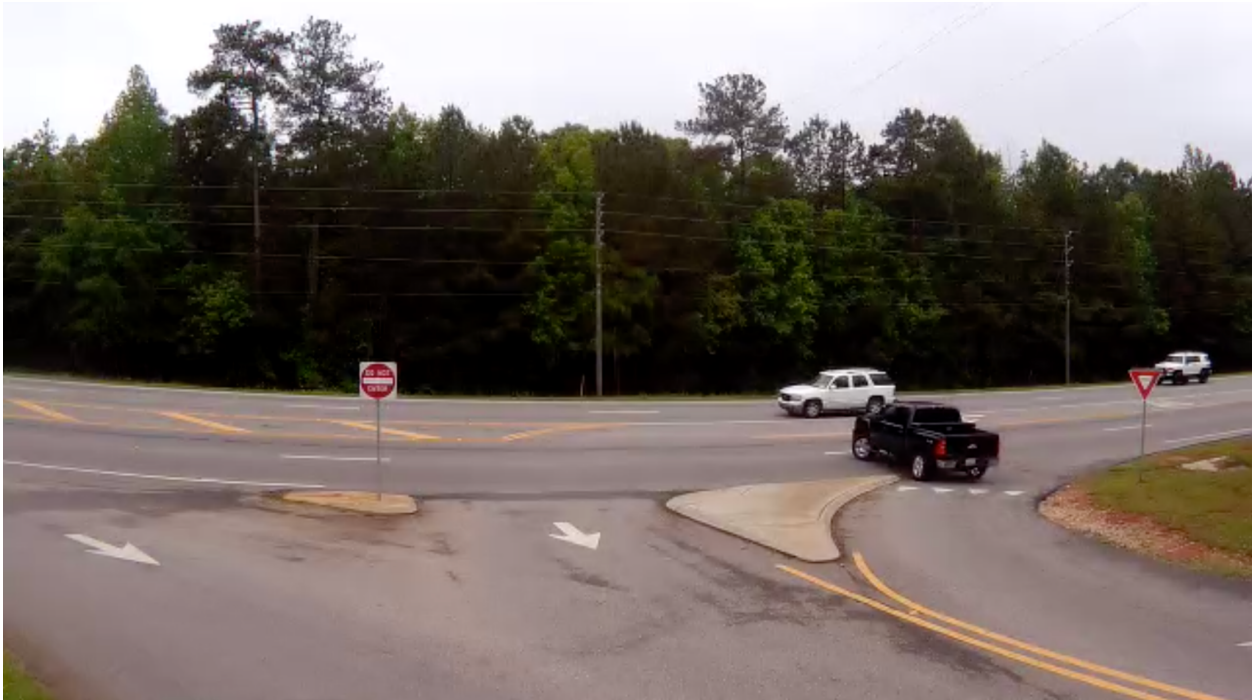
drivers drove over the channelized island or waited in the striped median to merge into oncoming traffic. At this location, there were no cases of driving on the wrong side of the channelized island. This is because this location has a “DNE” sign as well as pavement markings in the entrance lane. An example of an illegal left turn at this location can be seen in **Figure 21** below.

**Figure 21 Illegal left turn onto Shug Jordan Parkway at the Gas Station location**
