**A Study of Driver Behavior at Access Points with Restricted Left Turn Movements: Case Studies in Alabama**

A thesis submitted to the Graduate Faculty of  
Auburn University  
in partial fulfillment of the  
requirements for the Degree of  
Master of Science

Auburn, Alabama  
August 6, 2022

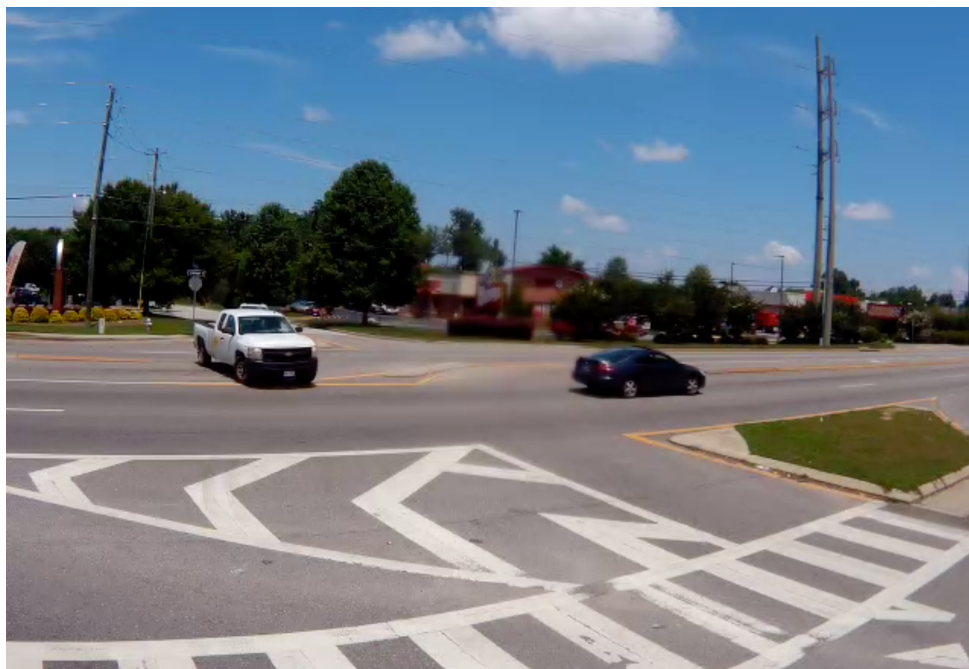
At Southparke Drive on South College Street, there were 1 in every 60 vehicles that made an illegal movement. Most illegal movements that were made were illegal left turns, but there were a couple cases where drivers illegally drove straight through the intersection. **Table 4** represents a sample of vehicles that approached the restricted left turn in 30-minute periods. It was observed at this location that drivers would wait in the left turn lane on South College Street to merge into oncoming traffic. It was also observed that the small concrete median installed at the major road was effective in preventing illegal left turns, but there are still points of improvement. In **Figure 22** below, an example can be seen of a vehicle making an illegal left turn and waiting in the left turn lane to yield onto South College Street.

**Figure 22 Illegal left turn onto South College Street at Southparke Drive**

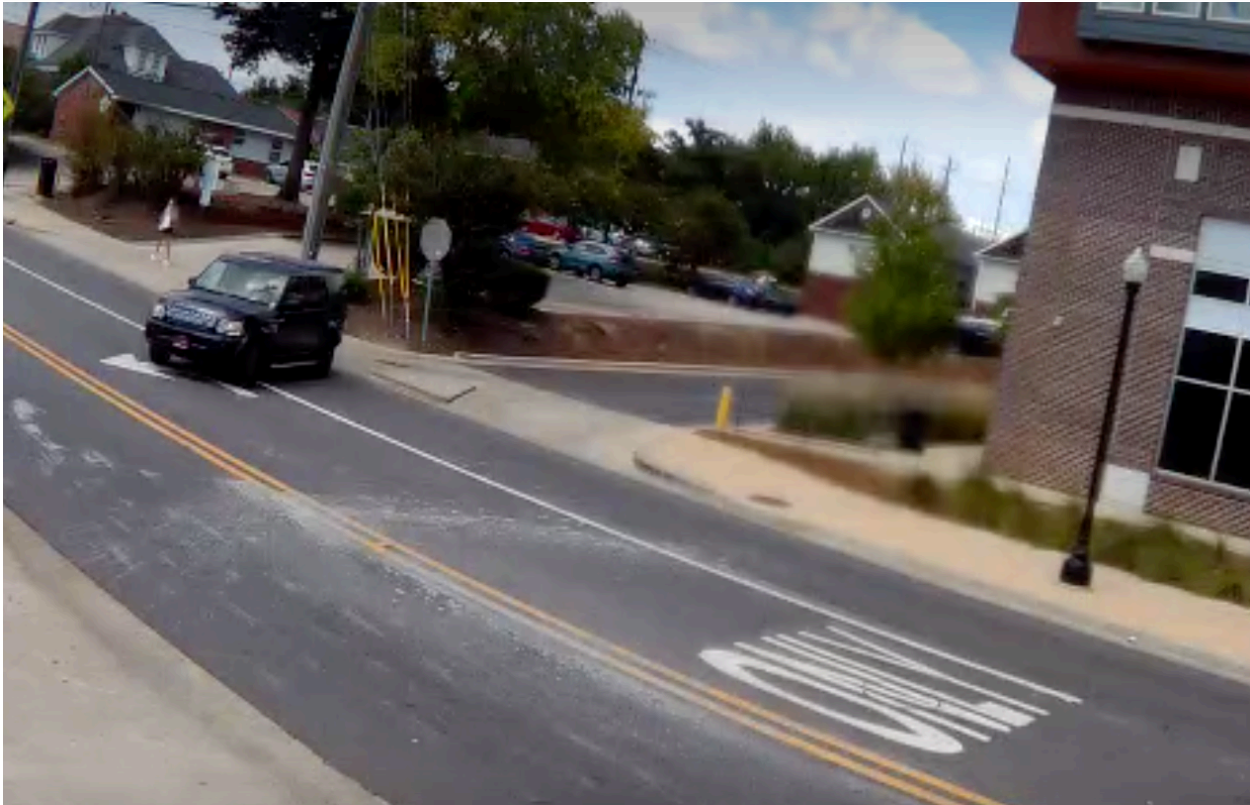
At the apartment location on Glenn Avenue, it was found that approximately 35% of vehicles were making an illegal left turn before yellow pavement markers were added. These yellow pavement markings were added as a deterrent to motorists making an illegal turn. It was found that after the yellow markers (8” round two-way yellow ceramic pavement markers) were added,

**Figure 23 Illegal left turn onto Glenn Avenue at the Apartment Location**

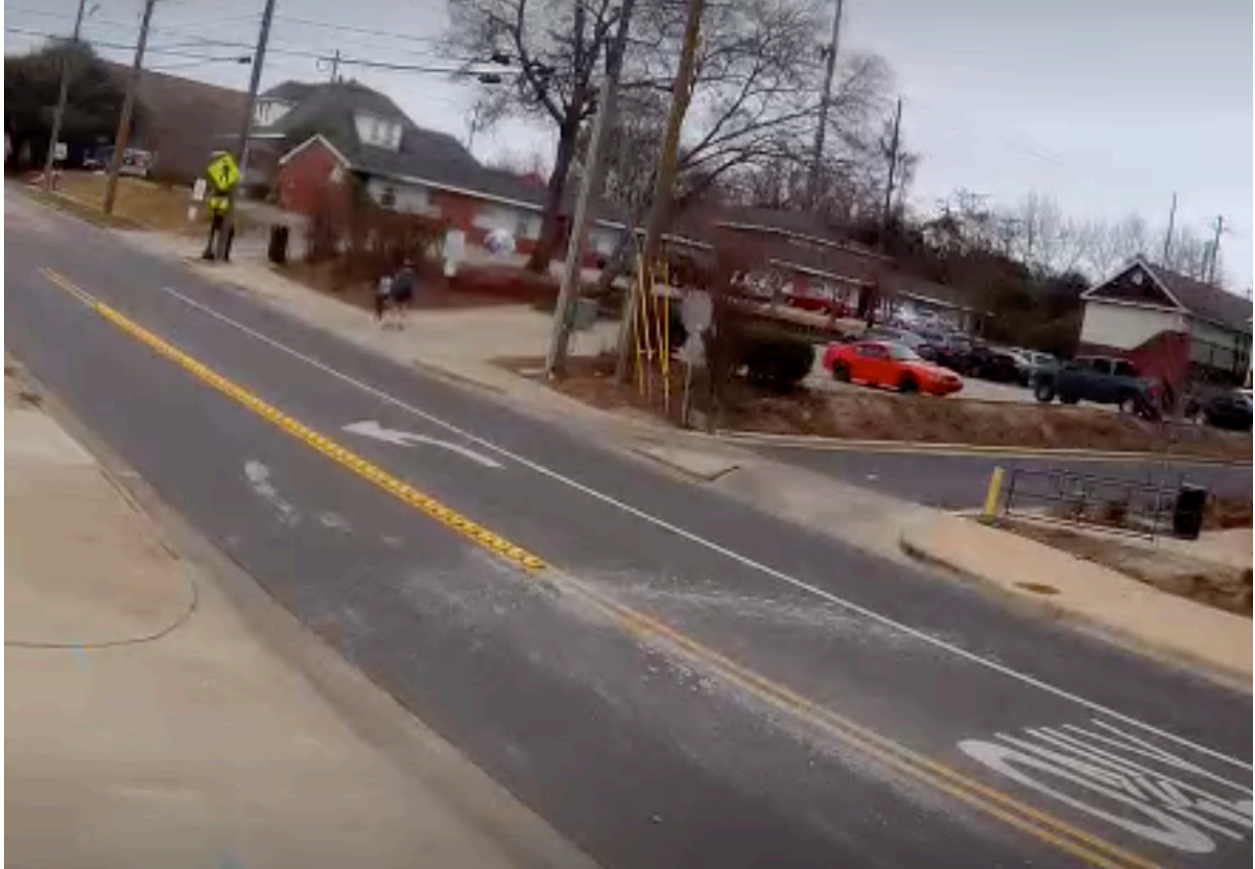
the percentage of vehicles making an illegal left turn was just 8%. **Table 5** represents the number of vehicles that approached the restricted left turn in 30-minute time periods before the markers were constructed. At this location, there were some cases of driving on the wrong side of the channelized island. **Table 6** represents the number of vehicles that approached the restricted left turn in 30-minute time periods after the markers were constructed. An example of an illegal left turn at this location before the construction of the yellow markers can be seen in **Figure 23** below. **Figure 24** is a picture of the location after the construction of the yellow markers.

**Figure 24 Glenn Avenue at Apartment Location (Note the addition of Yellow Markers)**

For the presence of 8” round two-way yellow ceramic pavement markers, the two scenarios that were compared were before the addition of yellow ceramic pavement markers on Glenn Avenue at the apartment entrance, and after the addition of yellow ceramic pavement markers at the same location. The value of Z calculated was 8.2394. The value of p was less than 0.00001. This value is lower than 0.05. Thus, the result was statistically significant. Therefore, the presence of 8” round two-way yellow ceramic pavement markers significantly reduce the number of illegal left turns.

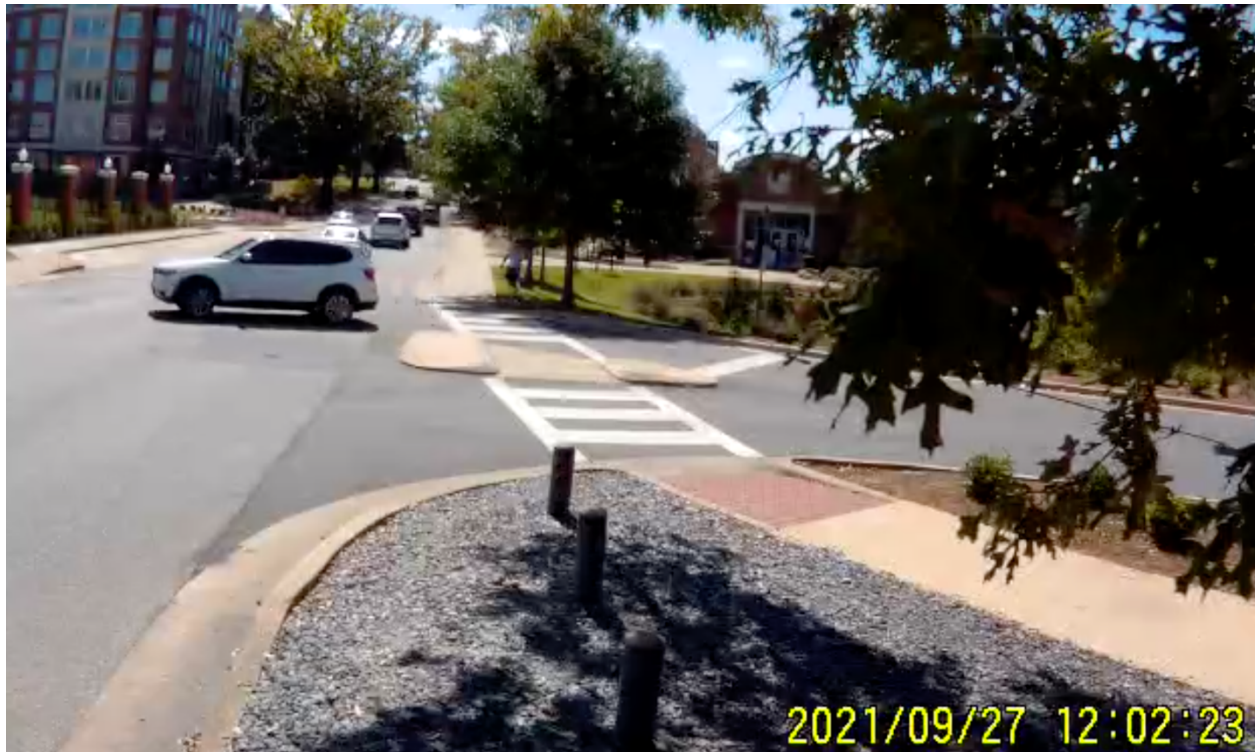
At the baseball field location on Donahue Drive, it was found that approximately 14% of vehicles were making an illegal left turn. **Table 7** represents the number of vehicles that approached the restricted left turn in 30-minute time periods. At this location, there was at least one case of driving on the wrong side of the channelized island. An example of an illegal left turn at this location can be seen in **Figure 25** below.

**Figure 25** Illegal left turn onto Donahue Drive at the Baseball Field Location

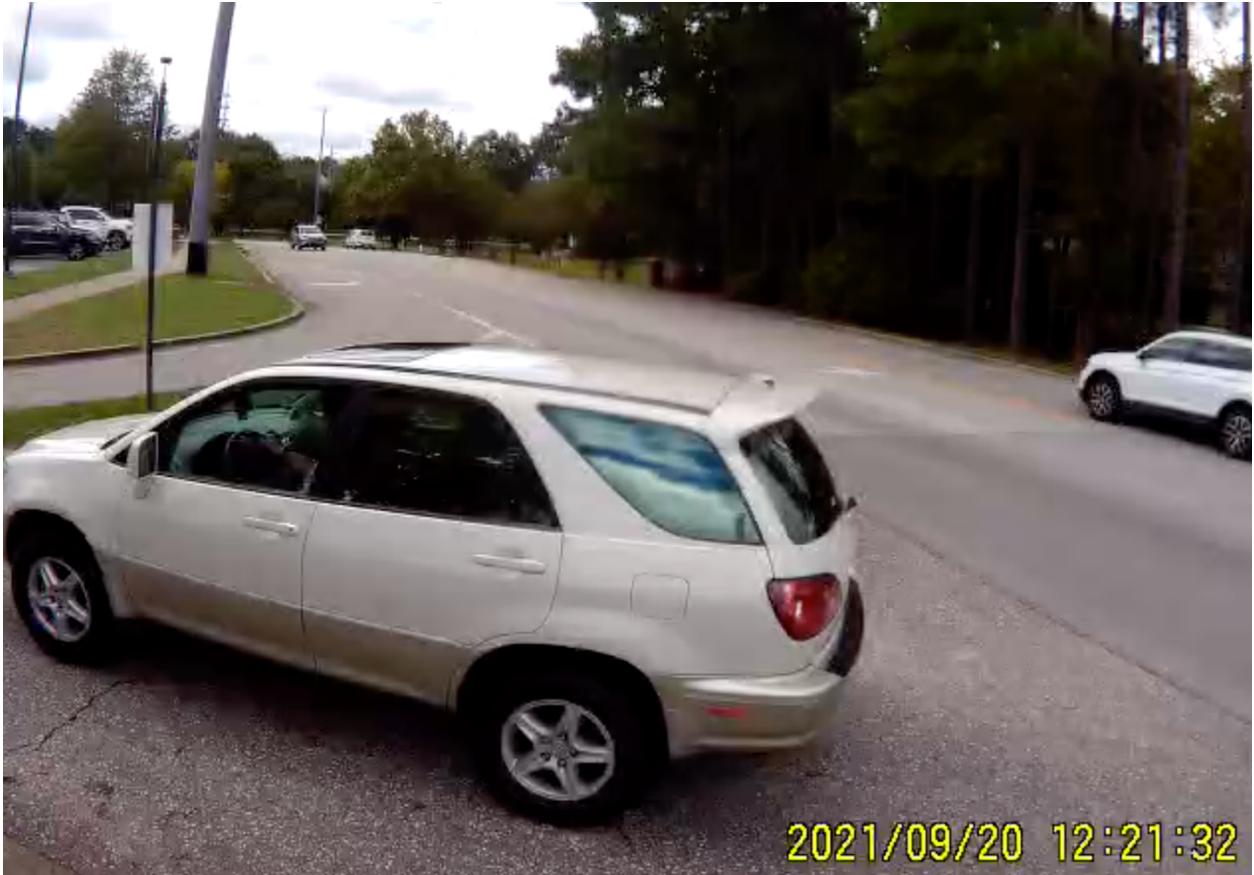
At the location on Wire Road, it was found that approximately 1 in 23 vehicles were making an illegal left turn. **Table 8** represents the number of vehicles that approached the restricted left turn in 30-minute time periods. At this location, there was at least three cases of driving on the wrong side of the channelized island. An example of a motorist driving on the wrong side of the channelizing island at this location can be seen in **Figure 26** below.

**Figure 26 Motorist Driving on Wrong Side of Channelizing Island at Wire Road Location**

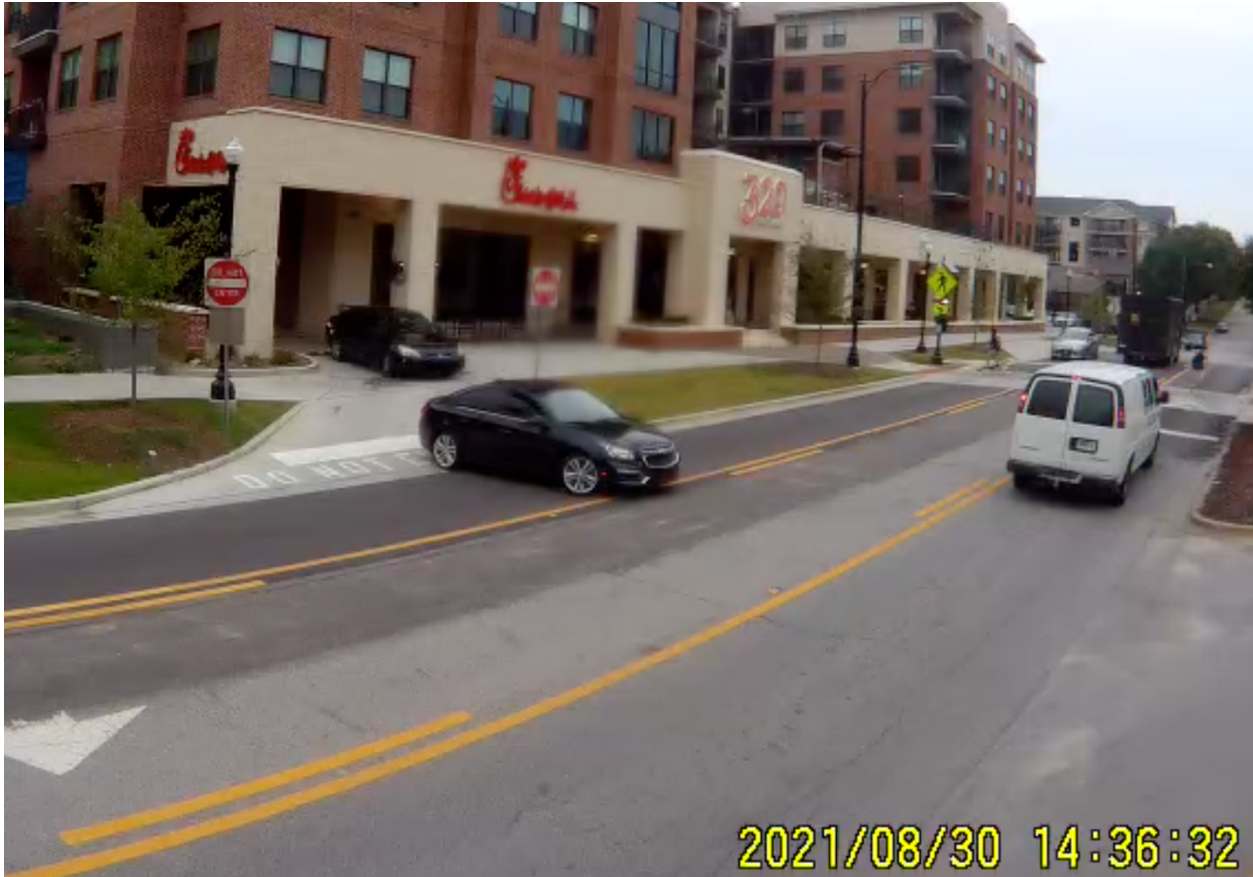
At the location on Magnolia Avenue, it was found that approximately 4% of vehicles were making an illegal left turn. **Table 9** represents the number of vehicles that approached the restricted left turn in 30-minute time periods. An example of a motorist making an illegal left turn at this location can be seen in **Figure 27** below.

**Figure 27 Illegal left turn onto Magnolia Avenue at the Restaurant Location**
