Acoustic Emission Testing of
Repaired Prestressed Concrete Bridge Girders

Thomas James Hadzor

A thesis submitted to the Graduate Faculty of
Auburn University
in partial fulfillment of the
requirements for the Degree of
Master of Science

Auburn, Alabama
August 6, 2011

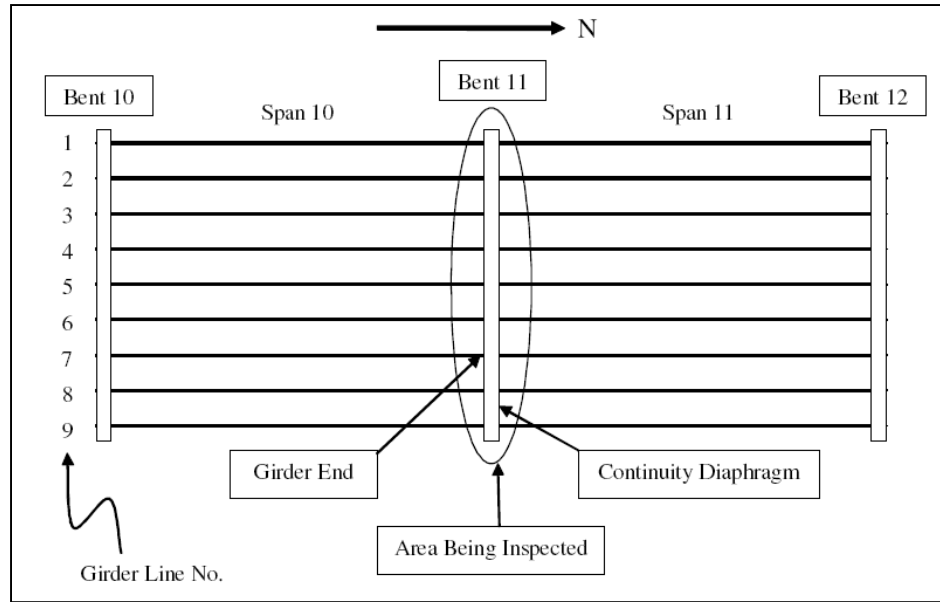
Figure 4-3: I-565 layout and numbering system (Xu 2008)

A visual inspection was the first step in the testing procedure. After assessing the bridge, it was determined that the study was to focus on the most damaged girders. This included Girders 7 and 8 supported by Bent 11 connecting northbound Spans 10 and 11. Figure 4-3 shows the basic layout and orientation of the girders, spans, and bents under consideration.

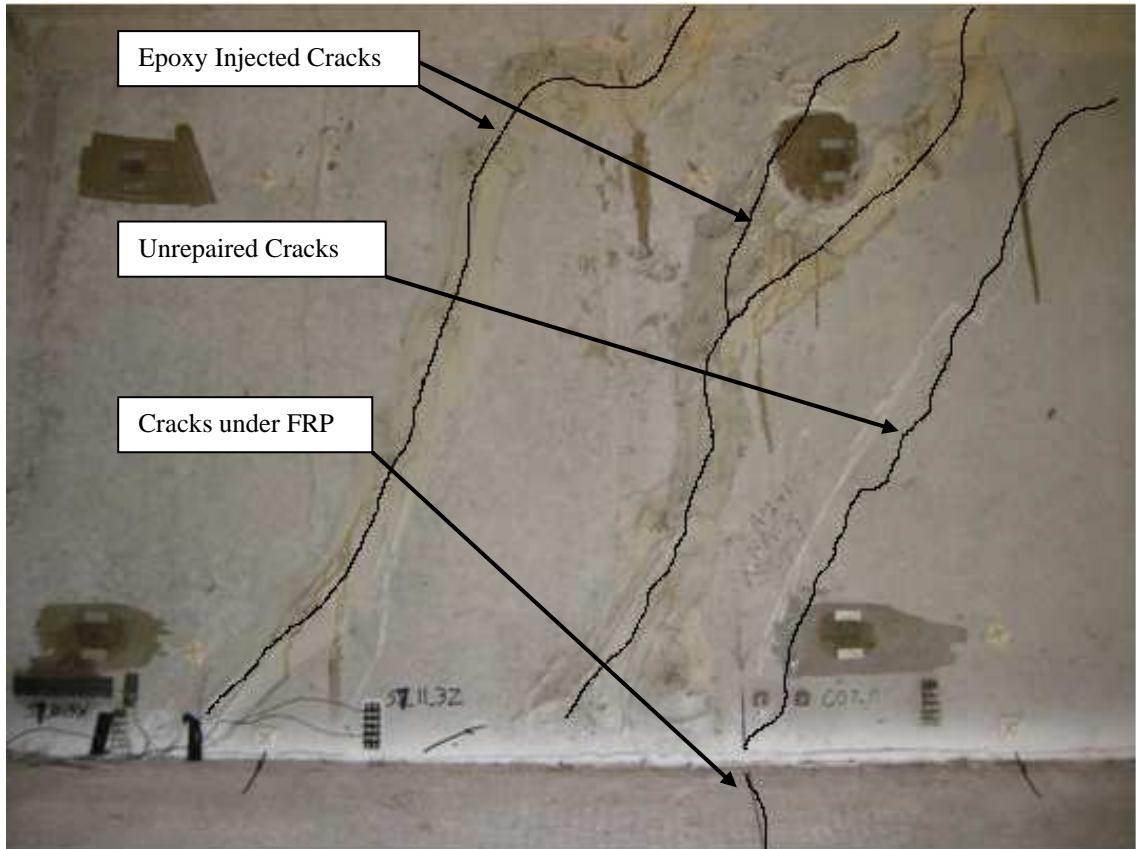
Cracks under FRP

Figure 4-4: Cracks in east face of Span 11 Girder 7

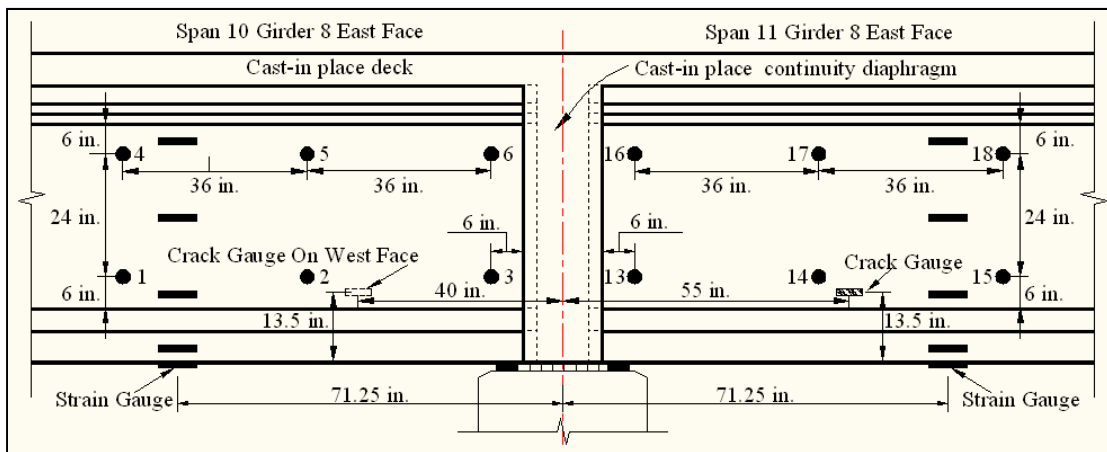
Figure 4-7: Sensor configuration on east face of Girder 8 (Xu 2008)

Based on the preliminary investigation, Girder 8 had a number of sealed cracks along both Spans 10 and 11. Girder 8 in Span 11 had a very long unsealed crack close to the continuity diaphragm, while smaller unsealed cracks were present in Span 10. Figure 4-7 shows the configuration of sensors along Girder 8 and Figure 4-8 shows the arrangement of Sensors 13-18. Six sensors (1 through 6) were installed on the east face of Span 10 on Girder 8 (S10G8) near the continuity diaphragm. The grid of AE sensors was 24 in. (0.61 m) high x 72 in. (1.82 m) wide. Likewise, another 6 sensors (13 through 18) were installed on the east face of Span 11 on Girder 8 (S11G8). This grid also had dimensions of 24 in. (0.61 m) x 72 in. (1.82 m).

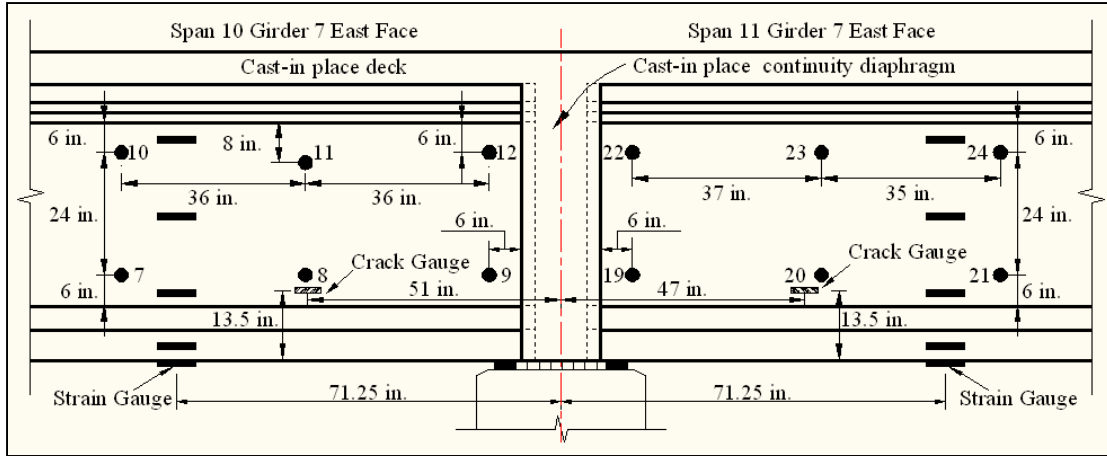
Figure 4-9: Sensor configuration on east face of Girder 7 (Xu 2008)

of S10G7 near the continuity diaphragm as shown in Figure 4-9. As seen in this figure,

Figure 4-9. Sensors 20 and 23 were shifted 1 in. (25 mm) to the right to avoid being

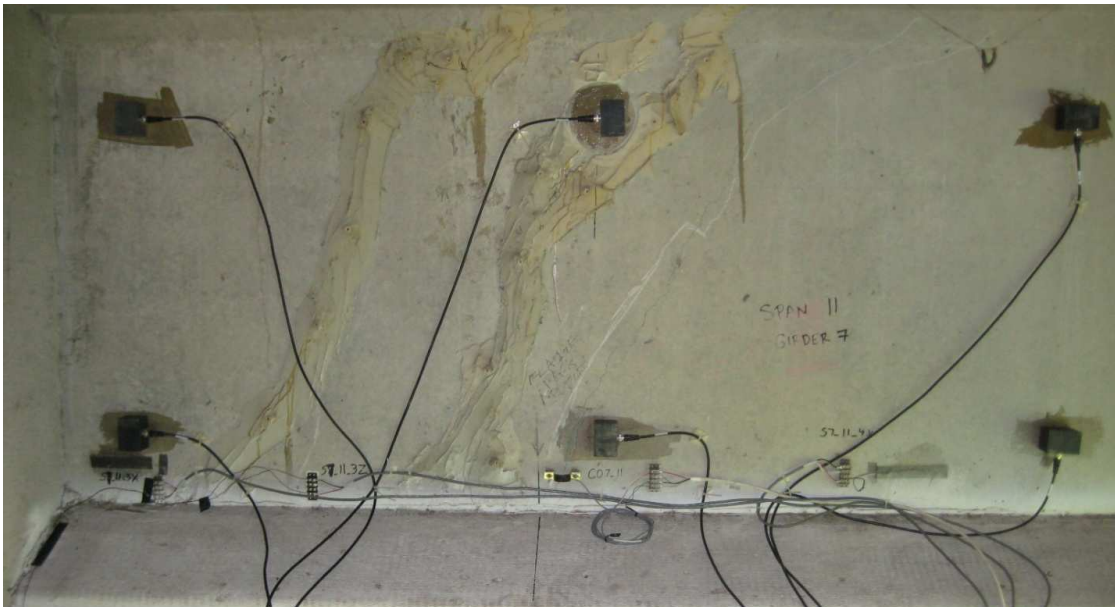
Figure 4-10: Arrangement of Sensors 19-24 on Girder 7

placed over a crack. The configuration of sensors 19-24 can be seen in Figure 4-10.

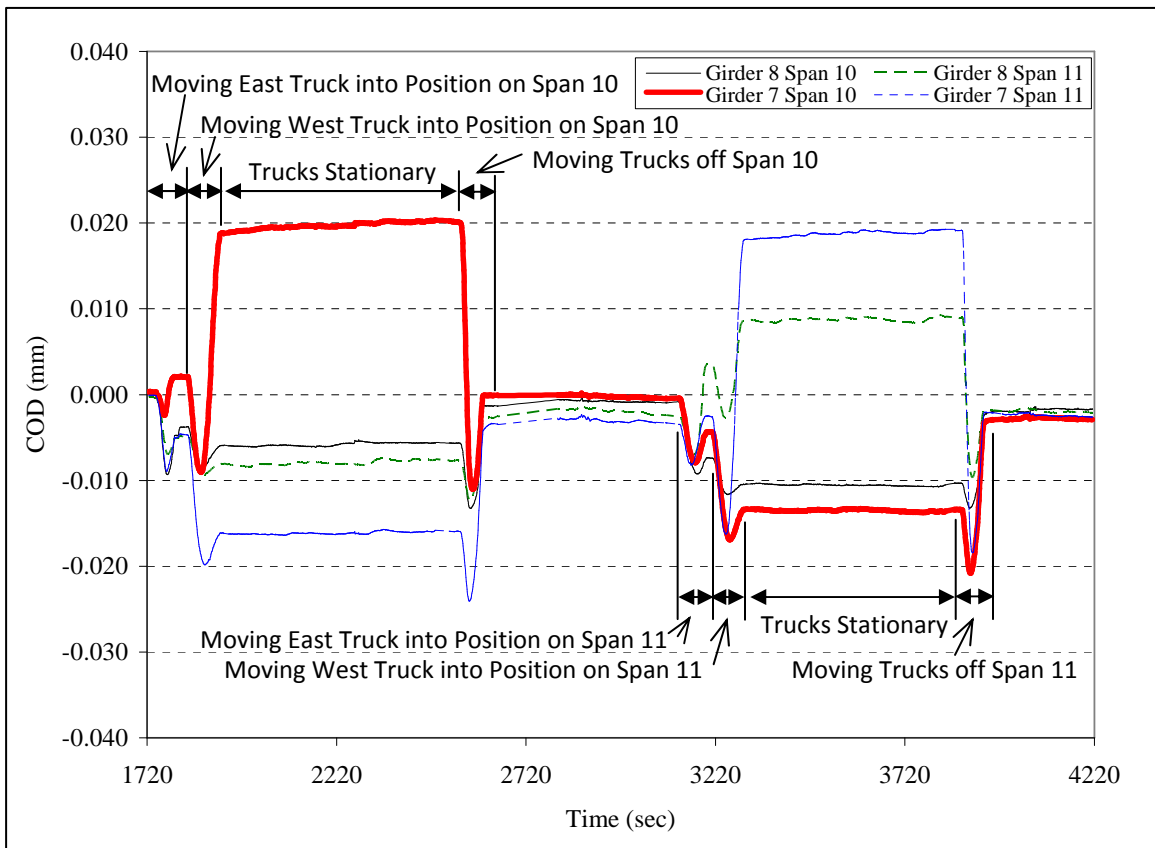
Figure 5-1: Crack-opening displacement during first night loading (Xu 2008)

The results from the crack-opening displacement (COD) measurements can be seen in Figure 5-1. This figure represents the crack width changes at the four gauge locations during the first night's loading. A positive value of COD indicates an opening of the crack relative to the original reading; a negative value indicates a relative closing of the crack. The crack-opening device on Span 10, Girder 8 (S10G8) was on the west face of the girder; the other three were on the east face of each girder. The SP10G8 COD was located on the opposite face (relative to the other CODs) because this crack did not extend all the way through the beam. According to Xu (2008), the behavior of the SP10G8 COD was different from the other three CODs because of out-of-plane bending. Also seen in Figure 5-1 are the CODs relative to each other. The behavior of each crack is shown through the entire loading sequence. For instance, the crack located in Girder 7 of Span 10 (S10G7) was much more sensitive when the loading was being performed on Span 10. Likewise, for Span 11, the most sensitive COD was S11G7. This also leads into another interesting point: the Girder 7 CODs were much more sensitive than the

Girder 8 CODs. Both S10G7 and S11G7 had a range of about 0.04 mm, which was much larger than S10G8 and S11G8 with ranges of 0.005 and 0.02 mm, respectively. Considering that the position of the crack-opening devices and the dimensions of the girders were the same, Xu (2008) hypothesized that Girder 7 was more damaged than Girder 8 based of the increased COD values. Xu (2008) also showed that the values for the COD in S10G7 and S11G7 produced during the load hold in their respective spans were almost the same, indicating that Girder 7 had similar characteristics and condition in Spans 10 and 11.

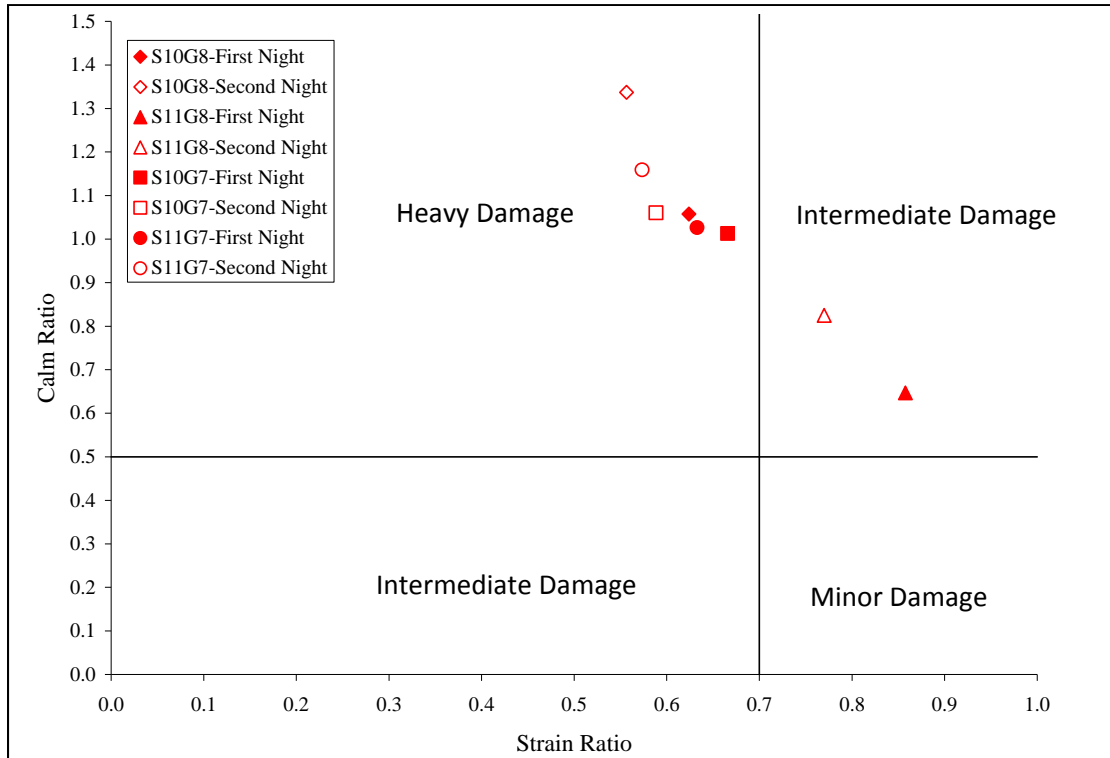
Figure 5-4: Damage qualification based on NDIS-2421 method (Xu 2008)

According to the limits provided and the data shown, Xu concluded that S10G8, S10G7 and S11G7 were classified as "heavy damage" and S11G8 was classified as "intermediate damage." These classifications showed a reasonable agreement with the crack-opening displacement data. Based on this agreement, Xu stated that the damage level of prestressed concrete girders could be reasonably qualified by the NDIS-2421 criterion based on the strain ratio and the calm ratio (Xu 2008).

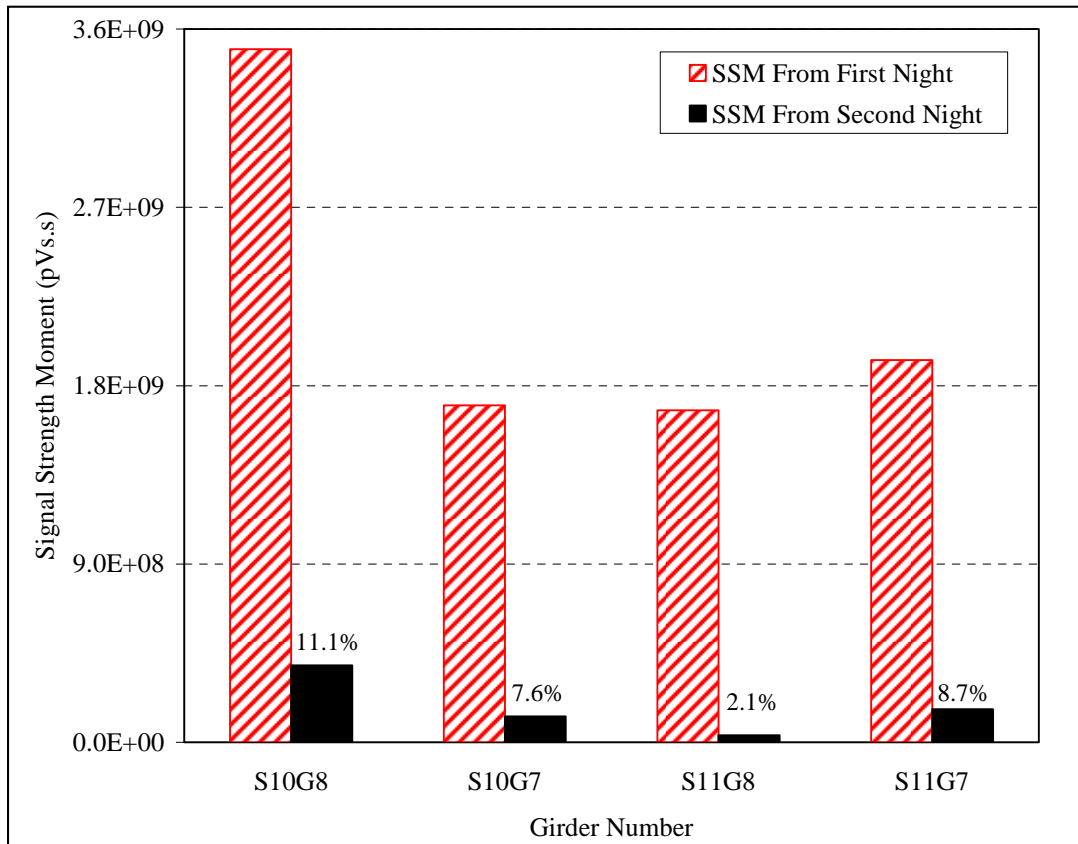
Figure 5-5: Signal strength moment (SSM) ratio during holds (Xu 2008)

As can be seen in Figure 5-5, the respective SSM ratio values indicate the different
damage levels. The results showed that S10G8 was the most damaged with an SSM ratio
of 11.1%. According to the results, S11G8 was damaged the least. Xu combined these
results with laboratory test results and concluded that prestressed beams were heavily

damaged when the SSM ratio exceeded 4%. Based on this, S10G8, S10G7 and S11G7 were heavily damaged and S11G8 was not heavily damaged (Xu 2008).

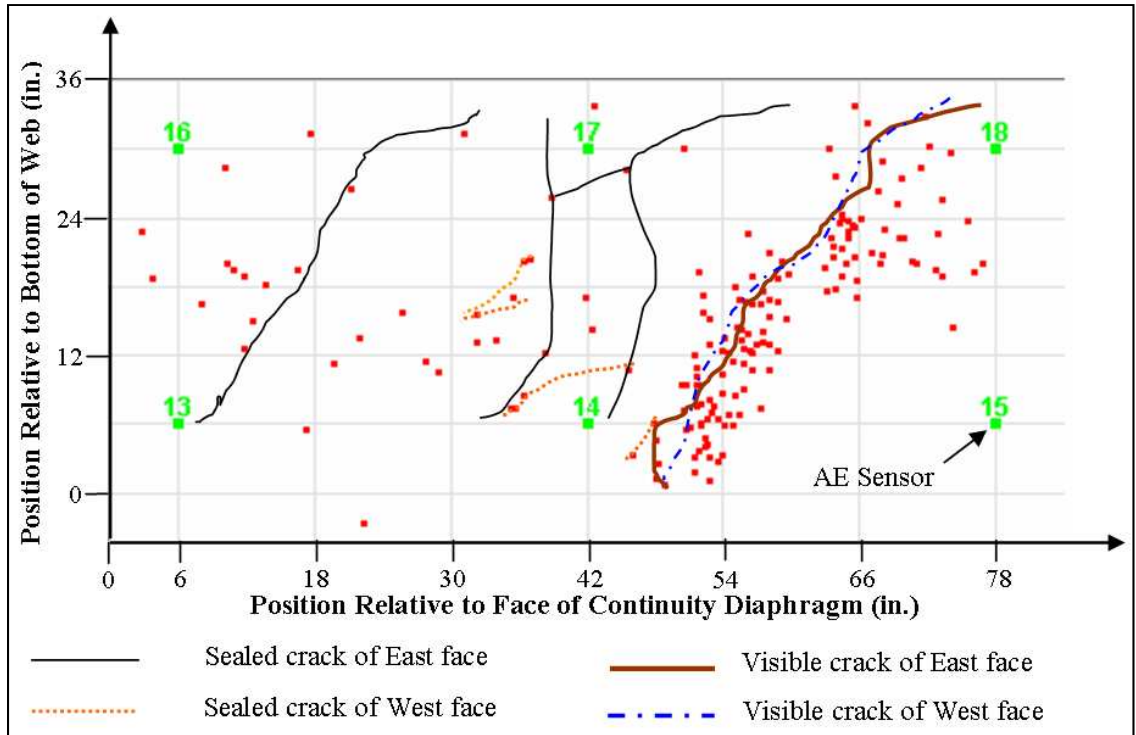
The resulting event locations produced using AE 2D-LOC for the end of Girder 8 in Span 11 can be seen in Figure 5-6. Each triangulated source location is represented by a small square marker. The larger, numbered square markers are the sensor locations. For comparison, the actual visible crack pattern was superimposed on this plot. Cracks from both the east and west face of the girder are shown.

Figure 5-6: AE event location and crack pattern of Span 11 Girder 8 (Xu 2008)

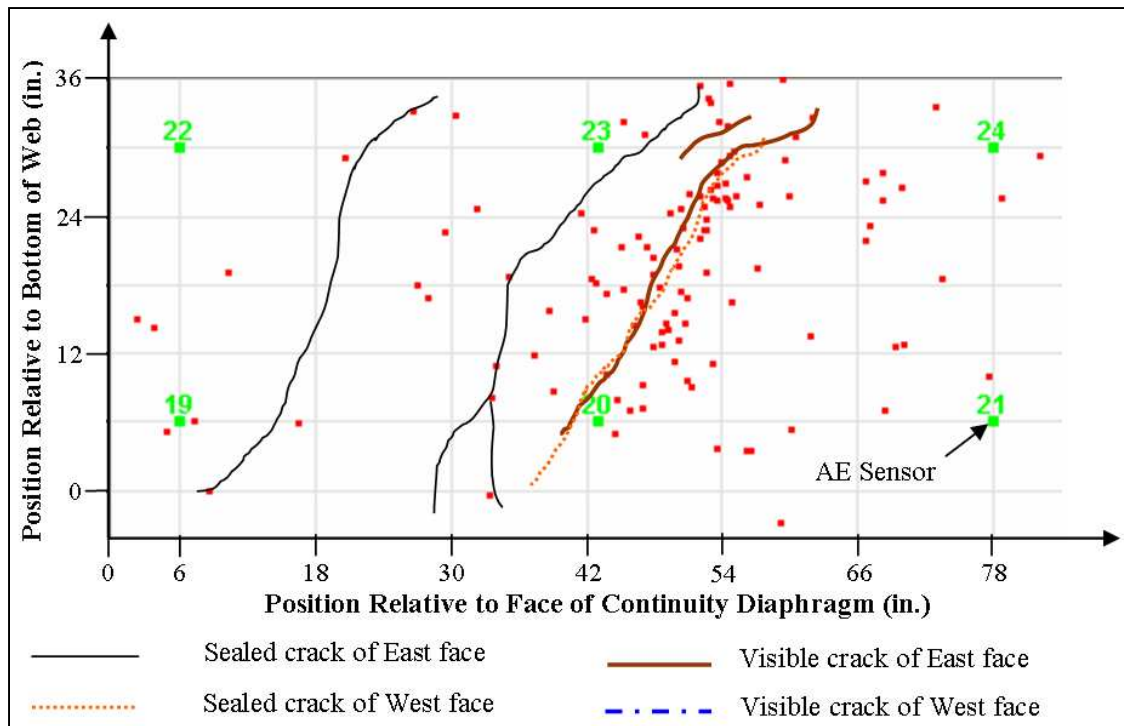
The plot of event locations for the end of Girder 7 of Span 11 is shown in Figure 5-7. The visible crack pattern is superimposed to compare the results. For Xu's testing, the events plotted were restricted to the beginning of the testing trucks moving onto Span 11 and end with the testing trucks moving off the bridge. As seen in Figure 5-6 and Figure 5-7, the event locations correlate well with the crack patterns visible on the surface of the girder. It should be noted that the AE is most concentrated at the "active," unrepaired cracks, rather than the ones that were sealed previously.

Figure 5-7: AE event location and crack pattern of Span 11 Girder 7 (Xu 2008)

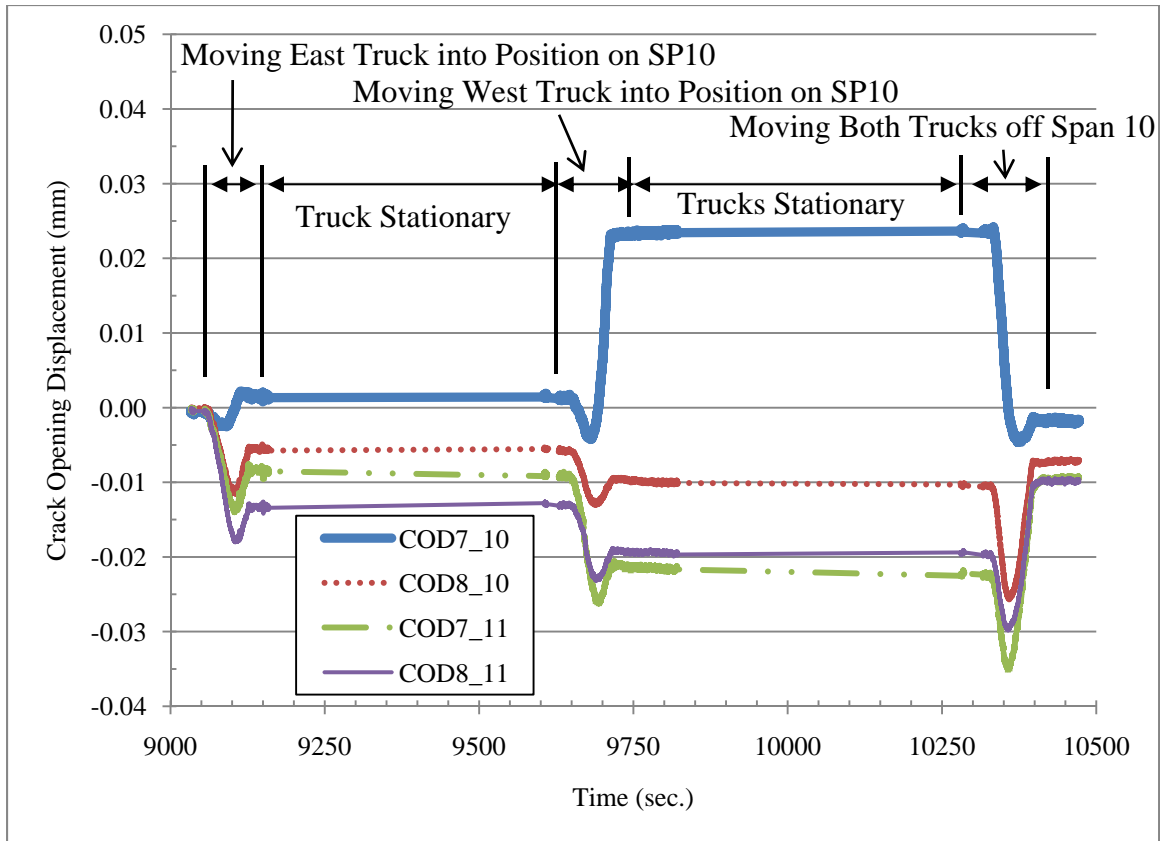
Figure 5-10: Crack-opening displacement during Night 1 loading of Span 10

Figure 5-10 shows the results of crack-opening displacement measurements produced in four gauge locations during the Span 10 loading on the first night. The crack-opening devices were placed in the same position as the pre-repair testing, with the S10G8 device (COD8_10) placed on the west face of the girder, and the other three (COD7_10, COD7_11, COD8_11) placed on the east face of the girders. Because of this, the S10G8 COD data showed significantly different behavior compared to the other COD data. Like the pre-repair testing, this was most likely due to out-of-plane bending. The SP10G8 COD behavior was also different due to the nature of the crack itself. Unlike the other cracks that extended all the way through the girder, the SP10G8 crack was only visible on the west face. Therefore, the only location for the COD device was on the west face. This crack was also located closer to the bent, which may have caused some different behavior.

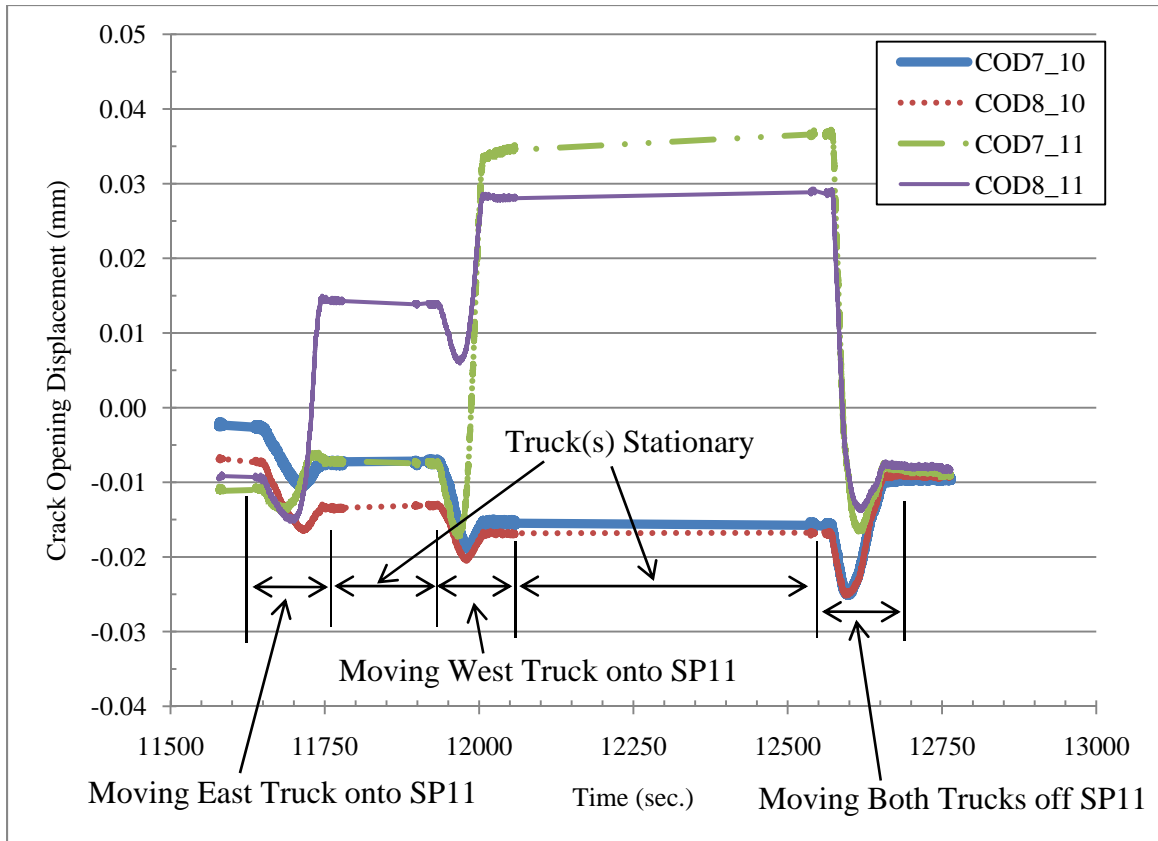
Figure 5-11: Crack-opening displacement during Night 1 loading of Span 11

The Span 10 and Span 11 loading COD data were split up to see more detail of the data and loading process. As can be seen in Figure 5-10, the COD data for S10G7 and S11G7 produced the maximum values for the Span 10 loading. Figure 5-11 shows the rest of the first night loading sequence of Span 11. Much like the pre-repair data, it can be seen that SP11G7 yields the maximum COD value for Span 11 loading. This information strengthens the argument that the cracks in Girder 7 were more flexible than in Girder 8 in both Span 10 and Span 11.

It should be noted that in the pre-repair testing, it was found that the COD data for Girder 7 in both Span 10 and 11 were very similar. The maximum values for the COD were roughly the same for both the Span 10 and Span 11 loading. This was not the case for the post-repair testing. For the Span 10 testing, the maximum COD value for Girder 7 was 0.024 mm. For the Span 11 testing, the maximum COD value for Girder 7 was 0.037 mm. This shows that the pre-repair conclusion that the condition of Girder 7 was similar in Spans 10 and 11 did not hold true for this testing. It shows that the cracks in Span 11 opened more, which indicates that Girder 7 of Span 11 was in a different condition than Girder 7 of Span 10.

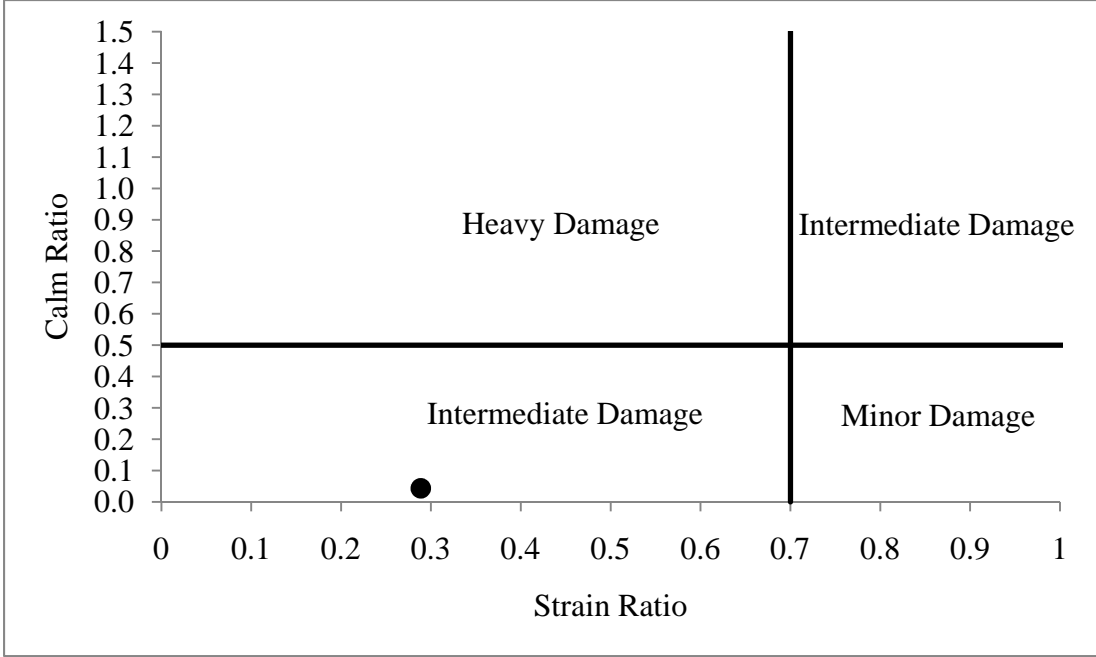
Once the strain and calm ratios were determined, the NDIS-2421 plot was produced for each of the four girders. Figure 5-21 shows the NDIS plot for SP10G7. It can be seen that, according to the NDIS-2421 criterion, SP10G7 falls into the quadrant of intermediate damage.

Figure 5-21: Damage qualification based on NDIS-2421 for SP10G7

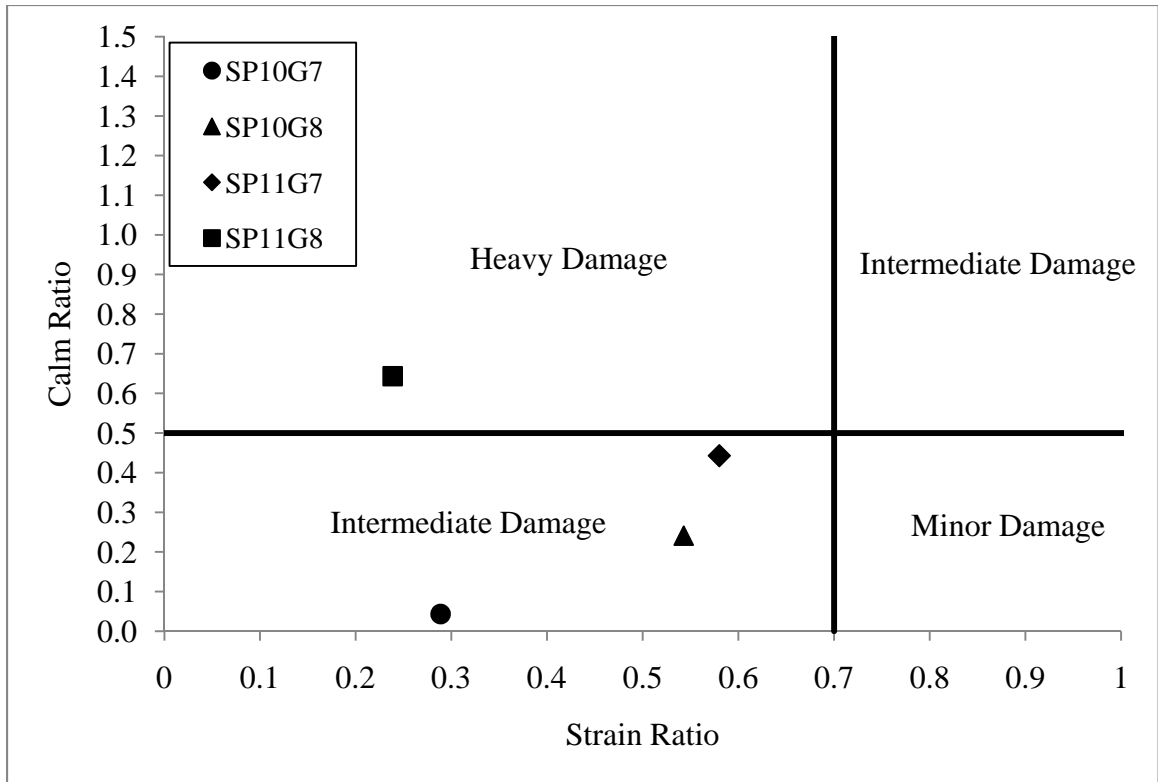
Figure 5-22: Damage qualification based on NDIS-2421 for all four girders

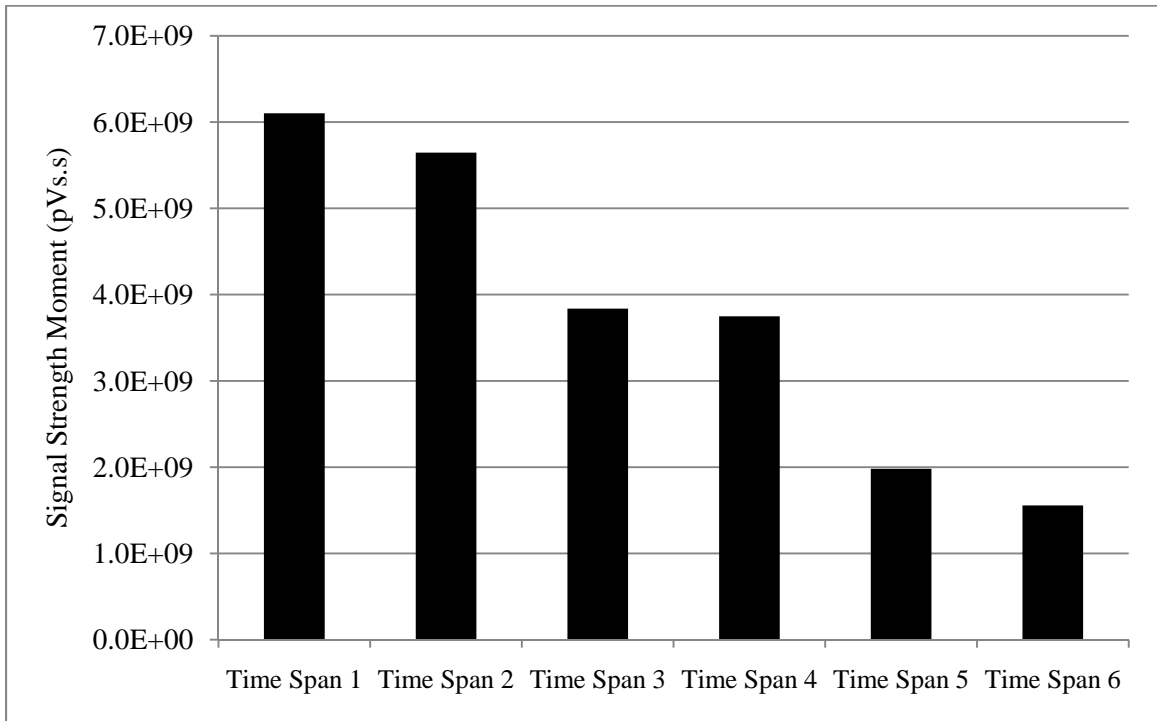
Figure 5-24: SSM for different 240 second time spans for SP10G8 on Night 1

Figure 5-24 shows that most AE activity occurs in the first 240-second time span. This seems to be evident since AE data should be occurring for a brief time after the trucks are in place. Any AE occurring throughout the rest of the nine minute load hold is caused by environmental/ambient noise or the continuing propagation of damage. The first 240-second time span seems to be the best option for the SSM ratio since the most data are being collected during that time.

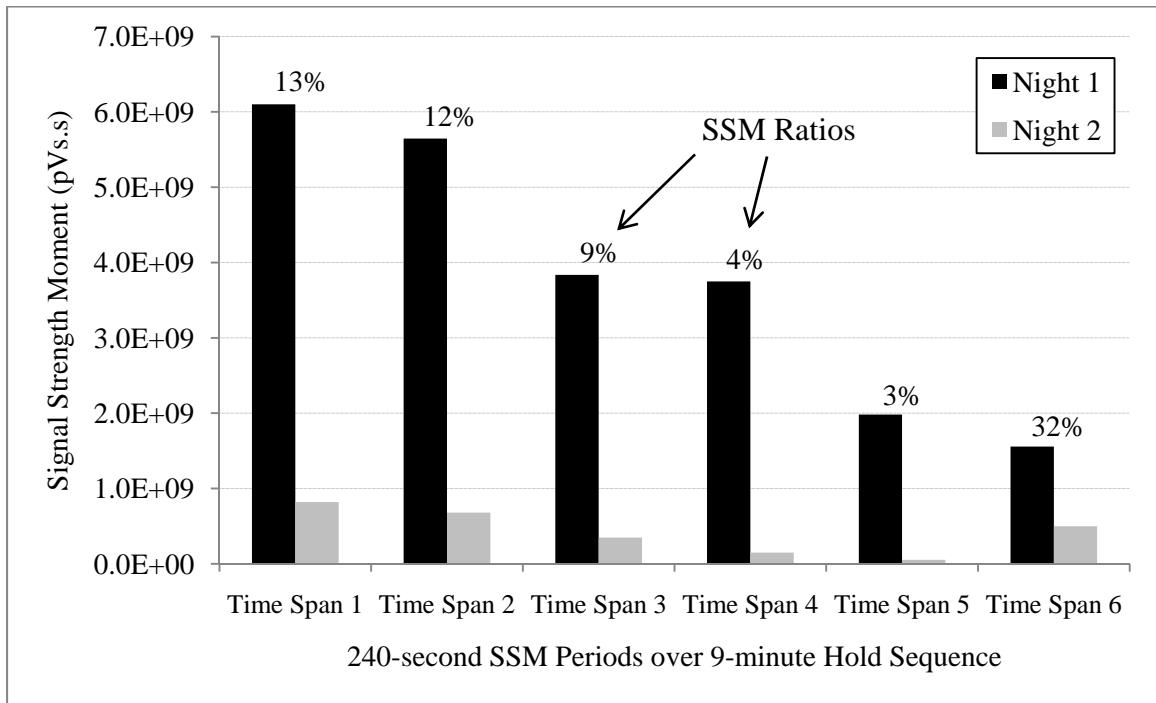
Figure 5-25: SSM ratios for different 240-second time spans for SP10G8

It can be seen that the 240-second time span chosen for the SSM ratio analysis does have an effect on the SSM ratio. According to Xu's 4% threshold, Time Spans 1, 2, 3, and 6 would have resulted in a classification of "heavily damaged" girders, while Time Spans 4 and 5 would have indicated "not heavily damaged" girders. This is a concern for the SSM ratio analysis, and it should be noted that more testing should be done to improve the selection of which 240-second time span should be used in the analysis. However, since it has been seen that the most AE data occurs right after the trucks are in position, further analysis for this study was conducted using Time Span 1.

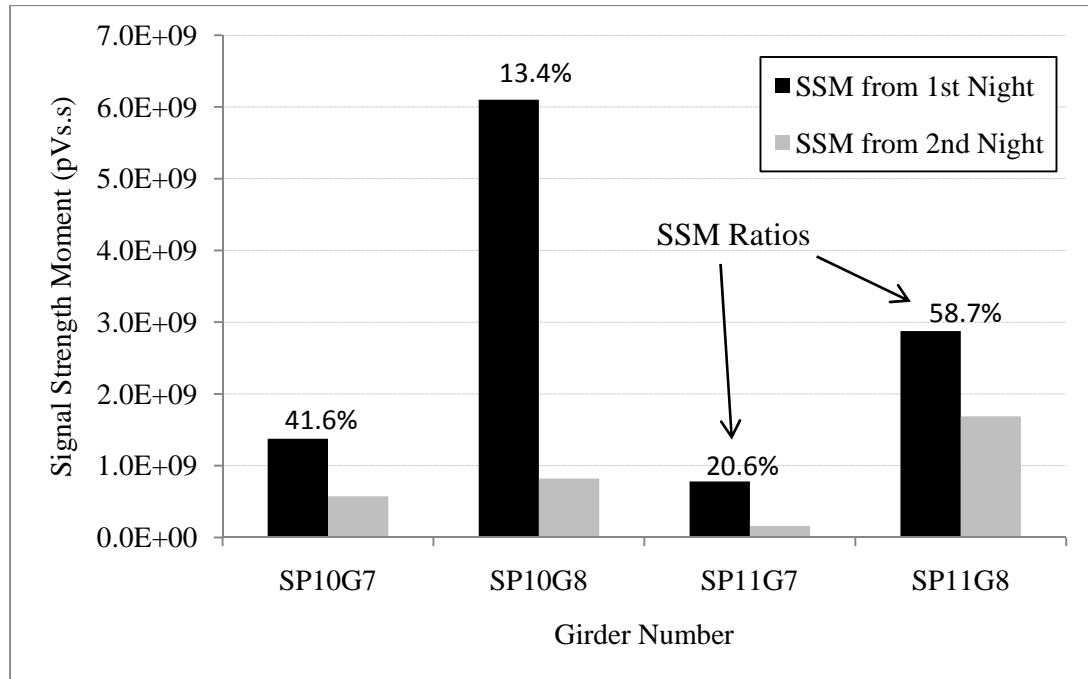
Figure 5-26: Signal strength moment (SSM) ratio during holds

According to Xu's 4% threshold, all four girders are "heavily damaged." However, according to the SSM ratio analysis, there is no indication of what "heavily damaged" actually means. More extensive testing should be done to see if the 4% that was obtained using laboratory tests does indeed carry over to be applicable to prestressed girders with an FRP repair. Also, the testing should be done in such a way as to determine the actual damage level associated with a 4% SSM ratio value.

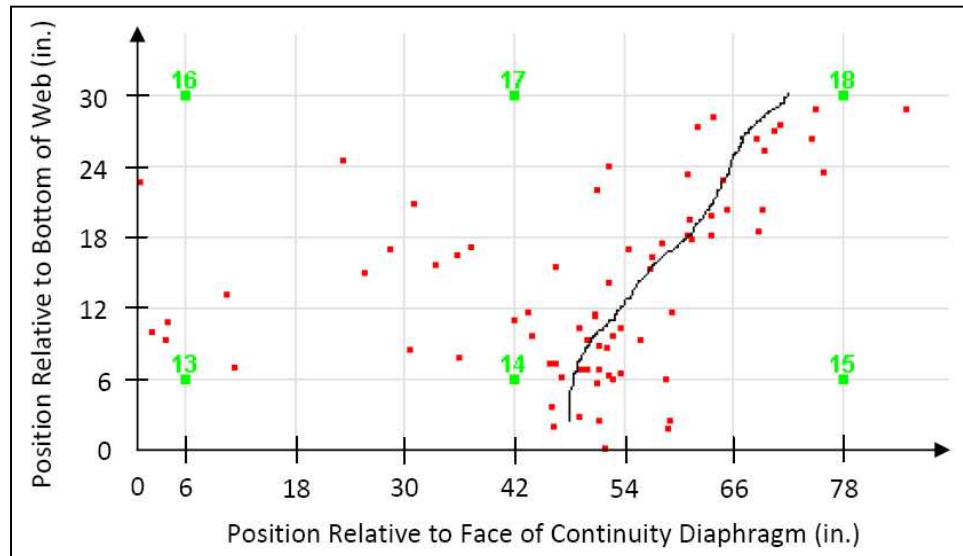
Figure 5-27: AE 2D-LOC source locations for SP11G8

the face toward Sensor 18. An estimated crack pattern was drawn based on this AE data

after the epoxy was injected, which has been traced and labeled. Comparing Figure 5-27 and Figure 5-28, an agreement can be seen between the source locations and the visible, unsealed crack. This agreement shows that the AE 2D-LOC software can give fairly accurate results when trying to locate active cracks in the concrete. This also matches the results found by Xu (2008).

It should be noted that there seem to be "random" event source locations plotted in Figure 5-27 and Figure 5-29. Like the pre-repair testing, this can be attributed to the friction caused by the concrete and prestressing strands, from environmental or ambient noise, or reflections of the AE. Another possibility for the random source locations could

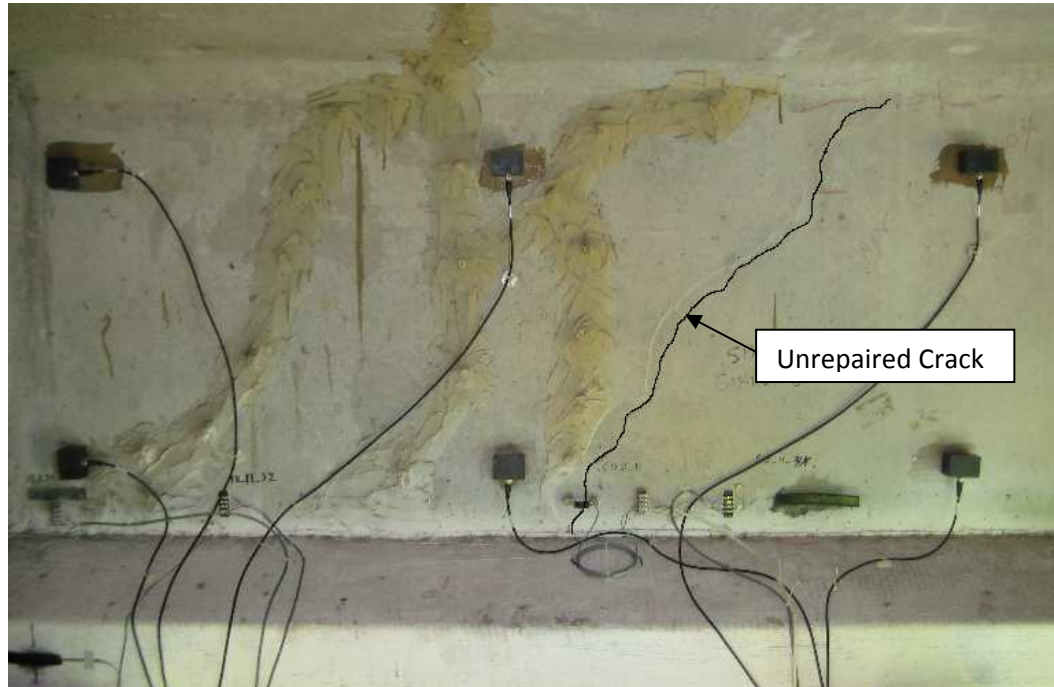
Figure 5-28: Visible cracks on face of SP11G8

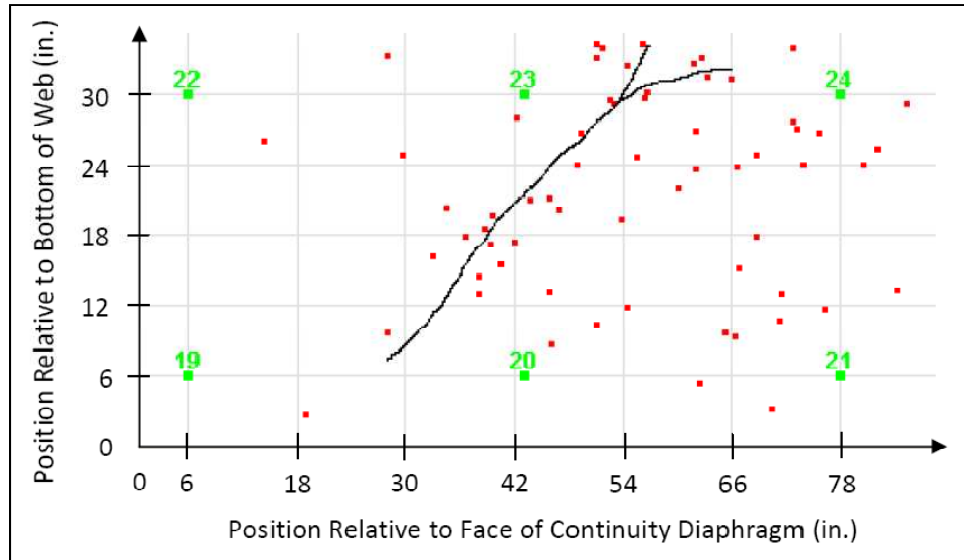
Figure 5-29: AE 2D-LOC source locations for SP11G7

To verify the results from SP11G8, another girder was evaluated to see if similar results could be replicated. The source locations for SP11G7 (Sensors 19—24) are shown in Figure 5-29. Once again, a general pattern of event locations can be seen moving from the left of Sensor 20 to the right side of Sensor 23.

For comparison purposes, Figure 5-30 shows the actual cracks located on the face of SP11G7. Like SP11G8, this girder has two types of cracks; the epoxied cracks and a new crack that formed after the epoxy hardened. Once again, there exists a general agreement between the event source locations in Figure 5-29 and the unsealed crack in Figure 5-30.

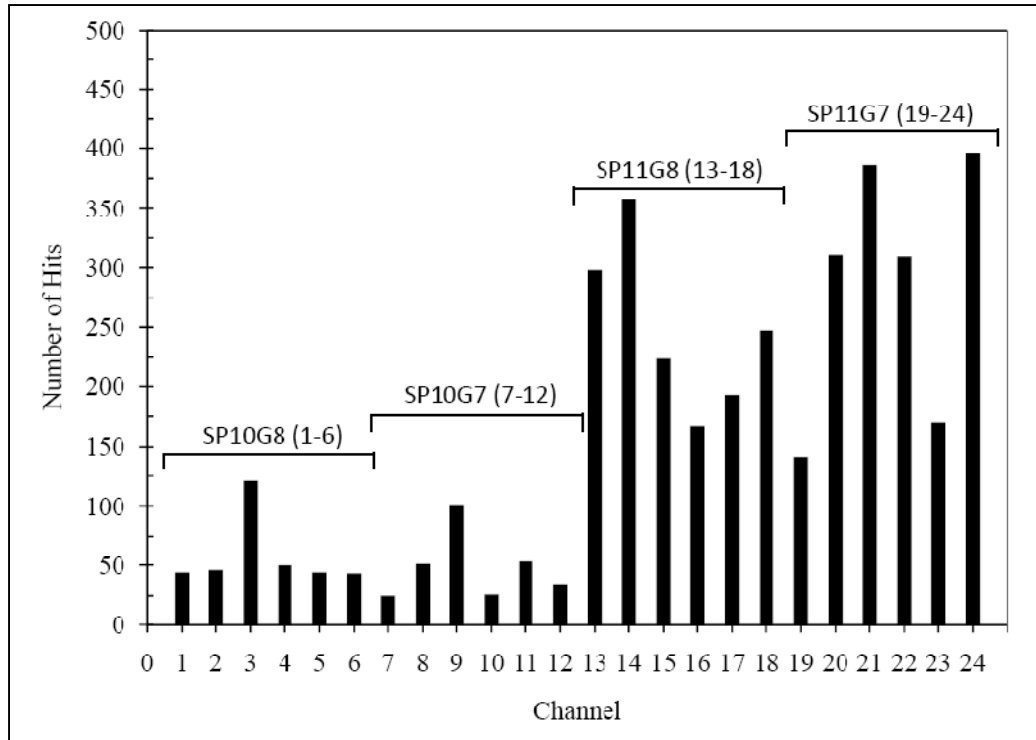
Figure 5-31: Channel hit frequency for Span 11 loading on Night 1

It can be seen that the sensors (channels) located on the Span 11 girders (channels 13-24) were much more active than those on Span 10 (channels 1-12). However, Span 11 loading did produce AE in Span 10, as well. It should be noted that Channels 3 and 9, the two channels located closest to the interior bent (and Span 11) produced the most Span 10 AE hits during the Span 11 loading. Figure 5-31 also shows that the most active channels in Span 11 correspond to the sensors located closest to the AE-2D LOC crack locations.

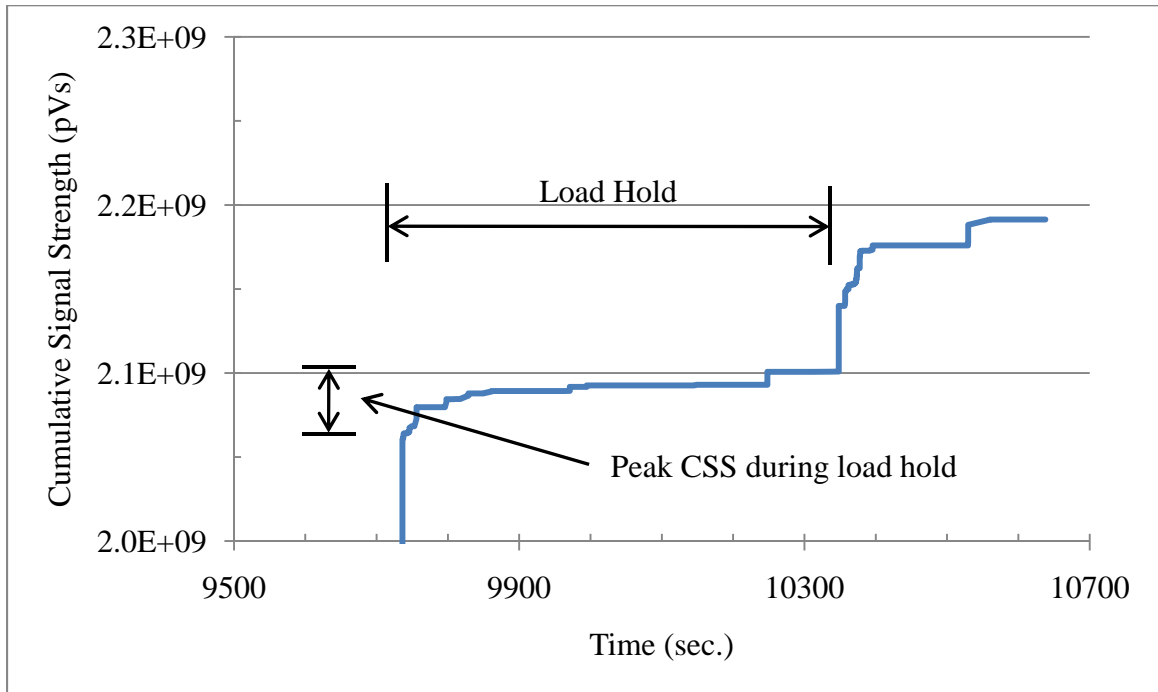
Figure 5-32: CSS from SP10G7 on Night 1

The peak CSS for Night 1 would be defined as the CSS accumulated during the load hold right before both trucks began driving off of Span 10. This hold period is labeled on Figure 5-32. The CSS plot from SP10G7 on Night 2 is plotted in Figure 5-33.

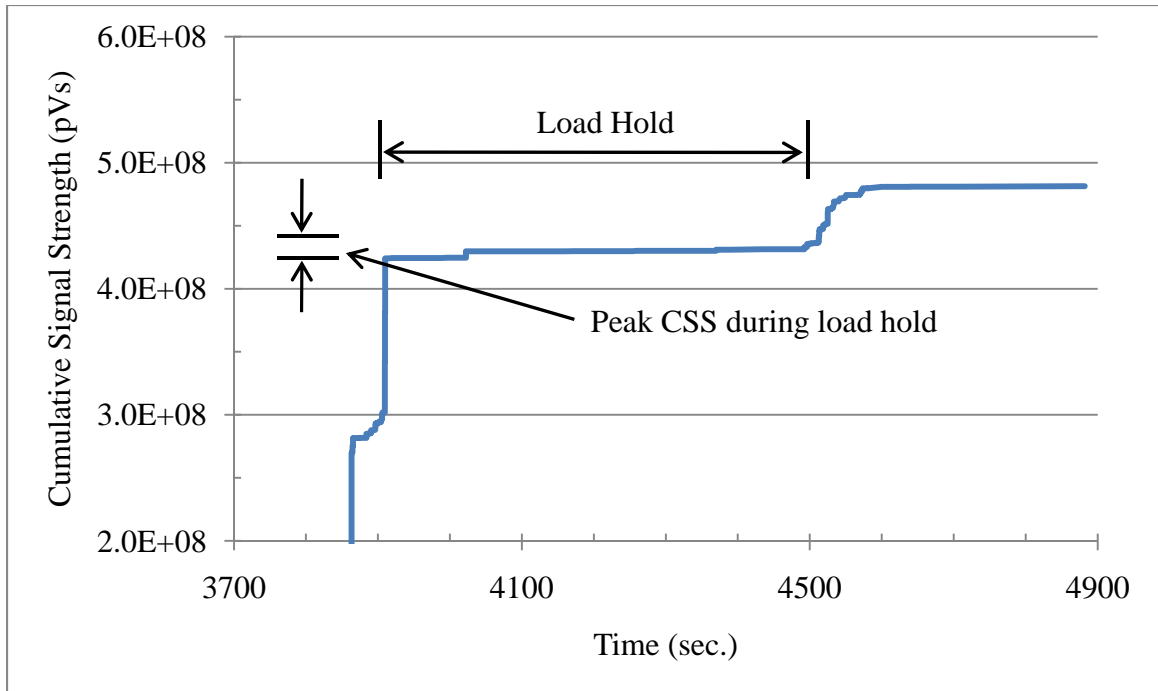
Figure 5-33: CSS from SP10G7 on Night 2

The reload period was defined as the Night 2 loading and the initial load period was

defined as Night 1. After dividing the Peak CSS from Figure 5-33 by the Peak CSS in

Figure 5-32 and multiplying by 100%, the Peak CSS ratio was calculated to be 8%.

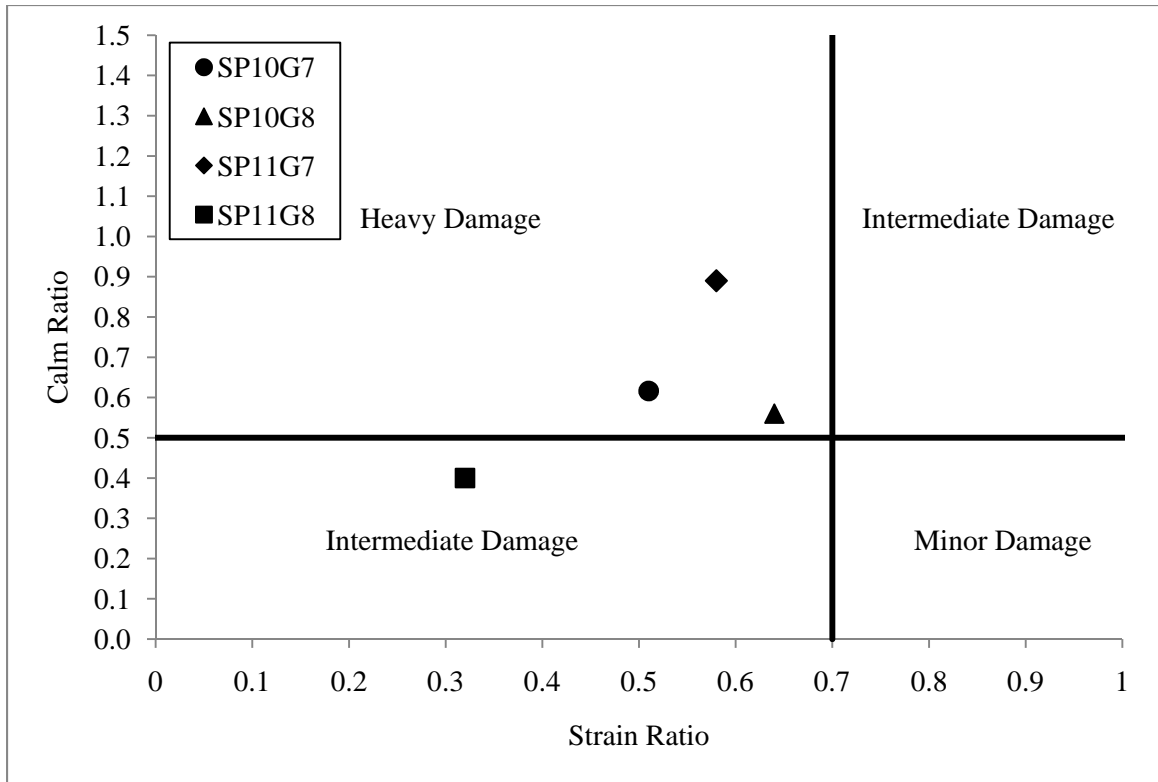
Figure 5-34: Damage classification based on adapted NDIS-2421 for pre-repair

As seen in the above figure, the adapted NDIS-2421 criterion classified SP10G7,

SP10G8, and SP11G7 in the "heavy damage" quadrant, while classifying SP11G8 in the

"intermediate damage" quadrant. These results actually agree with the results from the

pre-repair NDIS analysis performed by Xu (2008), presented in Section 5.2.2.1.
