Acoustic Emission Testing of
Repaired Prestressed Concrete Bridge Girders

Thomas James Hadzor

A thesis submitted to the Graduate Faculty of
Auburn University
in partial fulfillment of the
requirements for the Degree of
Master of Science

Auburn, Alabama
August 6, 2011

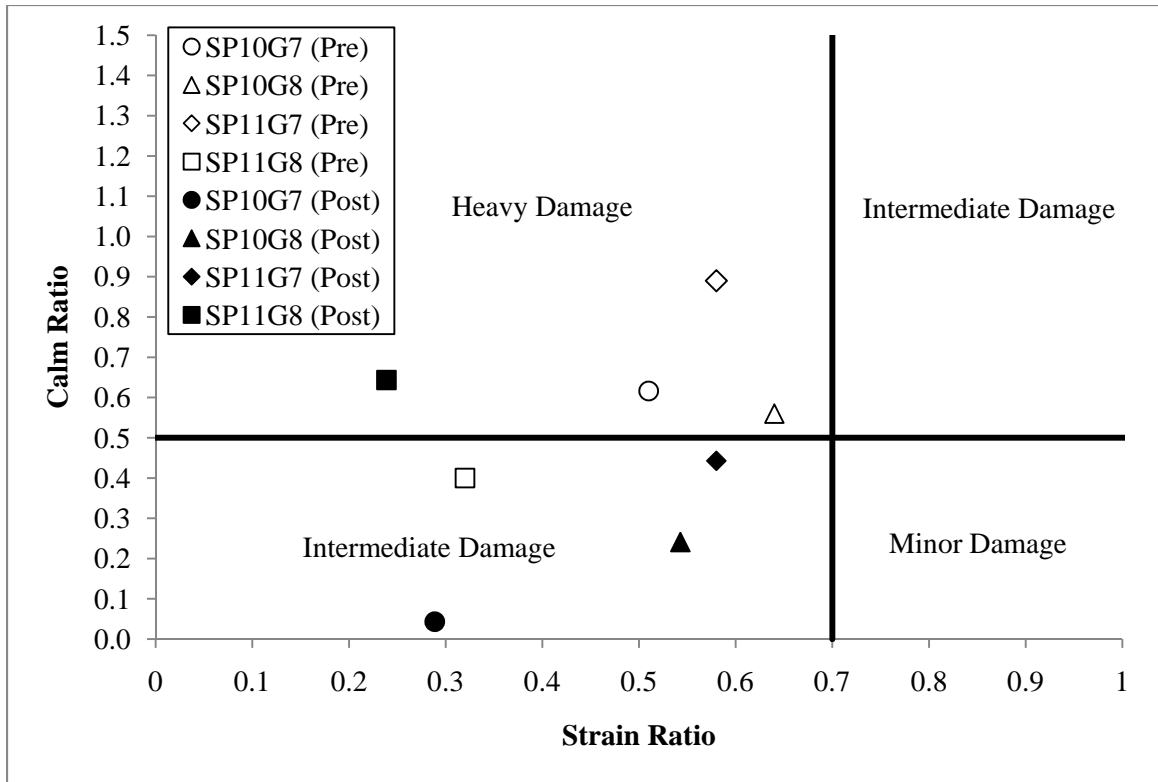
Figure 5-35: Adapted pre-repair and post-repair NDIS-2421 results

As can be seen from the NDIS-2421 results, SP10G7, SP10G8, and SP11G7 showed

improvement by moving from the "heavy damage" to the "intermediate damage"

quadrant, indicating a decrease in condition. No direct conclusions can be made from

this plot because of the difference between the support conditions for the two tests.
