**Behavior of a Damaged Prestressed Concrete Bridge  
Repaired with Fiber-Reinforced Polymer Reinforcement**

A thesis submitted to the Graduate Faculty of  
Auburn University  
in partial fulfillment of the  
requirements for the Degree of  
Master of Science

Auburn, Alabama  
December 12, 2011

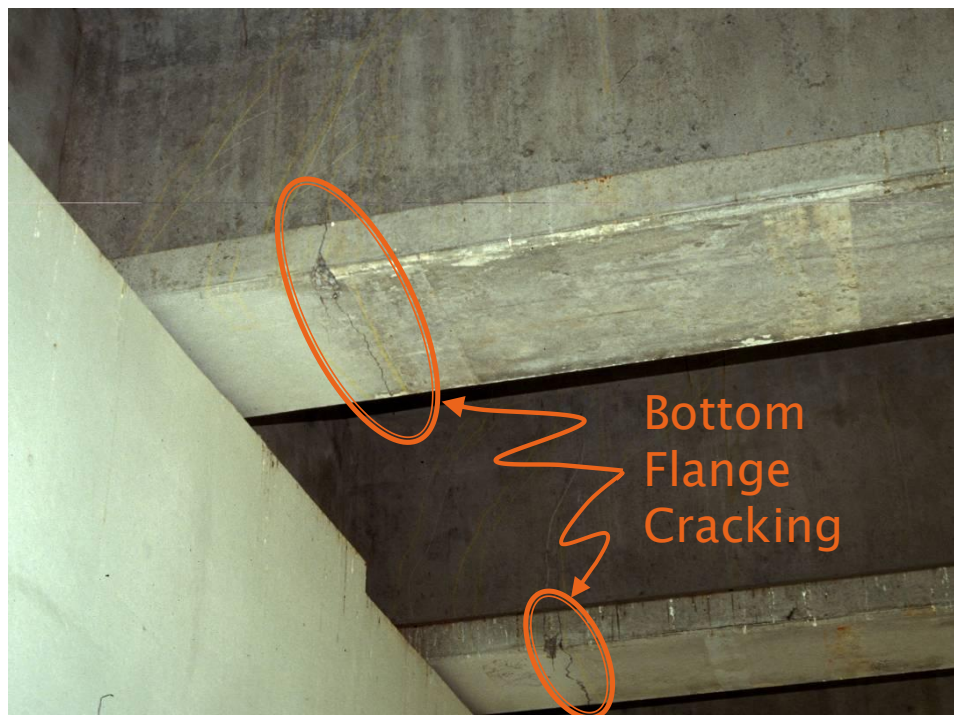
**Figure 1.3:** Cracked pre-tensioned bulb-tee girders of I-565 (Barnes et al. 2006)

Cracked girders were found at ten different sites between Eighth Street and Oakwood Avenue (ALDOT 1994). The portion of I-565 containing cracked bridge girders is illustrated in Figure 2.15. The pattern of cracking found in one BT-54 girder of Span 5 is illustrated in Figure 2.16. The inclined web cracks were limited to approximately 0.06 in. (1.5 mm) due to the transverse reinforcement that the cracks intersected. The vertical bottom-flange cracks only crossed the longitudinal prestressed strands and crack widths were not controlled by transverse reinforcement. Some of the larger bottom-flange cracks with widths up to 0.25 in. (6 mm) were visible from the ground in 1994, as shown in Figure 1.3.

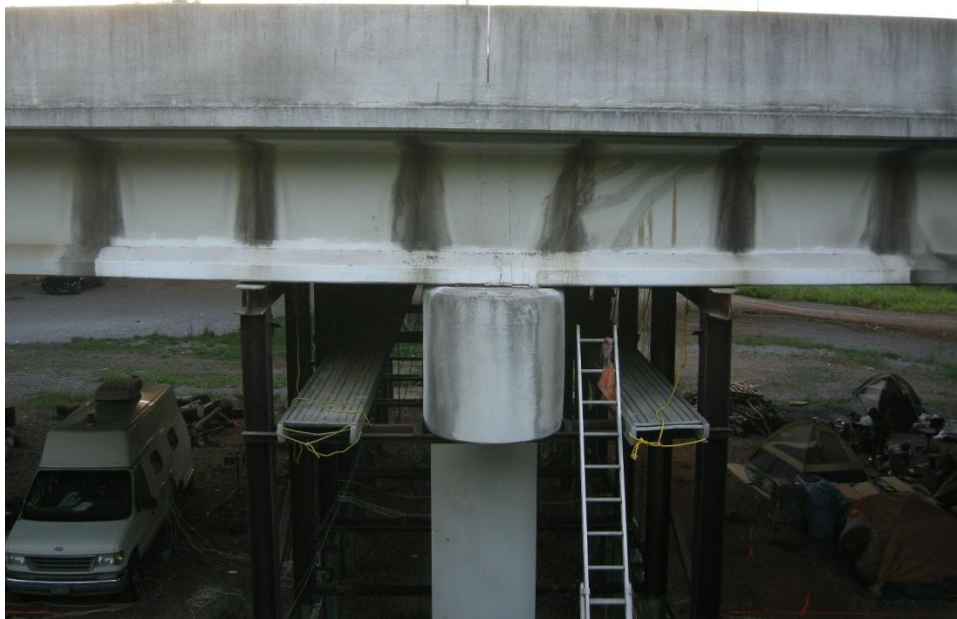
**Figure 1.4:** Girder 9 of Northbound Spans 10 and 11—repaired

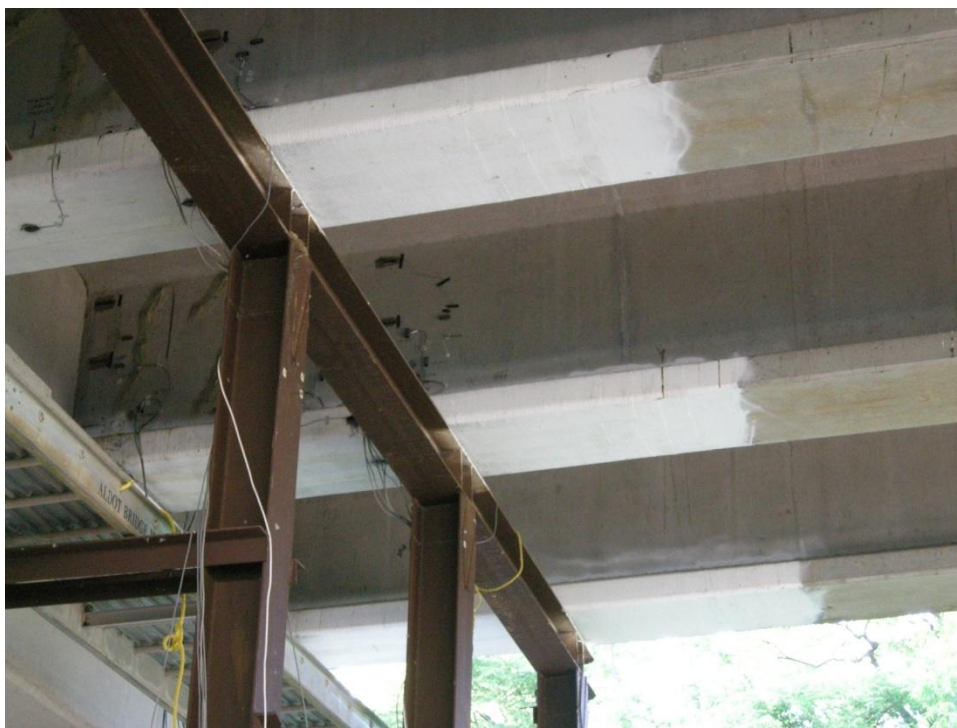
**Figure 1.5:** Girders 7, 8, and 9 of Northbound Span 10—repaired

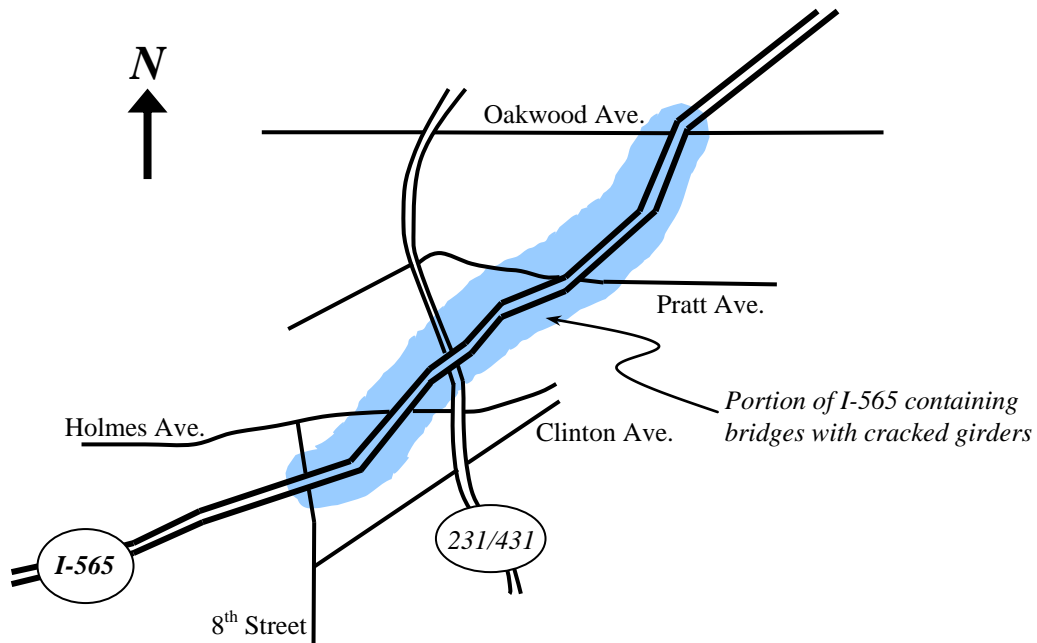
**Figure 2.15:** Portion of I-565 containing cracked bridge girders (Swenson 2003)

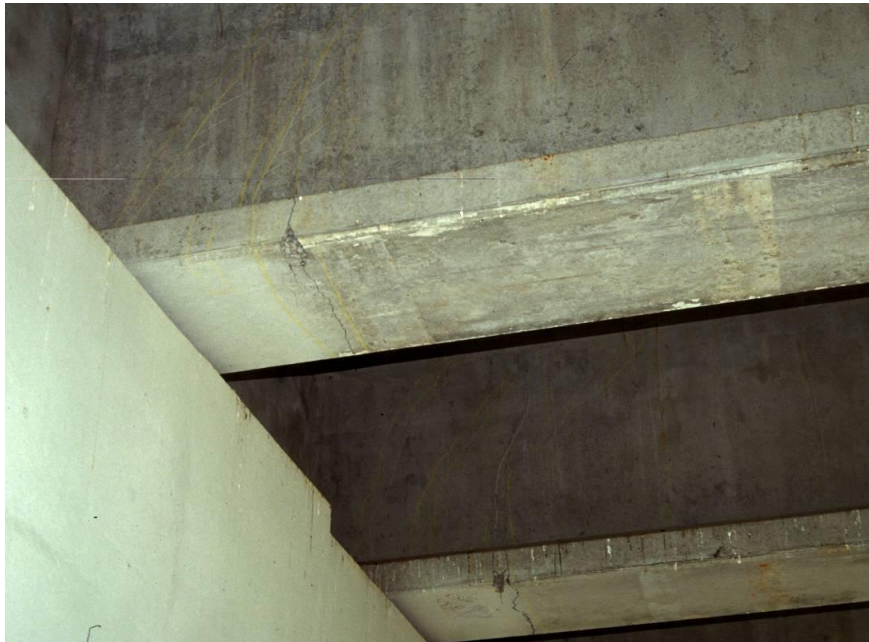
**Figure 2.17:** Cracked pre-tensioned bulb-tee girders (Barnes et al. 2006)

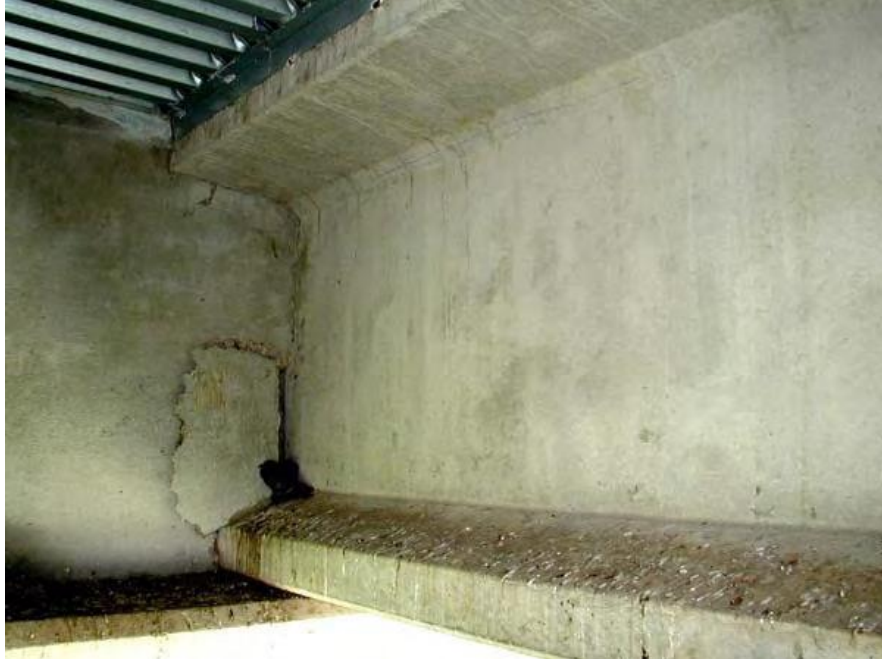
The 1994 investigation also resulted in the discovery of continuity diaphragm cracking. The two types of cracks present in some of the continuity diaphragms were face cracks and end cracks. An example of a typical continuity diaphragm face crack can

be seen in Figure 2.18, and an example of a typical diaphragm end crack can be seen in Figure 2.19. Approximately 57 percent of bents supporting bulb-tee girders contain diaphragm face cracks, and roughly 85 percent of bent contain diaphragm end cracks. All interior bents in two-span continuous structures constructed with BT-54 girders exhibit diaphragm end cracks (ALDOT 1994).

**Figure 2.18:** Typical diaphragm face crack (Swenson 2003)

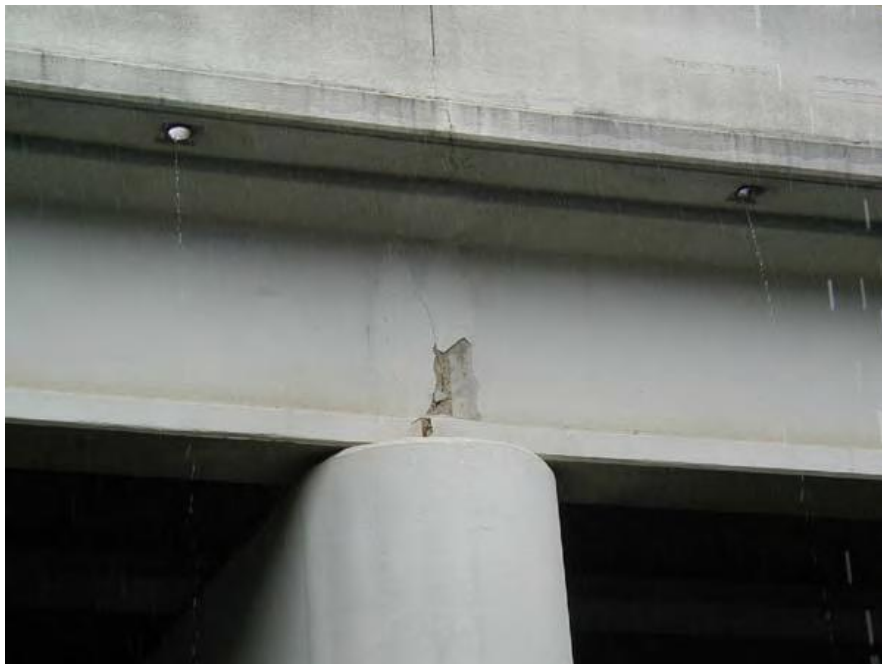
**Figure 2.19:** Typical diaphragm end crack (Swenson 2003)

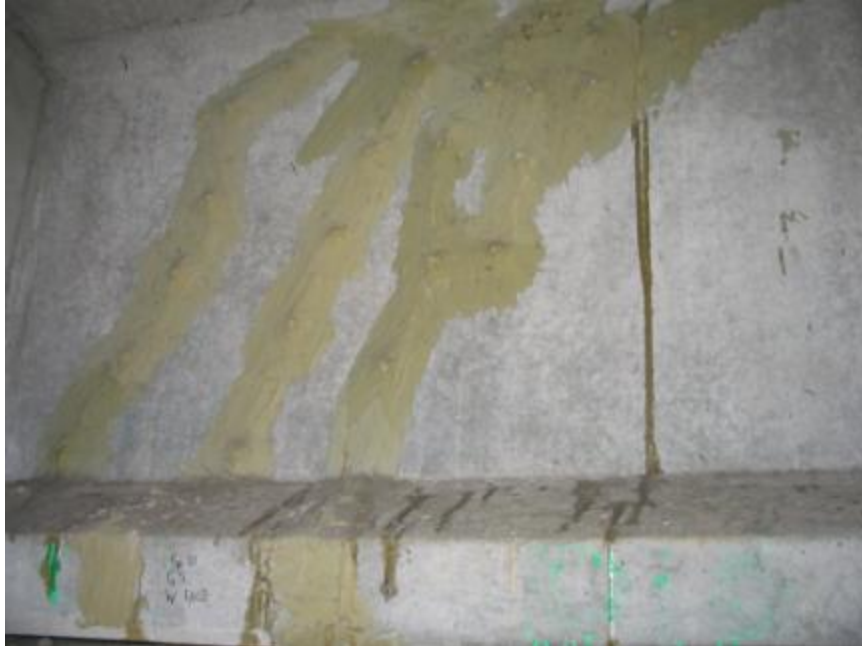
The severity of the cracks required immediate attention, and ALDOT personnel responded to the situation accordingly. The initial repair technique involved injecting the cracks with a structural epoxy, as shown in Figure 2.20, in an attempt to seal existing cracks and prevent future crack growth. However, new cracks often formed near the

epoxy-injected cracks, and many epoxy-injected cracks reopened, indicating that this repair technique was ineffective. Other safety measures had to be implemented before a more effective repair method could be determined.

**Figure 2.20:** Cracks injected with epoxy (Fason 2009)

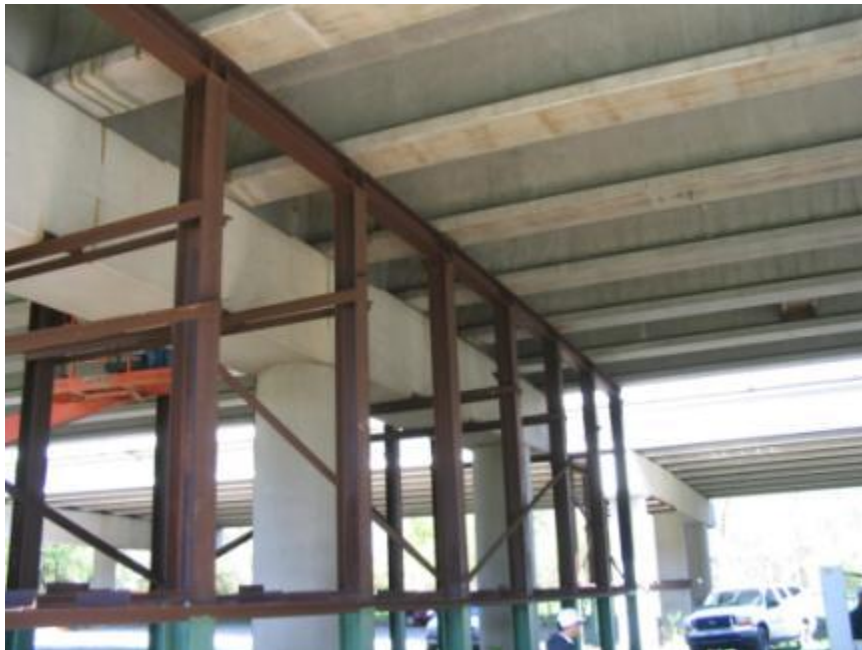
**Figure 2.21:** Steel frame false supports (Fason 2009)

Steel frame false supports, as shown in Figure 2.21, were installed near all bents that were associated with girders containing cracked end regions. The false supports were positioned slightly beyond the cracked regions. The false supports were also installed with clearance of roughly 1 in. between the top of the false support and the bottom of the girder. Elastomeric bearing pads were installed between the false supports and each girder bottom to allow the false supports to carry loads, if necessary, while limiting impact forces that could result in damage to the girders or false supports. Although the bearing pads were installed to limit impact-related damage, it was undesirable for bearing pads to remain in contact with bridge girders. An installed bearing pad with proper space between the pad and girder is shown in Figure 2.22. A bearing pad that is in contact with a girder and transferring loads through the false support is shown in Figure 2.23.

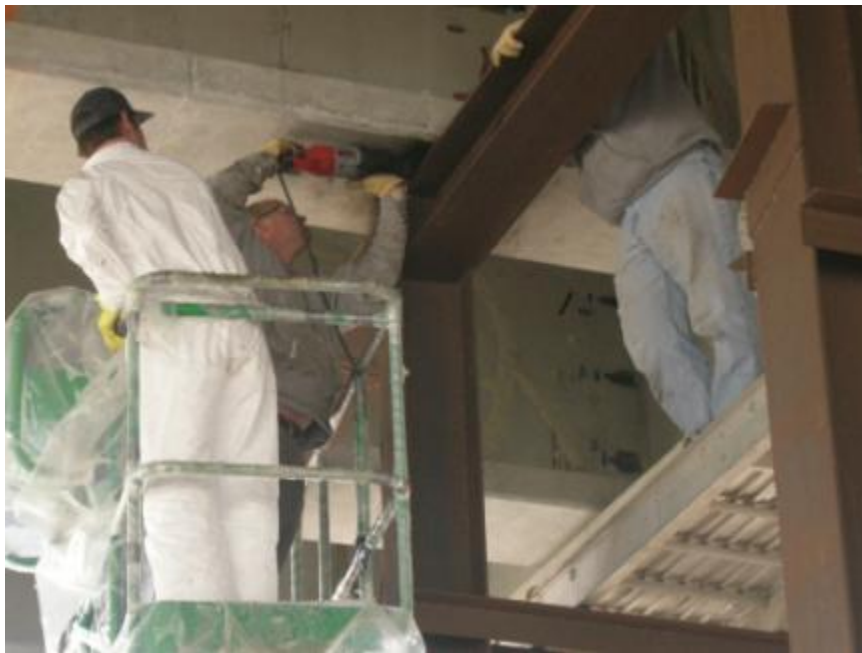
**Figure 2.30:** Use of saw for bearing pad removal

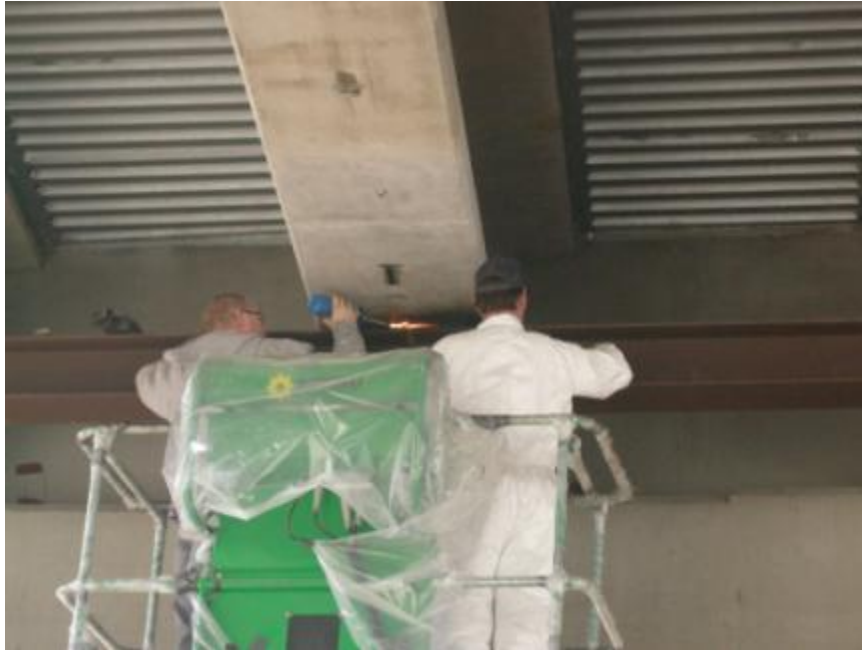
**Figure 2.31:** Use of torch for bearing pad removal

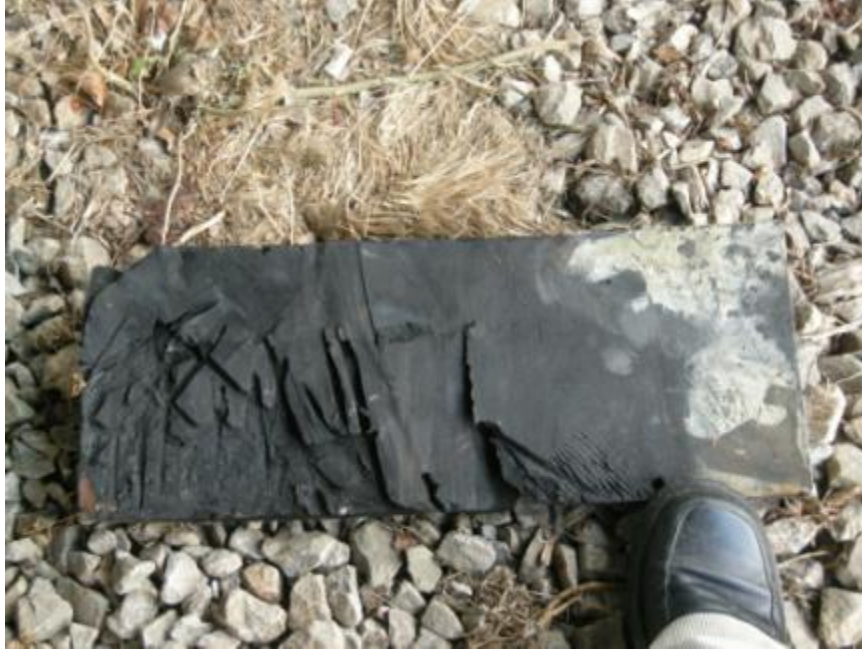
locations. The bearing pads under Span 11 were, in general, more difficult to remove than the bearing pads under Span 10. Initially, the contractor attempted to remove each bearing pad by punching it out of place using a chisel and hammer. When a bearing pad was under enough pressure to prevent removal, the contractor then used a reciprocating saw on the pad to alleviate some of that pressure, as shown in Figure 2.30. In some cases, saw cutting alone was not effective at alleviating enough pressure for successful bearing pad removal. In these cases, a propane torch was used to soften the rubber and allow for a more effective sawing process, which is shown in Figure 2.31. After successful pressure alleviation, the bearing pad was removed using the initial chisel-and-hammer removal method, as shown in Figure 2.32. An example of a bearing pad that required extensive removal efforts is shown in Figure 2.33.

**Figure 2.33:** Bearing pad after forceful removal

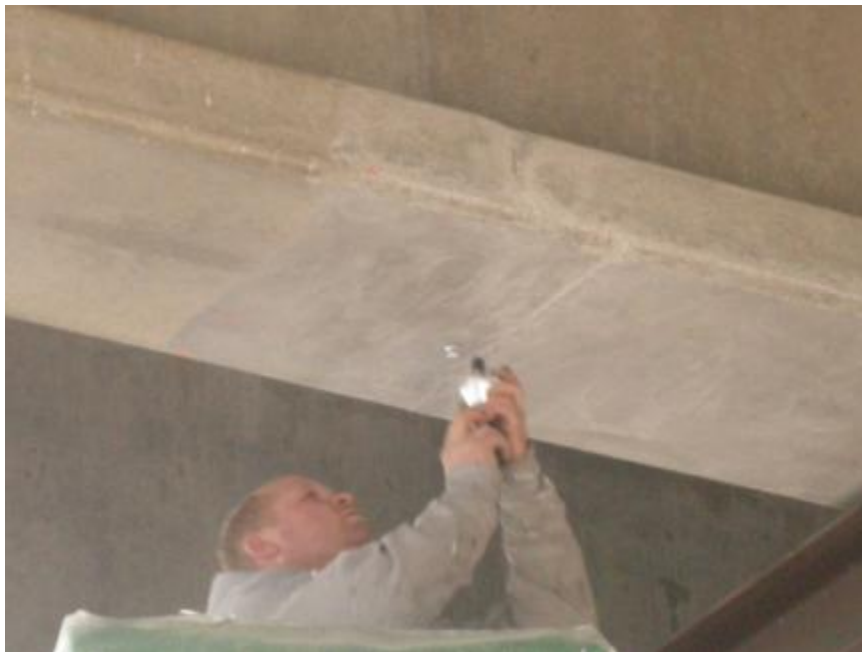
**Figure 2.35:** Performance of on-site adhesion test

Tyfo S saturant epoxy manufactured by Fyfe Co. was used throughout the FRP installation. Adhesion testing of the Tyfo S epoxy on the concrete surface was required to ensure that the bond strength of the epoxy exceeded the tensile strength of the concrete. The adhesion tests were conducted in accordance with the requirements given in ASTM D4541. Detailed description of the ASTM D4541 adhesion testing procedure has been reported by Swenson (2007). A minimum of three tests were required for each day in which FRP reinforcement was installed, and a minimum of one test was required per 500 square feet of installed FRP reinforcement. Adhesion testing equipment is shown in a laboratory setting in Figure 2.34. On-site adhesion testing is shown in Figure 2.35.

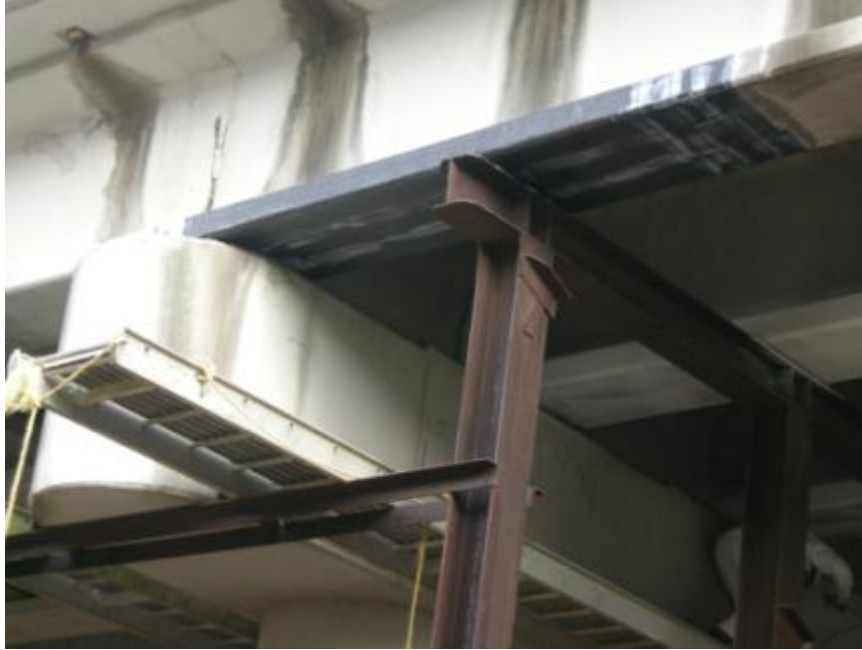
**Figure 2.42:** Four layers of installed FRP fabric

The FRP reinforcement repair consisted of four layers of FRP fabric. Due to the width of FRP fabric required to wrap around a typical bottom flange, three FRP fabric sheets were necessary per layer of installation. Two of the fabric sheets were of equal width and the third fabric sheet was narrower.

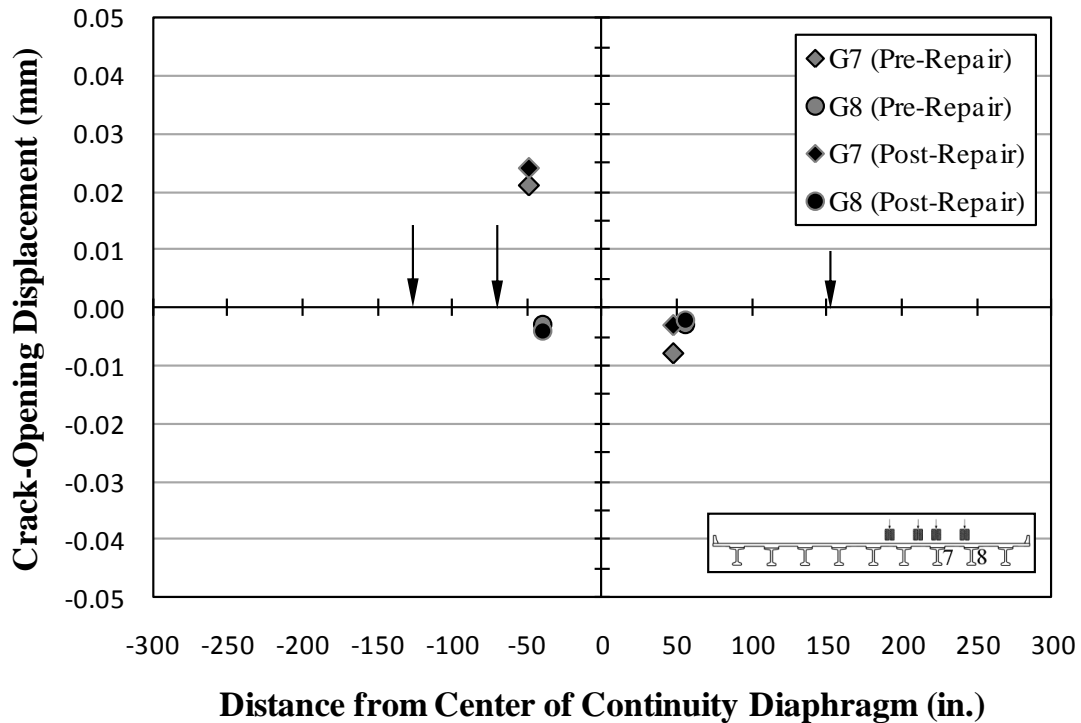
**Figure 5.1:** Crack-opening displacements—pre- and post-repair—A4

The comparison of crack-opening displacements from the pre- and post-repair tests in response to the same truck positions is one behavior that indicates that the bearing pads had a significant effect on the pre-repair measurements. Stop positions that resulted in crack openings were analyzed. Stop position locations are described in Section 4.4 of this thesis. During both the pre- and post-repair tests, Stop Position 4 had the greatest effect on the Span 10 crack openings, and Stop Position 7 had the greatest effect on the Span 11 crack openings. The pre- and post-repair crack-opening displacement measurements for Stop Positions A4, A7, C4, and C7 are presented in Figures 5.1–5.4 and Table 5.1. The arrows in the figures represent the position of the wheel loads on the bridge.

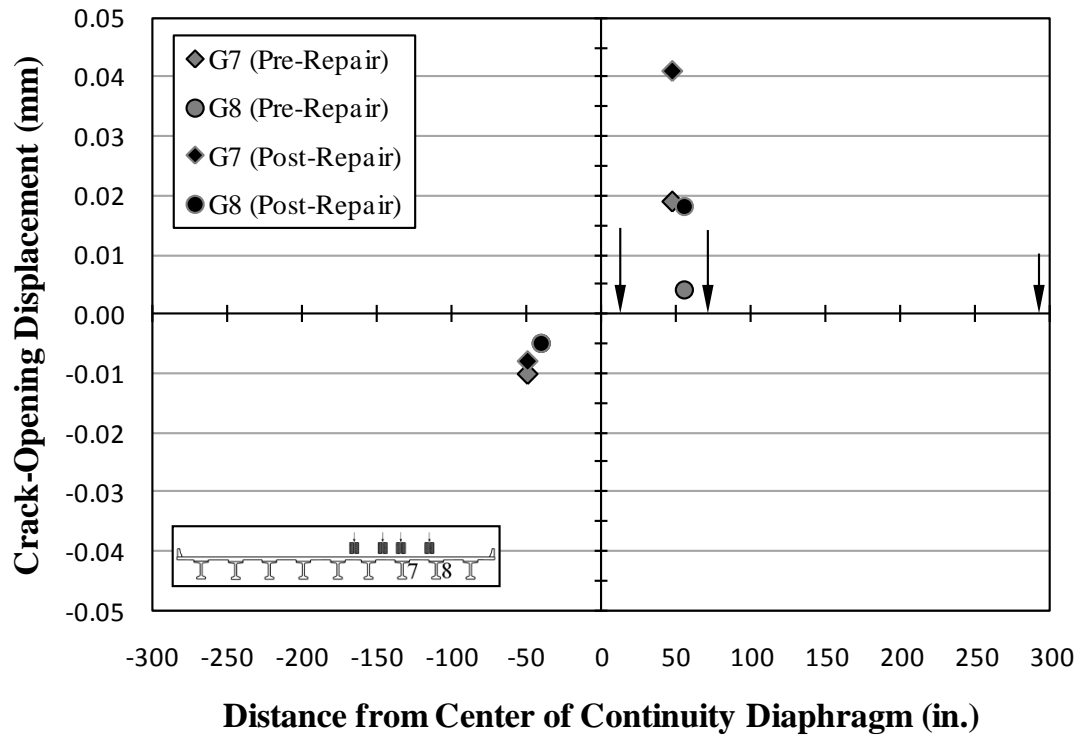
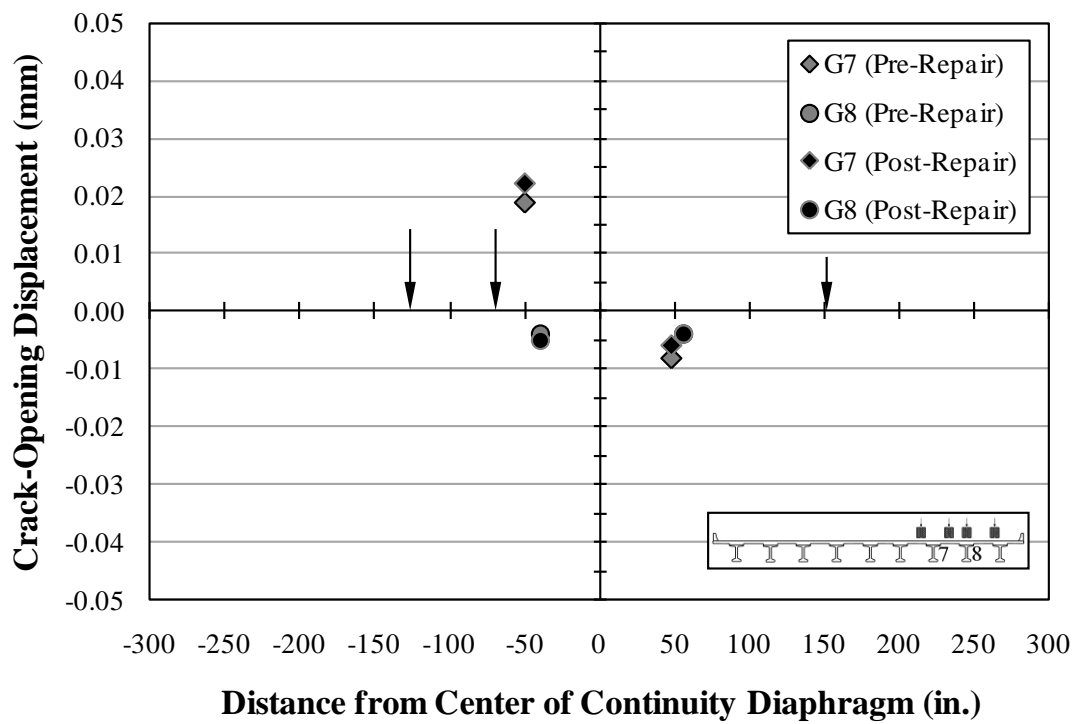
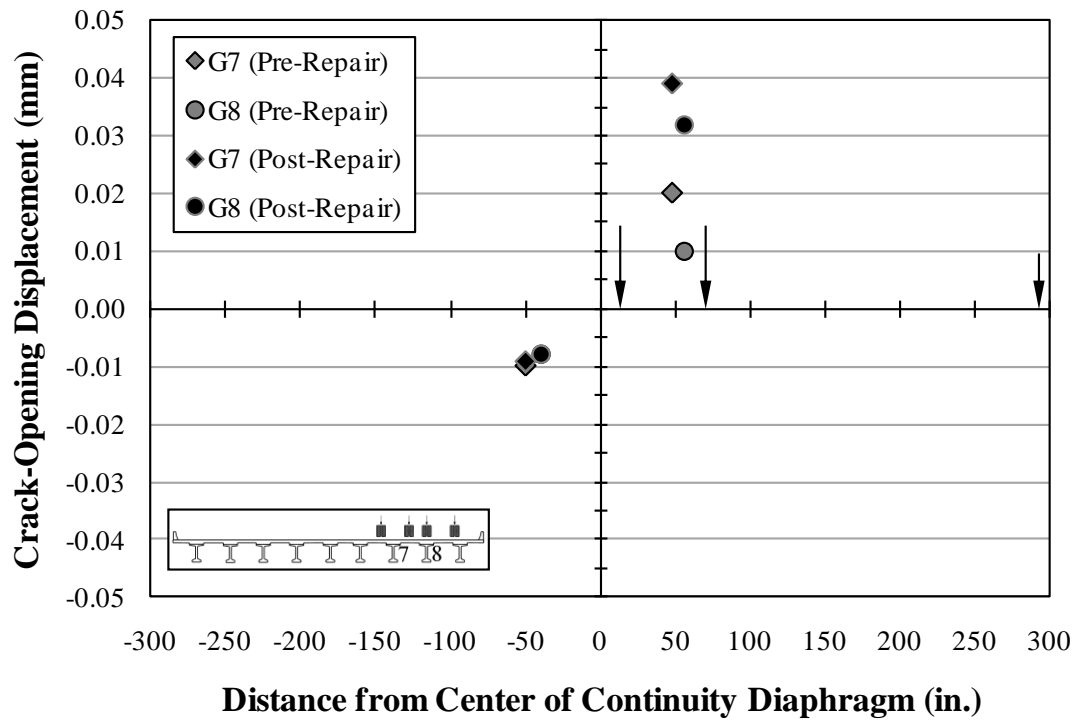
**Figure 5.2:** Crack-opening displacements—pre- and post-repair—A7

The crack-opening displacements measured in Span 10 were similar for both pre- and post-repair testing, but the crack-opening displacements measured in Span 11 in response to the Stop Position 7 load condition of the post-repair test increased in comparison to the crack-opening displacements measured in response to the same load condition during pre-repair testing. This behavior corresponds with the Span 10 bearing pads being partially removed prior to pre-repair testing, and the Span 11 bearing pads being under enough pressure to prevent any removal prior to pre-repair testing. It is apparent that girder contact with the false support bearing pads under Span 11 resulted in additional

support conditions that affected pre-repair measurements. This conclusion is further supported by the other comparisons that are located in Appendix K.

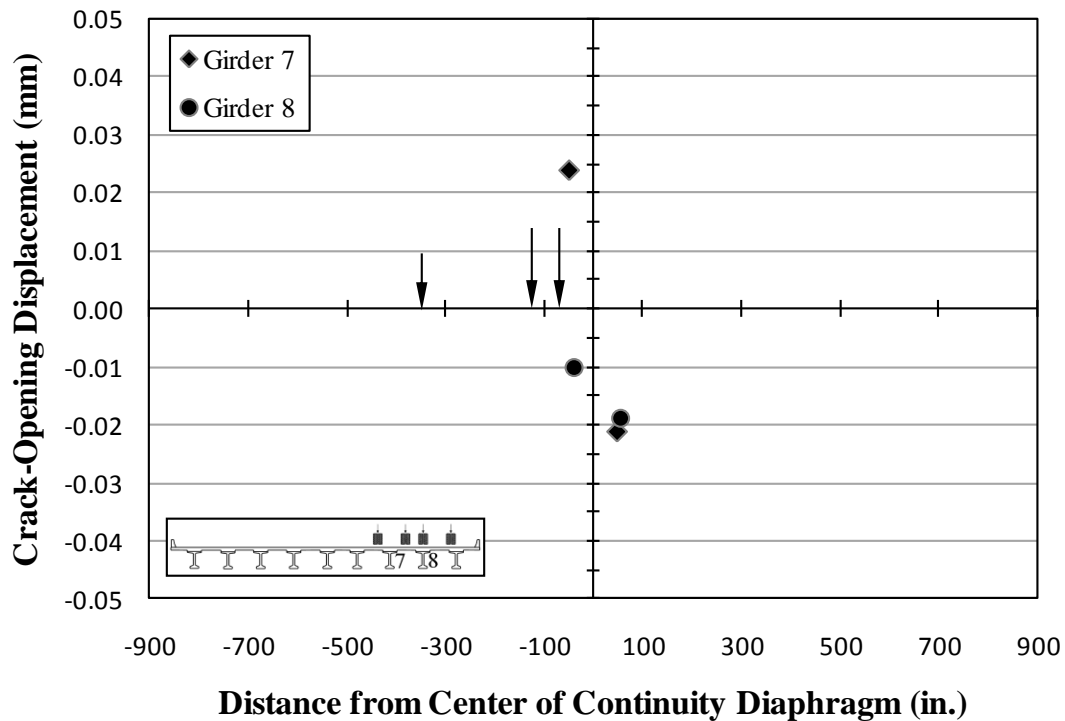
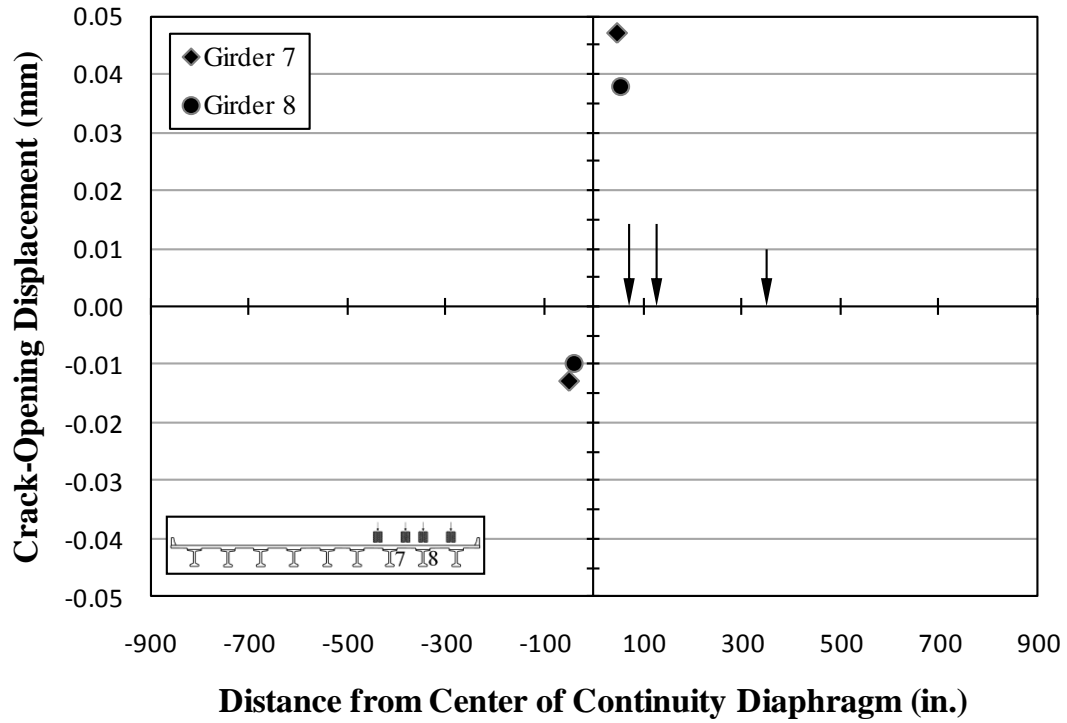
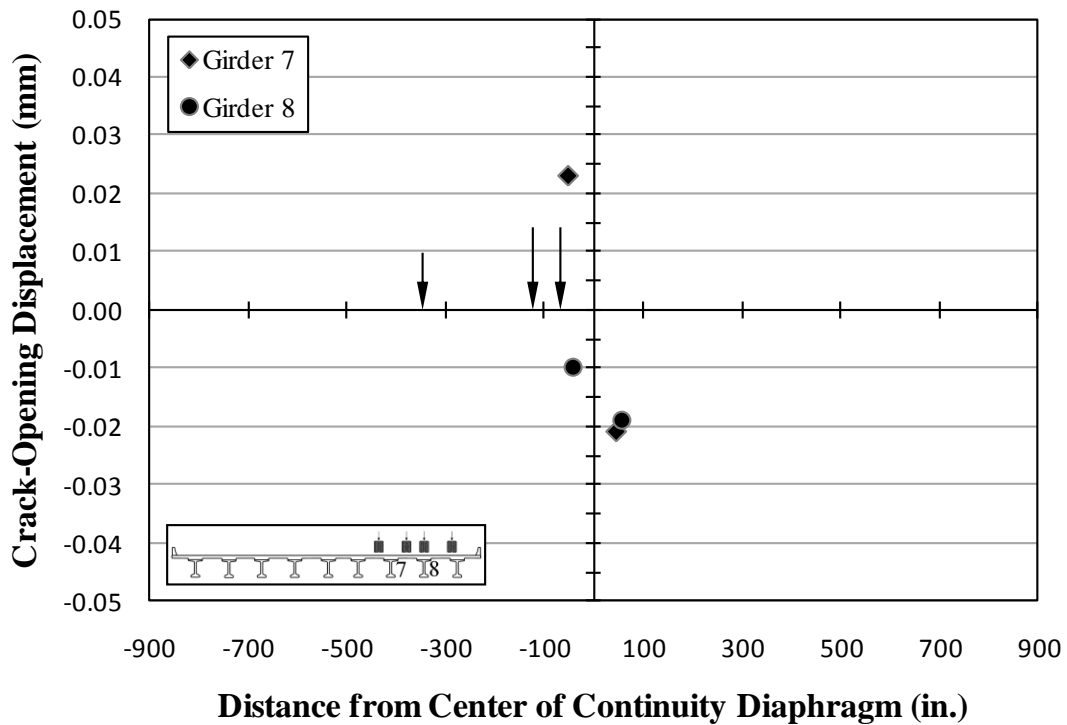
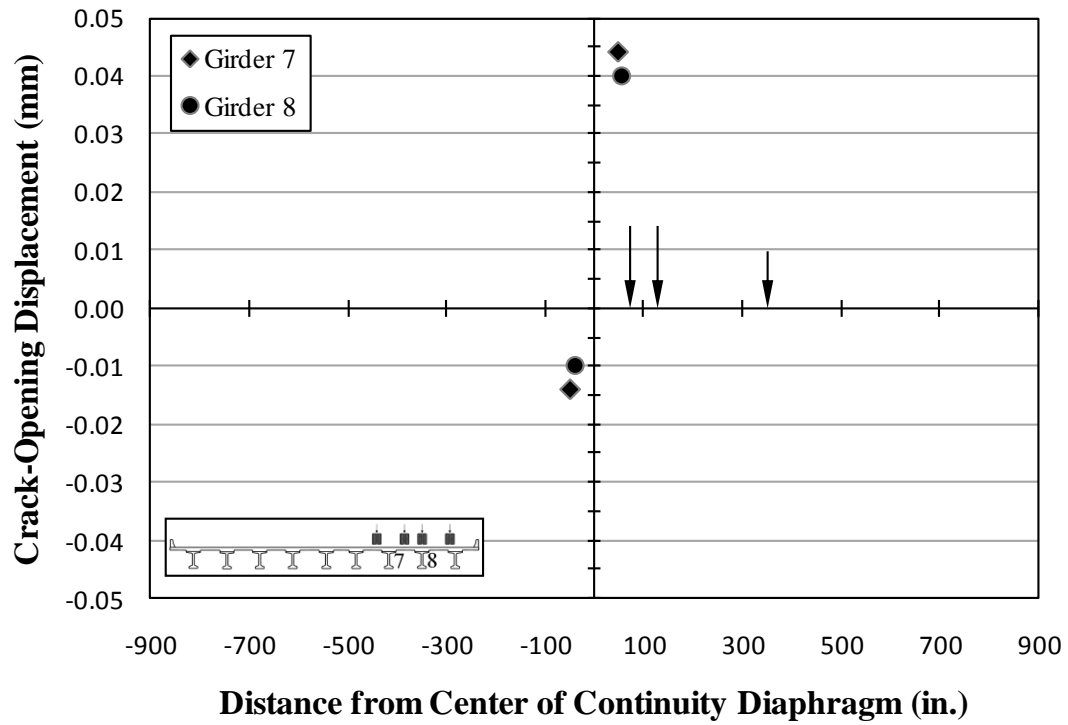
**Figure 5.11:** AE Span 10 truck position—crack-opening displacements—LC-6.5

A maximum crack opening of 0.047 mm ( $1.83 \times 10^{-3}$  in.) was measured by the COD gage on the east face of Girder 7 in Span 11 in response to the AE Span 11 static position. A maximum crack closure of 0.021 mm ( $0.84 \times 10^{-3}$  in.) was measured by the same COD gage on the east face of Girder 7 in Span 11 but in response to the Span 10 static position. The COD gage on the west face of Girder 8 in Span 10 did not measure a crack opening due to any of the AE static positions.

The crack openings measured on the instrumented girders of Span 11 due to the Span 11 static position were of greater magnitude than the Span 10 crack openings due to the Span 10 static position. Similarly, the crack closures measured on the instrumented

girders of Span 11 due to the Span 10 static position were of greater magnitude than the Span 10 crack closures due to the Span 11 static position. In response to trucks with consistent load-block configurations, the maximum range of crack-opening displacements on an instrumented Span 11 crack was 0.068 mm ( $2.67 \times 10^{-3}$  in.) measured by the COD gage on Girder 7 of Span 11. The maximum range of crack-opening displacements on an instrumented Span 10 crack was 0.037 mm ( $1.47 \times 10^{-3}$  in.) measured by the COD gage on Girder 7 of Span 10.

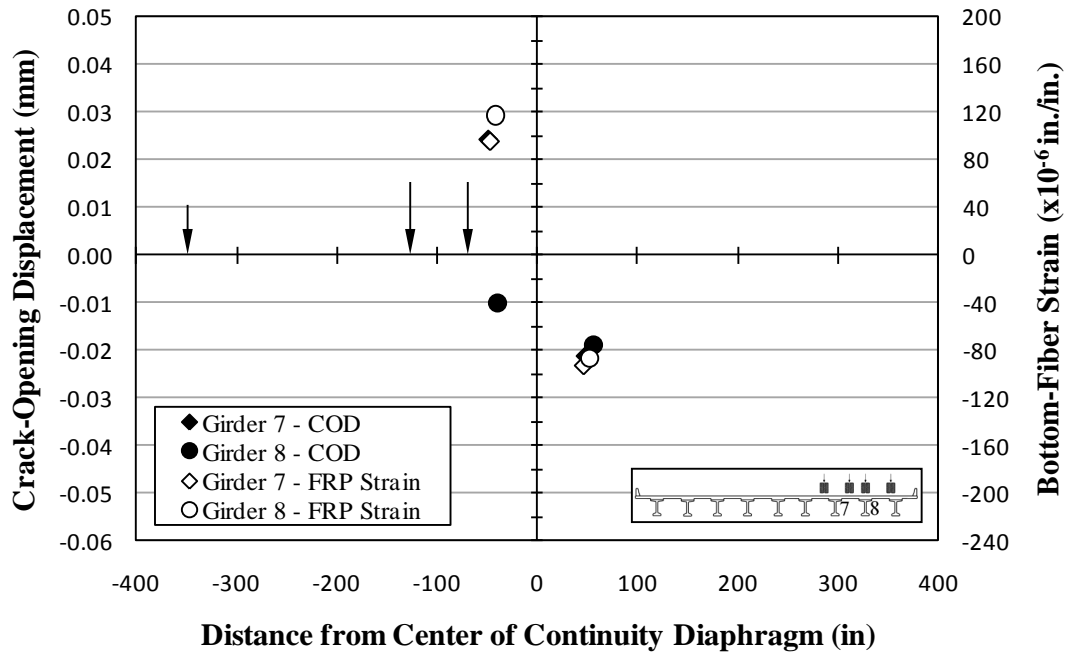
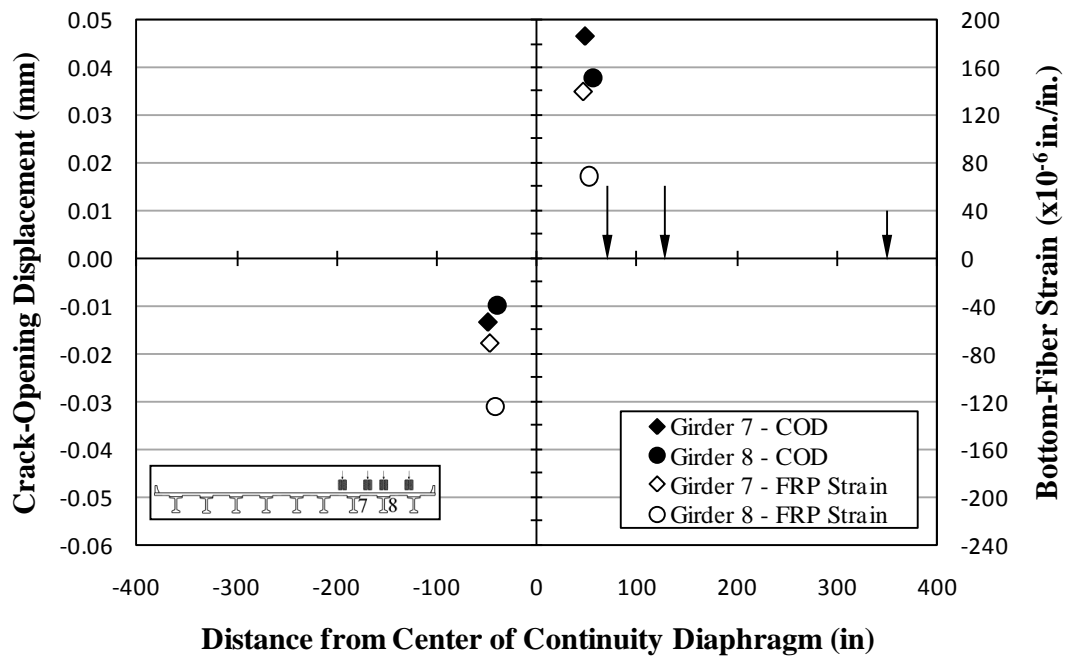
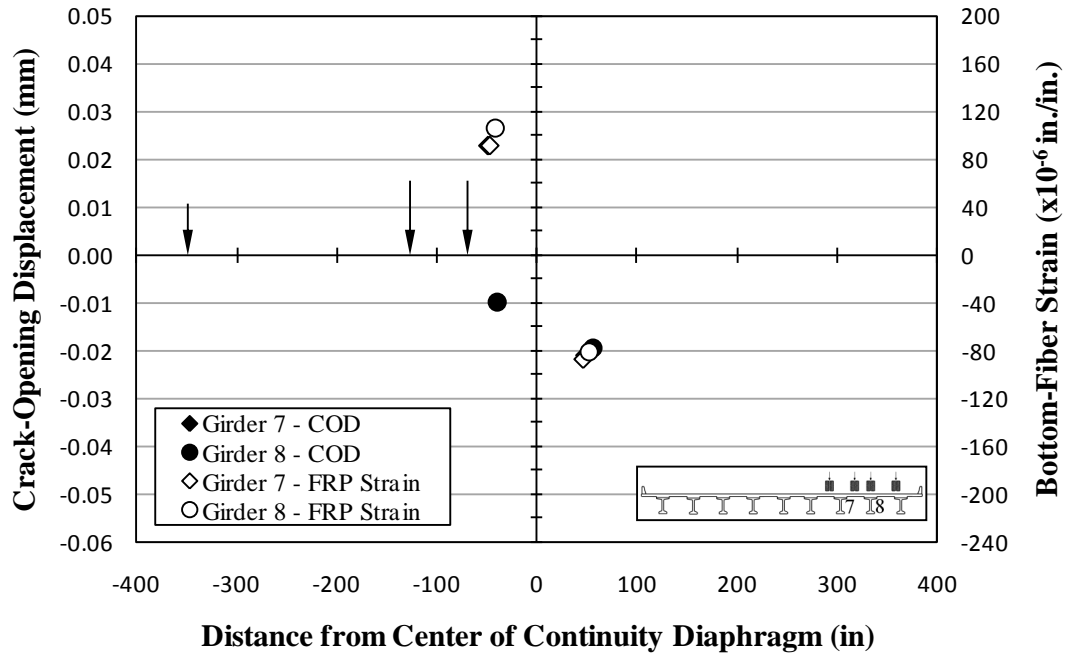
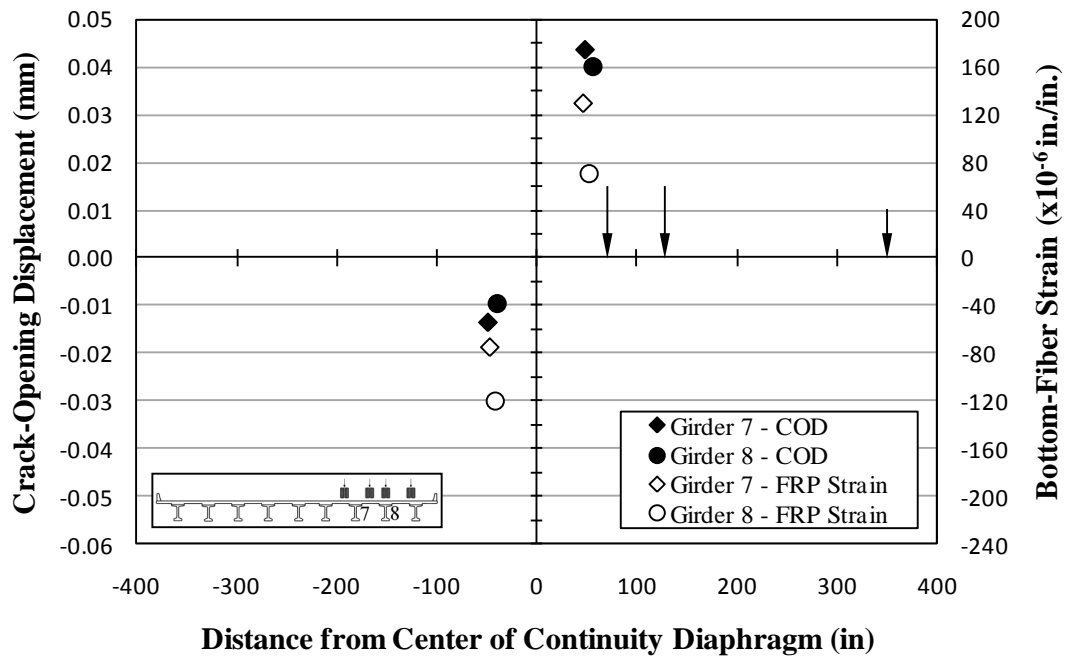
**Figure 5.19:** COD and bottom-fiber strain comparisons—LC-6.5—AE Span 10

The COD and near-crack bottom-fiber strain measurements of Girder 8 in Span 10 exhibited contradicting behavior. Crack closure was measured in response to the Span 10 load condition while a near-crack bottom-fiber tensile strain was measured. The tensile strain measured at the Girder 8-Span 10 near-crack strain gage location was similar to the tensile strain measured at the Girder 7-Span 10 near-crack strain gage location in response to the same Span 10 load condition. The difference between the Girder 8-Span 10 COD gage and the Girder 7-Span 10 COD gage is that the COD gages are installed on opposite girder faces. The combination of similar bottom-fiber strain behavior and conflicting crack-opening displacement behavior for the Girder 8-Span 10 COD gage supports the conclusion that out-of-plane bending behavior has an effect on crack-opening displacements measured during live-load testing—particularly when a wheel load is placed very close to the girder cross section under investigation.
