**Behavior of a Damaged Prestressed Concrete Bridge  
Repaired with Fiber-Reinforced Polymer Reinforcement**

A thesis submitted to the Graduate Faculty of  
Auburn University  
in partial fulfillment of the  
requirements for the Degree of  
Master of Science

Auburn, Alabama  
December 12, 2011

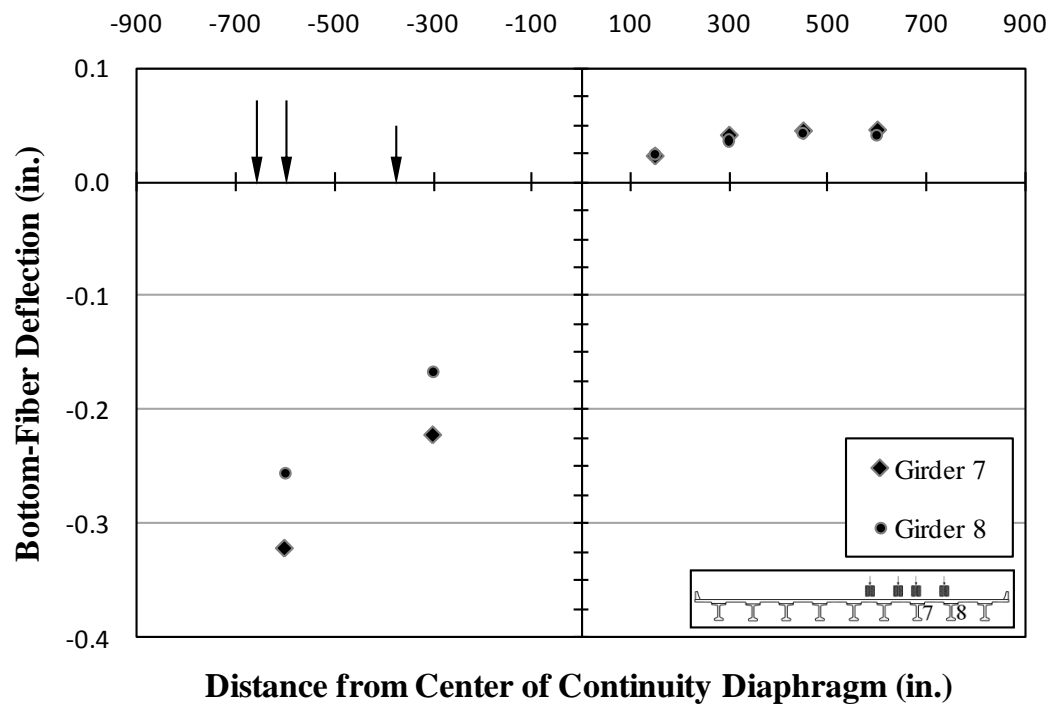
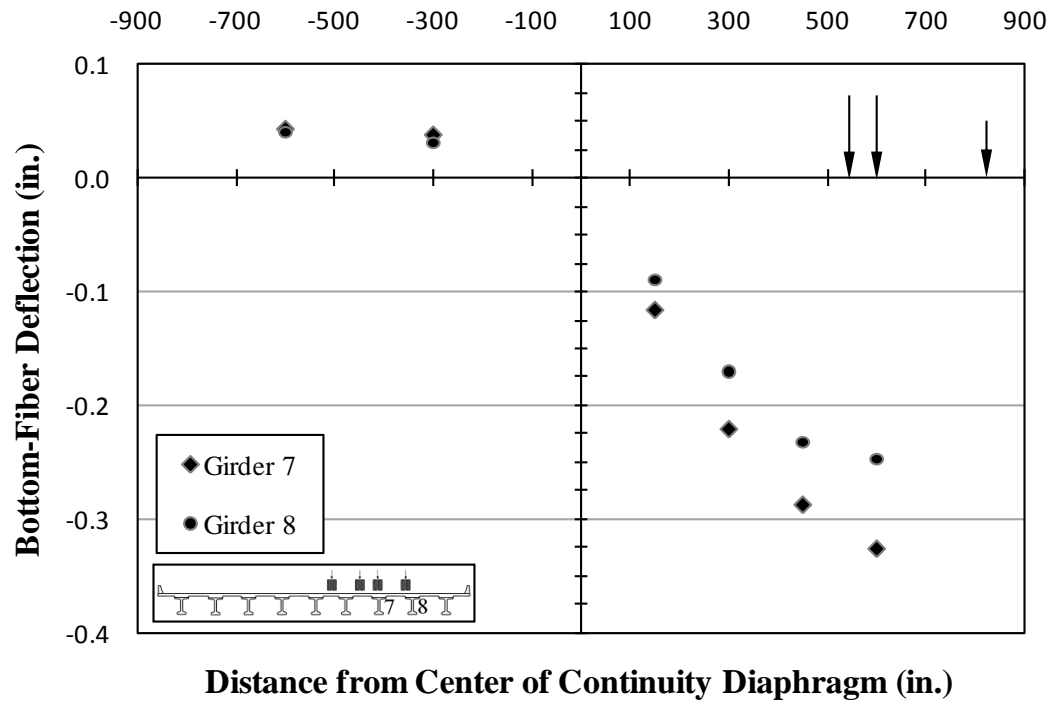
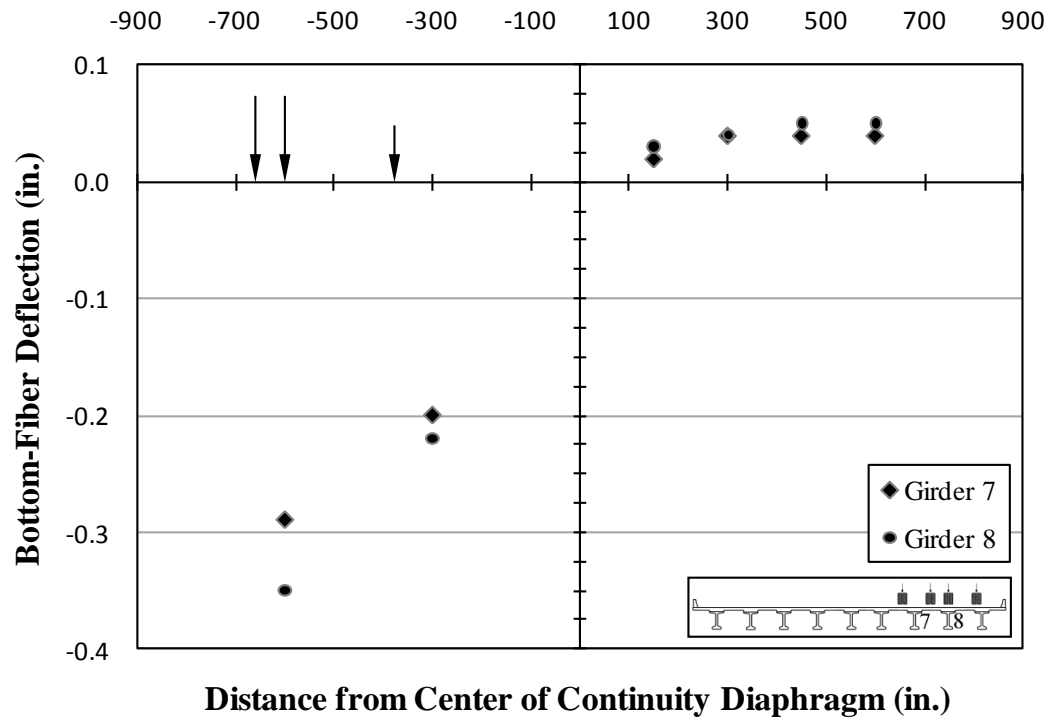
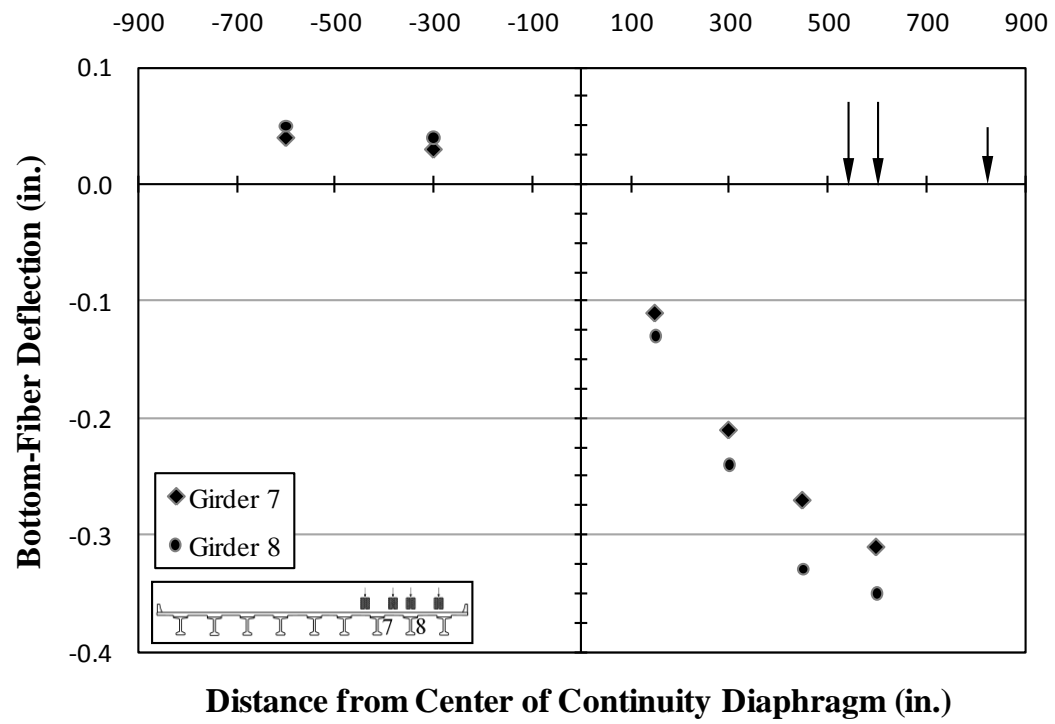
Figure 5.23: Deflections—A1

A maximum downward deflection of 0.35 in. was measured at the midspan location of Span 11 due to the Span 11 midspan load condition. A maximum upward deflection of 0.05 in. was measured at three different locations due to separate load conditions. The upward deflections due to live loads are an indicator that partial continuity has been preserved.

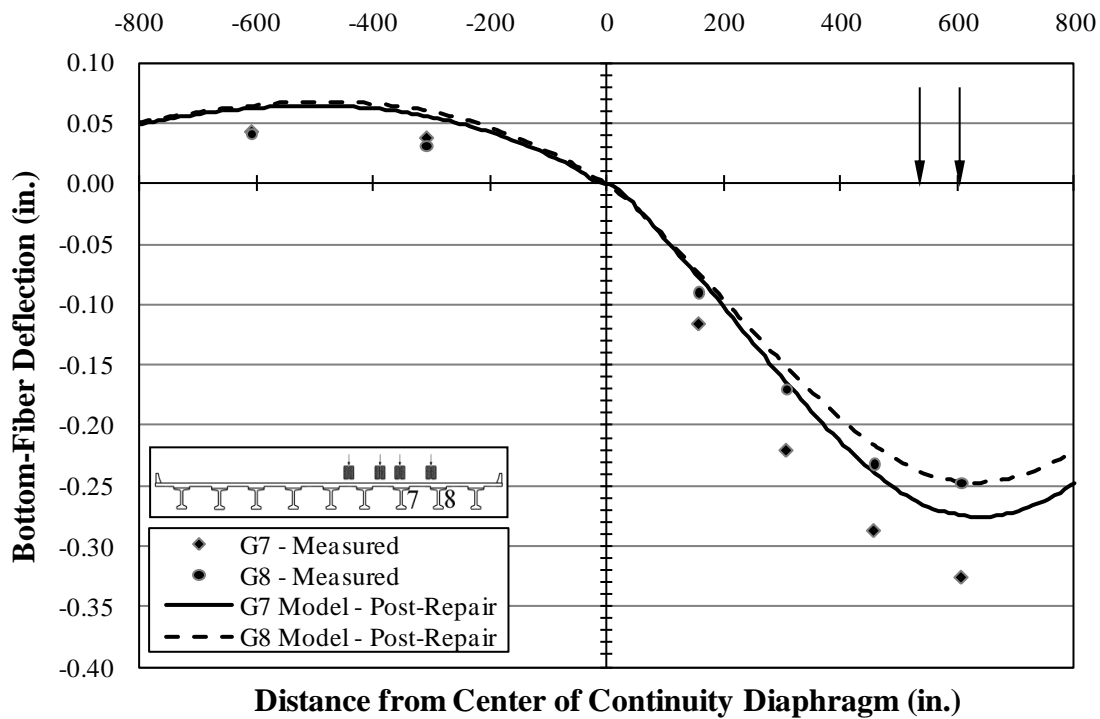
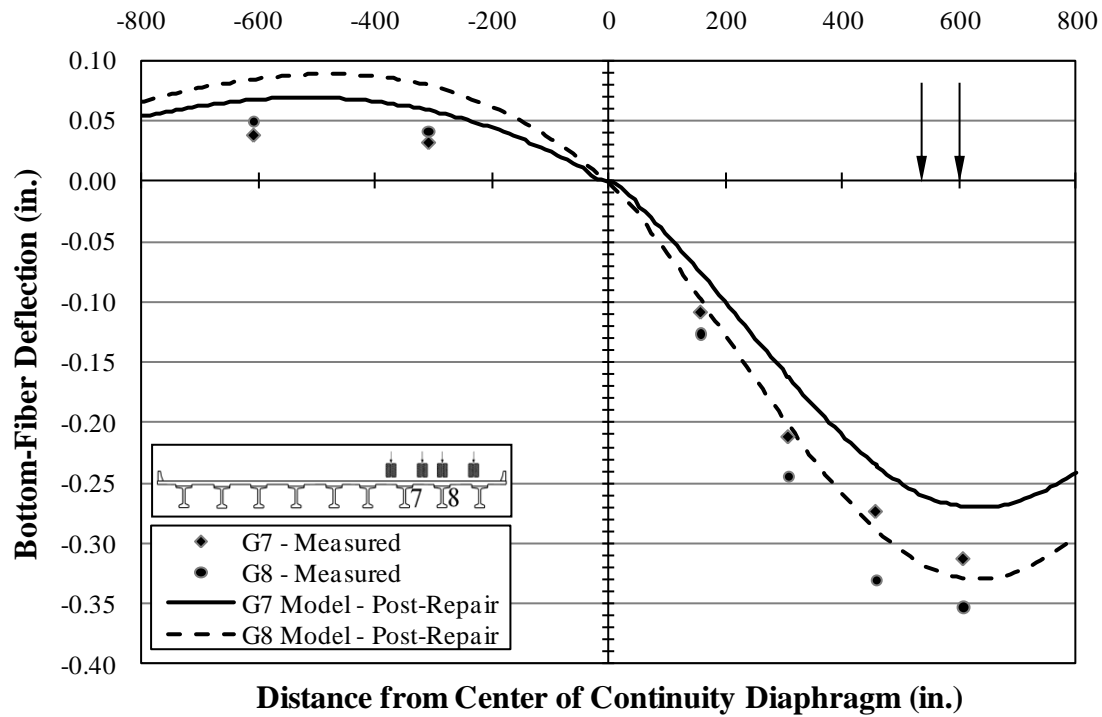
**Figure 5.27:** Deflections—post-repair—measurements and predictions—A9

Post-repair deflection measurements are an indication that the *modeled* post-repair structure exhibits more apparent stiffness and continuity than the *actual* post-repair structure. The downward deflections measured in the loaded span were greater than the downward deflections predicted. The upward deflections measured in the non-loaded span were less than the upward deflections predicted.

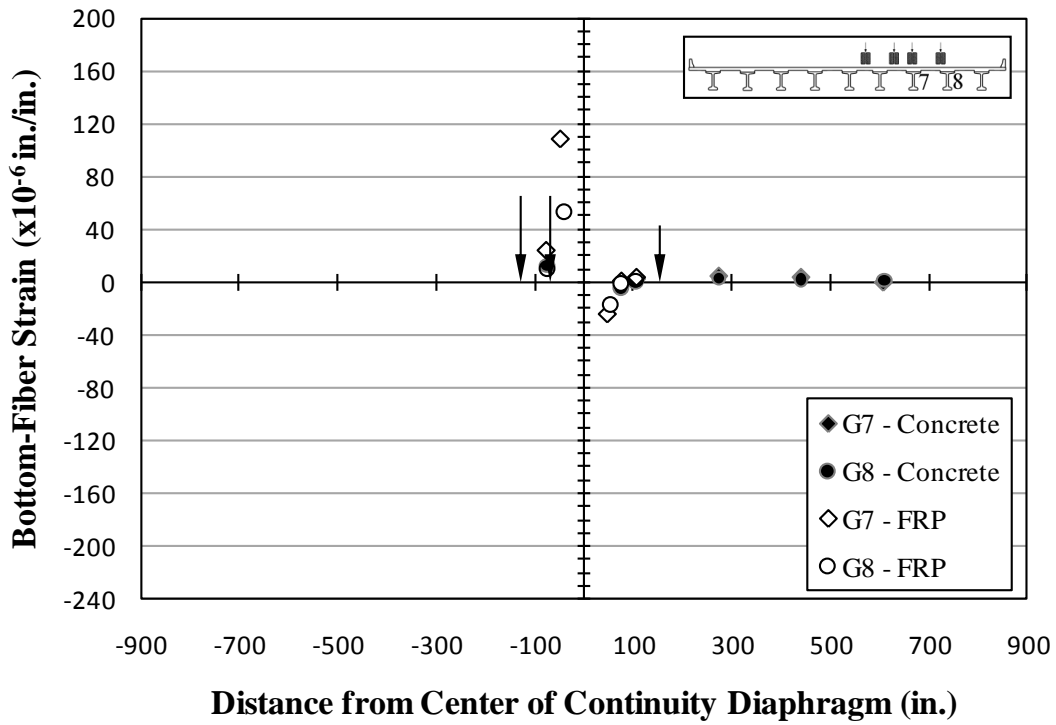
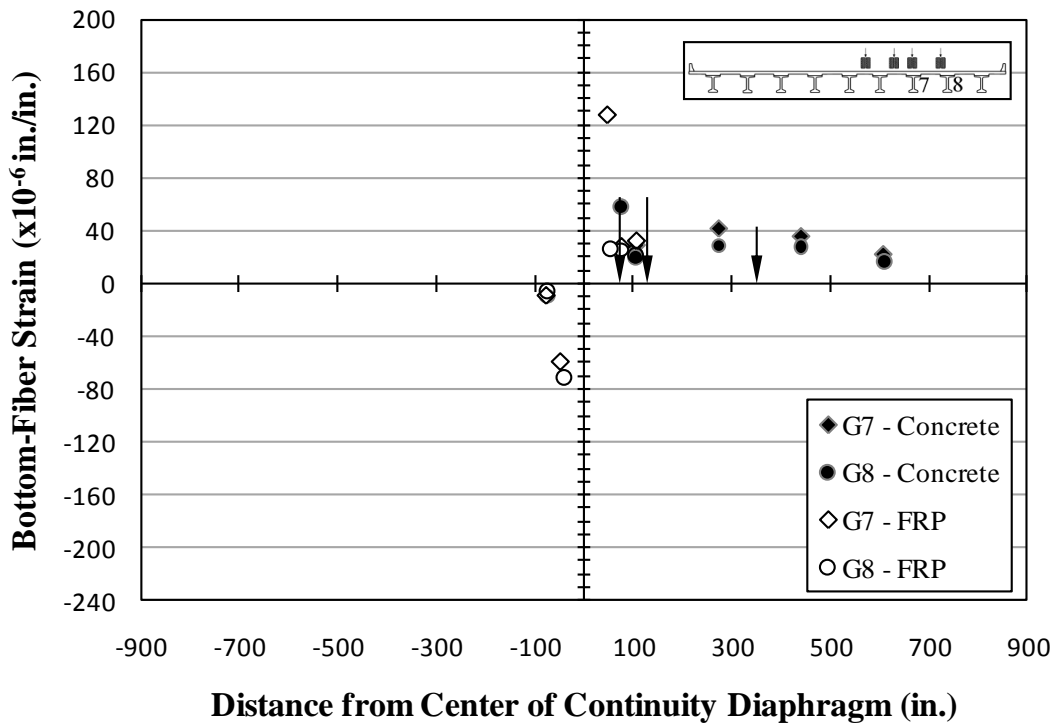
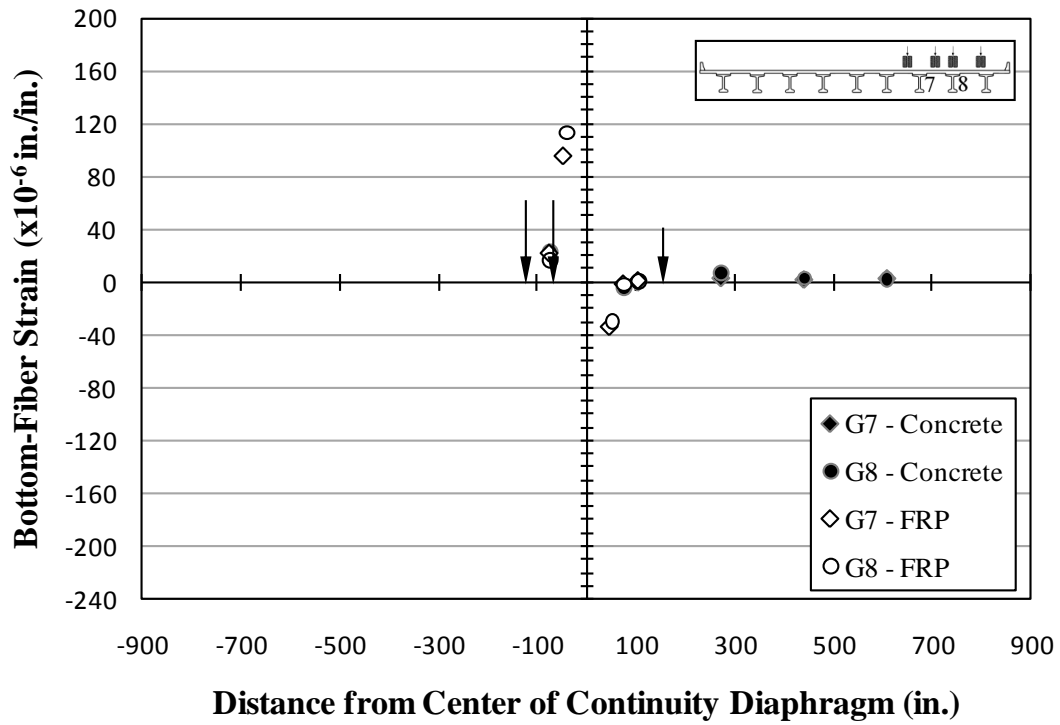
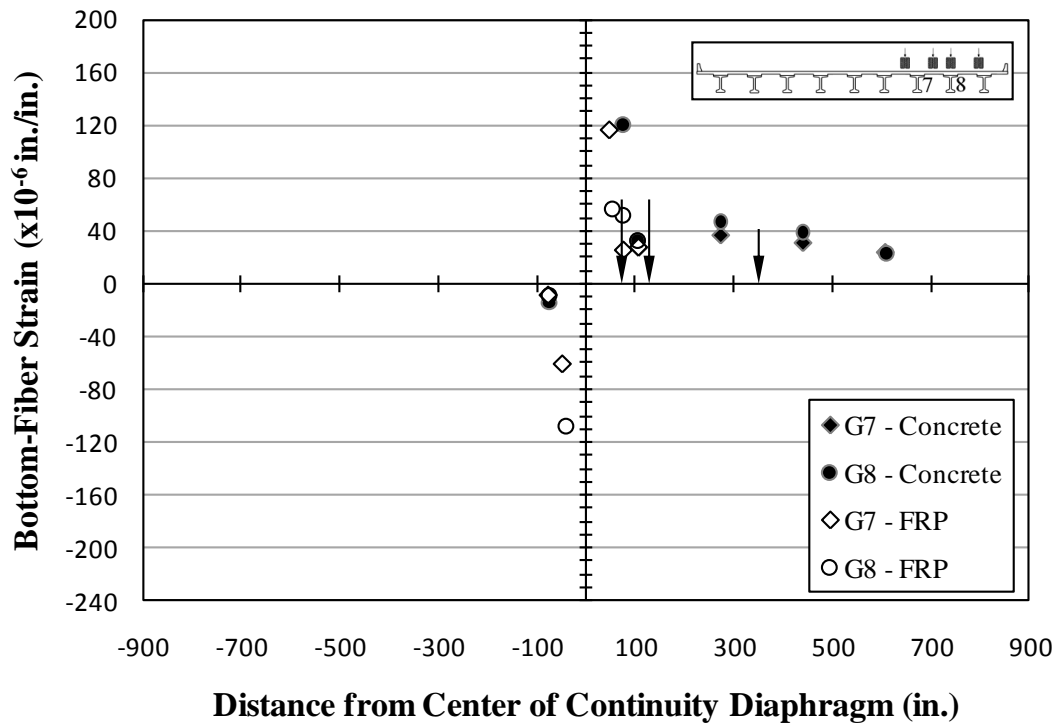
Figure 5.33: Bottom-fiber strain—A4

The maximum bottom-fiber tensile strain measured in response to the eighteen post-repair traversing-load-test truck positions was  $128 \times 10^{-6}$  in./in. near the crack location 47 in. from the continuity diaphragm along Girder 7 of Span 11 in response to trucks aligned with Lane A and positioned near the damaged section (A7). A bottom-fiber tensile strain of  $28 \times 10^{-6}$  in./in. was measured 74 in. from the continuity diaphragm along the same girder and in response to the same load condition. This bottom-fiber tensile response near the continuity diaphragm is a sign of local behavior that decreases the overall continuity of the bridge structure.

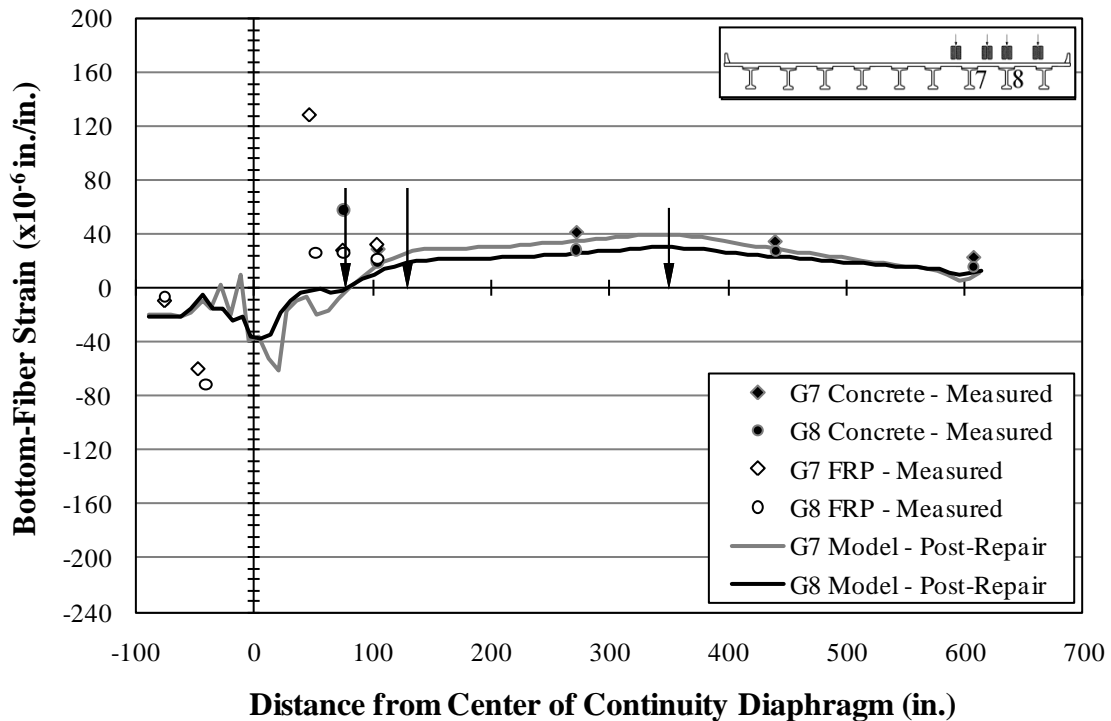
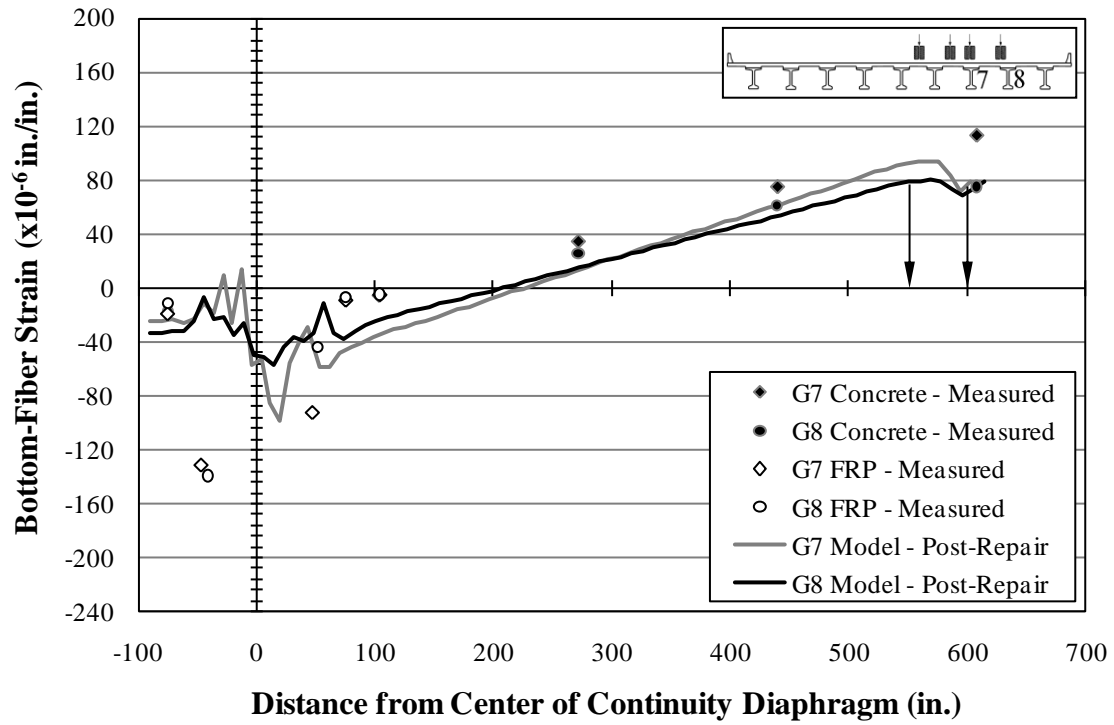
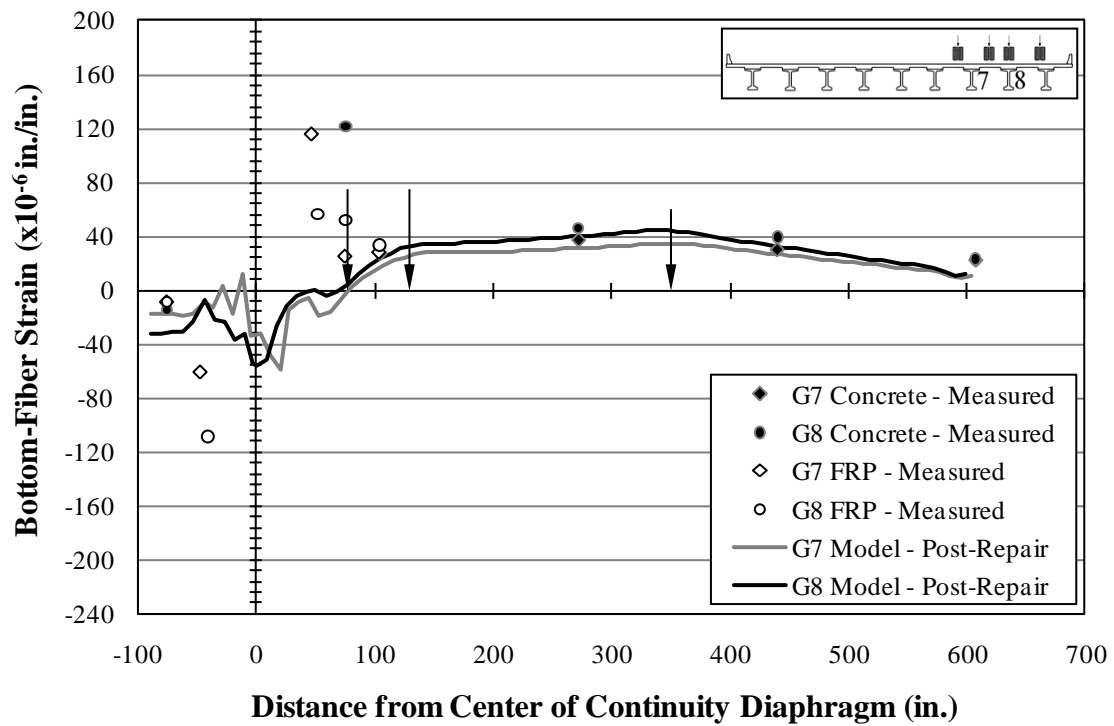
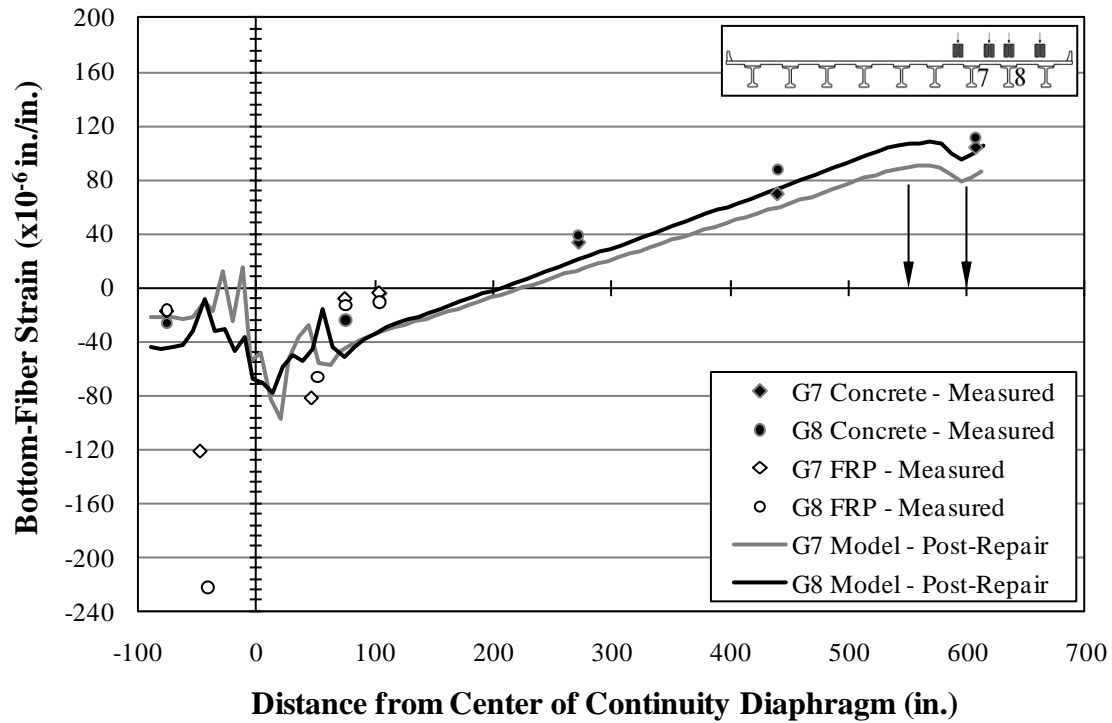
**Figure 5.37:** Bottom-fiber strain—post-repair—measurements and predictions—A7

Bottom-fiber strains measured beyond the damaged regions were similar to the predicted strains, but they were slightly more tensile. This is an indicator that the bridge structure is behaving continuously, but with slightly less apparent stiffness than modeled. The measured bottom-fiber strains near the damaged region were not similar to the predicted strains. When the trucks were positioned near the damaged regions of Span 11, the bottom-fiber strains measured near the crack locations of Span 11 were more tensile than predicted. When the trucks were positioned near midspan of Span 11, the bottom-fiber strains measured near the crack locations of Span 10 were more compressive than predicted.

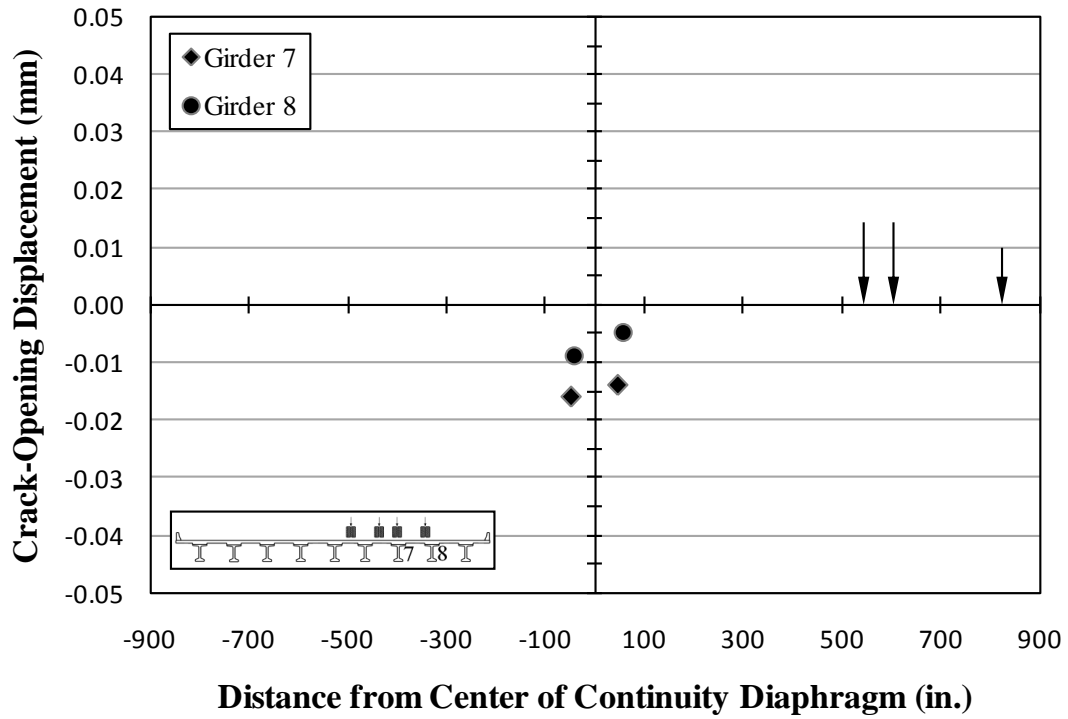
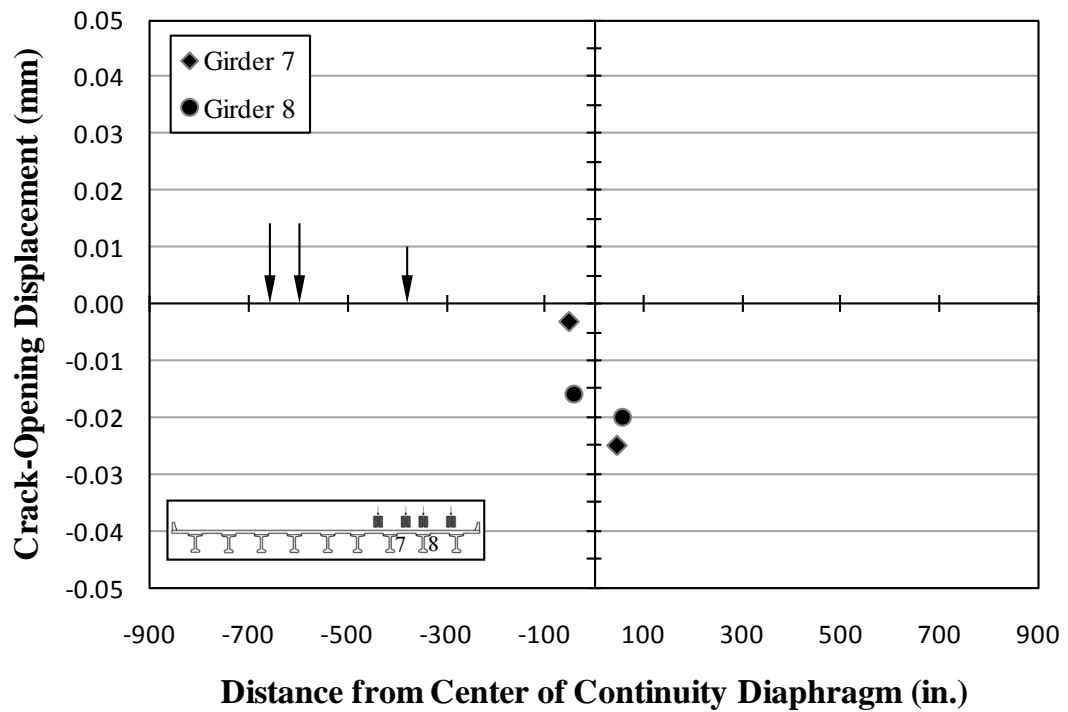
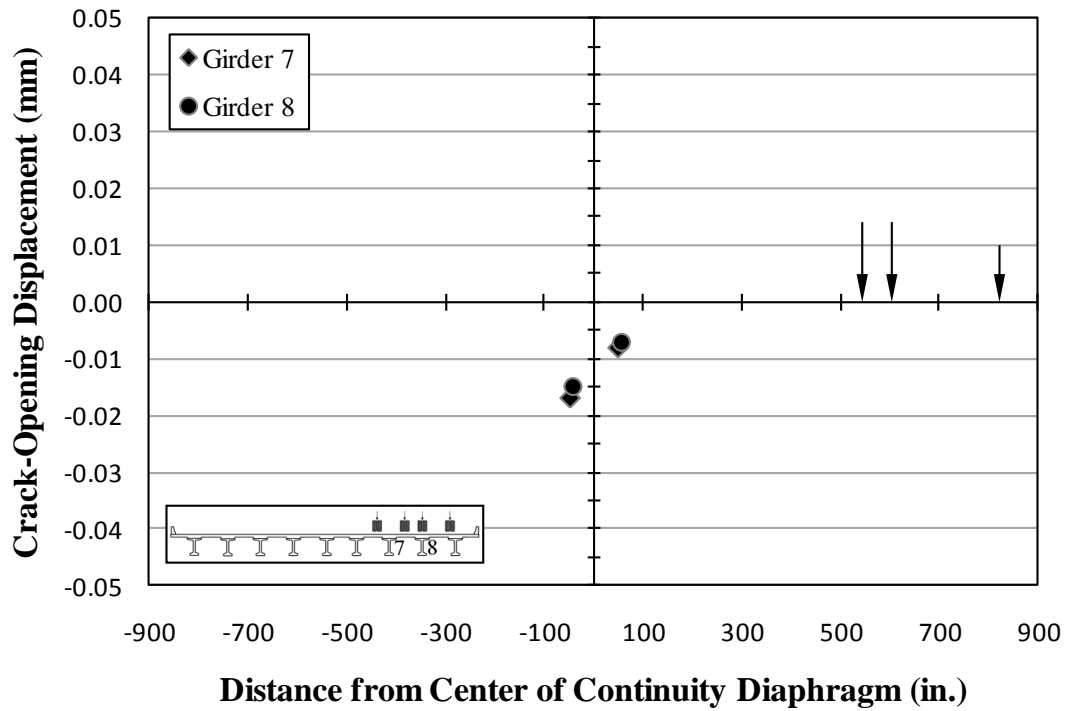
**Figure 5.42:** Midspan truck positions—crack-opening displacements—A9

**Figure 5.43:** Midspan truck positions—crack-opening displacements—C1

**Figure 5.44:** Midspan truck positions—crack-opening displacements—C9

Crack closures were measured at all of the COD gage locations in response to all four midspan truck positions of the post-repair traversing load test. The maximum crack closure measured during the post-repair traversing load test was 0.027 mm ( $1.08 \times 10^{-3}$  in.) at the crack location of Girder 7 in Span 11 in response to the Lane A midspan load condition of Span 10 (A1). The maximum crack closure of Span 10 was 0.017 mm ( $0.65 \times 10^{-3}$  in.) at the crack location of Girder 7 in response to the Lane C midspan load condition of Span 11 (C9). Crack closures measured at damaged regions of both spans in response to midspan truck positions are signs of continuous behavior being partially preserved as well as decreased local apparent stiffness.

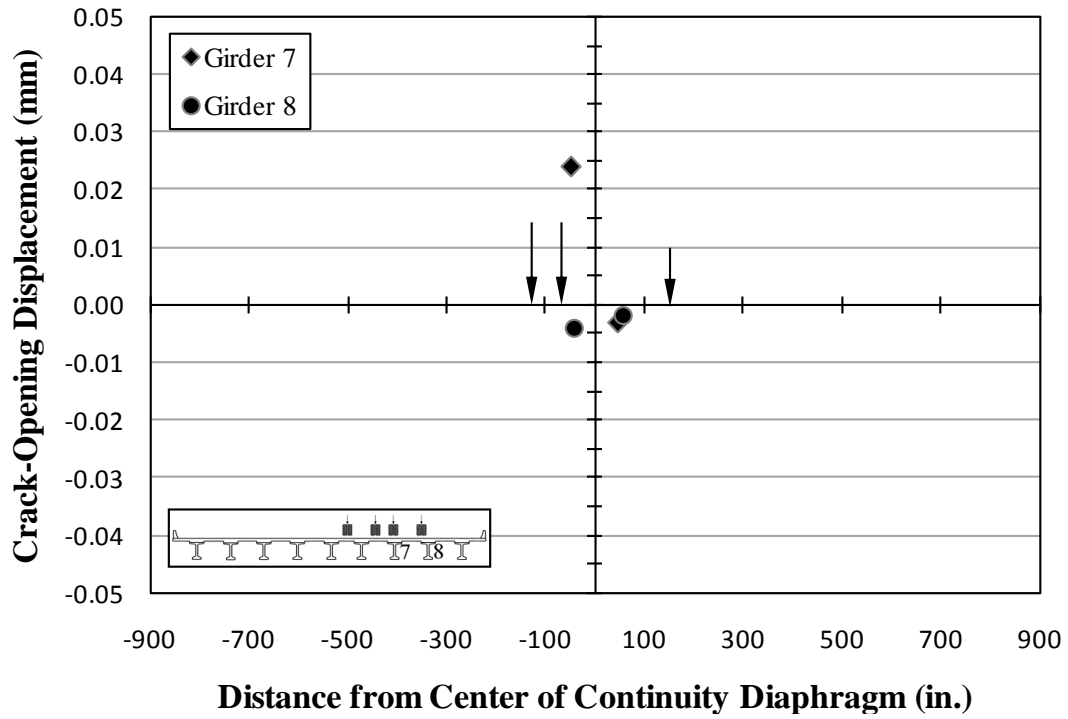
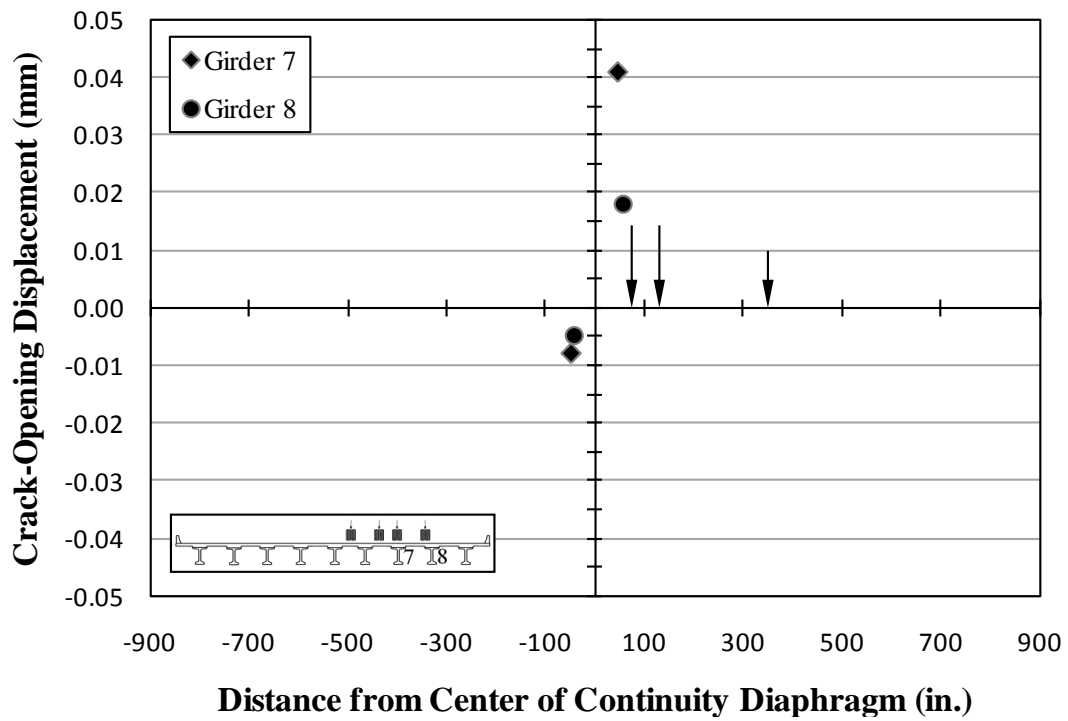
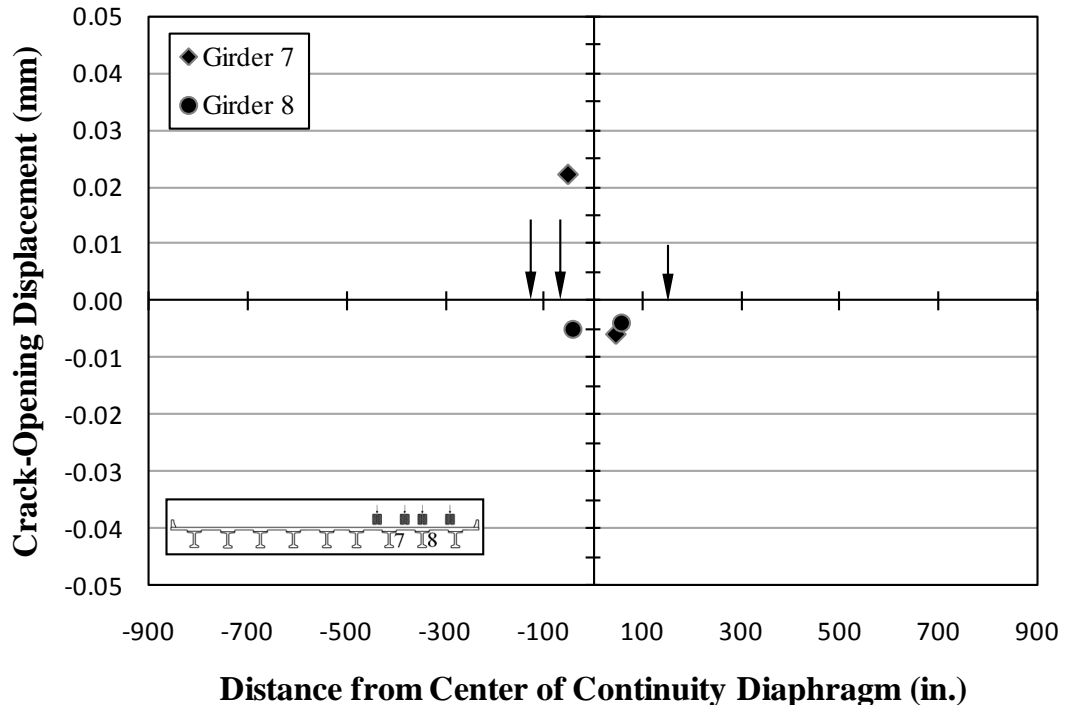
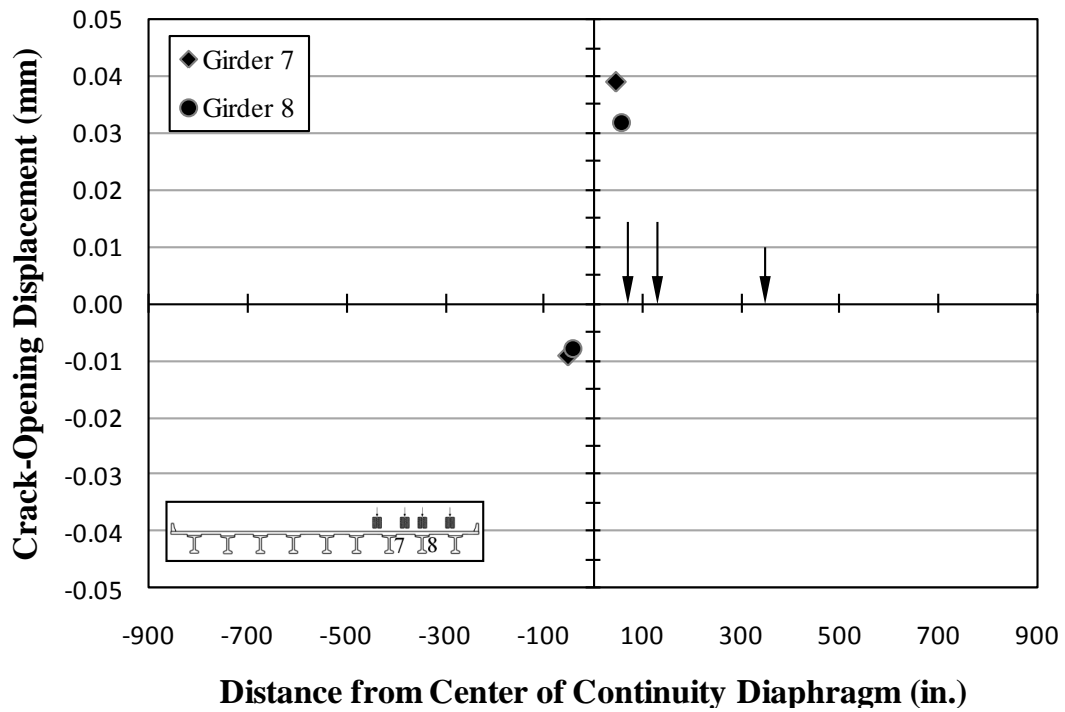
**Figure 5.45:** Damaged region truck positions—crack-opening displacements—A4

**Figure 5.46:** Damaged region truck positions—crack-opening displacements—A7

**Figure 5.47:** Damaged section truck positions—crack-opening displacements—C4

**Figure 5.48:** Damaged region truck positions—crack-opening displacements—C7

The maximum crack opening measured during the post-repair traversing load test was 0.041 mm ( $1.62 \times 10^{-3}$  in.) at the crack location of Girder 7 in Span 11 in response to the Lane A load condition with trucks near the Span 11 damaged sections (A7). The maximum Span 10 crack opening measured was 0.024 mm ( $0.95 \times 10^{-3}$  in.) at the crack location of Girder 7 in Span 10 in response to the Lane A load condition with trucks near the Span 10 damaged sections (A4). Crack openings measured within a loaded span are also signs of decreased apparent stiffness within damaged regions.

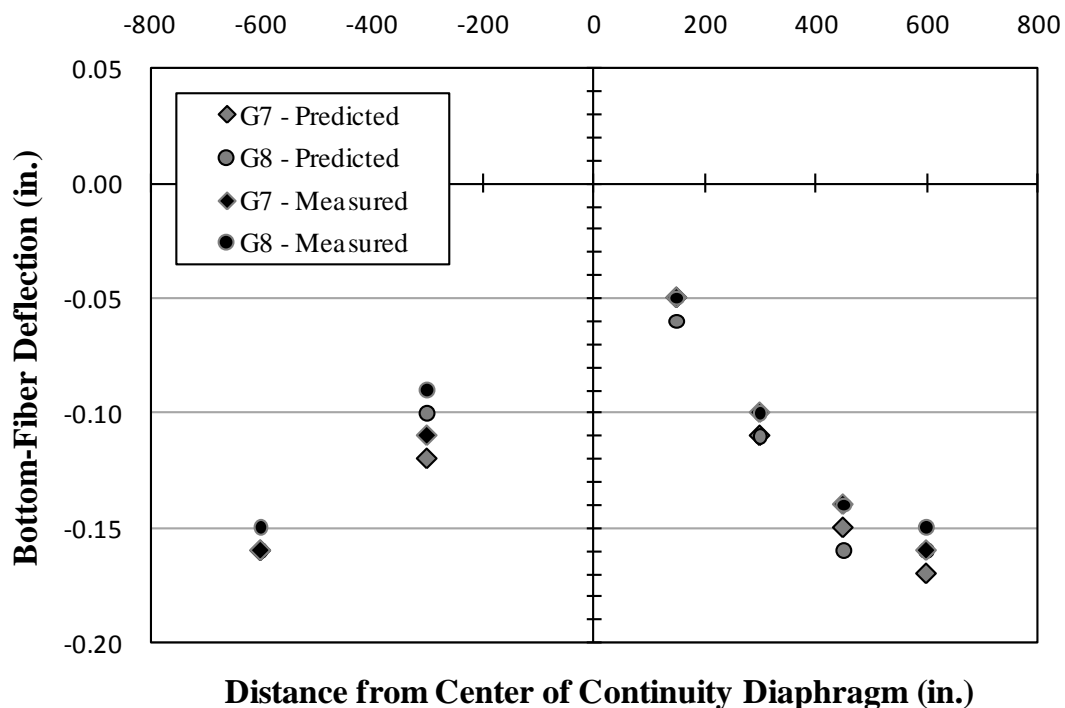
Deflections measured during the post-repair superposition test were analyzed to assess the general behavior of the bridge structure. The predicted and measured superposition deflections are illustrated in Figure 5.49. The differences between the predicted and measured superposition deflections are presented in Table 5.13.

**Figure 5.49:** Superposition—deflections—predicted and measured

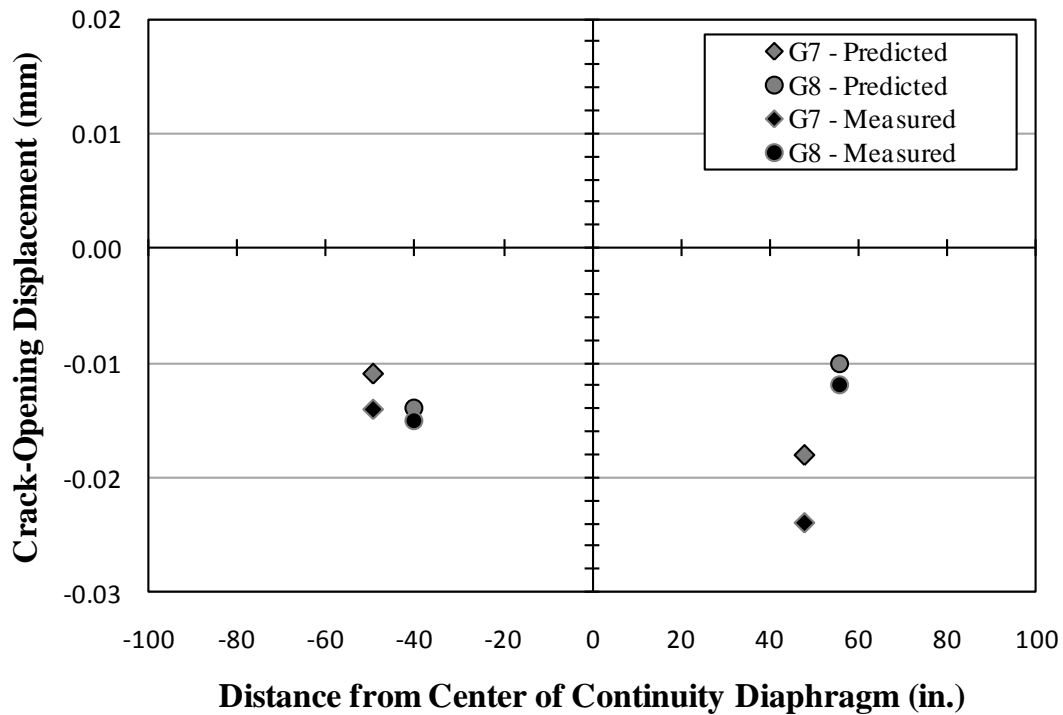
**Figure 5.50:** Superposition—crack-opening displacements—predicted and measured

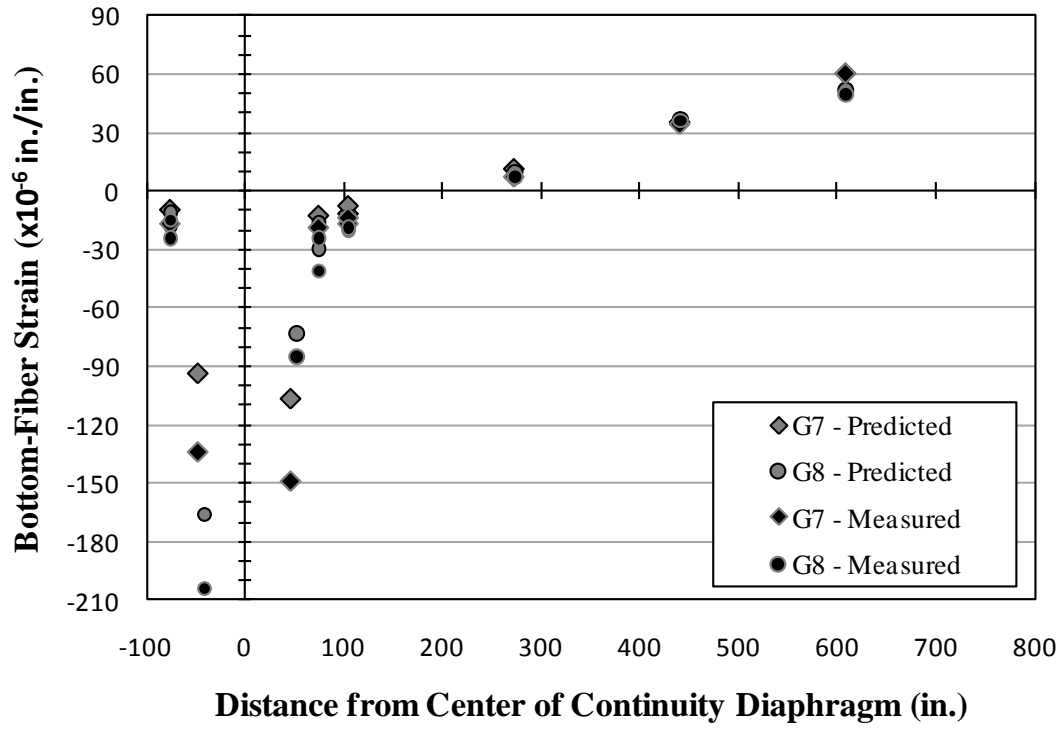
**Figure 5.51:** Superposition—bottom-fiber strains—predicted and measured

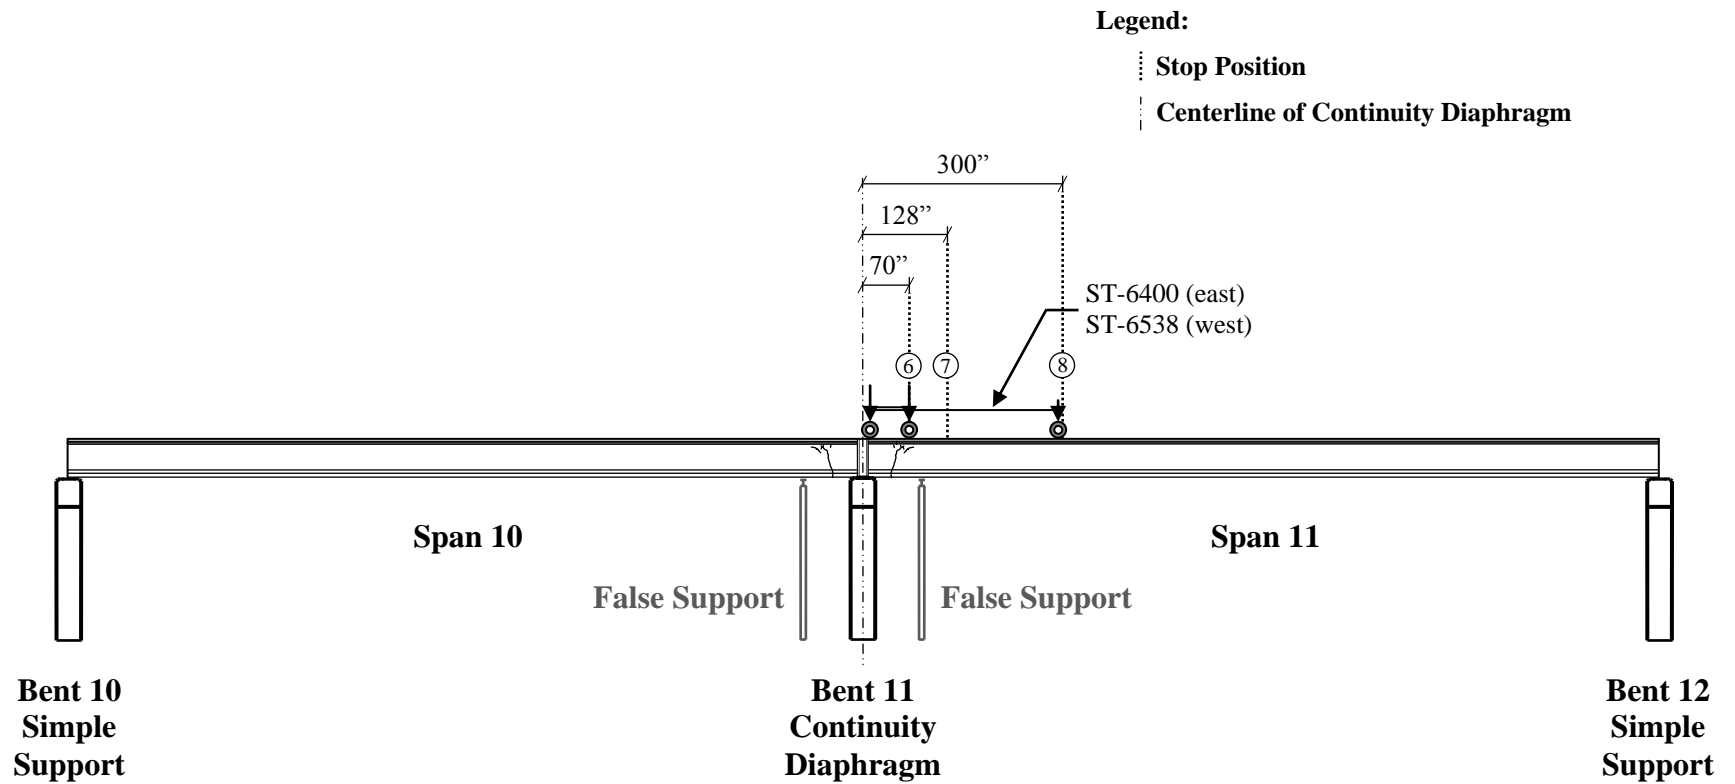
**Figure 5.52:** Longitudinal truck positions—C6

When the trucks are at Static Position C6, the back axles of each truck straddle the damaged region. The middle axle is positioned 70 in. from the center of the continuity diaphragm, and the rear axle is approximately 13 in. from the center of the diaphragm, as shown in Figure 5.52. The distance between the rear axle and middle axle is 57 in. for the standard ALDOT load truck.

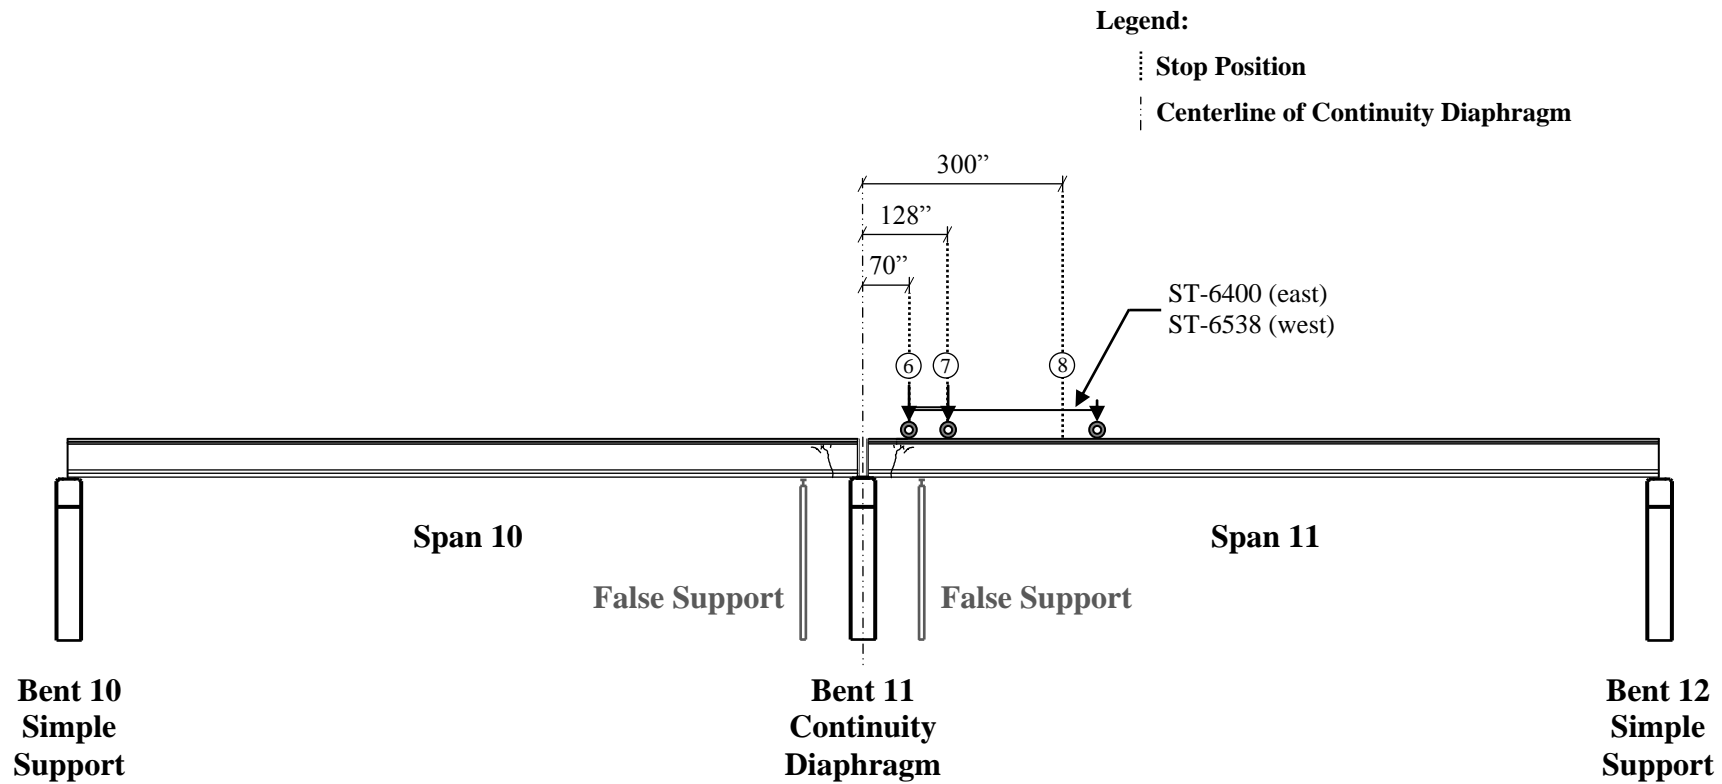
**Figure 5.53:** Longitudinal truck positions—AE LC-6 Span 11 and C7

The Span 11 static position of the AE tests is similar to Static Position C7 of the multiposition load-tests. These stop positions are similar enough to be presented as one stop position, as shown in Figure 5.53, however, there is a slight difference between the two truck positions. Truck positioning for AE testing was based on aligning the rear axle, and truck positioning for the multiposition tests was based on aligning the middle axle. For the AE Span 11 static position, the rear axle is positioned 70 in. from the center of the continuity diaphragm, and the middle axle is approximately 127 in. from the center of the diaphragm. When the trucks are at Static Position C7, the middle axle is positioned 128 in. from the center of the continuity diaphragm, and the rear axle is approximately 71 in. from the center of the diaphragm.
