**Behavior of a Damaged Prestressed Concrete Bridge  
Repaired with Fiber-Reinforced Polymer Reinforcement**

A thesis submitted to the Graduate Faculty of  
Auburn University  
in partial fulfillment of the  
requirements for the Degree of  
Master of Science

Auburn, Alabama  
December 12, 2011

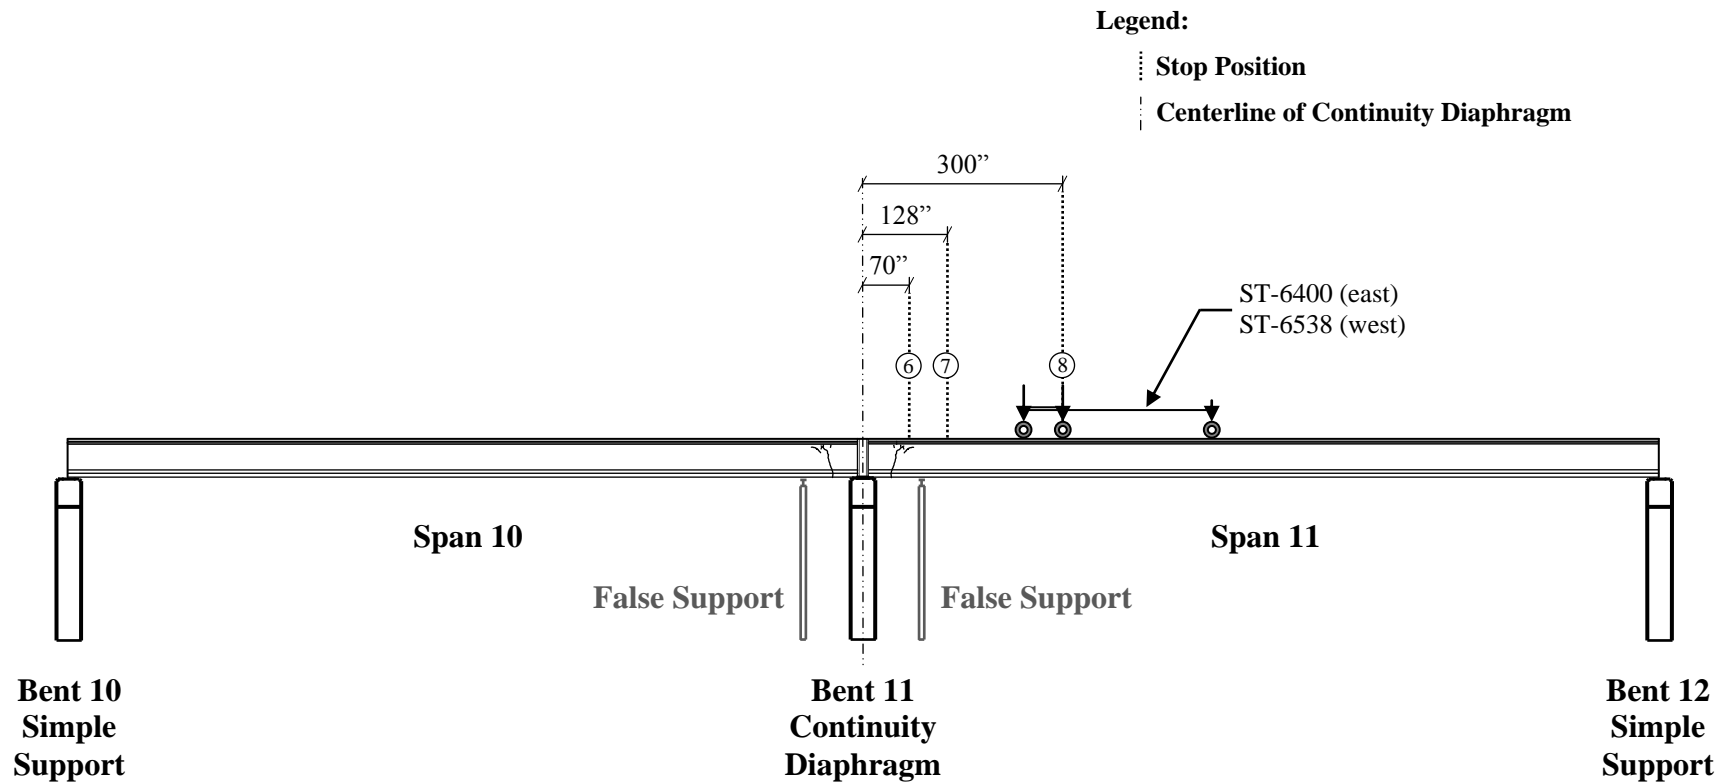
**Figure 5.54:** Longitudinal truck positions—C8

When the trucks are at Static Position C8, all truck axles are beyond the damaged region. The middle axle is positioned 300 in. from the center of the continuity diaphragm, and the rear axle is approximately 243 in. from the center of the diaphragm, as shown in Figure 5.54.

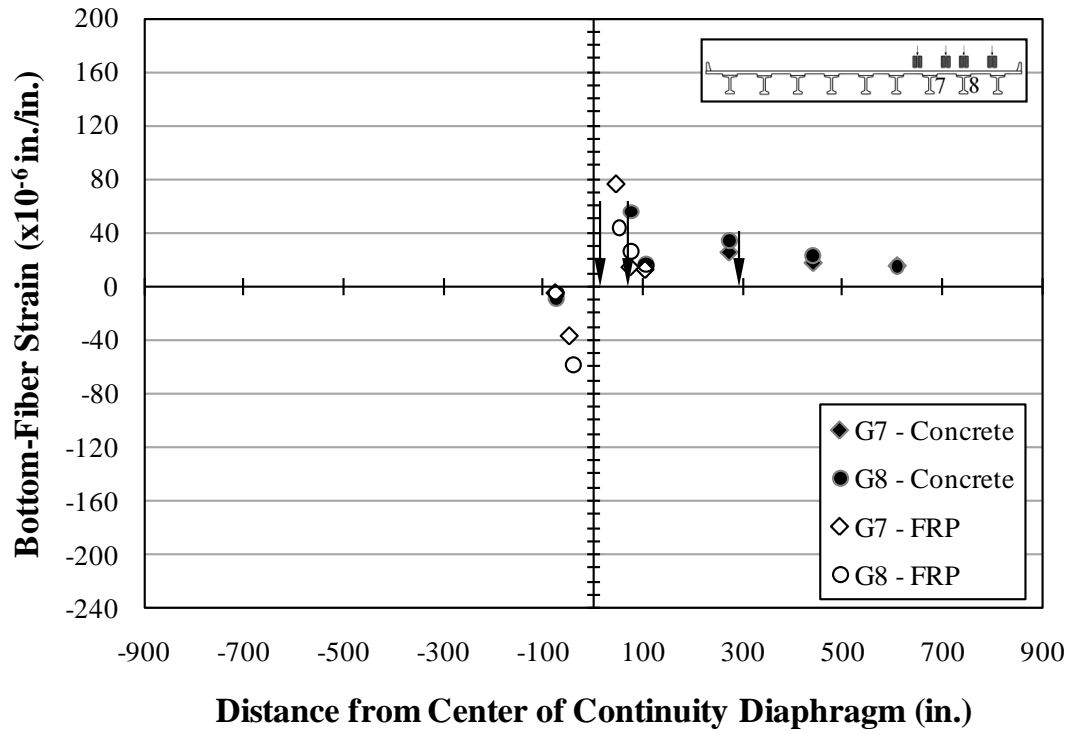
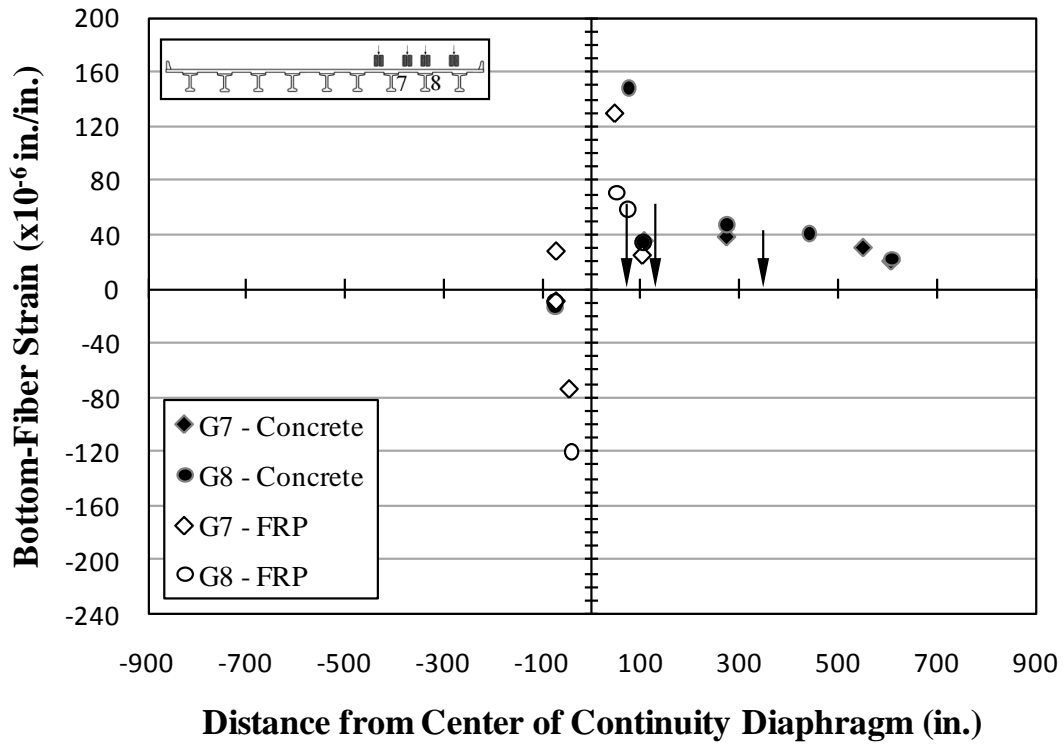
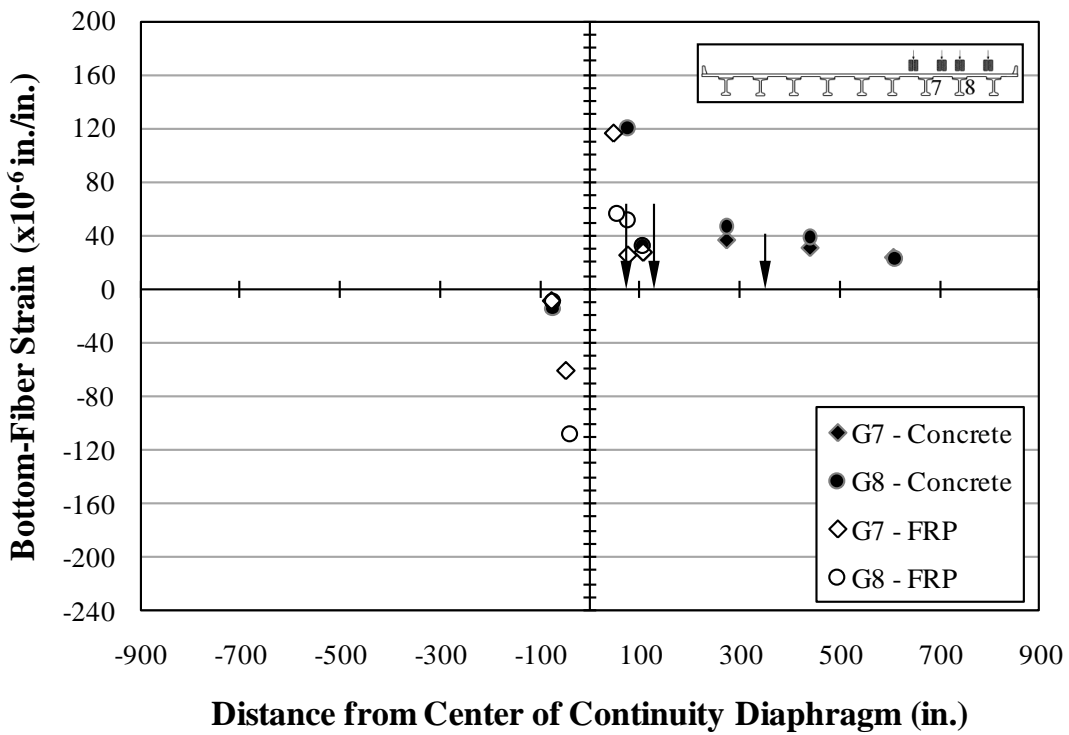
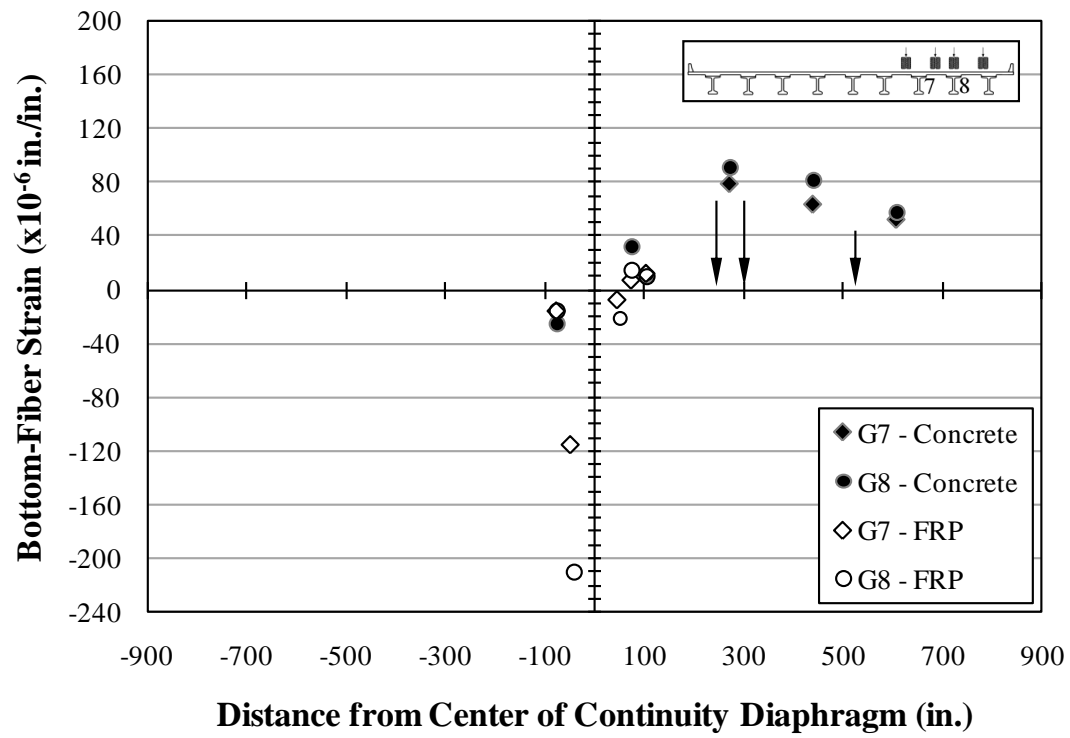
These four static positions were tested with the LC-6 load truck block configurations of the second night of bridge testing. The bottom-fiber strains measured in response to these four truck position are presented in Figures 5.55–5.58. To indicate the FRP tensile demand, the Span 11 bottom-fiber FRP strains have been presented in Table 5.17. To

Figure 5.55: Bottom-fiber strains—C6

**Figure 5.56:** Bottom-fiber strains—AE LC-6 Span 11

**Figure 5.57:** Bottom-fiber strains—C7

**Figure 5.58:** Bottom-fiber strains—C8

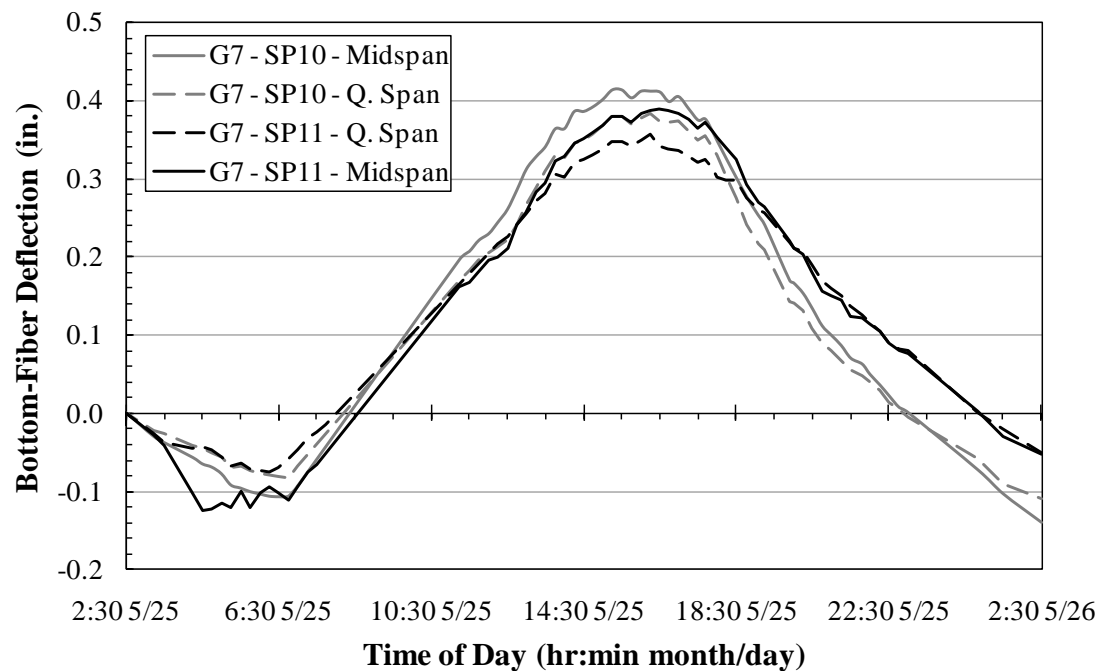
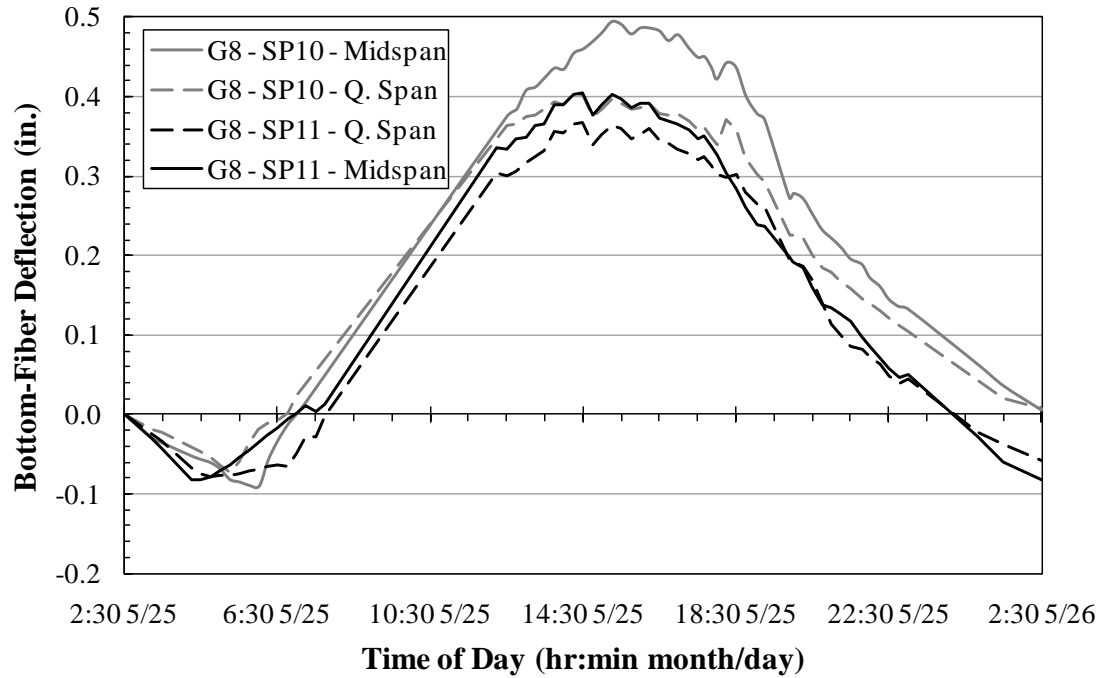
**Figure 5.70:** Deflections—normal traffic—twenty-four hours—Girder 7

**Figure 5.71:** Deflections—normal traffic—twenty-four hours—Girder 8

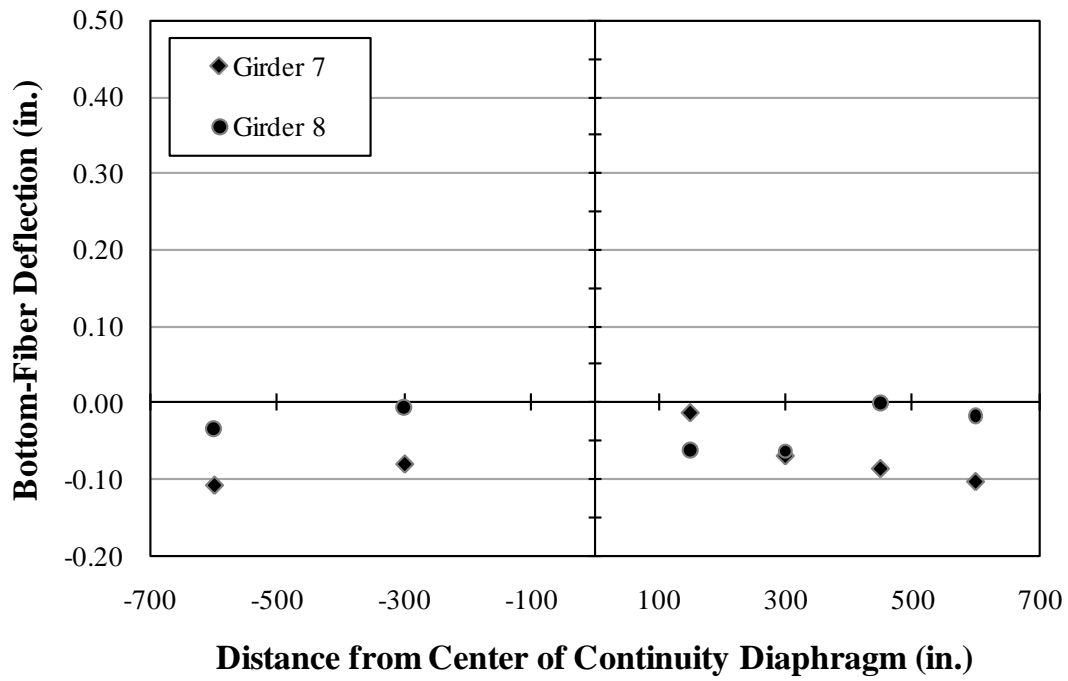
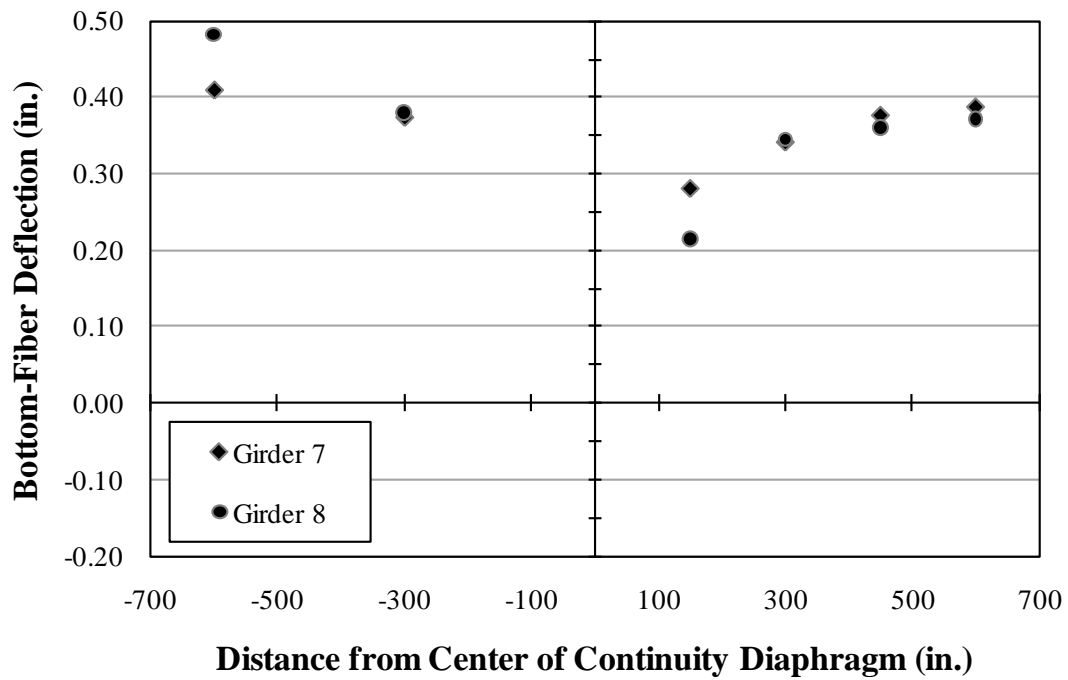
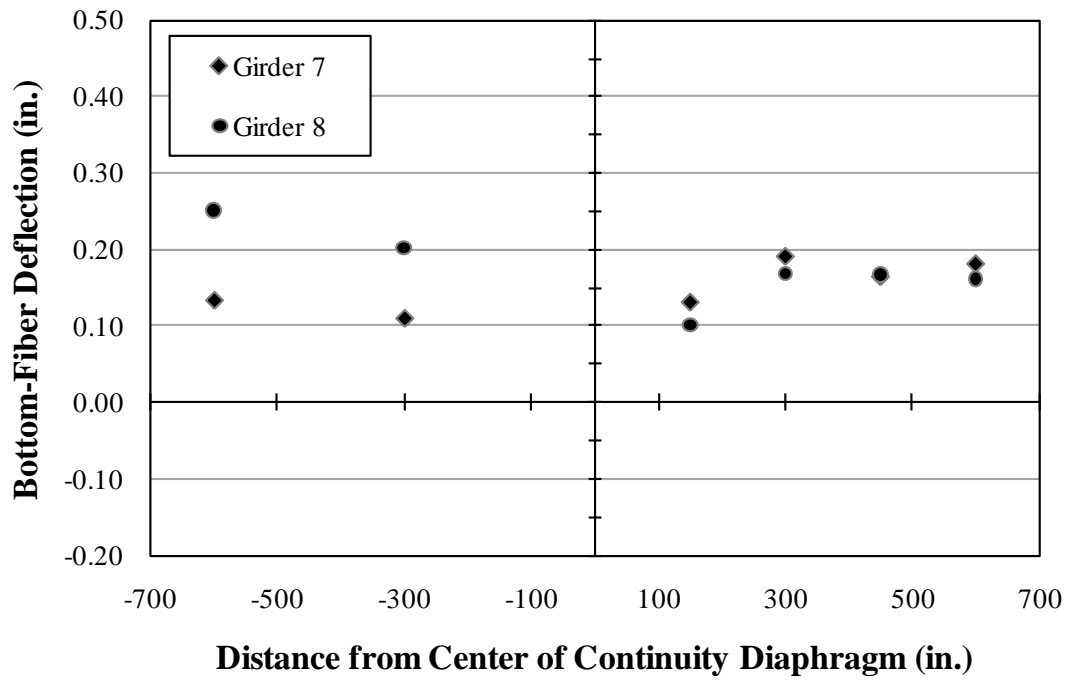
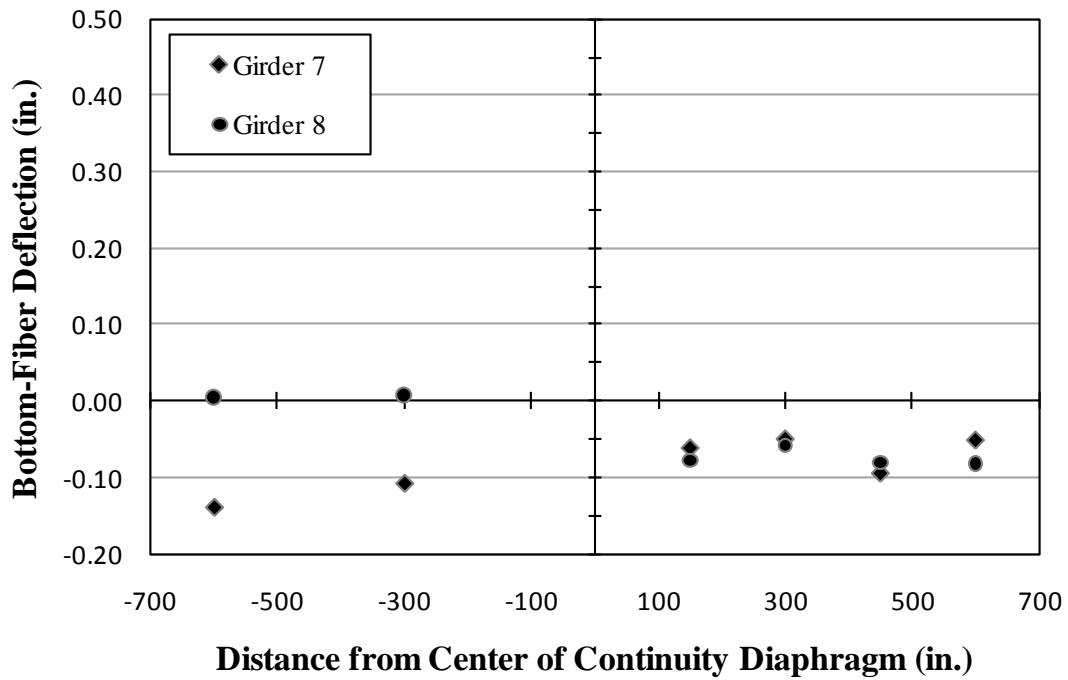
**Figure 5.72:** Deflections—8:30 a.m.

**Figure 5.73:** Deflections—4:30 p.m.

**Figure 5.74:** Deflections—8:30 p.m.

**Figure 5.75:** Deflections—2:30 a.m.

The deflections measured at 4:30 p.m. and 8:30 p.m. result in deflected shapes that are similar to the deflected shape expected of a continuous structure subjected to a thermal gradient as shown in Figure 5.69. However, additional measured deflections would be useful for providing clearer evidence of an inflection point in response to restrained thermal effects.

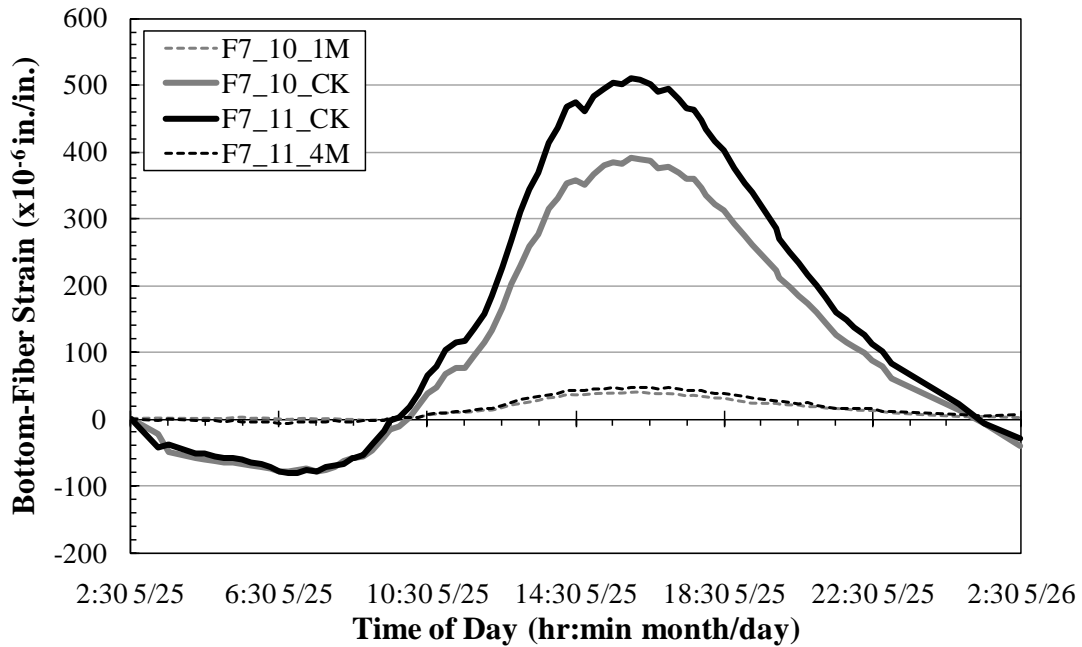
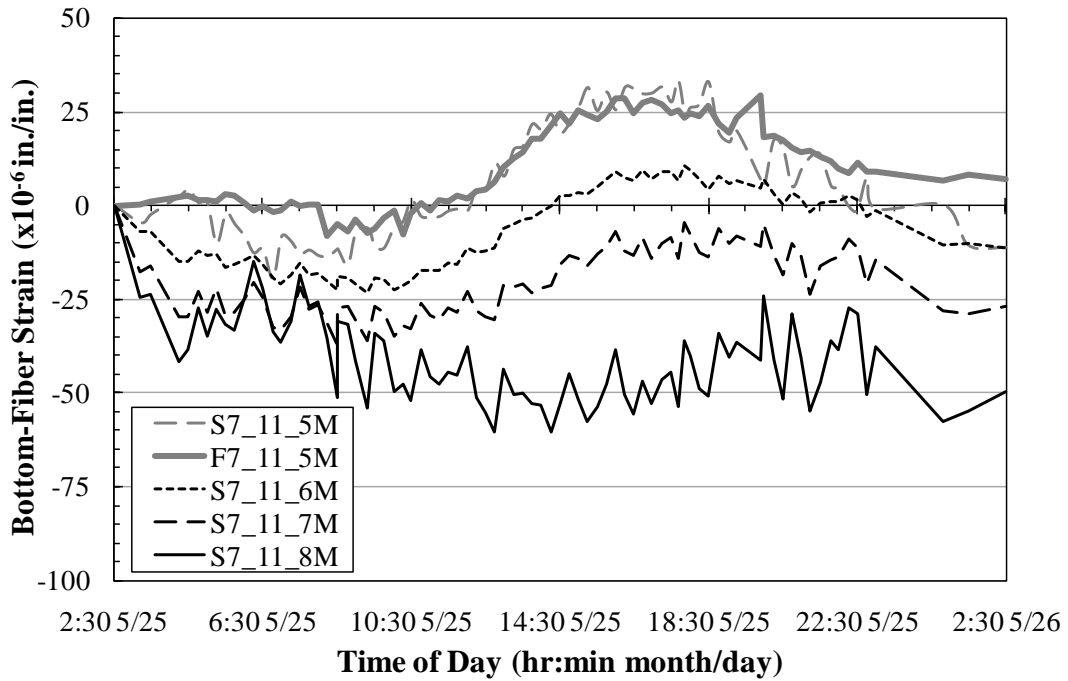
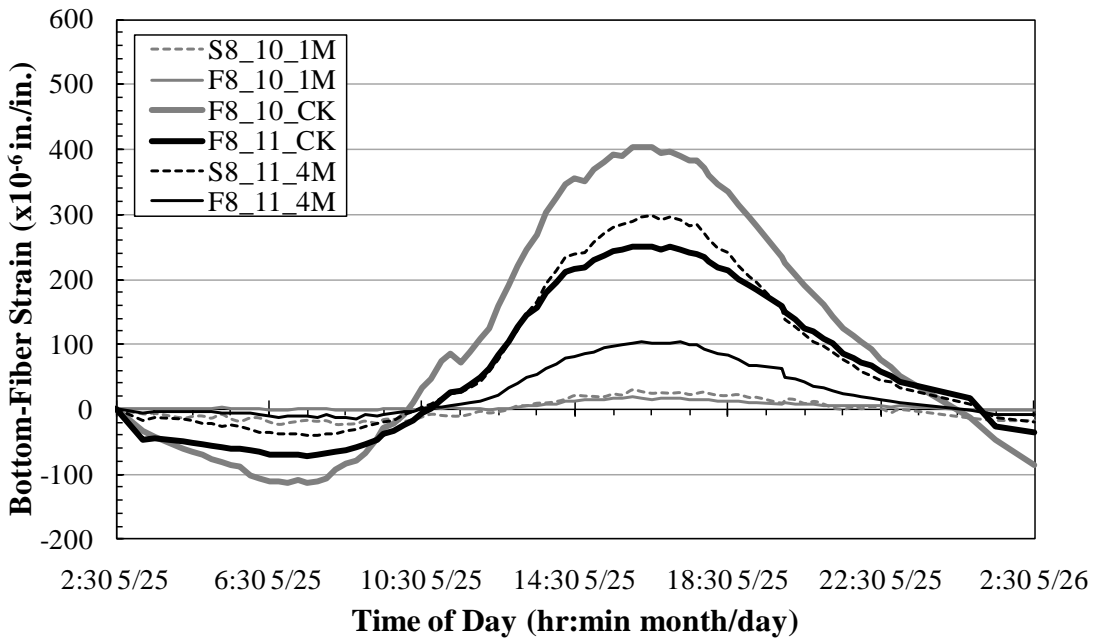
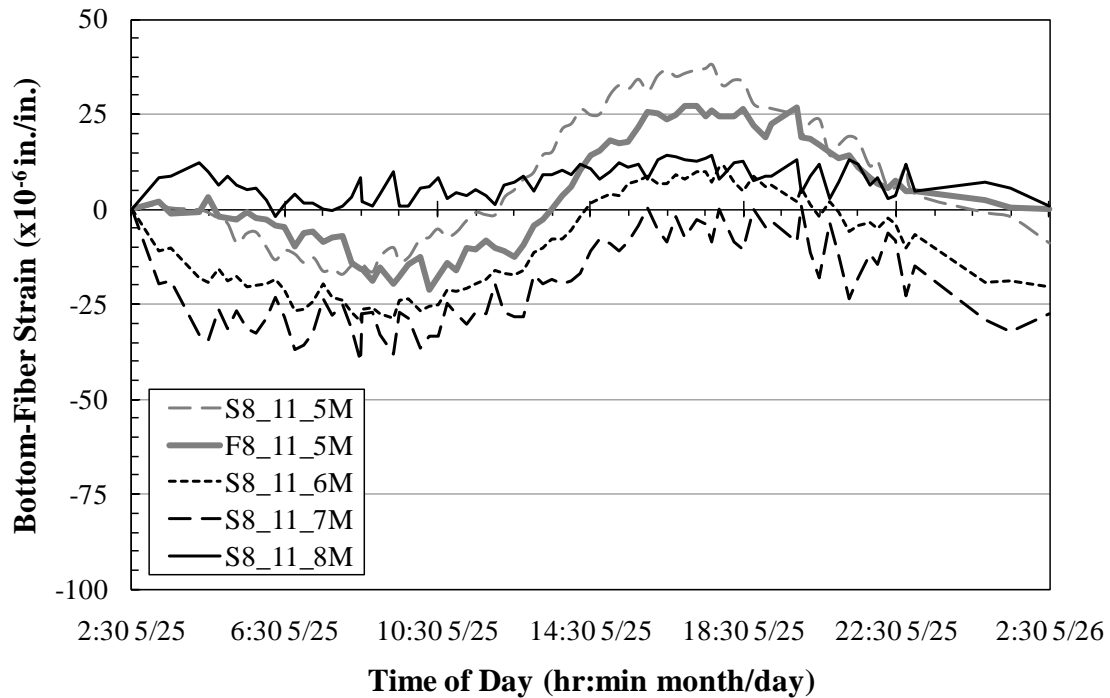
**Figure 5.76:** Bottom-fiber strains—Girder 7—within 80 in. from diaphragm

**Figure 5.77:** Bottom-fiber strains—Girder 7—beyond 80 in. from diaphragm

**Figure 5.78:** Bottom-fiber strains—Girder 8—within 80 in. from diaphragm

**Figure 5.79:** Bottom-fiber strains—Girder 8—beyond 80 in. from diaphragm

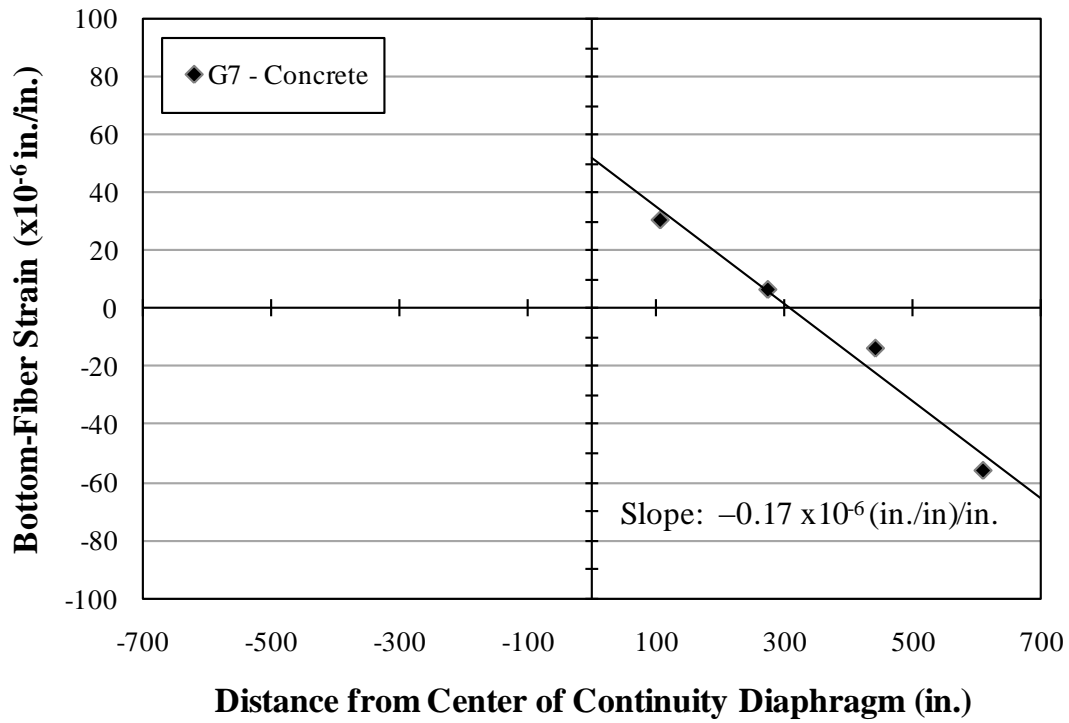
**Figure 5.85:** Bottom-fiber strains—concrete—Girder 7—4:30 p.m.

The slope of the bottom-fiber strain profile expected due to these conditions is  $-0.24 \times 10^{-6} (\text{in./in.})/\text{in.}$ , which is similar to the  $-0.17 \times 10^{-6} (\text{in./in.})/\text{in.}$  slope of the measured strain profile for Girder 7 in Span 11 at 4:30 p.m. as presented in Figure 5.85. The slope of the measured strain profile is less steep than the slope of the theoretical strain profile, which could be an indication that the girder is not exhibiting fully continuous behavior as theoretically assumed, or that the actual temperature gradient was less than the estimated value. This decrease in continuity exhibited by the slope of the measured strain profile is likely due to the local behavior of the damaged region.

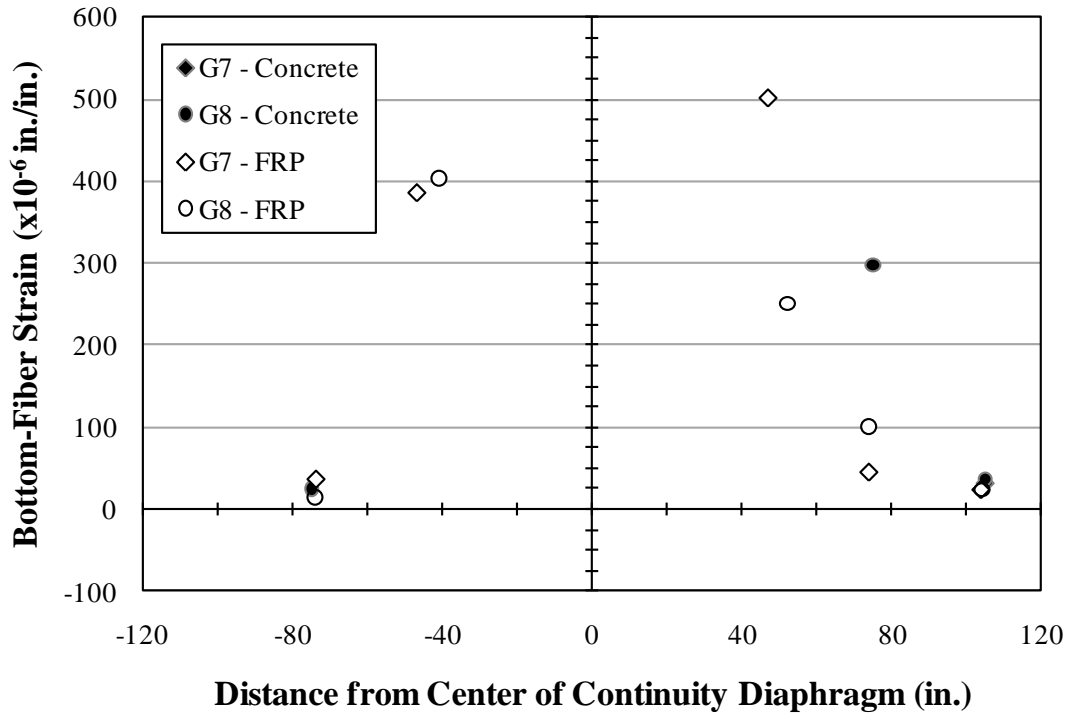
**Figure 5.93:** Bottom-fiber strains—damaged region—4:30 p.m.

The bottom-fiber strains near the damaged region are shown to be greater than the strains projected by trend lines associated with concrete strains beyond the damaged region. These near damage zone bottom-fiber strains are presented in Figures 5.92–5.95. The magnitudes of the bottom-fiber tensile strains measured within the damaged region at

4:30 p.m. as shown in Figure 5.93 are an indication that the ambient thermal conditions have a significant effect on the damaged regions.

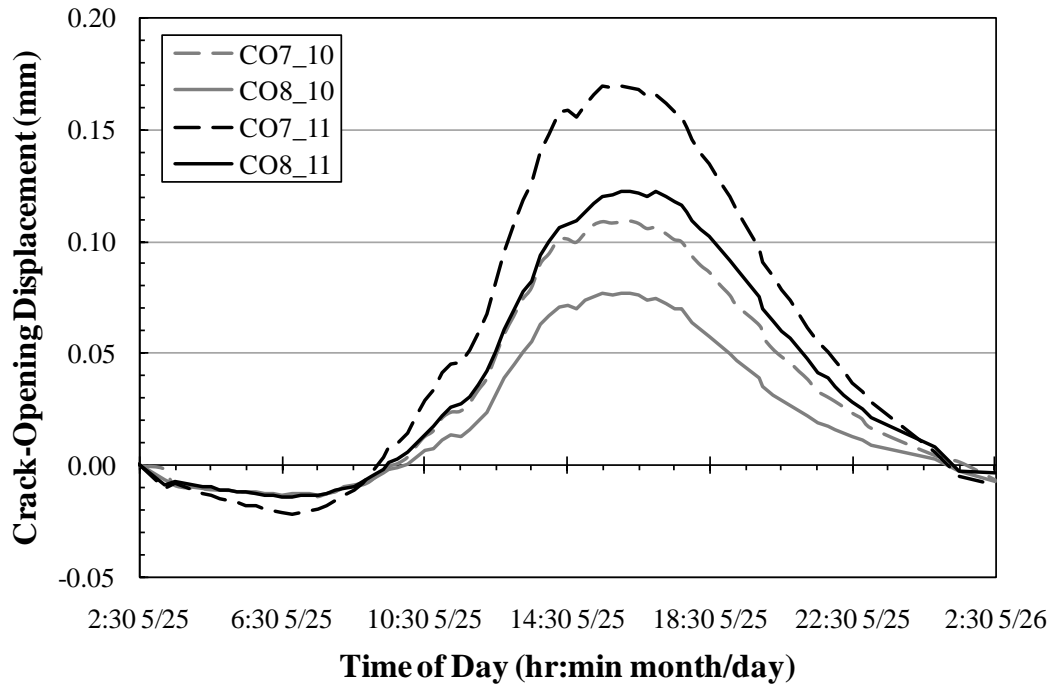
**Figure 5.96:** Crack-opening displacements—normal traffic—twenty-four hours

Crack-opening displacements in response to ambient thermal conditions are relative to initial conditions at 2:30 a.m. on the first night of bridge testing. Positive crack-opening displacement measurements indicate crack openings compared to the initial conditions, and negative crack-opening displacement measurements indicate crack closures compared to the initial conditions. The crack-opening displacements measured in

response to ambient thermal conditions are presented in Table E.1. Graphical presentations of these crack-opening displacements are shown in Figure 5.96.

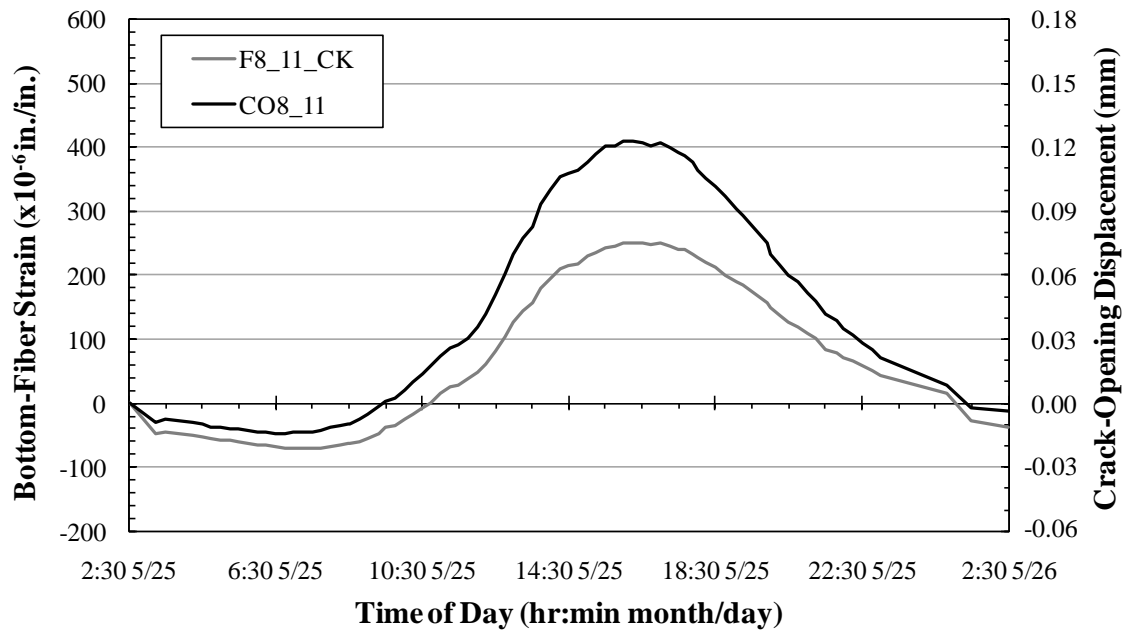
**Figure 5.100:** Bottom-fiber strain and COD—thermal conditions—Girder 8—Span 11

The FRP strains measured at the crack location of Girder 8 in Span 11 were consistently the least tensile of the four instrumented girders. This behavior is not consistent with the crack-opening displacements measured by the COD gage on the same girder. The relationship shown in Figure 5.100 between the COD measurements and the bottom-fiber FRP strain measurements at the crack location of Girder 8-Span 11 supports

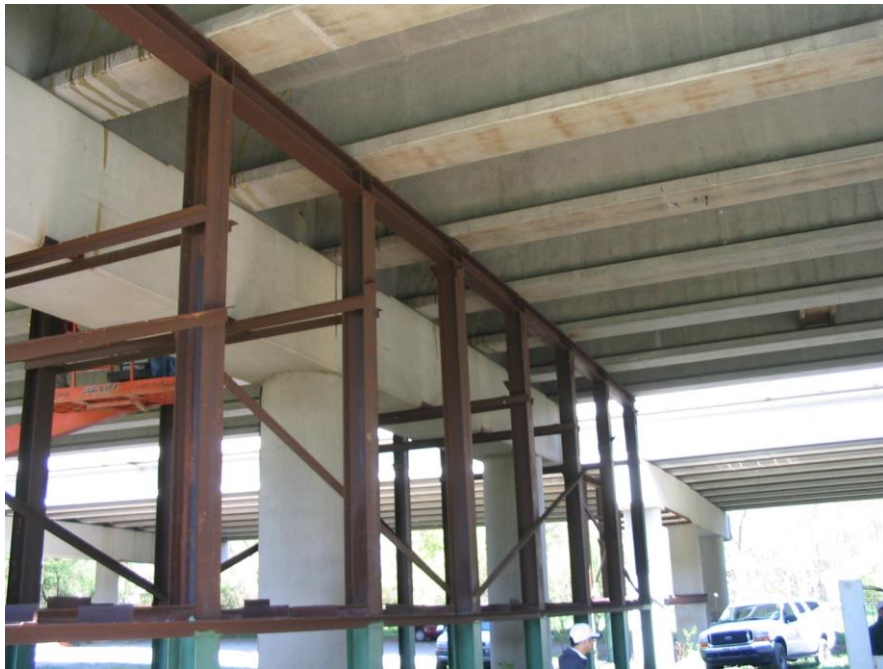
**Figure K.1:** Steel frame false supports

In response to the severity of cracking observed at the continuous ends of prestressed concrete girders of I-565, ALDOT installed steel frame false supports under spans containing damaged girders, as shown in Figure K.1. False supports were installed within ten feet of the bents, allowing the cracked regions of damaged girders to be contained between false supports and the nearest bent.

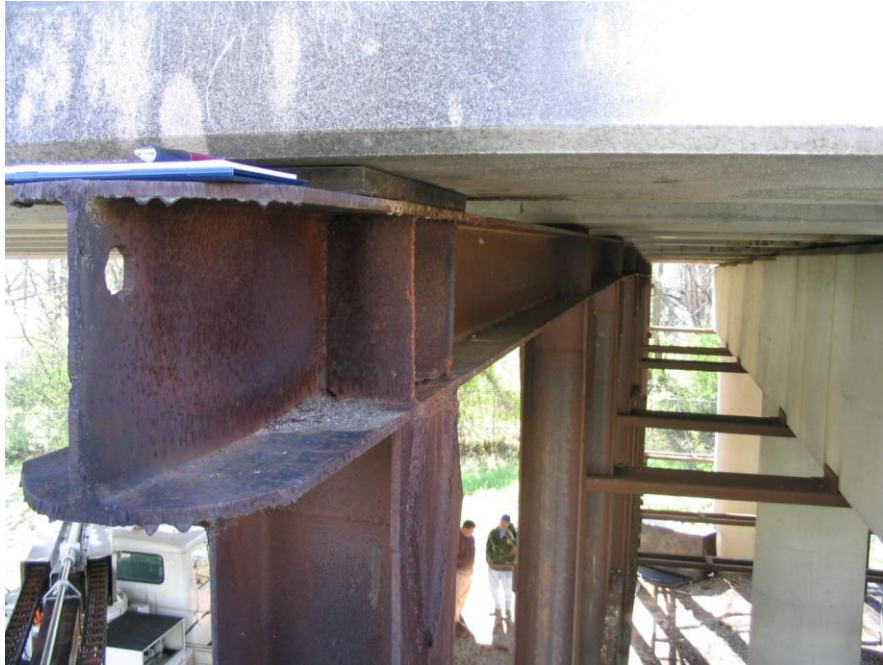
**Figure K.2:** Bearing pad between false support and exterior girder

The false supports were installed to leave a gap of at least one inch between the top of false supports and the bottom of girders before adding bearing pads. Elastomeric bearing pads were then installed under each girder, attaching them to the tops of the false supports, as shown in Figure K.2

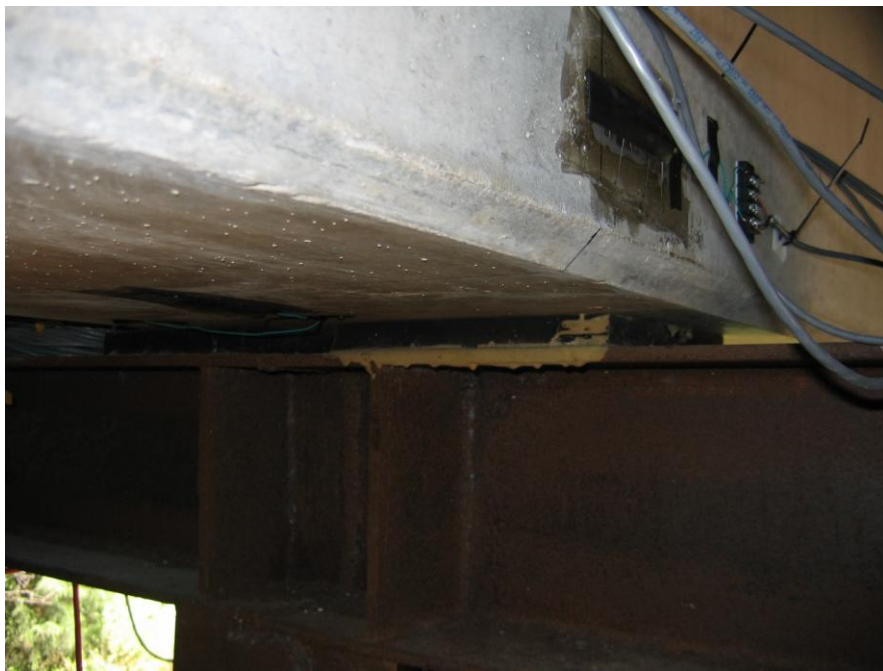
**Figure K.5:** Bearing pad in contact with girder during pre-repair testing

During initial test preparation, it was observed that some of the gaps between bearing pads and false supports had closed, and bearing pads were in contact with instrumented girders, as shown in Figure K.5. The closure of gaps between girders and false support bearing pads was likely due to downward creep deformations of the girders or settlement of the bridge structure.

An attempt was made to remove the bearing pads; however, initial removal attempts were unsuccessful. A surface-mounted strain gage was attached to one column of the false supports to determine if the false supports were supporting normal traffic loads due to the bearing pads being in direct contact with the girders. Due to the measurement of small

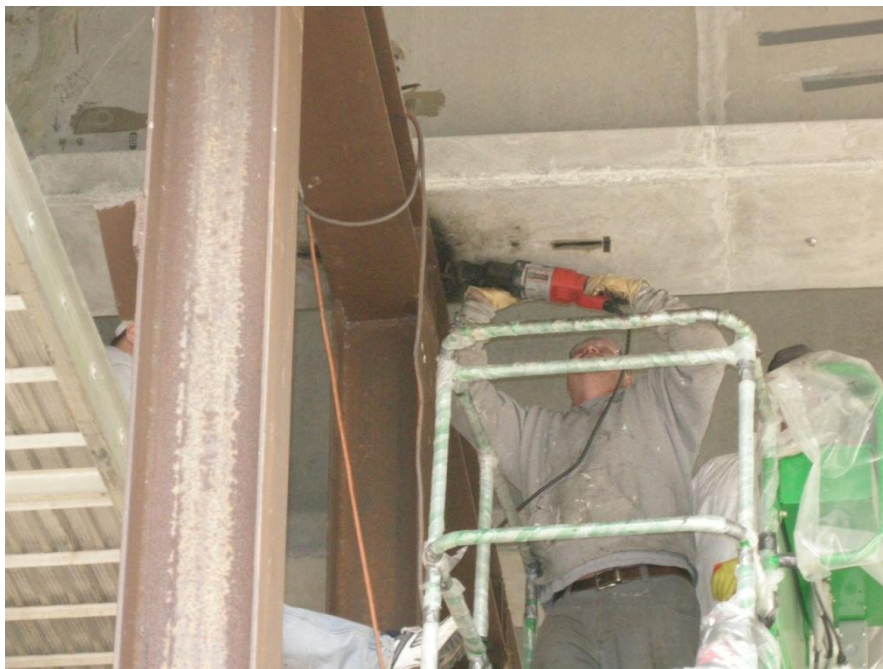
**Figure K.6:** Use of reciprocating saw during bearing pad removal

These bearing pads inhibited FRP installation to the bottom of the girder at false-support locations. The bearing pads under Span 11 were, in general, more difficult to remove than the bearing pads under Span 10. Initially, the contractor attempted to remove each bearing pad by punching it out of place using a chisel and hammer. When a bearing pad was under enough pressure to prevent removal, the contractor then used a reciprocating saw on the pad in an attempt to alleviate some of that pressure, as shown in Figure K.6.

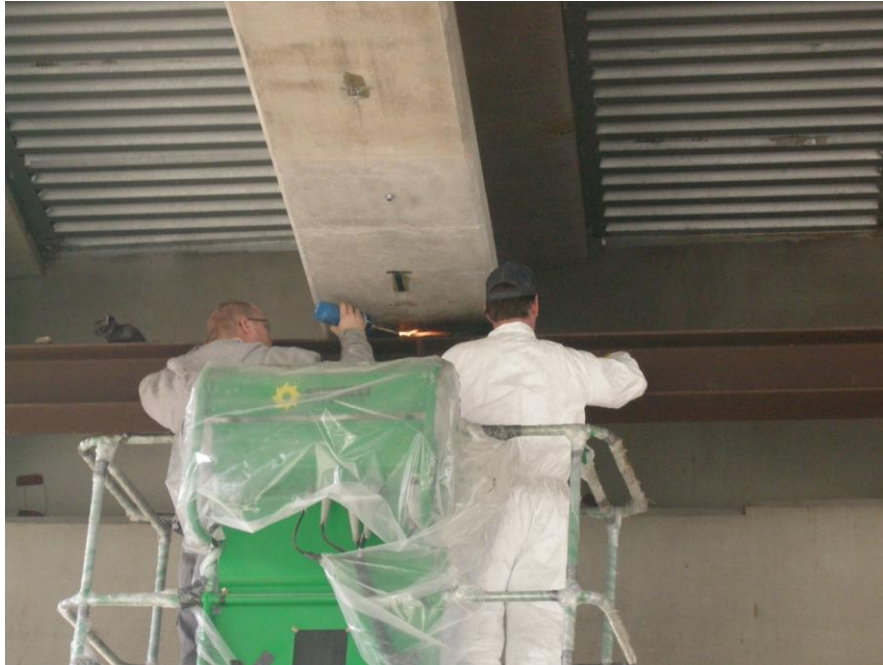
**Figure K.7:** Use of propane torch during bearing pad removal

In some cases, saw cutting alone was not effective at alleviating enough pressure for successful bearing pad removal. In these cases, a propane torch was used to soften the rubber, as shown in Figure K.7, which then allowed for a more effective sawing process.

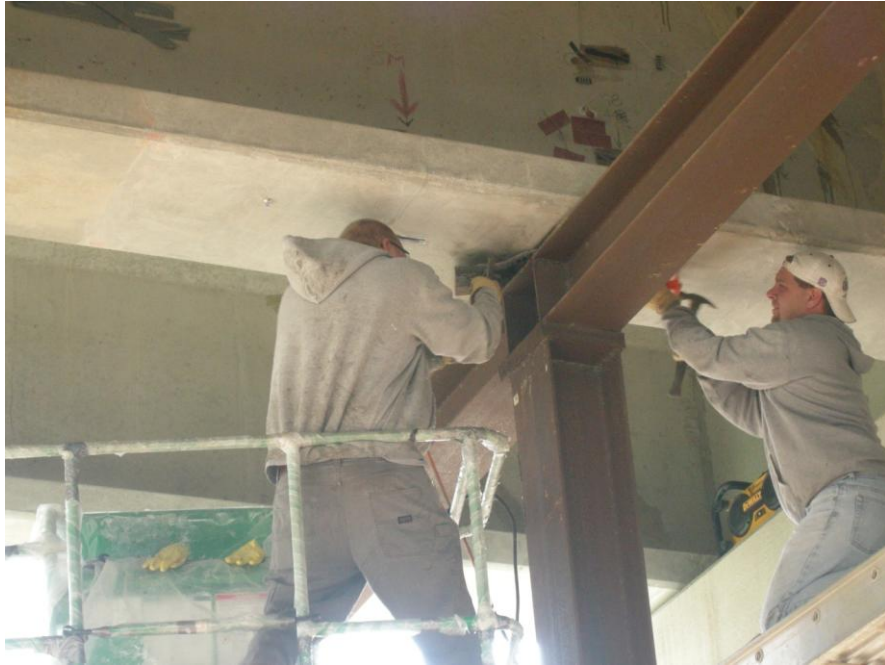
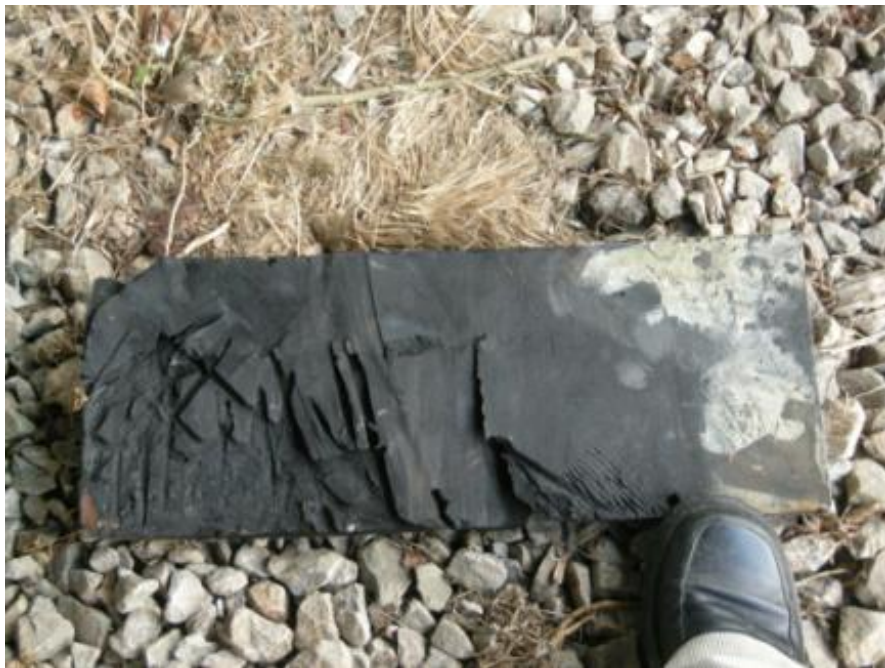
After successful pressure alleviation, the bearing pad was removed using the initial chisel-and-hammer removal method, as shown in Figure K.8. An example of a bearing pad that required forceful removal is shown in Figure K.9. Bearing pads were *not* replaced following the installation of the FRP reinforcement.

**Figure K.8:** Successful removal of bearing pad

**Figure K.9:** Bearing pad after forceful removal
