**Behavior of a Damaged Prestressed Concrete Bridge  
Repaired with Fiber-Reinforced Polymer Reinforcement**

A thesis submitted to the Graduate Faculty of  
Auburn University  
in partial fulfillment of the  
requirements for the Degree of  
Master of Science

Auburn, Alabama  
December 12, 2011

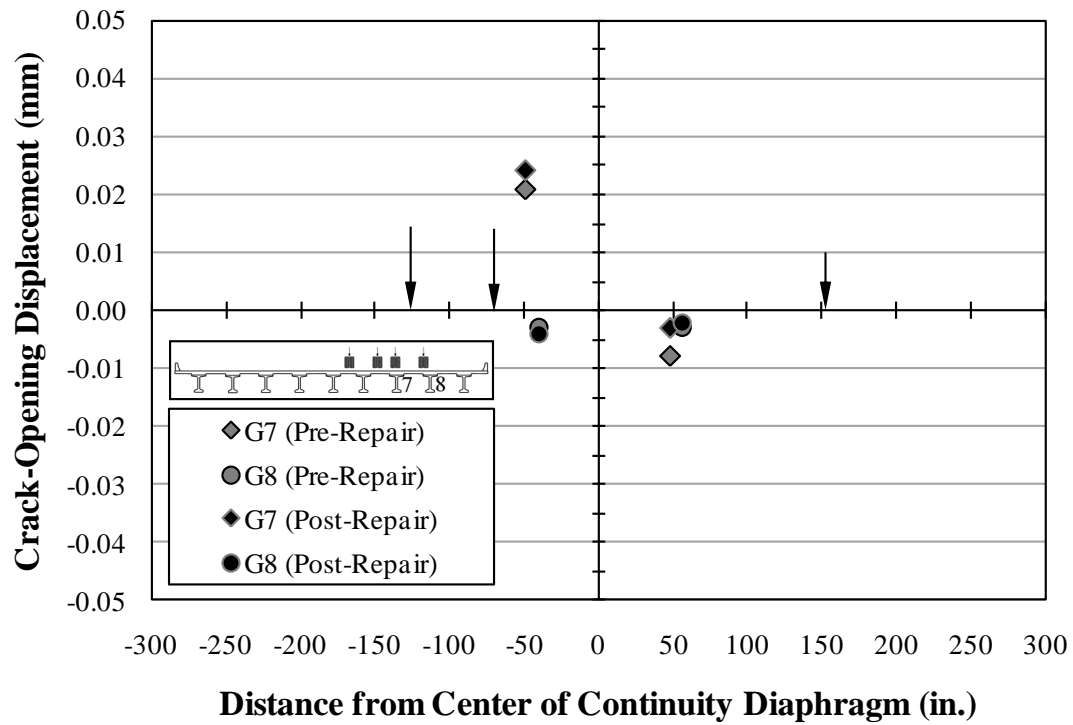
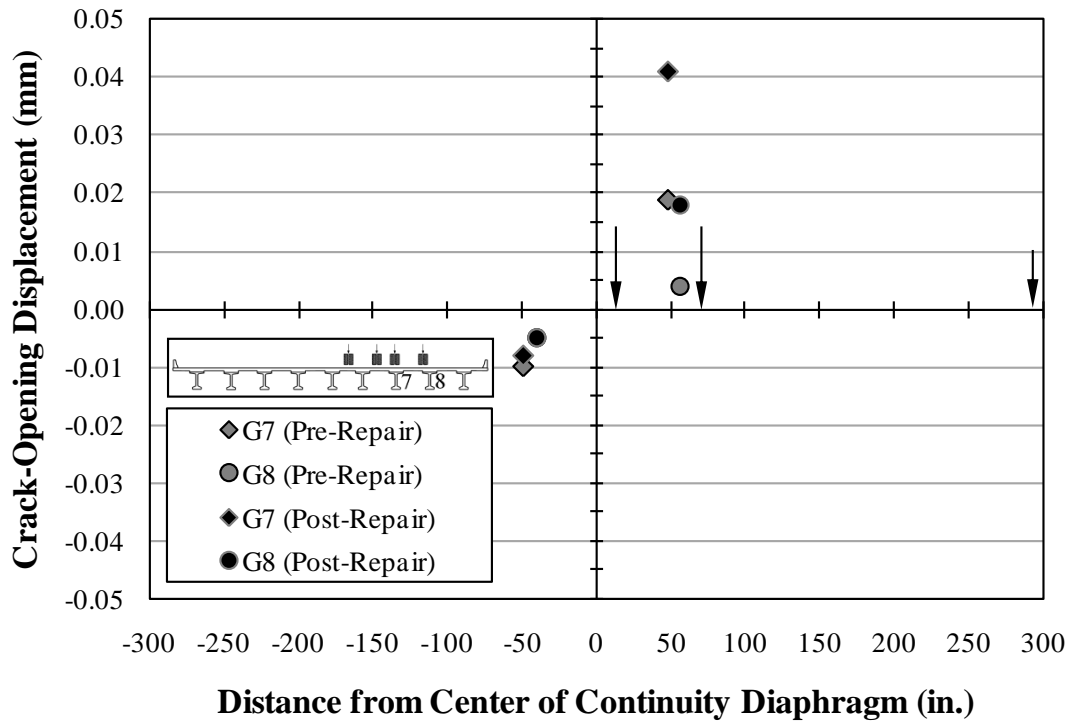
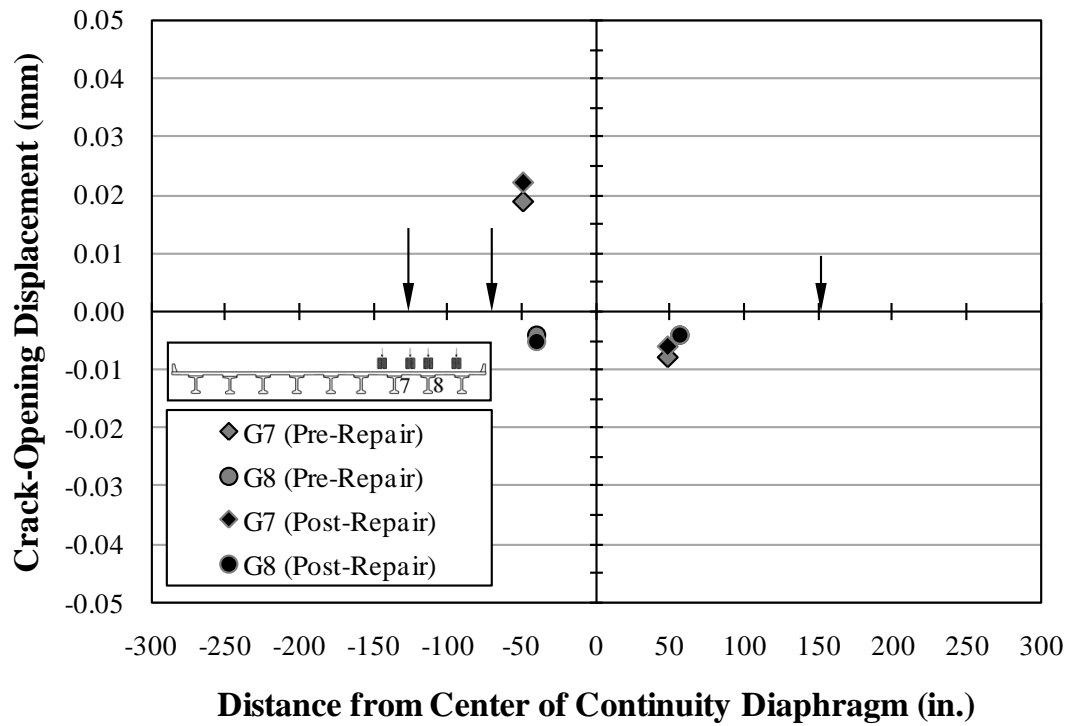
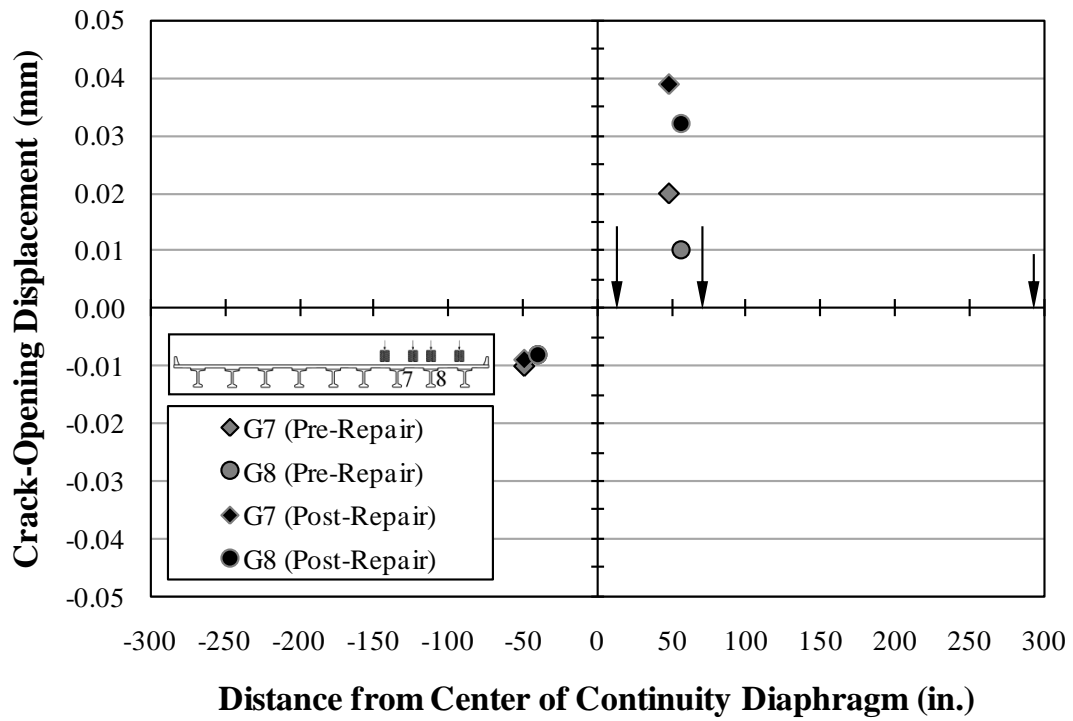
Positions A4, A7, C4, and C7 are presented in Figures K.14–K.17 and Table K.5. The arrows in the figures represent the position of the wheel loads on the bridge.

The crack-opening displacements measured in Span 10 were similar for both pre- and post-repair testing, but the crack-opening displacements measured in Span 11 in response to the Stop Position 7 load condition of the post-repair test increased in comparison to the crack-opening displacements measured in response to the same load condition during pre-repair testing. This behavior corresponds with the Span 10 bearing pads being partially removed prior to pre-repair testing, and the Span 11 bearing pads being under enough pressure to prevent any removal prior to pre-repair testing. It is apparent that girder contact with the false support bearing pads under Span 11 resulted in additional support conditions that affected pre-repair measurements.
