**Analysis of Manufactured Home Vulnerability in Extreme Winds**

Brett Maxwell Davis

Auburn University

Civil Engineering, Master of Science

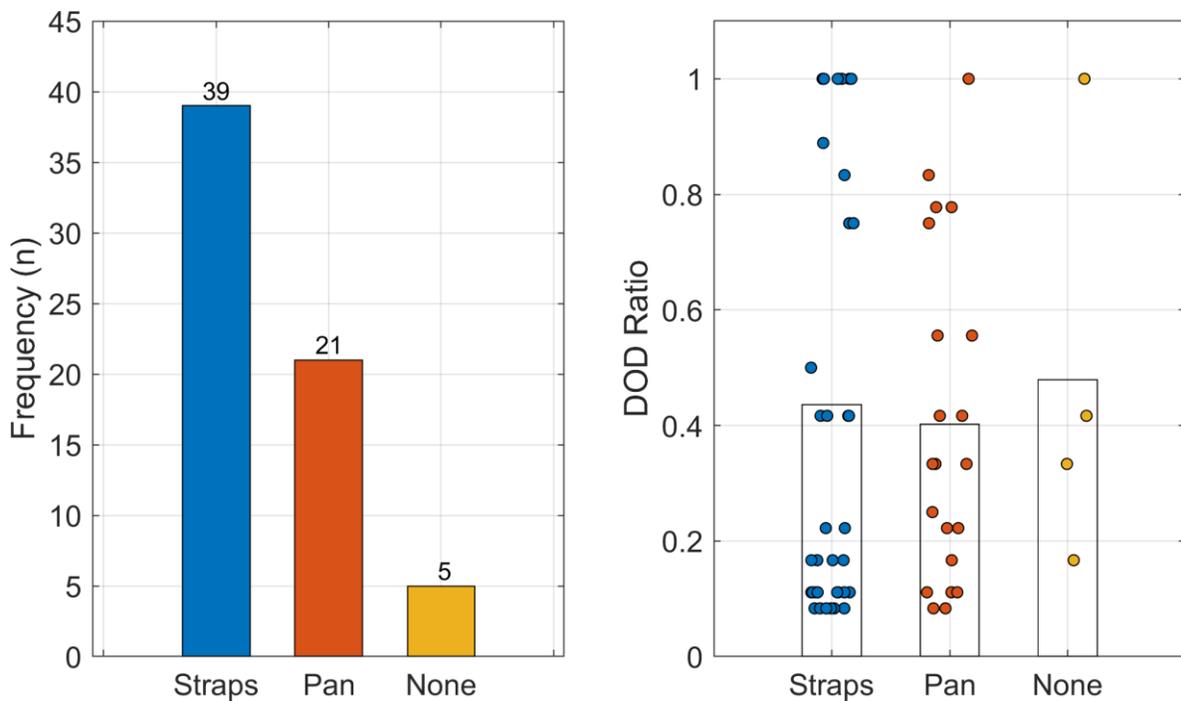
Although several characteristics of each home were recorded during the field assessments, the focus of the following analysis is the anchorage information gathered. The anchorage failures were focused on due to the overwhelming evidence pointing to it as the primary failure mechanism in destroyed homes, as shown in Section 4.1.2 above. A total of 140 MMH were documented through the field assessments, but unfortunately not all information was available for each one. In homes that were not severely damaged, oftentimes the anchorage system was hidden behind the vinyl skirting or stem walls. Additionally, the drive-by assessments conducted after the Lee County tornado did not capture detailed anchorage information, although those were typically homes with little to no damage and located well outside the tornado center. However, every single structure assessed was assigned a DI and DOD. Of the 140 homes assessed, the anchorage system was identified in 65 of them, and the frequency of each major anchorage type is shown in Figure 4-24 (left). The right side of Figure 4-24 shows the distribution of damage for each anchorage type. The

Figure 4-24. Anchorage type statistics (left) and damage distribution (right)

Although Figure 4-24 above shows that strap systems and pan systems performed similarly overall, the more detailed analysis shown in Figure 4-27 indicates otherwise. On average, pan systems experience approximately a 10% greater DOD ratio than that of adequate strap systems. Additionally, the DOD ratio increase from adequate strapping to inadequate strapping is greater than 20%.

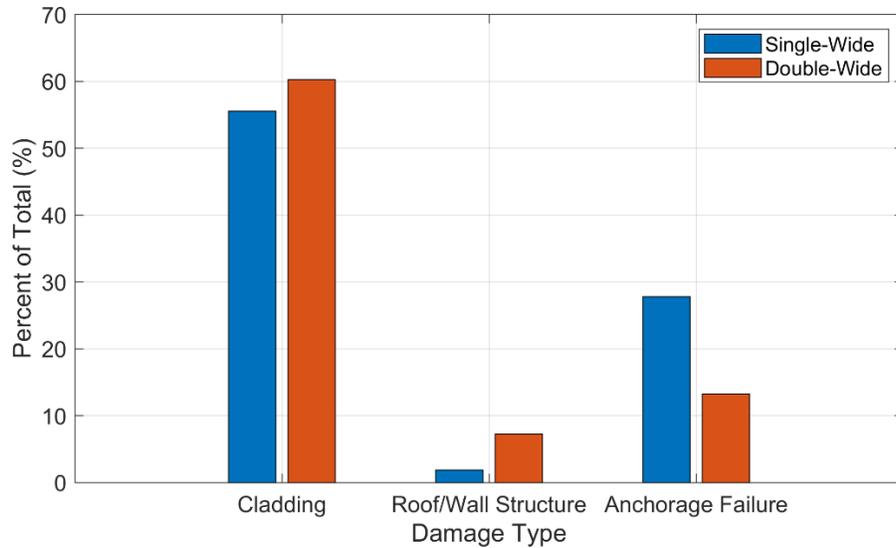
To reinforce the field observation that anchorage failure was the primary failure mechanism leading to destruction, each DOD was grouped into one of three categories: cladding damage, roof/wall structure damage, and anchorage failure. The specific grouping of the DOD’s can be seen in Table 4-5. The cladding group included any damage that was not structural, such as

*Figure 4-25. Failure mechanisms for MMH*

In contrast, a MMH is typically destroyed from the bottom-up, with the anchorage failing first, and then everything else is destroyed as the structure rolls and/or is lofted. As seen in the field assessment pictures in Section 4.1.2 above, the failure of the anchorage system usually results in the destruction of the home. However, a top-down failure such as a failed roof-to-wall connection typically leaves the structure still standing, protecting the occupants within, and also reduces the wind loads acting on the structure.

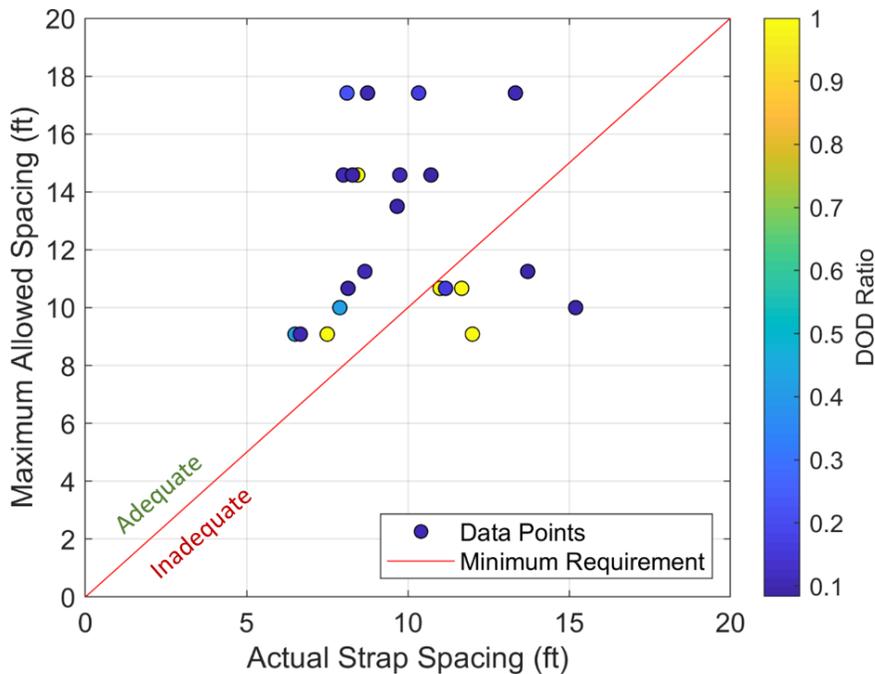
the 39 MMH structures that had strap systems, 22 of them contained all of the data necessary to calculate the maximum allowed strap spacing, as well as the actual number of straps present. It was assumed that the I-beam rail spacing was 99.5 in., unless the code did not allow it for the given pier height, in which case the 82.5 in. I-beam spacing was used. This assumption was based on the author's field experience. These results are shown in Figure 4-26. The red line indicates the code requirements, with any data point above the line representing a home that meets those requirements. The color corresponds to the DOD ratio of the home, representing a normalized damage value. Of the 22 homes, 16 of them met code requirements (73%), and they mostly performed well. However, the sample is likely biased as it was more difficult to collect all the data necessary for this assessment for homes that were completely destroyed.

Figure 4-26. Comparison of required strap spacing to actual spacing

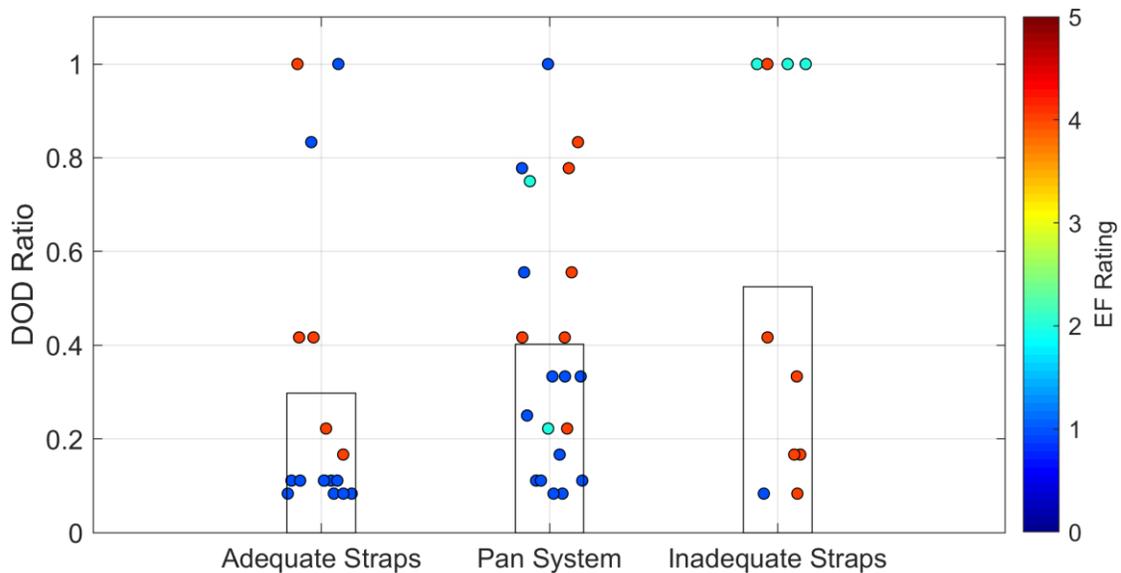
A more detailed analysis of the strap data can be seen in Figure 4-27, with the results separated by the homes that met the code requirements and those that did not. The data in the “Inadequate Straps” column includes the homes with too few straps calculated in Figure 4-26, as well as homes with no apparent anchorage system at all. Also, the damage results for pan anchorage systems are included for comparison. The color represents the EF rating assigned to the tornado that was responsible for causing the damage to each data point. Although the EF rating and DOD are highly correlated, the EF rating is determined for the tornado overall. Therefore, it gives a more complete picture of the tornado as a whole and aids in identifying anchorage systems that performed better or worse than expected. However, the distance from the home to the center of the tornado path is not accounted for, so the EF rating should only be used to put the overall event into context for each home.

Figure 4-27. Comparison of damage ratios for strap and pan systems

The last observation from the field assessment data compares the performance of strap and pan anchorage systems. As seen in Figure 4-27, properly installed strap systems typically outperform pan systems during tornado wind loading. Although several factors contribute towards these results, the main factor is most likely the capacity of each system to resist uplift. Strap systems are designed to resist uplift independent of the home's weight, while basic pan systems have little to no uplift resistance. Furthermore, pan systems actually rely on the downward force from the home to maintain a high static friction between the pan and the soil. This frictional force works to resist lateral loads applied to the home, such as wind. Consequently, if a large enough uplift force decreases the static friction between the pan and soil, the lateral resistance of the home is also decreased. Tornadoes are able to produce peak wind speeds well above design, exerting enough uplift to compromise the lateral resistance of the pan system. The combined lateral and uplift forces can then loft or roll these homes, even in weaker tornadoes. Additionally, strap

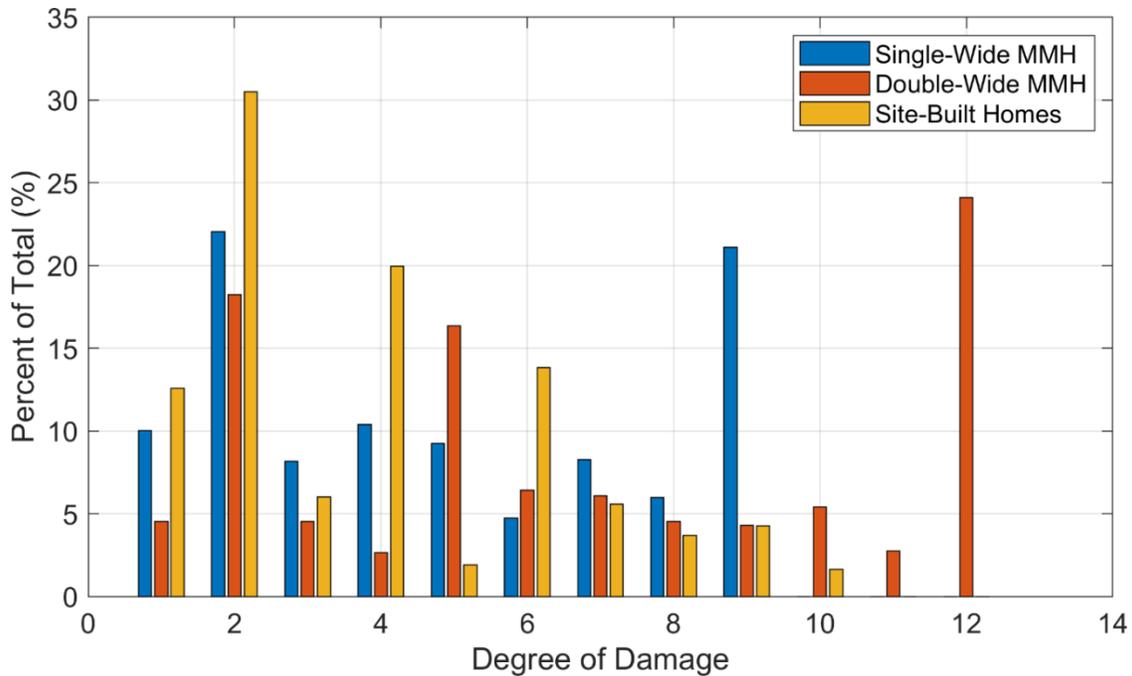
The DOD provides a specific damage rating for each home type and can provide insight into the overall failure mechanism of the structure. Figure 4-28 shows the DOD statistics for each home type. It is important to note that site-built homes have a maximum DOD of 10, while single-wide MMH have a maximum DOD of 9 and double-wide MMH have a maximum DOD of 12. An emerging trend for site-built homes is that the percentage of homes decreases as the degree of damage increases. This trend is logical, as higher wind speeds should be required to cause greater damage, and higher wind speeds simply occur less often. It also implies that a site-built home is typically destroyed from the top-down, with the roof failing first, then the exterior walls, and finally the interior walls and everything else. However, neither of the MMH types follow this trend. While the most common degree of damage for single-wide homes is minor roof cover damage, the second most probable damage state is the complete destruction of the unit (DOD 9). Even more concerning is the fact that the complete destruction of a double-wide MMH (DOD 12) is the most probable outcome in a tornado, with it occurring nearly 25% of the time. These trends highlight the most important difference in the failure patterns between site-built homes and MMH.

Figure 4-28. DOD distribution of each type of structure

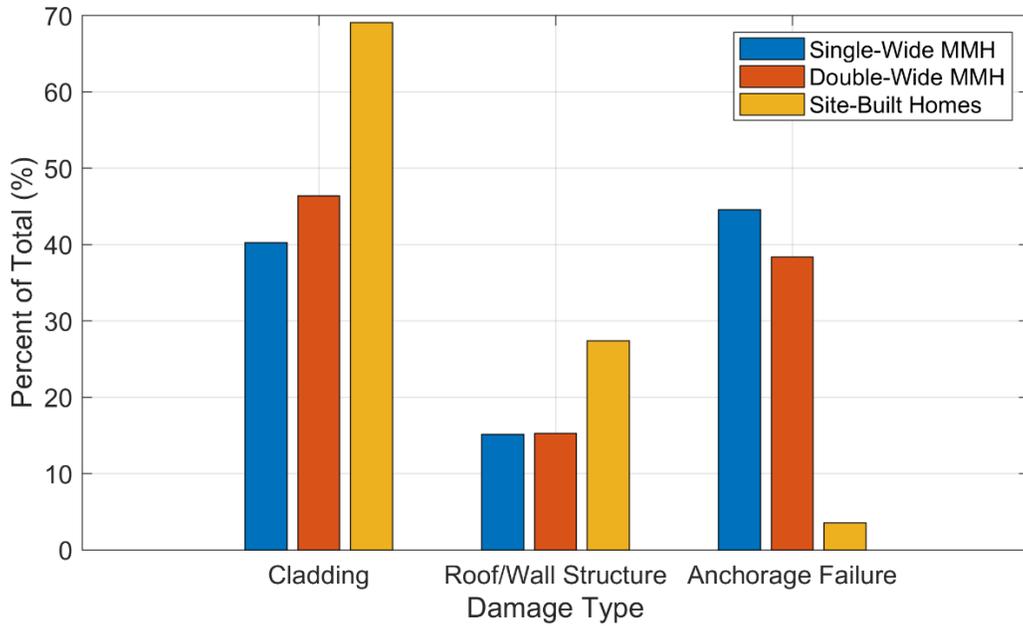
The DOD distribution results are simplified in Figure 4-29, and it further illustrates the different failure mechanisms. The figure was created using the same parameters used to create Figure 4-25, with the addition of site-built homes. For the site-built homes (DI 2), DODs 1-4 were classified as “Cladding” damage, DODs 6-9 were classified as “Roof/Wall Structural Failure”, and DODs 5 and 10 were classified as “Anchorage Failure”. Both MMH type anchorage systems show a similarity to the field assessment data results in that the distribution of damage is concentrated at each extreme end of the damage spectrum. However, for site-built homes, the likelihood of anchorage failure is much lower than that of roof/wall failure. This reinforces the idea that MMH have a tendency to fail from the bottom-up while site-built structures typically fail top-down.

Figure 4-29. Failure mechanisms for MMH

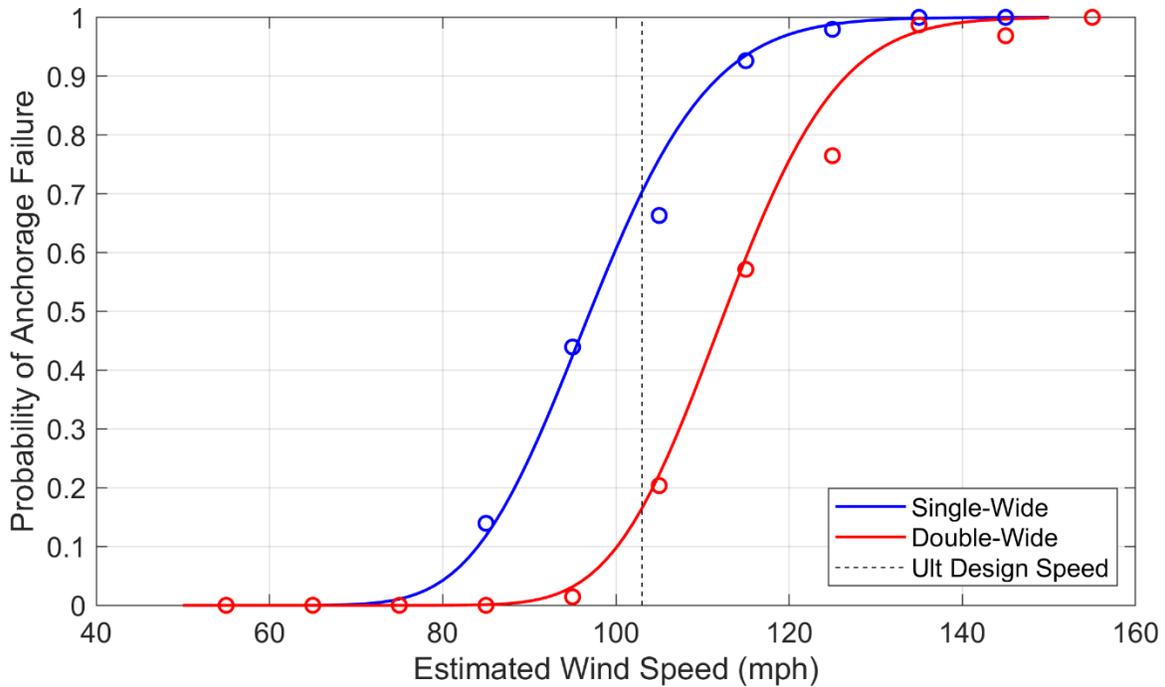
In Figure 4-30, the data is plotted for both single-wide and double-wide MMH for comparison. The figure shows that double-wide anchorage systems typically can resist higher wind speeds than those of single-wide homes. For example, on average, a single-wide anchorage system will fail 50% of the time at an ultimate wind speed of about 97 mph, while a typical double-wide anchorage system will fail less than 5% of the time at the same wind speed. These results imply that single-wide and double-wide homes perform differently under similar wind speeds, challenging the fact that the MHCSS requires the same design for both types. Another important takeaway is that at 103 mph, a single-wide manufactured home anchorage system will fail approximately 70% of the time. This is alarming because HUD requires that these homes be designed to resist the pressures resulting from an ultimate wind speed of 103 mph. This issue is not quite as prevalent for double-wide homes, although they have the same design wind speed and still fail about 15% of the time.

While these findings are concerning, it must be remembered that the wind speeds shown in Figure 4-30 are only estimates based on damage, and can therefore be biased by perceptions of the wind speeds required to damage single-wide homes vs double-wide homes held by the NWS surveyors.

Figure 4-30. Fragility curves for each MMH type using data from the NWS DAT

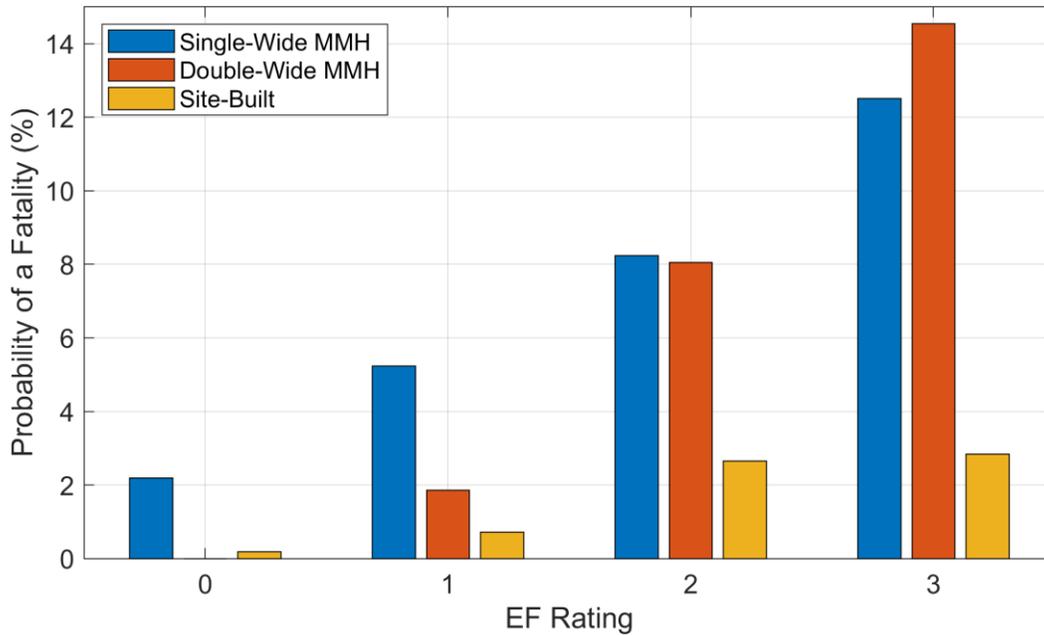
The injury and death statistics from the NWS data are important information to analyze, as their sociological affects can be devastating. Table 4-6 shows the breakdown of this data for all tornados documented in the DAT since 2008. The differences in the probability of an injury or fatality occurring in a MMH as compared to a site-built home are significant. Even more concerning is the trend as the tornado strengthens, as shown in Figure 4-31. It shows the likelihood of a fatality occurring in each of the three building types for each EF rating. As expected, the likelihood is very low for an EF-0 and even for an EF-1, but the chance of a fatality occurring in either type of manufactured home greatly increases for an EF-2 or greater tornado. In comparison, the fatality risk in a site-built home remains relatively low even as the tornado strength increases.

Figure 4-31. Probability of a fatality occurring in each structure type at increasing EF ratings

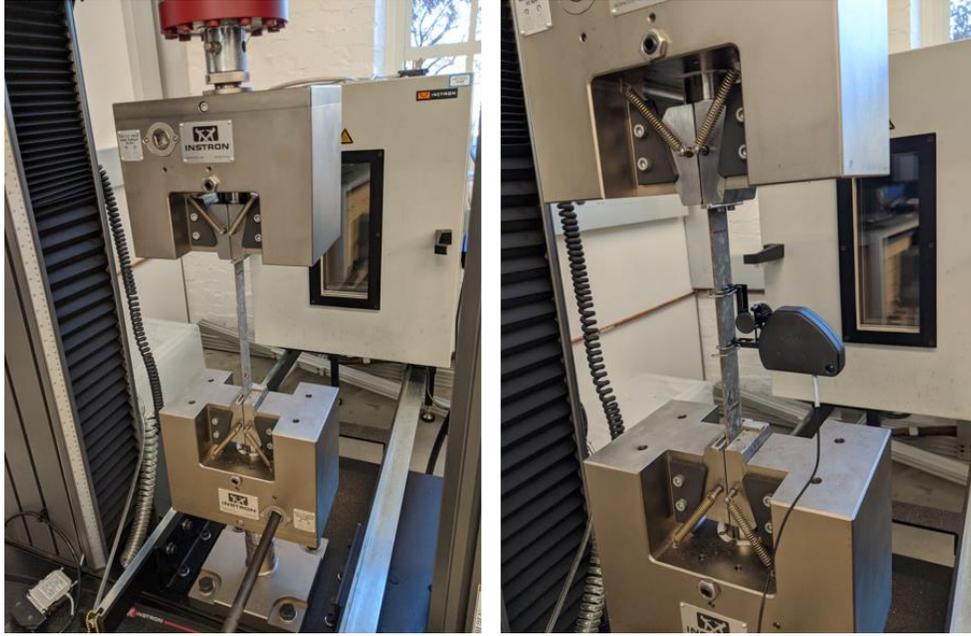
*Figure 5-1. Strap testing setup prior to loading*

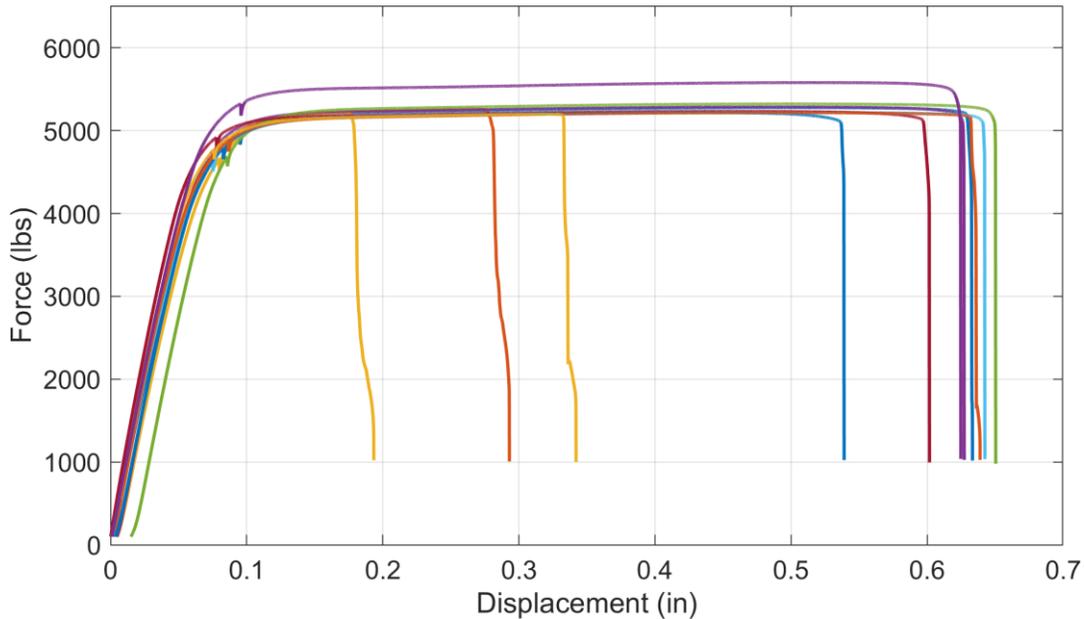
*Figure 5-3. Force vs. displacement for a single strap grouping*

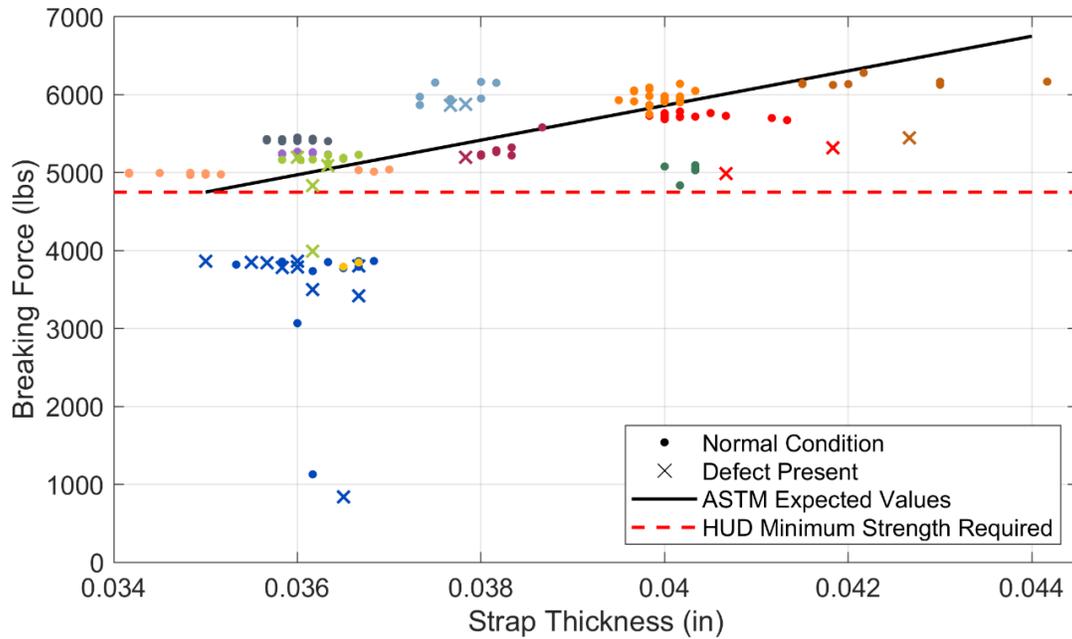
This data was collected for each of the 12 groupings and analyzed. The most straightforward variables extracted for each strap were the thickness and the maximum tensile force, or the breaking force. These two variables are compared in Figure 5-5, along with the expected values from ASTM D3953-15. The different colors simply represent the groups of straps from separate homes, while the “x” markers represent straps that had defects. These defects included corrosion and significant kinks or bends in each strap that could potentially affect the structural integrity of the strap, and examples of them can be seen in Figure 5-4. The ASTM expected breaking strength values are listed in a table corresponding to specific strap thicknesses, so interpolation was used to expand it to all applicable thickness values. However, the HUD

Figure 5-5. Comparison of expected strap breaking force against actual breaking force

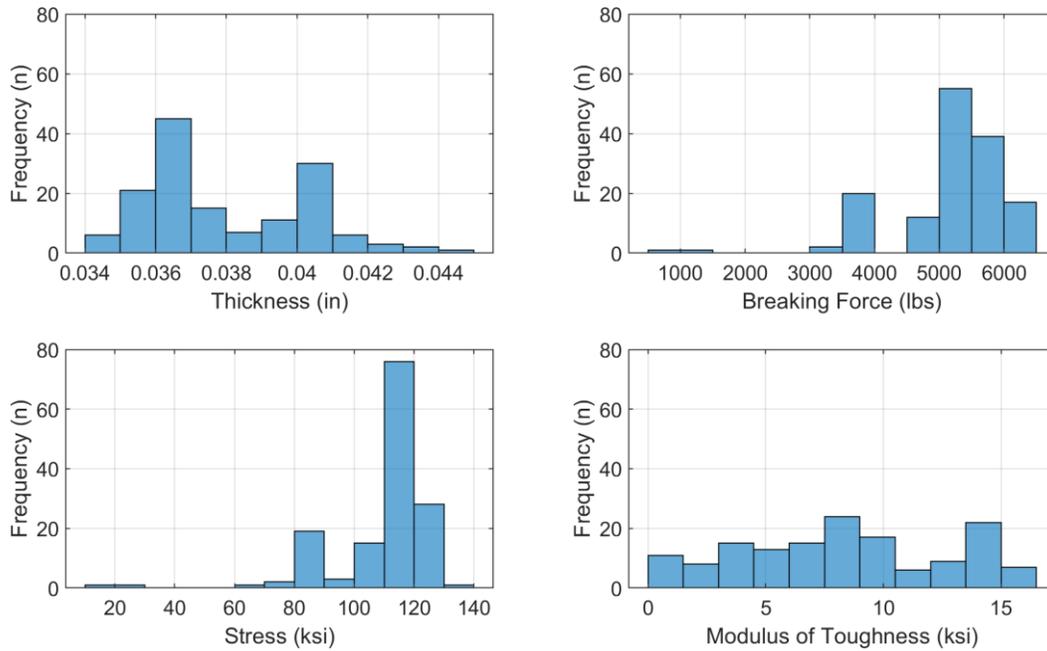
The frequency distribution for each factor is shown in Figure 5-6, combining data from all homes together. The highest frequency of thickness is concentrated just above the minimum HUD requirement of 0.035 in., which is expected. Also, aside from the two strap groupings that tested well below the 4,725 lb requirement, the majority of straps met or surpassed the required breaking strength. The cause of poor breaking strength for the weak strap groups is unknown, as every single strap failed below 4,000 lbs, regardless of defects. The lack of a more significant sample size prohibits determining if the weak groups are actually outliers, or if they simply appear to be so because of incomplete data. Regardless, the results confirm the possibility of homes anchored with straps of inadequate strength.

The maximum stress is dependent upon the breaking strength, so it also shows a small peak to the left of the main concentration of values. However, the modulus of toughness shows a very

wide distribution of values, ranging from slightly greater than 0 to approximately 15 kips per square inch (ksi). This illustrates a high degree of variability, indicating that it may change with time or other factors.

Figure 5-6. Histograms of all tested data divided into thickness, breaking force, stress, and MOT

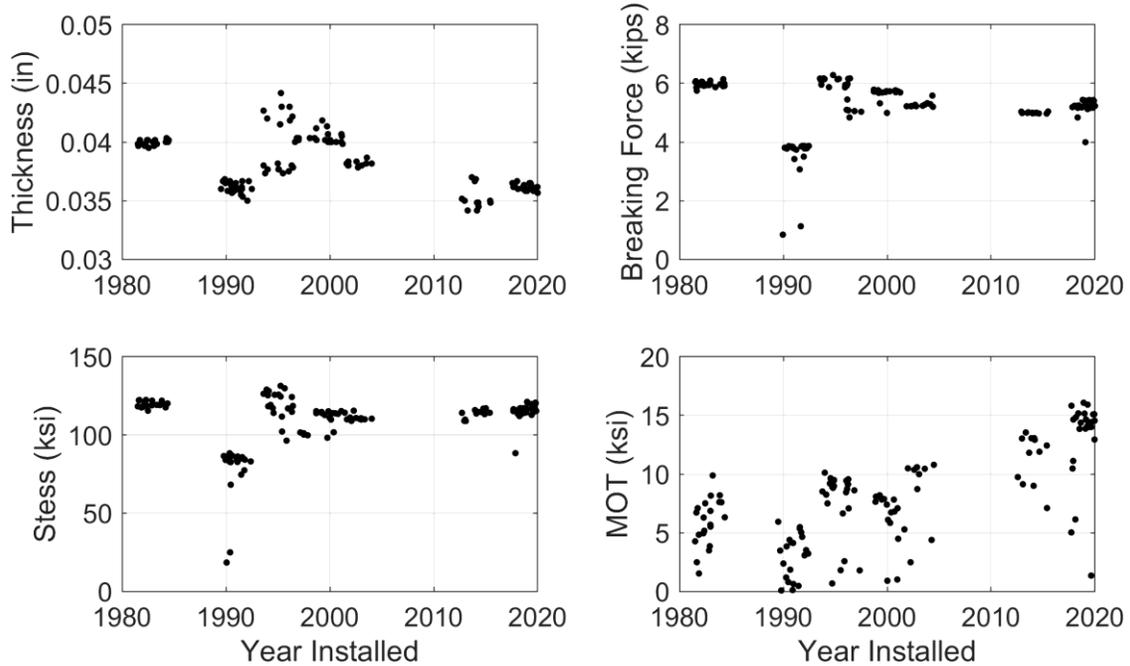
These same four main variables were also plotted against the age and are shown in Figure 5-7. The hypothesis was that the strength of each strap would be negatively correlated with age due to corrosion and wear, but the results indicate otherwise. The stress, which represents a breaking strength normalized by thickness, remains very consistent over time, aside from the weaker grouping previously discussed. However, the modulus of toughness does indeed appear to decrease over time, which indicates that tie-down straps may lose a portion of their plasticity over

time. Combining these two observations implies that straps typically become very brittle over time due to wear and/or corrosion, but they do not lose their ultimate strength capacity.

Figure 5-7. Thickness, breaking force, stress, and MOT compared against estimated age

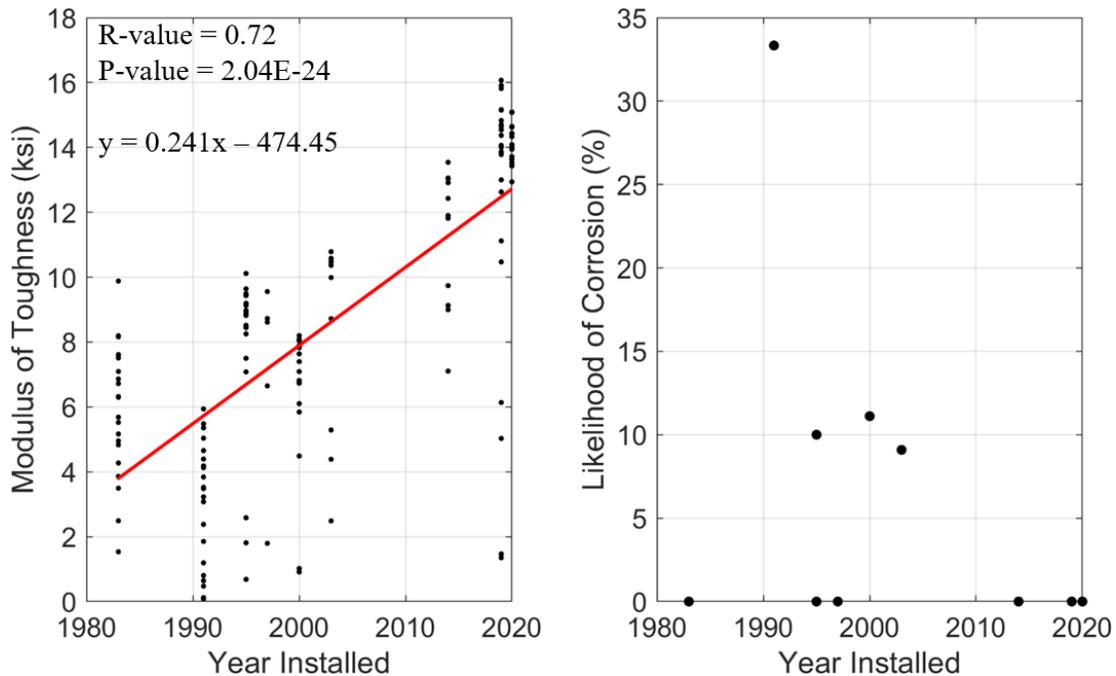
A correlation test was performed on the data to determine the significance of the relationship between MOT and age. Using linear regression, an R-value of 0.72 was calculated. Next, using a T-distribution test, the T-statistic value was calculated to be 12.39. This, along with the degrees of freedom for the sample, was used to calculate the P-value, which was  $< 0.05$ . This insinuates there is a significant correlation between MOT and age, and the best-fit line is shown in Figure 5-8 (left). Additionally, the equation for the line is listed in the top left of the plot, showing a slope value of 0.241 with a 95% confidence interval ranging from 0.203 to 0.279. Essentially, the modulus of toughness decreases from its original value at a rate of approximately 0.241 ksi

every year that it is in use. This reinforces the idea that anchorage straps should be replaced as they age due to their decrease in plastic capacity.

One may assume that the decrease in plasticity is directly tied to corrosion over time, but Figure 5-8 (right) seems to dispute this. The plot simply shows the likelihood of corrosion existing on any given strap of a specific age and is calculated by dividing the number of straps with corrosion by the total number of straps in each group. While the likelihood of corrosion does increase over time, older strap groupings with no corrosion still do exhibit lower MOT values. This implies that the overall decrease in MOT over time is consistent regardless of the presence of corrosion.

Figure 5-8. Statistical test of correlation between MOT and age (left), and the influence of strap corrosion on that correlation (right)

Although heavy corrosion is not the only factor causing this decrease, it certainly exacerbates the issue. As evident from Figure 5-8 (right), four of the strap groupings exhibited significant corrosion, while two other groupings had straps with other defects present. The direct effects of these defects are shown in Table 5-3. Surprisingly, the ultimate breaking force is not greatly affected by the defects, although 3 of the 6 groupings experienced a 7.5% or greater loss of strength. However, the MOT is extremely sensitive to the presence of defects. Of the 6 strap groupings, 4 of them lost over 64% of their MOT capacity, with 2 of those over 85%. The effects of corrosion can also be seen in the fracture mechanism of the straps, shown in Figure 5-9. The top two straps in the picture had no corrosion and fractured at an approximate 45 degree angle after elongating, similar to the majority of the straps. However, the two straps with corrosion fractured jaggedly across the width, indicating a non-uniform cross-section. This was a common issue with all of the heavily corroded straps.

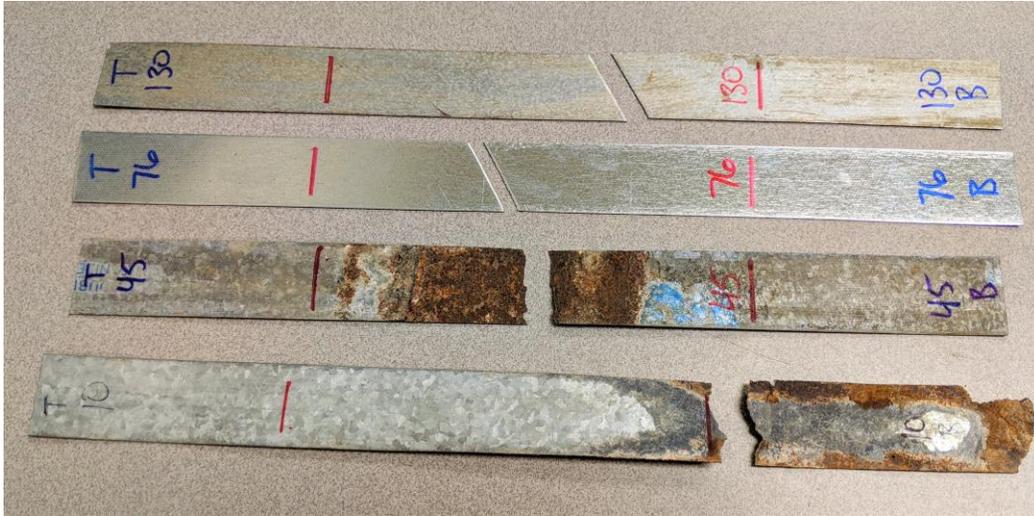
*Figure 5-9. Comparison of strap failure between no-defects and corrosion*

A strap's loss of plasticity over time is a significant issue, as the modulus of toughness represents the total amount of energy that can be dissipated prior to fracture. As seen in Figure 5-9, a strap continues to elongate once it reaches its ultimate strength in order to continue dissipating energy. Although manufactured home anchorage systems are designed to equally distribute the loading among the straps, the actual results are never perfect. Under design-level loads, a structure may distribute a higher force into one strap than the rest, causing that strap to exceed its capacity. A strap with sufficient plasticity would begin to deflect, causing the load to be partially redistributed into other straps. This at least enables the structure to resist the loading for a longer amount of time and may ultimately prevent the strap from completely fracturing. However, if the strap was very brittle, it would fracture shortly after reaching its ultimate capacity. The load originally resisted by the fractured strap would be redistributed to other straps, overloading and fracturing them as well. Even if the structure failed in both scenarios, the added time required to cause failure in the plastic-strap case could possibly prevent injury or fatality for the residents.

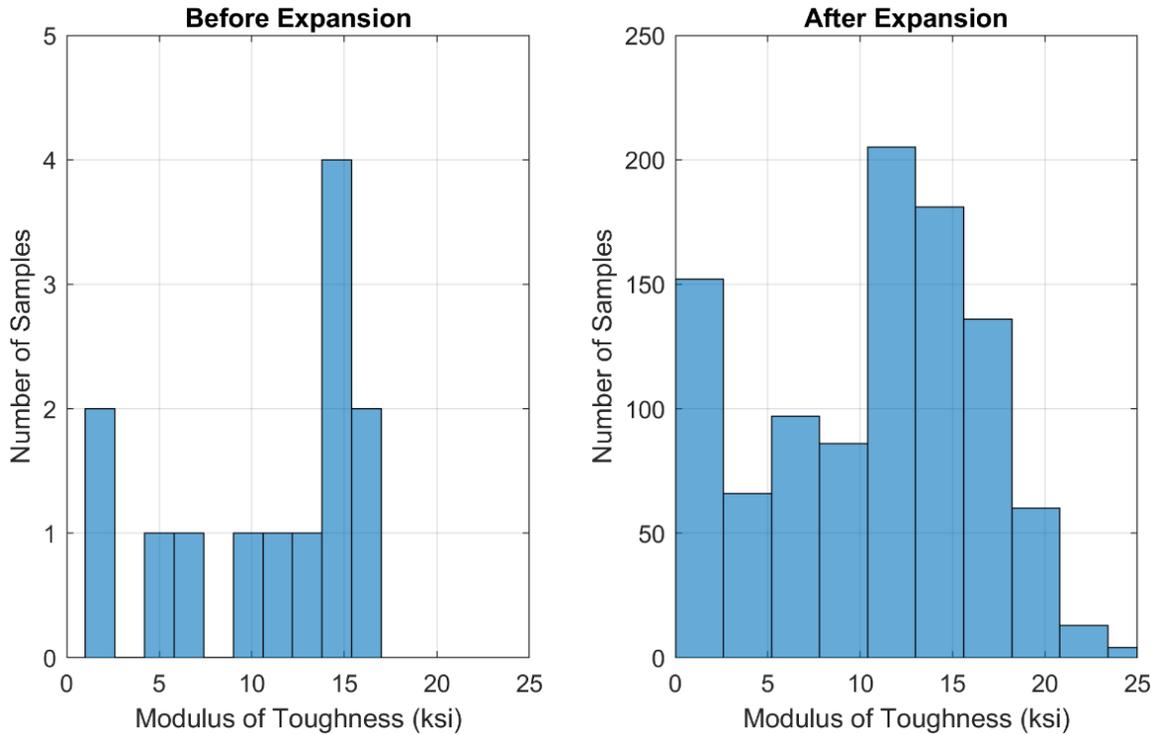
where  $\sigma$  is the standard deviation of the sample. Next, a Monte Carlo simulation was performed to increase the sample size to 1,000 points for each strap grouping by sampling from the kernel PDF. Figure 5-10 shows the before and after results of this expansion for a single strap grouping and property. One important note is that the new straps were not included in this analysis, as they were never exposed to environmental conditions or pre-loading of any kind. Also, the strap group with only two data points in it was excluded as well due to the lack of sufficient data to fit even a kernel density function. Overall, 9 strap groups were expanded to 1,000 data points each, totaling 9,000 data points to fit a distribution to. The primary reason for expanding the data points to 1,000 was

Figure 5-10. Results from Monte Carlo expansion for one strap grouping

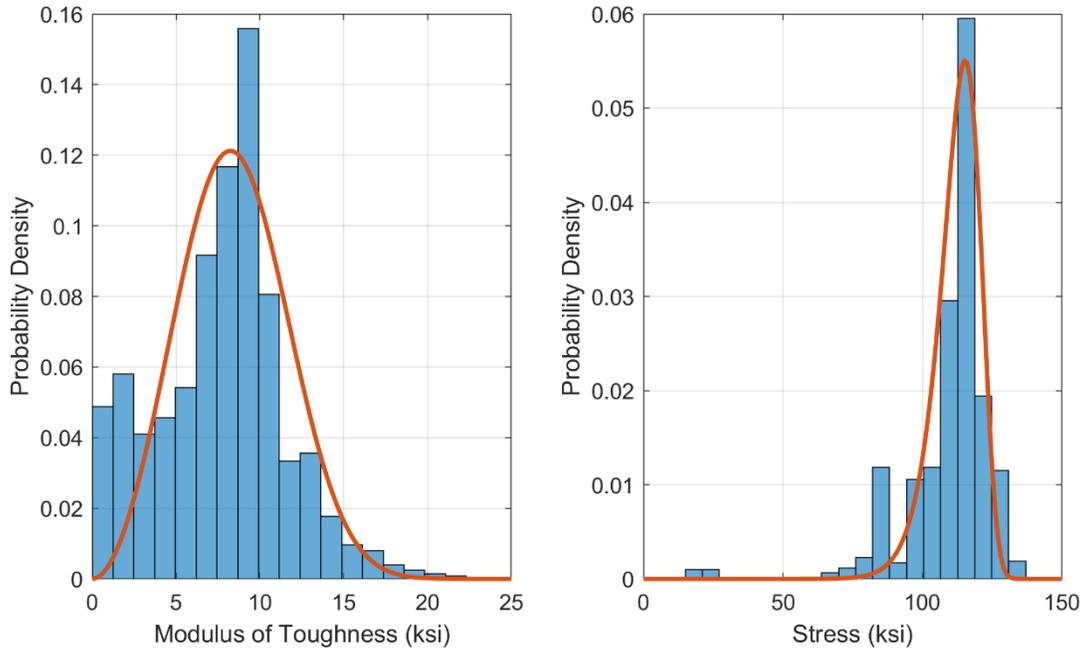
Figure 5-11. Weibull best-fit distribution for MOT (left) and stress (right)

These distributions can be used to calculate risk, such as probabilities of anchorage failure at given wind speeds. For example, assuming that a strap thickness of 0.036 in. is used and design level wind speeds exert 4,725 lbs of force into the straps, the total stress in the strap would be 105 ksi. Using the stress distribution curve, the probability of the stress exceeding the maximum stress capacity of the strap is approximately 17%.

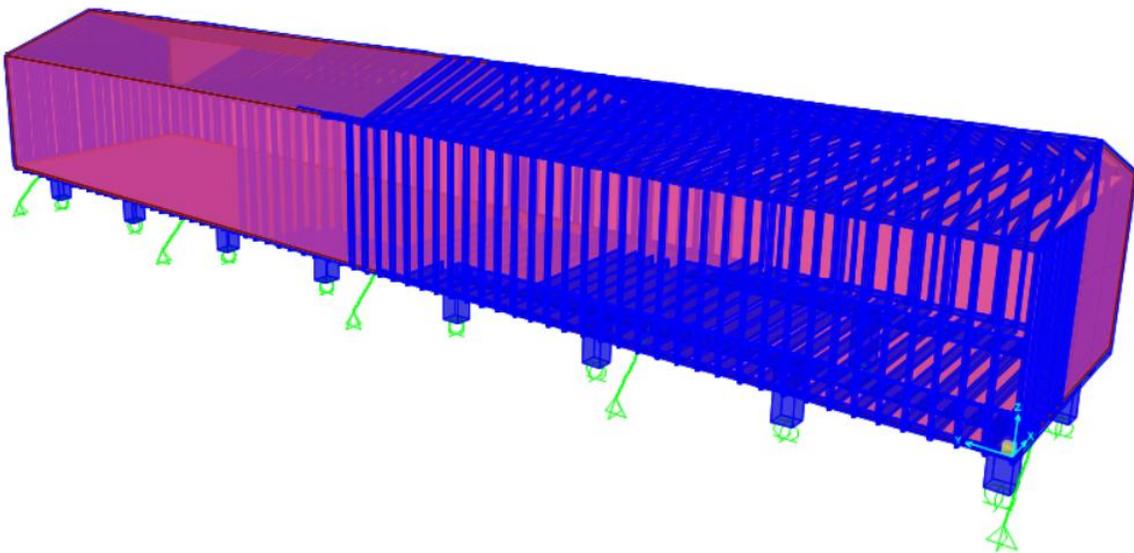
orthotropic material properties were taken into effect. The last element was the anchorage straps, which were modeled as cables and could only resist tension. The top ends attached to the I-beam chassis, while the bottom ends were modeled as a pin supports at the same level as the pier bottoms. The location of the ground attachment point for each strap change based on the strap angle specified and the spacing of the I-beams. An important note is that the straps were only modeled on the windward side of the structure, as leeward straps would not be engaged in tension until after failure, specifically, complete sliding or lofting of the home, or unless uplift forces were enough to overcome the weight of the home. In all test cases, the weight of the structure was greater than the uplift forces on the roof, so no leeward-side straps were needed. One of the models tested can be seen in Figure 6-1, with the frame elements extruded to show the relative sizes. The area elements (red) actually cover the entire exterior but are only partially shown to enable a view of the frame elements (blue).

Figure 6-1. Typical layout of a manufactured home modeled in SAP2000

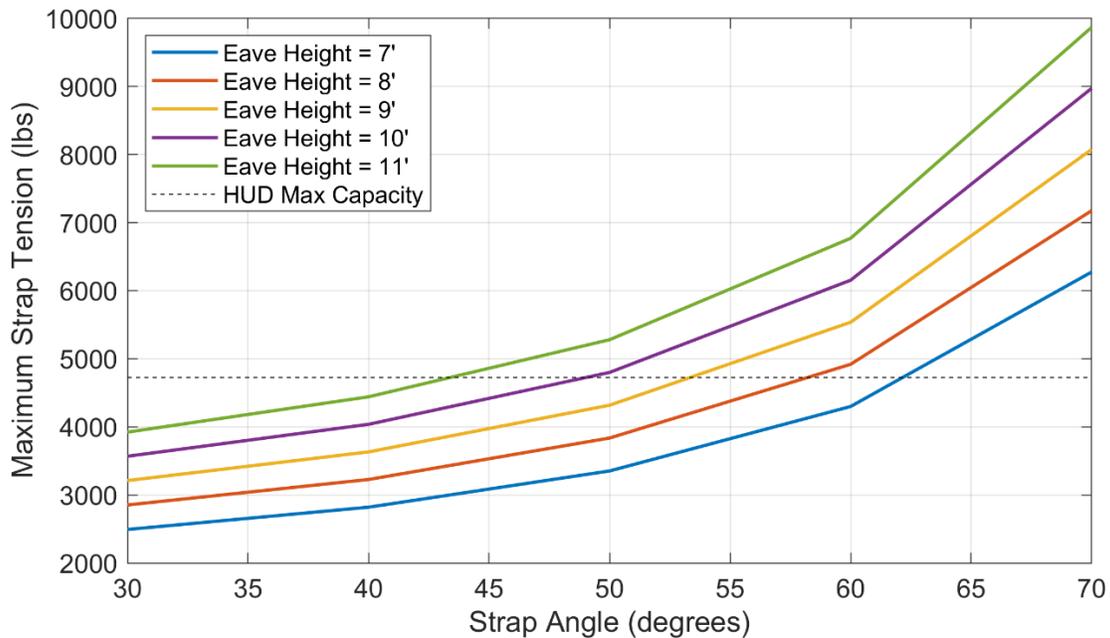
However, these values from the MHCSS requirements are based on specific assumptions about the eave heights and strap angles. The code assumes an eave height of 7.5 ft, but modern manufactured homes may at times be taller. These homes are designed to be transported already constructed, so the maximum height is limited by interstate overpass clearance, which is approximately 14 ft. The bottom of the homes are typically transported at a height of 1.5-2 ft off of the ground, and many actually have collapsible roof structures to allow for taller homes [61]. Therefore, eave height values were tested up to 11 ft, a large but possible height. Also, the MHCSS requirements allow for a maximum strap angle of 60 degrees, so additional strap angles were tested. Strap angles calculated from the code requirements are between 30-50 degrees, with an average of 41 degrees. However, using the strap data shown in Figure 4-26, the actual strap angles seen in the field were typically between 35-65 degrees, with an average angle of 48 degrees. To test these additional variables, a manufactured home with a length of 68 ft and width of 14 ft was chosen. A pier height of 33 in. was used, with the I-beams spaced at 99.5 in. and 5 straps along the windward wall. These dimensions matched a previously tested case, which had a maximum strap tensile force of 3,269.4 lbs. However, as seen in Figure 6-2, varying the strap angle and increasing the eave height significantly affected the maximum tensile force experienced. The dotted line in the figure represents a value of 4,725 lbs, which is the ultimate required capacity of the straps. A typical strap angle of 50 degrees, along with an eave height of 10 ft, increases the tensile forces in the strap to a value greater than their prescribed capacity. According to the MHCSS, this specific

case would require the anchorage system to be designed by a registered engineer or architect, and rightfully so. Overall, Figure 6-2 illustrates the significance of both the eave height and strap angle in regards to the tensile forces in the straps, and these factors should not be overlooked in the design and installation of the anchorage system.

Figure 6-2. Effects of varying eave height and strap angle on max strap tension
